Expandable Airlock Experiment (D021)

QUARTERLY PROGRESS REPORT No. 9, 10, 11

GOODYEAR AEROSPACE CORPORATION

Subject: D-21 Airlock Experiment Vacuum Chamber Deployment Failure Analysis Report

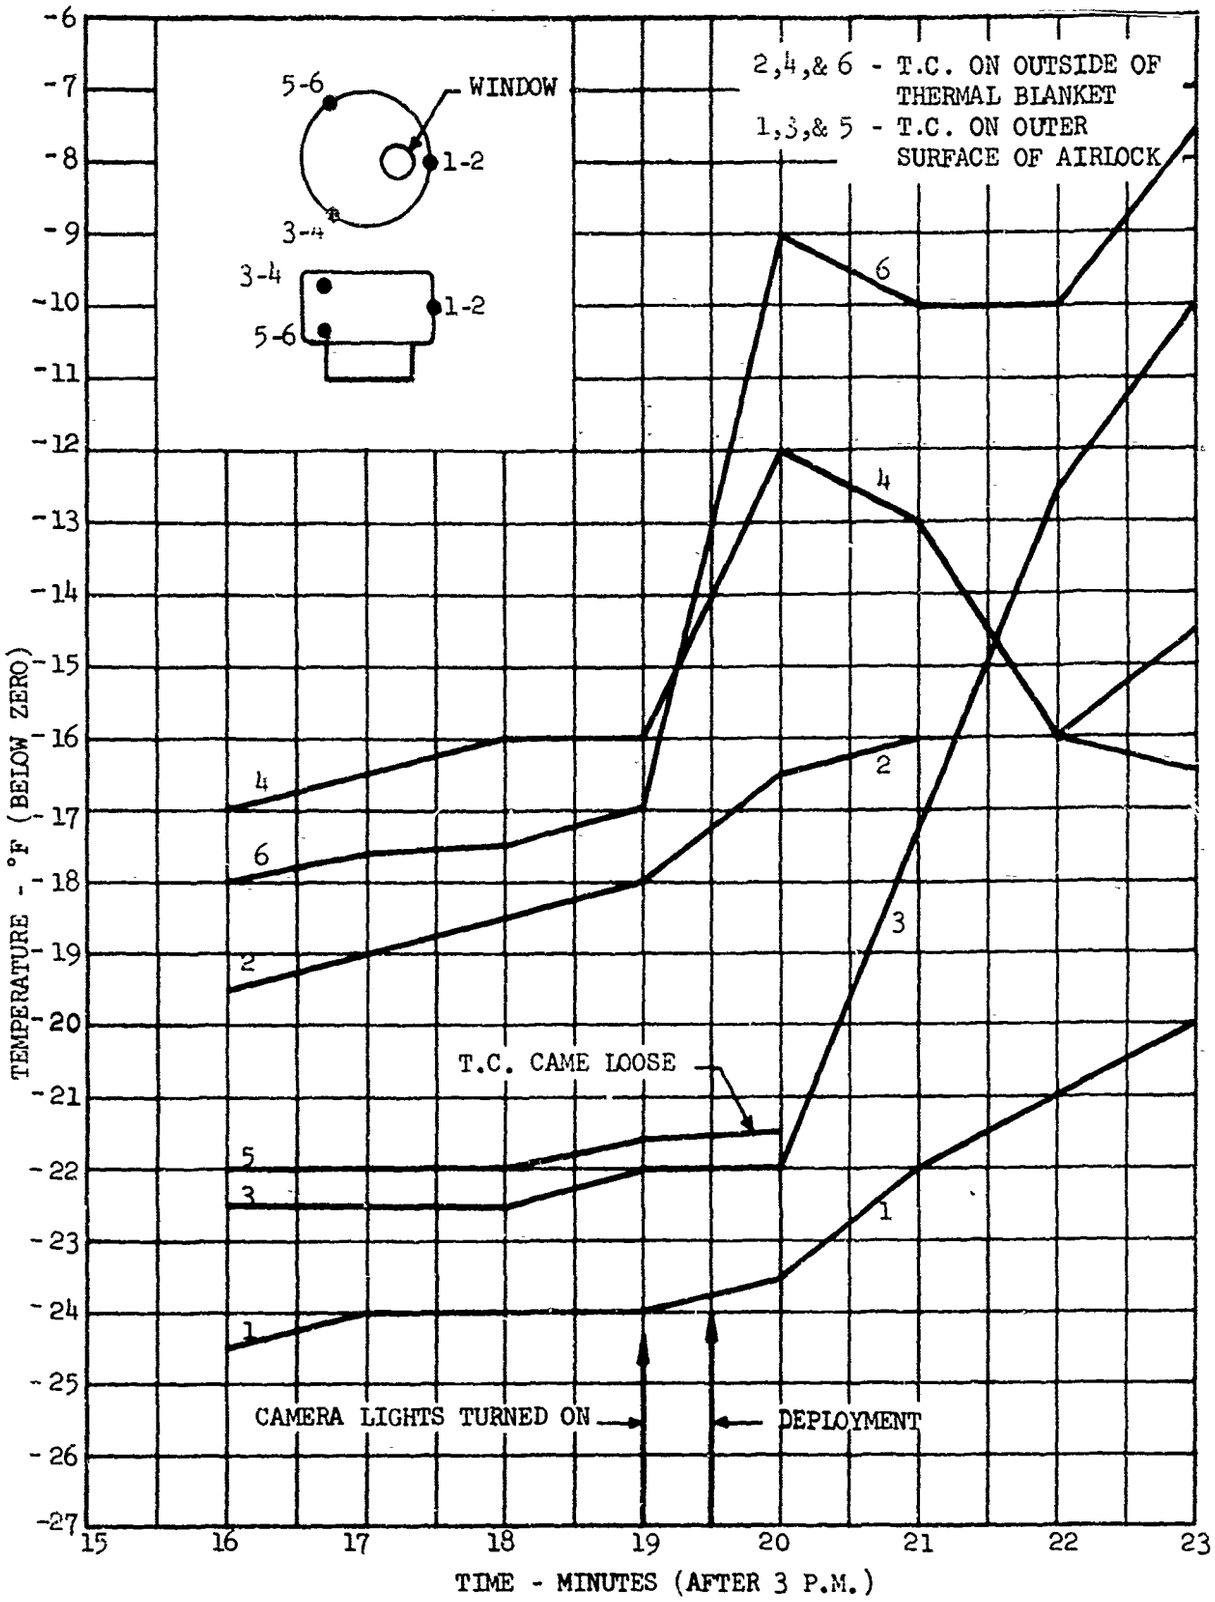
Figure 6. D-21 Airlock Low Temperature Vacuum Chamber Deployment
