NAVY EXPERIMENTAL DIVING UNIT
WASHINGTON NAVY YARD
WASHINGTON, D.C. 20390

(6) EVALUATION REPORT 6-56

FLATUS II SEMI-CLOSED CIRCUIT
MIXED GAS SCUBA.

PROJECT NS186-202 SUBTASK 2 TEST 8

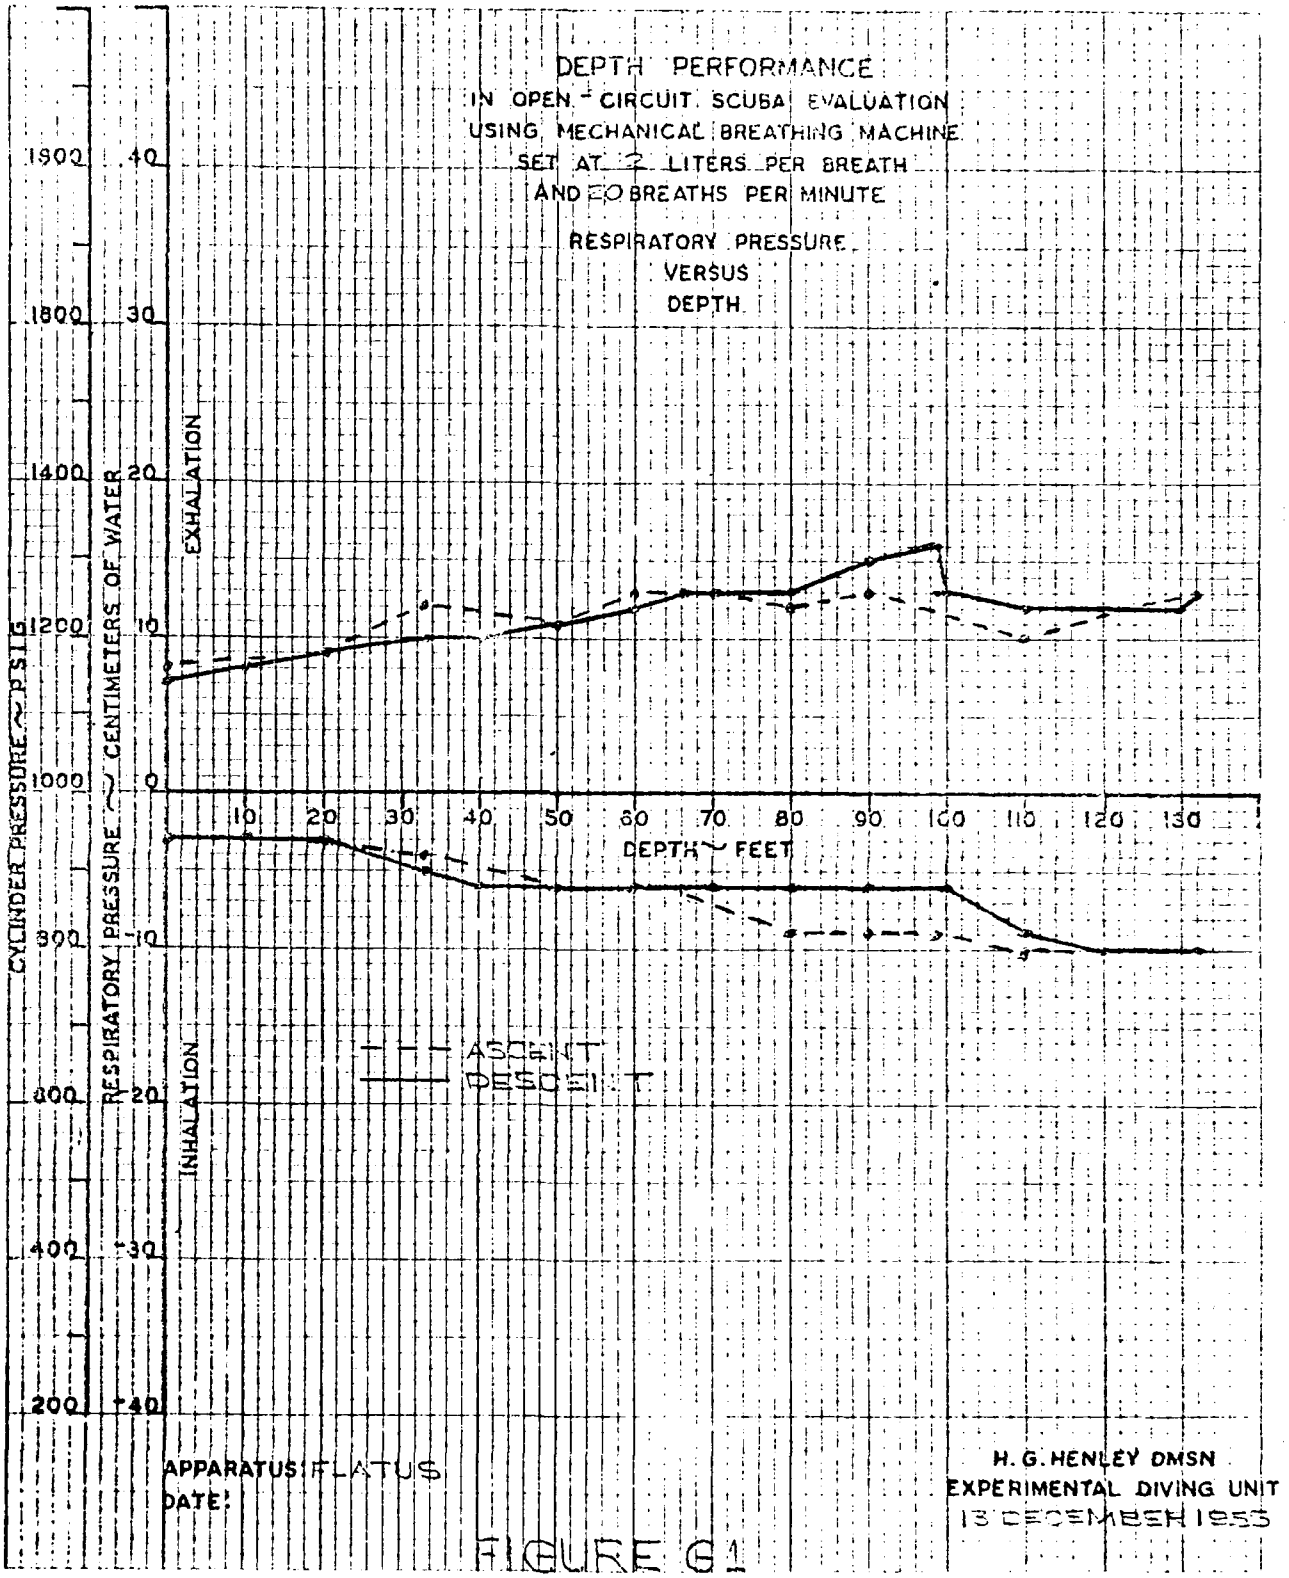
FIGURE G1

Figure G-1 shows breathing resistance from surface to 132 feet and return.

The maximum exhalation resistance was reached during descent at 98 feet. The maximum inhalation resistance was at 110 to 132 feet.

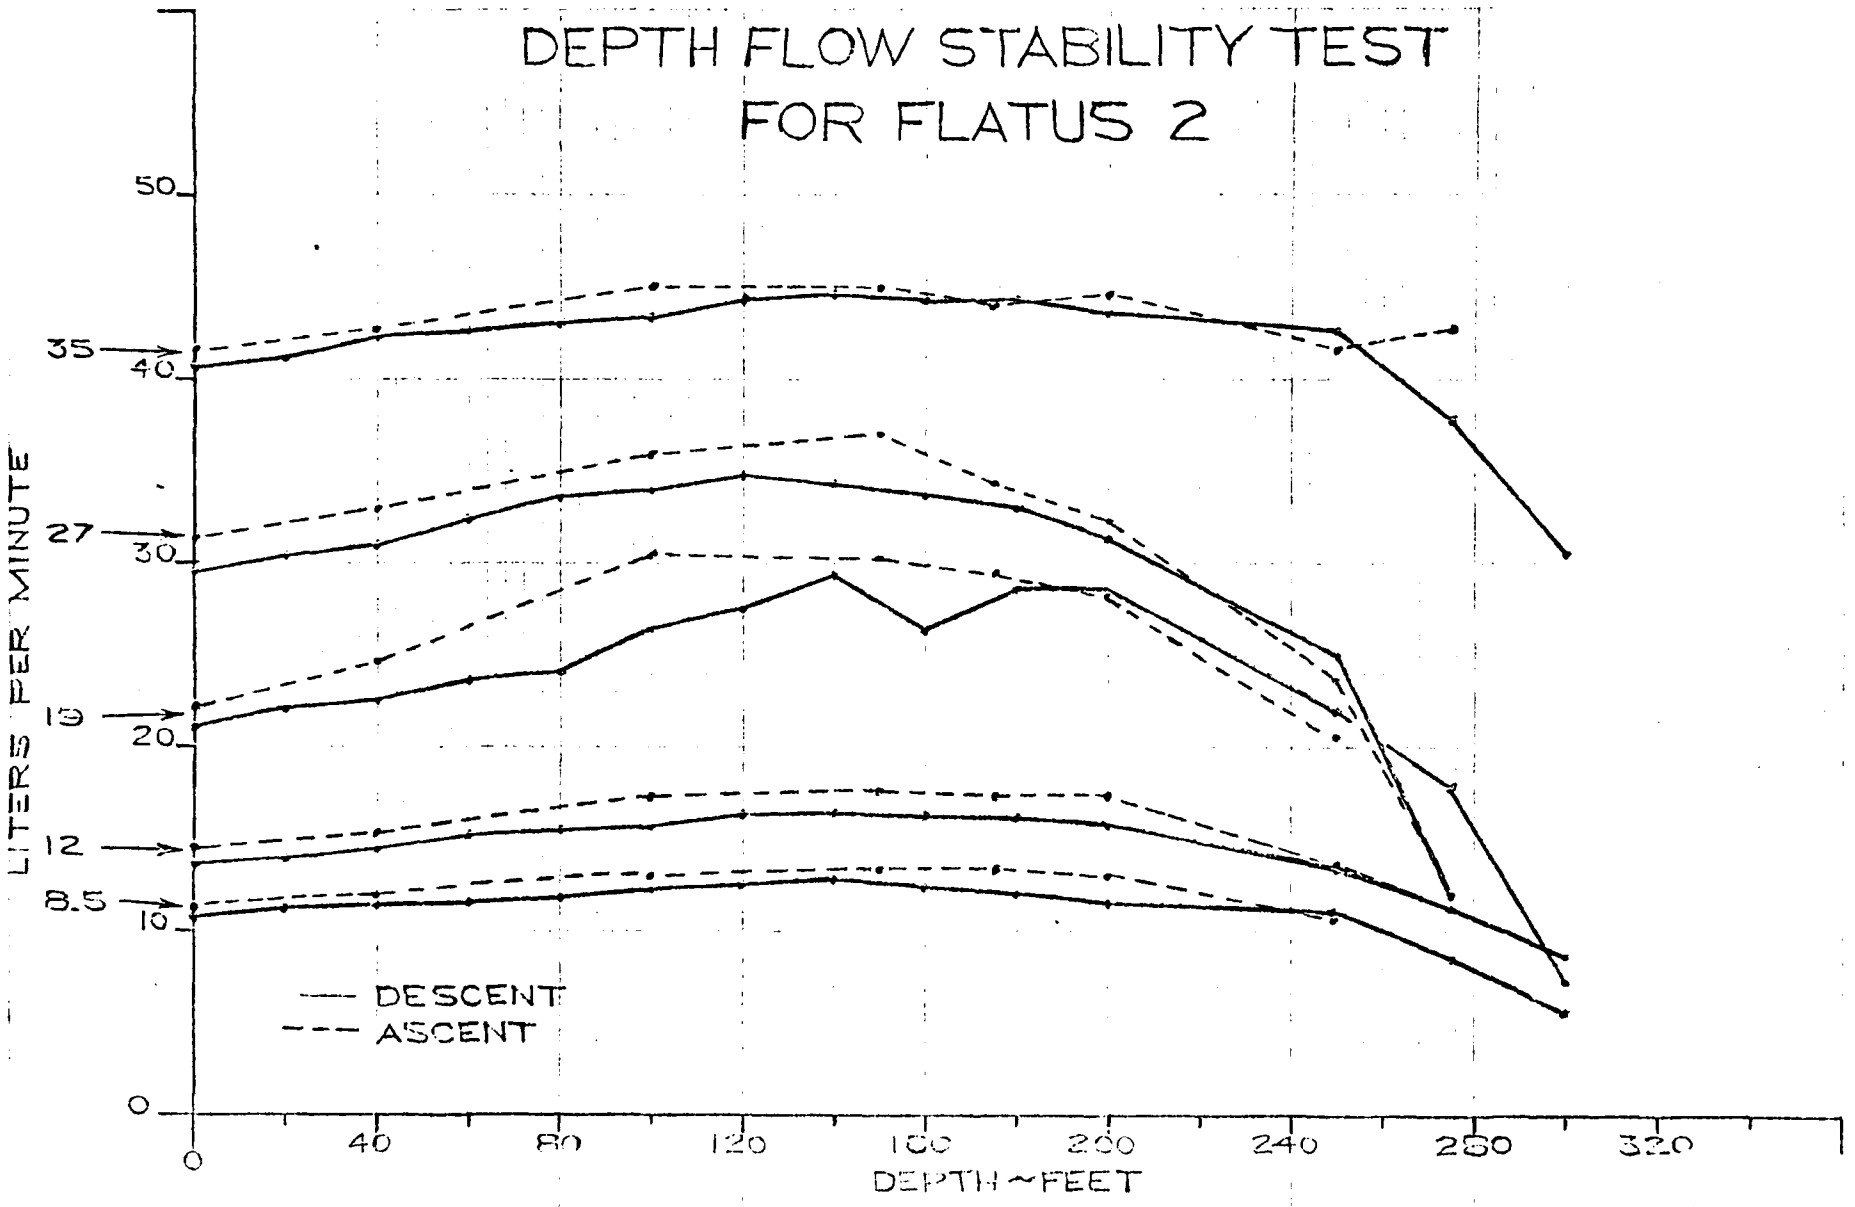
FIGURE 62

Figure G-2 shows depth stability test from surface to 200 feet and return to the surface for the 8.5, 12, 19, 27, and 35 LPM jet.

5.2.1 The flow test was performed with orifices ranging in size from one calculated to deliver 8.5 liters per minute to one calculated to deliver 35 liters per minute at the surface with 80 pounds per square inch supply pressure. The regulator pressure was set at 80 pounds per square inch before the test was started. However during the time between each run the regulator varied and the runs were made with initial regulator pressures between 83 and 95 pounds per square inch.

5.2.2 The semi-compensated regulator is satisfactory in its consistency of operation and reaction to depth pressure. The resultant flow of gas is sufficiently near a constant mass flow down to 250 feet.
