DETAILED EVALUATION REPORT

MISSILE N-23

TITAN II IGS CATEGORY II MAINTENANCE, LOGISTICS, RELIABILITY AND READINESS

**INERTIAL GUIDANCE SYSTEM
WEAPON SYSTEM 107A-2.**

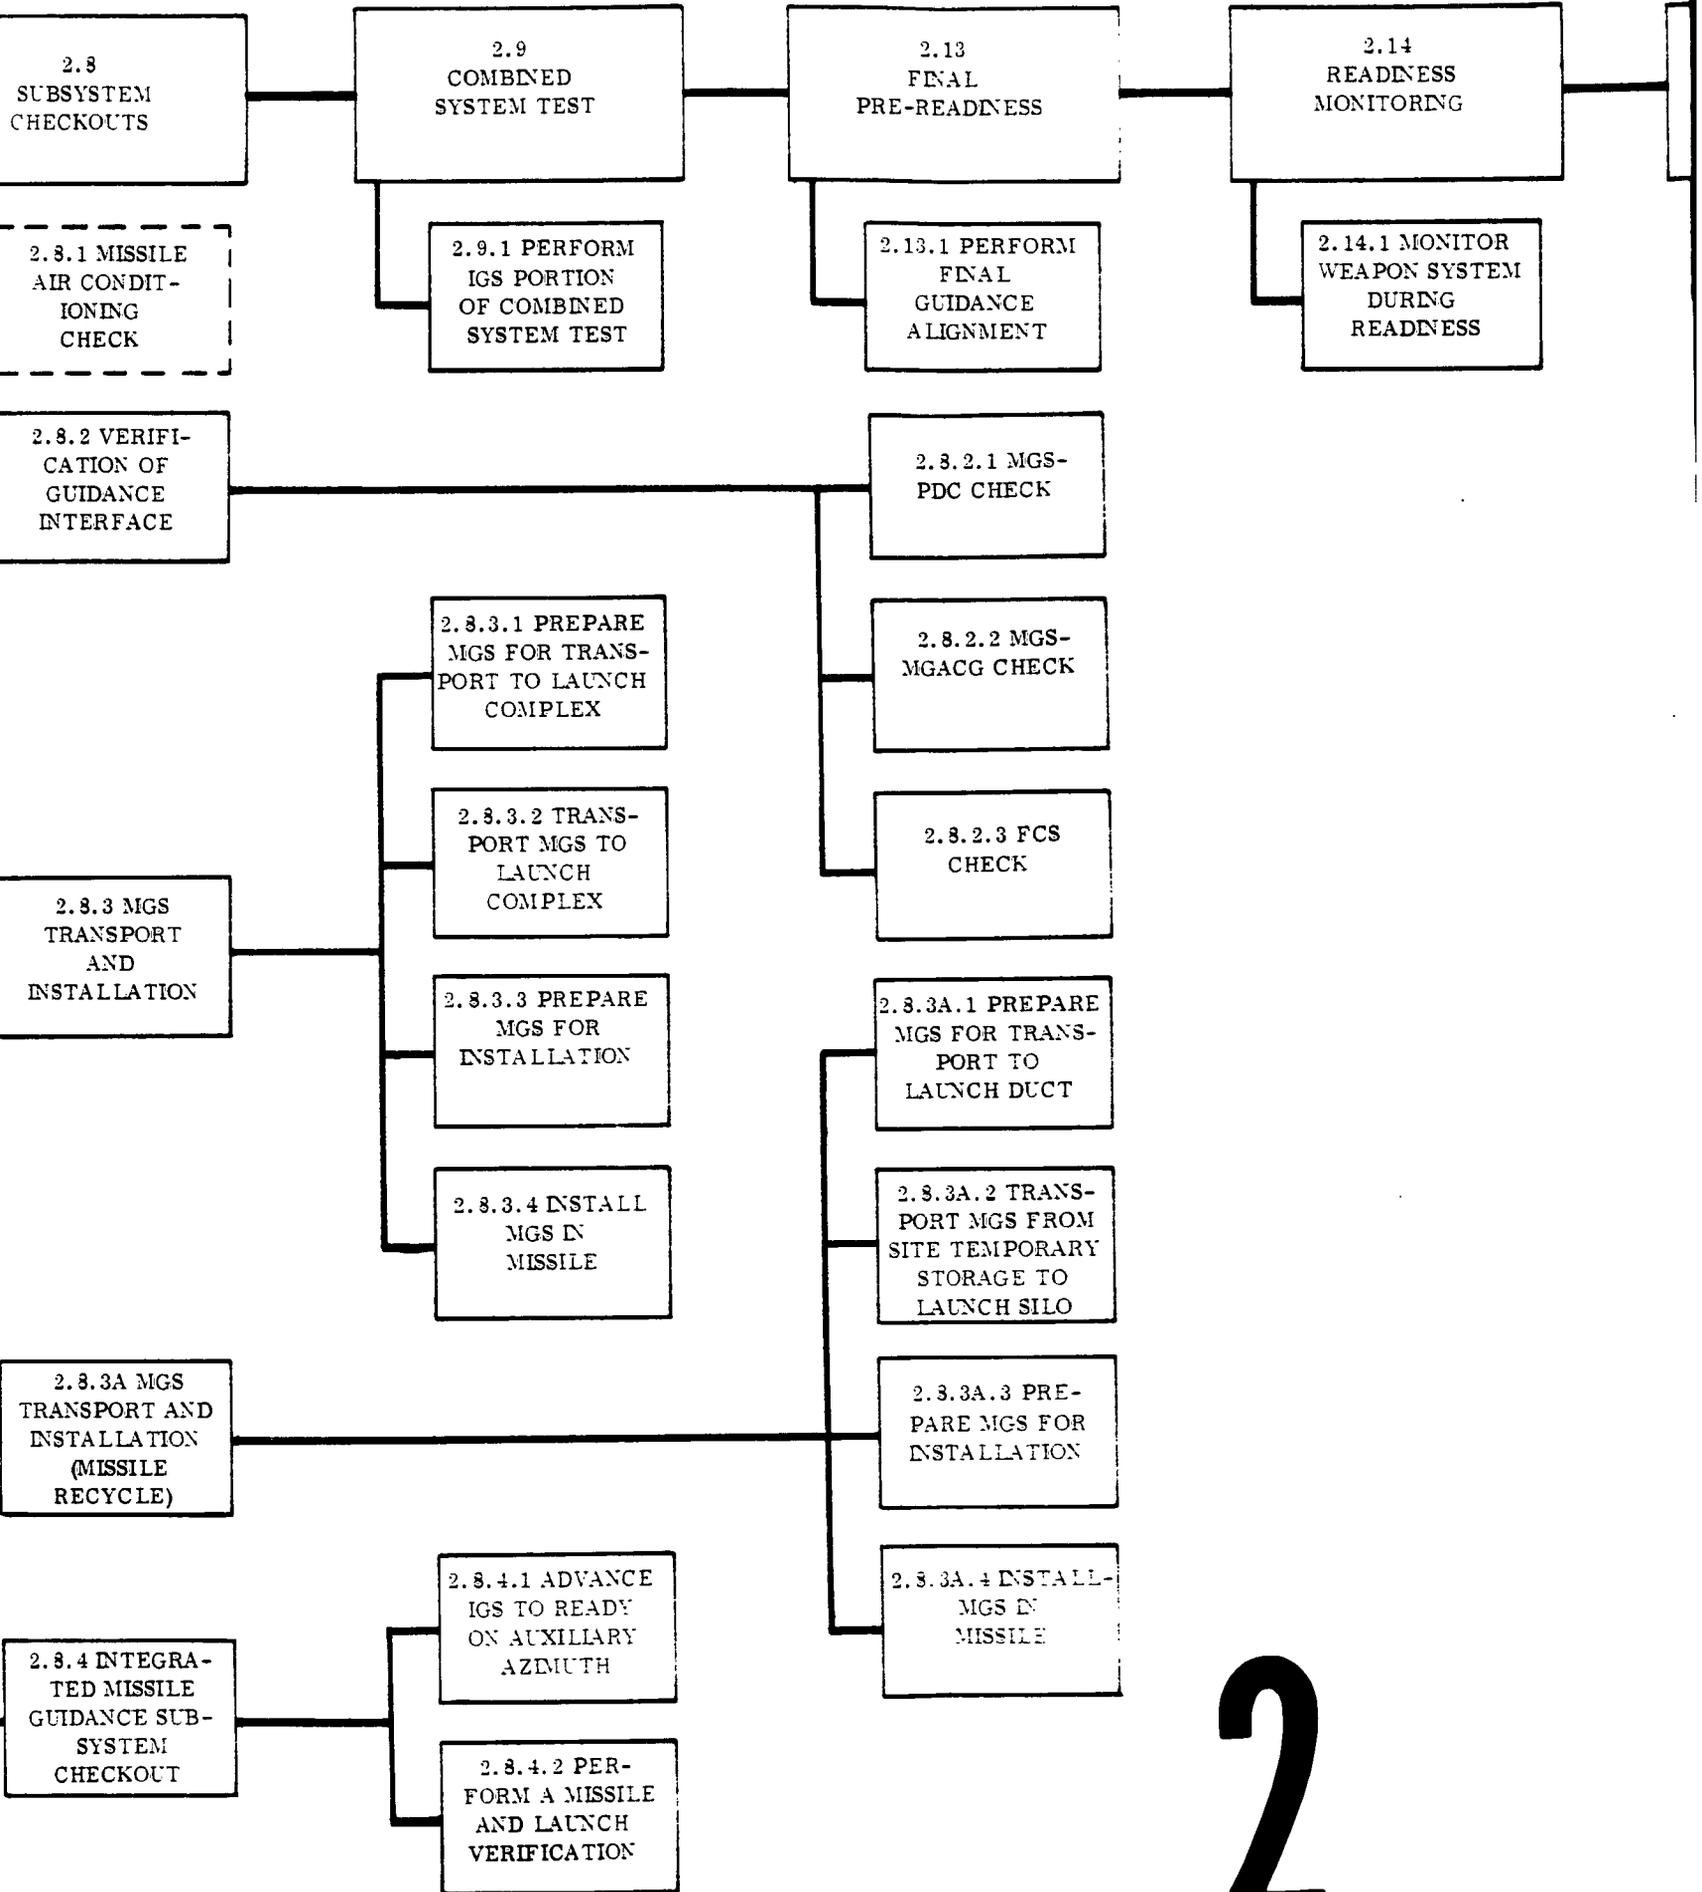
FIGURE 1

**TITAN II INERTIAL GUIDANCE SYSTEM
RECEIPT TO LAUNCH CYCLE
CR 62-2 (VOLUME I) REVISION 1**

This report is organized to present a general summary of guidance activities related to the receipt-to-launch of missile N-23. ~~following this section~~ The general summary is followed by the specific maintenance, logistics, reliability and readiness test results for N-23 guidance activities related to the CR 62-2 (Volume III) objectives. This latter section will present the specific guidance system maintenance, logistics, reliability and readiness problems uncovered during the receipt-to-launch sequence and ^a discussion of the impact of these problems on the sequence and on the accomplishment of program objectives. Guidance and guidance related activities involved in the Titan II receipt to launch sequence are presented diagrammatically in Figure 1 at the end of this section. These activities are titled and numbered as they appear in CR 62-2 (Volume I) Revision 1 "Category II Operational Readiness Verification Test Program".
