NSWC TR 84-66

CHEMICAL AND PHOTOGRAPHIC EVALUATION OF RIGID EXPLOSIVE TRANSFER LINES

BY ELEONORE G. KAYSER

MAY 1984

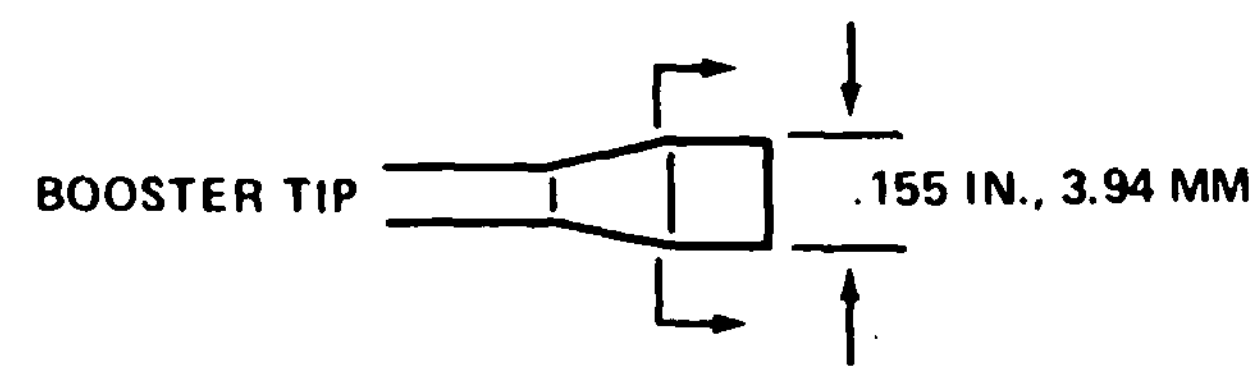
WT. % HNS +HNBiB = 99.1%
4 YEARS SERVICE AND
5.5 YEARS TOTAL AGE

WT. % HNS + HNBiB = 99.7%
4 YEARS SERVICE AND
8.5 YEARS TOTAL AGE

AV. WT. % HNS + HNBiB = 78.4%
4 YEARS SERVICE,
5.5 YEARS TOTAL AGE,
+450° F FOR 50 HOURS

FIGURE 20. PHOTOGRAPHIC ANALYSES OF F-111 BOOSTER TIP EXPLOSIVE
