AEDC-TDR-64-49

**OBSERVATIONS OF HYPERVELOCITY IMPACT
OF TRANSPARENT PLASTIC TARGETS**

von Kármán Gas Dynamics Facility
ARO, Inc.

TECHNICAL DOCUMENTARY REPORT NO. AEDC-TDR-64-49

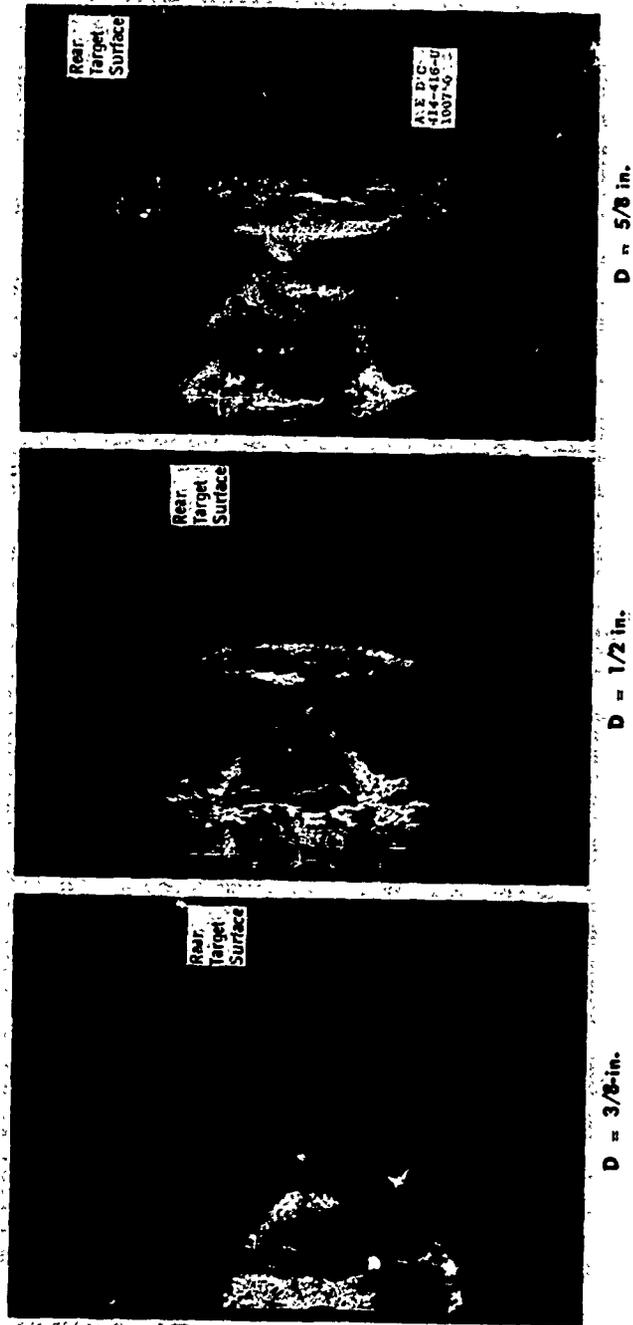
Fig. 3 Fractures Produced by Exploding Blasting Caps

Holes of 0.281-in. diameter were drilled in the faces of large 2-in.-thick Lucite blocks. Aluminum hemispheres of 0.25-in. diameter (rivet heads) were placed in each hole. Number 8 Hercules Powder Co. Blasting Caps were inserted in each hole and fired.

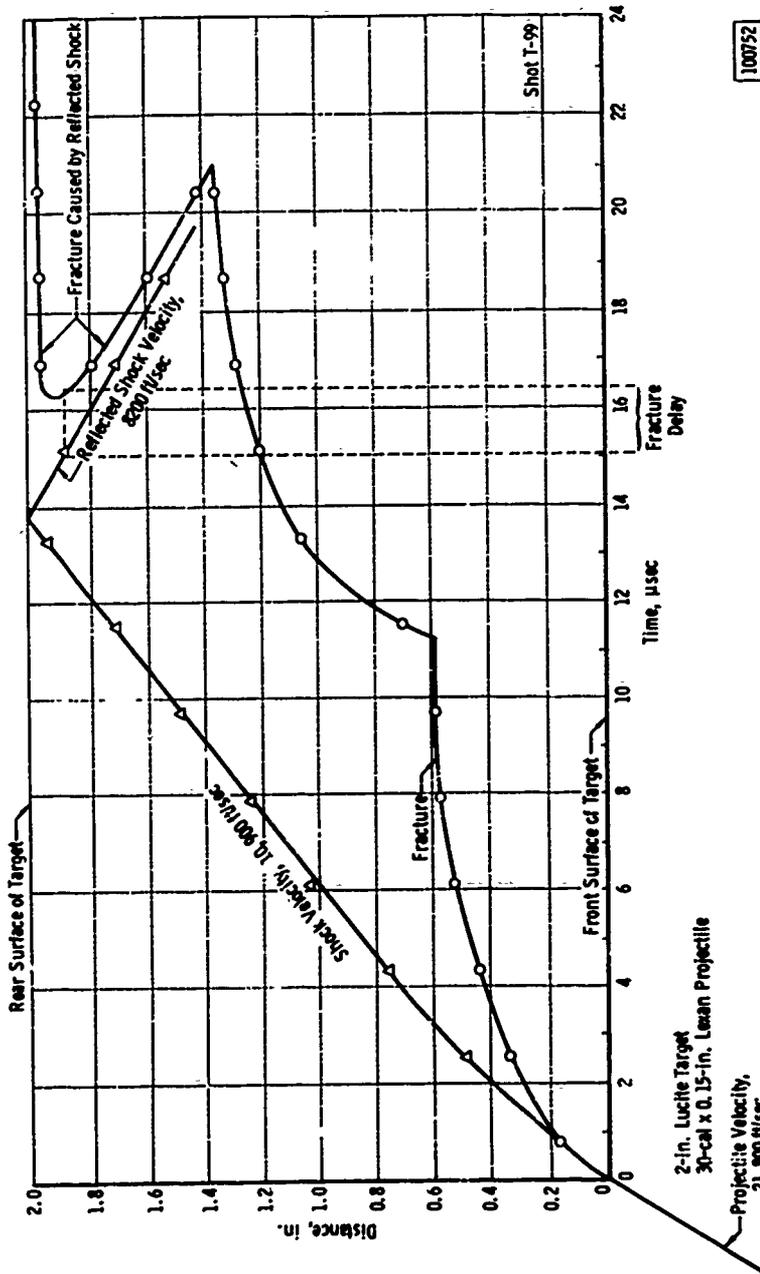
Fig. 5 Stress Waves and Fracture (199)

2-in. Lucite Target
 30-cal x 0.15-in. Leman Projectile
 Projectile Velocity,
 21, 900 ft/sec

Several interesting observations may be made from Fig. 17. When compared with Fig. 5, it is seen that the two are very similar during the early stages. The shock detaches itself after about 1μ sec and decays into an elastic wave at a distance of about 0.75 in. within the target after about 5μ sec. The initial fracture rate is about the same in both solid and laminated targets; however, the fracture does not cross the first lamination, and the needle-like radial fractures which are so prominent in the solid target are confined to the first sheet of the laminated target.

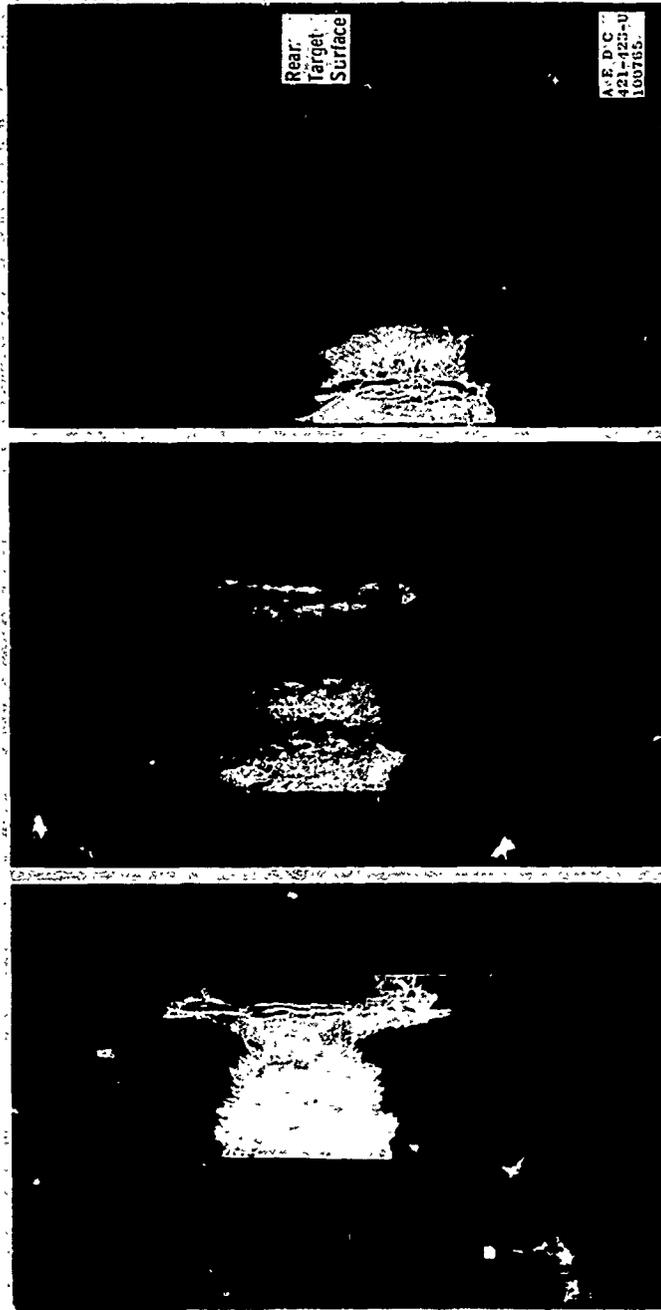
Fig. 18 Effect of Target Thickness

T = 1.50 in.

T = 1.25 in.

Fractures Produced by Exploding E-94 du Pent
Blasting Caps Inserted in 0.25- x 0.25-in.
Cylindrical Holes in Face of Lucite Blocks

Photographs of targets which have been fractured by the firing of blasting caps are shown in Fig. 18. These are interesting since the explosions were identical for all three, the only difference being the target thickness (1.00, 1.25, and 1.50 in.). The fracture produced by the reflected tensile wave is barely seen in the 1.50-in. target. As this threshold of fracture is found to occur at a distance of 0.3 in. from the rear surface, it indicates that the length of the stress pulse is twice this distance, or 0.6 in. This conclusion presumes that the stress amplitude at the leading edge is not exceeded by stress amplitudes elsewhere in the pulse. If the fracture strength of 1 kb (Ref. 6) were correct, this indicates that this explosion (E-94 du Pont blasting cap inserted in a 1/4- x 1/4-in. cylindrical hole) produces a stress pulse having an amplitude of 1 kb and a length of 0.6 in. when the wave front is 1.8 in. (1.5-in. target thickness plus 0.3-in. reflection distance) from the front surface of the target.

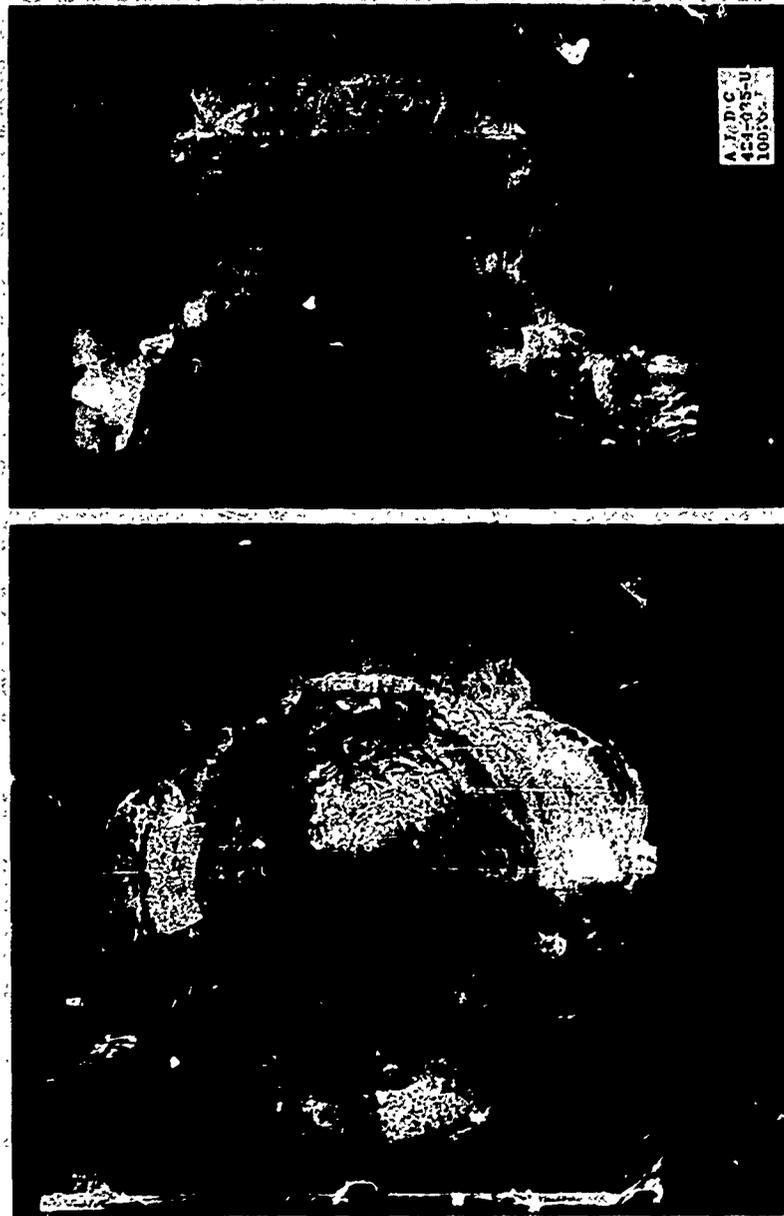
Fig. 19 Fractures in Targets Having Small Lateral Dimensions

Two Views of a 4- x 4- x 2-in.
Lucite Block Fractured by an Exploding
Blasting Cap

If the target does not have large lateral dimensions, so many fractures are caused by internal reflections that the result will be confusing. Figure 19 shows two views of a 4- x 4- x 2-in. Lucite block that was fractured by exploding a cap in the center of one of the 4- x 4-in. faces. These fractures are very helpful in studying the nature of shock geometry or "optics". No attempt will be made to explain the formation of all the fractures, but a few of the more common ones which occur in a rectangular block are isolated and shown in Fig. 20. In A, the fracture near the rear surface produced by the reflected tensile wave is shown. The fractures shown in B are formed in a manner similar to that in A, by reflection of tensile waves from the four sides. Those shown in C and D are produced by the combination of the tensile pulses reflected from two surfaces. As the waves are reflected from three intersecting surfaces, momentum is trapped at the corners of the block, producing the fractures shown in E. (The

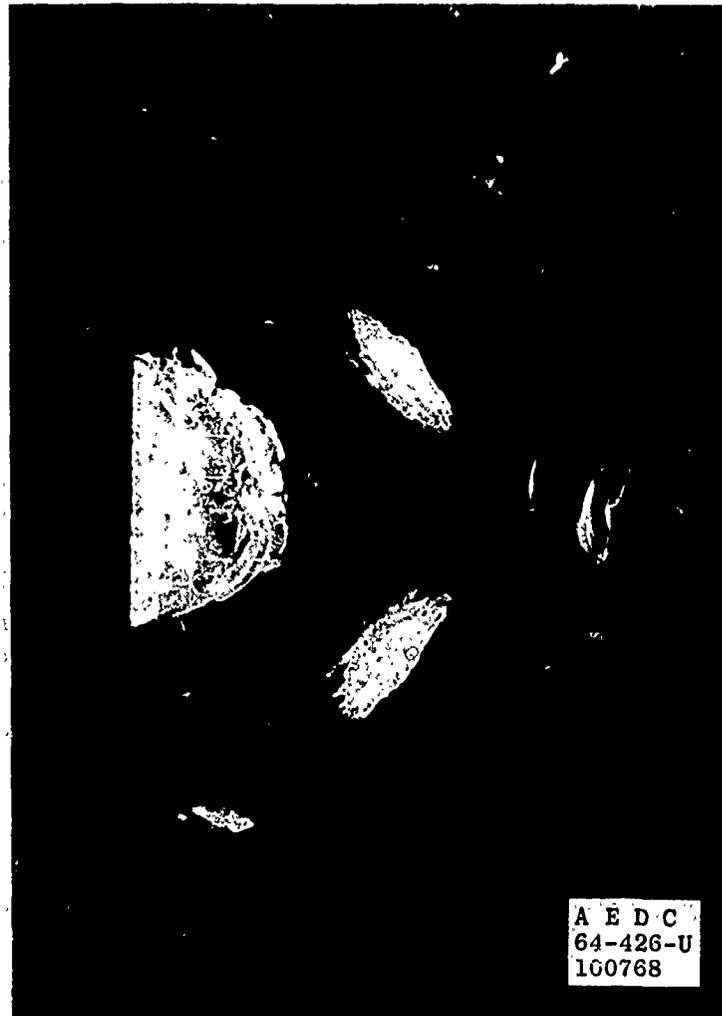
Fig. 21 Fractures in a Triangular Target

Approximately One-Half of a 4- x 4- x 2-in. Lucite Block
Fractured by a Blasting Cap Exploding at the Center of
the Hypotenuse.

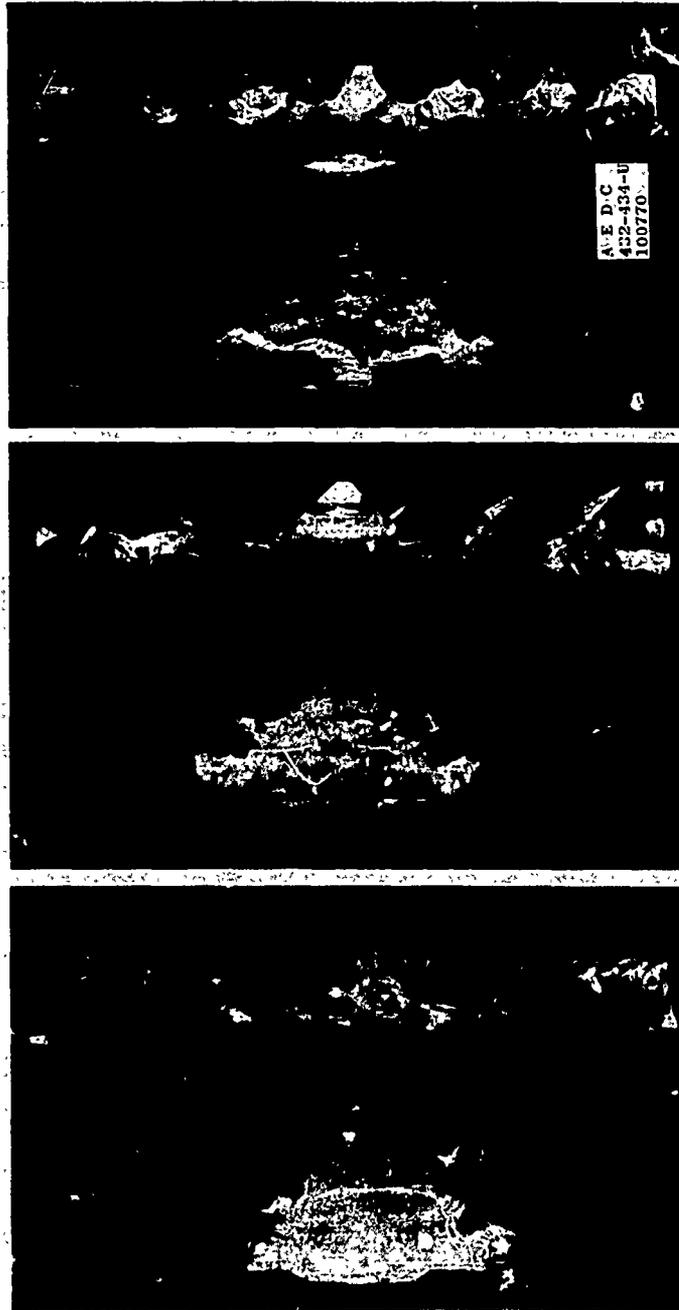
Fig. 23 Effect of Rear Surface Conditions

Lucite Blocks 4 x 4 x 2 in.
Fractures Produced by Exploding Blasting Caps.

As much of the damage to a material is caused by the shock reflection from the rear surface, it would be helpful if the rear surface could be designed so that the wave would be dispersed upon reflection, thus reducing the extent of the damage. In order to learn something of this possibility, three surface conditions were investigated. The target shown in Fig. 23-A had small V-shaped grooves cut in its rear surface. The form of the fracture was considerably different from those produced by shock reflection from a smooth surface, and cracks were formed at the root of each V. The block shown in Fig. 23-B also had V-shaped grooves in the rear surface, but they were larger than those shown in the previous figure. The fracture produced by the reflected pulse was concentrated as shown. Fractures were also formed at the bases of the V's. Except at the corners, none of the target surface became detached. The target shown in Fig. 23-C had semi-circular grooves in its rear surface. Although the explosion was identical to the two previous ones, considerable material was broken loose from the surface. The fan-like fractures described previously may be seen in these targets. Their exact cause is not known, but they do not appear in targets having large lateral dimensions.

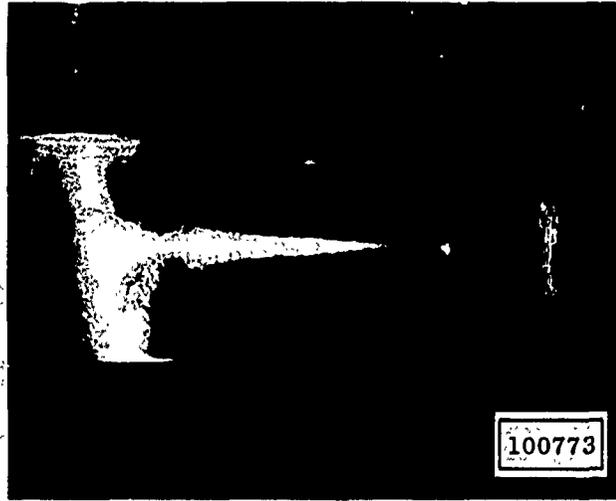
Fig. 26 Fractures Along Axis and at End
of a Cylindrical Rod

Lucite Rod 1.25 in. Diameter x 3.5 in. Long
