MEASUREMENT OF FLYING QUALITIES OF A DEHAVILLAND MOSQUITO F-8 AIRPLANE (AAF NO. 43-334960)

I - LATERAL AND DIRECTIONAL STABILITY AND CONTROL CHARACTERISTICS

By H. L. Crane, D. B. Talmage, and W. E. Gray, Jr.

MR No. L5D19

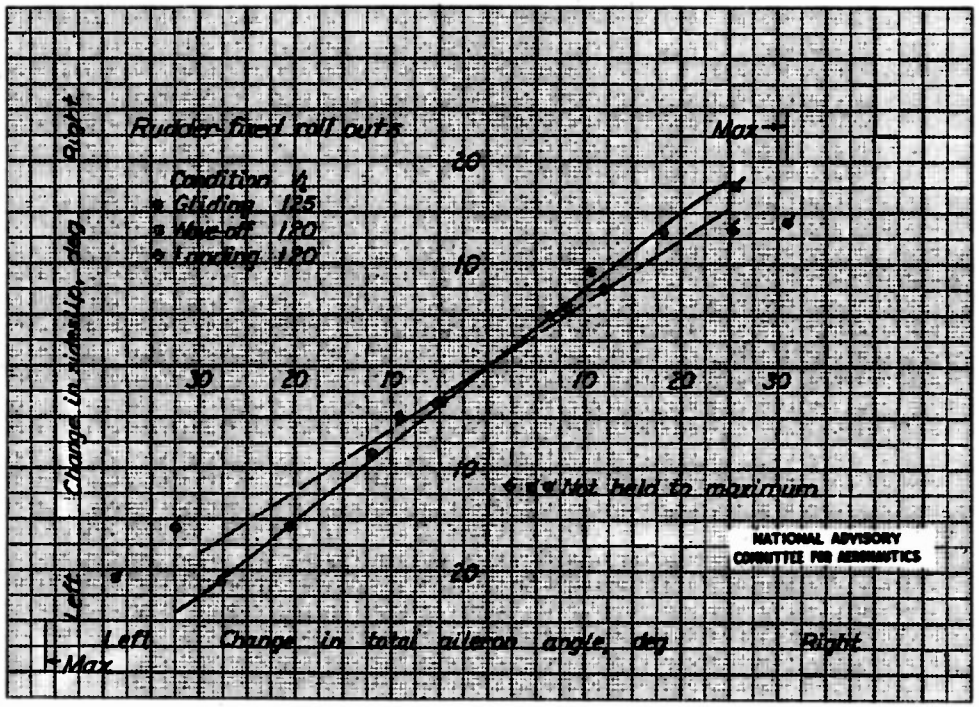
c. Rudder-fixed left and right rollouts with flaps down, landing gear down, rated power, shutters open, at 115 miles per hour. Engine cut out during right roll when airplane pitched down.

figures 25 through 28 indicate that on this particular Mosquito aileron overbalance occurred in rolls in all conditions below 200 miles per hour over a considerable range of aileron deflections. It has been stated previously that the ailerons tended to shake when fully deflected and that an example of aileron shaking is presented in figure 10(c).

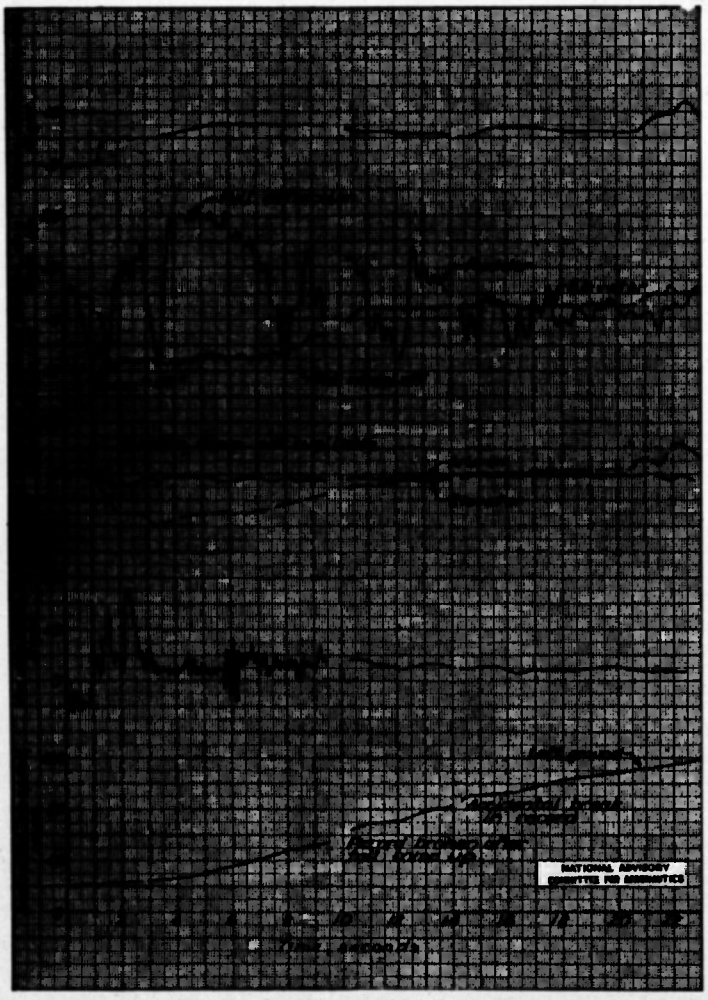
The rudder-free directional stability was positive in all conditions except at low speeds with power on, flaps and gear retracted, where the rudder-force variation with sideslip angle became negative at large angles of sideslip, and therefore did not satisfy the requirements of reference 1. A time history of a gradually increasing sideslip in which rudder lock occurred is given in figure 17. In the recovery from this maneuver, the engines were cut. Even with the large degree balance provided by the spring tab which made the rudder very light under normal conditions a force of nearly 200 pounds was required to return the rudder to neutral.

3. Control-fixed and control-free directional stability was positive except near the stall with power for level flight in the clean condition at large angles of sideslip where rudder lock occurred.

Figure 17. - Time history of right sideslip in the clean condition with power for level flight at 115 miles per hour, shutters open, in which rudder lock occurred, DeHavilland Mosquito F-8 airplane. Engines were cut to regain control.
