EXCAVATION AND SEISMOLOGY

HONEYWELL, INCORPORATED

EXCAVATION SEISMOLOGY  
Final Technical Report

Bureau of Mines Contract No. H0220070

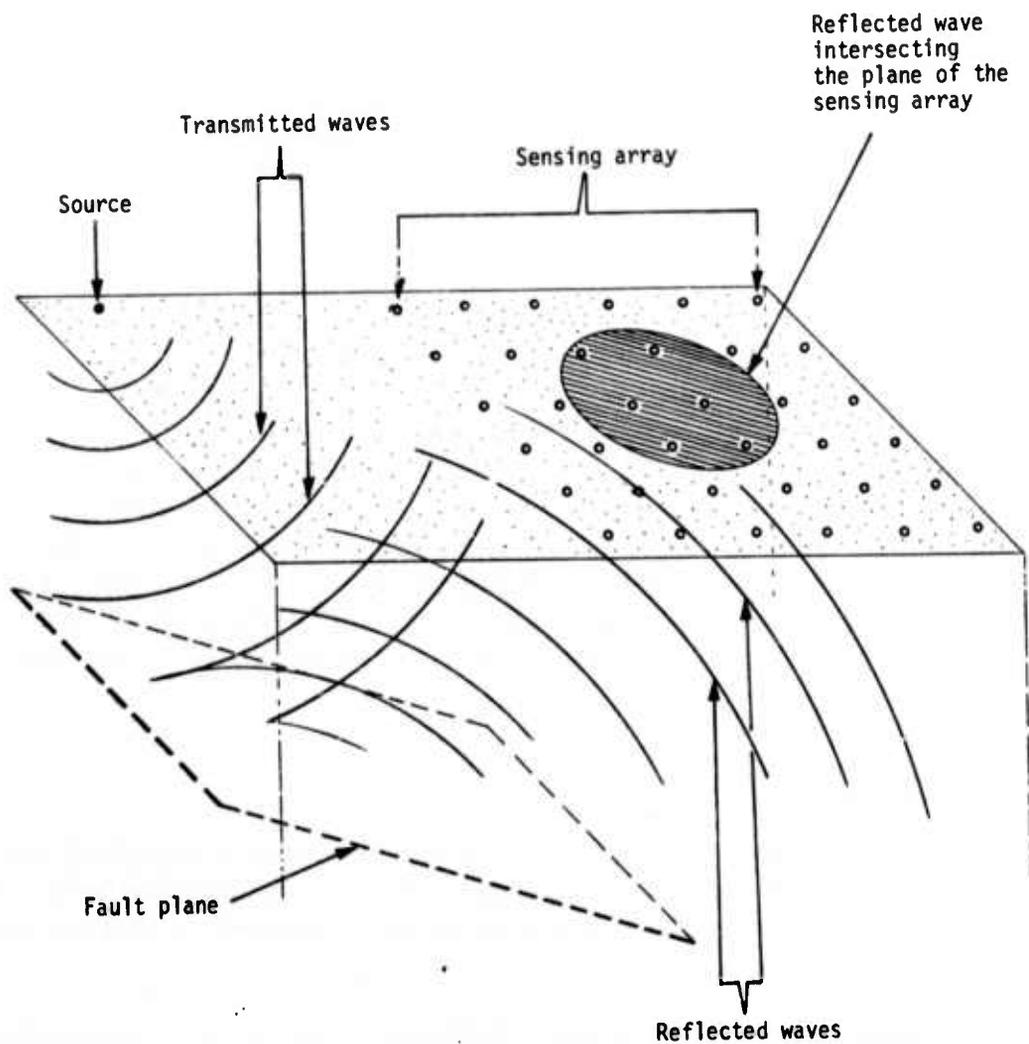
Figure 1. Detection of Fault by Sensing Array.

An acoustic pulse induced in the rock will propagate on a spherical wave front. This wave will be partially reflected at a fault, and the reflected wave can be detected by a plane array of acoustic sensing elements (see Figure 1).

As the reflected wave passes through the sensor plane, the intersection of the expanding wave front and the plane will be an expanding circle. The sensing element outputs at successive instants will show the positions of the expanding circle. A movie of the expanding circle can be made by constructing a set of pictures of the sensing array and showing the instantaneous sensor outputs on the pictures. Information about the reflecting surface can be gotten by measuring the images on the successive movie frames.

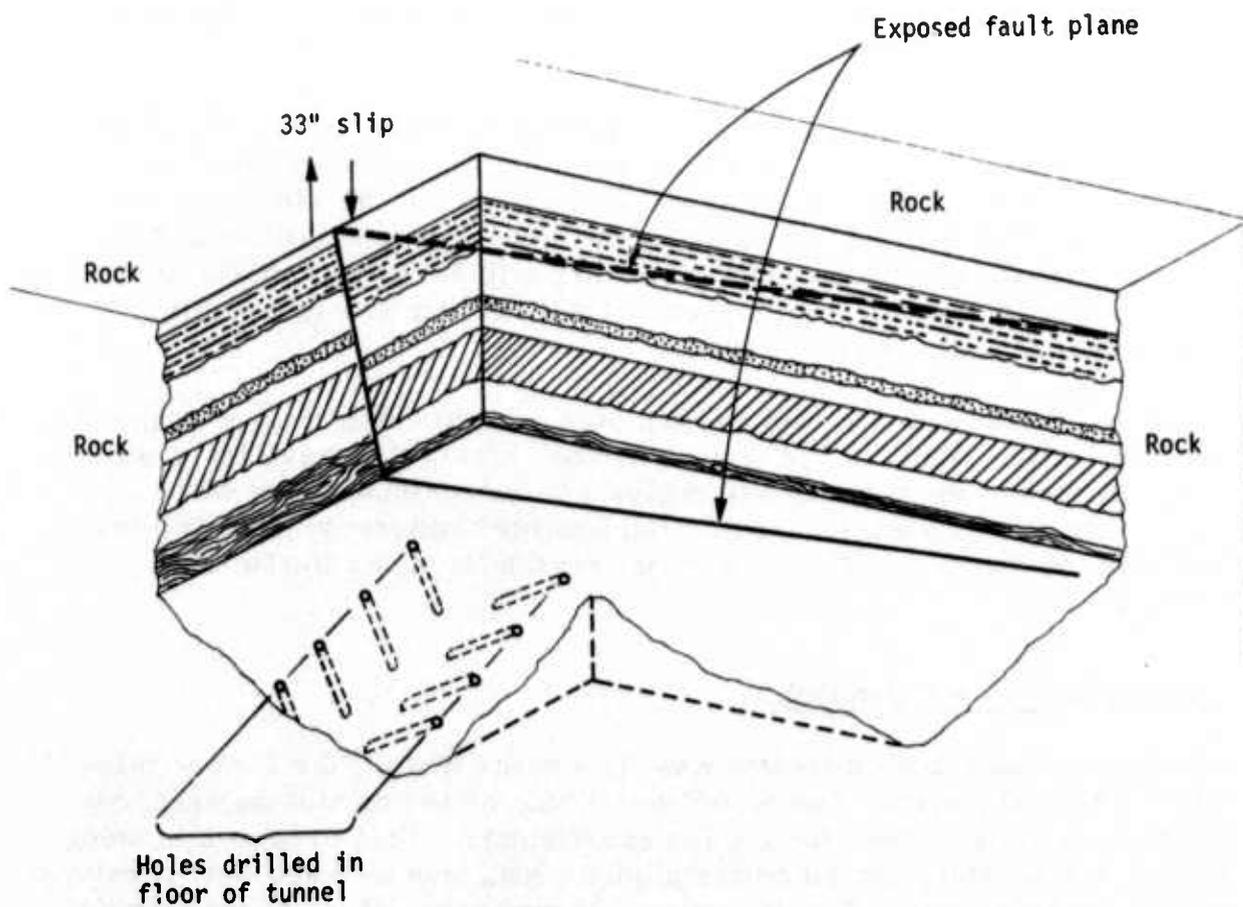
Figure 2. Cutaway View of Experimental Area.

The underground data collection was done in the White Pine Copper mine at White Pine, Michigan. The older part of this mine contains an area that has been frequently used for mining experiments. This area, while being neither a laboratory nor an active mining area, provided necessary features of both environments. Power, water, storage area, etc., needed for the equipment, were available as were White Pine technical personnel familiar with performing experiments in the underground environment. Also, the rock structure and exposed surface geometry were more like those of a working mine area than could be found in a surface quarry or simulated in the laboratory. Figure 2 depicts the data collection area.

Because of the fault, the tunnel makes a right angle turn at this point after penetrating approximately 8 feet beyond the fault. The fault is thus exposed on the back, ribs and floor, and there is a large, undisturbed rock mass beyond the fault. The holes for the source and the sensor were drilled into the tunnel floor (Figure 3). Four hole pairs were used, located nominally at distances of 4, 8, 12 and 16 feet from the fault. The plane

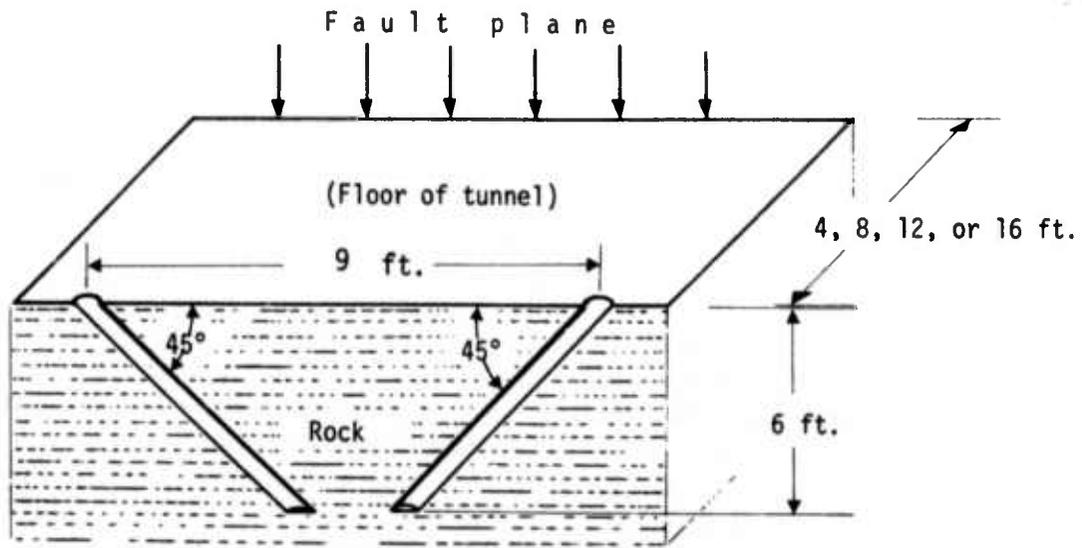
Figure 3. Nominal Arrangement of Test Hole Pairs.

defined by each hole pair was intended to be perpendicular to the tunnel floor and therefore not parallel to the fault. The actual holes were drilled manually by White Pine technicians and were put surprisingly close to the nominal positions and orientations. Each hole pair was slightly non-coplanar, but this did not interfere with the experiment. (On the contrary, it makes the experiment more realistic.)

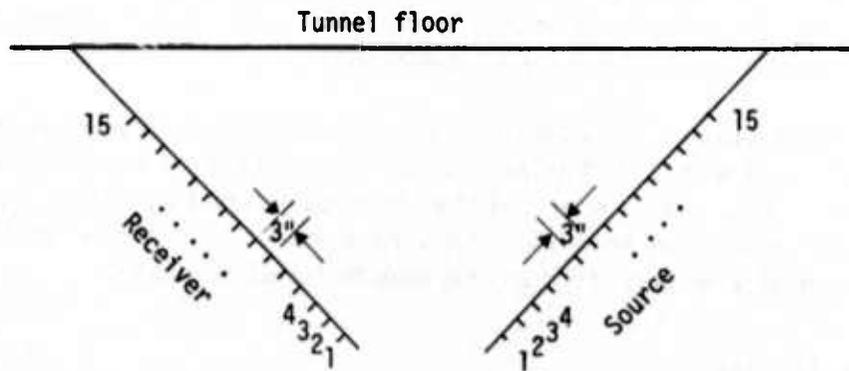
Figure 4. Nominal Source and Receiver Locations.

The majority of the experiments were performed using 15 source positions and 15 sensor positions. Figure 4 shows the nominal arrangement. The data collection procedure involved positioning the source and the sensor, discharging the source, recording and displaying the received signal interval and photographing the display. This was done for each of the 225 pairs of source and sensor positions. The line displays were recorded on adjacent line positions on film. Figure 5 shows the nominal structure of the film record. For each sensor position there are 15 adjacent lines corresponding to the 15 source positions, and there are 15 such groups of lines corresponding to the 15 sensor positions.

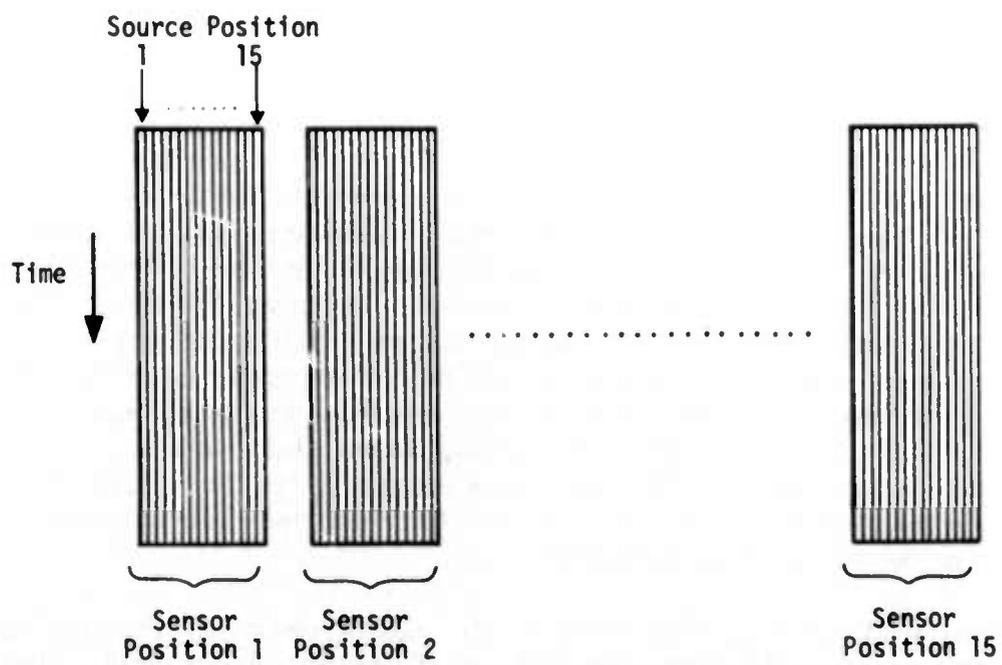
Figure 5. Nominal Film Recording Format.

Of 15 complete recordings, (i. e., format of Figure 5) made using four different hole pairs, only one record, from the hole pair located 4 feet from the fault, showed the reflected wave. The computer processing needed to make this reflected wave visible is described in Section IV. The remaining recordings, made from the same hole pair and at the 8 ft., 12 ft. and 16 ft. hole pairs, all show the direct wave, but the reflected wave was too obscured to be made visible in the movies.

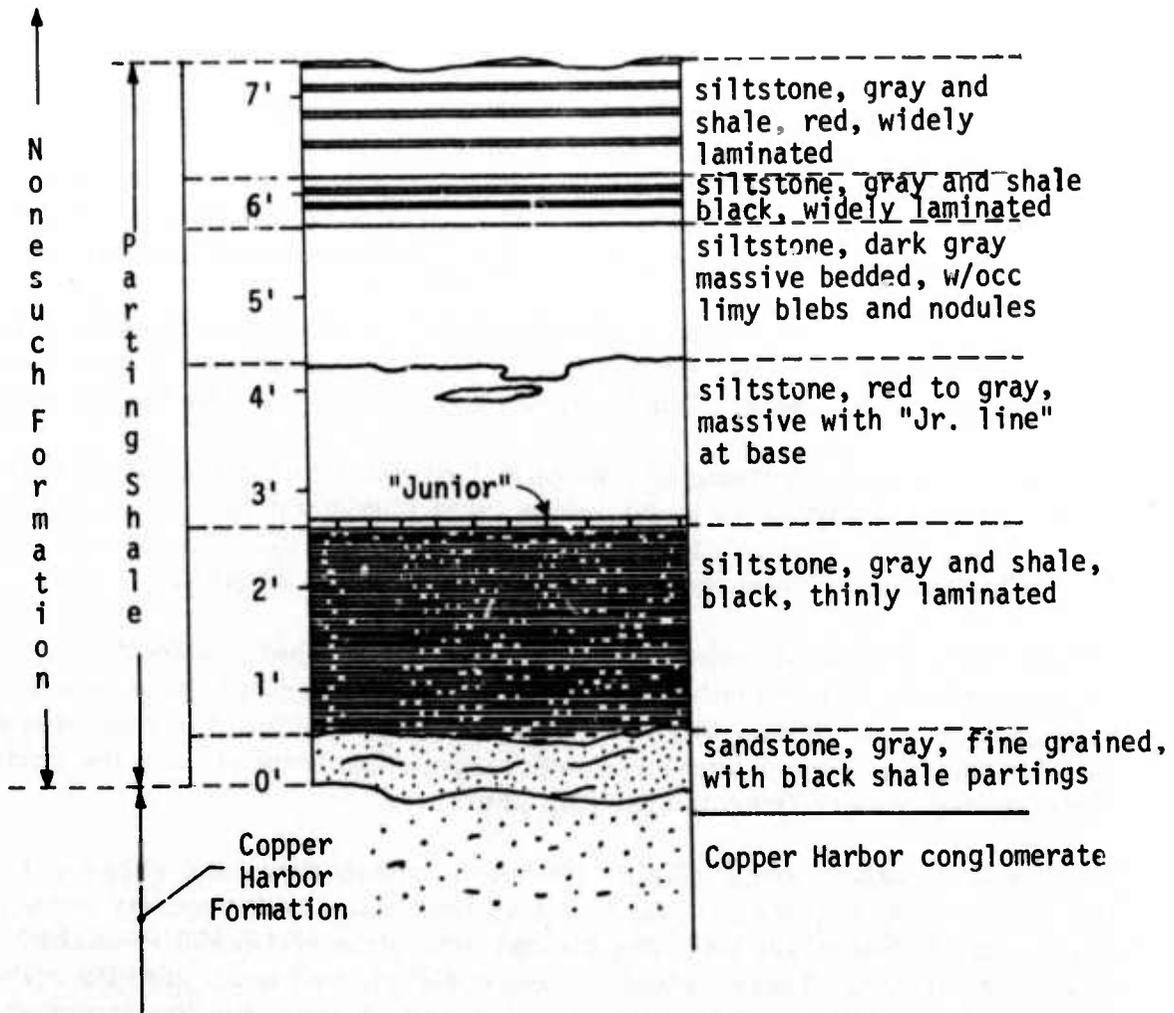
Figure 6. Geology of Ore Column in the Experimental Area.

The experimental area was located within the Upper Keweenaw Series in the White Pine District at the bottom of the Nonesuch Shale. Figure 6 shows a cross section through the drift. The rock surface on which we worked was approximately at the 0' level in Figure 6. This is the top of the the Copper Harbor Conglomerate into which the test holes were drilled. Figure 7 shows the geometry of the fault that was being studied. A fractured rock zone extended one to two feet on either side of the fault.

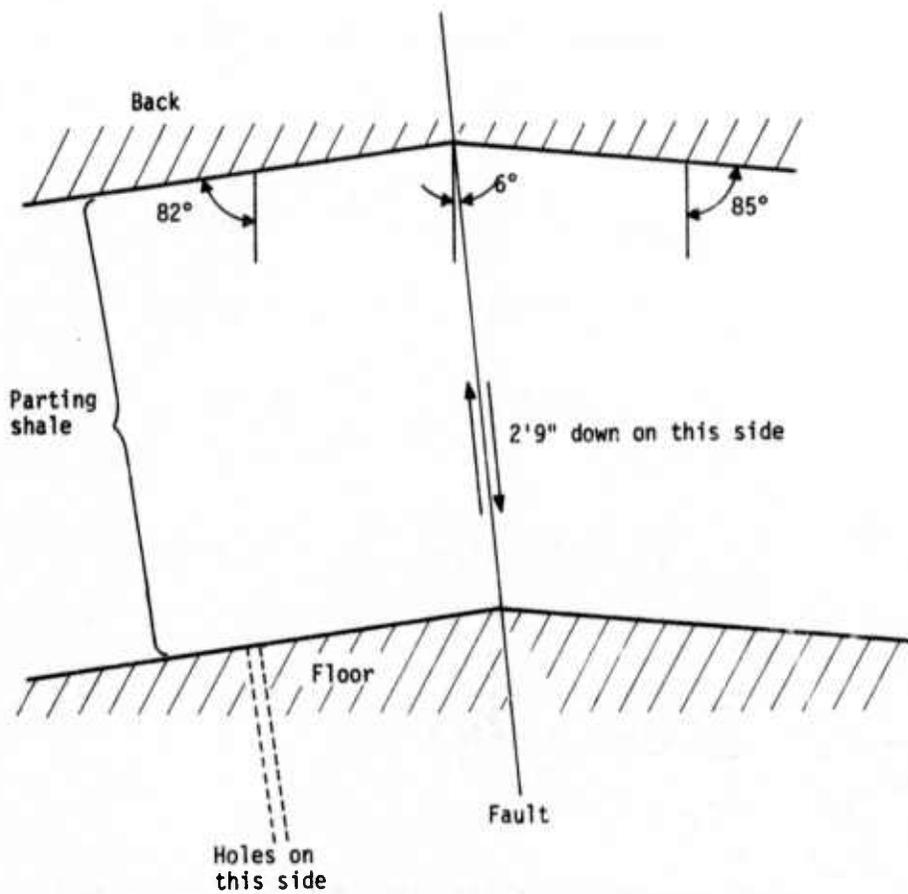
Figure 7. Geometry of the Fault.

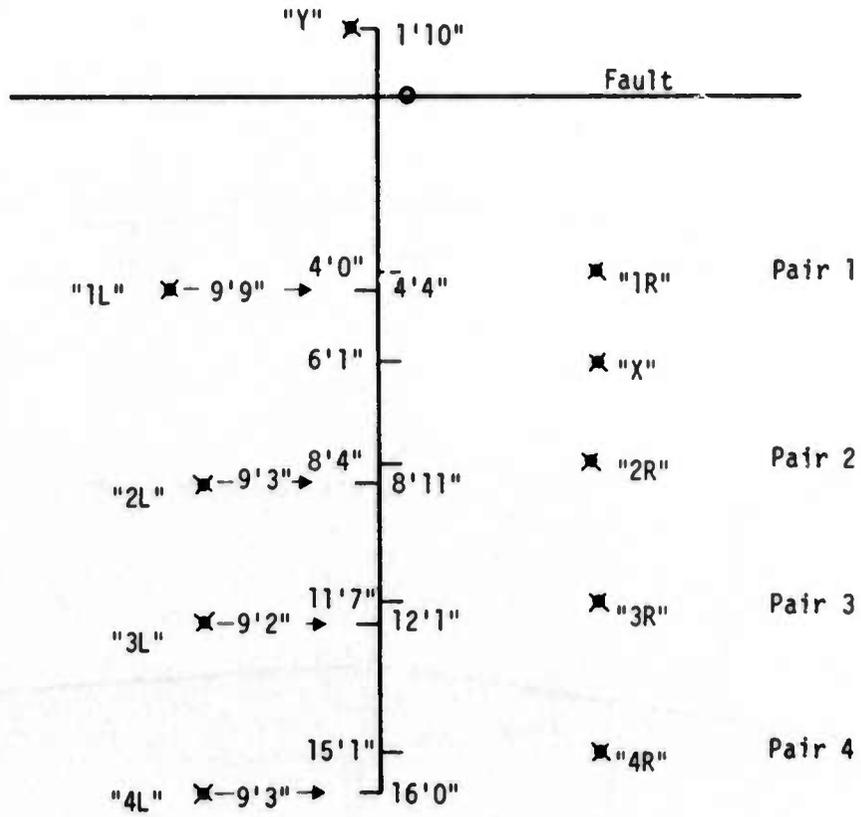
Figure 8. Locations and Names of the Test Holes.

Figure 8 shows the locations of the holes drilled for these experiments. This figure also shows the names (1L, 1R, X, etc.) that were used to denote the individual holes. These names are used in the test of this report.

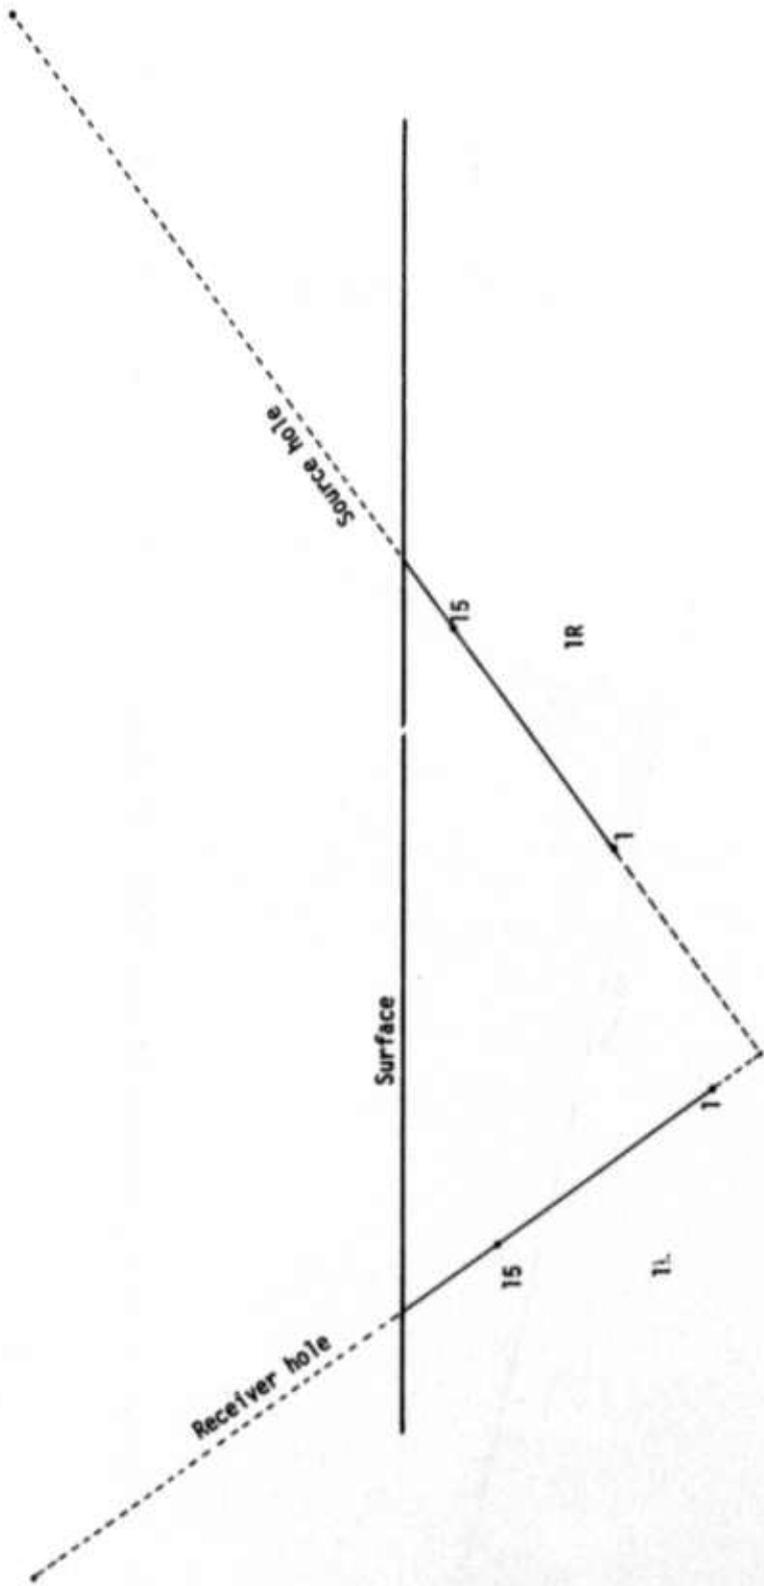
Figure 9. Scale Drawing of Hole Pair 1 Projected onto the Fault Plane.

Figure 9 is a scale drawing of hole pair 1 projected onto the plane of the fault. This and Figure 10 were drawn from measurements made at the site. The ideal 45 degree angles were not obtained, but this did not interfere with the experiment or the interpretation of the results.

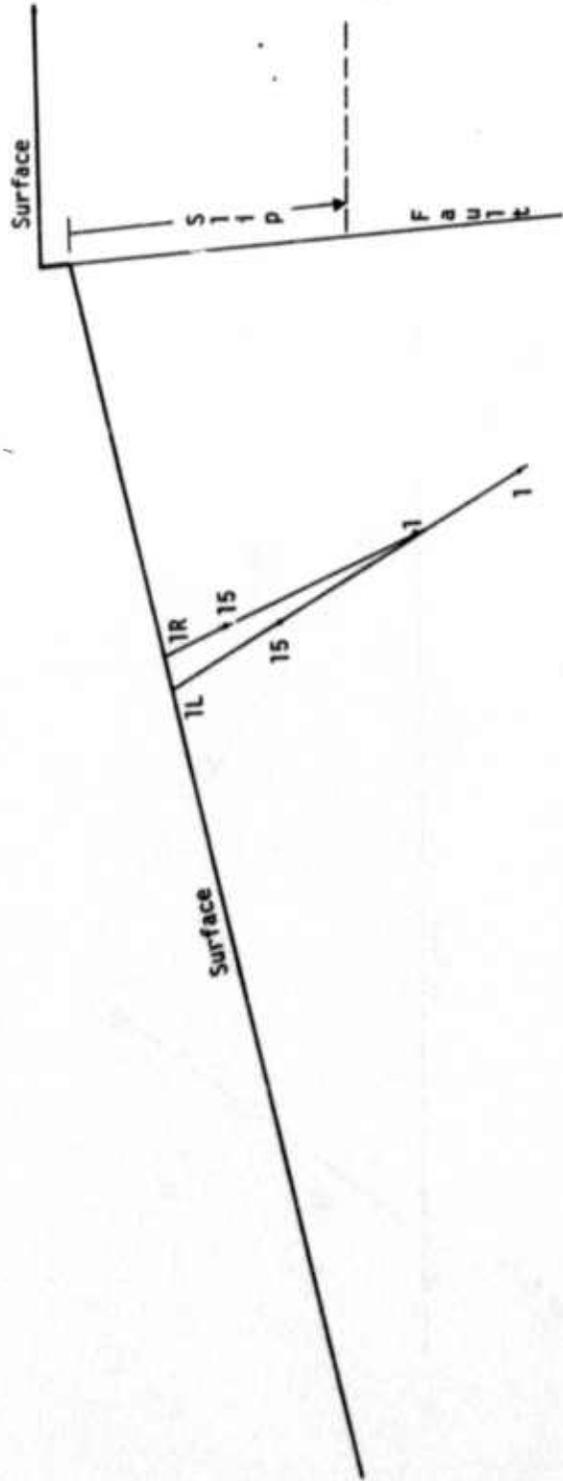
Figure 10. Scale Drawing of Hole Pair 1 Projected onto a Plane Perpendicular to the Fault.

Figure 10 is a scale drawing, perpendicular to the fault, showing the actual angles made by the two holes of hole pair 1. The parting shale location is also shown on the downside of the fault. This shows that the transmission was through the Copper Harbor Conglomerate (sandstone), and the reflections probably were from the parting shale.

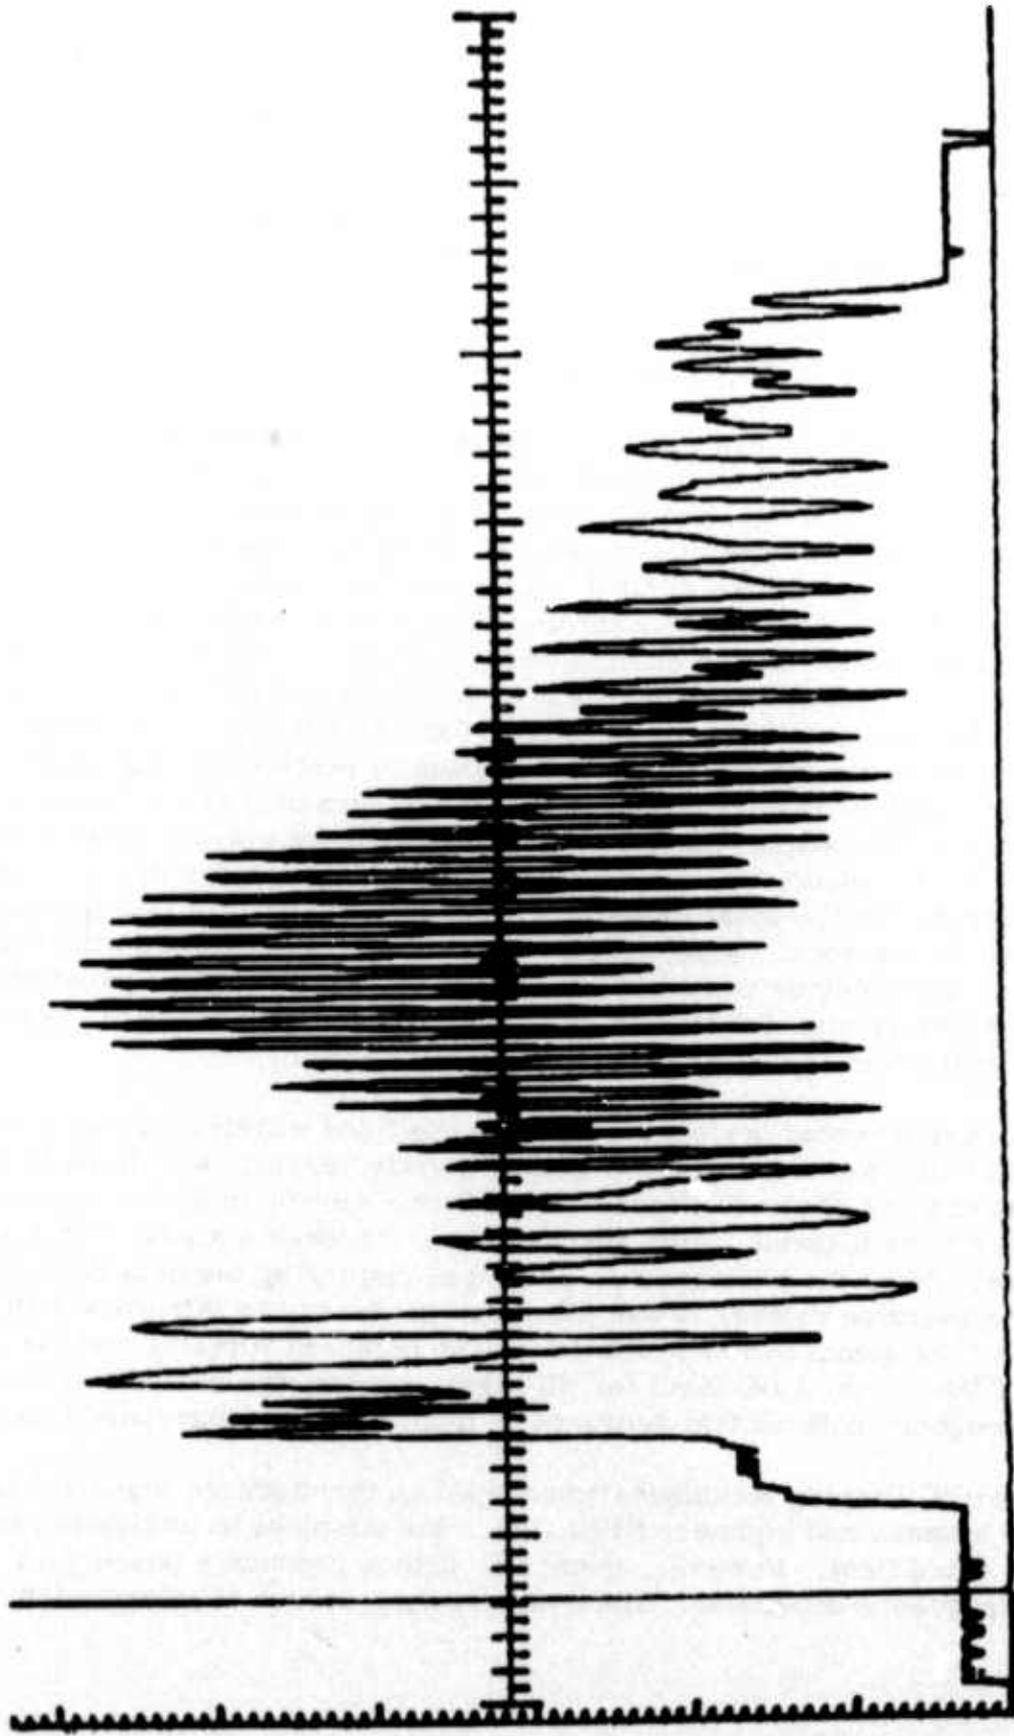
Figure 11. 500 Point Display of Digitized Sweep.

A typical raw waveform is shown in Figure 11. This is one of the waveforms that was obtained on the final data collection trip. It shows a slowly varying DC level that was probably due to the equipment. All of the equipment used during the experiments was AC coupled. The waveforms collected on the earlier trips did not show this DC level variation. The earlier trips concentrated primarily on low contrast photographs, while the final data collection trip concentrated on high contrast photos. The high gains that were needed to obtain the signals that would produce high contrast photographs may have saturated one or more of the amplifiers. This saturation could then have caused the DC level variation in response to signal pulse arrivals. Another feature of this signal is the presence of a 6 kilohertz pulse early in the signal waveform and a 12 kilohertz ringing pulse appearing later in the waveform. No experimental explanation for this phenomena was obtained, but the most probable explanation is that this is a filtering effect due to the rock. Also, in the waveforms produced when either the source or the receiver were near the rock surface, there is a persistence of a 12 kilohertz signal that lasts to the end and in many cases far beyond the end of the 5 millisecond sweep that was recorded.

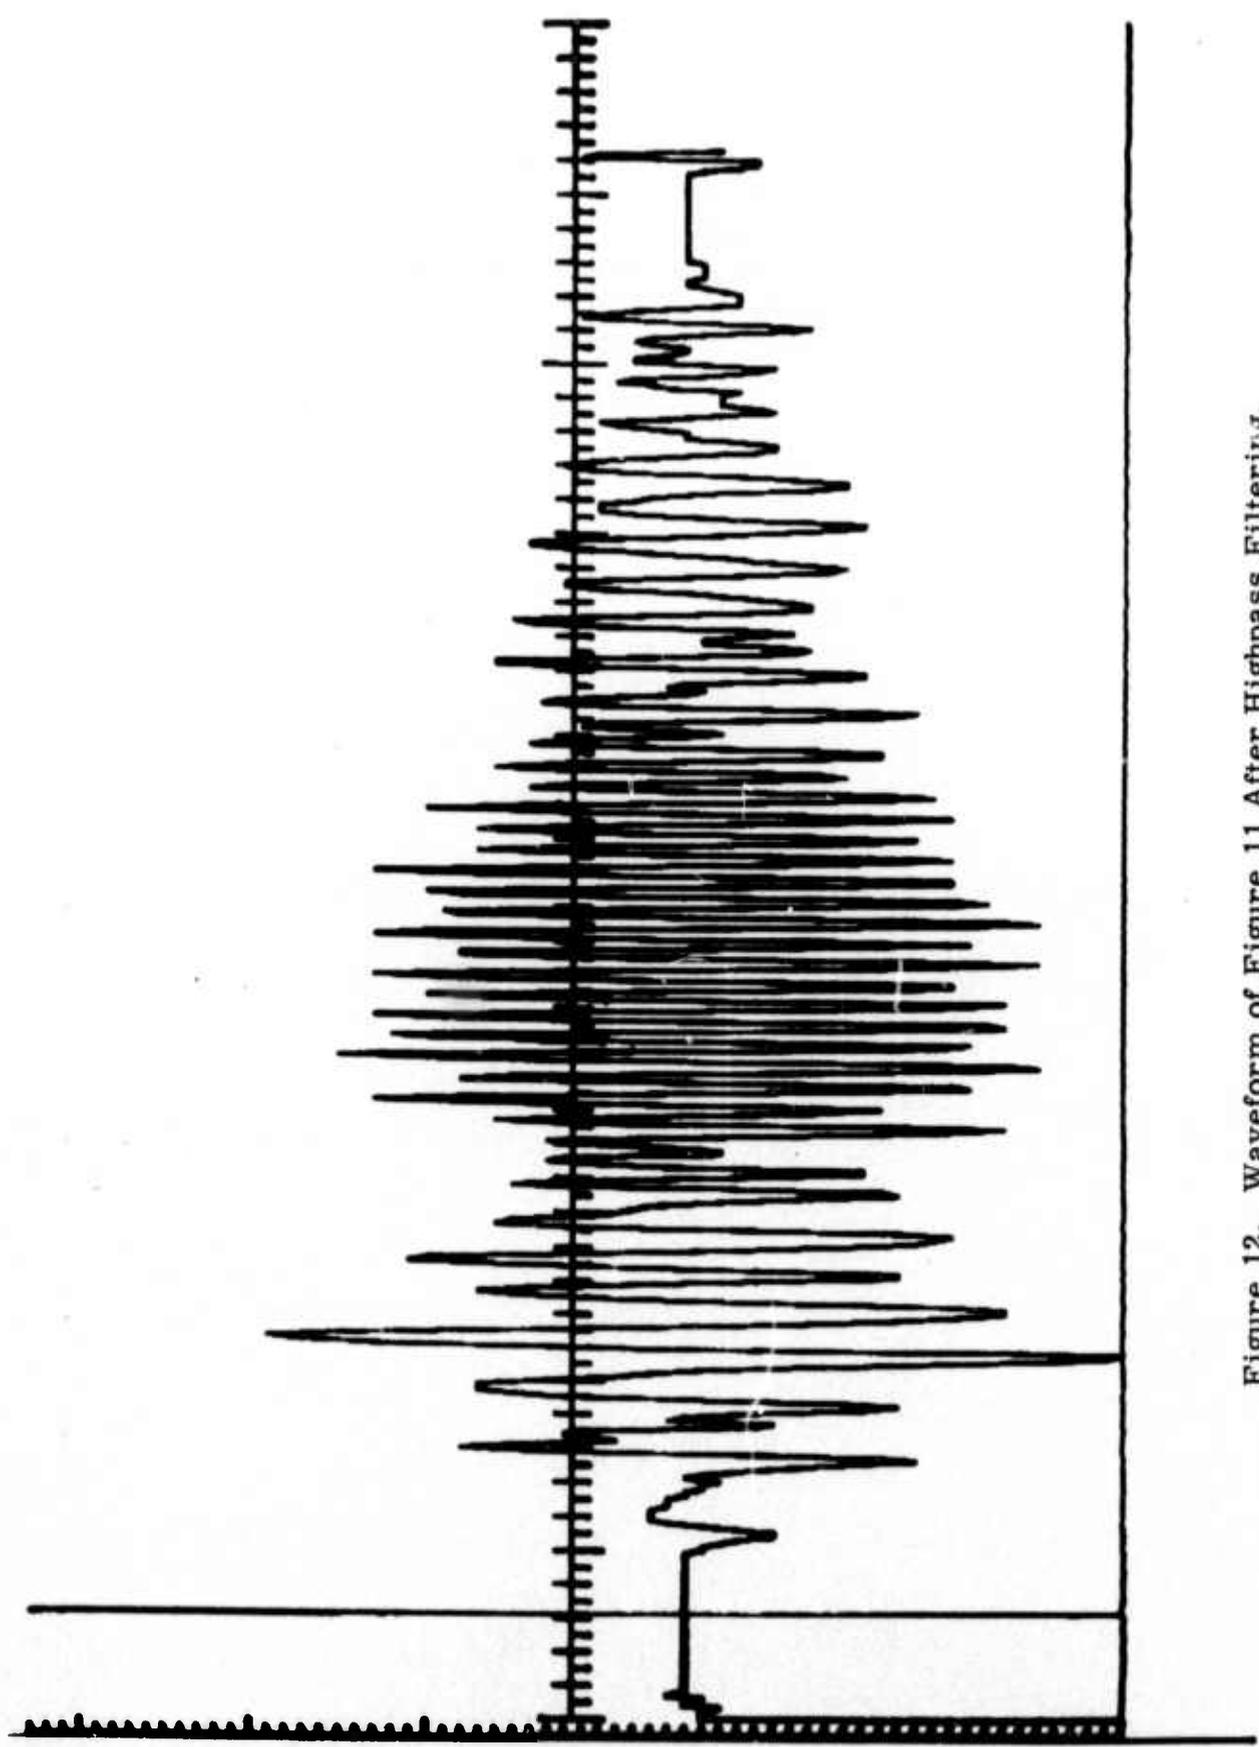
Figure 12. Waveform of Figure 11 After Highpass Filtering.

The primary filtering performed on these digitized waveforms was a high-pass filter that was used to eliminate the slowly varying DC. Results of this filtering are shown in Figure 12 where the waveform in the previous figure has been filtered. High pass filtering produces a signal with a zero DC value. Since the photographic method of displaying the data does not allow for negative values, it was therefore necessary to introduce a DC bias after the signal had been filtered. The highpass filtering and the addition of the constant DC level for all signal sweeps was found to eliminate the herringbone pattern that appeared in most of the photographed imagery.

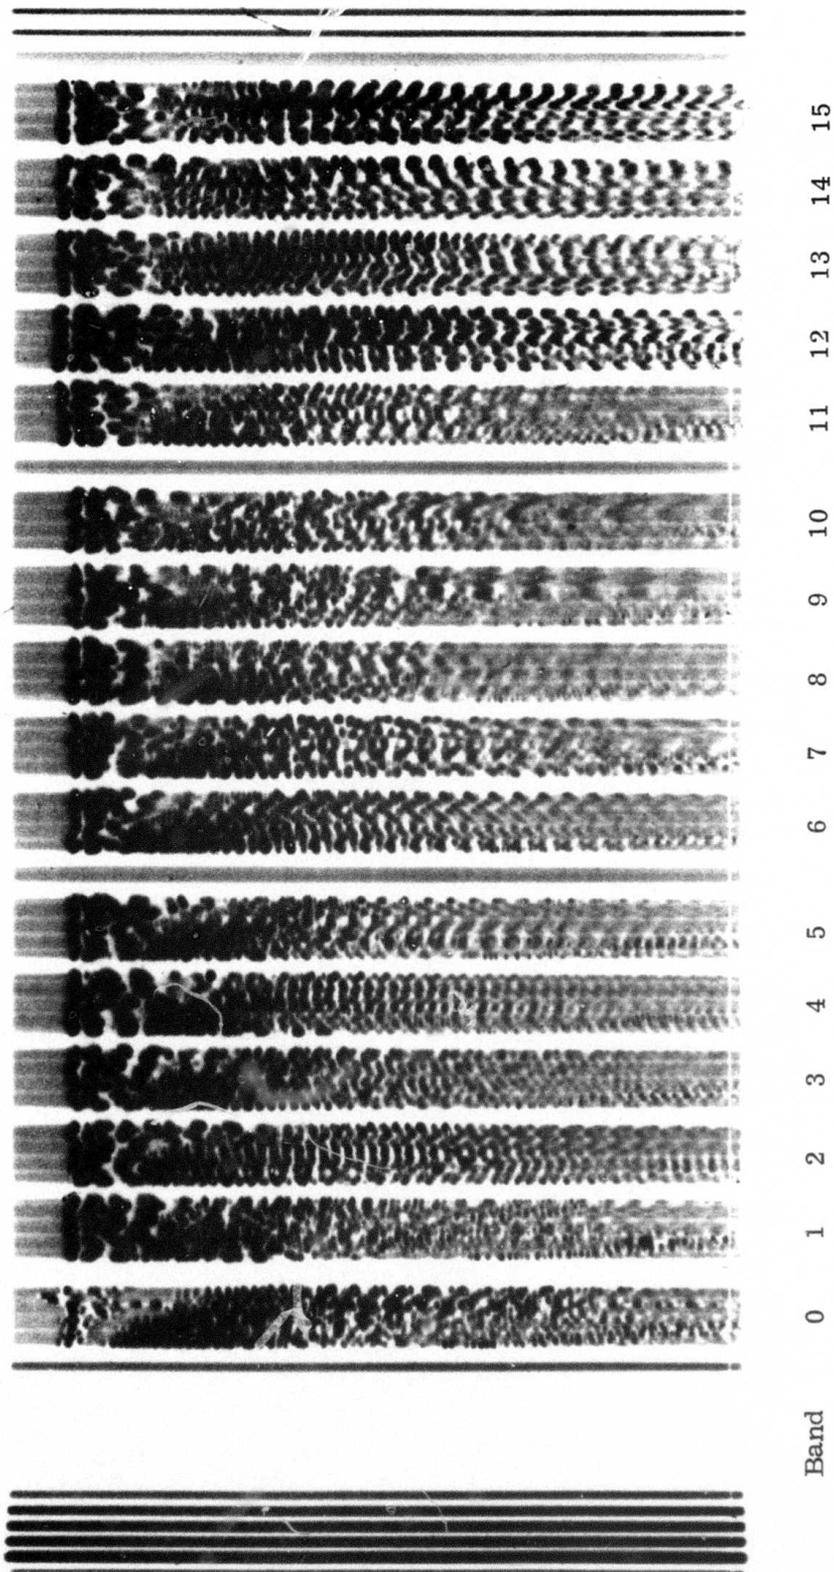
Figure 13. Frame 16: Data Recording from Hole Pair 1.

Figure 13 is an enlargement of frame 16 as it was recorded during the experiment. The various problems discussed earlier (extra bands, herringbone, flare, misalignment of trigger pulse) are all present in this frame. Band 0 was made using the external trigger, which was not operating properly. This band was not used for the data analysis. Bands 1 - 15 are the array recording and were made using internal trigger. A movie made from this frame, without processing, showed none of the expected features. Figure 14 shows frame 16 after the sweeps have been aligned by the first peak. (The sweeps were shifted in the computer so that the first maximum of the direct wave was in the same location in each digital record.) This alignment is not perfect, as the ragged appearance of the dark strip near the top of each band shows. (This is the peak used for

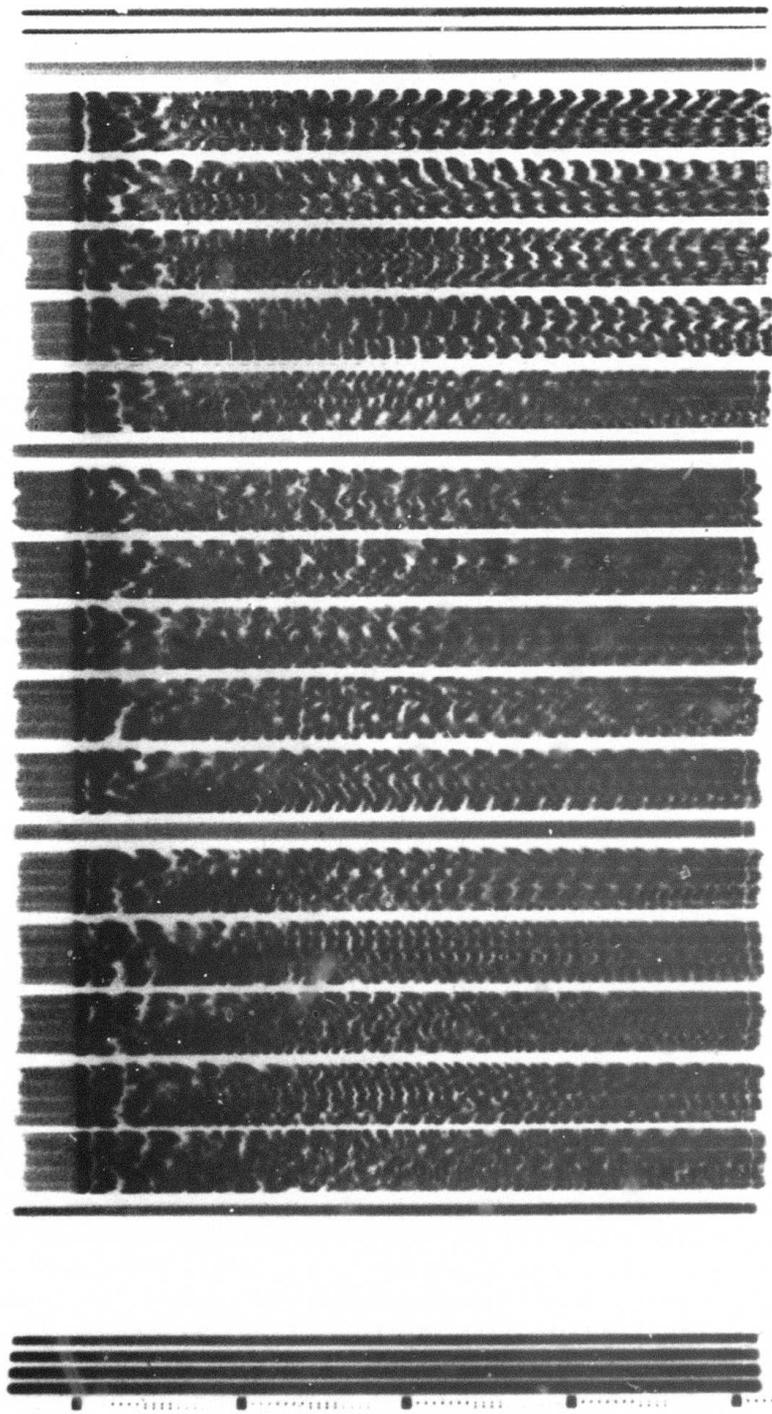
Figure 14. Frame 16 Aligned by First Peak.

alignment.) A movie made from this aligned version of frame 16, but with no other processing done on the data, showed dark movie frames corresponding to the first peak but no indications of any other direct or reflected waves.

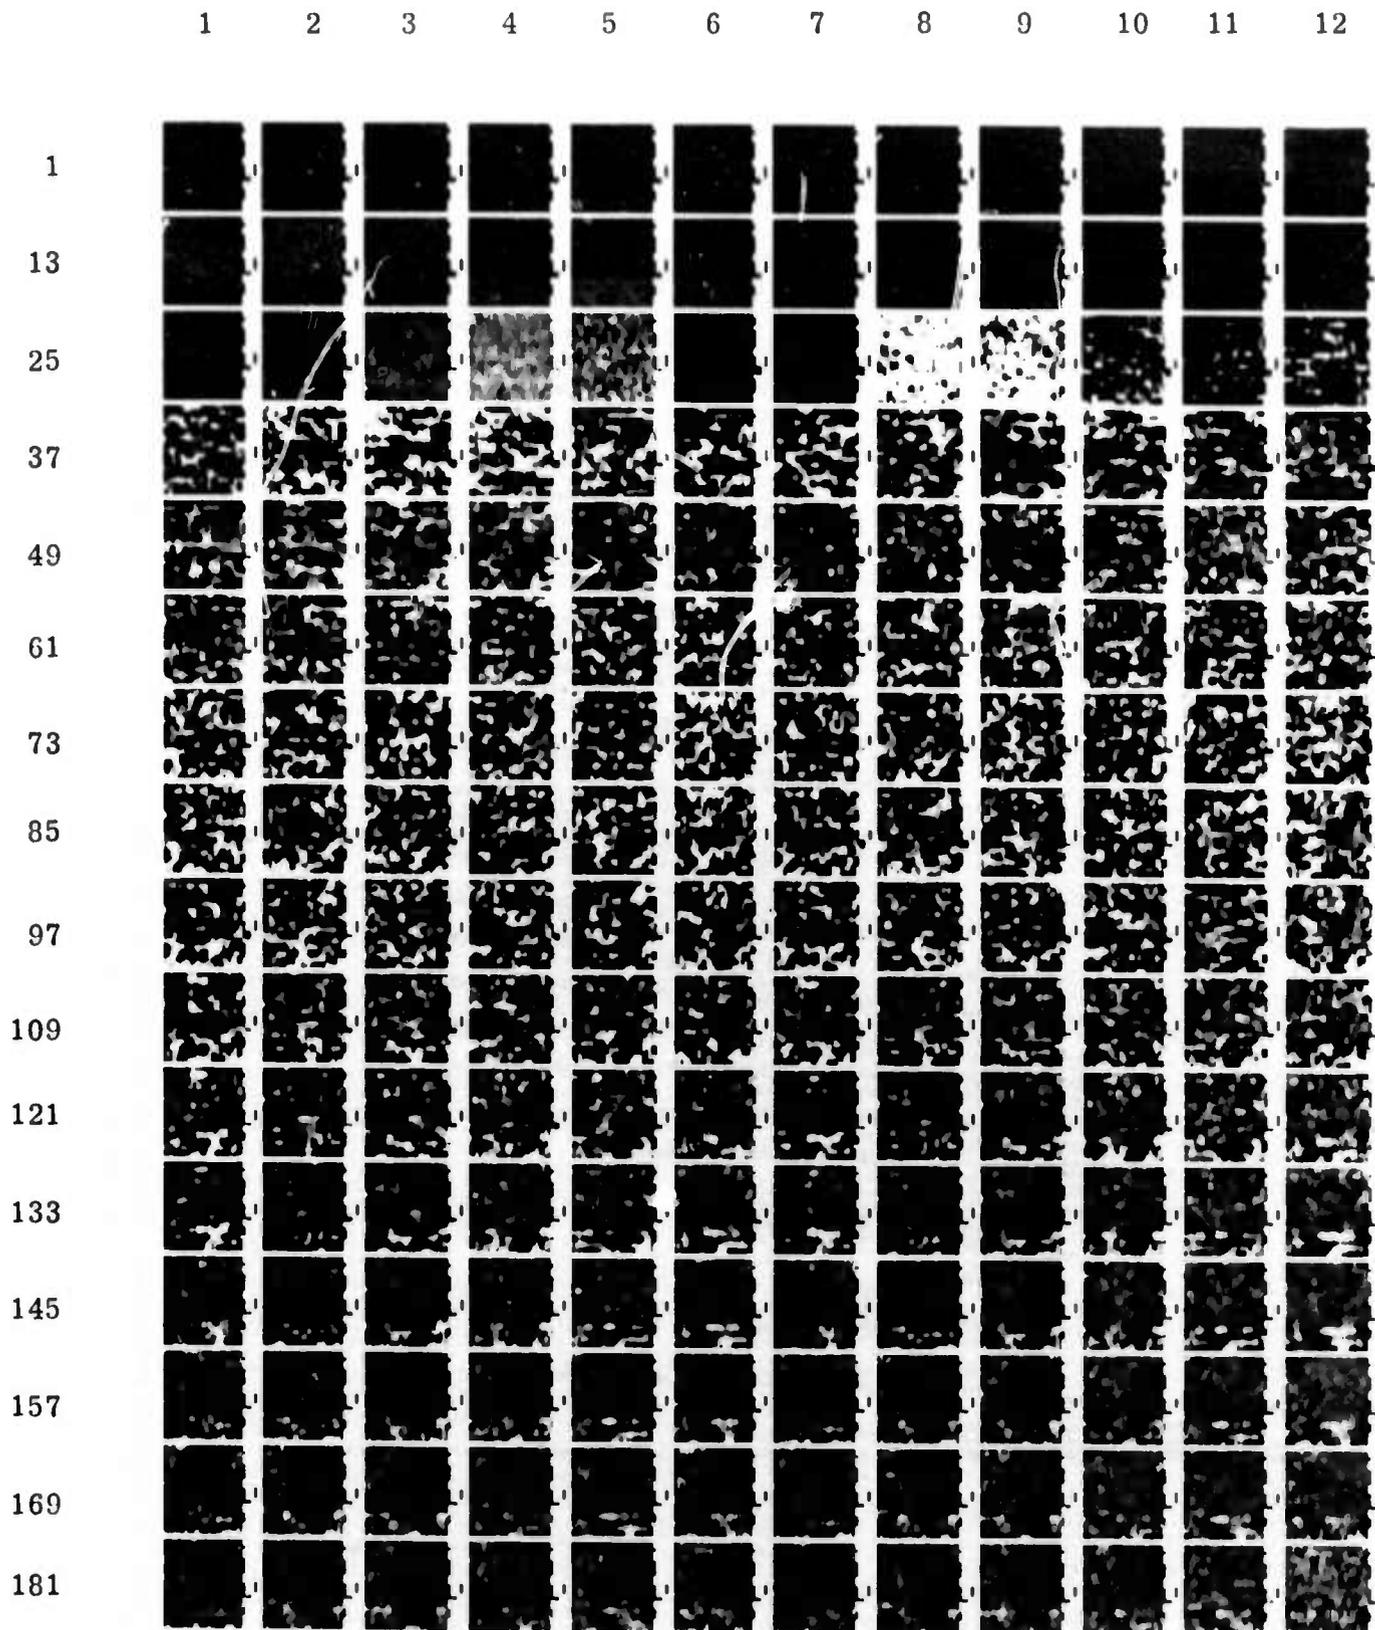
Figure 15. Movie of Frame 16 Aligned by First Peak and Highpass Filtered. (Movie frames read left to right starting at the top row. Frame interval is .014 milliseconds.)

Many different processing methods were tried (using the editing program) in an effort to get a movie that would show the reflected wave. The time waveforms showed large components near 6 kHz and 12 kHz, and, since we did not know which frequencies contained the desired information, the early attempts preserved the entire 5 kHz - 20 kHz frequency range that had been recorded. Broadly speaking, these methods were DC level shifting, extracting moving averages, highpass filtering, and amplification. None of these was successful. Figure 15 is a movie resulting from high-pass filtering of frame 16.

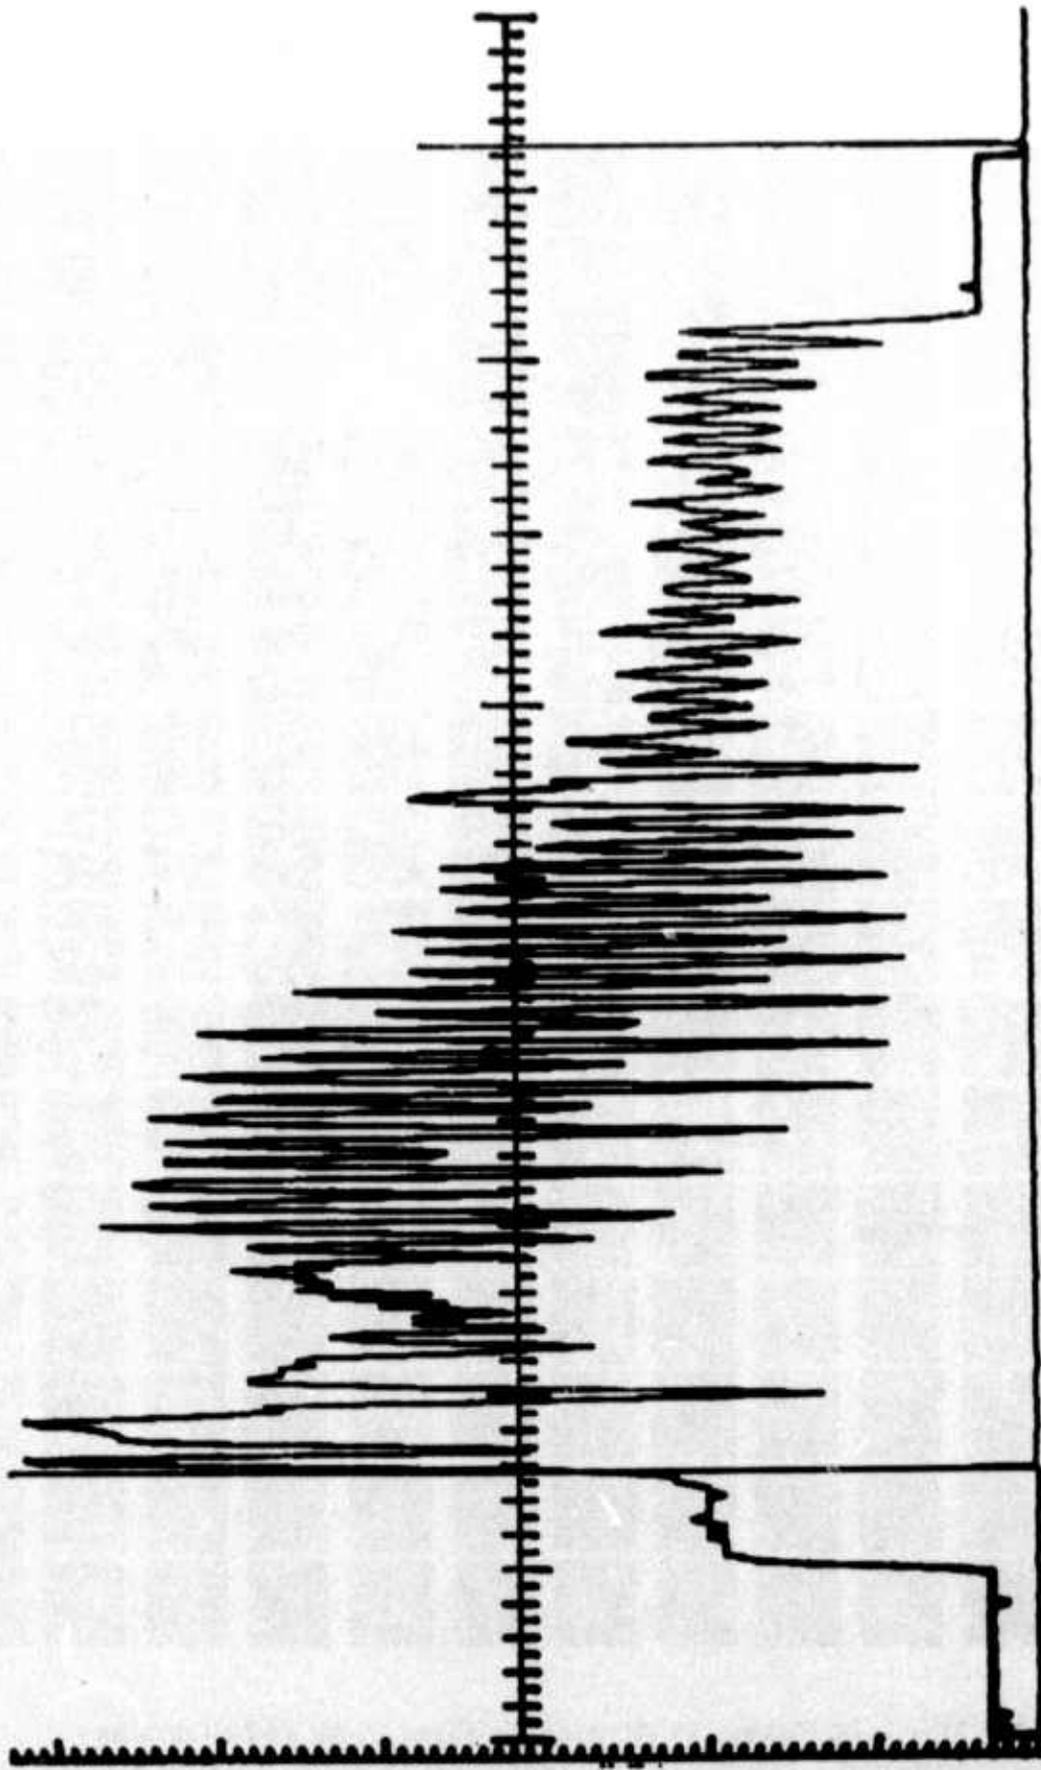
Figure 16. Figures 16-18 Show a Digitized Waveform and the Result of Bandpass Filtering It at 12 kHz and 6 kHz.

The second generation editing concentrated on the 6 kHz and 12 kHz frequency regions. Figure 16 shows the sampled time waveform for line 12, band 13. This is the 500 point edit display with each small interval on the time axis representing five samples or 70  $\mu$ s. The large DC level shift is a dominant feature of the unedited waveforms. The 6 kHz and 12 kHz components can be easily seen in the alternating negative peaks. Because they are simple to implement, the first kind of bandpass filter used was the recursive. Using recursive filters of various orders and bandwidths gave no positive results. The most likely explanation for their failure is that they introduce a phase shift that obscures or destroys the phase relations that would reveal the reflected wave in the movie.
