EXCAVATION AND SEISMOLOGY

HONEYWELL, INCORPORATED

EXCAVATION SEISMOLOGY  
Final Technical Report

Bureau of Mines Contract No. H0220070

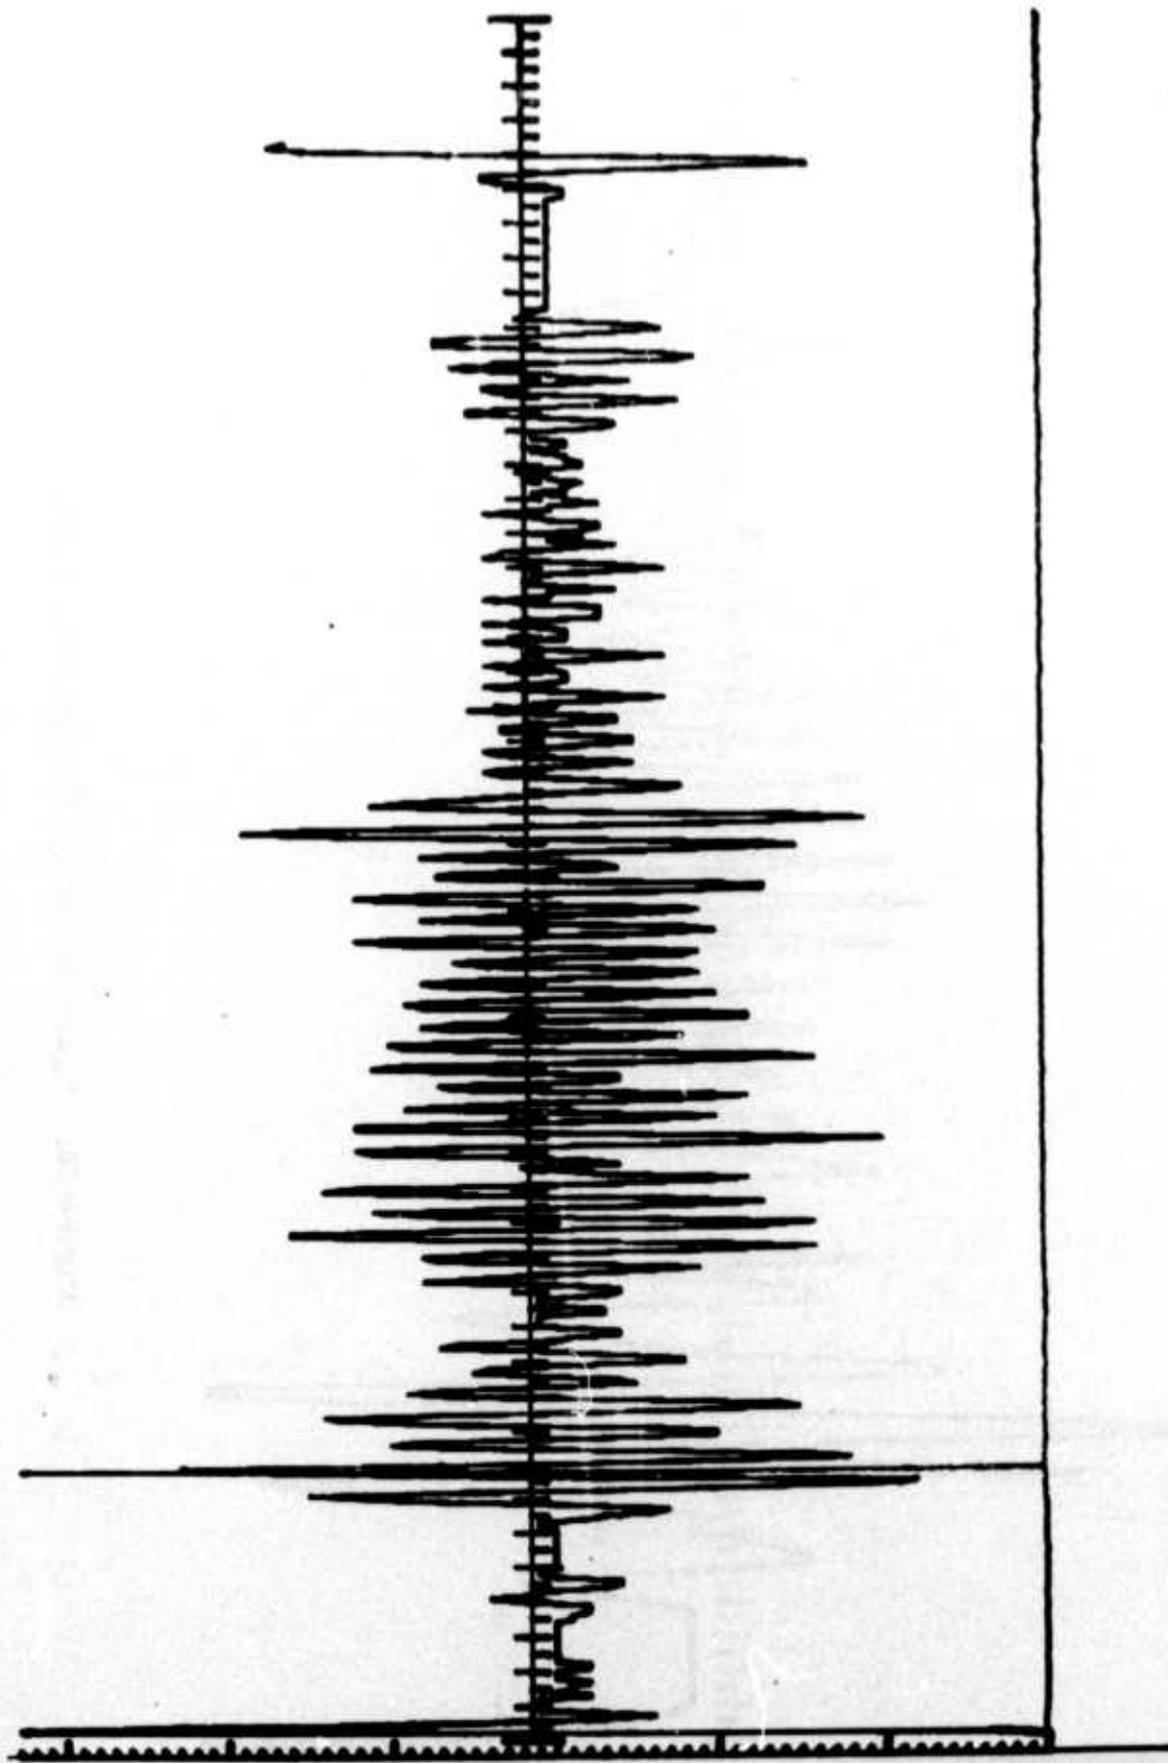
Figure 17. Figure 16 Bandpass Filtered at 12 kHz.

The next bandpass filtering method tried used a modified Hamming window that does not produce a phase shift. Figure 17 shows the waveform in Figure 16 after being filtered in this way. The passband in Figure 17 is 8 kHz - 14 kHz. Figure 18 shows line 13 of band 13 (adjacent line to Figure 17) filtered through a passband of 5 kHz - 7.5 kHz. The former filter produced no results, but the later one gave the movie shown in Figure 19. This movie shows the direct p-wave, the direct s-wave, and the reflected s-wave.

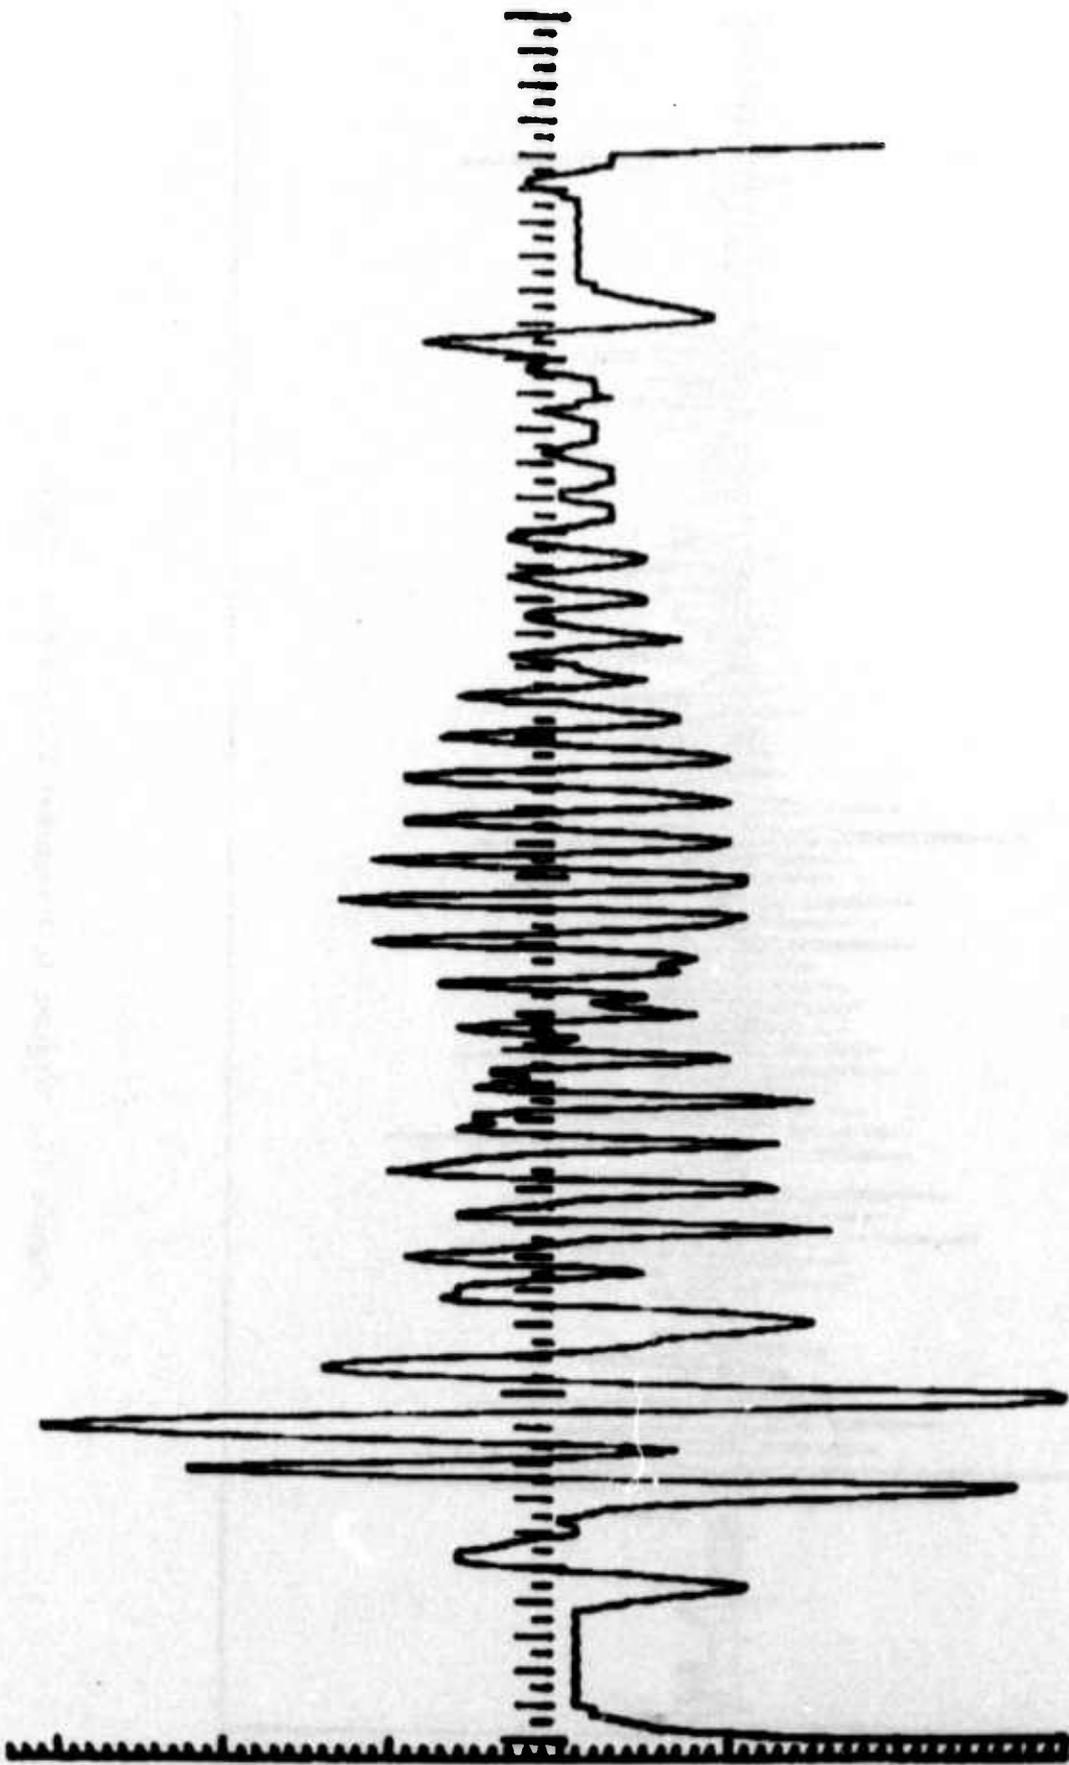
Figure 18. Figure 16 Bandpass Filtered at 6 kHz.

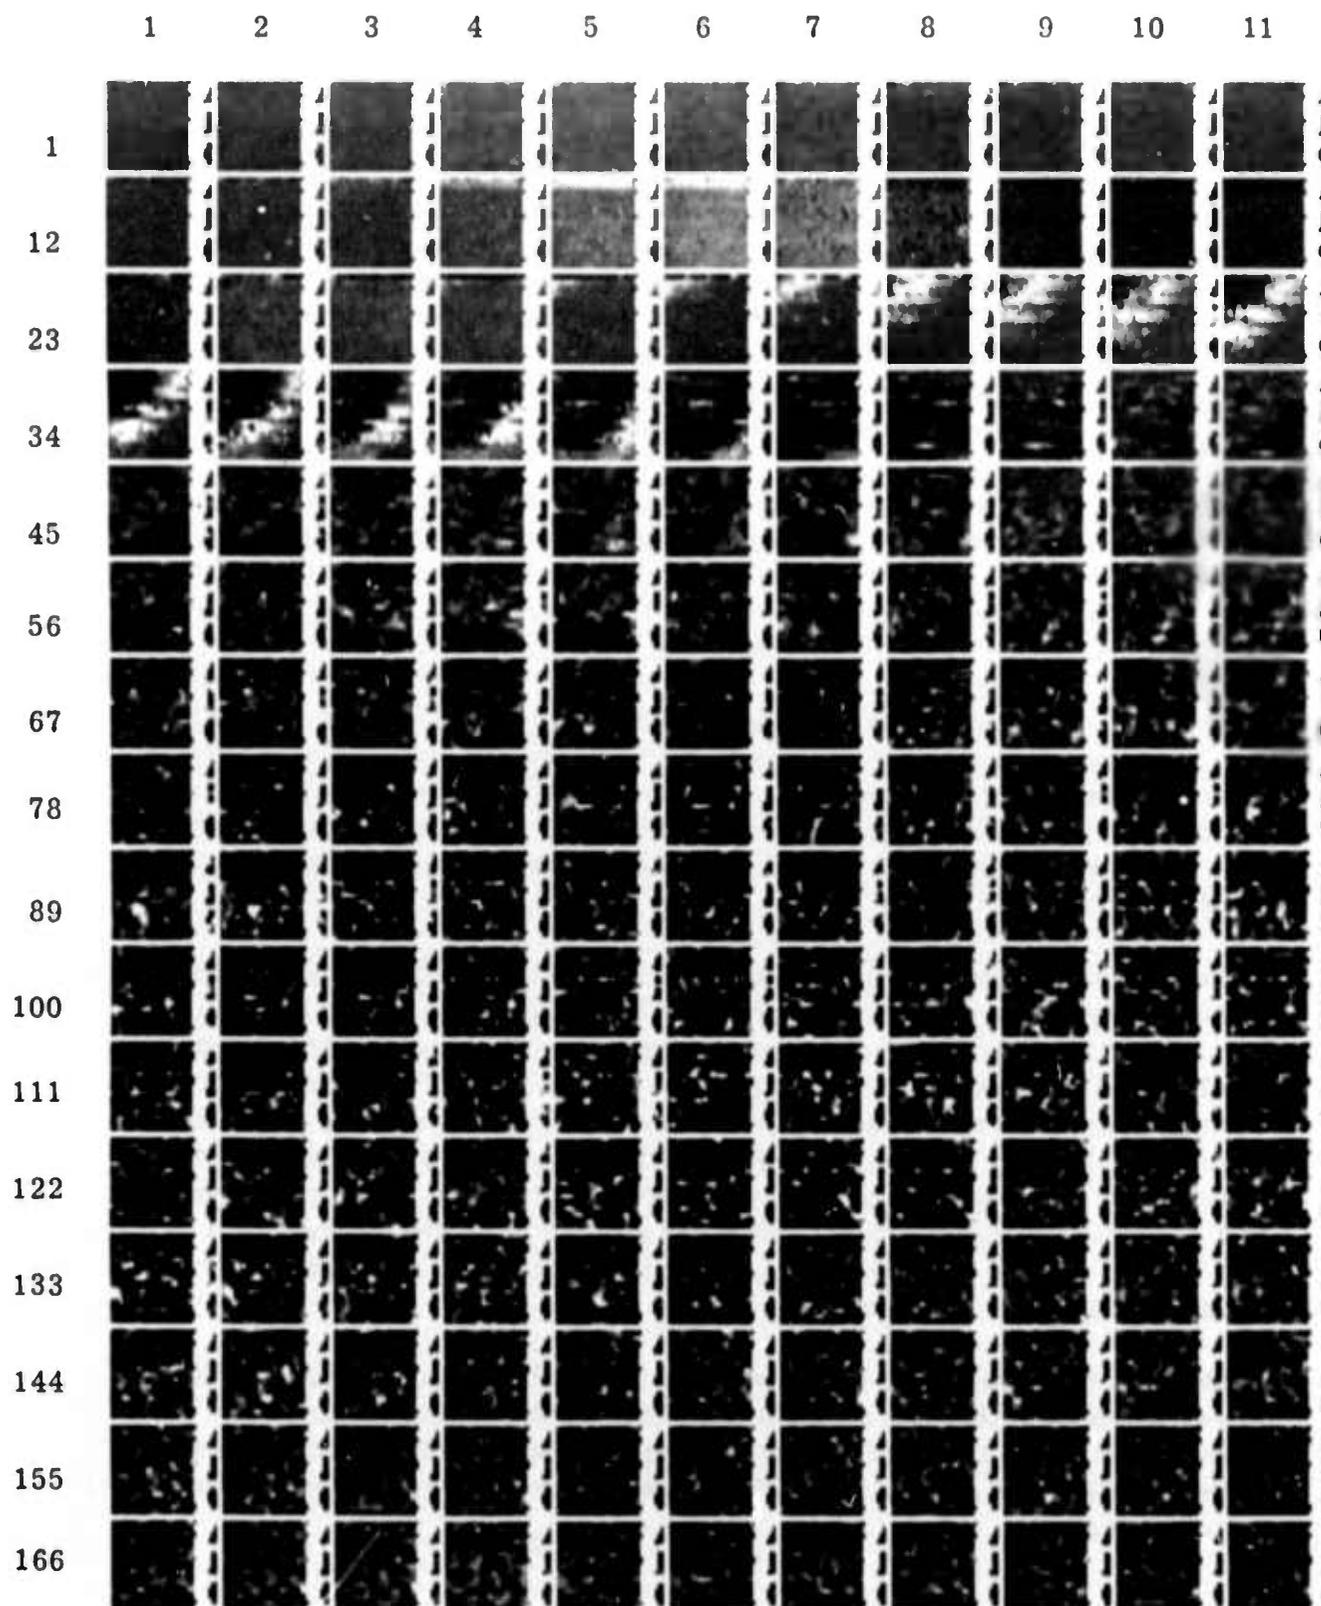
Figure 19. Movie of Frame 16 Showing Direct and Reflected Waves.  
(Movie frames read left to right starting at the top row.  
Frame interval is .014 milliseconds.)

In the following discussion of Figure 19, the individual frames are numbered starting with number 1 in the upper left corner, number 11 in the upper right corner, number 12 below number 1, etc., to number 176 in the lower right corner. Rows are numbered 1 to 16 from top to bottom. Each of the 176 frames is an array of .4 mm x .4 mm squares (pixels). Each frame is 29 pixels high and 28 pixels wide. In scanning the original

photograph with a .1 mm aperture, each band (15 lines) produced 28 samples. Since there were 15 bands, the natural movie frame format would be 28 x 15 pixels. Because of the slight overlap between adjacent lines on the original picture, this format looked fuzzy in the horizontal direction (due to the averaging effect of the overlap), but was very sharp vertically. The net effect was that of extreme astigmatism and was very uncomfortable to view. To counter this, an extra pixel row was placed between each two original rows. This extra row was generated by averaging the intensities of the two rows. This makes the frame equally fuzzy in both directions and thus easier to look at.

The time between frames in Figure 19 is .014 ms; thus the number of frames from frame 21 to arrival is

This says that the reflected p-wave arrives first at 15, 15 and moves toward 1, 1--opposite to the observed wave in Figure 19. The reflected s-wave moves in the correct direction, but it arrives too late and moves too fast to agree with Figure 19.

If we assume the wave in row 5 is a reflected pressure wave, then we know  $n_{rp}$  from Figure 19 and can calculate

Based on these two tests (direction of travel and perpendicular distance), the obvious choice for the identity of the wave in row 5 of Figure 19 is a shear wave.

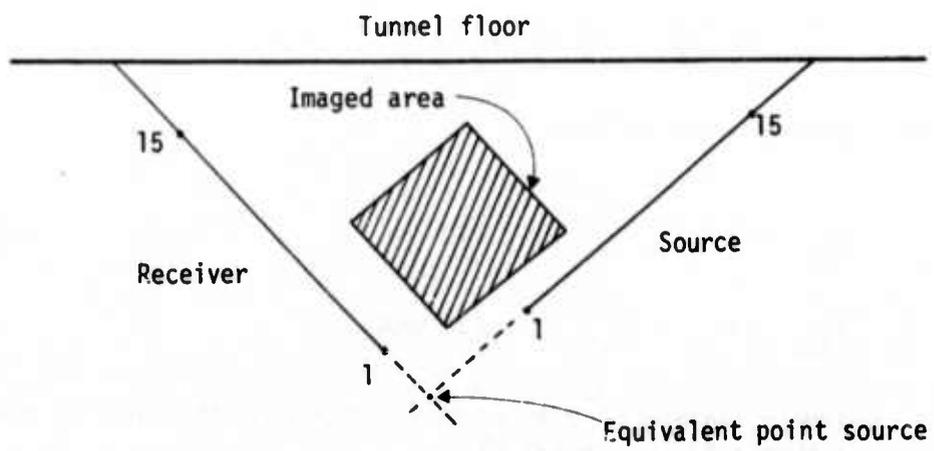
Figure 20. Image Area and Point Source Relative to Test Holes.

We can easily eliminate reflections from the surface by the direction of travel. The upper left corner of each frame corresponds roughly to the location of the equivalent point sound source. The rock surface is beyond the lower right corner. Figure 20 illustrates this. The upper left corner of each frame corresponds to source position 1 and receiver position 1. In the figure, this is at the midpoint of the line connecting source 1 to receiver 1. The shaded area is the equivalent image area corresponding to the frames, and the equivalent point source is at the intersection of the two lines. Thus a surface reflection would appear to propagate in the opposite direction to a direct wave.

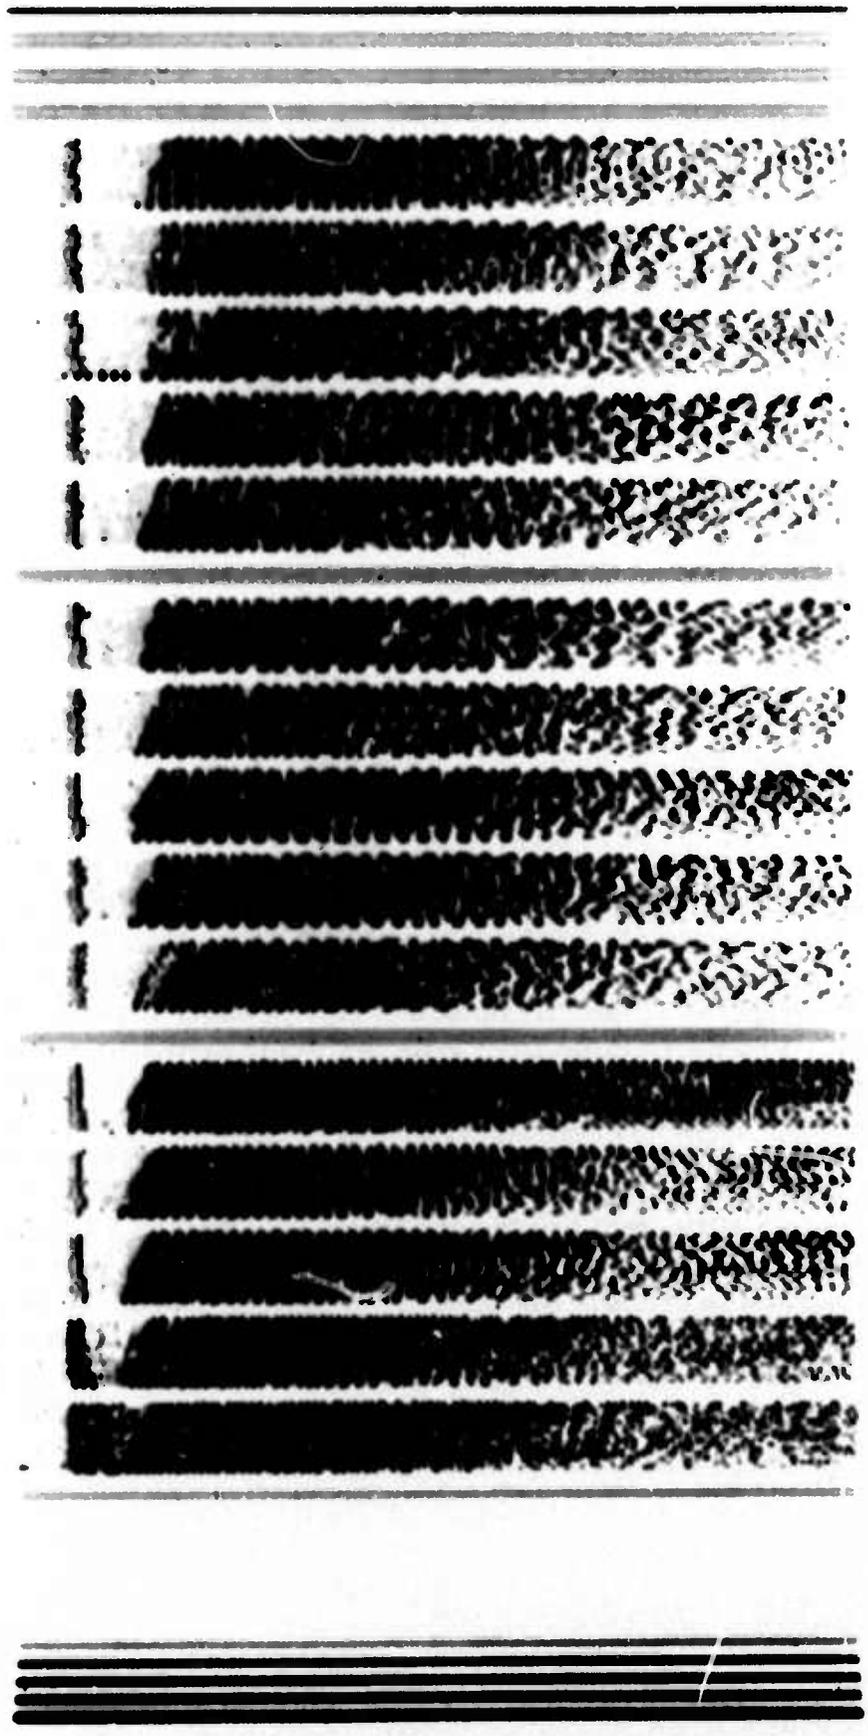
Figure 21. Frame 13: Data Recording from Hole Pair 4.

Frame 16 was one of five frames that were digitized, frames 3, 6, 13, and 19 being the other four. The reason for selecting these five frames was that they represent all 4 hole pairs and that the picture problems (alignment, intensity, etc.) were minimal (or at least solvable) for these five frames. Figures 21 and 22 show the raw data for frames 13 and 19, respectively. Frame 19 (hole pair 3) shows some structures that are probably due to propagating waves. However, it was not possible to align this frame, and the results from processing the unaligned data were negative. Frame 13 was produced while the external synch was working. This frame was easy to align, and it was processed with the same 5 kHz - 7.5 kHz bandpass filter that produced Figure 19. Figure 23 shows the resulting movie. This appears to show the synch pulse in row 3, but the rest of the picture is chaos. An explanation for the failure to reveal the direct waves was not pursued, but a computer program malfunction is suspected. In any event, it is doubtful that the reflected wave would be visible in this frame since its amplitude was so low for hole pair 1.

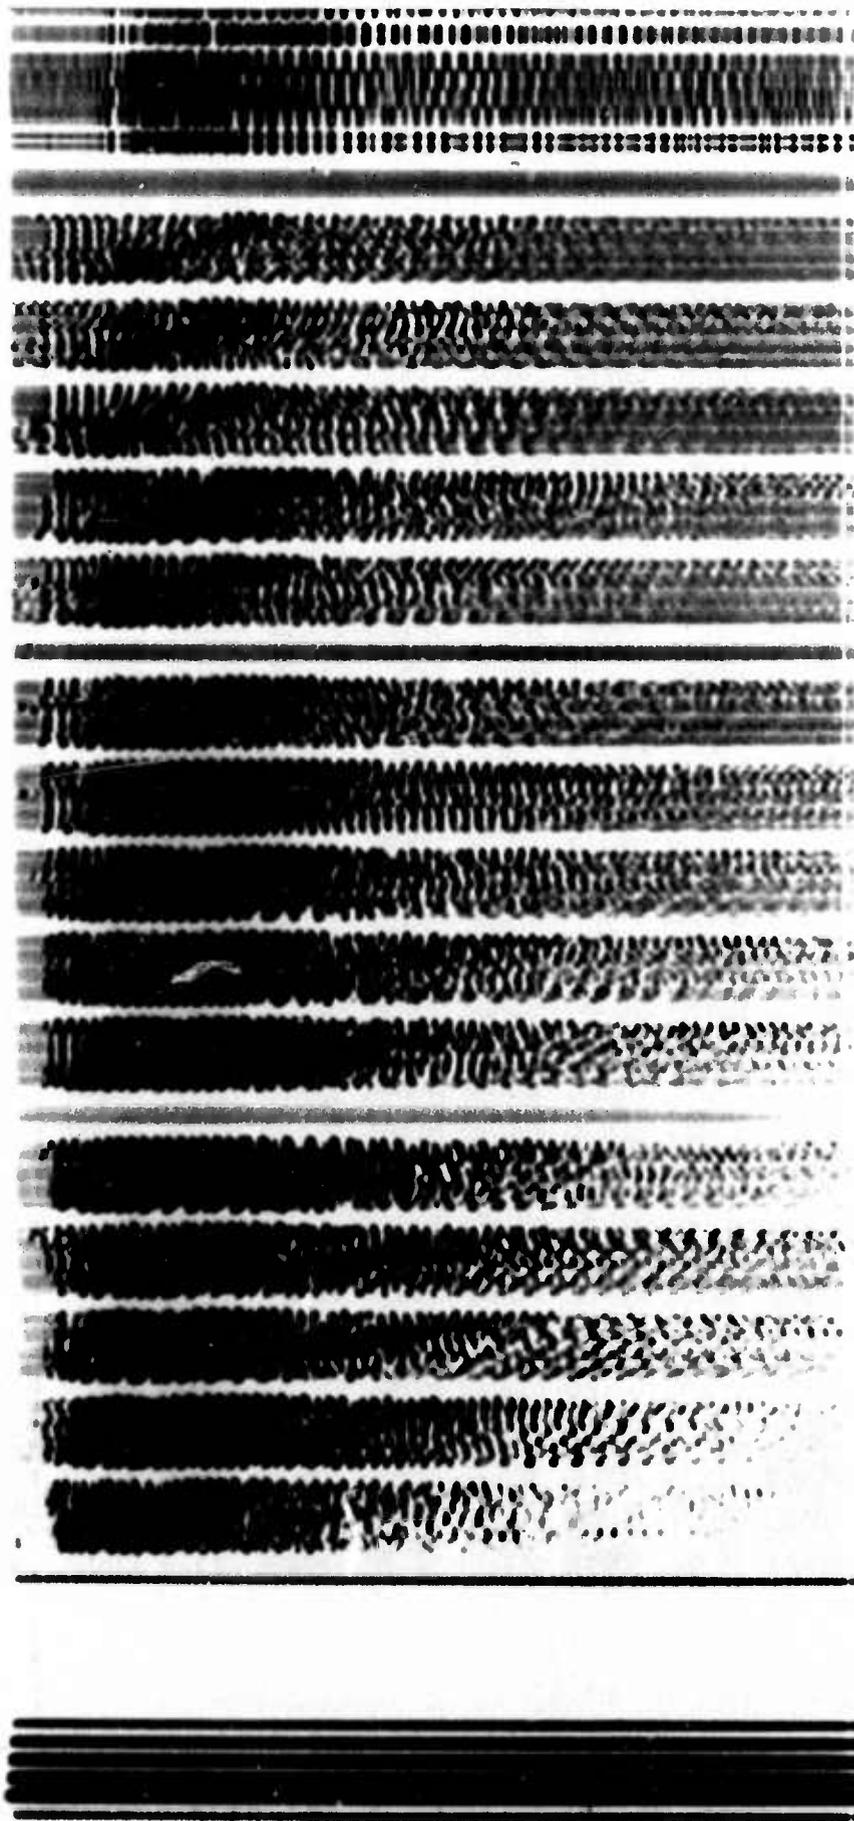
Figure 22. Frame 19: Data Recording from Hole Pair 3.

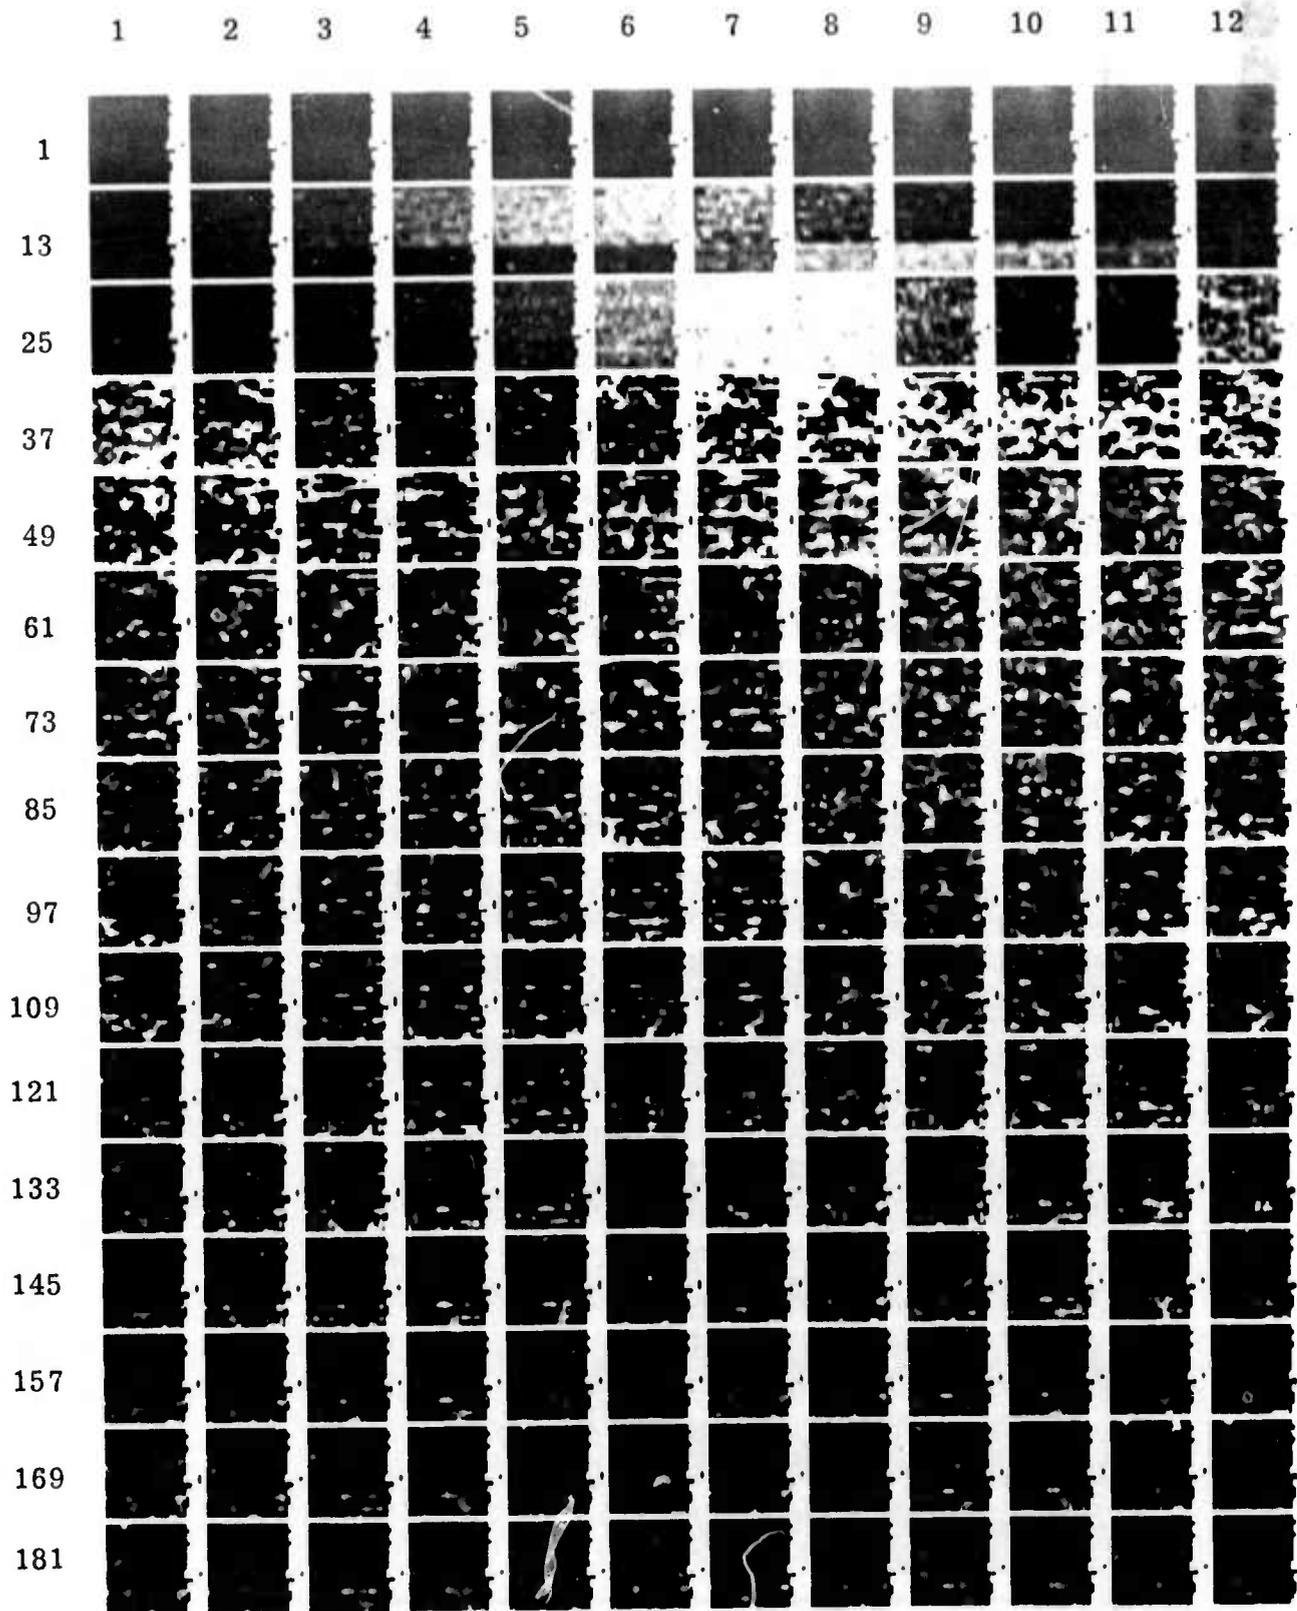
Figure 23. Movie of Frame 13. (Movie frames read left to right starting at the top row. Frame interval is .014 milliseconds.)

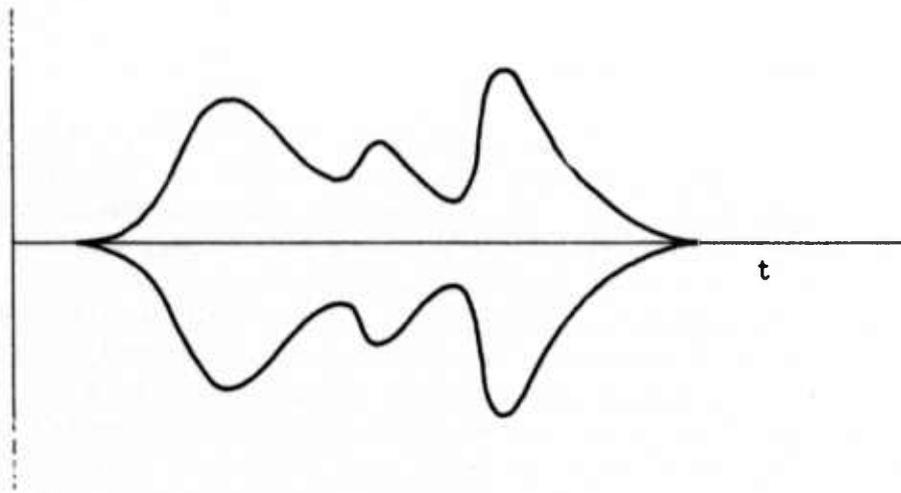
Figure 24. Sketch of Non-coherent Pulse Train Envelope.

During November 17, 19, 20, and 21 (November 18 was a day off), the transient recorder was operated with the internal trigger. Previous to this time the external trigger mode was used, but this started to cause problems that interfered with the data recording so the other mode was used. Thus, if the pulses had been happening earlier, they would not have been noticed. During November 17 and 19, there were time periods 20 to 50 minutes long when data collection could not be done because these pulses would trigger the transient recorder as soon as it was reset. During these times there were two kinds of pulses being detected. One was an exponentially decaying sinusoid with time constant of 1/2 ms to 1 ms, peak amplitude of 2 mv to 10 mv, and frequencies of 3-1/4 kHz, 6-1/2 kHz, and 13 kHz. The other kind was a non-coherent pulse train, lasting up to 50 ms, having peak amplitudes (for the individual pulses) of 2 mv to more than 100 mv. The envelopes of the individual pulses were generally quite smooth with the leading edge increasing somewhat more rapidly than the trailing edge decreased. Figure 24 is a rough sketch of this kind of envelope. Also in the second class were pulse trains and individual pulses with no clearly defined envelope. The exponentially decaying pulses were well explained on November 20 as being due to slippage of the rubber parts that held and supported the accelerometer mounting. This slippage was eliminated by lubricating the entire accelerometer assembly with silicon grease. The 6-1/2 kHz frequency was similarly identified as the resonant frequency of the accelerometer as it was mounted, the other frequencies being harmonics and sub-harmonics of this frequency.

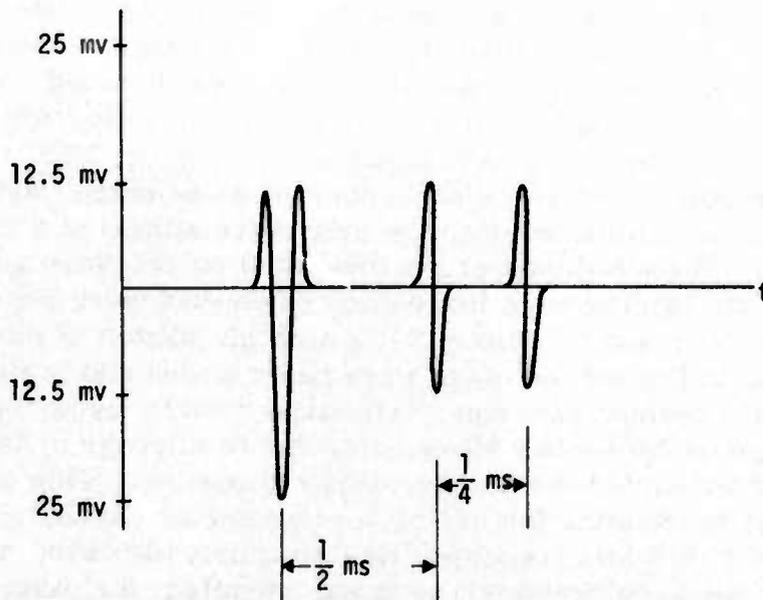
Figure 25. Pulse Shape Associated with Hydraulic Power Pack Starting.
