Advanced Techniques in Crash Impact Protection and Emergency Egress from Air Transport Aircraft

AGARDograph No.221
ADVANCED TECHNIQUES IN CRASH IMPACT PROTECTION AND
EMERGENCY EGRESS FROM AIR TRANSPORT AIRCRAFT

Richard G. Snyder, Ph.D.
Head, Biomedical Department, and Research Scientist
Highway Safety Research Institute
Institute of Science and Technology
and Professor of Anthropology
Department of Anthropology
The University of Michigan
Ann Arbor, Michigan 48105
U.S.A.

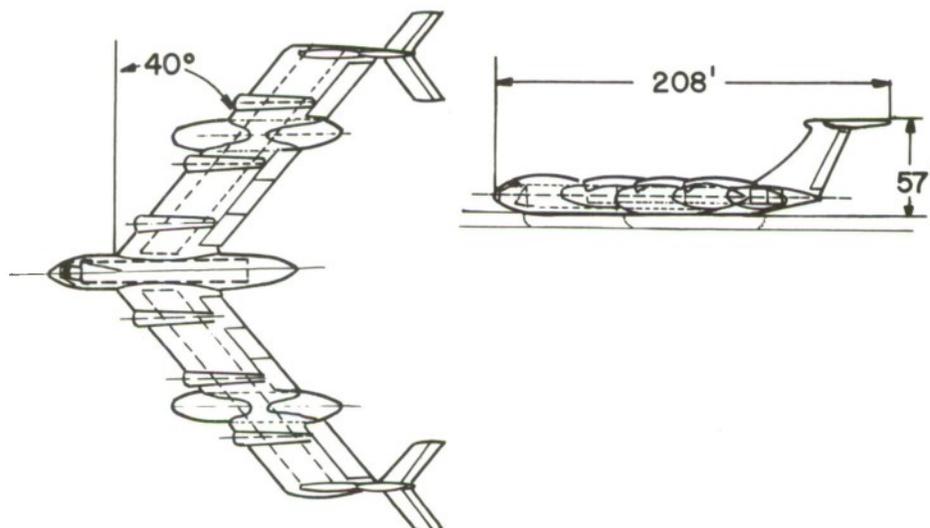
Fig. 1. Future concept for air cargo. NASA Spanloader cargo flying wing, having 2.4 million lb takeoff weight, span of 375 feet [Aviation Week, 1974 (28)], and utilizing air cushion landing system. After Lange, 1975 (53).

One unique proposed feature of the Spanloader is use of a three-element air-cushion landing system, permitting this air transport to be operated from unprepared terrain or water. The principal elements of the air cushion landing system are the trunks and ducting for air distribution. As illustrated in Fig. 2 the head-on profile shows an enlarged cross section through the center body, with the trunk inflated. The air supply duct is continuous from outboard body to outboard body, with air admitted to the trunks by valving. The air can be admitted to non-perforated inner liners and sealed off for parking. Such a system might also alter the crash impact pulse presently seen in air transport takeoff or landing accidents and increase potential occupant survivability.

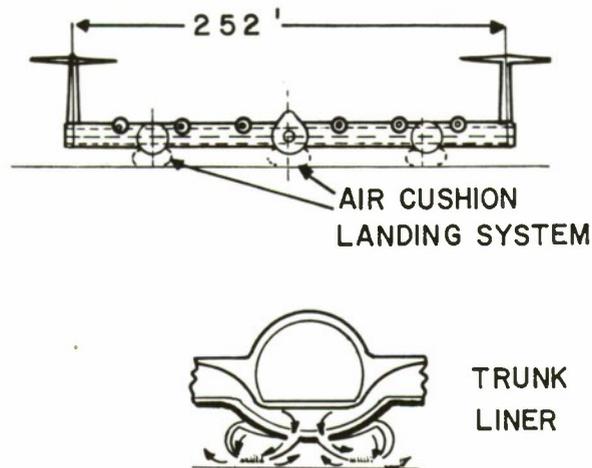
Fig. 2. Concept for air cushion landing system for Spanloader Transport Aircraft, showing enlarged section of air cushion. After Lange, 1975 (53).

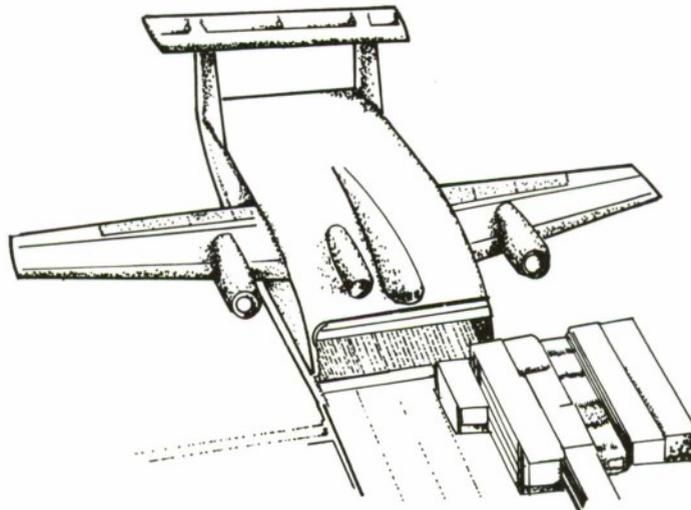
Fig. 3. International Husky Corporation/Boeing future concept lifting-body air freighter [Aviation Week, 1974 (32)].

1.3.4 Very Wide Lifting-Body Transports. For the past three years, Boeing has been studying a new freighter concept with Cole's International Husky Corporation, including extensive wind tunnel tests on an extremely wide fuselage in lifting-body shape housing five side-by-side cargo bays 27 m (90') long (Fig.3). The long-range version is intended to meet USAF's C-XX requirement for advanced cargo transport (57).

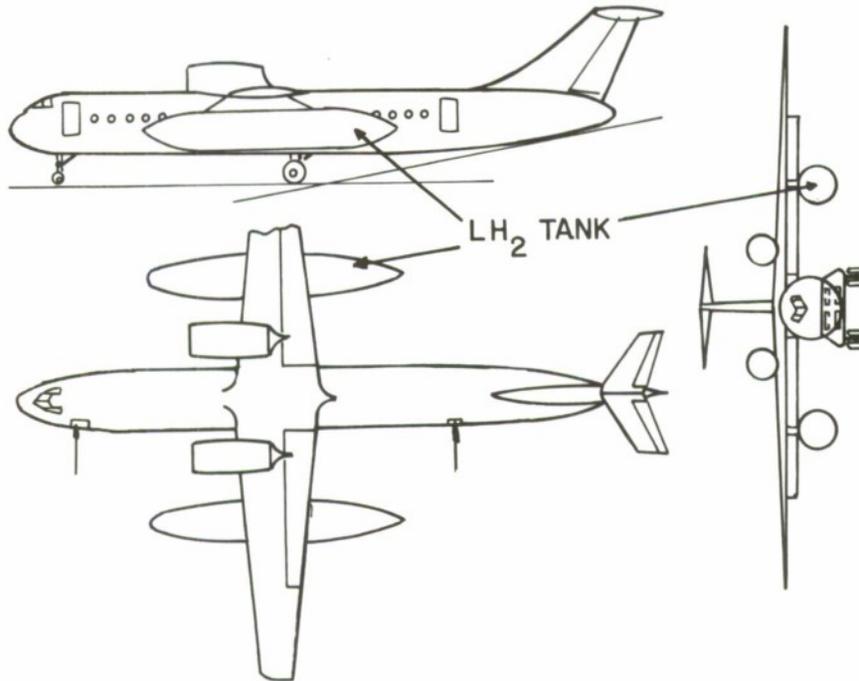
Fig. 4. Possible configuration of short-haul liquid hydrogen-fueled aircraft with external tanks [Automotive Engineering, 1975 (34)]. After Carline, 1975 (38).

1.3.5 Liquid Hydrogen-Fueled Transports. Some future air carrier aircraft may be fueled by liquid hydrogen as an alternative fuel. However, one of the design problems resulting from the use of low-density LH₂ fuel is the volume of tankage required when compared to conventionally-fueled aircraft. Wide-body aircraft employ high bypass ratio engines to reduce fuel volume required, while narrow-body transports utilize low bypass ratio engines. The LH₂-fueled aircraft would require approximately 4 times the volume for JP-fueled airplanes for a given gross weight, or 3.7 times when equal payload/range capability is considered [Carline, 1975 (38)]. Long-range large bodied aircraft might have LH₂ tanks located in the upper and rear fuselage. Short-haul smaller sized air transports of the McDonnell Douglas DC9-30 category might be designed with external tanks, as illustrated in Figs. 4 and 5.

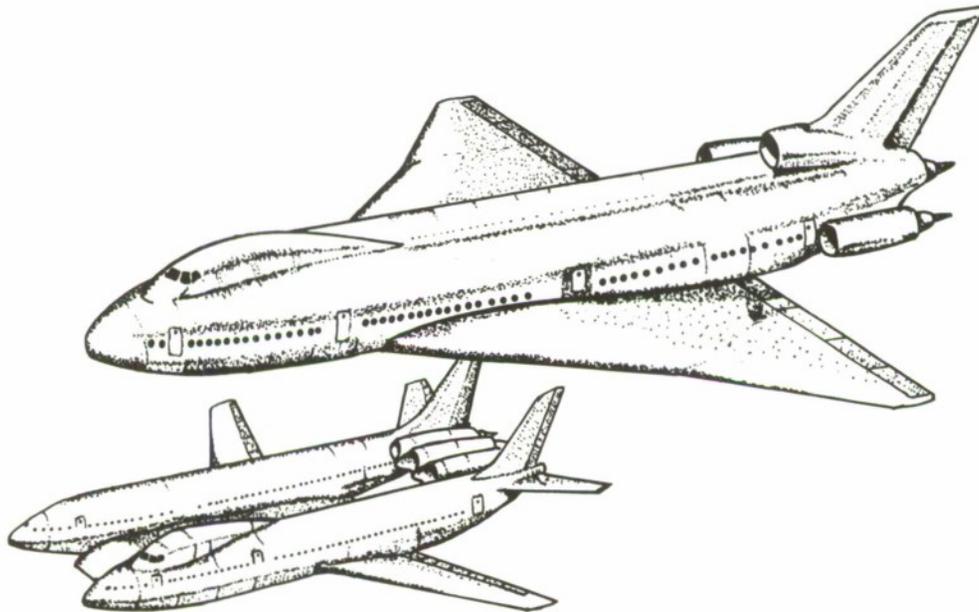
Fig. 5. Conception of long-range liquid hydrogen-fueled delta winged air transport and twin-fuselage configuration, featuring hydrogen tanks slung between two cabins [Automotive Engineering, 1975 (34)]. After Carline, 1975 (38).

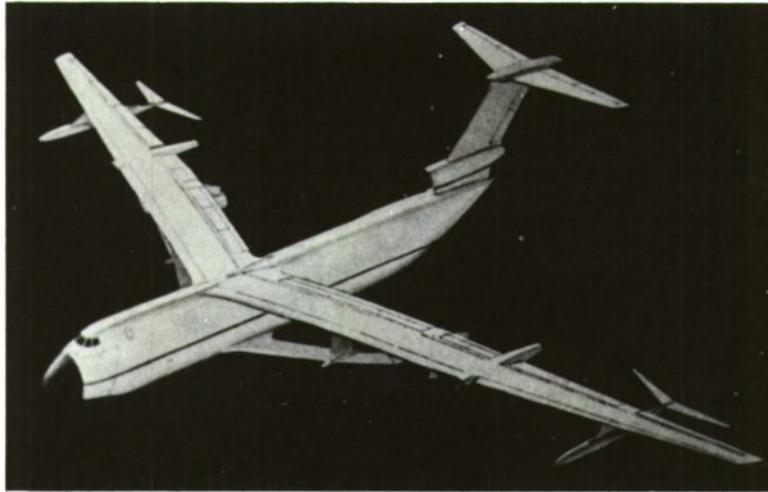
Fig. 6. Boeing concept of high wing air transport braced by struts. After Aviation Week, 1975 (29).

1.3.6 Very Large Transports. A Boeing Company concept for a laminar flow control future air transport features a high wing braced by a strut as shown in Fig. 6. The European aircraft industry may be expected to build upon the knowledge acquired from the Concorde and Airbus to design new transportation needs outside the present subsonic domination of the U.S. Dornier cites very large cargo aircraft as one area of future interest with cargo aircraft exceeding 600 t payloads. A ten-engine advanced design having 1,000 t payload capacity has been suggested by Dornier GmbH [Dornier, 1975 (41)].

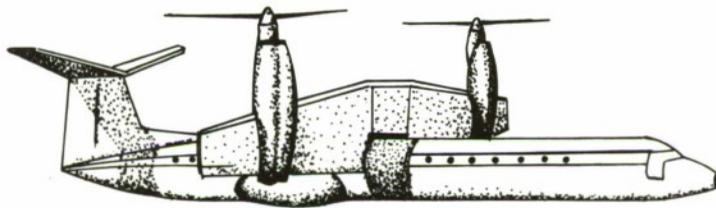
Fig. 7. British Westland VTOL two-engine tilt-wing commercial air carrier design. After Cook, 1975 (39).

McDonnell Douglas YC-15 AMST, are currently in prototype fly-off competition as a USAF replacement for the Lockheed C-130 Hercules transport aircraft [Boeing YC-14, 1975; Taylor, 1975 (33, 65)]. The Boeing YC-14 and McDonnell Douglas YC-15 advanced medium STOL transport AMST prototype programs are expected to provide technical fallout for new commercial transports. A 150-200 passenger airliner version could be in service by 1980, although a more realistic marketing date may be 1985 [Marks, 1976 (54)]. The AMST adaptability to future commercial versions is also being considered by NASA's Quiet Propulsive Lift Technology program for generating commercial transport innovation. However, the YC-15 military version with a high wing and Mach 0.75 cruise has resulted in negative airline reaction [Aviation Week, 1975 (28)]. Wind tunnel tests of other advanced short-haul designs for the 1980's are underway at Ames Research Center, NASA [Elson, 1975 (42)]. The major crashworthy hazards in slow approach military STOL aircraft involve fuselage crushing, flammable fluid ignition, crew, troop, and litter patient restraint failures, nose landing gear failure, and cargo restraint failure as described by Haley, 1976 (50). An early U.K. V/STOL design for a commercial airliner is shown in Fig. 7, illustrating a British Westland VTOL two-engine tilt-wing project [after Cook, 1975 (39)].

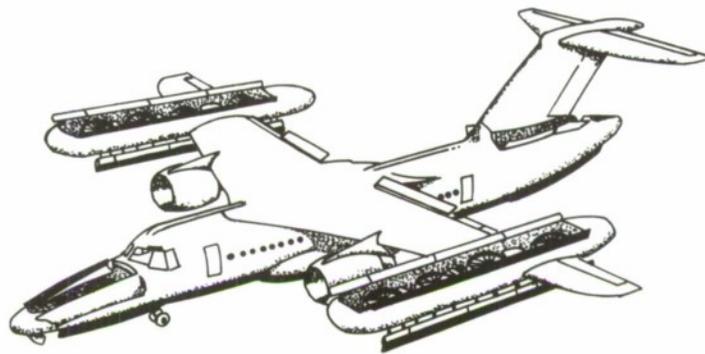
Fig. 8. The Dornier Do 231 V/STOL air transport design for the 1980's in vertical takeoff and landing configuration with lift engine doors open [Courtesy Dornier AG, 1974 (40)].

As a result of the experimental Do 31 E tests, Dornier designed the Do 231 V-jet, utilizing bypass jets for propulsion, supplemented by a large number of independent lift engines with very high bypass ratio for the V/STOL phase. This unique design (Fig. 8) is envisioned in two versions, one for military use with 800 km (500 mi) range including 400 km (250 mi) at low level with 10,000 kg (22,000 lb) military payload, and a civil transport version carrying 100 passengers, four stewardesses, and up to four crew on the flight deck. The engine system consists of two RB.220 bypass cruise engines mounted on pylons on the inboard wing sections, and 12 RB.202-25 lift engines. In the basic design the passenger cabin takes 16 rows of seats with 6 seats abreast. The evaluation committee of the German Ministry of Economic Affairs has selected the Dornier concept as the most promising line for future developments [Dornier, 1974 (41)].

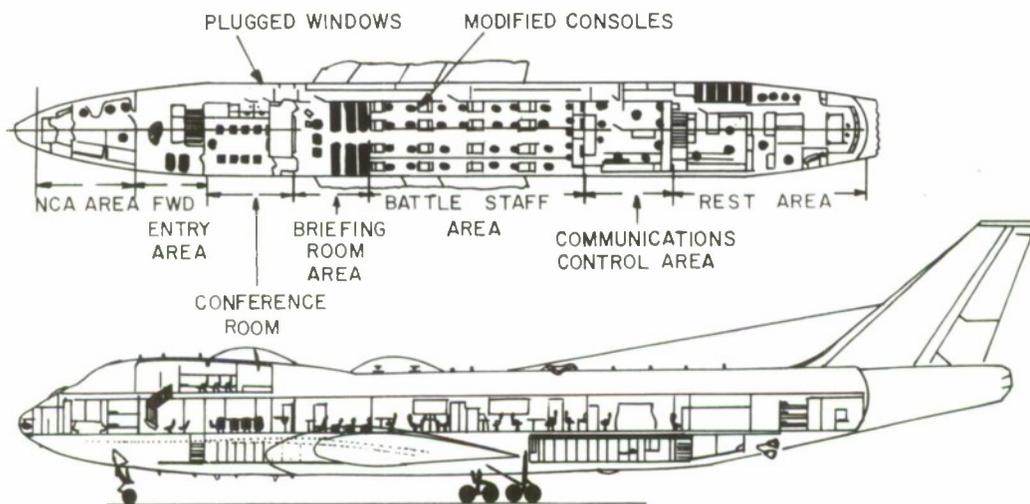
Fig. 9. USAF Boeing 747-E4A Advanced Airborne Command Post Design [Aviation Week, 1974 (32)].

1.3.8 Military Advanced Airborne Command Post. Advanced aircraft such as those discussed in this section may also pose new human factors, crash impact, and emergency egress problems. Some military transports may present special emergency egress problems, such as the USAF Boeing 747-E4A Advanced Airborne Command Post [Taylor, 1975 (65)], which primarily utilizes conventional seating rather than state-of-the-art, as shown in Fig. 9.

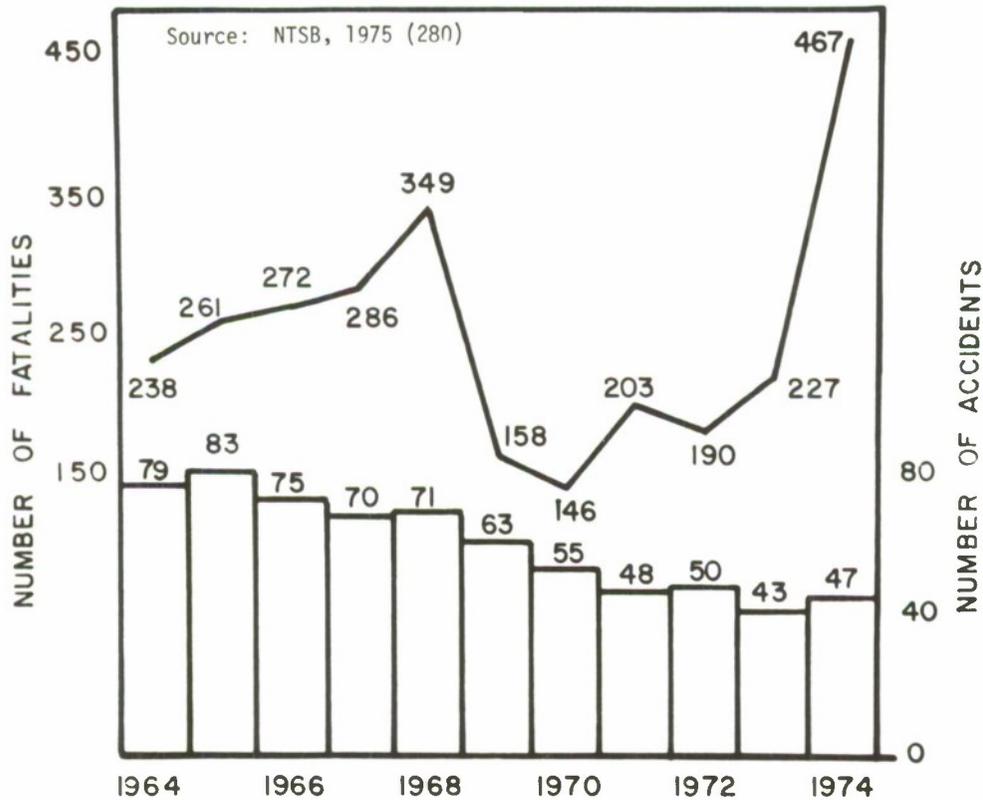
Fig. 10. U.S. Scheduled Air Carrier accidents and fatalities, 1964-1974.

In operations of U.S. air carriers from 1964 through 1974 there were 684 accidents reported, of which 109 were fatal accidents, with 2,797 fatalities for this most recent 10-year period [National Transportation Safety Board, 1972 (213); 1975 (280)]. During 1974 U.S. scheduled air carriers were involved in 47 accidents, including 9 fatal accidents, and totaling 467 fatalities [National Transportation Safety Board, 1975 (280)]. This was more than double the 1973 total of 227 fatalities, and in the case of U.S. scheduled air carrier operations the death toll was the highest since the 499 recorded in 1960. Fig. 10 provides accident data from 1964 through 1974.

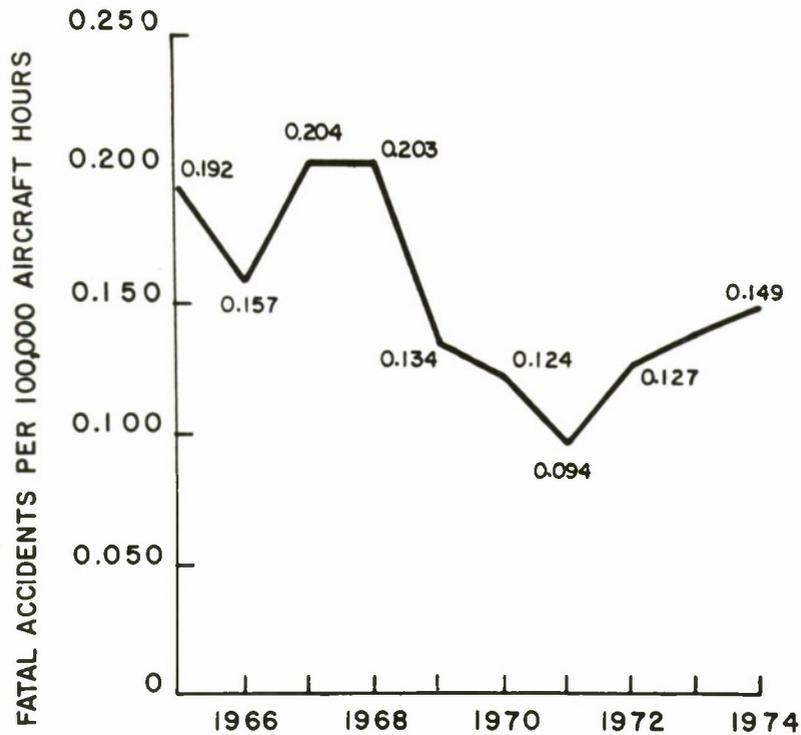
Fig. 11. Fatal accident rate. All U.S. airline flying.
(Fatal accidents per 100,000 aircraft hours. Includes certified route and supplemental air carriers.) NTSB Annual Report, 1975, p. 6.

Similarly, the fatal accident rate has increased in each of the last three years from the 0.94 per 100,000 hour rate achieved in 1971. The 1974 rate was the highest since 1968. The passenger fatality rate in certified route carriers' scheduled domestic and international passenger service has also shown an upward trend. The NTSB reports that from a record low of 0.001 passenger fatalities per 100 million passenger miles flown in 1970, this rate fluctuated to 0.119 in 1971 and 0.100 in 1972, rising to 0.115 in 1973 and 0.256 in 1974, the highest rate in ten years [National Transportation Safety Board Annual Report to Congress, 1975 (280)]. This is shown in Fig. 11.

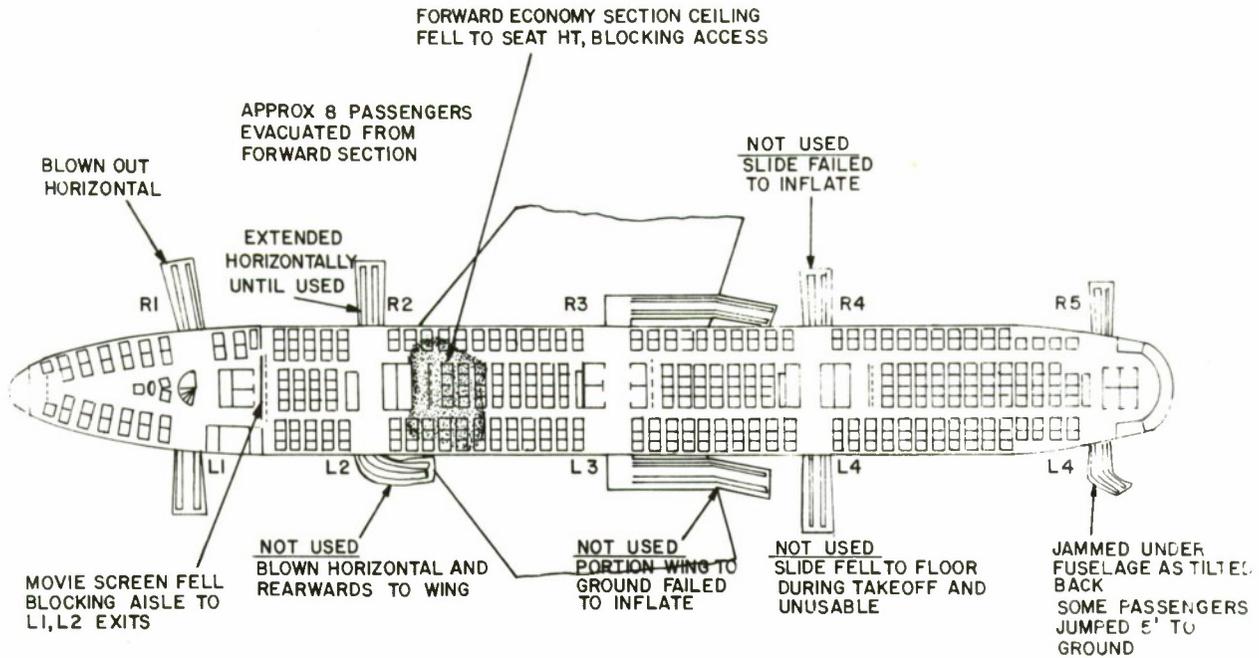
Fig. 13. Diagram of emergency egress hazards contributing to injuries in this Boeing 747 accident.

Motion pictures taken of the landing showed that right and left exits No. 1 were opened 30 seconds after the aircraft came to a stop. The right No. 2 exit was opened in 38 seconds, right exit No. 3 opened in 48 seconds, left and right exits No. 5 opened 1 minute 10 seconds after the aircraft stopped. The first occupant evacuated (right No. 1 exit slide) 43 seconds after the aircraft stopped, and the first occupant to use the left No. 1 exit slide did so 56 seconds after stopping. The evacuation of approximately eight passengers from the forward section of the aircraft, in addition to the movement of passengers to the rear of the passenger cabin because of failure or partial failure of emergency egress slides at five of the ten exits (L-2, L-3, L-4, R-4, L-5) resulted in a shift of weight which caused the aircraft to tilt back on the rear fuselages. This occurred as the right No. 5 door was opened (Fig. 14), and resulted in slide L-1 slanting aft. This slide was not used until someone on the ground pulled the slide to a more normal position. Slide L-2 was blown back across the wing and parallel to the fuselage, and was not usable. Slide R-2 extended in a horizontal position until a passenger entered the slide. The left-over-the-wing slide L-3 was not used because the slide portion over the wing flap to the ground did not inflate. The gas generator for this slide was in the left body gear wheel well and the trigger mechanism had sustained impact damage. The L-4 slide had fallen to the floor during the takeoff and was not usable. The R-4 slide did not inflate. The gas generator bottle, mounted in the upper portion of the door structure, had shifted toward the center of the aircraft and misaligned the trigger mechanism and the bottle. Slide L-5 was

jammed under the fuselage as the aircraft tilted to the tail-down position. The exit floor was then about 1.5 m (5 ft) above the ground and some passengers utilized the exit by jumping to the ground. The forward exit slides became almost vertical as the aircraft settled back on its tail. At least four persons were observed using slide L-1 and others used R-1 after the aircraft tilted. Eight passengers were hospitalized with serious back injuries after they used the No. 1 slides. Nineteen other persons received minor cuts, abrasions, contusions and sprains during the evacuation. There was no record of the total elapsed time required to complete the evacuation. Fortunately there was no smoke or fire to affect evacuation.

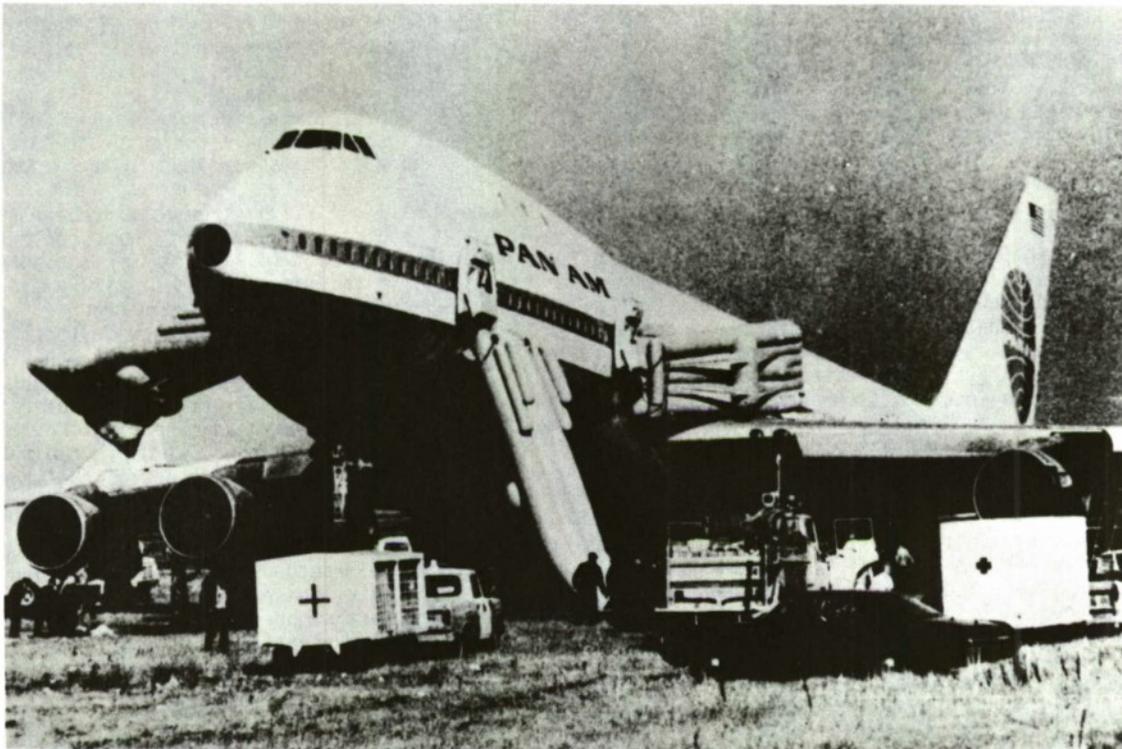
Fig. 14. Pan American Boeing 747 accident at San Francisco 30 July, 1971, resulting in nose-high attitude. 27 injuries were suffered in the subsequent evacuation. Note wind effect on left (L-2) slide, blown aft almost parallel to the wing, and right side (R-1) escape slides. The vertical deployment of left L-1 escape slide resulted in an almost vertical drop of approximately 27 feet (or a 3-story drop). (Photo courtesy NTSB. See ref. 191.)

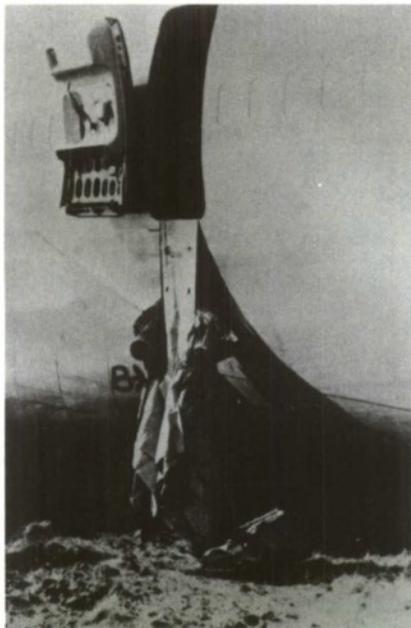
Fig. 15. Evacuation slide failure in Pan American Boeing 747 accident.

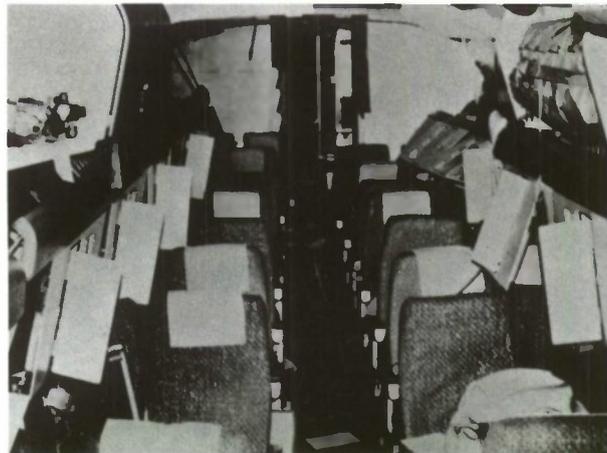
Fig. 16. Obstacles to passenger egress in Icelandic Airlines McDonnell Douglas DC-8-61 "hard landing" included failure of hat racks, injuring passengers, and failure of overhead compartments, spilling life rafts and an emergency escape slide pack into the aisle.

Typical obstacles which may impede passenger evacuation in an accident are shown in Fig. 16. In this case an Icelandic Airlines McDonnell Douglas DC-8-61 experienced a "hard landing" on 23 June, 1973 at John F. Kennedy International Airport, New York. Subsequent to impact the No. 1 engine broke off and a fire erupted in the engine pylon. Of 119 occupants, 30 received minor injuries and 8, including two stewardesses, were seriously injured due to the "hard landing." However, factors influencing this night evacuation included failure of the hat racks in the cabin, injuring passengers and creating egress obstructions; the overhead compartments spilled life rafts into the cabin aisleway; and the emergency escape slide pack on the right rear service door broke loose from its mounts.

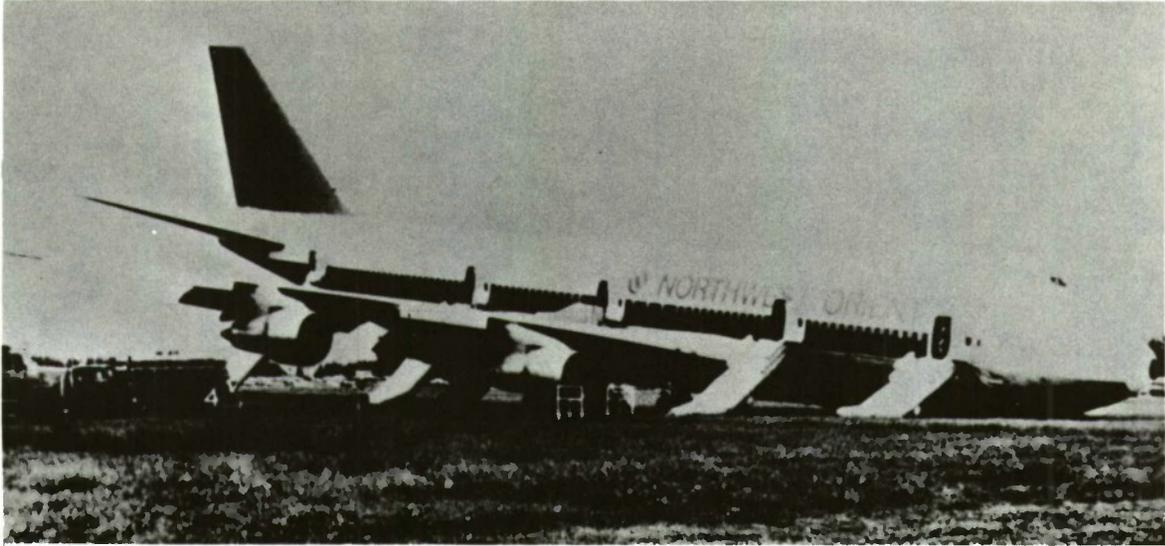
Fig. 17. Tail-high attitude in this Miami Boeing 747 accident rendered the rear emergency evacuation slide unusable (Photo courtesy Wide World Photos).

Evacuation can be hampered by other final orientations of the aircraft fuselage, which may render some emergency exits hazardous or unusable. For example, in a Northwest Orient Airlines Boeing 747 accident at Miami on 15 December, 1972 (244; 411), birds were ingested on takeoff, the nosegear collapsed after striking a concrete abutment, and the aircraft came to rest in a tail-high attitude (Fig. 17). No one was injured in the crash; however, four occupants received minor injuries in the evacuation, which was accomplished in about 2 minutes. In this case the 2 rear exits were unusable, and one evacuation slide failed to inflate, rendering that exit also unusable.

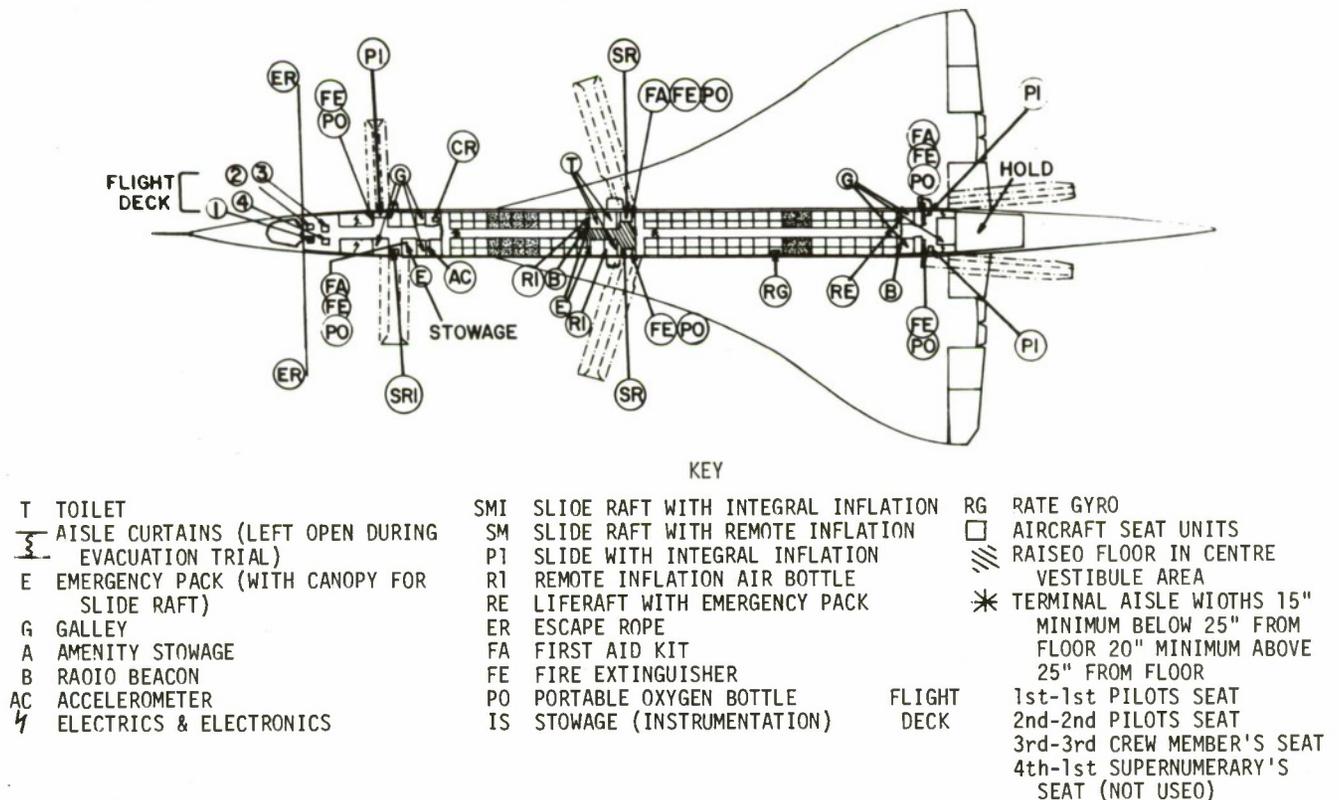
Fig. 18. Cabin layout, safety features, and emergency egress exits on the Concorde, as configured in production aircraft number 204, used in certification tests of February, 1975 (421).

test but the sliding rate decreased to 35 persons per minute (compared to 40 in the first trial, and 46 in the third). The second trial was abandoned after 90 seconds. Analysis of the second evacuation trial indicated that the unusability of the forward exit, uncertainty concerning safety of the center slide, and absence of cabin attendants in other than the exit doorways to redirect evacuees, all contributed to the slower (and possibly more realistic) evacuation test. A total of eight evacuees, all females, were injured in these three tests, and this suggests that emergency evacuation injuries may also be of concern with this new aircraft. As with other current wide body air carriers, the height above the ground of the exit doors when the gear is down is impressive, being 4.95 m (16 ft, 3 in) to the sill of the forward exit [Taylor, 1975 (65)]. However, as was noted in previous accidents, evacuations of wide-bodied air carriers such as the Boeing 747, can present hazardous situations when the sill height results in a high vertical drop of evacuees. Fig. 18 illustrates the various safety features and emergency exit locations of the Concorde aircraft, as positioned on production aircraft number 204, used in the certification tests of February, 1975.

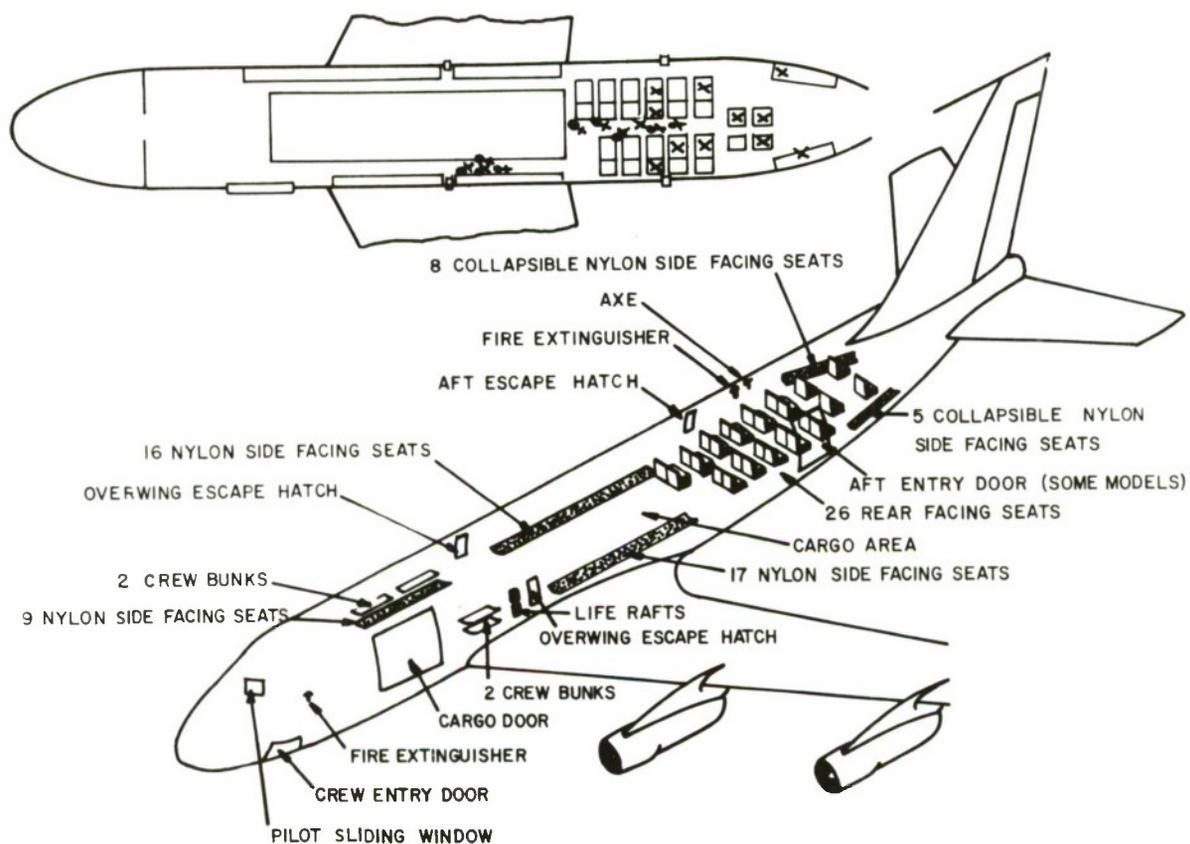
Fig. 19. Location of emergency egress exits and fatalities in Boeing KC-135 crash (Case #1).

In this case, investigation revealed that passengers were not briefed and the pilot did not know how many passengers were aboard. There was no announcement to passengers to prepare for landing. The crash was unexpected by the pilots, and no alarm bell was used prior to crash. Life preservers (LPV's) were not worn by the pilot or some crew members, and only 31 LPV's were worn during egress. Had this crash occurred in the ocean, some 305 m (1,000 ft) from the runway, egress from this aircraft could have resulted in more lives lost. Fire broke out in the aft section and the cargo compartment, and the flight deck filled with black smoke and apparently ammonia gas, causing panic among some passengers. Surviving passengers escaped through the crew entry door, the emergency hatch over the right wing, and the emergency hatch over the left wing.

The pilot, copilot, and boom operator received vertebral compression fractures in the impact due to either not having the shoulder harness on or not locking it prior to landing impact. The navigator noted all the equipment in the compartment above his station came down on his head on impact. Egress problems were noted on the flight deck, with both the pilot and copilot getting stuck in their respective window exits, blocking exit for other crew, and not having time to locate or use the escape rope. Evacuation was completed in 45 seconds. The location of exits and fatalities is shown in Fig. 19. Note the pile-up of four fatalities which occurred aft of the left overwing exit due to aisle blockage from small cargo, and the apparent inability of those passengers in the aft compartment to egress through the right or left aft escape windows, even though one individual was identified as sitting in the aisle seat adjoining the left aft window. In this configuration, 26 individuals used rear-facing seats, but six passengers sitting over the boom pod area would have had great difficulty in assuming the recommended ditching and crash landing position as found in T01C-135KA-1 [pp. 3-52 (436)], even if they had been pre-warned of the crash. Survivors reported that they had a great problem in attempting to evacuate through the available emergency exits from any seated position.

It was concluded by the investigators that the military Boeing KC-135 aircraft was not properly configured to perform passenger service with safe emergency egress, and that emergency escape was impossible under conditions of no emergency lighting, inadequate emergency exits for the number of passengers carried, and lack of briefing. As a result it was recommended that the number of passengers on KC-135 aircraft be limited to the number that can safely egress under simulated emergency conditions in one minute, using only the three escape hatches in the passenger compartment; that the loudspeaker system be modified to ensure positive communication between crew and passengers; that additional emergency exits or enlargement of existing escape hatches be considered; and that installing impact-activated emergency lighting systems for emergency exits also be considered.

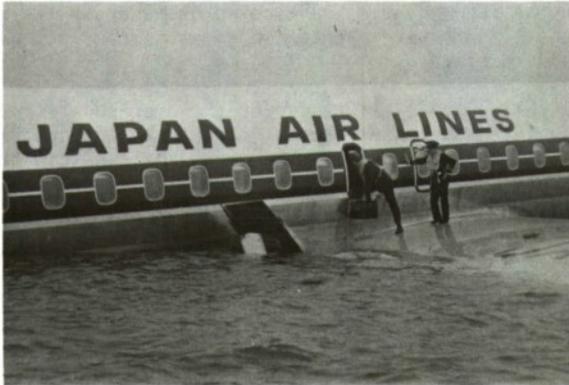
Fig. 20. Crew leaving the aircraft after inadvertent water landing of Japan Air Lines McDonnell Douglas DC-8 in San Francisco Bay, California (Photo courtesy J. Simpson, FAA, CAMI).

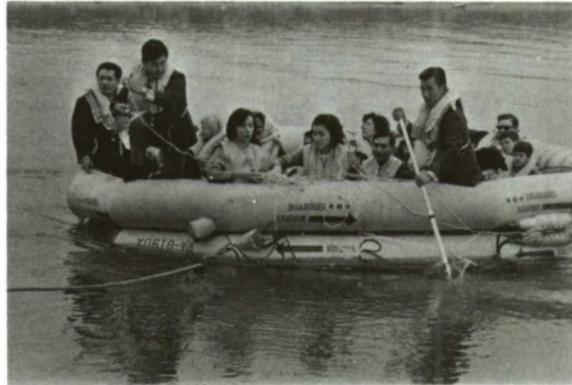
Fig. 21. Passengers evacuated in life rafts (Photo courtesy J. Simpson, FAA, CAMI).

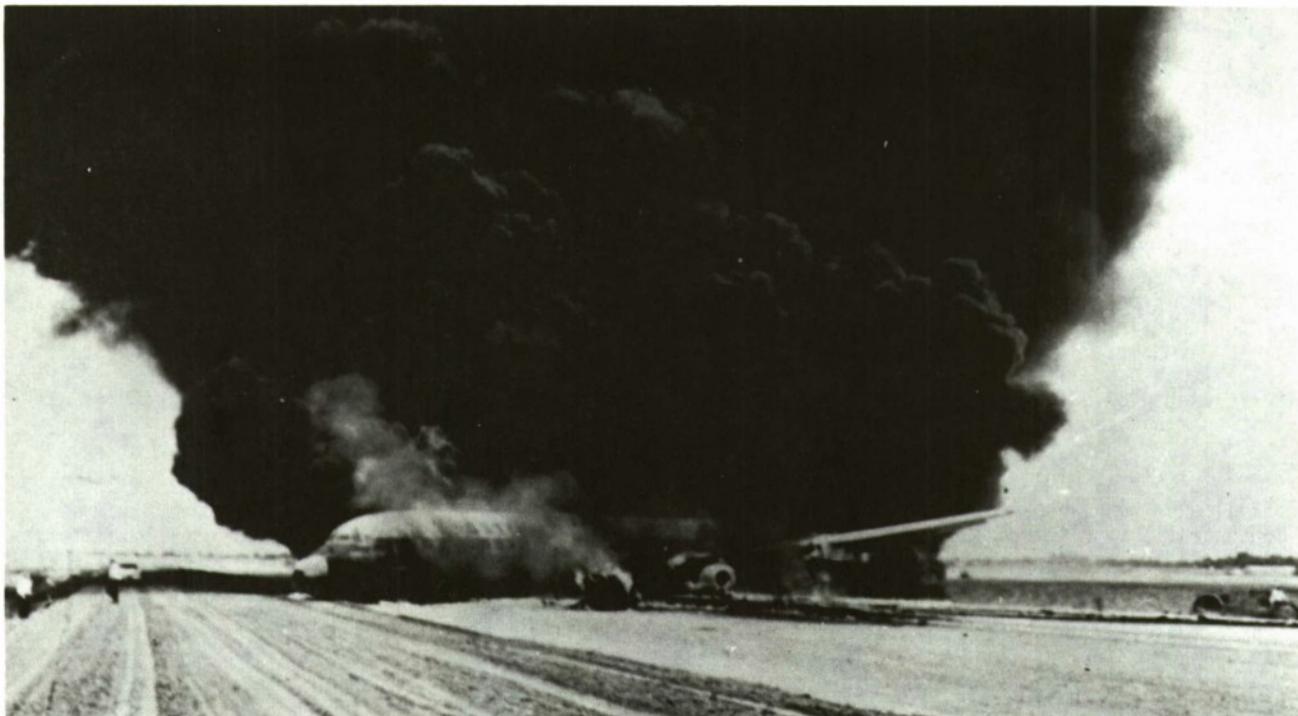
Fig. 22. Fire and heavy smoke resulted in 45 fatalities of 62 passengers in this Trans World Airlines Boeing 707-331 accident at Fiumicino Airport, Rome, 23 November, 1964 (Photo courtesy FAA).

(3) On the afternoon of 23 November, 1964 a Trans World Airlines Boeing 707-331 with a crew of 11 and 62 passengers aboard, crashed in an attempted aborted takeoff at Fiumicino Airport, Rome, Italy. While still traveling at an estimated velocity of 64 km/h (40 mph) it struck a steam roller, continuing some 243.8 m (800 ft) in the next 22 seconds. Twenty seconds after stopping, a center fuselage tank exploded and fire rapidly spread. The fire equipment arrived 3 minutes, 45 seconds after the accident (Fig. 22). This accident was fatal to 45 passengers (72.5%). Of the 17 survivors, 10 received minor injuries and 7 were hospitalized. Carboxyhemoglobin (COHgb) elevations of the 24 fatalities found in the cabin were from 13.8% to 49.0%, although two were only 3.0% and 10.4%. In general, death was attributed to thermal burns or asphyxia, whether the victims were found inside the cabin or were among the 17 whose bodies were found outside the cabin. In those outside the cabin, COHgb values were generally below 10%, but were as high as 35.8%. Four victims died later, primarily of thermal burns [Snow et al., 1971 (424)].

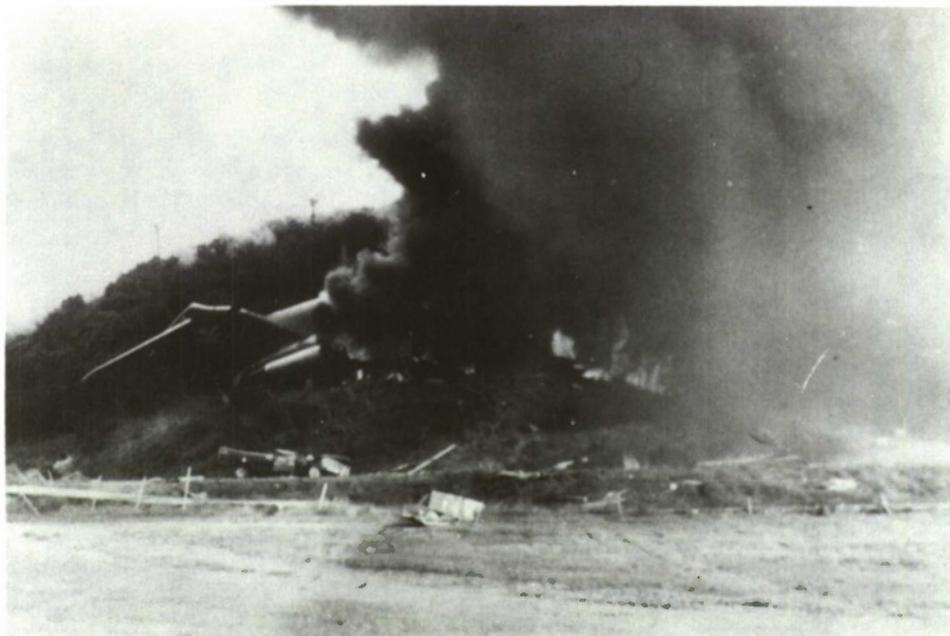
Fig. 23. Dense smoke and fire following crash of Boeing 727 at St. Thomas, Virgin Islands 28 December, 1970 (203) (Photo courtesy NTSB).

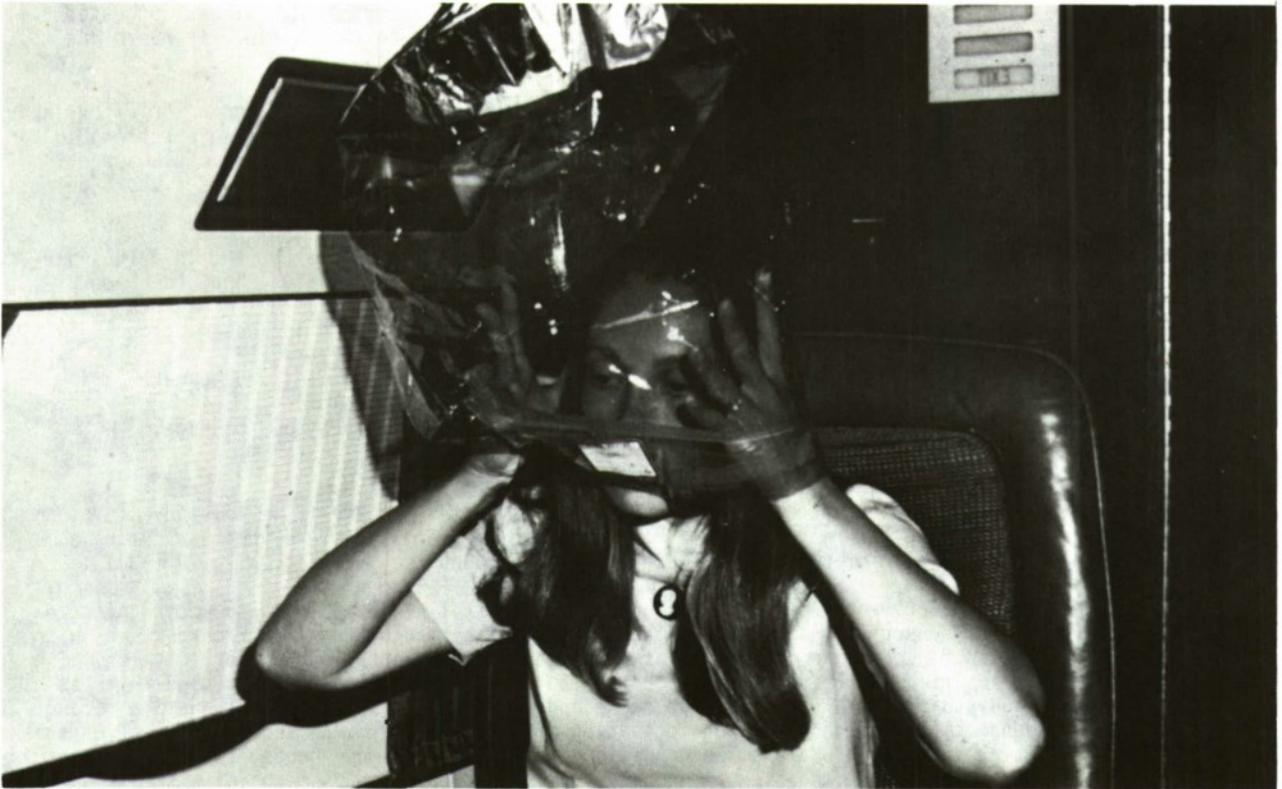
Fig. 24. Demonstration of passenger donning Schjeldahl "S" model "safety" hood in Chrysler Corporation Gulfstream. This smoke hood is presently in use in many corporate, FAA, and other aircraft and has been recommended in several studies for use in USAF air transport aircraft (Photo courtesy Chrysler Corporation).

3.2.2.7 Conclusions of FAA/CAMI 1970 Tests. The six studies summarized in the foregoing indicated that the currently available smoke hood devices tested did protect the individual from the respiratory effects of smoke and provided him with an air sample which was relatively uncontaminated and adequate for evacuation from current civil jet transports. However, there still remained some limitations, primarily that the hood did not increase visibility in smoke other than preventing eye irritation, and the air supply was limited. The septal seal neck of the new Schjeldahl Type S hood had been shown to be a distinct improvement over the older drawstring D type in preventing the penetration of noxious substances into the hood air sample. Several problems pointed out relating to the passenger locating the seal for donning, and the decrement of the seal through repeated usage, were felt to be solvable. Results from these briefing tests indicated that even with a minimal briefing most passengers should be able to use the hood adequately. The major improvement, which was explored in subsequent experimental developments, evaluated the incorporation of a self-contained oxygen supply and carbon dioxide removal agent. In view of the foregoing studies the FAA medical investigators felt that development of a safe "get-me-out" smoke protective device had progressed to the point where its use in civil air carriers should be mandatory. Figs. 24 and 25 illustrate the use of this particular device in the Chrysler Corporation G-2 Gulfstream.

Table XIV provides a summary analysis of the Schjeldahl septal neck seal (Type S) smoke hood, which has been evaluated as the best available device within the current state-of-the-art, and is a production item (see Figs. 24 and 25). Among the factors which tests to date have indicated may be problems are deterioration characteristics, durability, reusability, fit on passengers other than adults, ability to don the hood over glasses, hood fogging, vision, effect upon passengers with cardiac or pulmonary dysfunction, CO₂ buildup, hypoxia, and legal implications. Most of these problems appear solvable or

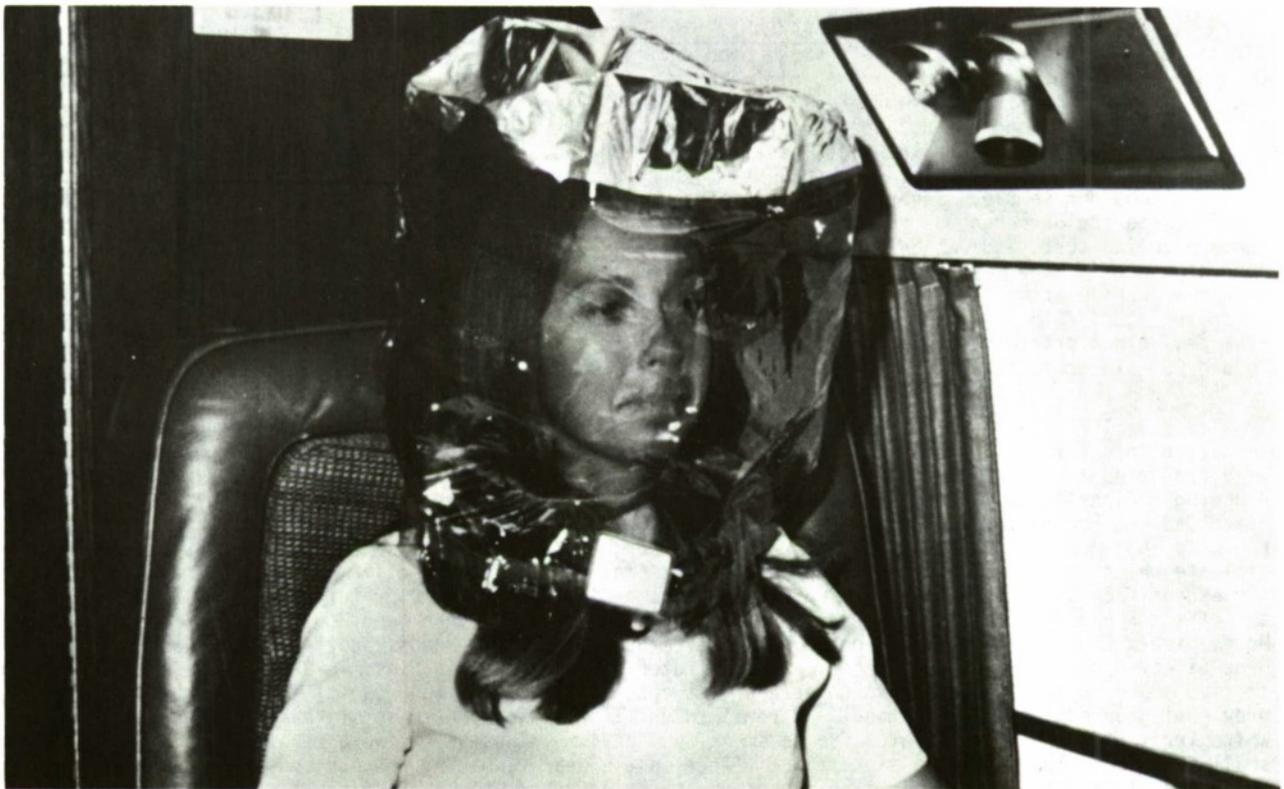
Fig. 25. Once smoke hood is donned it may protect the passenger against toxic fumes and smoke for 4 to 6 minutes, and protect the head and face against the effects of flames exceeding 800°C ($1,472^{\circ}\text{F}$), providing additional emergency egress capability (Photo courtesy Chrysler Corporation).

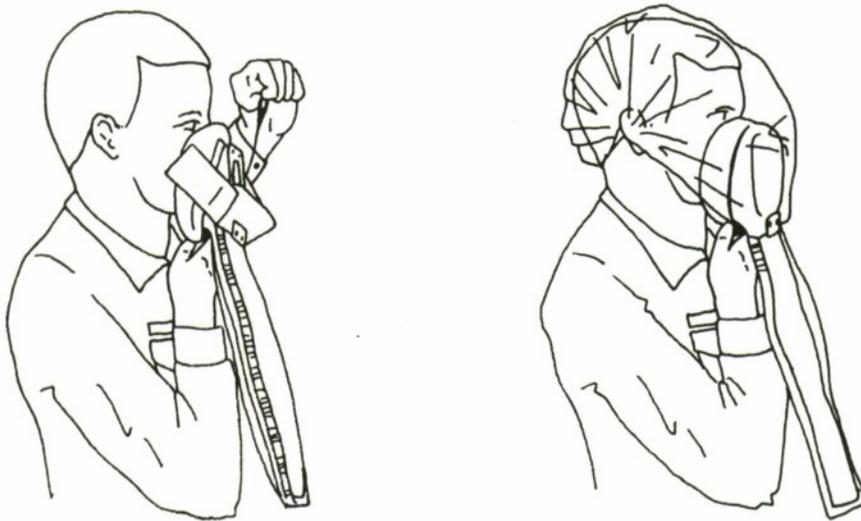
Fig. 26. Boeing Mask

Physical Description. 2 liter (.07 cu ft) polyimide (Kapton) rebreather bag mouthpiece mounted on polyurethane nose-blocking pad accordion-folded polyimide heat shield. Weight 184 grams (6.5 oz). Designed to install on seat back with only handle showing.

How Used. Grasp handle, blow up rebreather bag, hold mouthpiece with teeth. Pull thermal shield over head, rebreathe air in bag.

Availability. Experimental. Prototype used in 1967 AIA tests.

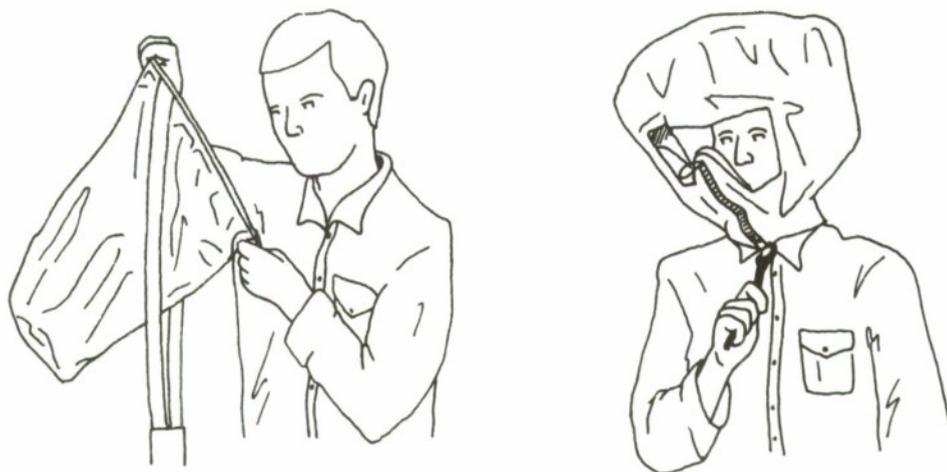
Fig. 27. John Hand Hood

Physical Description. Vinyl-coated fiberglass hood, clear fluorocarbon (Aklar) film view window, open-cell foam neck seal, with zipper closure. Weight 170 grams (6 oz).

How Used. Unfold hood and don over head. Position viewing window. Pull zipper down to join neck seal.

Availability. Experimental. Prototypes used in 1967 AIA tests.

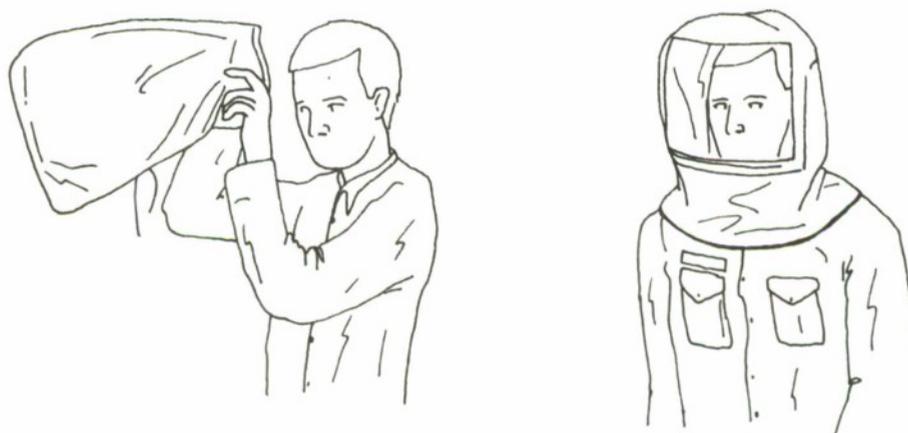
Fig. 28. Racine Glove Company Hood

Physical Description. Aluminized rayon hood, polyimide (Kapton) film view window. Coil-spring holddown in hood, lower rim stainless steel, vent screen on hood back. Velcro tab ends on straps hold hood down on body. Weight 340 grams (12 oz).

How Used. Remove from container. Automatically unfolds by coil spring action. Place hood over head and position view window. Place hold straps under arms and fasten about chest with Velcro tape.

Availability. Experimental. Prototypes used in 1967 AIA tests.

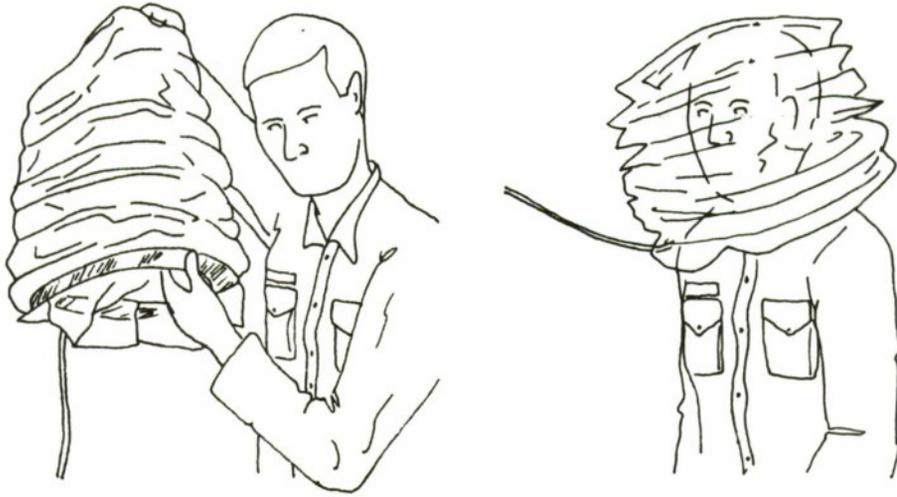
Fig. 29. Sierra Engineering Corporation Hood

Physical Description. Accordion polyimide (Kapton) cylinder with flat top. Supplemental air is vented into top, which inflates a toroidal neck seal (air supply, not yet designed). Weight 235 grams (8.3 oz) (without air supply).

How Used. Place hood over head. Activate supplemental air supply.

Availability. Experimental. Prototypes used in 1967 AIA tests.
