Advanced Techniques in Crash Impact Protection and Emergency Egress from Air Transport Aircraft

AGARDograph No.221
ADVANCED TECHNIQUES IN CRASH IMPACT PROTECTION AND
EMERGENCY EGRESS FROM AIR TRANSPORT AIRCRAFT

Richard G. Snyder, Ph.D.
Head, Biomedical Department, and Research Scientist
Highway Safety Research Institute
Institute of Science and Technology
and Professor of Anthropology
Department of Anthropology
The University of Michigan
Ann Arbor, Michigan 48105
U.S.A.

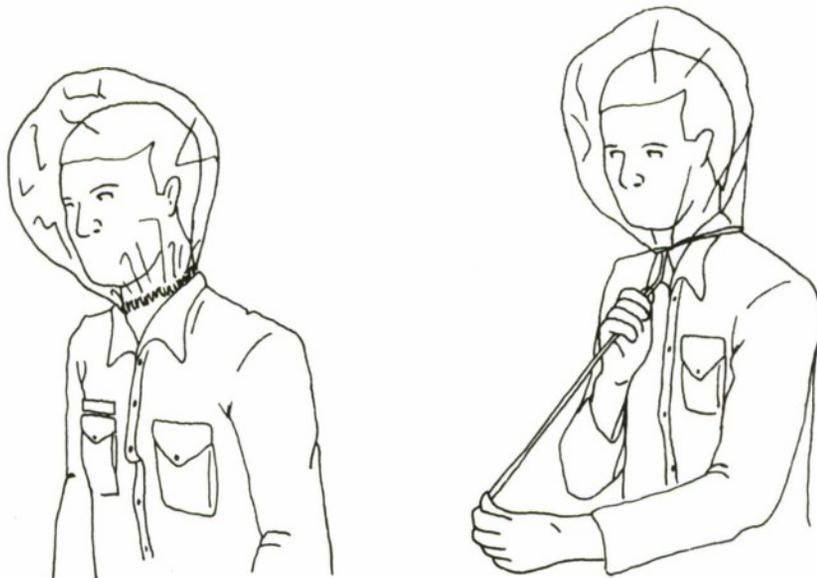
Fig. 30. Life Support Systems Hoods.

A. Elastic Neck Seal Type

How Used. Unfold and pull over head, push elastic ball up lanyard to form tight neck seal.

Availability. Experimental. Prototypes used in 1967 AIA tests.

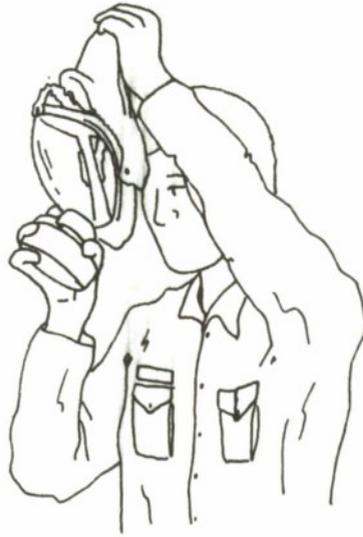
Fig. 31. Scott-O-Vista Mask

Physical Description. Polycarbonate plastic (Lexan) "bubble" face-piece, set in high-temperature-resistant rubber frame. Sealed filter canister for removal of smoke, fumes, CO, from inhaled air. Mask held to face by elasticized head-band, voice amplification by a vibrating resonator. Weight 260 grams (9.2 oz).

Availability. Production item.

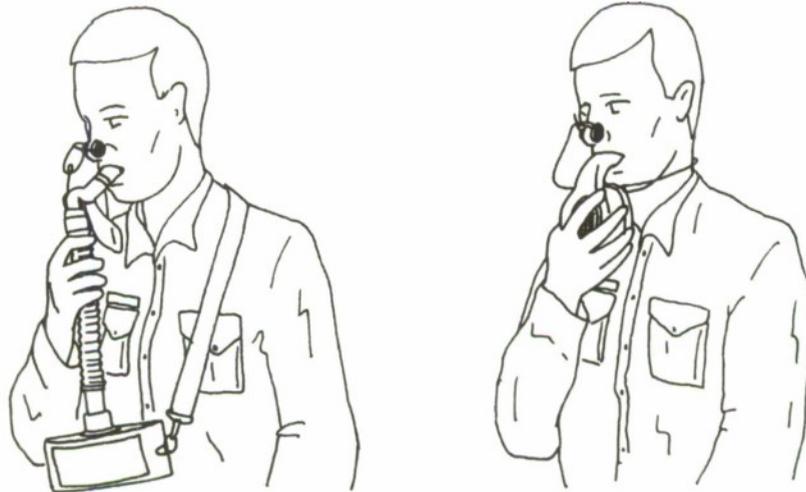
Fig. 32. Mine Safety Appliance Company Devices

- A. Canister Device (88480)
Ultra Filter Respirator (457117)

Physical Description. Removes large smoke particles and CO₂. Designed primarily for escape from CO₂ environment. Can only use once and must replace entire unit. Weight 510 grams (18 oz).

How Used. Remove or break seal. Place mouthpiece firmly in mouth. Put clip on nose.

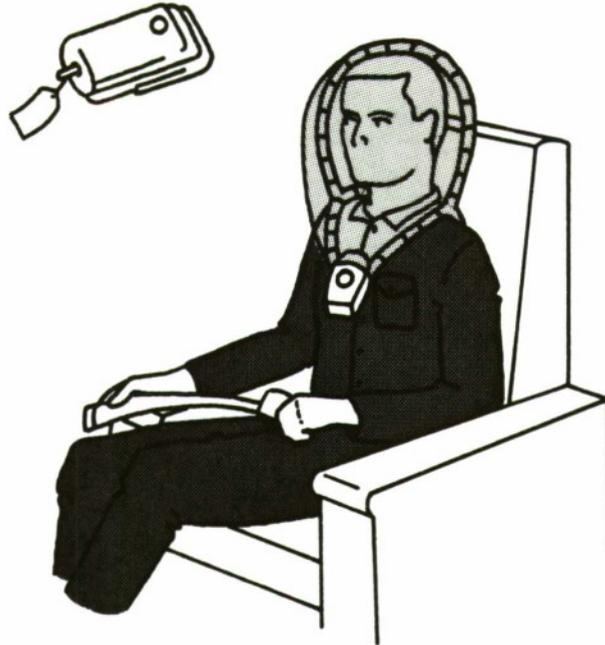
Fig. 33. North American Rockwell Hood

Physical Description. This smoke/flame hood concept would include three components: transparent hood, neck closure system, and compressed air supply. A short-range radio receiver could be incorporated for instructions from the crew.

How Used. Would be designed to fold into packet on seat back. Pull hood out of packet, don over head, and pull down into position.

Availability. Experimental. Prototype used in 1967 AIA tests.

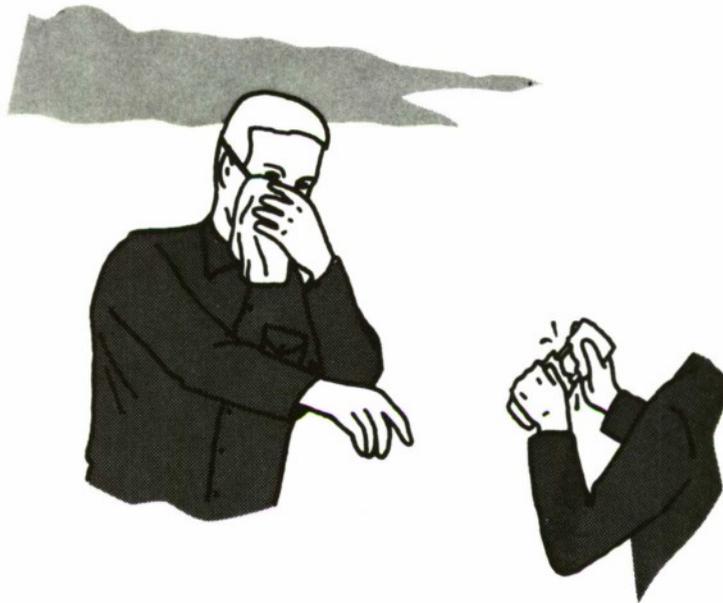
Fig. 34. North American Rockwell Smoke Mask

Physical Description. This concept consists of a moist cloth of several layers and large enough to cover the mouth and nose. An elastic band fits around the head.

How Used. Sealed in a plastic bag, the moist cloth would be held to the mouth and nose by hand, and by an elastic band over the head.

Availability. Experimental. Prototype used in 1967 AIA tests.

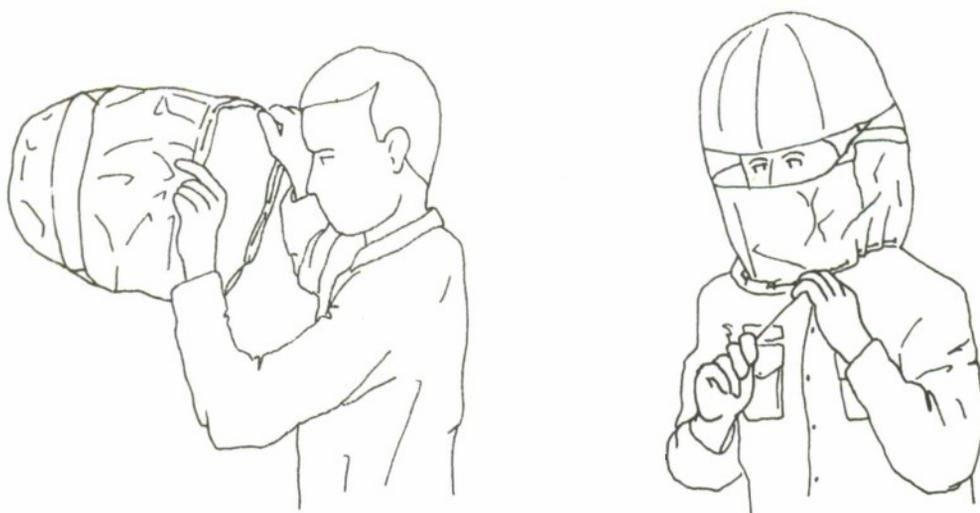
Fig. 35. Sheldahl Hood - "D" (drawstring) Model

Physical Description. Metalized polyimide (Kapton) hood. Volume 26.5 liters (0.9 cu ft). Cylindrical with domed top. Elastic fiberglass neck drawstring. 5 cm (2 in) vision band.

Availability. Prototype experimental device. Superseded by modified production "S" model.

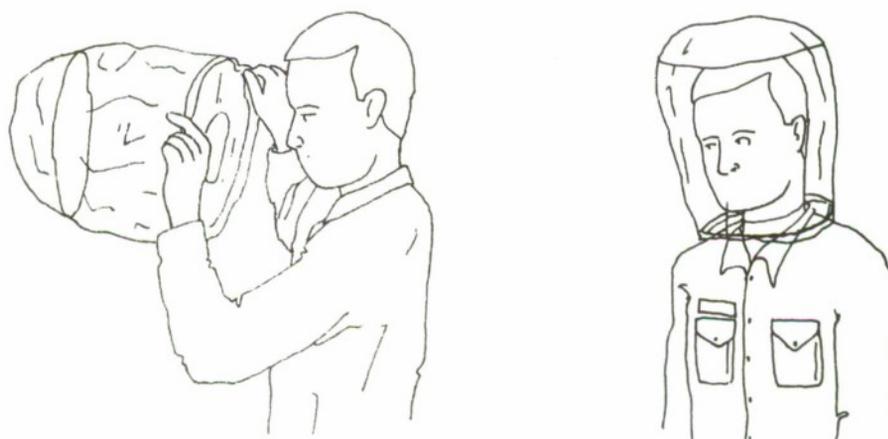
Fig. 36. Sheldahl Hood - "S" (Septal Neck Seal) Model

Background. The Sheldahl (or Sheldahl) smoke hood is the most prominent of the protective devices developed to offer respiratory protection. Although patents (Nos. 3,562,813 and 3,521,629) are held by the G.T. Sheldahl Co., Northfield, Minn., 55057 [Reynolds, 1970 (557,558); Origer, 1971 (548)], initial research and development were as a result of cooperative effort with E.B. McFadden, Chief of the Survival Equipment Research Protection and Survival Laboratories, Civil Aeromedical Institute, FAA, in studies reported 1965-1970. This has had the most extensive testing and development of any smoke hood device. About 600 have been sold for use to date.

Availability. Production item since 1969. Currently available from the manufacturer at \$49.95 each (Feb., 1976), or less for volume orders.

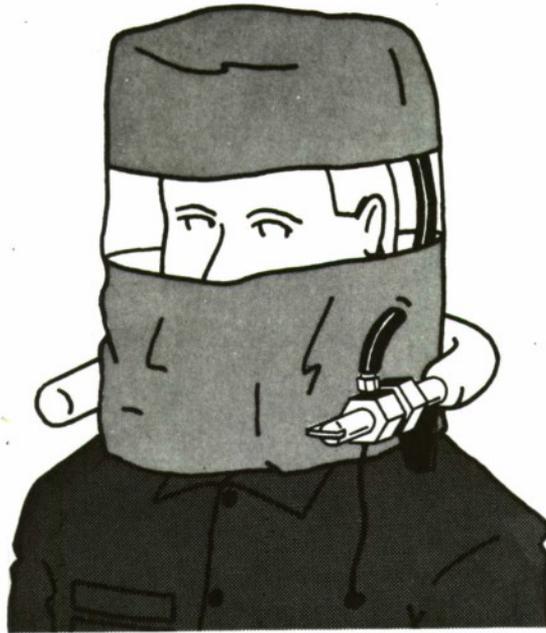
Fig. 37. Experimental FAA/Sheldahl Hood - Self-Contained Air Supply

Physical Description. Clear cylindrical hood with metalized polyimide domed top (2 mil Kapton). Annular neck ring of elastomeric film. V-shaped compressed air cylinder with rubber tube into hood; lanyard mechanical initiation. Compressed air unit snaps to hood, stabilized by two shoulder tabs. Air supply duration can be varied, 4-15 min.

Availability. Prototype experimental device developed for FAA/CAMI testing.

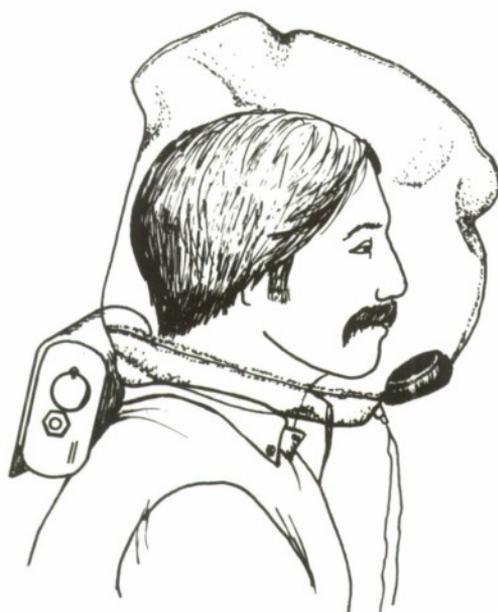
Fig. 39. Lear-Siegler Air Capsule

Physical Description. 5-minute duration. Breathing air (21% oxygen, 74% nitrogen, 5% helium) is stored at 351.8 kg/sq cm (5,000 psi) in a corrosion-resistant stainless steel tubing coiled into a compact reservoir. Transparent hood with drawstring. Carried in either biocular-size case or soft sock. Shelf-life 3 years (Model 5000).

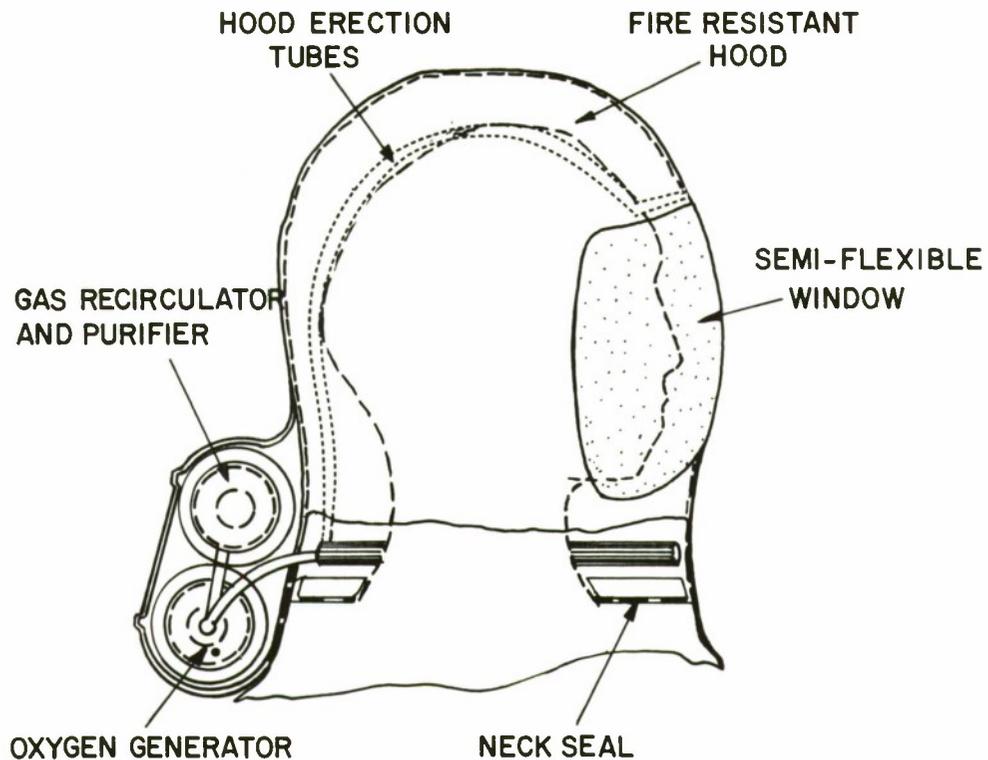
Fig. 41. Scott Aviation Emergency Smoke Hood and Breathing Device

Physical Description. This system consists of four major components: an oxygen supply source, a chemical carbon dioxide and water vapor "scrubber," a loose fitting hood, and a venturi pump, supplying 4 liters (244 cu in) per minute O_2 . 15-minute recirculation system. Solid-state oxygen generator with ten-year shelf life.

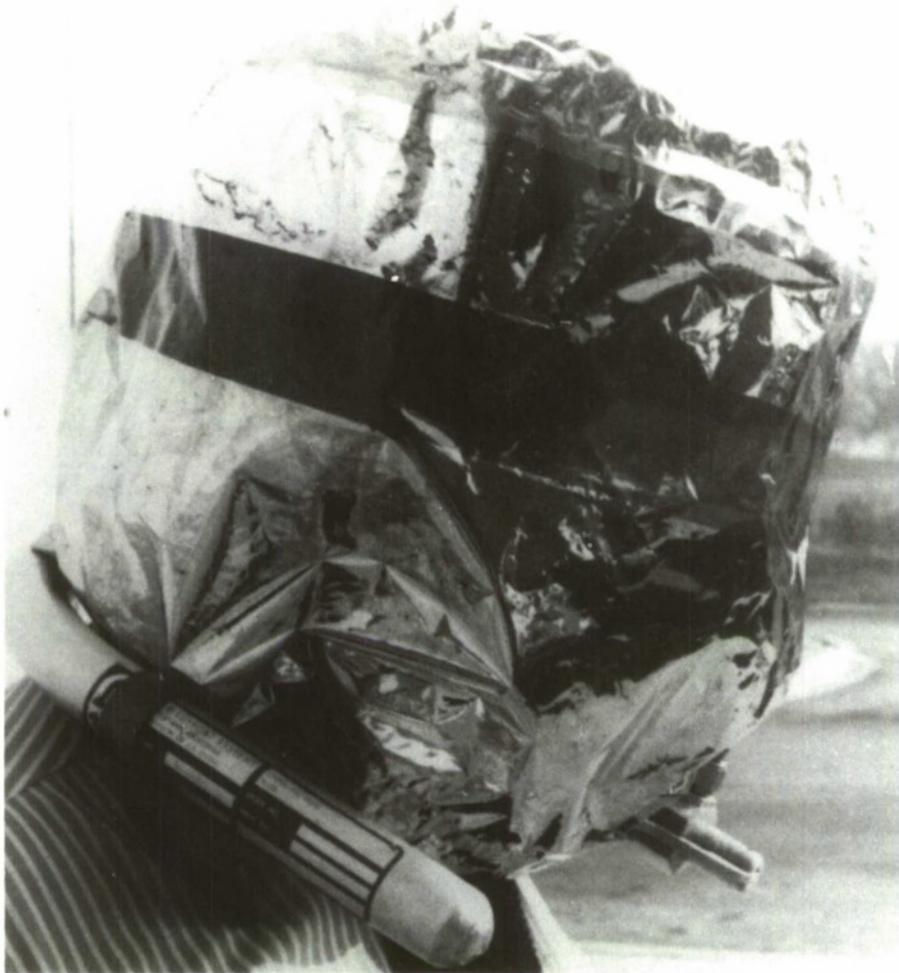
Fig. 42. Experimental FAA/Schjeldahl protective hood of 2 mil Kapton which can provide 4 to 8 minutes of breathing time using a self-contained supply of compressed air.

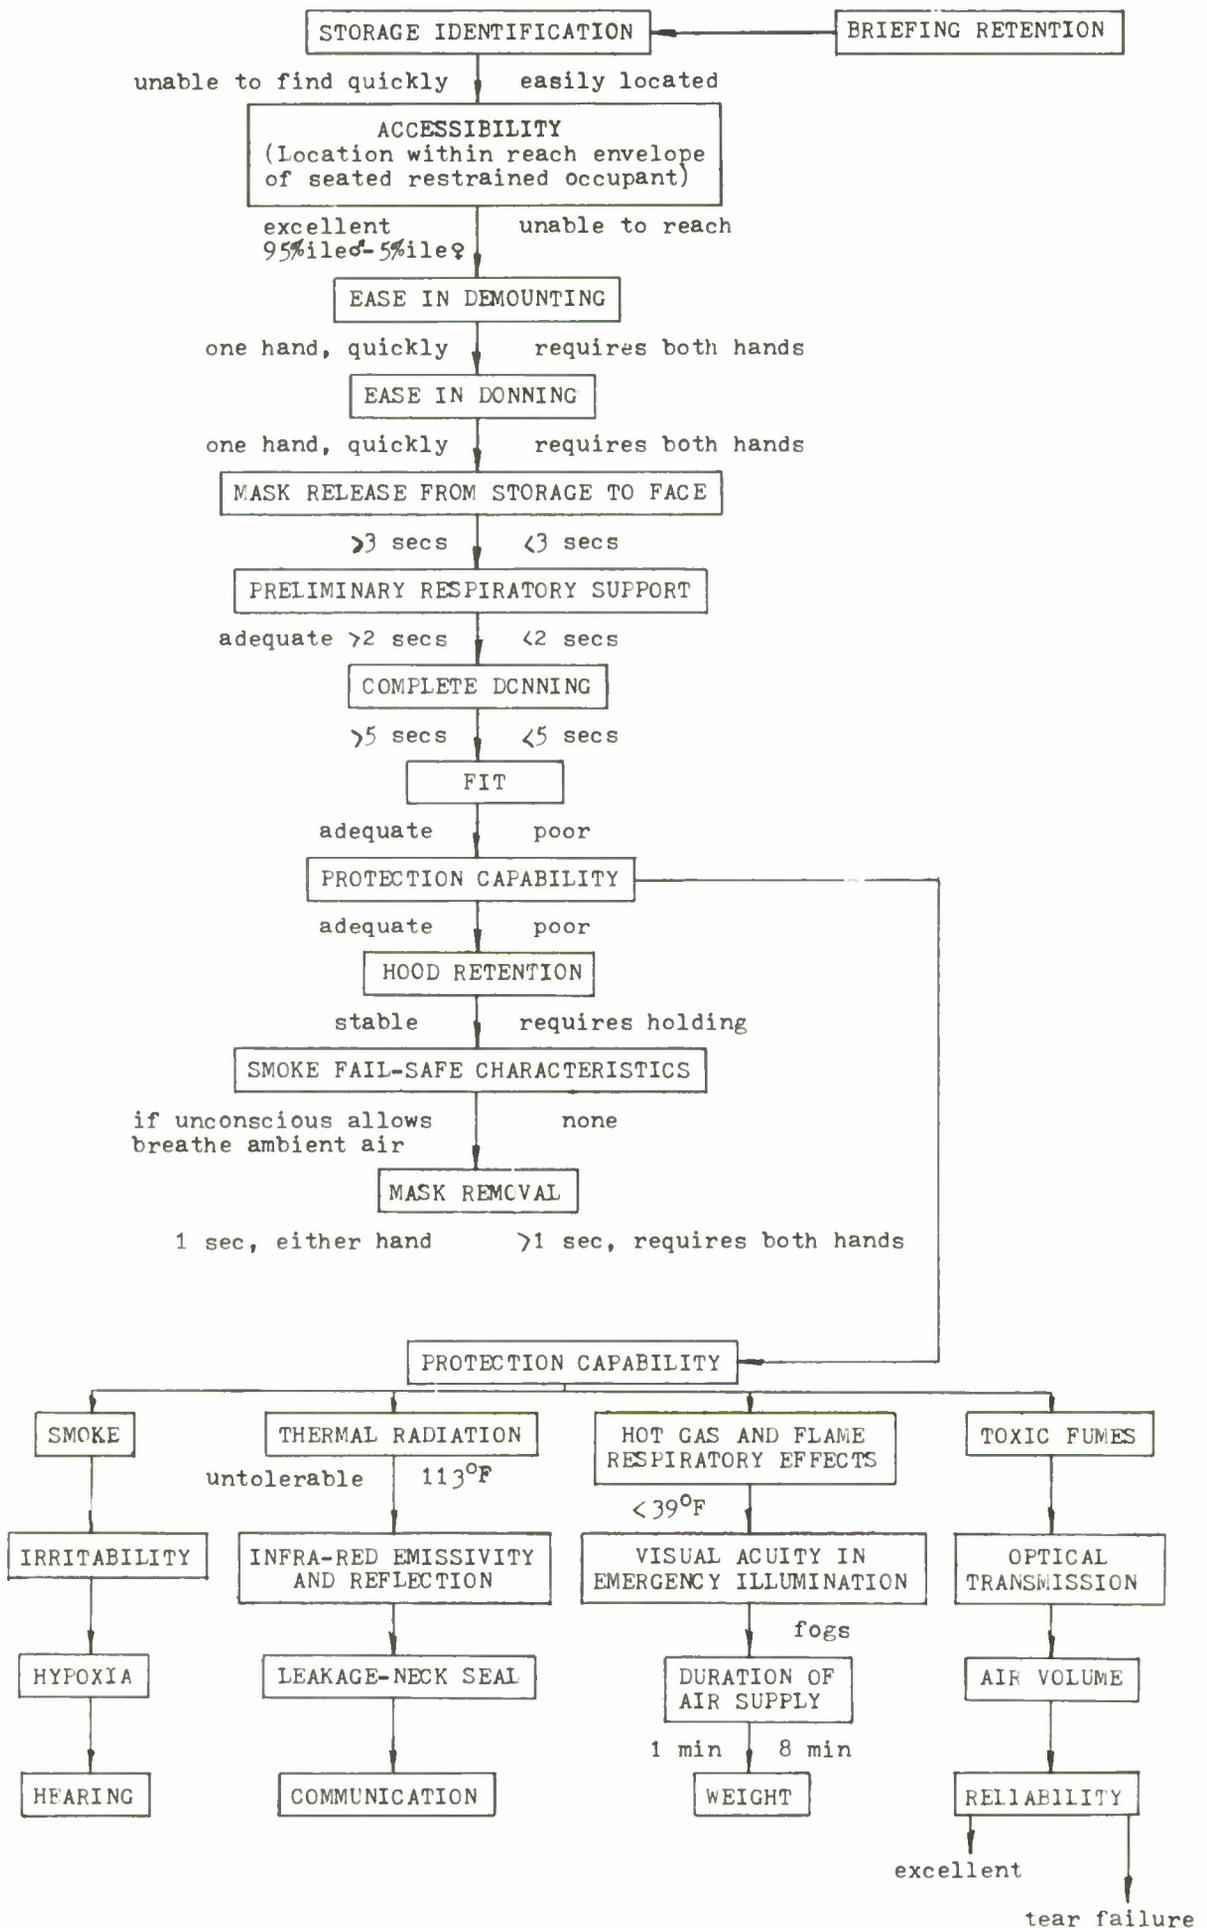
TABLE XV. SMOKE HOOD/MASK FUNCTIONAL FLOW FAULT TREE

AMBIENT ENVIRONMENT	MENTAL DEMANDS	HAZARD EXPOSURE	PHYSICAL DEMANDS
<ul style="list-style-type: none"> .Polyimide (amide) films capable of protecting in excess of 1400°F. .3-6 min O₂ supply. .Visual acuity not impaired at low .05-foot-candles levels of illumination (models). .Infra-red emissivity and reflectance excellent. .Optical transmission - not satisfactory with model D - excellent with model S. 	<ul style="list-style-type: none"> .Simple to don. .Tests show simple verbal briefing adequate. .Requires no mechanical aptitude or skill. .Requires little training, little judgement, ability to follow relatively simple written or oral instructions. .Requires moderate recall. 	<ul style="list-style-type: none"> .Available O₂ - when CO₂ critical level of about 8% reached sensation of choking will cause subject to remove hood. .Flammability protection - excellent. .Toxic hazards - excellent with model S, fair with model D. .Irritability protection - excellent with model S, fair to poor with model D. .Hazard level category II - marginal (can be counteracted or controlled without injury to personnel or major system damage (MIL-STD-282)). 	<ul style="list-style-type: none"> .Simple to don. with normal use of hands. .Can be donned with one hand with some difficulty. .Requires little expenditure of energy. .Readily learned by demonstration.

HUMAN FACTORS (MIL-STD-1472A)	SYSTEM SAFETY (MIL-STD-882)	TASK EXPOSURE
	<ul style="list-style-type: none"> .Some difficulty in quickly locating neck seal (needs color outline). .Instructions adequate. .Can increase donning time and decrease problems in donning with prior experience. 	<ul style="list-style-type: none"> .Present hood cannot remain in use beyond 3-6 min. .Hazard Level II. 	<ul style="list-style-type: none"> .Potential effect of improper task performance on system operation critical.
EQUIPMENT CHARACTERISTICS	RELIABILITY (MIL-STD-785)	MAINTENANCE (MIL-STD-470)	POTENTIAL VALUE
<ul style="list-style-type: none"> .Material:metalized polyimide (Kapton). .Weight. Not signif. .Size (stored) - packet (in use) 16" high 12" diameter. .Volume - 26.5 liters. .Shape - cylindrical, with domed top. .Closing (model D) - Elastic fiberglass neck drawstring. (model S) - Annular ring of elastomeric film (3"). .Heat resistance - Polyimide film with reflective coating. .Vision (model D) - 2" vision band. (model S) - clear hood. 	<ul style="list-style-type: none"> .General - excellent (only failure determined to date occurred when one mask ripped in coal mine test). .Life cycle decrement undetermined. 	<ul style="list-style-type: none"> .Accessibility - excellent. .May be problem with decrement with repeated usage (seal breakdown). .Periodic inspection and replacement would probably be necessary. .Effect on depth and frequency of maintenance requirements at each level. .Facilities, support equipment, skill levels and number of individuals required to be determined. 	<ul style="list-style-type: none"> .Tests to date indicate offers excellent protection to head and face in flammability. .Advanced model S septal neck seal model offers greater protection from toxic fumes, smoke, and eye irritability than earlier neck drawstring D model. .Tests of S model clear hood indicate no signif. vision acuity decrement under conditions of low illumination. .Limitation of 3-6 min breathing time can be increased by modification with self-contained O₂ generator or compressed air source.

A detailed analysis of the system safety, maintenance, hazards, reliability, and human factors of the various smoke hood/masks available within the state-of-the-art have been made and a smoke hood functional flow fault tree is shown in Table XV.

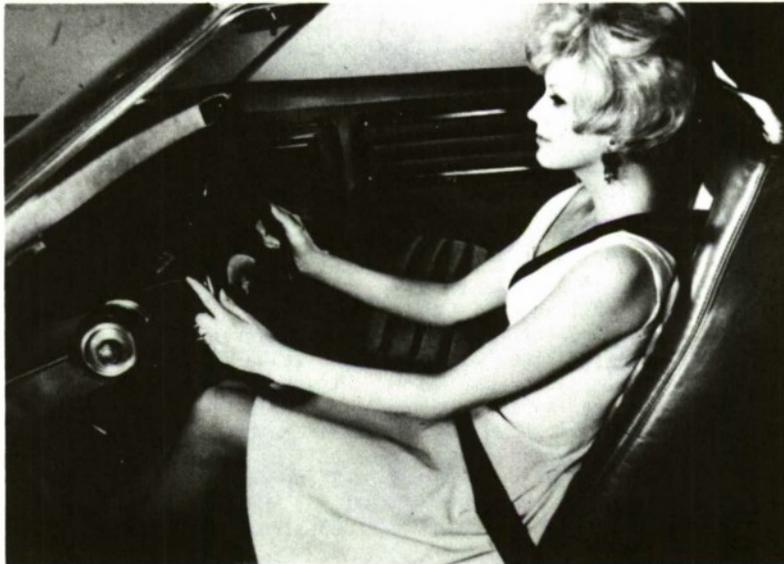
Fig. 43. An integrated harness system in which the upper torso restraint retracts into the seat back as designed for the Ford Techna future idea car (Photo courtesy Ford Motor Company).

4.5.1 Integrated Upper Torso Restraint. Integrated restraints are those in which the restraint is attached to (and retracts into) the seat itself. This concept was proposed in 1909 (783), and has been proposed in almost all recent automotive experimental vehicles, such as the Ford "Aurora" and "Techna," General Motors "Astro I," "Runabout," and "Mako Shark" and Chrysler Corporation's "300X" futuristic concept vehicles. Such systems have also been proposed for the Liberty Mutual capsule seat design, the Republic Aviation Division, Fairchild Hiller, New York Safety Sedan, the Cox seat (Cox of Watford, Ltd.), the Irvin Safety seat, and the Winebrenner concept, as detailed in reference 792. Fig. 43 illustrates one type of integrated harness, developed by Ford Motor Company, but never used in production vehicles. This can utilize either a single diagonal harness, as shown, or a double upper torso harness as proposed in 1909 (783).

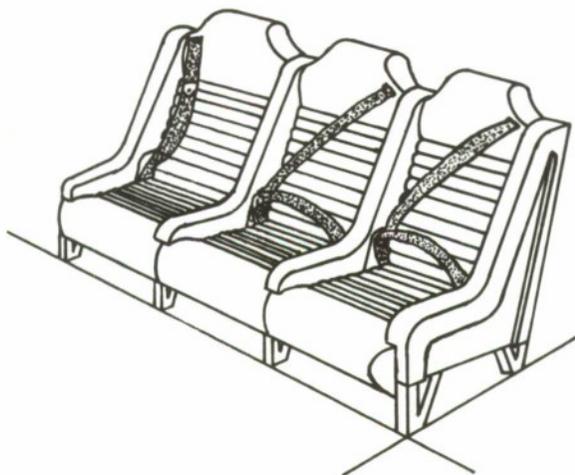
Fig. 44. Integrated bench seat-restraint system with 3-point harness [Robbins et al., 1971 (784)].

In a 1971 study conducted for the National Highway Traffic Safety Administration by the Highway Safety Research Institute, the University of Michigan, design concepts of integrated restraint systems were developed and tested [Robbins et al., 1971 (784)]. These tests were preceded by a series of analytical studies utilizing two- and three-dimensional mathematical models of an automobile crash victim. Impact tests were conducted in frontal, oblique, side, and rear tests using anthropomorphic dummies for one of these systems (described in Section 4.5.2). As shown in Fig. 44, one triple bench/bucket seat system (as could be utilized in an air transport aircraft) was developed which consists of an upper torso restraint which retracts by inertia reel into the seat belt, side protection, and an automatically adjusting lap belt. The other three systems included a (1) bucket seat with airbag torso restraint and energy absorbing lower panel (pure passive system), (2) bucket seat with inverted Y-yoke harness, and (3) bucket seat with 3-point harness system.

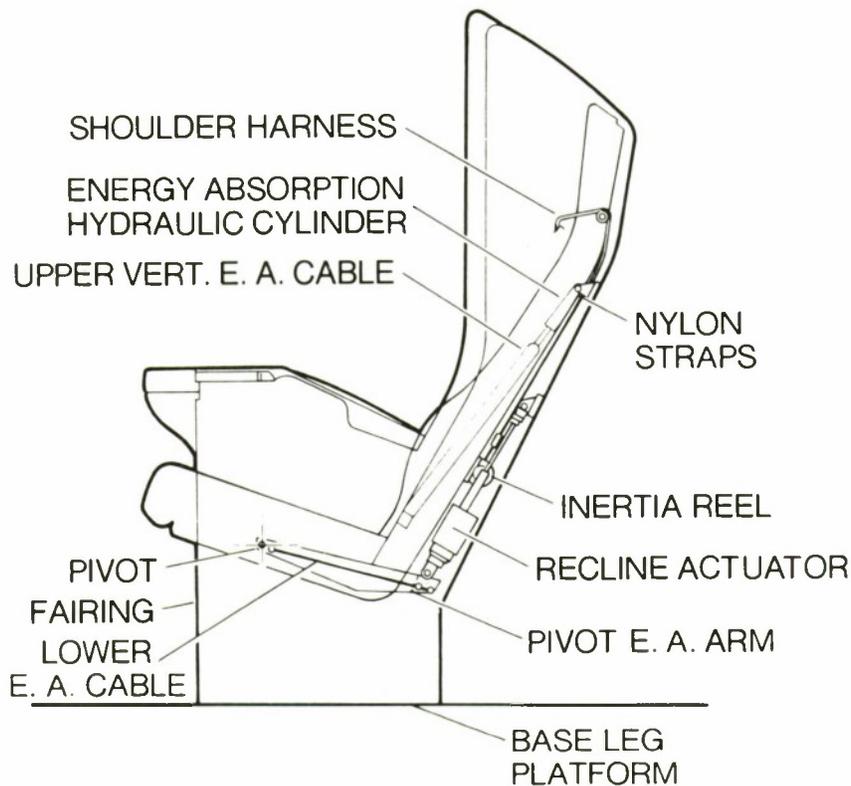
Fig. 45. The NASA Ames seat reclining system [After Kubokawa, 1974 (8)].

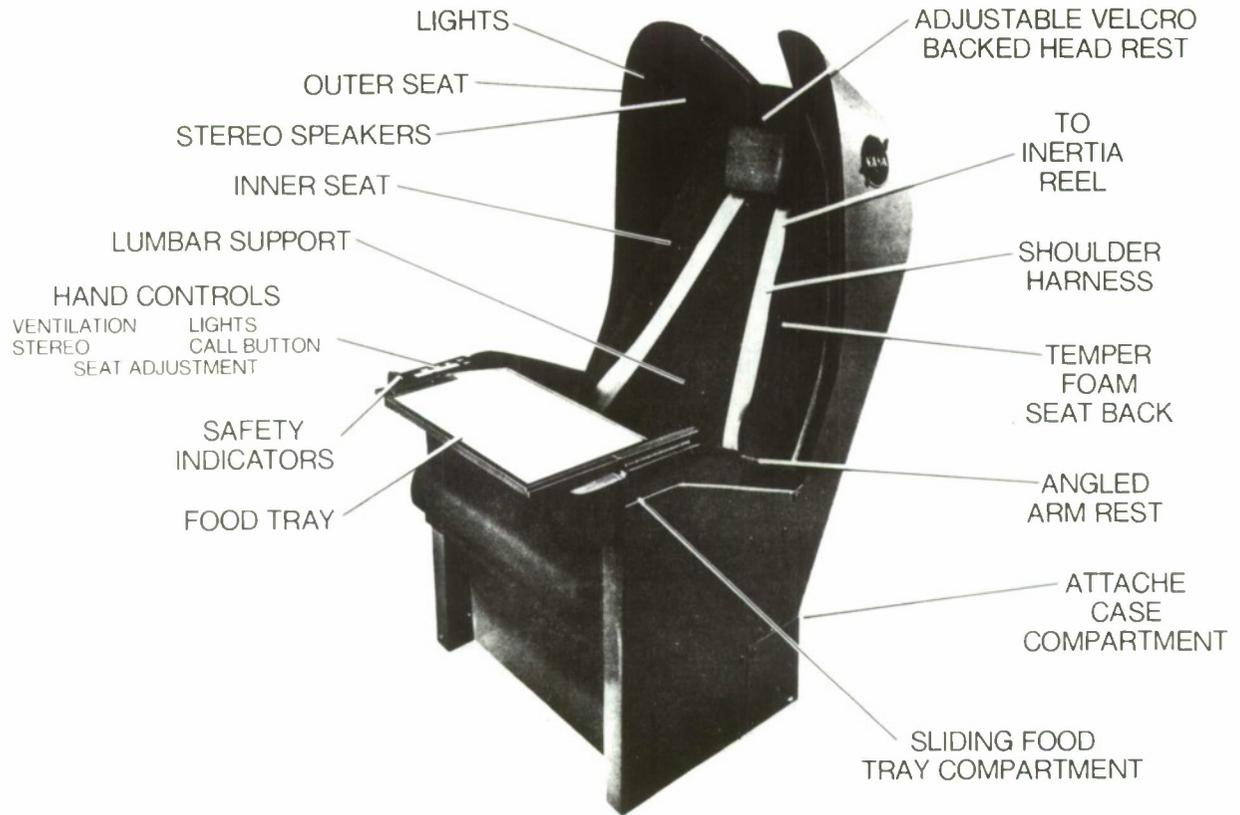
Fig. 46. NASA Ames integral aircraft passenger seat [After Kubokawa, 1974 (8)].

The NASA Ames airline seat is composed of two major elements, as well as special impact attenuating and passenger comfort equipment. An inner seat consists of an aluminum structure with a fixed seat angle of 105° between the seat pan and seat back. The seat pan is at a 6° incline from the horizontal when in the normal upright position. The inner seat, including both seat pan and back, can be placed in a comfortable reclining position up to 12° further by depressing a seat positioning switch and leaning back. The entire inner seat reclines from a single pivot point, while in present air carriers only the back of the seat reclines. The outer shell, which fastens to the floor, is the primary structure to which the impact attenuating devices and the inner seat are attached. The outer shell is an aluminum structure formed over with fiberglass, and bolted to the aircraft floor. The shell is padded on either side and provides passenger protection from lateral jostle and free-flying objects during impact. As shown in Fig. 46, various locations of the outer shell house the lights, attache case compartment, stereo speakers, food tray, warning indicators, volume balance, sound control, stewardess call, light control, seat control switches, and ash tray. The padded inside top area of both sides of the outer shell house the stereo speakers and lights. The armrests are constructed as part of the outer shell and the food tray is built into the left armrest, eliminating many hazards.

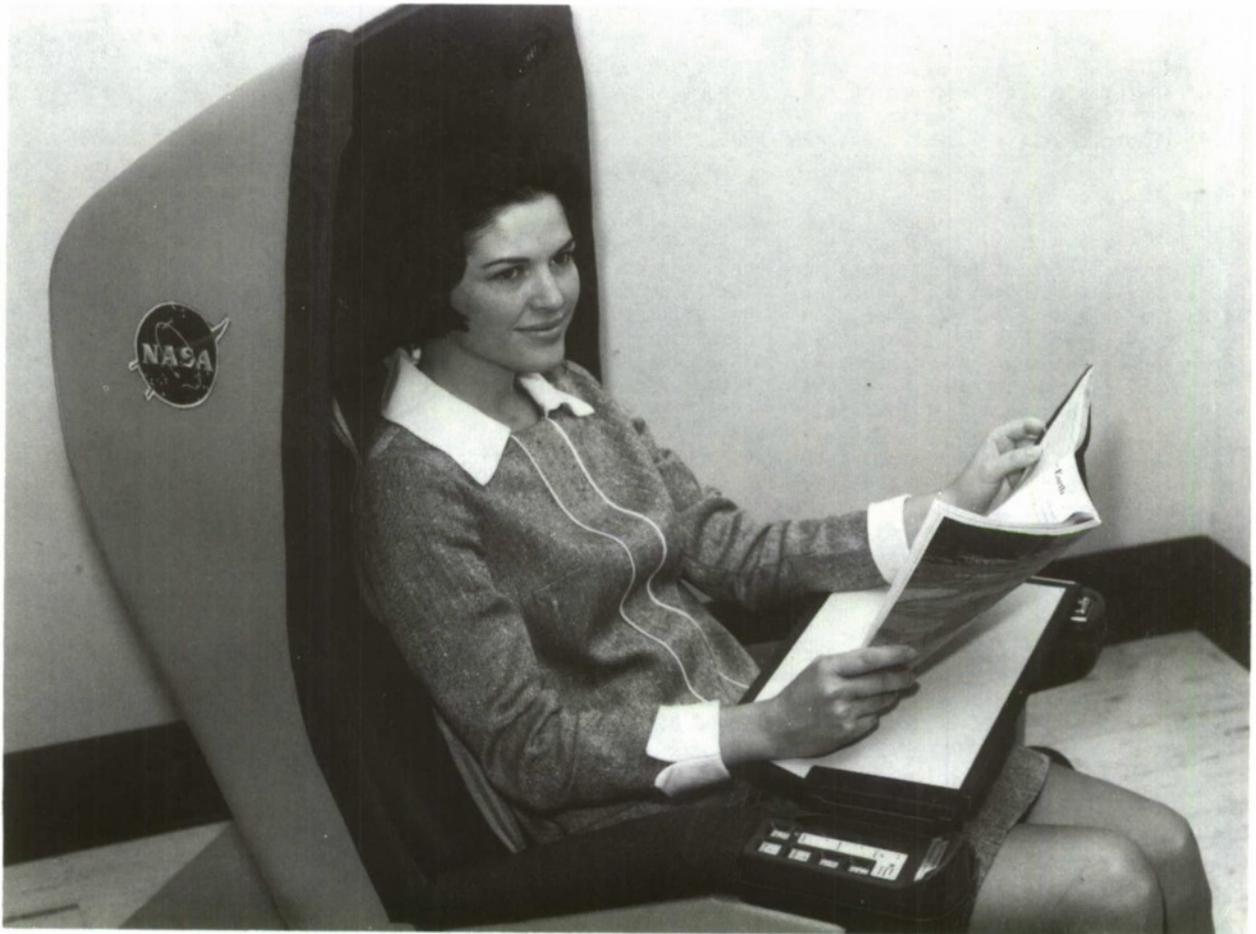
Fig. 47. Unrestrained passenger seated with food tray in place (folds back into side) in final configuration of NASA seat (Photo courtesy C. Kubokawa, NASA Ames).

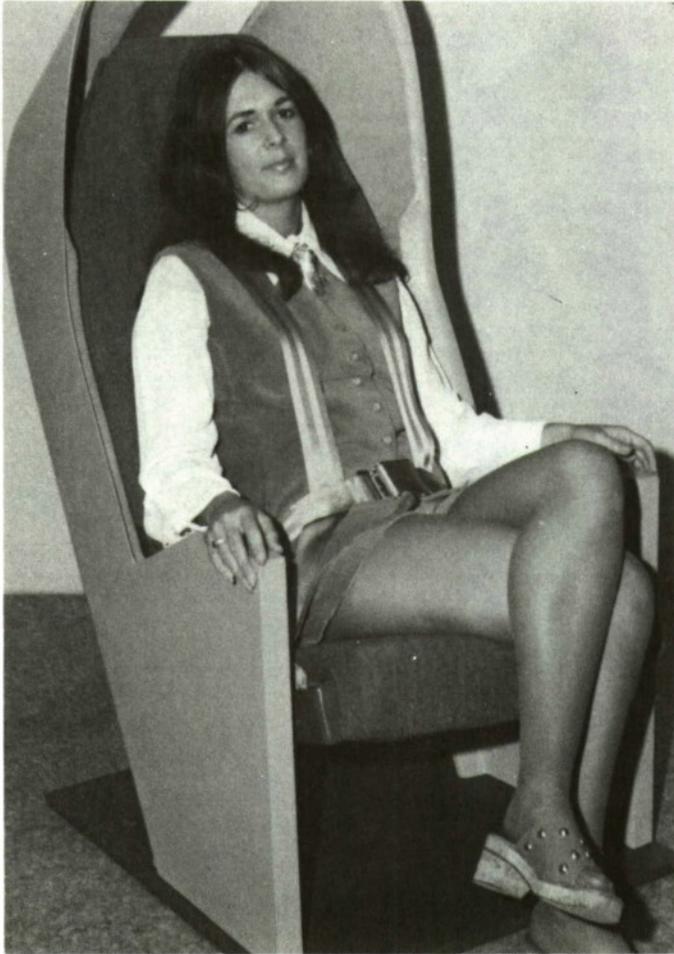
Fig. 48. The restraint system shown in this mock-up seat features upper torso protection. Freedom of movement is allowed by inertia reels in the integrated seat (Photo courtesy C. Kubokawa, NASA Ames).

The double torso belt with inertia reel seat belt restraint (Figs. 48 and 49) has been demonstrated to restrain a passenger safely at 22 G in the horizontal direction without submarining or ejection. In the NASA seat design, the peak load energy is absorbed by the stretching of energy absorbing cables and the activation of other energy absorbing mechanisms located between the inner and outer seat structures. The four portions of this structure include upper vertical and lower horizontal assemblies of Type 304 stainless steel wire, a pivoting hydraulic cylinder used to allow the fixed length cable to move with the inner seat, a nylon restraint webbing with specially stretched patterns, an outer shell structure, and inner energy absorbing seat cushions. The cushions (Temper Foam) were specially produced by Dynamic Systems, Inc. of Leicester, North Carolina.

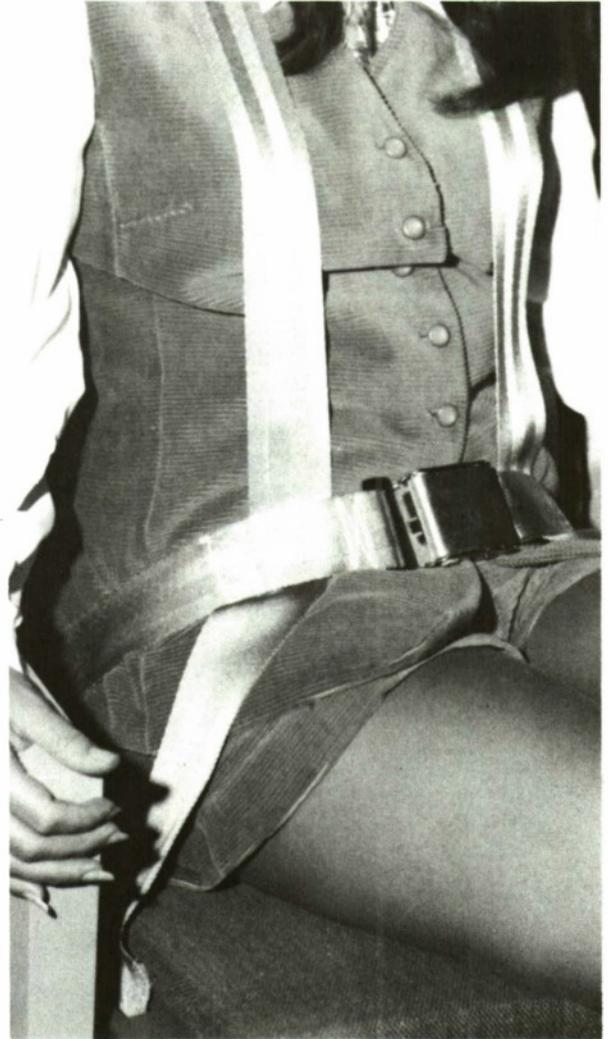
Fig. 49. Details of NASA Ames integrated restraint system in mock-up seat (Photo courtesy C. Kubokawa, NASA Ames).

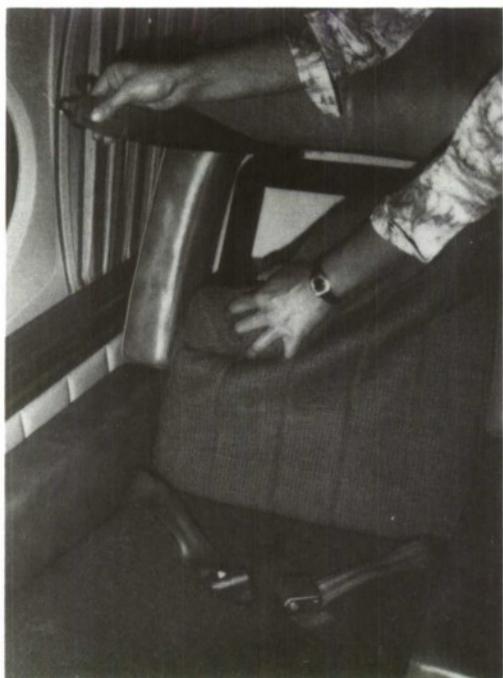
Fig. 50. Integrated seat utilized operationally in Chrysler Corporation's Grumman Gulfstream G-2 jet corporate aircraft.

4.5.1.2 Chrysler Corporate System. The Grumman Gulfstream G-2 corporate jet operated by the Air Transportation Division, Chrysler Corporation, Willow Run Airport, Ypsilanti, Michigan, contains a number of advanced safety devices, including passenger seats containing an upper torso integrated restraint system. As shown in Fig. 50, upper torso restraint is provided by a single diagonal belt (3-point system) attached to an inertia reel contained within the seat back. When the seat is not occupied, the belt retracts out of the way. The inertia reel allows comfortable normal forward movements of the head and shoulders, locking up and restraining the upper torso only in a deceleration exceeding approximately 2-3 G. When seated the belt is donned by buckling the lap belt and then bringing the upper torso belt down to attach (Fig. 51) at the center. In this respect it differs from the automotive 3-point belt, which generally attaches to the side. Additional protection from side (and head) impact is provided by deep side contours. This system (Fig. 52) is very similar to the integrated restraint system developed by Robbins et al. [1971 (784)] for NHTSA, at the University of Michigan (Fig. 53), except that in the latter system the upper torso connects to the lap belt at the side.

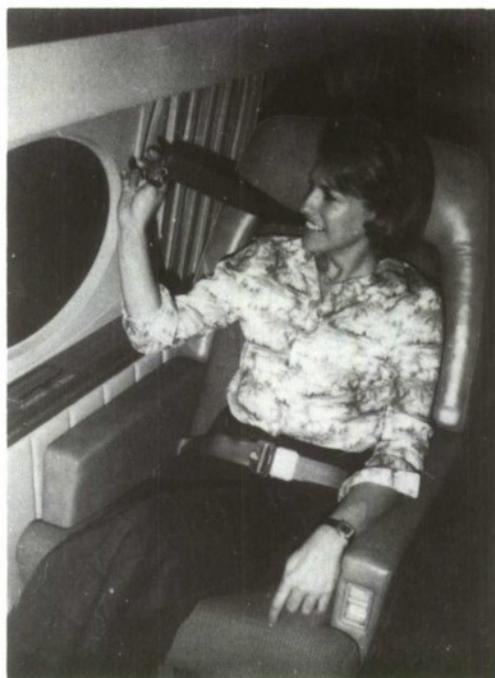
Fig. 51. The upper torso belt is attached to an inertial reel, allowing freedom of motion, but restraint in +2G deceleration.

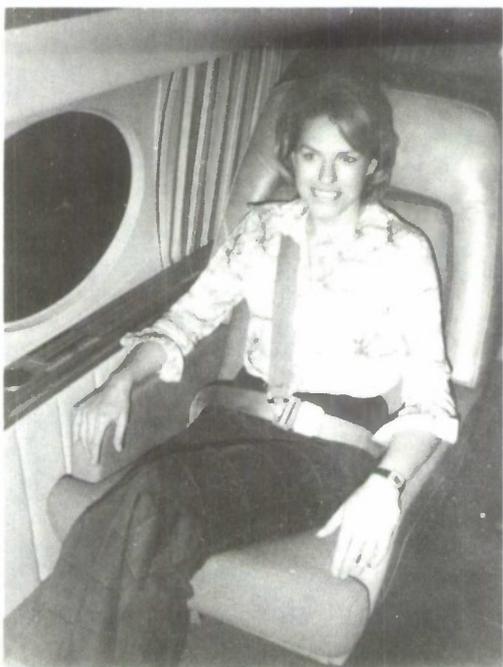
Fig. 52. In this configuration the belt buckles at the center. This seat is also capable of rotating 180° and can be used in a rearward-facing orientation.

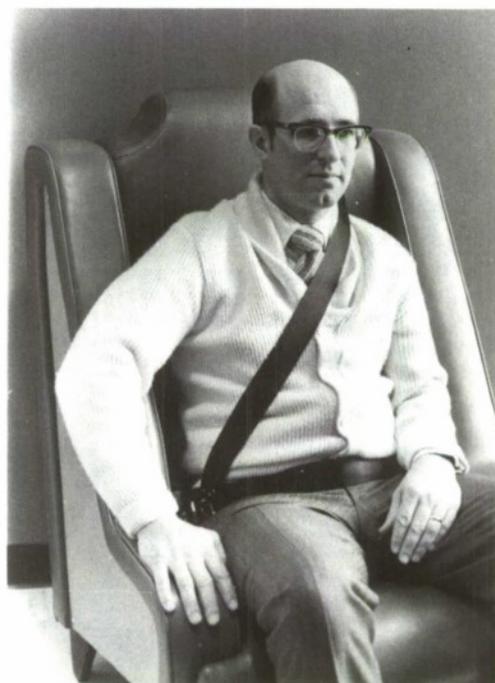
Fig. 53. Integrated restraint system designed and developed by HSRI, The University of Michigan on NHTSA advanced concepts contract (Robbins et al., 1971).

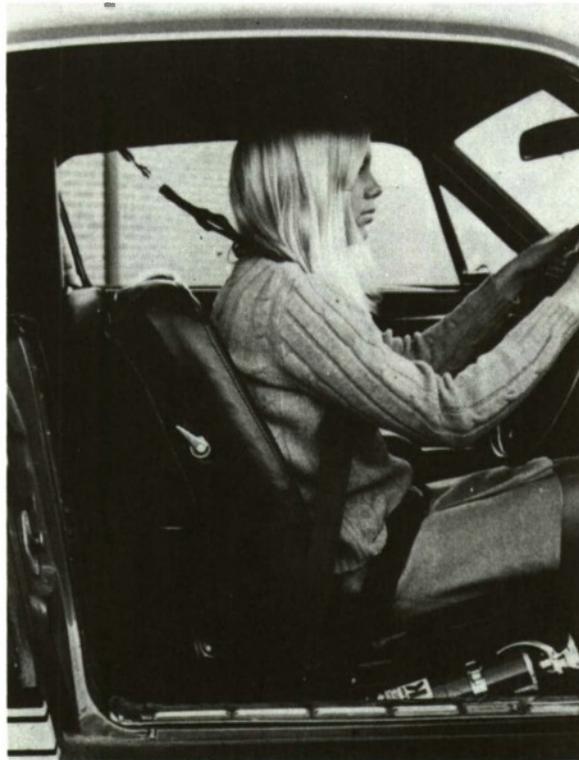
Fig. 54. Inverted Y-yoke harness system with inertia reel mounted in roll-bar, as used in specially modified Shelby American Ford G7-350 and GT-500 vehicles.

4.5.2 Y-Yoke Inertia Reel System. The Y-yoke harness with inertia reel is not a new system, but represents a distinct variation of an aircraft torso harness and inertia reel system in that the torso harness is independent of the seat back. As shown in Fig. 54, the reel is attached overhead, rather than to the seat, thereby avoiding any downward force on the shoulders (which may contribute to the submarining action), and direct loading to the top of the seat back (high C.G.). This system also differs in that the left and right shoulder belts come together as a yoke ("inverted-Y") behind the head, continuing upward to the reel as a single belt. The 1957 work by Barecki of the American Seating Company was probably the first design of this type of system (790). In 1958, several tests of this device were conducted by Col. Stapp at Holloman AFB, using cars which were towed and snubbed to a stop (790). In three tests, human volunteers with head positioned forward (pre-flexion) were exposed to 18 (average) G on the chest (26 peak G). In more recent tests Snyder et al. (791) exposed baboon subjects on the Daisy track at Holloman AFB, New

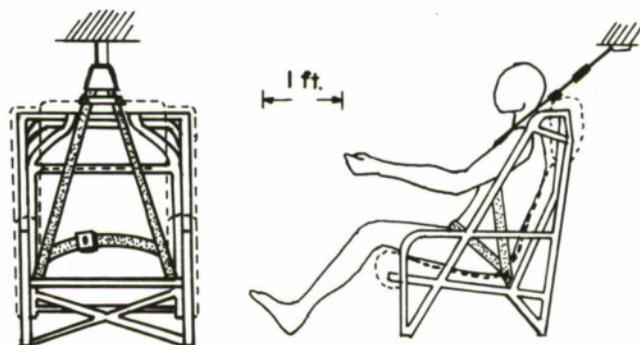
Fig. 55. Prototype inverted-Y integrated 40 G seat designed and impact tested for NHTSA by HSRI, The University of Michigan [Robbins et al., 1971 (784)].

The A-frame side structures are designed to withstand 40 G crash impacts from any direction with the added loading of a 95th percentile male occupant (97.5 kg [215 lb]). (Present FAR requirements for static tests are 77.1 kg [170 lb] dummies, with no requirement for dynamic testing.) Attached to the framework is 22-gauge sheet steel, designed to deform and absorb energy during impact. A 5.1 cm (2 in) layer of HD300 styrofoam covers the seat back, headrest, seat cushion, and inside of the side structures. This material is crushable under a load of about 10.5 kg/sq cm (150 psi). The prototype seat weighs 31.8 kg (70 lb), 10.4 kg (23 lb) heavier than current automotive production bucket seats, but this could be reduced. A series of fifteen impact sled tests were conducted at HSRI, the University of Michigan.

The inverted Y-yoke harness with inertia reel was tested in an integrated bucket seat concept, developed and impact tested for the National Highway Traffic Safety Administration by Robbins et al. [1971 (784)] at Highway Safety Research Institute, the University of Michigan. Fig. 55 illustrates the framework design of the prototype seat. This concept featured a bucket seat with side protection and was considered the most promising active system of those concepts considered, which included an airbag system.

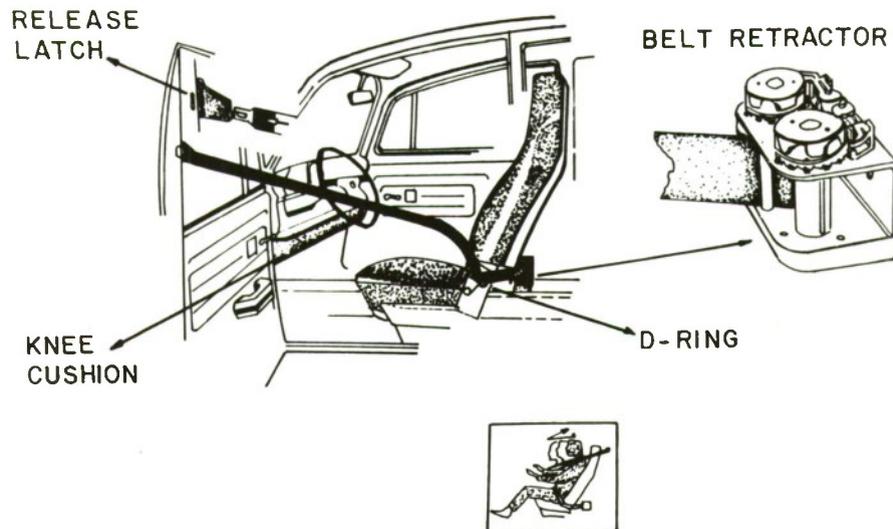
The components of this system are shown in Fig. 56. The upper torso belt is attached at one end to a release latch which is mounted on the door. The other end of the belt is wound around the retractor spool on the central tunnel (between the seats). The D-ring, which is mounted on the seat, guides the webbing from the retractor around the seat back, and assures that the lower anchor point does not change relative to the occupant. The retractor automatically takes up any slack webbing and maintains "gentle" tension on the belt. The retractor locks, for automotive application, at a vehicle acceleration of 0.45 G.

The upper end of the torso restraint is anchored by a tongue in the emergency release hatch. When the door is closed, the belt latch engages an anchor plate which is bolted to the normal torso belt anchor point of the B-pillar. This allows the belt forces during a crash to be transmitted to the anchor point rather than to the door itself. The knee restraint is a sheet metal frame covered with energy dissipating

foam and is attached below the instrument panel. There is also an emergency release to allow separation of the belt from the door anchor in case the retractor remains locked after a crash. In this system the belt automatically is positioned on the occupant (right and left front seats) when he or she opens the door, seats himself, and closes the door. No lap belt is used with this system, only the single upper torso diagonal belt, and knee cushion. The elimination of the lap belt requirement was approved by the National Highway Traffic Safety Administration in Federal Register 39 (81) 14594, April 25, 1974 as a result of a letter by Volkswagen of 8 March, 1974 requesting clarification of 57.2(b) of FMVSS 208. This system is currently standard equipment on 1975 and 1976 Volkswagen automotive vehicles.

Fig. 56. VW Automatic Restraint (VW-RA) passive system as developed for automotive vehicles [Redrawn after Seiffert et al., 1974 (815)].

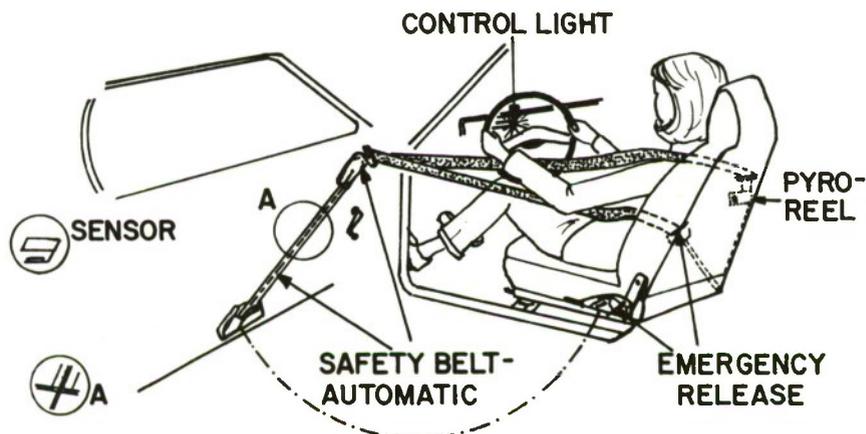
Fig. 57. Schematic of a "full passive safety belt system" designed by Ford-werke AG, Cologne, Germany [Redrawn after Hellriegel and Rauthmann, 1974 (809)].

The electronic system includes a sensor, seat-contact switch, ignition interlock (required under U.S. FMVSS at that time, but since rescinded by Congress), and non-function alert control. The belt transport system located in the door operates automatically, and the belt has an emergency release at the door sill and seat frame.

Ford Motor Company of Germany (Ford-werke AG, Cologne) at the 1974 5th ESV Conference in London, proposed a "full passive safety belt system" using the same general principle as Volkswagen, but with some interesting refinements [Hellriegel and Rauthmann, 1974 (809)]. As shown in Fig. 57, this system features a "self-applying" three-point harness (lap belt plus single upper torso diagonal belt) with anchorage to the seat-frame structure and seat-back frame in the area of the headrest and door sill. An inertia reel (Ford Pyro-Reel), which combines functions as a webbing-retractor and load limiting inertia reel, is located on the outboard upper seat.

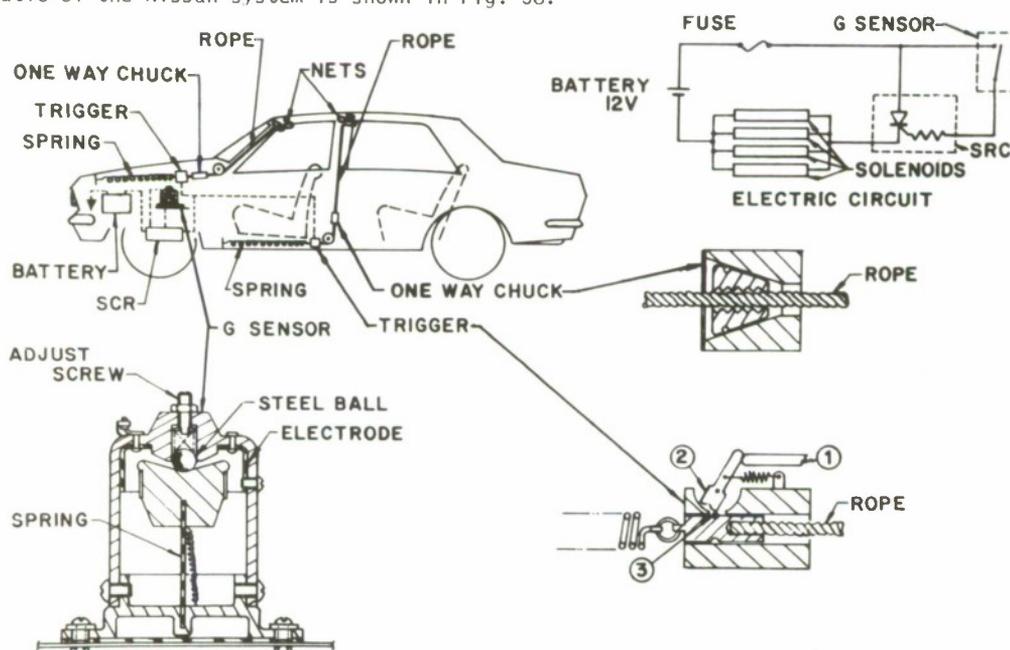
Fig. 58. Schematic composite diagram of Nissan automatic falling occupant-protecting net as developed for automotive use [Redrawn after Maki et al., 1970 (819)].

The nets tested were about 47 cm (18.5 in) wide and 105 cm (41 in) long (front seat), and 45 by 105 cm (17.5 by 41 in) for the rear seat of automobiles. Each upper end of the net is attached to the roof structure and the lower ends are tensioned by the nylon rope. The rope extends from the spring to the lower end of the net, has a breaking strength of 700 kg (1,543 lb), and is made of 3 nylon strands of .9 cm (.4 in) total diameter.

- (1) A G-sensor is actuated by the shock of collision. In tests this setting was established as 8 G and in case the impact is a half sine pulse and the peak value is above 20 G, the time delay between the onset of the jolt and the initiation of the G sensor is 9-10 msec.
- (2) An SCR (silicon controlled rectifier, 2SF124) control circuit is activated, supplying electric current to solenoids of triggers. The SCR is used to supply a current of approximately 150 amps to the solenoid of the trigger continuously.
- (3) Plungers of solenoids act to release the spring lock. The triggering device consists of four triggers, two for the front net and two for the rear net in the automobile. An electric current of 30 to 40 amps sent to the solenoid releases the spring locks, the force of the spring pulls the rope, and the net is stretched.

A schematic of the Nissan system is shown in Fig. 58.
