Advanced Techniques in Crash Impact Protection and Emergency Egress from Air Transport Aircraft

AGARDograph No.221
ADVANCED TECHNIQUES IN CRASH IMPACT PROTECTION AND
EMERGENCY EGRESS FROM AIR TRANSPORT AIRCRAFT

Richard G. Snyder, Ph.D.
Head, Biomedical Department, and Research Scientist
Highway Safety Research Institute
Institute of Science and Technology
and Professor of Anthropology
Department of Anthropology
The University of Michigan
Ann Arbor, Michigan 48105
U.S.A.

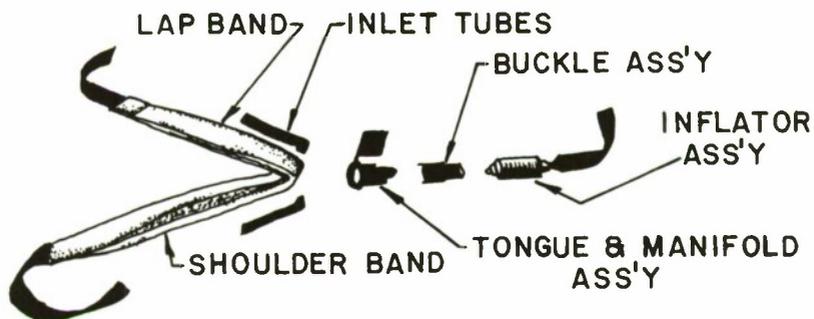
Fig. 59. Exploded view of Inflataband™ components [Redrawn after Burkes et al., 1975 (820)].

4.6.3 Inflatable Belt Systems. Another alternative system to the "air bag" passive restraint system has been developed by Allied Chemical Co. (820). The Allied Chemical Inflataband™ consists of an inflatable three-point harness system with both lap belt and upper torso diagonal belt. The system is comprised of four major assemblies consisting of the inflator, the buckle, the tongue and manifold, and the band (including both lap and upper torso portions).

Inflation is provided by a pressurized gas cylinder housing two electroexplosive devices. When an impact condition is detected by the sensor, an electrical signal is generated which activates the squibs. The activation of the squibs creates sufficient overpressure of the stored argon gas in the inflator to rupture a disk, which permits gas to flow through the ports in the buckle assembly and into the lap and shoulder segments. At full inflation the shoulder and lap band segments are reported to be approximately 45.5 cm (18 in) in circumference. Fig. 59 shows the Inflataband components.

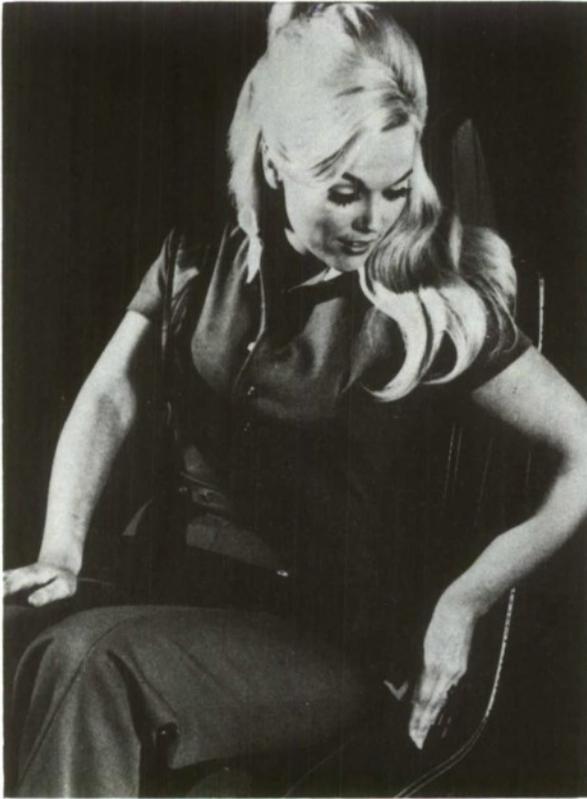
Fig. 60. The inactive system is donned as a regular active restraint system (Photo courtesy Automotive News).

This system combines the best features of the standard belt restraint system with the additional protection of the inflatable system (Figs. 60 and 61), except that while the system is automatically activated, it is not a passive system from the viewpoint that the wearer has to take action to don it. Once donned it then functions as an automatic system. One advantage is that should the inflation system fail, protection is still afforded by the locking standard restraint function.

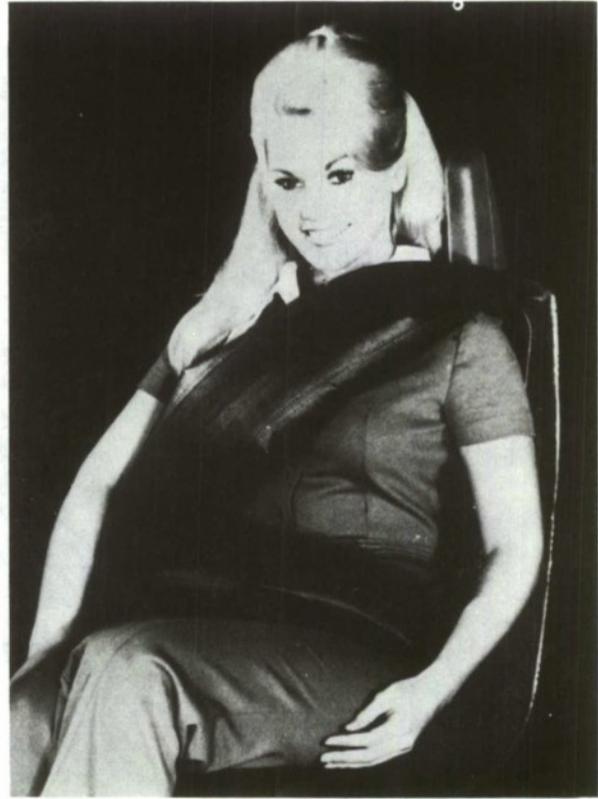
Fig. 61. Upon initiation, the Inflataband™ system inflates, providing additional passive protection to the occupant (Photo courtesy Automotive News).

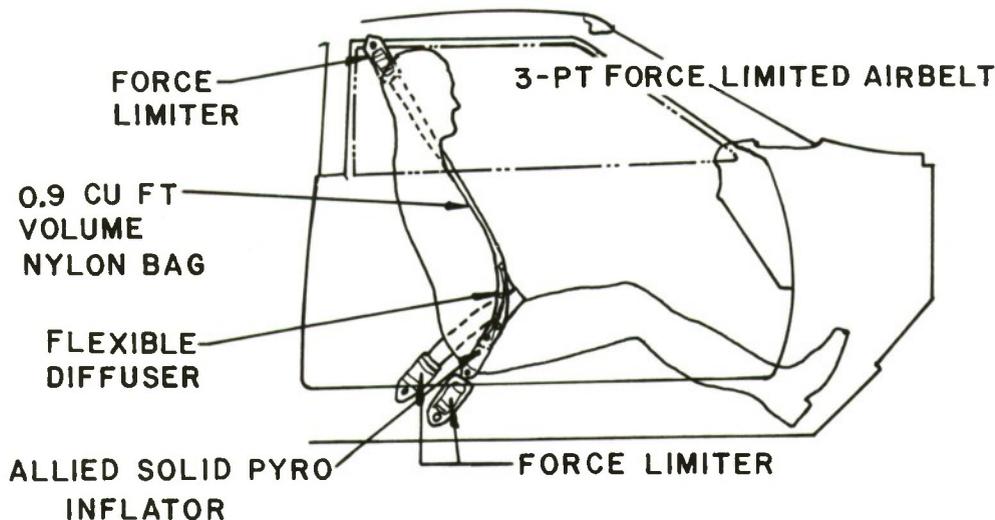
Fig. 62. Minicars Airbelt Restraint System developed under NHTSA contract [Redrawn after Fitzpatrick and Egbert, 1975 (821)].

The airbelt restraint system is primarily a two-point or three-point belt restraint modified to inflate upon impact, and anchor points modified to provide a controlled yielding in the system. Inflation of the belt is advantageous in substantially increasing the belt contact area thereby distributing the load over greater body surface area, preventing substantial forward head movement, and automatically taking all belt slack out of the system. A three-point belt system was found to be superior to the two-point diagonal torso belt as the latter allowed rotation "almost completely out of the restraint" (p.3-3). The energy-absorbing belt anchors (force limiters) are designed to attenuate the G levels transmitted to the passenger. This system is schematically illustrated in Fig. 62.

A 1.6 cm (5/8 in) diameter vent, located in the air bag portion attenuates rebound by dissipating a portion of the stored compressive energy in the gas. A diffuser is attached to the inflator inside the bag, and is designed to distribute the gas to various areas of the bag in order to prevent a local hot gas jet from burning a hole in the bag. The diffuser is constructed of radiator hose, 4.4 cm (1-3/4 in) inside diameter and 42 cm (16-1/2 in) long with .9 cm (3/8 in) diameter holes punched on 5.1 cm (2 in) centers. One end of the hose fits over the inflator nozzles, while the other end is pinched with a rivet, forming two holes in the end of the tube.

50-60 msec post-crash. On the other hand, the pyrotechnic system reaches its maximum rate of gas flow later in the event when the gas pressure in the inflator case reaches its maximum value (approximately 40 msec after squib initiation). The inflator is 10.2 cm (4 in) long and 4.4 cm (1-3/4 in) in diameter, and contains 60 grams (2 oz) of propellant.

The primary energy absorbers in the restraint system are the force limiters located at each of the three belt anchor positions. The roller diameters for the lap belt force limiters are 1.6 cm (5/8 in), while the roller diameters for the upper anchor is 1.9 cm (3/4 in). The lower outboard force limiter must react to both the force transmitted through the lower part of the torso belt as well as a portion of the lap belt load.

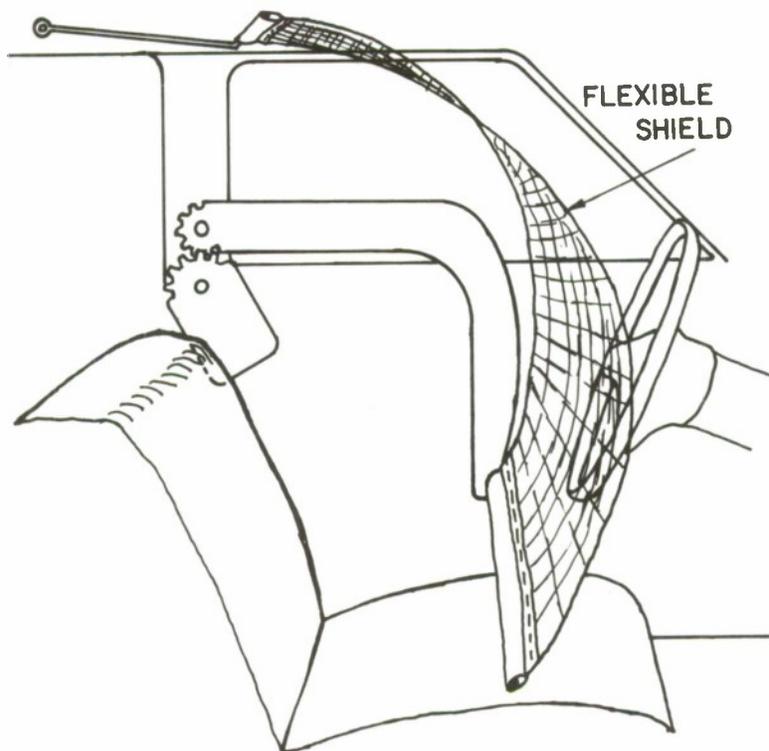
Fig. 63. Inertia switch flexible shield, stored overhead but swings into place during impact [Brown, 1972 (822)].

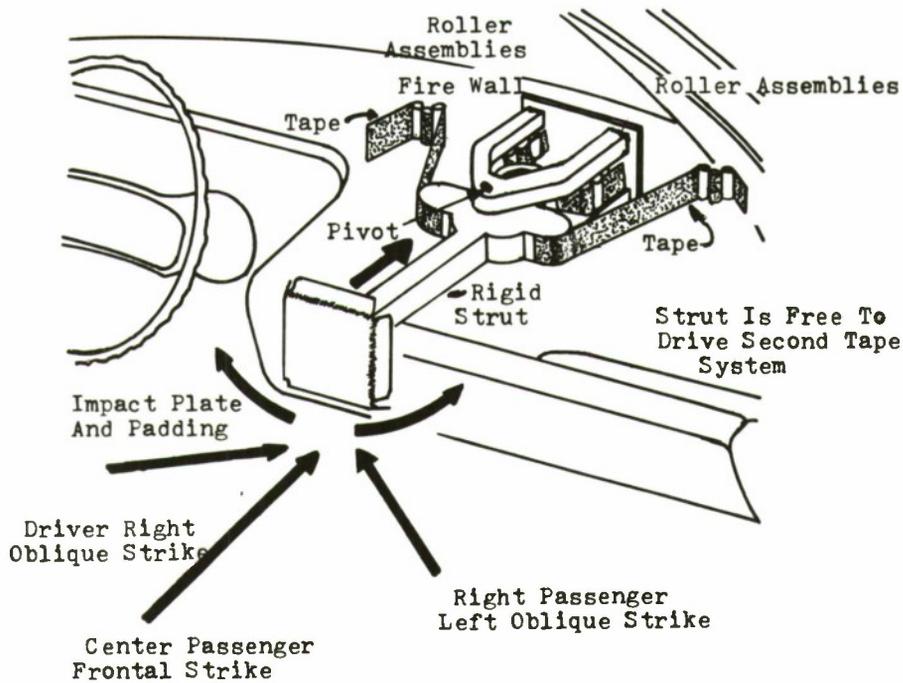
Fig. 64. Minicars Energy Absorbing Pylon Restraint configuration [Friedman et al., 1972 (829)].

4.6.7 Arms and Barriers. Concepts using arms or barriers for occupant protection include many variations. Minicars, Inc. of Galeta, California has developed a torso restraint roller-tape mechanism that is designed to swing into place as the door is closed [Friedman, 1972 (829)]. This work was done under contract to the National Highway Traffic Safety Administration. The bar consists of a roller-tape device that is designed to provide a constant force loading on the occupant's chest during impact. Five different concepts had been explored, and one operational device constructed and subjected to 14 impact tests using a Chevrolet Nova back. Among conclusions from these tests was that stroke and rebound must be handled by substantially reducing the exit velocity from the restraint. It was believed that the occupant could be returned to his or her original seated position after impact by providing more rebound velocity in the knee restraint than in the chest restraint. Fig. 64 shows one of two energy absorbing pylon configurations listed.

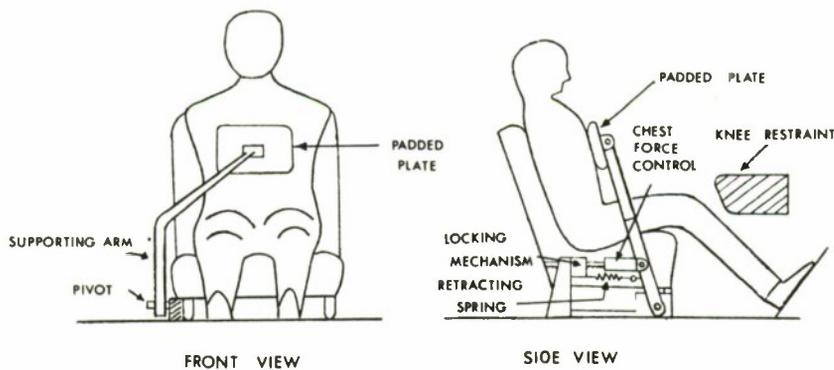
Fig. 65. Britax, Ltd. automatic cushion restraint [Grime, 1972 (831)].

Another approach, taken by Britax, Ltd., U.K., consists of a cushioned pad resting in the area of the upper torso that produces a constant force of 680 kg (1,500 lb) at the chest pad, and a knee restraint energy absorber which exerts a force of 907 kg (2,000 lb) [Grime, 1972 (831)]. As diagrammed in Fig. 65, this system is claimed to be effective in motor vehicle impacts for rollover, frontal, and side modes. A prototype has been used in a motor vehicle, and occupant response indicates there is ample freedom of shoulder and upper body movement. The major feature of the Britax automatic cushion restraint is that a pad or cushion is held in contact with, or close to, the chest of the vehicle occupant at all times. The pad can be pushed forward against light spring pressure so that the occupant is free to lean forward. At impact the arm is locked by a mechanism sensitive to vehicle deceleration. The lower part of the body is decelerated and prevented from submarining by a knee pad placed a short distance in front of the knees.

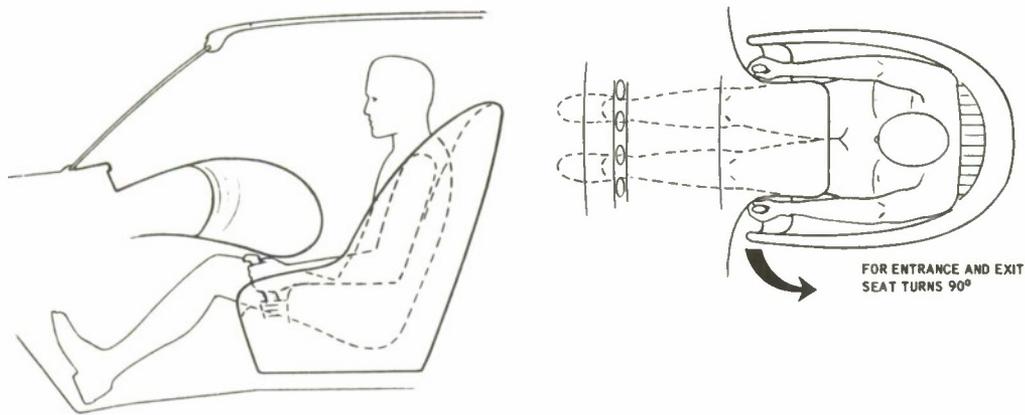
Fig. 66. Concept of seating capsule with protective energy-absorbing forward panel. Removal of steering assembly would allow use of passive restraint concept with no occupant belt system necessary. High sides of capsule offer side impact protection and head protection. Capsule could swivel to enter, or outboard section could be integrated with door [Snyder, 1969 (836)].

4.6.8 Static/Capsule Passive Restraint. Occupant protection can also be achieved by encapsulating the environment about the seat area to provide energy absorbing contact surfaces. In a concept designed for advanced automotive vehicles, Snyder suggested a capsule system using wrist-twist steering controls, which had been extensively developed and tested by both General Motors Corporation and Ford Motor Company by 1968 [Snyder, 1969 (836)], combined with a foam energy-absorbing forward panel and deep bucket side and head protection (Fig. 66). Advanced variations of this "static passive restraint" concept have been further explored by Ford of England [Egglestone and Suthurst, 1974 (835)], as reported at the Fifth International Conference on Experimental Safety Vehicles. No belts or other body contact restraints are envisioned with such a passive capsule environment.

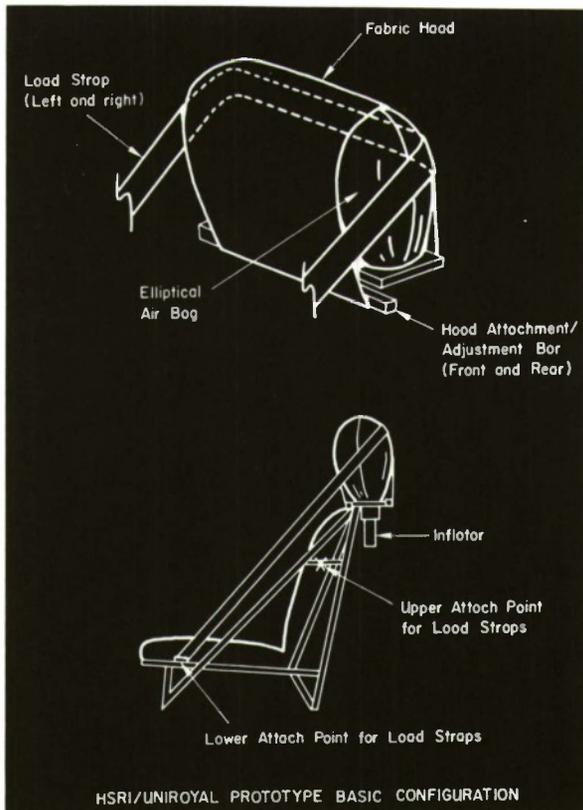
Fig. 67. HSRI/UniRoyal prototype deployable head restraint basic configuration (Photo courtesy J. Melvin, HSRI).

The HSRI/UniRoyal deployable head restraint, shown in Fig. 67 consisted of a coated fabric bag of elliptical cross-section, 25.4 cm (10 in) high, 20 cm (8 in) deep, and 45.7 cm (18 in) high. An inlet port for the Olin inflator (below the baseplate) was located in the bottom of the baseplate and bag. A gas generator system developed by Rocket Research Corporation (Redmond, Washington) was also considered but the Olin system tested was selected. To provide resistance to rearward loading, a fiberglass-reinforced vinyl hood 45.7 cm (18 in) wide was fastened to the front and rear of the baseplate. This allowed rearward loads applied to the hood/bag to be transmitted to the baseplate and seat structure. An additional load-strap was sewn across the top rear of the hood, then attached at its ends to the edges of the seat pan.

The HSRI/UniRoyal deployable head restraint system was subjected to 16 impact-sled tests simulating rear-end collisions of 32 km/h (20 mph), 96.5 km/h (60 mph), and 129 km/h (80 mph) car to car closing velocities, or velocity changes for the struck vehicle of 16, 48.3, and 64.4 km/h (10, 30, and 40 mph), equivalent to 10, 18, and 40 G peak sled pulses. Tests were conducted on the HSRI impact sled utilizing both 95th percentile male (98.4 kg [217 lb]) and 5th percentile female (48.1 kg [106 lb]) dummies. Fig. 68 illustrates an instrumented test dummy and prototype HSRI/UniRoyal deployable head restraint. In addition, 4 vehicle crash tests were conducted at Dynamic Science in Deer Valley, Arizona.

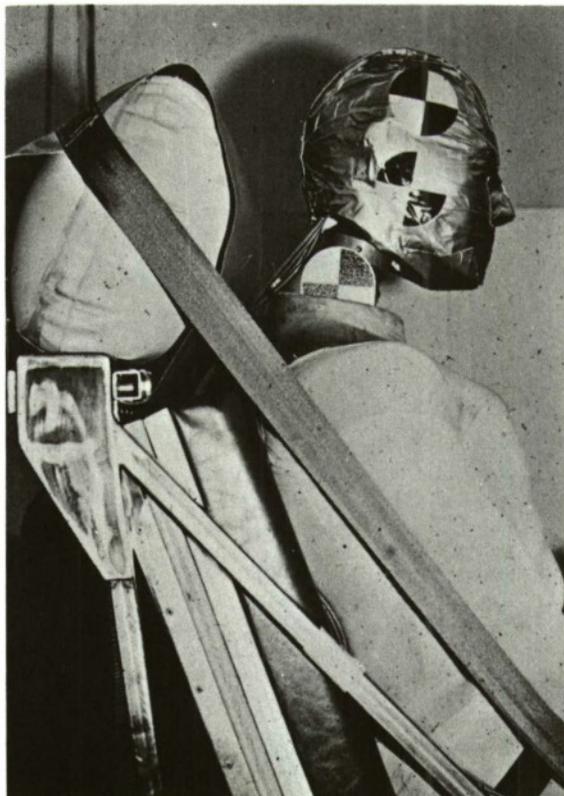
Fig. 68. Instrumented dummy and prototype deployable head restraint (Photo courtesy J. Melvin, HSRI).

It was found that the deployable head restraint effectively reduces head/neck hyperextension ("whiplash") that characterizes rear-impact kinematics. Typical performance for a 95th percentile male dummy, lap belted, in a 64 km/h (40 mph)/32 G direct rear impact was 32 msec deployment time, maximum head/neck extension 10-1/4°, peak head A-P acceleration 71 G, with moderate ramping and rebound. Storage volume was 51 x 10 x 2.5 cm (20 x 4 x 1 in). Since these tests of deployable head restraints were primarily a feasibility study, product development problems of packaging, protection from the elements, crash sensor integration, etc., were recognized but not explored. Tests of the oblique impact and out-of-position occupant were inconclusive. Although rear-end collisions in aircraft are rare, the aircraft passenger may be subjected to crashes in which head protection is needed. Headrests are required to provide adequate crew protection for the crash environments currently specified in both Army and Air Force crew seat design criteria. Currently proposed Army and Air Force design criteria call for crashworthiness at impact levels up to 18 G in the lateral direction and 30 G in the longitudinal direction (MIL-S-58095). The velocities associated with these G levels are 9.1 m/sec (30 ft/sec) and 15.2 m/sec (50 ft/sec) respectively, and significantly exceed the conditions known to be tolerable without a headrest. Injuries in USAF helicopter accidents to both crew and passengers have been attributed to lack of head restraint protection [Brinkley, 1973 (837)]. The deployable head restraint concept remains a promising solution.

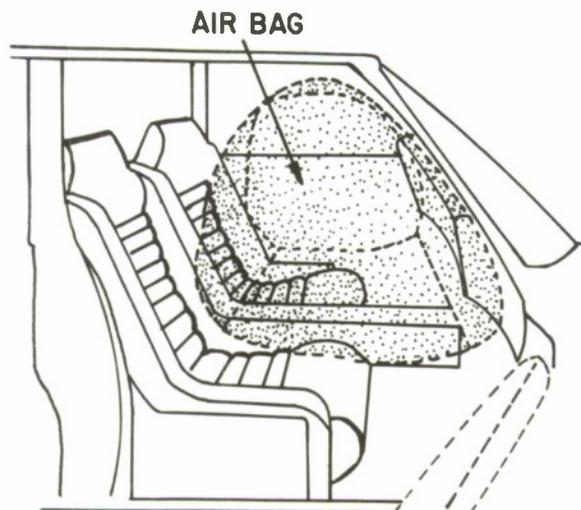
Fig. 69. Integrated seat-restraint system with air bag designed in University of Michigan HSRI concepts study for NHTSA [Robbins et al., 1971 (784)].

Fig. 69 illustrates yet another integrated seat-restraint concept which was proposed by Robbins et al. [1971 (784)] in a research study of advanced passive restraint systems undertaken for the National Highway Traffic Safety Administration. In this system the occupants are seated in specially designed

seats providing head restraint and some side restraint integral to the structure itself. Upon impact an air bag is deployed in front of the occupant to provide forward restraint. For airline use such a system would most effectively utilize a lap belt in addition which would retain an occupant in situations where turbulence was encountered below air bag deployable impact loads.

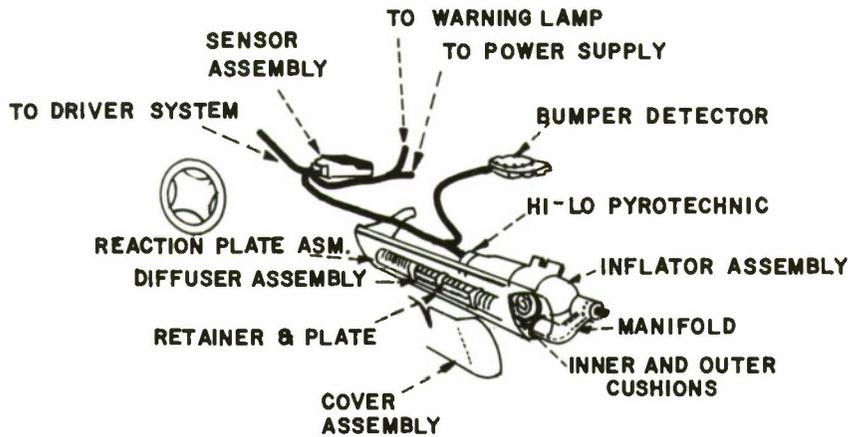
Fig. 70. Schematic of the basic driver and passenger air bag restraint system.

4.6.11.2 Inflating Occupant Restraint System Components. There are six basic components in an air bag type of passive restraint system. These consist of: (1) crash sensor-initiator, (2) energy (gas) source (stored gas and/or solid gas generator), (3) valve to release gas, (4) manifold (to distribute gas), (5) inflatable bag, and (6) malfunction detector and system readiness monitor. Each of these subsystems has its own set of environmental problems and components. Although the vehicle manufacturer, as well as NHTSA, is concerned with the total system, many of the suppliers concentrate their development efforts on one or more components. Fig. 70 illustrates these major subsystems.

The subsystems have been developed for automotive use, and the few aircraft tests conducted have utilized or adapted from these components. The sensor-initiator consists of an inertial switch or other device capable of sensing that a crash is about to or has begun to occur. The signal from the sensor is then fed to an initiator which triggers a supply of gas to the deployable bag. In the case of pyrotechnic gas sources, the initiator is an igniter whereas for the stored gas systems, the initiator is an explosive squib which fractures a diaphragm sealing the stored gas bottle. In all cases the necessary electrical signal is provided by a power source such as a battery, although a detonating cord has been proposed by one supplier.

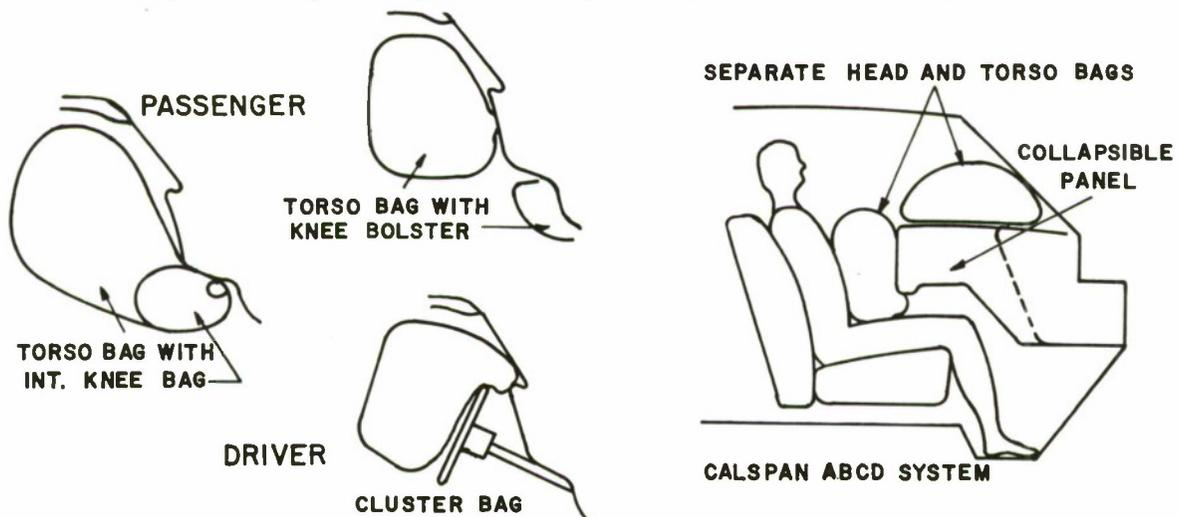
Fig. 71. General types of air bag configurations developed for automotive use [Seiffert and Borenus, 1972 (912); Shoemaker and Biss, 1974 (913)].

Calspan has developed an air bag on collapsible dashpanel (ABCD) passive restraint system having a total bag volume (76 liters [2.7 cu ft]) approximately one-half that of the conventional standard-size right front passenger system [Shoemaker and Biss, 1974 (913)]. This system includes a collapsible dashpanel, two small air bags which deploy at speeds above 32 km/h (20 mph) and a crushable kneebar for lower body restraint. Fig. 71 shows general types of air bags developed for automotive use.

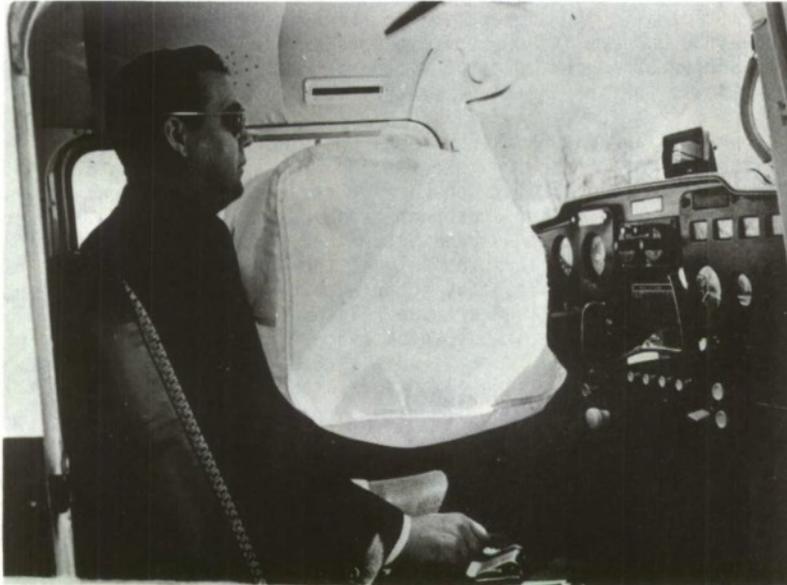
Fig. 72. Mock-up of air bag system for light aircraft use [HSRI, The University of Michigan, 1970].

The shape and deployment of the bag for aircraft use would be governed by approximately the same principles which apply to automotive use. A bag deploying from a position in front of the occupant's knees would provide a cushion for the knees and torso of the occupant. A bag deploying at chest level from a position in the seat back in front of the occupant would have to be supplemented by an energy-absorbing structure designed to minimize motion of the legs. Both of these designs have been tested widely and can provide equally high levels of protection. The high deploying bag concept has slight advantages in that the bag can be deployed more rapidly. An air bag system mocked up for general aviation aircraft use at HSRI, the University of Michigan in 1970, is illustrated in Fig. 72.

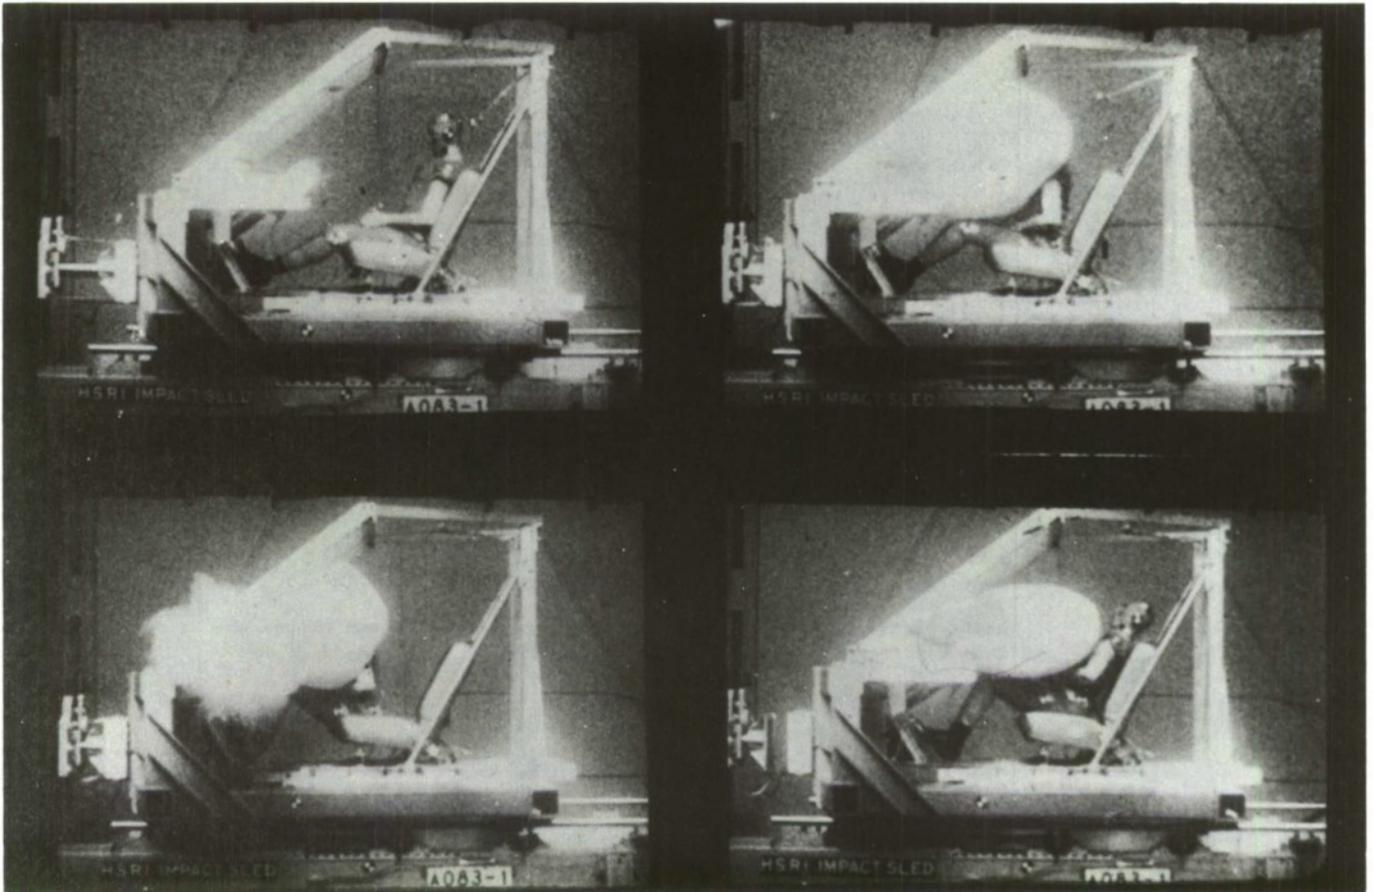
Fig. 73. Unbelted 50th percentile adult male dummy in HSRI sled deceleration at 32 km/h (20 mph) impact velocity, showing initial bag deployment, forward motion of the dummy into the deploying bag, and finally rebound back into the seat.

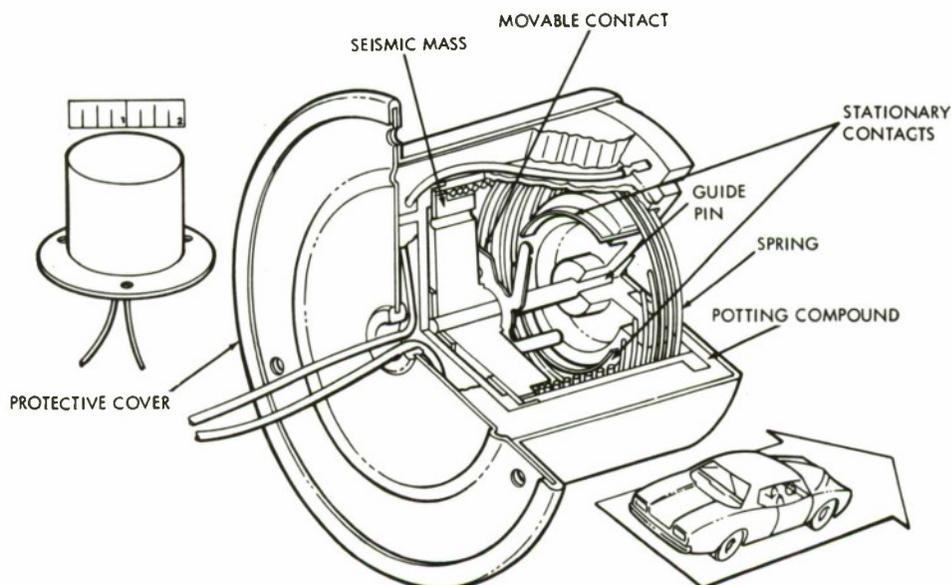
The Eaton Autoceptor crash sensor is a uniaxial mechanical spring-mass system which fires when the mass is displaced in a predetermined distance. The spring holds the mass against an end of the sensor in order to produce a bias force against the mass. This first-generation Eaton spring mass sensor (Fig. 74) was designed for the following characteristics: 1.3 cm (0.5 in) travel, 5 G preload, and 2 G/in spring rate. To 1972 some 3 million miles of road tests without inadvertent activation were reported by Eaton [Pujdowski, 1972 (937)].

Fig. 74. Eaton Autoceptor first-generation crash sensor [Pujdowski, 1972 (937)].

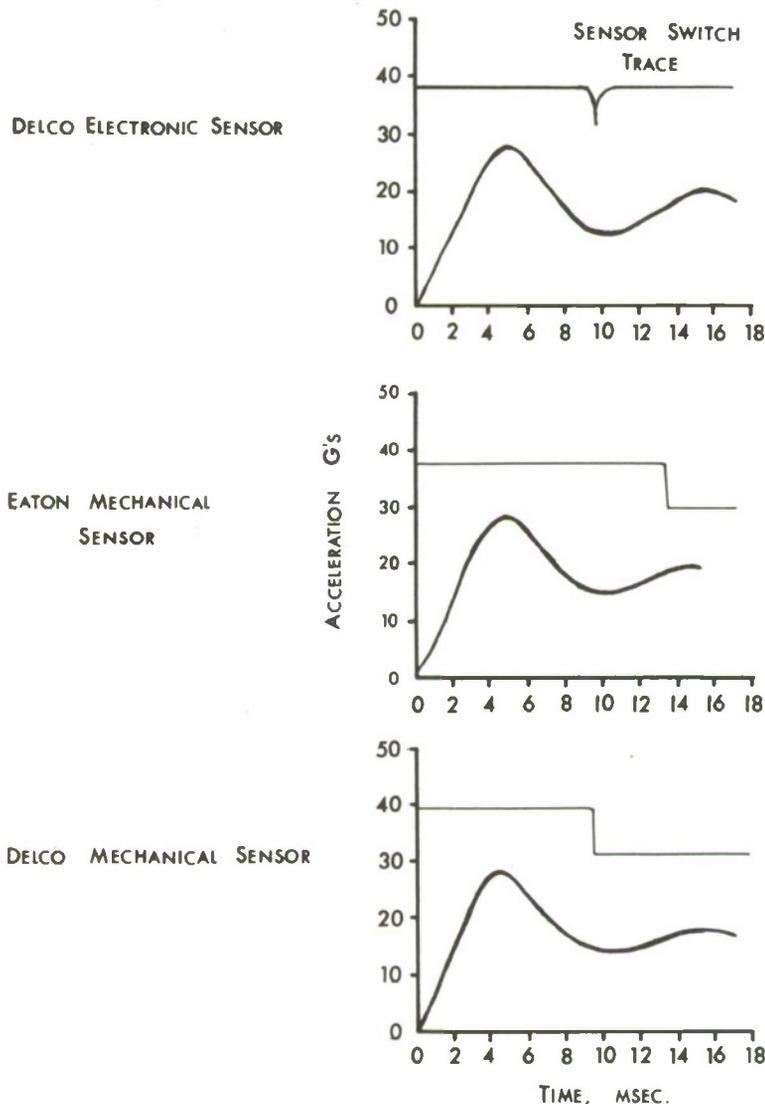
In the Eaton and GM sensors tested at HSRI, each of the sensors was mounted on the ram of a Plastechon high speed universal testing machine. This hydraulically actuated, electronically servo-controlled machine was programmed to subject the sensors to a variety of acceleration-time profiles. A Setra Model 110 accelerometer was mounted on the ram to measure the acceleration input to the sensor. The accelerometer output was filtered through a Burr-Brown filter meeting SAE J211 channel class 180 specifications. An automobile 12-volt battery was the power source for the sensors. Typical results are shown in Fig. 75. It should be noted that for these 30 G pulses typical of the initial sheet metal crush in a motor vehicle barrier crash, the air bag would have been triggered in from 10 to 14 msec.

Fig. 75. Crash sensor response tests [Robbins et al., 1971 (909)].

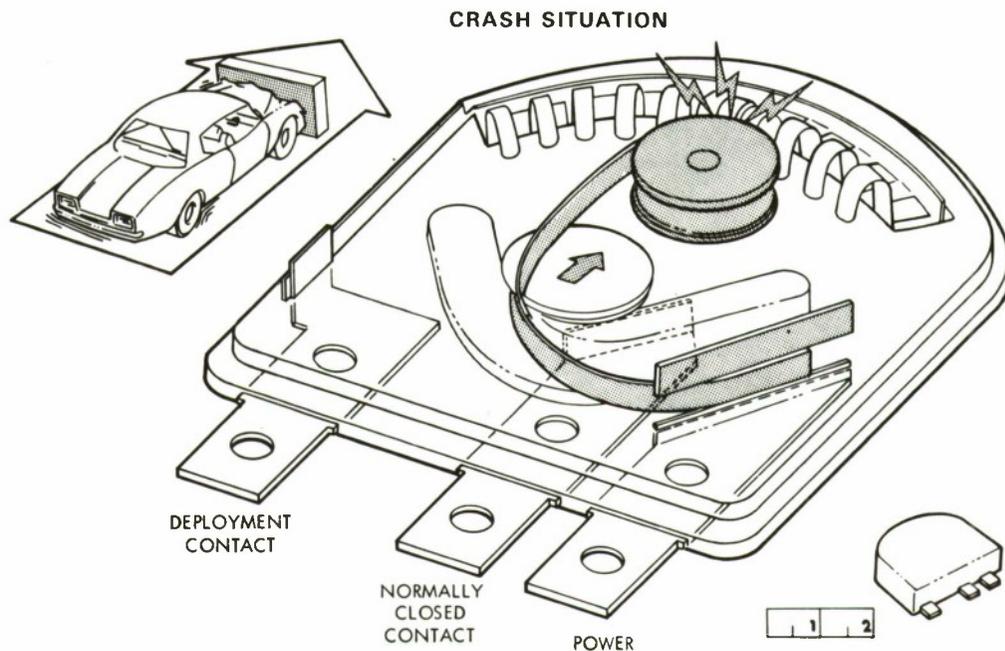
A more recent crash-active type of sensor is the wide angle crash sensor developed by Eaton as shown in Fig. 76.

Fig. 76. Eaton wide angle crash active sensor [Pujdowski, 1972 (937)].

Tests were performed on the Eaton sensor to establish the effect of off-axis acceleration on trigger time. Two different amplitude (11 G peak and 24 G peak) acceleration-time profiles were used. The sensor was subjected to the same pulse each time at angular increments of 10 off-axis starting at 0 and increasing until the sensor would not trigger. For the 11 G pulse, the G-switch triggered at 24 msec. At 20° off center, the triggering was delayed at 33 msec and the sensor would not trigger for larger off-axis angles. In the case of the 24 G pulses, the sensor triggered at 15 msec for a direct frontal pulse. This was delayed to 20 msec for a 30° oblique pulse. The system did not fire for larger angles (See Fig. 76).

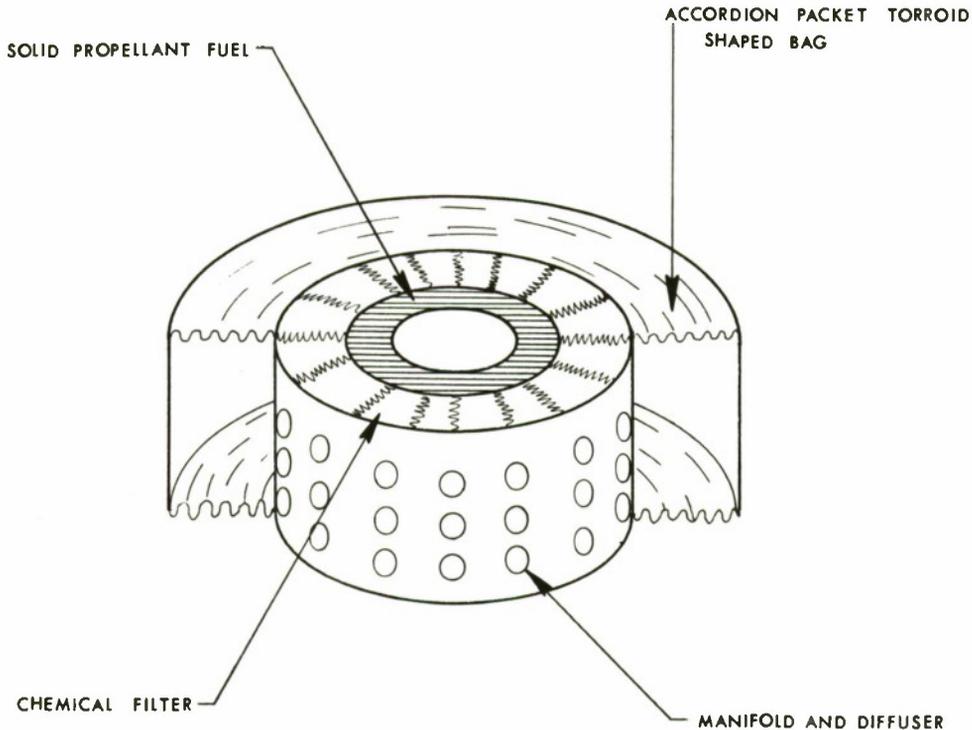
4.6.11.5.6 Solid-cooled solid propellant gas generator system. This light system which is in the early stages of development appears to avoid toxicity problems by the addition of a mechanical filter for solid particulate matter and a chemical filter for toxic fumes, as shown in Fig. 77.

Fig. 77. Solid-cooled solid propellant gas generator system.

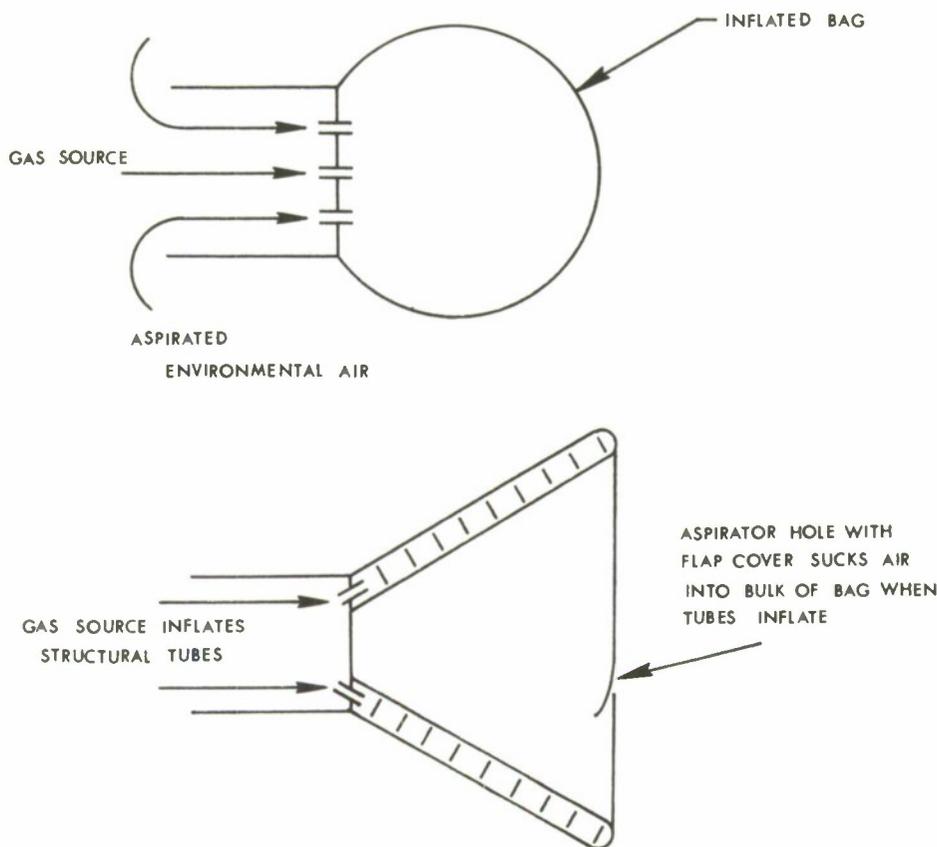
Three types of systems are under early development. In the first of these air is mixed with the propellant gas to fill the bag with cool gas. In the second, support structure for the bag is inflated with a gas generation system and the remainder of the bag by aspiration of cabin air. The major concern is that the amount of ambient air used decreases as inflation time decreases. For a jet transport the available inflation time is probably sufficient to make this system particularly attractive. (See Fig. 78.)

Fig. 78. Two types of aspirator systems.

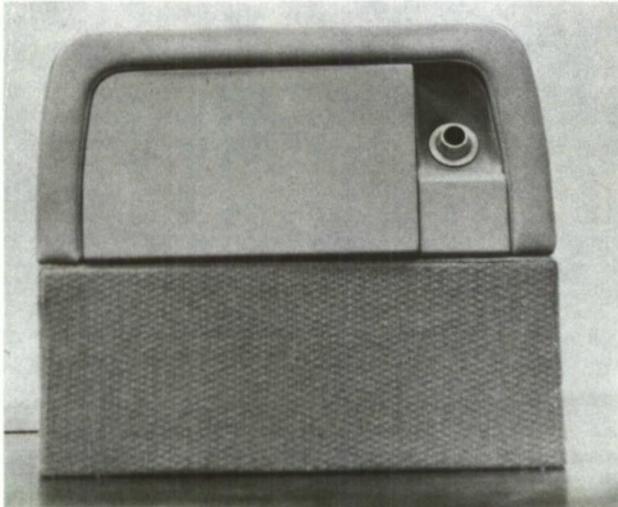
of sensors [Diamond, 1976 (1005)]. As shown in Figs. 79-82, this restraint system stows compactly in the seat back along with the passenger's emergency oxygen system. Activation of the prototype shown is by means of the same size carbon dioxide cylinder used for inflation of pneumatic life preservers (MIL-C-25369A Type# 137.5 gr). The prototype bag holds approximately 13 liters (793 cu in) of gas and has dimensions of 30.5 cm (12 in) wide, 28 cm (11 in) high, and 7.6 cm (3 in) deep. Weight of the prototype system, including the container structure, is approximately 2.9 kg (6.5 lb), less than previous estimates of Clark (863) and Carr and Phillips (852), but does not include any electronic initiator device. The air bag and CO₂ inflation system itself weighs only 435 grams (14 oz). (It should be noted that these data have been obtained from inspection of the prototype device and are not manufacturer's specifications.) In contrast to current automotive inflatable restraints, which would cost from \$75 to \$300 each to replace each time used, the Diamond system is equipped with a simple exhaust gas release, and once the bag has been deployed, it can be packed up again and reused immediately at no cost except for a new CO₂ cylinder. At present this device is only in a prototype stage and would require further development and dynamic testing; however, the concept and application to air transports merit further consideration.

Fig. 79. Prototype inflatable air bag restraint system stowed in passenger seat back, under development by F.L. Diamond Corporation, Granada Hills, California.

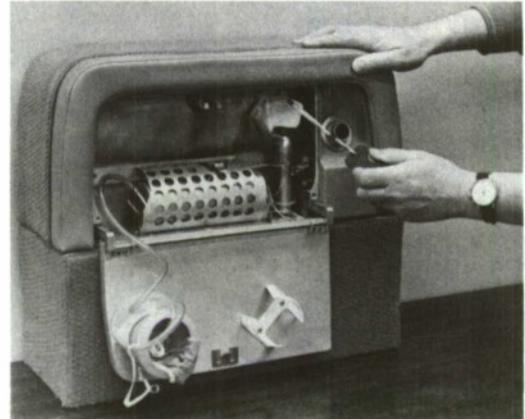
Fig. 80. Cover removed, showing stowage of bag at top, CO₂ cylinder at right. Activation is manual in this prototype.

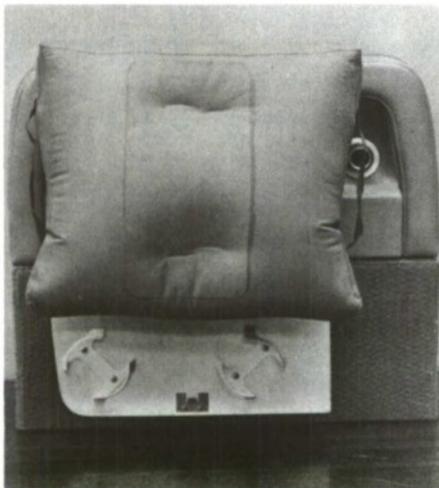
Fig. 81. Once the bag is inflated, it forms a protective cushion for head impact.

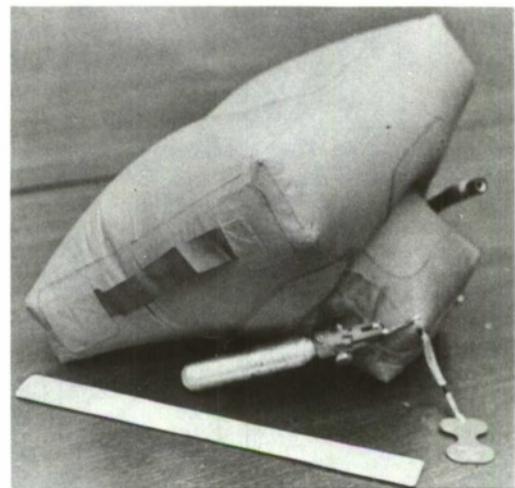
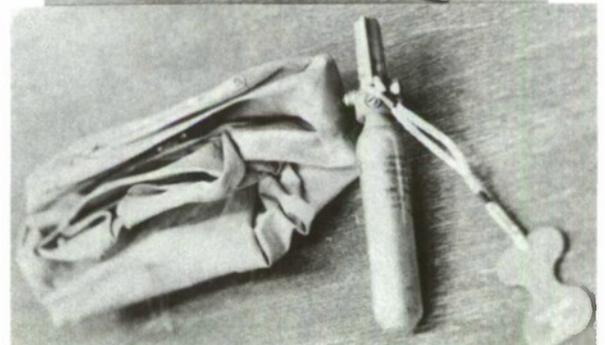
Fig. 82. The inflatable bag, shown in deflated and inflated configurations.

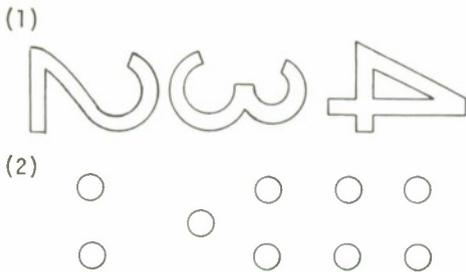
- (e) Raised numerical indicators.

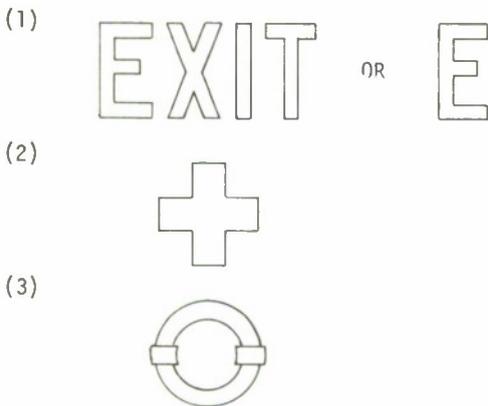
- (f) Raised name, symbols, or abbreviation indicators.

This technique is particularly useful on floor areas for crawling, or where continuous hand contact can be maintained and where minimum disturbance of surface, carpet or upholstery is required.

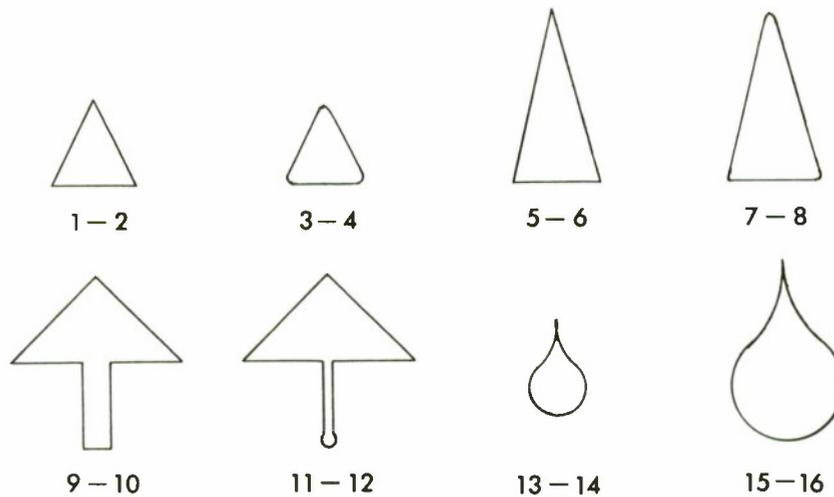
Results of these tests indicated that the teardrop-shaped (13-16) and elongated-triangle-shaped (5-8) forms were significantly better shapes with which to indicate direction. This result was evidenced by

quicker response times, significantly fewer errors, and fewer reversal errors (180° out of phase). The thickness variation (3.2 mm to 6.4 mm [1/8 to 1/4 in]) made no difference, but a subject preference was indicated for larger forms. The 5 cm (2 in) elongated triangle was recommended as the best tactile form tested. However, when groups of people were tested under evacuation simulation, it was found that tactile cues were relatively ineffective. Subjects used them infrequently, preferring to hold onto the person ahead, and additional time was lost in using them.

Fig. 82a. Shapes of 1/8 and 1/4 inch tactile cues used in AIA tests (1023).

The Aerospace Industries Association reported tests of the use of tactile aids for locating exits during adverse visual conditions. These tests were conducted by Douglas Aircraft Company in 1967 [Oden and Altman (1023)]. Fourteen subjects were tested individually under smoke conditions, using the accuracy of the direction indicated and latent response criteria to evaluate eight different tactile shapes. These forms were evaluated for two different thicknesses, 3.2 mm and 6.4 mm (1/8 and 1/4 in). Thus 16 different test conditions were evaluated. The tactile cues used in these tests are illustrated in Fig. 82a. The experimental design required the subject to place his left hand into a box that held the plywood tactile form and, by feeling this form, indicate its direction. This was done as rapidly as possible by turning a knob on a display board at the top of a box with the right hand and subsequently pressing a button to shut off the timing device. None of the tactile forms in the box were visible to the subject.

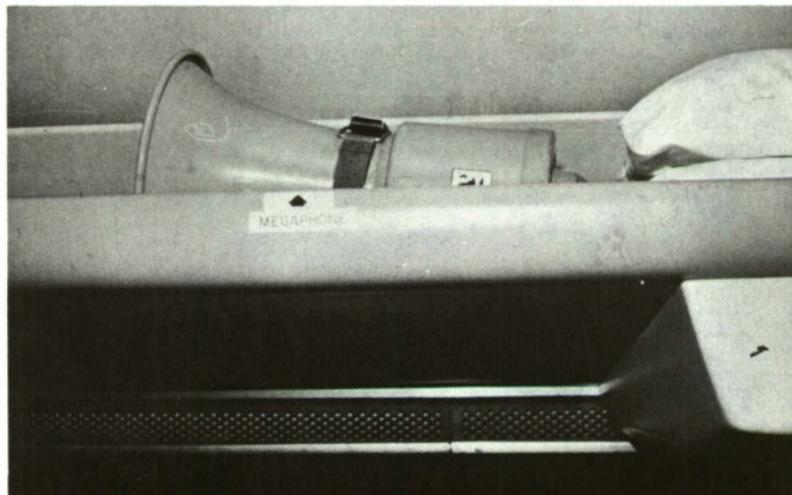
Review of Federal Air Regulations (Part 25; Part 121) revealed no specific requirements for civil air transport aircraft related to emergency evacuation signal systems prior to the new regulation effective 8 September, 1975, except as related to the bullhorn (Part 121; Part 309). In regard to this equipment, the FAA only requires that there be an emergency evacuation signal system and a statement of its location. The bullhorn is a portable, battery-powered lightweight megaphone. Fig. shows a typical installation in a civil air carrier aircraft, located in the aft section at the end of the overhead storage rack.

Fig. 83. Typical bullhorn emergency public address system installation in civil air transport.

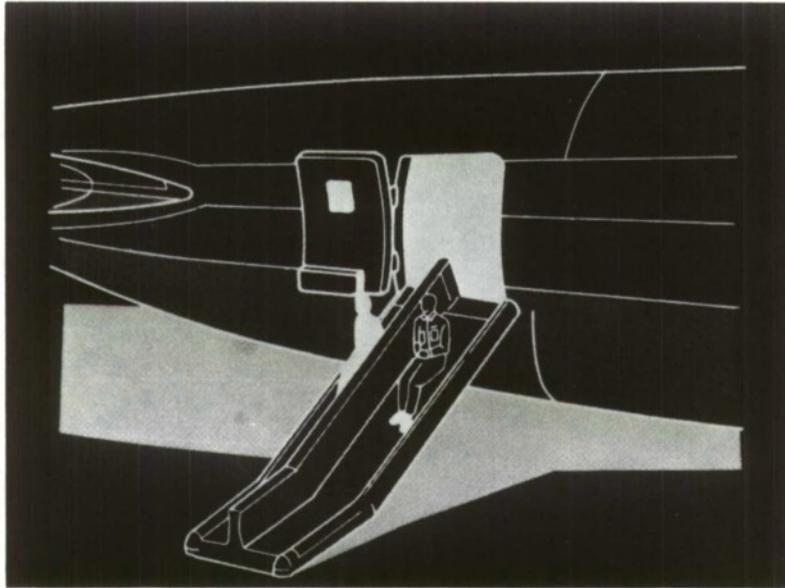
7.2.1.2 Double Escape Slide with Center Divider. This concept was proposed by McDonnell Douglas [Roebuck, 1968 (15)] and is a modification of the double escape slide described above. In this version an inflatable semi-rigid separator "fence" in the middle of the slide would in effect provide two adjacent slides, as shown in Fig. 84. The advantage of this would be to prevent persons sliding down side-by-side from getting entangled, or one passenger blocking egress from both sides. The primary purpose of the concept was to prevent hesitation caused by one passenger waiting for another beside him to get well down the slide before jumping. It would also provide an additional hand-hold. Suggested provision for chemical light along the top edge of the dividers would provide better illumination. The inflatable divider section, while increasing weight, storage bulk, and inflation capacity, would provide additional longitudinal rigidity. It was estimated that this would improve passenger flow rate by up to 10 percent; however, no tests are reported to confirm this estimate.

Fig. 84. Double escape slide with center divider [Roebuck, 1968 (15)].

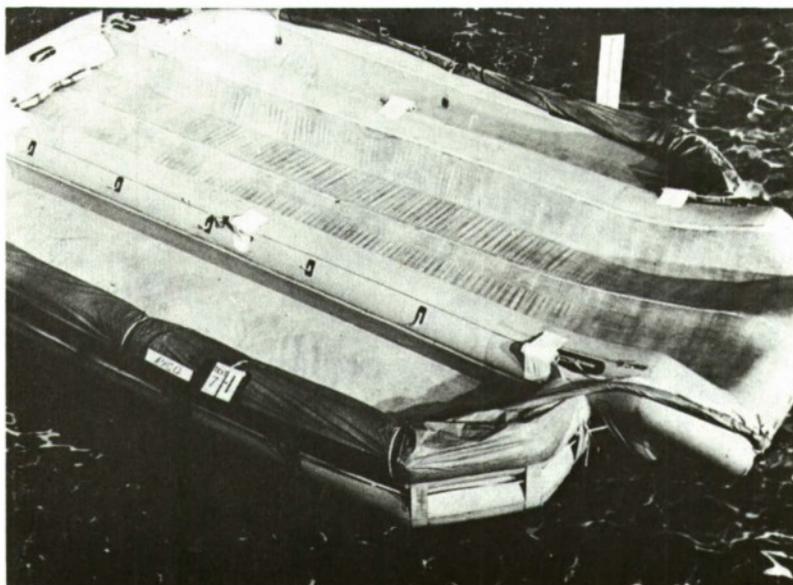
One of the larger slide/rafts designed for the McDonnell Douglas DC-10, a double lane, 7.9 m (26 ft) prototype, was evaluated in open water using larger boats to create increased wave conditions. Fig. 85 illustrates the slide/raft, designed by Pico. A usable seating area of 17.9 sq m (193 sq ft) was calculated for this configuration raft. The raft was alternately loaded with 44 subjects (.41 sq m [4.4 sq ft] per subject), 55 subjects (.33 sq m [3.6 sq ft] per subject), and 66 subjects (.27 sq m [3.0 sq ft] per subject). Under these conditions the slide/raft exhibited excellent buoyancy in all passenger loadings. Essentially rectangular in shape, slide/rafts tend to flex, bend and follow the contour of a swell. When the lower

tube was deflated, freeboard was reduced and waves induced by boat action at times introduced water into the slide/raft; however, the remaining buoyancy was adequate to maintain flotation with the maximum number of occupants. When one of the two compartments is deflated the structural rigidity of the slide/raft is normally reduced with the two sides pinching inward reducing the total apparent surface area of the slide/raft.

Fig. 85. Combination life raft escape slide recently certified for civil air carrier use on the McDonnell Douglas DC-10 (Photo courtesy E.B. McFadden, FAA).
