Advanced Techniques in Crash Impact Protection and Emergency Egress from Air Transport Aircraft

AGARDograph No.221
ADVANCED TECHNIQUES IN CRASH IMPACT PROTECTION AND
EMERGENCY EGRESS FROM AIR TRANSPORT AIRCRAFT

Richard G. Snyder, Ph.D.
Head, Biomedical Department, and Research Scientist
Highway Safety Research Institute
Institute of Science and Technology
and Professor of Anthropology
Department of Anthropology
The University of Michigan
Ann Arbor, Michigan 48105
U.S.A.

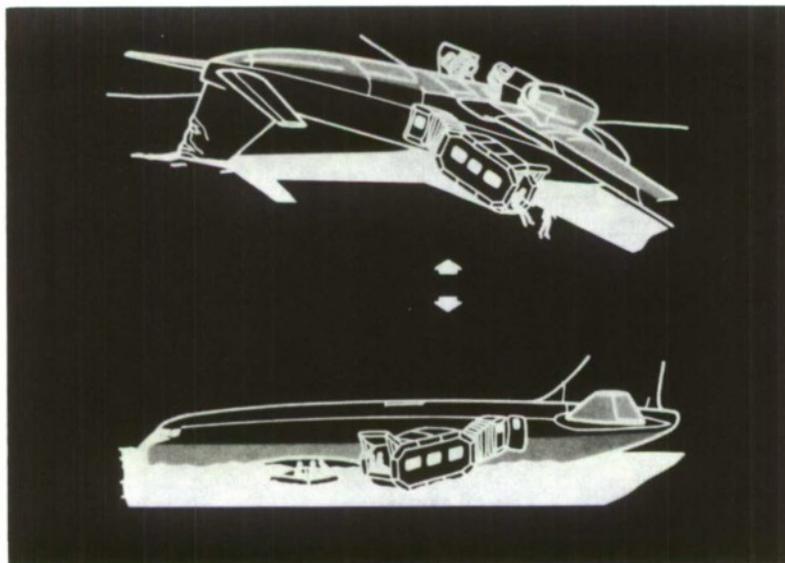
7.2.1.4 Inflatable Tubular Escape Slide/Raft. A different concept of an escape slide/raft device was proposed in 1968, involving an inflatable tubular structure as shown in Fig. 86 [Roebuck, 1968 (15)]. In this version flexible joint sections of the tubular escape structure would be designed to allow slide egress in any position, including from an inverted aircraft. Completely enclosed slides have not been used previously, and some protection from smoke and flame might result. On the other hand, an enclosed slide could act as an efficient flue if fire is present, which might shorten survival time. Windows of flexible transparent plastic would provide light, with chemical light strips inside for night egress. It could be used as a ramp walkway. The floor and ceiling (identical) would be constructed of Goodyear "air-mat" material with capability to inflate a 2.5 to 5.1 cm (1 to 2 in) thick stiff surface by auxiliary inflation bottles in case of a very shallow angle of egress. The attached end is extended from the aircraft by a tubular, sliding cable-restrained bellows, capable of universal flexure to some ± 25 degrees of arc, and torsion to about ± 30 degrees of arc. The bellows articulation would be a larger version of the shoulder joint in a space suit pressure garment. This concept was reported to have an estimated increase in passenger flow rate up to 50% in ditching; however, if compared to current ditching, life raft deployment requirements in aircraft such as the Lockheed C-141A would probably be considerably greater.

Fig. 86. Concept of a combination inflatable escape slide/life raft [Roebuck, 1968 (15)].

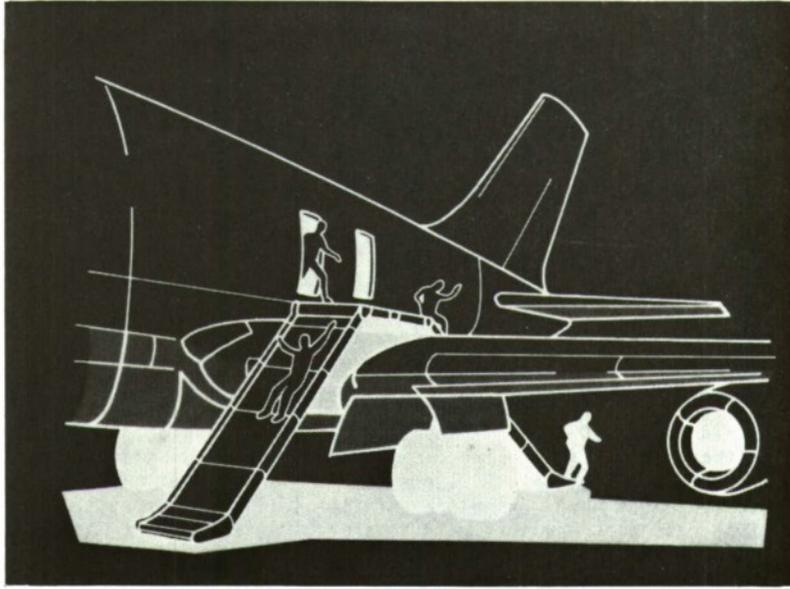
Fig. 87. Exterior platform slide entry for overwing escape [Roebuck, 1968 (15)].

7.2.1.5 Exterior Platform Escape Slide Entry. The purpose of this escape slide concept (Fig. 87) is to reduce a traffic-flow bottleneck at the emergency exit caused by psychological reasons [Roebuck, 1968 (15)]. The idea here is to get the passenger out on the wing (low-wing aircraft) and then utilize conventional inflatable slides, which would be automatically deployed from the platform package. This concept is within the state-of-the-art and is a modification of some current designs.

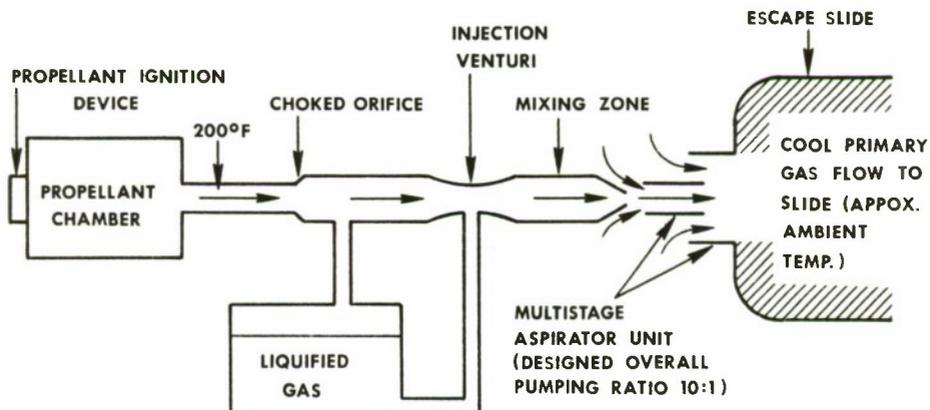
Fig. 88. Cool gas generator system for inflatable escape devices.

The conventional system of inflating escape slides is to duct high-pressure gas from a gas reservoir through an aspirator and into the slides. The aspirator contains a nozzle that expands the high-pressure gas to below ambient pressure. The aspirator casing contains doors designed to open when the pressure within the casing body falls below ambient pressure. Thus, the entering air is entrained by the expanding high-pressure gas, and the resulting mixture fills the inflatable escape slide. In the newer cool gas generator system the high-pressure gas cylinder is replaced with a solid propellant charge within a gas-generating chamber plus a coolant chamber. When ignited, this charge generates hot gas which is then cooled by one of several alternate methods when exhausted into a secondary chamber. The resulting cool gas is then directed to an improved external aspirator and subsequently into the inflatable device. Fig. 88 shows the cool gas generation system in schematic form.

Three types of gas generator systems include the solid coolant-solid propellant-aspirator system, the liquid coolant-solid propellant-aspirator system, and the liquid coolant-solid propellant-aspirator system. In the solid coolant system the hot gas resulting from the solid propellant charge ignition is passed over a catalytic bed, which acts as the coolant agent, and the resulting cool gas drives the aspirator. Hardware for this concept is still in development, and problems in gas temperature control have been reported. Although it appears to be a relatively simple and easily maintained system, this cannot be determined until tested. It also may be relatively costly. In the gas coolant system, a 211 kg/sq cm (3,000 psi) gaseous nitrogen mix is the primary coolant. By mixing with the hot gases generated by the ignition of the solid propellant charge the driving gas is directed to the aspirator. It has been indicated to be effective over a temperature range of -40°C (-40°F) to $+71^{\circ}\text{C}$ ($+160^{\circ}\text{F}$), and is capable of inflating a 4.5 cu m (160 cu ft) volume to a pressure of .09 kg/sq cm (1.4 psi) in approximately 8 seconds. Its cooling ability comes from high-pressure gas expansion, however, weight requirements for high-pressure gas cylinders may be relatively high. The third method uses a liquified gas as a coolant. The hot gas generated by the ignition of the solid propellant charge is used to provide the latent heat of vaporization required to evaporate the liquified gas coolant. It is capable of inflating an 8.2 cu m (290 cu ft) volume to a pressure of .14 kg/sq cm (2.0 psi) in less than 7 seconds, over a temperature range of -40°C to $+71^{\circ}\text{C}$ (-40°F to $+160^{\circ}\text{F}$). A detailed analysis of inflation devices and current state-of-the-art has been previously presented in Section 4.6.11.5; however, the requirements for use with inflatable restraints and inflatable escape slides differ considerably.

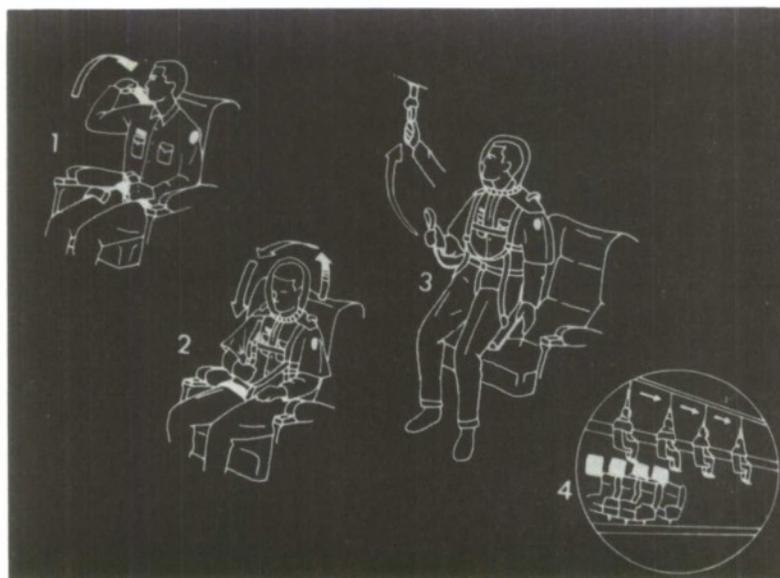
Fig. 89. In this system the passenger (1) attaches his seat belt to integrated seat-back straps, (2) hooks into an overhead hook, and (3) is automatically conveyed to an exit [Roebuck, 1968 (15)].

7.3.1 Seat Belt Escape Harness and Egress Conveyor System. This concept envisions an integrated system utilizing the restraint system and seat cover to allow the passenger to hook onto an overhead conveyor system which would automatically carry him to an exit, as shown in Fig. 89. There is some precedence for this type of seat-mounted escape device in the current use of survival kits in the seat pack of many aircrews. This concept was proposed in the FAA study by McDonnell Douglas [Roebuck, 1968 (15)]. The seat back cushion would be designed to contain an anti-smoke and flame hood with self-contained air supply, which could be quickly deployed. The sides would contain a life vest which could be pulled out and wrapped around the body. The passenger would hook his seat belt to the back cushion system, and attach the entire system to an overhead hook on a cable. The seat cushion cover and back cover would supply a chair-like support, and the conveyor system would take the passenger to the exit, where a deployment strap would disconnect the occupant either manually or automatically.

This is a complex system requiring a series of action by the user. It is within the state-of-the-art, however, and features a systems engineering design approach. Estimated additional weight was 1.36 kg (3 lb) per user; however, by using seat cushion cover storage, little extra volume would be required. A number of failure possibilities exist, in the deployment itself as well as in strength of parts, jamming of equipment, and failure of the power source. It would be non-usable in accidents involving significant structural intrusion or distortion. If everyone had to be hooked up before it operated it would be ineffective; yet if it operated as a continual conveyor belt system from the moment of crash-impact, some passengers might have difficulty in reaching a hook-up or might be struck down by passengers already hooked up and being conveyed out. Another hazard exists in that the passenger might be conveyed to a non-usable exit or directly into a burning area, unless there were direction control. Such a device could prove hazardous if the system failed while passengers were still attached; they would be near the ceiling where the heat, smoke and fumes would be greatest and would provide the poorest survival environment. Entanglement could be a further hazard. Also, this system might be difficult for many people psychologically to use without clear briefing and practice. It is not considered to be a reliable systems concept in this form, but could be further modified for consideration in a simpler, more automatic mode.

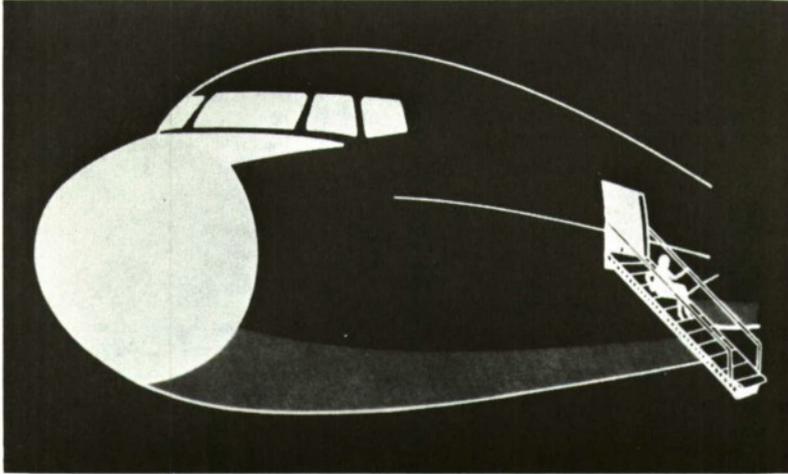
Fig. 90. Mechanical folding escape slide/stairway [Roebuck, 1968 (15)].

7.3.2 Folding Escape Slide. Actually a combination walkway and mechanical folding slide, this concept would consist of expandable pivoting structural elements which could be stored under Type I and Type II exits. It could be used as a firm ramp or evacuation slide. As shown in Fig. 90, a specially constructed, lightweight, extendable truss structure would be constructed to support stairs which can be folded down to form the surface of a slide or ramp. An advantage over inflatable devices might be that it would not puncture or tear. An analysis of mechanical versus inflatable escape devices by AIAA (1968) showed that mechanical devices require greater storage volume and heavier structural support. It was determined that a mechanical stair is more hazardous due to the quick foot movements required in descent which can lead to stumbling and falling. A fall on a stairway could seriously impede evacuation flow.

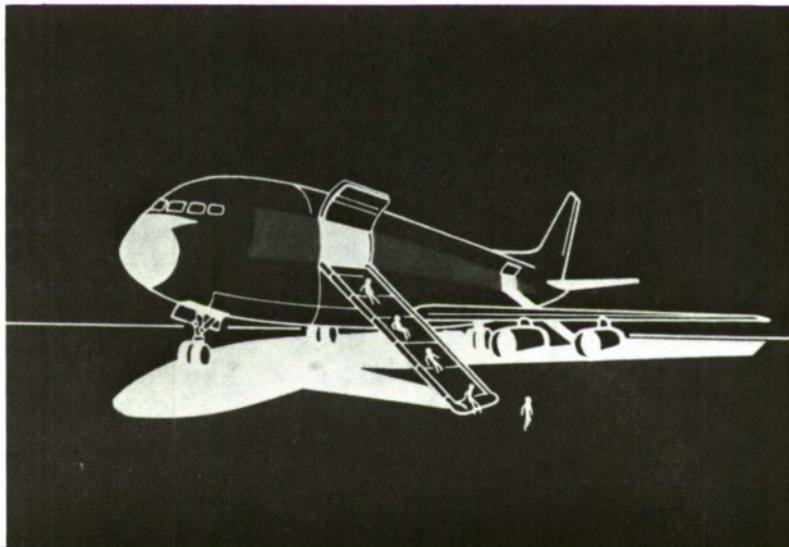
Fig. 91. Cargo-type emergency egress technique [Roebuck, 1968 (15)].

7.3.3 Cargo-type Emergency Egress Techniques. This concept would facilitate the evacuation of passengers by providing large openings in the nose, sides, and tail of passenger aircraft. This might be accomplished by using techniques presently in service in pressurized cabin cargo aircraft having swing-nose, clam shell or swing-tail, or large door loading capabilities. It was estimated that this system could reduce evacuation time and passenger flow rate by 90% and reduce the use of wrong exits by 10% to 20%. No data are available to validate these estimates. Fig. 91 shows a forward fuselage cargo-type exit.

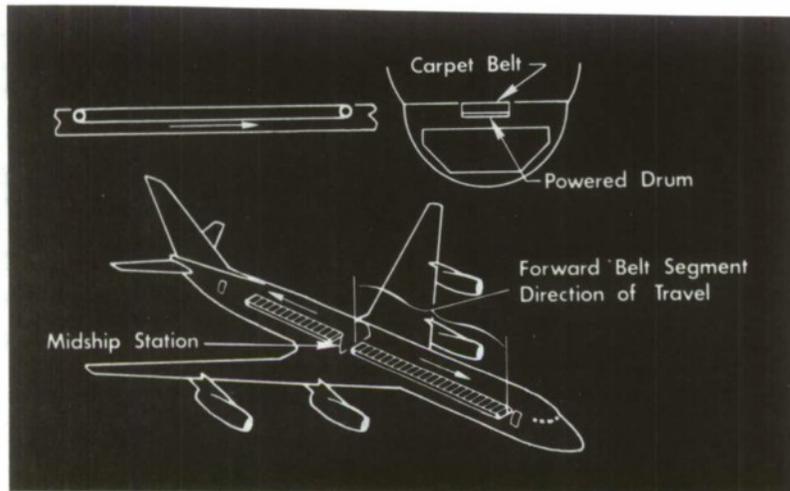
Fig. 92. Passenger egress from seat to emergency exit via conveyor belt [Roebuck, 1968 (15)].

The moving walkway passenger conveyor systems proposed to the FAA would consist of a forward conveyor belt intended to improve passenger evacuation time and reduce the problem of locating exits under smoke conditions [Roebuck, 1968 (15)]. An individual reaching the aisle could presumably be taken to an exit if he were incapacitated or injured. Such a system is within the state-of-the-art, but is considered to be unpractical, due to additional weight requirements, fail-safe aspects, the problem of "what if the conveyor belt is going in the wrong direction" to get to usable exits, as well as the problem of potential injury to disabled users who might get jammed against seats. This concept is illustrated in Fig. 92. However, another reason why such a concept would have limited utility is shown in Fig. 93. This photograph was taken subsequent to the FAA crash test of a Douglas DC-7 aircraft at Deer Valley, Arizona, and shows the buckling of the fuselage typical of many air transport accidents. In such instances a conveyor belt egress technique would be useless. Fig. 23 in Section 3.1.5.1 shows a recent Boeing 727 crash which also illustrates the extreme fuselage distortion which is often found.

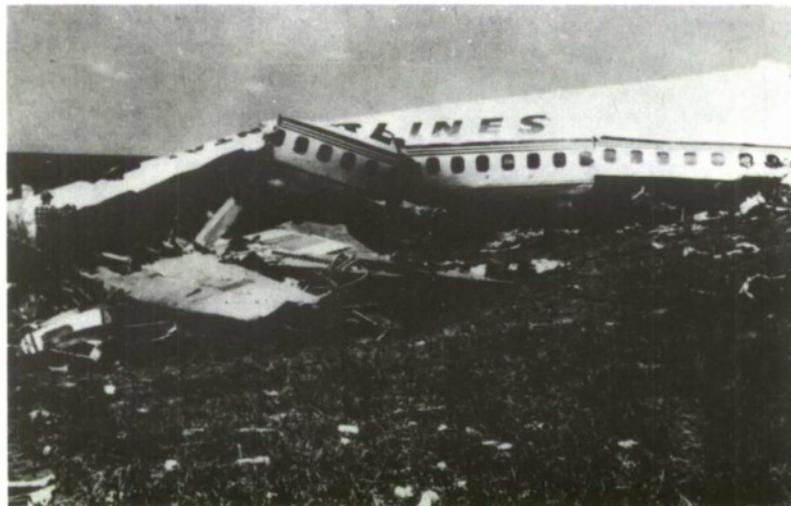
Fig. 93. Post-crash view of Douglas DC-7 aircraft crash-tested by the FAA showing typical extreme buckling of the fuselage (Photo courtesy FAA).

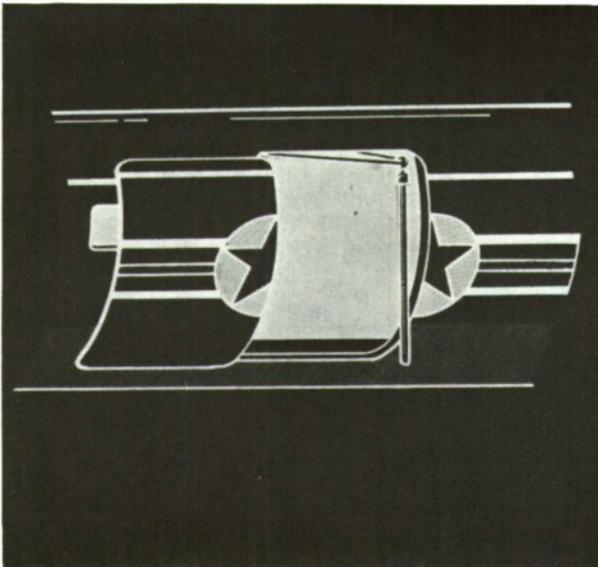
Fig. 94. Telescape swung into position for use at exit door.

In this system, the telescope is stored in a mounting near the top of the emergency exit. To use for an evacuation it is swung out into position (Fig. 94) and extended to a ground point (Fig. 95).

A short support arm (24.7 cm [9-3/4 in]) and a longer arm (73.1 cm [28-13/16 in]) were tested, with 45.7 cm (18 in) felt optimum. The mounting swings through 134° from the stored position against the exit bulkhead, to the out and locked position. Extension is accomplished by a CO₂ bottle providing a pressure range of 2.11 to 2.32 kg/sq cm (30 to 33 psi) at the telescope pressure inlet. Once the internally extended tube, comprised of four sections, touches the ground, a pressure of 1.4 kg/sq cm (20 psi) was found sufficient to retain pressure within the tube and hold it in place.

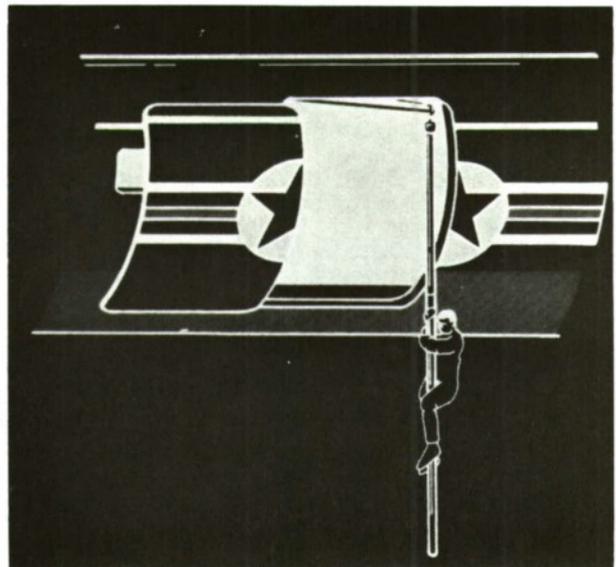
95. Evacuation using fully extended telescape device [Garner and Blethrow, 1962 (1056)].

Test passengers were found to use various techniques for sliding down this pole, and test evacuations were conducted at an average rate of 3.61 seconds per passenger on the first test and 3.31 seconds per passenger on the second test. A polished chrome finish proved satisfactory for surface friction, although less friction was recommended to prevent burns. Rate of descent was not injurious under the conditions tested.

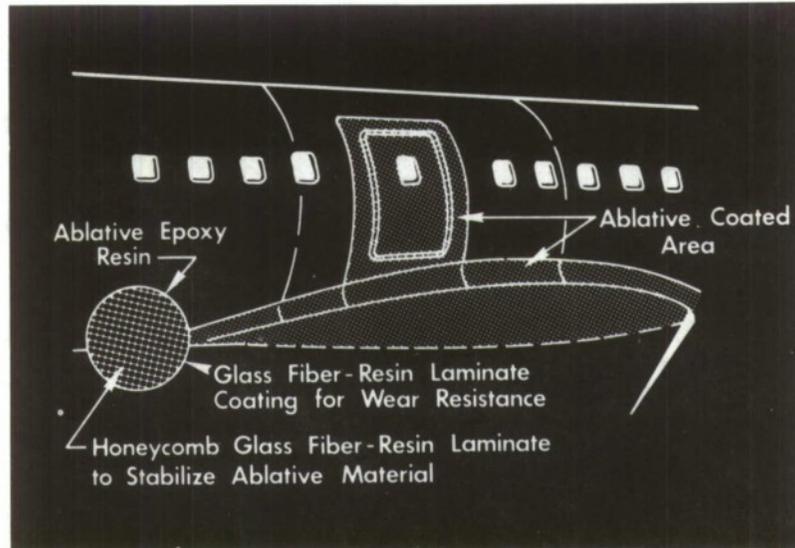
Fig. 96. Emergency exit area ablative coating [Roebuck, 1968 (15)].

7.4.1 Exit Area Ablative Coating. Severe heating from exterior fires or post-impact fires can distort exit structure and prevent opening at a later time, even if firemen have cleared a flame-free path to the exit. New, lightweight ablative coating materials applied to areas around and over the exits could form an insulative layer which also resists flame by charring and off-gassing, carrying heat away from structure. The Apollo heat shield is a composite material based on epoxy resin. Although relatively soft, such materials could be covered by a thin, glass-fiber laminate for wear resistance. The basic ablative material is stabilized by a glass-fiber laminate honeycomb bonded to the surface. For a reasonable evacuation period (2 to 5 minutes), a layer only .64 to .95 cm (1/4 to 3/8 in) thick could provide protection against fires of JP-4 or other fuels which burn cooler than spacecraft re-entry temperatures of 2200° to 2760°C (4000° to 5000°F). A typical exit area coating is illustrated in Fig. 96.

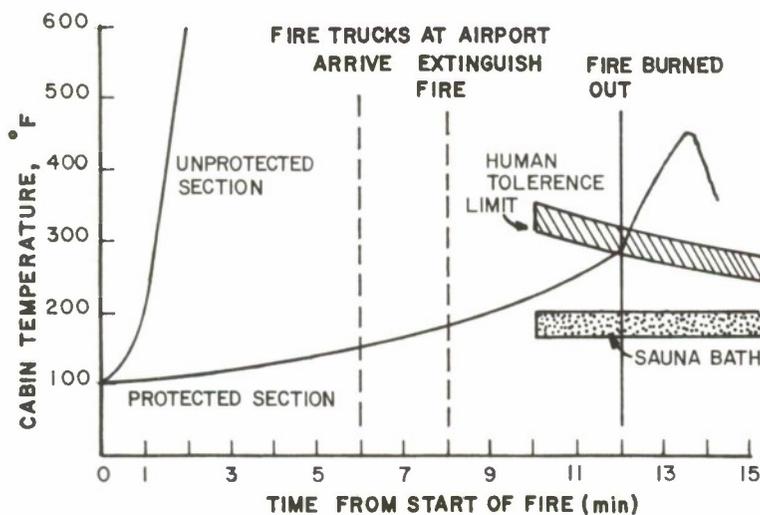
Fig. 97. Cabin air temperature in NASA C-47 cabin shield fire test [Neel et al., 1971 (1057)].

Results of this test were impressive as to the protection heat shielding could offer. In the unprotected standard Douglas C-47 cabin section the air temperature rose to 315.5°C (600°F) in less than 2 minutes after the initiation of the fire, and the section was destroyed within 2 minutes. In contrast, the heat-shield protected section withstood 6 minutes of fire with no increase in temperature, rising to 148.8°C (300°F) as heat finally penetrated, and the fire burned out at 12 minutes. A gas sample taken 5 minutes after ignition showed no toxic gas penetration. Fig. 97 illustrates the cabin-air temperature during these tests relative to human tolerance, while Fig. 98 shows the installation of the fire-protective shielding.

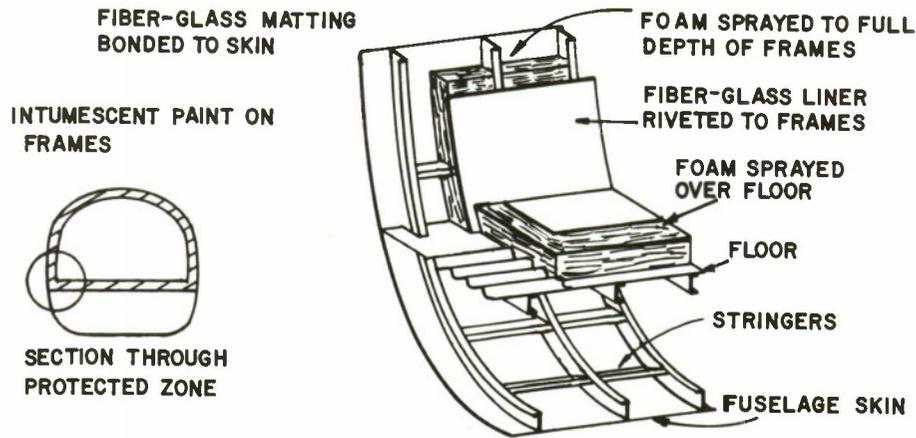
Fig. 98. Installation of fire-protective materials in NASA aircraft cabin test [Neel et al., 1971 (1057)].

7.4.2 Cabin Fire-Protective Shielding. The primary work in development of heat shielding, that is, surrounding the passenger compartment by a fire-retardant shell able to protect the occupants long enough for the fire to burn out or to be extinguished, has been conducted at NASA Ames Research Center [Neel et al., 1971 (1057)]. In tests conducted 13 August, 1970 at Otis Air Force Base, Mass., on sections of a Douglas C-47, the major objectives considered to influence survival in a crash fire were to minimize heat penetration and prevent intrusion of smoke and toxic gases. The fire-protection system consisted of frames painted with intumescent paint .127 cm (0.05 in) thick (to expand and fill any voids caused by shrinkage of the foam as it charred), over which a layer of loosely woven fiberglass matting was bonded to the skin to reinforce the charred zone of foam. Sprayed over the matting, the polyisocyanurate foam (density of approximately 64 kg per cu m [4 lb per cu ft]) was built up to the 6.35 cm (2-1/2 in) depth of the frames and 5.1-7.6 cm (2-3 in) over the floor structure. A liner of fiberglass-epoxy laminate, similar to present air carrier decorative interior paneling, of .79 mm (1/32 in) thickness, was cemented to the foam and then riveted to the frames. The floor foam was also covered with laminate, and all joints were sealed to exclude smoke and gases.

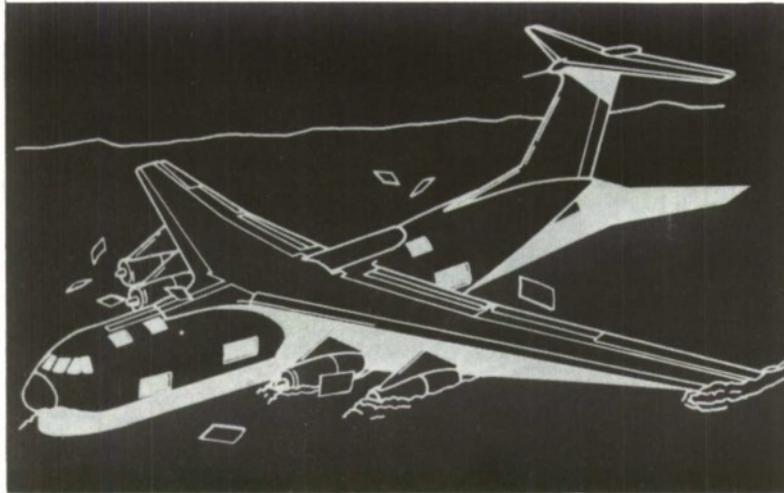
Fig. 99. ELSIE system for instantaneous egress as might be conceived for Lockheed C-141 aircraft.

7.5.1 **ELSIE**. A solution to this problem appears to be utilization of the ELSIE (Emergency Life Saving Instant Exits) system which uses "jet cord" flexible linear shaped charges to blow emergency exits at predetermined strategic locations in the fuselage skin, or where available exits have become jammed. Fig. 99 illustrates how this system might be applied to the Lockheed C-141 aircraft. ELSIE has been developed under contract to the Life Support System Program Office ASD/AFSC, Wright-Patterson AFB, by Explosive Technology, Fairfield, California, having evolved from their STEN (Stored Energy) concept developed in 1967 [Nicholson and Burkdoll, 1971 (1072); Burkdoll and Nicholson, 1971 (1066); Bogland, 1967 (1064); Explosive Technology, 1968 (1068); 1970 (1069)]. A similar concept has been reported by Space Ordnance Systems, Inc. of El Segundo, California, for providing "supplemental emergency exit doors" [Brown, 1967 (1065)], who had designed the crew escape module severance system for the General Dynamics F-111 aircraft and others.

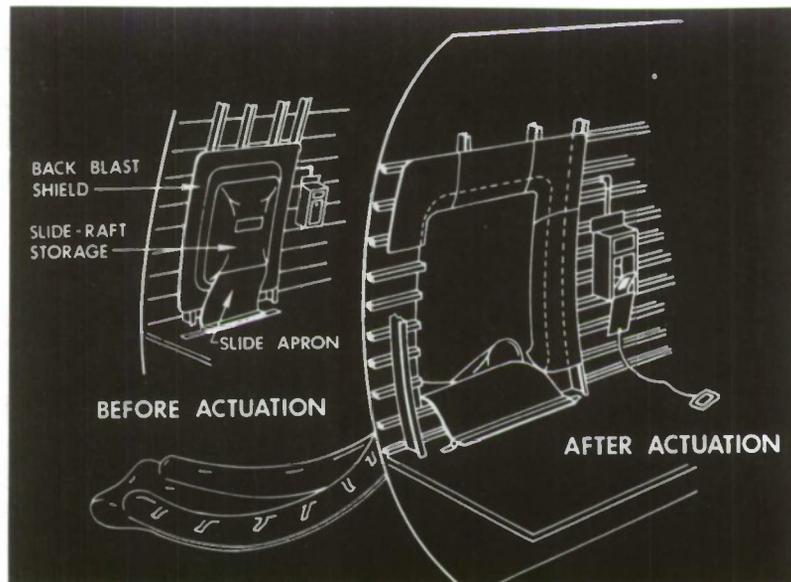
Fig. 100. Experimental high energy emergency exit configuration showing instantaneous deployment of slide/raft for subsequent emergency escape [Caldara, 1970 (4)].

An important proposed use of the ELSIE system would be to incorporate emergency equipment in the system so that activation would also automatically deploy slides, life rafts, or slide/raft combinations, or other devices. This would not only make available instantaneous (and larger) emergency exits, but also would save considerable time which is presently required to effectively deploy these devices.

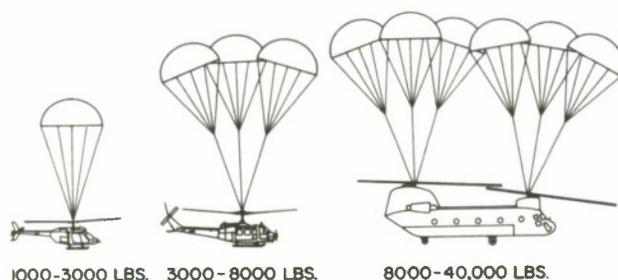
Fig. 101. Total aircraft recovery concept for helicopters [AGARD, 1973 (1087)].

Two of the systems which have been considered for helicopters may have application to commercial air carriers, those of capsule escape and total aircraft escape. Thus the evaluations given for use of these concepts in helicopters should be considered. In the total recovery concept, a cluster of parachutes would be deployed to slowly lower the helicopter to the ground (Fig. 101). In addition, shock absorption techniques such as inflatable bags and/or retrorockets might be required to reduce final impact loads. Problems include mounting of parachute containers, effect on helicopter flight dynamics and stability, long deployment times (precluding survival below 91.4 m [300 ft]), weight (6-10% of the helicopter's gross weight, which might be as great as 50% of other available payload), and the technical complexities involved. Total aircraft recovery was not considered a promising concept for helicopter in-flight escape by the AGARD Working Group, although the big advantages offered are that of effecting recovery of all of the occupants through a single system, and the possibility of repair and reuse of the vehicle.

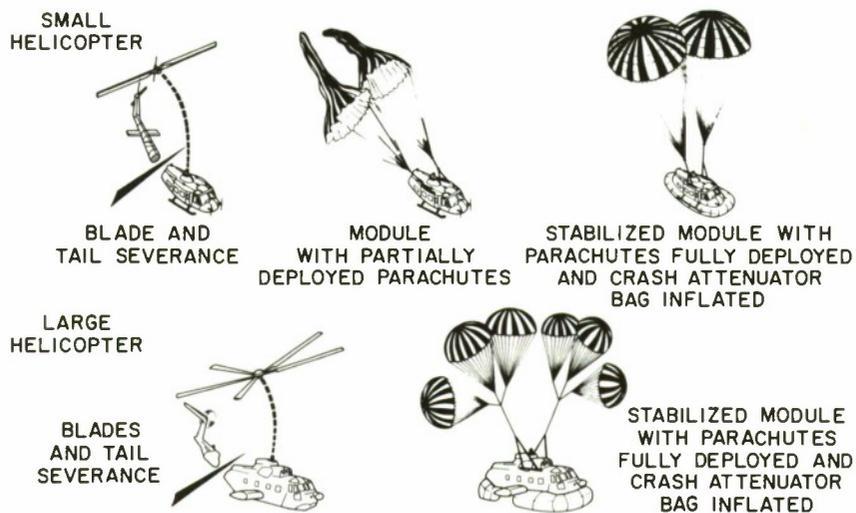
Fig. 102. Capsule recovery concept for helicopters [AGARD, 1973 (1087)].

For multi-place helicopters, especially those carrying passengers, the modular recovery concept in which the entire occupied section of the cabin is recovered "appears to be the only practical possibility for escape" (1087). Although this concept is essentially the same as for total aircraft recovery, the module weight is minimized. The occupied compartment would be separated by explosively severing airframe appendages, propulsion systems, tail cones, etc. A cluster of ballistically deployed and spread parachutes would be used for recovery, and would have to lower the module at a survivable descent rate of less than 9.1 m/sec (30ft/sec) [AGARD, 1973 (1087)]. Small explosive cutting charges can sever the tail boom assembly and rotor blades; within 0.1 second of the severance of these structural components, a "drogue gun" fires a nylon line attached to a parachute deployment package directly overhead, deploying the main descent recovery parachute which then lowers the fuselage module. The parachute is reportedly deployed in less than 0.5 second from the activating signal, and is designed to bring down the helicopter at a rate of about 10 m/sec (33 ft/sec) or less. The components have been tested at the U.S. Navy's Weapon Laboratory, Dahlgren, Virginia, and tested at El Centro Naval Air Facility, and may be considered within the state-of-the-art [Arnold and Pollard, 1968 (1088); Teledyne McCormick Selph (1104)]. Studies have also been performed at the U.S. Naval Air Development Center which have demonstrated the feasibility of a helicopter capsule escape system by Vertol Division of the Boeing Company [Millington and Thompson, 1966 (1101); Boeing Company, 1968 (1102); 1969 (1105)].

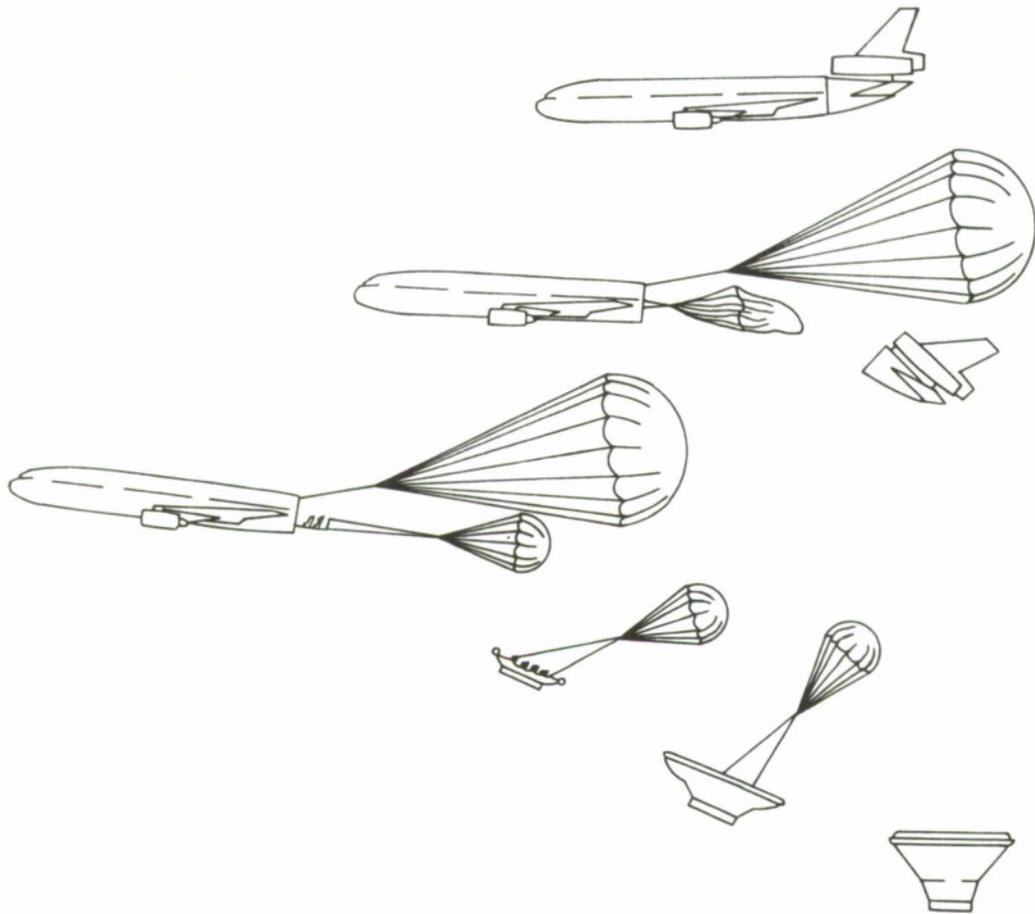
Fig. 103. Paracone emergency inflight egress concept [Kendall, 1970 (1098)].

7.6.2 Paracone Concept. Modification of the current operational technique of aerial delivery of cargo has been proposed by Kendall [1970 (1098)] utilizing the paracone technique. In this system the aircraft would be constructed as a shell with each floor made with rollers and hardware required in present USAF airborne cargo drops. All passenger seats would be mounted on pallets up to 7.3 m (24 ft) long (9' x 24' x 436L pallet) holding 24 passengers. The paracone device and its inflation system would be packaged under the floor. Deployment would be identical to the current military airborne drop except that rather than open doors, the tail section would be blown off. Pallets would be propelled out the rear on rollers, the first pallet deploying an extraction chute to provide for deployment of the succeeding pallet. This concept would have the extracting chute stabilize the pallet while the paracone deployed in approximately 4-5 seconds, as is shown in Figs. 103 and 104. The paracone escape and recovery system would be self-sufficient, having rafts and survival equipment self-contained. Kendall has proposed the use of inflatable air bags for the pallet passengers to protect them from initial airblast during deployment.

The paracone consists of a cone-shaped expandable and pneumatically inflatable structure that utilizes the advantages of the parachute. It is constructed of expandable material which is lightweight and can be packaged readily and is reportedly more effective than the parachute as an aerodynamic decelerator. It is cone-shaped with an open end and the payload, rather than being suspended as with a parachute, is located inside the open end of the cone with the inflated structure surrounding and supporting it. Between the impact attenuation floor and the payload is an inflation gas distribution plenum chamber which doubles as the flotation chamber in case of water landing. The paracone has been extensively tested with systems analysis and subsonic development by McDonnell Douglas. Drag co-efficients of from 0.6 to 1.2 were reported, and impact velocities of 8.5 to 15.2 m/sec (28 to 50 ft/sec) (27 to 30 G) for a time duration of 0.1 second were measured. Kendall's analysis [1970 (1098)] indicated that the paracone can be successfully dropped at very low altitude (61 to 106 m [200 to 350 ft]) and high velocity (482 to 965 km/h [300 to 600 mph]). Application studies have been conducted for space booster recovery, emergency astronaut escape and recovery from orbit, vehicle recovery from orbit at velocities over 10,668 m/sec (35,000 ft/sec), vehicle landings on planets, zero velocity-zero altitude, supersonic and hypersonic ejection, airborne cargo drops, paratroop, and emergency bail-out. This concept has been considered for application to the McDonnell Douglas DC-10 transport aircraft.

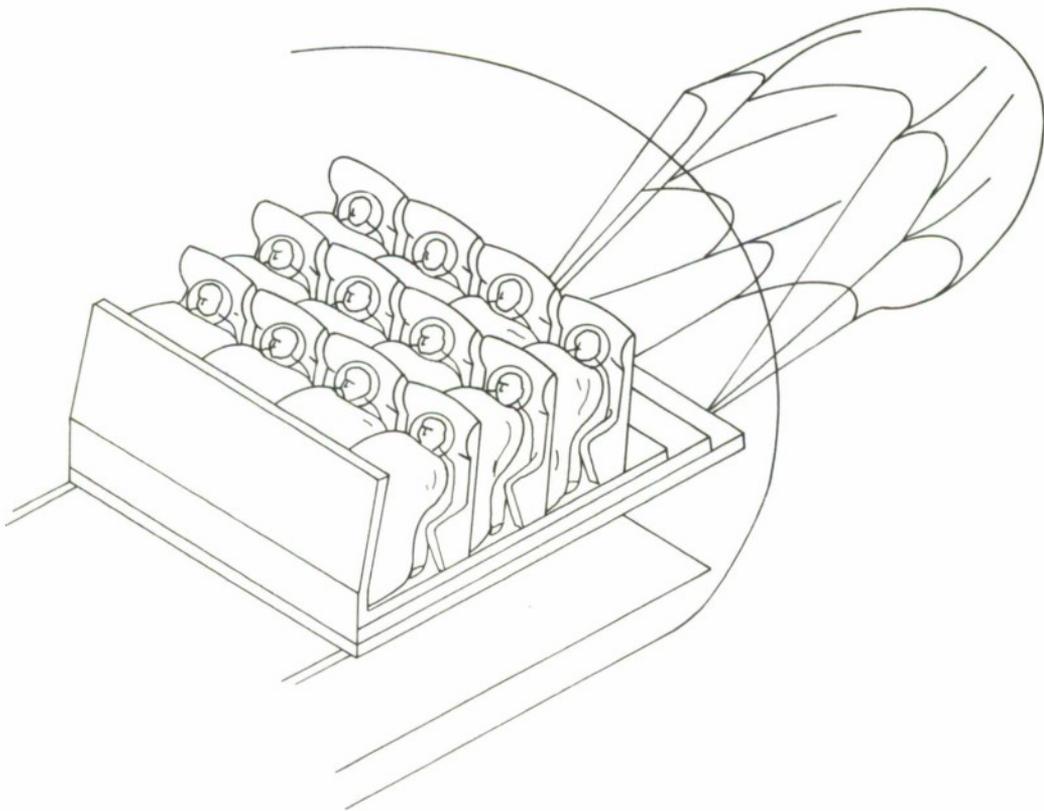
Fig. 104. Pallet passenger packaging at initiation of inflight emergency escape by paracone concept [Kendall, 1970 (1098)].

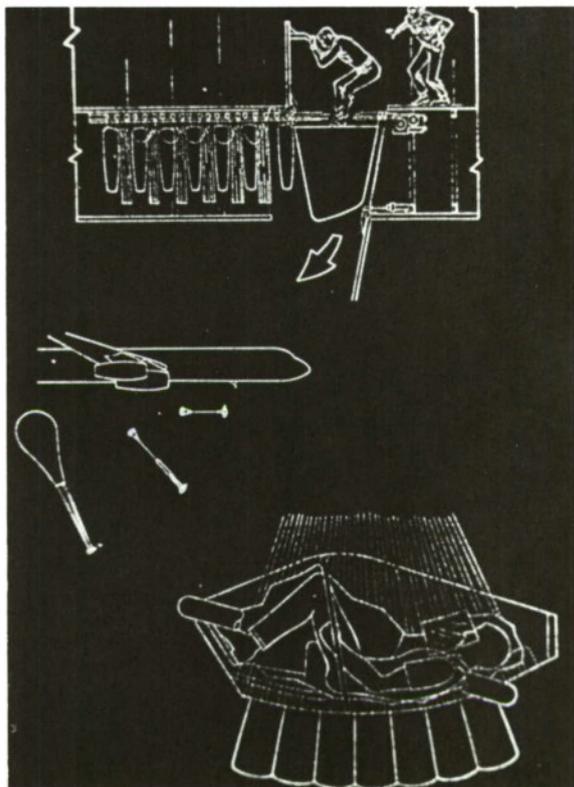
Fig. 105. Rapidjet emergency inflight egress system, deployment, and passenger cocoon container [McIntyre, 1969 (1099)].

7.6.3 Rapidjet. To provide fast inflight egress for passengers or crew without the necessity of donning flight clothes or parachutes, and when "the presence of fire, smoke, poor visibility, aircraft maneuvers, decompression, injuries, hypoxia, panic, or confusion impairs the ability" of the occupants to put on their equipment, the rapidjet concept was proposed [McIntyre, 1970 (1099)]. The rapidjet installation would consist of an escape slide with power operated inner and outer doors, a series of individual crew escape modules, and the power drive unit required for module advance and release. The escape module for each passenger consists of an encapsulation bag of "cocoon" and a parachute pack. The open end of the cocoon is stretched across the escape slide entrance so that the crewman enters the cocoon as he jumps into the slide. Upon reaching the bottom of the cocoon, a sequenced release mechanism is triggered. This closes the open end and the cocoon and parachute pack are then released from the aircraft. The release of the escape module from the aircraft triggers an oxygen supply to a mask within the cocoon, and this activates an automatic parachute recovery system. As soon as one module is released, the remaining modules are power indexed toward the slide and another cocoon is positioned in the slide ready to receive the next passenger. This sequence is estimated to require 6 seconds.

As the escape module is released, a 1.2 m (4 ft) diameter Hemisflo drogue chute is deployed to provide immediate stability, deceleration, and controlled descent from high altitude. When descent is made to 4,572 m (15,000 ft) altitude, an aneroid-controlled actuator opens the main parachute pack, and the 9 m (29.7 ft) diameter "skysail" parachute is deployed by the drogue, utilizing the sleeve principle (4% reefing is used for 1 second to maintain opening shocks under 10 G's). In egress below 4,572 m (15,000 ft) a 3-second time delay is employed. The egress sequence and cocoon containment system is illustrated in Fig. 105. This concept is passive in the sense that the only action necessary from the occupant, once he has jumped into the slide, is to use a control handle to release the parachute after the cocoon has landed. This system would not appear to be usable in a case where the aircraft was violently thrown about, or ended up in an unusual attitude, which would prevent passengers from reaching the escape slides. There might also be a reluctance for uninitiated individuals to "trust" jumping into any opening not knowing whether there would in fact be a chute to catch them or not. Also, at the given rate of 10 individual "bail-outs" per minute per slide, it would take considerable total time to evacuate a loaded aircraft, under conditions in which little time would presumably be available.

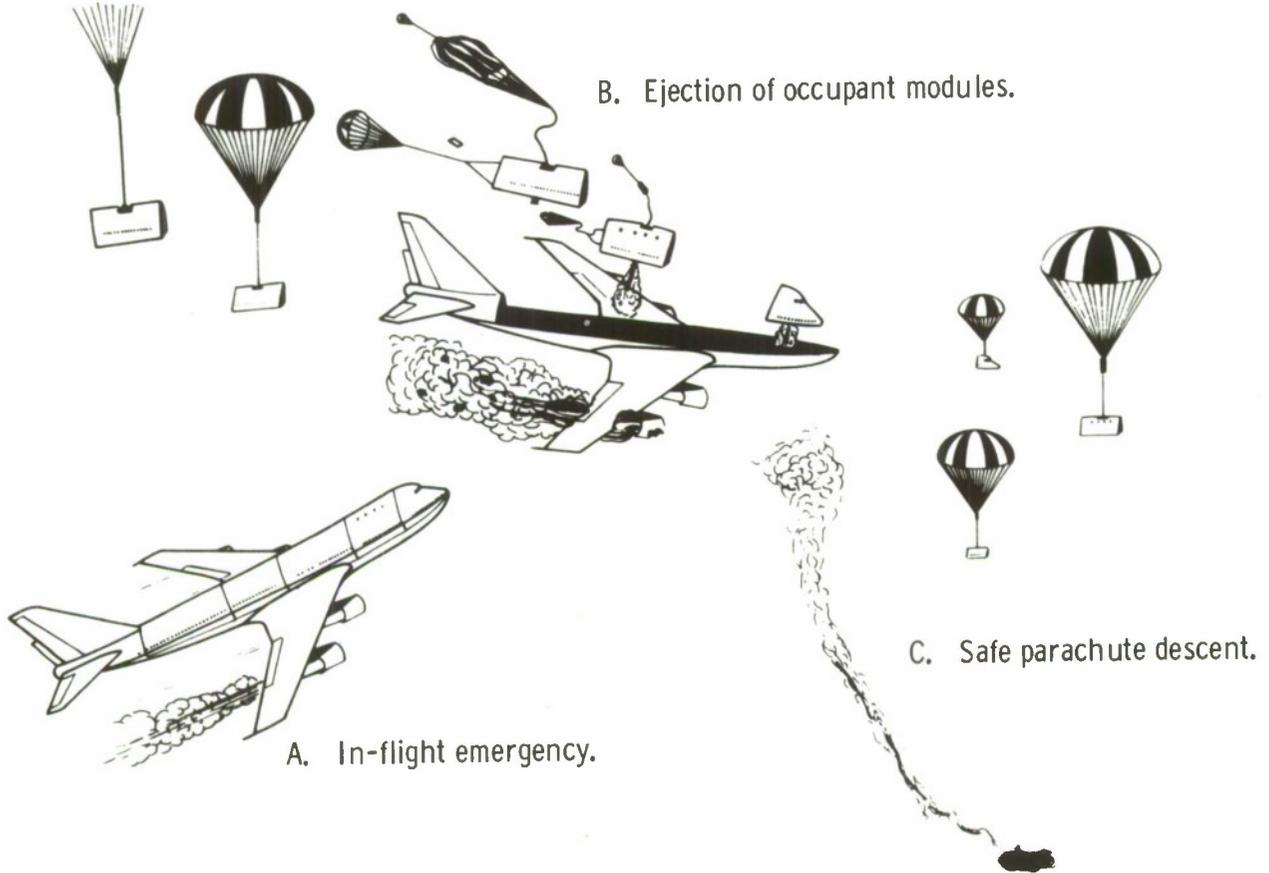
Fig. 106. Inflight ejection of encapsulated compartments from disabled airliner [Snyder and Stapp, 1969 (1103)].

In 1969 Snyder and Stapp (1103) proposed several concepts for inflight emergency egress, presenting the aeromedical aspects of a survival envelope necessary for salvage of a disabled air transport at sonic speeds and high altitudes. Fig. 106 shows the concept of inflight ejection of encapsulated compartments of a disabled aircraft. Such a system could not be retrofitted and would have to be designed into a future

aircraft. However, while such a system is utilized in military aircraft having a small number of highly trained crew members, such as the B-1 [Beers, 1974 (848)] or F-111 [Shaffer and Brinkley, 1974 (17)], it probably would not be practical for air transport consideration, even though technically within the state-of-the-art.

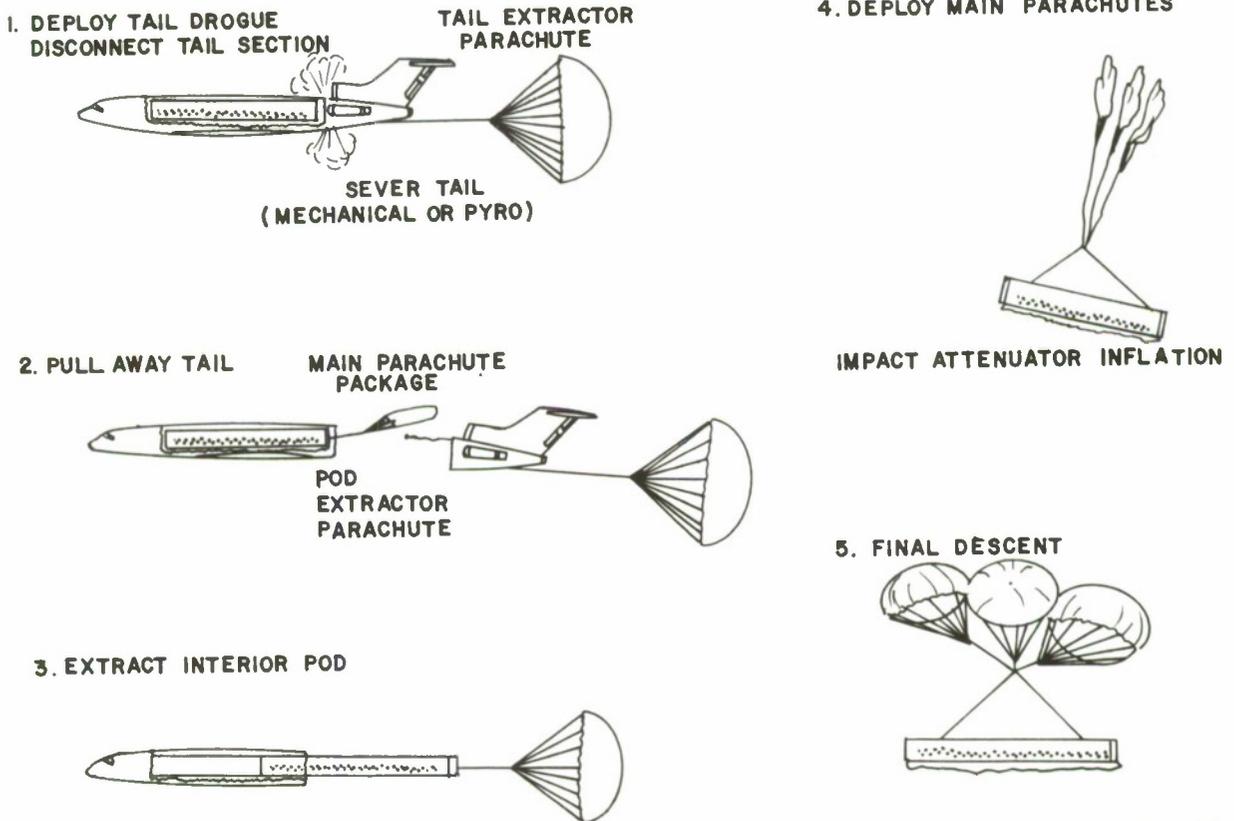
Fig. 107. Emergency inflight escape of passengers utilizing pod concept [Yost et al., 1970 (789)].

Yet another concept resulting from studies conducted for NASA, combining tail evacuation and capsule-pod emergency escape, is illustrated in Fig. 107 [Yost et al., 1970 (789)].

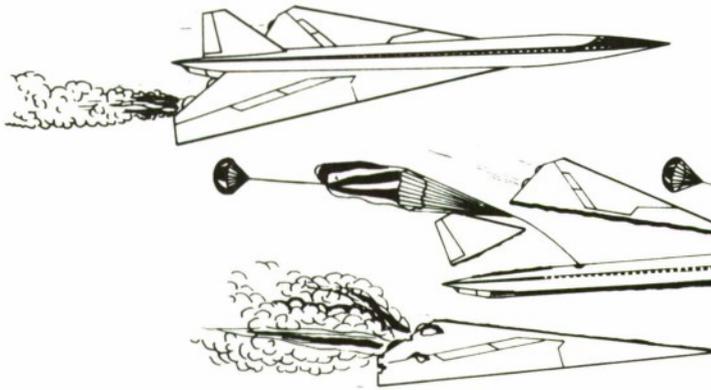
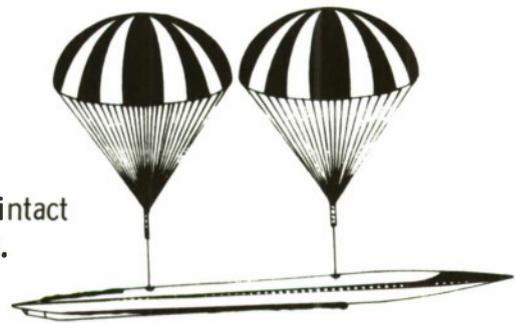
A. In-flight emergency.

B. Separation of engines, wings, tail structures from fuselage; slowing of forward velocity with small drogue chutes.

C. Parachute lowering of intact fuselage to soft landing.

Fig. 108. Concept of safe parachute lowering of passengers and crew in fuselage of air transport following major structural failure in flight [Snyder and Stapp, 1969 (1103)].

Still another concept is illustrated in Fig. 108. In this scheme the wings (or engines) and tail are separated by explosive technology (developed for military aircraft), drogue chutes then deploy to slow the velocity of the fuselage, and finally parachutes (probably multiple canopies) lower the fuselage to the ground (as with a space vehicle). The objective in this case is to salvage the occupants by keeping them as intact as possible in their own environment.

Among many problems which would be anticipated in the development and testing of such a concept are the fundamental ones of how to ensure that the separation, braking and parachute deployment systems would be intact and reliable after an inflight structural failure and how to prevent (with 100% reliability) inadvertent activation of any of these systems. Other very fundamental considerations are cost of structural modifications, and weight (increased fuel usage) penalties. While the concept of lowering the passengers to the ground within tolerable impact velocities, using the aircraft emergency oxygen system, and keeping the thermal environment within tolerable limits may be possible under favorable environments, the complexity of accomplishing these objectives in future aircraft would require considerable effort to develop and evaluate. A similar technique has been previously considered in solving the problem of saving helicopter crews and passengers from otherwise fatal mid-air emergencies [Arnold and Pollard, 1968 (1088); Teledyne McCormick Selph, n.d. (1104)].

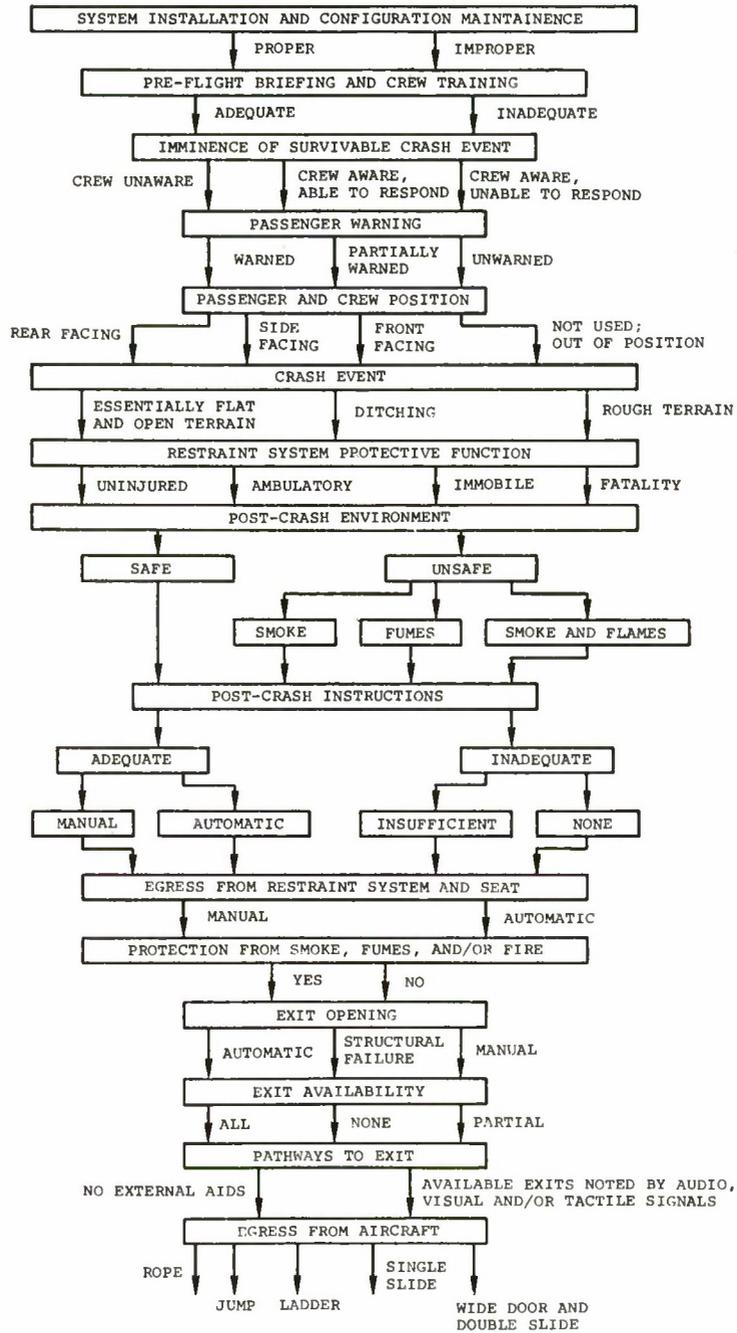
Figure 55. Crash Impact and Escape Flow Diagram

In order to provide a framework to determine the function level of each of the concepts included in this study, an event-oriented flow chart of the crash and escape event has been prepared (See Figure 55). The various events of a crash are included from system installation to egress after a crash. Each item can critically affect survival in event of a crash.

The analysis of reliability is tied closely to the event-oriented flow chart shown in Figure 55. The specific items which will be included in the reliability study are:
