RADC-TR-76-208
Interim Technical Report
July 1976

**INVESTIGATION OF DEFECTS AND IMPURITIES
IN SILICON-ON-SAPPHIRE**

Rockwell International Corporation

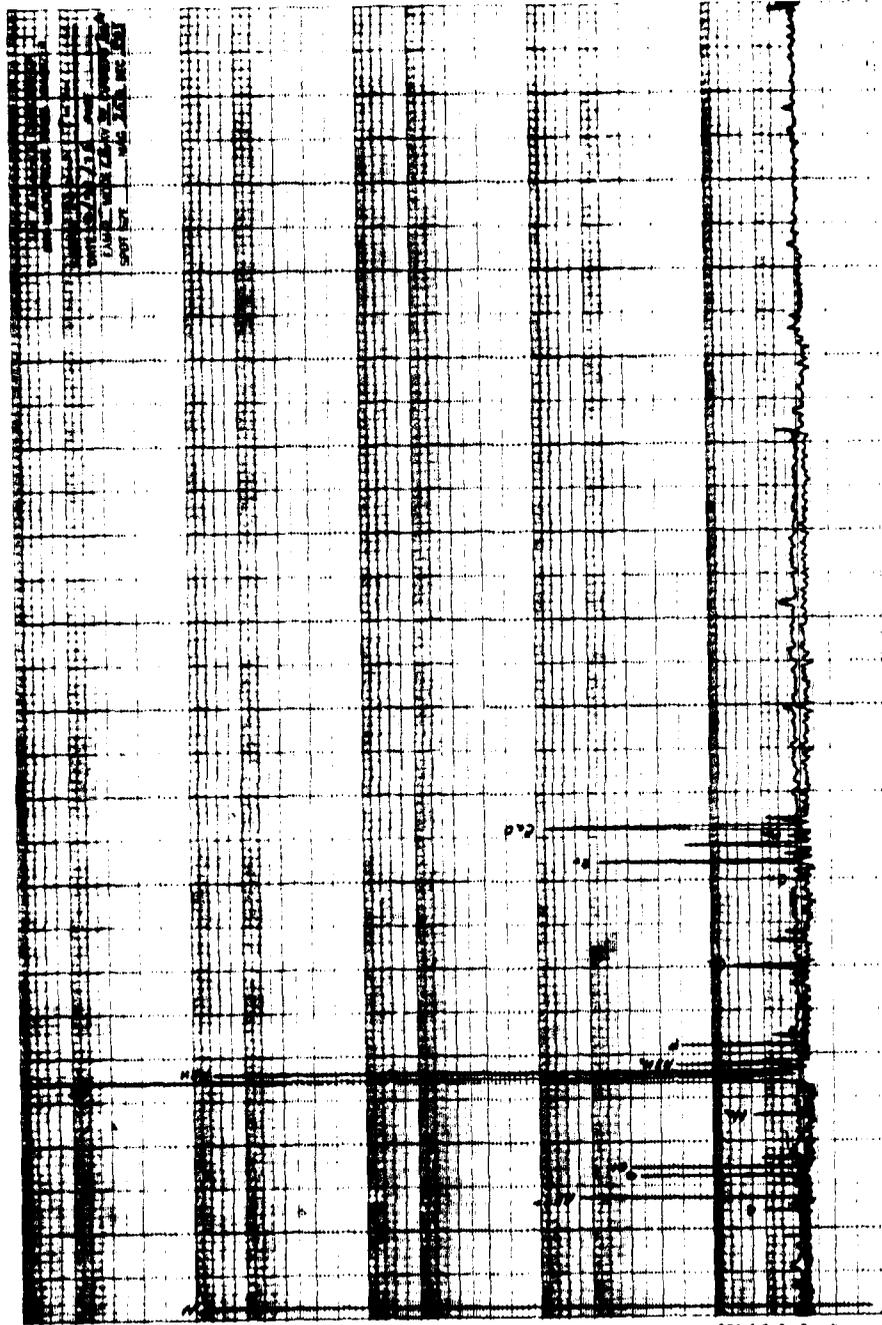
Figure 2. Elemental Scan of Tyco Sapphire Polished by Tyco

An IMMA elemental mass scan for the Tyco material is shown in Figure 2. The large peak at mass number 13.5 corresponds to doubly ionized aluminum (Al^{++}), and it is associated with surface charge-up of the sapphire.³

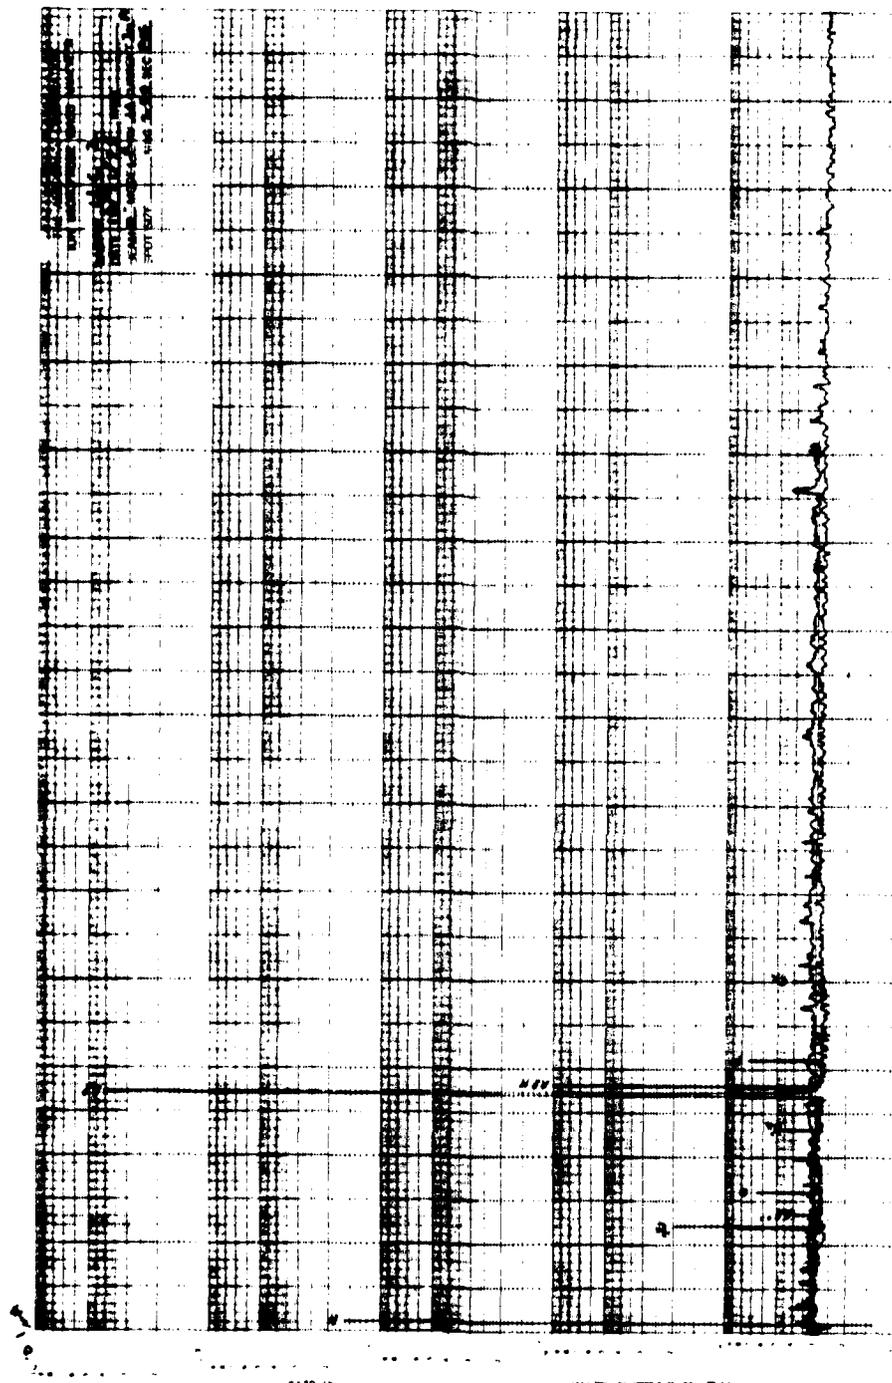
Figure 4. IMMA Elemental Scan of Union Carbide Sapphire at Surface

Samples to be analyzed were cleaned and mounted in the normal manner, and approximately 500 Å of gold was deposited on the surface to minimize surface charge-up. An elemental scan was made at the surface and then the beam current was increased to the maximum limit for the $^{160}\text{-}$ ion beam. Successive elemental scans were made after the sample had been sputtered for 10, 20 and 30 minutes. The data from these scans are presented in Figures 4, 5, 6, and 7.

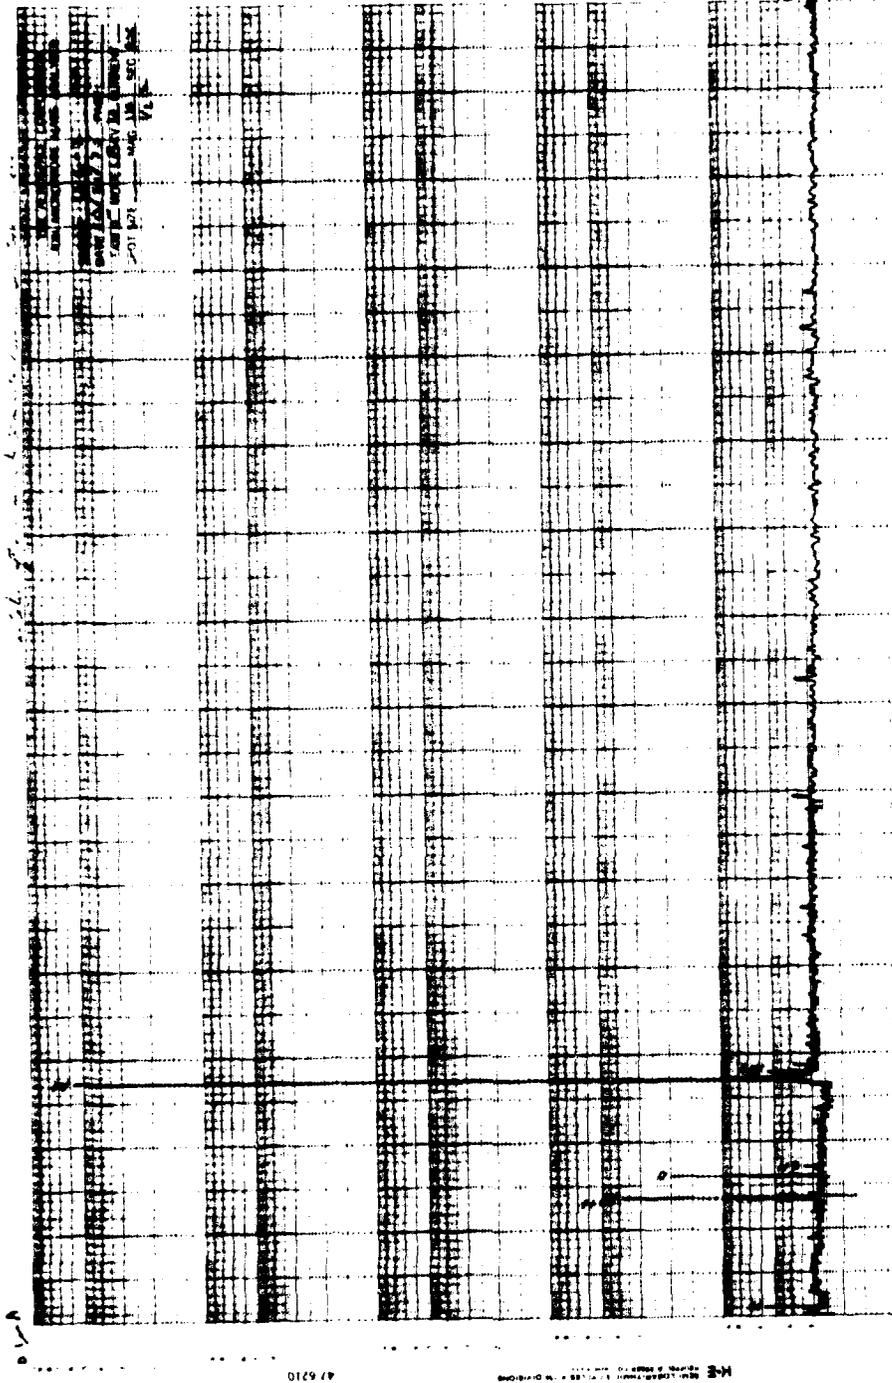
Figure 6. IMMA Elemental Scan of Union Carbide Sapphire After 20 Minutes

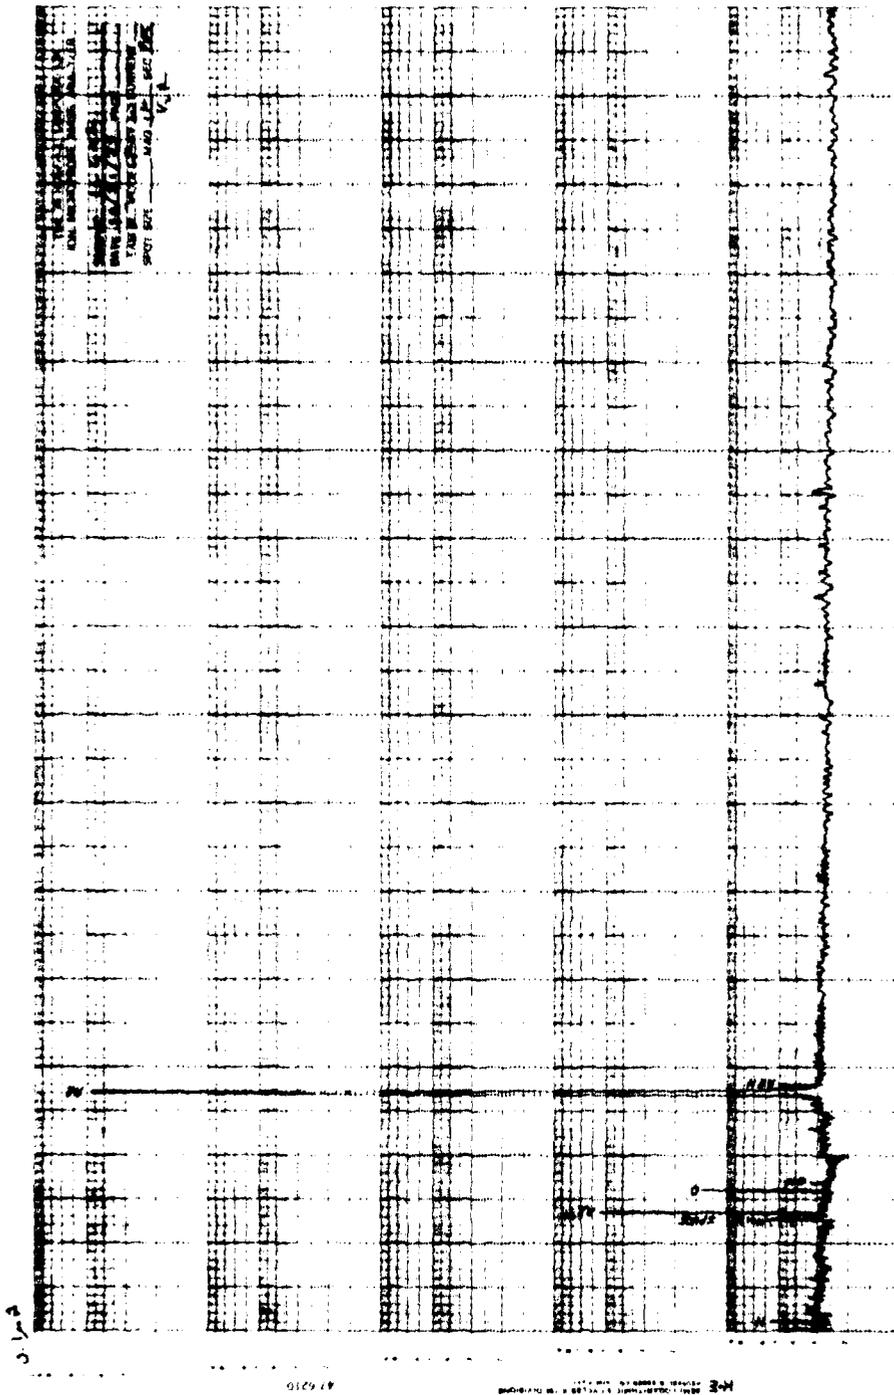
Figure 7. IMMA Elemental Scan of Union Carbide Sapphire After 30 Minutes

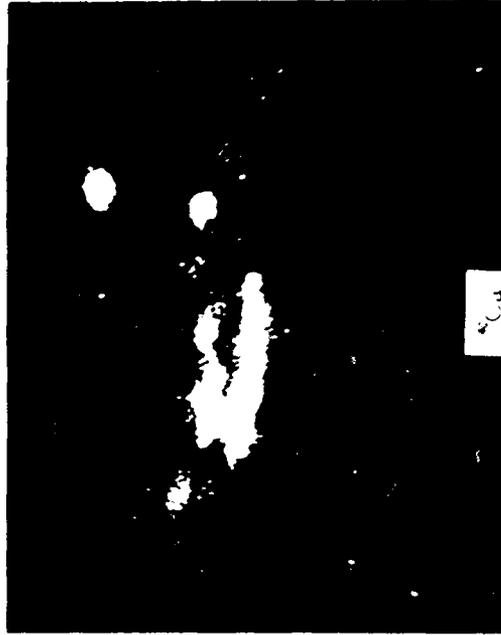
Figure 8. IMMA Elemental Surface Map of Union Carbide S0S Material

Silicon films deposited by Union Carbide and Hewlett Packard were analyzed using IMMA. Almost without exception, the contaminants found in the epitaxial silicon films were either on the surface or were distributed throughout the epitaxially deposited silicon layers. IMMA surface mapping analysis indicates that these contaminants consist primarily of residual polishing components and sapphire debris remaining in scratch regions on the surface of the sapphire substrate. Figure 8 shows an IMMA surface map of a sample of Union Carbide epitaxial silicon on Union Carbide sapphire. The individual elemental surface maps were made on the basis of overall impurity levels revealed by an initial elemental scan of the area of interest. The area mapped in Figure 8 was

subsequently examined with a scanning electron microscope which revealed an apparent defect in the sapphire substrate. An SEM photomicrograph of the area is shown in Figure 9(a) and 9(b). The photograph in Figure 9(a) shows a shadowy line, marked by arrows on either side of the photograph, which appears to be a defect in the sapphire substrate. The light colored irregularity in the center of Figure 9(a) corresponds very closely with the surface maps of Figure 8.

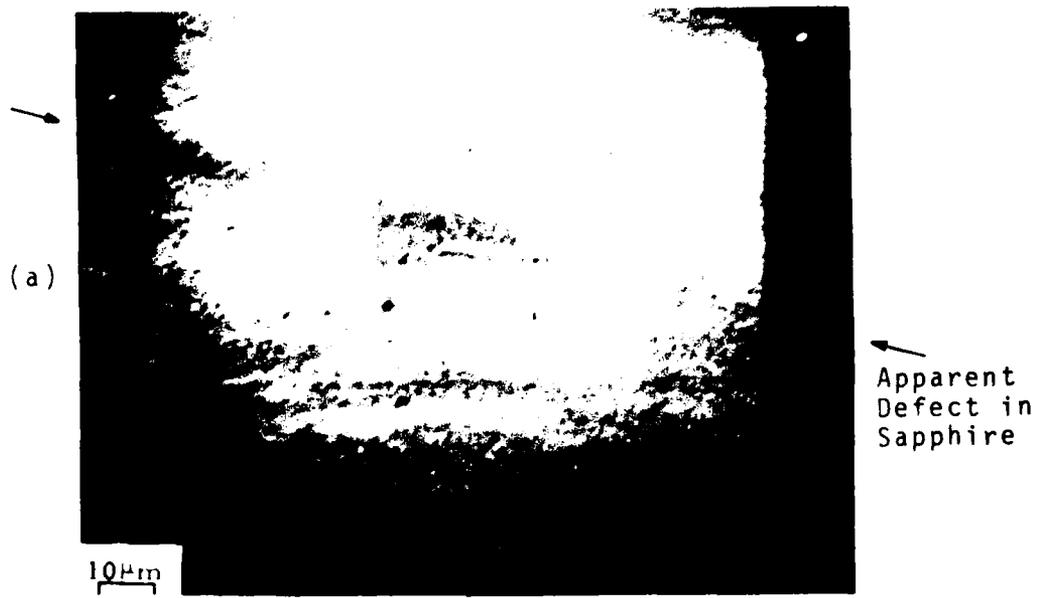
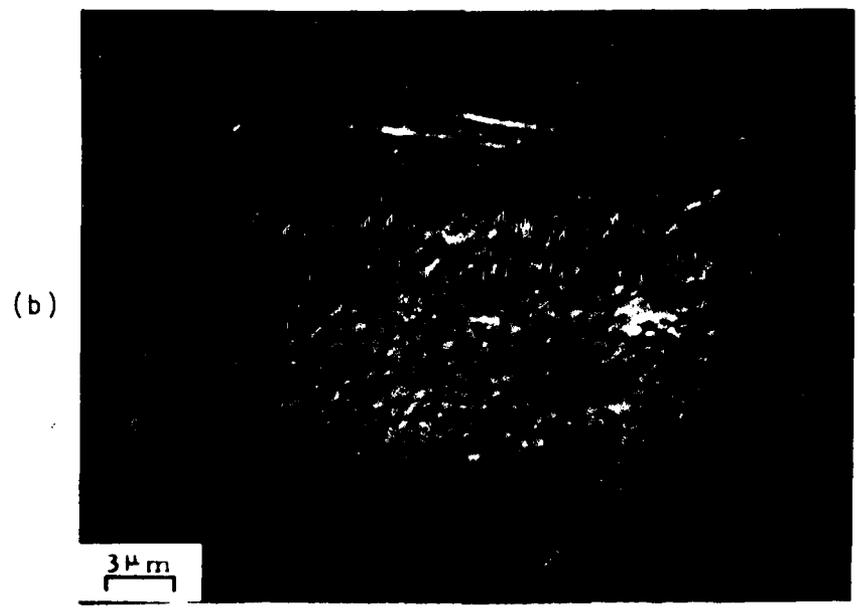
Figure 9. Scanning Electron Microscope Display of IMMA Surface Map Area

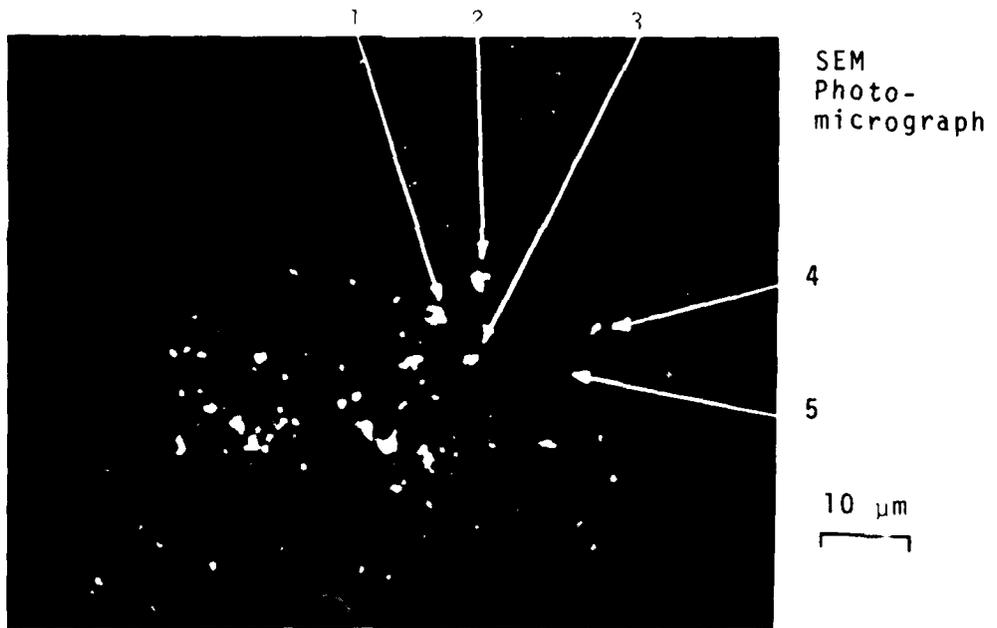
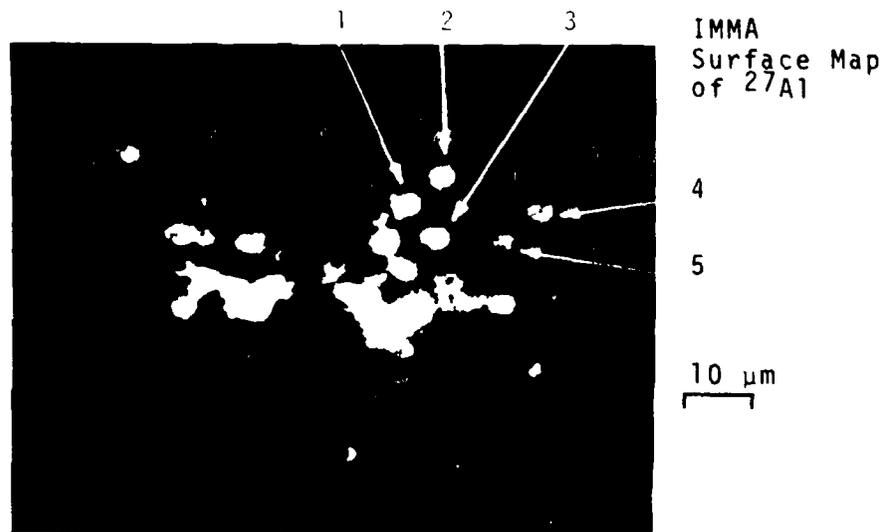
Figure 10. Comparison of IMMA and SEM Observations of Epitaxial Silicon-on-Sapphire

Approximate Area Covered by IMMA Raster

SEM
Photo-
micrograph

IMMA
Surface Map
of ^{27}Al

As noted earlier in this report, it was not possible to obtain the required films from the in-house source. Samples from one run, however, were saved as examples of "poorer" quality SOS films, resulting from inadequate process control. Figures 10 and 11 show IMMA surface maps and SEM photomicrographs of typical epitaxial silicon films that were obtained. In both figures, the main contaminant is aluminum appearing as particulate matter introduced during sapphire preparation.

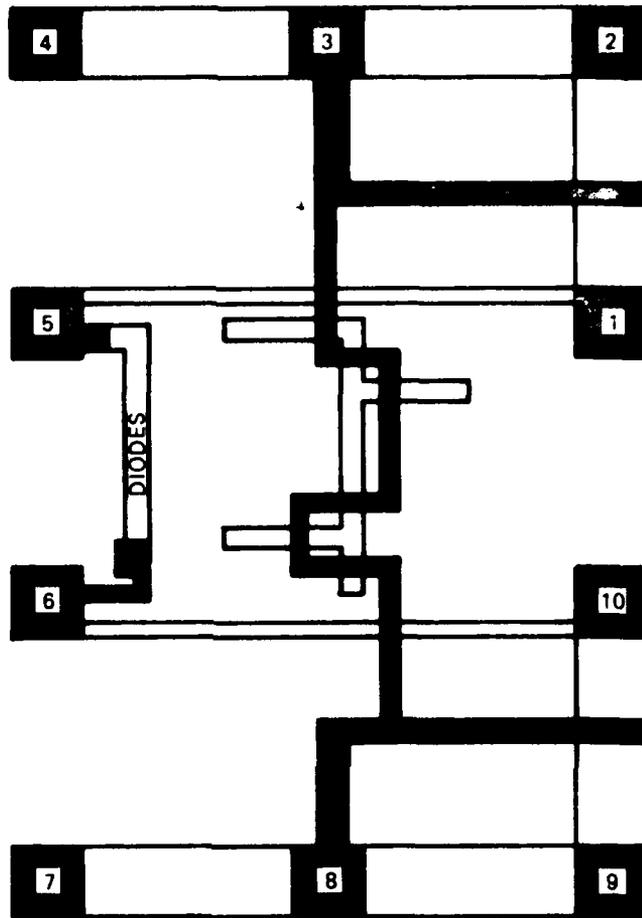
1. P CH DRAIN (0.3x3) AND P⁺ RES
2. P CH SOURCE
3. P CH GATE AND METAL CONTINUITY
4. P CH DRAIN (3x3)
5. GP DIODE AND P⁺ RES
6. GP DIODE AND N⁺ RES
7. N CH DRAIN (3x3)
8. N CH GATE AND METAL CONTINUITY
9. N CH SOURCE
10. N CH DRAIN AND N⁺ RES

Figure 12. 10 Pad Test Circuit

Each 4007 wafer contains a number of process evaluation test patterns shown in Figure 12. Seven test patterns were chosen

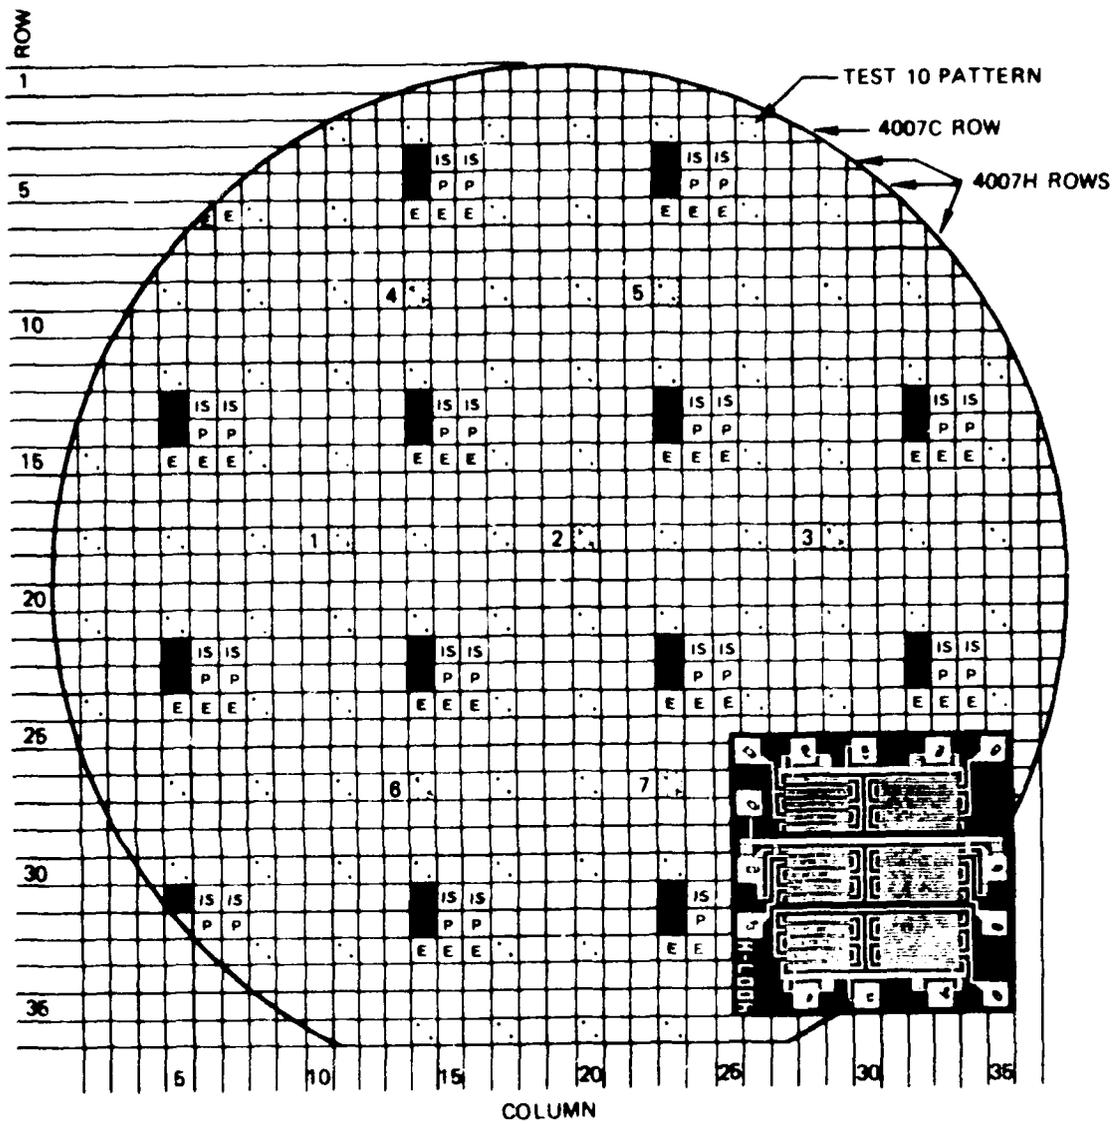
☐ SHADED TEST PATTERNS INDICATE SAMPLES USED FOR TEST 10

Figure 13. Wafer Die and Inverter Location

The wafer shown in Figure 13 contains a number of test circuits and 4007H dual complementary pair plus inverter circuits. The process evaluation test structure (test 10 pattern) has been previously discussed. Circuits identified as 4007C, P, and E in Figure 13 represent special versions of the circuit featuring

The following wafer map data are presented for the standard 4007H circuits (see inset Figure 13) designated by the unmarked squares in Figure 13. To facilitate computer-aided data acquisition, only rows consisting entirely of 4007H circuits were probed--neglecting those rows containing 4007H circuits in combination with one or more of the special circuits or test structures described above.

Each of the three structures (dual complementary pair plus inverter) in the 4007H circuit was checked for functionality (static switching between high and low states with a 10 volt power supply voltage and a 3 mA load) and for n- and p-channel junction leakages (gate shorted to the source and 10 volts applied between the drain and source terminals). The results of each test were printed out as shown in Figure 14. The first two entries identify the row-column location of the die being tested, followed by the p- and n-channel leakages in amperes, respectively, and then the magnitudes of the high and low output states, respectively. Three lines of data are shown for each location--each line designating the particular structure tested in the order 2, 1, 3, as shown in the inset of Figure 13.

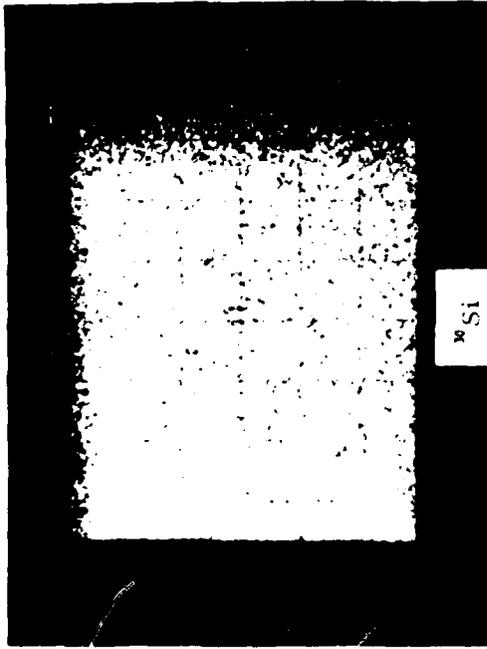
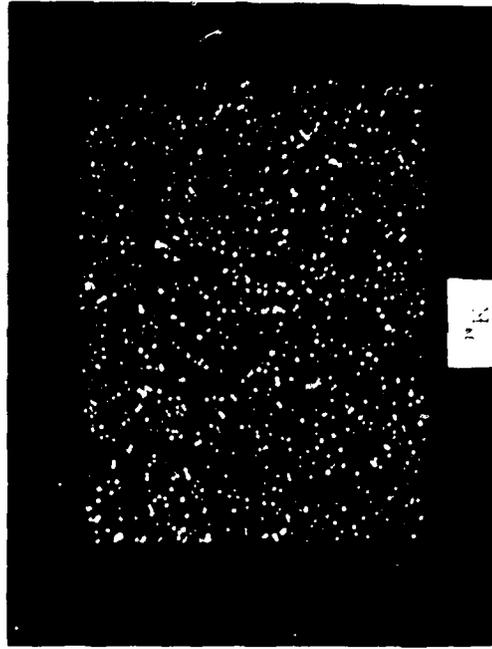
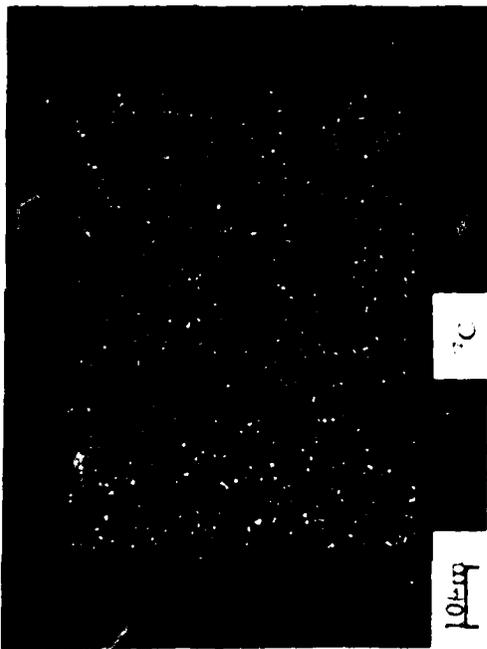
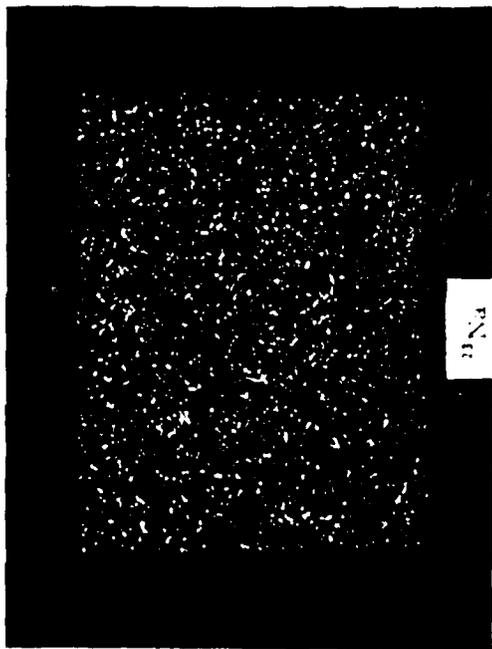
Figure 17. IMMA Surface Map of n-Channel Region of 4007 Device

IMMA examination of the circuits on Union Carbide sapphire showed uniform, low concentrations of contaminants over the entire n-channel devices. The set of surface maps shown in Figure 17 covers an area approximately 75 x 60 μm on one corner of an n-channel device. All eight channel edges were examined and found to be free of any localized sites of contamination.

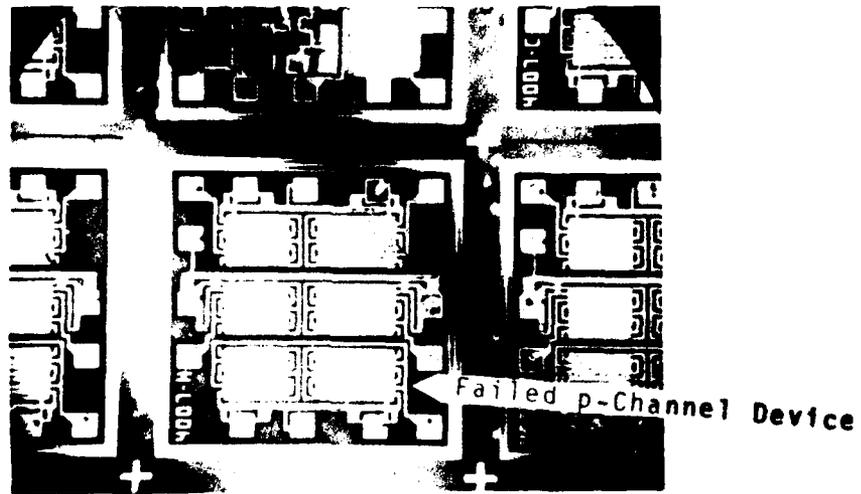
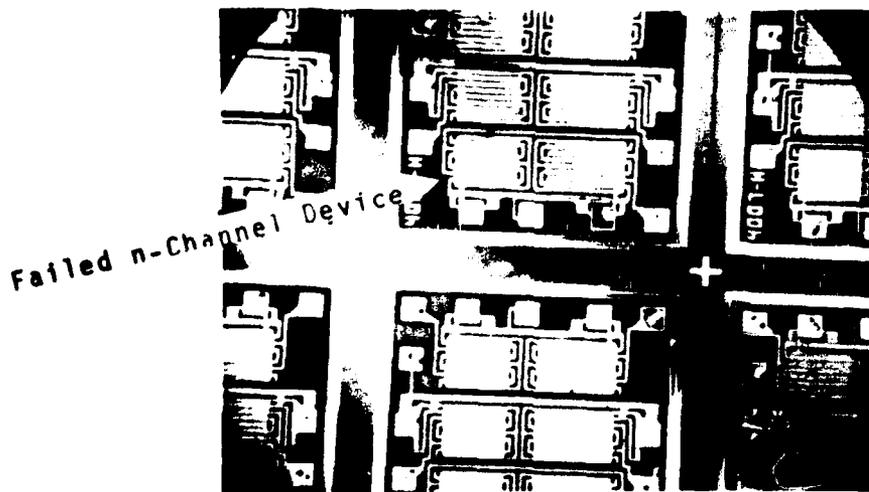
Figure 18. 4007 Circuits Fabricated on Crystal Systems Sapphire, Showing SAW Marks Running Through Failed Circuits

Figure 18 shows two different areas on circuits fabricated on the Crystal Systems/Insaco sapphire prior to stripping of silox and metal. The diagonal lines running through the circuits appear to be saw marks which remain after sapphire polishing. Surface map analysis of the failed devices showed that there were no differences in contamination levels in the saw marks and surrounding material. However, in the p-channel device, the ion-beam sputtered through the silicon more rapidly over the saw marks than in the surrounding area. This result indicates that one mechanism that should be further studied to explain the excessive n-channel leakage is phenomena associated with structural irregularities in the silicon caused by the nonuniformity in the surface of the substrate. Such irregularities may enhance

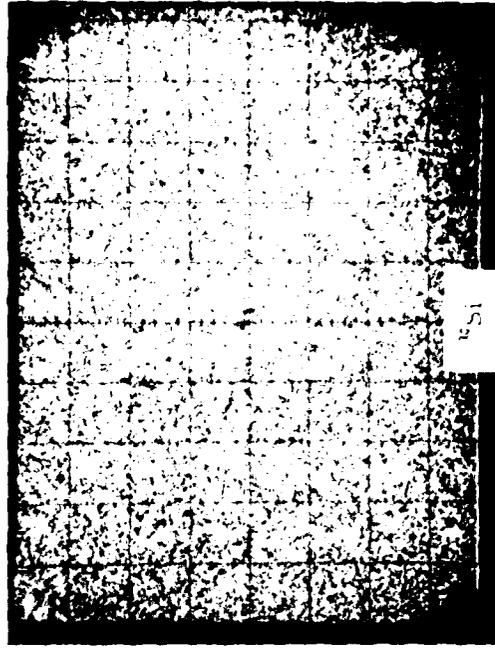
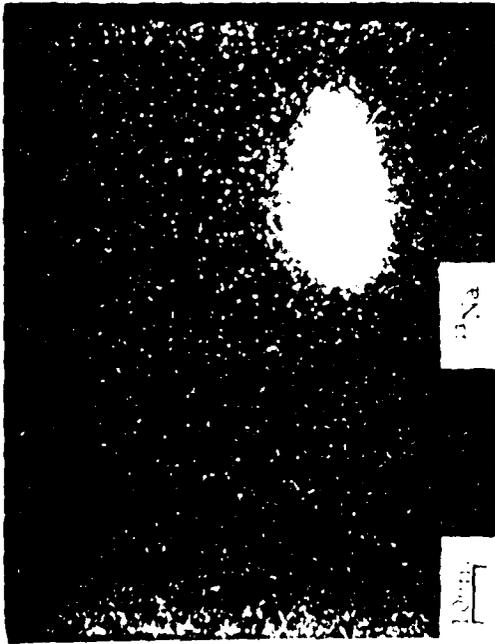
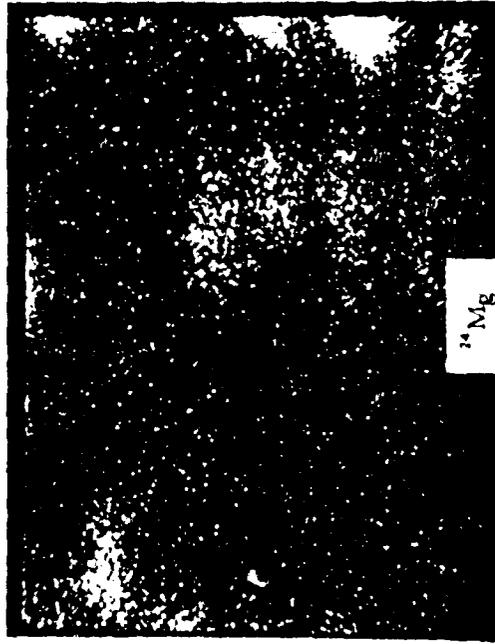
Figure 19. IMMA Surface Map of 1 mm² Test Pad on Union Carbide Sapphires with Union Carbide Epitaxial Silicon

Surface map analysis was also performed on the 1 mm square test areas, described above, representing starting and p-well implanted regions.* These test areas were not subjected to all the processing steps used in circuit fabrication and as a result very little of the original surface was consumed. A high degree of contamination was found in these areas, much of it being localized at point-sites. Surface maps are shown in Figures 19 and 20 for the Union Carbide and Crystal Systems substrates, respectively, with Union Carbide silicon epitaxy.

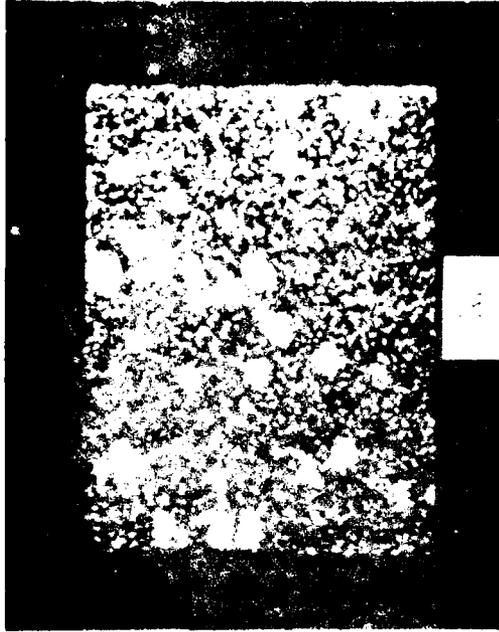
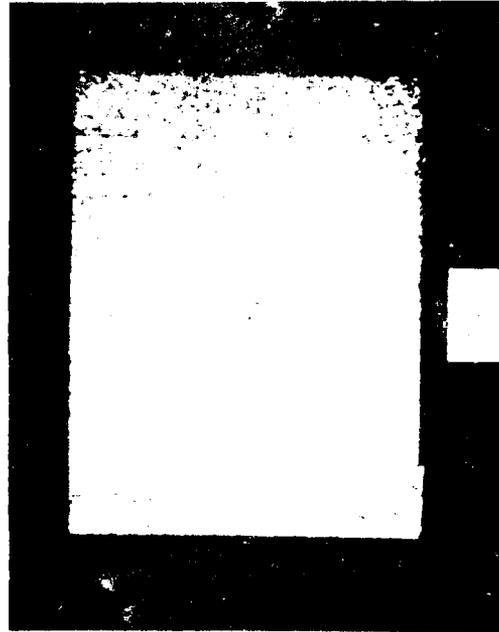
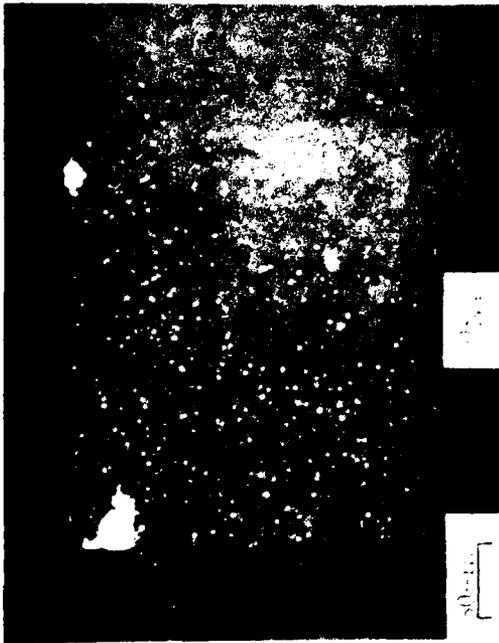
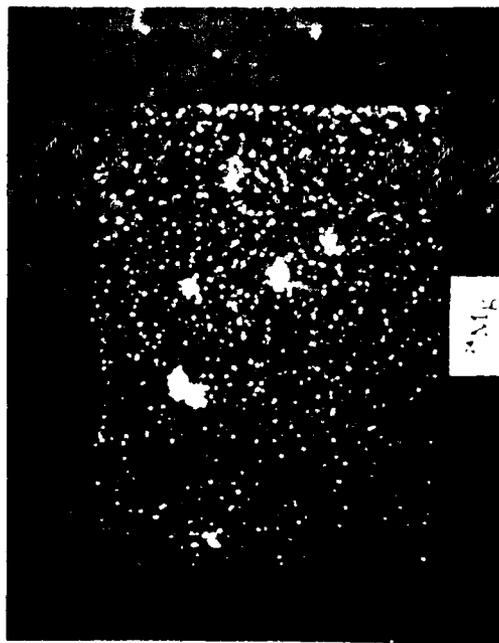
Figure 20. IMMA Surface of 1 mm² Test Pad on Crystal Systems Sapphire Polished by Insaco With Union Carbide Epitaxial Silicon

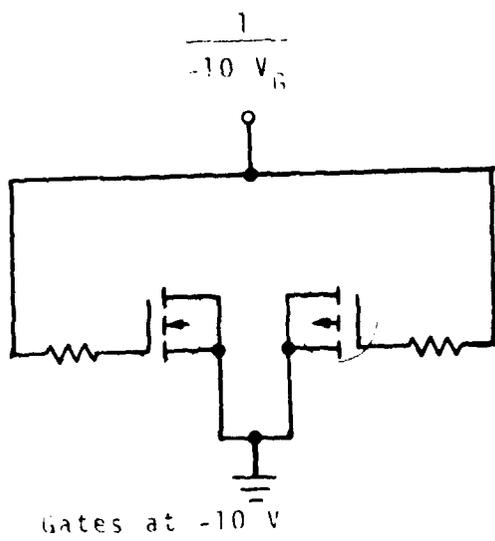
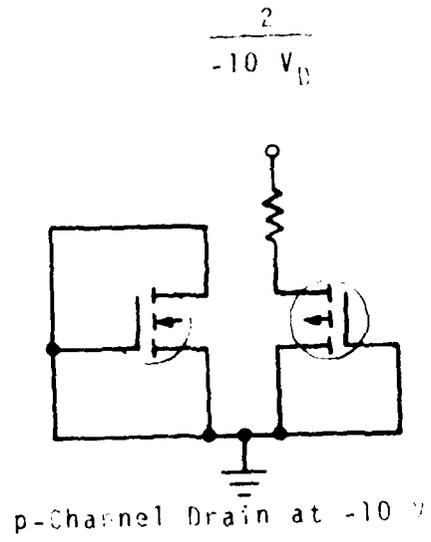
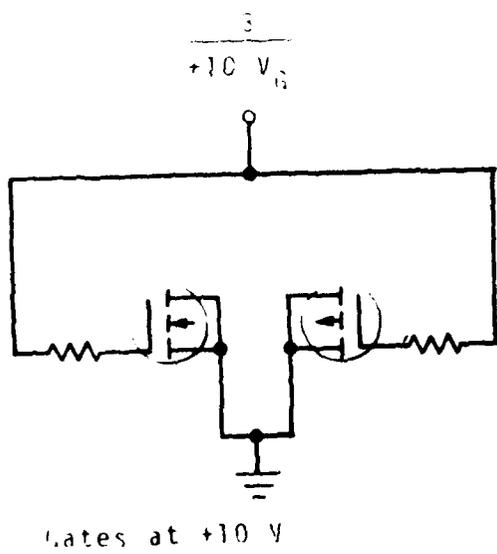
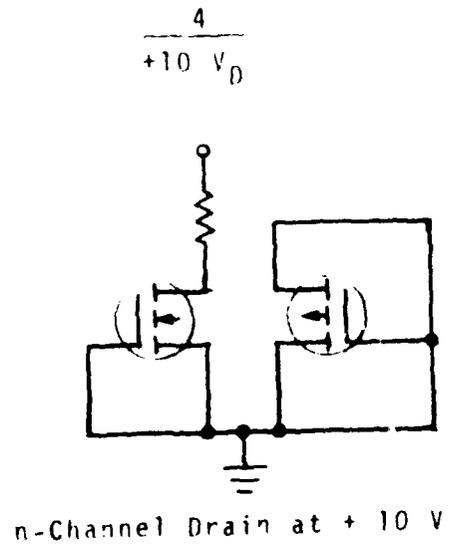
Figure 21. Bias Conditions Used During Co⁶⁰ Irradiation

Each complementary pair in the 4007H circuit was connected as an inverter and together with the remaining inverter, biased in one of four conditions. One inverter had its gate biased at -10 volts with the sources and drains tied to ground. Another had

the drain of the p-channel at -10 volts with the gate and source at ground. A third inverter had the gate at +10 volts and all other terminals grounded. The fourth inverter had the n-channel drain set at +10 volts with all the terminals grounded. These four bias conditions are shown in Figure 21.

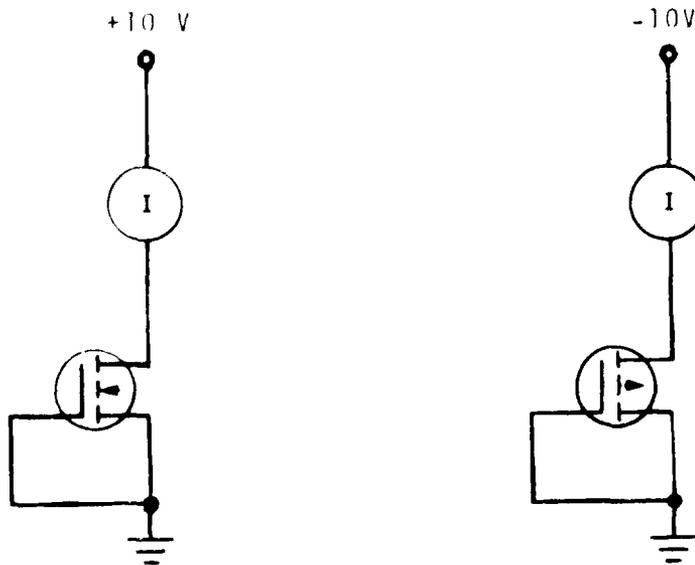
Figure 22. Drain Leakage Measurement

The drain junction leakage measurement was made by grounding the gate and source and measuring the current in the drain with +10 volts for the n-channel devices and -10 volts on the drain for the p-channel devices. These two test conditions are shown in Figure 22.

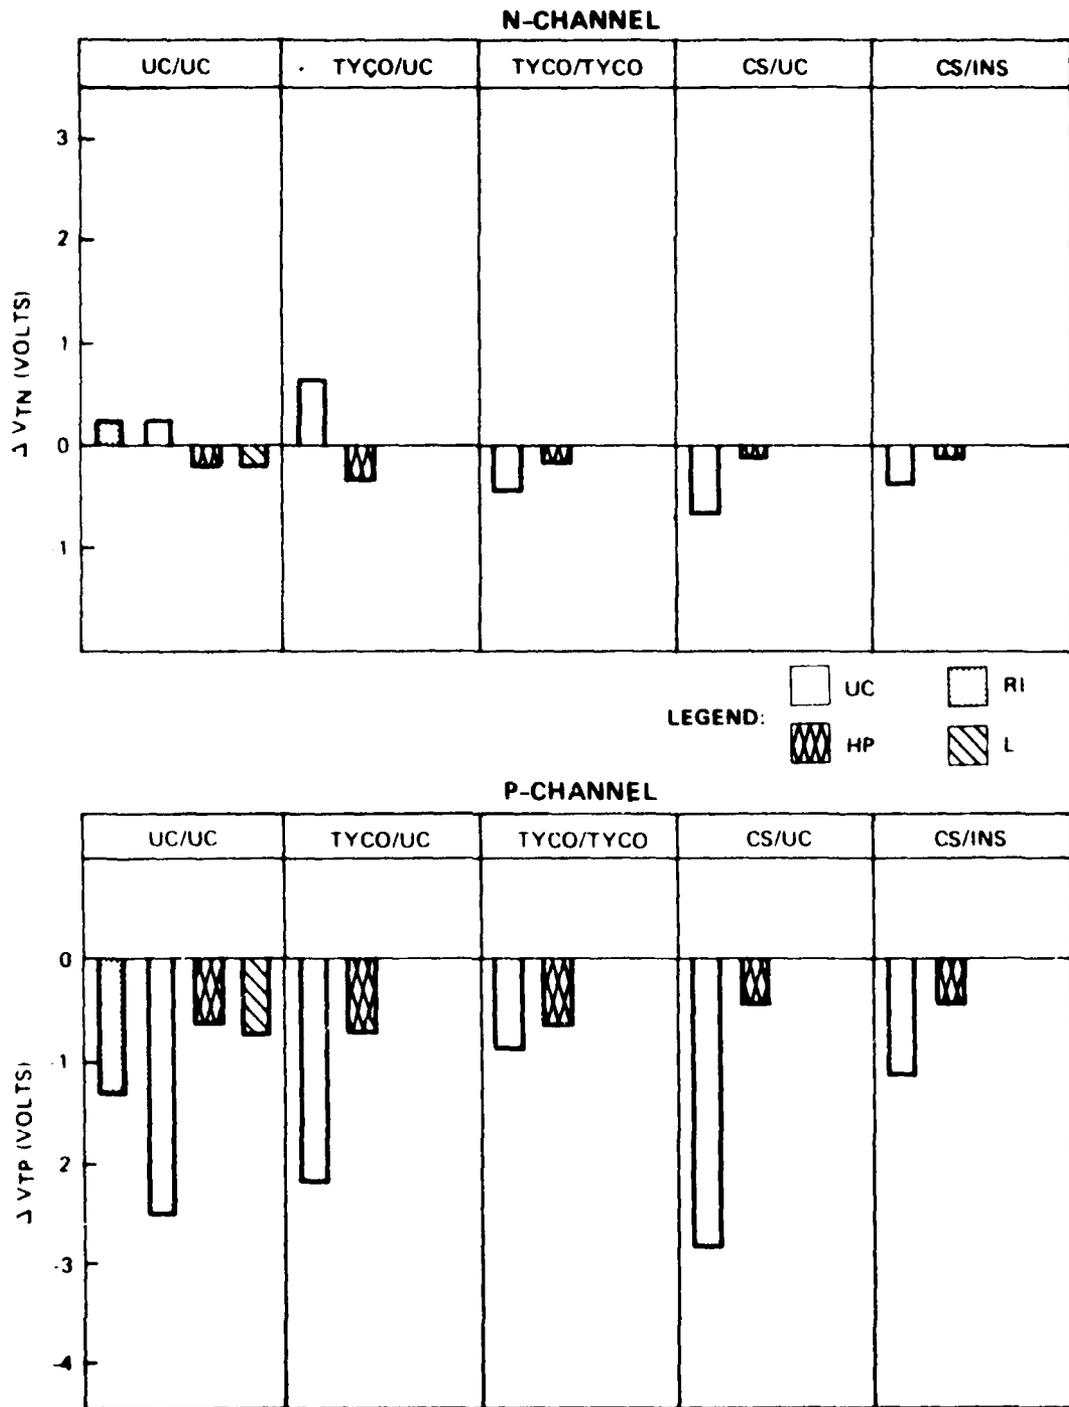
Figure 23. Radiation-Induced Threshold Voltage Shift Data After 10^6 rads(Si) and $V_G = -10$ Volts

The two measurements--conductance and drain junction leakage--were made prior to the first irradiation and after a series of radiation doses (.01, .1 and 1.0 megarads). Figures 23 through 26 show the radiation-induced shifts for each of the four bias conditions described above after exposure to a total ionizing dose of one megarad. Differences in radiation response of the devices fabricated on the various substrate combinations are observed. The Hewlett Packard material showed the best overall radiation response from the standpoint of gate oxide hardness. The results are very nearly the same for each bias condition for the various material groupings. This was not quite the case for the Union Carbide silicon films, which showed some variation from material group to material group.

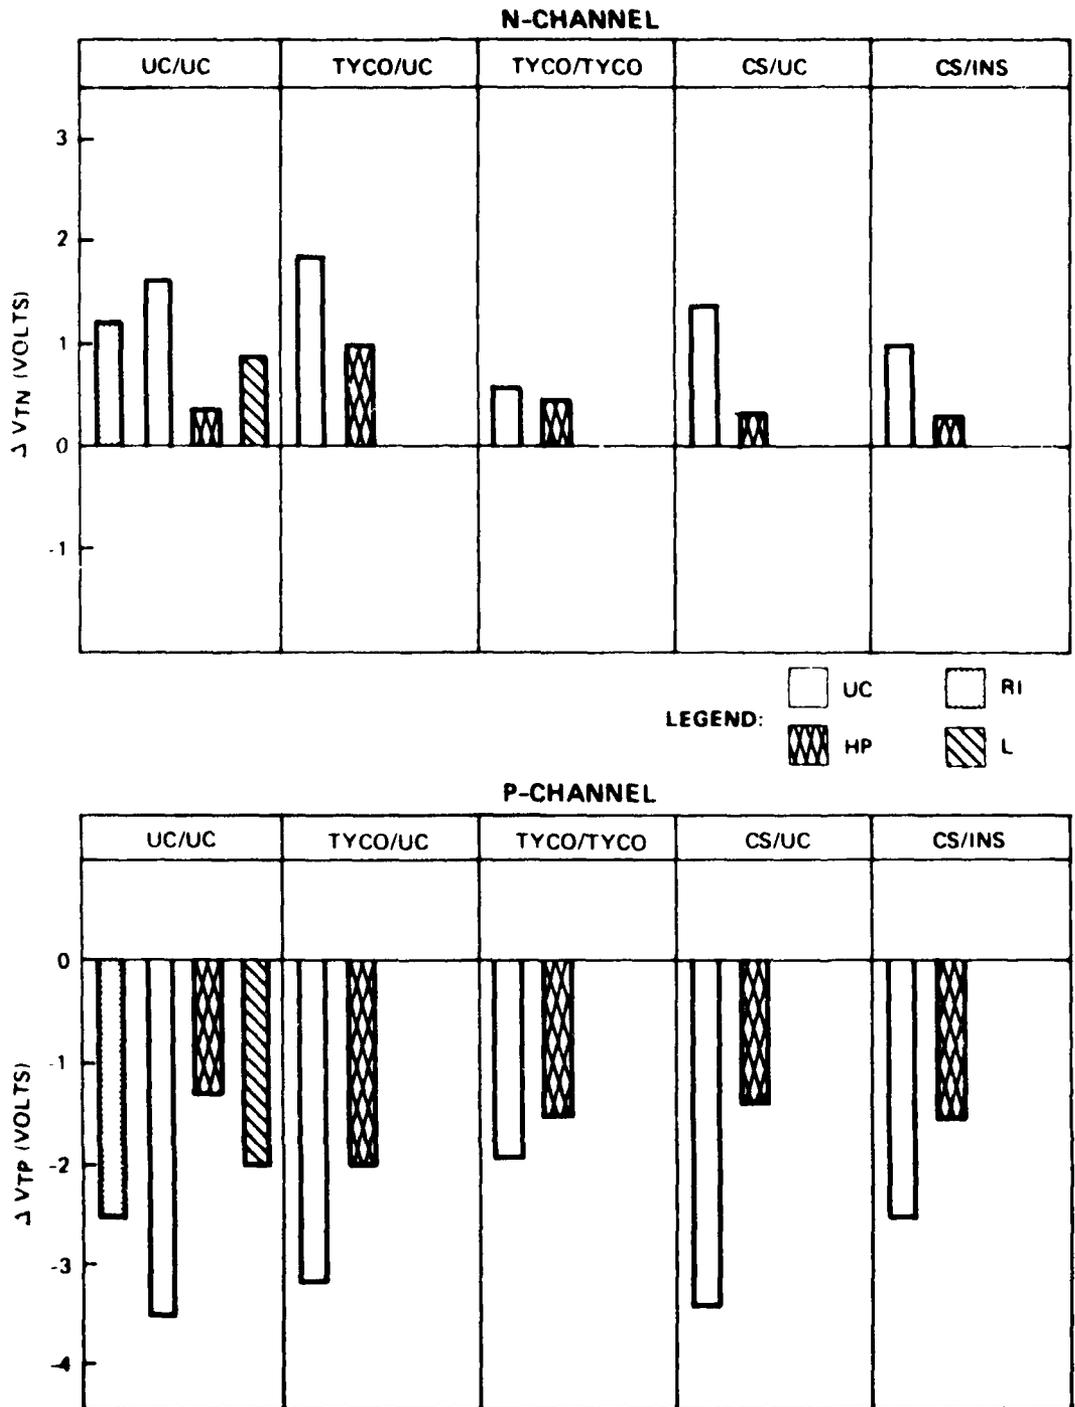
Figure 24. Radiation-Induced Threshold Voltage Shift Data After 10^6 rads(Si) and $V_{DP} = -10$ Volts, $V_{GN} = 0$ Volts

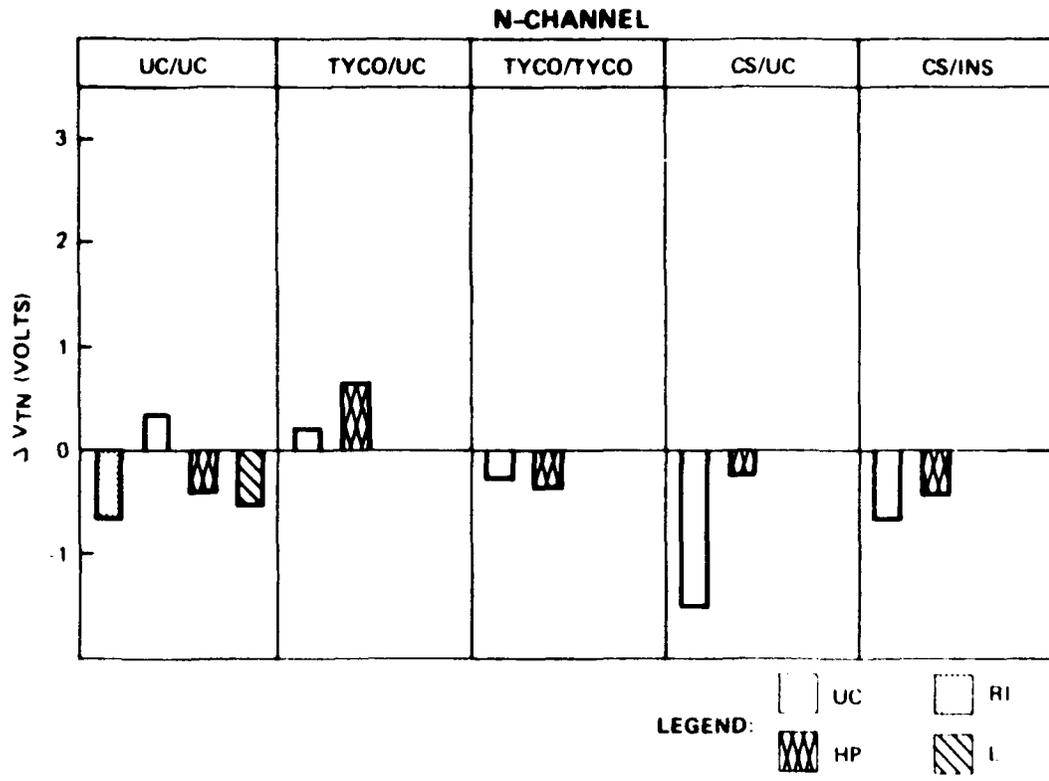
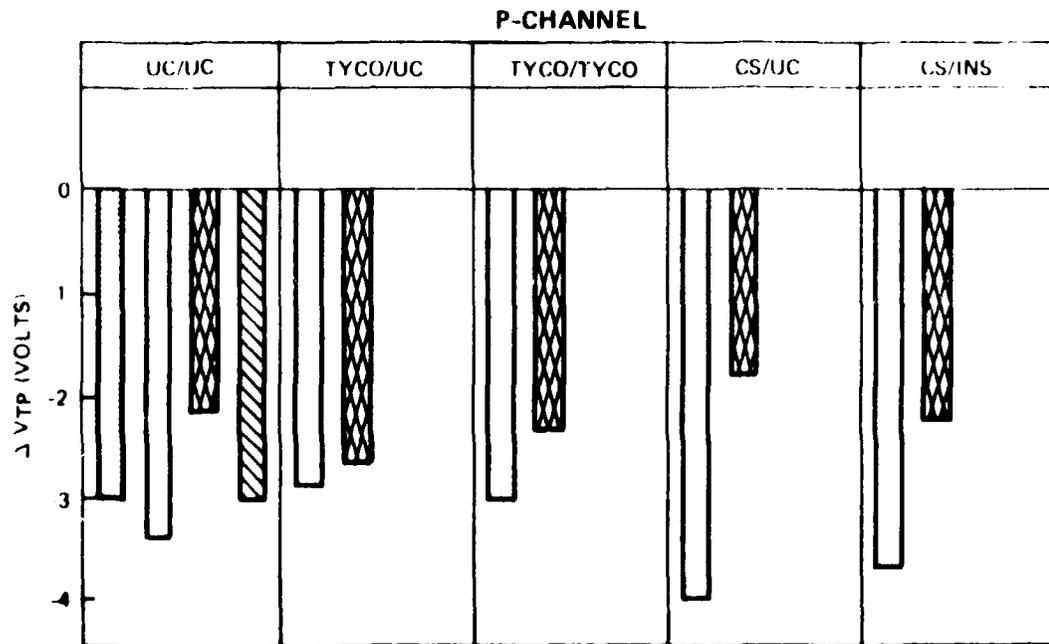
Figure 25. Radiation-Induced Threshold Voltage Shift Data
After 10^6 rads(Si) and $V_G = +10$ Volts
