RADC-TR-76-208
Interim Technical Report
July 1976

**INVESTIGATION OF DEFECTS AND IMPURITIES
IN SILICON-ON-SAPPHIRE**

Rockwell International Corporation

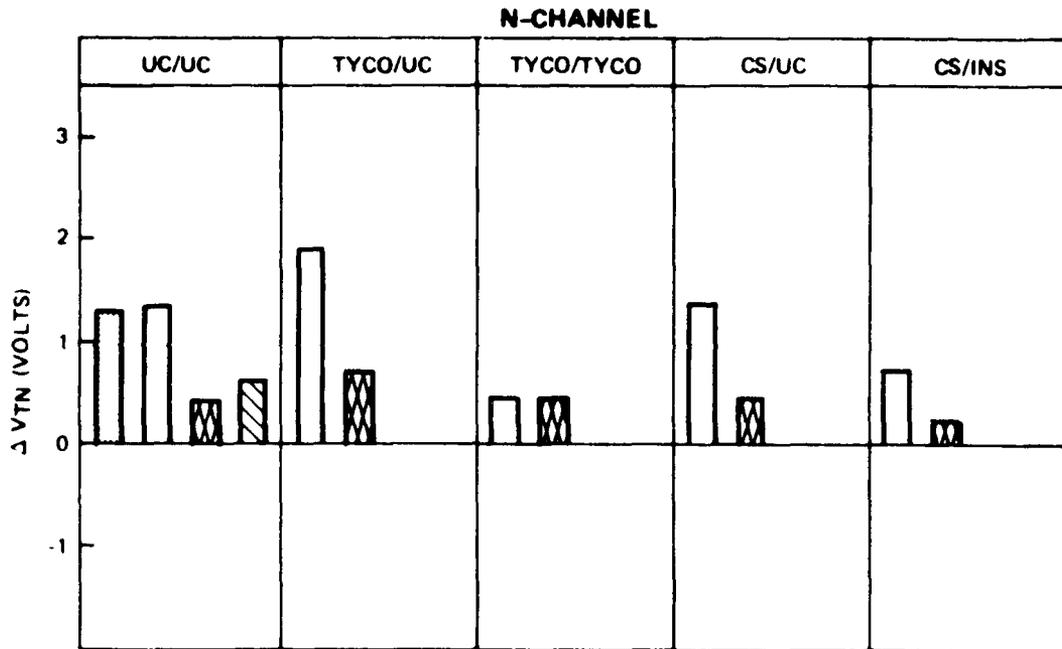
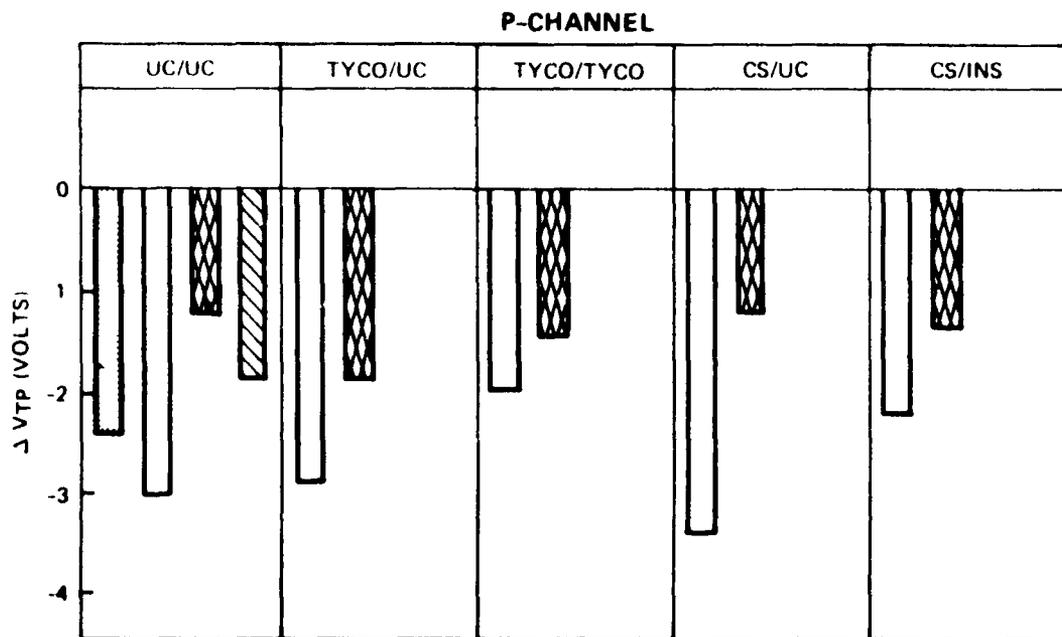
Figure 26. Radiation-Induced Threshold Voltage Shift Data After 10^6 rads(Si) and $V_{DN} = +10$ Volts, $V_{GP} = 0$ Volts

The two measurements--conductance and drain junction leakage--were made prior to the first irradiation and after a series of radiation doses (.01, .1 and 1.0 megarads). Figures 23 through 26 show the radiation-induced shifts for each of the four bias conditions described above after exposure to a total ionizing dose of one megarad. Differences in radiation response of the devices fabricated on the various substrate combinations are observed. The Hewlett Packard material showed the best overall radiation response from the standpoint of gate oxide hardness. The results are very nearly the same for each bias condition for the various material groupings. This was not quite the case for the Union Carbide silicon films, which showed some variation from material group to material group.

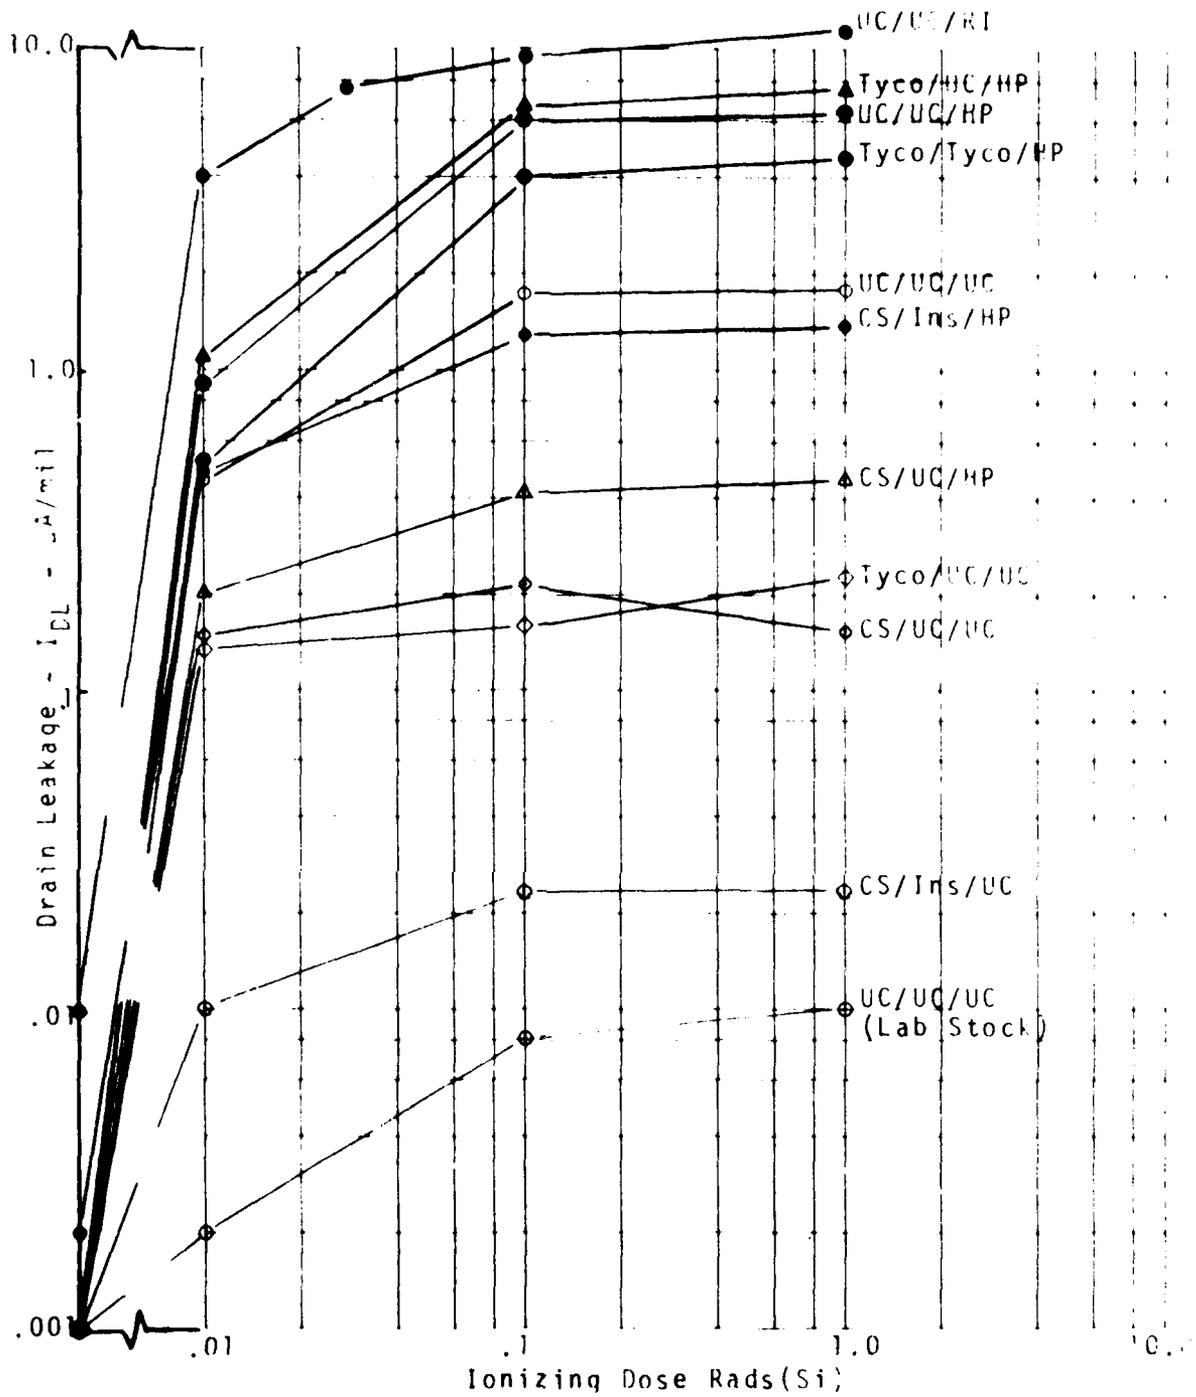
Figure 27. Radiation induced drain leakage current, I_{DL} , for the condition $V_{DD} = +10V$, $V_G = V_S = 0V$ on n-channel devices fabricated on Union Carbide (UC), Lockwell International (RI), and Hewlett Packard (HP) silicon epitaxies. Each point is the average of three samples across each wafer.

The radiation-induced drain leakage results for lots 504, 505 and 507 are shown in Figure 27. The results from lot 504 with the Union Carbide films was excellent for the Tyco, Crystal Systems, and Union Carbide (lab stock). The excellent results observed for lot 504 were confirmed by leakage data from lot 503, although these data are not shown here. The U.C. films tended to be the cleanest silicon depositions. The Rockwell films in lot 505 showed the worst response and by far had the worst silicon cleanliness. The Hewlett Packard results were intermediate--they ranged from good to poor.

Results observed here tend to show the same trends as those observed for other internally-funded material research projects. It was found that the more contaminated the silicon films, the worse the radiation-induced backchannel leakages. The cleanliness of this silicon film does not seem to affect the radiation hardness of the gate oxide, however.
