USAAMRDL-TR-76-9

• **DEVELOPMENT PROGRAM FOR FIELD-REPAIRABLE/EXPENDABLE  
MAIN ROTOR BLADES**

Kaman Aerospace Corporation  
Old Windsor Road  
Bloomfield, Conn. 06002

Final Report

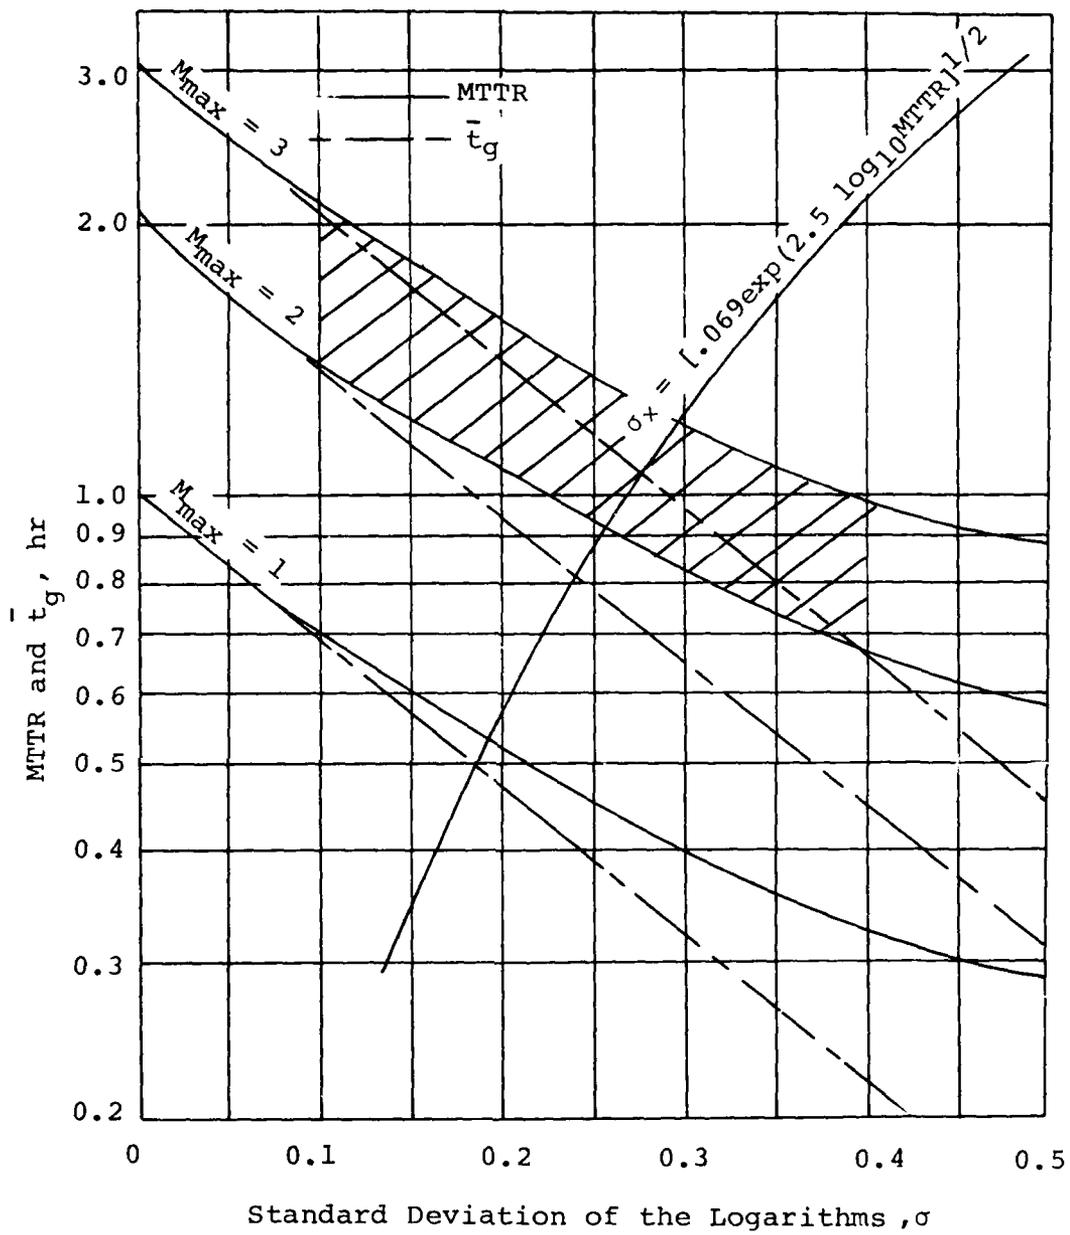
Figure 1 shows the area of trade-off between the mean repair time (MTTR) and the variance for a log normal repair time distribution at 95th percentile repair times ( $M_{max}$ ) of 3 hours, 2 hours and 1 hour. (Rationale for selection of a log normal distribution of repair times is discussed in Reference 1.) MTTR and the geometric mean repair time,  $\bar{t}_g$ , are shown plotted against the standard deviation of the distributed repair times. The area under the MTTR curves is the mean/variance trade-off area, with the shaded area representing the range of realistic alternatives. Also shown on the figure is a plot of the standard deviation as a function of the MTTR based on a regression equation developed by Kaman for use in maintainability predictions. (The equation and its derivation are also described in Reference 1.) The portion of this curve which intersects the potential trade-off area was viewed as the region of most likely mean/variance combinations, based on past history.

Figure 1. Maintainability Trade-Offs.

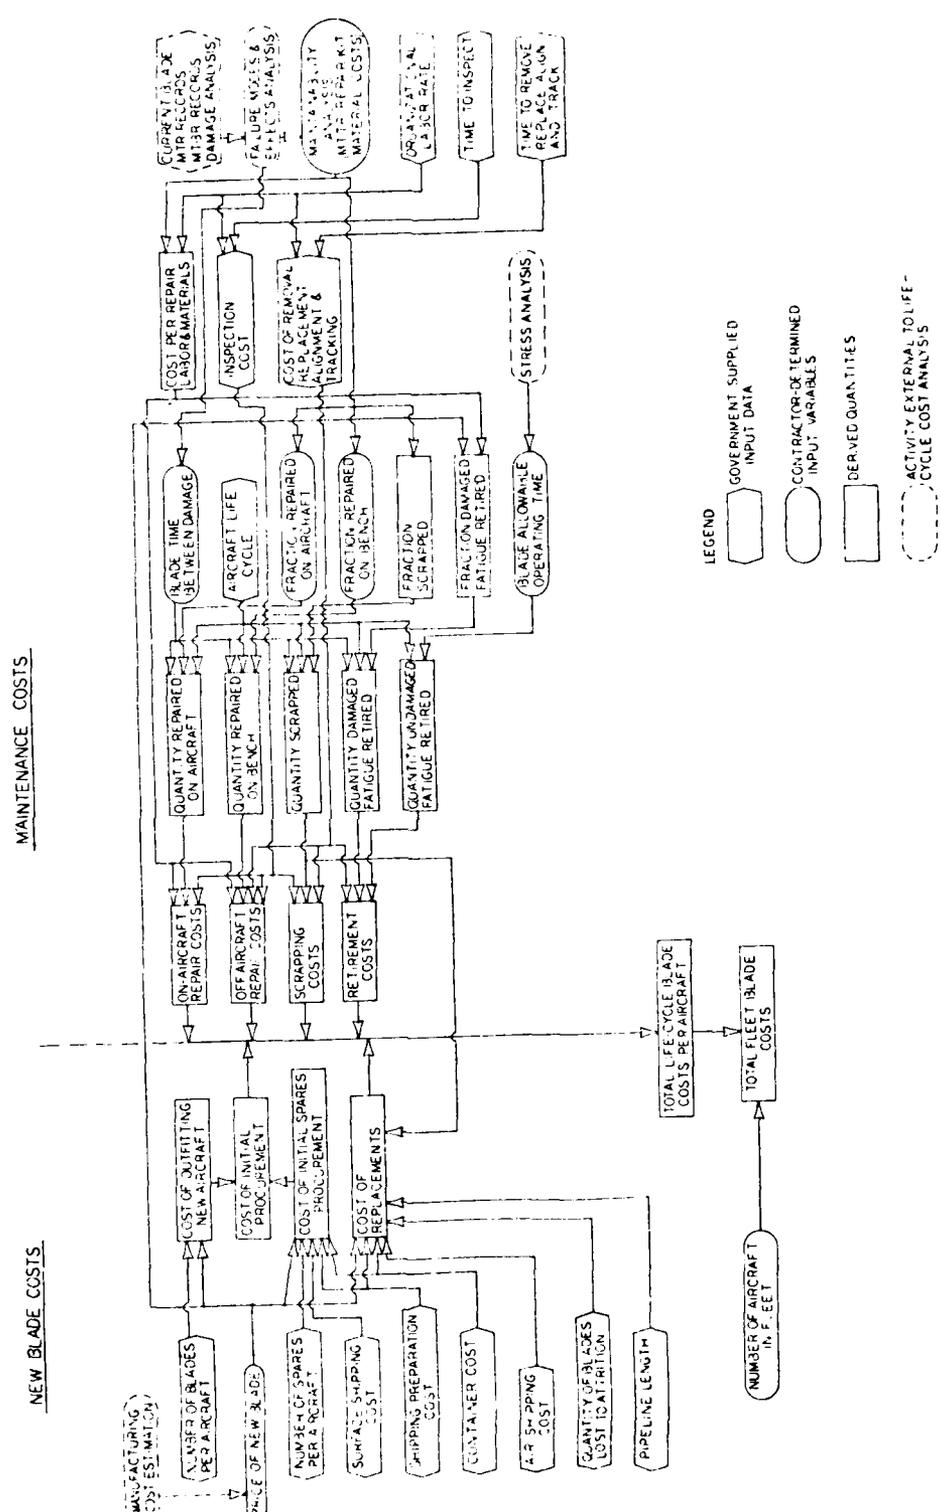
Two time-sharing computer programs were developed to fill this need. The first program merely recorded all of the failure modes projected for the blade, their frequency of occurrence, and repair requirements. This program allowed evaluation of overall MTBFs and repair time, and comparison of the effect on these parameters of elimination of certain failure modes or improvements in repair time. The second and more useful program was a life-cycle cost model which allowed studies of life-cycle cost sensitivity to initial blade cost, MTBF, repairability, repair time, etc. This program uses the flow chart given in Figure 2 to predict blade-related aircraft life-cycle costs.

Figure 2. Life-Cycle Cost Model Flow Chart.

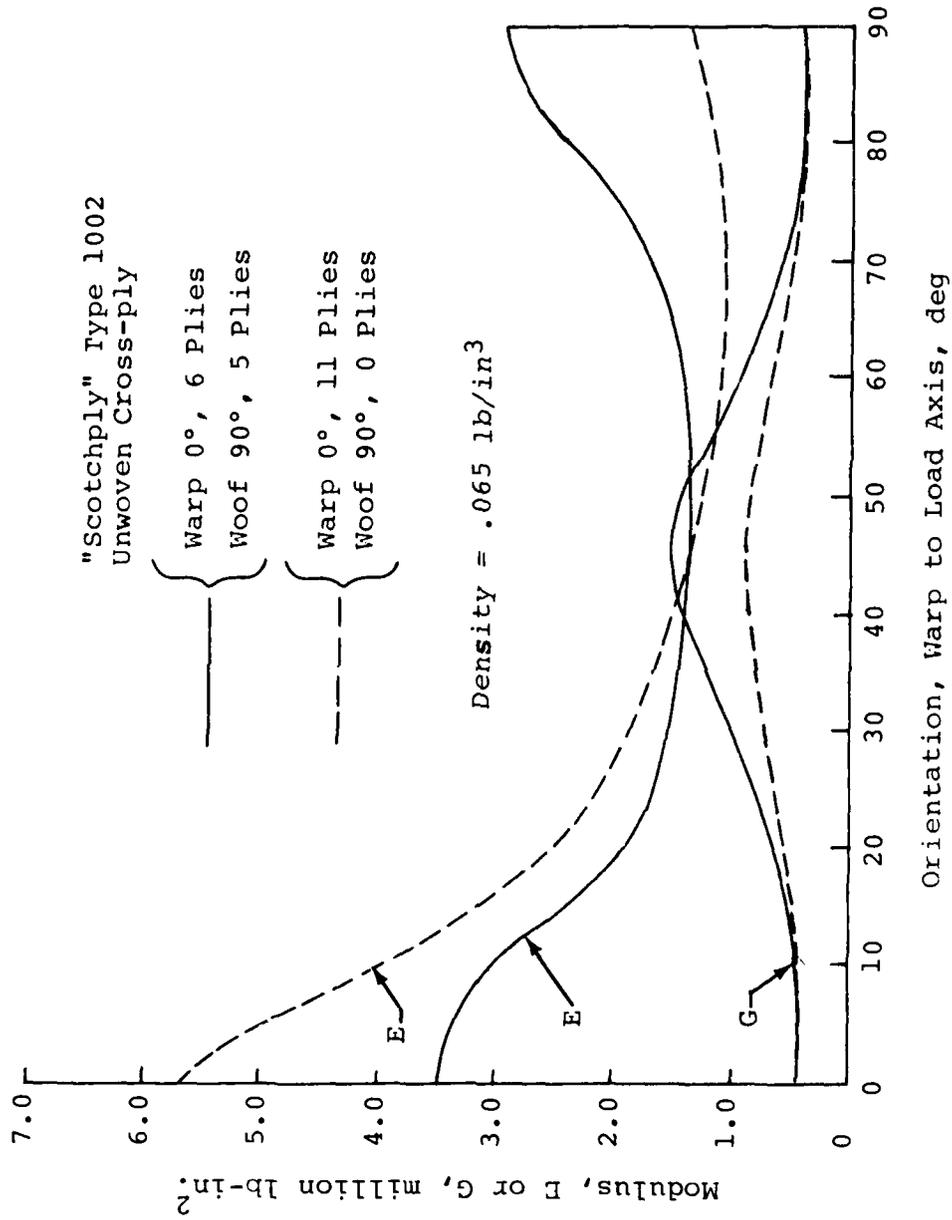
Figure 3. Modulus Variation With Fiber Orientation, Glass-Fiber-Reinforced Plastic.

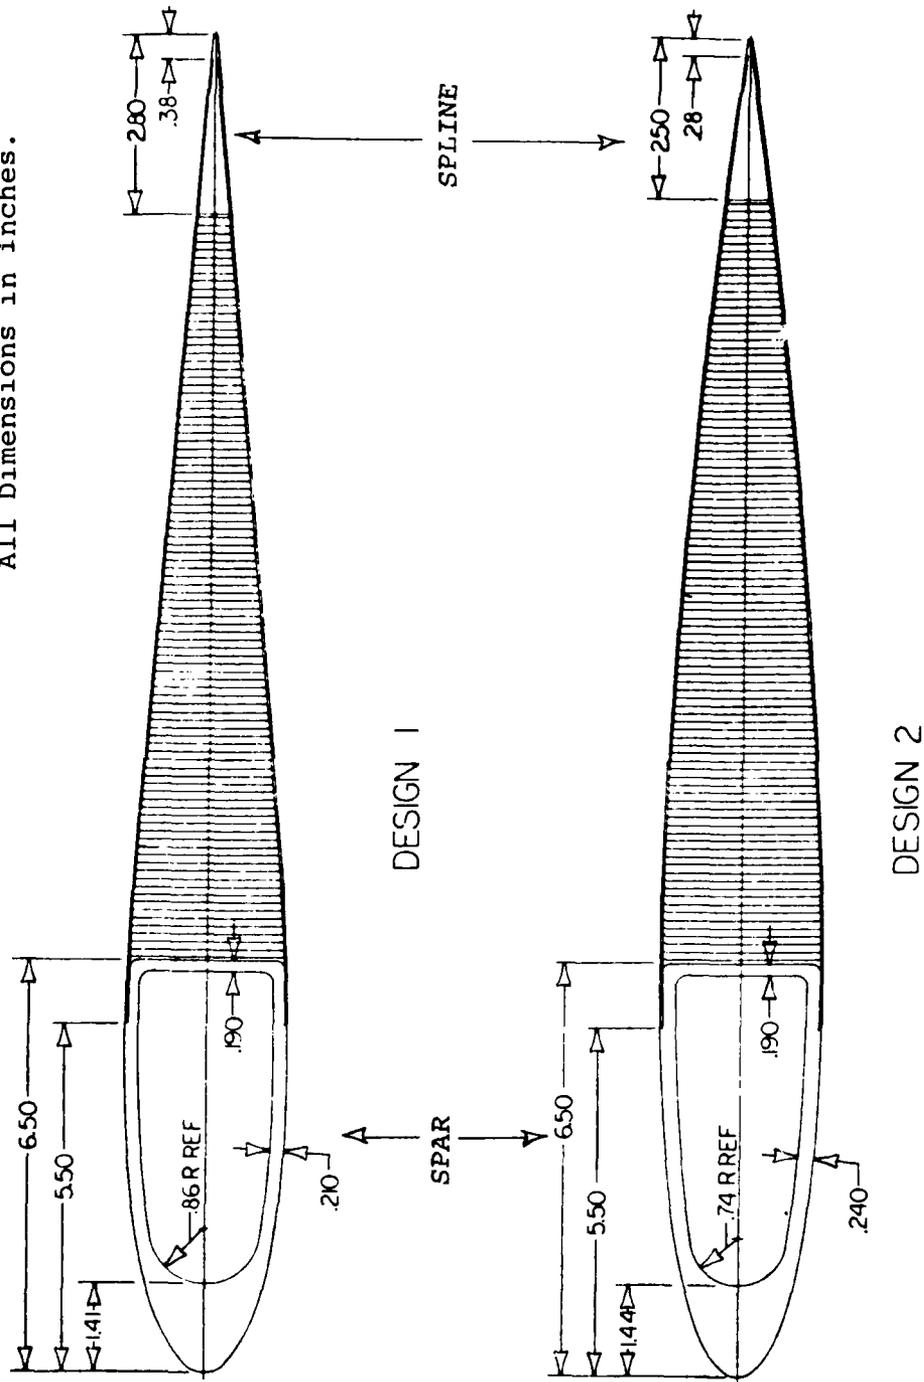
Based upon the previously stated considerations, the twelve concepts listed in Table 2 were selected for further consideration. Representative cross sections of these concepts are given in Figures 4, 5 and 6. Concepts 1 through 6 are shown in these figures. Concepts 7 through 12 have the same basic configurations as Concepts 1 through 4, differing only in doubler makeup, skin composition, and the use of an abrasion strip. Further description of these concepts is given in Reference 1. Although the inexpensive composite materials lend themselves to relatively inexpensive fabrication techniques, the questionable torsional stiffness of composite spars eliminated them from further consideration. Glass fiber reinforced plastic skins and polyamide paper core were chosen as the best skin and afterbody filler for the reasons given above. The metal for the spars could be either stainless steel with an S-glass spline or extruded aluminum.

Figure 4. Cross Sections Through Concepts 1 and 2 at Station 81.

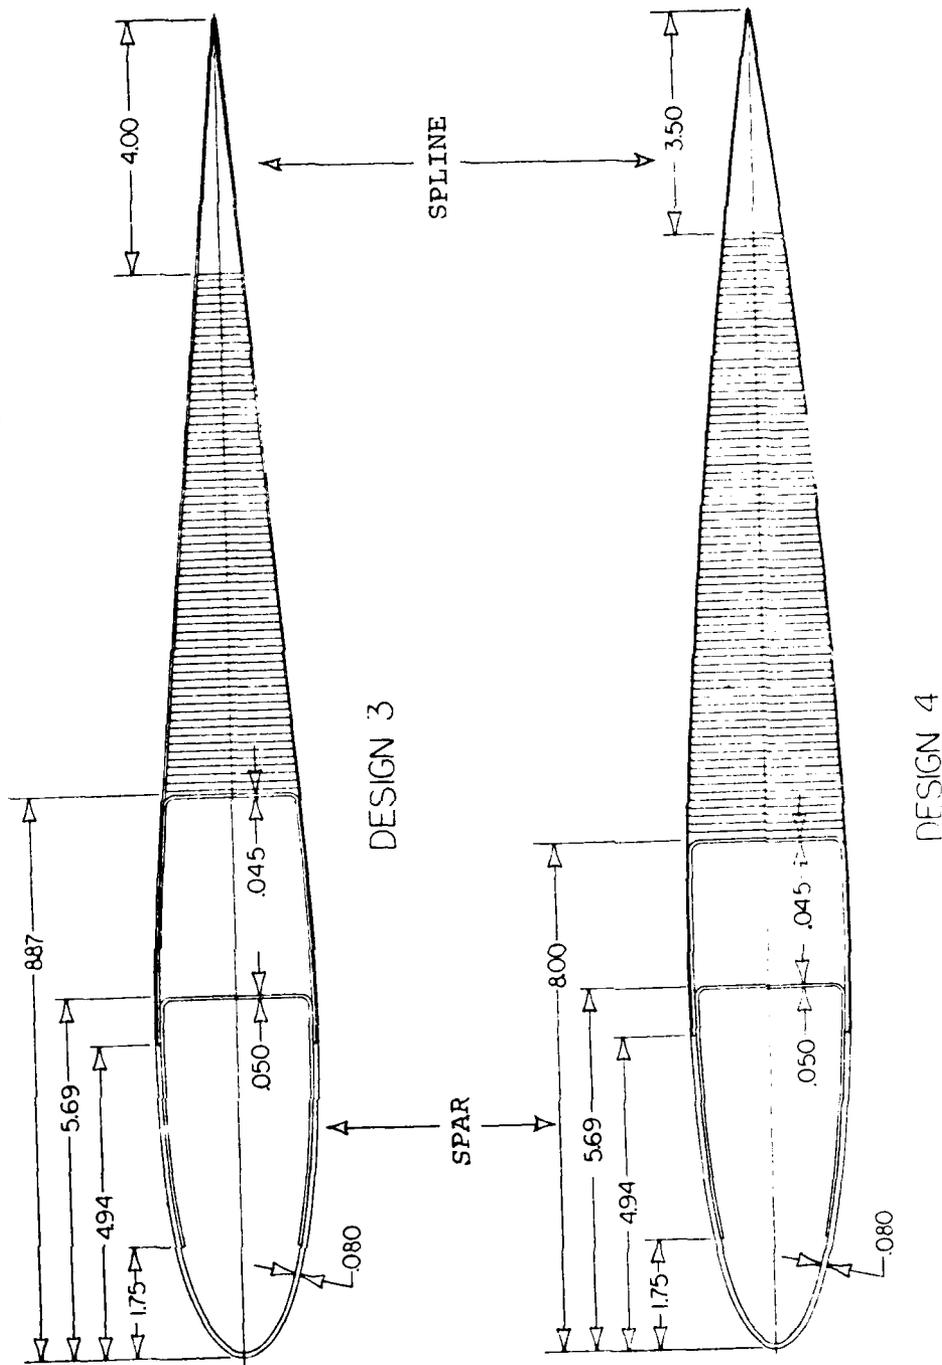
Figure 5. Cross Sections Through Concepts 3 and 4 at Station 81.

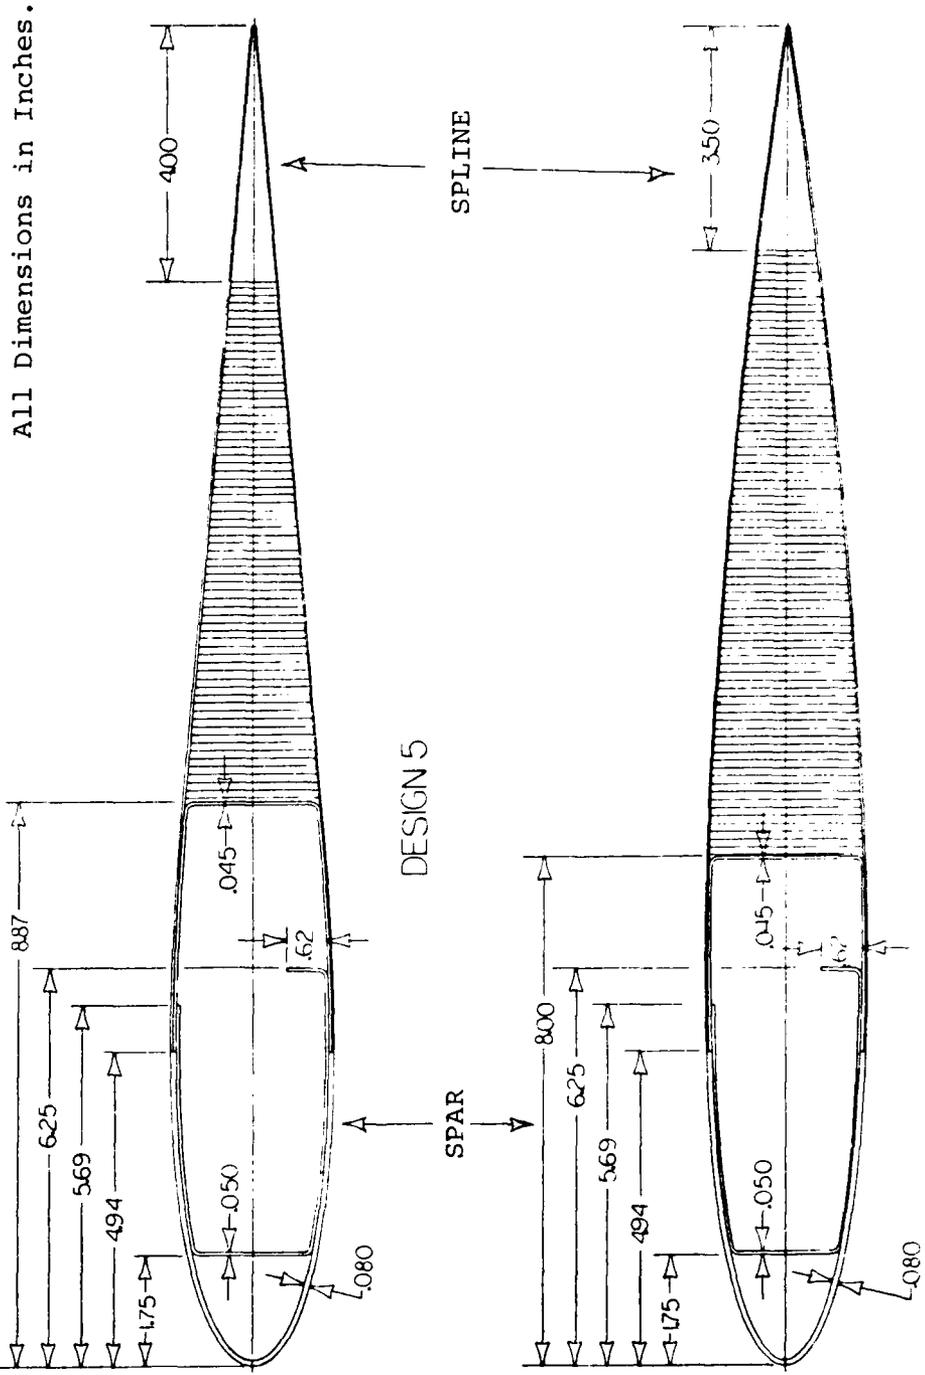
Figure 6. Cross Sections Through Concepts 5 and 6 at Station 81.

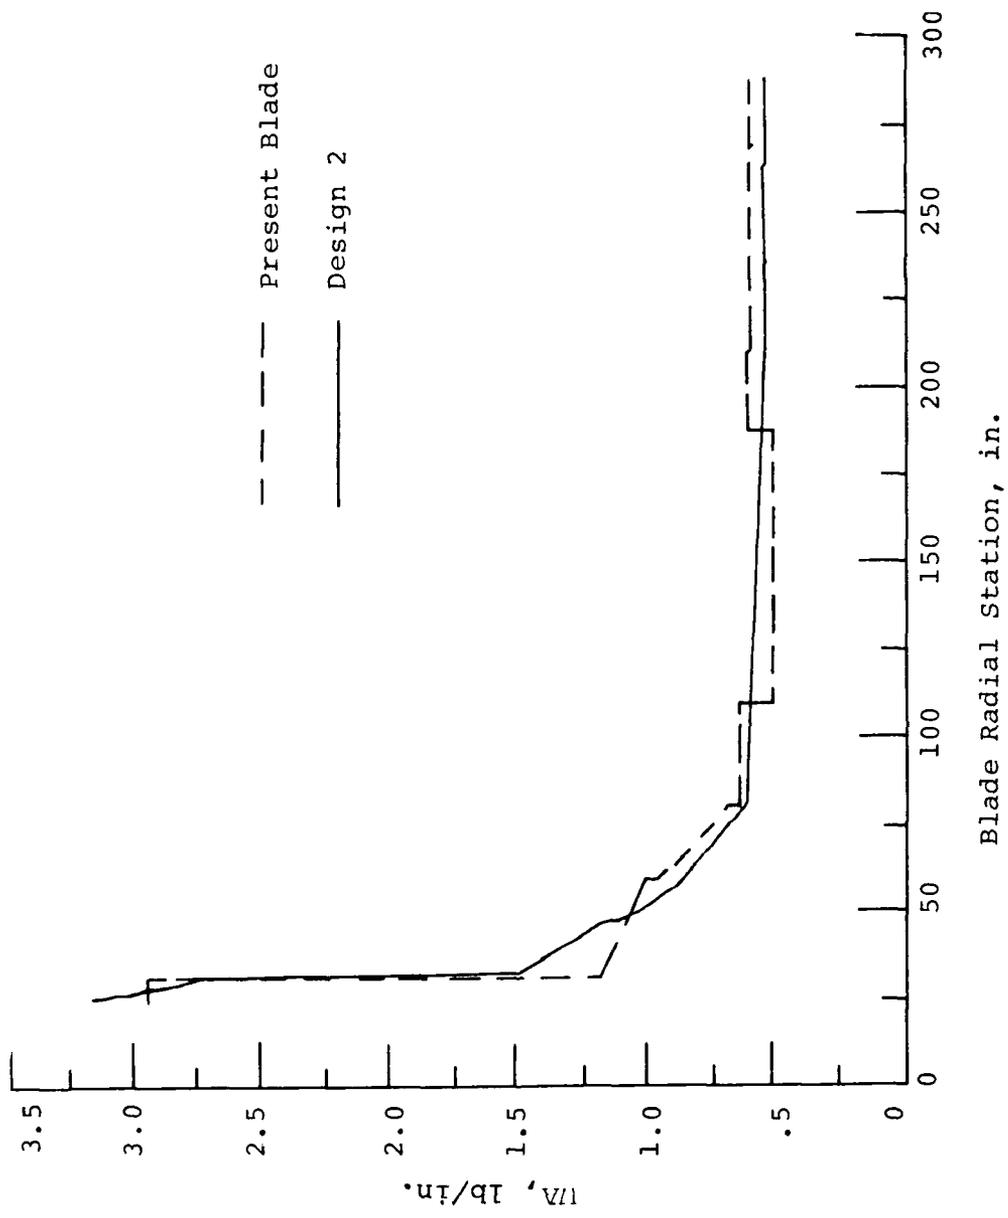
Figures 7 through 12 allow comparison of the weight properties, pertinent section parameters, natural frequencies and bending moments at 107 knots for the current UH-1H blade and for Concept 2. Table 3 summarizes the weight and balance of the six design candidates. Concept 2 is representative of the section properties for all of the candidate concepts considered. As can be seen from these plots, the present blade has a number of discontinuities. These are due to the large number of pieces from which it is made. All of the candidate concepts utilize main structural elements that extend from the root to the tip, decreasing cost and fabrication difficulty and increasing reliability by reduction of joints within the structure.

Figure 7. Concept 2, Current Blade Section Weight Distribution Comparison.

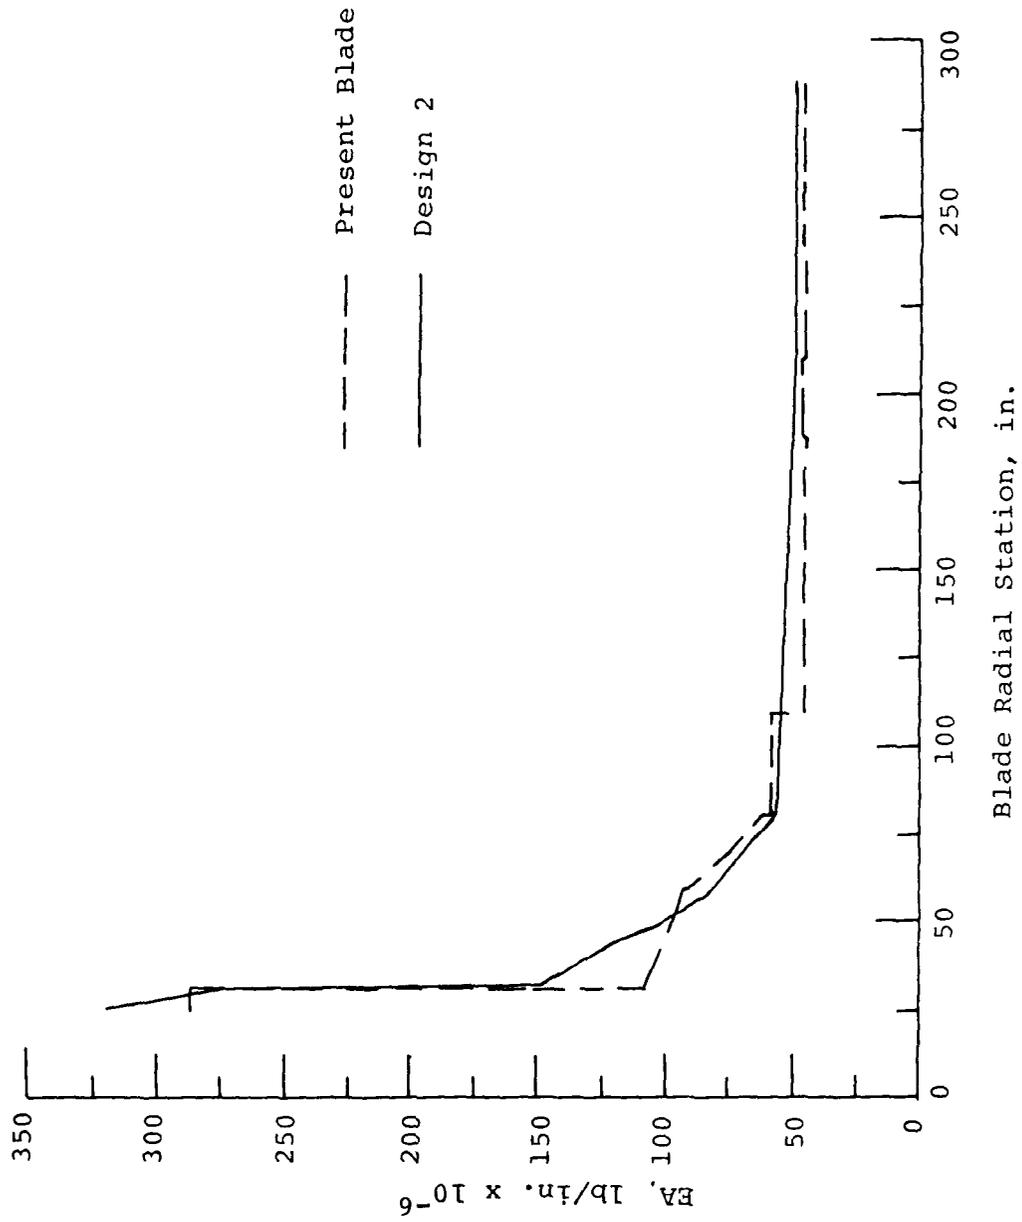
Figure 8. Concept 2, Current Blade Tensile Stiffness Distribution Comparison.

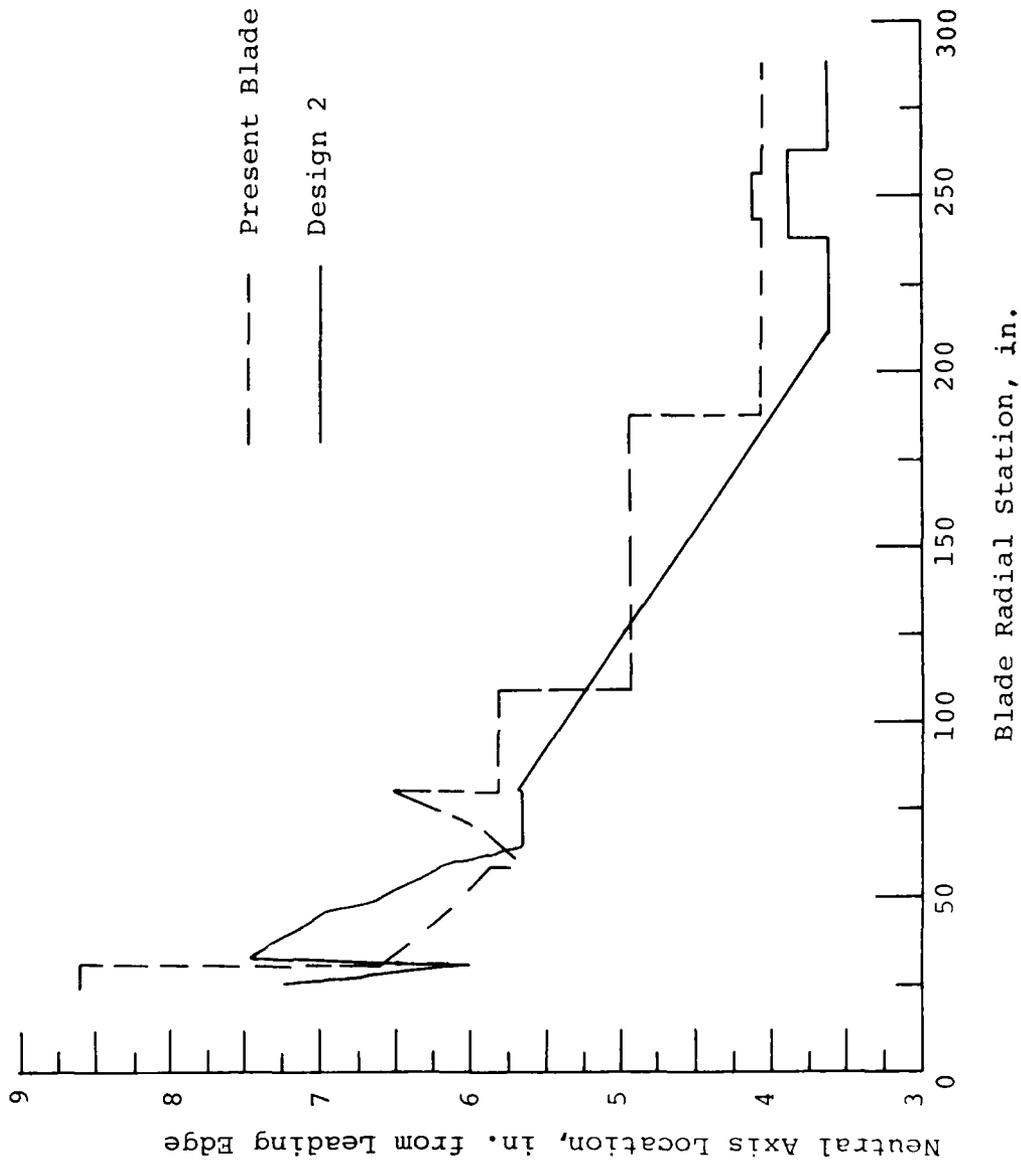
Figure 9. Concept 2, Current Blade Neutral Axis Location Distribution Comparison.

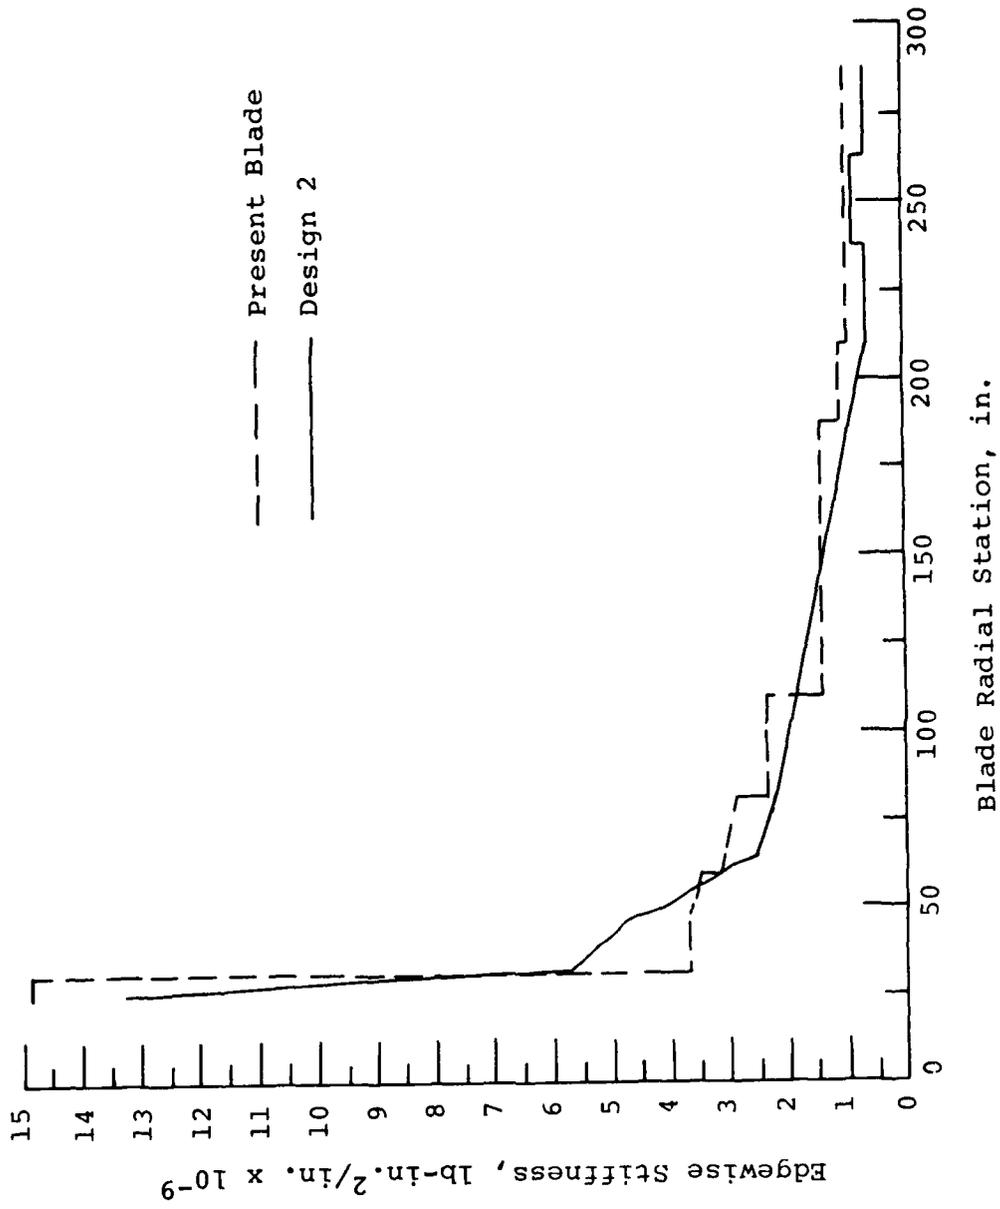
Figure 10. Concept 2, Current Blade Edgewise Stiffness Distribution Comparison.

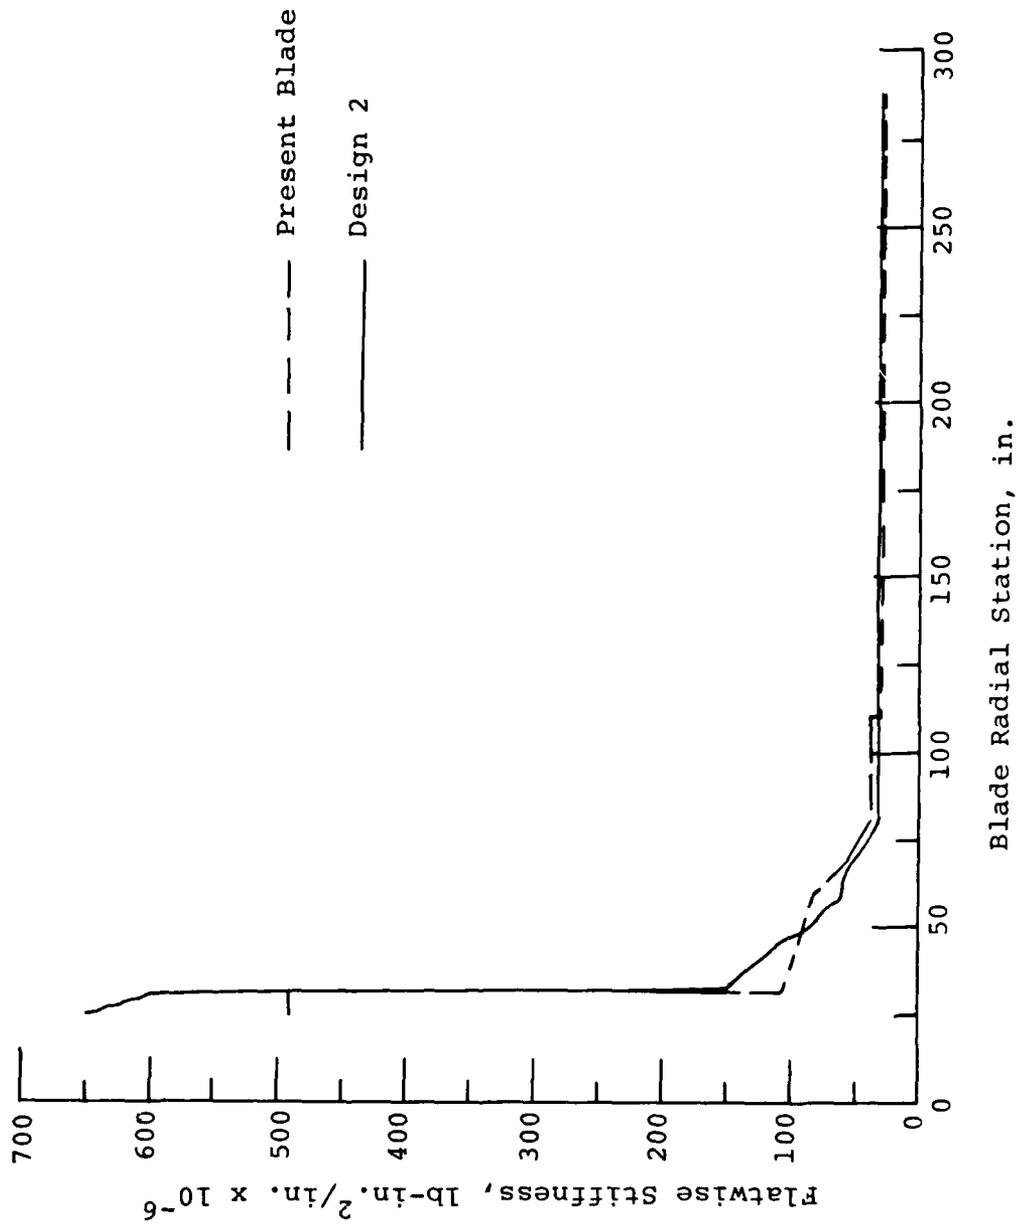
Figure 11. Concept 2, Current Blade Flatwise Stiffness Distribution Comparison.

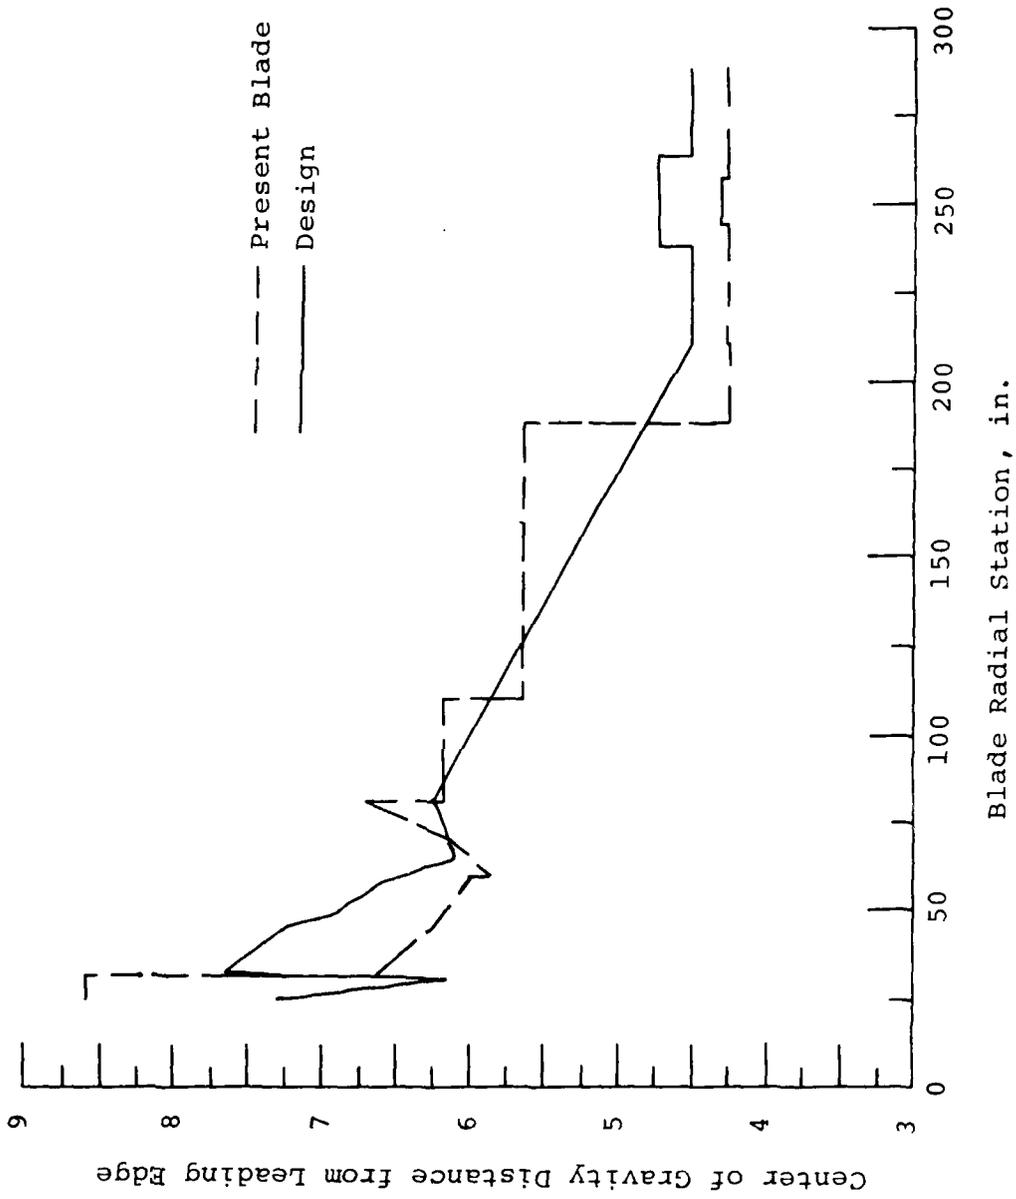
Figure 12. Concept 2, Current Blade Center of Gravity Distribution Comparison.

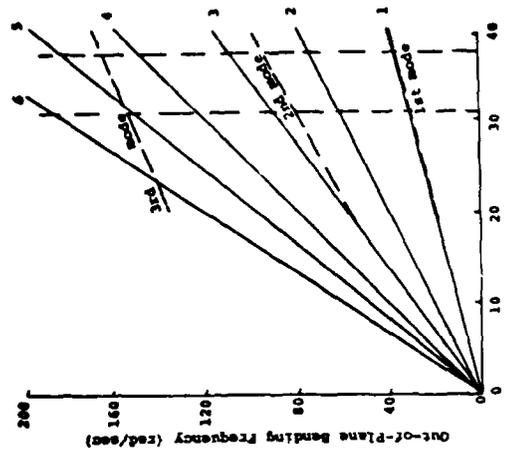
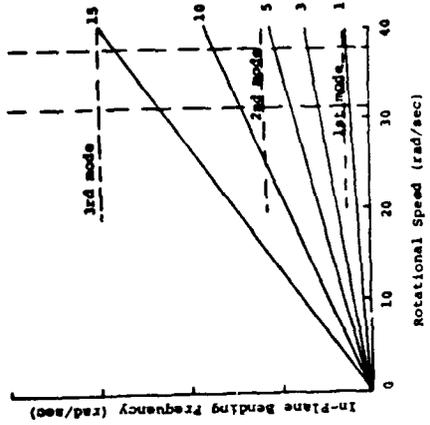
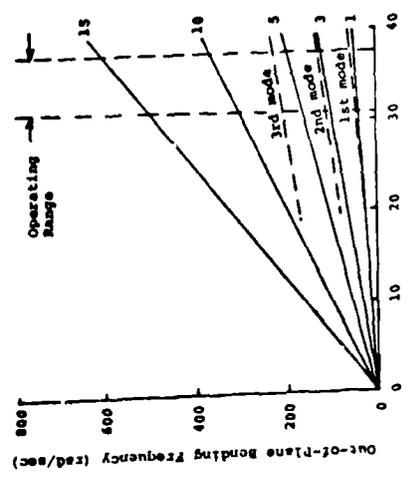
Figures 13 and 14 give Campbell diagrams for Concept 2 and the present blade. Again, Concept 2 displayed natural frequencies representative of the twelve candidate design concepts. The in-plane and out-of-plane cantilever and out-of-plane pin end modes for Concept 2 are very close to those of the present blade, and are predicted to produce negligible change in the vibration characteristics of the UH-1 system.

Out-of-Plane Pin-End

In-Plane Cantilever

Out-of-Plane Cantilever

Figure 13. Natural Frequencies, Current UH-1H Blade.

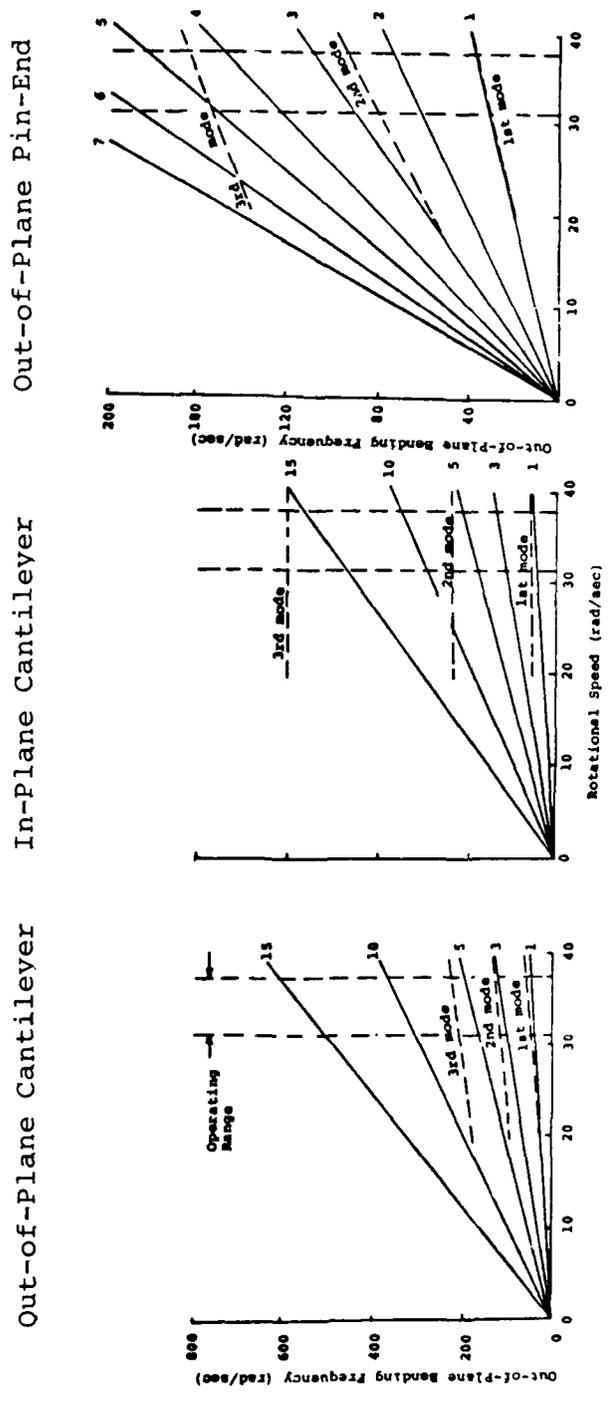
Figure 14. Natural Frequencies, Concept 2.

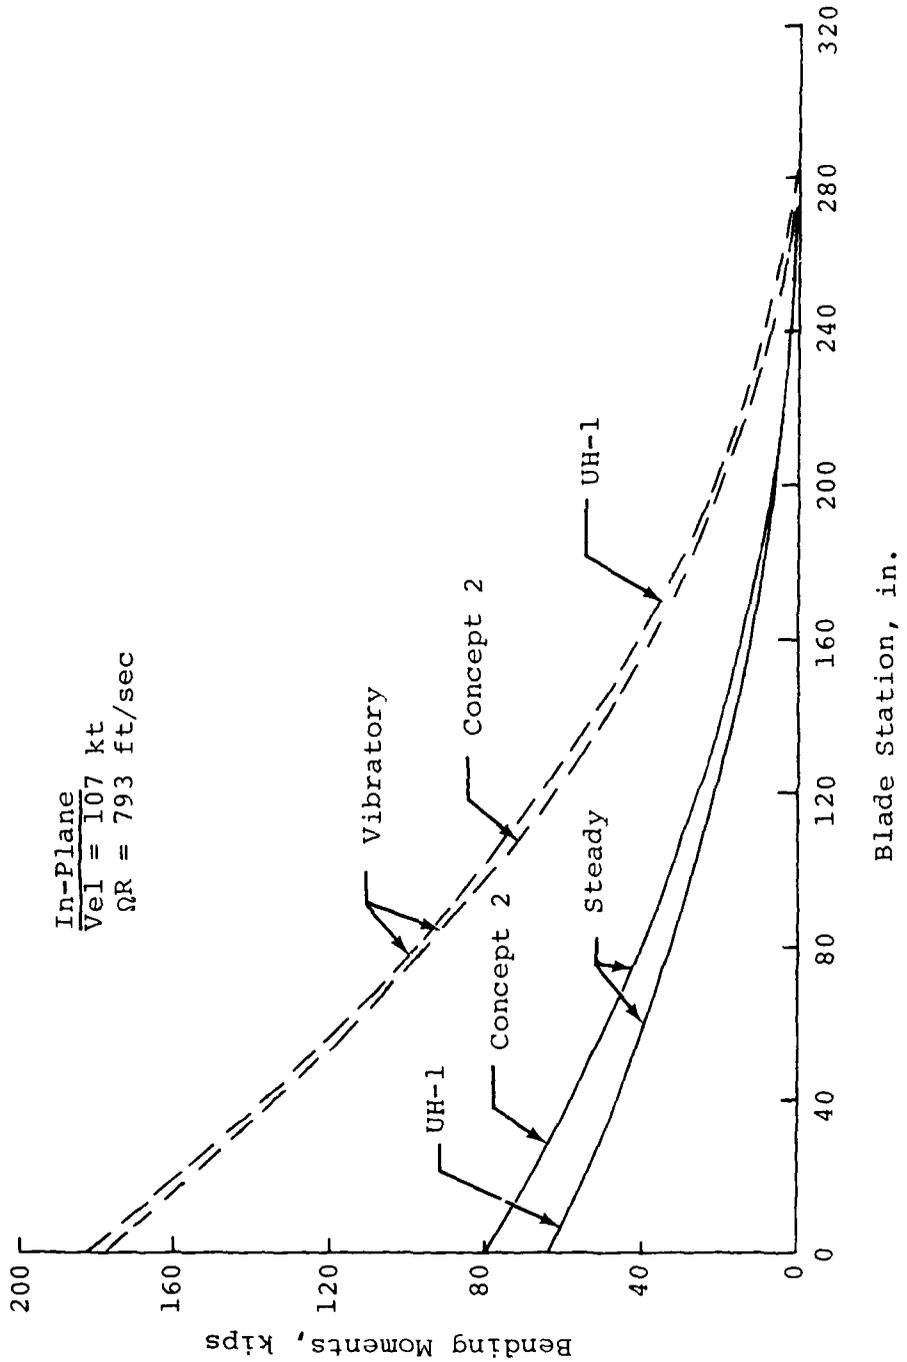
Figures 15 and 16 give plots of the in- and out-of-plane dynamic bending moments predicted for Concept 2, as well as the current design. Again, there is very little change between the moment levels predicted for the present design and those for Concept 2. The 107-knot condition was chosen as representative of the UH-1 flight spectrum.

Figure 15. Concept 2, Current Blade Edgewise Bending Moment Distribution Comparison at 107 Knots.

The blade has been analyzed at stations 60, 81 and 210, under fatigue and ultimate loads. These loads and conditions are defined by Figures 15, 16, 30 and 31. The material properties

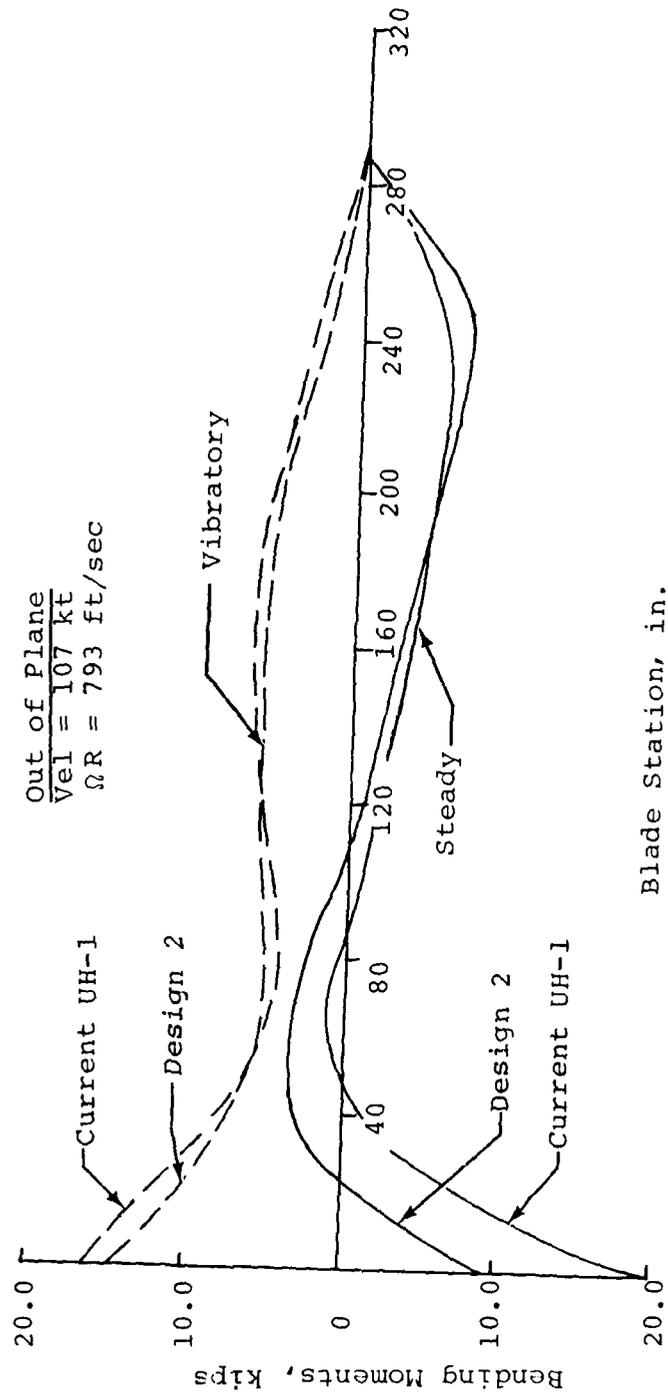
Figure 16. Concept 2, Current Blade Flatwise Bending Moment Distribution Comparison at 107 Knots.

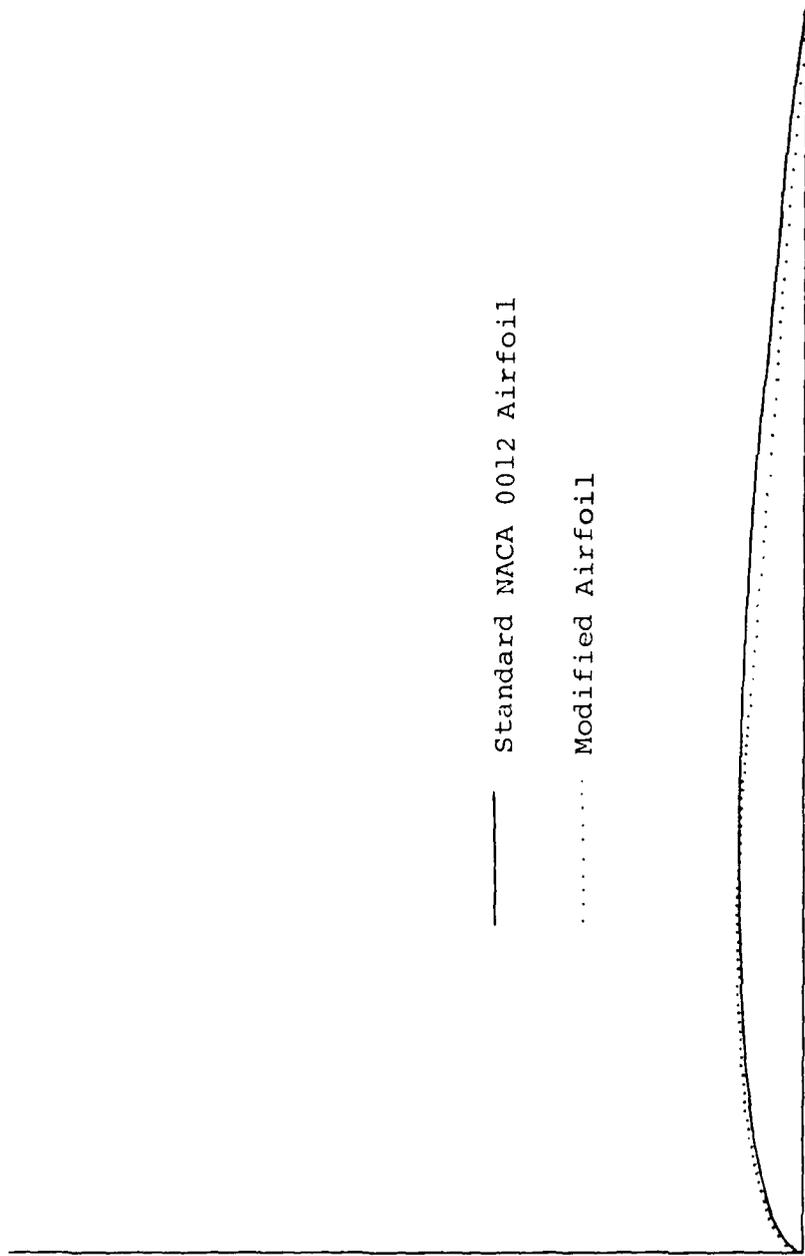
Figure 17. Standard and Modified Airfoil Comparison.

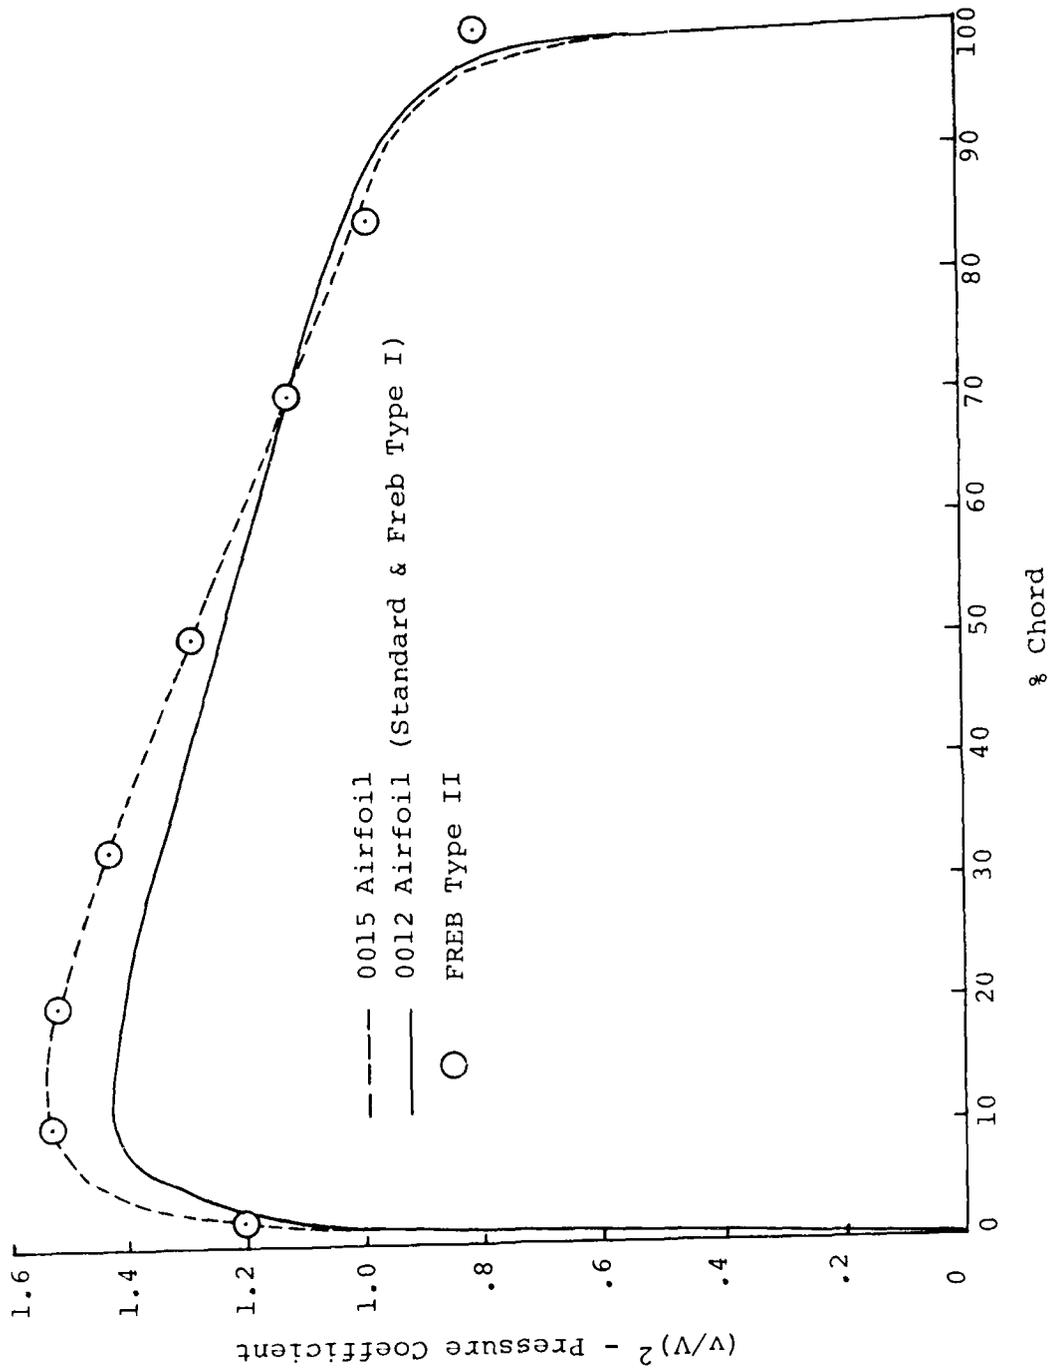
Figure 18. Airfoil Pressure Distribution for 0015, 0012 and FRED Type II Airfoils.
