USAAMRDL-TR-76-9

• **DEVELOPMENT PROGRAM FOR FIELD-REPAIRABLE/EXPENDABLE  
MAIN ROTOR BLADES**

Kaman Aerospace Corporation  
Old Windsor Road  
Bloomfield, Conn. 06002

Final Report

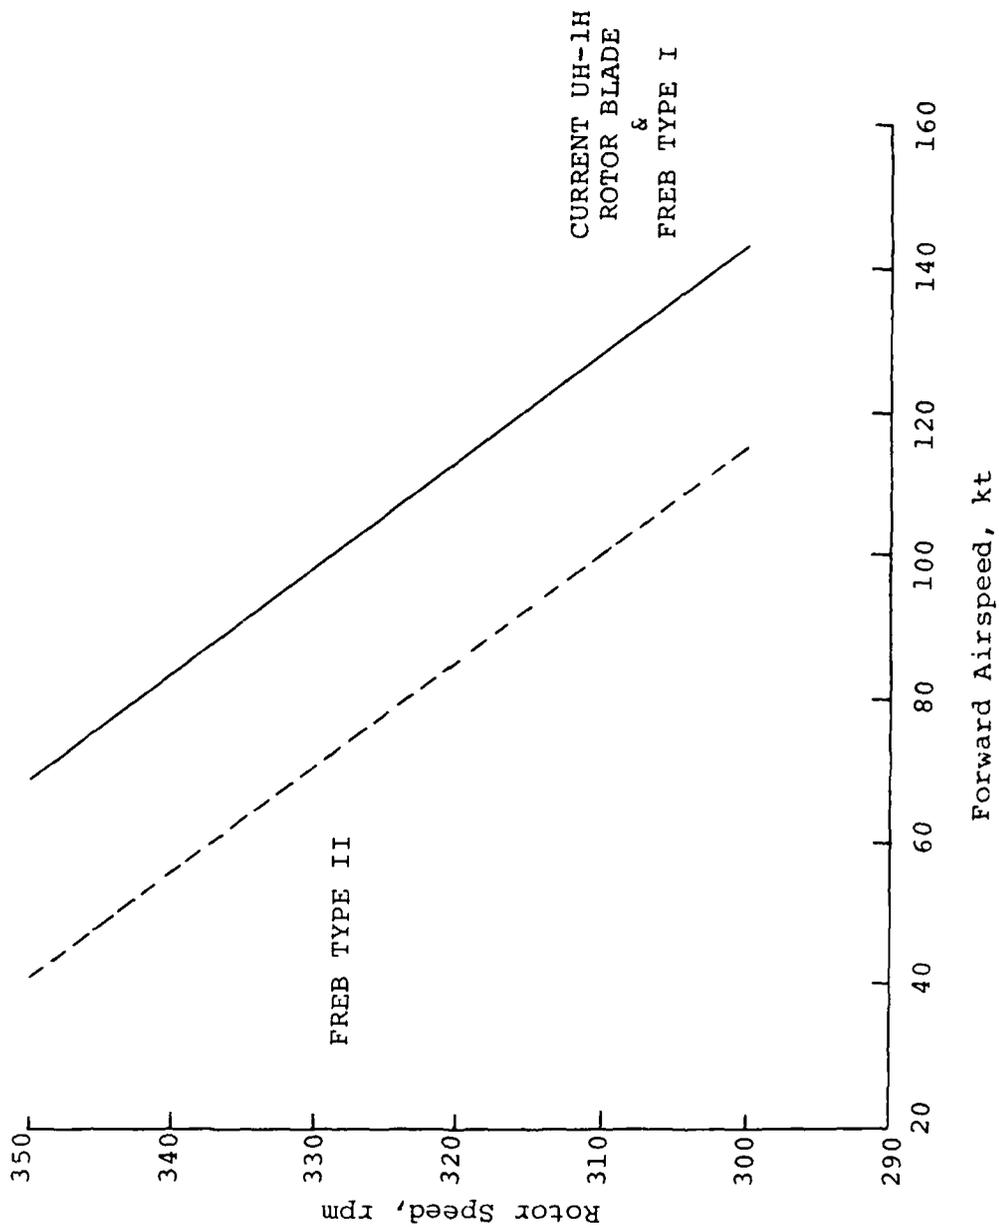
Figure 19. Rotor Speed vs. Forward Airspeed for Constant Aural Detection Range.

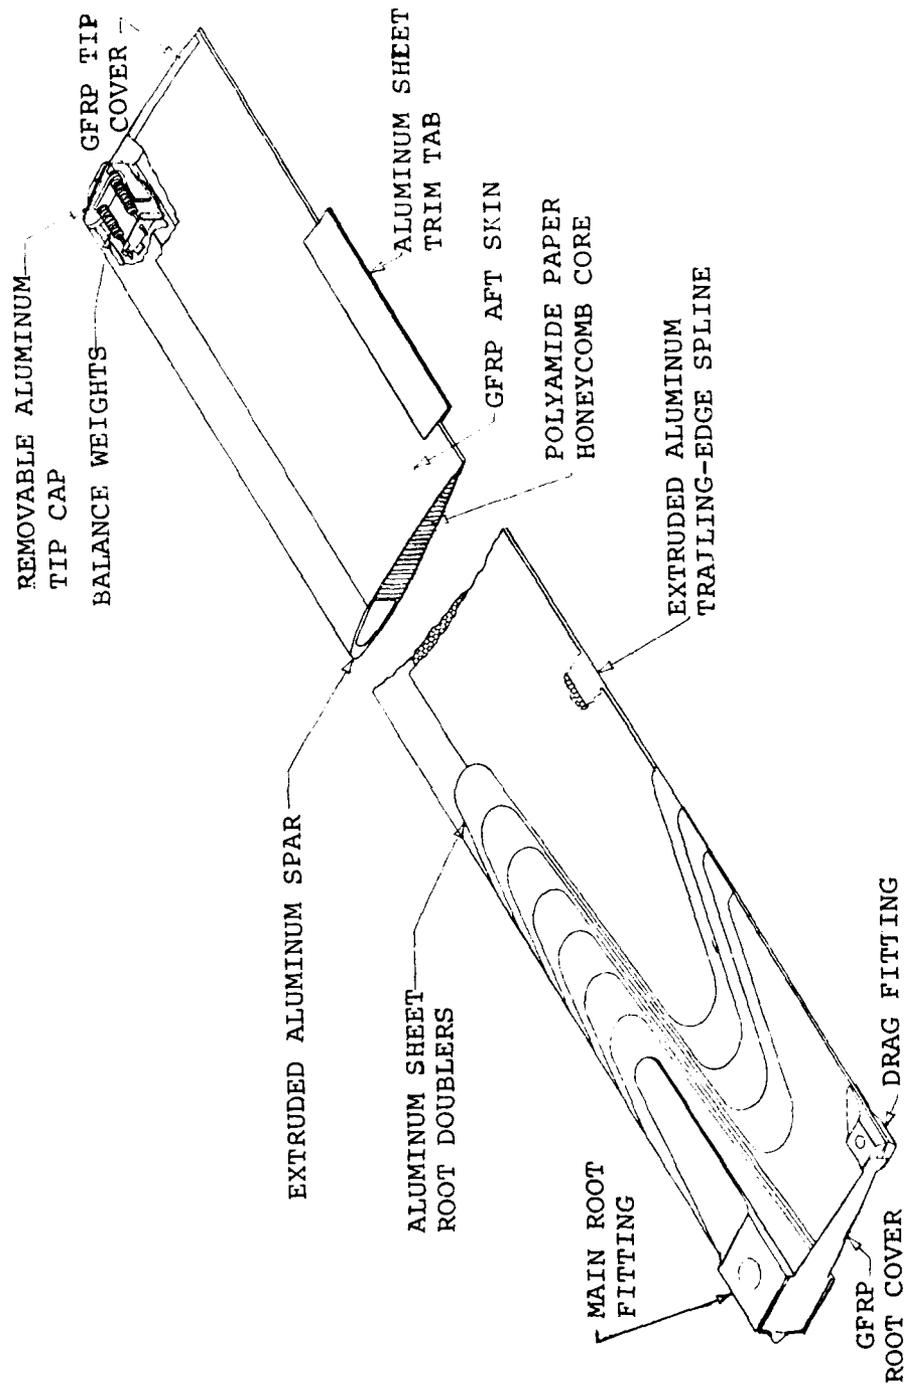
Schematics of the blade design are given in Figures 27, 28 and 29. The FREB has the same chord (21"), span (288" at tip) and airfoil (NACA 0012) as the existing blade. Its main features are the single-piece, extruded spar and spline and the composite afterbody. The spar is used in the as-extruded condition and is twisted prior to final blade assembly. The trailing edge spline is also extruded and is slab-cut prior to final blade assembly. The cut tapers the chordal dimension from 2.78" at station 81 to .78" at station 210, and then retains the .78" dimension out to the tip. The root reinforcement is very similar to that of the existing blade. For cost reduction the sheet aluminum doublers have the same shape and are staggered. The aluminum trim tab was lengthened and reduced in chordal dimension to provide increased bond area on the spline. In addition, the trim tab's reduced width makes it a stiffer "beam", less susceptible to handling damage. The tip weight retention is designed for ease of modification after blade repair. Removal of four screws on the tip cap allows ready access to the tip weight "washers" which are moved in accordance with a re-balancing chart.

Figure 27. FRED Blade Schematic.

The remaining three candidate concepts, numbers 2, 4 and 6, exhibit similar degrees of afterbody repairability. The stainless steel spar sections of Concepts 4 and 6 are thought to be less susceptible to dents and dings than the heavy-walled section of Concept 2. However, Concept 2 offers fewer components and their resulting bond lines than the multi-piece stainless steel spars of Concepts 4 and 6. Additionally, Concept 2 offers the lowest life-cycle costs of the remaining three candidates. Therefore, Concept 2, as shown in Figure 27, was chosen as the candidate most likely to be able to meet the program requirements.

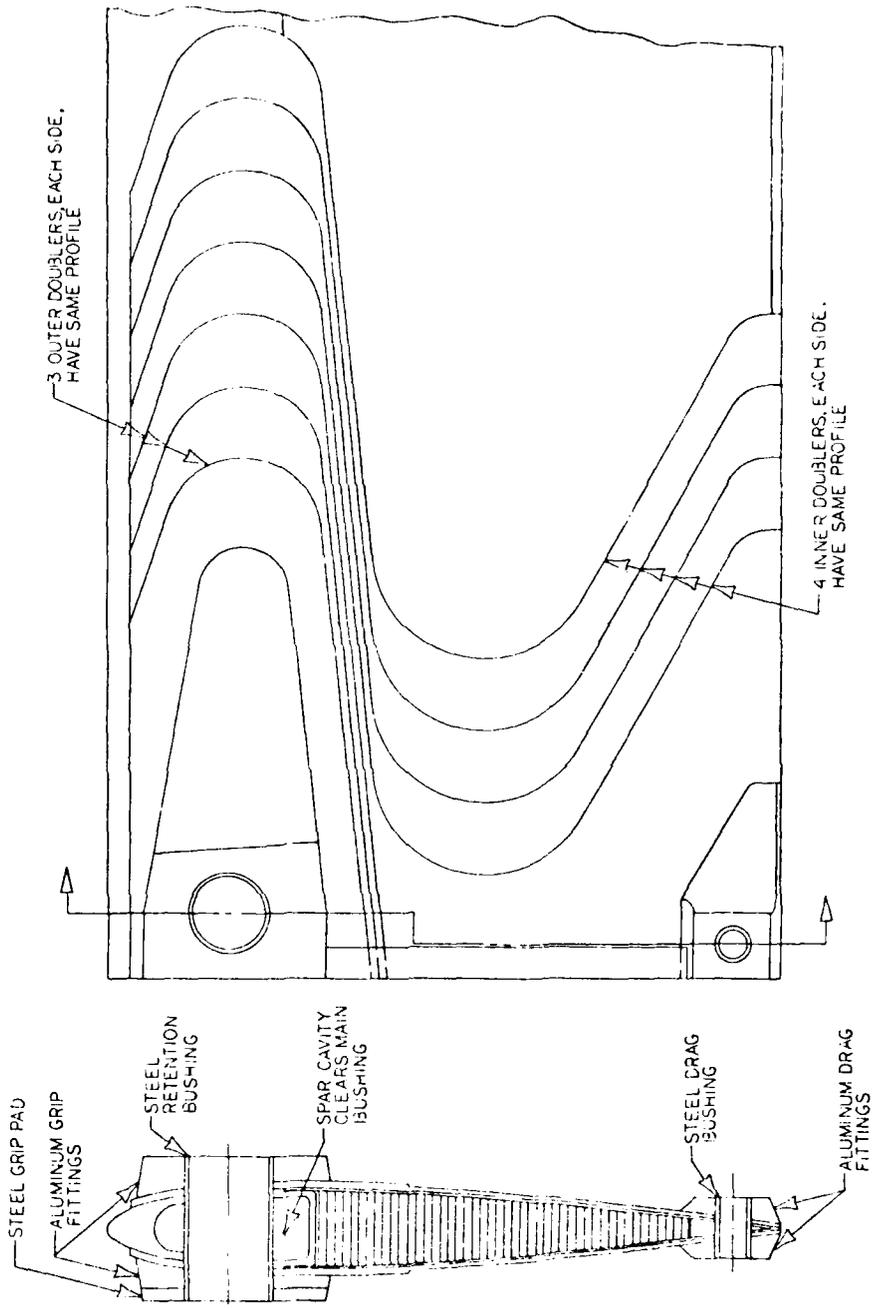
Figure 28. FREB Root End Schematic.

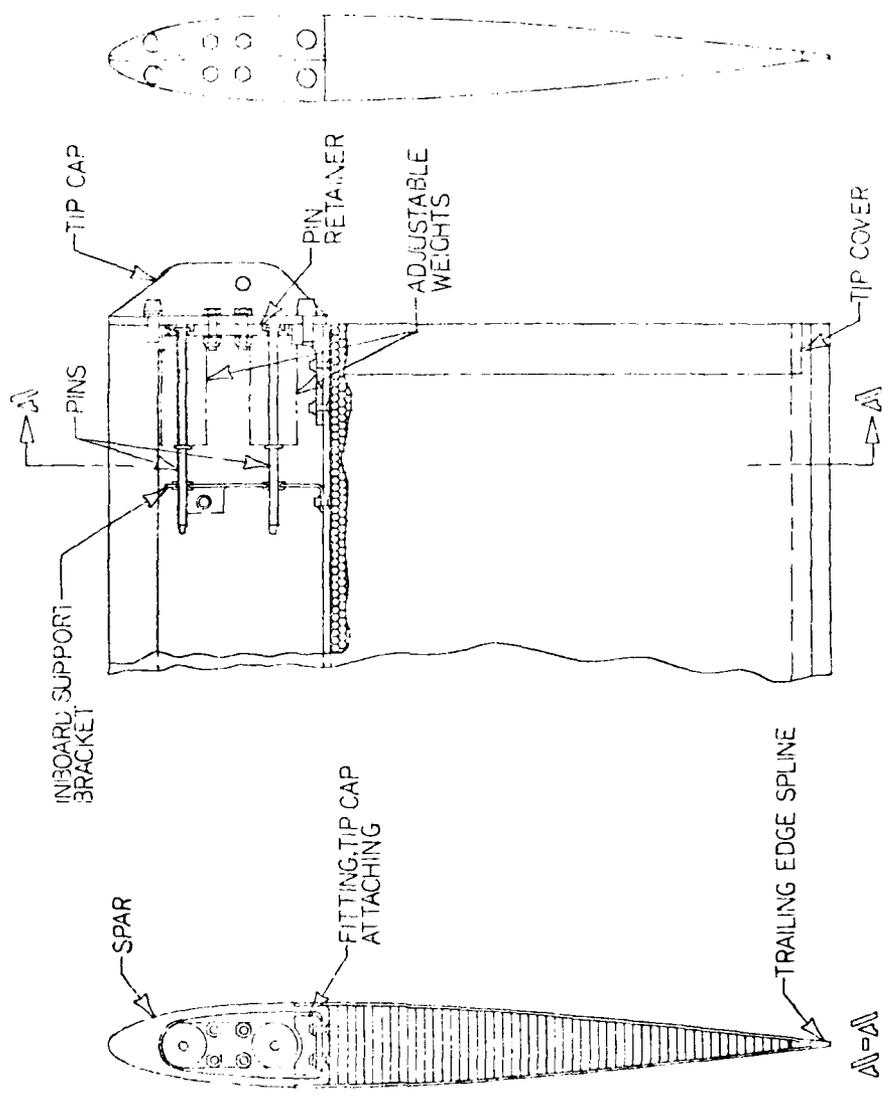
Figure 29. FREB Tip Weight Schematic.

The tip weight retention for the FREB is shown in Figure 29. The following weights contribute to the centrifugal force on the four retainer bolts:

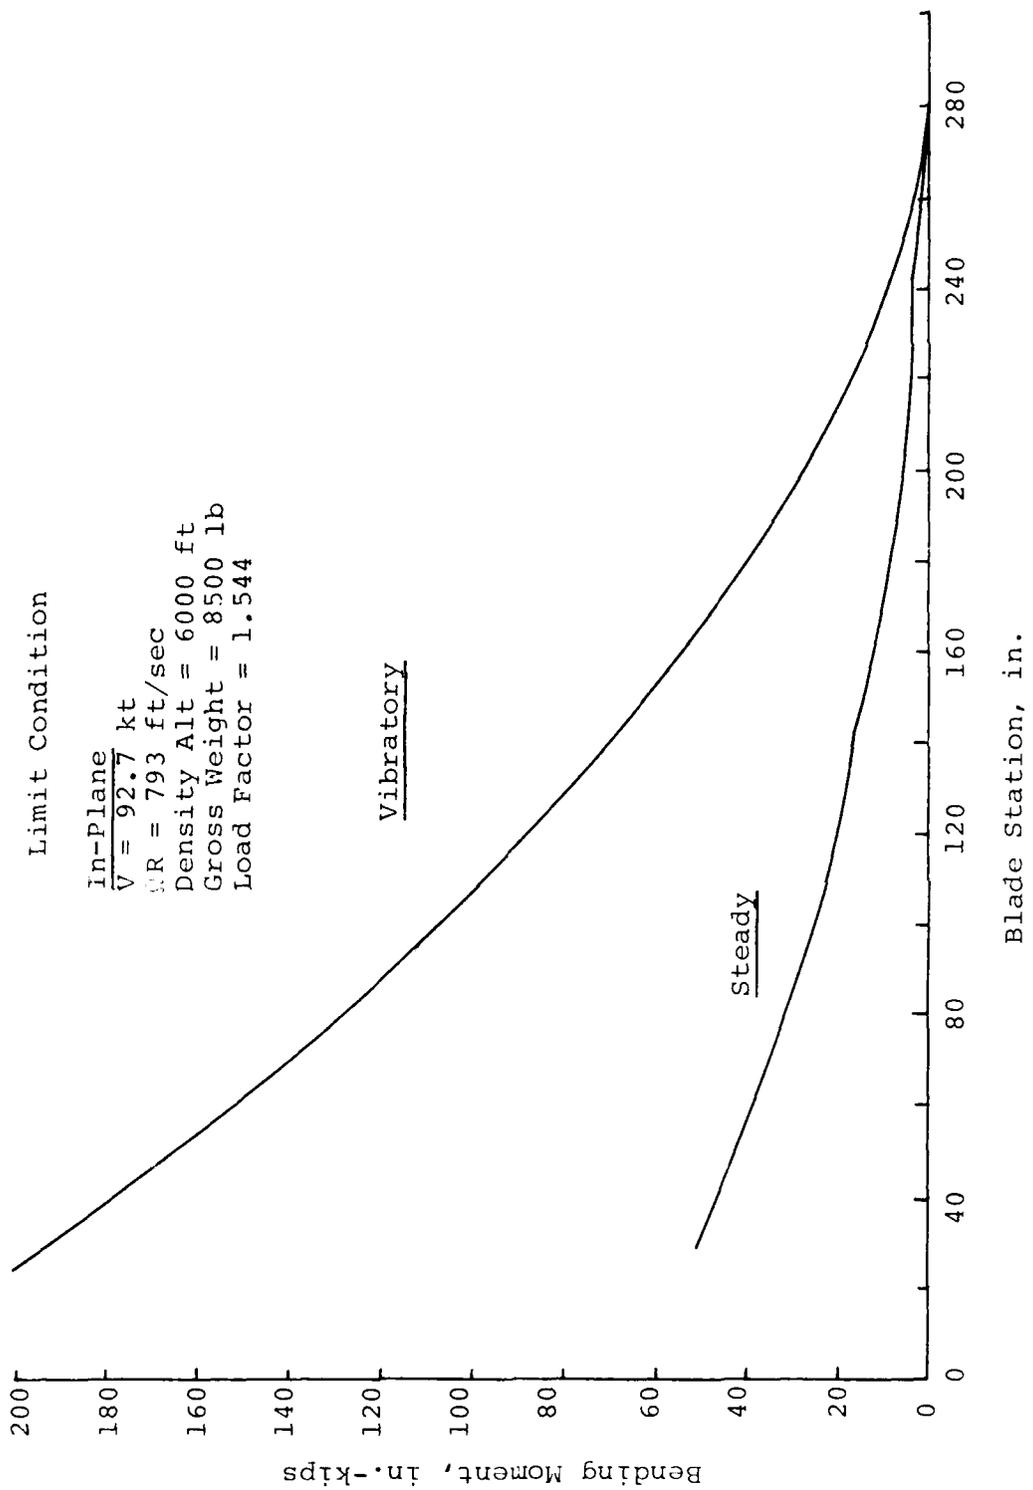
Figure 30. FREB In-Plane Bending Moment Distribution for Limit Condition.

The blade has been analyzed at stations 60, 81 and 210, under fatigue and ultimate loads. These loads and conditions are defined by Figures 15, 16, 30 and 31. The material properties

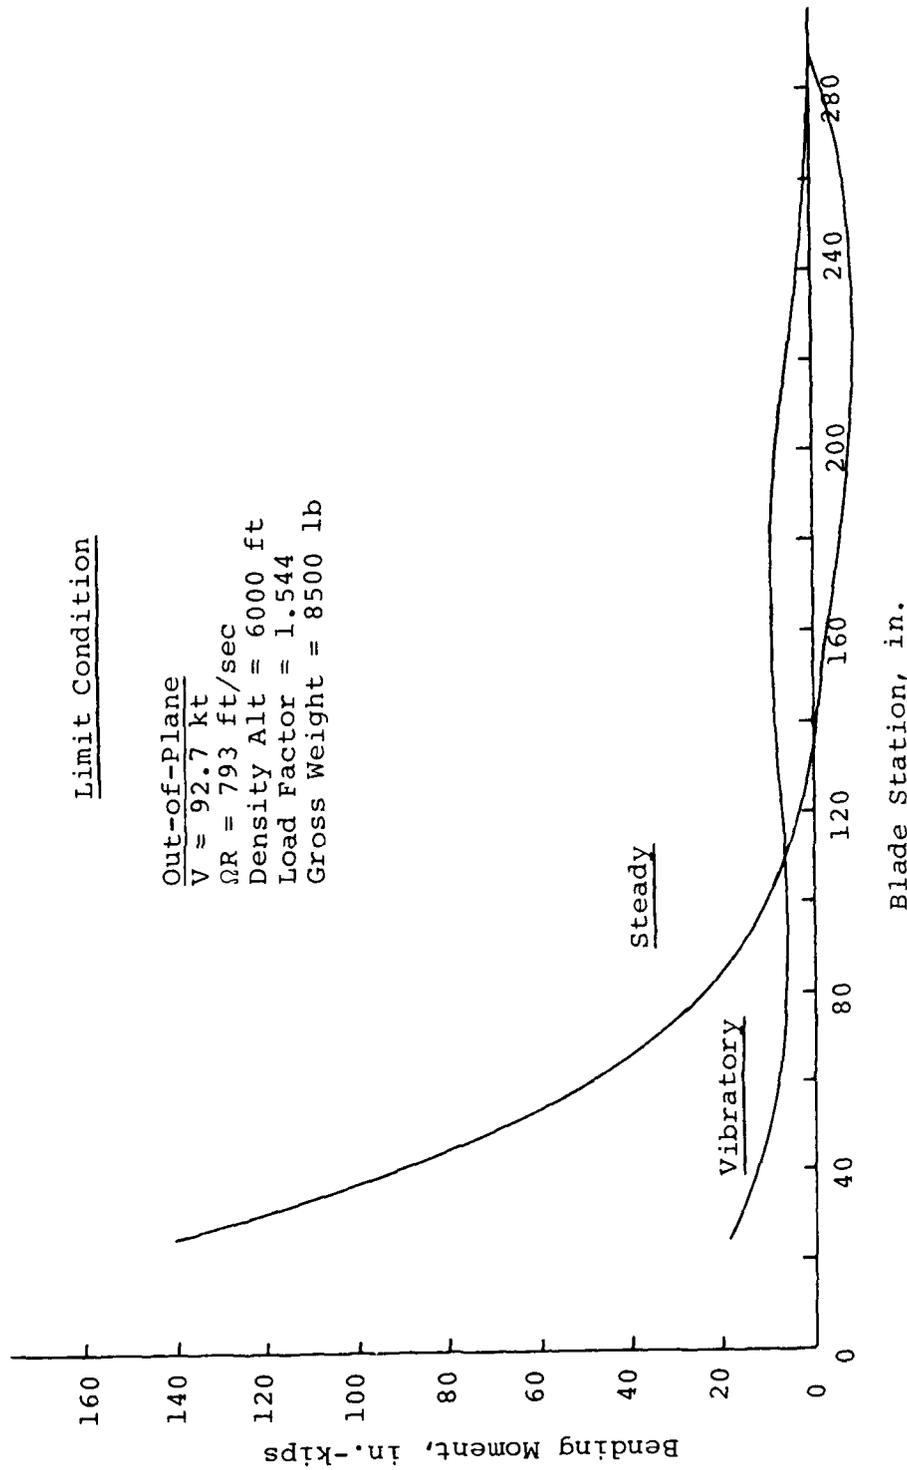
Figure 31. FREB Out-of-Plane Bending Moment Distribution for Limit Condition.

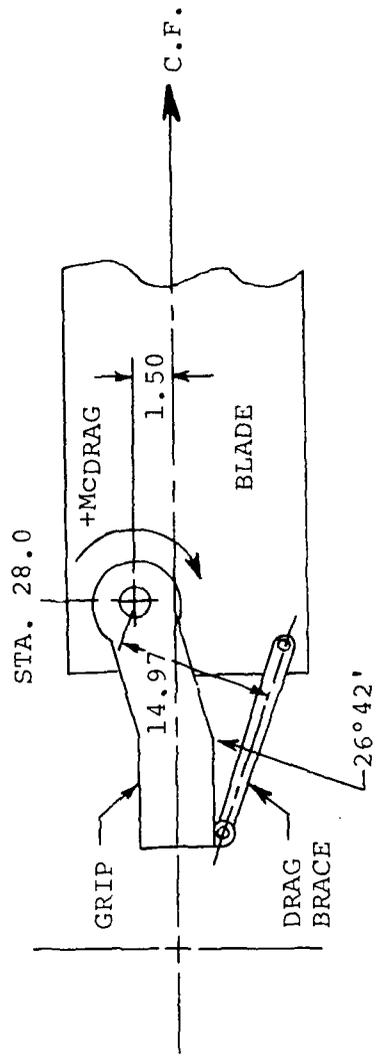
The following analysis conservatively assumes that the main pin reacts all the flatwise moment, while the main and drag pins together react the edgewise moment and centrifugal force. The following equations will be used, based upon the geometry shown in Figures 32 and 33:

Figure 32. FREB Blade Root Geometry.

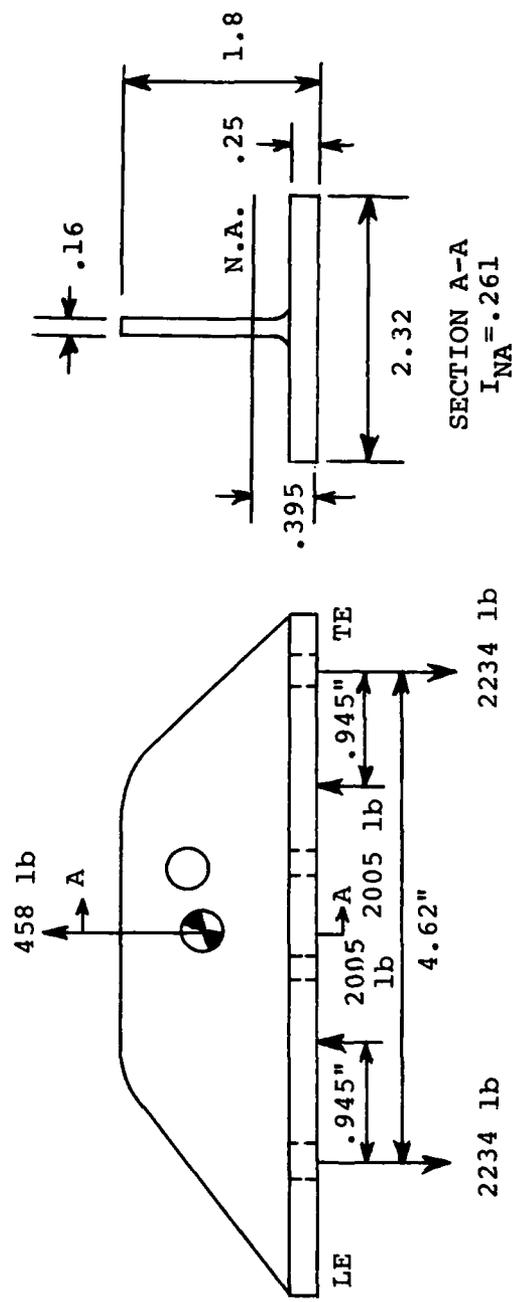
MAT'L: 7075 T73511  
 $F_{TU} = 68Ksi$

Figure 34. Tip Cap Free-Body Diagram.

The tip cap will be analyzed using the free-body diagram shown in Figure 34.

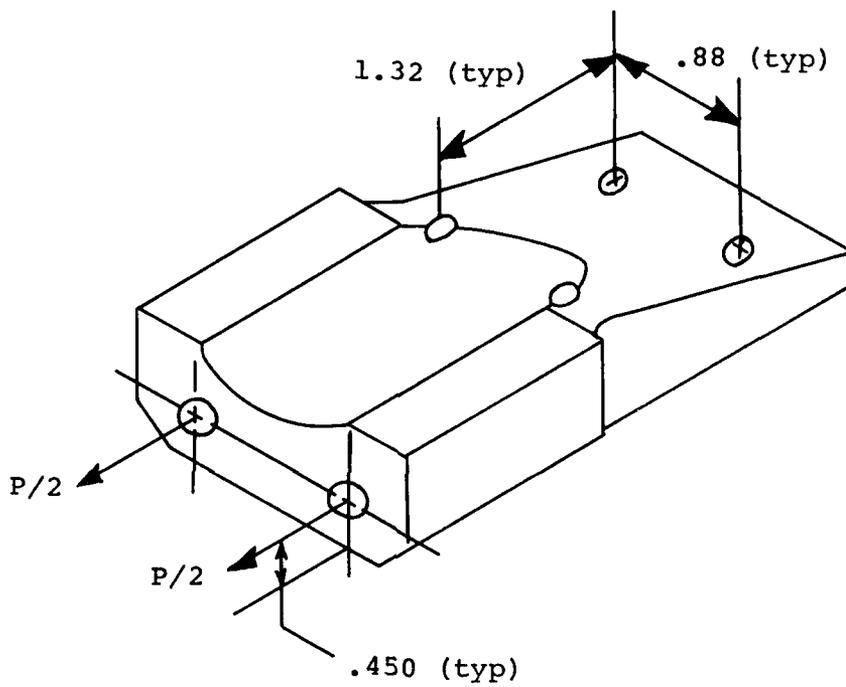
The aft end of the tip cap is held to the spar by the K30-118 fitting. The critical area on this fitting is the rivet attachment to the aft spar wall. The fitting is attached to the spar by four MS 21140-0606 rivets. The margin of safety on these rivets will be computed as shown in Figure 35 and as follows:

Figure 35. K30-118 Tip Weight Retention Fitting Free-Body Diagram.

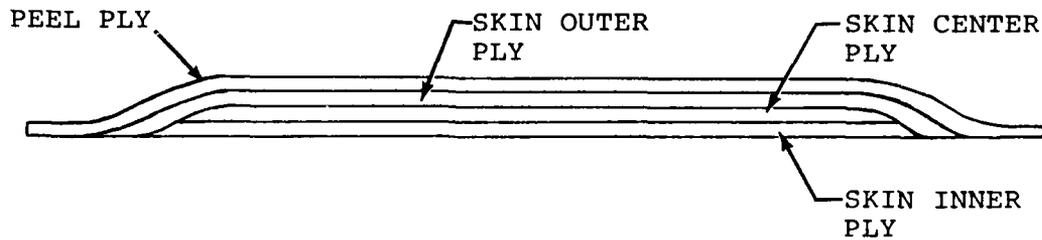
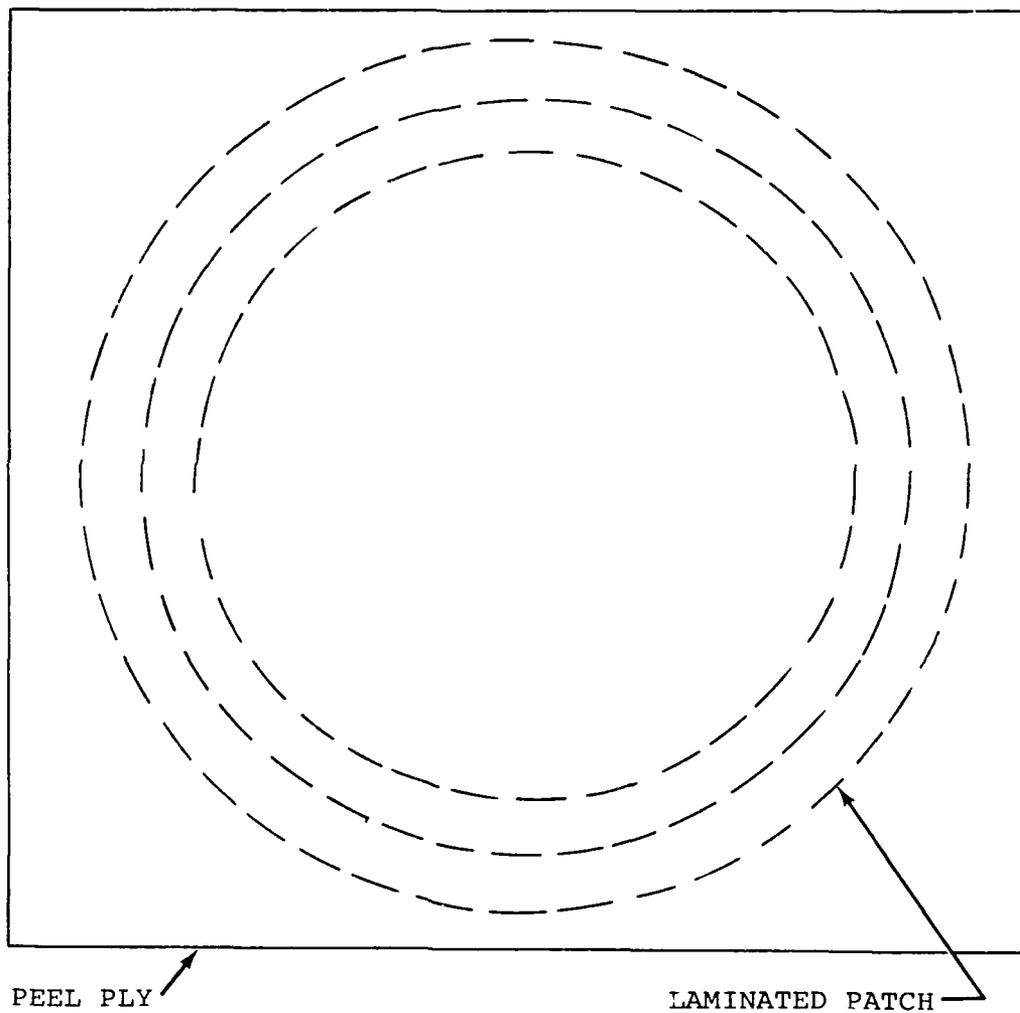
The skin patch, shown schematically in Figure 36, is a buildup of three doublers of impregnated glass fabric and scotchply material. After bonding, a molded patch is formed, sized to permit a 1-inch overlap around the damaged area after cleanup. Originally, the patch was supplied with two peel plies to protect the inner and outer surfaces from contamination. The peel plies were the same diameter as the patch, which made removal difficult and required the use of a parting cloth over the patch to prevent the adhesive squeeze-out from coming in contact with the bladder of the pressure/heat pack during curing. The final configuration eliminated the inner peel ply and made the outer ply larger in diameter than the patch, eliminating the

(PLY THICKNESSES DRAWN OVERSIZE FOR CLARITY)

Figure 36. Typical Skin Patch Construction.

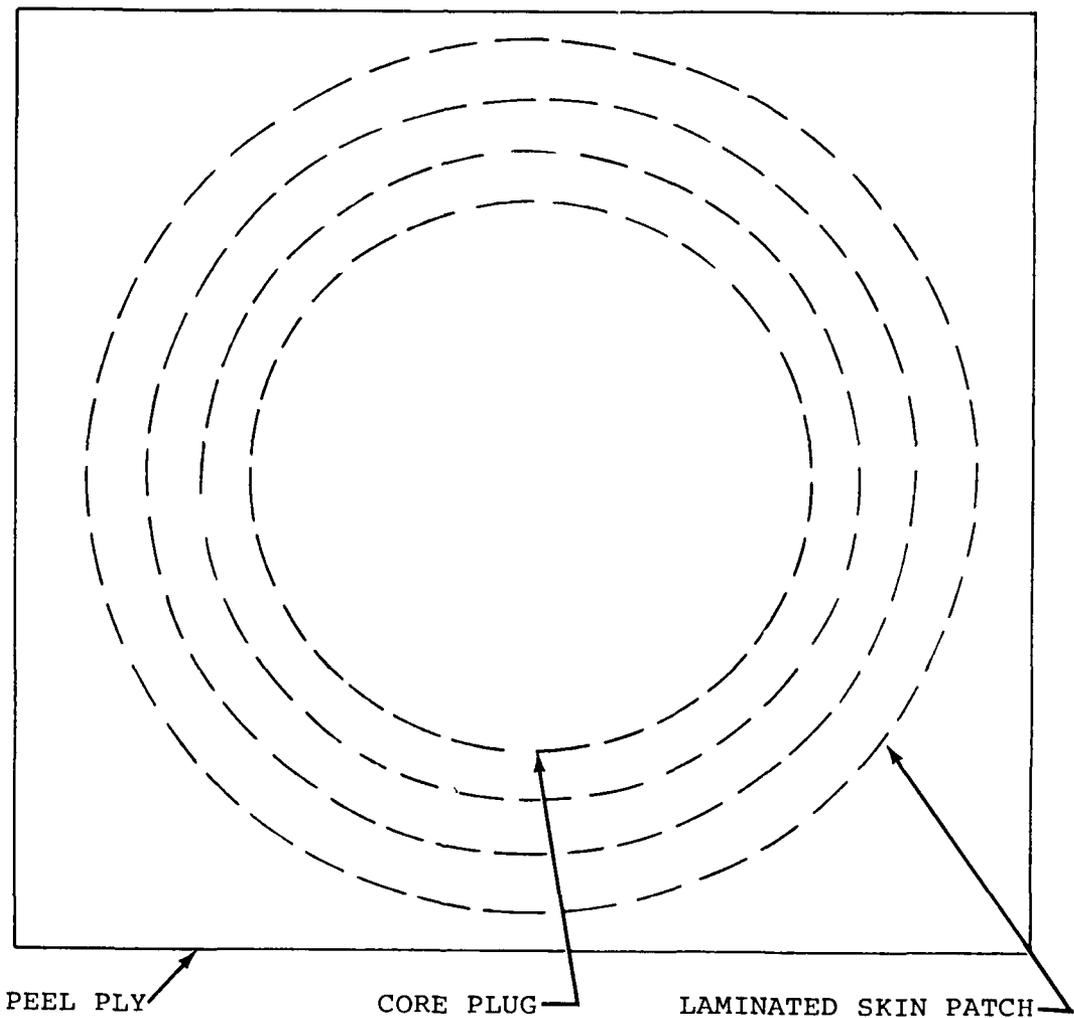
Figure 37. Typical Plug Patch Construction.

The plug patch, shown schematically in Figure 37, is a skin patch to which a cylindrical section of core material, smaller in diameter, is bonded. Installation of a plug patch, the specific procedure for which is explained in Appendix B, essentially involves removing the damaged core, cleaning and abrading the surface surrounding the cavity, and bonding the plug into place under heat and pressure using an epoxy adhesive. Like the skin patch, the first plug patch used two peel plies of the same diameter as the patch and were later modified to use only an outer ply, larger than the patch, to accommodate the adhesive squeeze-out and to facilitate removal. The plug patch is also packaged in a plastic bag.

(PLY THICKNESSES DRAWN OVERSIZE FOR CLARITY)

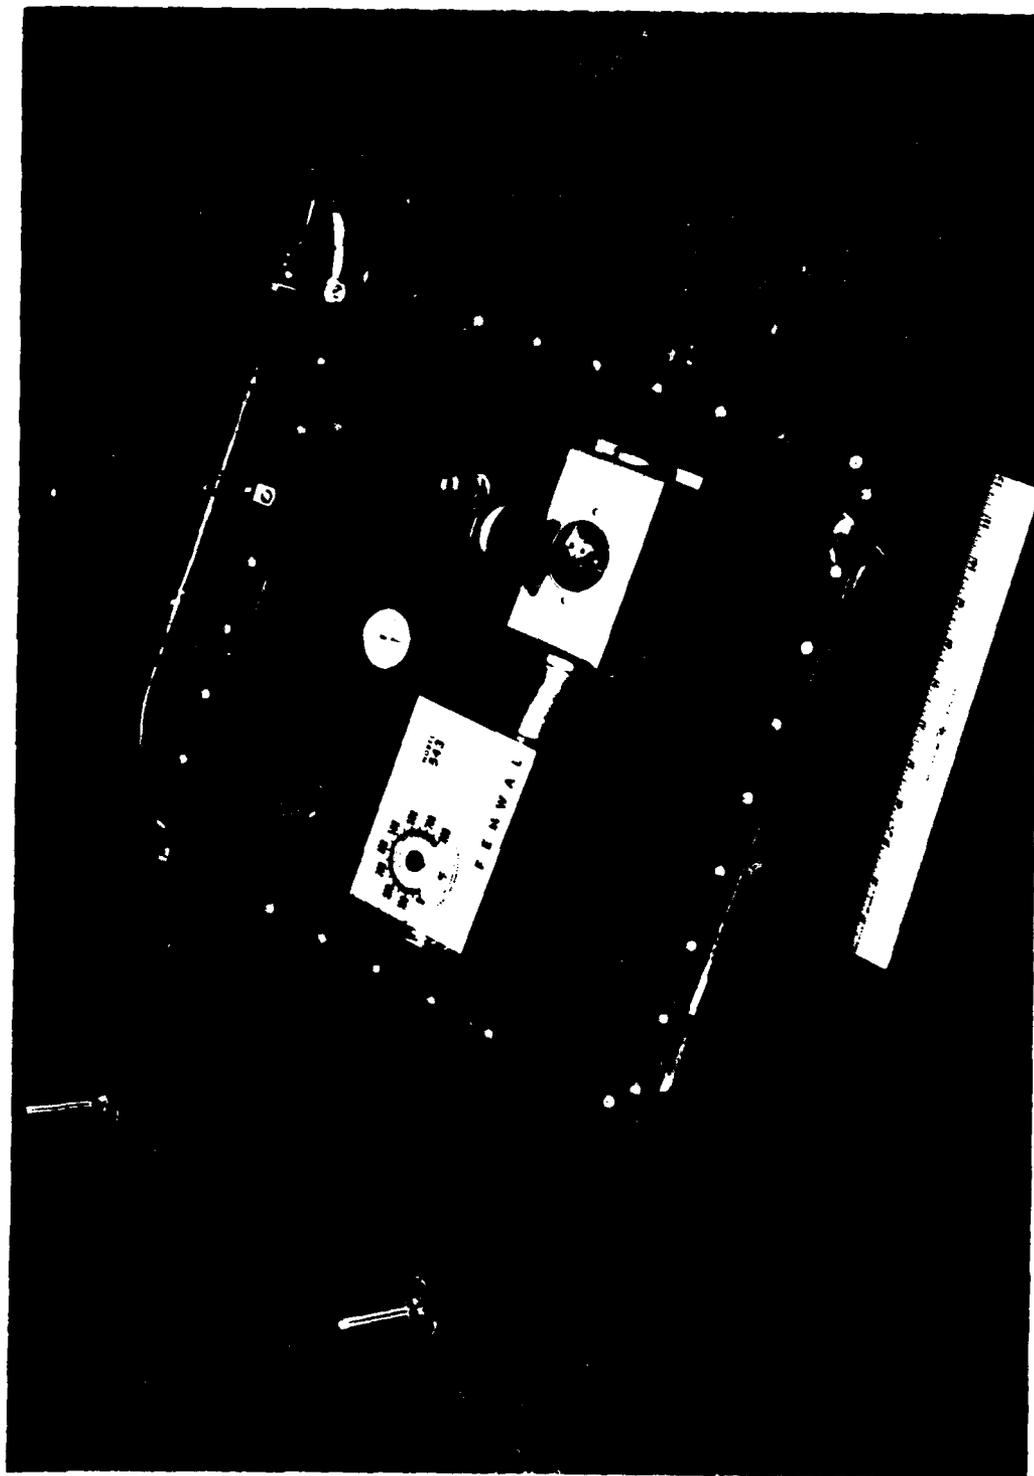
Figure 38. Pressure/Heat Pack.

the area where the trim tab attached to the blade, which sacrificed repairability along a significant section of the blade. (No effective way of bridging the trim tab was conceived.) To overcome this problem, it was necessary to add channels to the pressure/heat pack which would carry the straps over the trim tab. But, having added these channels, it became apparent that another set of channels on the opposite side of the blade would obviate the need for straps altogether. The unit was thus modified to eliminate the straps by providing metal channels, hinged at the trailing edge, and secured to the blade with swing-up draw bars at the leading edge. The final configuration is shown in Figure 38. Views of the installed heat and pressure pack are shown in Figures 39 through 42.

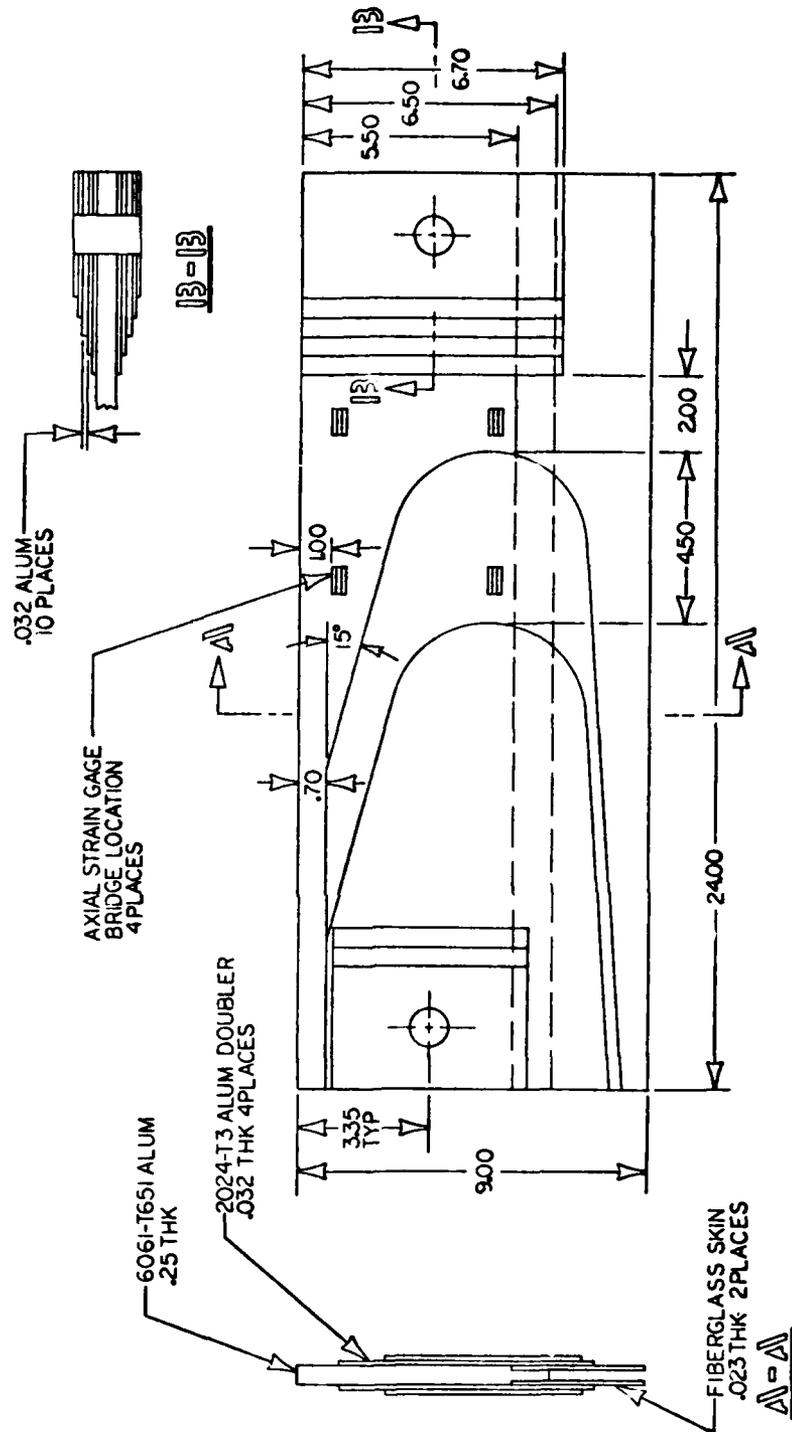
Figure 43. Root Doubler Bond Fatigue Test Specimen Schematic.

The specimens described in Figure 43 were representative of the FREB root doubler bond. The specimens were made by acid etching the aluminum, and then priming it (250°F for 40 min., t = .0001 - .0003) with Plastilock 718-2 primer. The representative skins were precured with a peel-ply on the exterior surfaces. The peel-ply was removed, and the "skins" were bonded to the primed aluminum with Plastilock 717 adhesive film. The specimens were cycled from 500 pounds to 23,500 pounds axial load. This load produced a stress of 14.08 Ksi at the doubler tip, equivalent to the limit stress in the blade at the doubler tip during normal operation. Each specimen was intended to be run to 3000 cycles, but several specimens were run considerably longer in an attempt to produce failures. Three-thousand cycles at this load level is in excess of all the ground-air-ground cycles that a blade is likely to experience on the UH-1 helicopter.

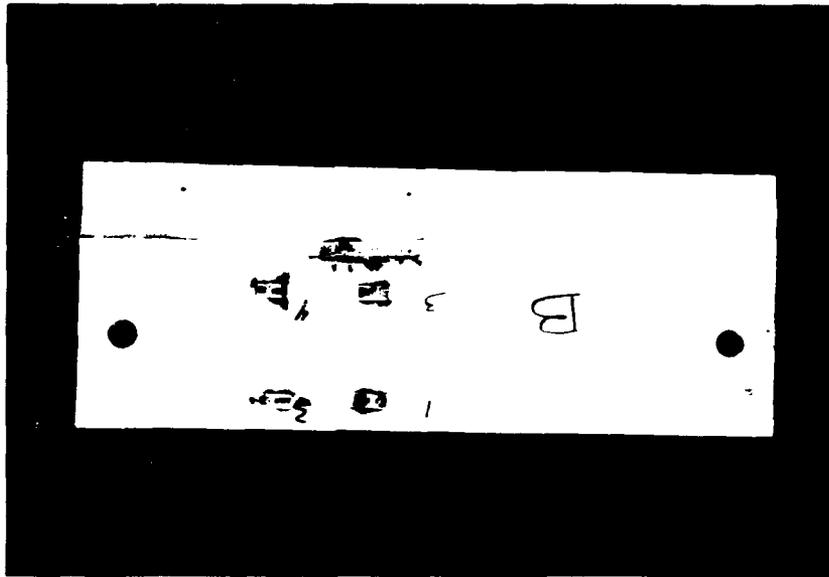
Figure 44. Root Doubler Bond Fatigue Specimen and Specimen Installed in Environmental Chamber.

The results of this testing, summarized in Table 20, show that the root doubler bond on the FREB should remain unaffected by the extremes of heat and humidity encountered in the Army's operating environment. Figure 44 shows a close-up of the specimen and a view of the specimen mounted in the environmental test chamber.

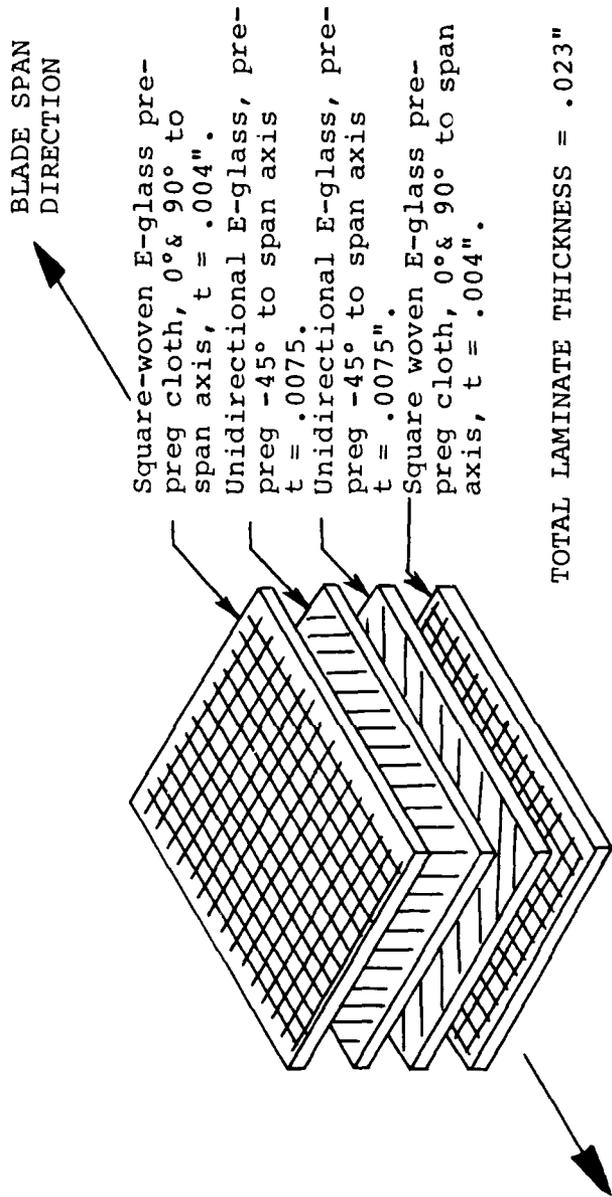
Figure 45. FREB Skin Laminate Schematic.

The composite layup used for the FREB skins is shown schematically in Figure 45. A representative skin laminate, the same as that shown in Figure 45, but with .005-inch thick cloth, (total laminate thickness of .025-inch) was tested for tensile strength and modulus variations with changes in environment. Tensile specimens were cut out of a large sheet of laminate. Specimens were 1 inch wide and 8 inches long by .025-inch thick. Reinforcing plates were bonded to the ends of the specimens for ease of load introduction, and the specimens were cut so that the uni-directional plies were at + 45° to the load axis. The specimens were tested in a Tinius-Olsen testing machine at a strain rate of .05 inch/minute. Environmental exposure consisted of both soaking the specimens at constant heat and humidity, and putting the specimens through a "weather cycle exposure" consisting of 48 hours of 95% RH and 120°, 8 hours direct sunlight, 8 hours of - 65°, 8 hours of 130°, and then tested after 6 cycles.

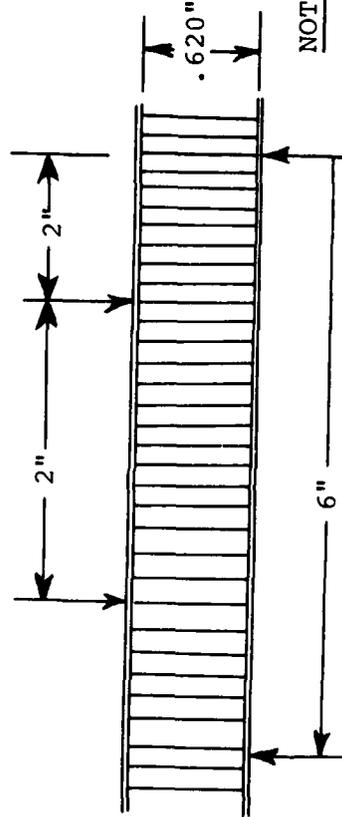
Loading Configuration

Short-beam flexural strength and core shear strength testing was performed to evaluate the shear strength variation in the core shear strength and the core/skin bond strength under variations in temperature and humidity. Specimens were fabricated by bonding the representative skins to either side of a "web" of Nomex core (1/8-inch cells, 1.8 pcf) using Plastiloc 717 adhesive. Specimens were loaded as shown in the diagram accompanying Table 22. In all of the test cases the core failed, and the failing shear loads were unaffected by variations in heat and humidity.

NOTE: All failures were in the core

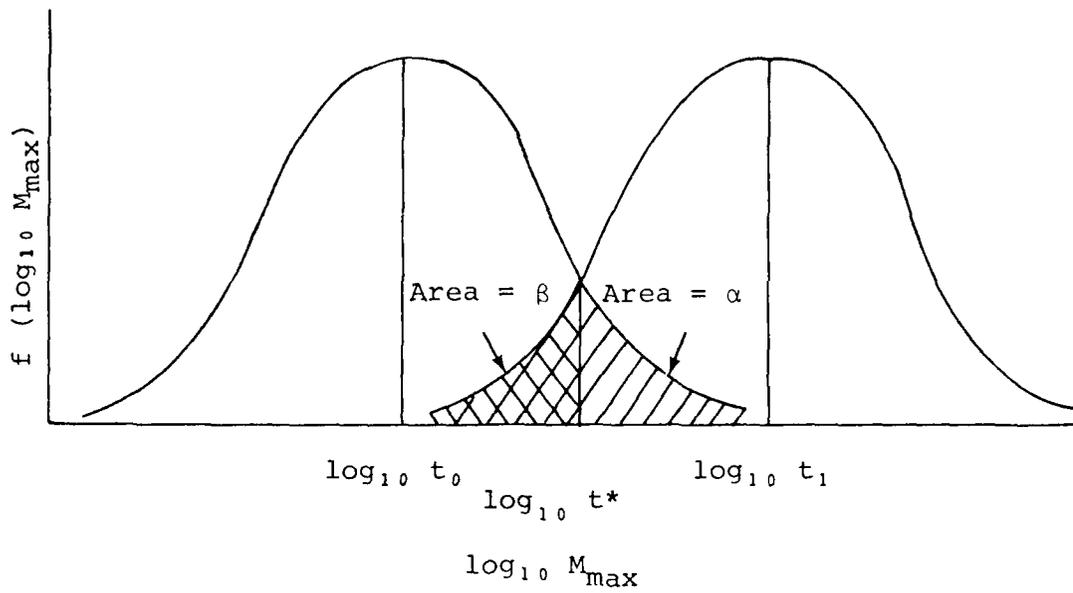
Figure 58. Producer's Risk,  $\alpha$ , and Consumer's Risk,  $\beta$ , Illustrated.

The test requires assignment of a producer's risk,  $\alpha$ , and a consumer's risk,  $\beta$  (Figure 58).

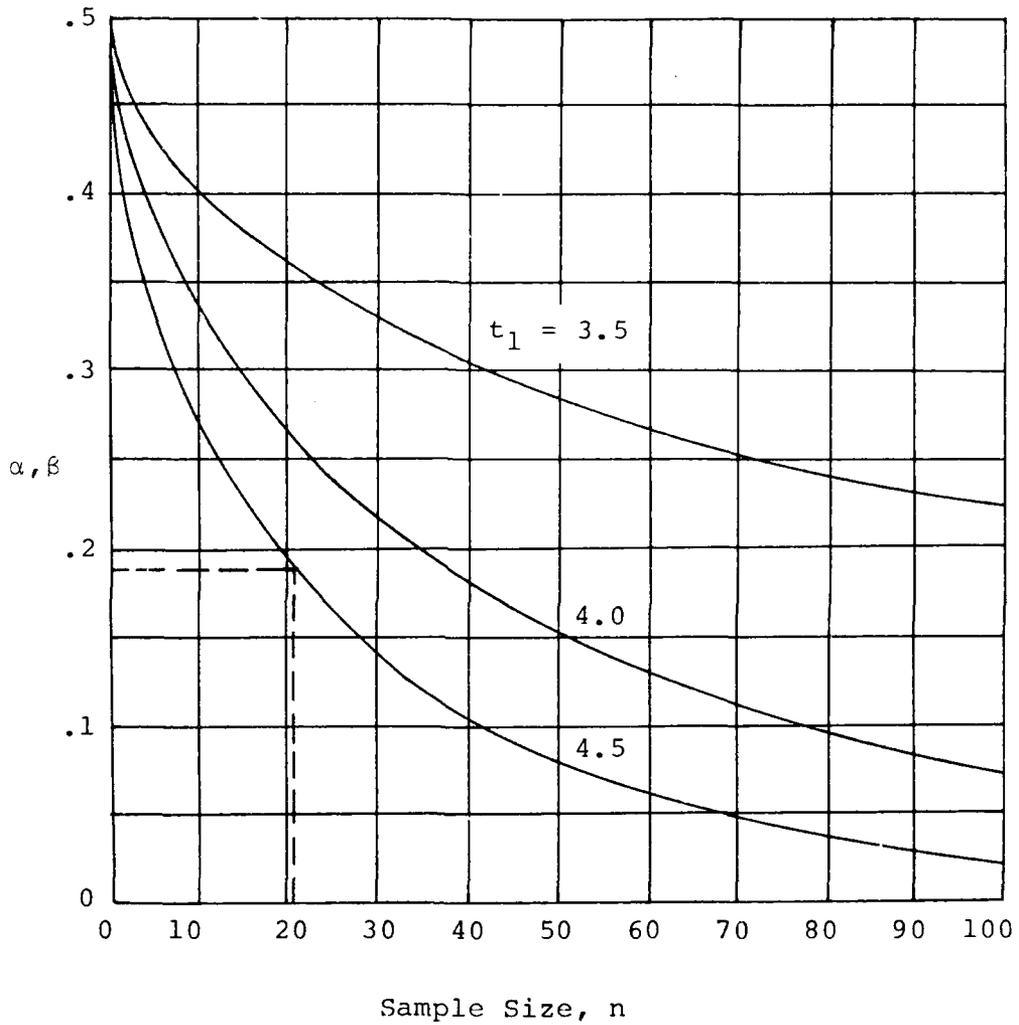
Figure 59. Producer's and Consumer's Risk Versus Sample Size.

Figure 59 shows the relationship of the  $\alpha$  and  $\beta$  risks to task sample size (assuming equal risks) for several values of  $t_1$  and an estimated value of  $\sigma_x^2 = .0805$ .

The contract work statement called for a sample of approximately twenty tasks and two additional tasks for whirl testing. From the curves of Figure 59, a sample of this size was found to be adequate for an  $H_1$  hypothesis:  $t_1 = 4.5$ , and assigned risks:  $\alpha = \beta = .18$ . Better discrimination and/or lower risk values would require a larger task sample.

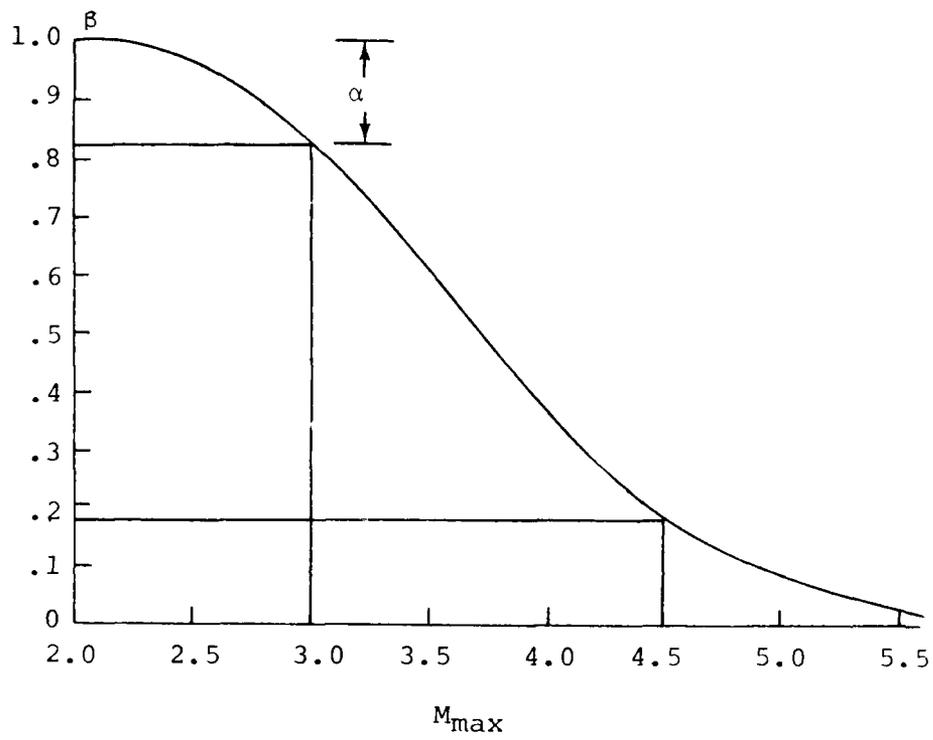
Figure 60. Operating Characteristic Curve.

The operating characteristic curve for this test, shown in Figure 60, is derived from

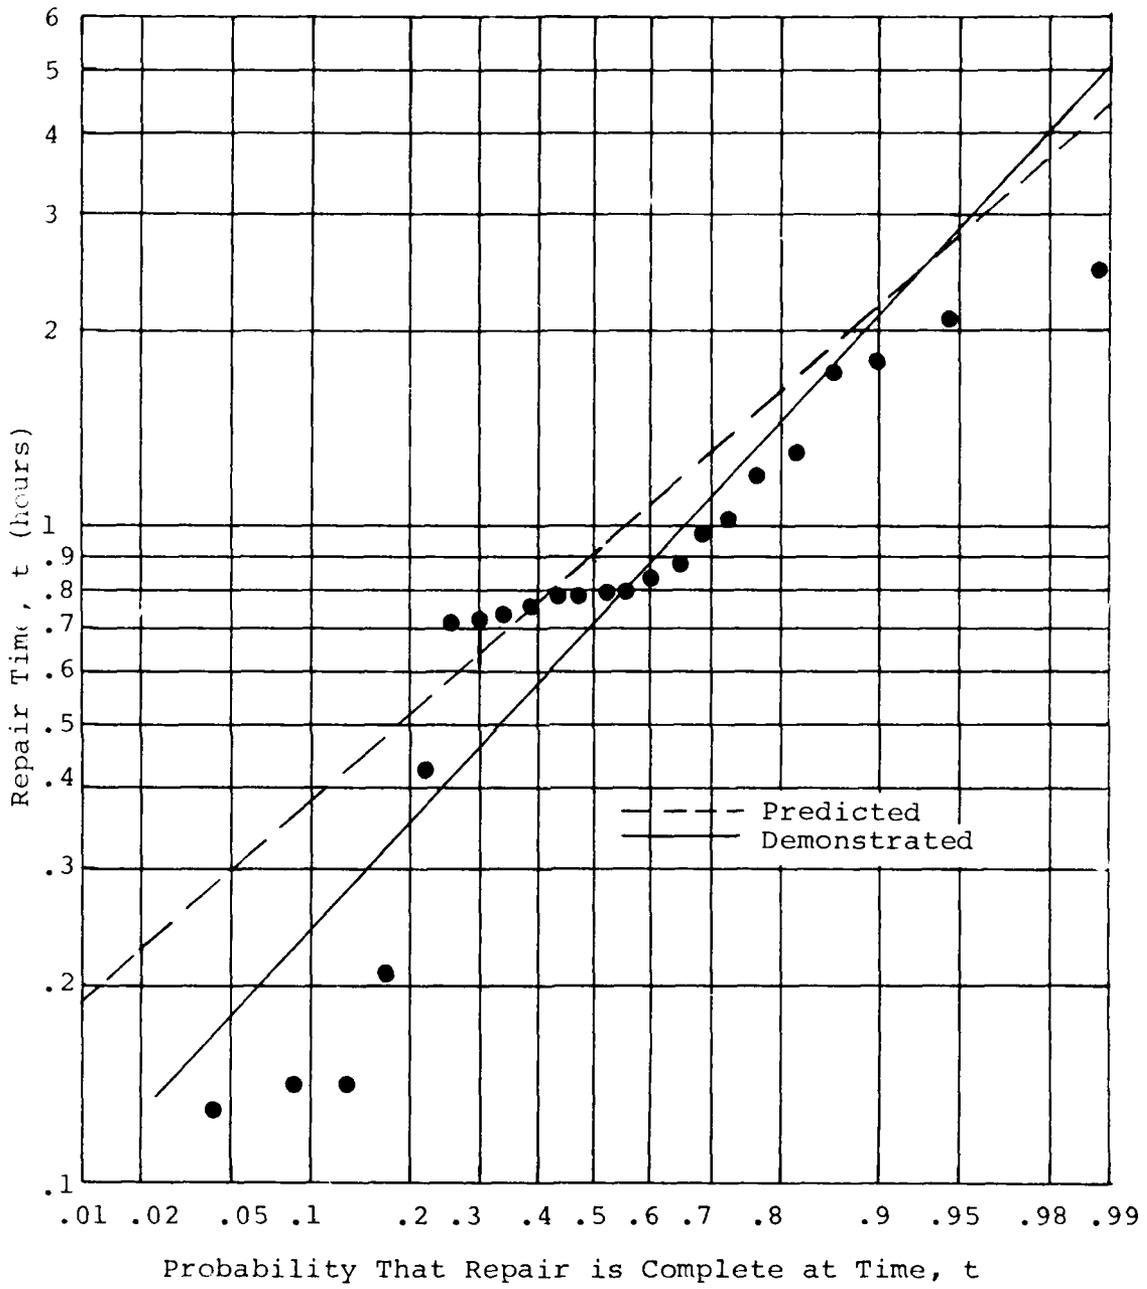
Figure 61. Maintainability Demonstration Task Times and Cumulative Repair Time Functions.

The statistical variance of the sample is larger than that predicted, also influenced, however, by inclusion of the extra two double plug repairs. The 95th percentile maximum repair time calculated from the sample data is larger than the predicted value, but below the 3-hour requirement specified by the Army. Figure 61 is a plot of the demonstration sample data points and the repair time functions predicted and demonstrated.
