USAAMRDL-TR-76-9

• **DEVELOPMENT PROGRAM FOR FIELD-REPAIRABLE/EXPENDABLE  
MAIN ROTOR BLADES**

Kaman Aerospace Corporation  
Old Windsor Road  
Bloomfield, Conn. 06002

Final Report

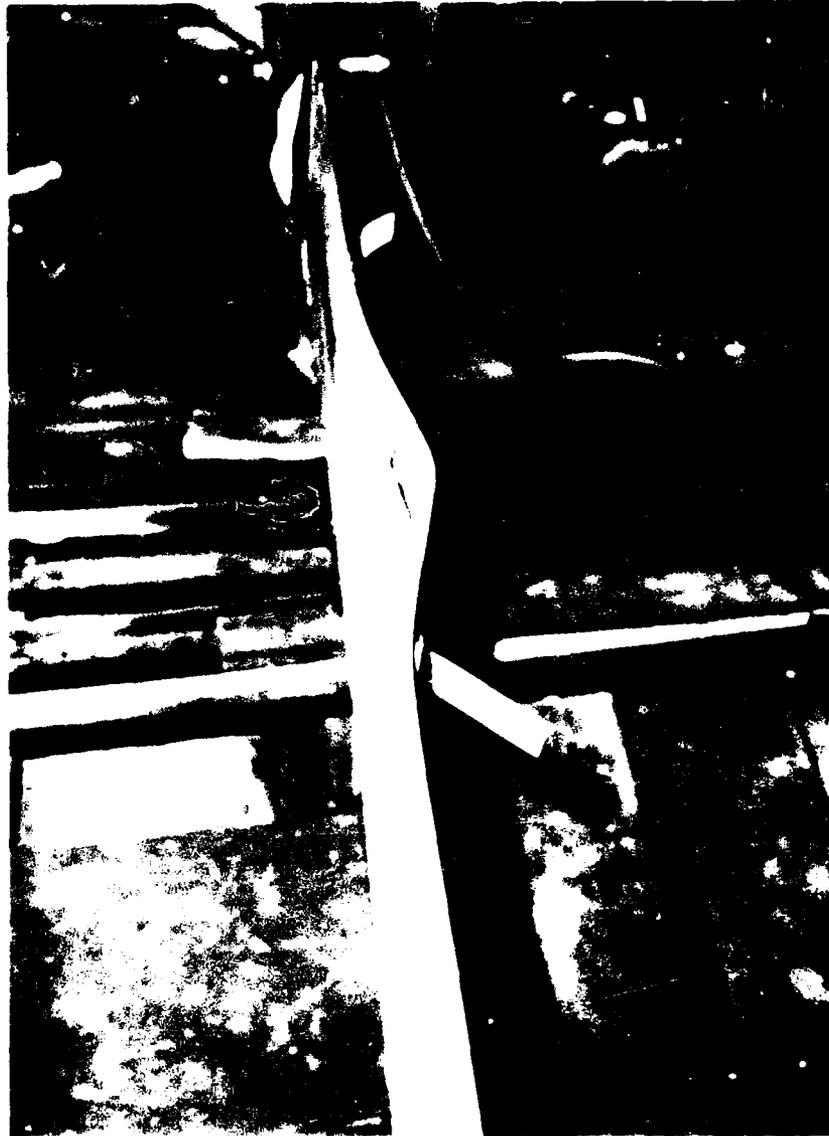
Figure 64. Top View of Edgewise Static Load Specimen After Failure.

Subsequent to the deflection tests, the blade was loaded to ultimate load in the flatwise direction (4-G ground handling loads) without failure. The blade was then loaded to failure in edgewise bending. Failure occurred at 280% of limit load (290% of hard start loads) when the trailing-edge spline buckled, as shown in Figure 64. After failure, it was obvious that neither the spline nor the skins could carry edgewise load. The spar, however, was able to still carry 140% design limit load.

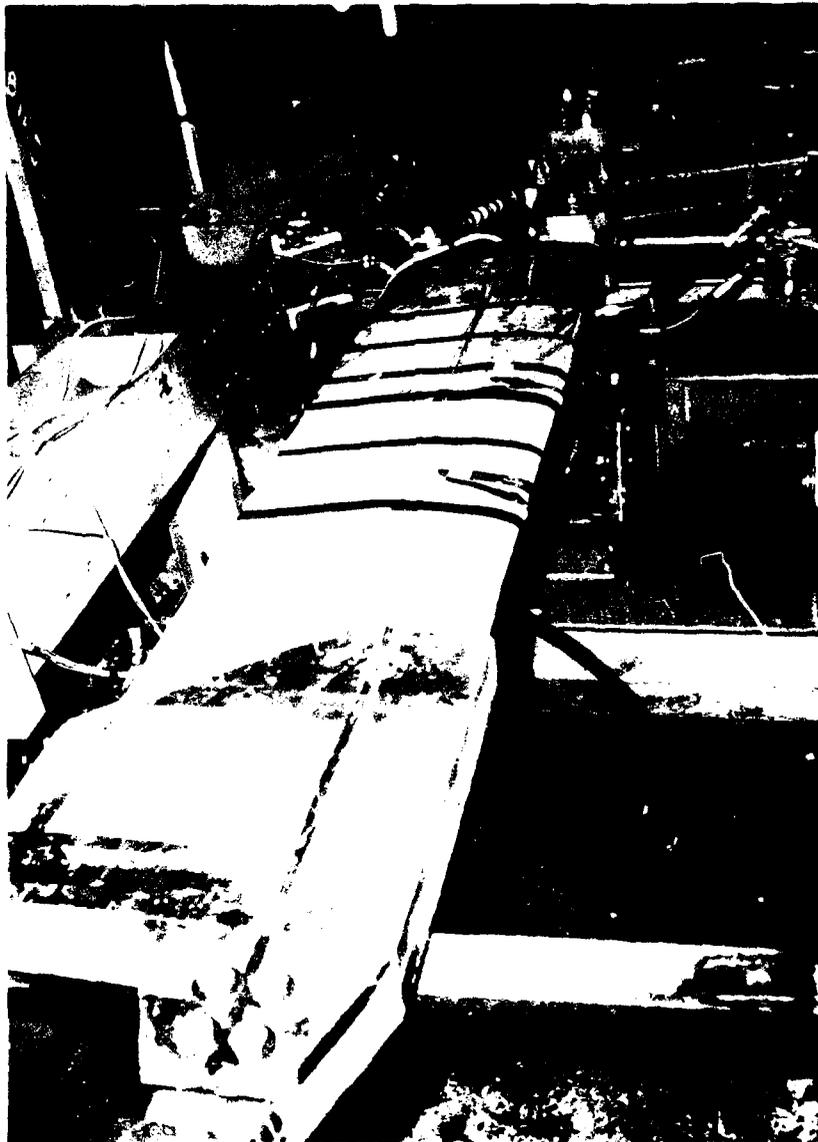
Figure 65. View of FREB Root End Specimen Mounted in Test Rig (View Looking Inboard).

Specimens consisting of the first 100 inches of the blade with reinforcement at the outboard end were used to evaluate the static strength of the blade root end. A test specimen is shown mounted in the test fixture in Figure 65. This fixture allows simultaneous application of static and/or dynamic edgewise and flatwise loads and CF loads. For the static test, limit stresses were those peak stresses predicted to occur on the blade during flight at 92.7 knots, 6000 ft,  $N = 1.544$  with a gross weight of 8500 pounds. At the maximum test condition, loads to the undamaged specimen were as given in Table 40. This

This testing used the same setup shown in Figure 65 for the root-end static test. Fatigue loads consisted of static CF, flatwise and edgewise moment with simultaneously peaking flatwise and edgewise vibratory moments superimposed on them. Three load spectra were applied: fatigue loads consisting of moments the blade is predicted to see at 107 kt, 6600 lb straight-and-level flight, a high level intended to produce early failure, and an intermediate load level. The testing produced only a drag brace evaluation rather than a blade evaluation because the drag braces used in the testing all failed, leaving the test specimens undeteriorated. Two specimens were tested undamaged, and a third was first tested at the fatigue load level with several damages inflicted (two .75-inch dia. jagged through-holes; see Figure 68) and then tested at the

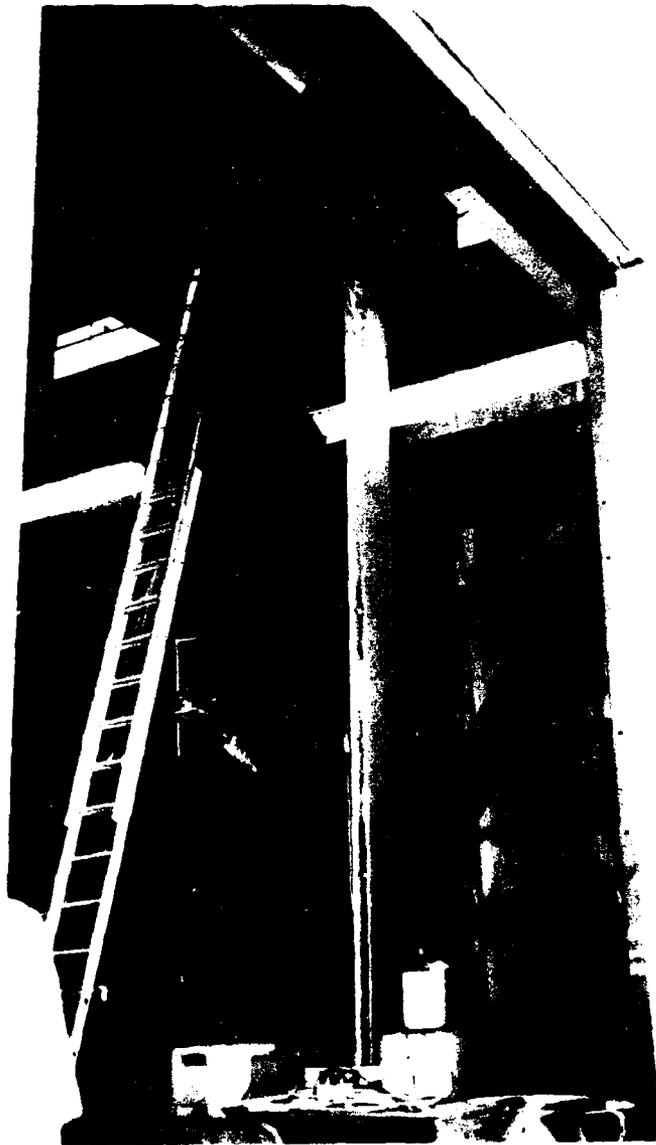
Figure 66. FREB Suspended for Nonrotating Natural Frequency Test.

Full blade specimens were suspended with root ends both fixed and pinned, and excited near predicted mode points in order to measure beam natural frequencies. The suspended blade is shown in Figure 66, while the shaker attachment is shown in Figure 67. The modal frequencies and shapes were determined for flatwise and edgewise loading with the root end both pinned and fixed. For the pin-ended modes, the blade was hung from knife edges; while for the fixed modes, the blade was bolted to the standard UH-1 blade retention which was in turn rigidly mounted to the Contractor's static test rig. Specimen excitation was by a 50-lb electromagnetic shaker. For the flatwise modes, excitation was at the quarter chord, edgewise excitation was at the leading edge, and flatwise/torsion coupled modes were excited at the trailing edge. Table 41 gives a comparison of the test frequencies obtained from the FREB and the present UH-1 blade. Test results showed that the dynamic characteristics of the FREB are very close to those of the present UH-1H blade.

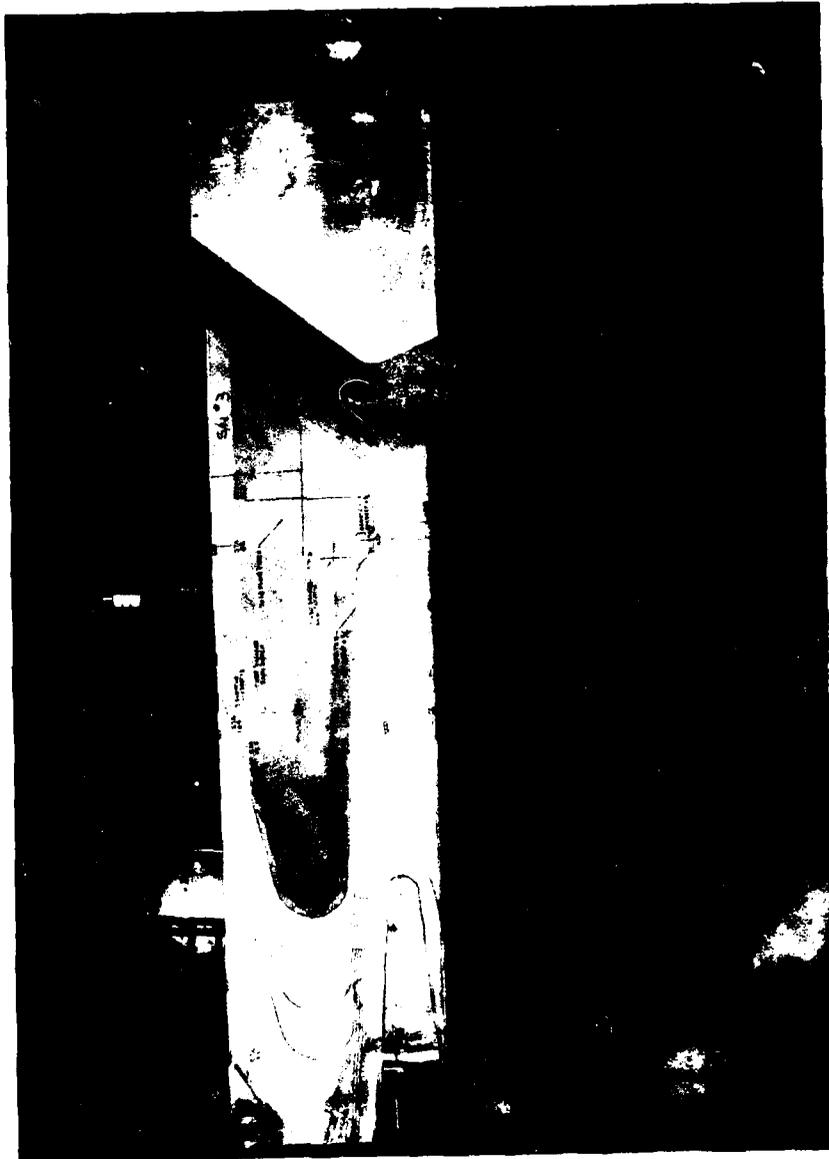
Figure 69. Damage inflicted on S/N 3 During Test (Bottom Surface).

high load level with the original damages repaired and other damages inflicted and repairs made (see Table 42 and Figures 69 and 70). The drag braces had all seen an unknown spectrum of flight previous to testing, and the drag brace used with specimen 3 had been used for 53 hours of whirl test. The drag brace used with specimen 3, however, had been magnafluxed prior to testing. Typical drag brace failures are shown in Figure 71.

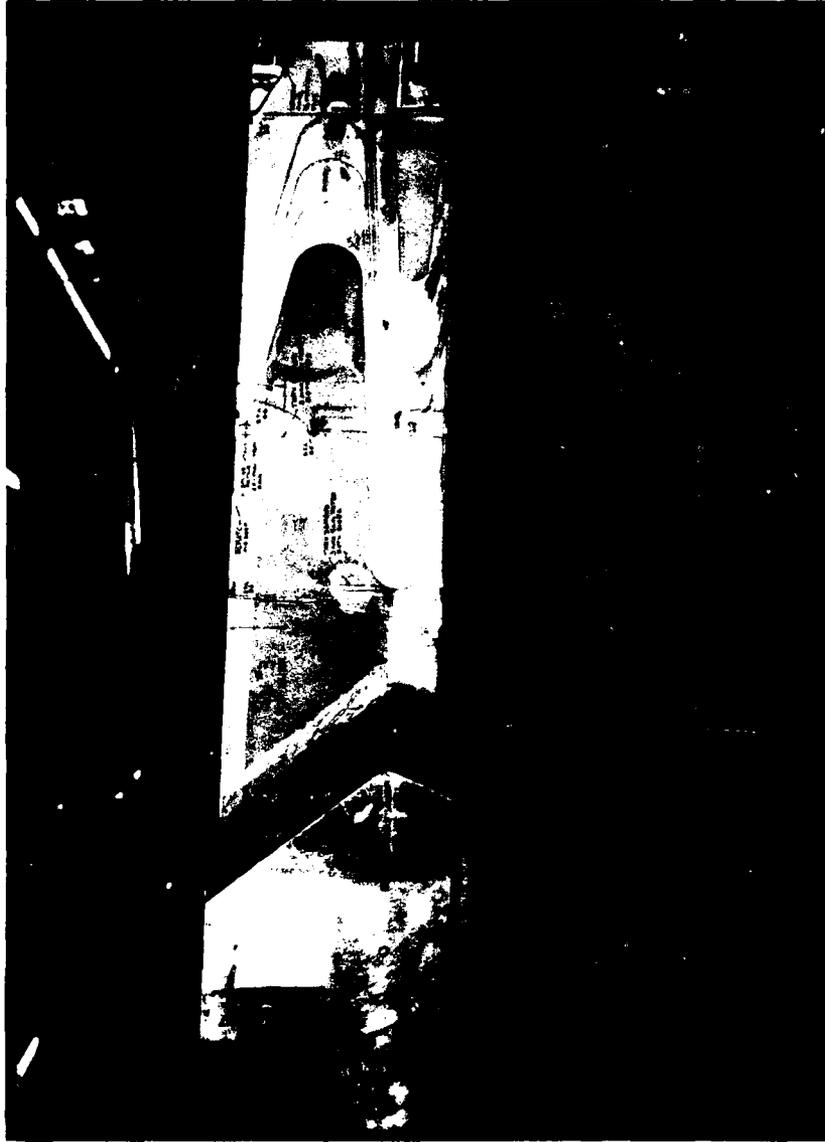
Figure 70. Damage Inflicted on S/N 3 During Test (Top Surface).

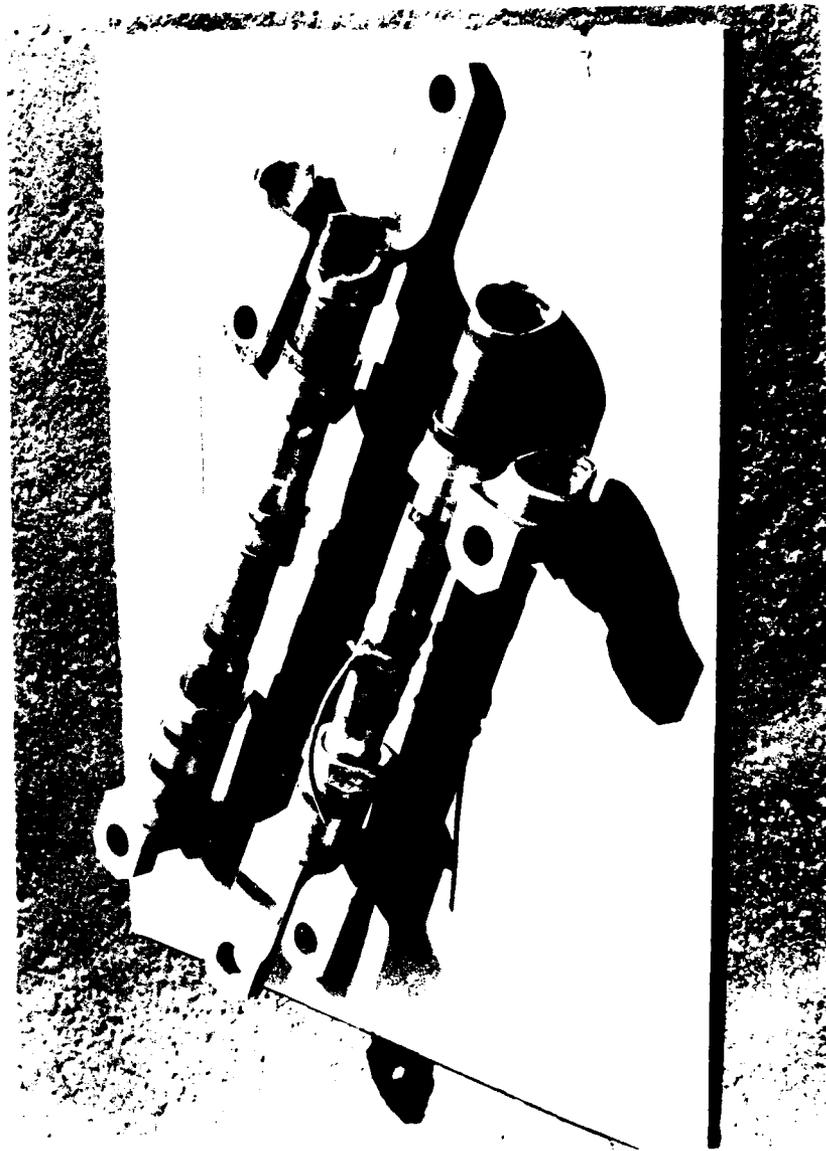
Figure 71. Typical Drag Brace Failures.

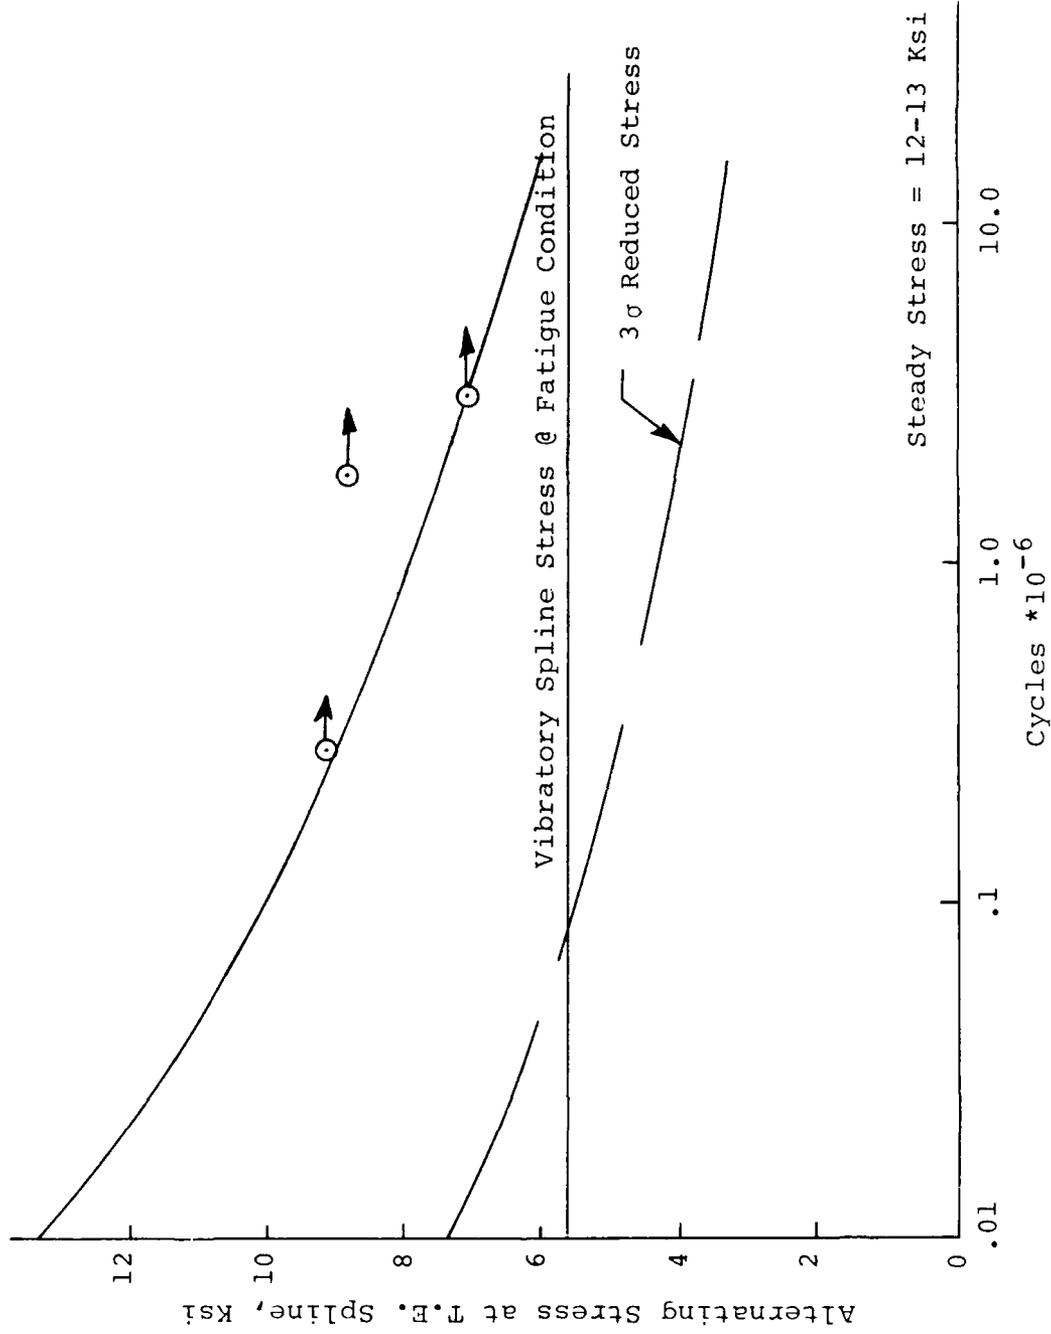
Figure 72. S/N Curve for Root End Fatigue Specimens.

The loads applied during test and the cycles to drag brace failure are given in Table 43. Figure 72 is a projected fatigue curve, based on the data obtained from this testing. In this curve, the runout points are plotted with arrows and the fatigue curve is drawn through these points. This introduces an unknown level of conservatism into the curve with respect to the blade. The curve could be thought of as a drag brace fatigue curve because of the relatively high strength of the blade in comparison to the drag brace.

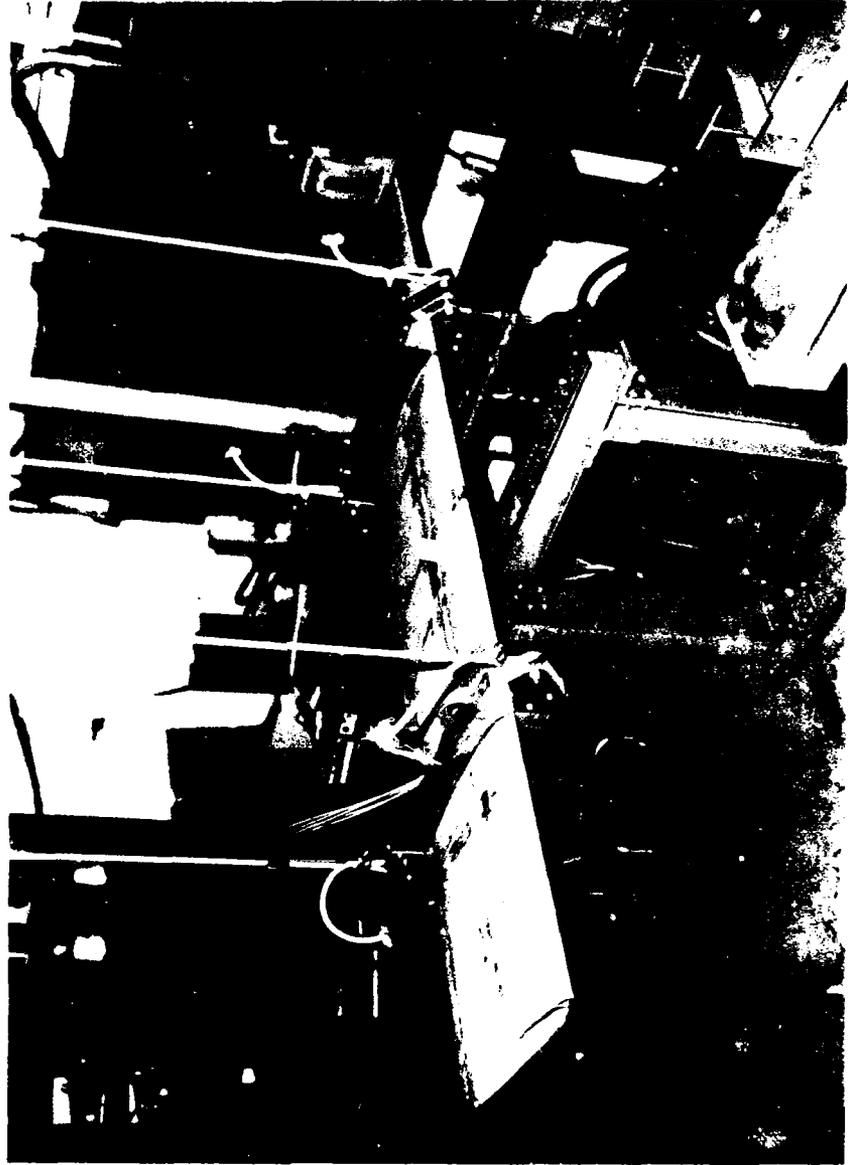
Figure 73. Test Setup for Free-Free Beam Fatigue Tests.

In order to evaluate the reversed bending fatigue strength of the FREE outboard section, full-length spar-skin-core-spline assemblies were cut into an inboard section 100 inches long and an outboard section 163.5 inches long. The specimens were suspended as shown in Figure 73. Soft springs (bungee cords) supported the blade, and an electromagnetic shaker was used to drive the specimen slightly off a node point. In order to drive the specimens at reasonable frequencies, the edgewise specimens were end-loaded with 30-lb weights while the flatwise specimens were used as received. Table 44 gives a summary of the specimen types, applied loads and cycles to failure.

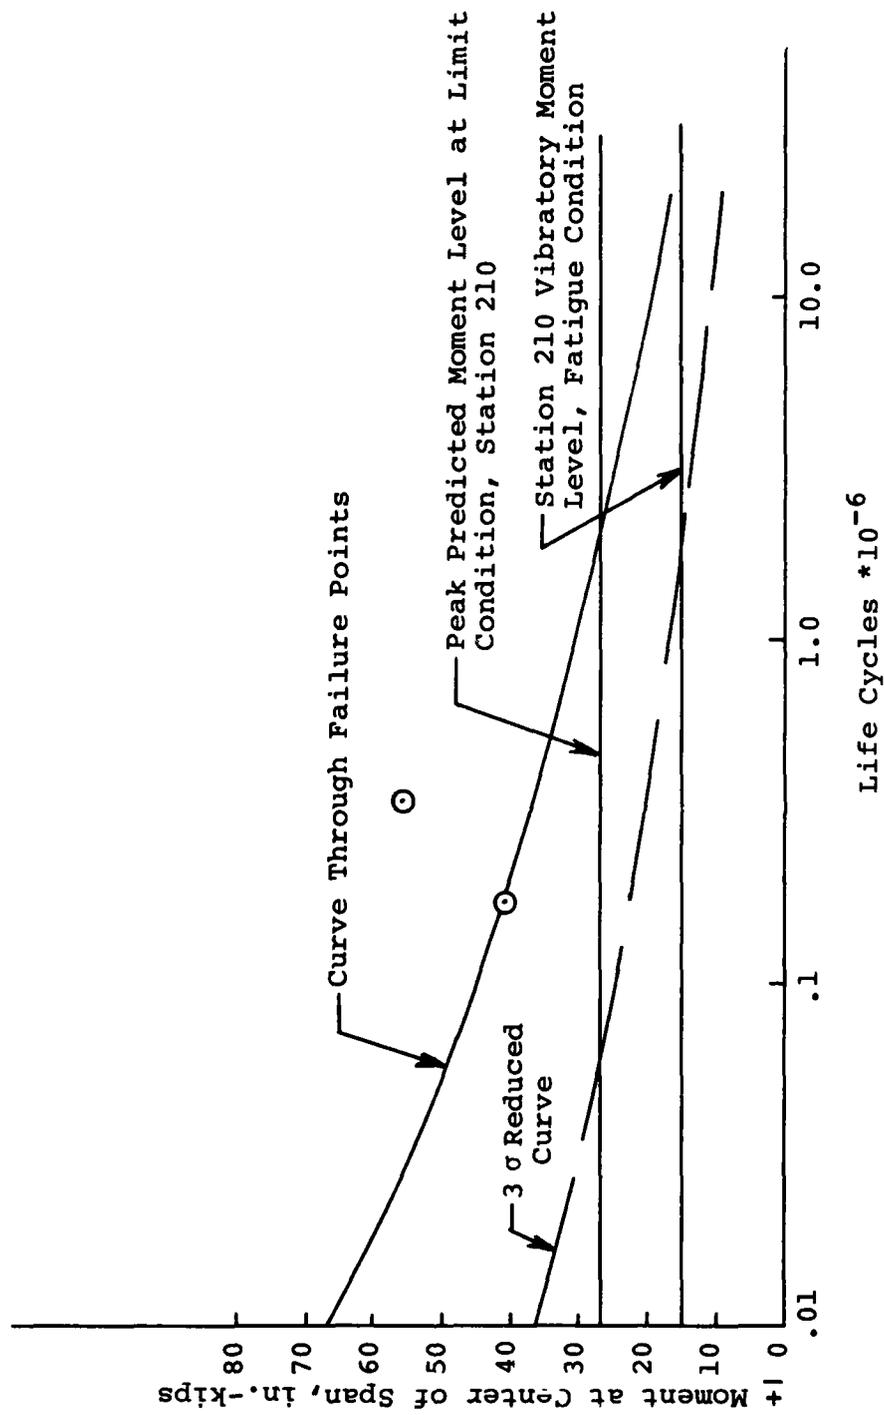
Figure 76. Flatwise Free-Free Beam Fatigue Curve.

repair. Specimen 7F withstood a failing level of flatwise load for 351,000 cycles before a fatigue crack originated at the spar rebate. A fatigue curve generated from these two data points is shown in Figure 76, along with reference load levels of the peak flatwise moment predicted at station 210 and the fatigue moment predicted at station 210.

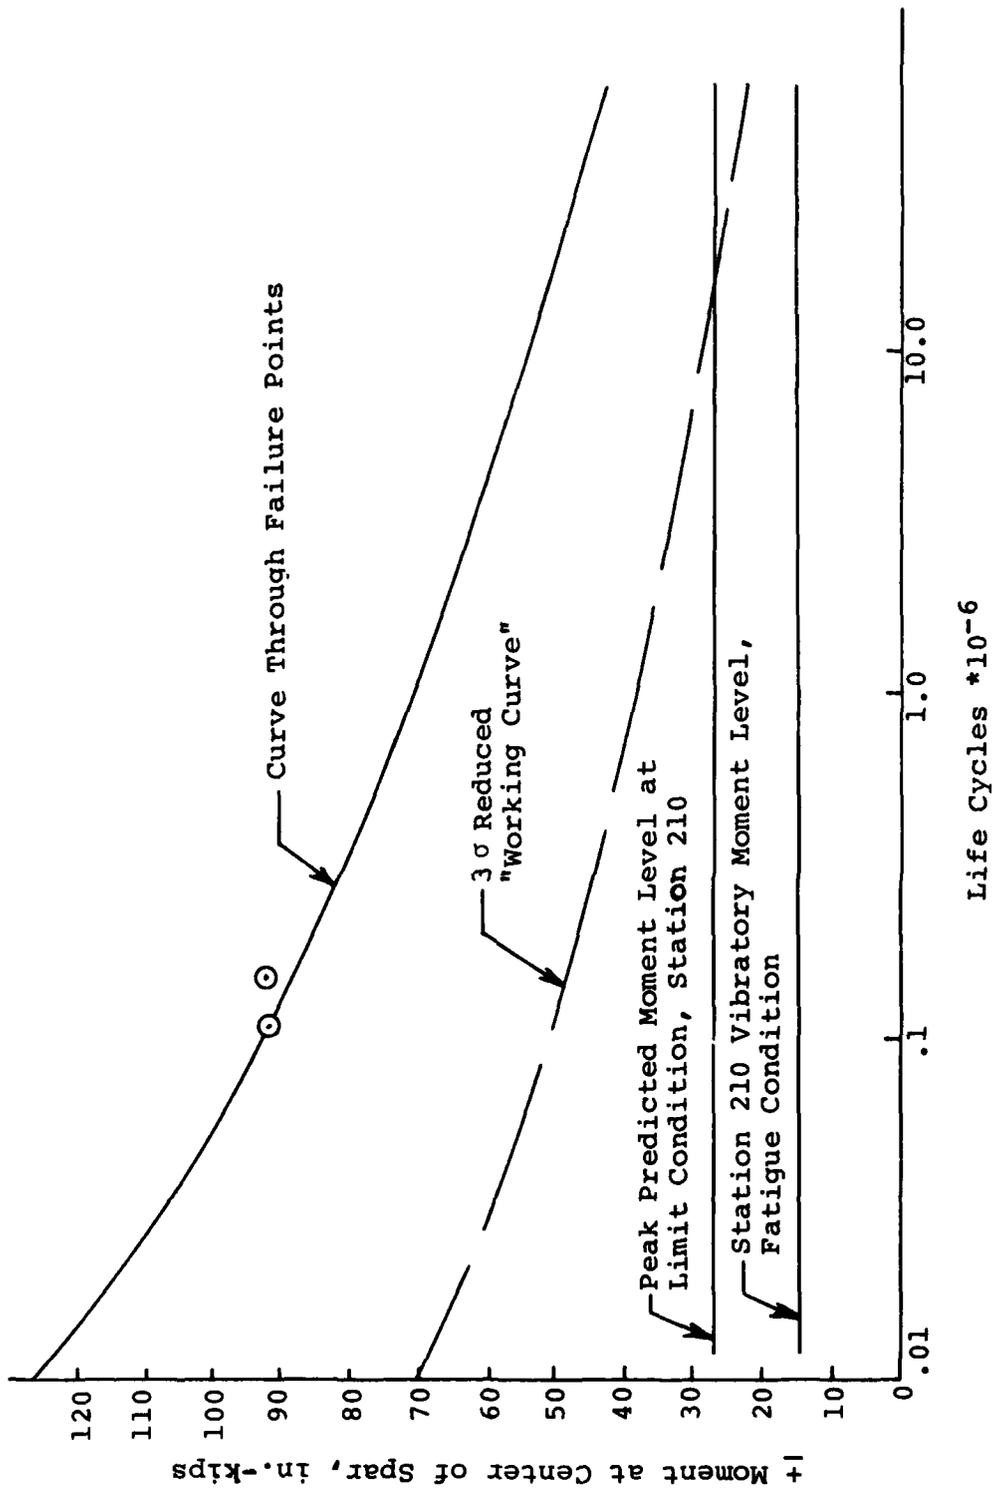
Figure 78. Edgewise Free-Free Beam Fatigue Curve.

The edgewise testing of specimens 11E and 7E was conducted in a similar manner. Specimen 11E was tested at a high load level intended to fail the specimen in a short time. A crack was started on the spline, and failure was noted by a distinct change in driving power required at 152,000 cycles. The spline crack and its effect on the skin are shown in Figure 77. Specimen 7E was first damaged with a through-hole and a chordwise slit. The specimen withstood 10 equivalent flight hours at the fatigue level without deterioration of the holes. One of the holes was then enlarged to 3 inches in diameter, and 1/2 inch deep, and testing continued for an additional 10 hours equivalent, again with no deterioration. After repair, another 10 equivalent flight hours was withstood at the fatigue level, again without specimen deterioration. The load level was then increased to the high-level (early failure) fatigue load, and a failure was finally noted on the spline after an additional 104,000 cycles. These two points were interpreted to give the fatigue curve of Figure 78.

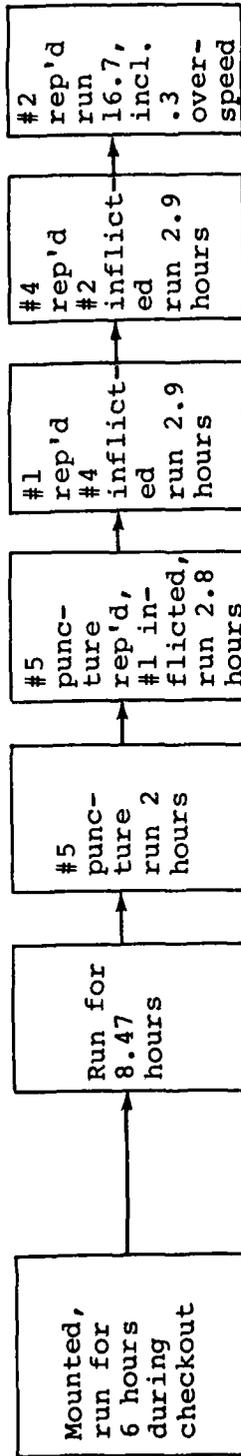
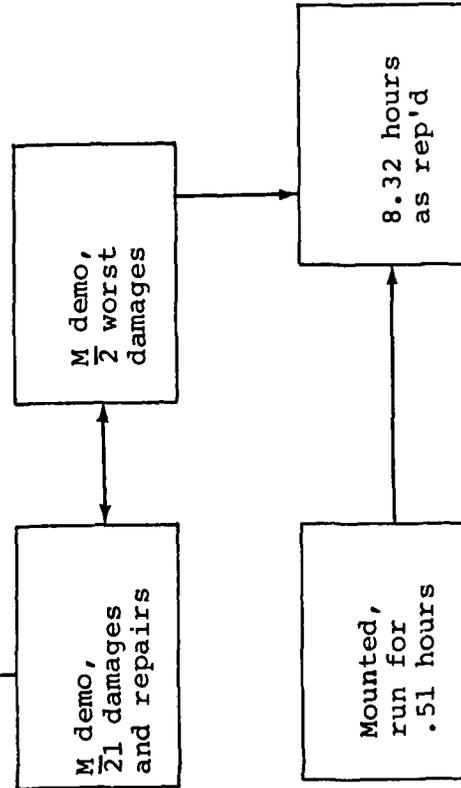
Figure 80. Whirl Test Flow Chart.

Figure 80 shows a flow chart of the whirl test, including where the various damage and repair events occurred in the test sequence. Table 45 goes with Figure 80 and describes the damage and repair events in more detail. The whirl test was designed to demonstrate three aspects of the FREB:

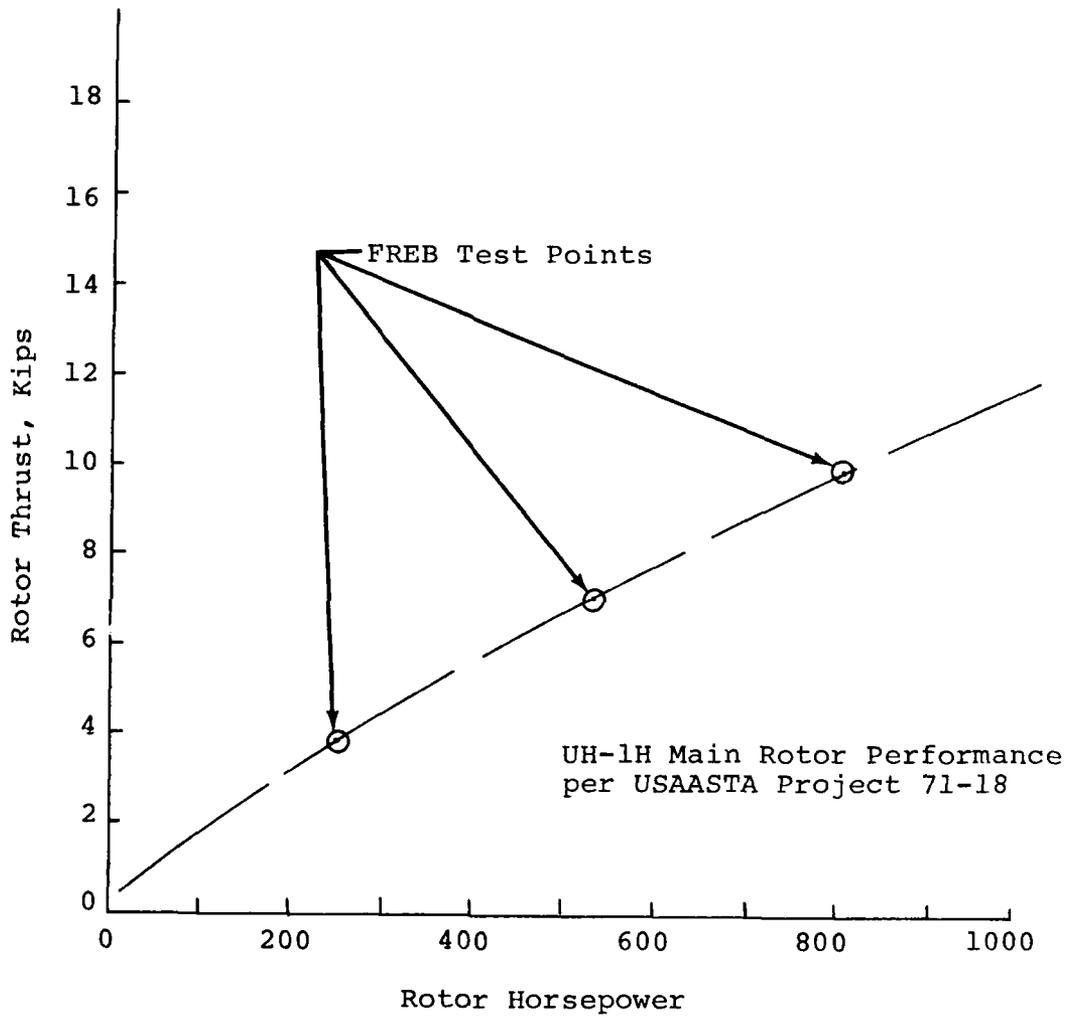
Figure 81. Comparison of Thrust/Horsepower for Standard UH-1H Blade and FREB.

During the entire whirl test sequence, the undamaged blades showed no distress, the damage inflicted to the blades did not progress, and the repairs did not deteriorate. The applied loads included 10% rotor overspeed, as well as full thrust of 9900 lb. Blade balance and track before damage, after damage and after damage repair remained within acceptable limits. Figure 81 compares the thrust versus horsepower requirements of the FREB to that of the present UH-1H blade under similar test conditions.

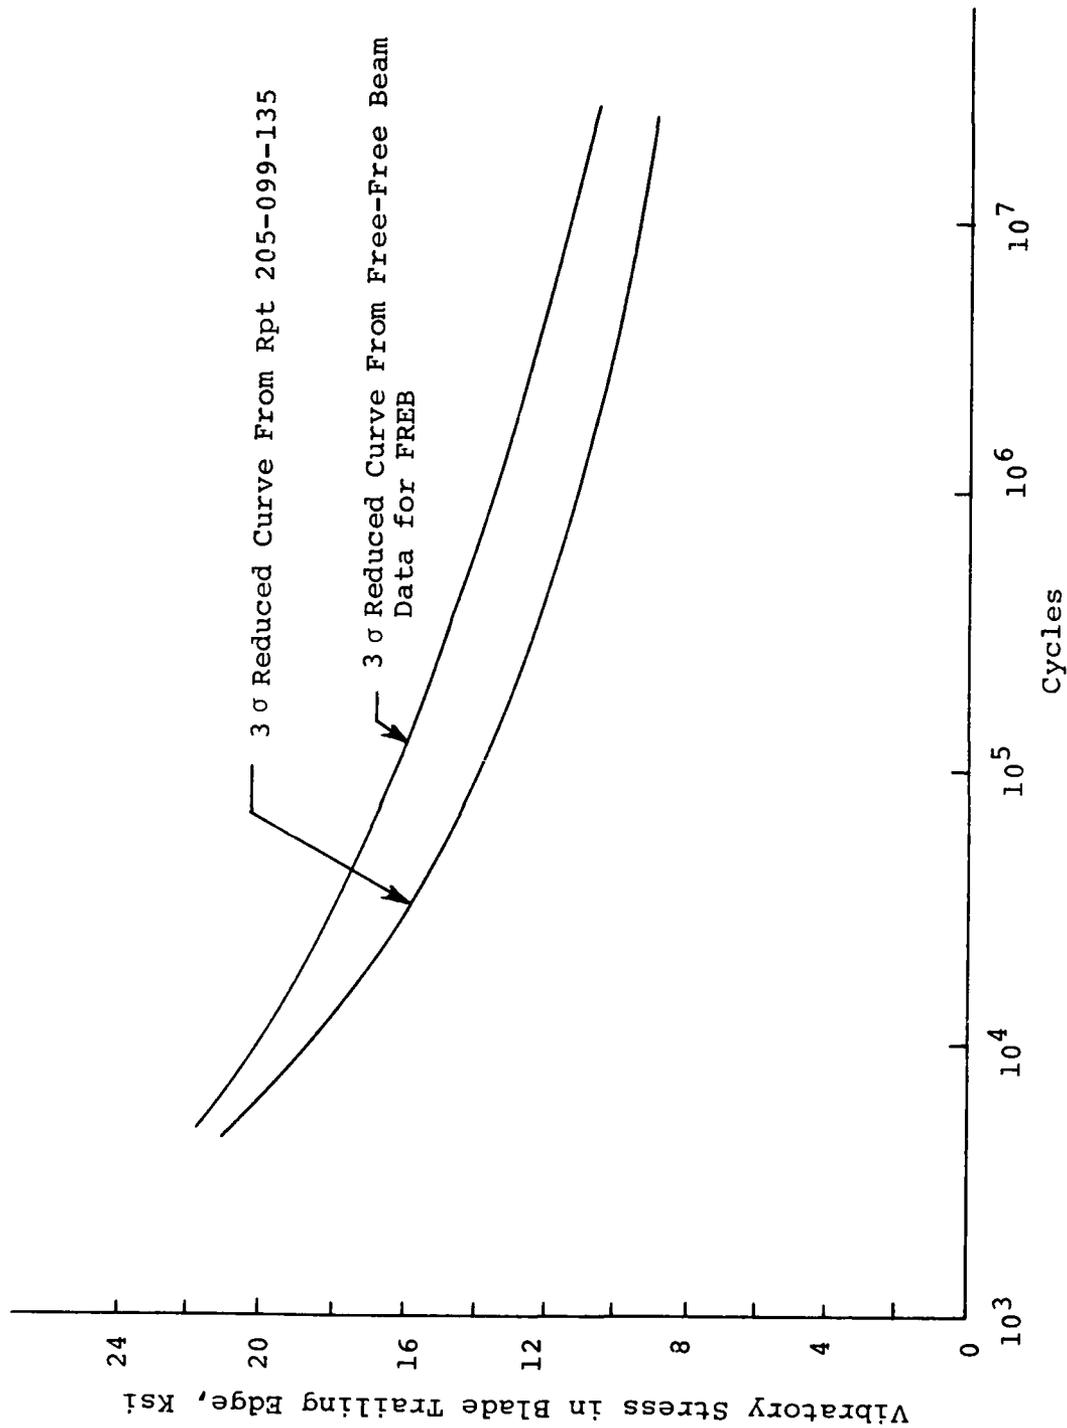
Figure 82. Comparison of S/N Curves for FREB and Present UH-1 Outboard Blade Section.

Some estimate of the fatigue life of the FREB can be made by comparing FREB bench test data to the fatigue life predictions given for the present UH-1D main rotor blade in Reference 3. In this reference, the blade life is based on edgewise vibratory moment at station 192, where the spline is the critical component. Figure 82 shows the 3 reduced S/N curves for the present UH-1 blade at station 192 on the spline and for the FREB at station 210 on the spline. The present UH-1 curve was used to predict a life of 2200 hours. The FREB curve shows a significant increase in life at load, indicating that the critical outboard station on the FREB should have a fatigue life well in excess of the 3000-hour life used for life-cycle cost predictions.

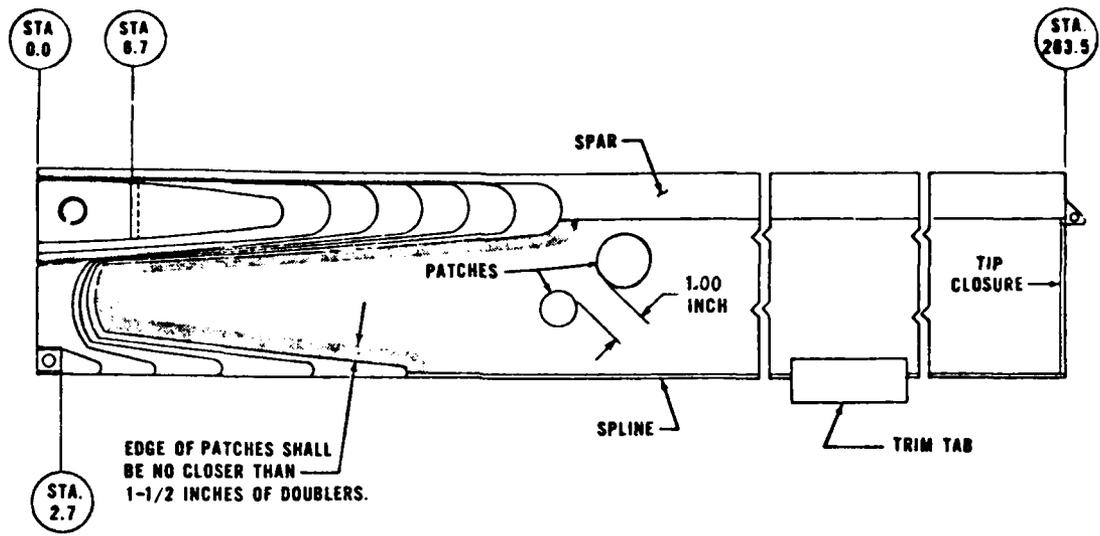
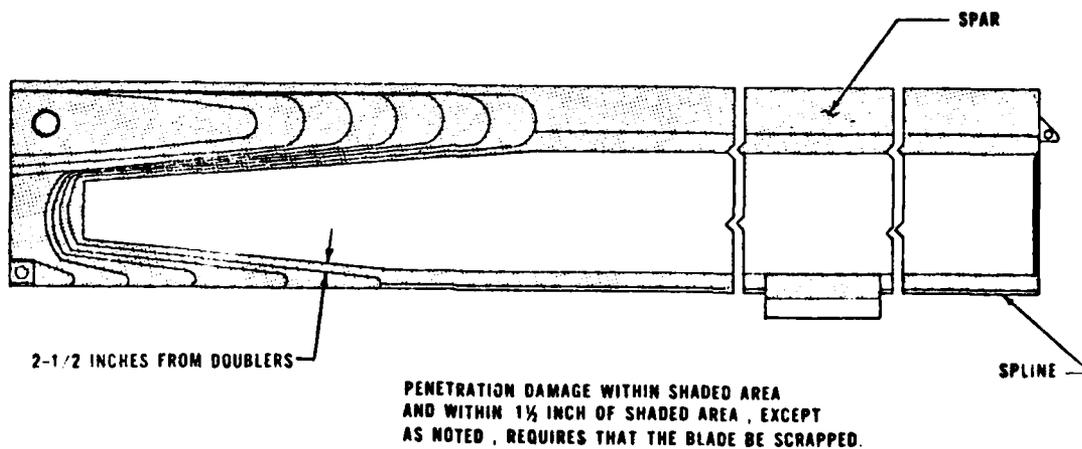
Figure B-1. Repair Limits for Skin and Core Areas.

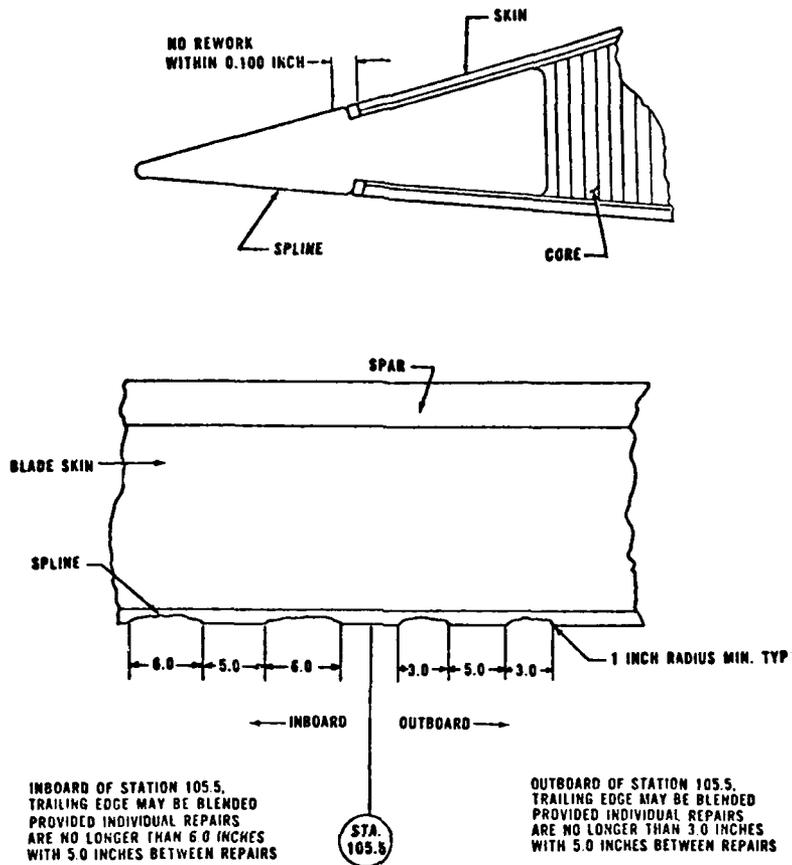
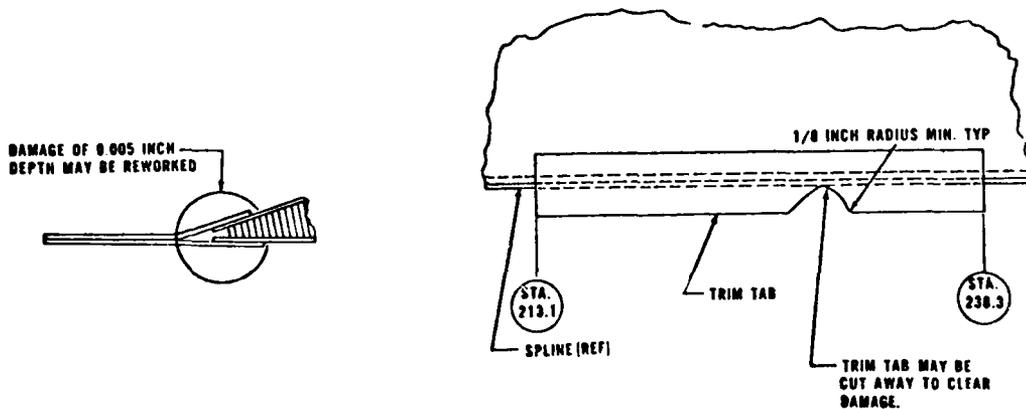
Figure B-2. Blend Limits for Spline and Trim Tab.

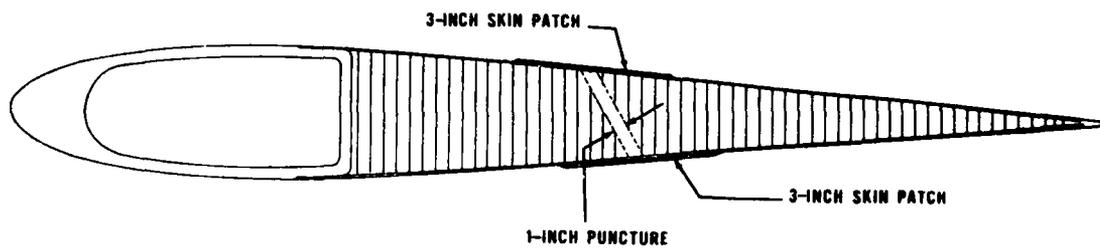
Figure B-3. Typical Double Skin Patch Repair.

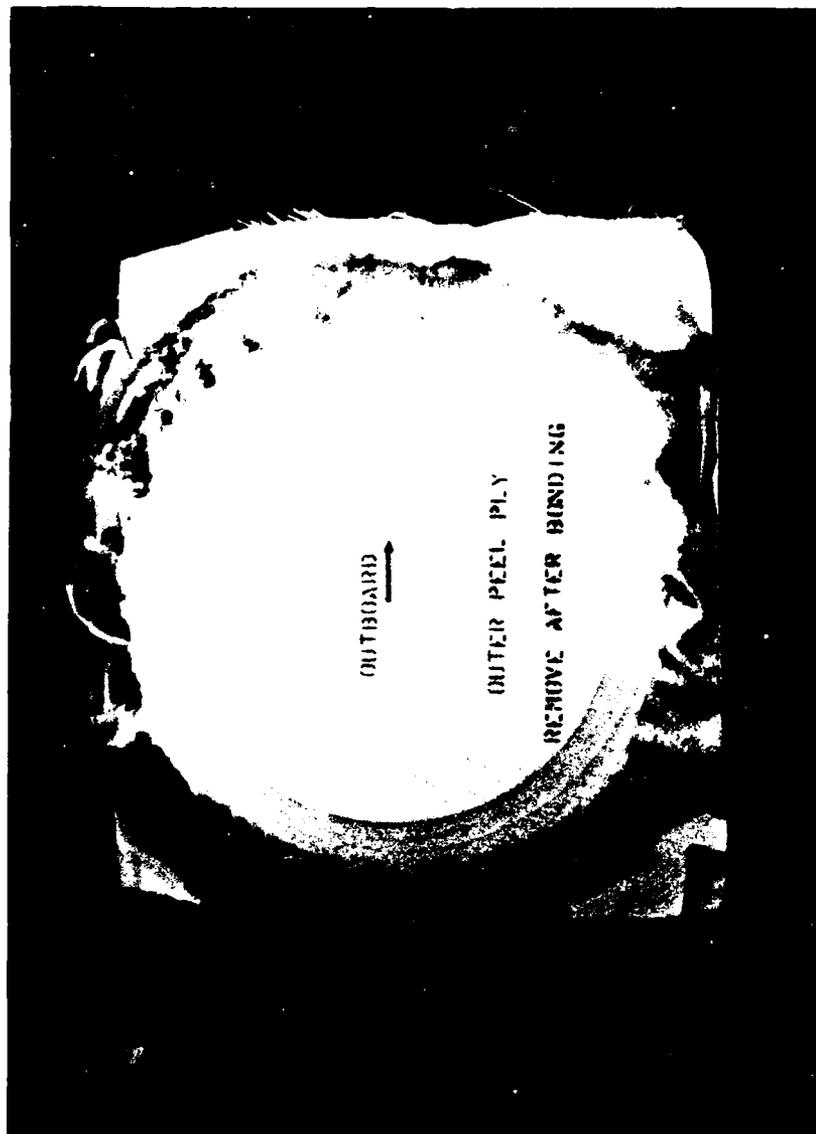
Figure B-4. Patch Outer Marking.

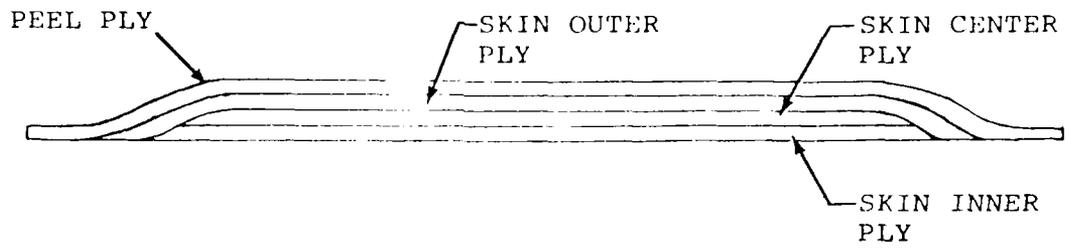
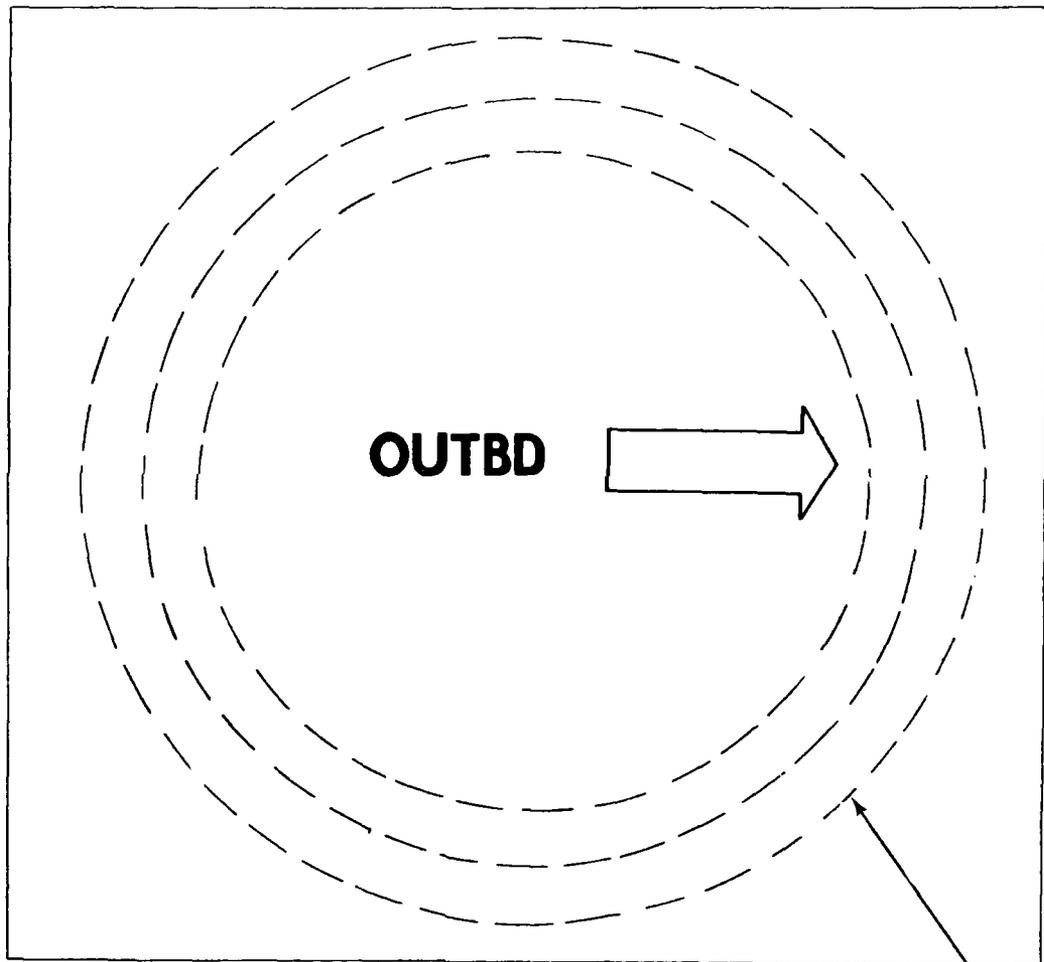
(PLY THICKNESSES DRAWN OVERSIZE FOR CLARITY)

PEEL PLY

(TO BE REMOVED AFTER BONDING IS COMPLETE)

Skin patches are prefabricated from several plies of material as shown in Figure B-5. There is a peel ply on the outer surface which will serve to keep squeezed-out adhesive from contacting the pressure/heat pack during the curing process. The peel ply is to be removed after the adhesive has cured. An arrow is stenciled on the peel ply to indicate proper orientation of the patch when being applied to the blade. Patches are packaged in plastic bags in order to keep the bond surfaces contamination-free.

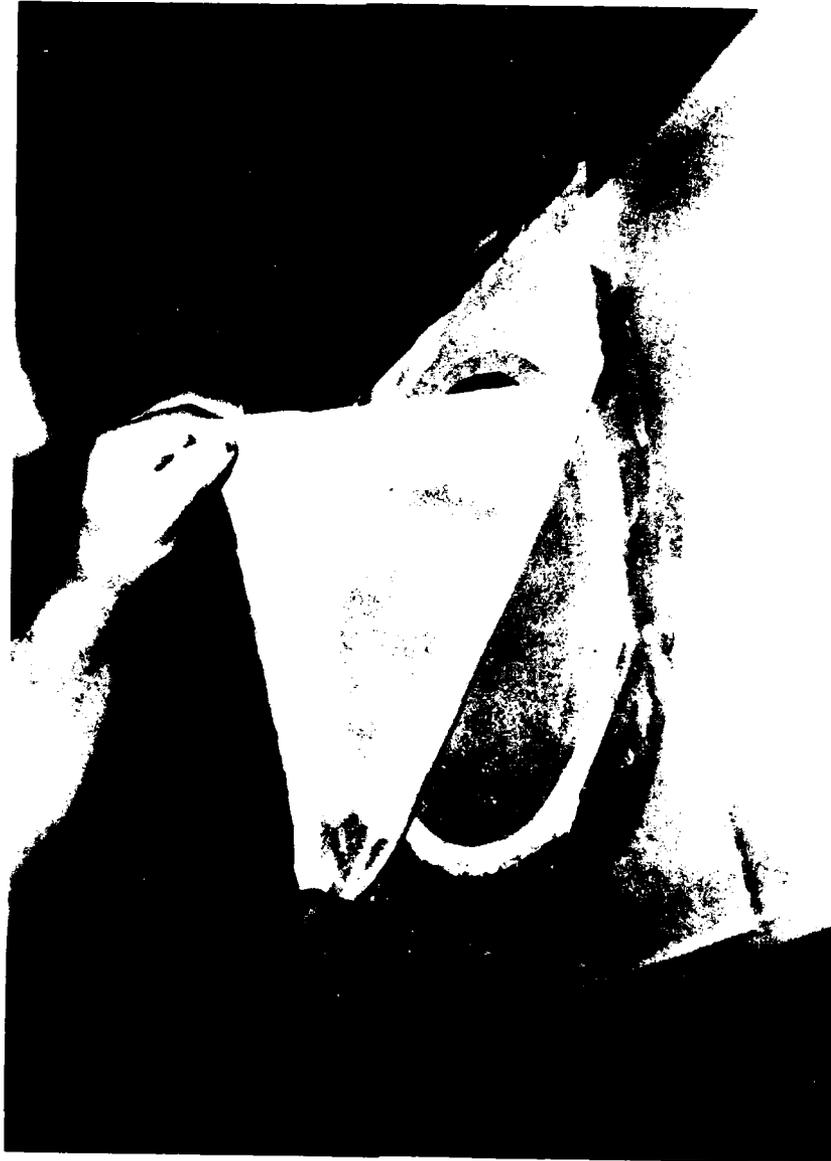
Figure B-8. Removal of Peel Ply.
