USAAMRDL-TR-76-9

• **DEVELOPMENT PROGRAM FOR FIELD-REPAIRABLE/EXPENDABLE  
MAIN ROTOR BLADES**

Kaman Aerospace Corporation  
Old Windsor Road  
Bloomfield, Conn. 06002

Final Report

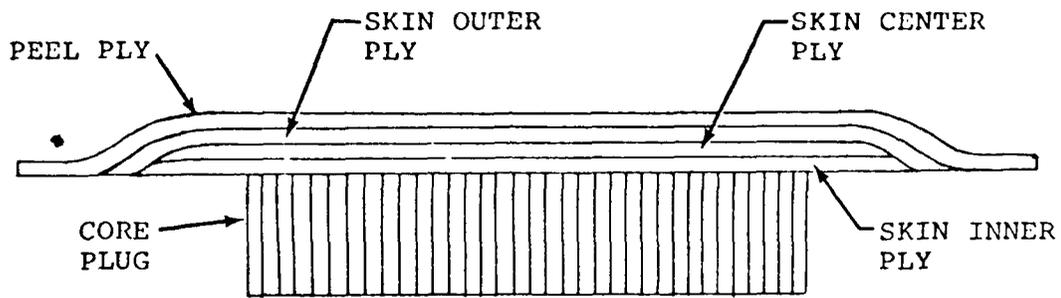
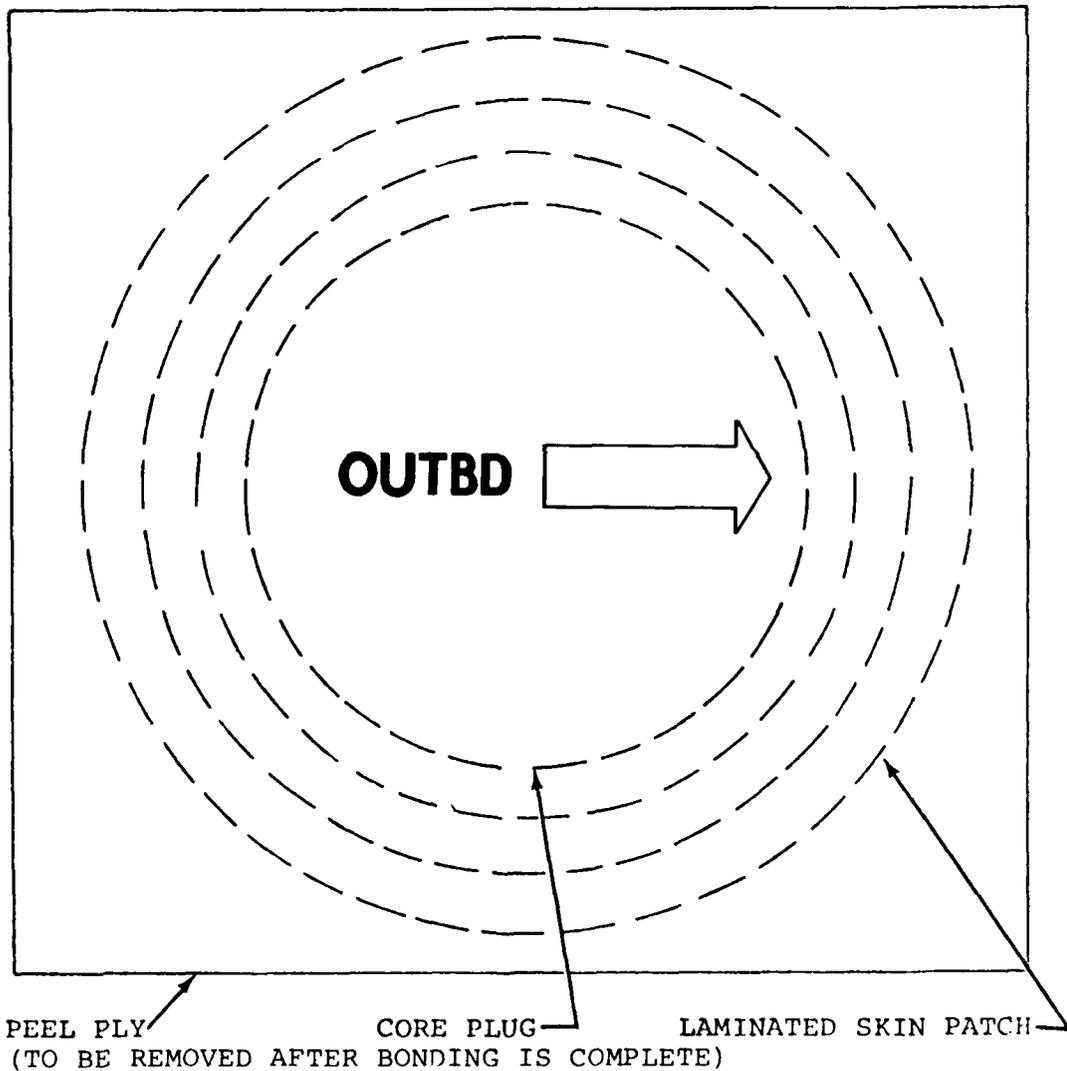
(PLY THICKNESSES DRAWN OVERSIZE FOR CLARITY)

Figure B-9. Typical Plug Patch Construction.

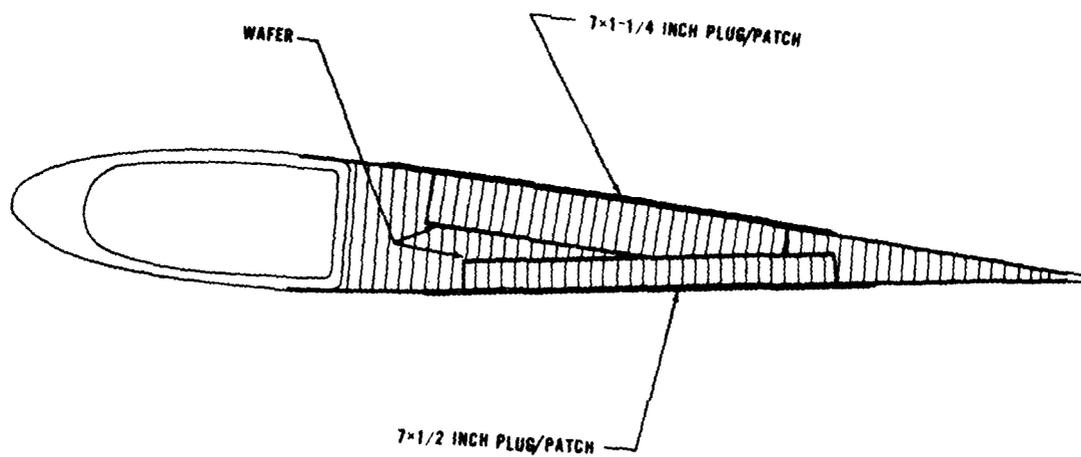
Figure B-10. Typical Double Plug Patch Repair.

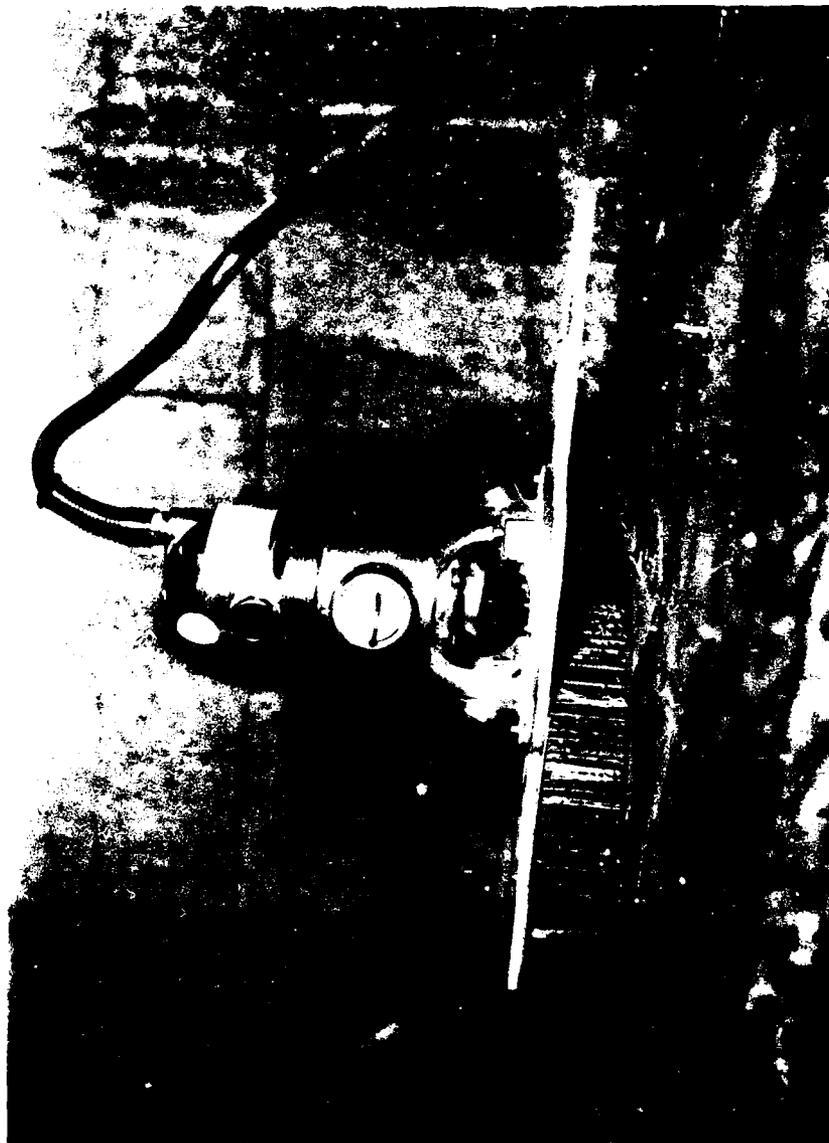
Figure B-11. Using Plug Patch as Gage.

To use plug and wafer as gauge, place plug/patch on flat surface with plug up. Place wafer on plug. Set router base on wafer with router bit along side of plug and adjust router base until router bit comes in contact with inner surface of patch. Lock router base by tightening locking screw (reference Figure B-11).

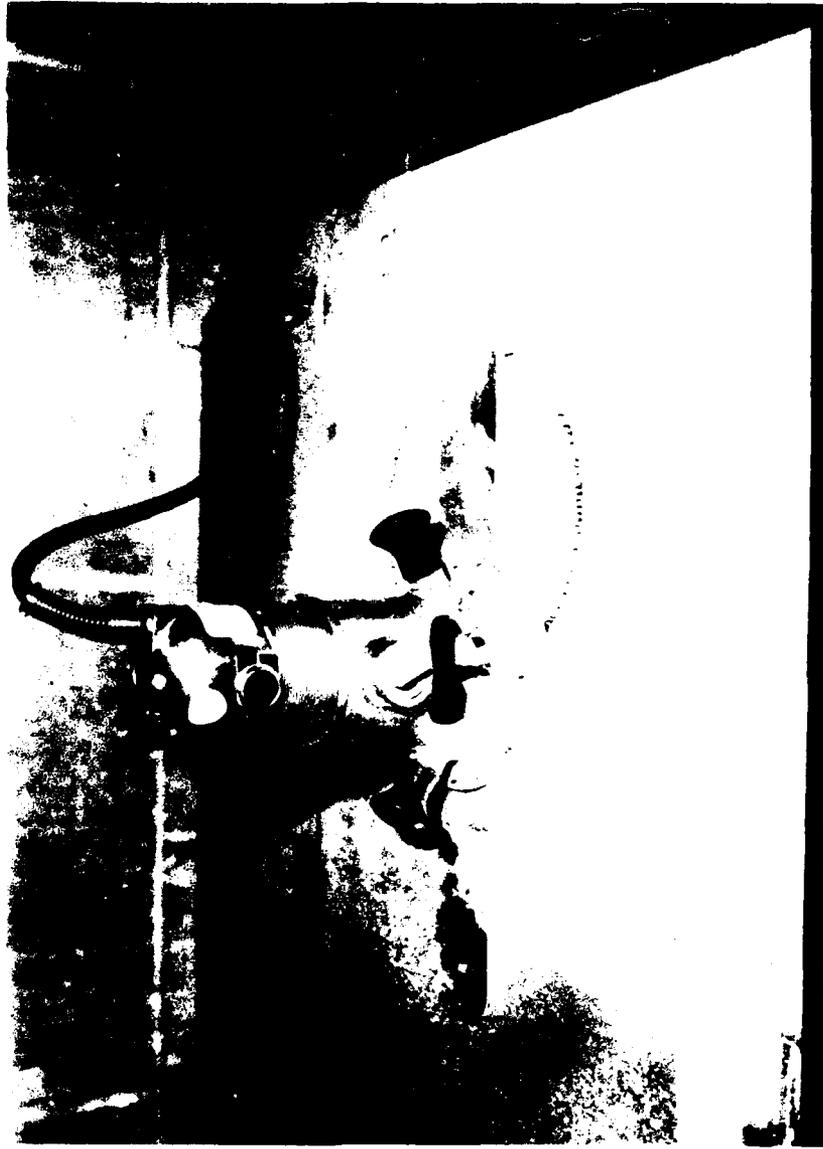
Figure B-12. Routing Skin.

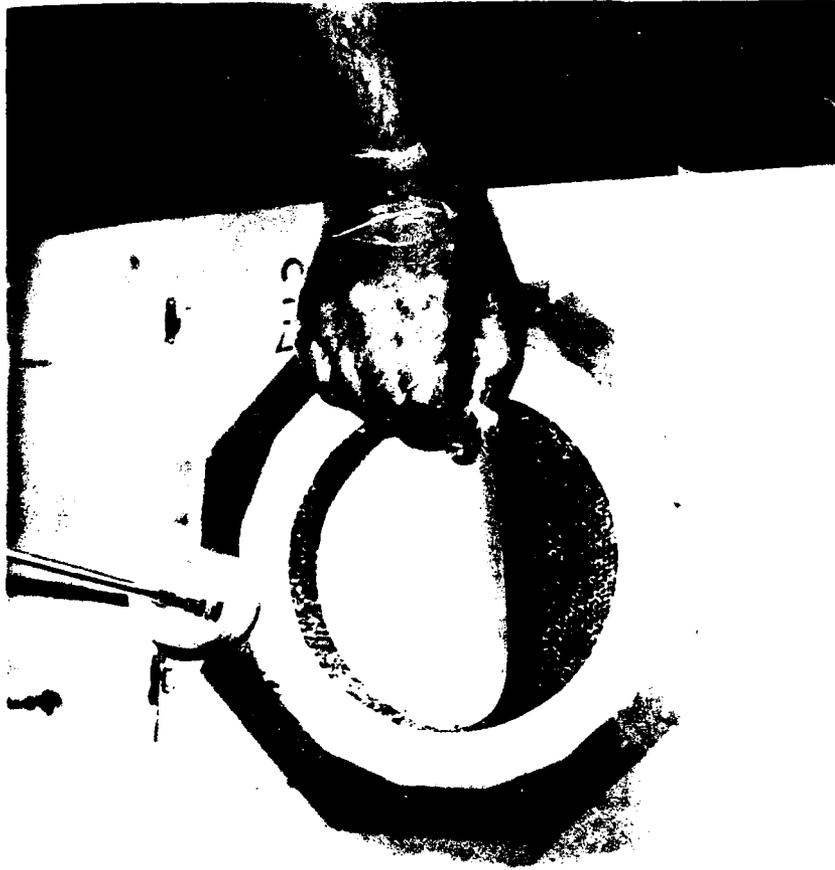
Figure B-18. Placing Wafer in Cavity.

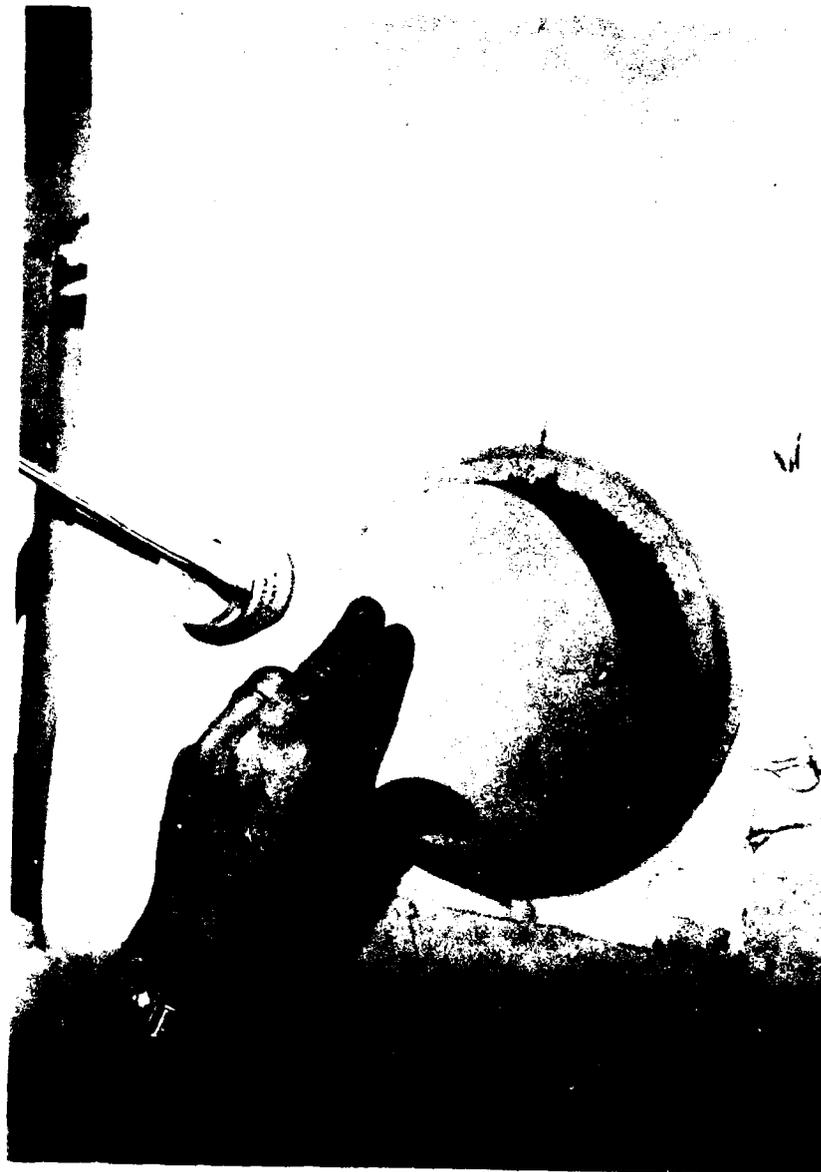
Figure B-19. Placing Wafer on Plug.

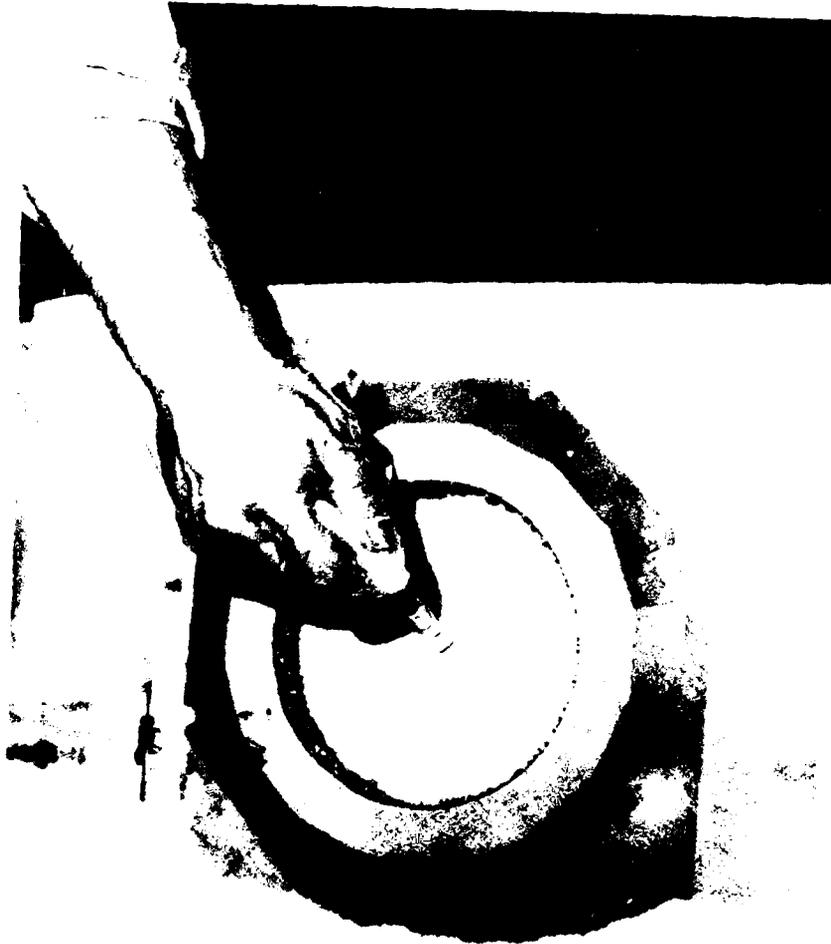
Figure B-20. Applying Adhesive to Remaining Side of Wafer.

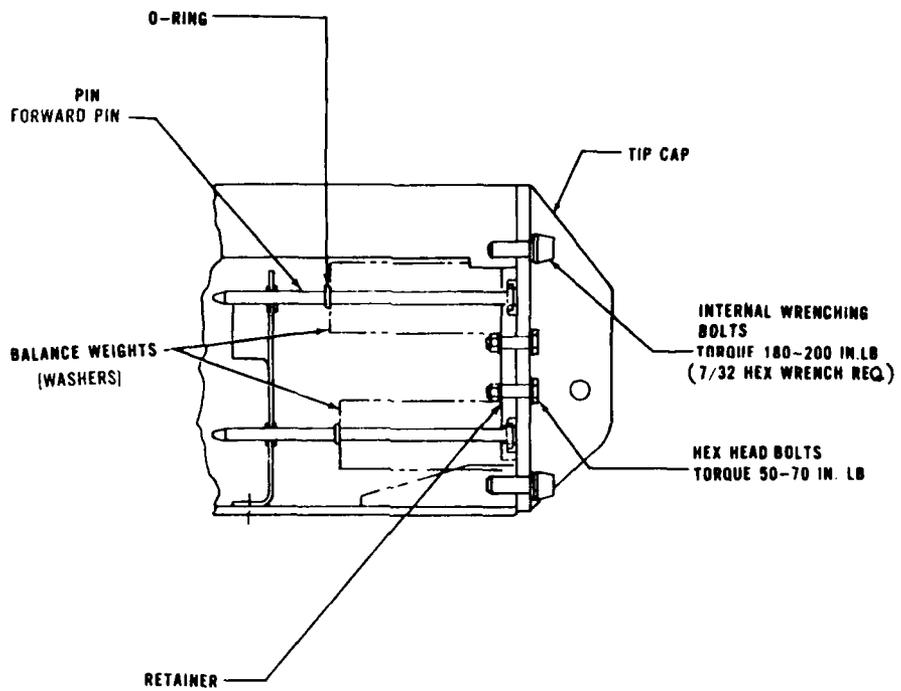
Figure B-21. Tip Cap Replacement.

Do not attempt to loosen the four external wrenching hex head bolts which pass through the tip cap at this time. These bolts retain the balance weights to the interior surface of the tip cap.

Do not spill balance weights from weight pins while handling tip cap and weight assembly. An O-ring is installed on each pin and will retain the weights below it under normal handling conditions. Mark forward pin for later reinstallation in same position.

(1) Transfer weights assembly to replacement tip cap. Ensure that weight pin previously marked as forward pin is installed in that position. Torque hex-head bolts to 50 - 70 in-lb.
