12
INTERIM REPORT M-200
January 1977

FRACTURE CHARACTERISTICS OF TWO HIGH-STRENGTH,
LOW-ALLOY AND TWO STAINLESS STEELS

by
J. K. Scott
E. P. Cox

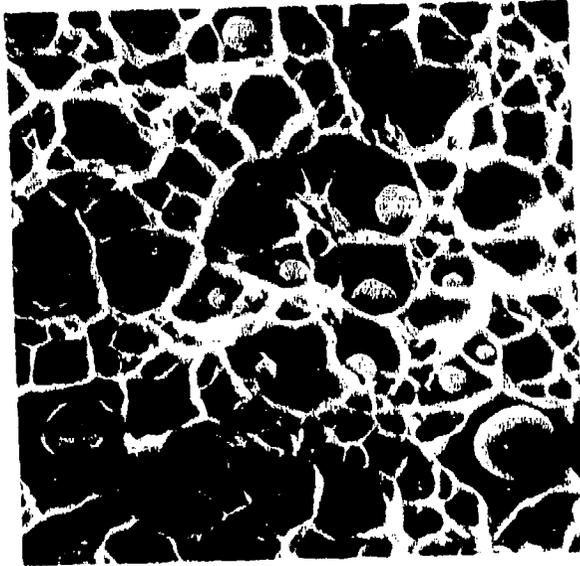
Figure 1. Equiaxed dimples containing inclusions, 4250X.

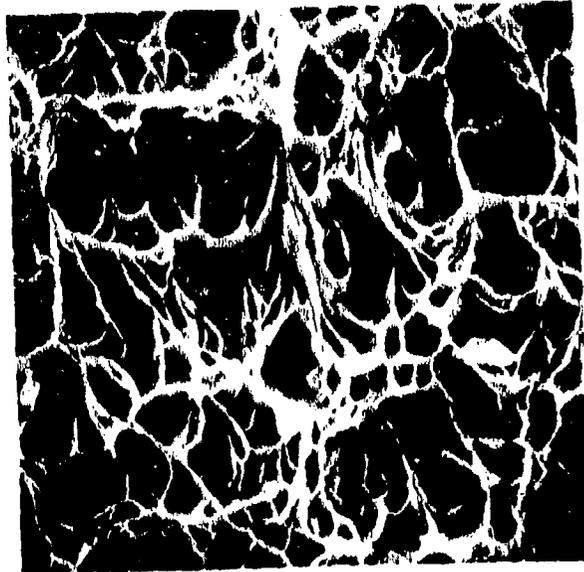
Figure 2. Elongated dimples, 3750X.

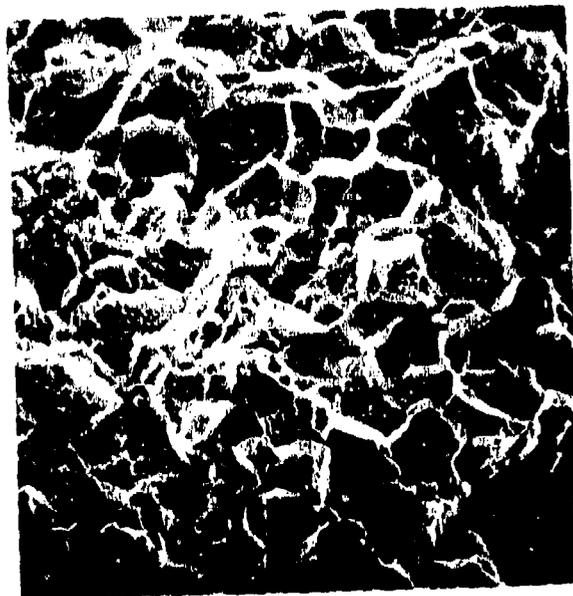
Figure 6. Intergranular fracture, 300X.

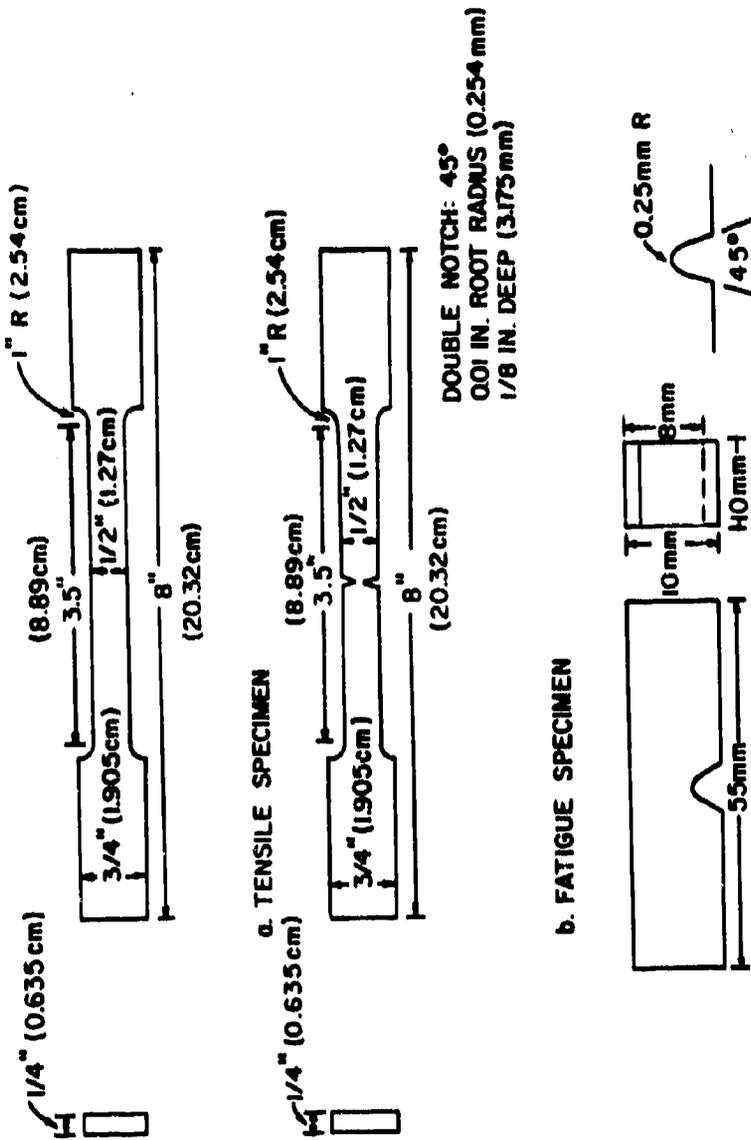
Figure 11. Specimen geometry for tensile, fatigue, and Charpy impact tests.

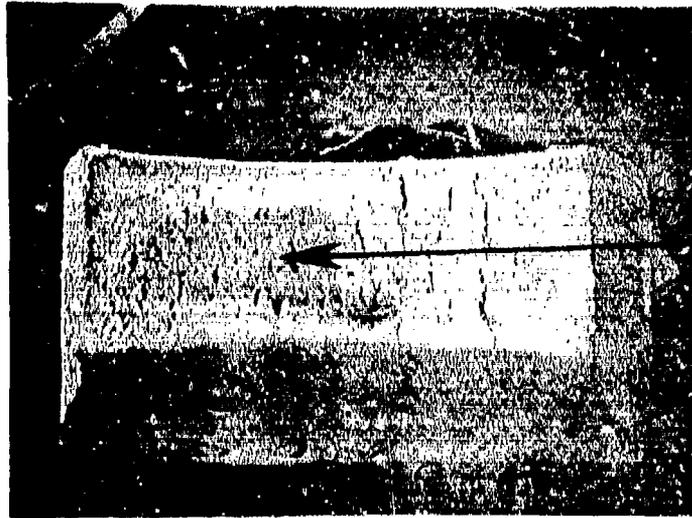
Figure 12. Tensile fracture surface of A-588 steel, 8X. Note the large reduction in area of the fracture surface and separation at elongated inclusions.

The hydrogen-embrittled A-588 specimen (Figure 17) shows considerably less necking before failure than the control specimen (Figure 12). Further indication of hydrogen embrittlement is confirmed by a higher magnification micrograph (Figure 18) which shows large cleavage facets. The river patterns show the direction of crack propagation within each facet.

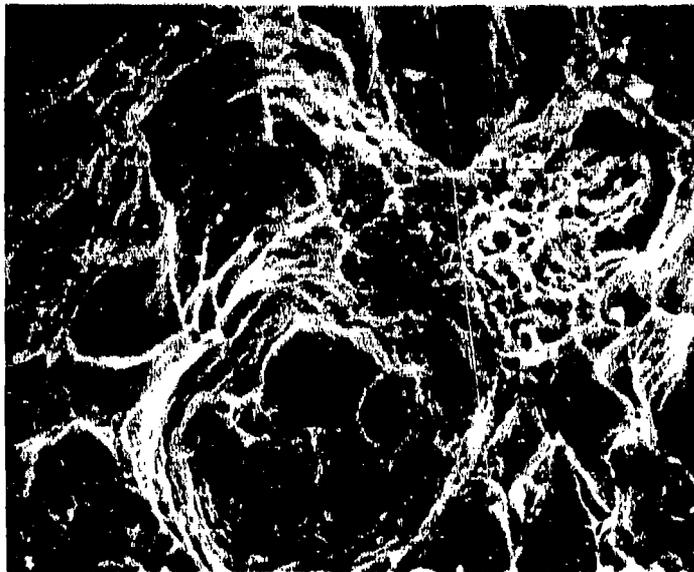
Figure 13. Dimple rupture in A-588 steel, 1500X.

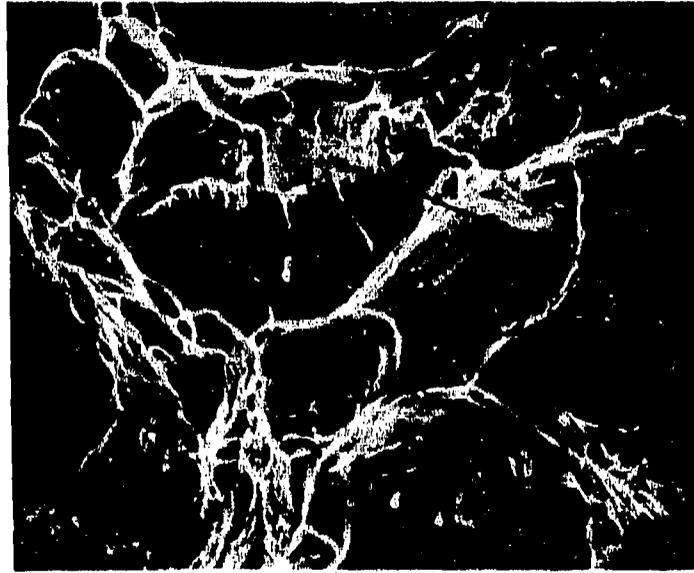
Fractured
Pearlite
Colonies

Figure 20. Dimple rupture and fractured pearlite colonies in hydrogen-embrittled A-588 fatigue specimen, 1500X.

it contained various mixed modes of fracture. Figure 20 shows areas of dimple rupture interspersed with areas of fractured pearlite colonies. The combination of fatigue striations and intergranular fracture shown in Figure 21 is somewhat uncommon; intergranular fracture occurred in the regions that had a preferred grain-boundary fracture path, in this case probably the result of hydrogen accumulation in the grain boundaries.

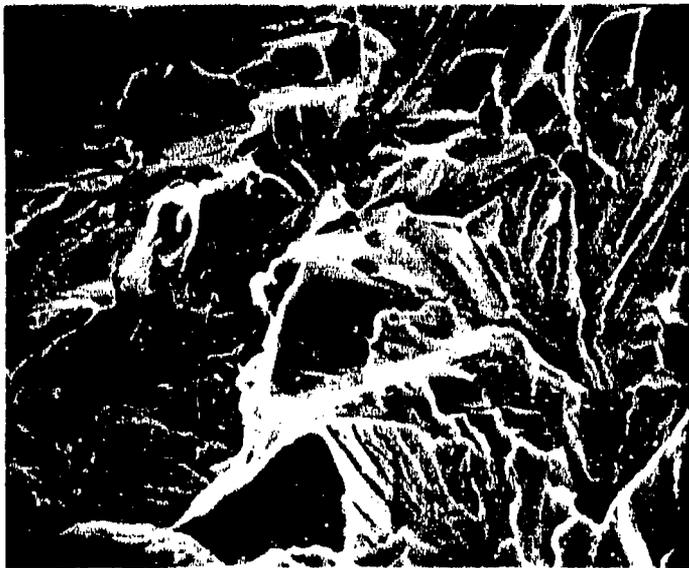
Figure 23. Cleavage facets in an A-588 Charpy specimen tested at -196°C , 1000X.

Figure 22 shows the fracture surface of an A-588 Charpy impact specimen tested to failure at -196°C. A higher magnification of the surface (Figure 23) shows that failure occurred by cleavage. Numerous river patterns are found on the facets. For the Charpy specimen tested at -103°C, the fracture surface consisted primarily of cleavage facets with some interspersed dimpled regions (Figure 24). When fracture occurred at -18°C, the interior surface showed primarily cleavage facets; at the edges, however, regions of mixed cleavage and dimples appeared. At room temperature (23°C), one area in the interior of the surface failed by cleavage; however, most of the specimen had failed by a combination of cleavage and dimple rupture (Figure 25), which gave the surface a fibrous texture (Figure 26).

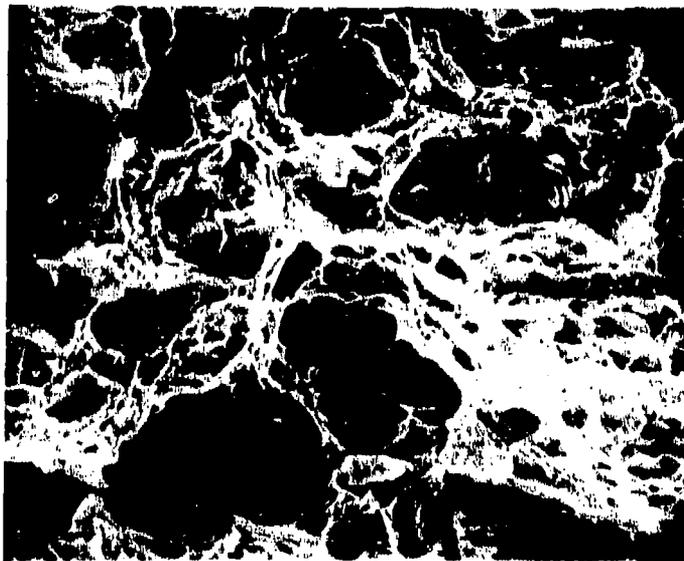
Figure 29. Inclusion-generated dimple rupture in an A-242 transverse specimen, 500X.

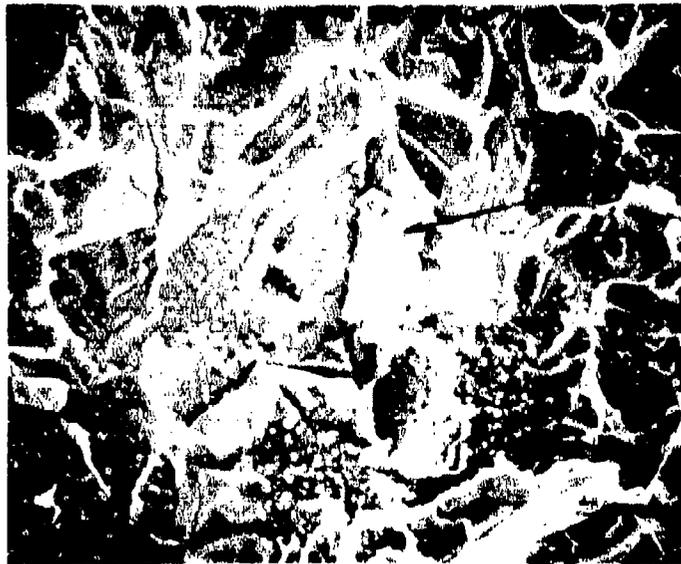
Grain
Boundary
Precipitation

Figure 43. Grain boundary precipitation in A-242 Charpy specimen tested at -196°C , 1000X.

The fracture surfaces of the A-242 Charpy specimens were shiny and faceted—indicating brittle fracture. The Charpy specimens tested at liquid nitrogen temperature (-196°C) were quite flat, and showed no lateral contraction (Figure 39). Both the longitudinal (Figures 40 through 46) and transverse specimens failed by cleavage; in some places the fracture propagated along grain boundaries and the fracture surface reveals the presence of some type of precipitate (Figure 40). The amount of lateral contraction on the fracture surface increased as the testing temperature increased from 0°C (Figure 40) to room temperature (Figure 43), to 121°C (Figure 44). Failure occurred at all temperatures by cleavage (Figure 45) in the center of the specimens, and by a combination of cleavage and dimple rupture in the shear lips (Figure 46). In all cases the Charpy impact energy was much lower than normal. Even at room temperature the energy value was only 8.0 ft-lb (10.8 J).

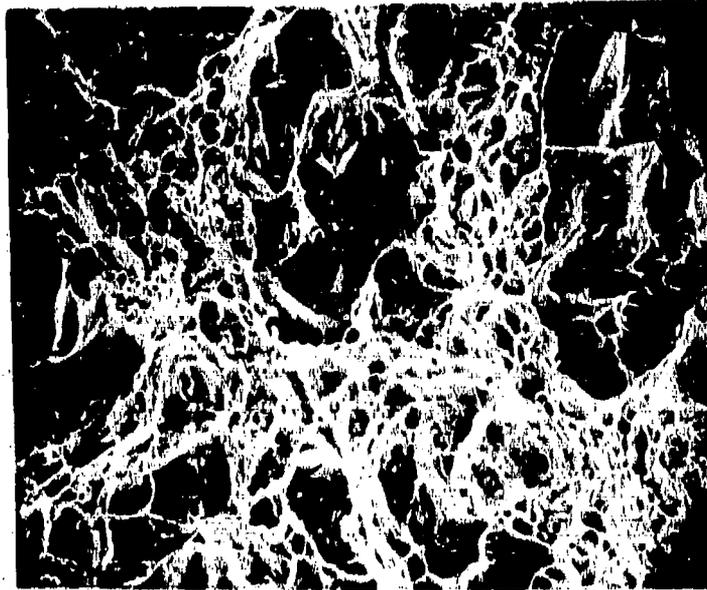
Figure 46. Dimple rupture and cleavage fracture in an A-242 transverse Charpy specimen, 500X.

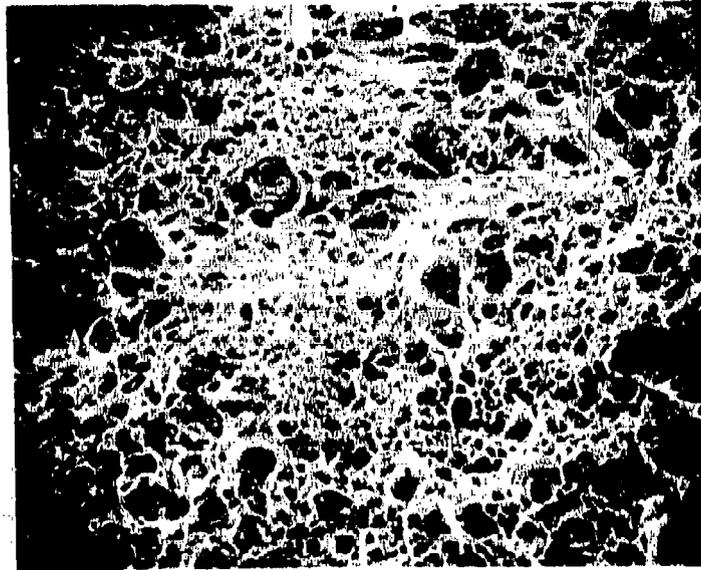
Figure 48. Dimple rupture in a solution heat-treated 17-4PH tensile specimen, 700X.

The fracture surface of the 17-4PH solution heat-treated tensile specimen is shown in Figure 47. Failure resulted from dimple rupture and microvoid coalescence (Figure 48). A small amount of necking occurred before failure.

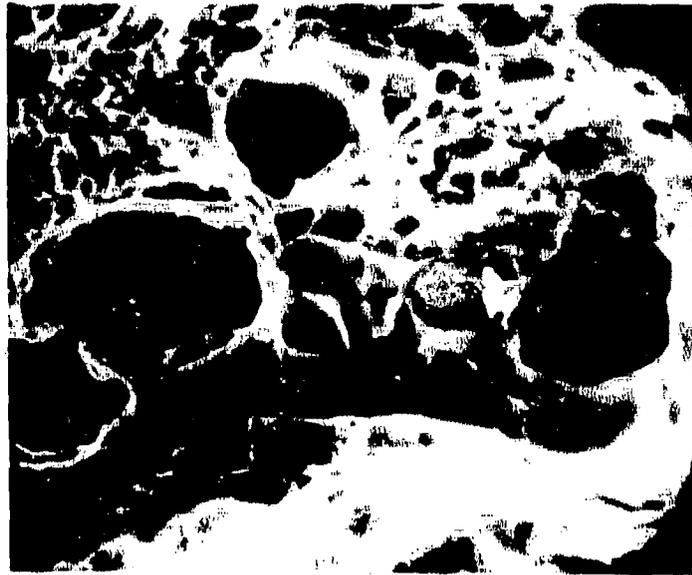
Figure 50. Inclusions in a 17-4PH tensile specimen aged at 538°C, 3500X.

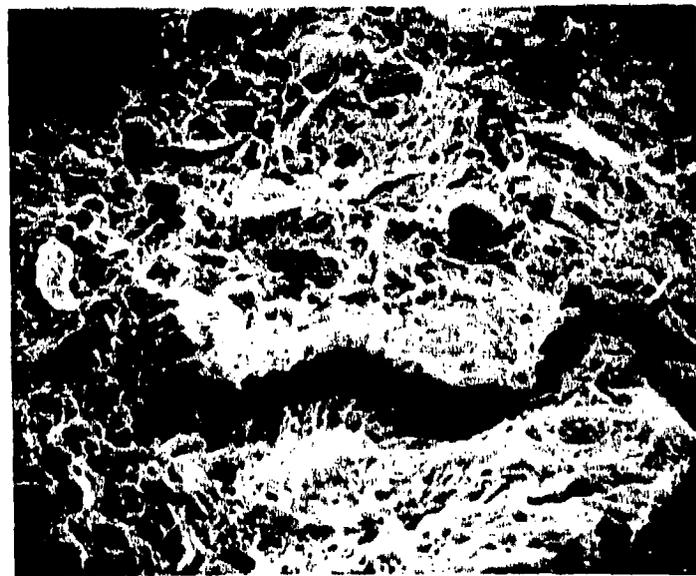
Figure 51. Dimple rupture and microvoid coalescence in a 17-4PH tensile specimen aged at 454°C, 700X. The crack-like regions are separations along elongated inclusions.

The fracture surfaces of the tensile specimens which were quenched and subsequently age-hardened at either 482°C , 454°C , or 538°C were similar. Characteristic illustrations of these tensile fractures are as follows: (1) Figure 49 indicates that some necking occurred before failure, with shear lips developing on all sides of the fracture (in other specimens this phenomenon was not consistent, since shear lips occurred only on one side); (2) Figure 50 shows extensive secondary cracking around large inclusions; and (3) Figure 51 indicates that failure occurred by the mechanisms of dimple rupture and microvoid coalescence.

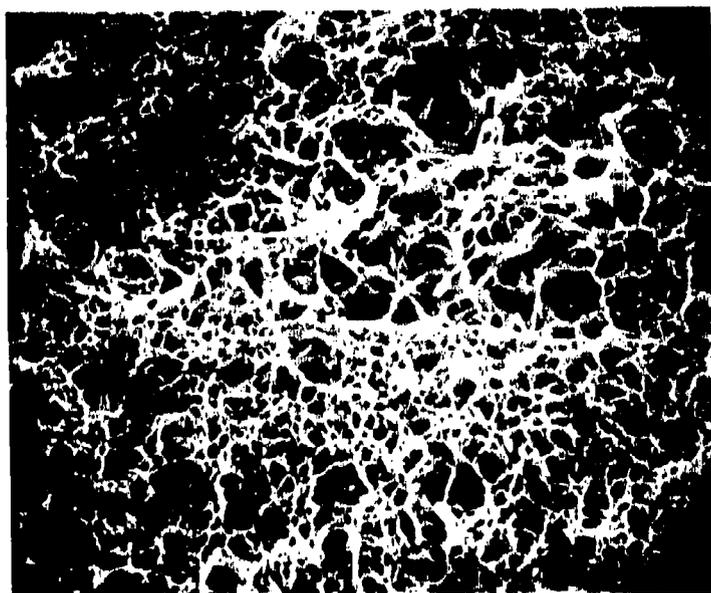
Figure 53. Dimple rupture in a 17-4PH hydrogen-charged tensile specimen, 1000X.

The hydrogen-charged 17-4PH tensile specimen is shown in Figure 52. The fracture surface slants towards a prominent shear lip on one side. The mechanism of failure was dimple rupture (Figure 53).
