USARTL-TR-78-26

**DESIGN, TEST, AND ACCEPTANCE CRITERIA FOR  
HELICOPTER TRANSPARENT ENCLOSURES**

Bruce F. Kay  
Sikorsky Aircraft Division  
United Technologies Corp.  
Stratford, Conn. 06602

Final Report for Period 27 June 1974 - 26 July 1976

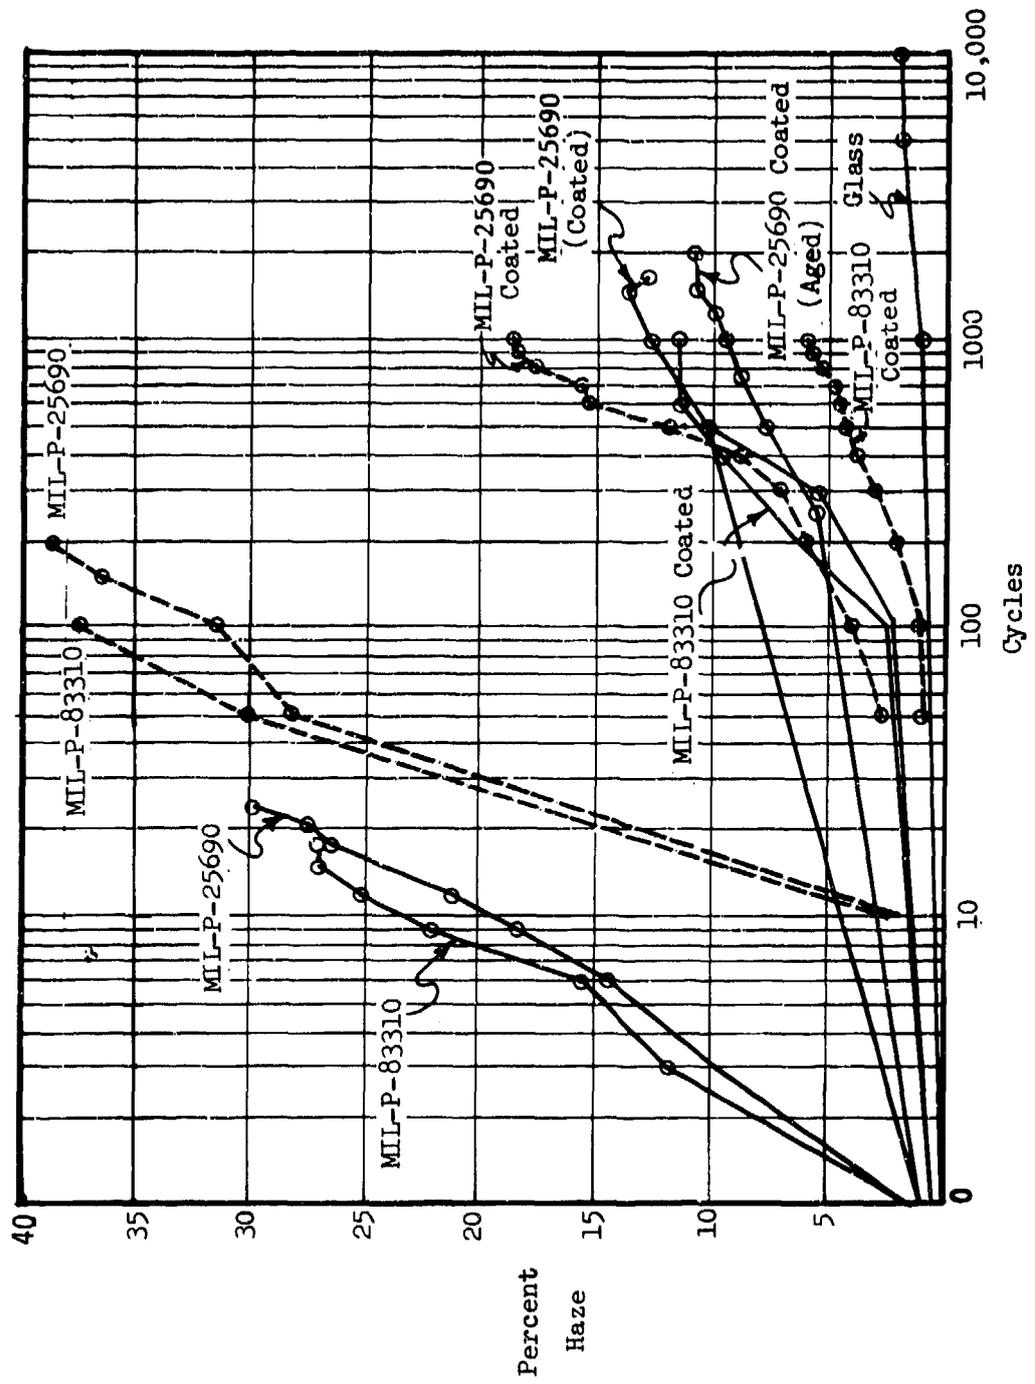
Test results are summarized in Table 3 and Figure 2. The dashed lines shown in Figure 2 are the average results from the AMMRC tests. Figure 3 shows a polycarbonate test specimen where the lighter rectangular shaped region is the abraded area.

Figure 2. Dry Rubbing Abrasion Test Results.

Artificially aged (250 hours exposure to 100% humidity at 160°F) hard-coated acrylic was more abrasion resistant than the unaged hard-coated acrylic. However, the effect of artificial aging was found to degrade adhesion of the hard coat to the polycarbonate substrate. Massive adhesive failure between the hard coat and the polycarbonate resulted in very high haze values after 1200 cycles.

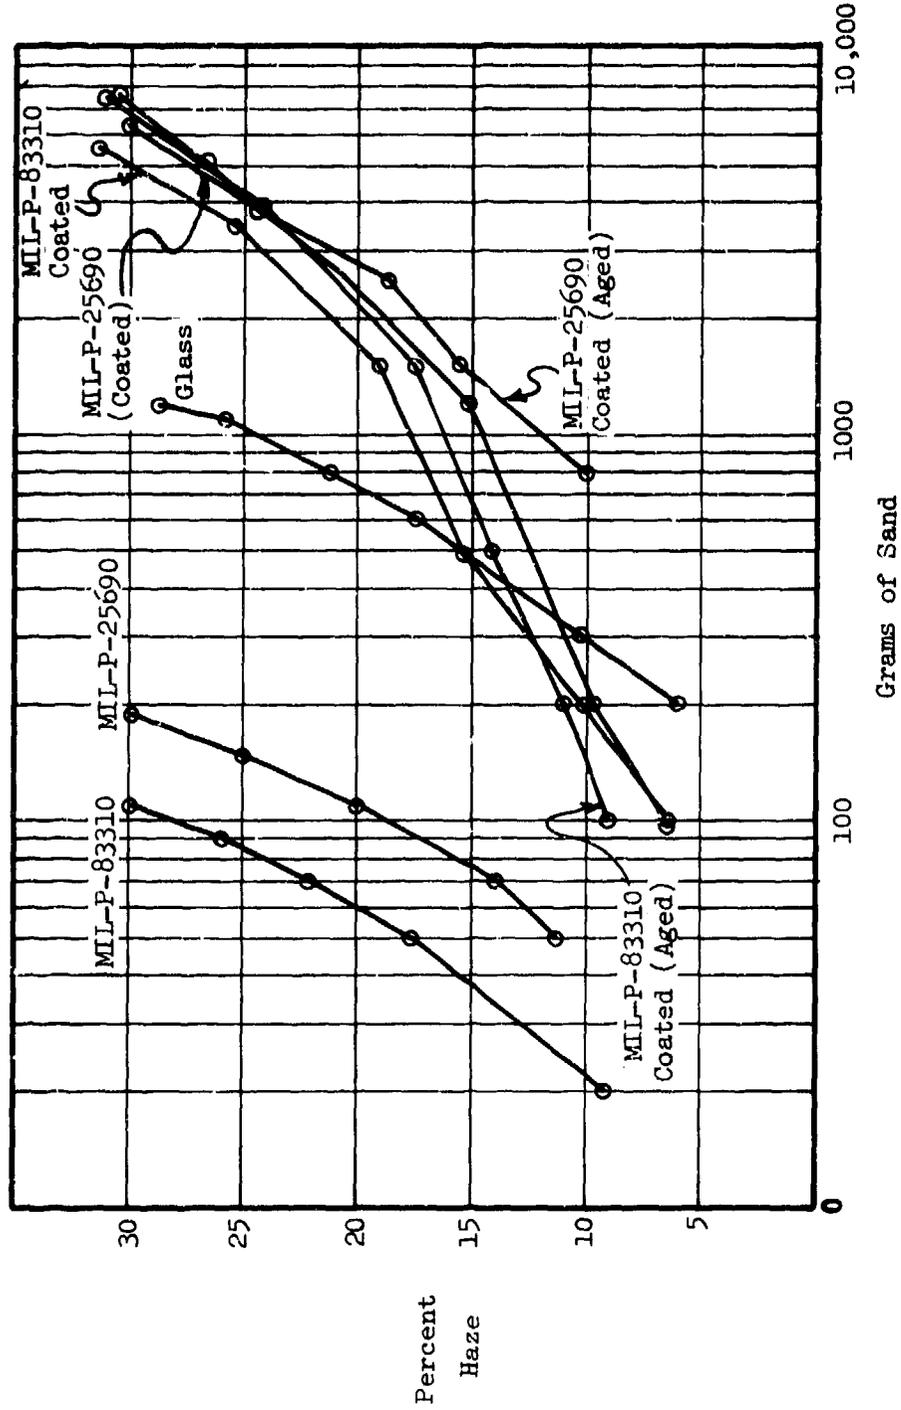
Test results are summarized in Table 4 and Figure 4 as a function of the amount of sand required to produce a given level of haze.

Figure 4. Falling Sand Test Results.

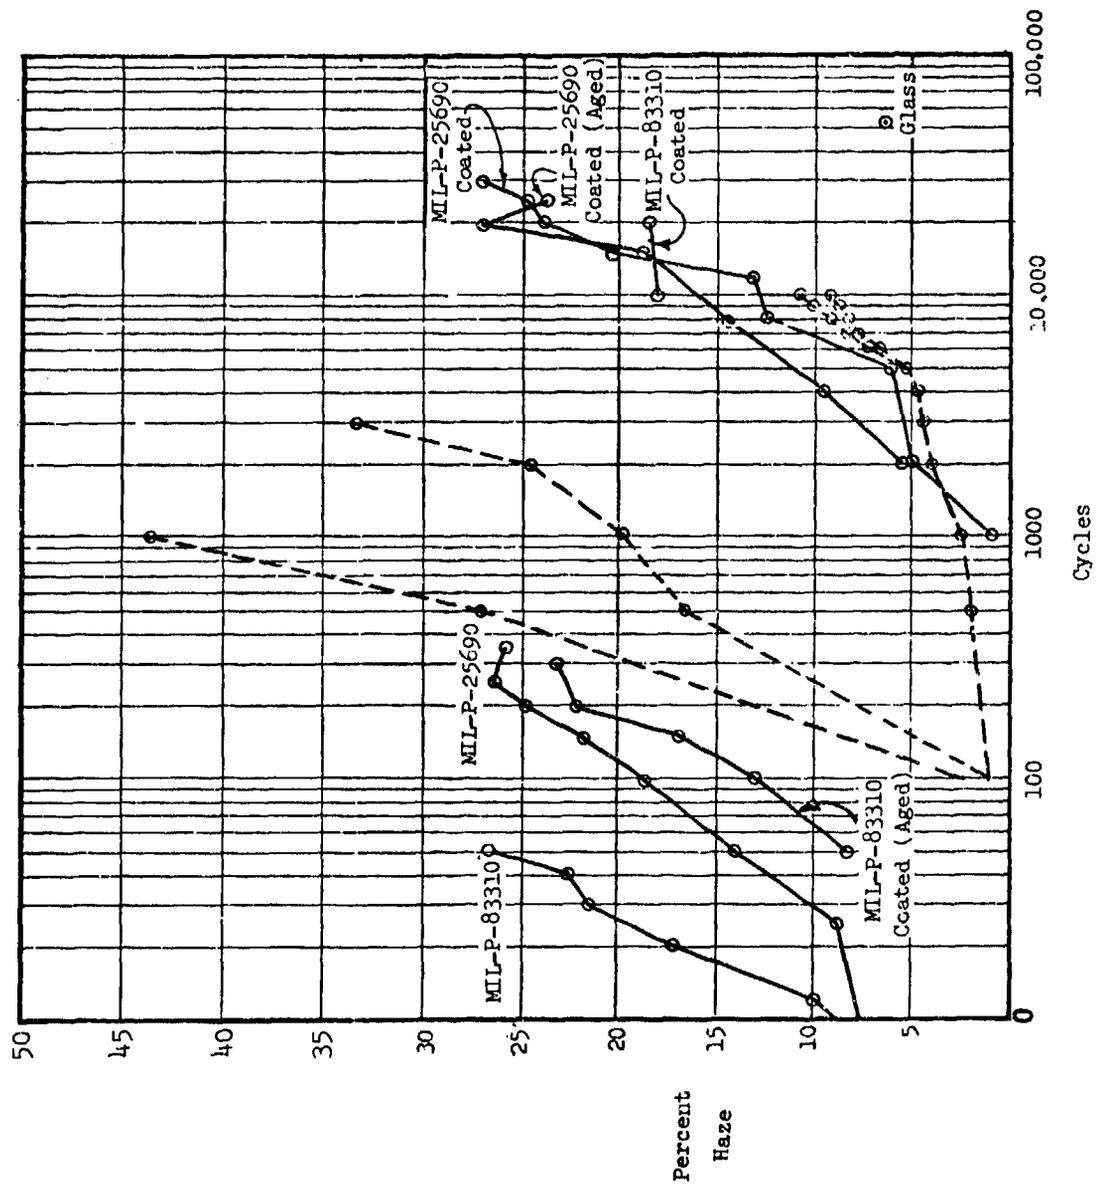
Test results are summarized in Table 5 and Figure 5. The dashed lines shown in Figure 5 are the average results obtained from the AMMRC tests.

Figure 5. Windshield Wiper Test Results.

Uncoated polycarbonate and stretched acrylic suffered immediate degradation from the wiper actions. The tests showed no significant difference in abrasion resistance between aged or unaged hard-coated acrylic specimens. However, the aging process had an apparent deleterious effect on the hard-coated polycarbonate, as evidenced by marginal adhesion of the coating to the substrate on some specimens. The marginal adhesion of the hard coat adversely affected the testing of two out of five specimens at 10,000 cycles, whereas the other three exhibited high readings only after 50,000 cycles.

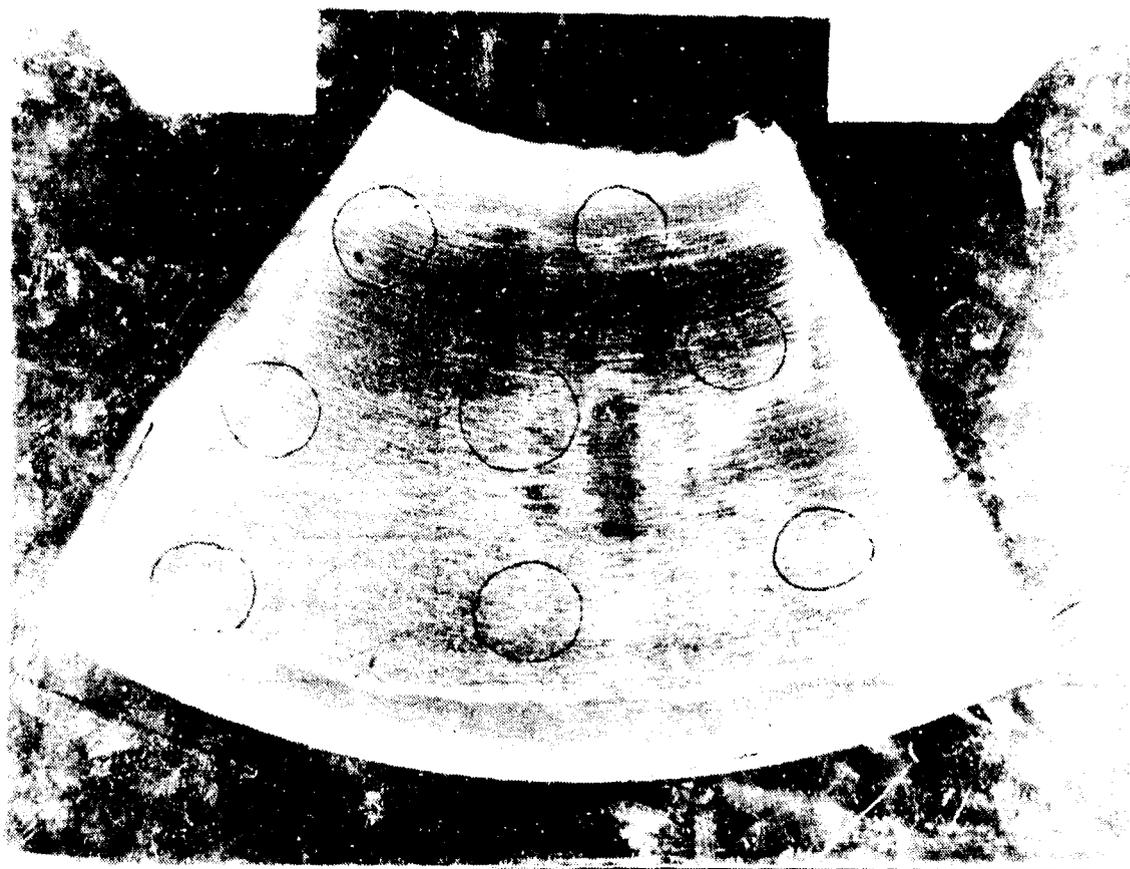
An abraded specimen is shown in Figure 6. The circles on the specimen indicate the locations where haze measurements were taken.

Figure 6. Windshield Wiper Test Abraded Sample.

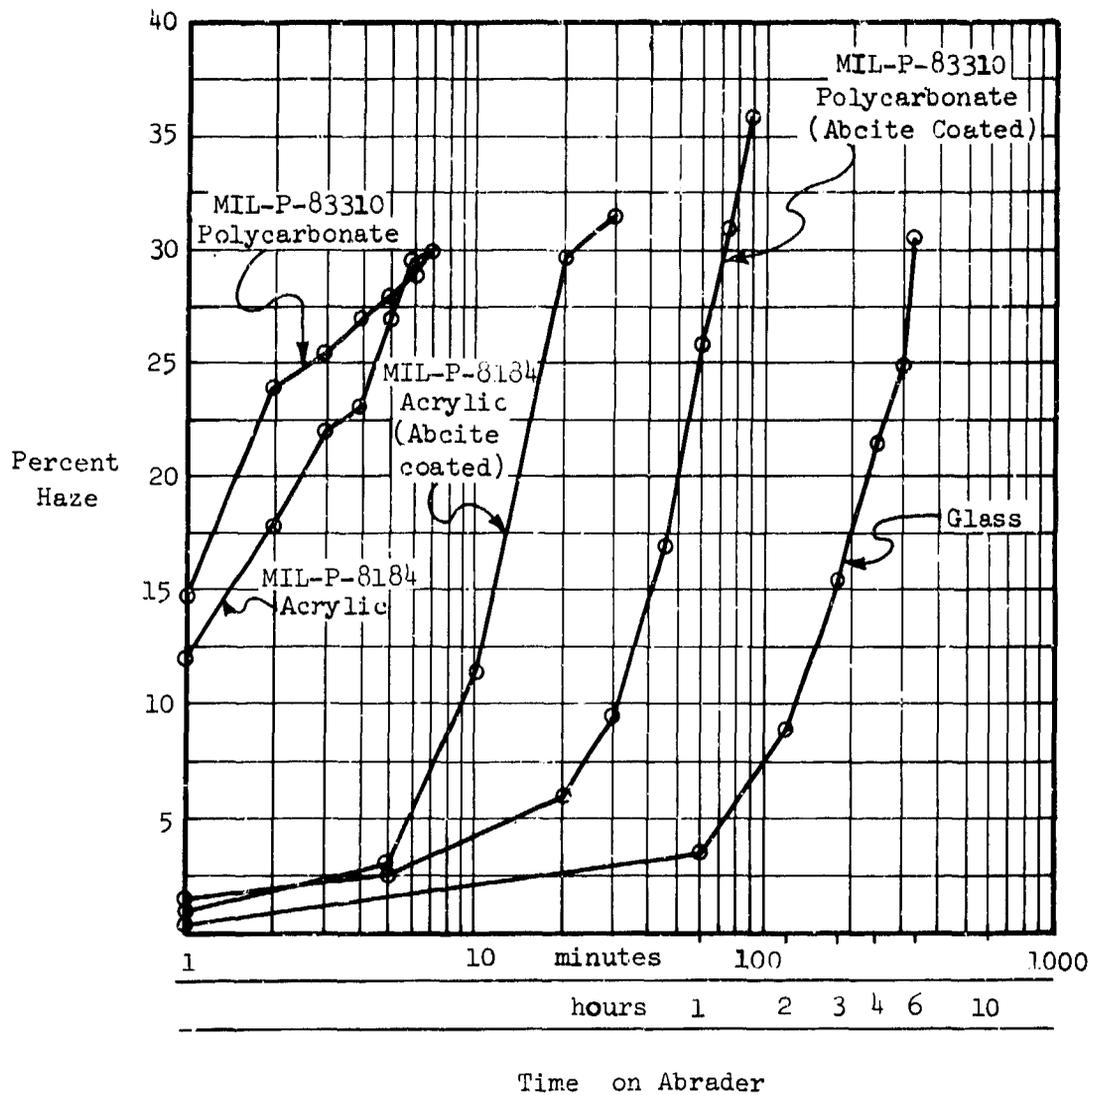
In this test, inconsistency of abrasion caused deviations greater than 1% haze, and an average deviation of approximately 5% haze. Test results are shown in Table 6 and Figure 7 for each material.

Figure 7. Wet Rubbing Abrasion Test Results.

The relative performance of the coated versus uncoated materials showed that significant benefits were obtained from the hard coats. The hard-coated polycarbonate was found to be superior to the hard-coated acrylic. It is also interesting to note that it was possible to abrade the glass specimen to 30% haze with this test, while the dry rubbing abrasion test could only achieve 2% haze after 10,000 abrasion cycles.

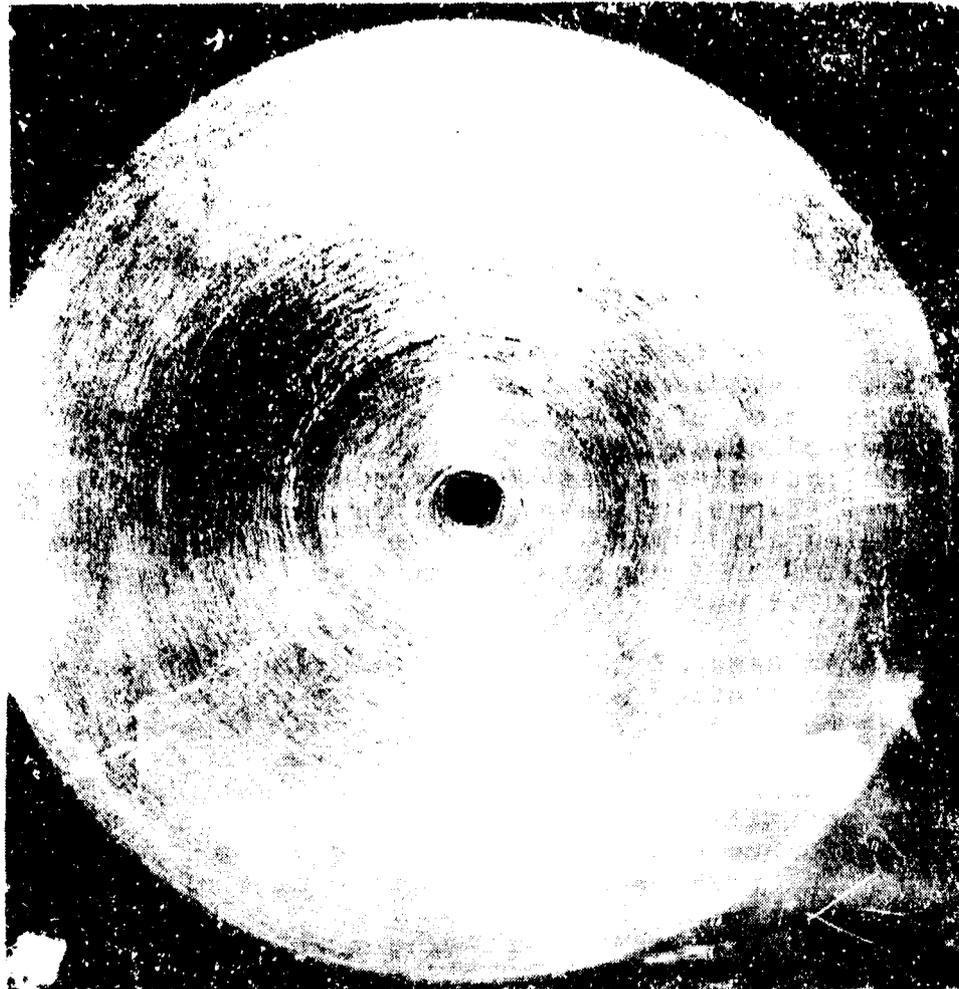
The characteristic abrasion marks produced by the test are illustrated in Figure 8.

Figure 8. Specimen From Wet Rubbing Abrasion Test.

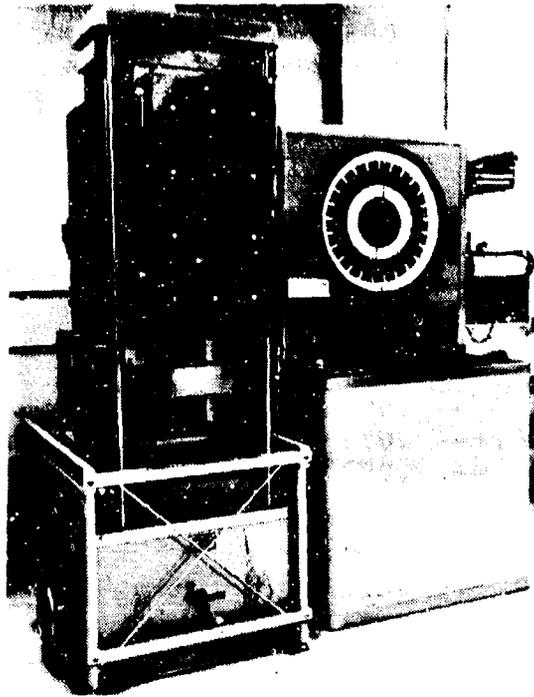
A BLH Universal Testing Machine, Model PIE12 (Figure 9), was used in all tests. This testing machine was equipped with the necessary drive mechanism for imparting to the crosshead a uniform, controlled velocity with respect to the base. Also, it incorporated a load-indicating mechanism capable of showing the total load carried by the test specimen. This mechanism was essentially free from inertial lag at the specified rate of testing and indicated the load within the specified accuracy of +1.0 percent of the indicated value.

Figure 9. Baldwin Model 3LH PIE-132 Universal Testing Machine.

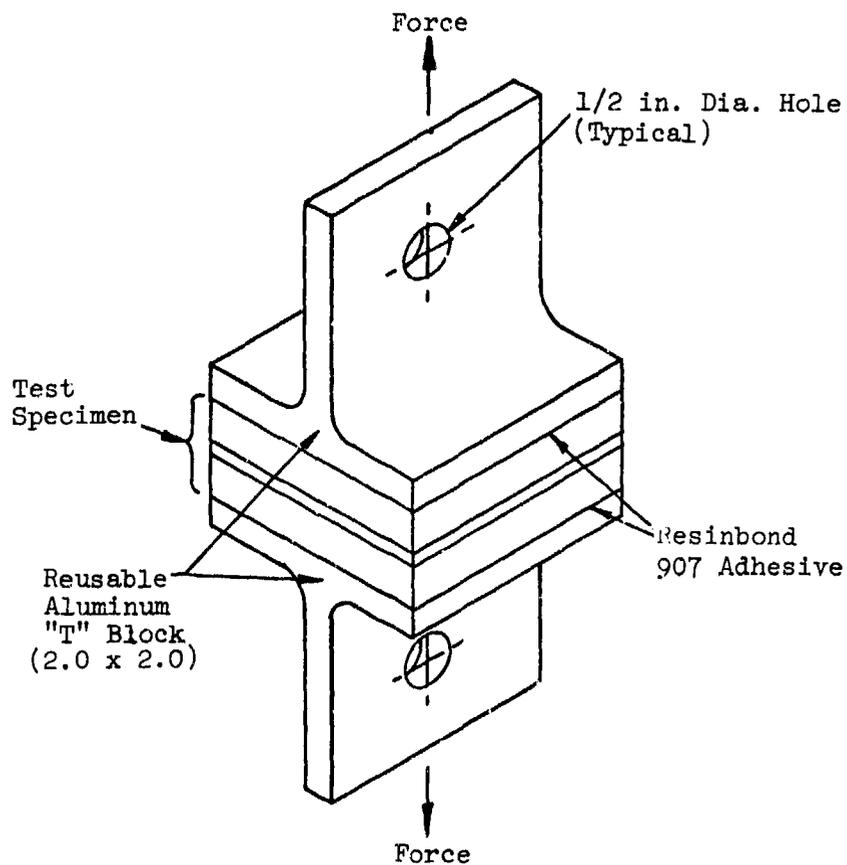
Metal blocks were made using an aluminum "T" section cut to a 2-inch square. A hole was drilled in the upright section of each "T" block (see Figure 10) to accommodate a metal pin or holding device correlative to the test machine used.

Figure 10. Bond Tensile "T" Blocks.

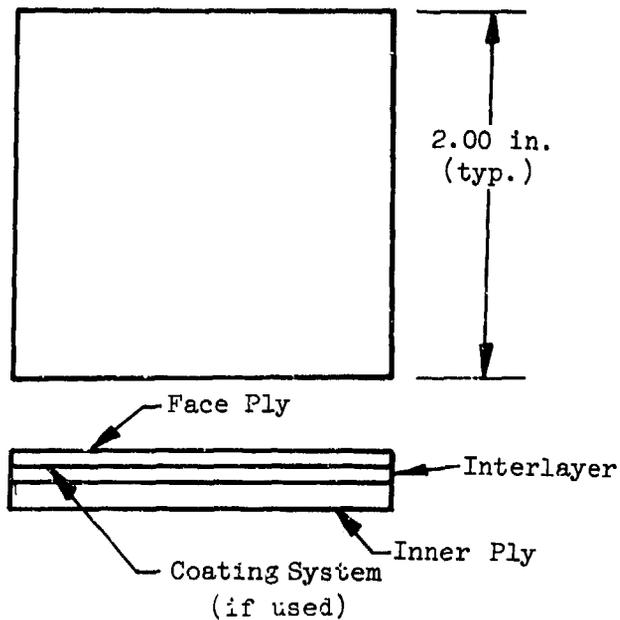
The coupon specimens for this test were fabricated as shown in Figure 11.

Figure 11. Test Coupon, Tensile Bond.

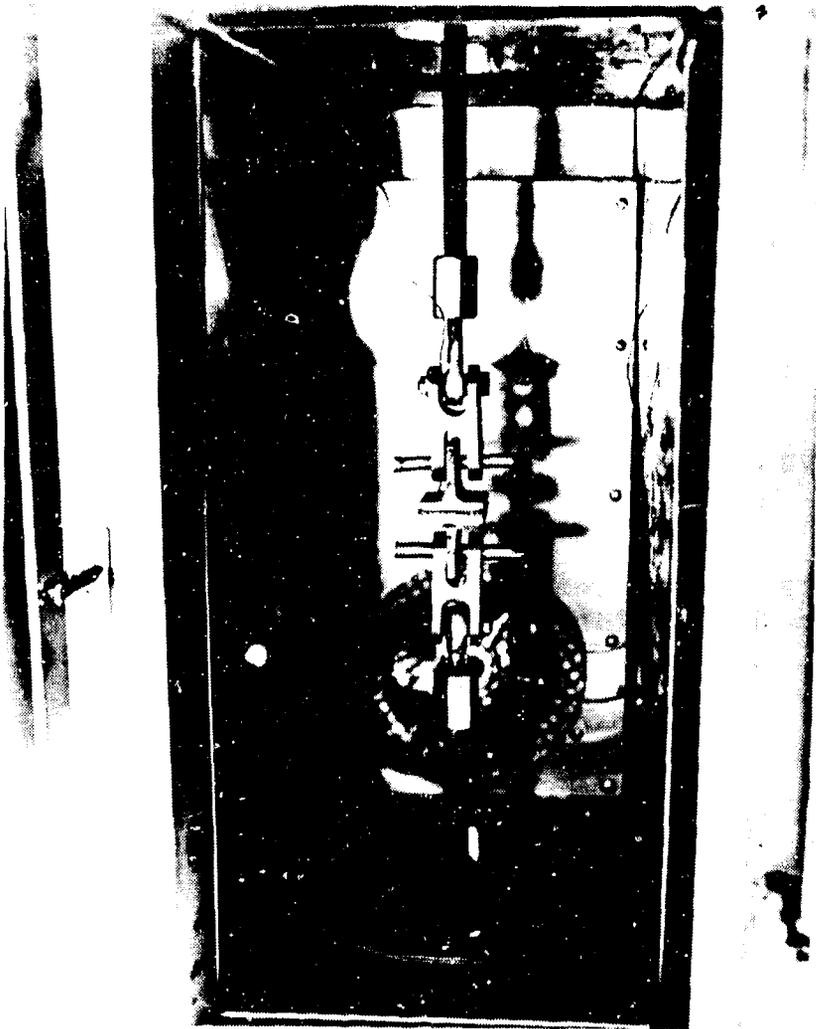
1. Three specimens of each configuration were tested at each temperature.
2. The specimens were each placed in the tensile testing machine with self-aligning holders, Figure 12, and loaded to failure at a rate of 0.2 inch/minute.
3. Step 1 was repeated at a temperature of  $-65^{\circ}\text{F} \pm 5^{\circ}\text{F}$ .
4. Step 1 was repeated at a temperature of  $+125^{\circ}\text{F} \pm 5^{\circ}\text{F}$ .

Figure 12. Bond Tensile Test Setup.

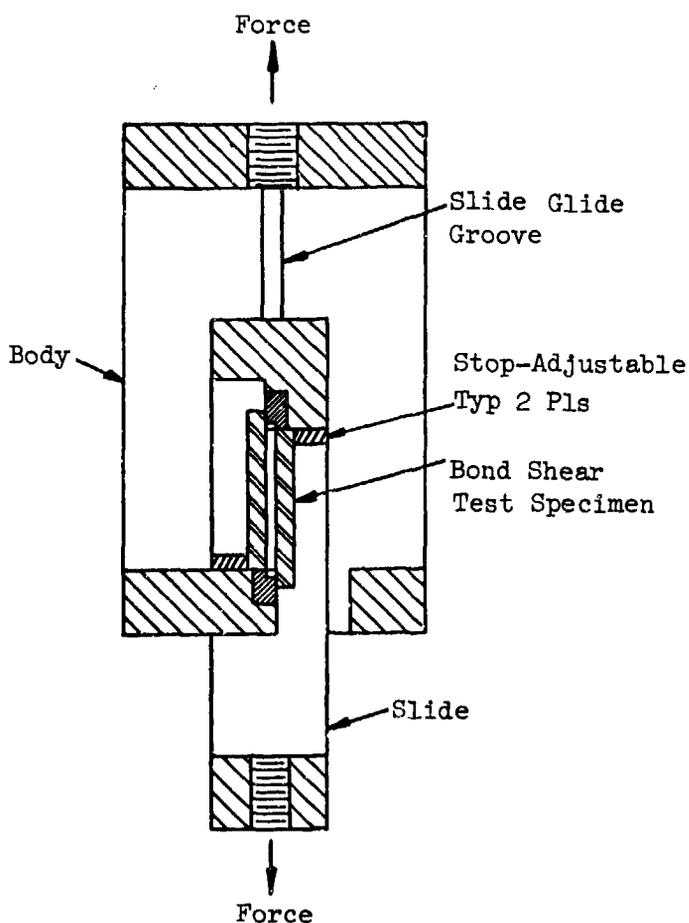
The shear test fixture was a sliding type constructed so that it imparted a shearing load on each side of the interlayer directly to the rigid outer plies. A cross section is shown in Figure 13.

Figure 13. Bond Shear Test Fixture.

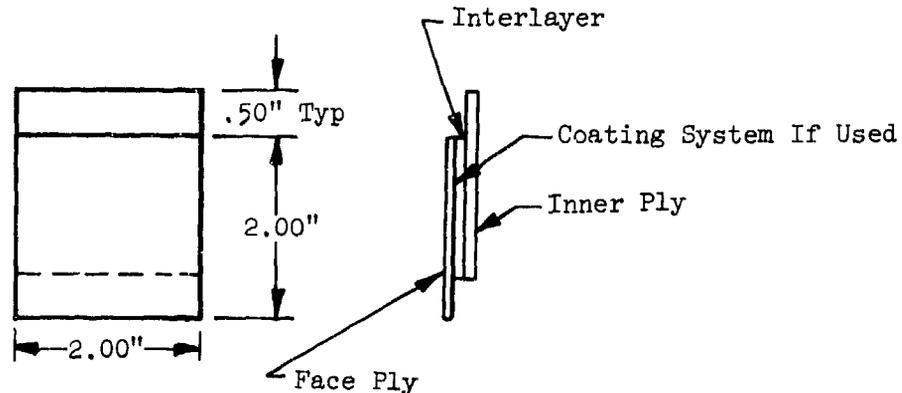
The coupon specimens for this test were fabricated as shown in Figure 14.

Figure 14. Bond Shear Test Specimen.

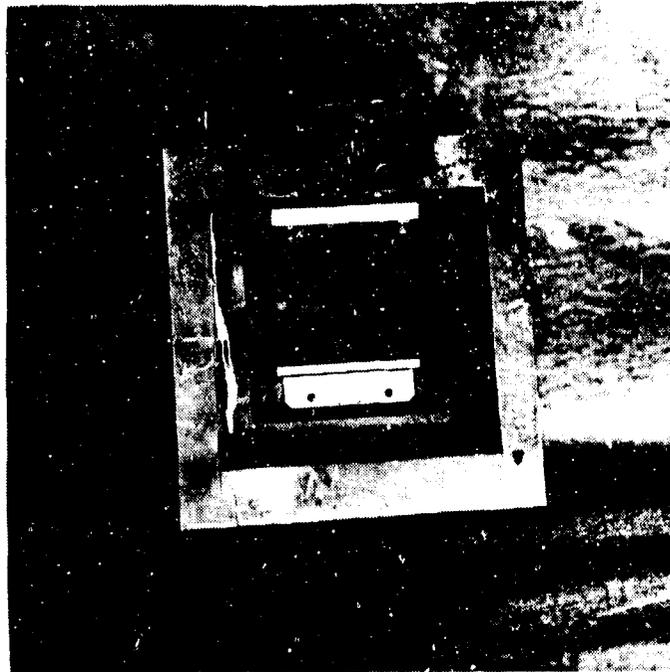
1. The length, width, and thickness of the bond area were measured to the nearest 0.001 inch and recorded.
2. The specimen was mounted in the test fixture, Figure 15, by carefully aligning the loaded end of the specimen parallel to the loading bar. A dial indicator, capable of measuring deflections to 0.001 inch, was mounted on the machine to measure crosshead motion.

Figure 15. Shear Fixture.

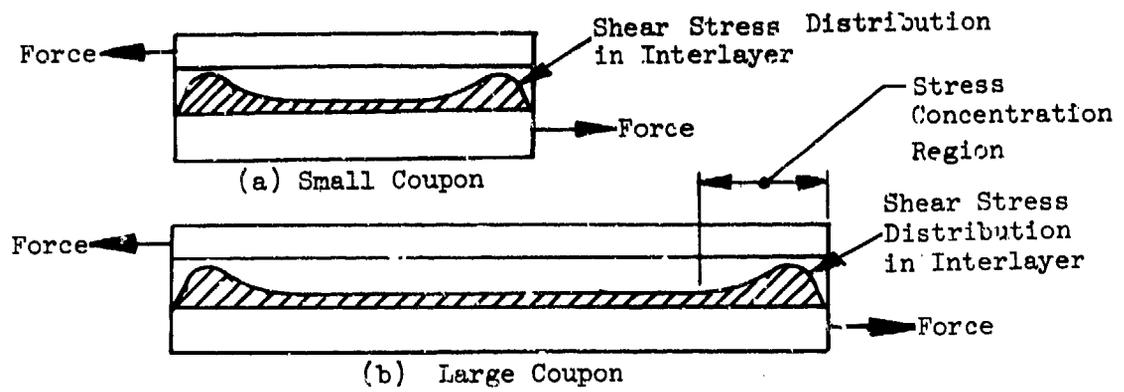
It should be noted that the bond shear test results obtained for these small samples include interlayer stress concentrations at the sample edge as shown in Figure 16(a). That is, for small samples such as those tested, the stress concentration region is a much larger portion of the total shear area than it is for full-scale panels. Therefore, the gross shear strength data determined from the small 2-inch-square specimens could be considerably higher.

Figure 16. Shear Stress Distribution in Interlayer.

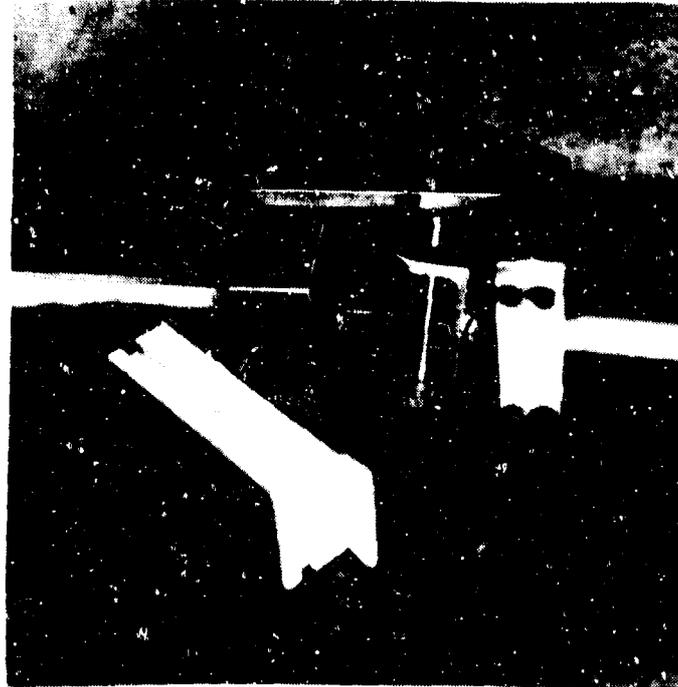
A test fixture was provided as shown in Figure 17. It was constructed so that one specimen was held rigidly against a stationary metal block while a moveable ram applied a load to the extended edge of the specimen, Figure 18.

Figure 17. Cleavage Test Fixture With Restrainer to Prevent Loading Pin Deflecting Away From Coupon.

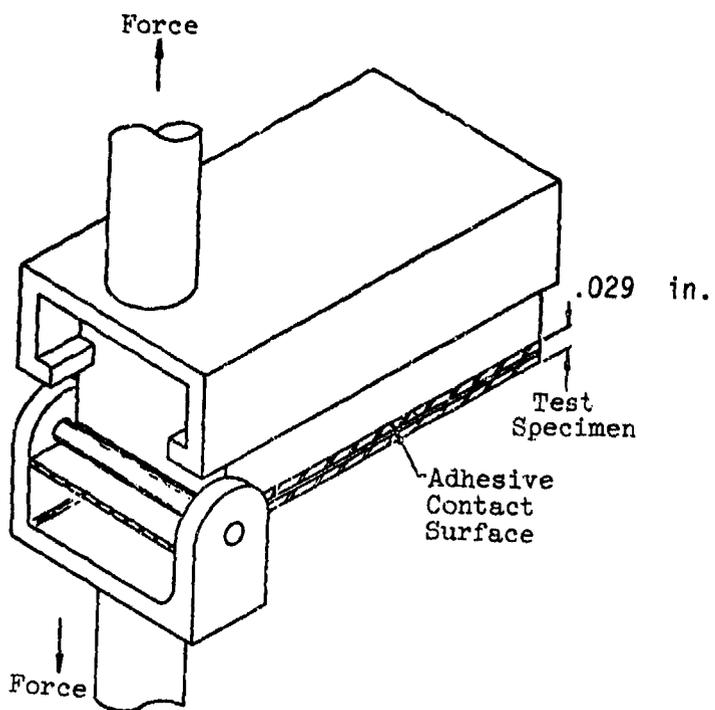
Figure 18. Cleavage Test Fixture.

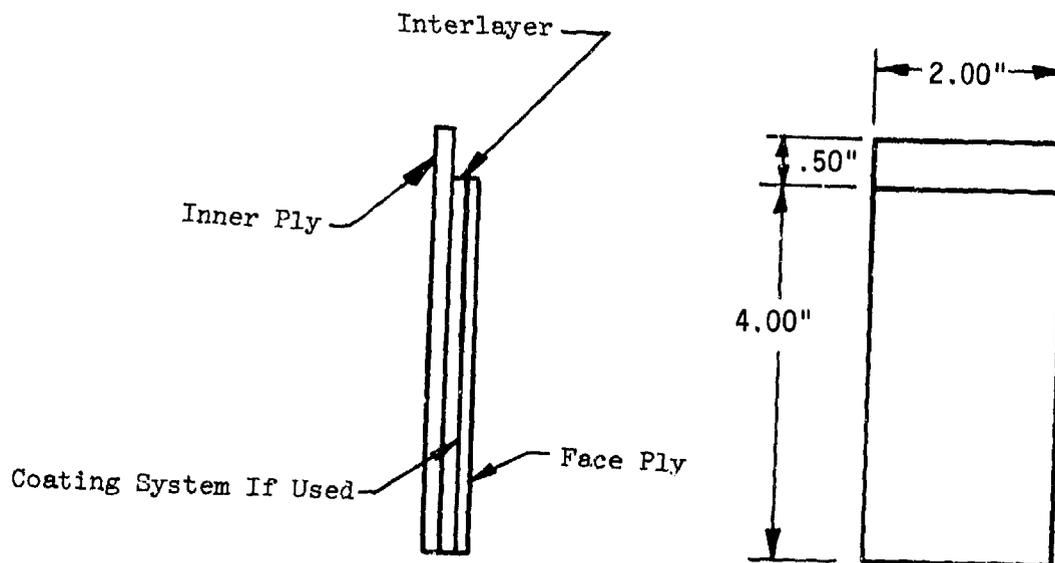
The coupon specimens for this test were fabricated as shown in Figure 19.

Figure 19. Bond Cleavage Test Specimen.

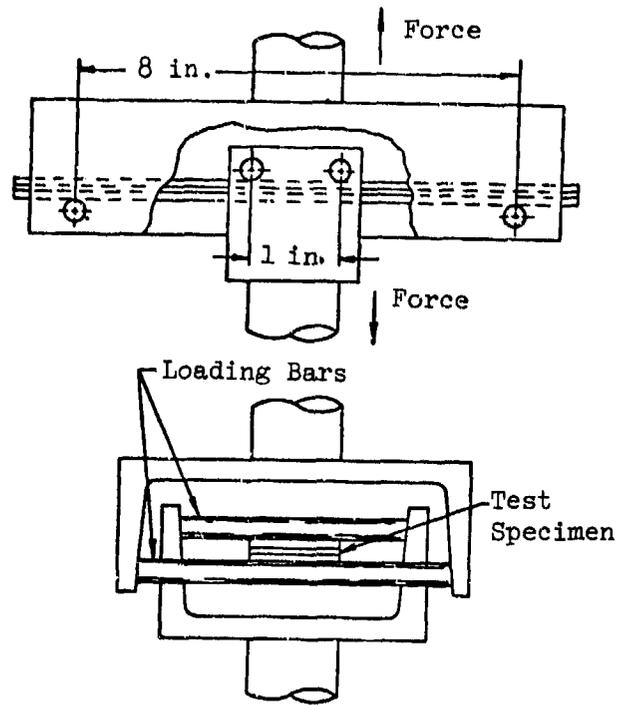
A four-point beam loading setup was provided to load the specimen as shown in Figures 21 and 22. The distance between the lower supports was 8 inches and the distance between the loading bars was 1 inch. All supports were constructed in accordance with the method shown in ASTM D-690.

Figure 21. Flexural Test Setup.

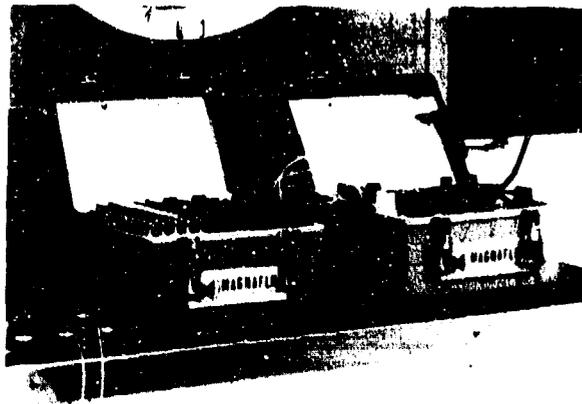
A Starrett 0 to 1 inch (0.001 inch subdivisions) dial indicator, calibrated to  $\pm 0.001$  inch, was used to measure deflection. A Magnaflux Bridge and Balance Unit, Model GB-100 (Figure 23), with an accuracy of  $\pm 1$  microstrain; a Strain Indicator Model GA-100, accurate to  $\pm 1$  microstrain; and Strain Gauges, Model PA06-250BA-120, accurate to  $\pm 1\%$ , were used to determine strain characteristics during flexural testing.

Figure 23. Strain Measuring Equipment.

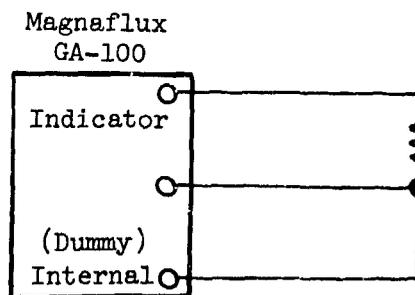
To allow for strain gauge thermal compensation, a quarter bridge, three-wire circuit (Figure 24), using the indicator internal dummy, was used; this caused temperature changes to appear equally in adjacent arms of the bridge and resulted in a strain measurement that was unaffected by changes in lead resistance caused by changes in temperature.

Figure 24. Strain Gauge Thermal Compensation.

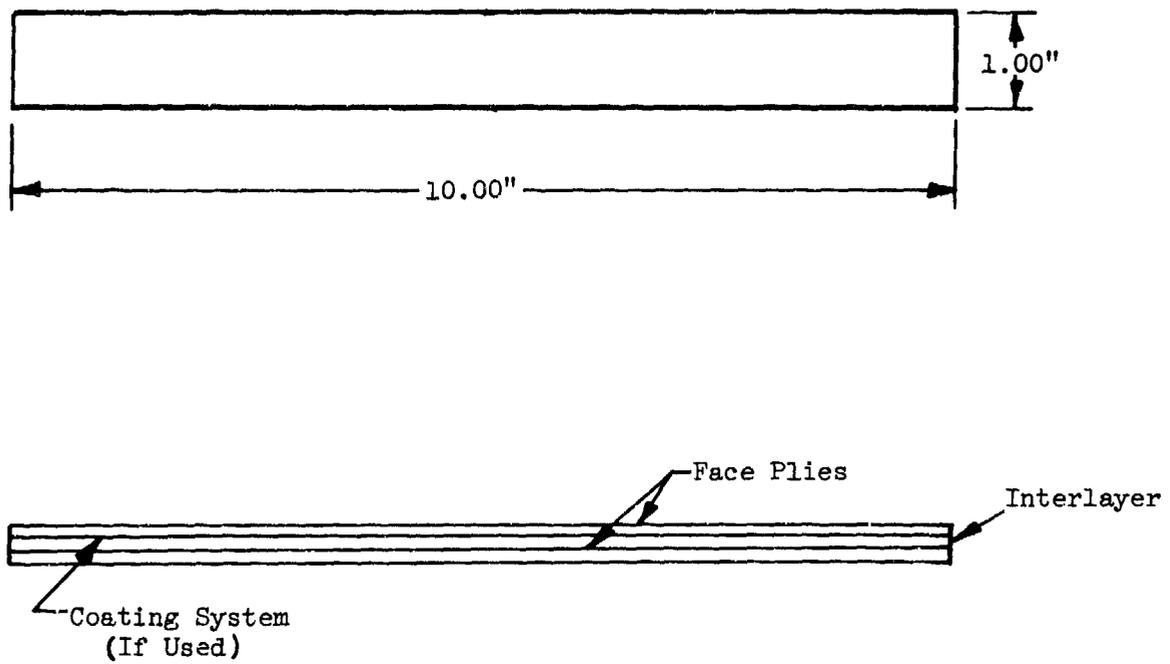
The coupon specimens for this test were fabricated as shown in Figure 25.

Figure 25. Flexure Test Typical Specimen.

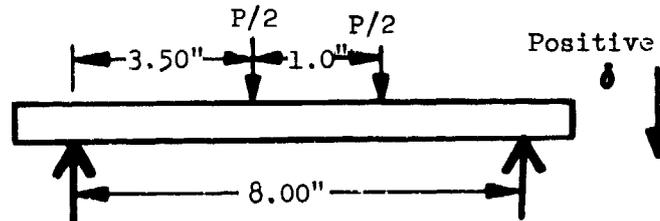
Using the geometry shown in Figure 27, the following relationship was derived:

- P = total applied load (lb)
- E = modulus of elasticity (psi)
- I = moment of inertia (in.<sup>4</sup>)
- $\delta$  = beam deflection at midspan (in.)

Figure 27. Beam Loading Geometry.

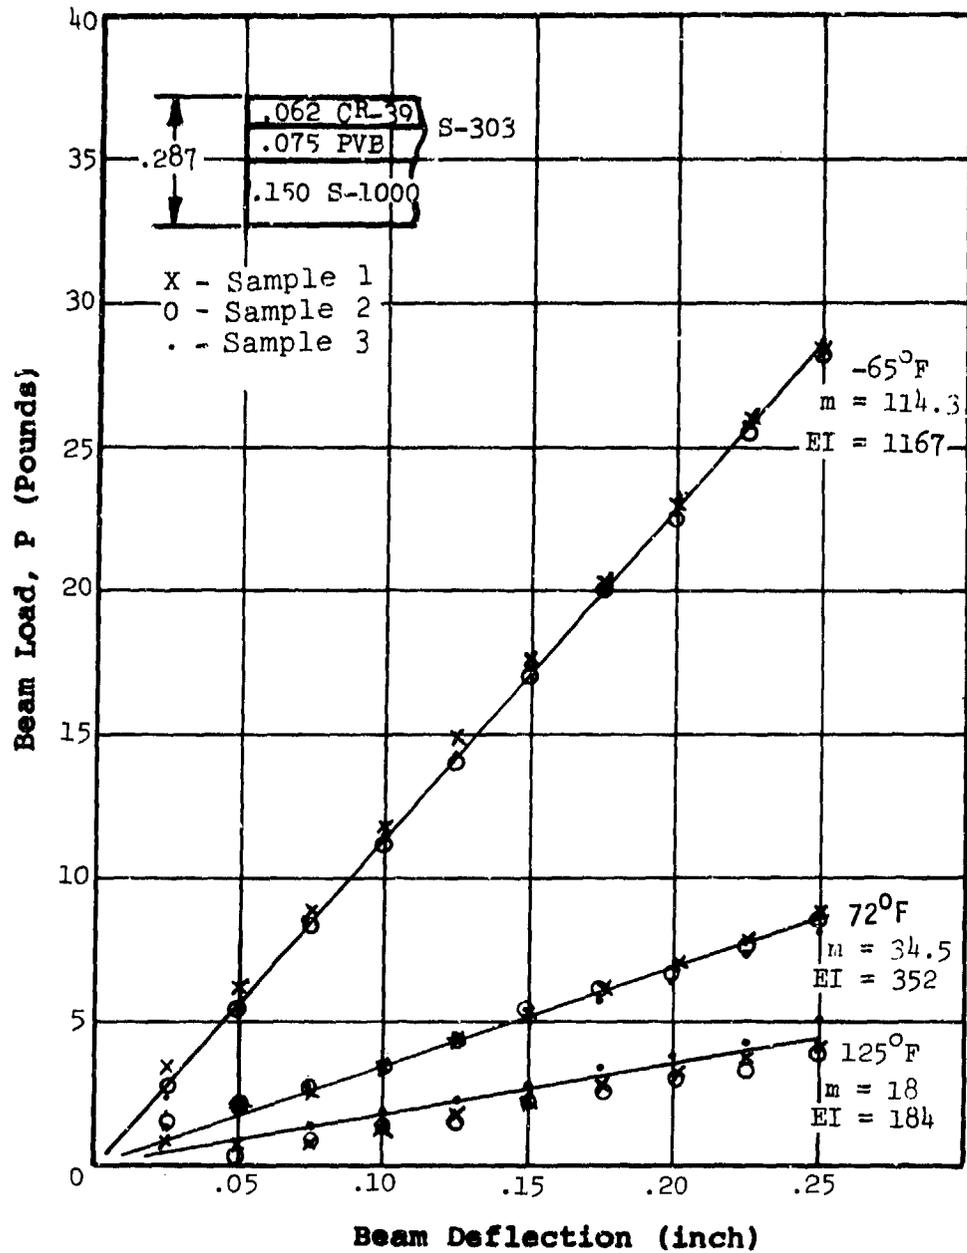
Figures 28 through 31 show the load deflection lines derived from the test data. The slopes, m, and the EI were determined for each test temperature.

Figure 28. Load Deflection Test Data, Polyester/PVB/Acrylic Laminate with Coating.

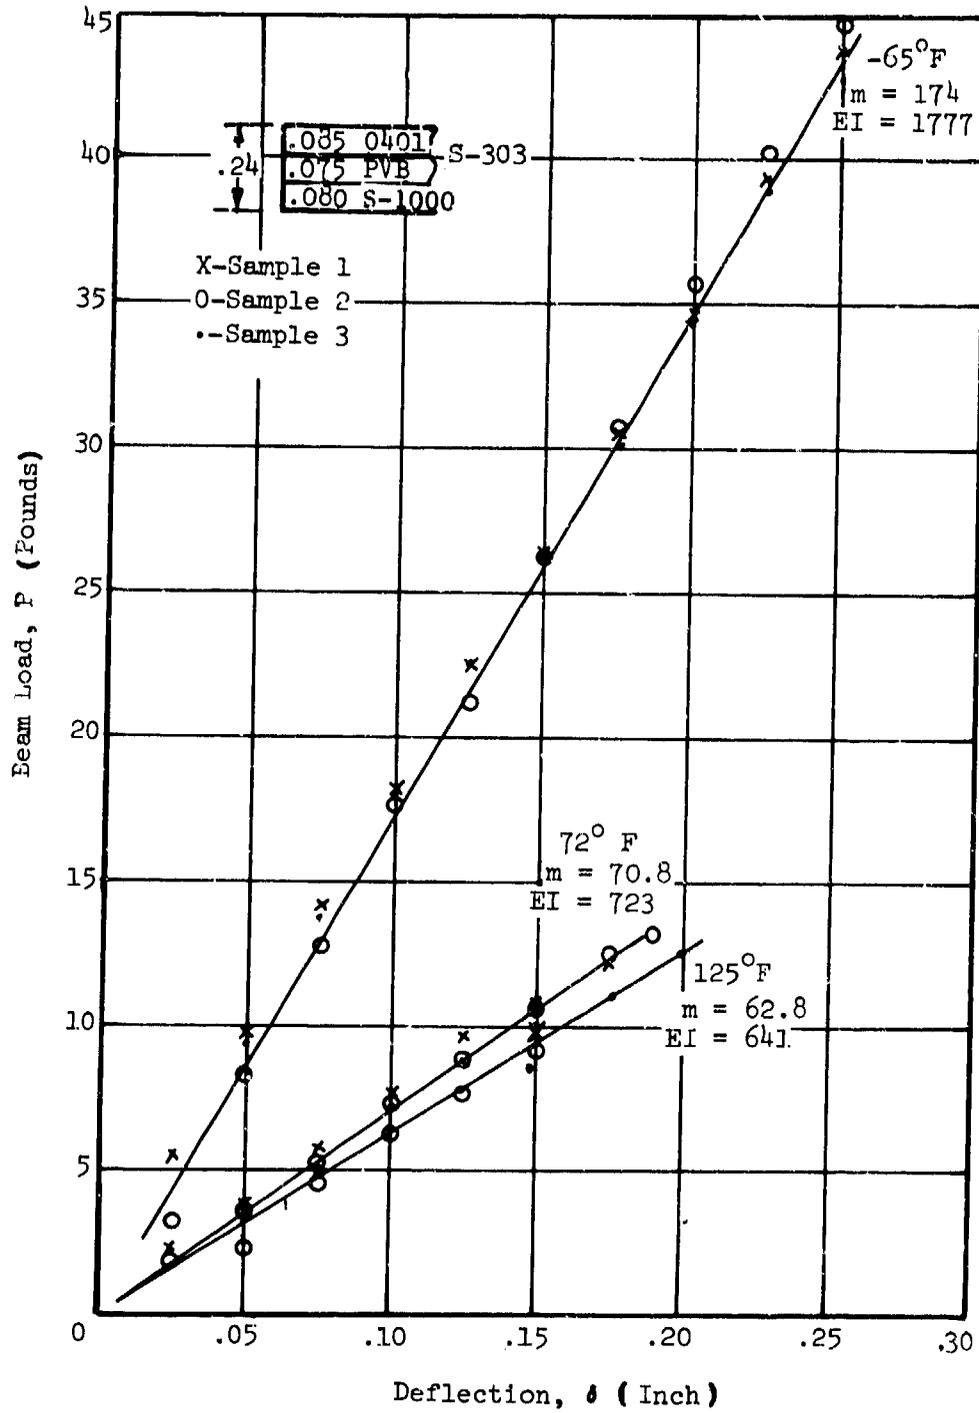
Figure 29. Load Deflection Test Data, Glass/PVB/Acrylic Laminate with Coating.

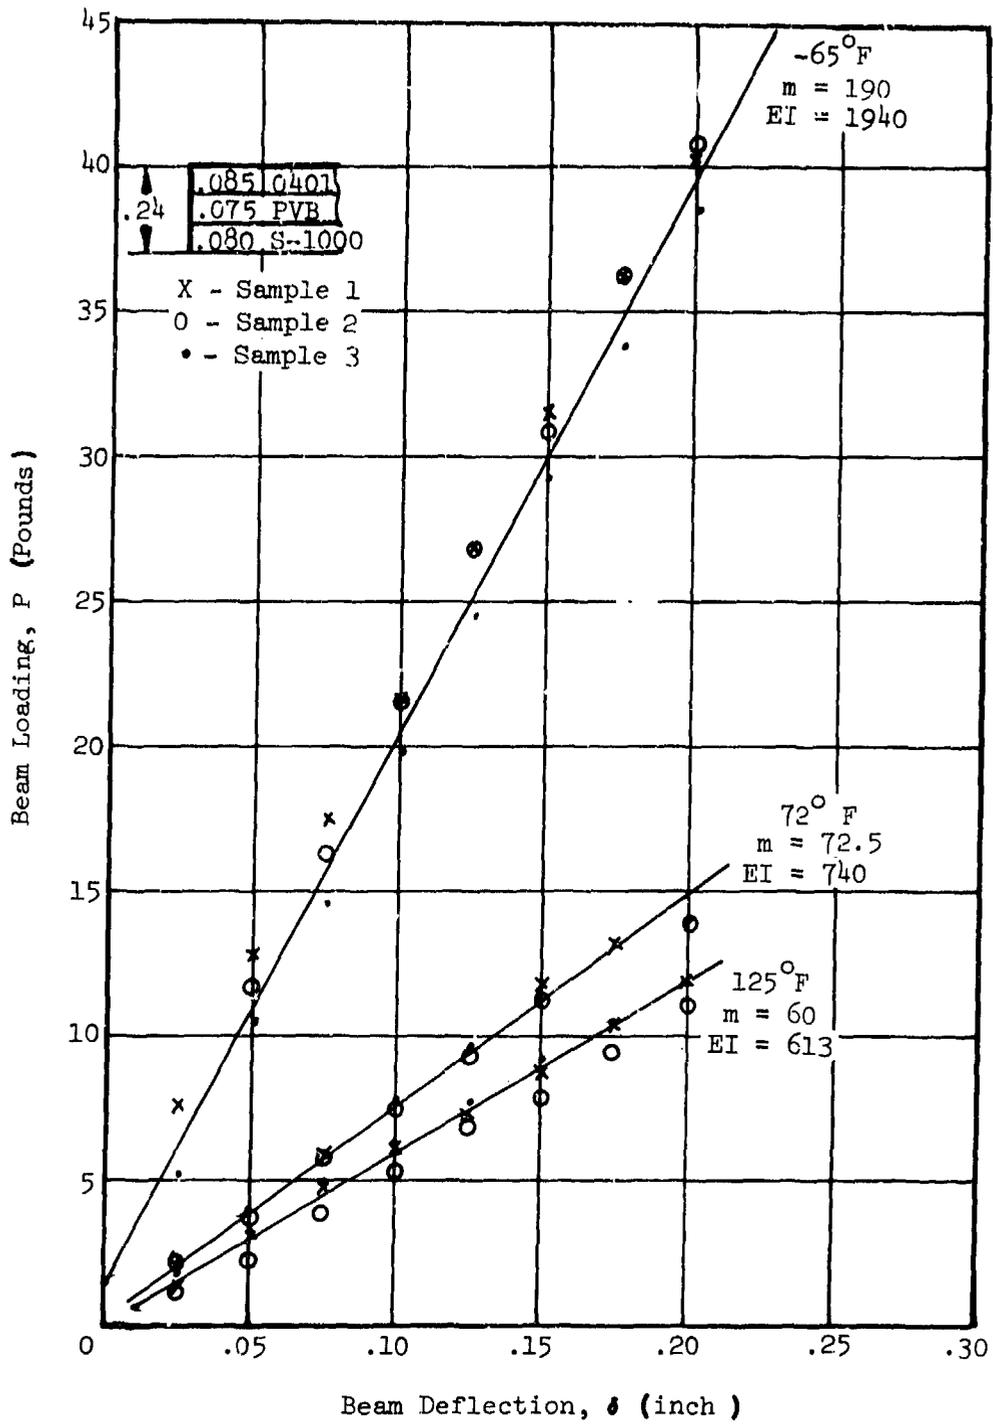
Figure 30. Load Deflection Test Data, Glass/PVB/Acrylic Laminate, No Conductive Coating.

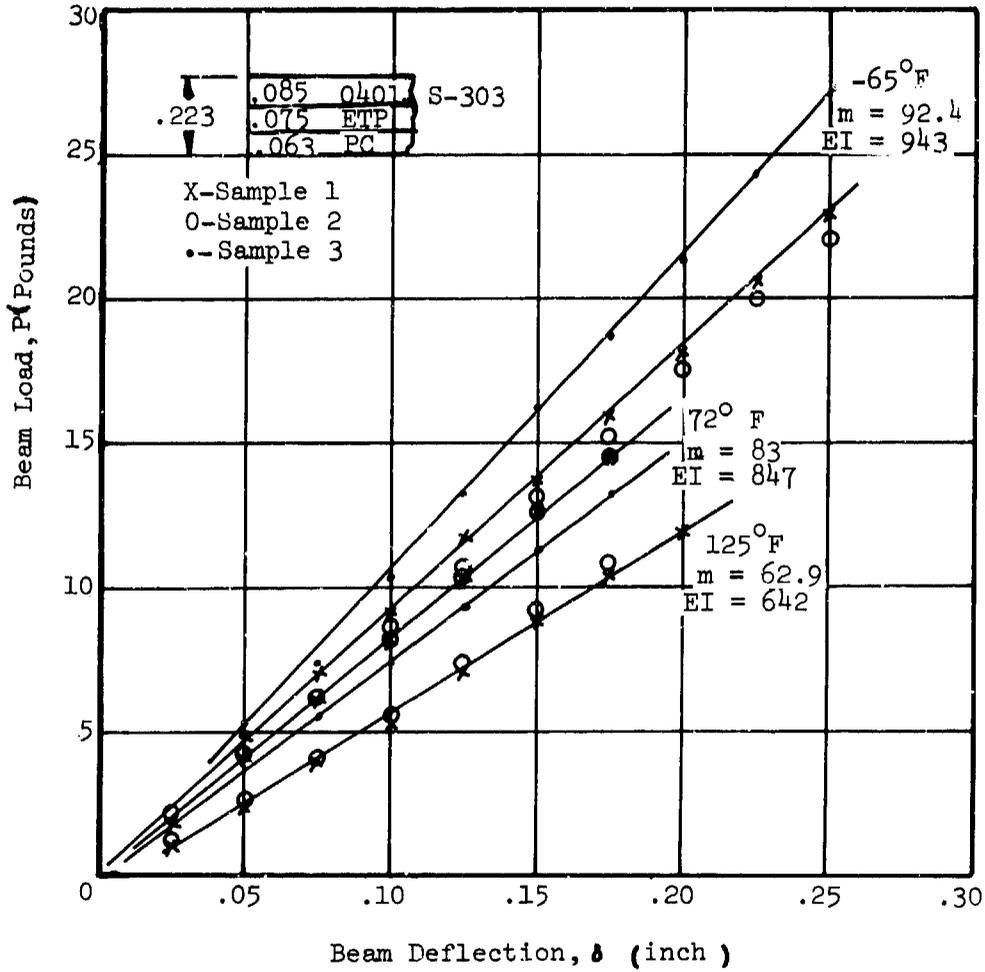
Sample Number 3 in Figure 31 showed inordinately high values when tested at -65°F and +125°F. Since these were broken during test, reruns were not possible. Therefore, the slope and stiffness results for this test disregard the data from these samples.

Figure 31. Load Deflection Test Data, Glass/ETP/Polycarbonate Laminate with Coating.

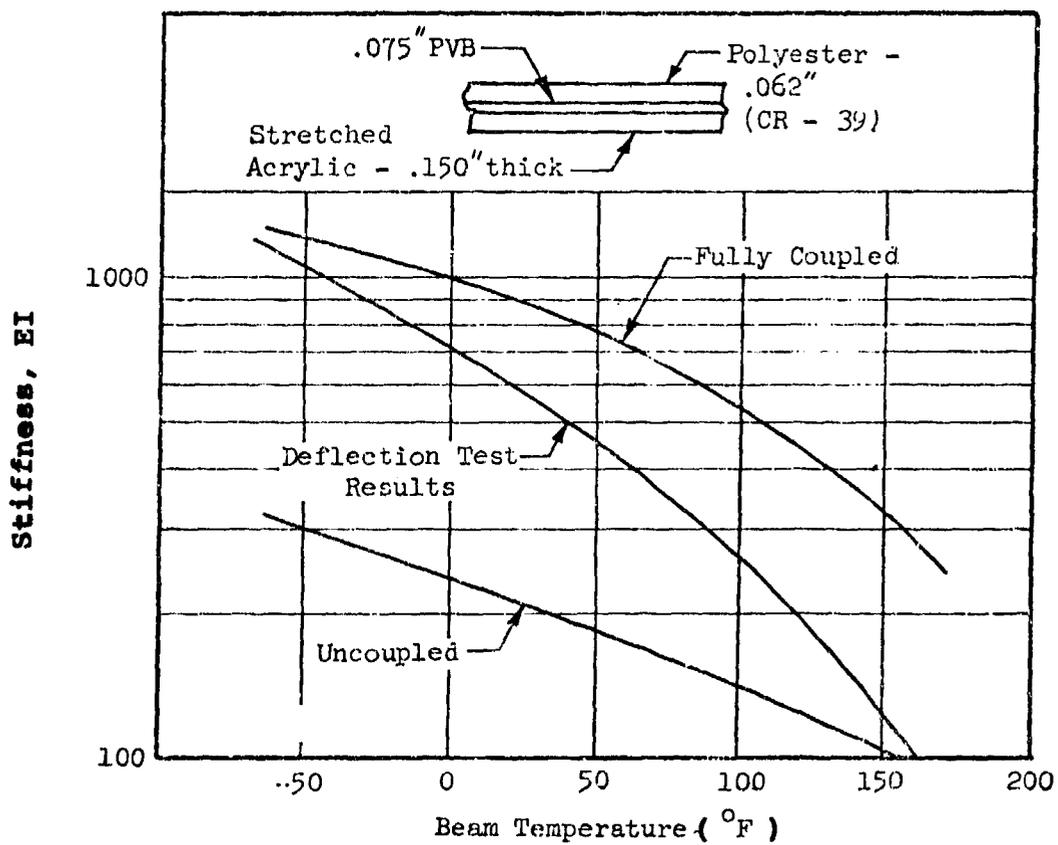
Figures 32, 33 and 34 show curves of the expected stiffnesses for the ideal coupled and uncoupled beams as well as the equivalent stiffnesses derived from the load deflection curves. The glass-PVB-stretched acrylic specimens, with and without conductive coatings, are plotted on the same curve since the coatings do not affect stiffness. The calculations for the theoretical stiffnesses were obtained from Equations (3) and (4).

Figure 32. Variation in Stiffness With Temperature, Polyester-PVB-Stretched Acrylic.
