USARTL-TR-78-26

**DESIGN, TEST, AND ACCEPTANCE CRITERIA FOR  
HELICOPTER TRANSPARENT ENCLOSURES**

Bruce F. Kay  
Sikorsky Aircraft Division  
United Technologies Corp.  
Stratford, Conn. 06602

Final Report for Period 27 June 1974 - 26 July 1976

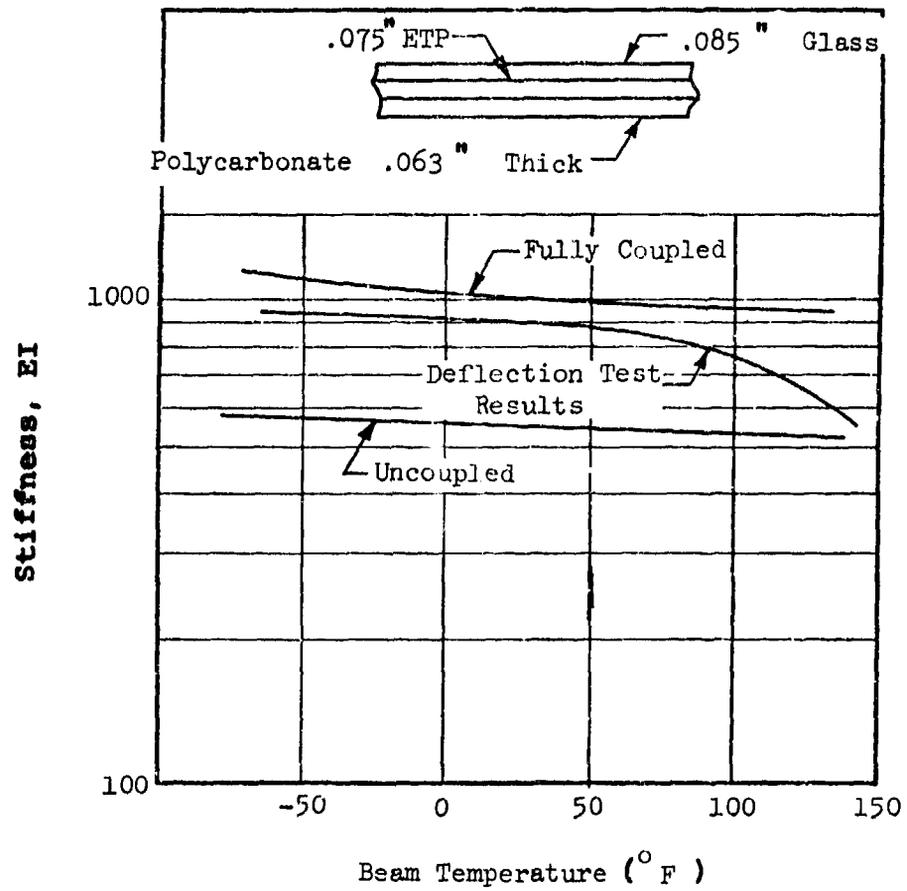
Figures 32, 33 and 34 show curves of the expected stiffnesses for the ideal coupled and uncoupled beams as well as the equivalent stiffnesses derived from the load deflection curves. The glass-PVB-stretched acrylic specimens, with and without conductive coatings, are plotted on the same curve since the coatings do not affect stiffness. The calculations for the theoretical stiffnesses were obtained from Equations (3) and (4).

Figure 33. Variation in Stiffness With Temperature, Glass-ETP-Polycarbonate.

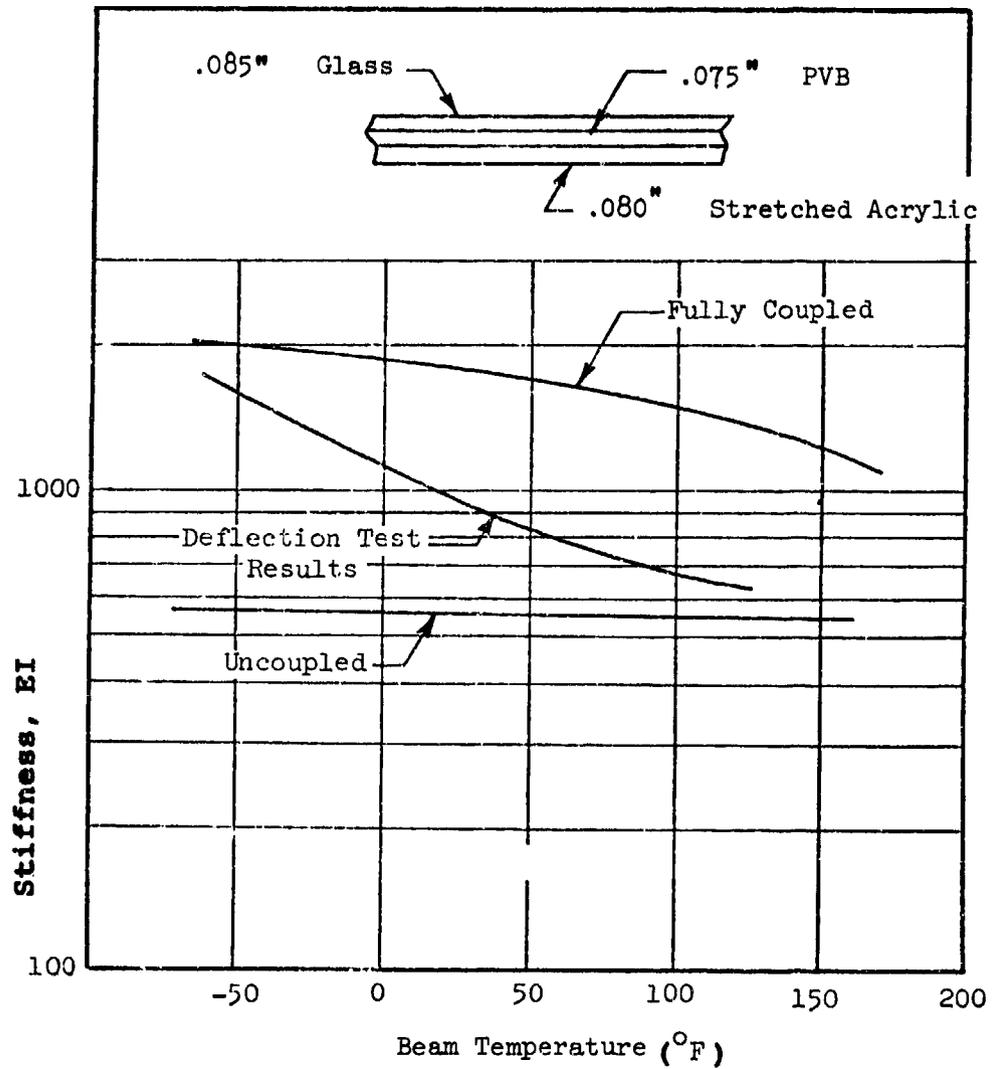
Figure 34. Variation in Stiffness With Temperature, Glass-PVB-Stretched Acrylic.

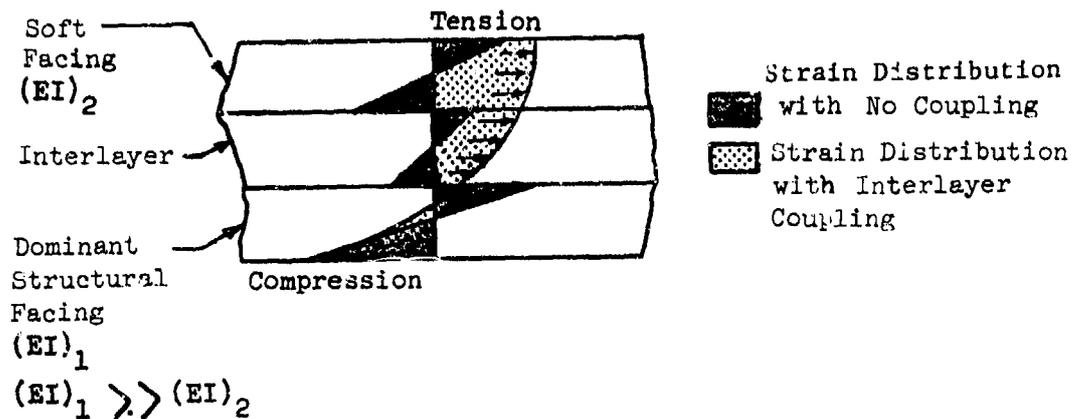
When there is a significant difference in stiffness between the two facings, partial coupling creates a strain distribution similar to that shown in Figure 35. Here the neutral axis remains within the dominant structural facing, and the interlayer coupling induces a higher strain in the softer ply than would occur if it were considered uncoupled.

Figure 35. Strain Distribution in Uncoupled and Partially Coupled Composite Beam.

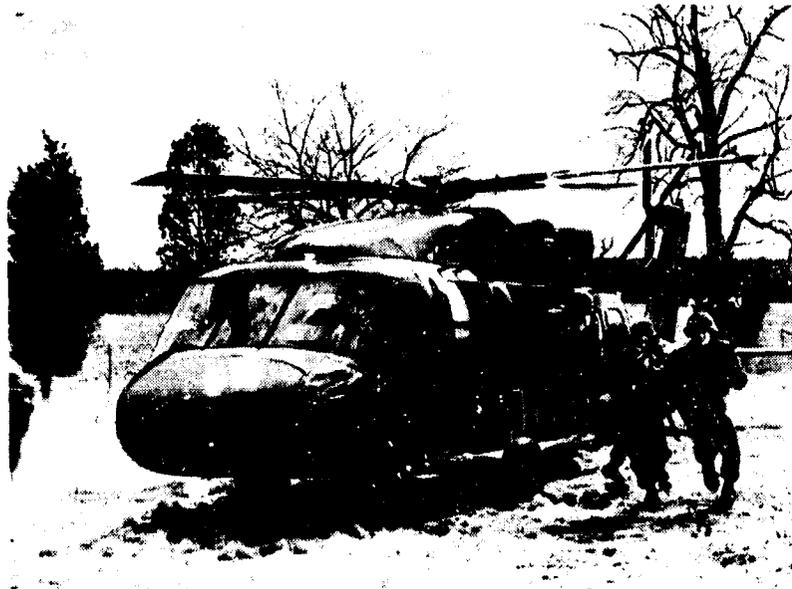
The aircraft selected for this study was the Sikorsky YUH-60A Utility Tactical Transport Aircraft System (UTTAS). UTTAS represents the newest generation of Army helicopters, has relatively large windshields supported by slender posts (Figure 36), and is subjected to high aerodynamic pressure and maneuver loads.

Figure 36. Sikorsky YUH-60A UTTAS.

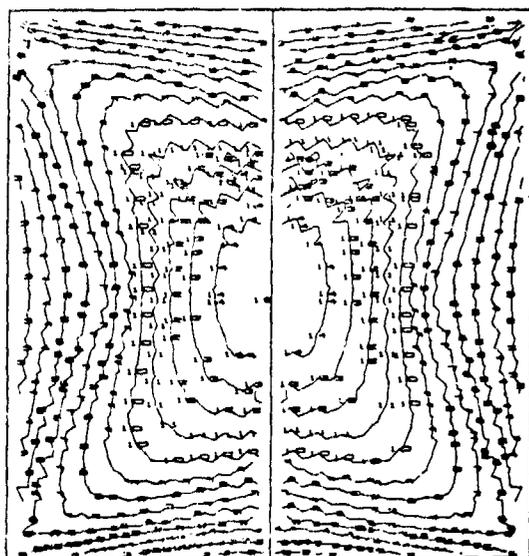
Figure 50. Stress Pattern in Flat Windshield.

Fracture Pattern  
from Pressure Test

Computer Generated  
Stress Contour Plot

The instrumented windshield tests are described in a subsequent section of this report. Also, using test results, a visual correlation of stress patterns can be observed in Figure 50, which compares a NASTRAN generated stress contour plot and a glass fracture pattern from a test conducted on a specimen loaded under similar conditions.

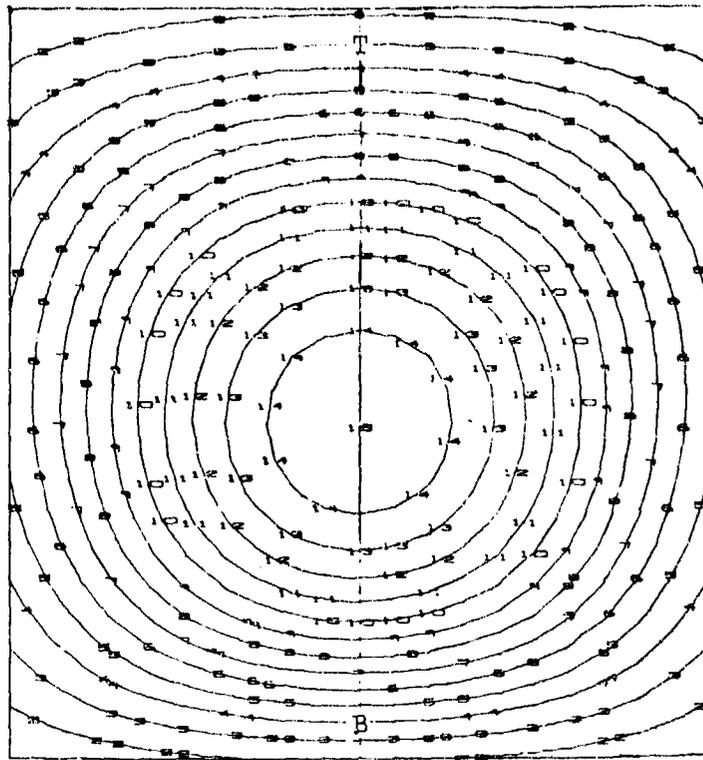
Figure 52. Deflections, 1 psi Pressure Load, Glass/Glass Windshield.

Symbol	Deflection (in.)
1	.000
2	.044
3	.089
4	.133
5	.178
6	.222
7	.267
8	.311
9	.356
10	.400
11	.445
12	.489
13	.534
14	.579
15	.623

Two structural effects of elastic windshield supports are readily detectable in the computer generated displacement plot shown in Figure 52. In the illustration, the total deflection is divided into 14 equal increments, with each increment, or iso-displacement, represented by one line forming a contour plot of the deflected windshield. First, it may be observed that several iso-displacement lines intersect each edge of the windshield, indicating a pronounced sagging of the supports. For example, the maximum displacement midspan on the long edges is 0.178 inch, a value which by itself exceeds the thickness of the windshield, and would therefore be suspected to have a significant effect on analyses based on rigid supports.

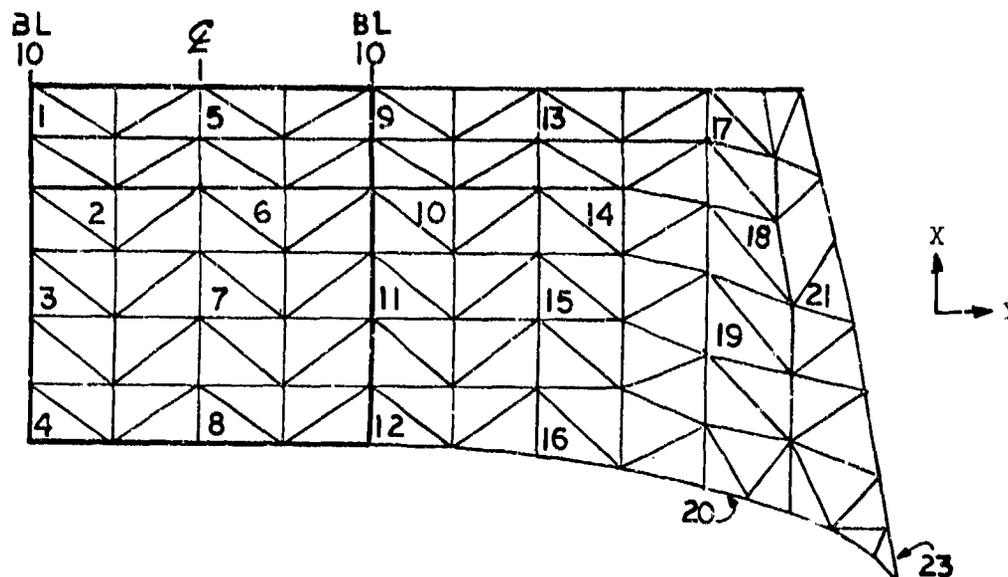
Figure 53. Stress Distribution, 0.3 psi Pressure Condition, Glass/Glass Windshield.

Point	NASTRAN Element No.	Normal Stress, Y Direction (psi)		In-Plane Component (psi)	Bending Component (psi)
		Outer Surface	Inner Surface		
1	5887	-152	92	30	-122
2	5884	-570	510	-30	-540
3	5881	-240	-232	-236	4
4	5877	-28	-170	-99	71
5	4875	759	-769	-5	764
6	4872	-866	809	-28	-837
7	4869	-1220	1300	40	-1260
8	4965	801	-788	6	794
9	4899	-126	41	-42	-83
10	4896	91	-148	-28	119
11	4893	-260	-191	-225	-34
12	4889	-26	-170	-98	72
13	4923	-231	296	32	-263
14	4920	27	52	39	-12
15	4917	166	91	128	37
16	4913	-143	120	-11	-131
17	4948	-46	50	2	-48
18	4945	-104	-148	-126	22
19	4942	-84	-4	-44	-40
20	4937	-	-	-	-
21	4957	-21	10	-5	-15
22	4953	108	-133	-12	120
23	4964	-51	-450	-250	199

Curvature has the effect of creating in-plane forces that tend to relieve bending stresses. This effect can be seen in Figure 53, which shows a distribution of normal stresses for selected elements of the windshields. The numbered "points" in the figure refer to triangular plate elements, and the stresses reported are the average stresses occurring in each. Bending and in-plane components of the normal stress are also given. The illustration shows that the stresses in the outboard panel were predominantly in-plane, while the stresses in the center panel were predominantly bending. It is interesting to note that the YUH-60A windshield used in this example has mild curvature, transitioning from a flat shape at B.L. 10 to a 16-inch radius of curvature tangent to the outboard post.

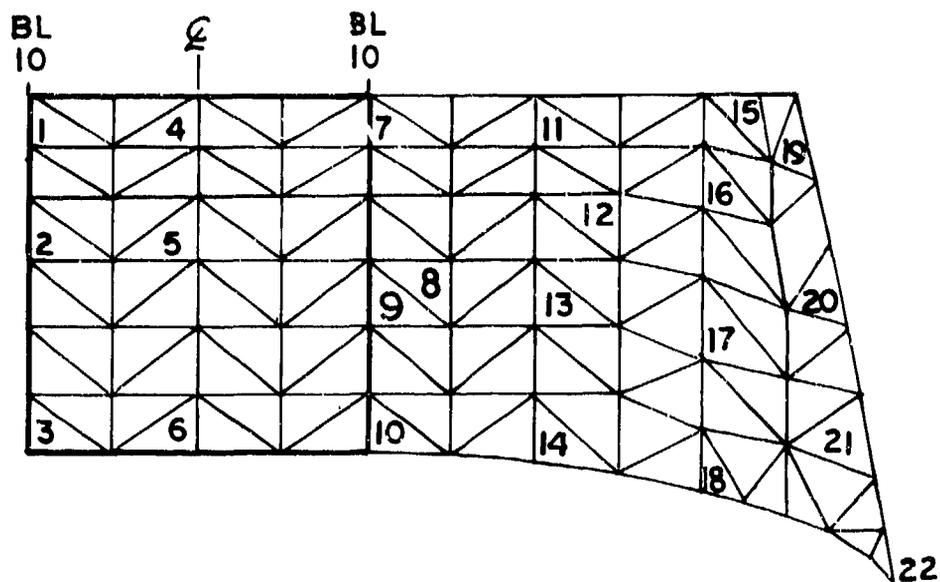
**Figure 57. Major Principal Stress, 1 psi Pressure  
On Center Windshield, Differential  
Stiffness Solution.**

**Major Principal Stress  
(psi)**

Point	NASTRAN Element No.	Outer Surface	Inner Surface
1	5887	1973	1547
2	5883	3018	-762
3	5877	1784	1562
4	5875	3260	1532
5	5871	-5166	7807
6	5965	2729	637
7	4899	1560	942
8	4894	2141	-383
9	4893	2757	-507
10	4889	1021	1003
11	4923	-22	423
12	4920	215	213
13	4917	510	359
14	4913	-7	268
15	4948	48	-14
16	4946	75	30
17	4942	3	12
18	4937	522	-179
19	4961	110	288
20	4957	165	-80
21	4953	99	-78
22	4964	175	-11

Figure 57 shows the distribution of major principal stresses in both windshields. The maximum stress calculated for this condition was 7807 psi located approximately in the middle of the center windshield. The effect of panel interactions was evident by the presence of stresses of up to 2757 psi in the unloaded outboard windshields. The stresses in the outboard panel diminished as the distance from the center panel increased.

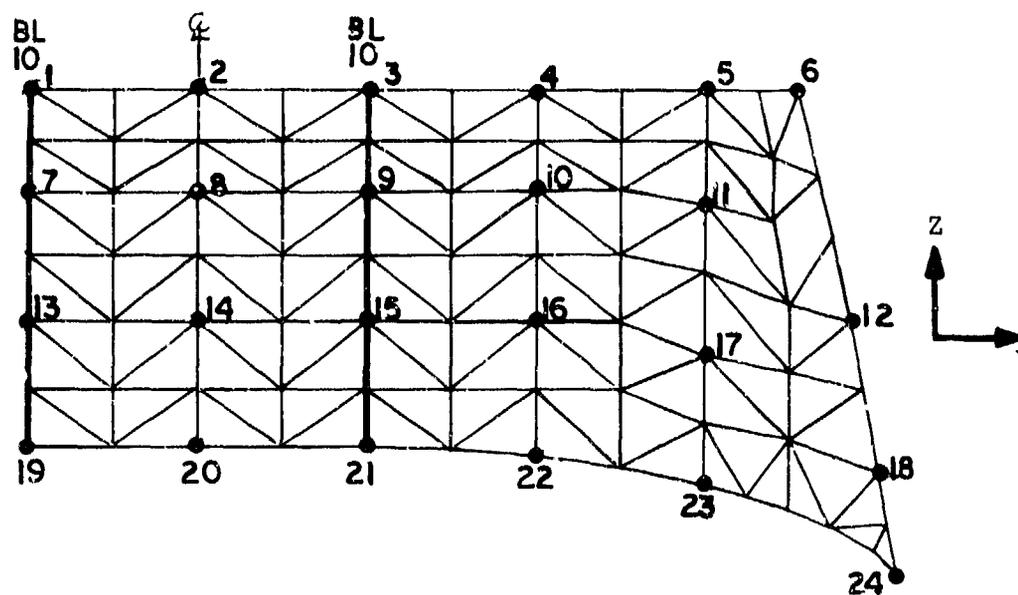
Figure 58. Displacements, 1 psi Pressure on Center Windshield, Differential Stiffness Solution.

Point	NASTRAN Grid No.	Displacements (in.)		
		x	y	z
1	9510	.061	.000	-.149
2	8390	.085	.000	-.175
3	8510	.060	.000	-.149
4	8630	.017	-.003	-.102
5	8750	-.008	-.010	-.075
6	8800	-.010	-.011	-.073
7	9490	.110	.000	-.202
8	8370	.361	.000	-.471
9	8490	.110	.000	-.202
10	8610	.003	-.006	-.088
11	8730	-.008	-.010	-.076
12	8850	-.023	-.023	-.062
13	9470	.102	.000	-.193
14	8350	.394	.000	-.507
15	8470	.102	.000	-.193
16	8590	.000	-.007	-.084
17	8710	-.009	.011	-.074
18	8830	-.028	-.027	-.057
19	9080	.038	.001	-.123
20	8020	.062	.000	-.150
21	8080	.030	-.000	-.124
22	8140	.008	-.004	-.093
23	8200	-.014	-.013	-.069
24	8330	-.025	-.022	-.060

The distribution of displacements for selected points on the windshields are shown in Figure 58. This distribution shows how pressure applied to the center windshield caused the entire structure to deform, thereby causing adjacent transparencies to share the load.

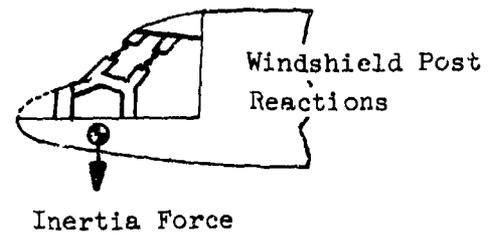
Figure 60. Schematic Representation of Windshield Structure Reaction to Inertia Loading.

Table 22 compares the maximum internal loads in the windshield support structure from cockpit vertical bending for two cases, with and without a windshield. For the with-windshield situation, the glass/glass laminated construction was assumed. These cases are shown schematically in Figure 60. Two moments are listed for each element. The primary value is for bending in the plane of the deepest dimensions, and the secondary value is for bending in the plane of the shortest dimensions, as shown in Figure 61. These results show that significant redistribution of internal loading occurred, which can only be attributed to the stiffening effect of the windshield on the overall structure.

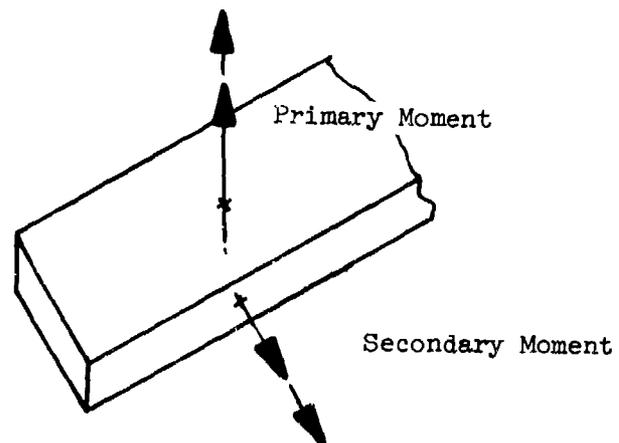
Figure 61. Moment Definition for Posts and Sills.

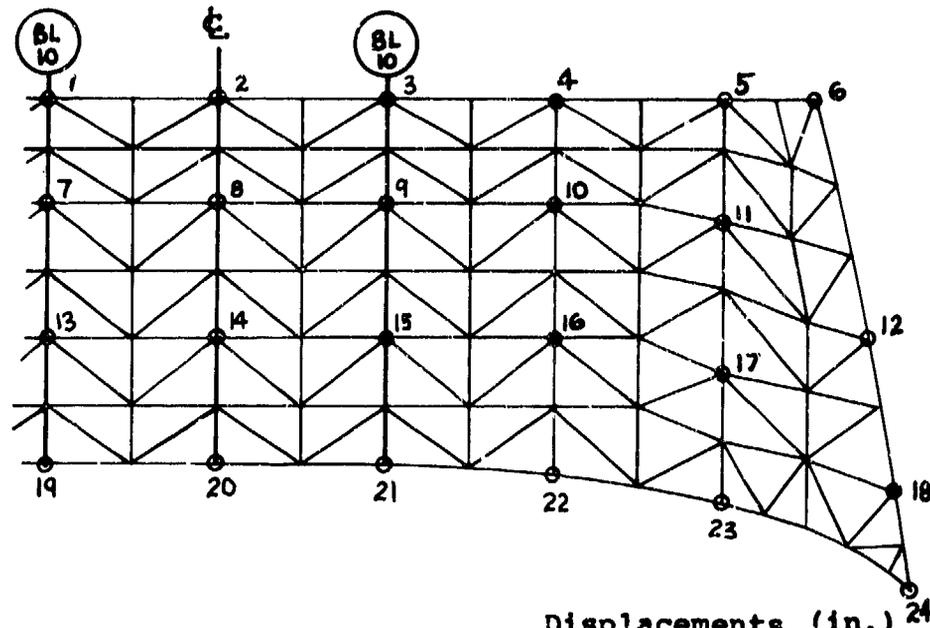
Point	NASTRAN Grid No.	Displacements (in.)					
		Without Windshield			With Windshield		
		x	y	z	x	y	z
1	9510	.125	.000	-1.144	.084	-.006	-.889
2	8390	.104	.000	-1.198	.135	-.006	-.945
3	8510	.128	.001	-1.158	.088	-.006	-.996
4	8630	.030	-.004	-1.034	-.033	-.015	.766
5	8750	-.062	-.029	-0.855	-.109	-.032	-.675
6	8800	-.082	-.034	-0.718			
7	9490	.097	.028	-1.119	.095	-.006	-.902
8	8370	-	-	-	.169	-.005	-.982
9	8490	.102	-.041	-1.135	.101	-.005	-.910
10	8610	-	-	-	-.041	-.017	-.758
11	8730	-	-	-	-.101	-.037	-.692
12	8850	.009	-.064	-0.779	-.134	-.078	-.648
13	9470	-.057	.050	-0.963	.061	-.005	-.864
14	8350	-	-	-	.112	-.005	-.921
15	8470	-.051	-.109	-0.981	.068	-.005	-.874
16	8590	-	-	-	-.030	-.015	-.770
17	8710	-	-	-	-.086	-.038	-.707
18	8830	-.127	-.062	-0.688	-.144	-.106	-.635
19	9080	-.158	-.039	-0.863	.013	-.003	-.814
20	8020	.231	-.043	-0.498	.049	-.004	-.852
21	8080	-.152	-.047	-0.879	.021	-.005	-.824
22	8140	-.183	-.040	-0.854	-.014	-.011	-.788

Figure 62. Displacements, Vertical Bending, Differential Stiffness Solution.

While the loads induced in the canopy structural elements were small in relation to the overall cockpit loading, they were significant with respect to the individual members. More important, however, were the displacements that occurred around the perimeter of the windshields. Figure 62 compares displacements for the same flight condition, with and without the windshields installed.

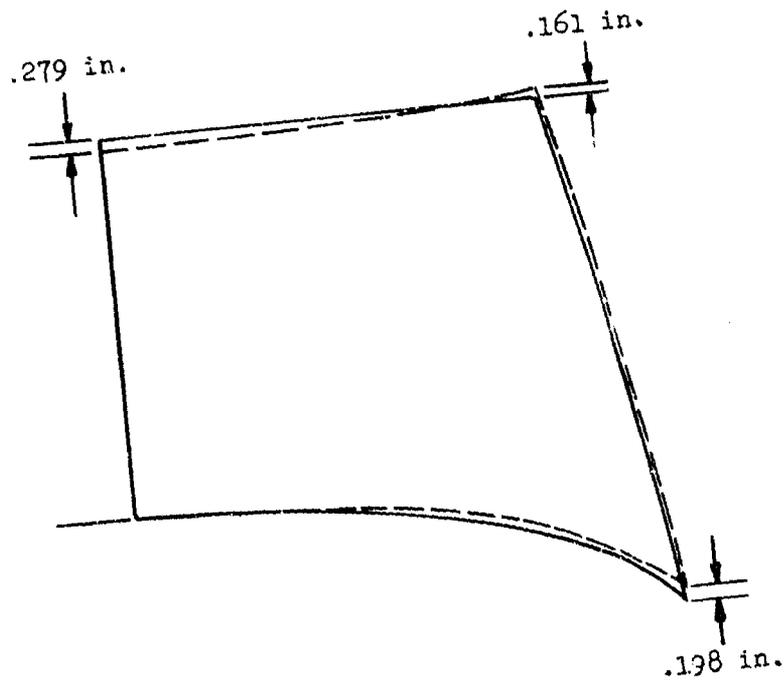
Figure 63. Deformed Shape of Windshield Cavity.

Insight as to the significance of these displacements can be gained by observing the deflection modes of the structure. Figure 63 shows the deformed outboard windshield structure superimposed on the undeformed shape. This illustration shows graphically how fuselage racking tended to warp and twist the windshield's cavity. Although windshields are normally mounted with a certain degree of flexibility via oversize holes and gaskets, for the conditions analyzed, the displacements and loads were large, and could not be absorbed entirely by edge attachment flexibility.

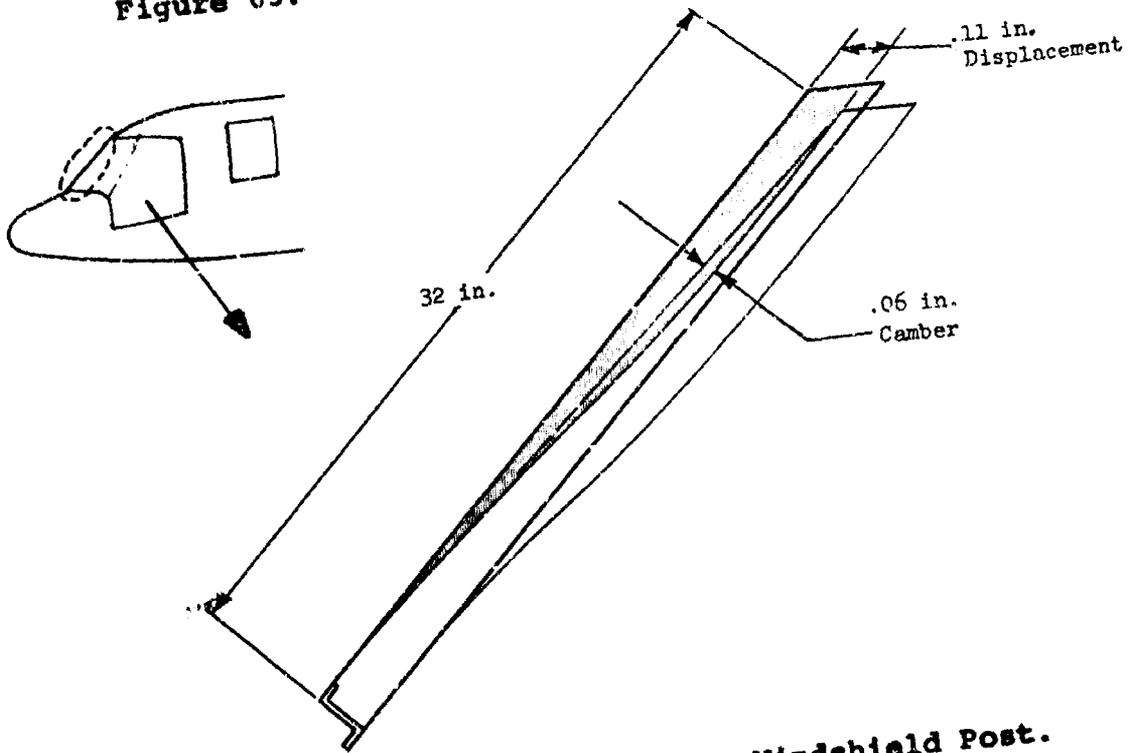
Figure 64. Deflection Mode for Windshield Post.

Figure 64 is a profile view of the center post deflected shape. Note that the post had a maximum camber of approximately 1/16 inch. Since the post was stiffer than the windshield, this camber was certain to induce windshield stresses, and when the vertical bending condition was reanalyzed with the windshield in the model, maximum tensile stresses in the windshield were calculated to be approximately 2000 psi. The highest stresses were located at, and adjacent to, the edges, which was to be expected since the loads are applied at the edges. The distribution of major principal stresses for this case is shown in Figure 65.

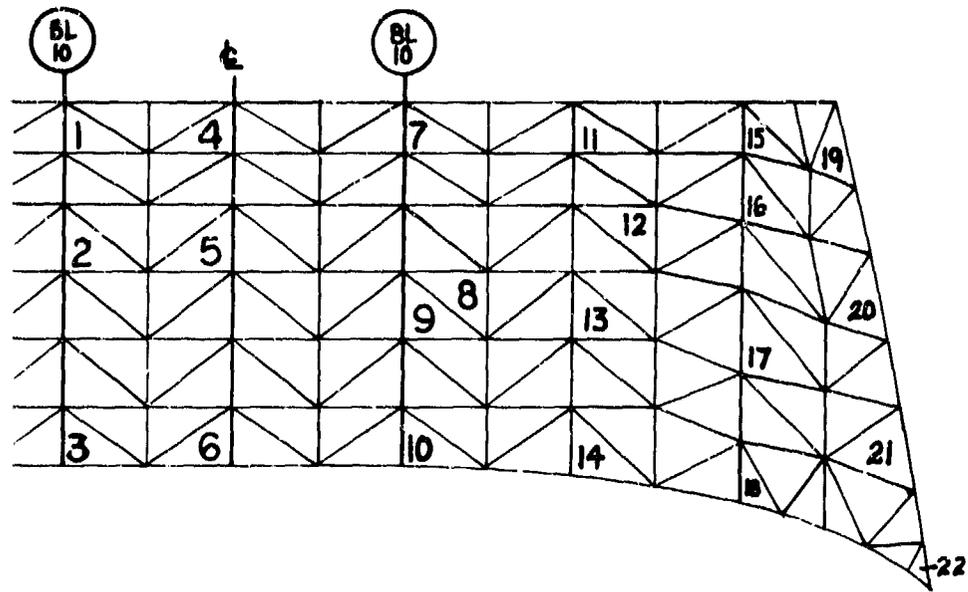
Point	NASTRAN Element No.	Major Principal Stress (psi)	
		Outer Surface	Inner Surface
1	5887	-269	1047
2	5883	-375	505
3	5877	1765	1392
4	5875	-459	494
5	5871	-852	1039
6	5965	546	1738
7	4899	-404	1528
8	4894	-174	418
9	4893	-87	1055
10	4889	1654	2132
11	4923	202	146
12	4920	604	239
13	4917	606	228
14	4913	767	1387
15	4948	36	128
16	4946	425	281
17	4942	339	326
18	4937	225	-28
19	4961	491	1848
20	4957	724	-226
21	4953	800	-482
22	4964	1145	-289

Figure 65. Major Principal Stresses, Vertical Bending Condition, Differential Stiffness Solution.

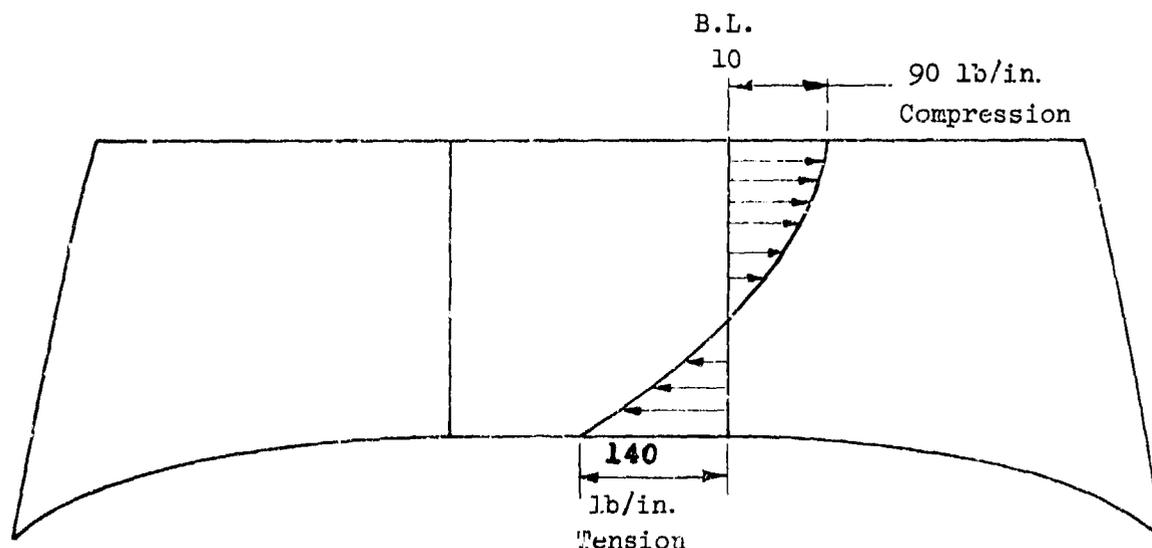
Figure 66. In-Plane Forces Normal to B.L. 10 Post,  
Vertical Bending Condition.

The distribution of in-plane windshield forces normal to the center posts is plotted in Figure 66. Additional edge force data is presented in Table 24. These distributions are indicative of how cockpit deflections induced in-plane bending loads in the windshields.

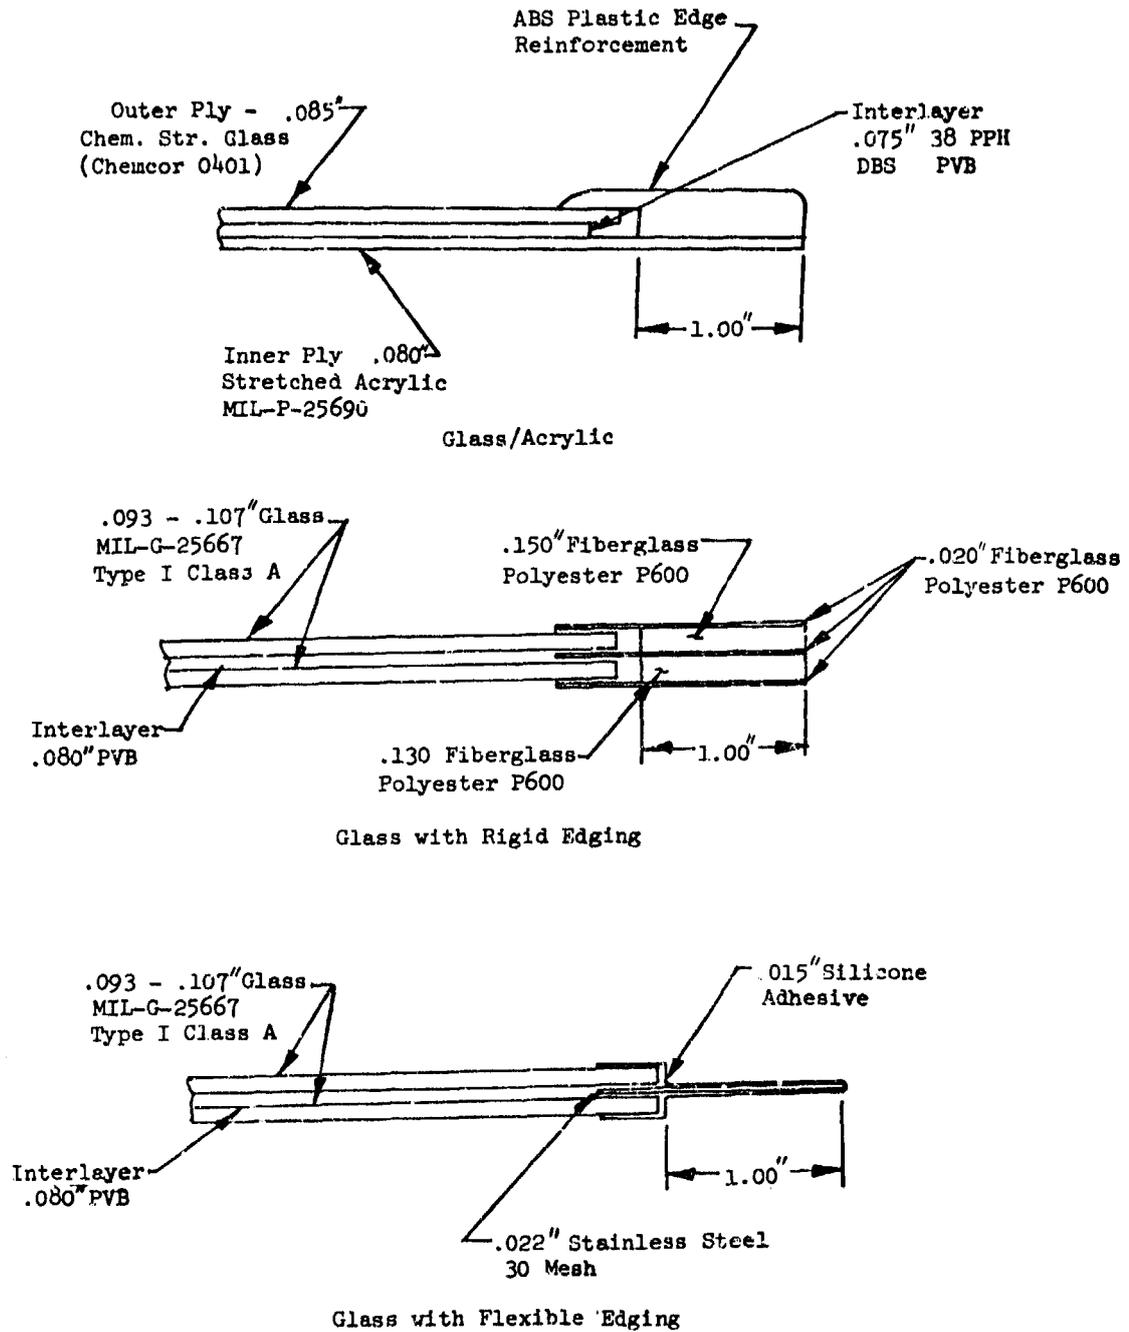
Figure 67. Laminated Test Specimen Edge Configurations.

Three different 24-inch-square laminated sample windshield configurations (Figure 67) were tested. The first configuration consisted of a glass outer surface, a polyvinyl butyral (PVB) interlayer, a plastic (stretched acrylic) inner surface, with a bonded Acrylonitrile Butadiene Styrene (ABS) edge reinforcement. The second configuration had glass inner and outer surfaces, a PVB interlayer and a bonded fiberglass edge reinforcement. The third configuration was the same as the second except for a bonded flexible impregnated fabric edge reinforcement.

The laminated glass with rigid fiberglass edge reinforcement, the second configuration in Figure 67, was found to be the stiffest design and exhibited a spring rate of approximately 233,000 lb/in. The composite glass/plastic design had a spring rate equal to 7700 lb/in. and the laminated glass panel with flexible edging had a spring rate of only 2100 lb/in. The spring rates are compared in Figure 69.

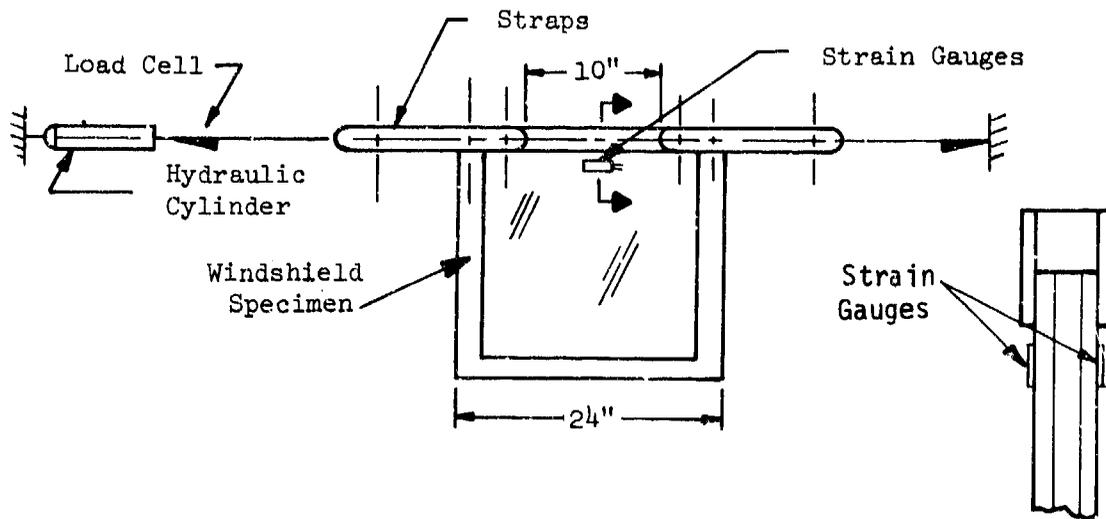
Figure 68. Stiffness Test Setup.

Tensile stiffness tests were conducted on each of the three specimens by application of incremental tensile loads to one edge of each specimen using a hydraulic cylinder. A calibrated load cell in series with the cylinder and the test article was used to measure applied load. 500-lb incremental loads were applied to a maximum of either 5000-lb load, 0.010-inch specimen elongation or 3000 psi resultant stress in the windshield. Resultant strains and specimen elongation between points 10 inches apart were measured at each load increment. Figure 68 shows the test setup.

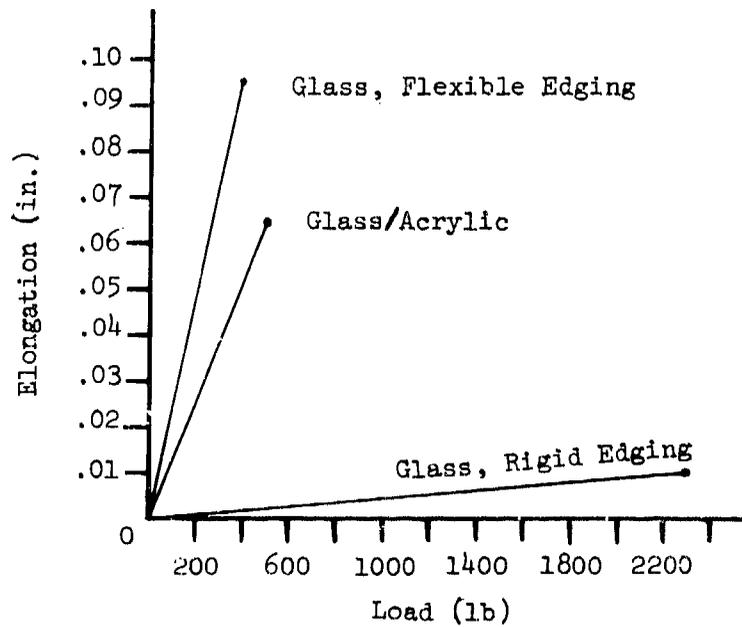
Figure 69. Spring Rate Test Data.

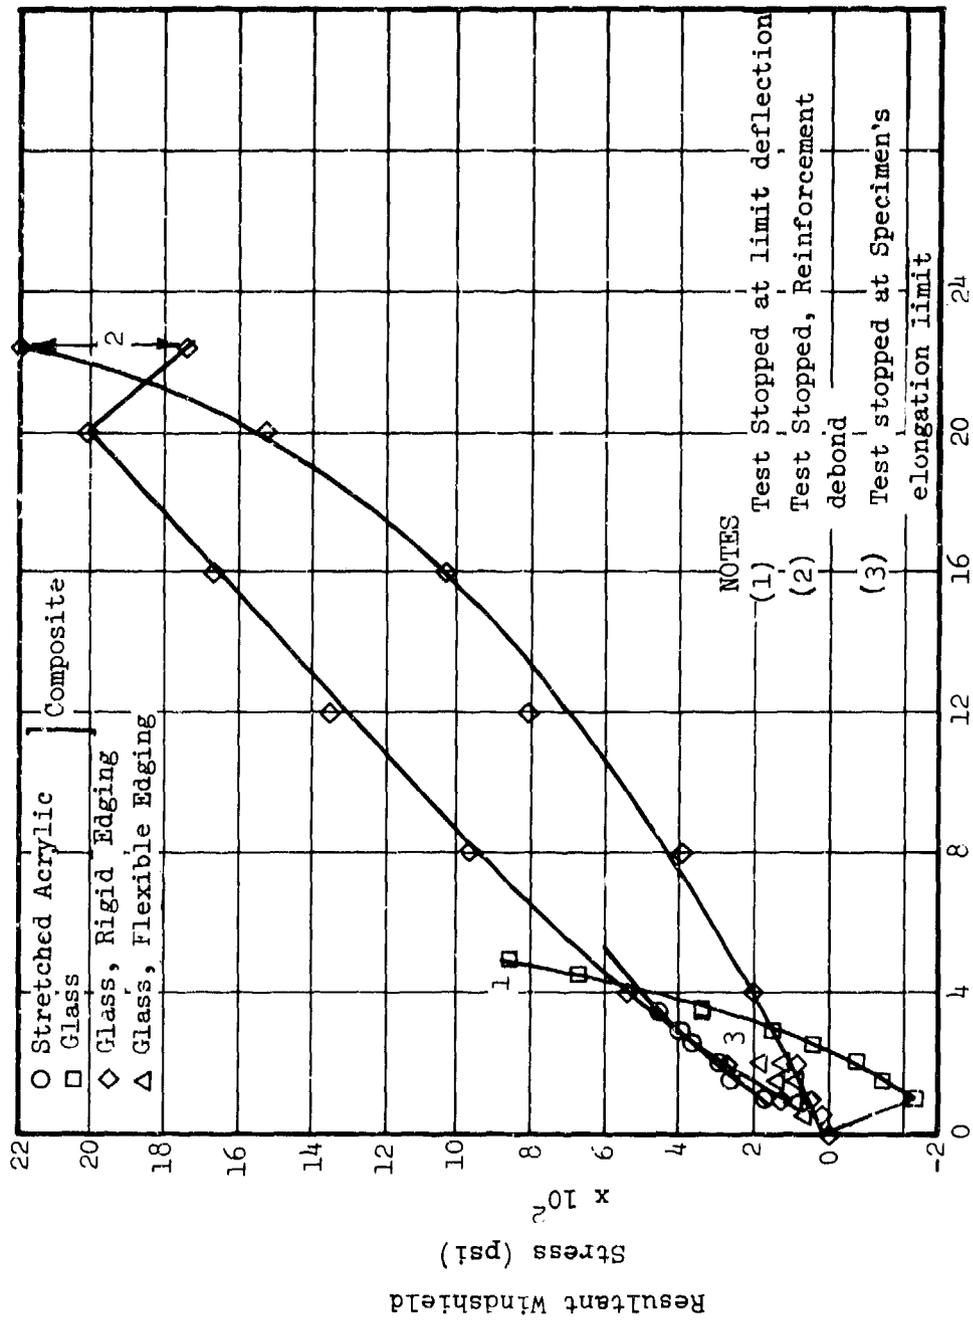
Figure 70. Load vs Stress Test Data.

Figure 70 presents plots of resultant stress vs load for each configuration. Testing of the glass/acrylic configuration was stopped at 500-lb load when the deflection limit was reached. The initial compression stresses in the glass in this configuration were attributed to a warped condition of the specimen prior to loading. In the free state, the glass/acrylic panels were slightly bowed, and the initial tensile loading caused the panels to straighten out, which induced a compressive stress in the glass facing. The effect of straightening was more pronounced for the glass ply because of its higher modulus, which is an order of magnitude greater than that for stretched acrylic.

Testing was stopped at 2230-lb load on the glass with rigid edging when there were indications of debonding of the fiberglass edge reinforcement. The two plots for this configuration represent data from gauges on each side of the specimen. The uneven load sharing between the two glass plies was attributed to slight eccentricities in the test setup. Although these effects were significant in comparison to overall strains, the magnitude of the deviations was about 0.001 microinch, which is considered to be small.

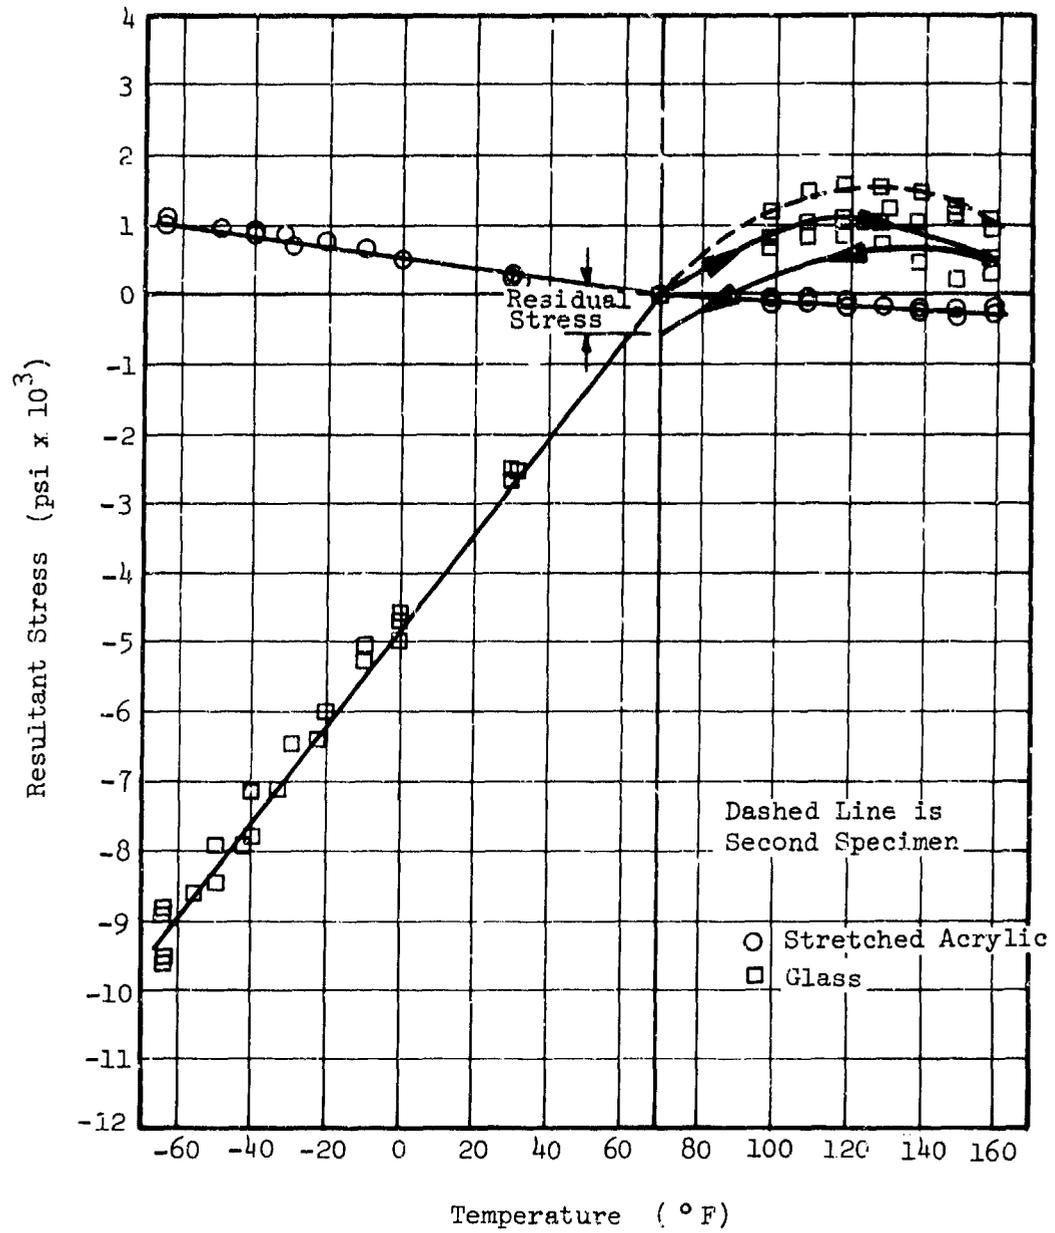
Figure 72. Thermal Test Data, Temperature vs Stress, Glass/Acrylic Specimen.

When temperatures were increased, glass stresses increased to a maximum of approximately 1200 psi at 120°F and were observed to drop off with increasing temperature to 160°F, as shown by the solid line in Figure 72. When the specimen was cooled back to room temperature, residual stresses of -660 psi and 60 psi were recorded for the glass and acrylic. The decrease in stress with increasing temperature above 120°F was attributed to softening of the PVP interlayer. The residual stresses were attributed to relieving of built-in manufacturing stresses in each facing.

A second specimen was tested; it exhibited similar decreases in glass stress at temperatures above 120°F. Residual stresses for the second specimen were -1220 psi and 20 psi for the glass and plastic, respectively. Each specimen was tested again to 160°F, and glass stresses of approximately 1700 psi were achieved at 120°F to 130°F. These runs are shown (dashed line) in Figure 72.

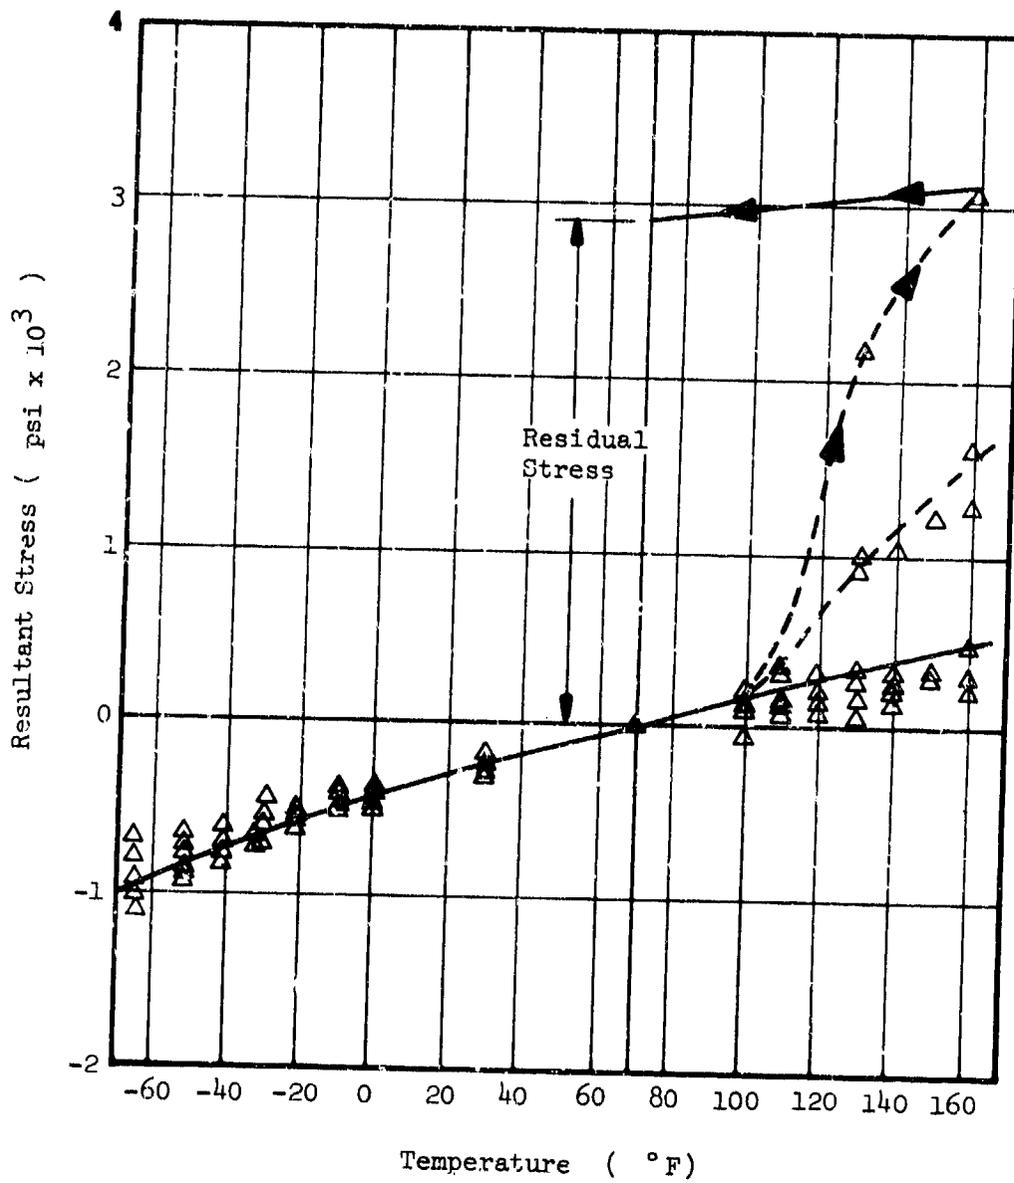
Figure 74. Thermal Test Data, Temperature vs Stress, Glass Panel With Flexible Edging.

Temperatures to  $-65^{\circ}\text{F}$  resulted in glass stresses of approximately  $-1000$  psi on the glass panel with flexible edging. During initial runs to  $160^{\circ}\text{F}$  (dashed lines) manufacturing residual stresses were  $2900$  psi. Subsequent tests resulted in stresses to  $500$  psi as shown in Figure 74 (solid line).

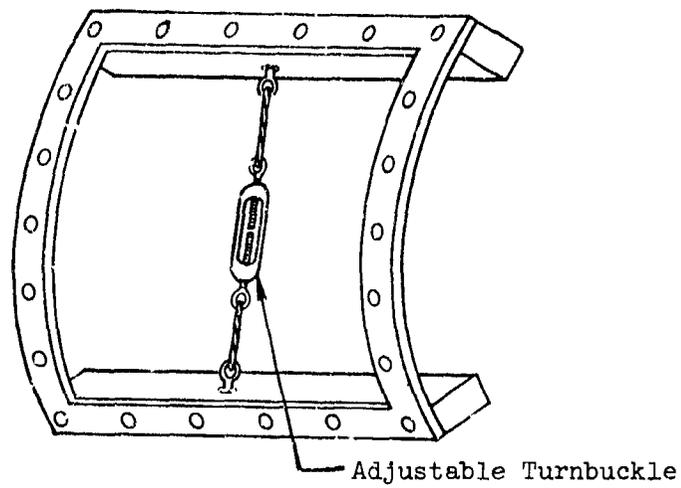
Figure 75. Schematic Representation of Cambering Fixture.

Installation preload tests were conducted to determine a method for establishing recommended windshield dimensional manufacturing tolerances based on induced stresses resulting from windshield/airframe contour mismatch. A cambering test fixture, shown schematically in Figure 75, was fabricated with an adjustable surface contour to simulate various degrees of contour mismatch. Strain gauges installed on opposite sides of the test specimens at the flexed edge were used to measure flexural stress.

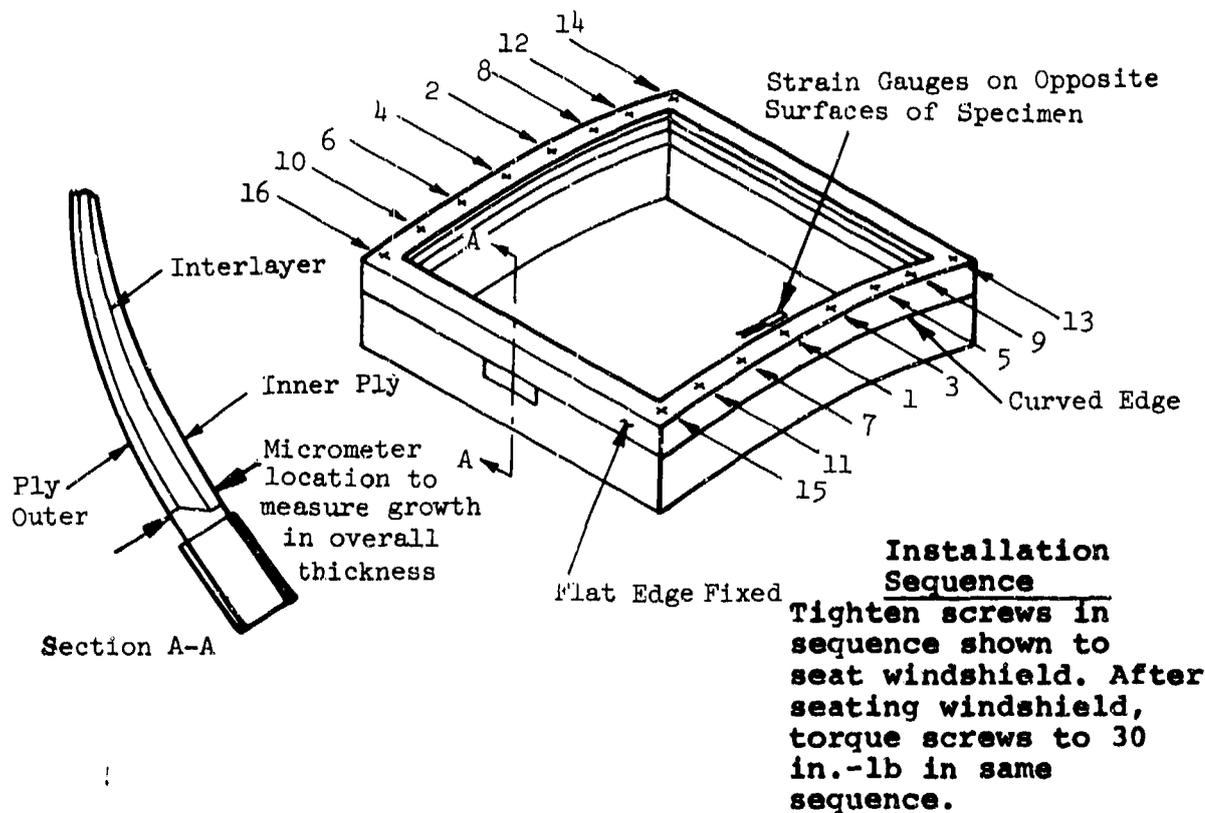
Figure 77. Torquing Sequence.

Each specimen was attached to the test fixture shown in Figure 76, and strains were recorded to provide a reference position. After each specimen was removed, the test fixture was adjusted to provide a smooth curvature and to produce a  $1/16$ -inch camber. The test specimen was torqued to the fixture for each camber configuration following the torque sequence of Figure 77, and the resultant strains were recorded at increments of  $1/16$  inch camber until the camber was  $0.5$  inch, or  $3000$  psi was measured on the glass material. Micrometer measurements were also taken to measure the change in laminate thickness at the unflexed edge as shown in Figure 77.

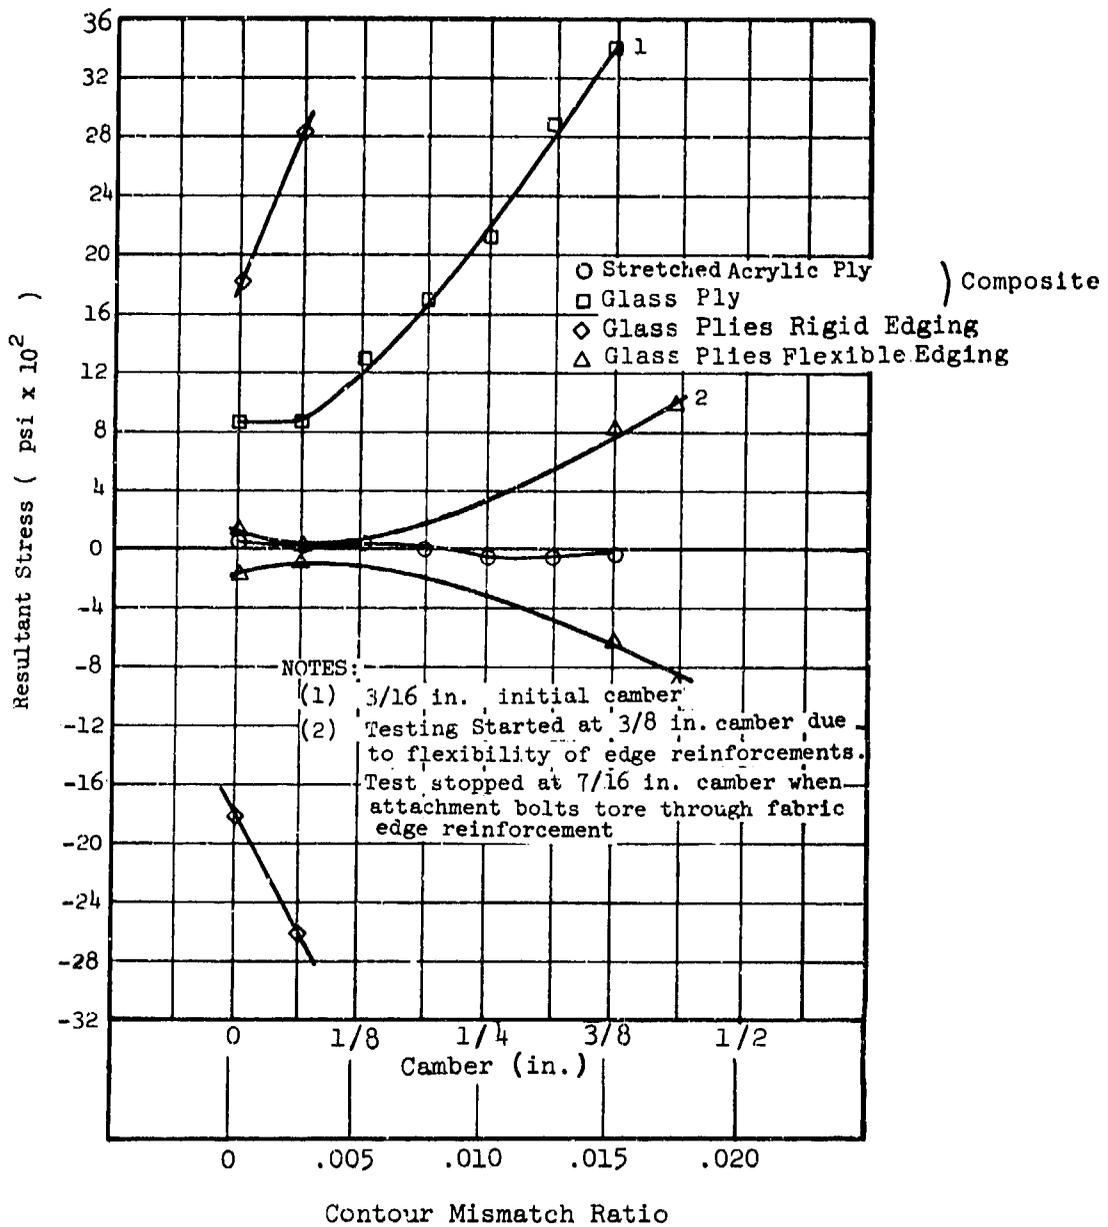
Figure 78. Windshield Installation Preload Tests, Induced Stress vs Camber.

Figure 78 shows plots of stress vs camber for each configuration. The abscissa also shows the normalized ratios of camber to panel length. Testing of the glass/acrylic specimen, which had a built-in  $3/16$  inch camber from manufacture, was discontinued at  $3/8$  inch camber when limit stress was reached in the glass. Testing of the glass panel with rigid edging configuration was discontinued at  $1/16$  inch camber when limit stress was reached in the glass. Testing of the glass panel with flexible edging configuration was started at  $3/8$  inch camber due to the flexibility of the fabric edge reinforcement. Testing of this configuration was discontinued at  $7/16$  inch camber when the attachment bolts tore through the fabric edge reinforcement. There were no measurable changes in laminate thickness in any windshield configuration.

These tests showed that the more rigid the edge reinforcement, the higher the facing stresses would be for a given contour mismatch.
