USARTL-TR-78-26

**DESIGN, TEST, AND ACCEPTANCE CRITERIA FOR  
HELICOPTER TRANSPARENT ENCLOSURES**

Bruce F. Kay  
Sikorsky Aircraft Division  
United Technologies Corp.  
Stratford, Conn. 06602

Final Report for Period 27 June 1974 - 26 July 1976

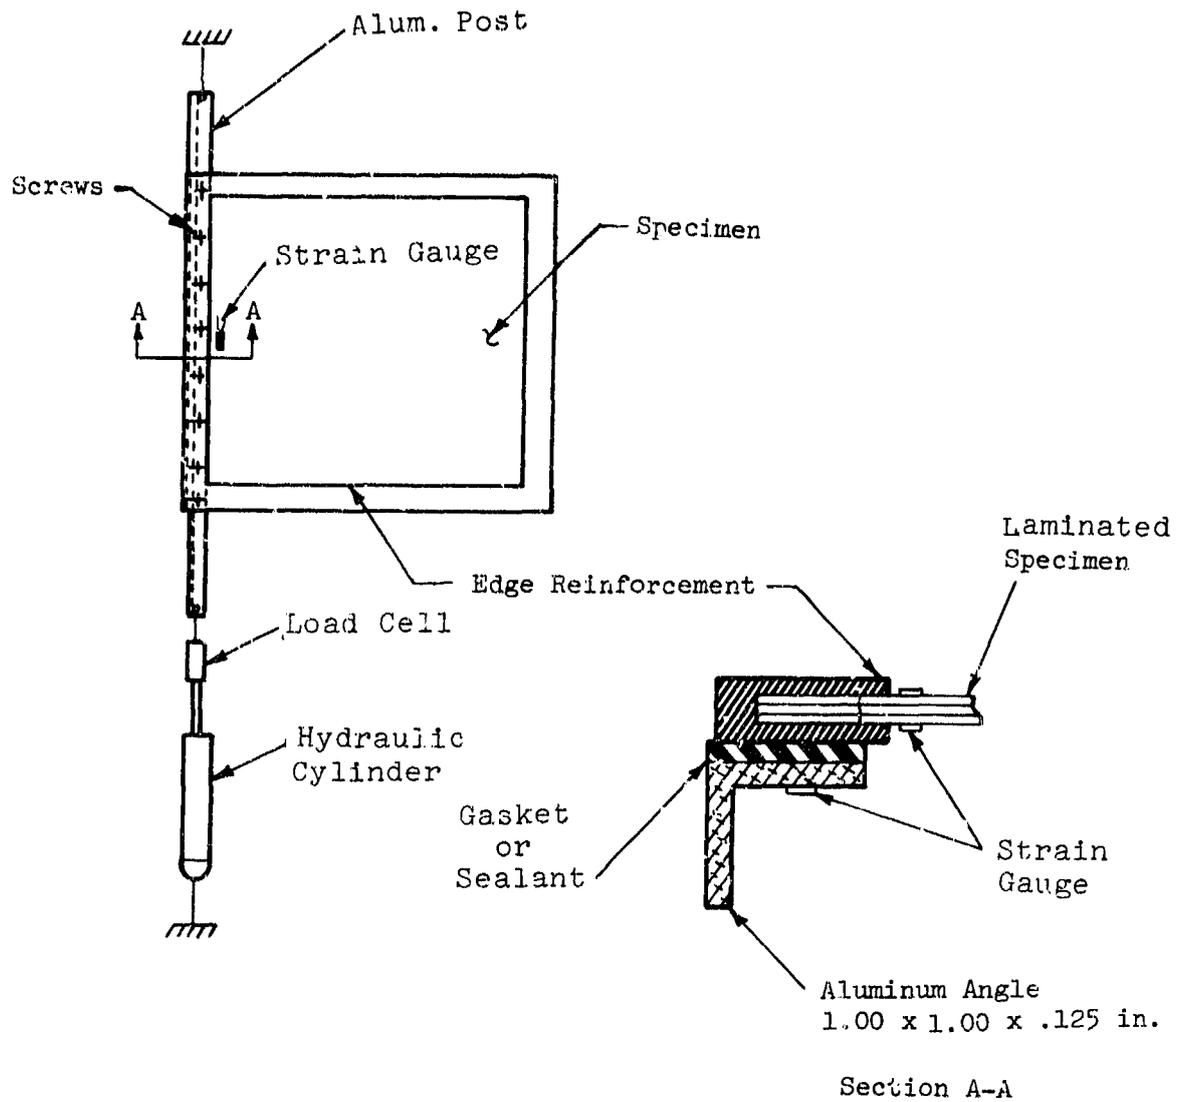
Figure 79. Windshield Assembly Test Setup.

Each of the test specimens was assembled in turn to a representative aluminum post configuration, Figure 79. The posts were 1.00 inch x 1.00 inch x 0.125 inch 2024-T3 aluminum angle extrusions that are similar in cross-sectional area to typical helicopter transparency support structures. The specimens were assembled with AN-3 bolts torqued to 30 in.-lb, except as noted. Hole size was 0.190 +.002/-.001 inch and the gasket material was 0.125 inch neoprene sponge rubber except where noted otherwise.

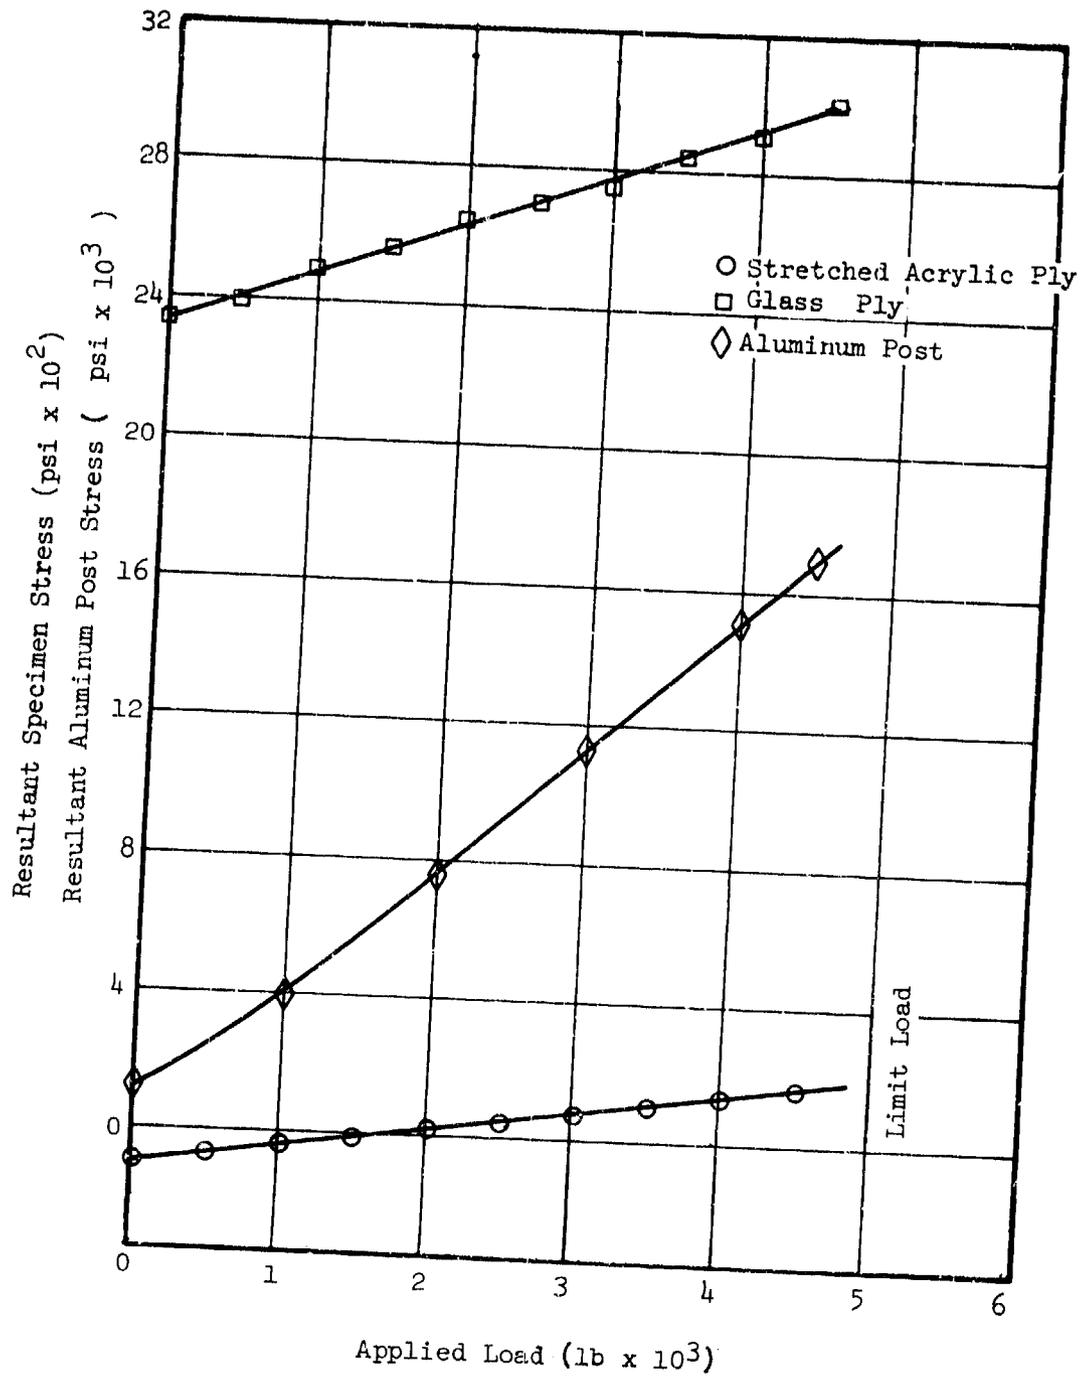
Figure 80. Assembly Tensile Test, 1/8 Inch Neoprene Gasket, 0.190-Inch-Dia Holes, 30-in.-lb Torque, Glass/Acrylic Specimen.

Condition 1 - 0.190 inch holes, 30 in.-lb torque. Figures 80 and 81 present plots of applied load vs resultant stress for each configuration. Testing of the glass/acrylic configuration was stopped at 4500 lb when limit stress was reached in the glass. Testing of the all-glass specimens was limited to 5000-lb load.

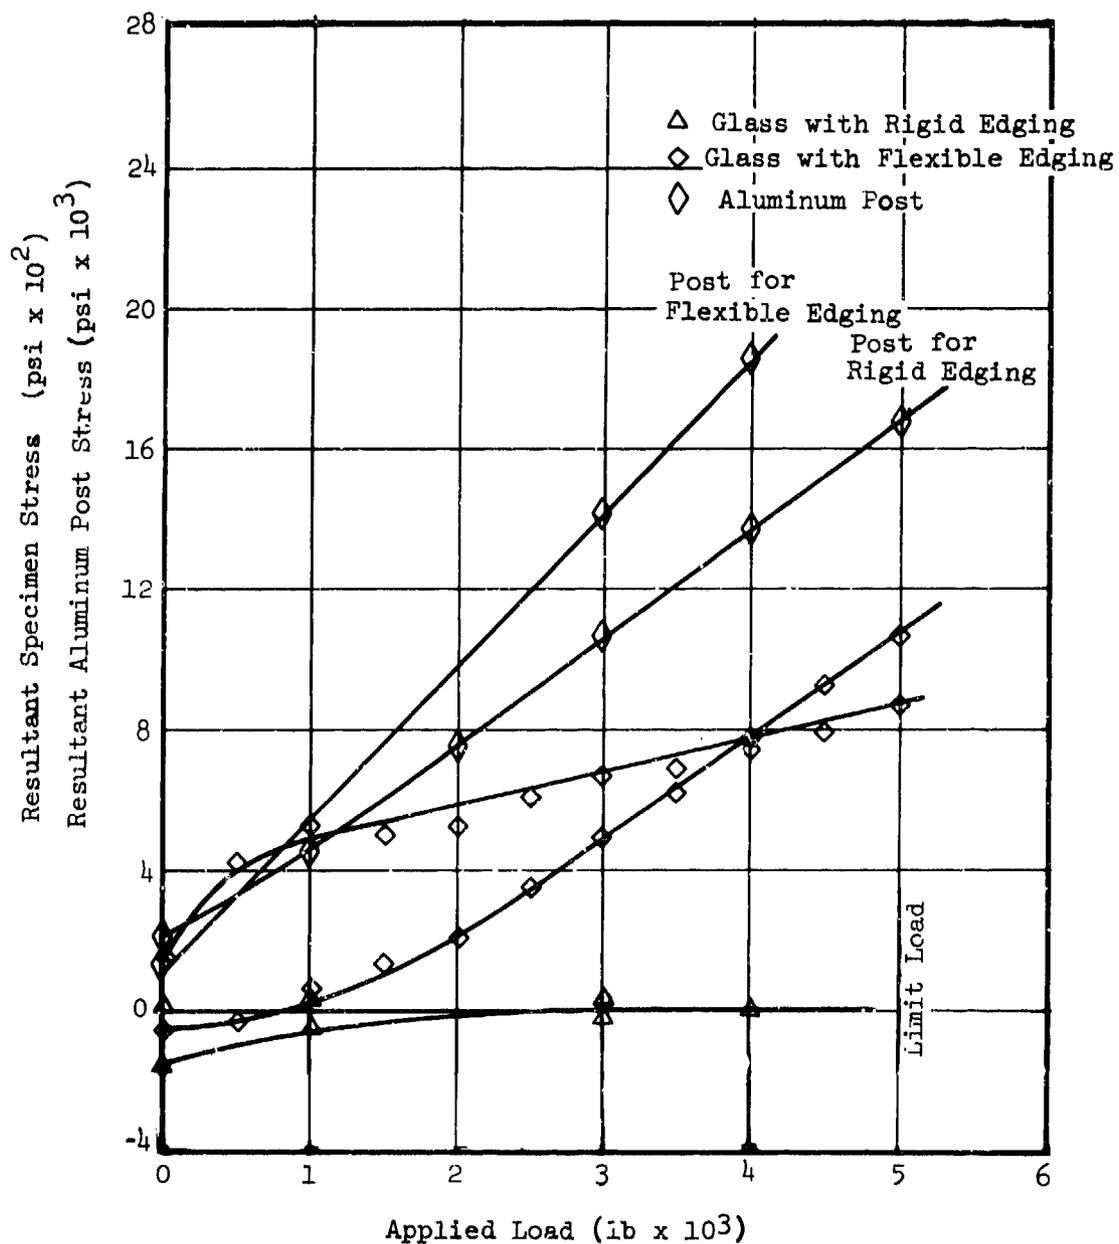
Figure 81. Assembly Tensile Test, 1/8 Inch Neoprene Gasket, 0.190-Inch-Dia Holes, 30 in.-lb Torque, All-Glass Laminated Specimens.

The all-glass laminate with flexible edging offered virtually complete isolation from axial loads that were applied to the posts. Glass facing stresses remained exceptionally low (<100 psi) for all loading conditions up to the maximum post load of 5000 lb.

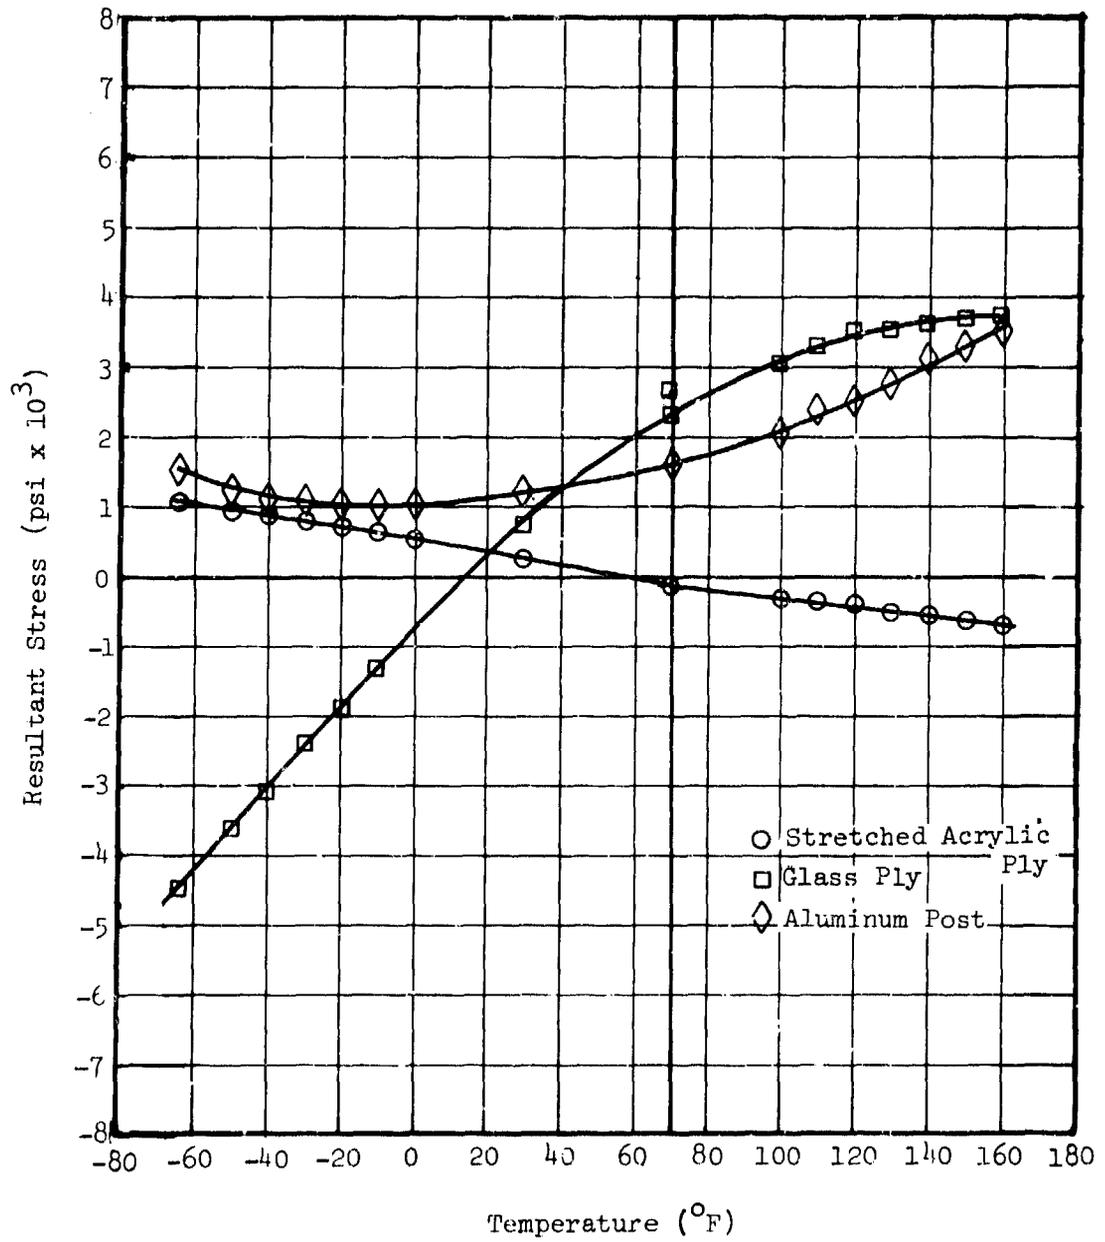
Figure 83. Assembly Thermal Tests, 1/8-Inch Neoprene Gasket, 0.190-Inch-Dia Holes, 30-in.-lb Torque, Glass/Acrylic Specimen.

Conditions 2 and 3 - Thermal Test, 0.190-inch-dia Holes, 30-in.-lb torque. Figure 83 presents plots of temperature vs resultant stress for the glass/acrylic specimen. Preload effects of the bowed specimen were observed when the specimen was torqued to the post and resulted in stresses of 2700 psi and 1800 psi in the glass and aluminum post, respectively. Thermal effects of the post were significant at low temperatures when smaller stresses were noted in the glass ply of the restrained specimen as compared to stresses in the unrestrained specimen previously tested.

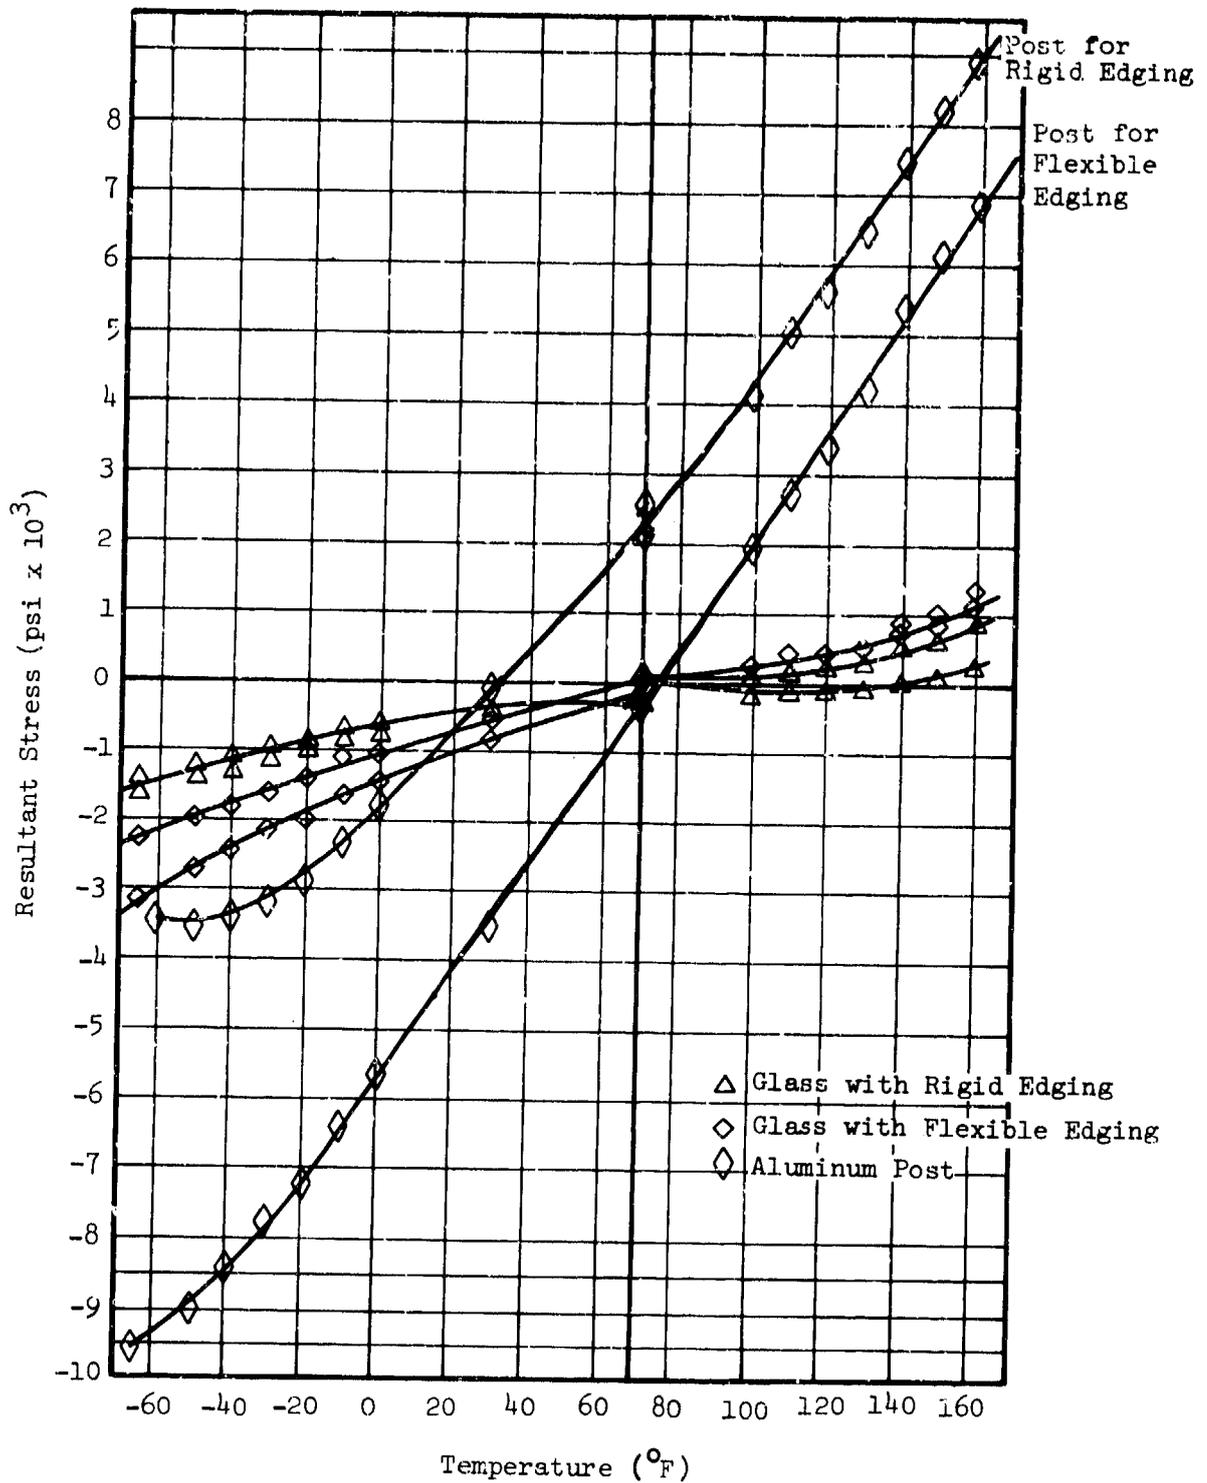
**Figure 84. Assembly Thermal Tests, 1/8-Inch Neoprene Gasket, 0.190-Inch-Dia Holes, 30-in.-lb Torque, All-Glass Laminated Specimens.**

Figure 84 presents plots of temperature vs resultant stress for the all-glass specimens. Resultant stress magnitudes for both configurations were similar to the results of thermal tests without aluminum posts within the limits of hysteresis and experimental error.

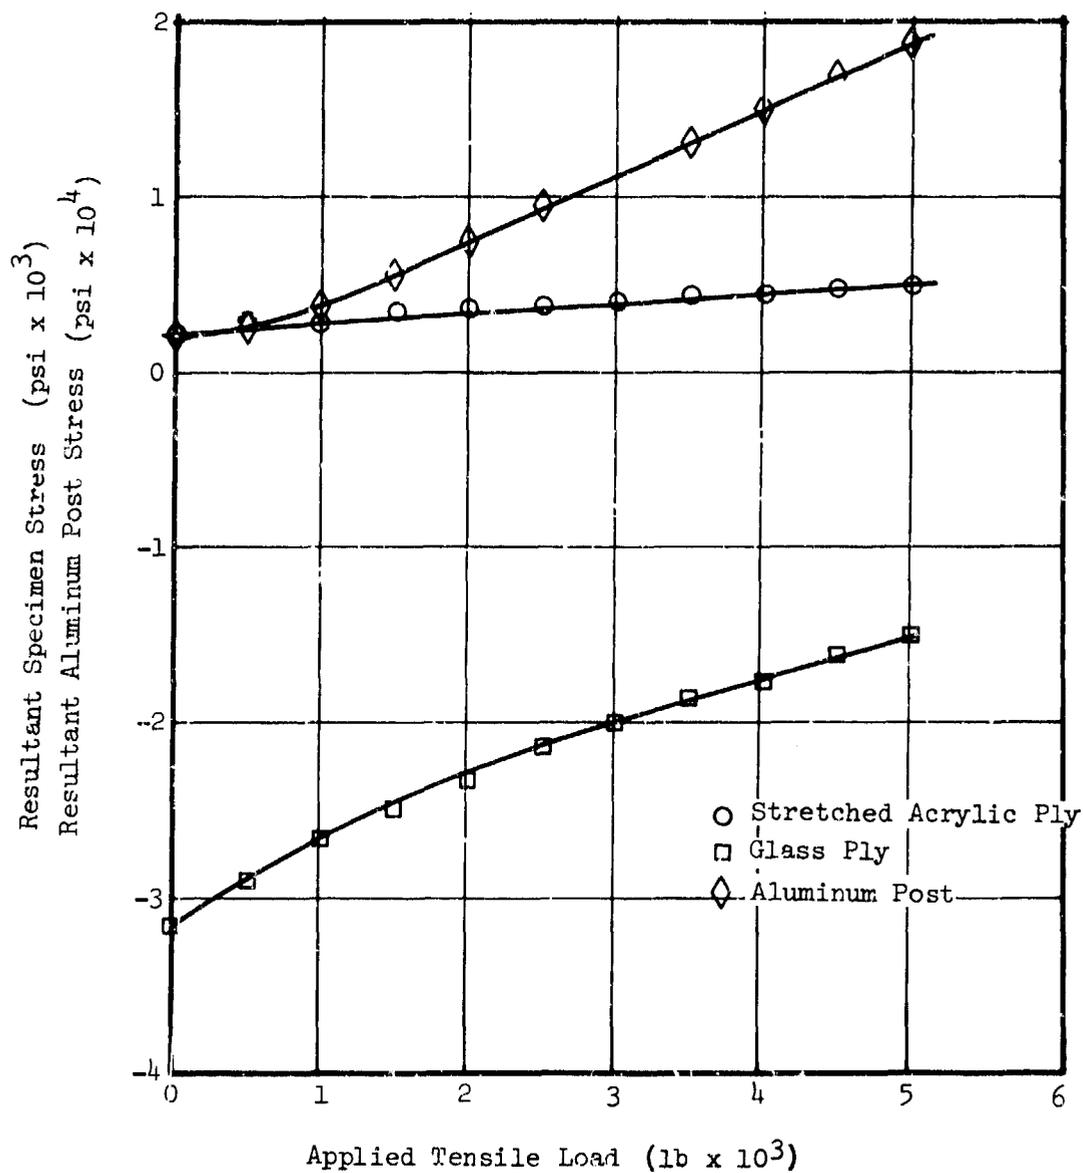
Figure 85. Assembly Tensile Tests, 1/8-Inch Neoprene Gasket, 0.310-Inch-Dia Holes, 30-in.-lb Torque, Glass/Acrylic Specimen.

Conditions 4, 5 and 6 - Hole Size, Fastener Torque and Sealant Material. The results of these tests, plotted in Figures 85 through 90, indicate that a high degree of isolation from axial loads is present with each type of post attachment.

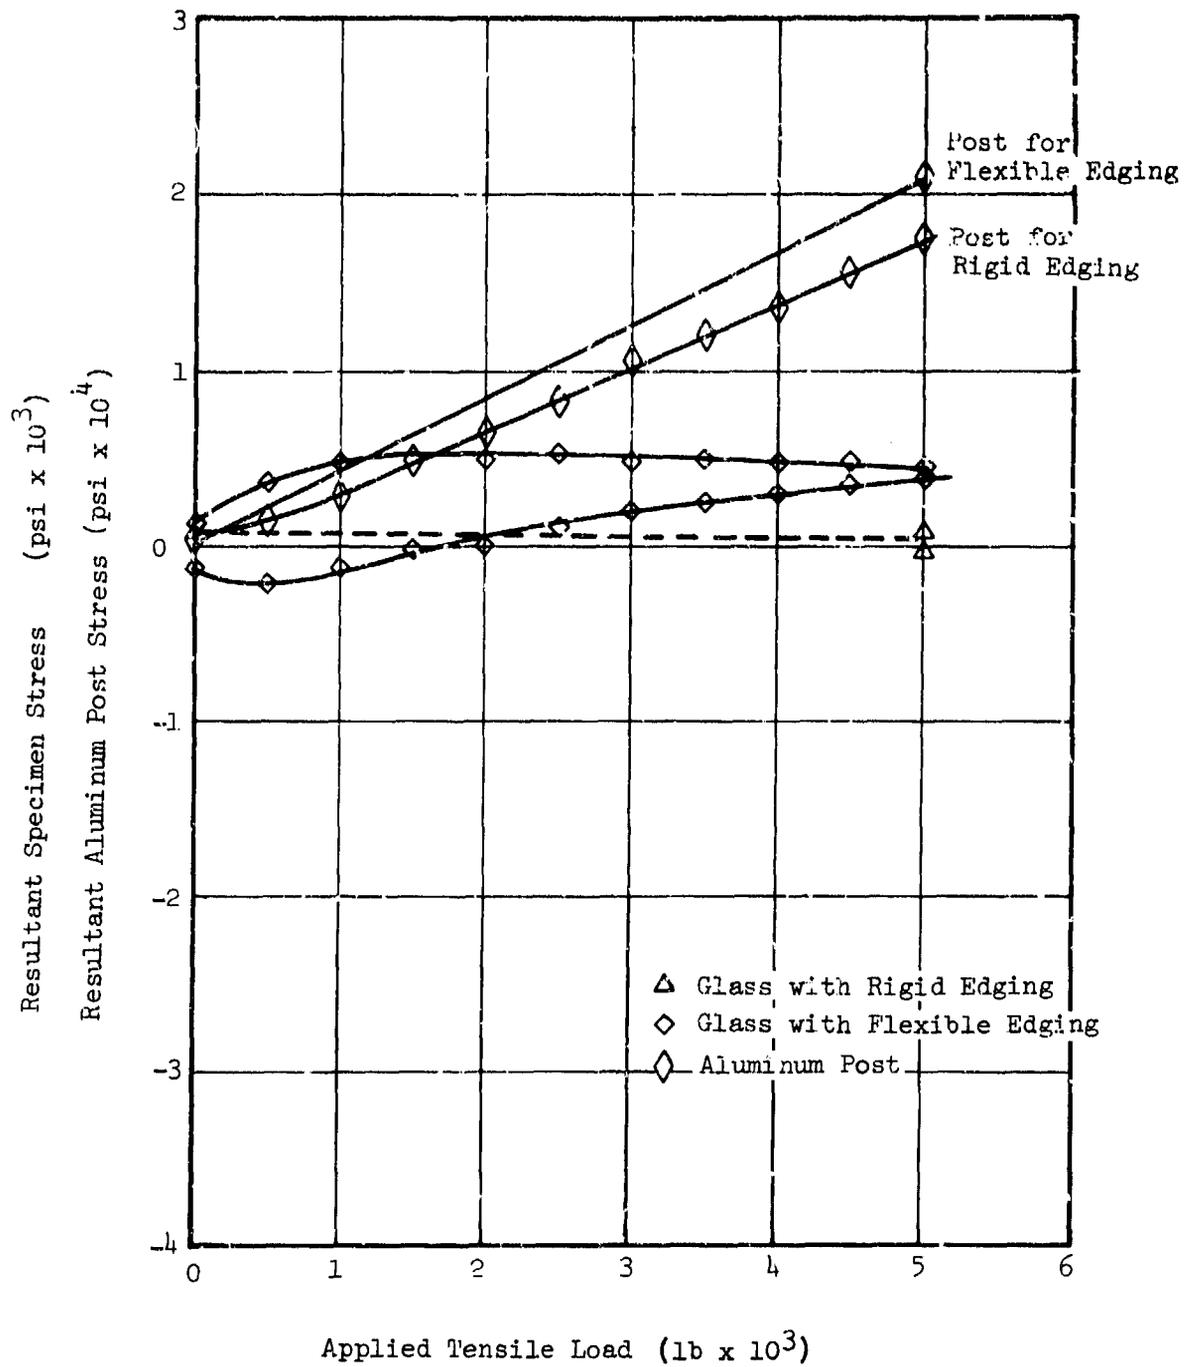
**Figure 86. Assembly Tensile Tests, 1/8-Inch Neoprene Gasket, 0.310-Inch-Dia Holes, 30-in.-lb Torque, All-Glass Laminates.**

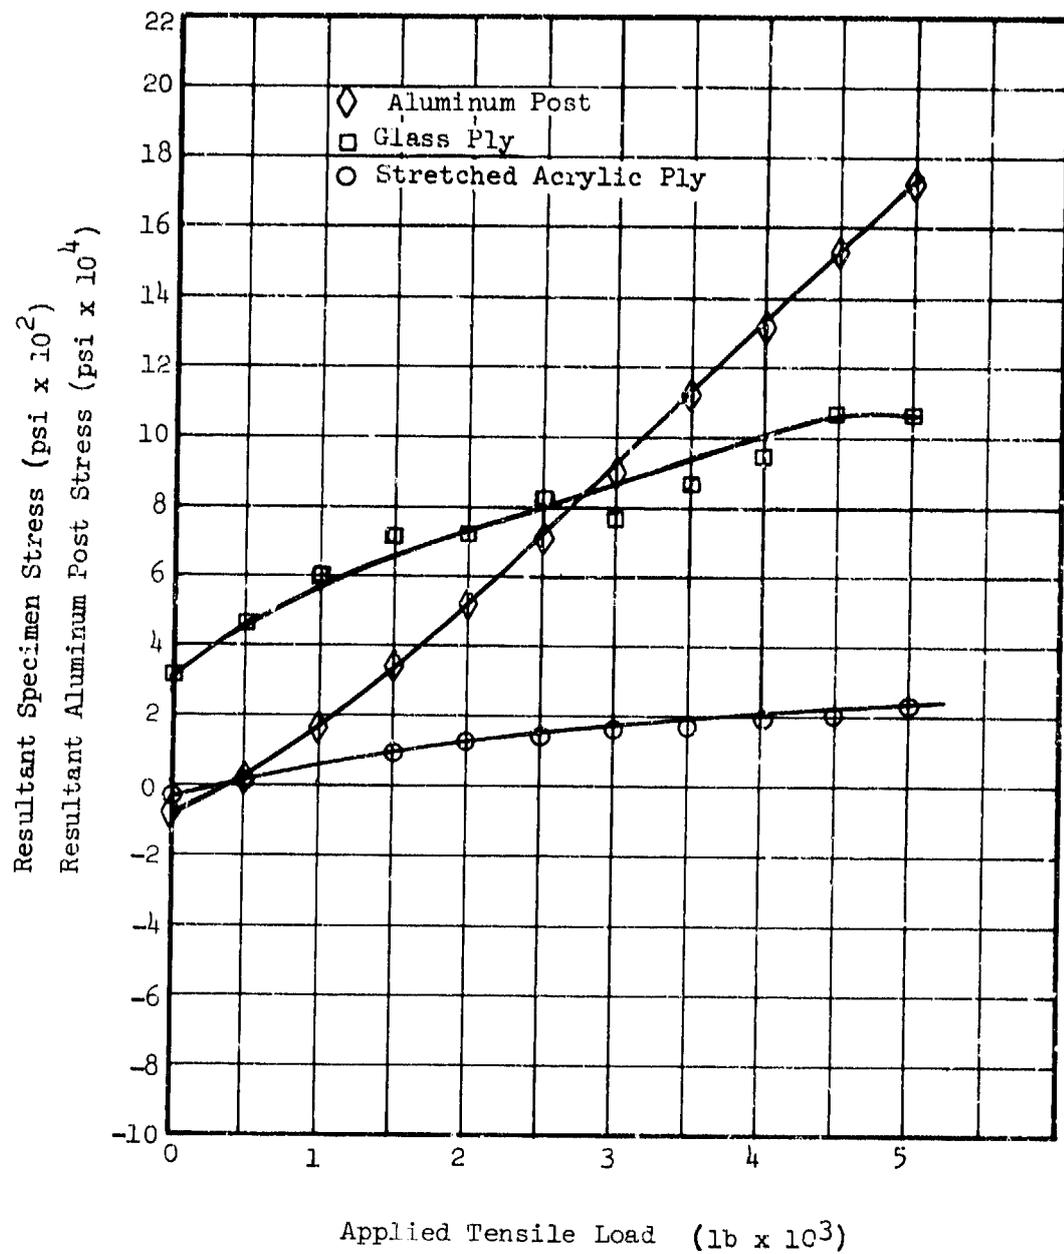
Figure 87. Assembly Tensile Test, EC-1675 Wet Sealant, 0.310-Inch-Dia Holes, 30-in.-lb Torque, Glass/Acrylic Specimen.

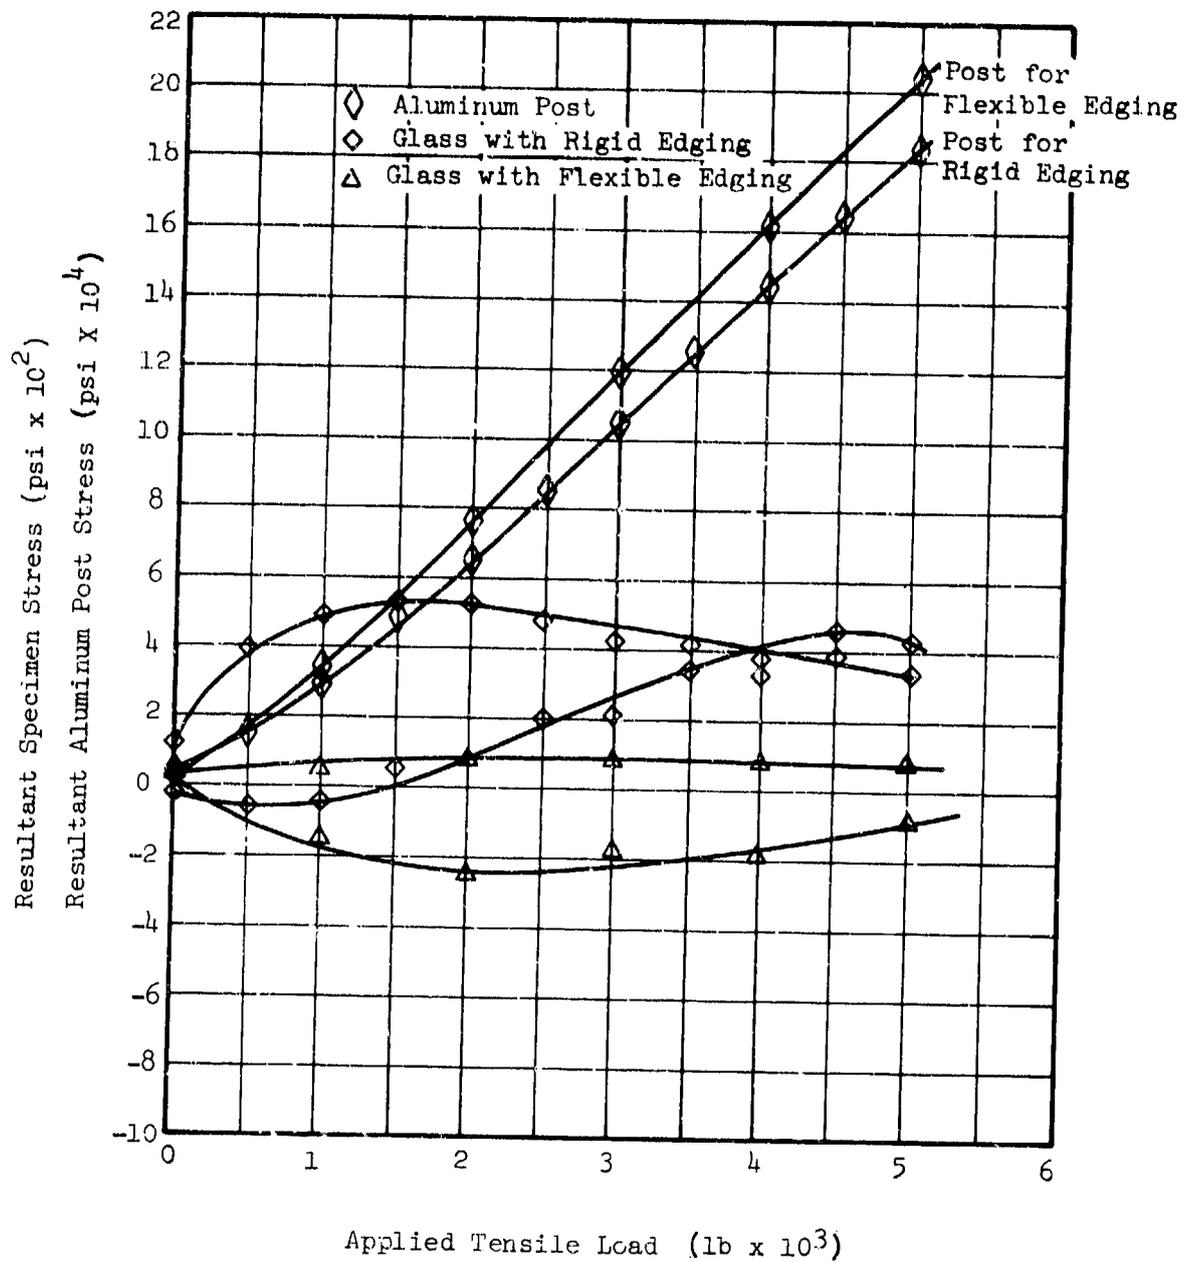
Figure 88. Assembly Tensile Test, EC-1675 Wet Sealant, 0.310-Inch-Dia Holes, 30-in.-lb Torque, All-Glass Laminates.

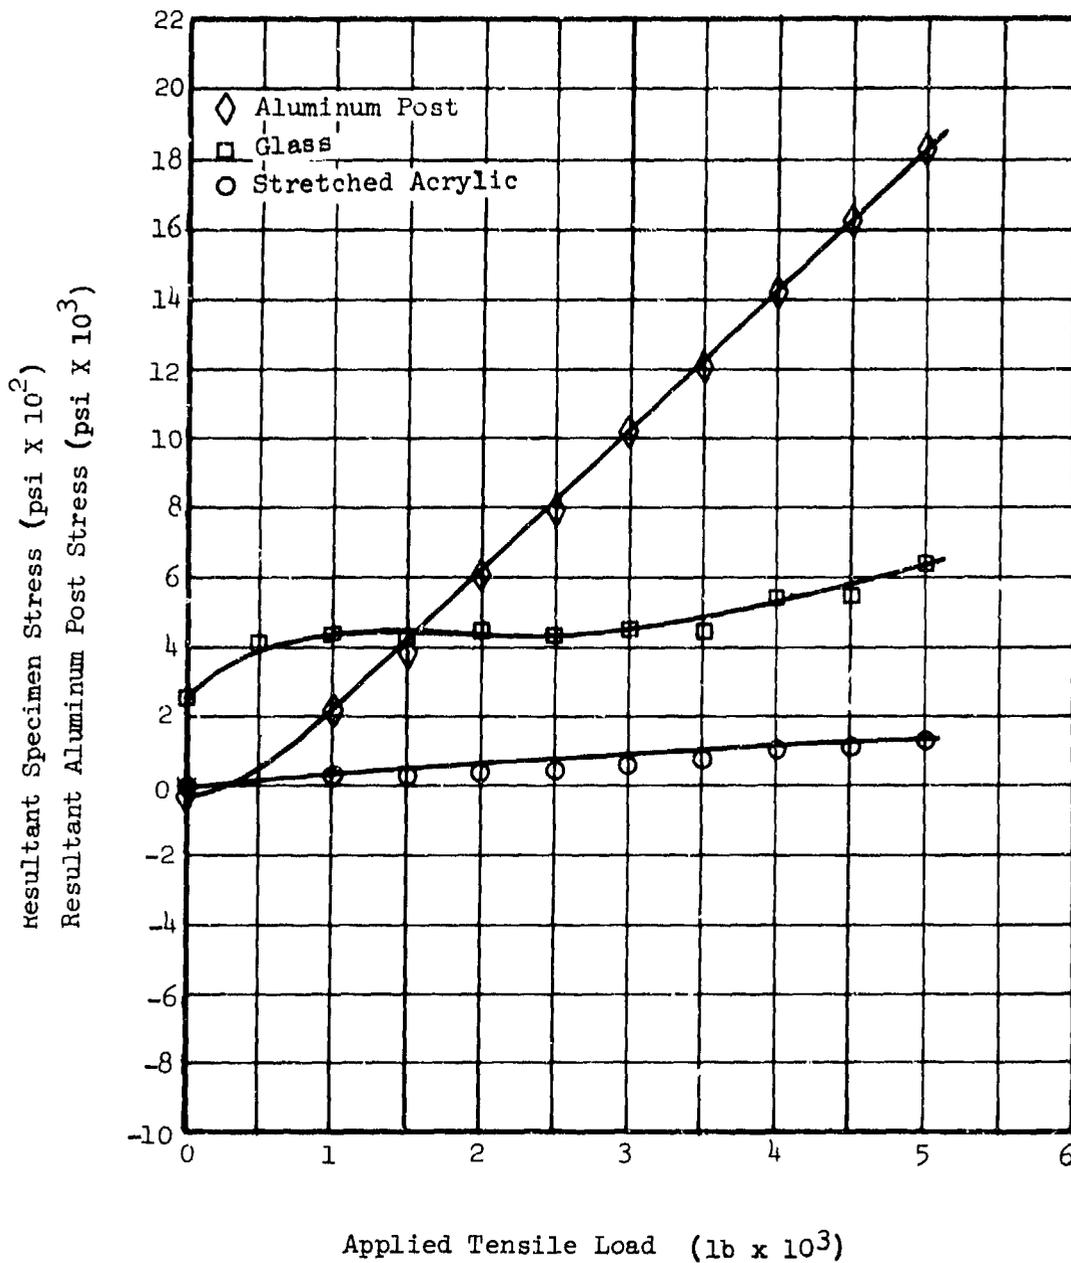
**Figure 89. Assembly Tensile Test, EC-1675 Wet Sealant, 0.310-Inch-Dia Holes, 10-in.-lb Torque, Glass/Acrylic Specimen.**

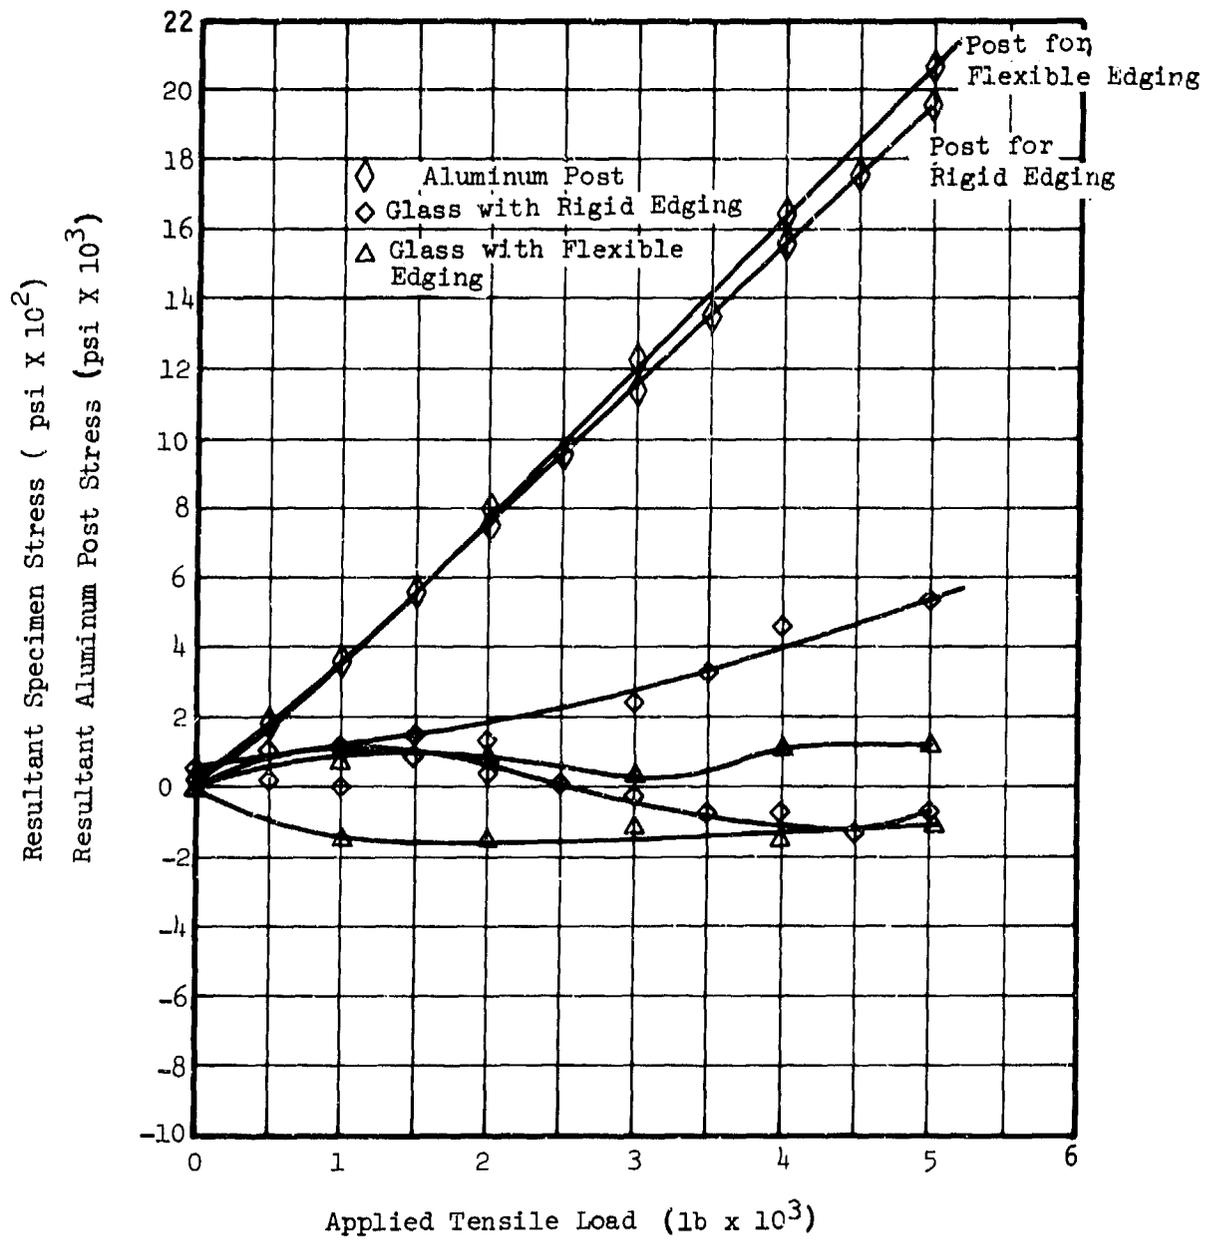
Figure 90. Assembly Tensile Test, EC-1675 Wet Sealant, 0.310-Inch-Dia Holes, 10-in-lb Torque, All-Glass Laminated Specimens.

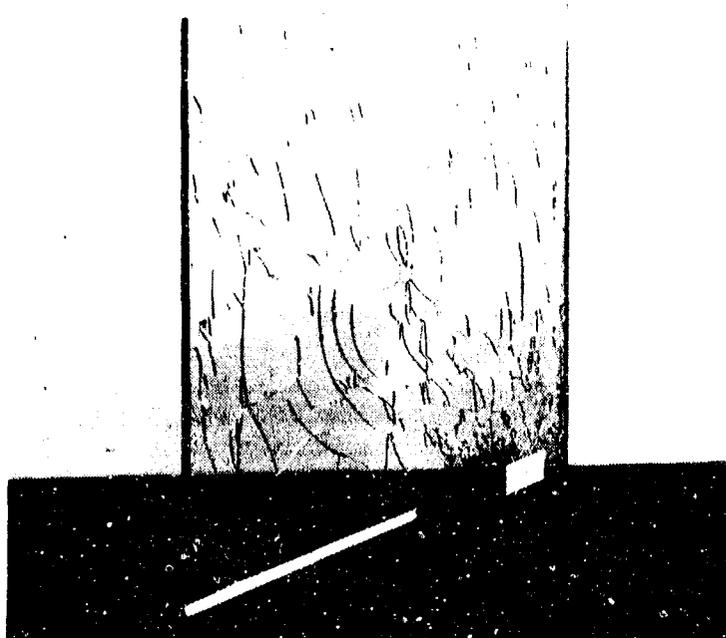
Figure 93. Chemically Tempered Glass (40,000 psi MOR)  
Fracture Pattern - 250 Particles/Ft<sup>2</sup>.

The five specimens were mechanically fractured by striking the center of each panel with a center punch. The resultant fracture patterns are shown in Figures 91 through 94. The annealed glass and 16,000 psi thermally tempered glass panels developed identical chips at the point of impact. Therefore, in order to obtain a reasonable variation between specimens, an additional specimen was added to the lot. The additional

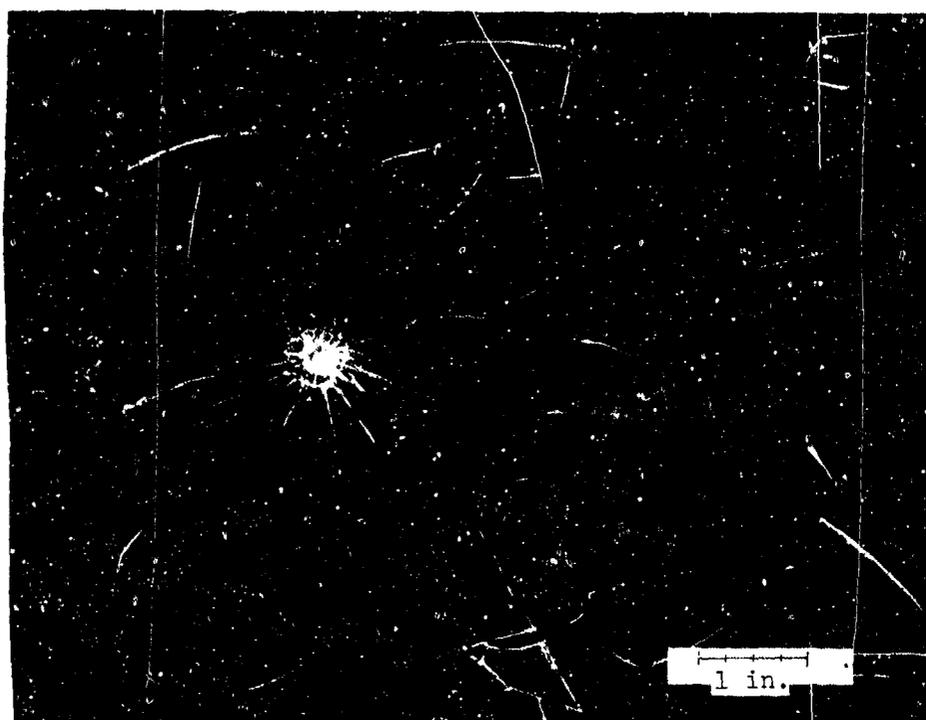
Figure 96. Particle Density, 250 Per Square Foot.

Each specimen was classified relative to the fracture density in particles per square foot, as shown in Figures 96 through 101.

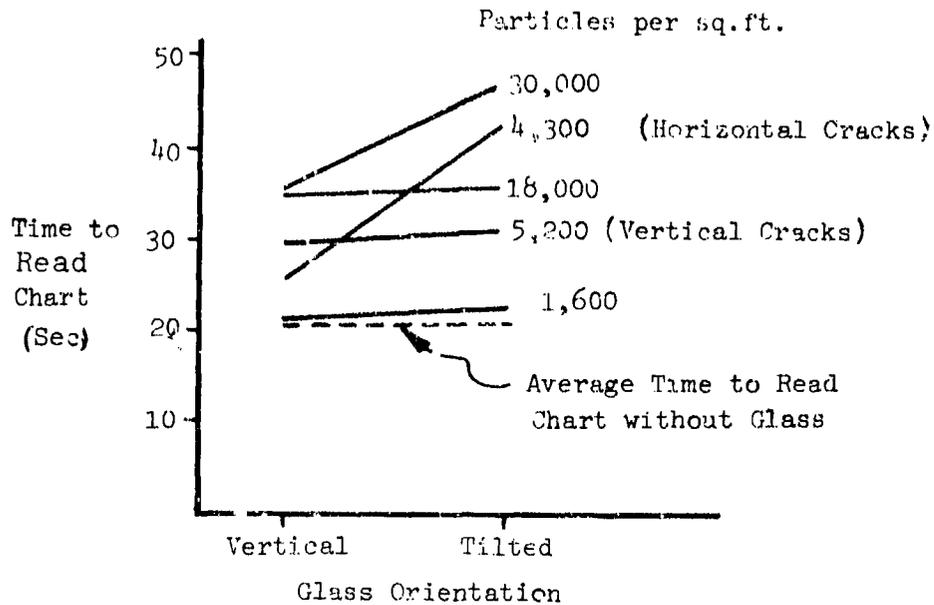
Figure 103. Effect of Crack Density on Visual Response Time.

A comparison of time scores for untilted and tilted glass is shown in Figure 103. Examination of the data showed that as the angle of incidence increased, the subjects took longer to read the chart. For the vertical case, it can be seen that time to read the charts increased with particle count. In the tilted column, the results still varied in a predictable manner except for the case in which the fractures formed a horizontal pattern. Horizontal fractures are particularly sensitive to window tilt because the action of tilting the window increases the visual angle obscured by each fracture. Crack patterns, especially horizontal ones, tend to obscure targets rather than to reduce the acuity of vision through the glass. Those areas not crossed by fractures have the same acuity as unfractured glass. This condition is shown in Figure 104.

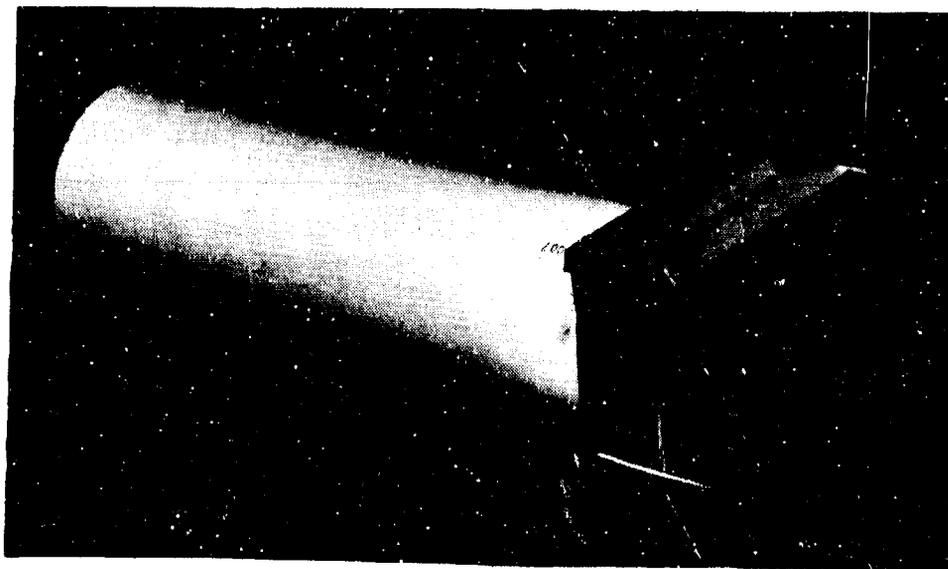
Figure 105. Viewer for Rating Haze Levels.

A set of eight abraded acrylic specimens with varying degrees of scratch intensity, ranging from clear (0.4% haze) to almost opaque (52% haze), were prepared. Specimen haze was measured by the U. S. Army Aeromedical Research Laboratory at Fort Rucker. The scratches were produced by pulling steel wool across the surface of the specimen under a constant pressure. A viewer consisting of a flat black tube with a holder to support the specimen at a fixed distance from the eye was constructed (Figure 105). Pilots were asked to look through the device at external scenes and were given the following instructions to rate the haze specimens.

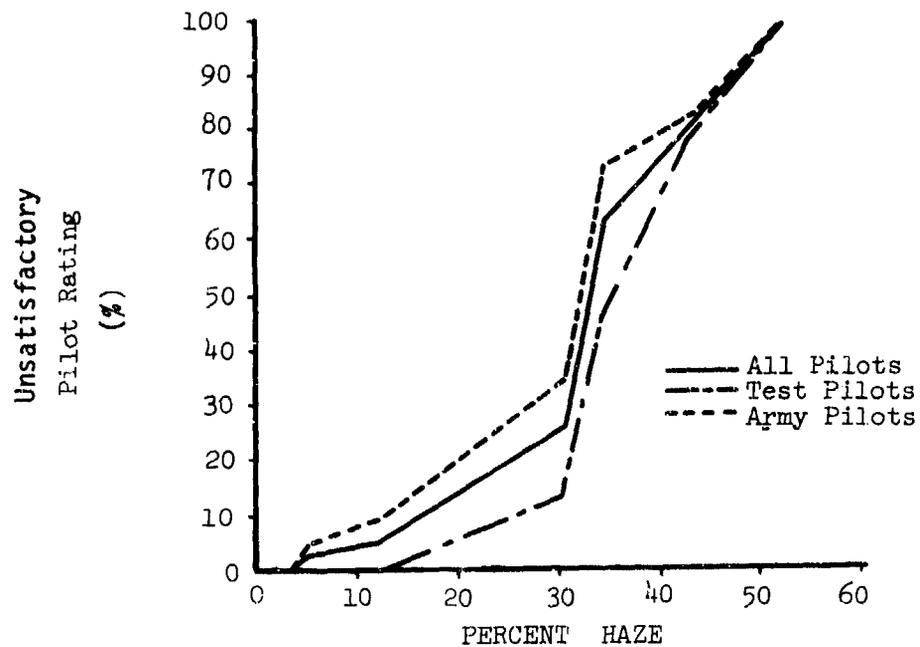
Figure 106. Plot of Unsatisfactory Pilot Ratings vs Haze.

Since the goal of the study was to determine the level at which haze would cause pilots to request corrective action, the ratings were divided into two groups. Ratings of 1 through 6 were considered satisfactory and ratings 7 through 9 were unsatisfactory. Figure 106 is a plot of the percent of unsatisfactory ratings against the percentage of haze in the chips.

The point at which the curve begins to rise rapidly is indicative of how much haze will be tolerated by flight personnel before a removal is effected. The data collected showed that a level of haze between 15% and 20% was accepted by at least 80% of the Army pilots tested. Comparison of the test chips with helicopter windows at Fort Rucker showed that almost all windows exhibited haze levels of less than 12%.

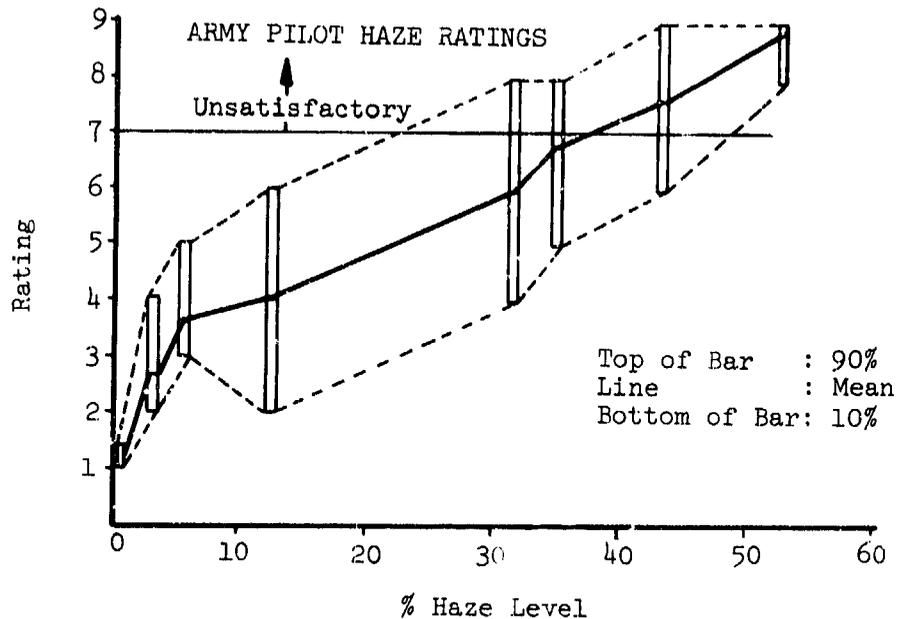
Figure 107. Army Pilot Haze Ratings.

Figure 107 is a plot of pilot ratings against percentage of haze in the samples. It is provided to show the consistency with which pilots reacted. The vertical bars show the range between the 10th percentile and the 90th percentile for each sample.

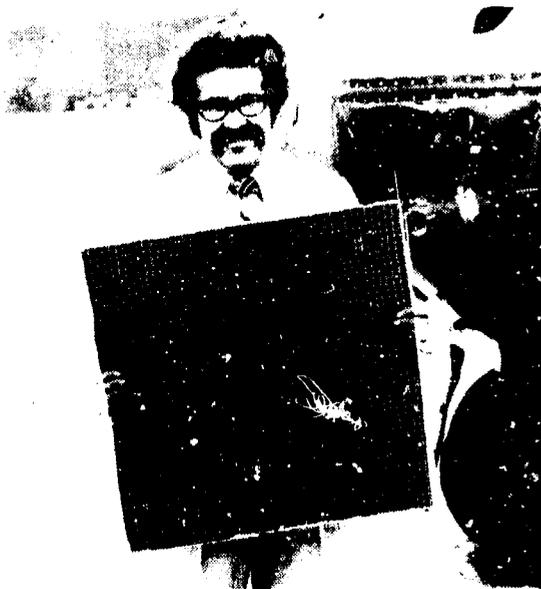
Figure 108. Test Grid Used to Measure Distortion.

A portable grid for evaluating optical distortion, shown in Figure 108, was used to locate and quantify optical distortion. Considerable experimentation was required to develop a technique for producing photographs with resolution adequate for measuring grid slope variation. The procedure finally adopted was to place the grid board approximately ten feet from the transparency with the camera at the pilot's eye position. A 4x telephoto lens was used to enable the grid to completely fill the picture. High-speed film with a shutter speed of 1/250th of a second was found to be necessary to prevent blurring lines due to motion of the grid or camera.

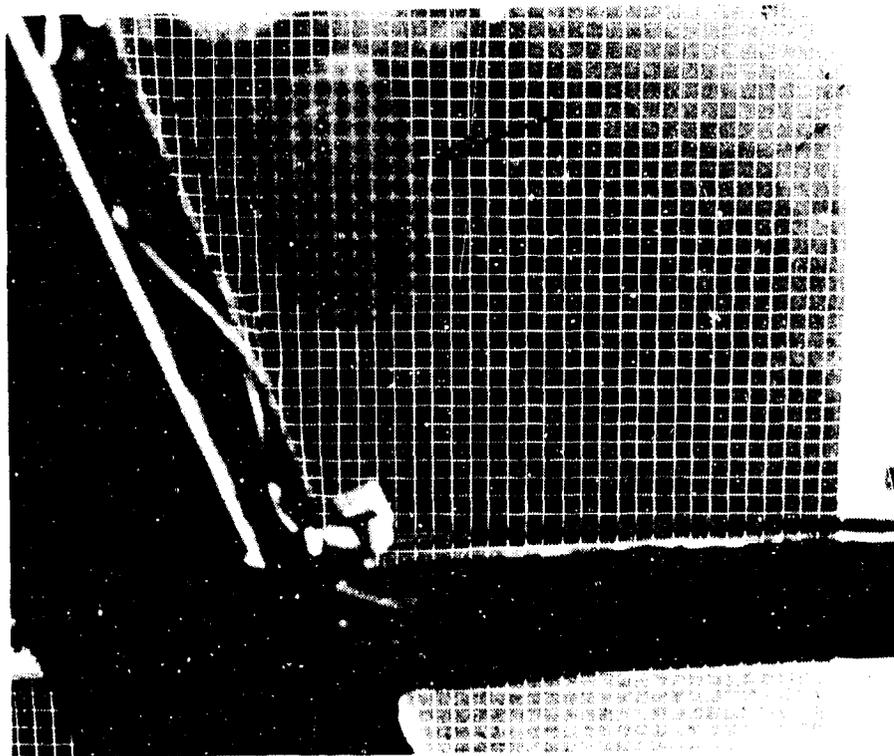
Figure 109. CH-53 Windshield Delamination.

However, Figure 109 shows a delamination in the left front canopy of a CH-53A that was in for overhaul. The photograph shows that delaminations do not cause distortions, but increase opacity of the window. The picture also shows some edge distortion next to the delamination spot. Figure 110 is an external view of the aircraft showing the location of the delaminations.

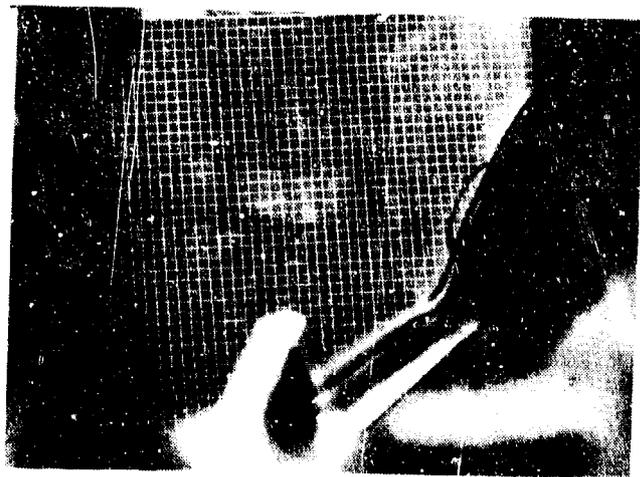
Figure 112. Cobra, Left Side Window.

Pictures taken through the canopy showed little distortion except around the window edges as seen in Figure 112. The photograph, taken from the aft seat, looks out the left side of the helicopter and shows distortion on the front edge of the canopy. The lighter spots on the grid are caused by dirt and abrasions on the canopy surface.
