USARTL-TR-78-26

**DESIGN, TEST, AND ACCEPTANCE CRITERIA FOR  
HELICOPTER TRANSPARENT ENCLOSURES**

Bruce F. Kay  
Sikorsky Aircraft Division  
United Technologies Corp.  
Stratford, Conn. 06602

Final Report for Period 27 June 1974 - 26 July 1976

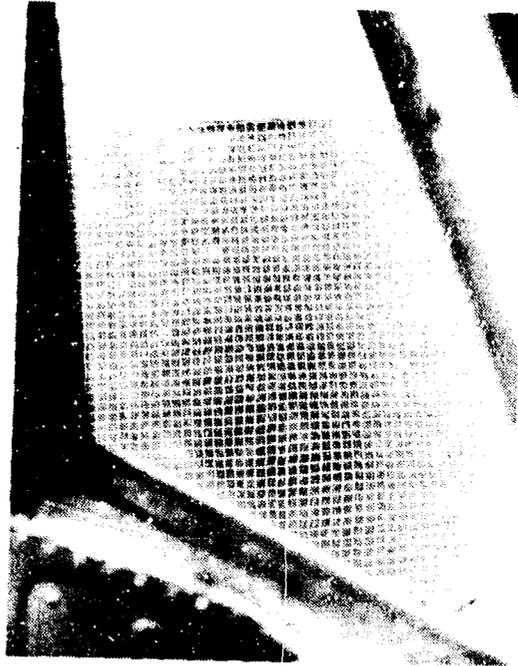
Figure 116. UH-1, Front Door Window, Wave Distortion.

As in the Cobra, optical distortion could be found around the edges of the canopies. Figure 116 shows a typical situation at the edge of the front window in the UH-1 door. Measurements of the distortion showed a slope of about 1:10, which meets existing criteria for door windows.

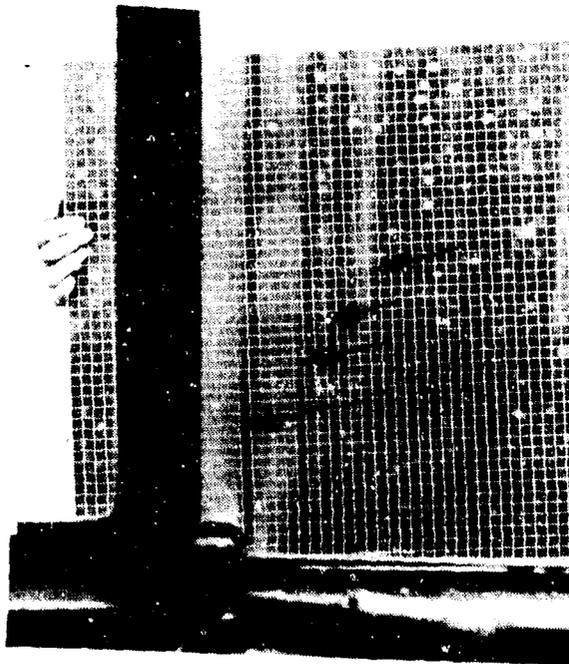
Figure 117. UH-1, Crew Door Window Abrasion.

A common observation of the UH-1 at Fort Rucker was a series of scratches on the side door windows. This window opens by sliding down into the door structure. Figure 117 is a view from inside the aircraft and shows translucent bands due to the scratches. Some of the pilots complained about side vision through this window. This defect was uncorrected in most aircraft because repair of the window requires replacement of the entire door since the window is not removable.

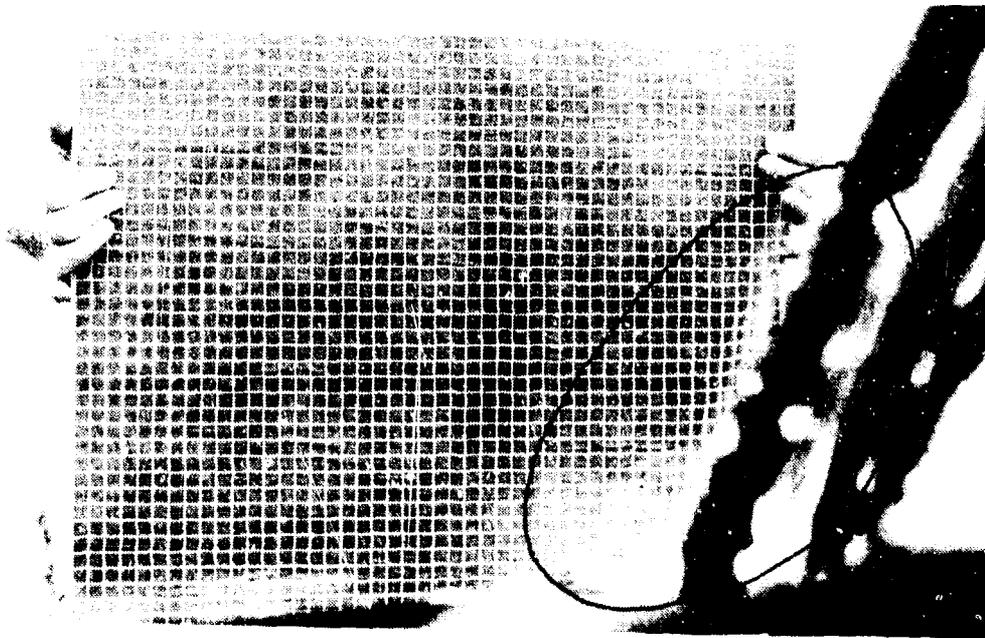
Figure 120. OH-58, Bottom Front Window, Edge Distortion.

Examination of the OH-58's at Fort Rucker showed edge distortion, as was found in all vehicles (see Figure 120). Figures 121 and 122 show the results of an impact by a hard object on the lower surface of the right window. As can be seen, the effect is one of localized distortion and an obscuring of the view.

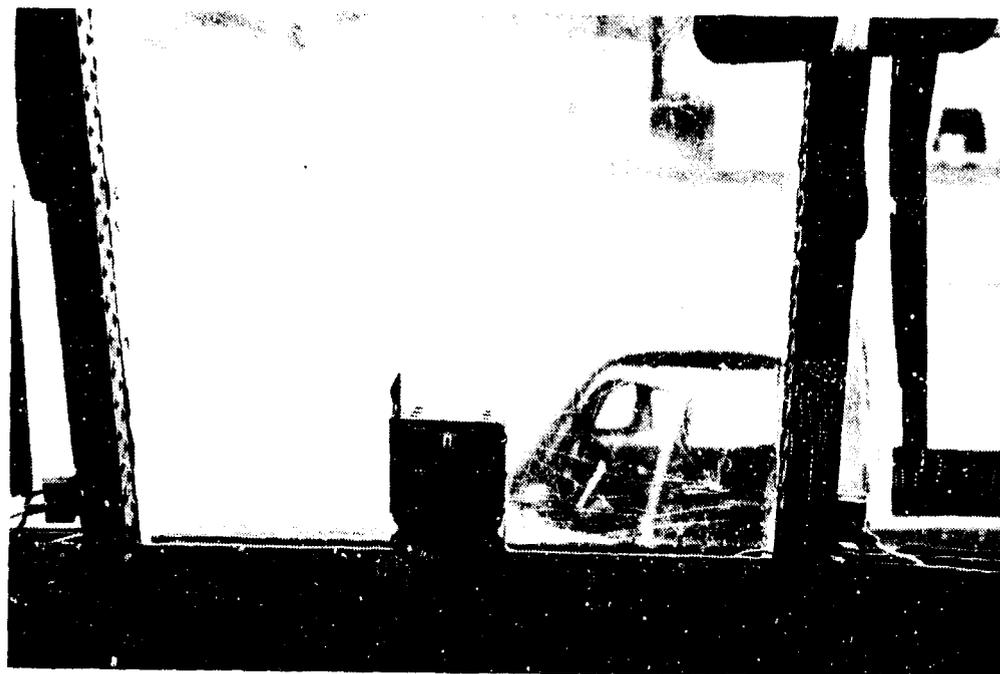
Figure 125. CH-47, Center Windshield Scratches.

Figure 125 shows the effects of scratches on vision through the center window. The scratches in this window were compared with the haze chips evaluated by pilots, and it was estimated that this window had a haze level of about 12%.

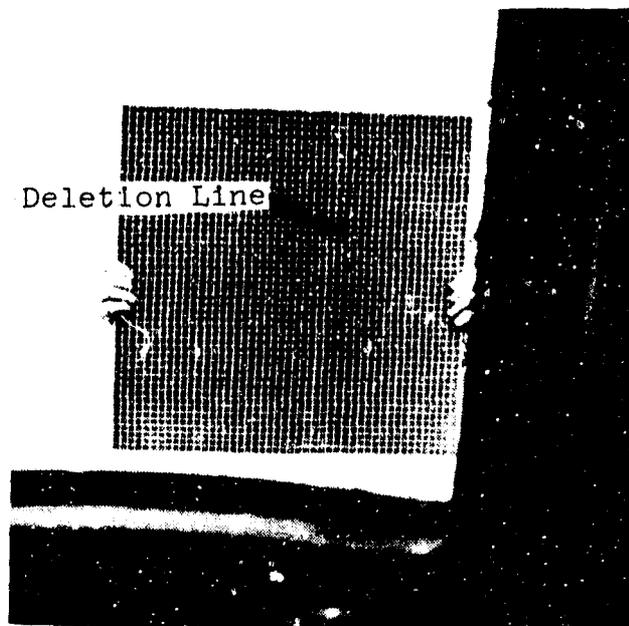
Figure 126. CH-47, Windshield Deletion Line.

Figure 126 shows the appearance of the deletion line in the center windshield of a CH-47. This is an area where the windshield coating has been left off for electrical reasons. As can be seen, it caused little or no distortion. Figure 127 is an overall view of the CH-47 nose section.

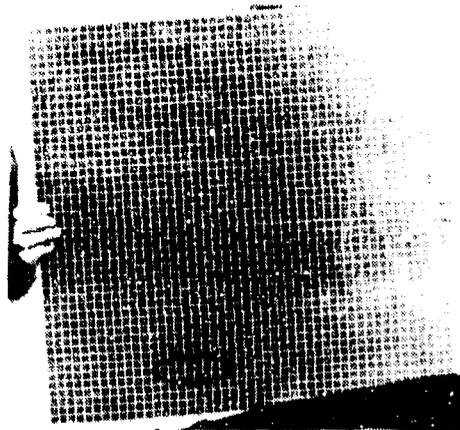
Figure 129. TH-55, Front Windshield Distortions.

TH-55: The TH-55 (Figure 128) is used as a training aircraft and has a windshield made of relatively thin plastic. Figure 124 shows the appearance of the test grid through the front windshield. The grid does not show large distortions, but careful observation shows many small bends in the grid pattern throughout the entire window. This was typical of the TH-55's at Fort Rucker. In all other aircraft types, the central portion of the windshield usually showed no distortions at all. Measurement of the local distortion grid slopes in Figure 129 showed them to be 1:8. However, examination of the questionnaire data showed that no TH-55 pilots complained about windshield distortion.

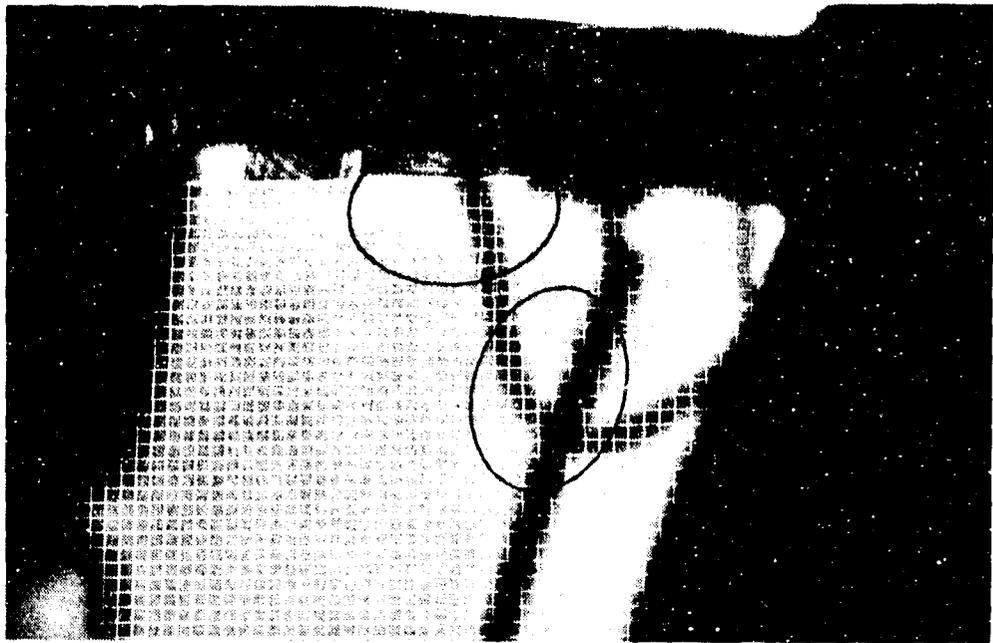
Figure 132. OH-6, Bottom Window Distortions.

OH-6: Only one OH-6 could be located at Fort Rucker. In this helicopter some distortion (1:10) was observed in the lower front window, as shown in Figure 132. The side door window, Figure 133, is made of very thin material that is reinforced with three ridges of plastic. The ridges are translucent and obstruct vision, as shown in Figure 134.

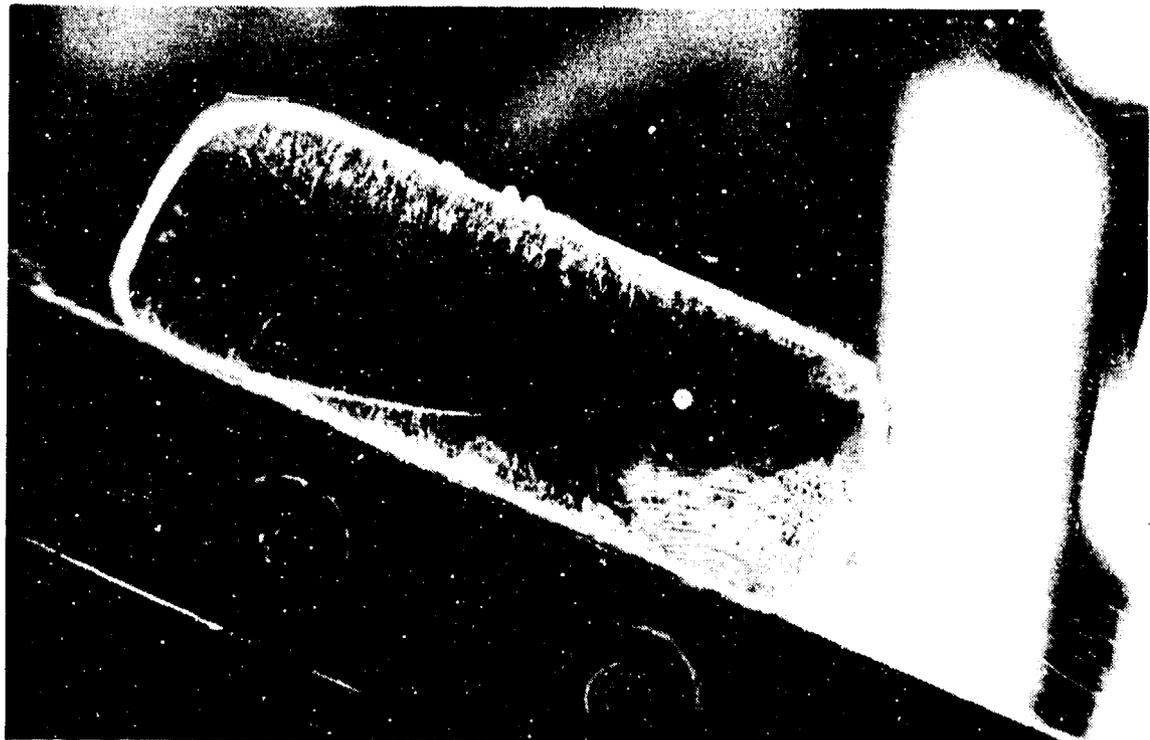
Figure 135. Patch Method of Repair.

6. The method of repairing cracks in plastic windshields has been to glue a patch over the crack as shown in Figure 135. These patches are translucent but not transparent. Patches such as this were found in the OH-58, TH-55 and CH-47. This type of repair solved maintenance problems but tended to degrade operational use of the vehicle.

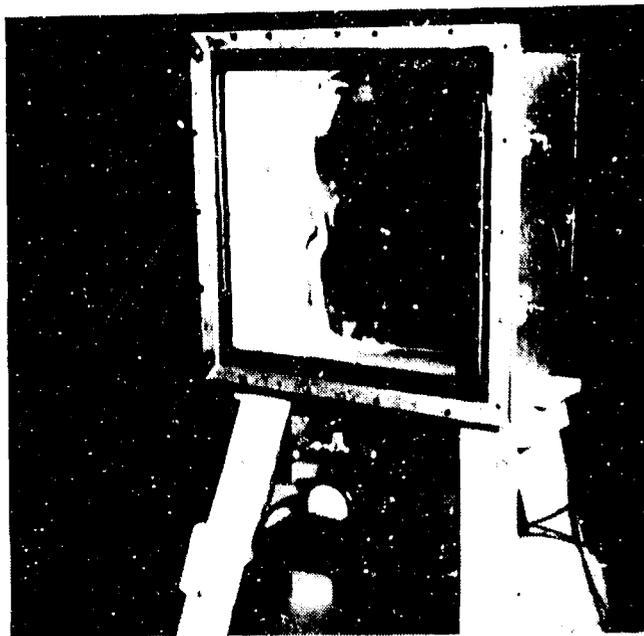
Figure 136. Pressure Box and Pump.

The pressure box was designed to aid in determining the energy of any spall fragments ejected from the specimen at impact. Six inches behind the specimen was a 0.002-inch-thick aluminum foil witness sheet for recording spall dispersion patterns. A wooden frame maintained a 1-inch space behind the witness sheet. The presence of this void aided in differentiating between those fragments which merely punctured the foil and fell back and those which fully penetrated the foil. Behind the spacer were five layers of one-half-inch-thick expanded polystyrene foam (1 lb/cu ft density). This foam was also used to characterize the energy of spall fragments.

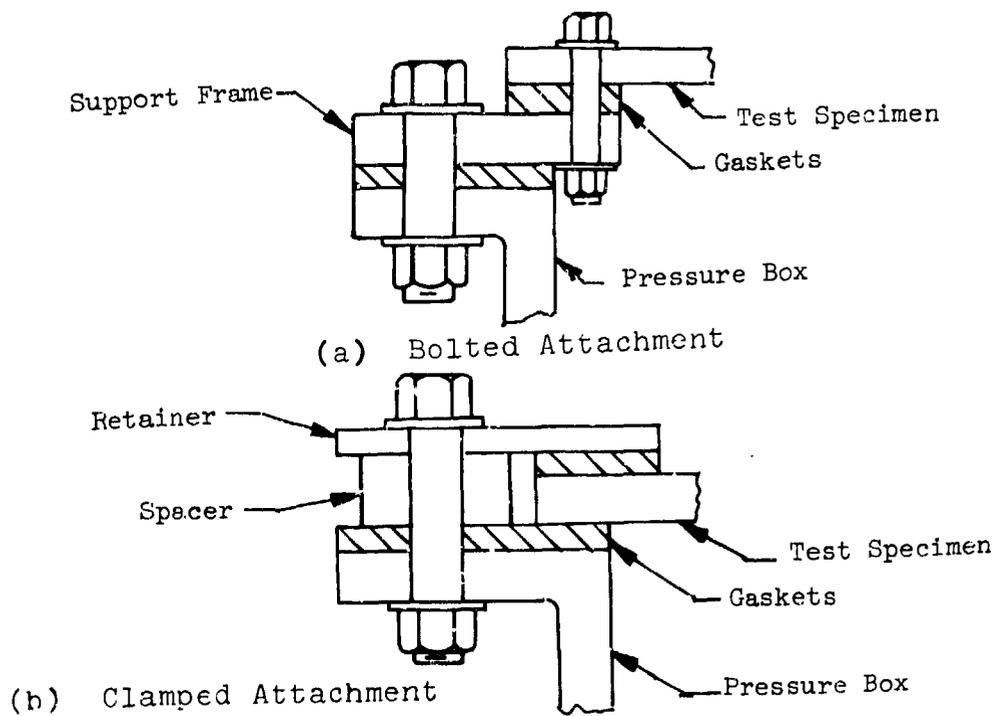
Figure 137. Methods of Attaching Test Specimens.

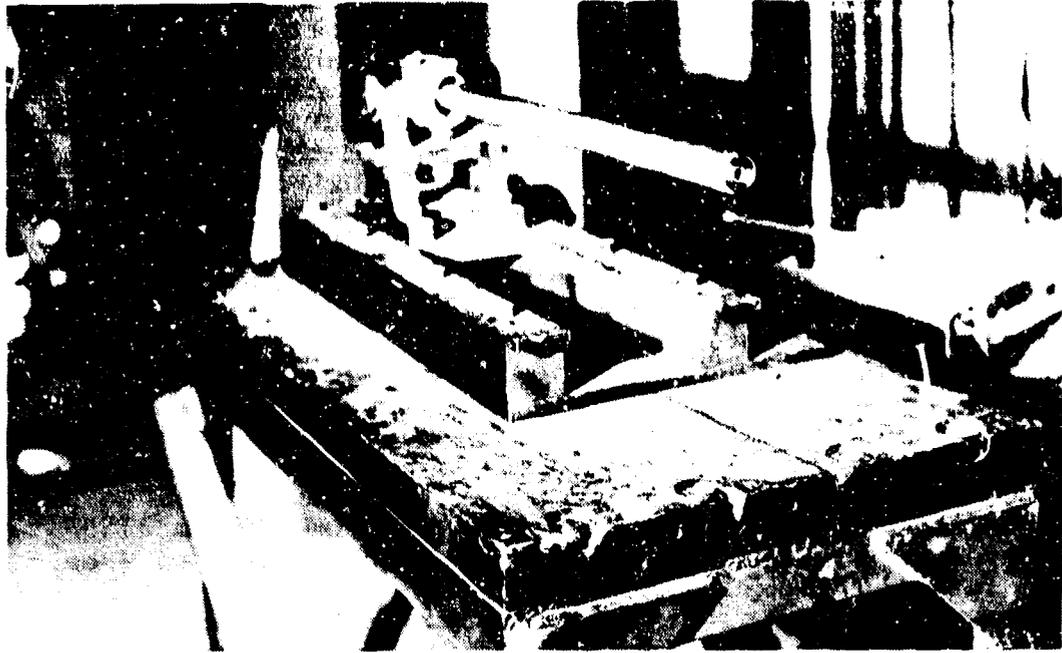
Figure 138. Mann Barrell and Mount.

The ballistic rounds were fired from the mount and barrel shown in Figure 138. The round velocity was determined by the device shown in Figure 139, which measured the time of flight over a three-foot distance. Each round was either 7.62mm ball or 7.62mm armor-piercing ammunition.

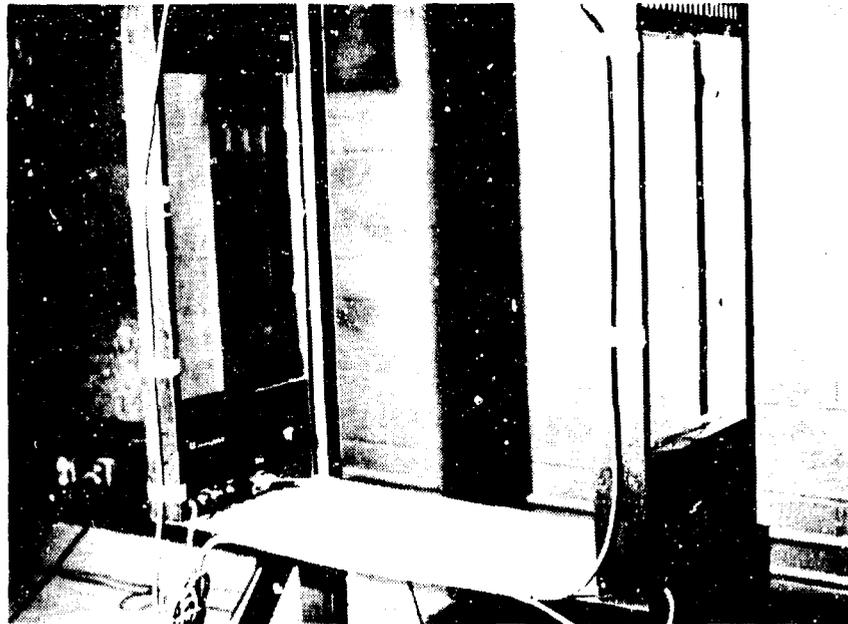
Figure 139. Velocity Measuring Equipment.

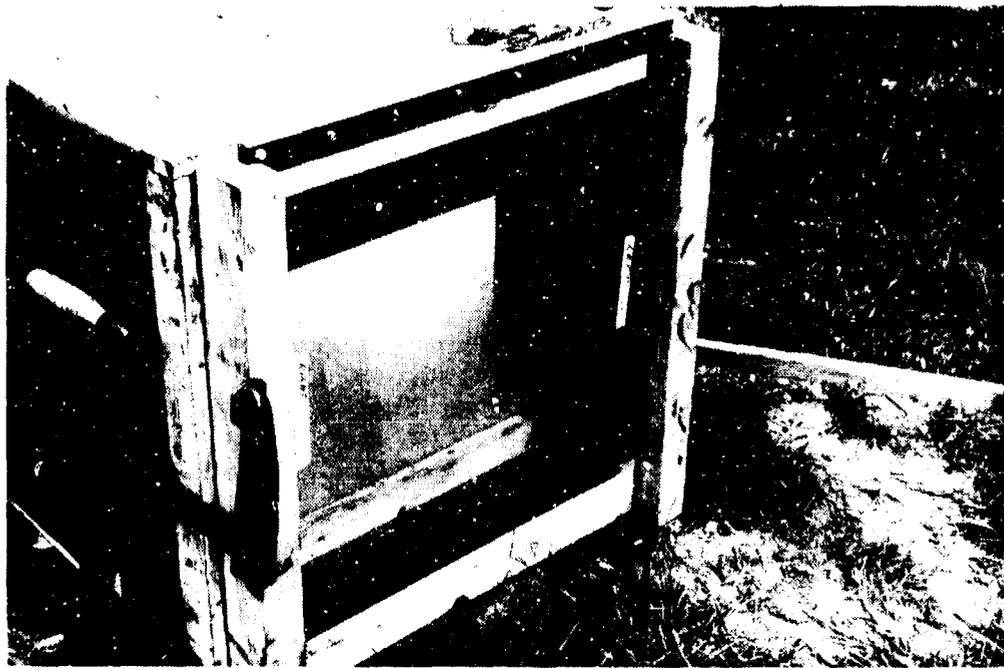
Figure 141. Screening Test Fixture.

Some of the screening tests were performed with a wooden test box shown in Figure 141. An aluminum foil witness sheet and layers of wall board were placed in the box to evaluate spall damage. The criteria for ballistic damage included size, amount and density of spall as well as reduction in visibility.

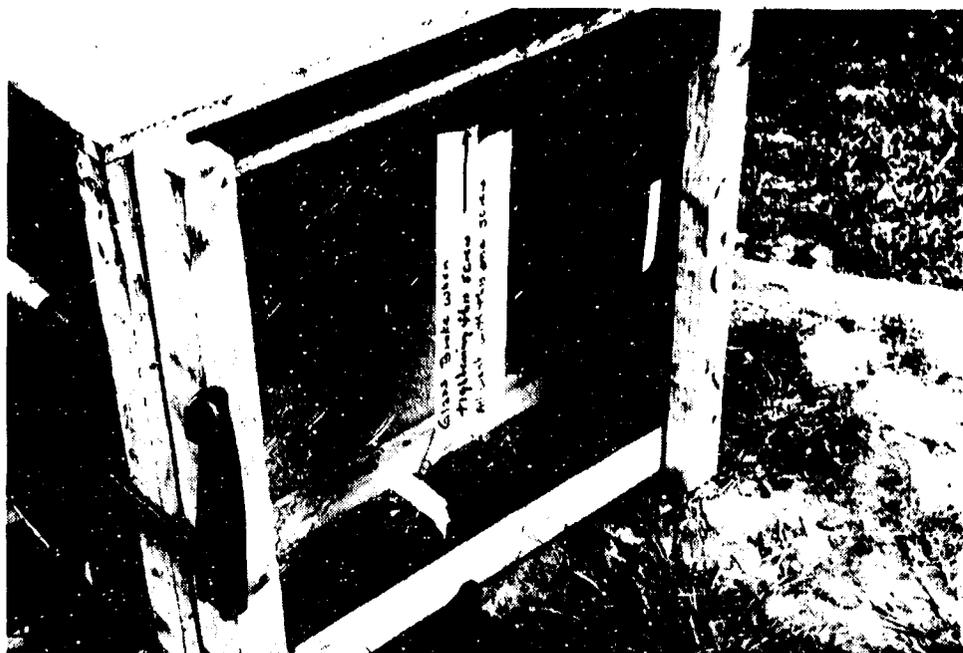
Figure 142. Damaged Ballistic Specimen.

Two glass/acrylic panels were cracked before testing during installation. The damage occurred because the flexibility of the edge reinforcement was sufficiently low to permit excessive bending to occur between fasteners when they were torqued. This created undue stresses which cracked the glass. However, the resultant cracks in the glass were widely spaced and did not interfere with the target area, which enabled the damaged panels to be successfully tested (Figures 142 and 143).

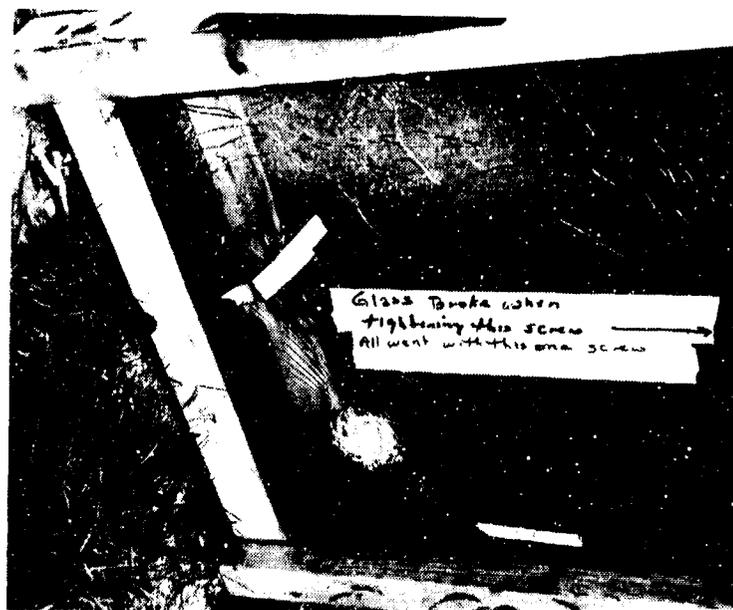
Figure 143. Ballistic Impact on Damaged Specimen.

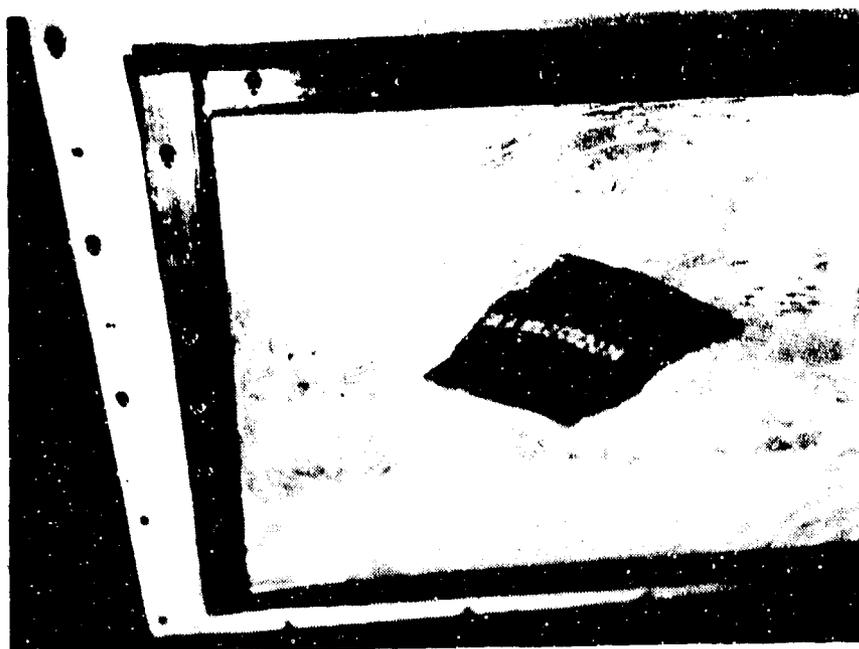
Figure 144. Soft Rubber Patch Maintains Vacuum for Fail Safe Test.

After ballistic penetration, each specimen was subjected to a fail-safe test to determine whether or not the damaged specimen was capable of supporting the required aerodynamic loads. The entry hole created by the test round was sealed by a soft rubber gasket, as shown in Figure 144, and the original pressure was reinstated. In most cases where the specimen supported this load, pressure was maintained for one minute to test for any time-dependent effects.

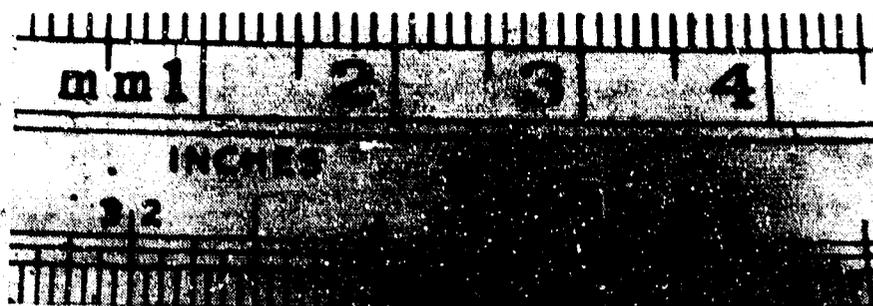
Figure 145. Ballistic Penetration of Polycarbonate.

The polycarbonate showed excellent residual visibility. No surface cracks occurred and the entry hole closed up to become smaller than the round itself, as shown in Figure 145.

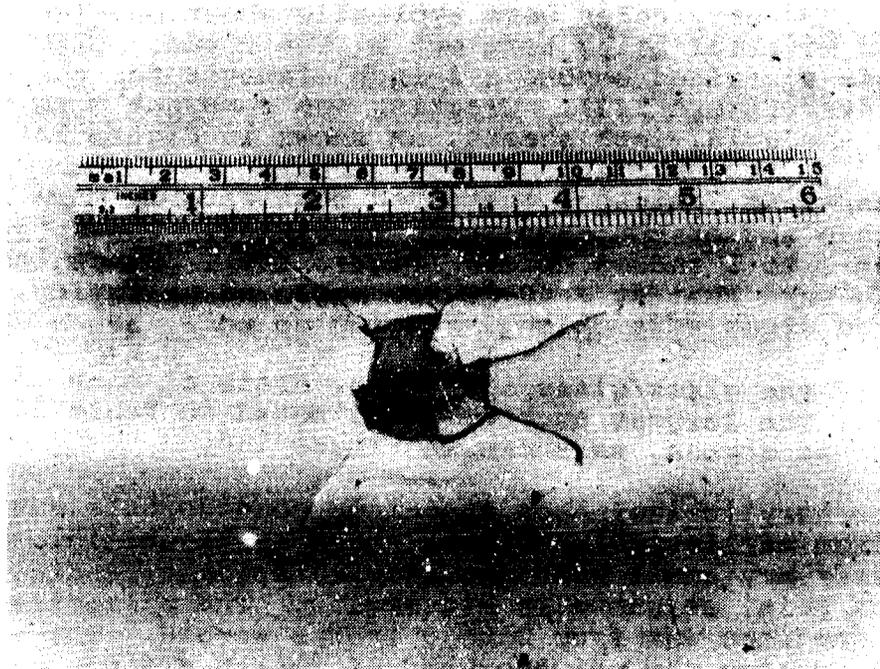
Figure 147. Ballistic Penetration of 0.080 Inch Cast Acrylic.

The cast acrylic specimens suffered primarily localized damage. The entry holes were typically about one-inch across with some material being torn out by the round. Little damage was sustained beyond a 3-inch diameter for the 0.080-inch sheets (Figure 147). Cracking was somewhat more extensive for the 0.187-inch sheets, as shown in Figure 148.

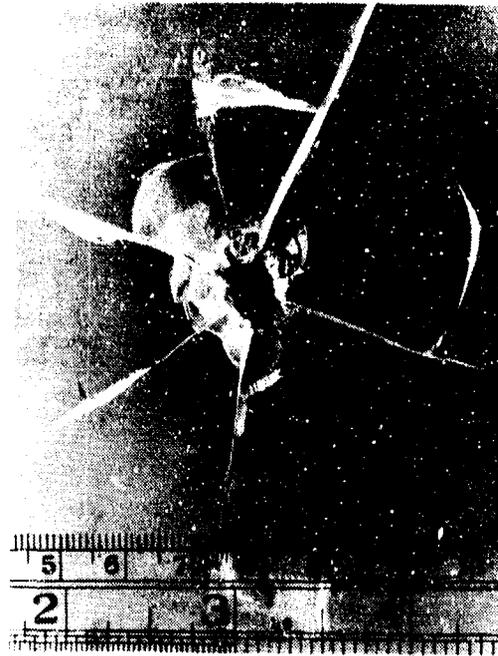
Figure 148. Ballistic Penetration of 0.187  
Inch Cast Acrylic.

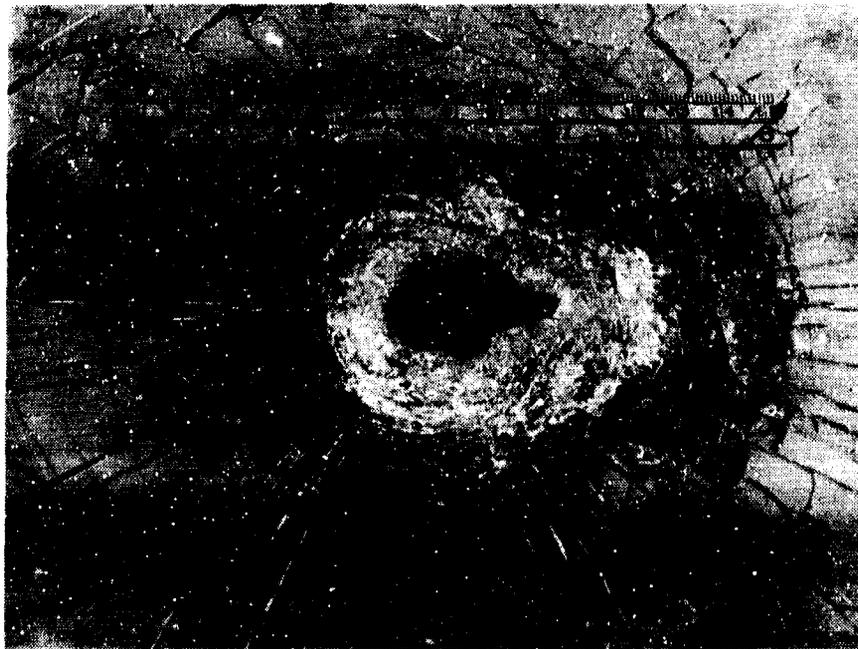
Figure 149. Ballistic Penetration of  
All-Glass Laminate.

The glass/glass laminates sustained considerably more surface damage than any of the monolithic specimens. The entry holes were from 1 to 2 inches across (Figure 149). Since the specimens were shot at a 60-degree angle of obliquity, the pulverized areas were oblong, ranging up to 4 inches across.

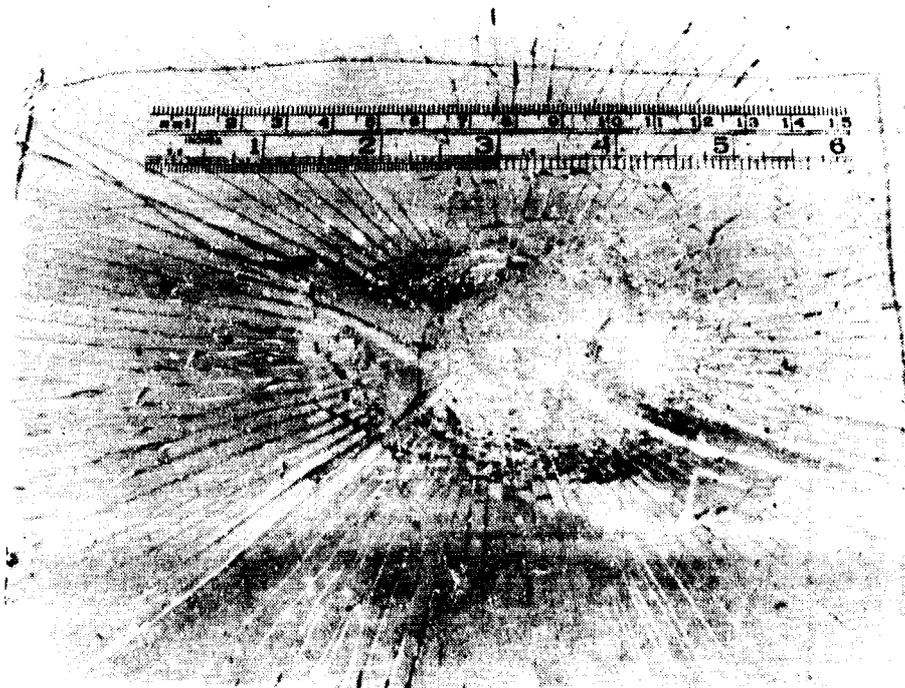
Figure 151. Ballistic Penetration of Glass/Acrylic Laminate.

The glass/acrylic laminates sustained considerable surface damage from ballistic impact, as shown in Figure 151. Entry holes were very small with the soft interlayer tending to close the hole, as shown in Figure 152. The pulverized area of each specimen was from 2 to 3 inches across. The crack patterns outside the neighborhood of impact did not exceed the poor visibility level, although in many areas they did reach about 800 particles per square foot.

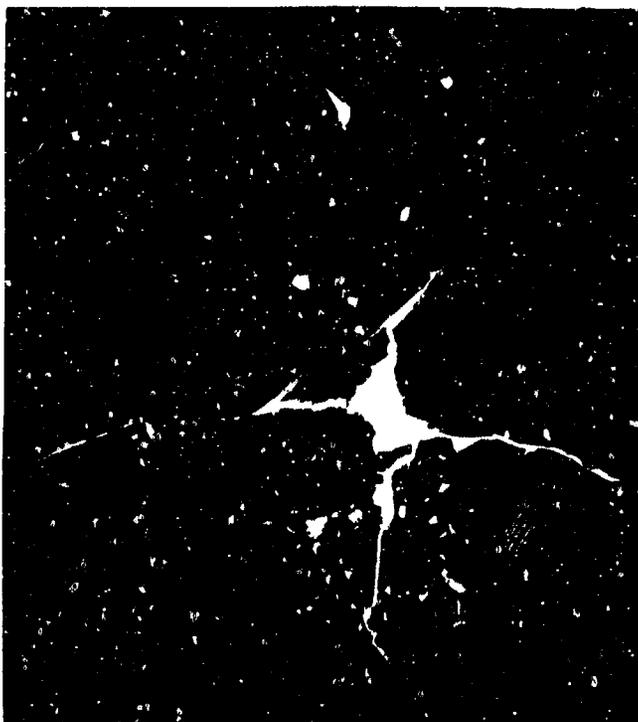
Figure 159. Typical Witness Sheet Penetration Pattern for All-Glass Laminate.

The witness sheets for the glass/glass laminates sustained serious damage. For every round, a large piece of the interlayer, weighing at least two grams and measuring at least an inch and a half across, was blown free from the specimen. This projectile caused severe rips in the foil. A large number of additional penetrations occurred within a 14-inch by 10-inch area, the most serious being in the neighborhood of ballistic impact. A typical witness sheet is shown in Figure 158. The penetration pattern for this sheet is shown in Figure 159. It should be noted that the amount and scatter of damage were much less for the clamped specimen, as reflected in Figure 160.

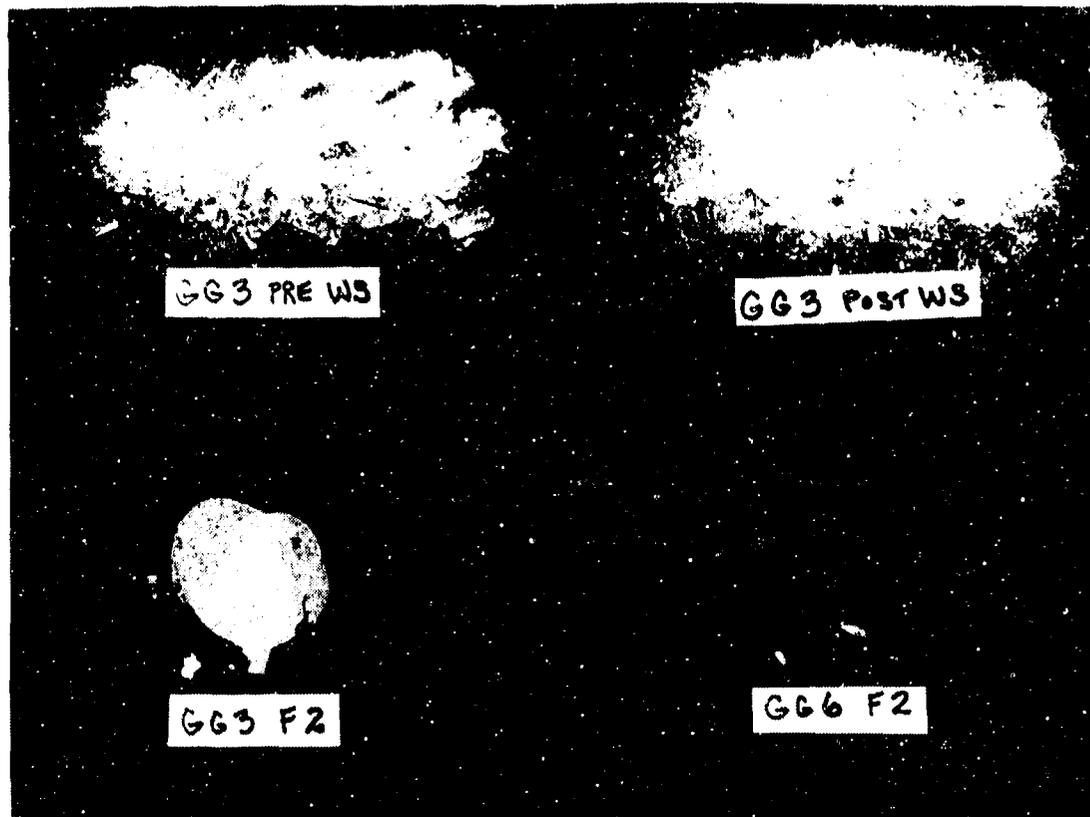
Figure 161. Typical Spall Fragments From All-Glass Laminates.

Table 40 contains a general description of the spall fragments collected for each type of material. These fragments can be seen in Figures 161, 162 and 163.

Specimen	Prewitness Sheet	Postwitness Sheets	Foam Sheets
Glass/Glass Laminate (See Figure 161.)	Powdered glass with a large proportion of small jagged fragments up to 1/8 inch across and a few larger jagged fragments up to 3/4 inch across.	Powdered glass with small jagged fragments up to 1/8 inch across and a few larger jagged fragments up to 1/2 inch across.	Large flat plug of soft inter-layer, primarily circular but with frequent jagged protrusions of up to 1-1/2 inches across. Also, a small number of fragments up to 1/4 inch across in the shape of a sliver or wedge.
Glass/Acrylic Laminate (See Figure 162.)	Some powdered acrylic with several thin jagged acrylic fragments up to 3/4 inch across.	Several small, thin, jagged, acrylic fragments less than 1/4 inch across and a small number of larger wedge-shaped fragments up to 1/2 inch across.	A few thin jagged wedge-like pieces up to 3/4 inch across.

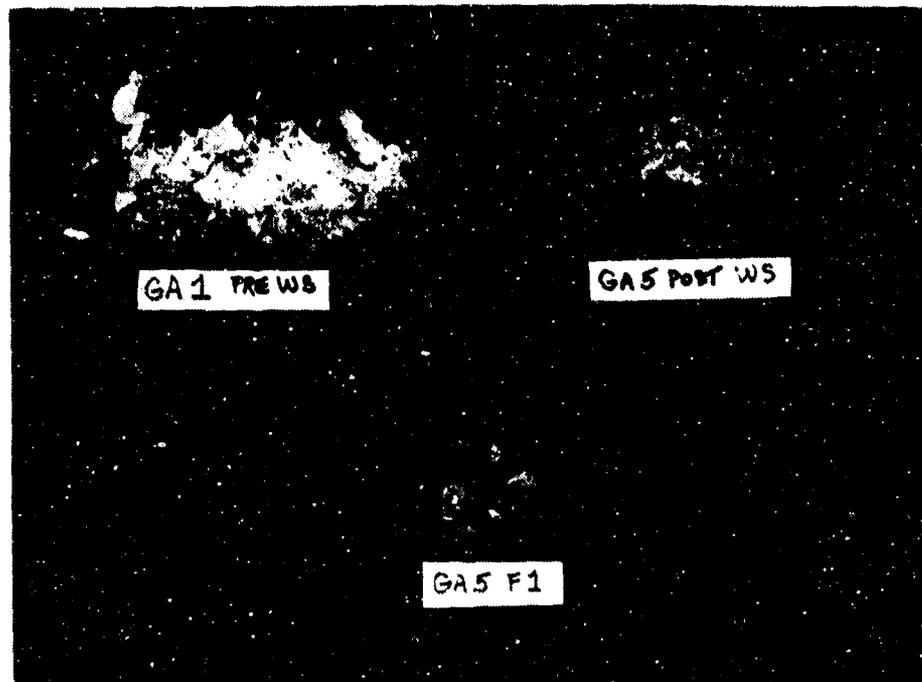
Figure 162. Typical Spall Fragments From Glass/Acrylic Laminate.

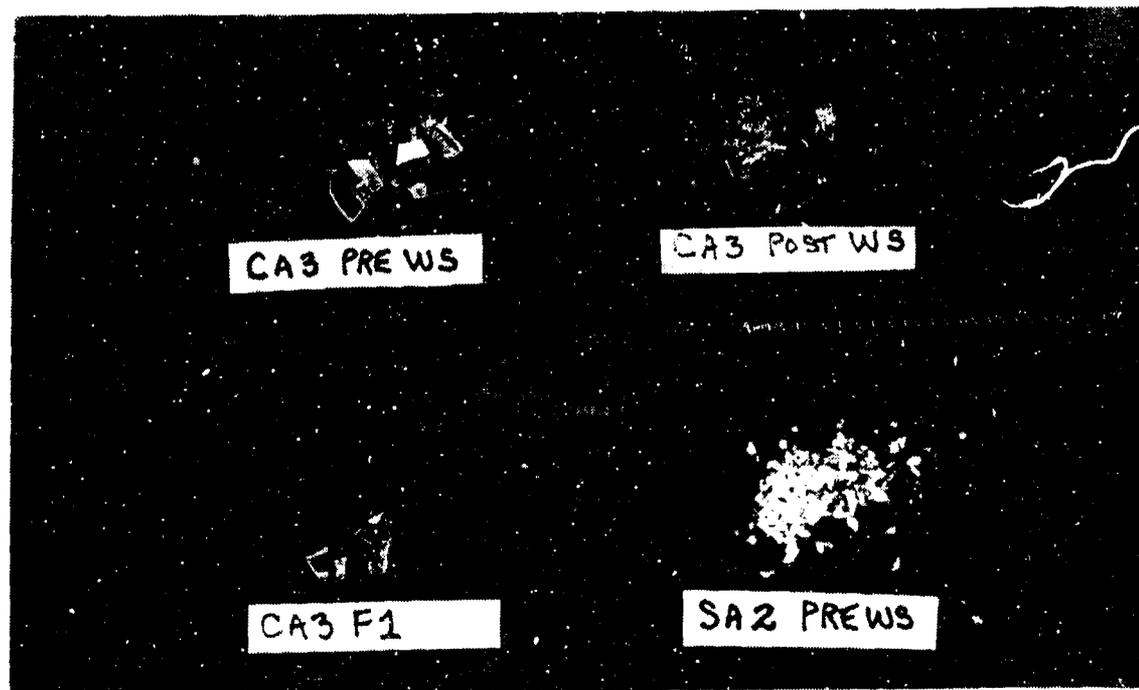
Figure 163. Typical Spall Fragments From Acrylic Specimen.

Cast Acrylic (See Figure 163.)	A few very small fragments and about a half dozen jagged, wedge-like fragments up to 3/8 inch across.	A few small fragments about 1/16 inch across and several jagged wedge-like fragments up to 1/4 inch across.	A small number of jagged, wedge-like fragments up to 1/4 inch across.

Specimen	Prewitness Sheet	Postwitness Sheets	Foam Sheets
Stretched Acrylic (See Figure 163.)	Several small shavings of pulverized acrylic up to 1/8 inch across.	A very small number of similar fragments.	None observed.
Polycarbonate	A couple of very small fragments less than 1/16 inch across.	None observed.	None observed.

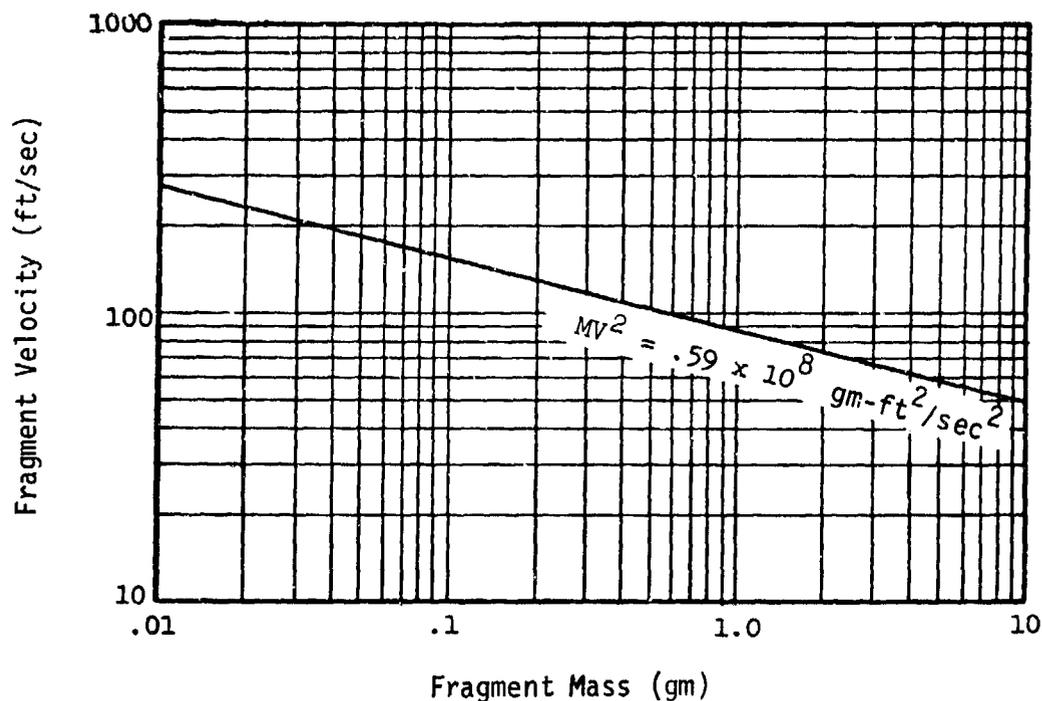
Figure 164. Wounding Model, Skin Laceration by Glass Fragments.

Figure 164 shows combinations of fragment mass and velocity that represent a threshold for lacerating or penetrating the skin. The model was derived from several wounding models and empirical data.<sup>11,12</sup> Fragments whose mass and velocity describe a point below the threshold line have less than a 5-percent chance of effecting a wound. The model may, therefore, be considered as a conservative criterion for evaluating the spall resistance of candidate transparent materials.

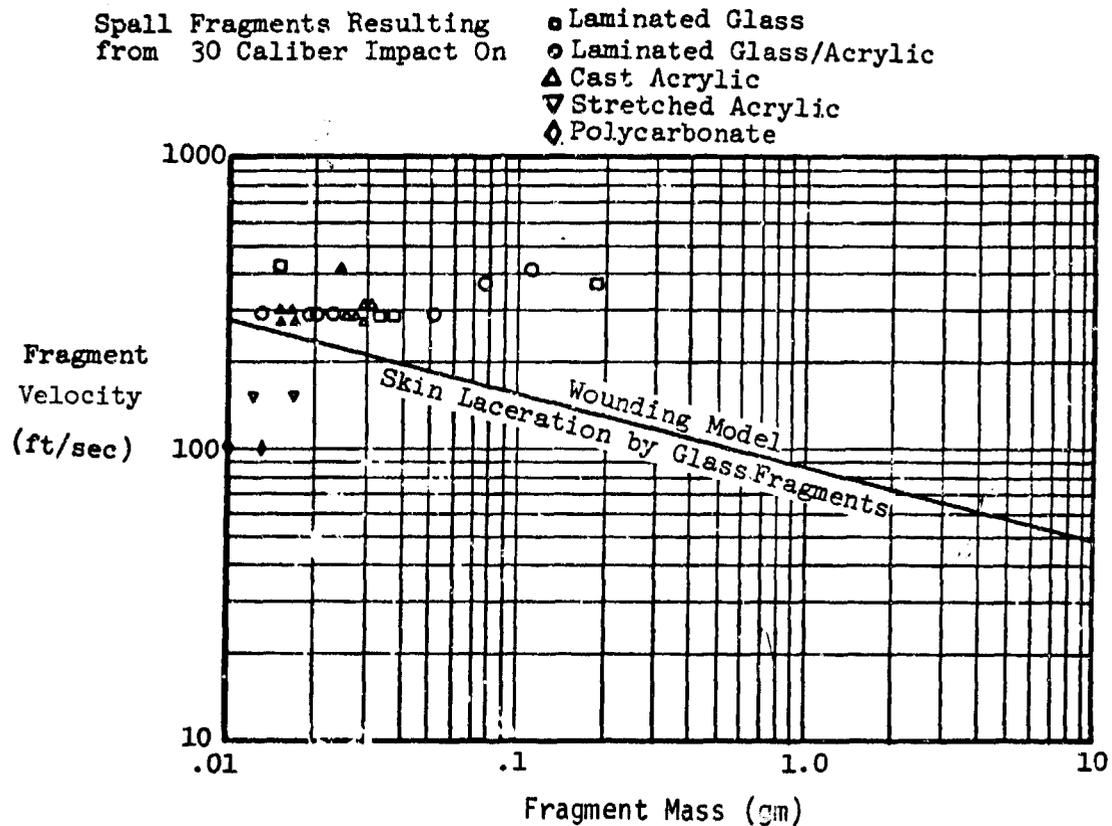
Figure 165. Spall Data Compared to Wounding Model.

Using this data and the test results contained in Table 38, the spall characteristics for the five materials tested are compared to the wound model in Figure 165.

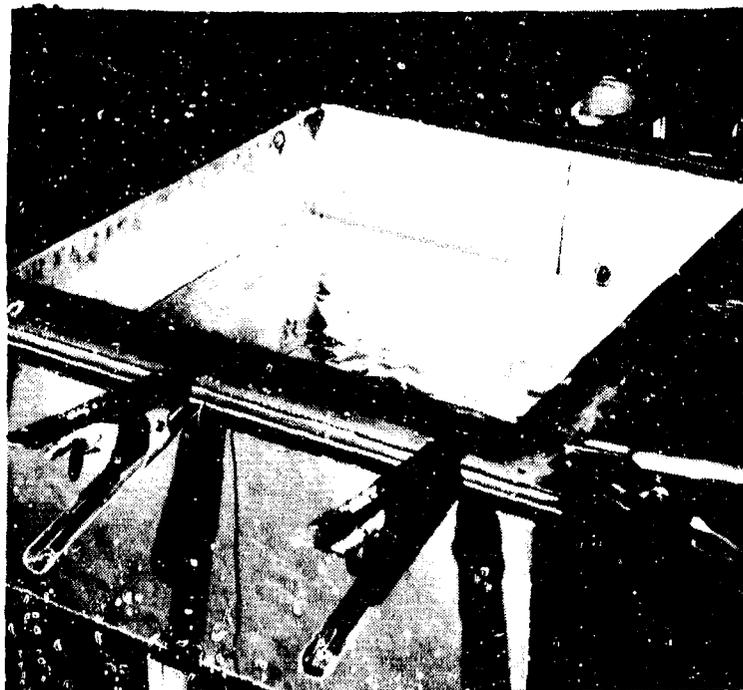
Figure 167. Clamped Attaching Arrangement.

The basic test setup for the impact tests is shown in Figure 166. The test specimens were secured to an aluminum box designed for ballistic and impact tests. The specimen was held rigidly in place by two different methods. In both cases, the specimen rested on a support frame rimmed by a rubber gasket. A metal retainer fit over the periphery of the specimen, leaving most of it exposed. In one configuration, this frame was secured to the test box by twelve spring clamps (Figure 167). In an alternative configuration, the metal retainer was bolted to the box by capscrews placed in drilled, tapped holes along the frame rim (Figure 168).

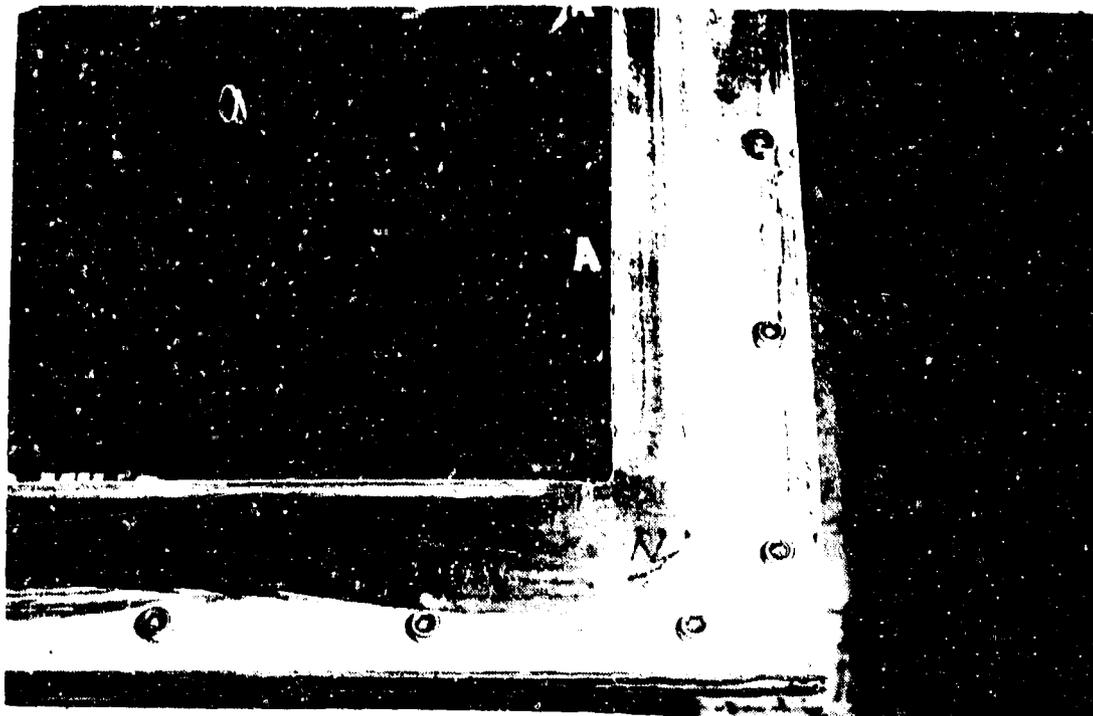
Figure 168. Bolted Attaching Arrangement.

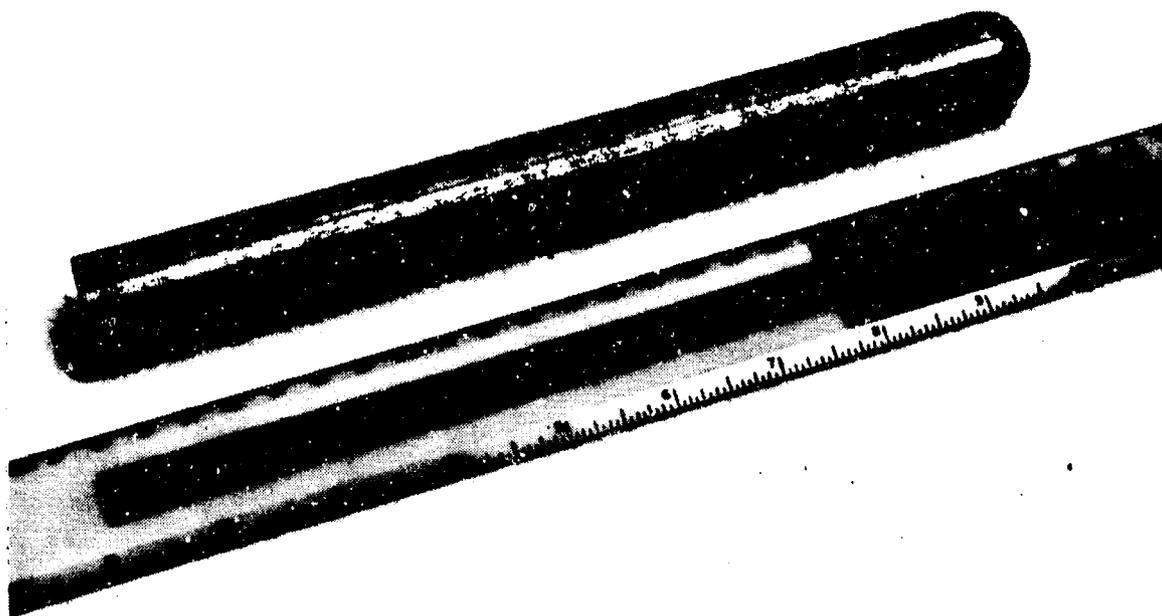
Figure 169. Impact Dart.

The impact projectile was a 2-pound cylindrical steel dart as shown in Figure 169. This dart was dropped from a height of 10 feet above the specimen through the pipe shown in Figure 166. The impact energy of the dart was therefore 20 ft-lb, which was arbitrarily chosen as being representative of FOD hazards and also sufficient to enable characterization of material shattering effects.

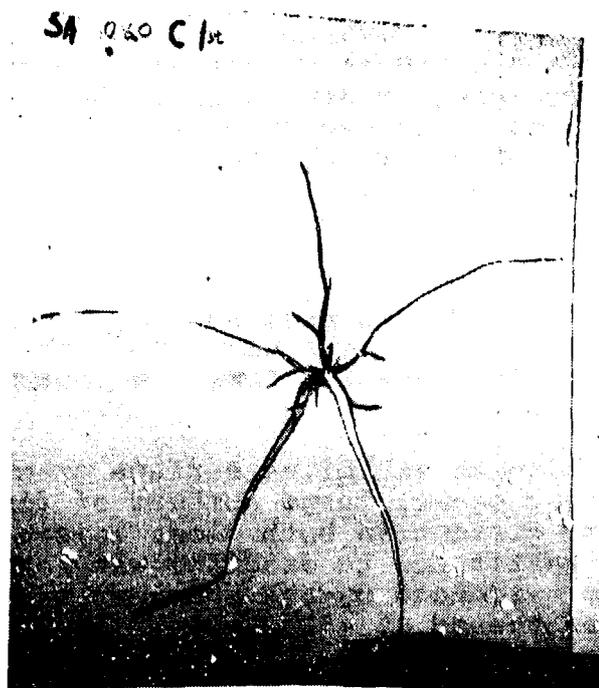
Figure 170. 0.080-Inch Stretched Acrylic Specimen, Low-Temperature Impact Test.

The polycarbonate and 0.250-inch cast acrylic sheets were the only materials sustaining no damage throughout the test. The stretched acrylic was undamaged at high temperatures and ambient conditions. However, at low temperatures, this material did crack. The typical cracks were long, jagged and sheared in a layer-like fashion similar to mica, as shown in Figure 170.

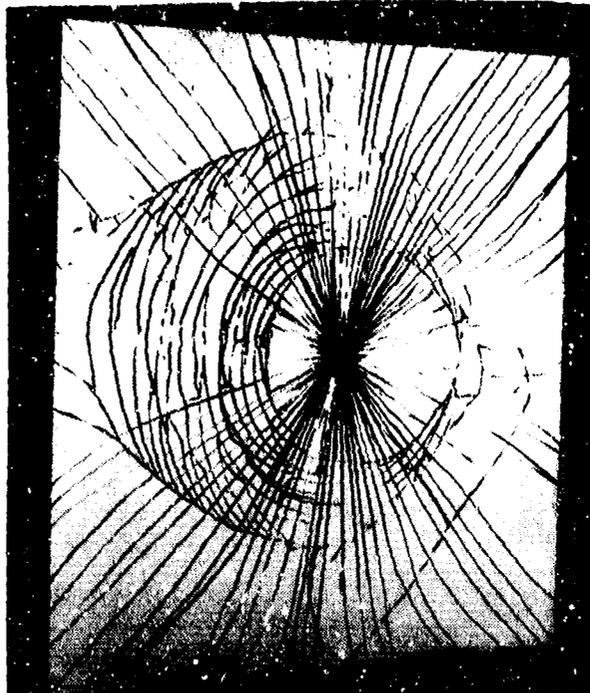
Figure 172. Glass/Glass Laminate, Ambient-Temperature Impact Test.

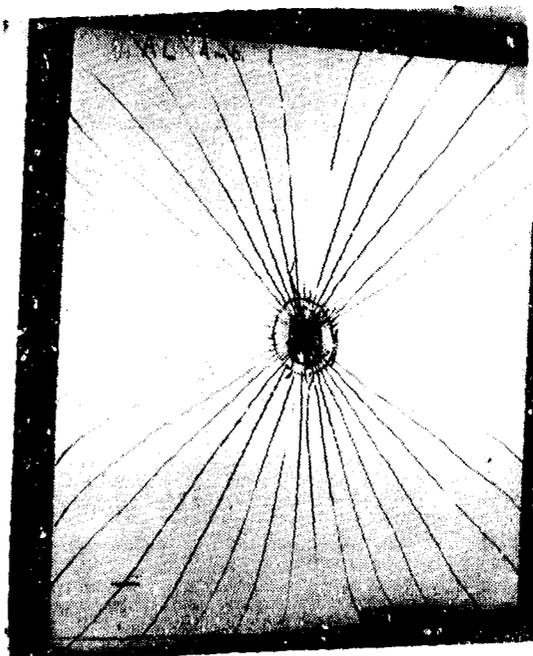
Figure 173. Glass/Acrylic Laminate, Ambient-Temperature Impact Test.

The glass/acrylic laminate exhibited varying crack patterns. The ambient and high-temperature tests exhibited radial patterns as shown in Figure 173. However, the low-temperature tests, due to high thermal stresses, produced concentric patterns (Figure 174). One specimen was actually broken in the environmental chamber by these high thermal stresses (Figure 175).

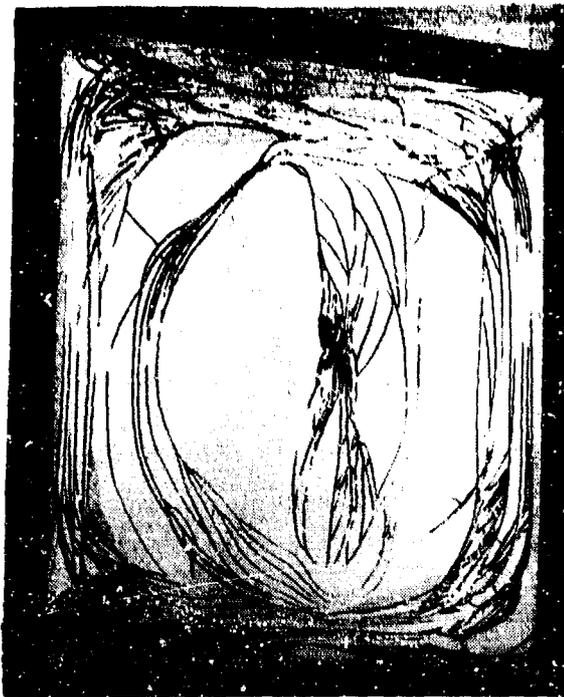
Figure 174. Glass/Acrylic Laminate, Low-Temperature Impact Test.
