USARTL-TR-78-26

**DESIGN, TEST, AND ACCEPTANCE CRITERIA FOR  
HELICOPTER TRANSPARENT ENCLOSURES**

Bruce F. Kay  
Sikorsky Aircraft Division  
United Technologies Corp.  
Stratford, Conn. 06602

Final Report for Period 27 June 1974 - 26 July 1976

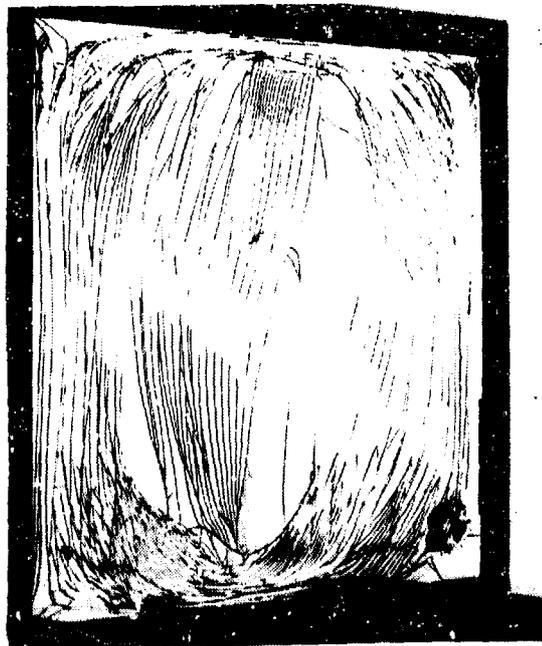
Figure 175. Glass/Acrylic Laminate Broken in Environmental Chamber at Low Temperature.

The glass/acrylic laminate exhibited varying crack patterns. The ambient and high-temperature tests exhibited radial patterns as shown in Figure 173. However, the low-temperature tests, due to high thermal stresses, produced concentric patterns (Figure 174). One specimen was actually broken in the environmental chamber by these high thermal stresses (Figure 175).

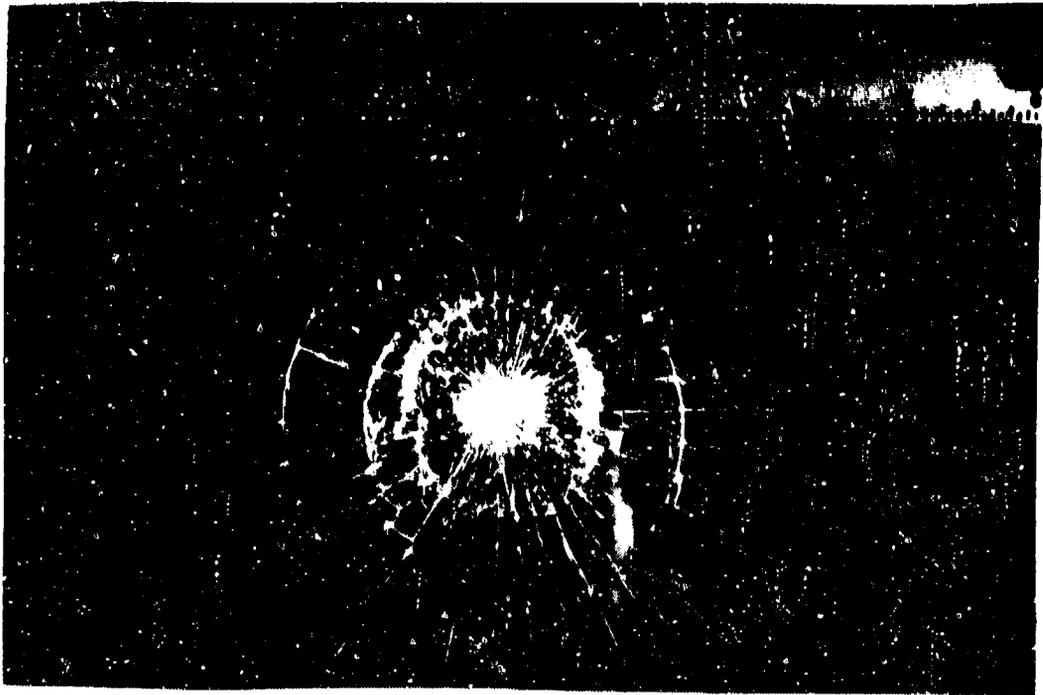
Figure 176. Close-up of Glass/Acrylic Laminate Impact Area.

Only the laminates sustained such damage, their glass layers being pulverized locally by the dart. Close-up shots of this damage are shown in Figures 176 and 177.

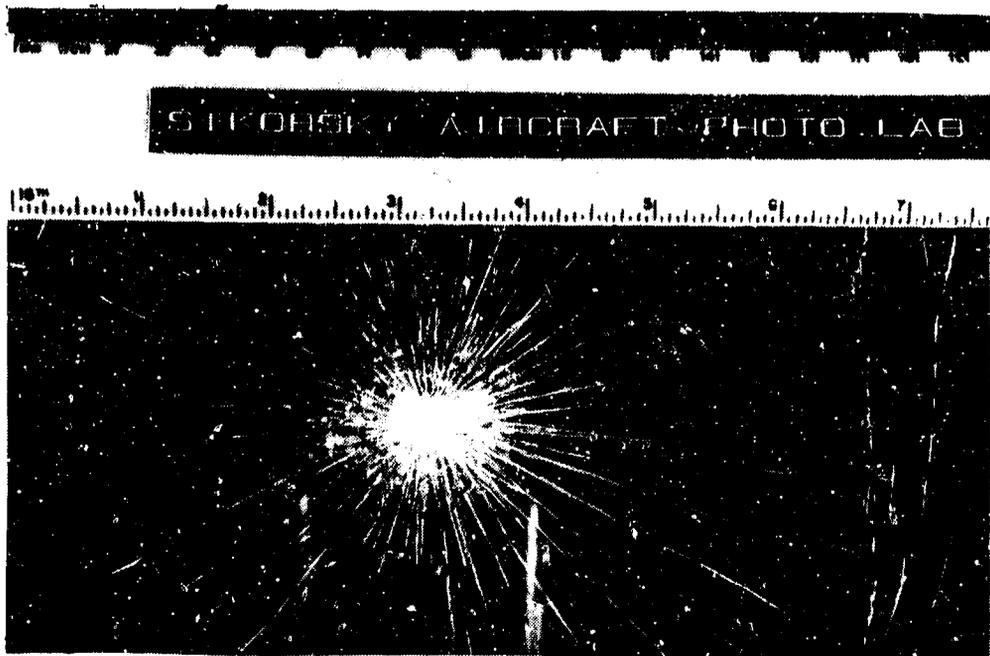
Figure 177. Close-up of Glass/Glass Laminate Impact Area.

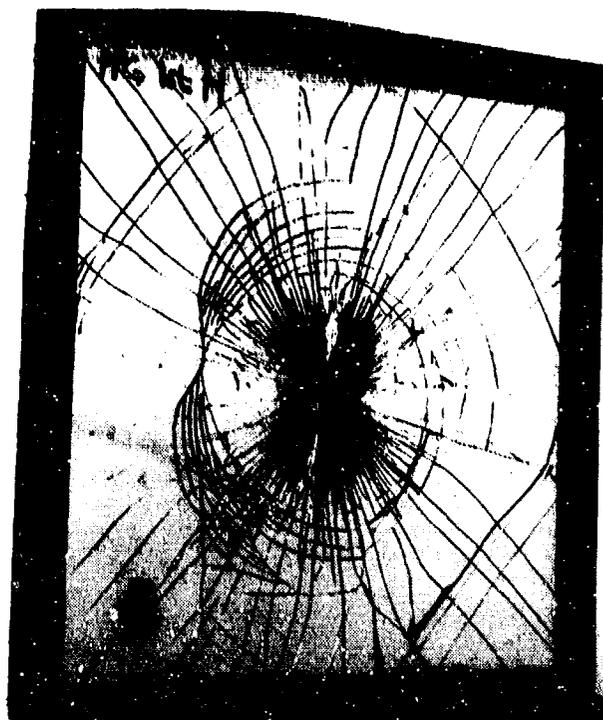
Figure 178. Glass/Glass Laminate, High-Temperature Impact Test.

Severe cracking occurred in the all-glass laminate at both temperature extremes. It extended typically two to three inches beyond the diced area as shown in Figure 178. Such damage was generally limited to the impact center and specimen edges in the glass/acrylic laminate at cold and ambient conditions. However, at high temperatures, the glass layer was severely shattered, badly impairing visibility as shown in Figure 179.

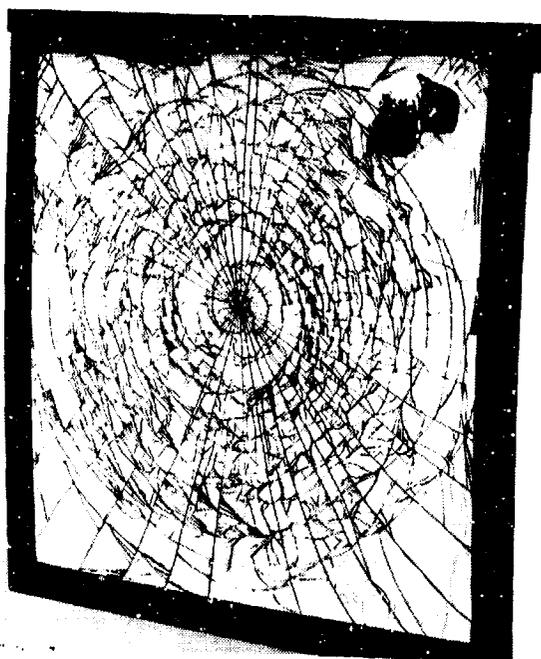
Figure 179. Glass/Acrylic Laminate, High-Temperature Impact Test.

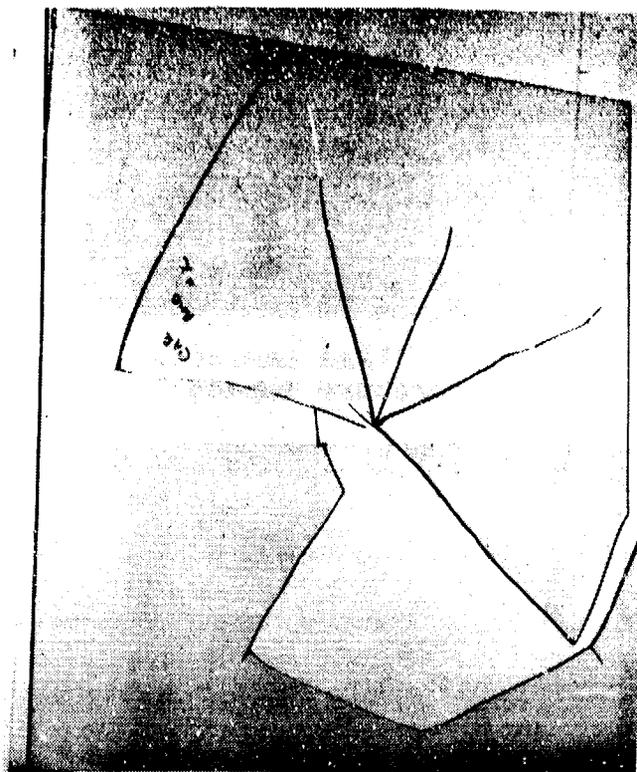
Figure 180. 0.125-Inch Cast Acrylic Specimen,  
Ambient Temperature Impact.

Witness sheet damage occurred only in the tests of the 0.080-inch and .125-inch cast acrylics. This was primarily due to dart penetration. However, for certain specimens, primarily of the .125-inch thickness, the witness sheet was occasionally punctured or torn by large pie-shaped fragments broken off by the dart. The clean sharp points of these acrylic chunks could possibly cause tissue injuries to aircraft personnel. The area vacated by such fragments can be seen in Figure 180.

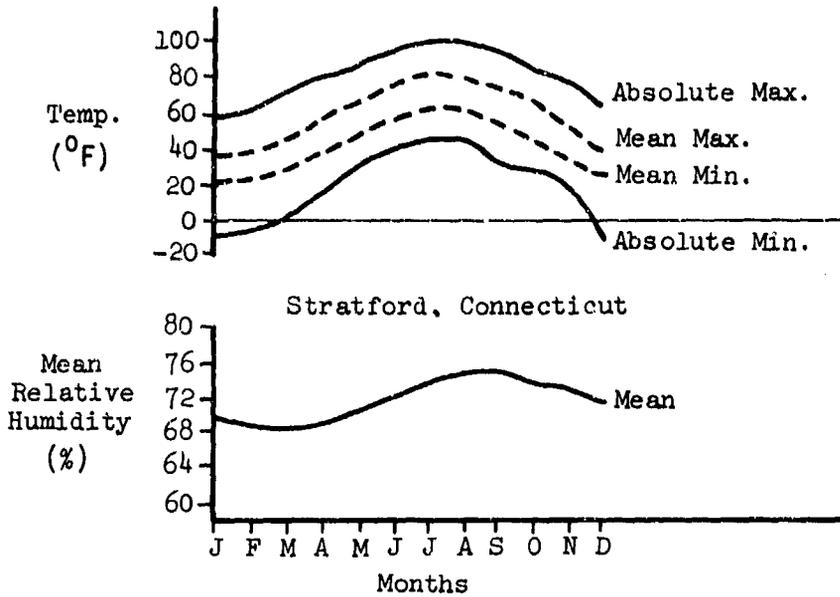
Figure 181. Typical Moderate Climate, Annual Diurnal Temperature/Humidity Variation.

Helicopter operations are essentially conducted at low altitude where local geographic weather conditions prevail. Therefore, to establish a realistic temperature spectrum, actual worldwide climatic variations were reviewed and typical climates were analyzed. Figures 181 through 184 show a sampling of representative annual temperature distributions for the different climates<sup>14</sup> that were analyzed during this study.

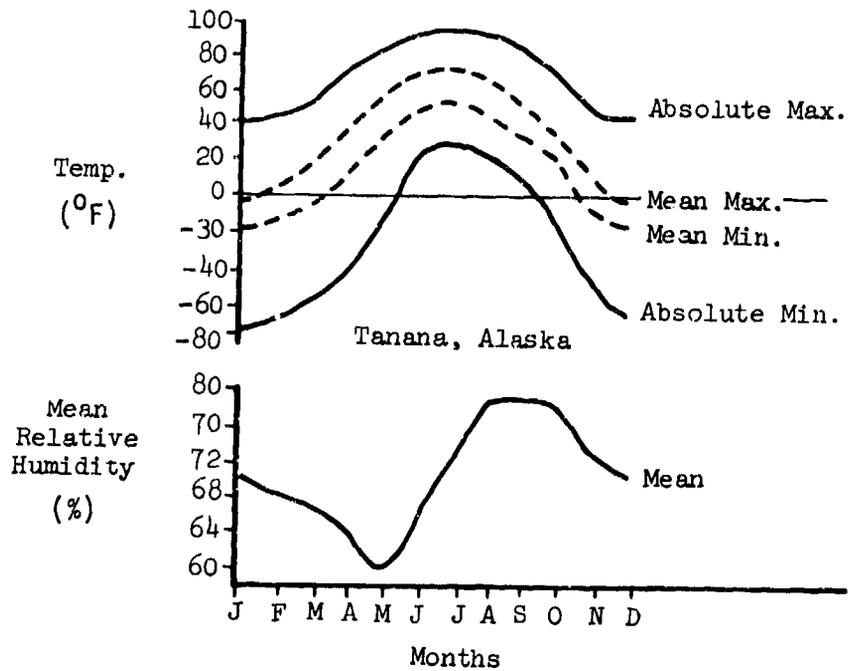
Figure 182. Typical Extreme Cold Climate, Annual Diurnal Temperature/Humidity Variation.

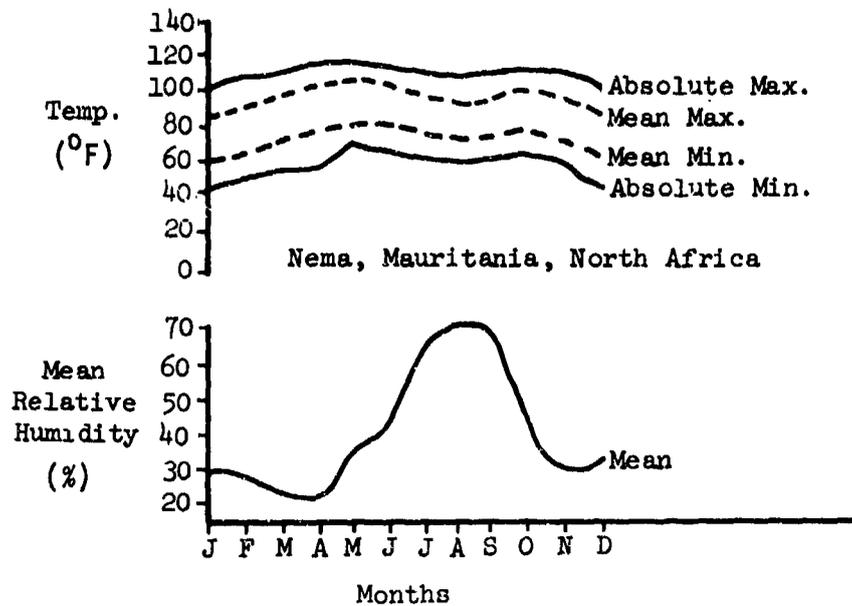
Figure 183. Typical Hot/Dry Climate, Annual Diurnal Temperature/Humidity Variations.

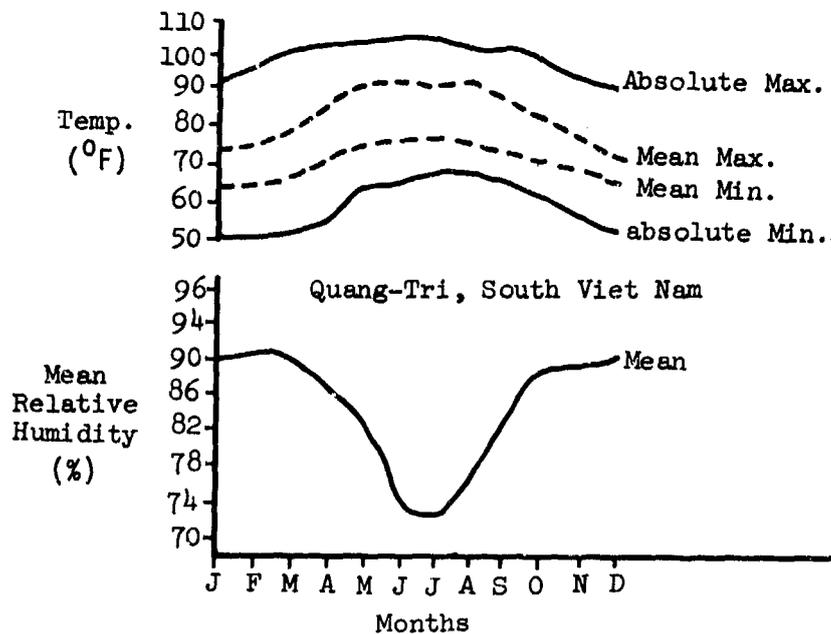
Figure 184. Typical Hot/Wet Climate, Annual Diurnal Temperature/Humidity Variations.

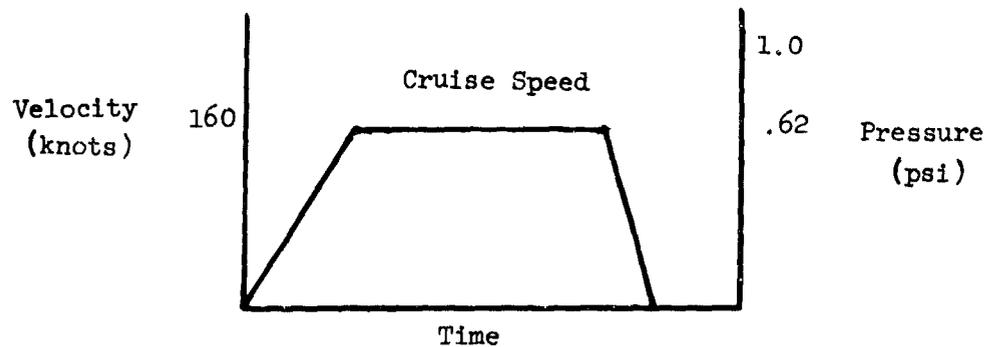
Figure 185. Aerodynamic Pressure Ground-Air-Ground Cycle, UTTAS Helicopter.

For cargo or utility helicopters, the basic mission calls for level flight at cruise speed between origin and destination, and the aerodynamic pressure GAG cycle for this condition would simply appear as shown in Figure 185. The average pressure coefficient was assumed to be 1.0 for this case. Similar GAG cycles for other airspeeds were constructed in a like manner.

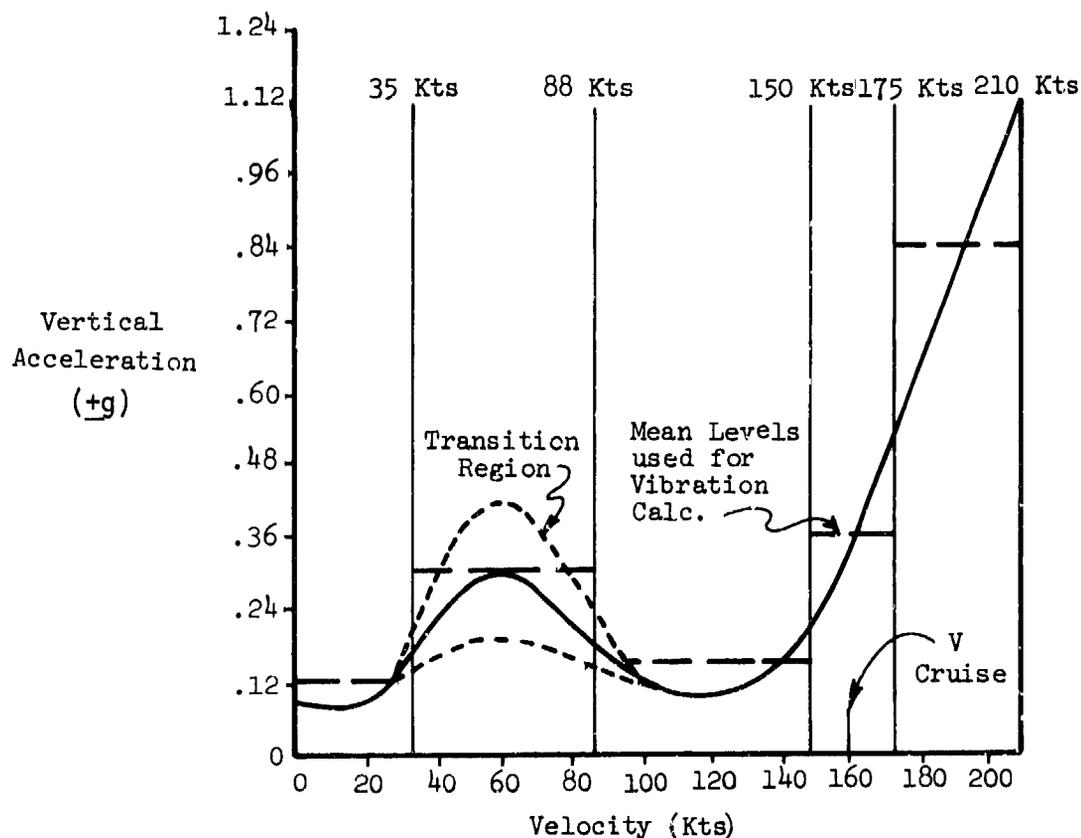
Figure 186. Windshield Vibration vs Aircraft Velocity, 1.0 g Level Flight.

Flight test data from the NH-3A<sup>17</sup> (high speeds) and the CH-53A<sup>18</sup> (low speeds) were used to generate a curve of windshield vibration level versus velocity as shown in Figure 186. The increment in vibration above the 1-g level as a function of load factor was also estimated from flight test data and is presented in Table 54. The dashed lines in the figure indicate the range of data for the condition. This increment was assumed to be zero for load factors equal to or less than 1.0 g.

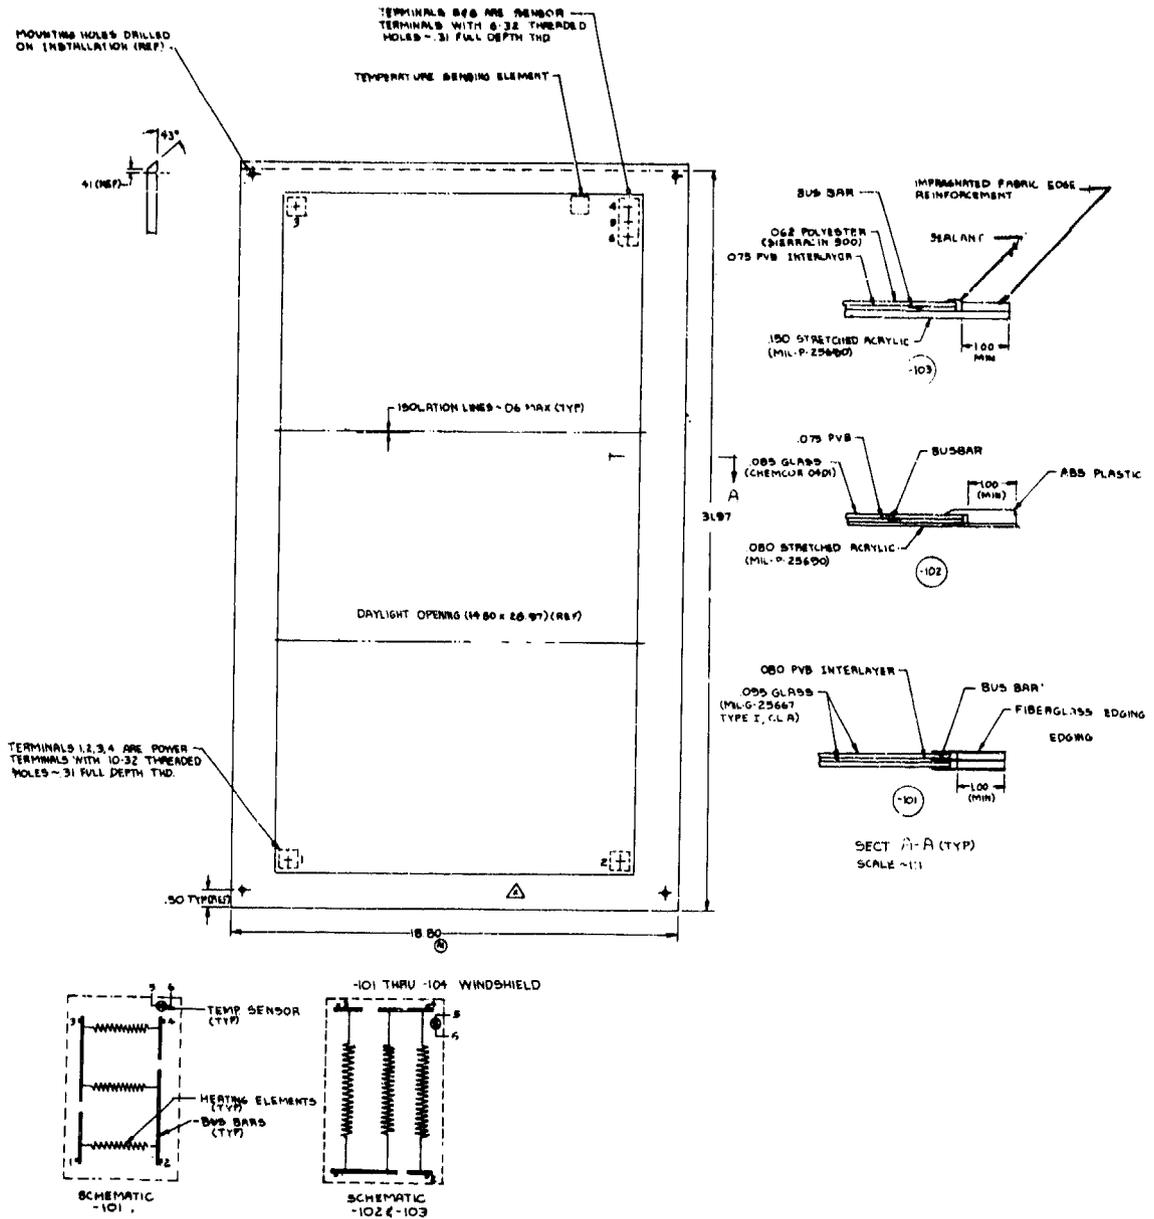
Figure 187. Windshield Test Specimens.

Four windshields of each of the three types were provided; Table 56 lists the serial numbers and relevant manufacturers; Figure 187 illustrates the configuration details of all three types. Temperature uniformity checks had been conducted prior to testing, either by the manufacturer or by Triplex, and the results are given in Table 57. The locations of the hot spots correspond to the dimensions shown in Figure 188.

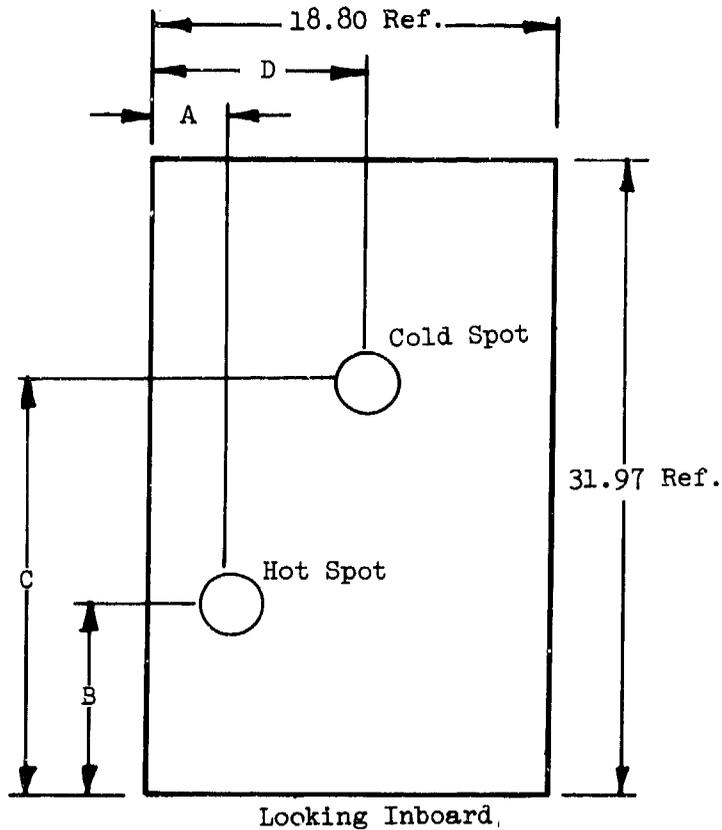
Figure 188. Hot and Cold Spot Locations.

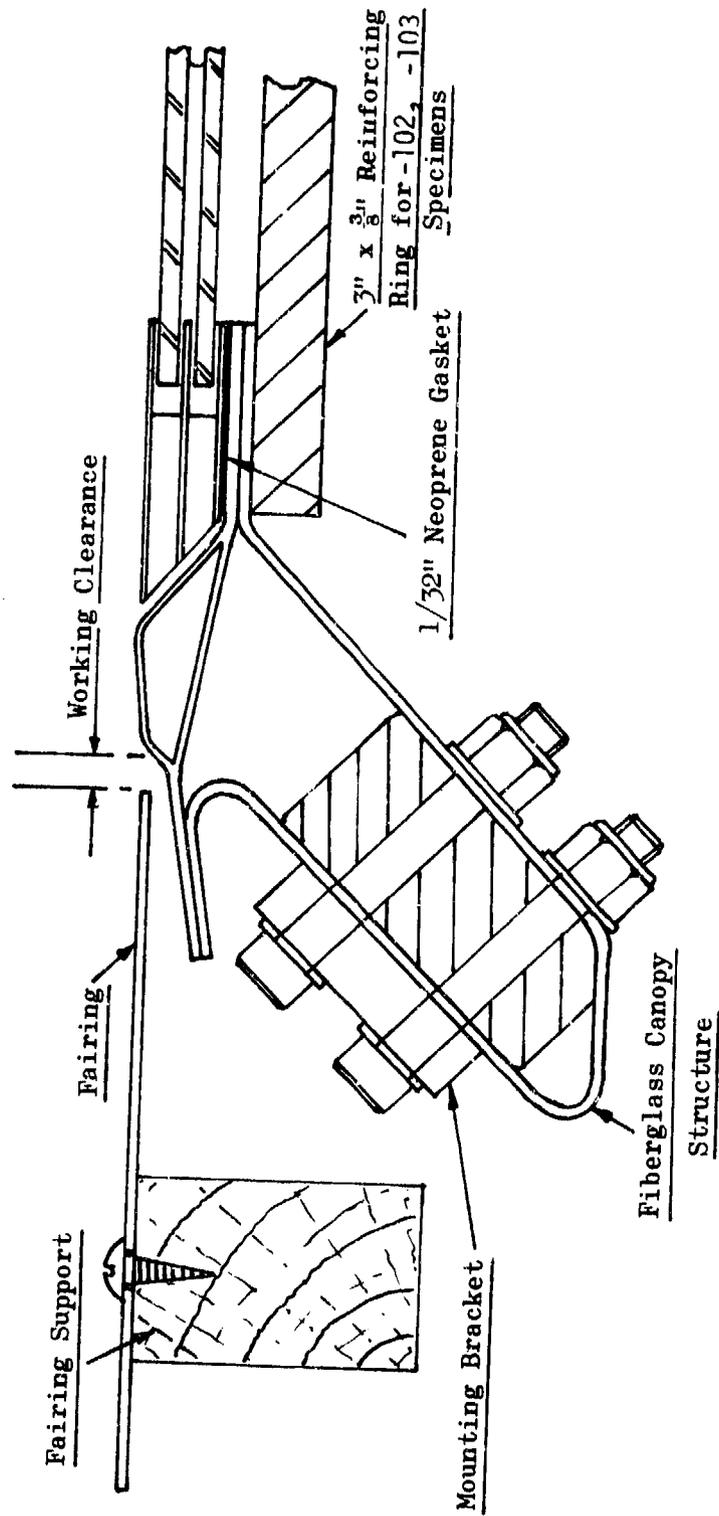
Figure 189. Assembly of Windshield Canopy Structure and Reinforcing Ring.

All specimen windshields were required to be installed in a fully representative portion of canopy structure. An actual section of the YUH60A cockpit structure was used for this purpose. A cross-sectional view showing a typical part of this structure with a windshield installed is shown in Figure 189.

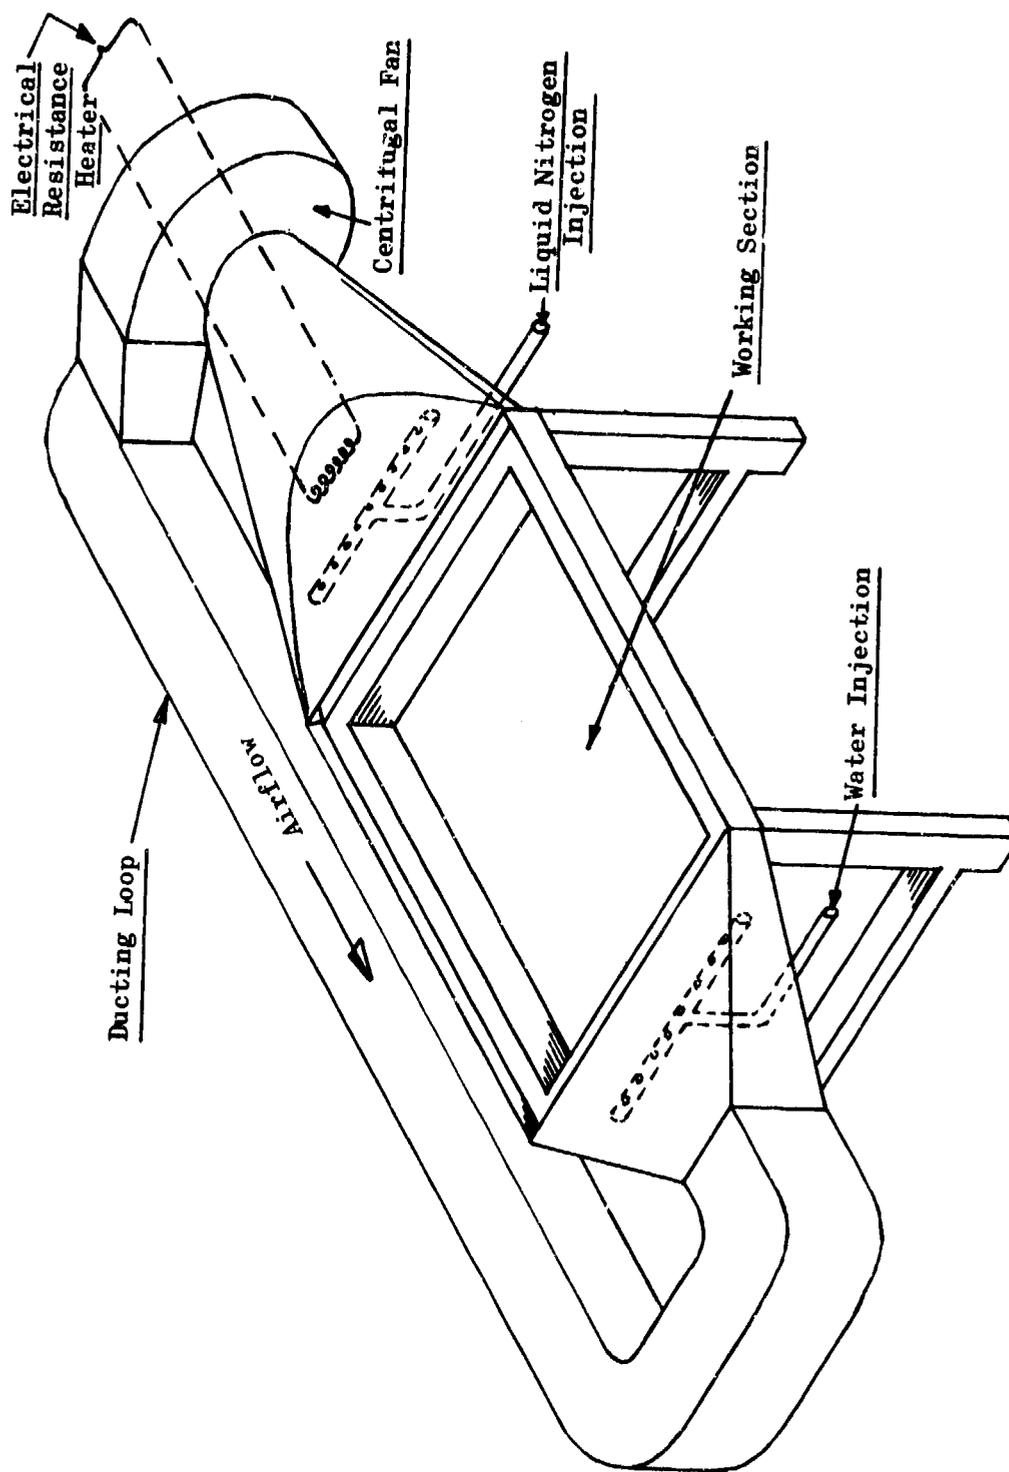
Figure 190. Schematic View of Basic Testing Facilities.

For heating, a bank of electrical resistance elements were mounted in the duct. Cooling was achieved by the controlled injection of gaseous nitrogen, fed from a liquid nitrogen bulk storage tank. A general schematic of the facility is shown in Figure 190. All of the required parameters could be controlled manually if necessary with a master programmer defining the sequence and control of the various operations for cyclic testing.

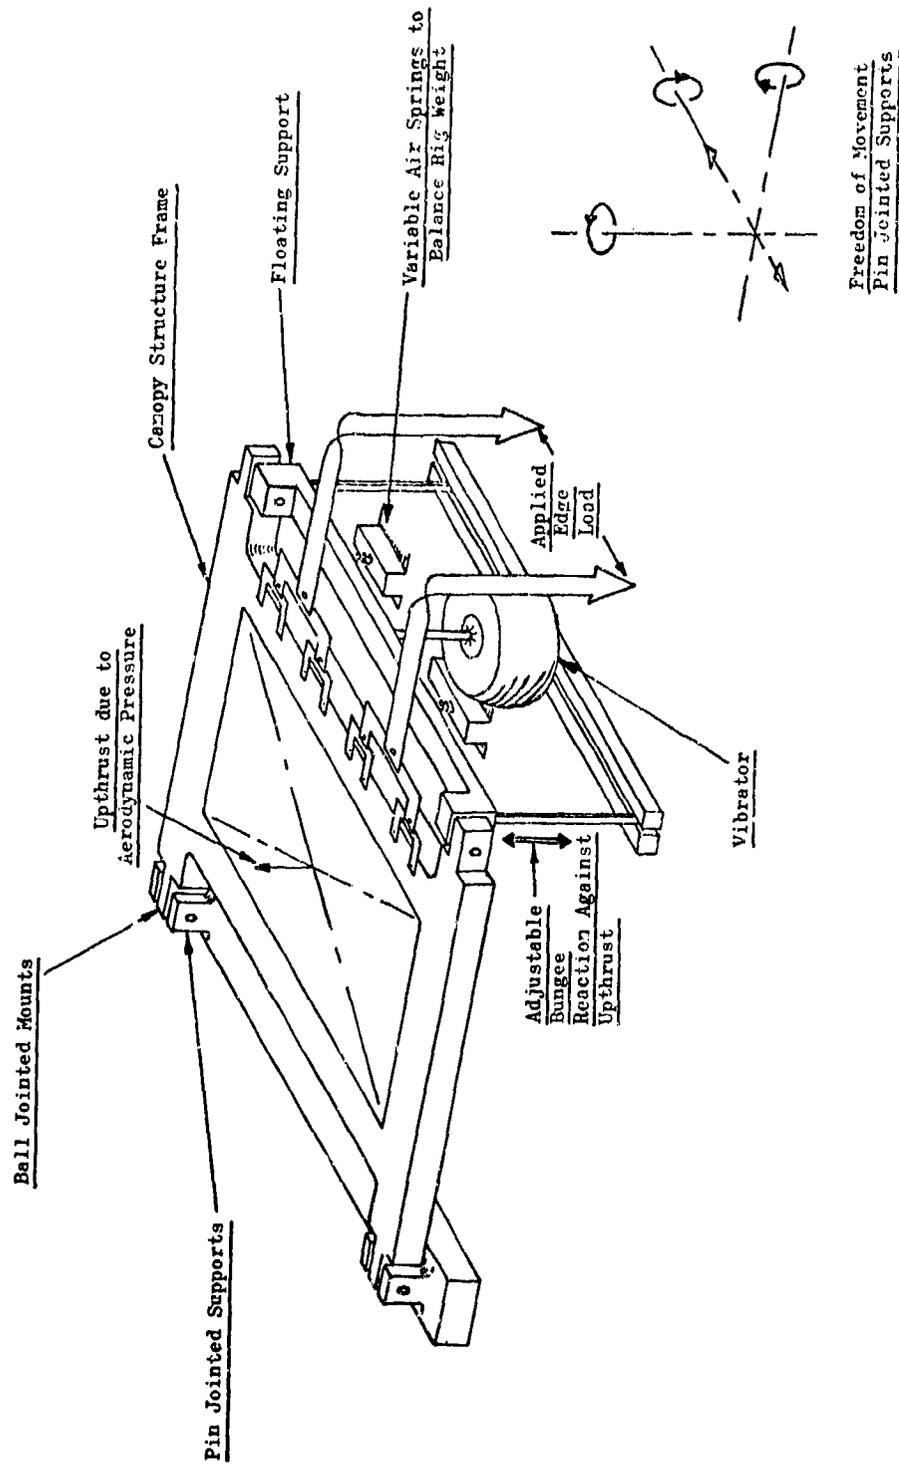
Figure 193. Schematic View of the Frame Support and Mass Balance System.

This is shown schematically in Figure 193.

It was necessary to carefully mass balance the loads applied to the windshields either because of the aerodynamic pressure or the specimen and structural dead weight. This was to ensure that the exciter commenced its action from a neutral unloaded condition. Bungee loops and inflated air bags provided a good means of achieving this condition. These are shown schematically in Figure 193 and photographically in Figure 195.

Five accelerometers were bonded to the outside surface of the specimen in use at positions as close as possible to the strain gauge locations shown in Figure 196. As a control, a sixth accelerometer was installed on the floating support described in Figure 193, exactly in line with the vibratory input.

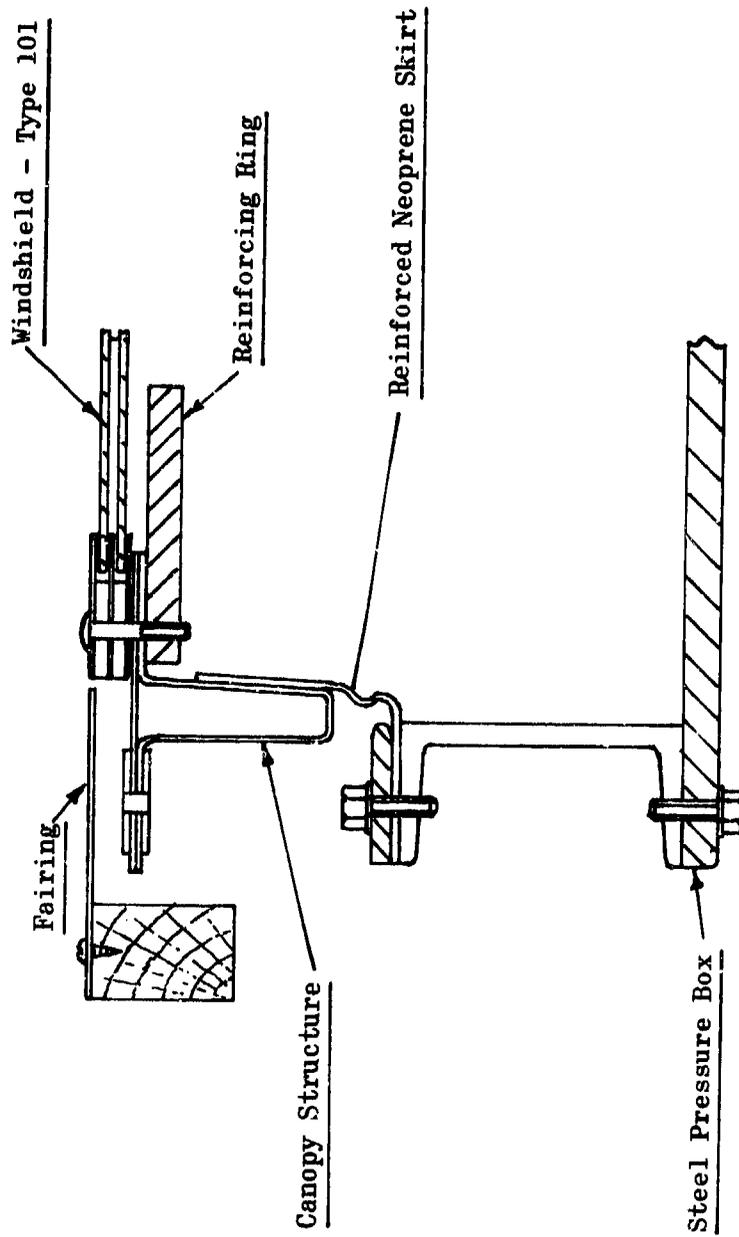
Figure 194. Windshield Installation and Pressure Box.

Because it was important to maintain the correct edge stiffness and because the entire windshield structure had to float under vibratory excitation, the pressure box had to be structurally independent. This was achieved by attaching the posts and sills of the structure to the steel pressure box with a reinforced neoprene "skirt," as illustrated in the typical edge shown in Figure 194.

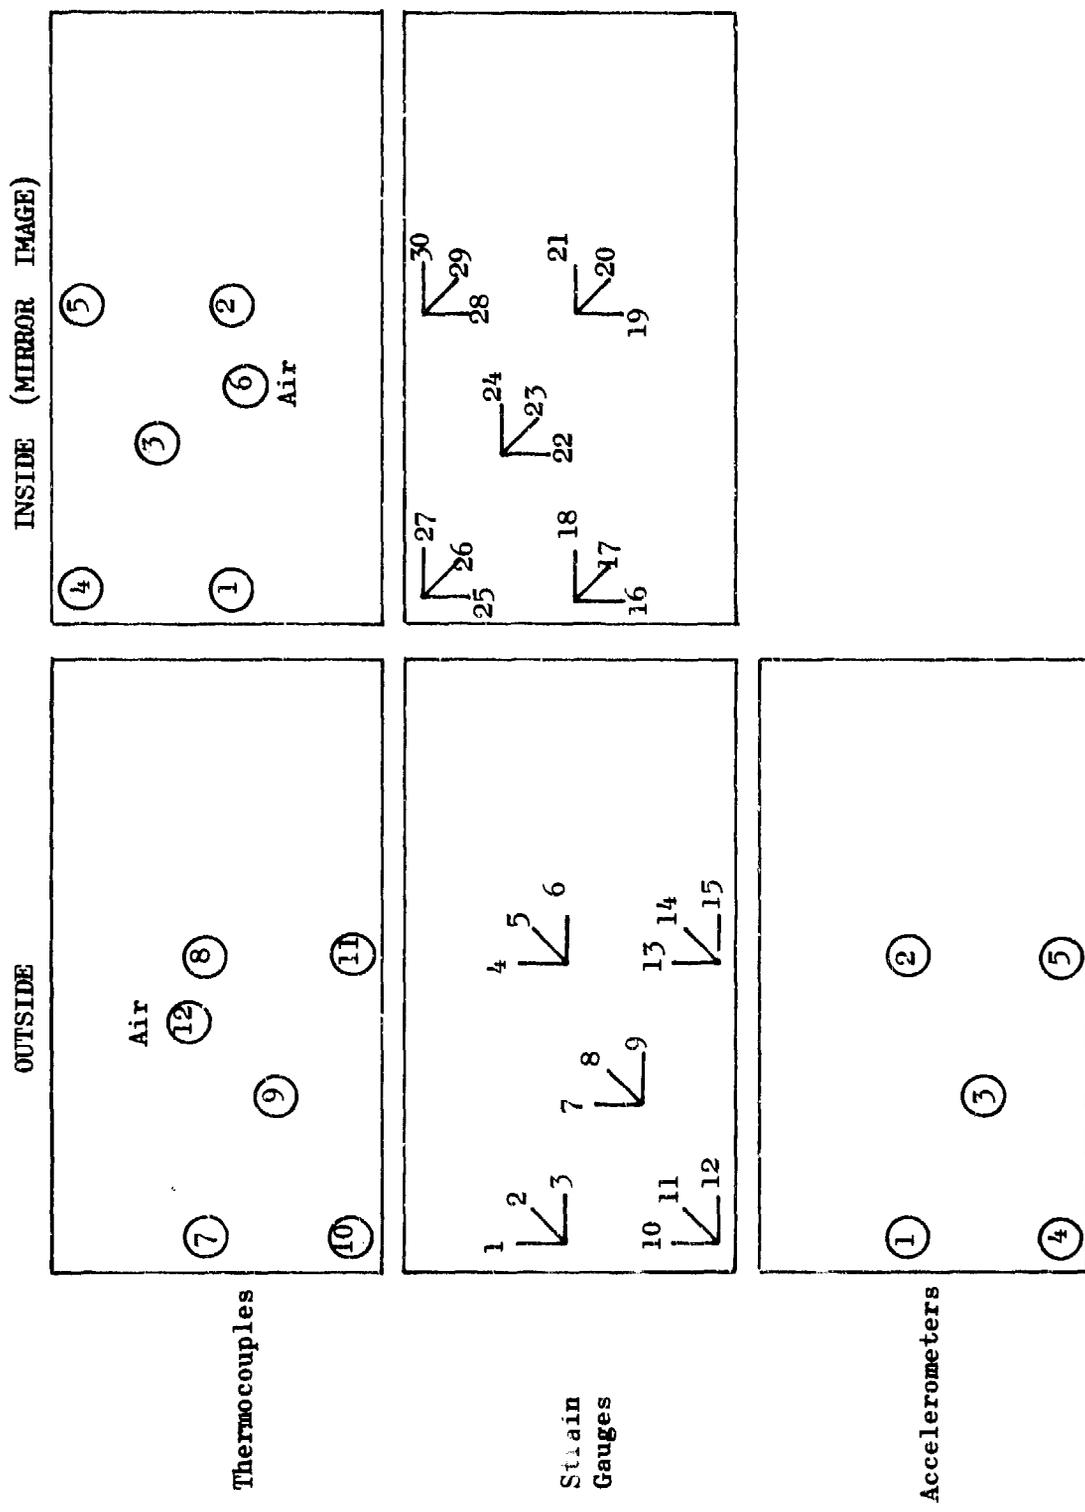
Figure 196. Location of Instrumentation.

Gauges were bonded to the surface using 'M' Bond AE10/15 adhesive (manufactured by Micro-Measurements Inc.) and the gauges were held in contact during adhesive curing by the use of a vacuum bag. A thin protective coating of silicone rubber was applied over the gauges. Gauges were positioned and orientated as shown in Figure 196.

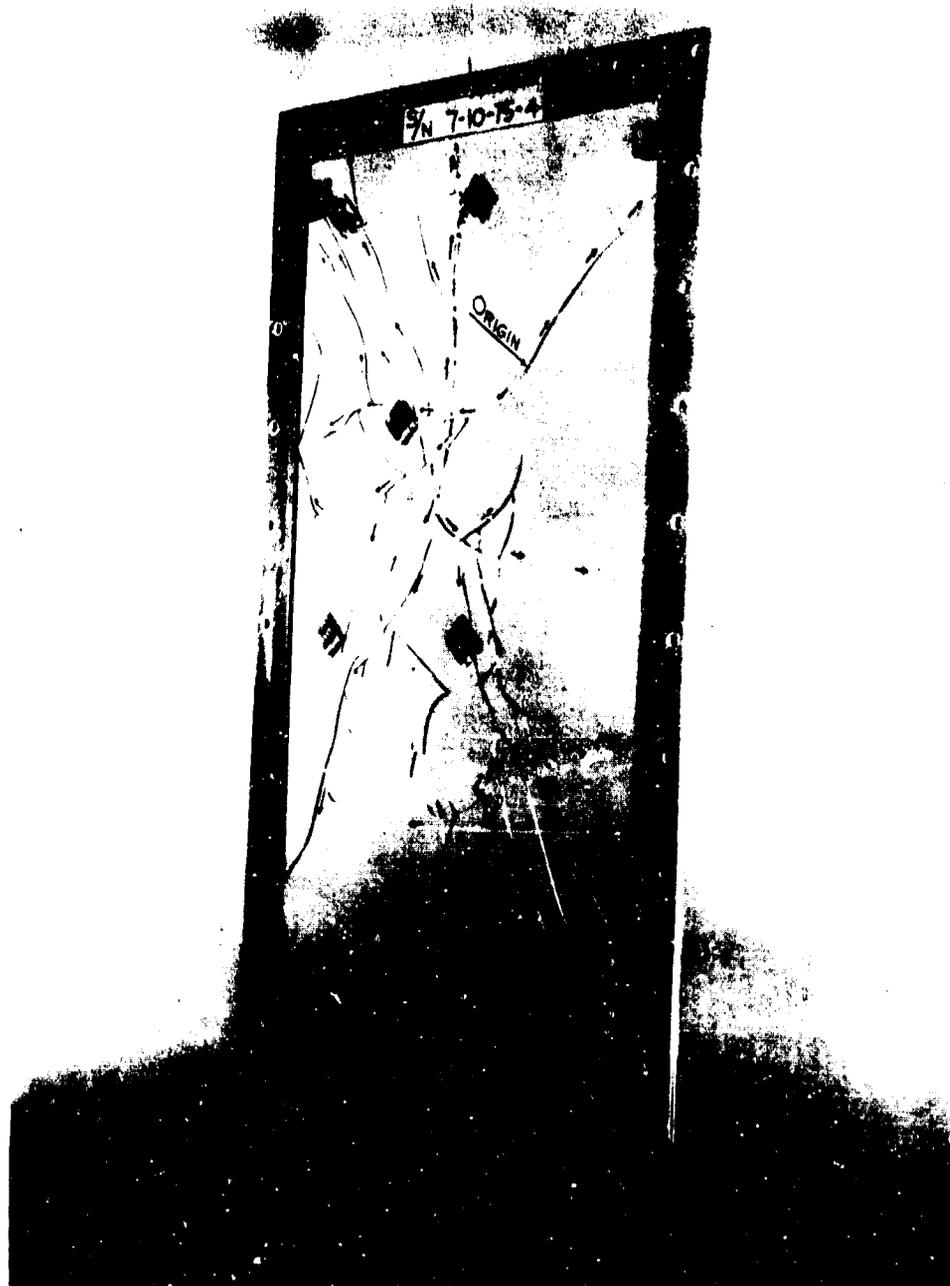
Figure 197. Failure of Glass/Glass (-101) Windshield,  
Serial No. 7-10-75-4, During Run 61, Case 21.

During application of Case 21 (cold shock and aerodynamic pressure), a failure of the facing ply occurred on windshield serial number 7-10-75-4. As shown by the overall view from outside in Figure 197, only the outboard glass ply was broken. Fracture started in the vision area 6-1/2 inches from the right edge and 8-1/2 inches from the top edge. Subsequent analysis revealed that the fracture origin was located on the outboard surface at a severe scratch 0.40 inch long. Fissures from this damage were about 0.017 inch deep, which almost completely penetrated the 0.020-inch compression layer. Because of this severe surface damage, very little mechanical or thermal load was required to cause fracture. This is supported by the fact that the origin fracture face revealed that the tension stress at failure was less than 1500 psi.

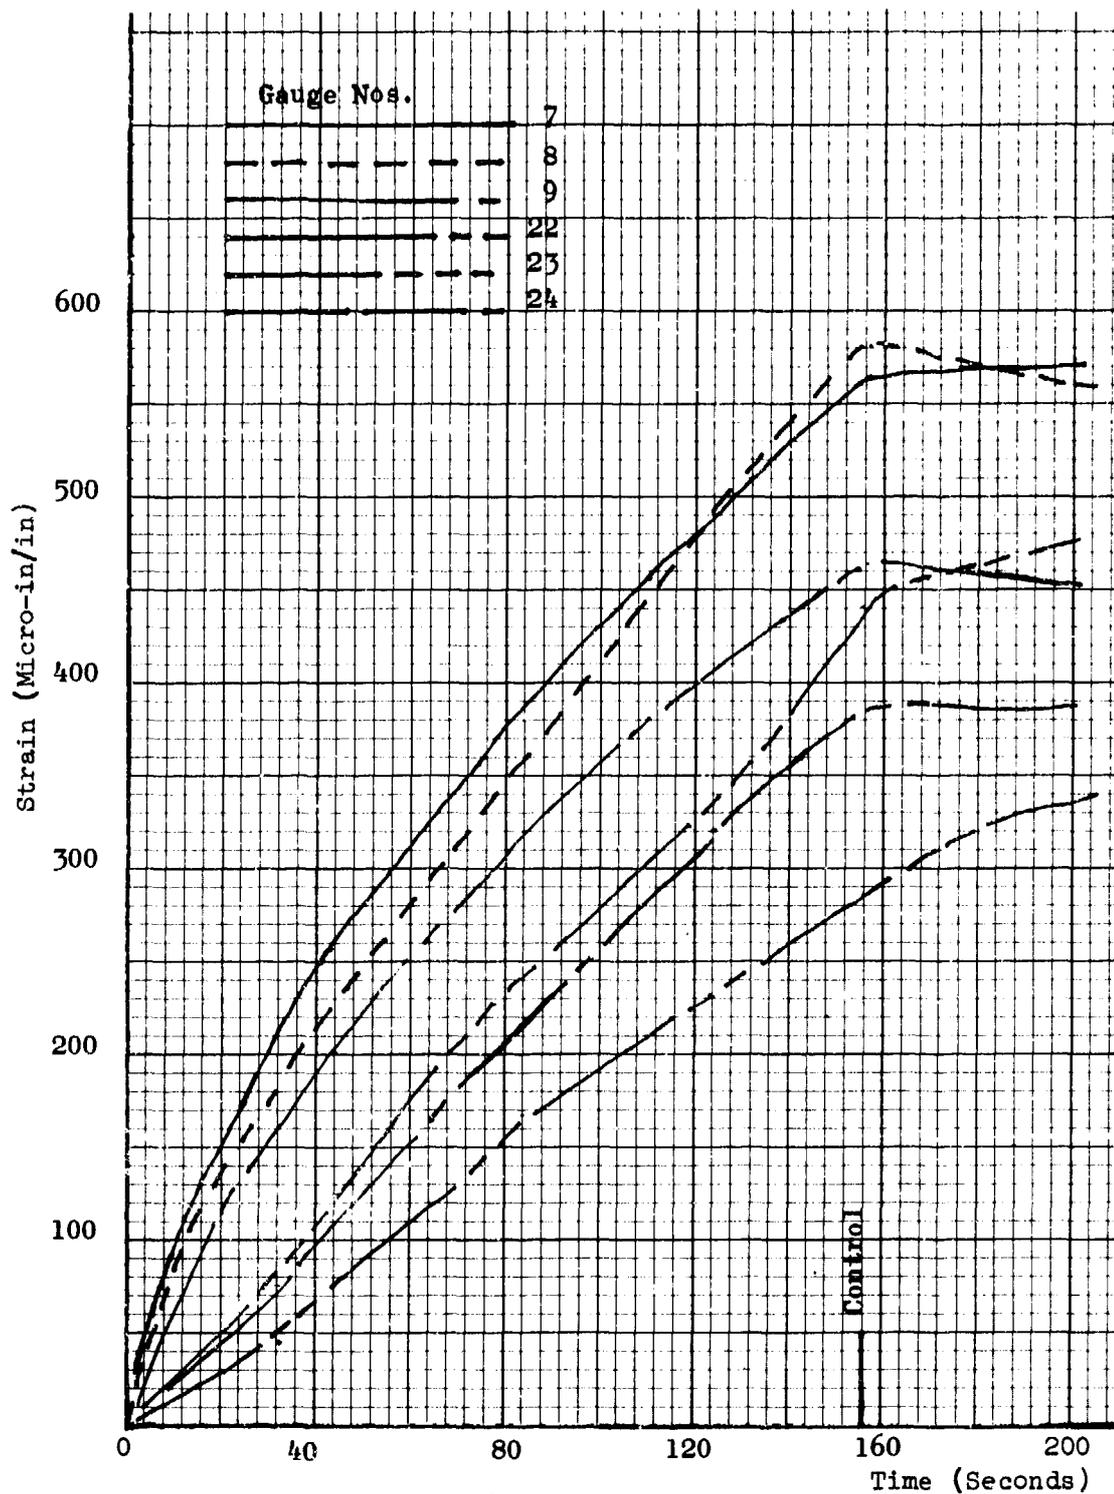
Figure 199. Strain Gauge Data  
 Glass/Glass Windshield (-101)  
 Thermal Shock, Case No. 3.

Thermal Shock - This parameter indicated the highest relative change in strain levels. Changes in surface strain measurements occurring during windshield warmup reached a maximum of 600 microinches per inch as shown in Figure 199.

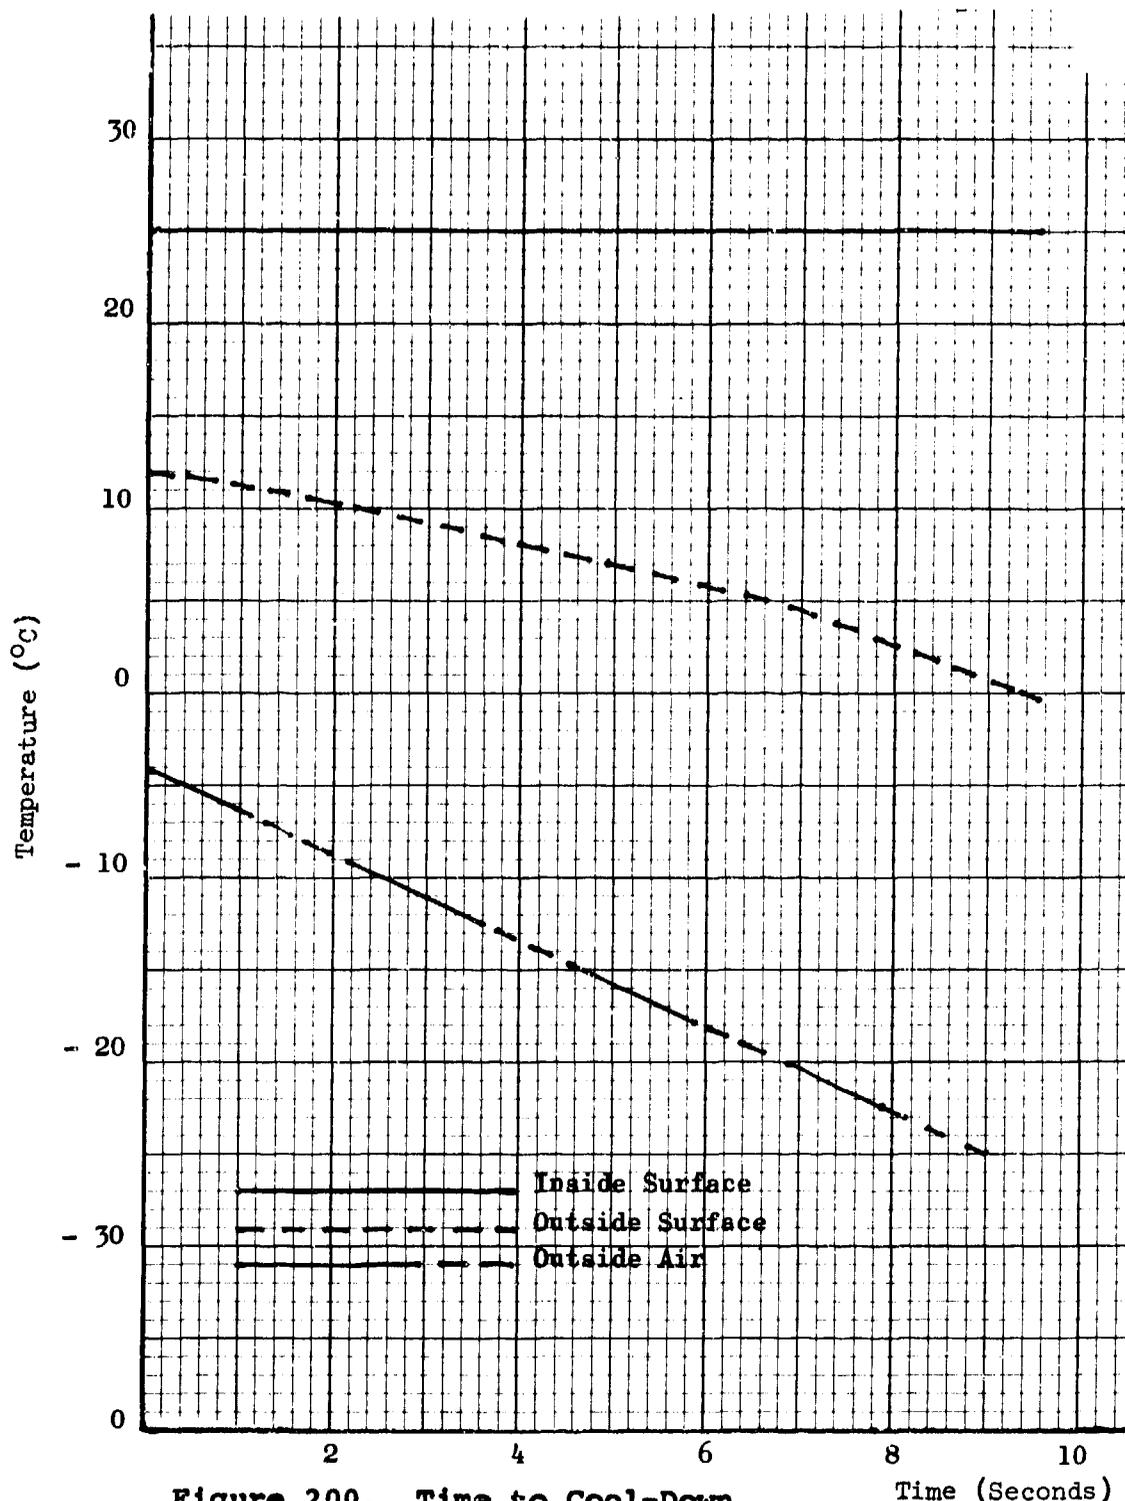
Figure 200. Time to Cool-Down  
 Glass/Glass Windshield (-101)  
 Cold Shock, Case No. 4.

Cold Shock - Owing to the very short time scale during which the cold shock occurs, highly significant hysteresis effects were considered to be present in the strain gauge circuits. The analysis of strain gauge signals naturally depends upon the gauge itself being at the temperature of the glass surface. Because of rapidly changing temperature gradients this was not so; thus, large errors could be present. Surface temperatures during cool-down are shown in Figure 200.

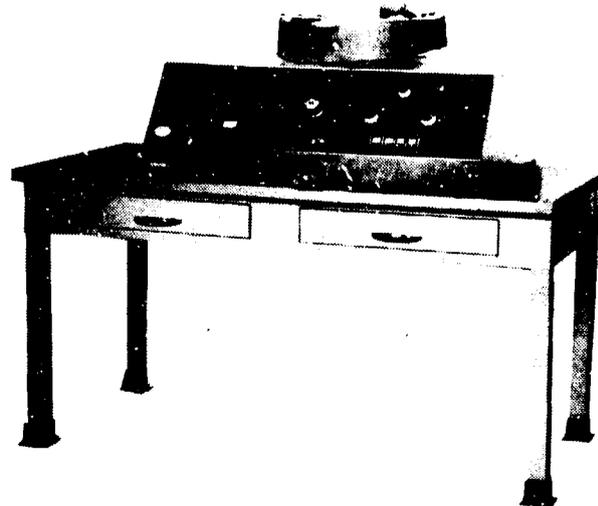
Figure A-2. Gardner Hazemeter.

The apparatus consisted of a reciprocating motion abrader designed to provide a wiping action that simulates conditions encountered during field cleaning of transparencies by aircraft personnel. Abrading head pressure was adjustable up to 1 psi (see Figure A-1). The abrasive was 400 grit boron carbide impregnated in a dry felt pad with 500 grams of load. The Gardner Hazemeter, shown in Figure A-2, was used in Tests 1, 2, and 3 to measure haze.

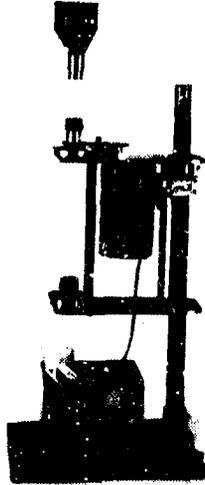
Figure A-3. Apparatus for Falling Sand Test.

The apparatus consisted of a hopper and glass tube rotating about 7 rpm, which allowed abrasive to free fall at 200 to 250 grams/minute from the fixed height of 25 inches. The test specimen was 3 x 6 inches and was held at a 45° position to the falling abrasive particles (see Figure A-3).

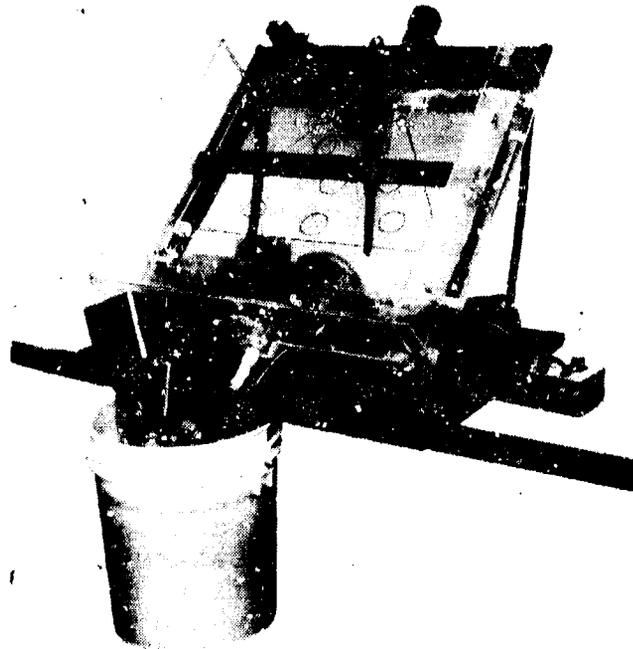
Figure A-4. Windshield Wiper Test Apparatus.

The apparatus consisted of a specimen holding fixture mounted at approximately 45° with provisions to mount material specimens. A 12-inch Hycar rubber wiper blade (30 to 40 shore hardness) and a windshield wiper driver arm were attached to an aircraft type motor which was mounted to the test fixture. A system for regulating and discharging the abrasive slurry onto the 16-x-21-inch test specimen at 300 ML/minute rate was attached to the test fixture (see Figure A-4). A peristaltic pump was used to recirculate and apply the slurry. The haze measurements were confined to specific locations by the use of a marking mask. Eight holes were located on the mask periphery, Figure A-5, as well as in the middle of the mask.
