USARTL-TR-78-26

**DESIGN, TEST, AND ACCEPTANCE CRITERIA FOR  
HELICOPTER TRANSPARENT ENCLOSURES**

Bruce F. Kay  
Sikorsky Aircraft Division  
United Technologies Corp.  
Stratford, Conn. 06602

Final Report for Period 27 June 1974 - 26 July 1976

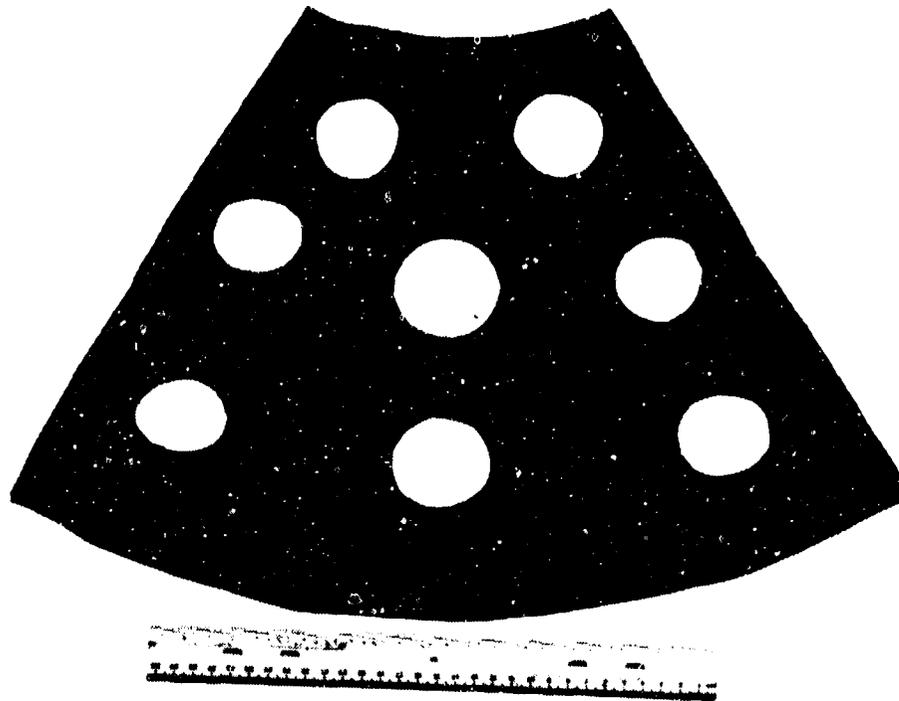
Figure A-5. Windshield Wiper Locating Mask.

The apparatus consisted of a specimen holding fixture mounted at approximately 45° with provisions to mount material specimens. A 12-inch Hycar rubber wiper blade (30 to 40 shore hardness) and a windshield wiper driver arm were attached to an aircraft type motor which was mounted to the test fixture. A system for regulating and discharging the abrasive slurry onto the 16-x-21-inch test specimen at 300 ML/minute rate was attached to the test fixture (see Figure A-4). A peristaltic pump was used to recirculate and apply the slurry. The haze measurements were confined to specific locations by the use of a marking mask. Eight holes were located on the mask periphery, Figure A-5, as well as in the middle of the mask.

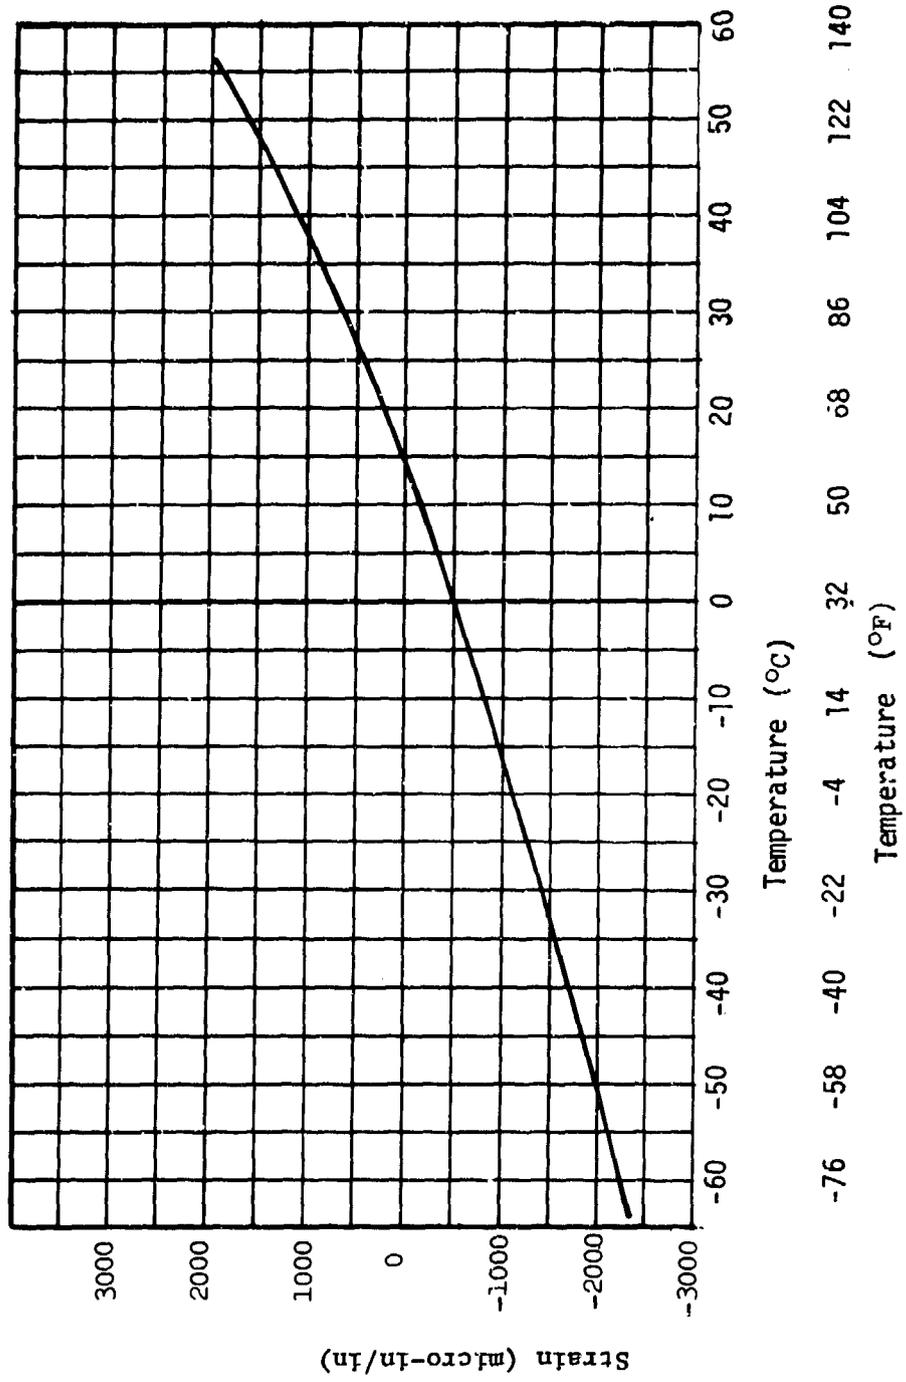
**Figure B-1. Temperature Induced Apparent Strain on Stretched Acrylic.**

At that time, it was considered that any error in gauge/coefficient matching could be allowed for by establishing an apparent strain curve for each material type and applying this as a correction to the results. This would assume that the precise temperature of the gauge at any moment was known. Correction curves were established and these are shown in Figures B-1 and B-2.

Corrections required to temperature compensate the strain gauges were found to exceed the value of the strains actually being measured. For example, as shown in Figure B-1, at 125°F the strain gauge correction factor for stretched acrylic is approximately 30  $\mu$ -in./°F. Measured strains were on the order of 150  $\mu$ -in. This meant that a temperature variation between thermocouple and strain gauge as small as 5°F could create an error of 100%. Even more of a problem was the non-regular correction curve for polyester. Because of the apparent illogical wave-form seen, the calibration plot was repeated numerous times using three different gauge arms and completely separate instrumentation methods. All of these repeatedly indicated the same trend.

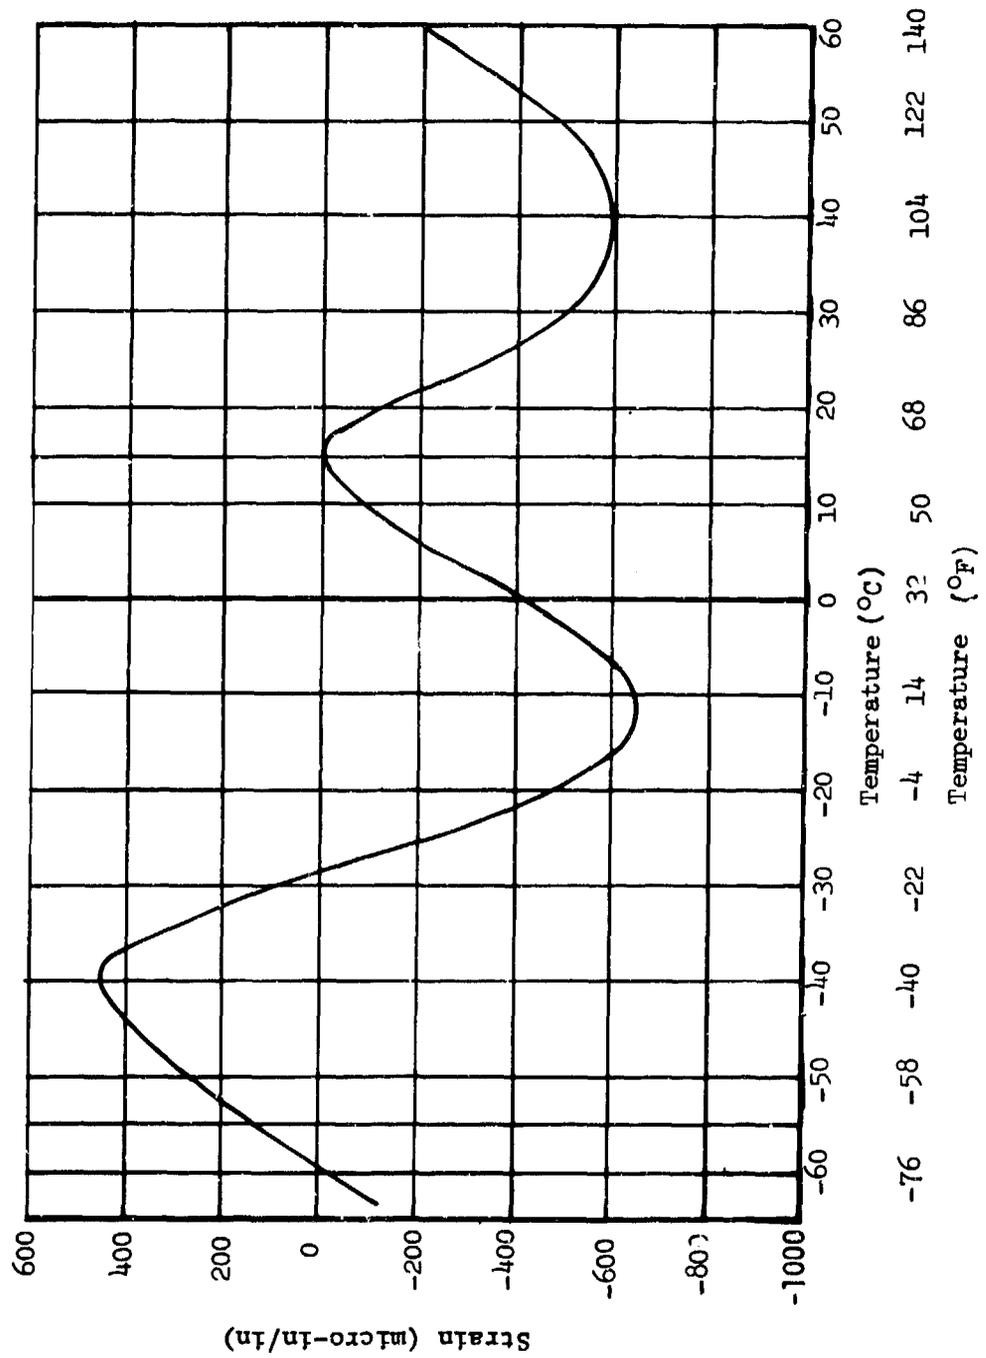
**Figure B-2. Temperature Induced Apparent Strain on Polyester.**
