HIGH-TEMPERATURE RADIAL TURBINE DEMONSTRATION.(U)

HIGH-TEMPERATURE RADIAL TURBINE DEMONSTRATION

Donald S. Monson, B. A. Ewing
DETROIT DIESEL ALLISON DIVISION
General Motors Corporation
Box 894
Indianapolis, Ind. 46206

Final Report for Period 15 June 1977 - 15 November 1979

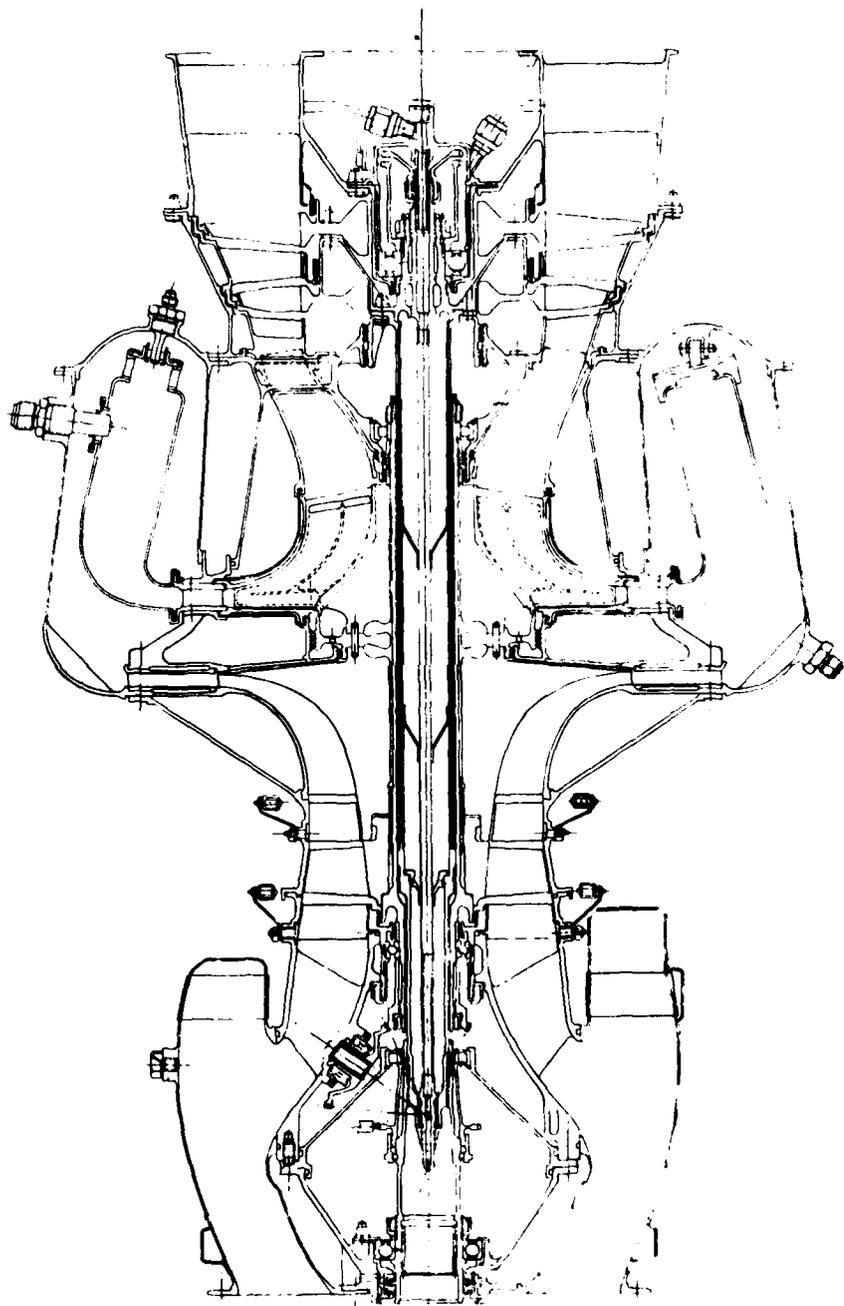
Figure 3. Engine configuration comprising air-cooled radial turbine.

The general engine arrangement, illustrated in Figure 3, comprises an axial-centrifugal compressor, a reverse-flow annular combustor, a radial-inflow gas generator turbine, and a two-stage axial power turbine. The engine compressor configuration is an adaptation of Allison XC-9 and Model 250-C30 technology. The design goals and the demonstrated experience are compared in Table 2. The centrifugal stage is based on the -C30 impeller with a 0.150-inch reduction in impeller exit radius to account for the decrease in design pressure ratio from 8.5 to 8.0. The -C30 ID and OD have been modified to account for the reduction in corrected inlet flow from 5.6 to 3.826 lbm/sec. The -C30 diffuser OD remains unchanged; its ID is reduced by 0.300 inch.

Figure 3 shows the turbine rotor in a typical design application as a radial gas generator turbine in a small, front-drive turboshaft engine.

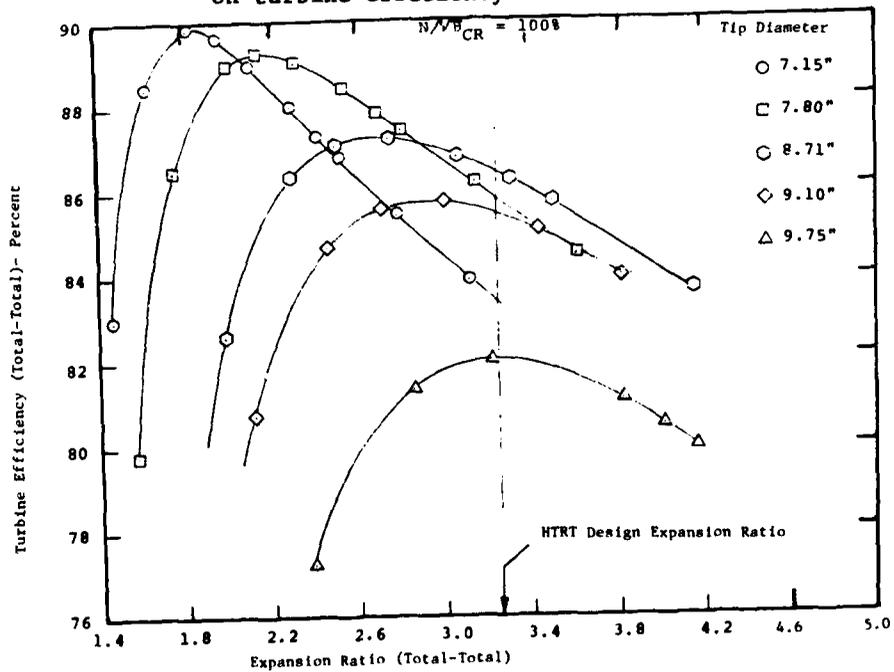
Figure 5. Influence of tip diameter on 100% speed line performance.

This selection results in an efficiency penalty of less than 1/2% but offers approximately an 8% reduction in disk stress. For a given gas generator RPM, tip speed is directly proportional to tip diameter. Figure 5 illustrates the influence of rotor tip diameter on 100% speed line performance characteristics. Reduced tip diameters, as would be expected, cause the efficiency to optimize at reduced expansion ratios. Peak efficiencies tend to be higher for reduced-diameter rotors because of lower velocity levels and reduced surface area. At the design expansion ratio, however, the small-diameter rotors suffer a substantial efficiency penalty. Figure 6 presents the effect of tip diameter on turbine efficiency at the design expansion ratio of 3.25. The selected HTRT tip diameter of 8.71 inches appears to be an optimum value.

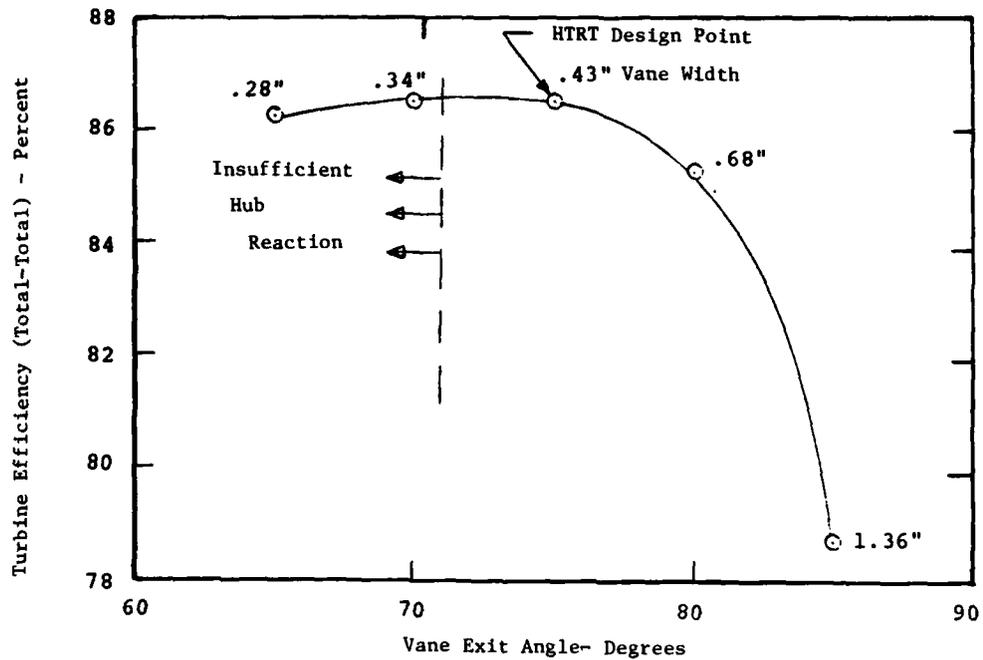
Figure 7. Influence of vane angle on efficiency at design expansion ratio.

Reduction in the rotor inlet blade width reduces blade and disk stresses as a result of lower blade weight. For a specified flow rate, a reduction in inlet width necessitates a reduced exit flow angle (measured from radial). This tends toward reduced efficiency because of reduced reaction and increased end-wall loss levels. Figure 7 illustrates the predicted effect of vane exit angle on turbine efficiency. The HTRT vane angle selection of 75° provides optimum performance.

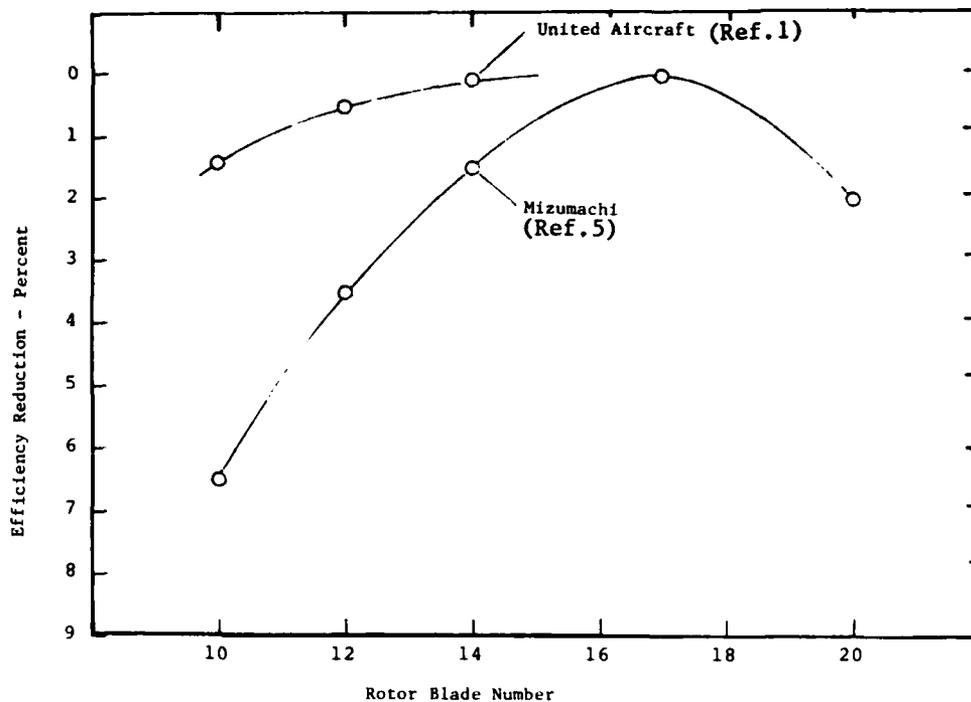
Figure 8. Experimental effect of blade number on turbine efficiency.

loss. Figure 8 illustrates the experimental effect of blade number on turbine efficiency. Mizumachi data⁵ show that a larger number of blades is required for optimum performance than do the United Aircraft data.¹ DDA experience and preliminary HTRT velocity distribution studies coincide more closely with the United Aircraft results. A blade number of 12 has been selected for the HTRT rotor design.

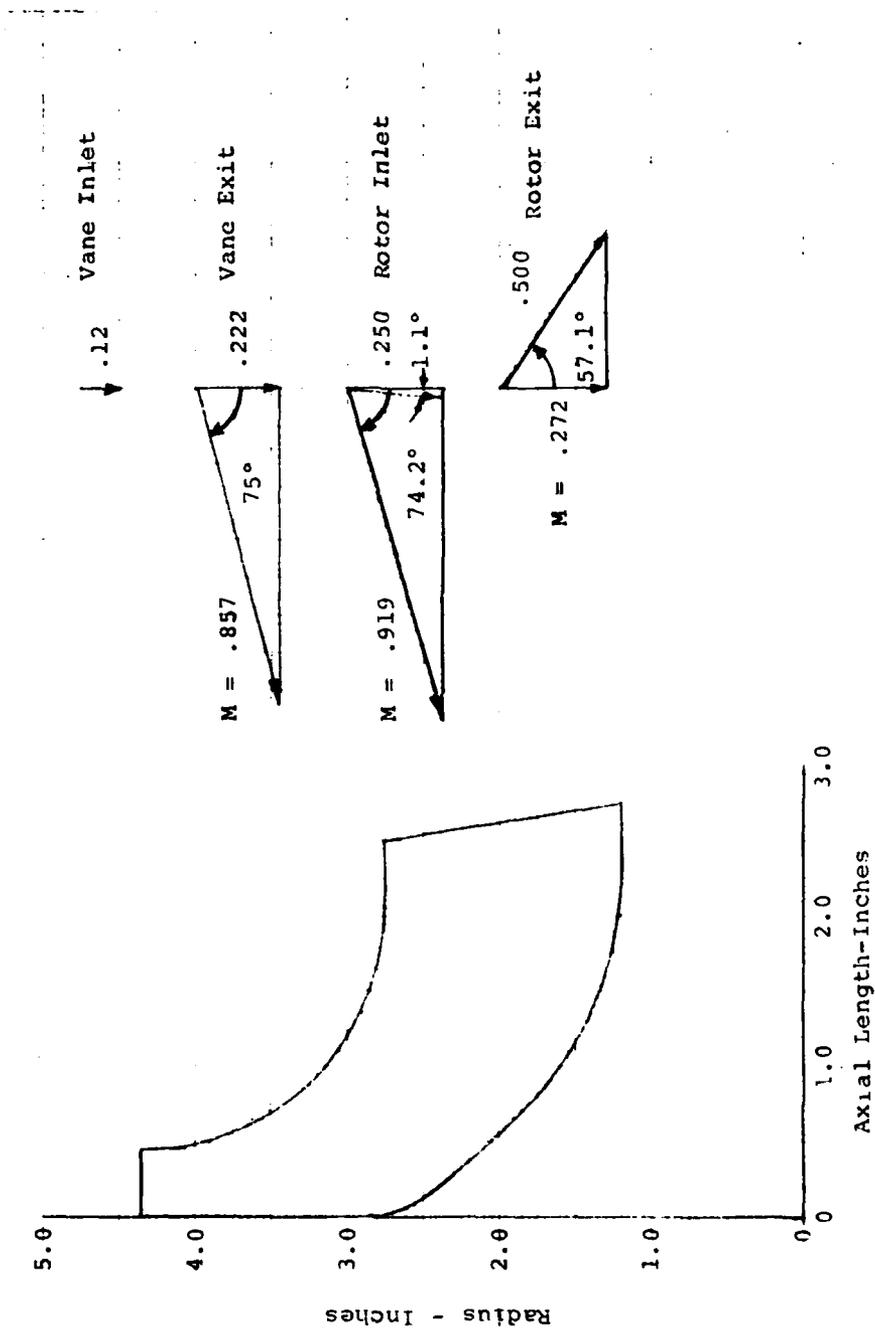
Figure 9. HTRT flow path and mean velocity diagrams.

The turbine rotor flow path and initial meanline velocity diagrams resulting from the specification of design point conditions and the selection of aerodynamic design parameters are shown in Figure 9. Salient features of the flow path include the following:

Rotor tip diameter	8.710 in.
Rotor inlet width	0.438 in.
Rotor exit hub diameter	2.433 in.
Rotor exit tip diameter	5.611 in.
Rotor axial length	2.750 in.
Exducer hub-tip radius ratio	0.434
Inlet width/tip diameter ratio	0.050
Tip diameter/exducer tip diameter ratio	1.552

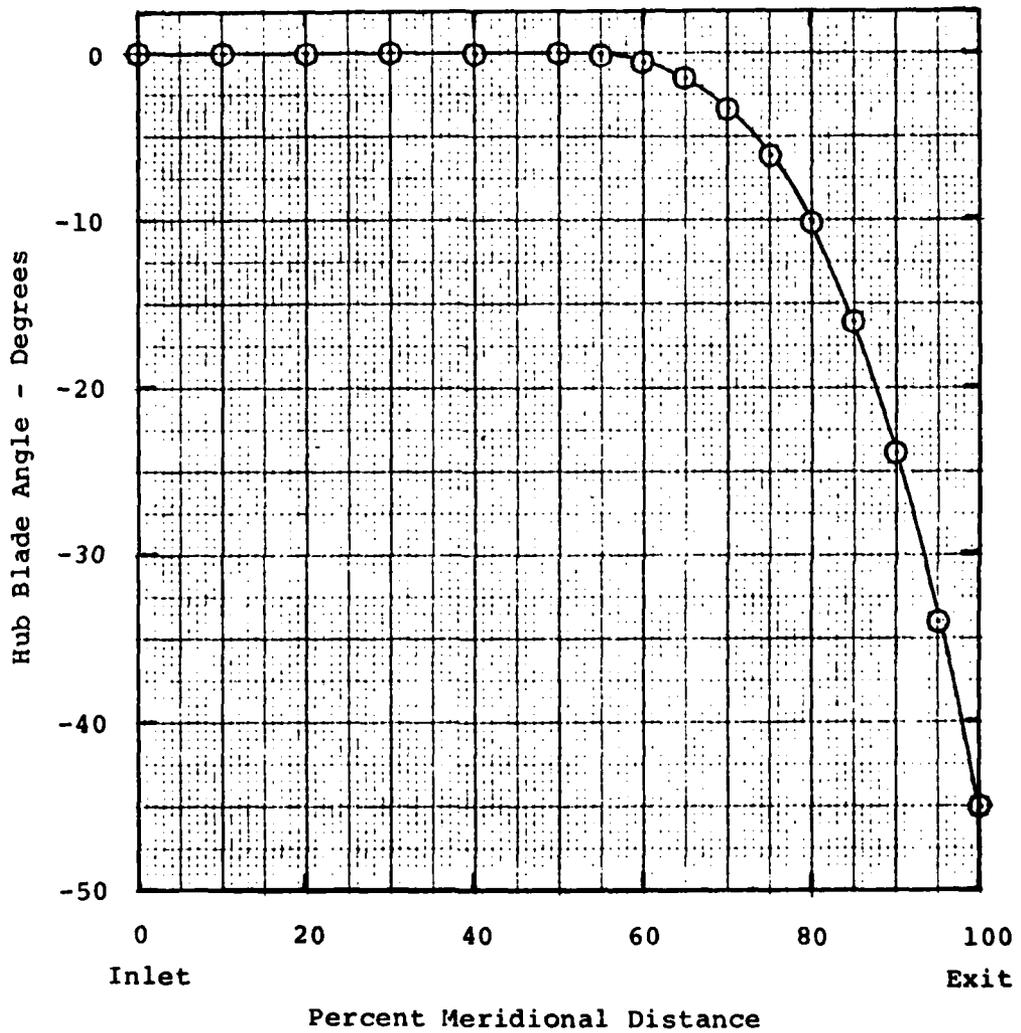
Figure 10. Meridional distribution of blade angle along hub streamline.

Uniform inlet flow conditions have been applied for the rotor design. The input meridional distribution of blade angle along the hub streamline is presented in Figure 10. Blade angles for all other streamlines are calculated via specification of radial blade elements. The radial distribution of exit blade angle is presented in Figure 11. Calculated distributions of design point work and exit swirl are presented in Figure 12. Final velocity diagrams, based on meridional flow analysis, are presented in Figure 13. The approximate blade-to-blade velocity distributions are illustrated in Figures 14 through 16 for the hub, mean, and shroud streamlines. Calculated streamline positions are shown in Figure 17.

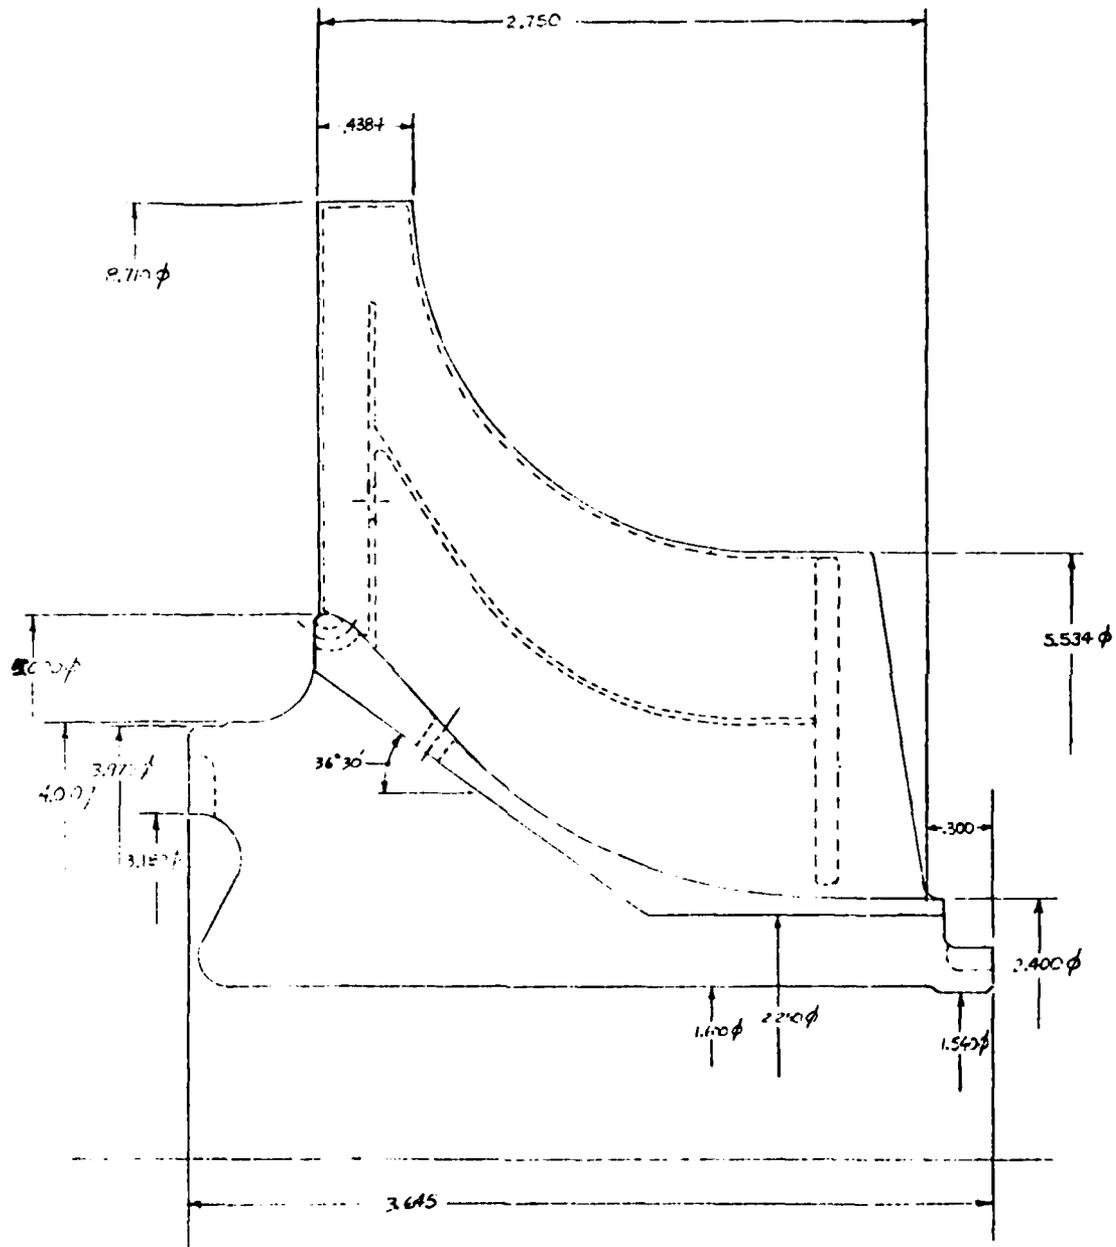
Figure 26. HTRT rotor final configuration.

The turbine rotor resulting from detailed design (Figure 26) has a bore diameter sized to accommodate a power turbine shaft of the 1000-shp class engine. In an extension of the aft rotor hub, opposed radial slots provide a means of driving the test rotor. The extension also facilitates piloting of the drive shaft and provides stock for rotor balance. An extension at the forward face of the rotor hub would serve as a drive mechanism in an engine application. A pilot is machined at the outer diameter of this "dummy" drive extension, and a provision for removal of balance stock has been made at the inner diameter.

The rotor incorporates as-cast finishes on all blade surfaces and the outer diameter of the wheel. The wall thickness at the blade tip (0.025 in.) was determined by minimum casting thickness. Blade taper was then established to yield the required design life but minimize wheel load.

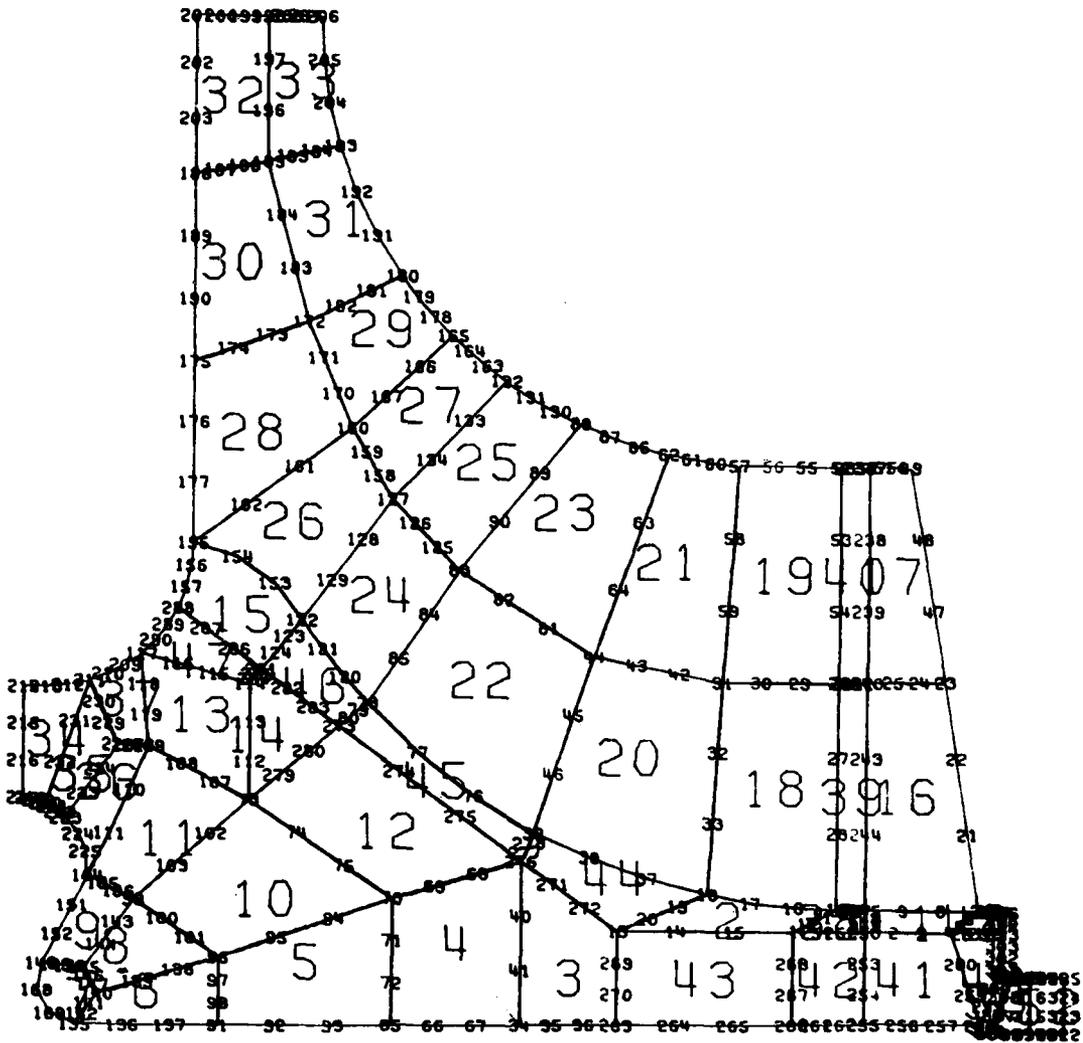
Figure 27. Finite element model used for stress analysis.

Stress was analyzed with a finite element computerized model. The blades were added to this model as plates with equivalent tangential thicknesses. The analysis is elastic and "in plane" (i.e., creep and out-of-plane blade loading are not included). Figure 27 shows the finite element stress model. Figure 28 shows blade tangential thickness, and Figure 29 shows the true blade thickness for the final design.

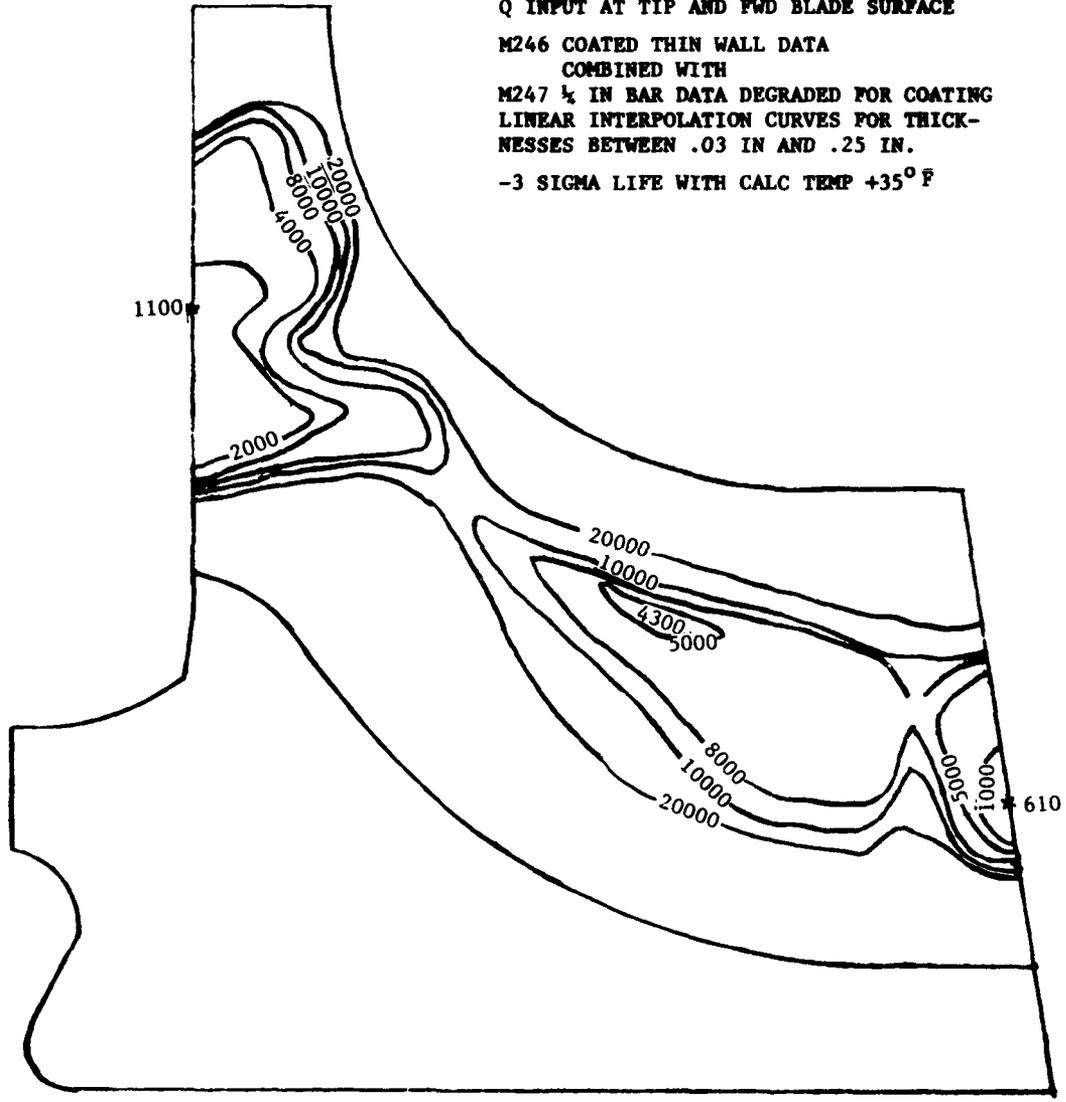
Figure 35. Stress rupture life in hours.

STRESS RUPTURE ISOLIFE LINES 100% IRP
 BLADE COOLING FLOW 3% SPLIT 2.3% - .7%
 FILM COOLING BETWEEN BLADES 1%
 BORE COOLING .5%
 INLET PROFILE 1.05
 Q INPUT AT TIP AND FWD BLADE SURFACE
 M246 COATED THIN WALL DATA
 COMBINED WITH
 M247 1/2 IN BAR DATA DEGRADED FOR COATING
 LINEAR INTERPOLATION CURVES FOR THICK-
 NESSES BETWEEN .03 IN AND .25 IN.
 -3 SIGMA LIFE WITH CALC TEMP +35° F

Stress rupture has been analyzed on a local stress, local temperature basis. Because of the large variation in blade thickness, two Larson-Miller stress rupture curves were used to assess life. Data derived from 0.030-in.-thick stylized Alpak coated specimens were used for the portions of the blade up to 0.030 in. thick. Bar data from 0.25-in. Alpak coated specimens were used for the 0.25-in. or thicker portions of the blade. Thicknesses within this range (0.030 in. to 0.25 in.) were linearly interpolated between these two data sets. Figure 35 shows isolife lines for the airfoil for the 100% IRP design point. One point at the blade trailing edge has a calculated life of 610 hr. This limiting life point indicates that a decrease of 17°F in calculated metal temperature is needed to reach the design goal of 1000 hr life at 100% IRP. Because a 35°F margin has been added to calculated temperatures, and creep redistribution is not included in the analysis, this calculated discrepancy at one location is not significant.

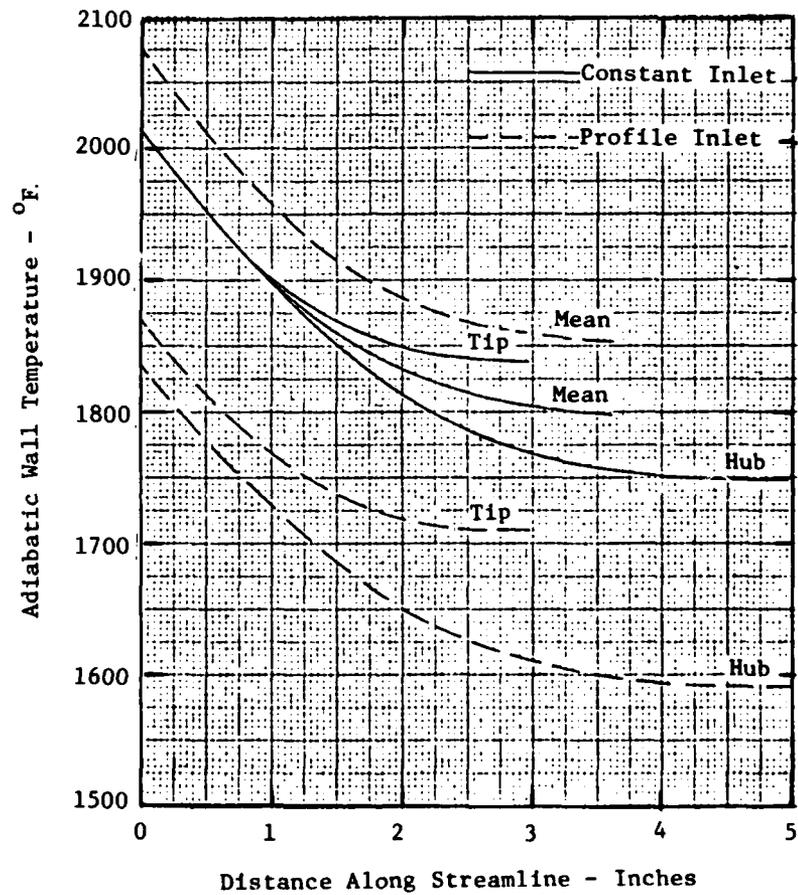
Figure 38. Blade external adiabatic wall temperature.

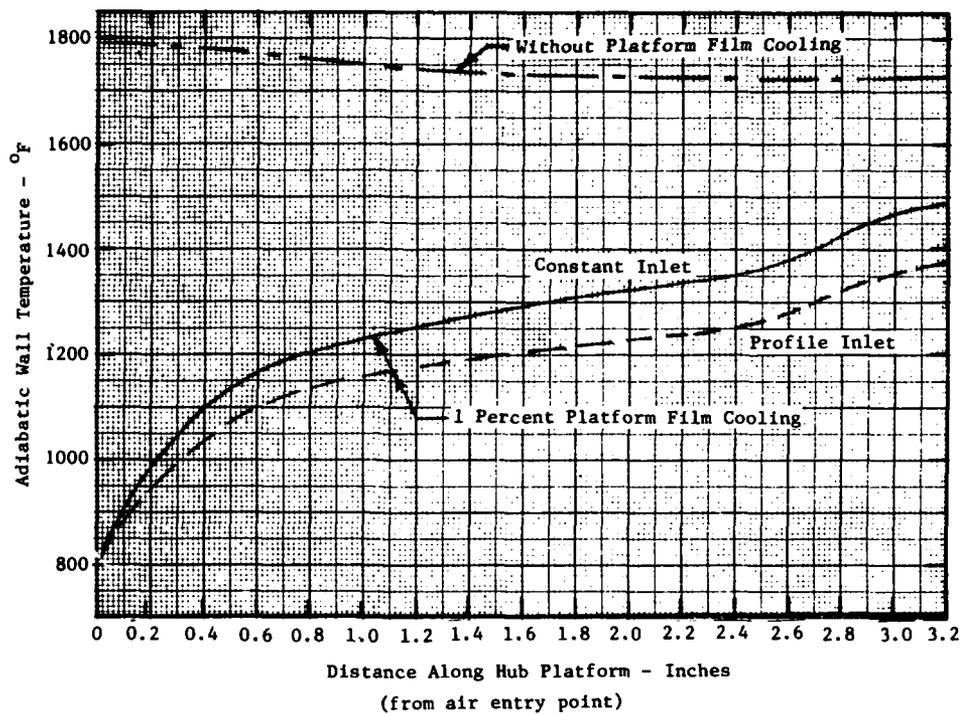
Figure 39. Platform film adiabatic wall temperature.

The resulting adiabatic wall temperature which is applied to the surface between blades is shown in Figure 39.

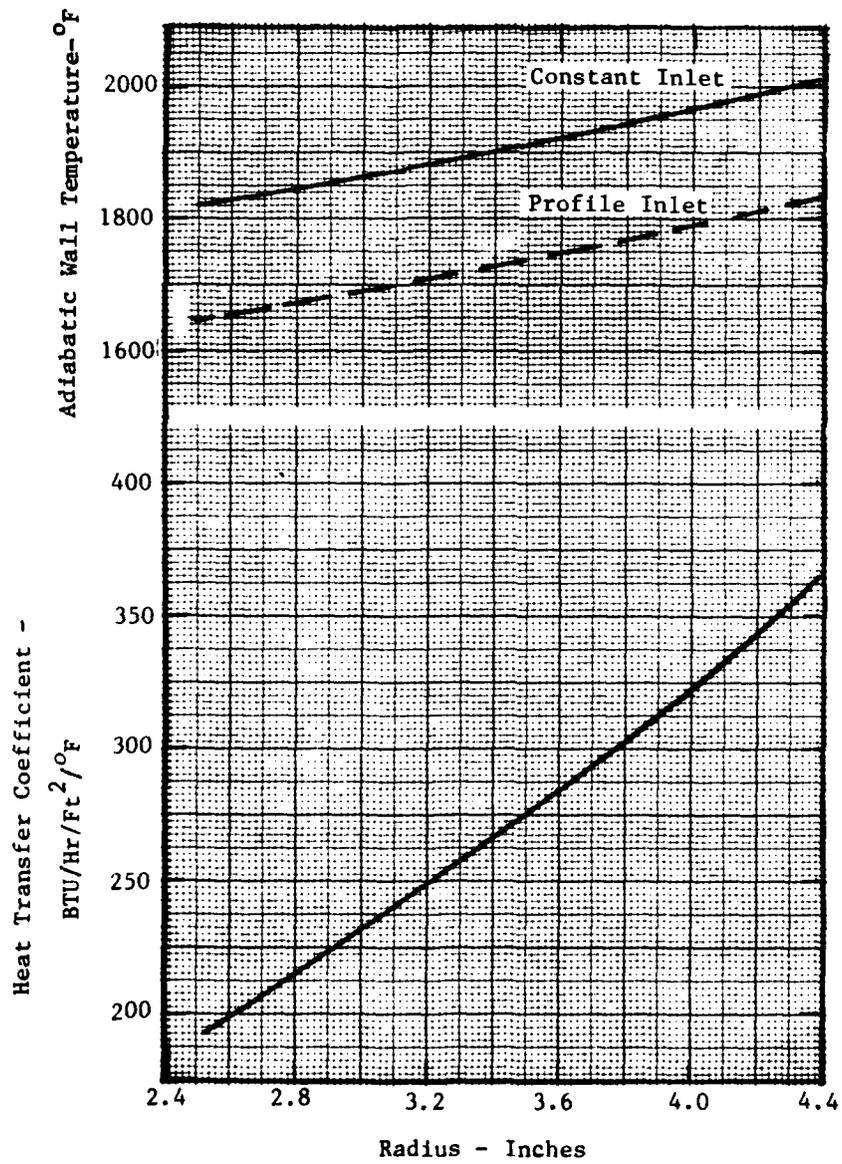
Figure 40. Forward face boundary conditions.

The heat transfer coefficients and adiabatic wall temperatures (from aero hub streamline data) as a function of blade forward face edge radius are shown in Figure 40.

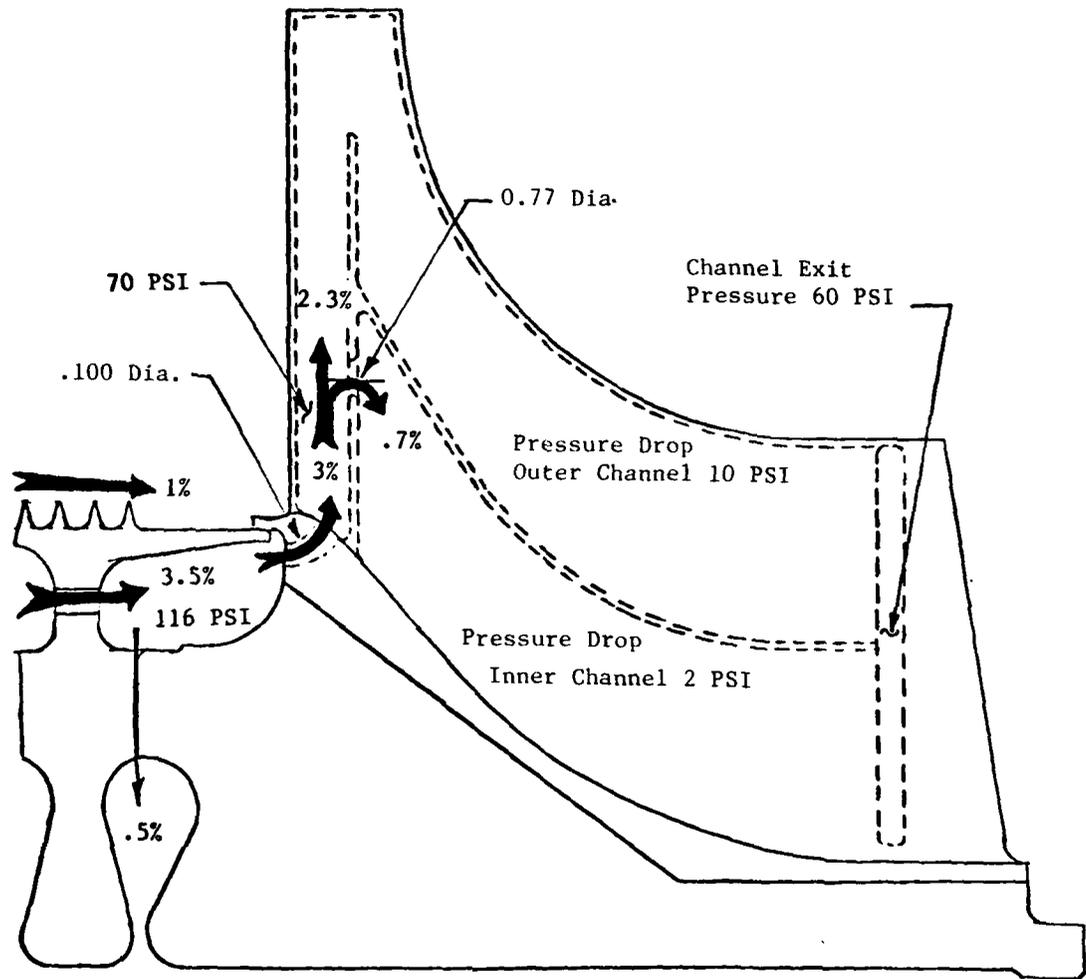
Compressor Discharge Pressure
174.6 PSI At 100% IRP

Figure 41. IRP internal flow pressures.

The cooling air feed orifice into the blade has been sized for 3% flow with a pressure differential across the inlet orifice of 46 psi and a pressure drop in the outer channel of 10 psi. The orifice into the inner channel has been sized for 0.7% flow with a ΔP across the orifice of 8 psi and a pressure drop in the channel of 2 psi. Figure 41 shows internal pressures and cooling flows.

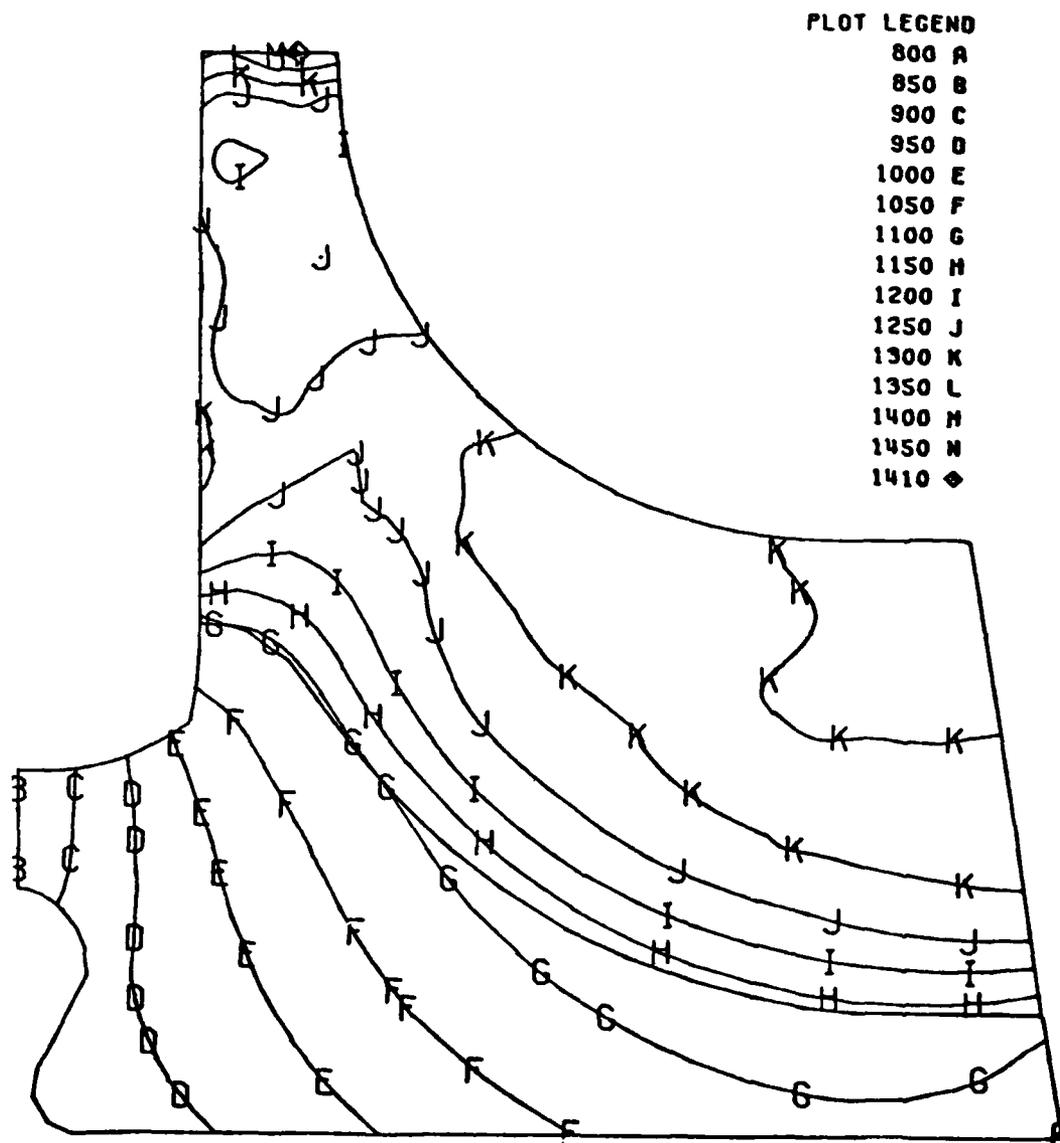
Figure 42. Isotherm plot for 75% IRP.

An isotherm plot for the 100% IRP design point is shown in Figure 34. An analysis was also completed for the 75% IRP point. An isotherm plot for this condition is shown in Figure 42.

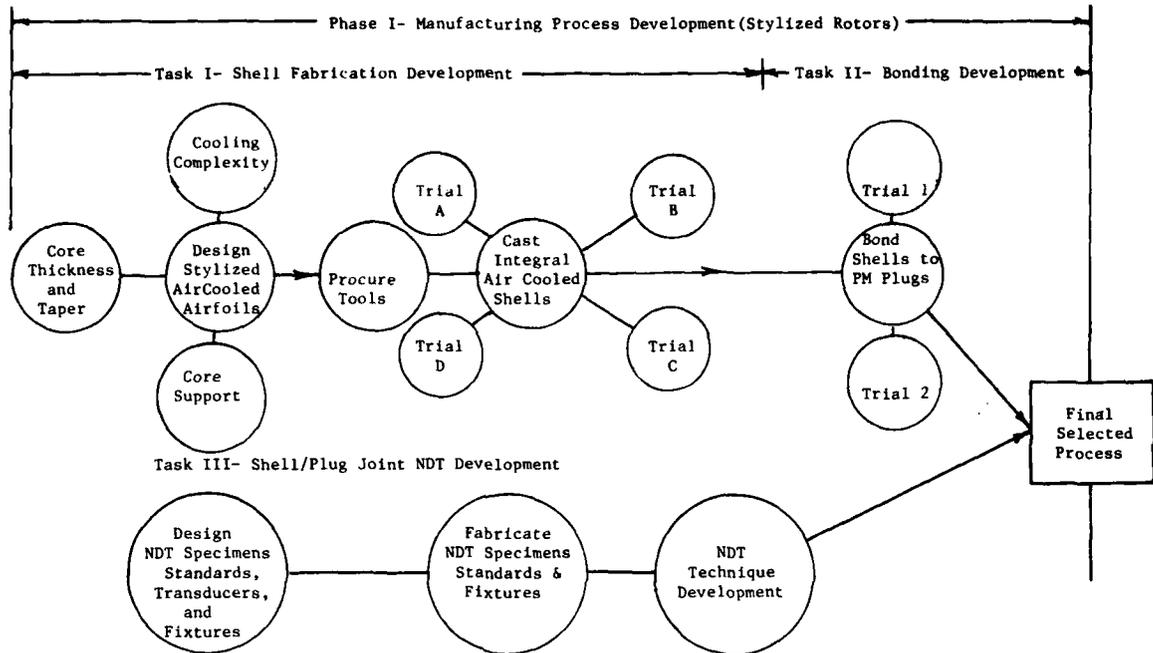
Figure 43. Manufacturing process development program.

To demonstrate the applicability of the HIP-bond process to the fabrication of cost effective air-cooled radial turbine wheel designs, a limited process development program (shown schematically in Figure 43) was

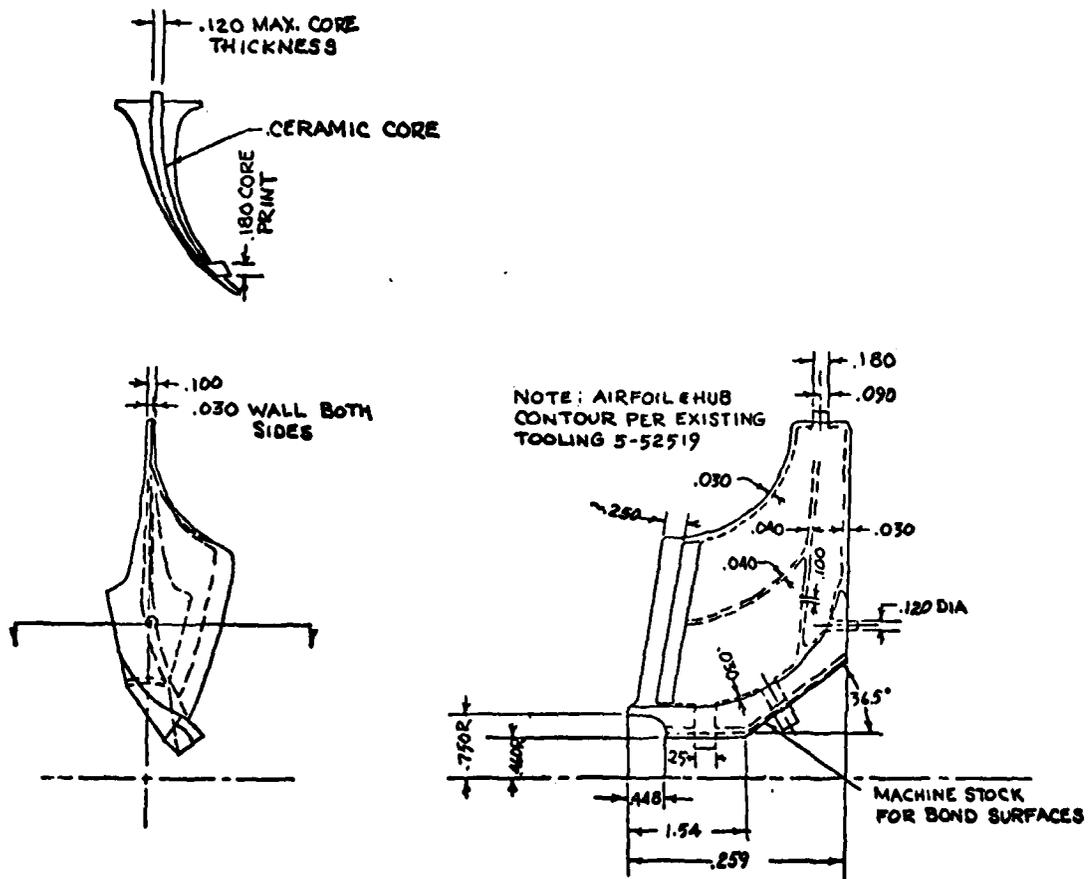
Figure 44. Stylized airfoil shell detail.

The wax pattern die for the existing uncooled AGT-2 rotor was used as the primary "work aid" for the construction of stylized airfoil wax pattern and ceramic core dies. The airfoil shell detail is presented schematically in Figure 44. Figure 45 is a photograph of the core before and

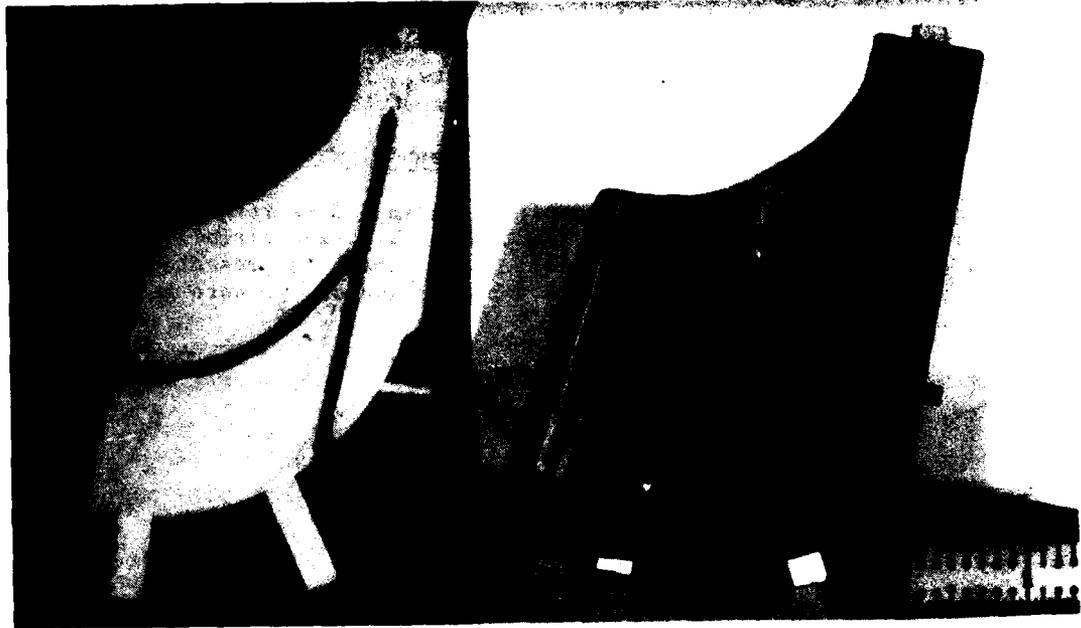
Figure 45. Typical core before and after wax injection.

after wax injection. To assemble the individual airfoil patterns with contained cores, they were placed in a fixture and joined by wax welding to form a complete 360° airfoil ring. Typical airfoils in the assembly fixture are shown in Figure 46. An assembled HTRT rotor is shown in Figure 47.

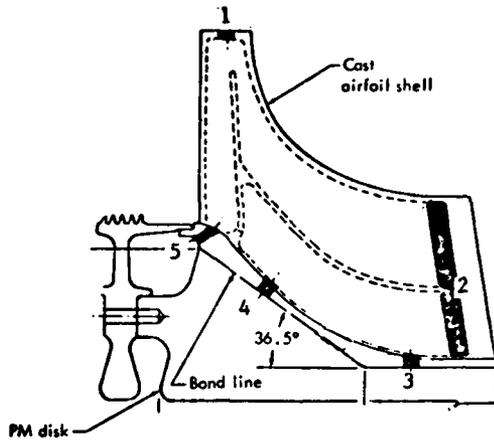
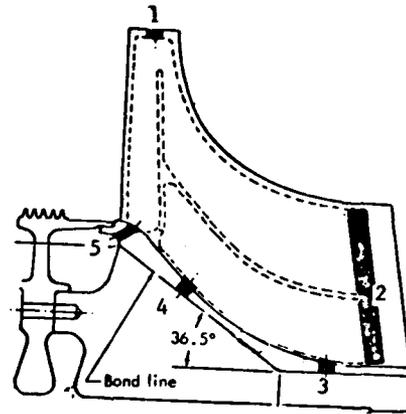
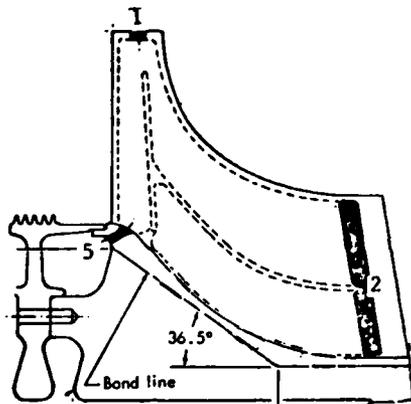
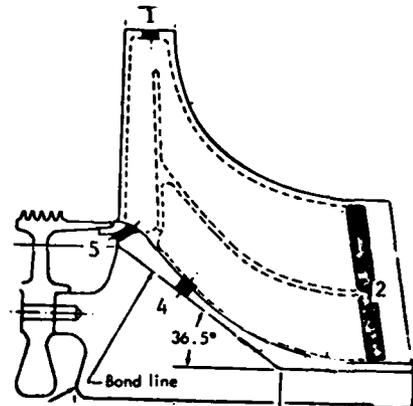
Trial 1- Maximum core support-locations 1-5 each of 14 blades

Trial 2- Rainbow core support-locations 1 through 5
4 blades locations 1 through 5
5 blades locations 1,2,4&5
5 blades locations 1,2&5

Trial 3- No ID core support-locations 1,2&5 each of 14 blades

Trial 4- Partial ID support-locations 1,2,4&5 each of 14 blades

Figure 48. Core printout variations investigated during Phase I.

As is indicated by Figure 48, the maximum support that was built into the stylized HTRT casting tooling was employed to produce the pattern assembly for the first shell casting of the program. The fabrication of this first rotor assembly, however, was complicated when, during the injection of cored details, a small amount of core shift developed in a localized area near the exducer portion of the airfoil which necessitated the application of a slight amount of wax to build the wall thickness up to a desired minimum of 0.020 in. The absence of core pins in this simplified tooling to locate the core die consistently within the die cavity during the wax injection process resulted in extra efforts during follow-on casting trials to stabilize the core during injection. For the full-scale rotor, production quality tooling with core locating pins was used, thereby precluding the problem.

Pattern assembly 2 was fabricated to gain further insight into the degree of core support that would be required to satisfactorily produce integral air-cooled airfoil shell details. As shown in Figure 48, this assembly employed four airfoils with maximum core support (printouts at exducer, inducer, rear face, ID shaft, and ID conical locations) to provide a baseline condition. These core printouts were identical to those employed in the construction of shell number 1. In addition to these four airfoils, five others with the printout removed from the ID shaft location (core printout in the ID conical location was maintained) were used. Five additional airfoils with the printout removed from both ID cylindrical and ID conical locations rounded out the airfoils used in the assembly. A photograph showing the ID areas in which core printout locations were varied is shown in Figure 50.

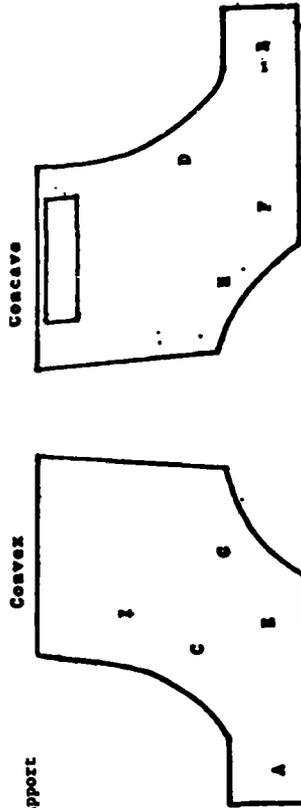
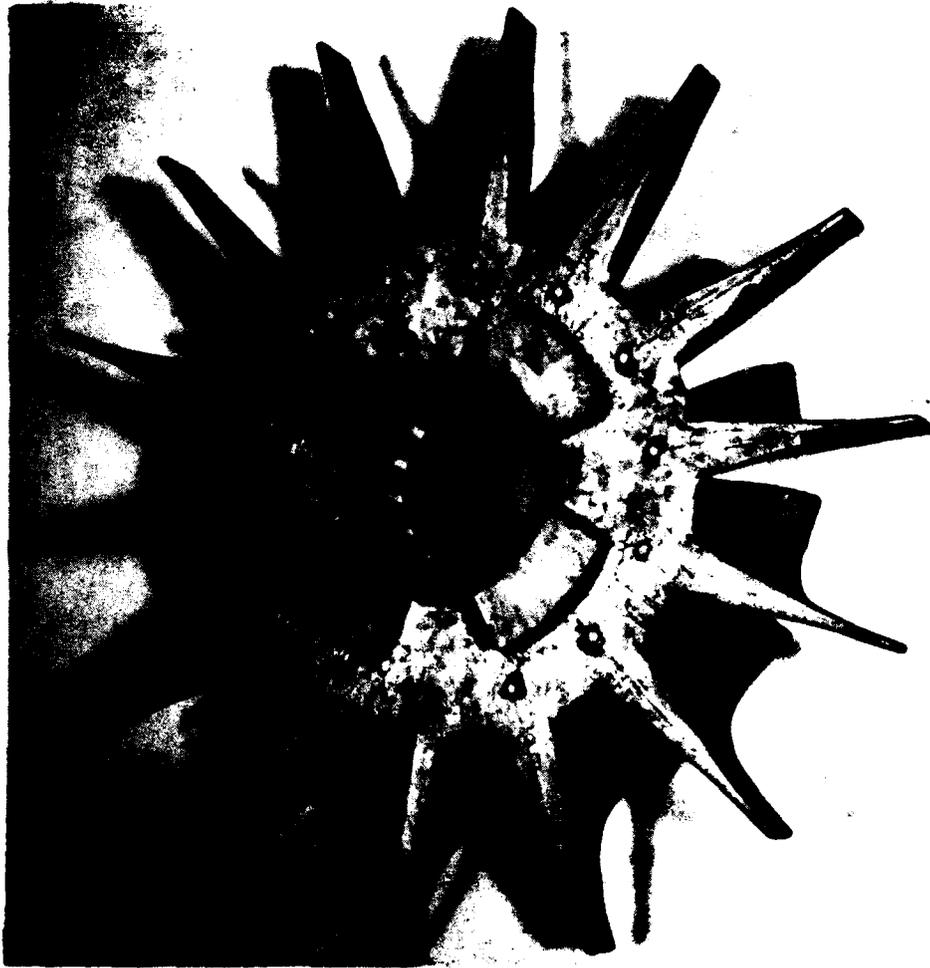
Figure 50. Oblique rear face view of No. 2 airfoil casting showing the ID and where core printout variations were investigated.

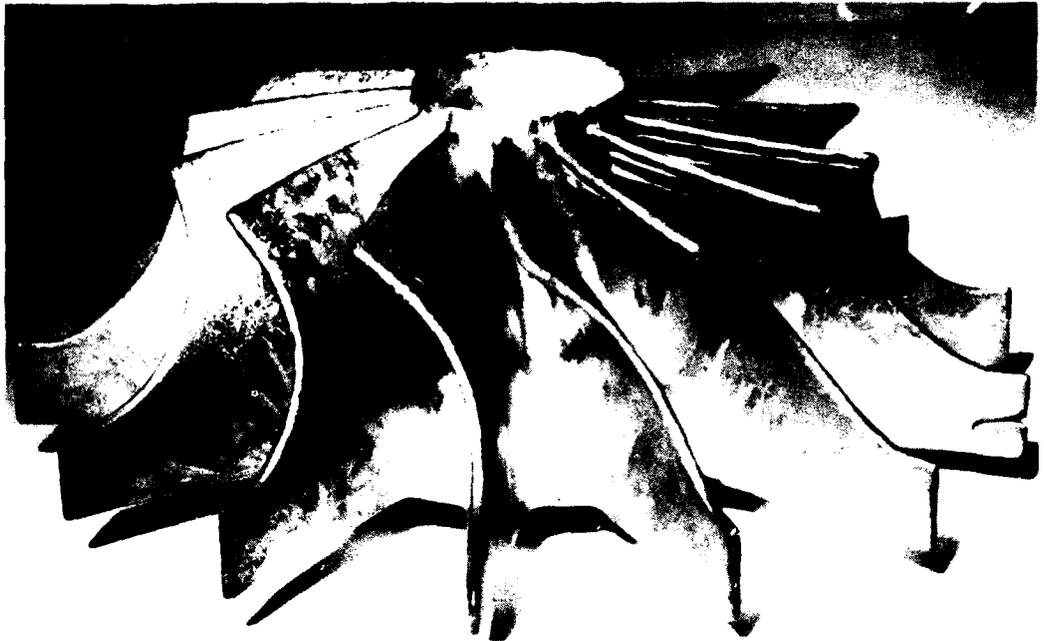
Figure 54. Side view of macroetched No. 2 airfoil casting showing misrun in inducer vane location.

The pouring conditions for this assembly were modified slightly from those used for the first wheel assembly in an attempt to achieve a finer and more uniform grain by lowering the mold and pour temperatures from 2000°F to 1950°F and from 2900°F to 2850°F, respectively. As shown in Figures 51 through 54, a grain size refinement was achieved; however, reduced fluidity caused misruns in five airfoils.

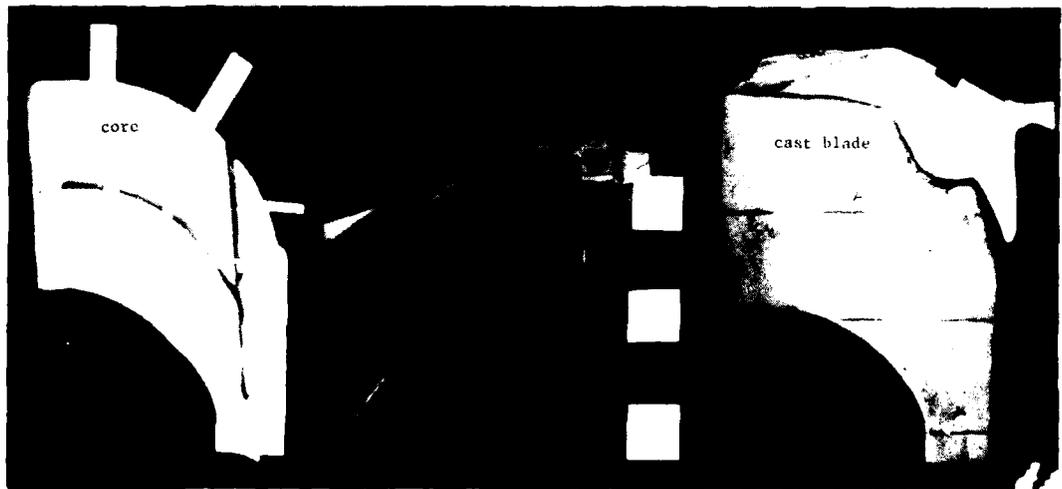
Figure 55. Typical airfoil cross sections from airfoil casting No. 2 (shows cooling channels).

Figure 55 is a typical cross section of one of the airfoils from this casting and shows the complexity and uniform wall thickness of the airfoil.
