HIGH-TEMPERATURE RADIAL TURBINE DEMONSTRATION.(U)

HIGH-TEMPERATURE RADIAL TURBINE DEMONSTRATION

Donald S. Monson, B. A. Ewing
DETROIT DIESEL ALLISON DIVISION
General Motors Corporation
Box 894
Indianapolis, Ind. 46206

Final Report for Period 15 June 1977 - 15 November 1979

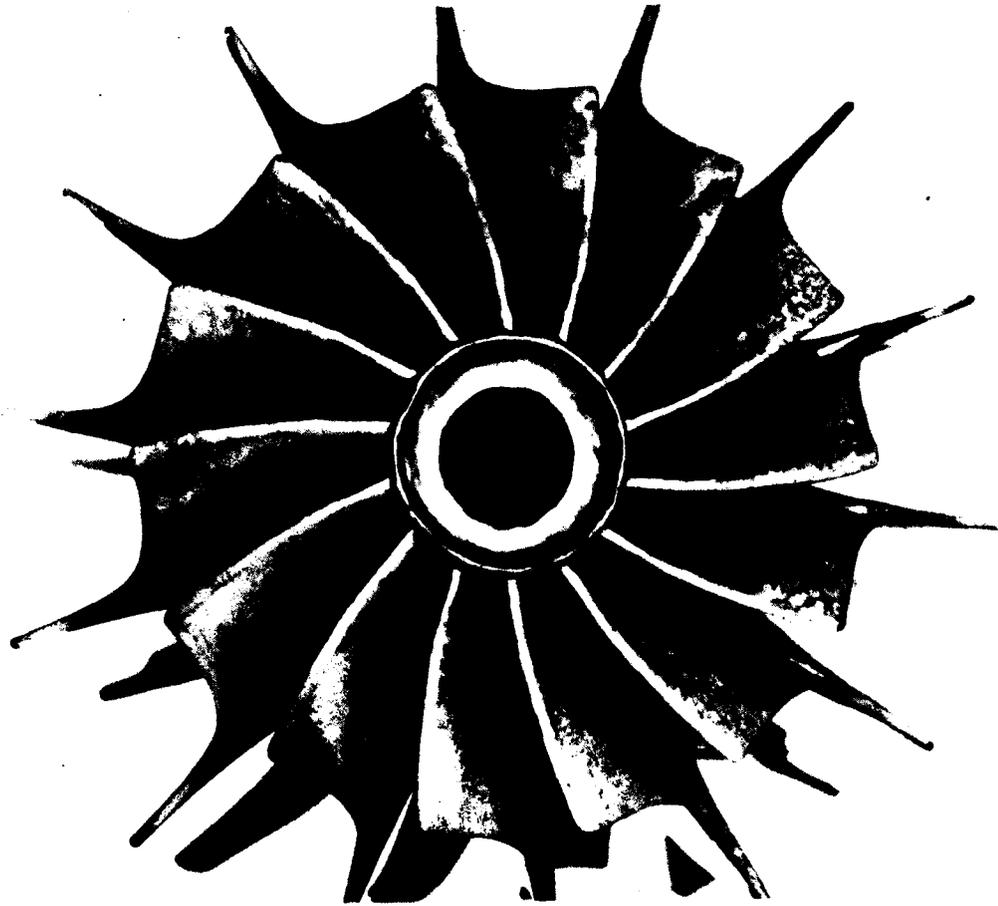
Figure 56. Macroetched appearance of No. 3 airfoil casting. (Mold preheat temperature was inadvertently 75^oF lower than desired and gross misrun resulted.)

As is indicated by Table 5 and Figures 56 and 57, gross misrun occurred in casting 3 because too low a mold temperature was used inadvertently. (A mold temperature of 2000°F was to have been used; however, thermocouple records indicated that the mold temperature was 1925°F.) As with the first two castings, wall thicknesses were ultrasonically determined for nine locations on each blade. As indicated in Table 6, the wall thickness varied significantly between locations G and H where the thicknesses would have been expected to be nearly the same.

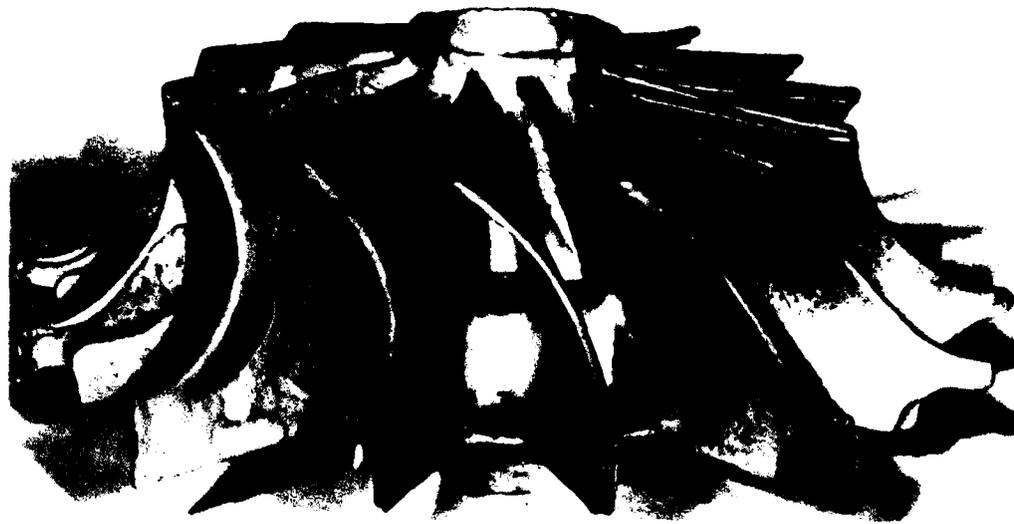
Figure 57. Side view of macroetched No. 3 airfoil casting.

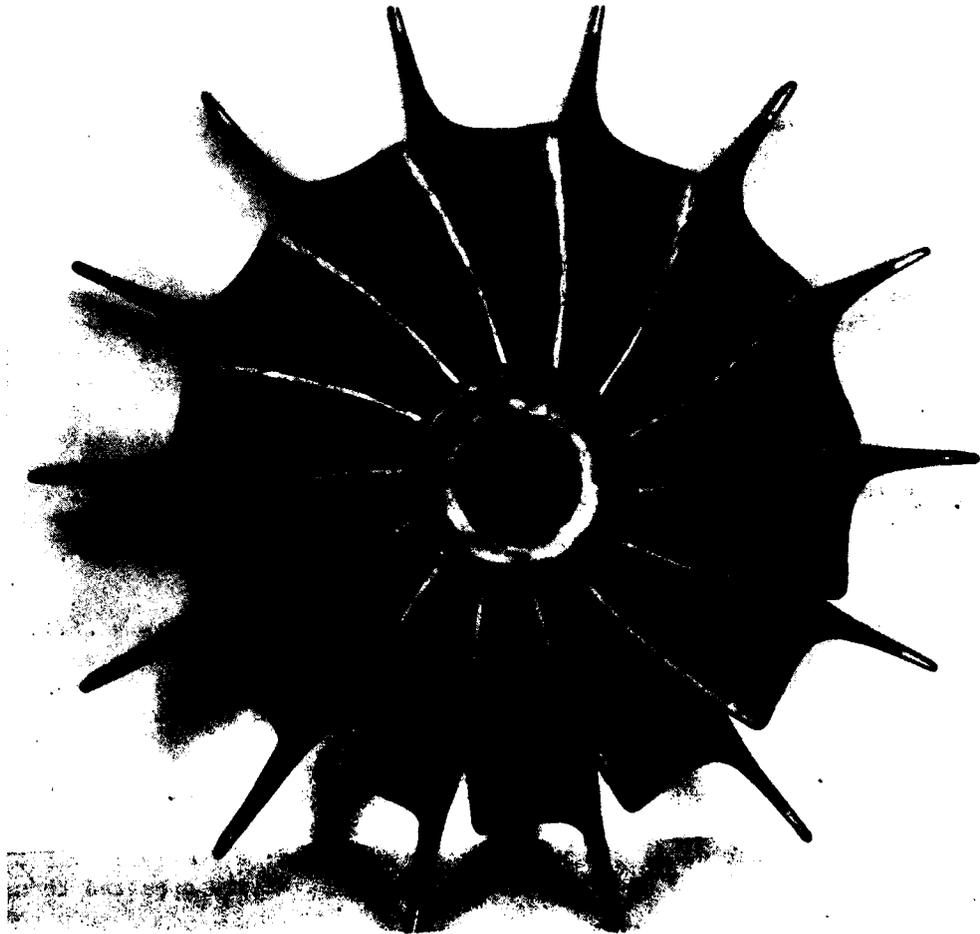
Figure 59. Macroetched appearance of No. 4 airfoil casting. (Excellent fill and good grain size control were developed in this casting; however, core "kissout" developed in one airfoil.)

As is seen in Figures 59 and 60, total fill was achieved in this casting, and a more refined macrostructure was obtained. Unfortunately, core "kissout" developed on the convex surface of one blade. Relative to wall thickness results, the data for this rotor in the critical G location, on an average basis, seemed slightly better than those for casting 3. There was, however, significant variation in the thickness data (a range of 0.028 to 0.045) as there was for rotor 3.

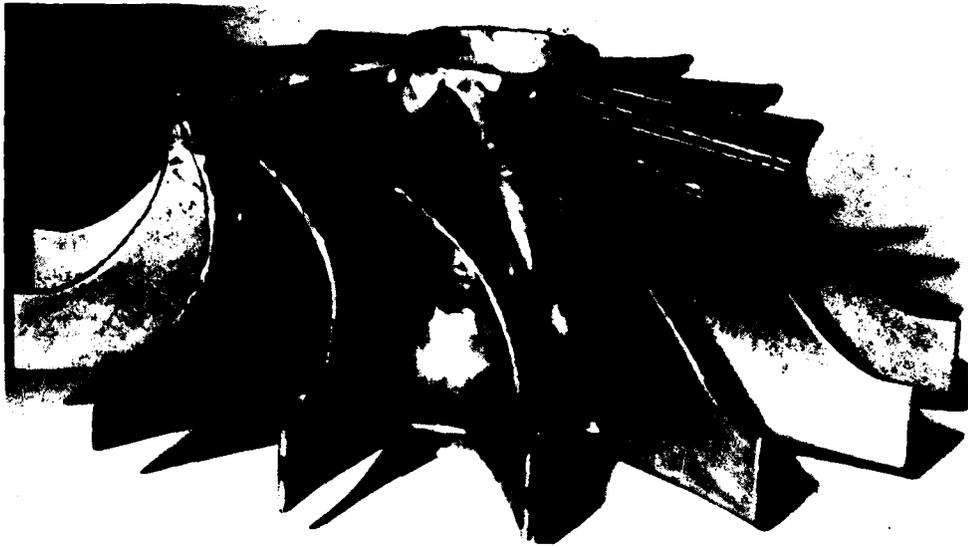
Figure 61. Side view of No. 5 airfoil casting.

The pour rate for casting 5 was slowed from that of casting 4. The intended effect of the slower pouring rate was to provide a "gentler" metal stream so as to lessen the possible disturbance to the airfoil cores. The other pouring parameters remained the same as for casting 4, which exhibited good fill characteristics. As shown in Figure 61, the result for casting 5 was a single defect in the convex surface of one airfoil similar to the apparent kissout observed in casting 4. Wall thickness data in the problem area (G) were generally improved over those for castings 3 and 4; however, the improvement apparently was not sufficient to keep the core from flexing during pouring.

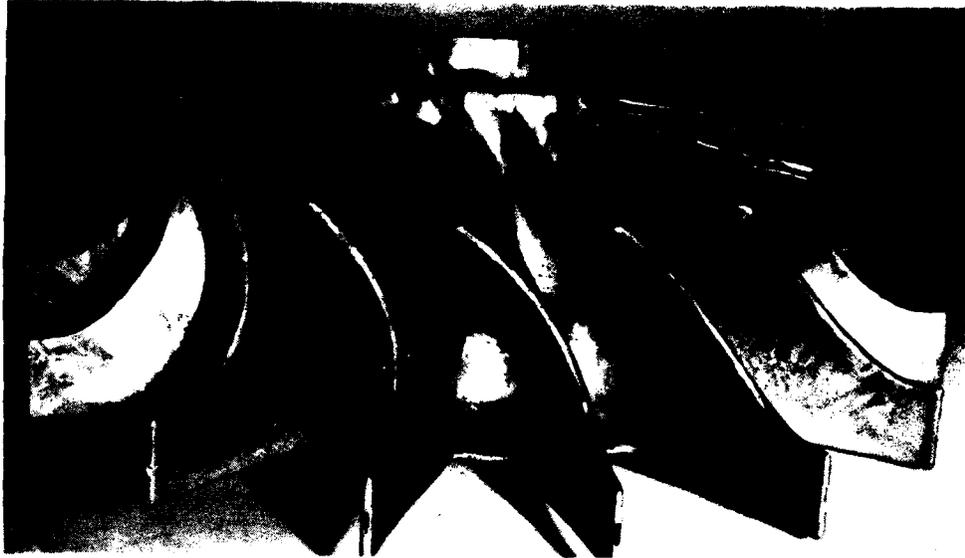
Figure 62. Side view of No. 6 airfoil casting.

The result for casting 6 was again a kissout in one of the blades. Figure 62 shows the casting with a core kissout on the convex side of one blade. As with casting 5, the wall thickness data were generally improved over those of castings 3 and 4; however, core instability appeared to have occurred during pouring.

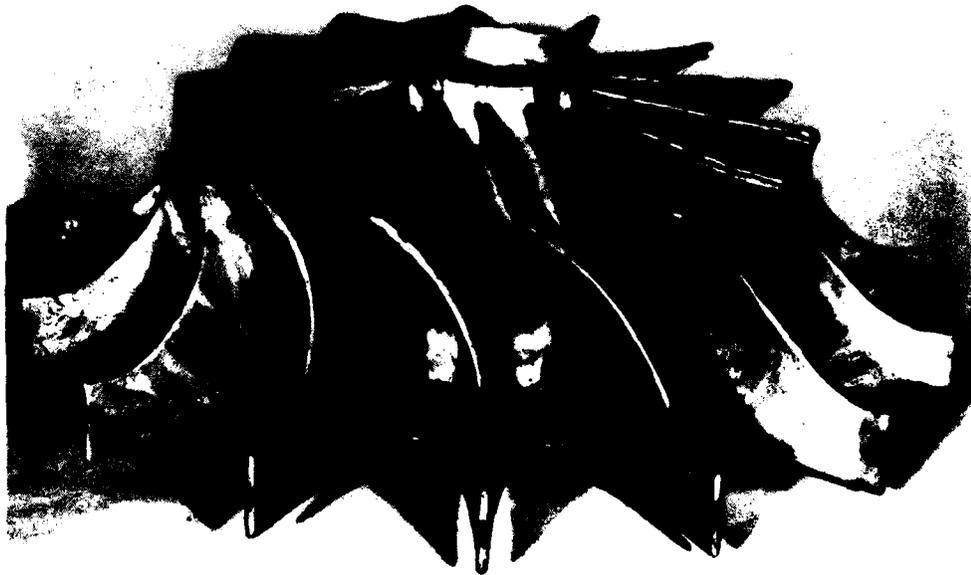
Figure 63. Side view of No. 7 airfoil casting showing good fill and core stability.

Pouring parameters for casting 7 were identical to those of casting 6. They resulted in an excellent casting, free of kissout and possessing good surface quality, as shown in Figure 63. Wall thickness checks (Table 6) were very satisfactory and showed good consistency. Especially notable is the consistency of wall thicknesses in location G where previous kissouts had surfaced. The reduced scatter of wall thicknesses in location G (0.006 in.) indicates a greatly improved core stability and is attributable to the added ID core printout. The ID printout in the conical surface is shown in Figure 64.

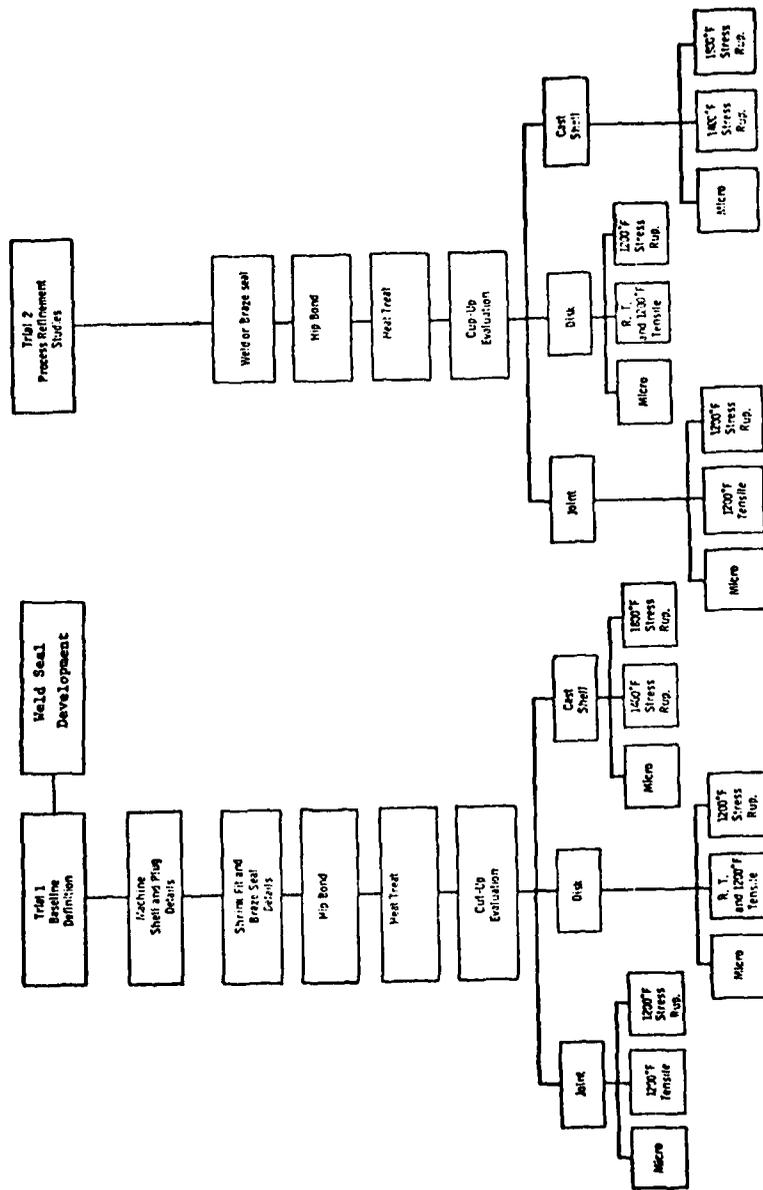
Figure 65. Bonding development program.

The development of an alternative method using electron beam welding could reduce thermal distortion risks associated with braze sealing. This alternative method also has the potential for the application of automated processing, which could substantially improve the consistency of bond quality and reduce manufacturing costs. As shown in Figure 65, a series of development trials aimed at optimizing joint integrity was conducted.

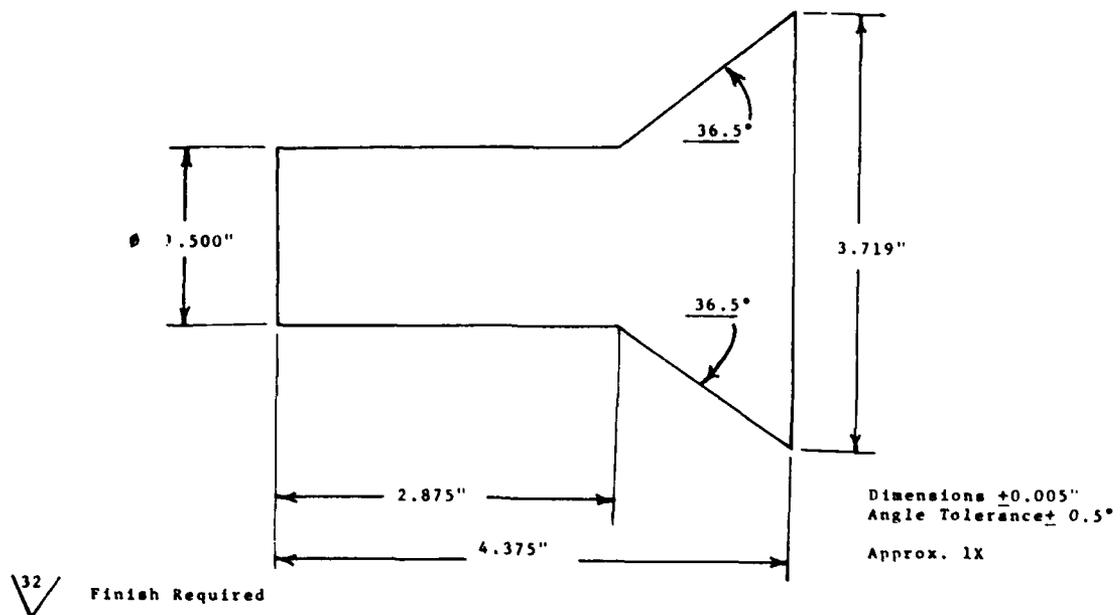
Figure 66. Subscale PA101 plug for bonding development.

For this purpose 11 metal can HIP-consolidated PA101 preforms were obtained from the Udimet Powder Metals Division of Special Metals Corporation. The configuration obtained is shown schematically in Figure 66; the composition and sieve analysis of the material are listed in Appendix A. Photographs of the canned and fully machined appearance of the PA101 plug are shown in Figure 67. Upon receipt at DDA, the material was fluorescent penetrant and sonic inspected and judged to be acceptable. Following the NDT work, thermally induced porosity (TIP) tests and microstructural checks were run on samples cut from each of the PA101 plugs. A flat pancake, approximately five inches in diameter and one inch thick, representative of the same master heat and consolidation practices employed for the plug, was also TIP tested. It was also heat treated to a cycle consisting of 2 hours at 2050°F, gas fan cooled to room temperature, 24 hours at 1600°F, and air cooled to room temperature. Specimens from the pancake were then evaluated for tensile and stress rupture capability.

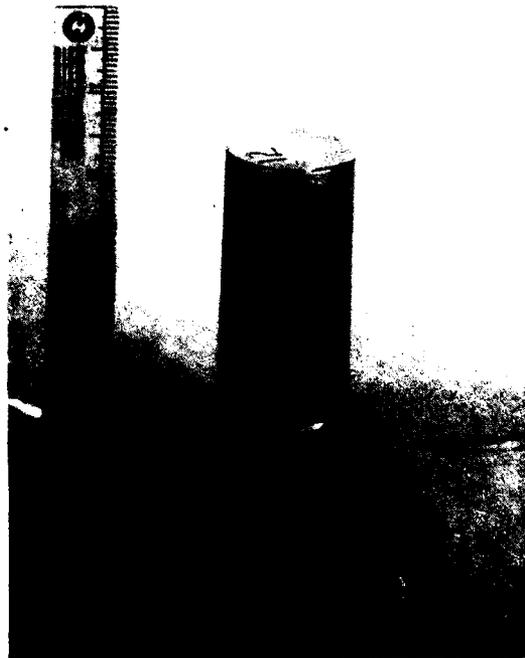
Figure 67. Powdered metal plug.

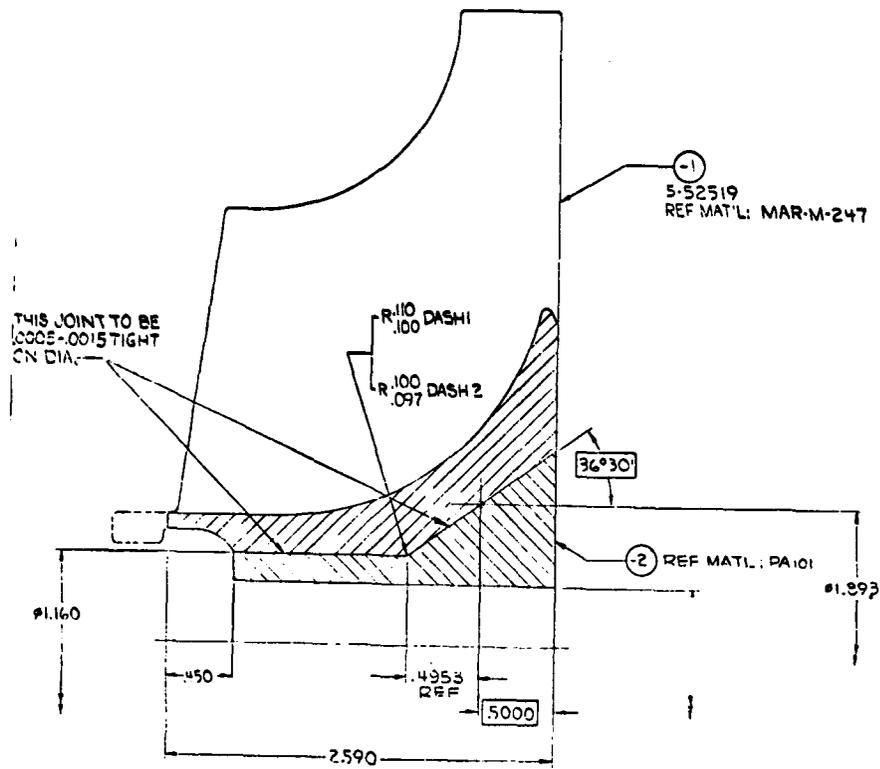
Figure 68. Stylized rotor assembly.

Following inspection of the PA101 plug material and upon availability of castings, two shell castings (3 and 4, with no ID core support) and two plugs (1 and 4) were machined to the configurations defined by Figure 68. The appearance of typical details in their as-machined condition is shown in Figure 69.

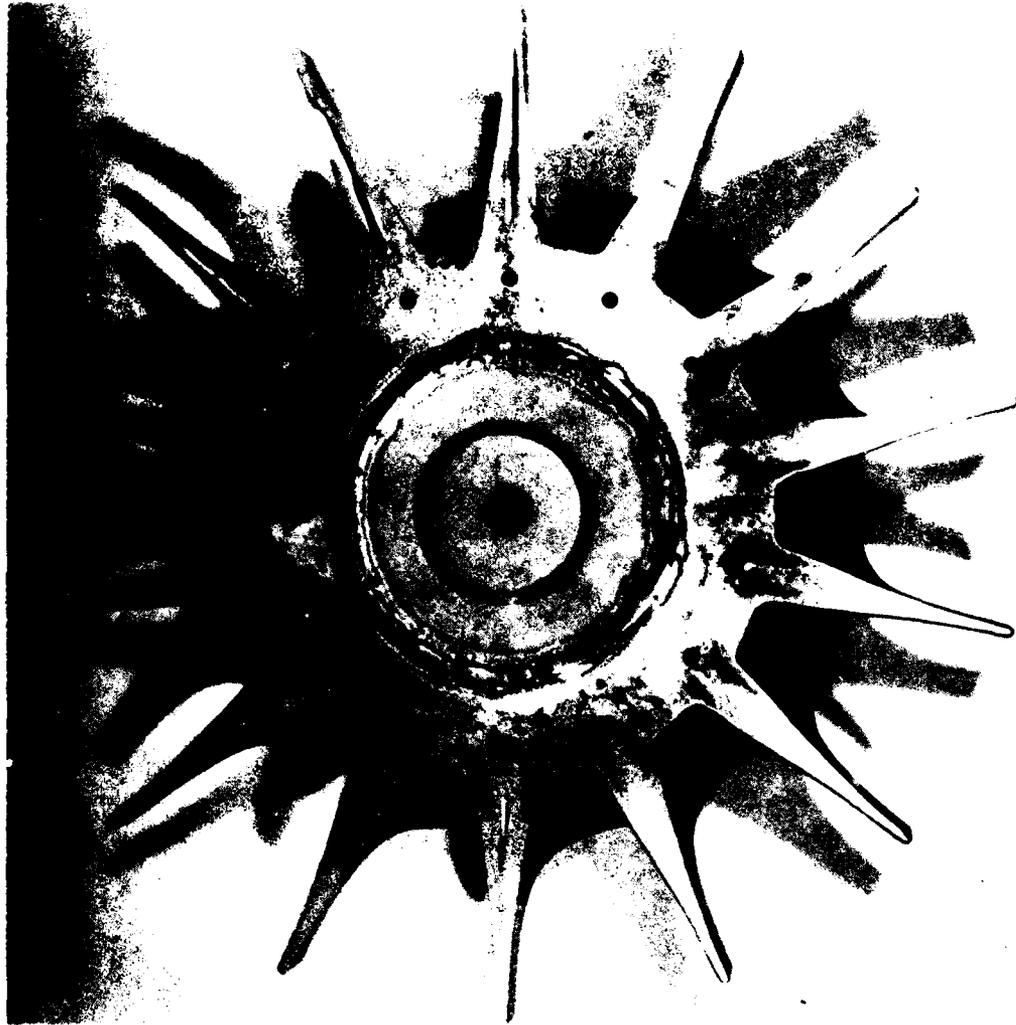
Figure 70. Braze sealed rotor assembly prior to HIP bonding.

The assembly details selected for the first HIP bonding trial received identical processing. Preparation of the rotor shell and plug details began with an outgas cycle (2100°F/1 hr/vacuum) to clean the mating surfaces. The shell was then heated to 450°F and the plug was cooled in liquid nitrogen (-320°F) to create a loose slip fit when the plug was inserted in the shell. An interference fit resulted when the detail temperatures were equalized. The exposed shell-to-plug interfaces were braze sealed with a boron-silicon modified Mar-M247 braze alloy as indicated in Figure 70. The following braze cycle was used in successive steps.

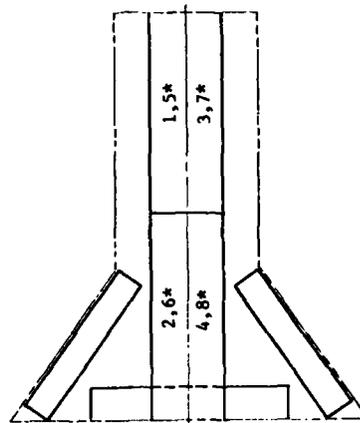
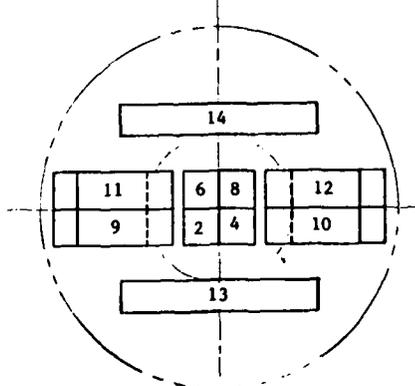
Figure 75. Joint specimen location.

side view

bottom view

After heat treatment, the PA101 plug as well as the two rotors were sectioned into blanks for testing as shown in Figures 75 and 76. In the case of the rotors, the bond joint was centered normal to the major axis of the blank and at the approximate mid-length so that half of the bar was Mar-M247 material and the other half was PA101. Following blanking (1 inch long by 1/4 inch square for the joint specimens and 1-1/2 inch long by 3/8 inch square for the parent metal PA101), the material was sent to Metcut Research Associates of Cincinnati, Ohio, for final machining and specimen testing. Accompanying this material for testing were the cast-to-size Mar-M247 test bars (heat 2741) which had been ground approximately 0.003 inch per surface in the gage area to remove a thin film (0.001 inch) of oxidation that developed during the HIP bonding cycle. (Chemistries and casting parameters for Mar-M247 heat 2741 as well as for the other Mar-M247 heat used in the program are summarized in Appendix B.)

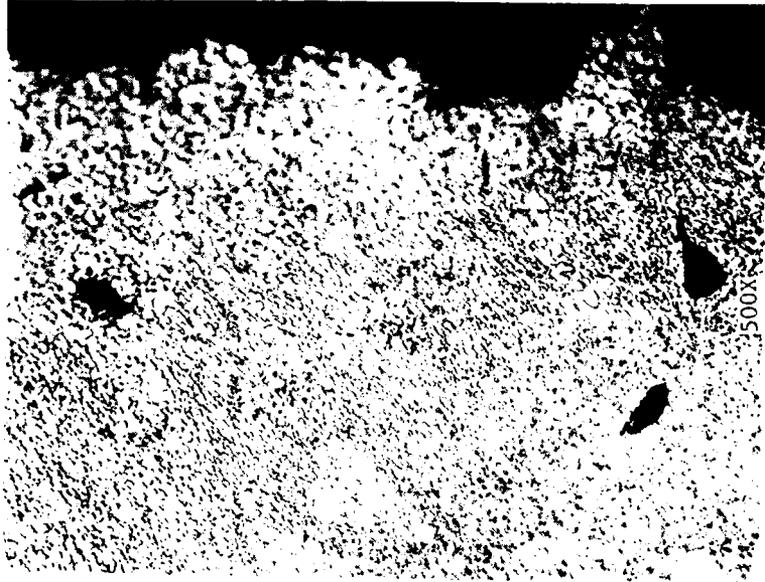
Figure 78. Fine microshrinkage associated with low ductility-
1400° F Mar-M247 stress rupture bar.

In the case of the Mar-M247 cast-to-size test bars, good properties were generally realized. However, in the case of testing at 1400°F, low life (one specimen) and ductility (two specimens) were observed; based on metallographic analysis (Figure 78), microshrinkage was found in the failure area, indicating a probable cause for the anomalies in performance. Overall, however, the results of testing performed on the HIP-bond processed Mar-M247 test bars revealed attractive levels of strength/temperature capability.

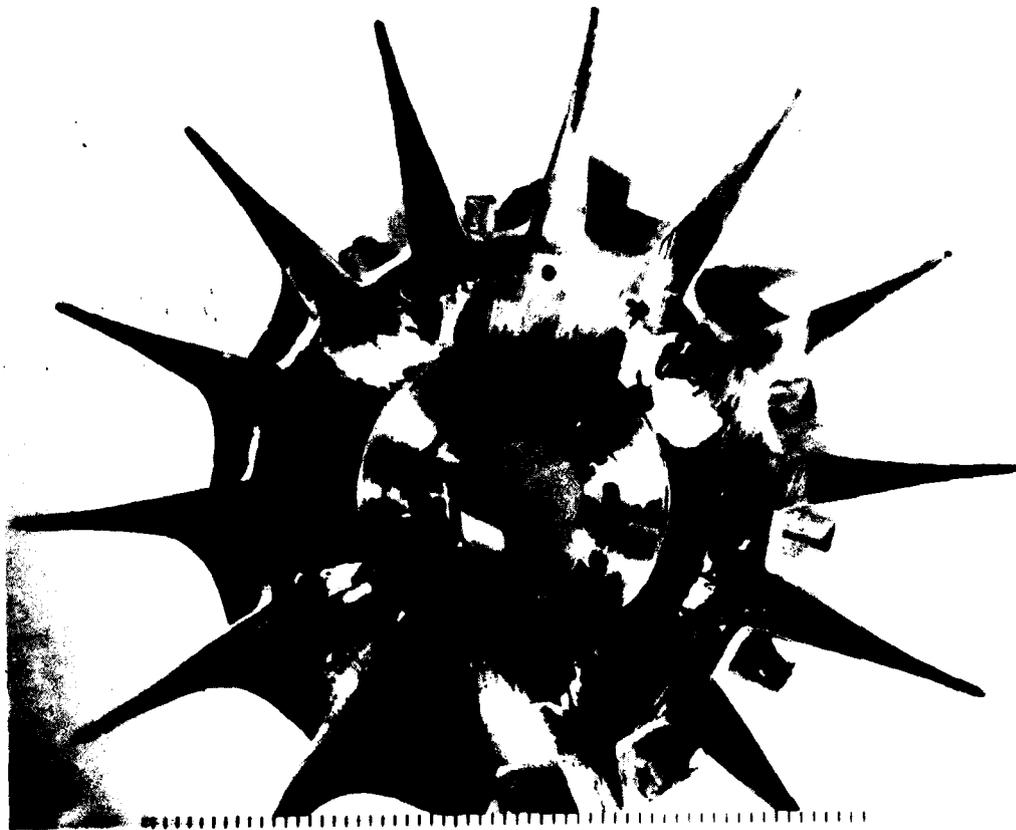
Figure 82. Rotor No. 4 rough machined showing three plugs prior to insertion into printouts.

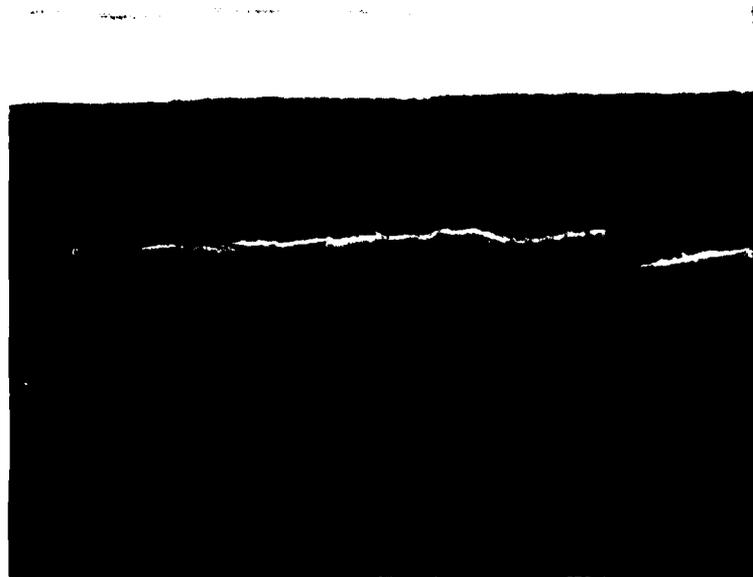
Figure 93. Cracking observed in circle generator electron beam welds.

In attempts to satisfy the requirements of the program for two groups of weld coupons (as-machined and vacuum outgassed bond surfaces), cracking in the Hastelloy S filler wire continued to be a problem which necessitated extensive repair to make the welds pressure tight. These cracking difficulties led to the application of a circle generator type of electron beam weld in which the beam is caused to oscillate in a circular fashion. This produces a wider but shallower weld and in tests on flat plates produced extremely promising crack-free welds. However, when this concept was applied to offset joints of the type being used for the bond specimens, gross center-line cracking through the length of the weld filler wire occurred as shown in Figure 93. Despite several attempts at modifying weld parameters, the promising welds developed on flat specimens could not be reproduced. Consequently, emphasis in the work reverted to the more conventional electron beam weld techniques in use at the beginning of the program.

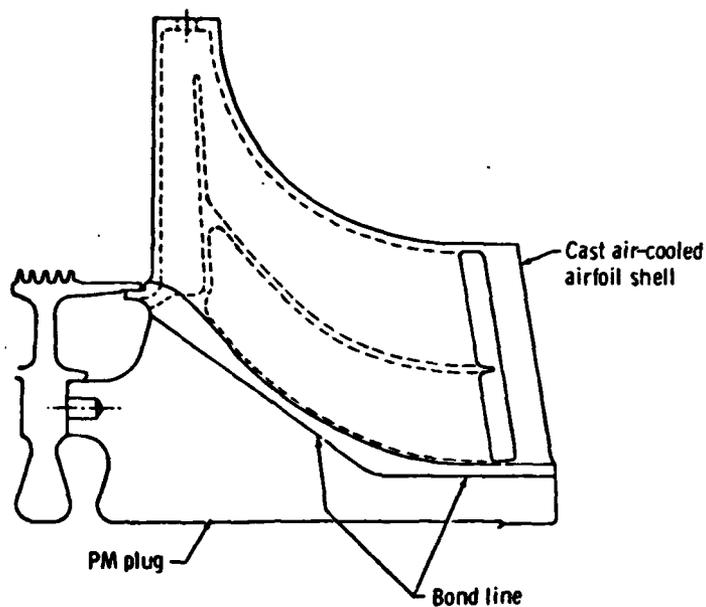
Figure 97. Schematic showing joint design for a HIP-bond processed air-cooled radial turbine wheel.

Because the air-cooled radial turbine rotor has a hollow bore, it was decided to inspect the bond interfaces by using a transducer positioned in the bore. The bond line configuration shown in Figure 97 was selected as having a good potential for ultrasonic inspection from the bore as well as for cost effective manufacture.

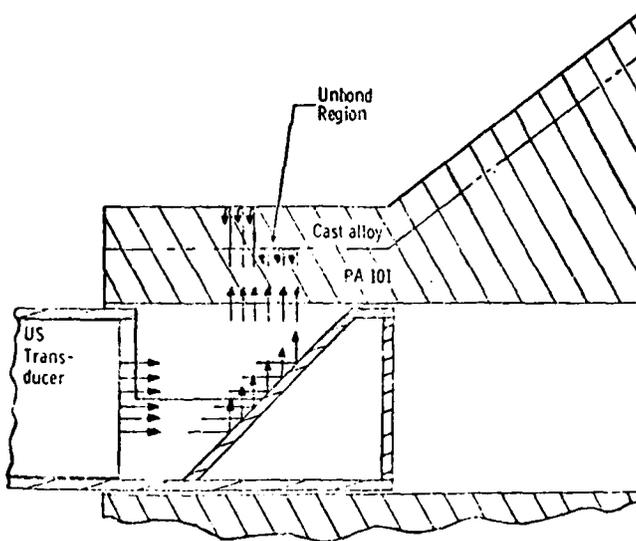
Figure 98. Test setup for the ultrasonic inspection of the cylindrical portion of a bond line.

Figure 98 shows a cross-sectional view of the portion of the test setup for cylindrical inspection. A pulse echo technique was used in which the ultrasonic transducer receives an electrical pulse which it converts to ultrasonic energy at its resonant frequency (10 MHz in this case). The ultrasonic energy is propagated through water into the wheel after a right-angle reflection from the beam reflector. (The ultrasonic beam is shown by the dotted lines.) The ultrasonic energy then propagates into the PM portion of the wheel until it reaches the interface with the cast alloy shell. In a case where the diffusion bond is incomplete so that an interface exists, the ultrasonic energy will be reflected as shown and return to the transducer by the same path. If the joint is well bonded,

the ultrasonic energy will continue into the cast alloy shell with very little reflection and travel to the free surface where it is scattered. A small portion will return along the previous path to the transducer. In this setup, the ultrasonic transducer converts the received signal into an electronic signal which is received by shaping and display electronics. Because of differences in metal path length, the return signals are time discriminated to determine if they were reflected from the bond interface or the wheel free surface. To fully inspect the cylindrical joint surfaces in this portion of a HIP-bond radial wheel, the wheel is rotated and the ultrasonic transducer is moved laterally to achieve a helical scan of the complete interface.

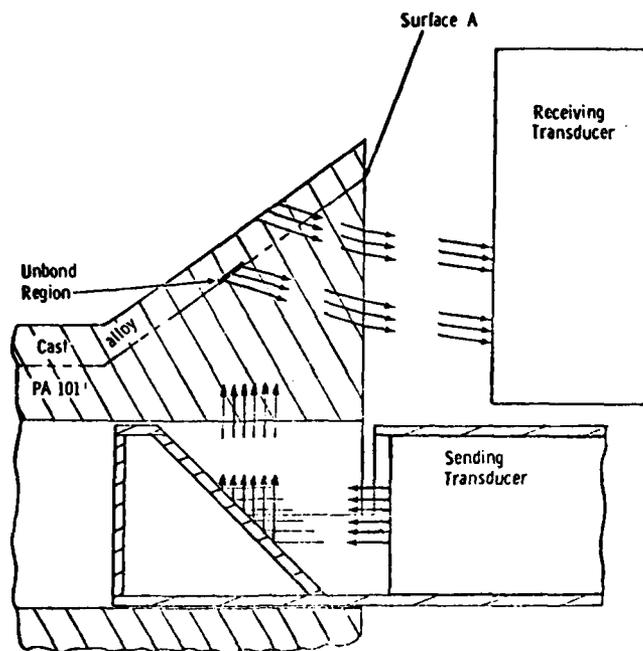
Figure 99. Test setup for the ultrasonic inspection of the conical portion of a bond line.

Figure 99 shows a cross-sectional view of the inspection setup for the conical portion of the HIP-bond radial turbine wheel. The inspection technique is referred to as through transmission or a "pitch and catch" technique. The electrical "transmit" pulse is converted to an ultrasonic burst by the transducer. Ultrasonic energy then travels through water into the wheel. The signal from either the defective interface or the part-free surface is then reflected at an angle equal to the incident angle to the 36° surface. Therefore, a second transducer with a broad area is used to receive the reflected energy and provide an electronic signal output to the shaping and display electronics. Because of the difference in sound path length, the bond joint reflection and free sur-

face reflection can be time discriminated. As in the inspection technique for the cylindrical bond portion of the wheel, a helical scan is used to cover the total conical surface interface.

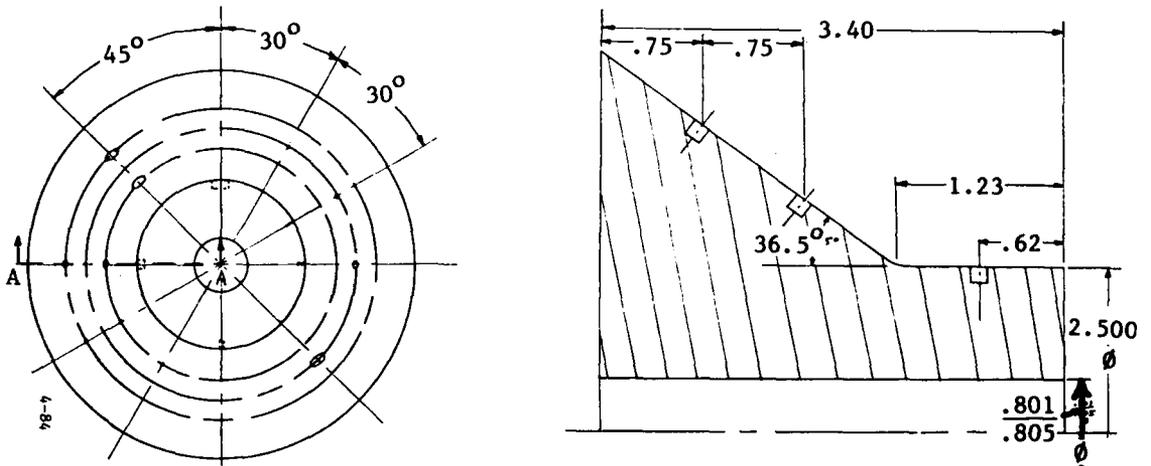
drill 4 each flat bottom holes in locations shown .125 in. deep; hole dia. are 1/4, 1/8, 1/16, 1/32, 1/64 in.

Figure 101. Resolution test piece sketch.

Once the transducers and instrumentation were adjusted, the positioning piece was carefully replaced with the resolution piece which contained flat-bottom holes drilled to a depth equivalent to the interface as shown in Figure 101. Ultrasonic inspection of this piece defined the smallest-diameter flat-bottom hole, simulating an unbond area which could be detected. Figure 102 shows the resolution test pieces for the stylized and full-scale design to illustrate relative size.

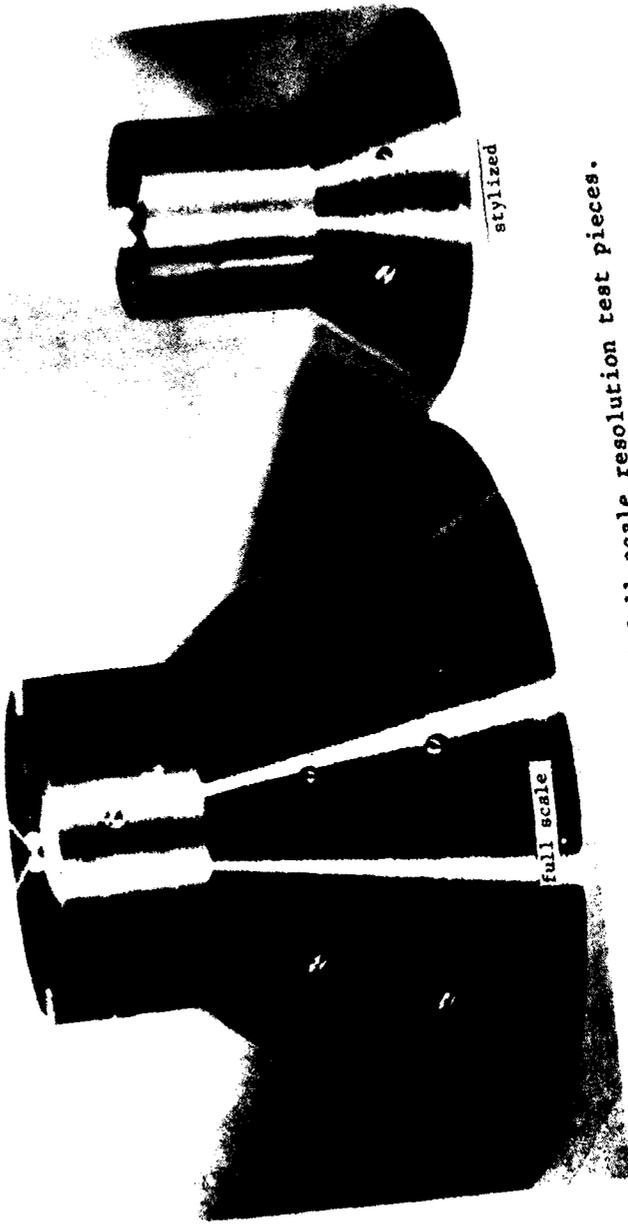
Figure 102. Stylized and full-scale resolution test pieces.

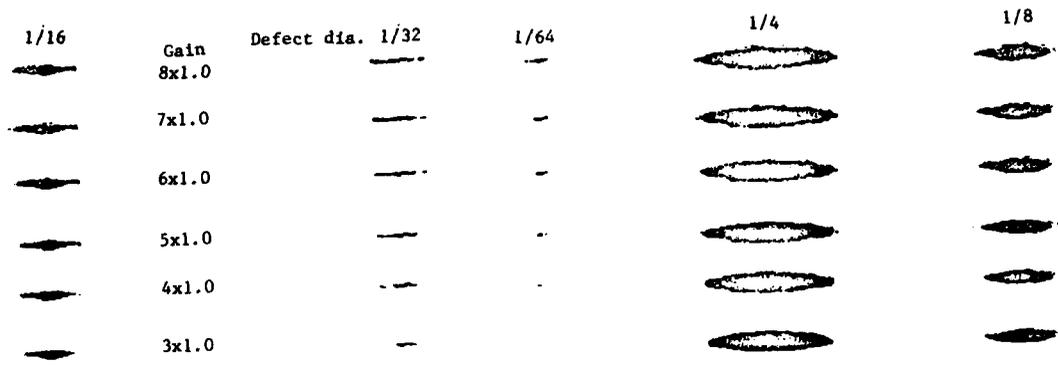
Figure 103. Resolution piece multiple C-scans with increasing gain for stylized cylindrical section.

During inspection, flat-bottom holes were electrically recorded from the ultrasonic signal received by the instrumentation. Paper width was synchronized with the rotating mechanism to show 360° rotation, and paper length was directly related to the linear transducer movement to produce a circumference versus length record. Figures 103 through 106 show the C-scan recordings of flat-bottom holes detected in each of the stylized and full-scale resolution test pieces. The recorded flat-bottom holes are elliptical because the 360° rotation represented by the recording is not, in general, scaled to that of the flat-bottom hole.

These test results show the relatively good detection capability of standard ultrasonic transducers; however, defect sensitivity decreases as configuration size increases. The finer resolving capability in the stylized cylindrical portion (1/64-inch-diameter flat-bottom hole) resulted from the use of a standard transducer which had focal length nearly optimized for this surface.

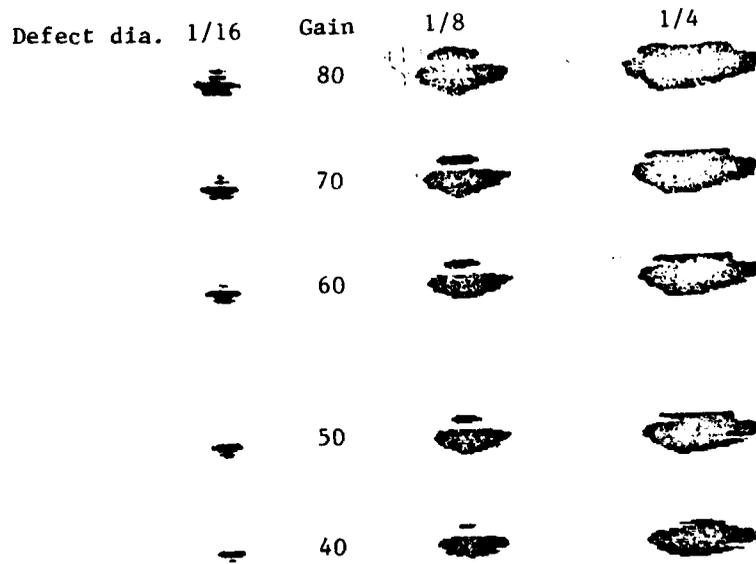
Figure 104. Resolution piece multiple C-scan record for stylized conical section.

During the inspection of the conical section of the stylized configurations, mismatch between focal length and the surface increased and sensitivity decreased. The mismatch was further increased in going to the larger full-scale design and sensitivity was further decreased. Thus, special or tailored transducers made to focus the ultrasonic energy at the interface surface are necessary to concentrate the beam in an optimized fashion so that defect sensitivity can be improved in the stylized conical portion and in both portions of the full-scale design.

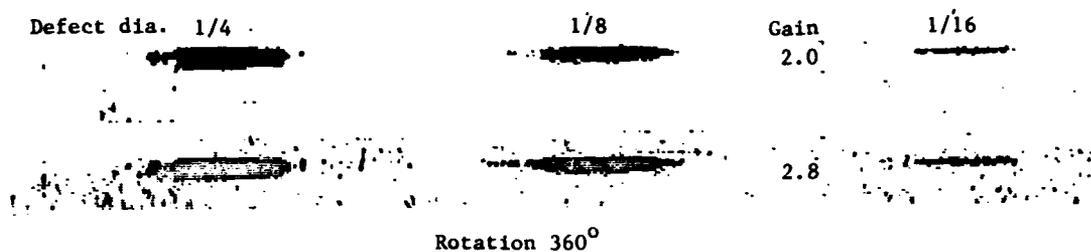
Figure 105. Resolution piece multiple C-scan record for full-scale cylindrical section.

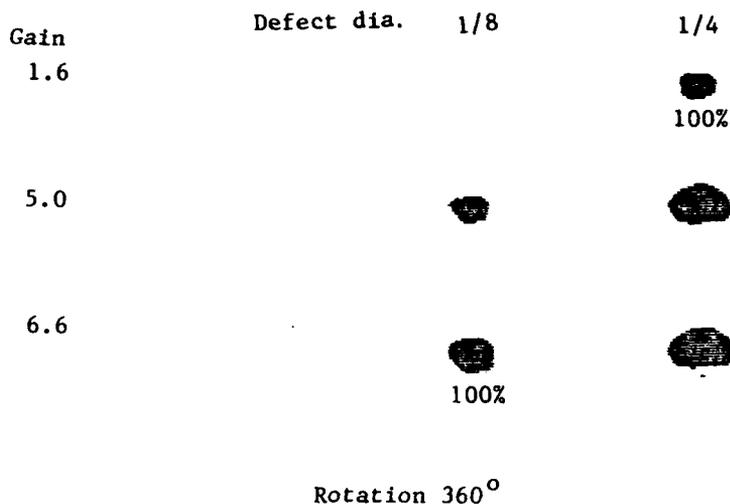
Figure 106. Resolution piece multiple C-scan record for full-scale conical section.

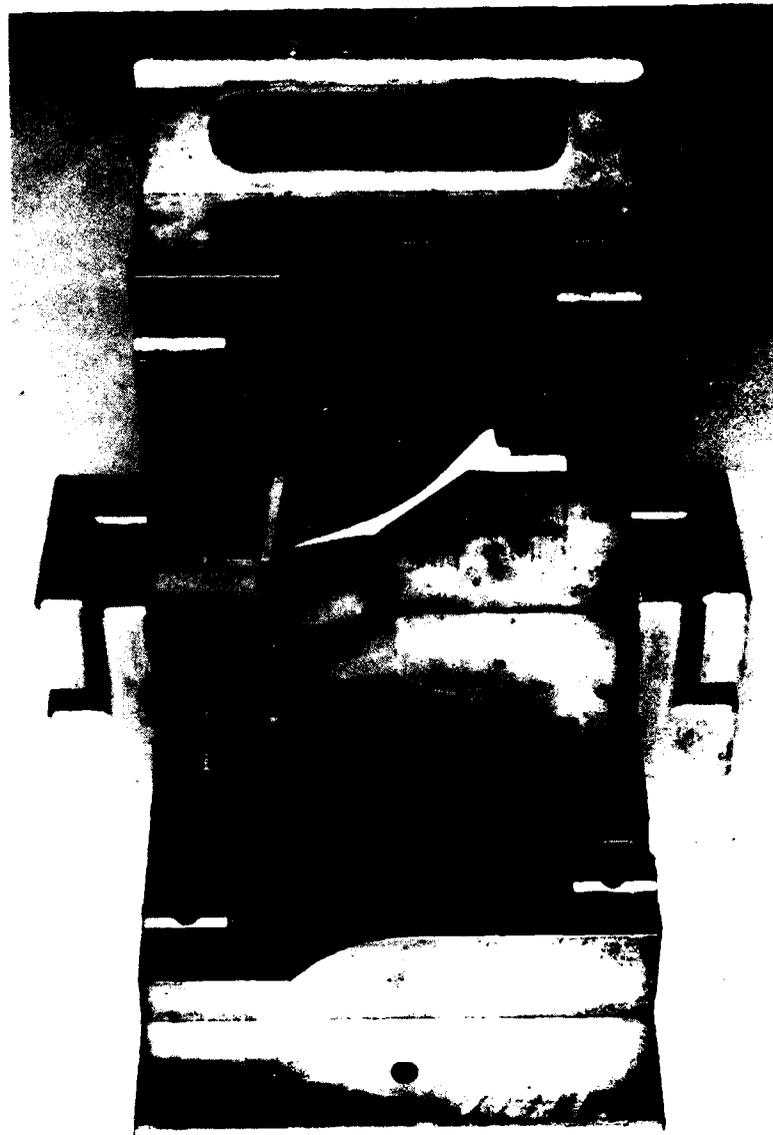
Figure 108. Core die and resultant core for an air-cooled HTRT airfoil shell.

These features were included in the full-scale tooling, which consisted of a ceramic core die, core setter dies for core curing, a wax airfoil die, and an assembly fixture. These tools are shown in Figures 107 through 109.

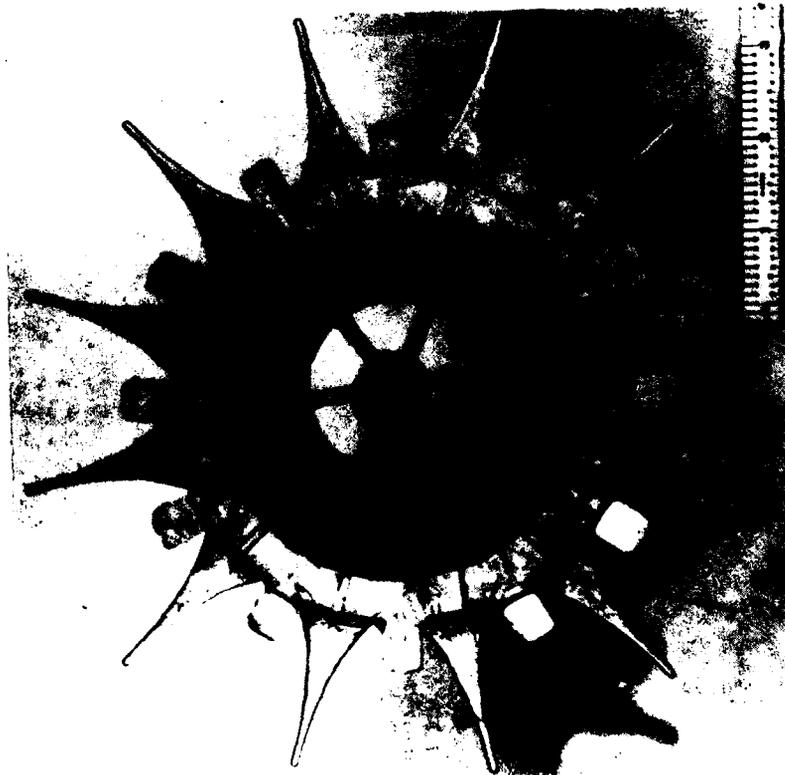
Figure 118. Full-scale HTRT casting No. 2 (downstream view).

The overall casting quality was generally good--specifically, the surface finish was good (no dirt, fins, or roughness); however, there was evidence of "heat wrinkling" as a result of the airfoils in the rib area. The grain structure is shown in Figures 117 and 118. Grain size was generally 1/8 to 1/4 in. equiaxed with some columnar grain originating at the exducer core print and areas of powder fine grain at the extreme airfoil tips and at the cold folds.

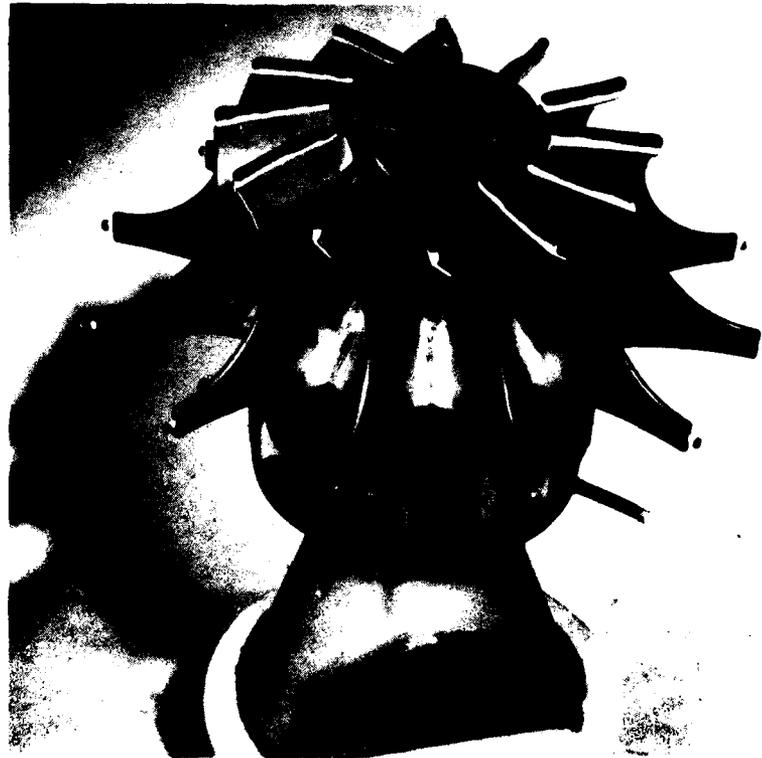
Figure 120. Oblique view of wax pattern and gating assembly for HTRT casting No. 3, showing exducer feed gates (inverted position).

exducer section to feed twelve radial gates as shown in Figure 120. The philosophy behind this gating design was to fill more from the bottom and to reduce the flow pressure on the concave side of the core.

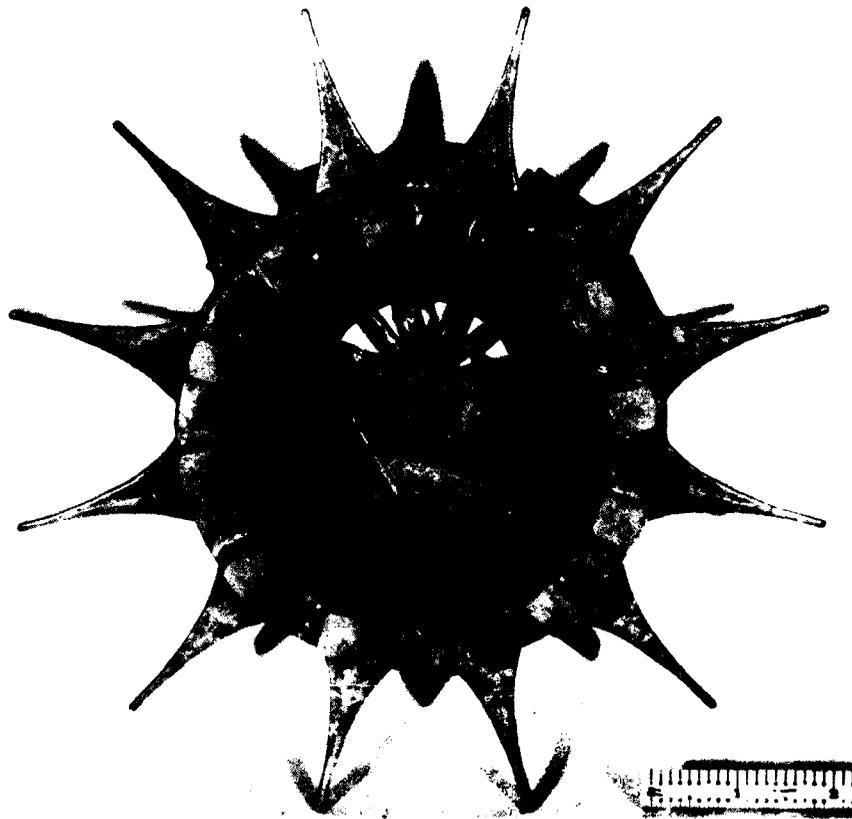
Figure 121. Ingates, tapered downpole, exducer gates, and ID grain size in HTRT casting No. 3.

The back side of the rotor casting is presented in Figure 121 which shows the gating modifications, i.e., gates shifted over the convex side of the airfoil, tapered center downpole, and exducer gates to each airfoil. This photograph also shows the equiaxed and uniform grain structure on the ID of the casting. Figure 122 shows the airfoil grain structure which is exceptionally uniform and fine considering the extremely high mold preheat (2050°F) and pouring temperatures (2950°F).

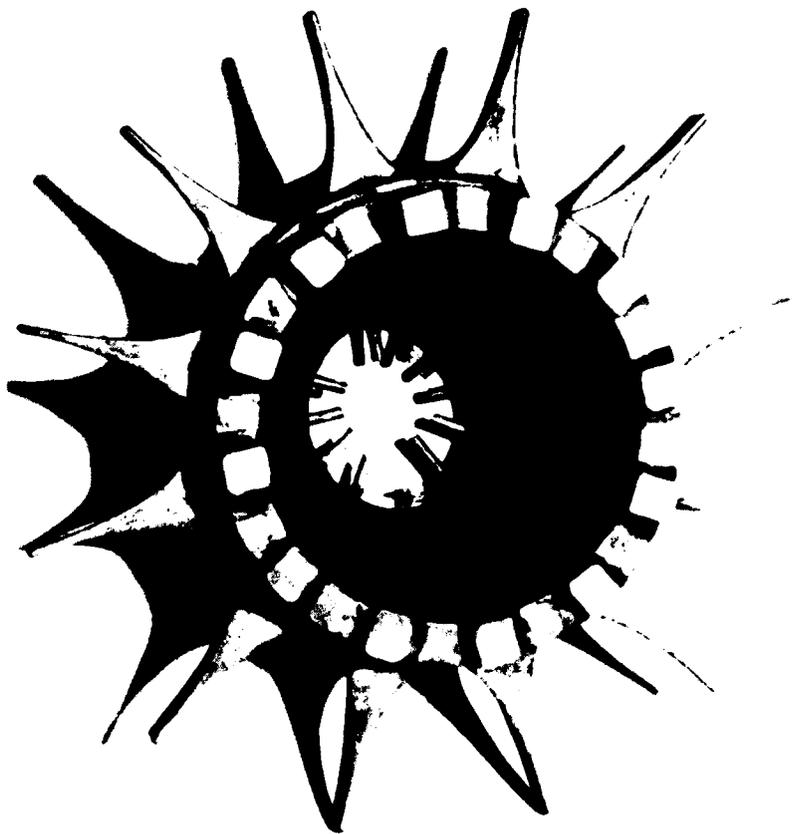
Figure 123. Casting No. 4 with area of shrinkage.

With core stability difficulties resolved by gating modifications, three additional castings were produced to the same parameters as used for rotor No. 3. In each case, the core stability and resultant airfoil wall quality was excellent, and no further difficulties with core printout were encountered. However, shrinkage was observed in the conical section of the bore of casting No. 4 as shown in Figure 123. This was caused by a small mold leak as indicated by a metal deposit in the cylindrical bore at the four o'clock position.
