HIGH-TEMPERATURE RADIAL TURBINE DEMONSTRATION.(U)

HIGH-TEMPERATURE RADIAL TURBINE DEMONSTRATION

Donald S. Monson, B. A. Ewing
DETROIT DIESEL ALLISON DIVISION
General Motors Corporation
Box 894
Indianapolis, Ind. 46206

Final Report for Period 15 June 1977 - 15 November 1979

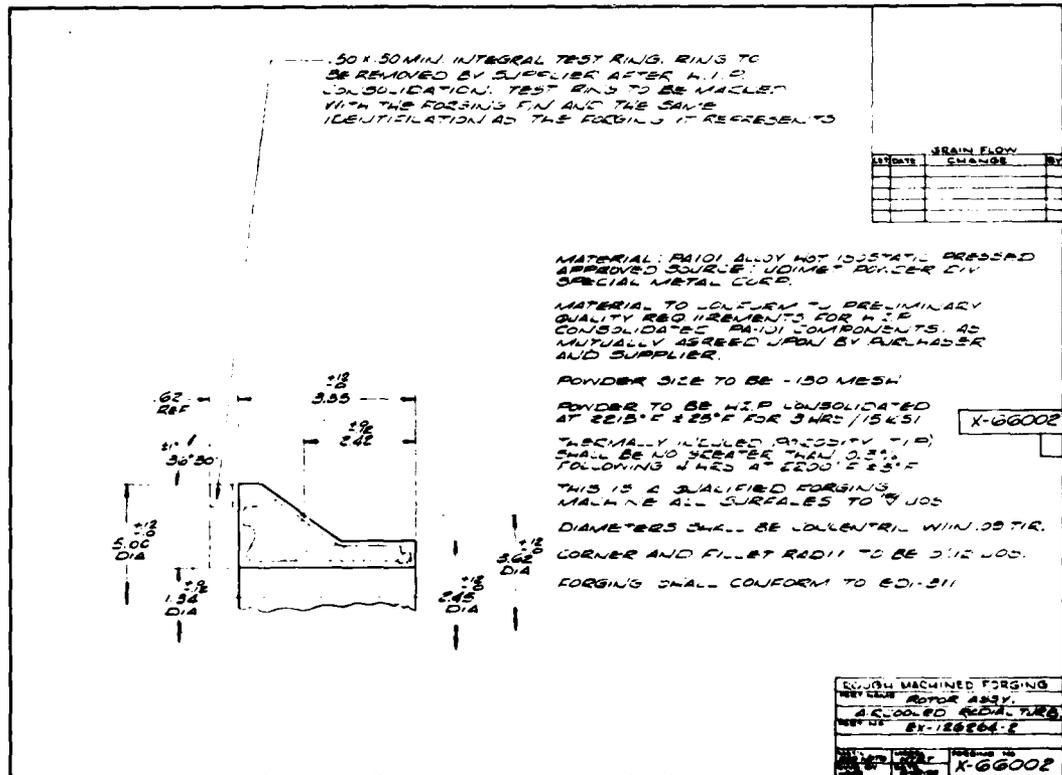
Figure 124. Schematic of a full-scale PA101 plug detail for HTRT rotors.

The near-shape PA101 plugs for the full-scale HTRT rotors were procured from the Udimet Powder Metals Division of the Special Metals Corporation, Ann Arbor, Michigan. The plugs, shown schematically in Figure 124, were produced from argon-atomized powder by direct HIP metal can consolidation techniques. The design emphasized near shape to minimize machining time. In general, the consolidation practice used for the full-scale plugs was equivalent to that used for the stylized plugs in the Phase I effort. However, in terms of mesh size, the full-scale plugs were produced from -150 mesh powder as opposed to the -60 mesh powder utilized for the stylized plugs. This was done in an attempt to minimize the incidence of ceramic inclusions in the final product and was based on industry experience and trends that were not available at the beginning of the Phase I effort.

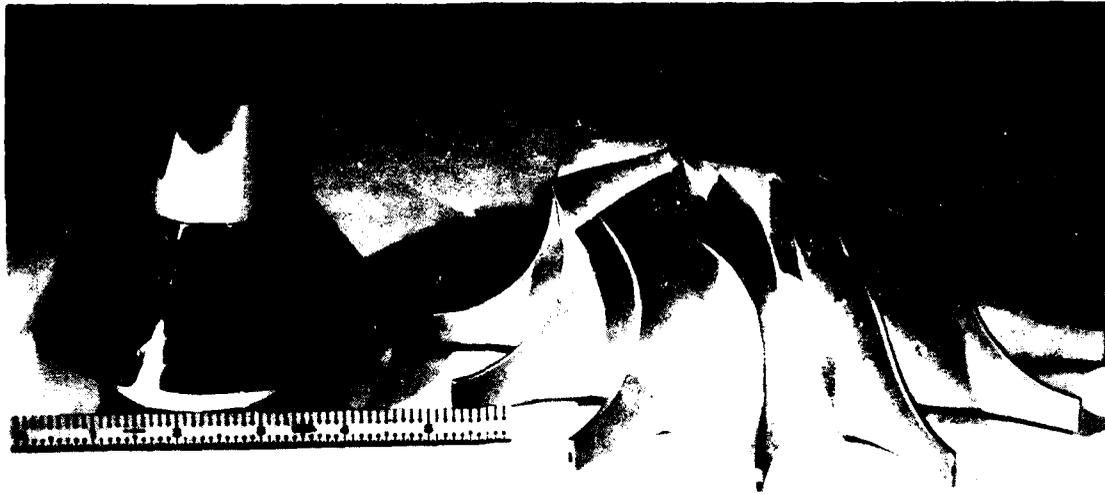
Figure 127. Machined details prior to assembly (Rotor 1).

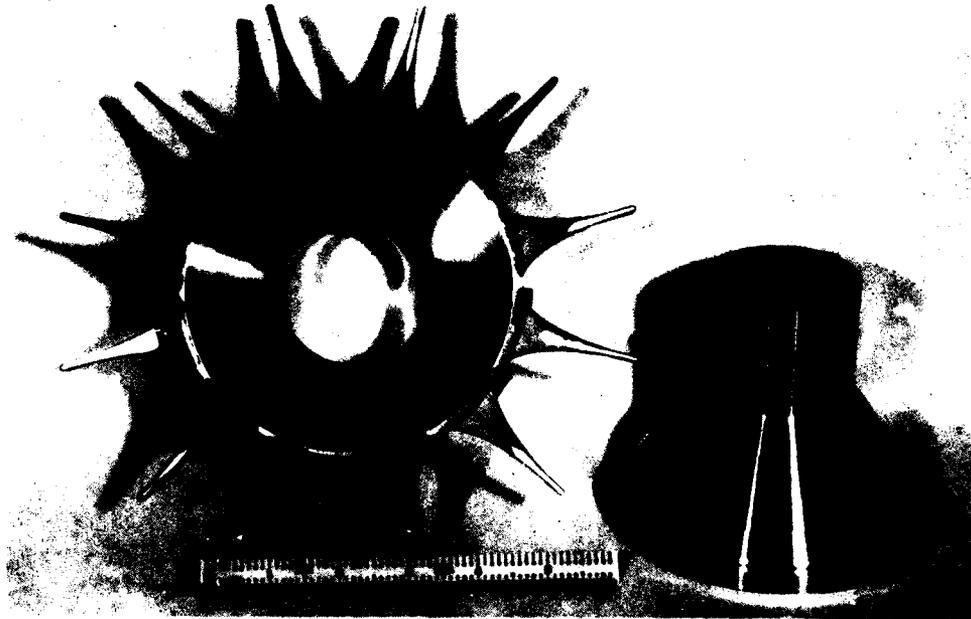
Figure 133. Machined shell and hub detail for rotor assembly No. 3.

This rotor incorporated a modified rear conical joint design with a flange built into the PM hub to prevent braze spalling (Figure 133). After a braze seal cycle, in which the heating rate from 1900°F to the melting range of the braze alloy was approximately half that used for assemblies No. 1 and 2 (20°F versus 8°F per minute), the rotor was successfully leak checked. Significantly, the flange eliminated the alloy powder spalling problem experienced for assemblies No. 1 and 2. However, some questionable porosity after the first braze cycle in the conical location prompted the decision to braze a second time to maximize the probabilities for success.

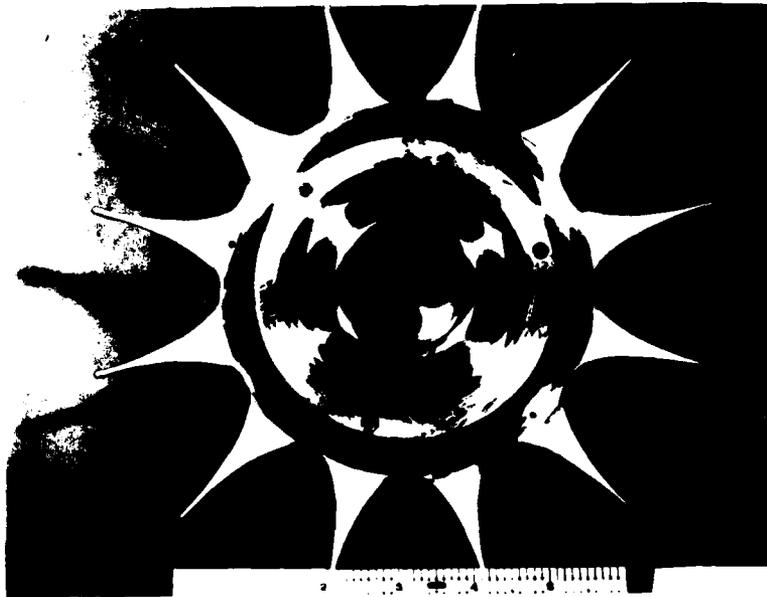
Figure 134. Forward face of finish-machined HTRT rotor assembly showing retention scheme.

Following braze sealing, the rotor was HIP bonded and, upon subsequent ultrasonic inspection, proclaimed to be sound. After heat treatment, rotor No. 3 was finish machined. Figures 134 through 136 show the rotor after machining.

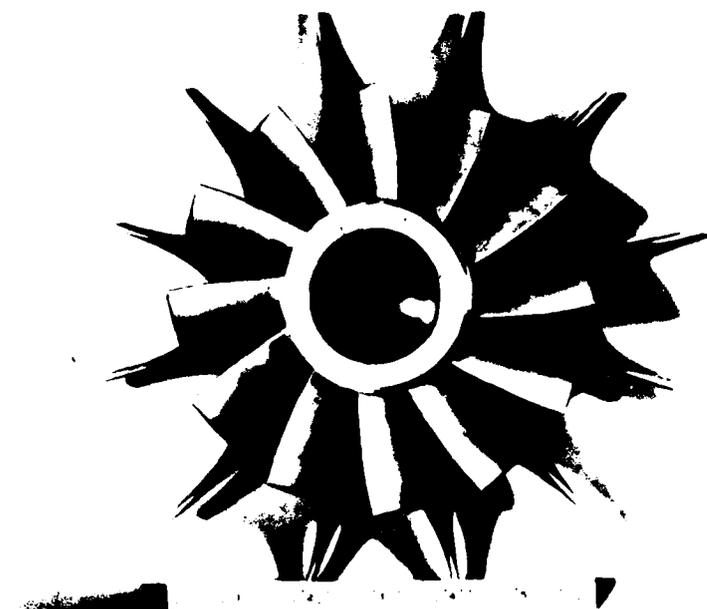
Figure 135. Aft (exducer) face of HTRT rotor assembly.

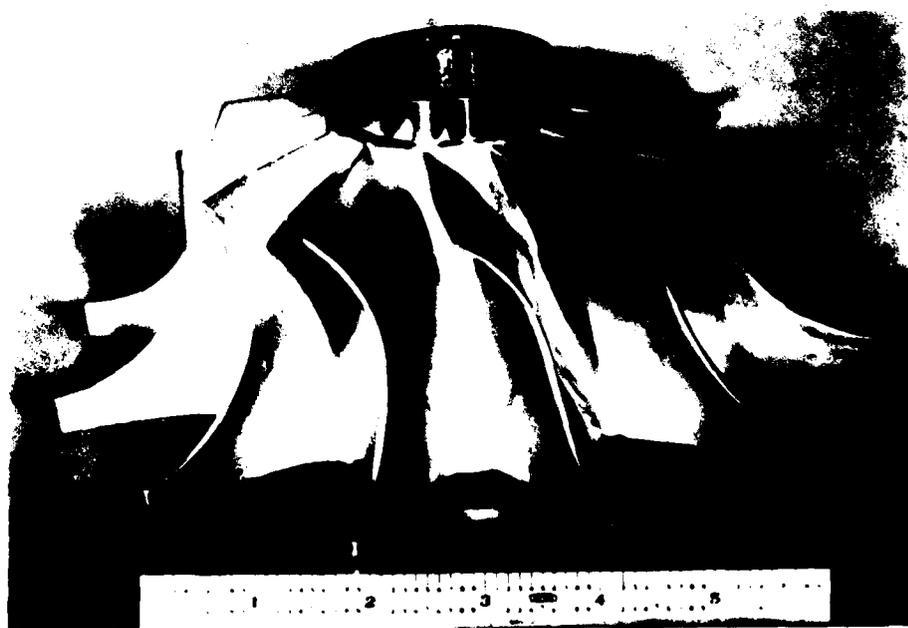
Figure 136. Side view of finish-machined HTRT rotor assembly.

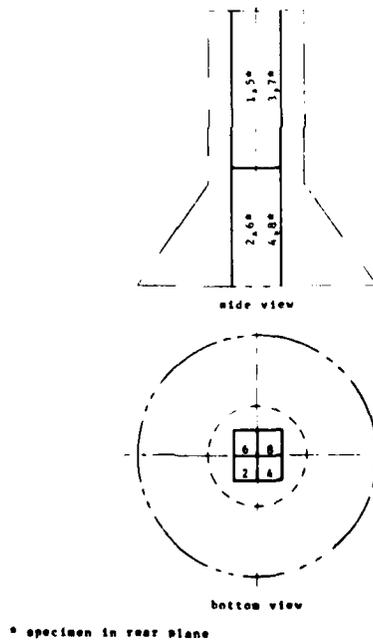
Figure 137. Specimen location for PA101 hubs.

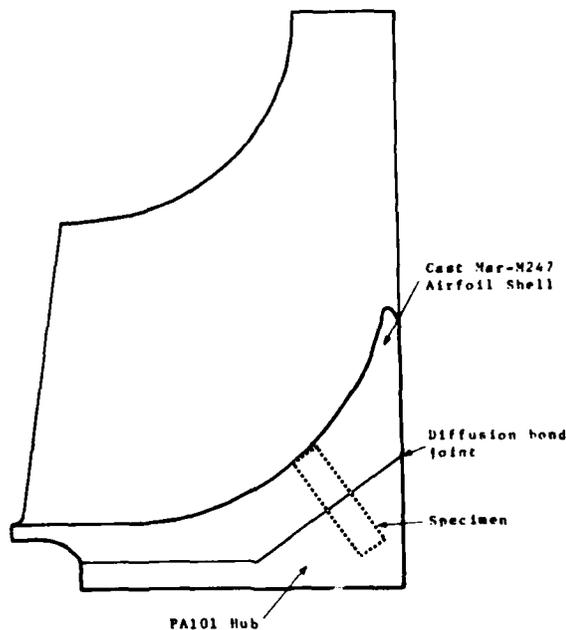
Figure 138. Specimen location for stylized rotors.

As shown in the test schedule (Table 16), 1200°F tensile, low cycle fatigue, and stress rupture testing was performed on butt type specimens that were removed normal to the bond line in the conical portion of stylized rotors No. 5 and 6.

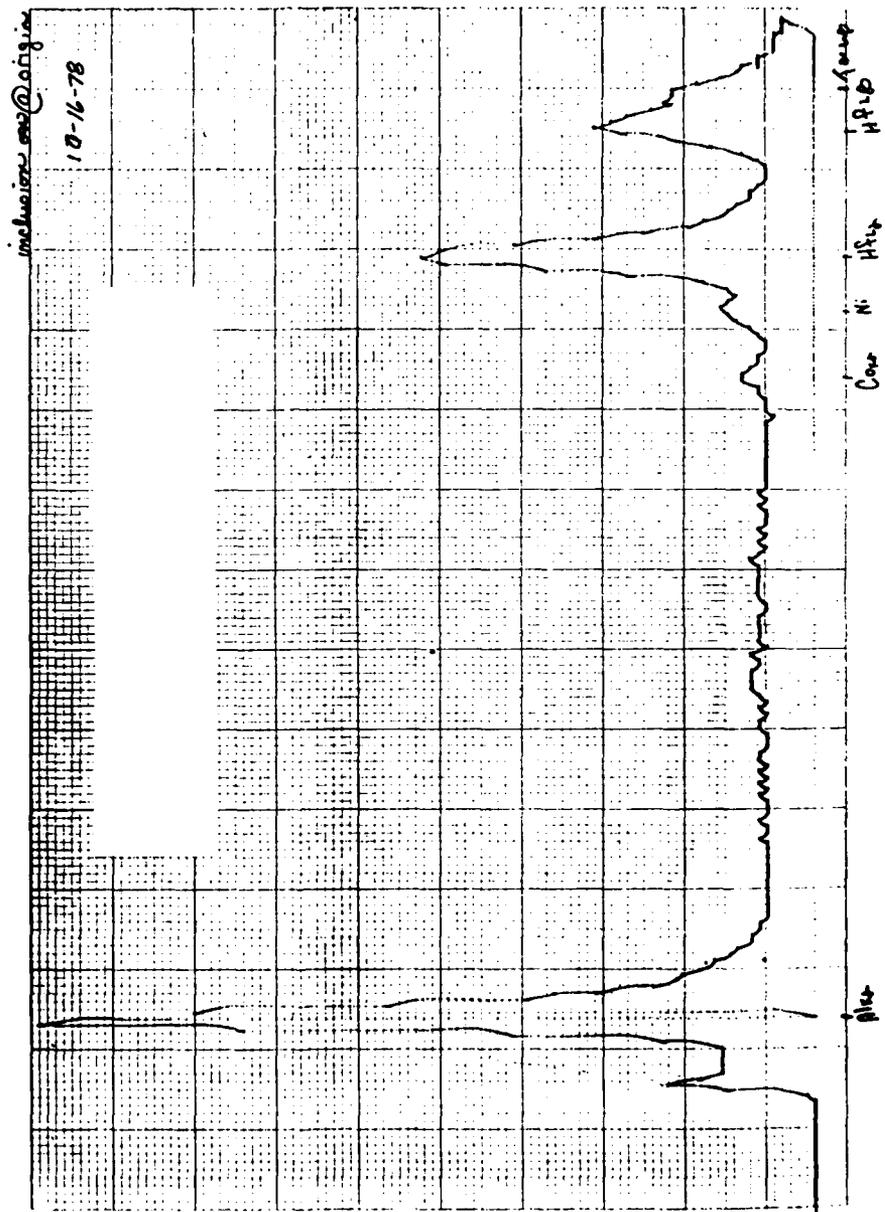
Figure 141. Analysis of inclusion in Figure 140 showing it to be aluminum-hafnium rich.

presence of inclusions. An EDAX analysis (Figure 141) of the pictured inclusion indicated that the inclusions were aluminum-hafnium rich and that they probably originated during the powder manufacturing process as a result of erosion of the ceramic nozzles which are used to atomize the PA101 alloy. In one long life case (Figure 142), the failure origin appeared to be a subsurface pore which was apparently caused by an argon-induced hollow powder particle. The use of a -150 mesh product in the full-scale rotors (the stylized PM product represented by these results was -60 mesh) should decrease the incidence of inclusions in future rotor configurations. Nevertheless, the threat of inclusion contamination in the PA101 alloy seems to be real, as others have experienced with AF95. The powder manufacturers, however, have recognized this threat and are moving aggressively to minimize it. Future PA101 procurement is expected to benefit significantly as a result.

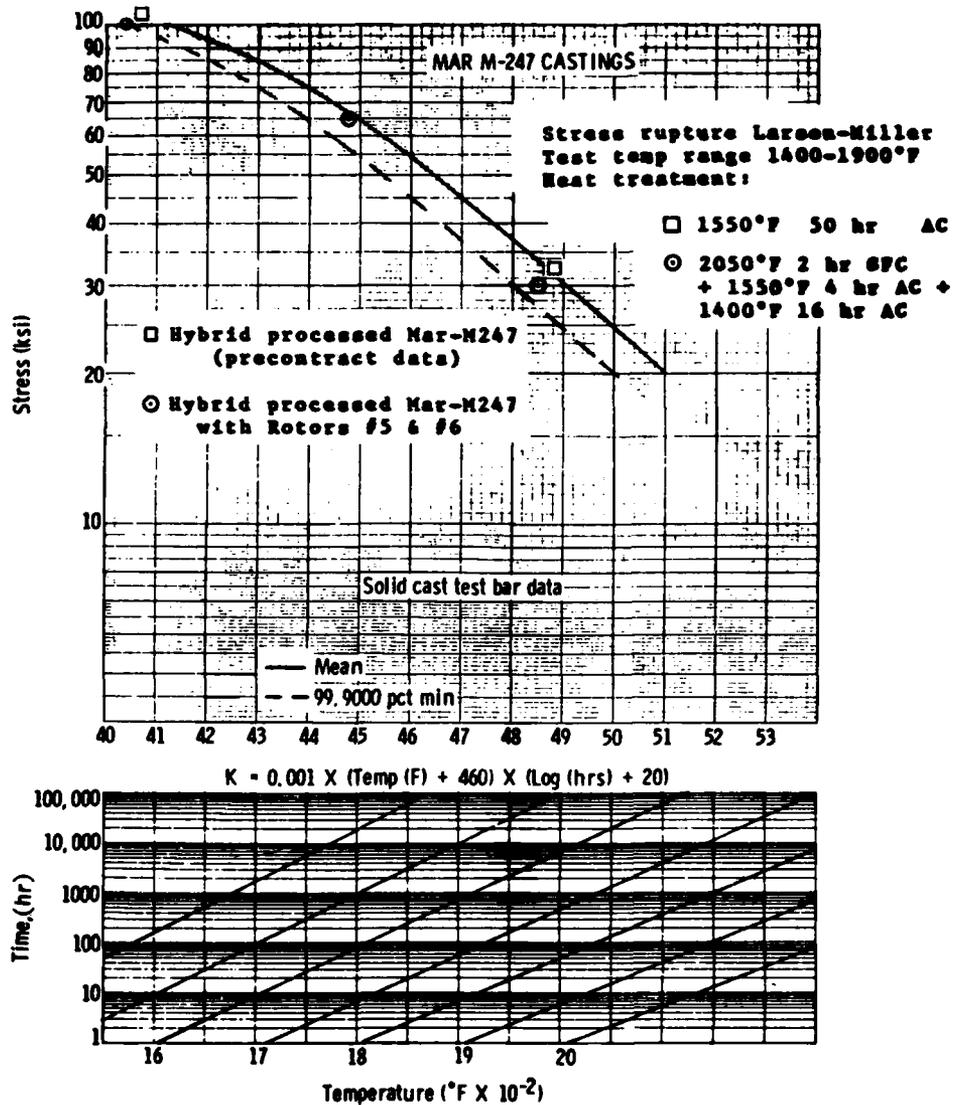
Figure 143. Comparison of hybrid processed Mar-M247 cast-to-size bars (processed with rotors No. 5 and No. 6) and non-HIP-bond-processed (baseline) cast-to-size Mar-M247.

Creep rupture, stress rupture, and room temperature results generated for cast-to-size test bars processed to hybrid schedules are presented in Table 19. Overall rupture properties, as shown in Figure 143, appear to be adequate for the HTRT design. However, 1400°F rupture lives and ductilities appear to be on the low side of those desirable. Residual microshrinkage of the type noted previously appeared to be a significant influencing factor.

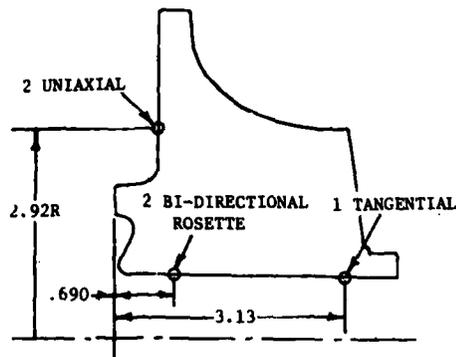
Figure 145. Strain gage locations.

Five strain gages were installed on rotor assembly number 3 at the locations shown in Figure 145. In addition, thermocouples were located adjacent to the strain gages to allow correction of the strain gage output. Prior to the spin test, an apparent strain calibration was run on each from room temperature up to 250°F.

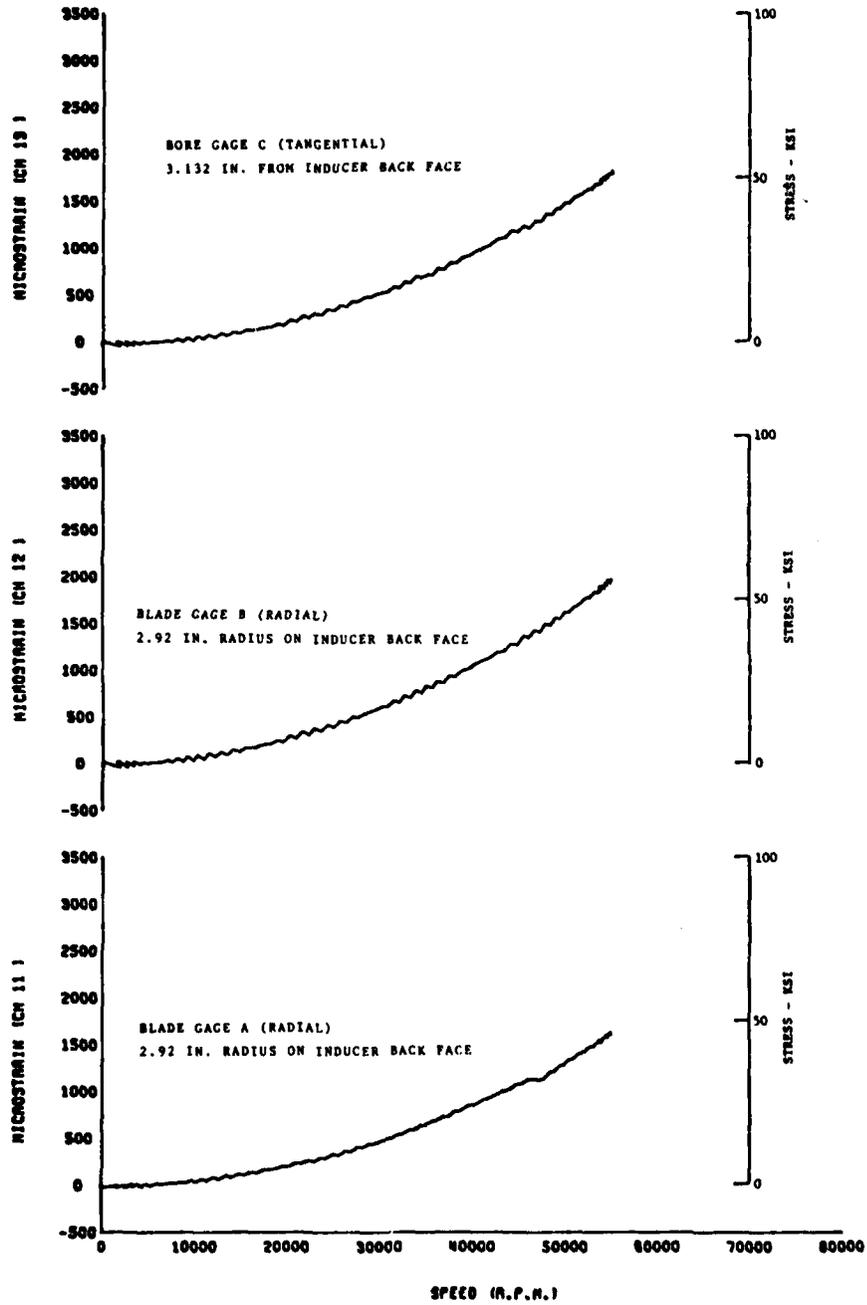
RUN 1

Figure 146. Microstrain and stress versus speed.

The test method used was to accelerate slowly to design speed and record microstrain and temperature at the strain gages. Test results, which are compensated for temperature, are presented in terms of microstrain and stress versus rotor speed in Figures 146 and 147. Excellent agreement was obtained between predicted cold and actual cold stresses as indicated on Table 20. Also shown on Table 20 are the predicted hot gradient stresses.

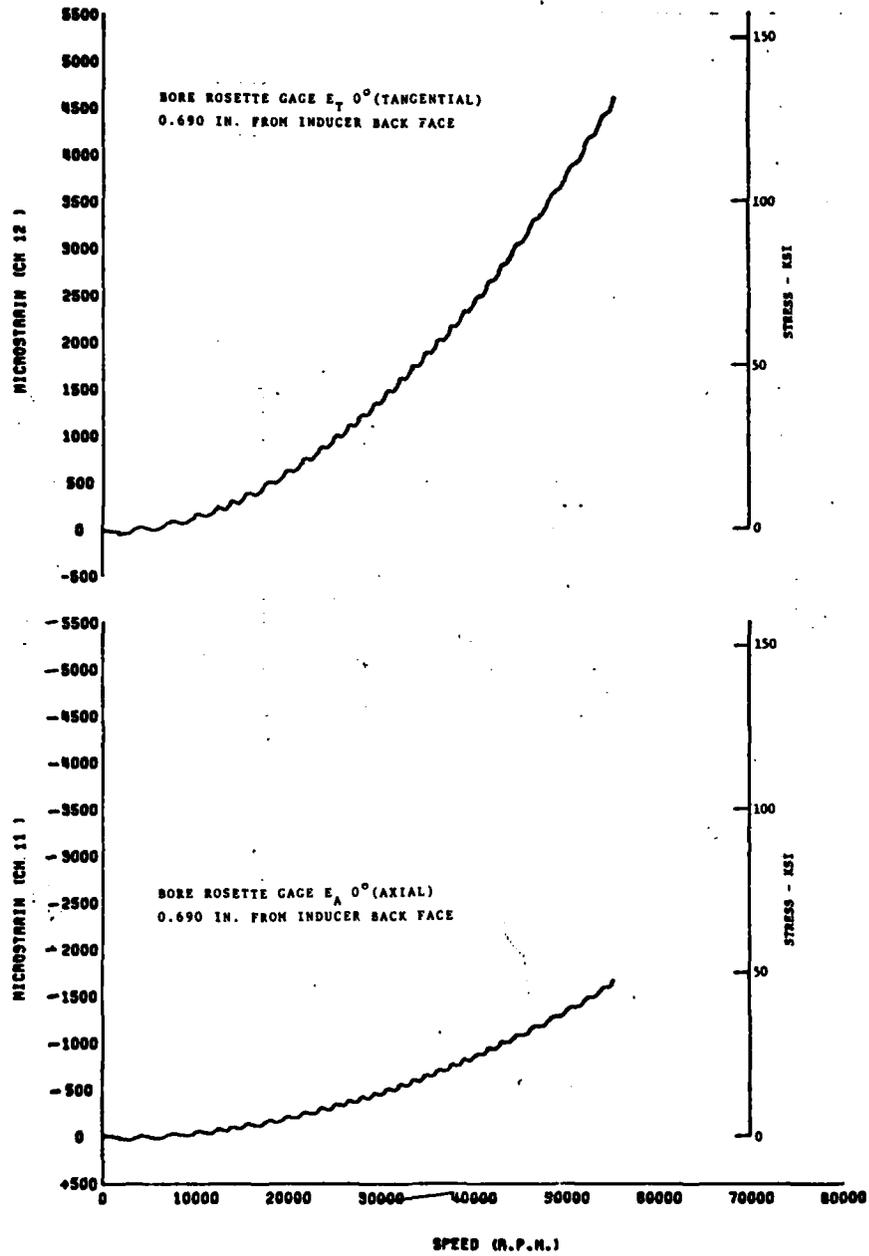
HIGH TEMP. RADIAL TURBINE SPIN TEST
RUN 2.

Figure 147. Microstrain and stress versus speed.

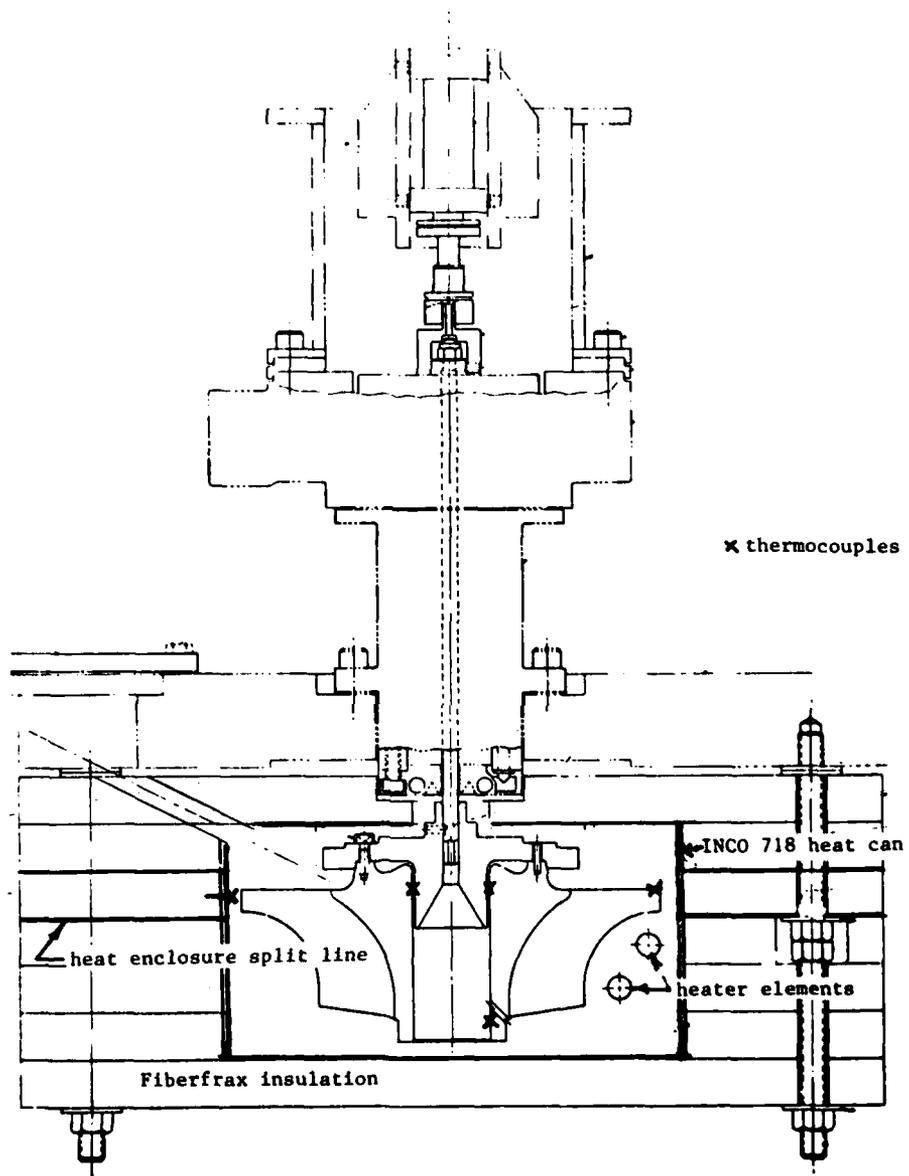
Figure 148. Heat enclosure configuration.

Prior to initiating the elevated temperature low cycle fatigue test a temperature correlation and spin pit shakedown run were conducted. Some difficulties were encountered with erosion of the heat enclosure. This problem was resolved by installing a heat enclosure liner or can of INCO 718 as shown in Figure 148.

Also shown on Figure 148 are the locations of the temperature correlation thermocouples. During the low cycle fatigue test the metal temperature was to be controlled to 1100°F at the bore or 1500°F on the blade tip on a not-to-exceed basis for each position.

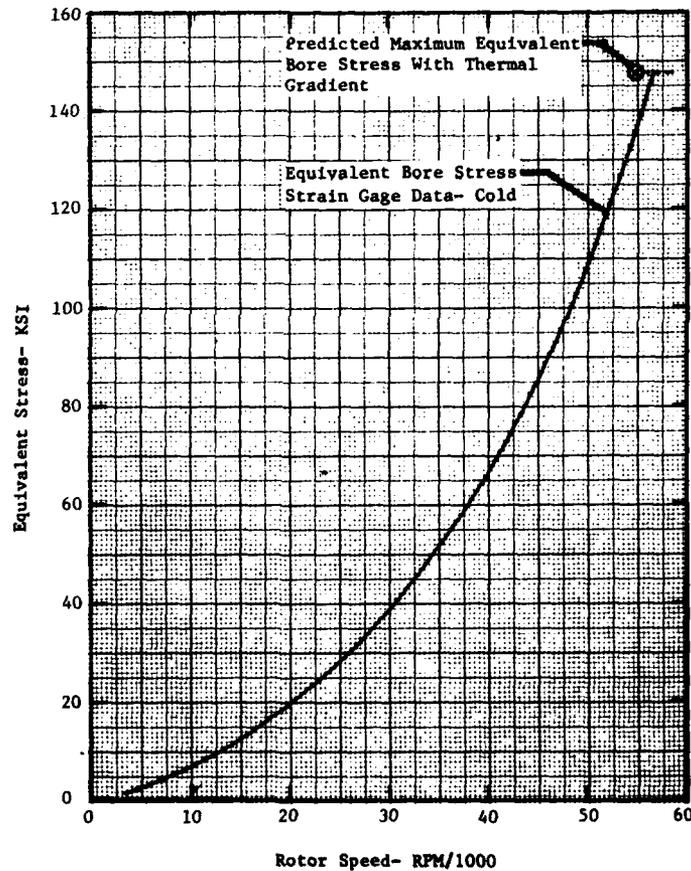
Figure 149. Equivalent bore stress versus speed.

In order to compensate for the lack of thermal gradient, the maximum cycle speed was increased from 55,000 to 57,000 rpm. Figure 149 shows that nonthermal gradient and thermal gradient maximum bore stresses match at this speed.

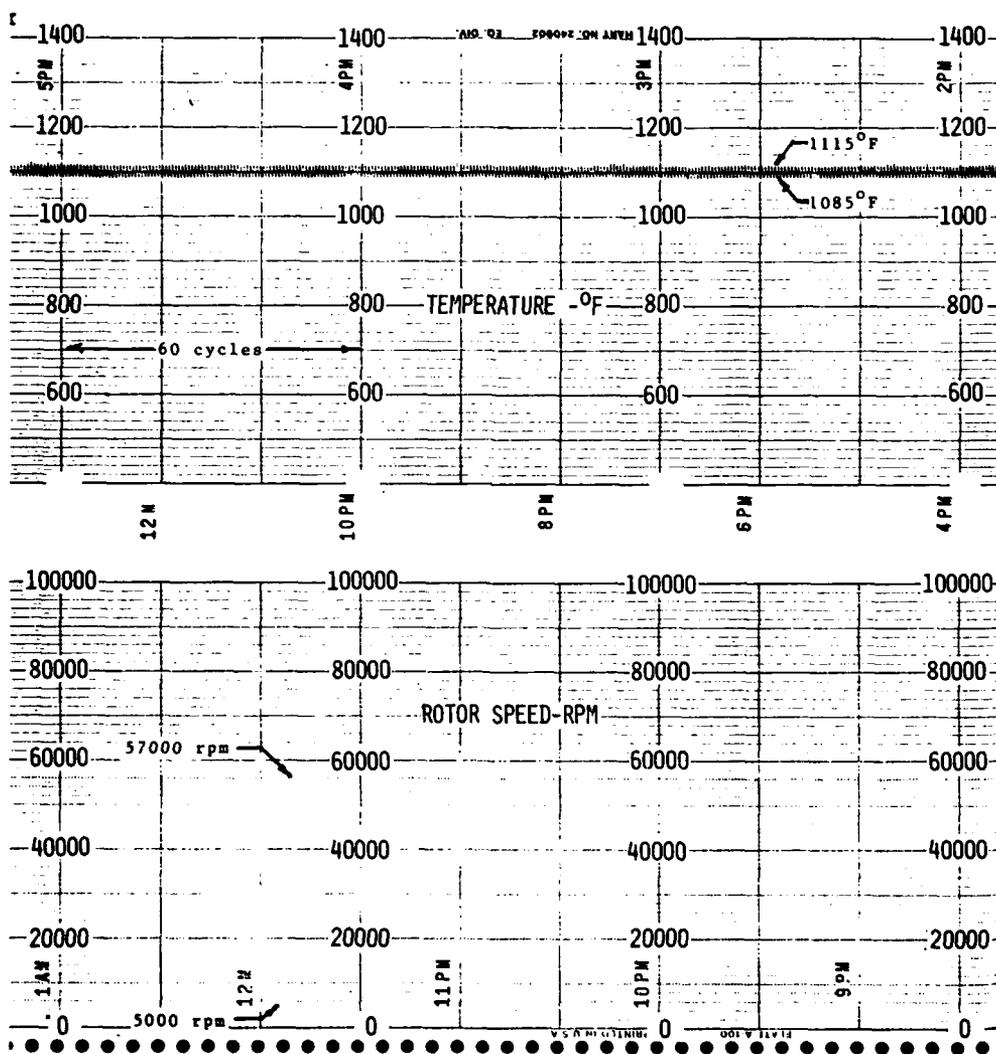
Figure 150. Elevated temperature low cycle fatigue test time-speed-temperature sample record.

Continuous recordings of speed and temperature were obtained. Figure 150 is such a record showing that the rotor was cycled between 5000 and 57,000 rpm in 55 sec. This figure also shows that the average temperature of 1100°F was maintained with a peak temperature of 1115°F at maximum speed and a minimum temperature of 1085°F at minimum speed. This fluctuation was a result of windage effects, even though the test chamber pressure was reduced to 2 mm Hg absolute.

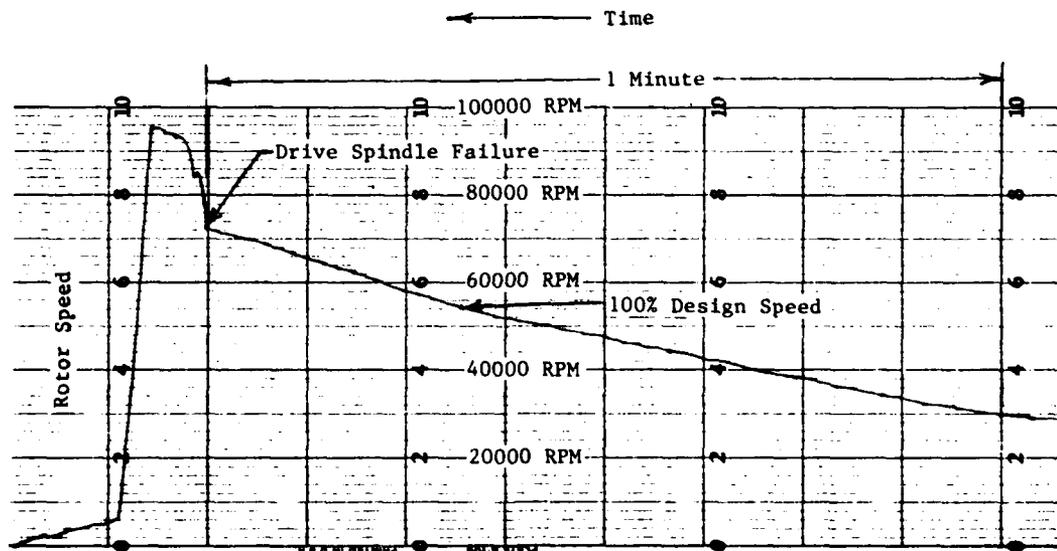
Figure 151. Attempted HTRT rotor burst.

The test was conducted by increasing rotor speed slowly until burst occurred. Figure 151 presents the speed versus time trace taken during this test. At 72,000 rpm, a failure (which is indicated by a sharp increase in the acceleration rate of the drive turbine) occurred. Inspection of the pit after the failure revealed that the rotor was intact with the exception that considerable impact damage had occurred on the blade tips as shown on Figure 152. It was also found that the spin adapter (Figure 153) and the rotor assembly (Figure 154) had separated. Examination of Figure 154 shows that the three cap screws holding the two components together were failed. It is believed that the drive spindle failed, dropping the rotor, and that the two pieces were separated on impact with the spin pit liner.

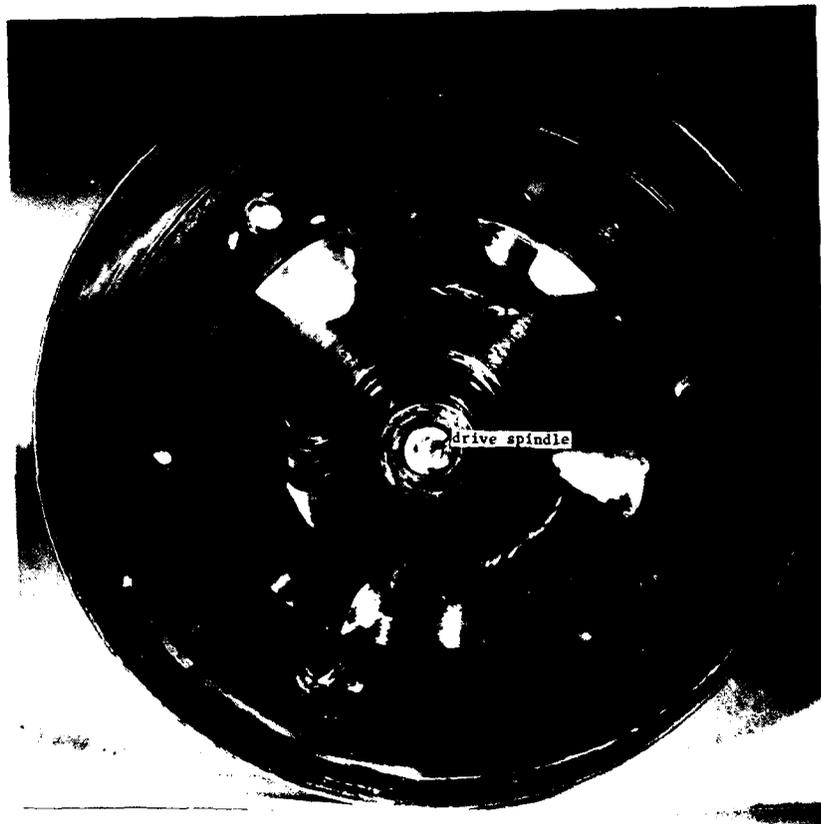
Figure 153. Spin adapter.

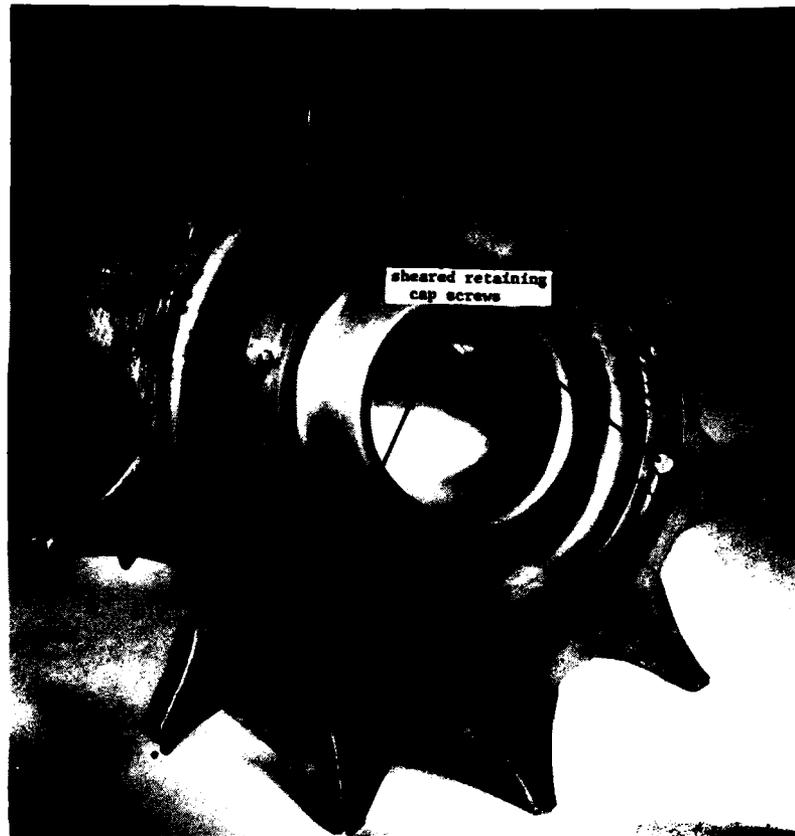
Figure 154. Rotor assembly front face.

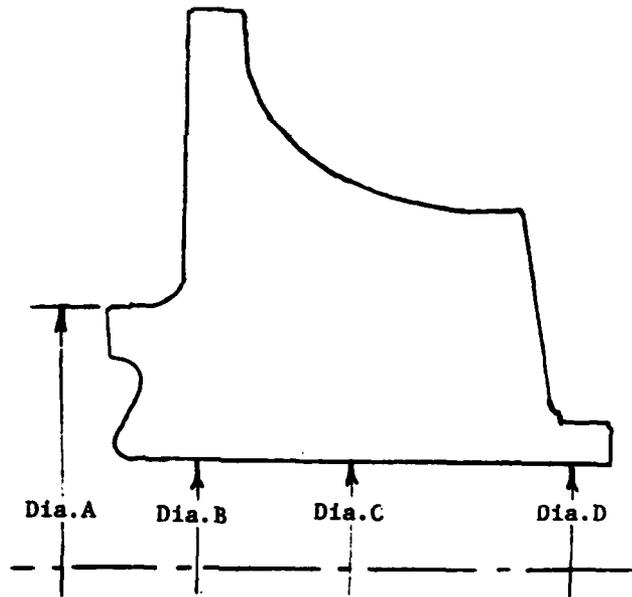
Figure 155. Macroetched polished section of rotor assembly.

A cut-up evaluation was then accomplished. Figure 155 is a photograph of a macroetched polished section of the rotor assembly after test. Photomicrographs of the bond line, Figure 156, at both the conical and cylindrical sections of the rotor indicate that the high stress encountered during this test did not affect bond line integrity.

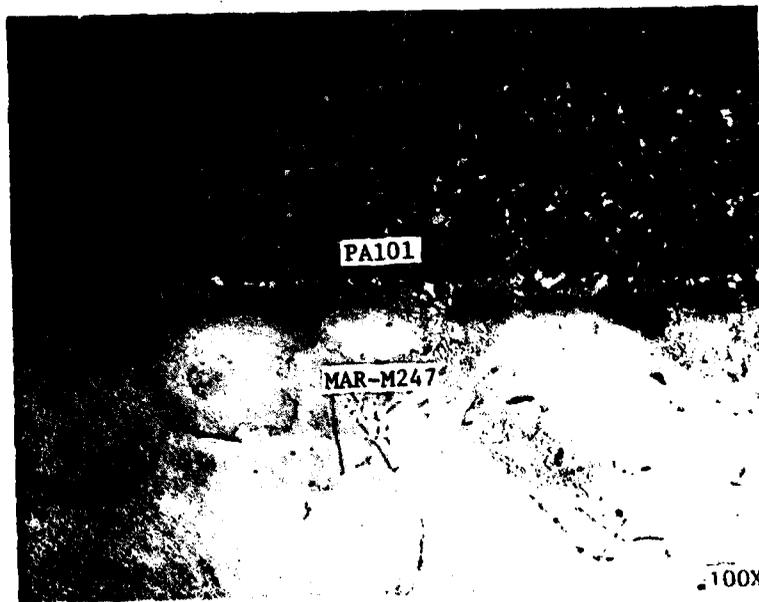
cylindrical section

conical section

Figure 156. Photomicrographs of bond line.

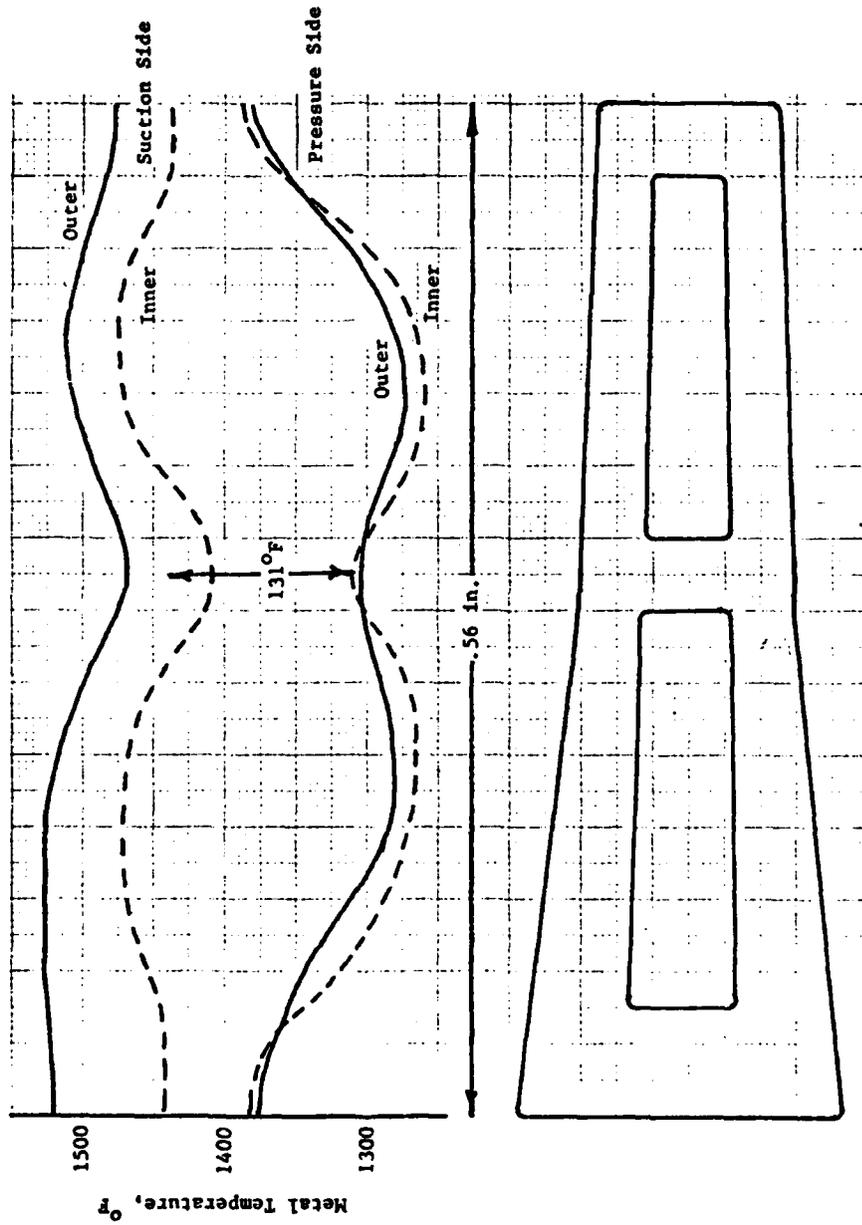
Wall Metal Temperature @ 20% Mean Streamline
100% IRP Design Point

Figure D-1. Wall metal temperatures.

The results of this analysis indicate that localized fins or pins may be required for an aircooled radial turbine entering Engineering Development.
