HEADQUARTERS STRATEGIC AIR COMMAND

9 Final Engineering Report, No. P-372

6 Alert Aircraft Roll Over Chocks

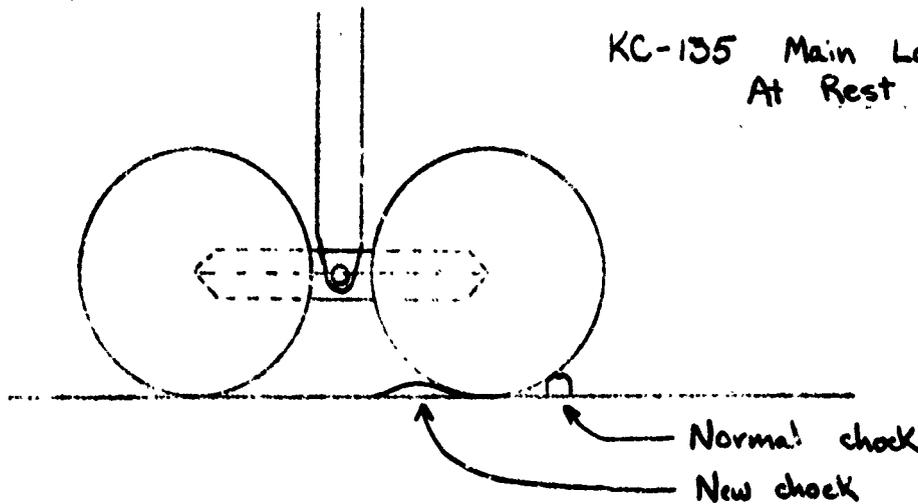
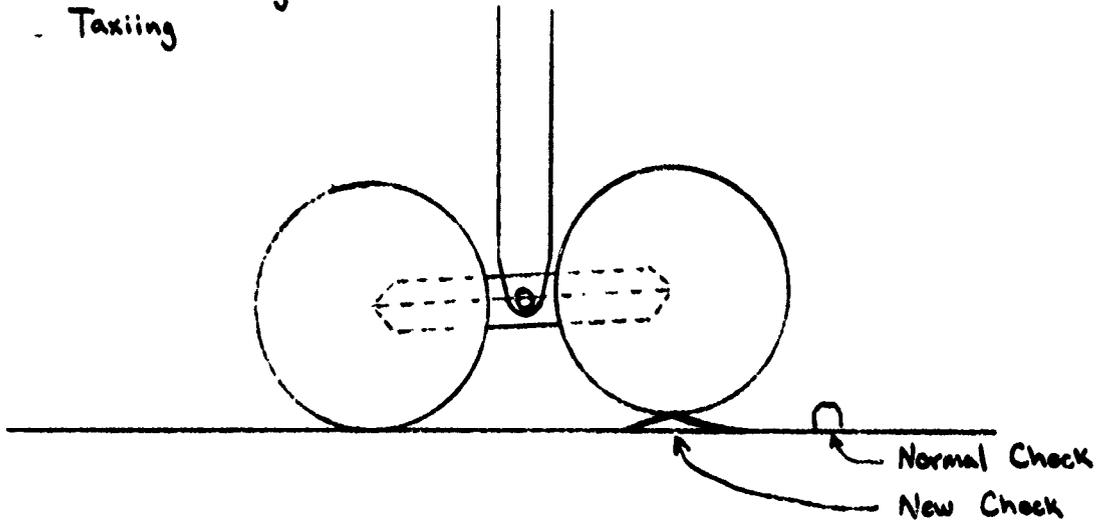
Fig 1

KC-135 Main Landing Gear
At Rest

Not to scale

KC-135 Main Landing Gear
Taxiing

1. In order to taxi over a chock and not overstress the gear or the aircraft, only the aft most wheels should be chocked. If the tanker is chocked this way, only four tires of the main gear would experience the bump and only one end of the main gear truck will flex up and down (see Fig 1). If it were chocked in the normal manner, two bumps would be experienced as each set of wheels went over the chock. When chocking the B-52, only the aft gear should be chocked for the same reasons. The B-52 and KC-135 are designed to go over a 4" bump without sustaining any damage so taxiing over these chocks should not present a problem.

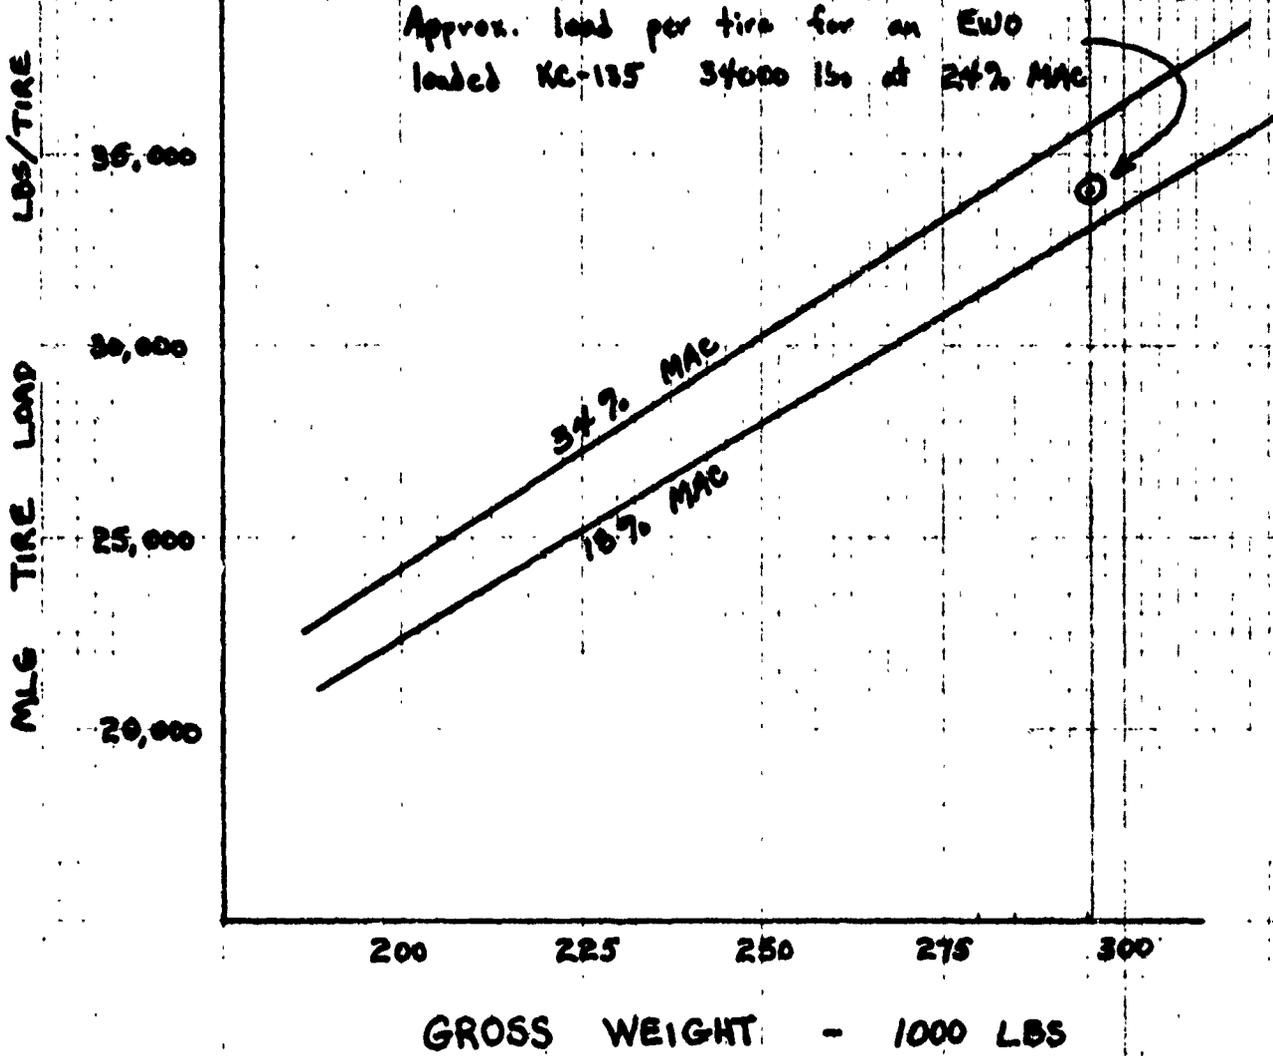
C/KC-135

Source of graph - internal Boeing document dated 21 May 1965

**Calculated using graph in Fig 2 obtained from Boeing Co. assuming 296,000 gross weight and 24% MAC center of gravity.

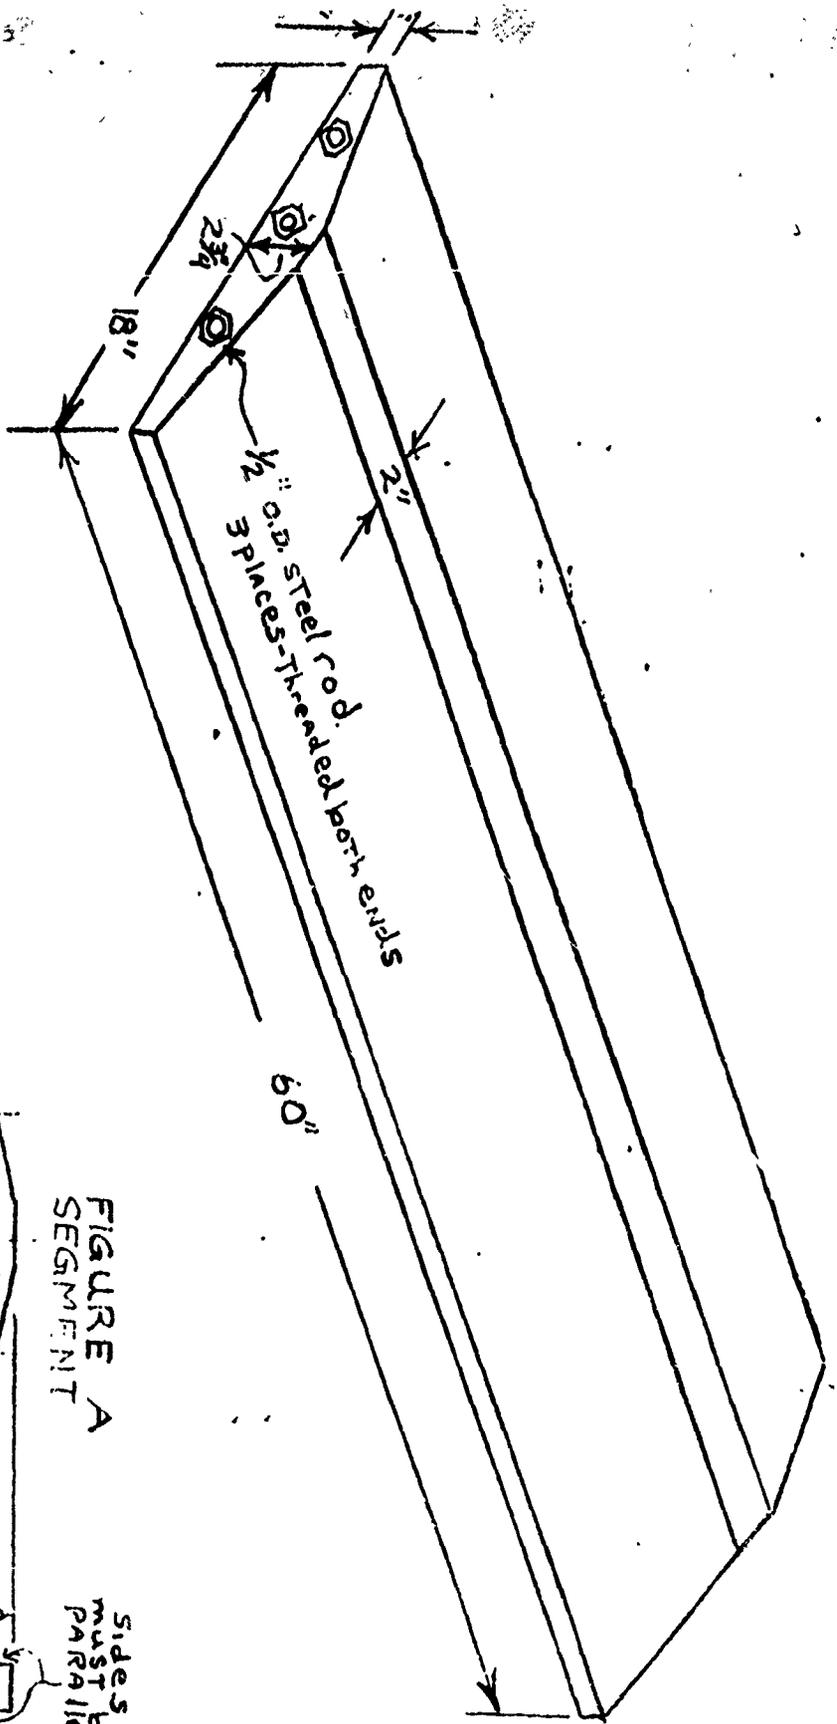
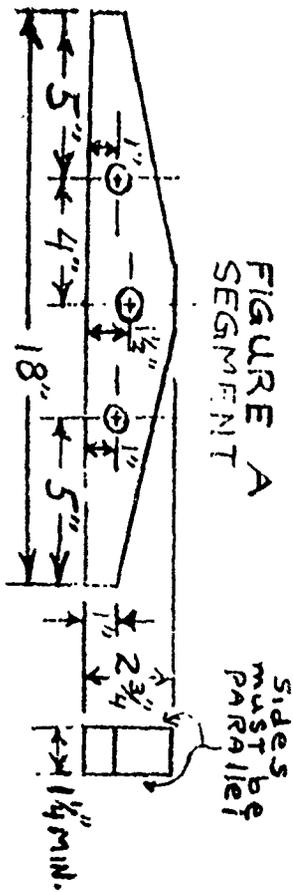
Figure A
ATTCH. 1

11. Paint the chock AGE yellow (#13538).

12. Stencil in black on the 2" flat of the chock "FOR COCKED ALERT AIRCRAFT ONLY". Letters should be a minimum of 1" high.

FIGURE A
SEGMENT

FIGURE B
END PLATE PLACEMENT

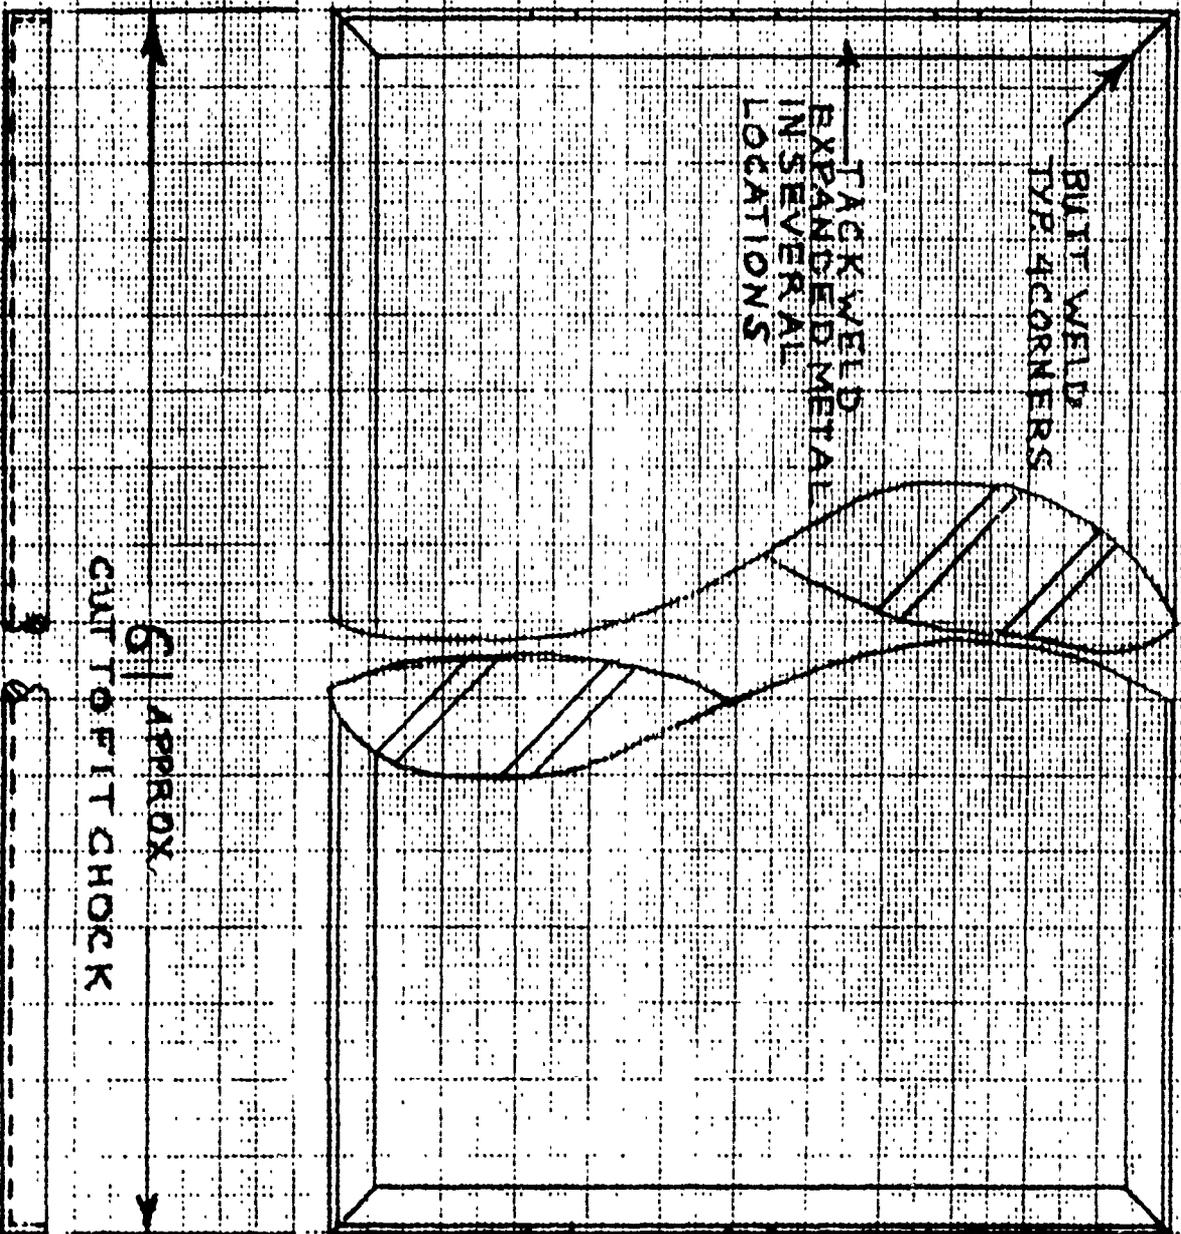
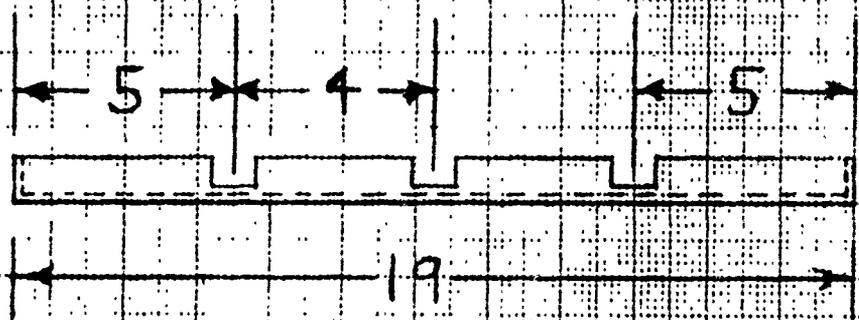
ATTACH. IV

ALL DIMENSIONS
IN INCHES AND
ARE APPROX.
MANUFACTURE
TO FIT
MATERIAL: 3/4 ANGLE
IRON.
