MARTIN MARIETTA AEROSPACE DENVER CO QUALITY ASSURANC--ETC F/G 11/4
ENHANCED X-RAY STEREOSCOPIC NDE OF COMPOSITE MATERIALS. (U)

**ENHANCED X-RAY STEREOSCOPIC NDE
OF COMPOSITE MATERIALS**

TECHNICAL REPORT AFWAL-TR-80-3053
Final Report for Period July 1979 - May 1980

**FLIGHT DYNAMICS LABORATORY
AIR FORCE WRIGHT AERONAUTICAL LABORATORIES
AIR FORCE SYSTEMS COMMAND
WRIGHT-PATTERSON AIR FORCE BASE, OHIO 45433**

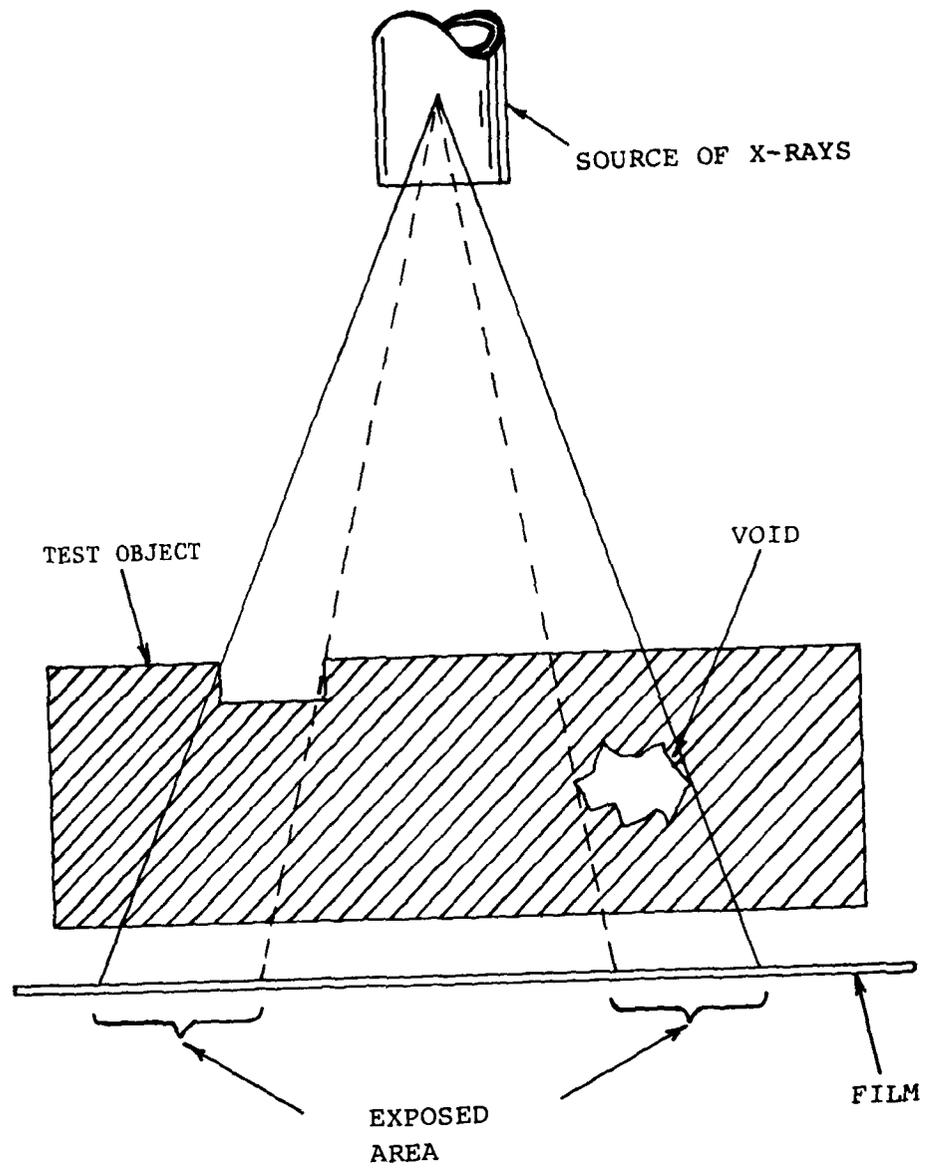
FIGURE 1 DIAGRAM OF THE RADIOGRAPHIC PROCESS

In general, X-radiography, a beam of penetrating radiation is typically directed perpendicularly toward the part under inspection (Figure 1) at a fixed-focus film distance. A portion of this energy is absorbed as it passes through the part and a portion is scattered. Absorption of energy by the test part is dependent upon the material composition, thickness and density. Energy which passes through the part is converted by an appropriate imaging media (film, fluoroscopy, etc.) to produce a "shadow image" of variable portions of the part.

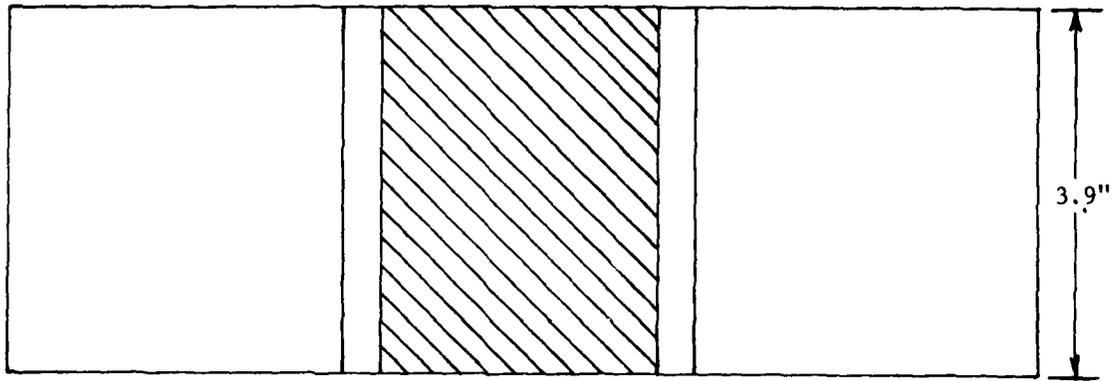
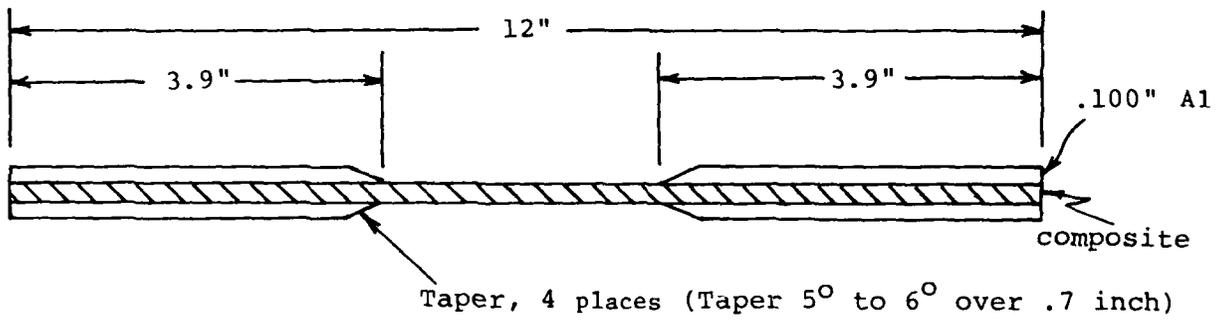
FIGURE 2

FATIGUE TEST SPECIMEN

6061-T6 aluminum alloy doublers (grip end reinforcement) 3.9 inches X 3.9 inches X 0.100 inches thick were bonded to both sides of both ends of each specimen using "Hysol" EA 9030, epoxy resin (a room temperature curing adhesive). Prior to bonding, a 5 degree tapered edge was machined in the end of each doubler plate as shown in Figure 2.

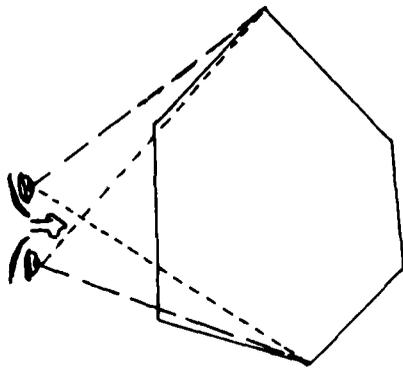
FIGURE 6 HUMAN STEREOSCOPIC VISION
The viewer is aware of the three dimensional effect caused by two slightly different images.

Stereo X-radiography is the X-radiographic equivalent of optical stereography in which two images are produced as viewed from slightly different angles and are then optically recombined to produce an apparent three dimensional image. The image emulates the two images normally viewed by the human eyes due to the spacing between the eyes. (See Figure 6).

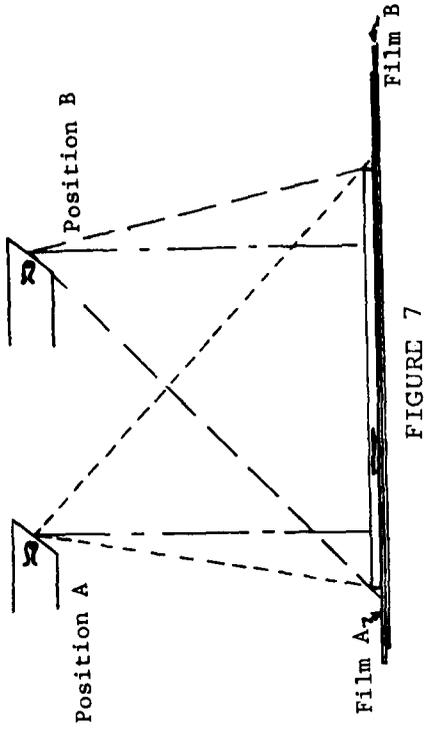
FIGURE 7
STEREORADIOGRAPHY - SOURCE DISPLACEMENT METHOD

- a. The source displacement method shown in Figure 7 involves holding the test object immobile while the X-ray tube is shifted in order to expose two X-radiographs from a slightly different perspective. Generally, the tube shift is one-tenth the target to film distance (1:10, ratio). At short target to film distances, the ratio may be increased to 1:13 to 1:16 to reduce eye strain. The tube is generally positioned such that the two exposures are made with the tube positioned at an equal distance on either side of the centerline of the test object.

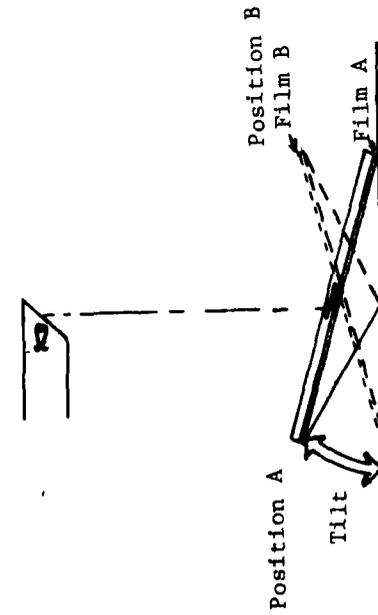
FIGURE 8
STEREORADIOGRAPHY - OBJECT TILT METHOD

- b. The object displacement method shown in Figure 8 involves holding the X-ray source immobile while shifting (laterally displacing) the test object in order to expose a stereo X-radiograph pair. The source displacement and tube displacement methods produce identical results and may be used interchangeably for convenience in test set-up.
- c. The object tilt method shown in Figure 9 involves holding the X-ray source immobile and tilting the test object with respect to the source axis to expose a stereo X-radiograph pair.

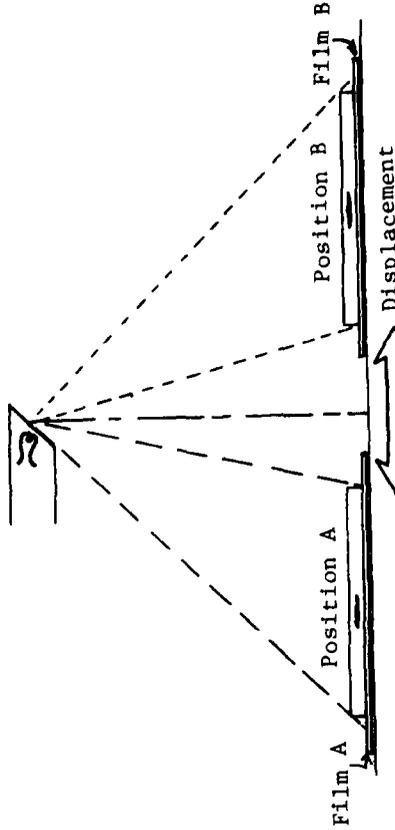
FIGURE 9
STEREORADIOGRAPHY - OBJECT DISPLACEMENT METHOD

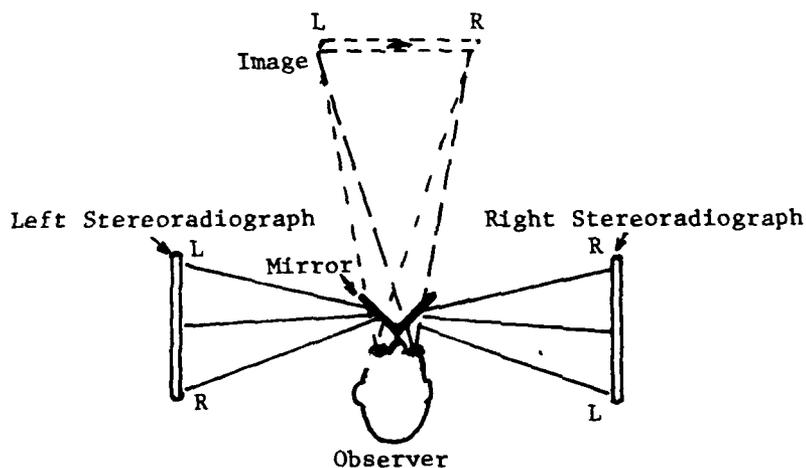
FIGURE 10 DIAGRAM SHOWING VIEWING OF A STEREO X-RADIOGRAPH PAIR

The stereo X-radiographic pairs may be viewed with the aid of a "stereo viewer" to "recombine" the images for viewing in the three dimensional mode. Figure 10.

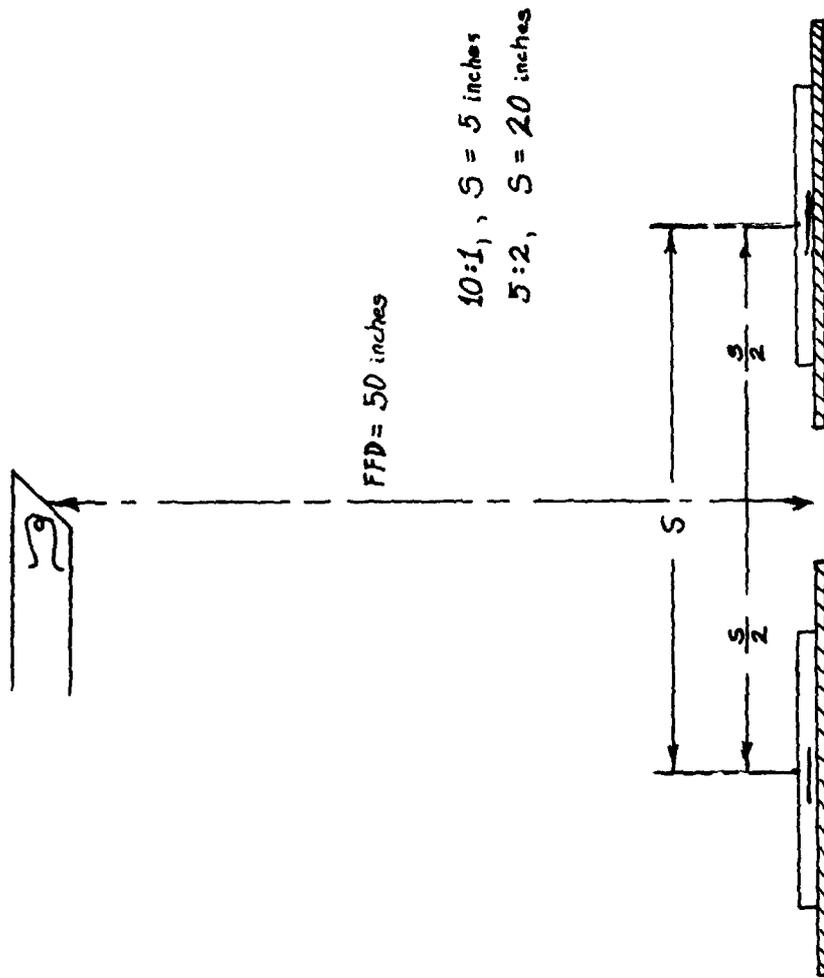
FIGURE 14 GEOMETRY OF STEREO X-RADIOGRAPH EXPOSURES AT TWO SHIFT RATIOS

An impact damaged, 16 ply specimen with ZLX-418B, penetrant was used to compare techniques. Exposures were made using the established exposure parameters by the object displacement method at 10:1 and 5:2 shift ratios. (See Figure 14). The 5:2 shift ratio was judged to be the maximum value obtainable within the uniform cone of radiation at a 50 inch FFD. (Focal Film Distance) Figure 15 is a stereo-x-ray image pair of an impact damaged (15 inch-pounds, no backing), area in the center of a 16 ply specimen. Exposures were made at a 10:1 shift ratio. Figure 16 is a stereo x-ray image pair of the same specimen with exposures made at a 5:2 shift ratio. (See Appendix B for tips on viewing Stereo-X-Radiographs). Exposures made at the 5:2 shift ratio produced greater apparent image depth as viewed. A 5:2 shift ratio was selected for all subsequent exposures.

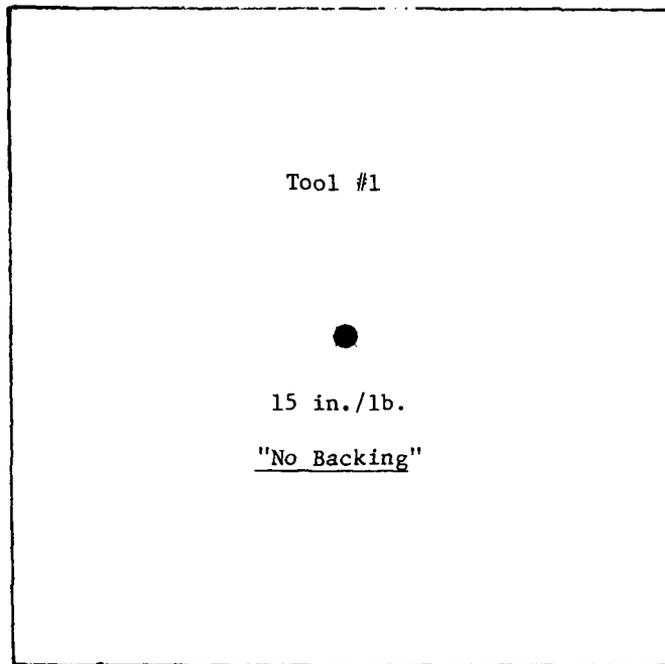
FIGURE 17 - LOCATION OF IMPACT DAMAGE IN TEST VALIDATION SPECIMEN NO. 24-29

Impact damage was inflicted in a 24 ply specimen (No. 24-29) using punch No. 1 at 15-inch pounds with no backing. (See Figure 17). An X-radiograph of the specimen without penetrant revealed no apparent damage. (See Figure 18). ZLX-418B penetrant was applied to the top side of the specimen (over the damaged area) and allowed to dwell for 30 minutes. An X-radiograph of the specimen showed very little capillary action or movement of penetrant into the damaged area. (See Figure 19)

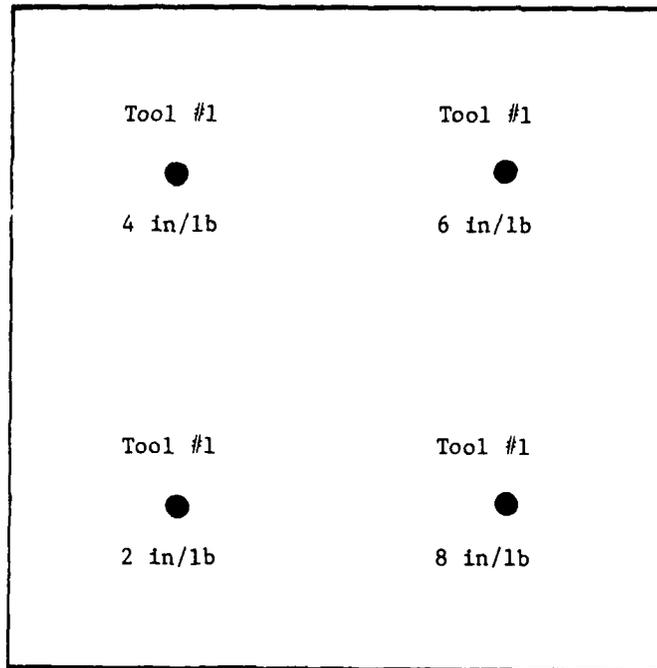
FIGURE 23 DAMAGE LOCATIONS IN SPECIMEN 8-29
(SPECIMEN SHOWN ACTUAL SIZE)

- 1). Specimen 8-29. Impact damage was inflicted on specimen 8-29 with no backing, in four (4) locations using tool (punch) No. 1 at 2, 4, 6 and 8 inch-pound energy levels. Damage locations are shown schematically in Figure 23.

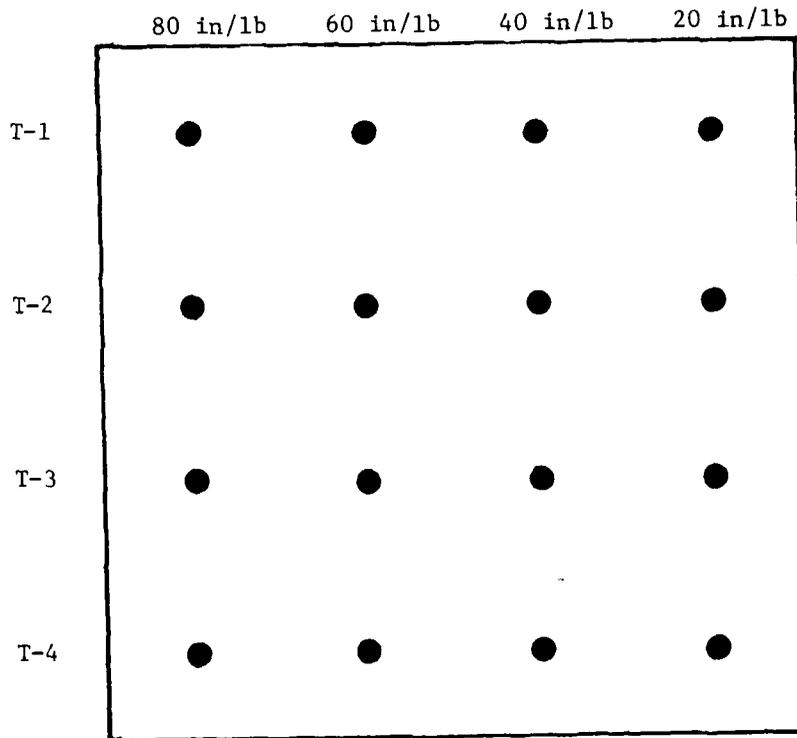
FIGURE 25 DAMAGE LOCATIONS IN SPECIMEN 8-30
(SPECIMEN SHOWN ACTUAL SIZE)

- 2). Specimen 8-30. Impact damage was inflicted on Specimen 8-30, with solid backing, in sixteen (16) locations using tool (punch) No. 1, 2, 3 and 4 at 20, 40, 60 and 80 inch-pound energy levels. Damage locations are shown schematically in Figure 25. Conventional X-radiography, with no penetrant, revealed extensive damage from tools No. 2, 3 and 4 and slight damage from tool No. 1. (Figure 26)

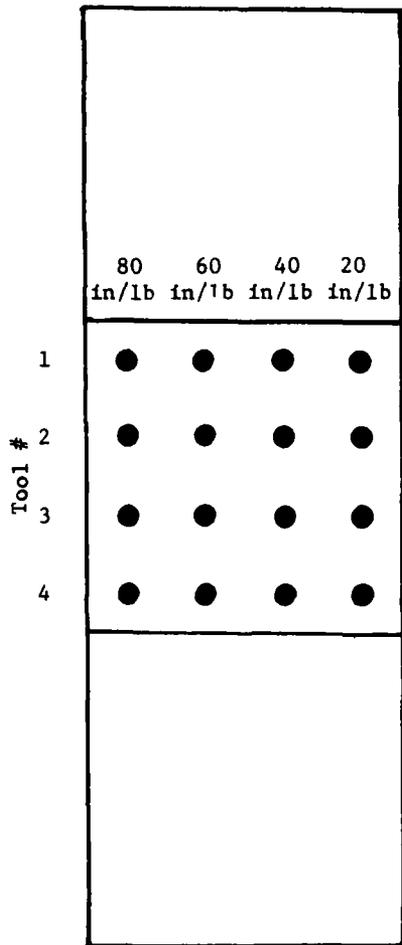
FIGURE 27 DAMAGE LOCATION
IN SPECIMEN 16A-10
(SPECIMEN SHOWN HALF-SIZE)

- 1). Specimen 16A10. Impact damage was inflicted on specimen 16A-10, with no backing, in sixteen (16) locations using tool (punch) No. 1, 2, 3 and 4 at 20, 40, 60, and 80 inch-pound energy levels. Damage locations are shown schematically in Figure 27. Conventional X-radiography, with no penetrant, revealed damage from tool No. 2, 3, and 4 at all energy levels. No apparent damage from tool No. 1 was revealed (Figure 28).
- 2). Specimen X16-20. Impact damage was inflicted on specimen X16-20, with no backing, in three locations, using tool (punch) No. 1 at 10, 15, and 20 inch-pounds. Damage locations are shown schematically in Figure 29. Conventional X-radiography, with no penetrant, revealed no apparent evidence of damage. (Figure 30)

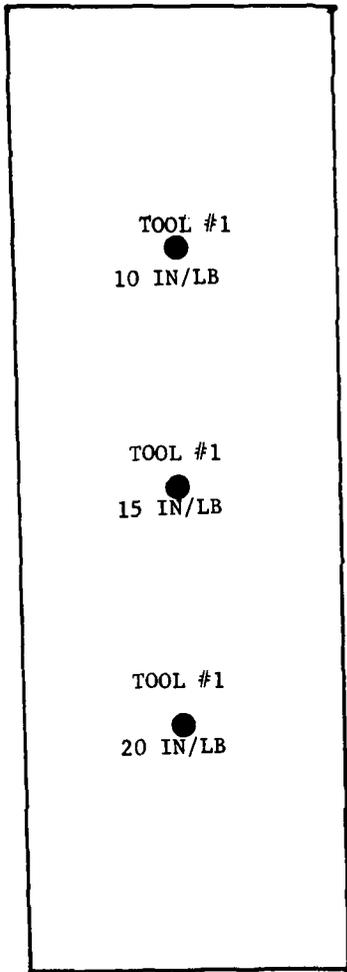
FIGURE 29
DAMAGE LOCATIONS IN SPECIMEN X16-20
(SPECIMEN SHOWN HALF-SIZE)

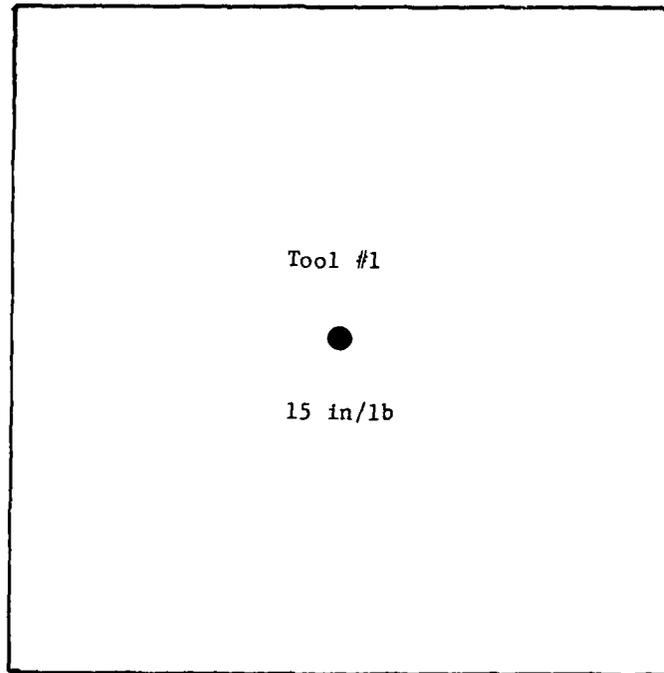
FIGURE 31 DAMAGE LOCATION IN SPECIMEN 24-24
(SPECIMEN SHOWN ACTUAL SIZE)

- 1). Specimen 24-24. Impact damage was inflicted on specimen 24-24, with no backing, in one (1) location using tool (punch) No. 1 at a 15 inch-pound energy level. Damage location is shown schematically in Figure 31. Conventional X-radiography, with no penetrant, revealed no apparent damage (Figure 32).

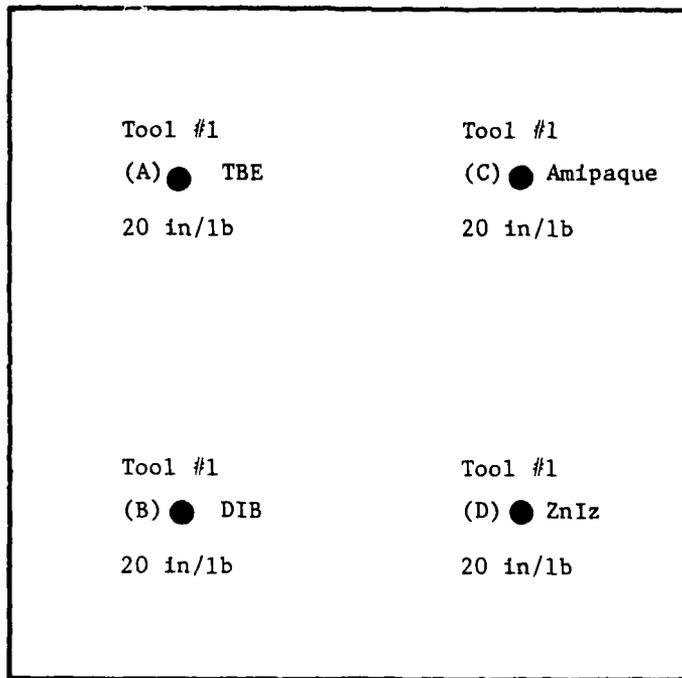
FIGURE 33 DAMAGE LOCATION IN SPECIMEN 24-26
 (SPECIMEN SHOWN ACTUAL SIZE)

- 2). Specimen 24-26. Impact damage was inflicted on specimen 24-26, with no backing, at four (4) locations using tool (punch) No. 1 at a 20 inch-pound energy level. The four (4) locations (A through D) were designated for application of various penetrant materials in subsequent comparative evaluations. Damage locations and penetrant designation are shown schematically in Figure 33. Conventional X-radiography, with no penetrant, revealed no apparent damage (Figure 34).

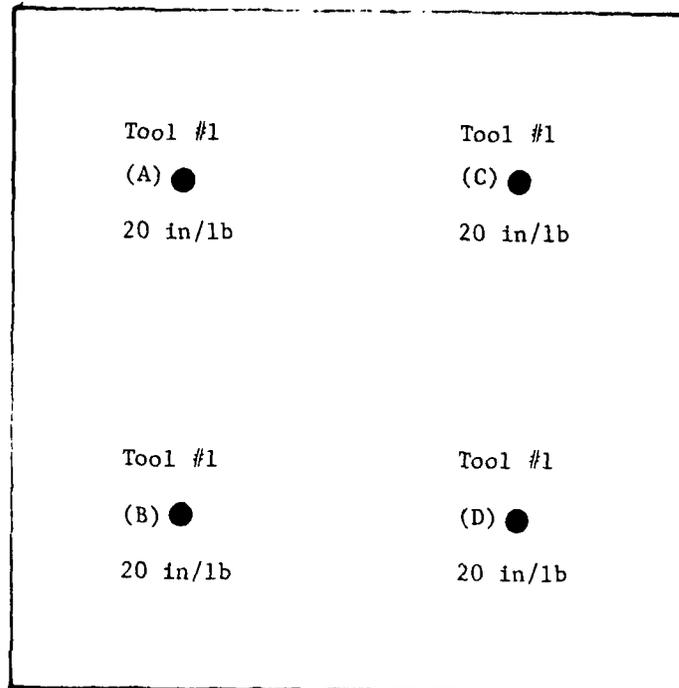
FIGURE 35 DAMAGE LOCATION IN SPECIMEN 24-27
(SPECIMEN SHOWN ACTUAL SIZE)

- 3). Specimen 24-27. (Specimen 24-27 was identical to specimen 24-26). Impact damage was inflicted on specimen 24-27, with tool (punch) No. 1 at a 20 inch-pound energy level. The four (4) locations (A through D) were designated for application of various penetrant materials in subsequent applications. Damage locations are shown schematically in Figure 35. Conventional X-radiography, with no penetrant, revealed no apparent damage (Figure 36).

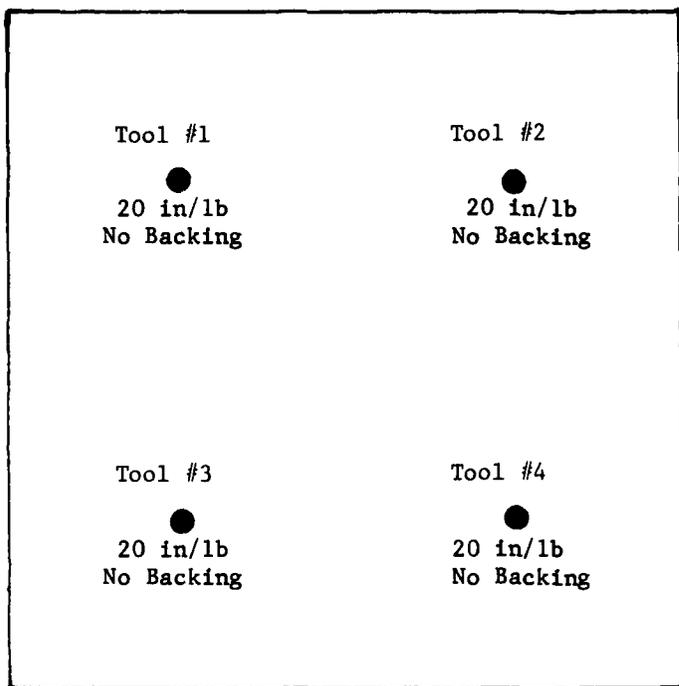
FIGURE 37 DAMAGE LOCATION IN SPECIMEN 24-28
(SPECIMEN SHOWN ACTUAL SIZE)

4.) Specimen 24-28. Impact damage was inflicted on specimen 24-28, with no backing, at four (4) locations using tool (punch) No. 1, 2, 3, and 4 at a 20 inch-pound energy level. Damage locations are shown schematically in Figure 37. Conventional X-radiography, with no penetrant, revealed no apparent damage (Figure 38).

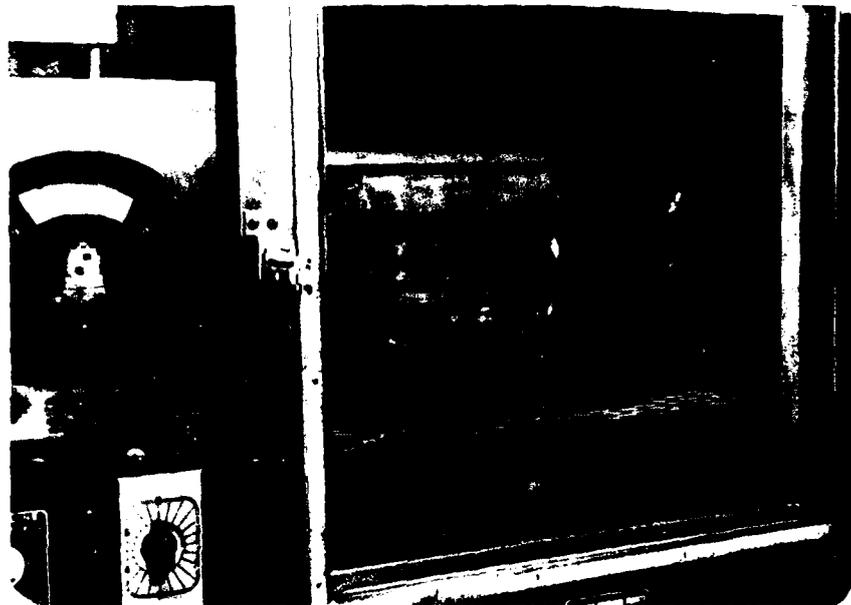
FIGURE 65 BLUE M - ELECTRIC OVEN WITH PYREX CONTAINERS
IN PLACE

Specimen sets were placed into a shallow pyrex container along with small samples of the respective penetrants. A glass lid was used to cover each container thereby establishing an equilibrium exposure with volatile components of each respective penetrant. The containers were placed in a "Blue M" thermostatically controlled and electrically heated oven (equipped with oven temperature protection) and the temperature was raised to 100° F. (See Figure 65)

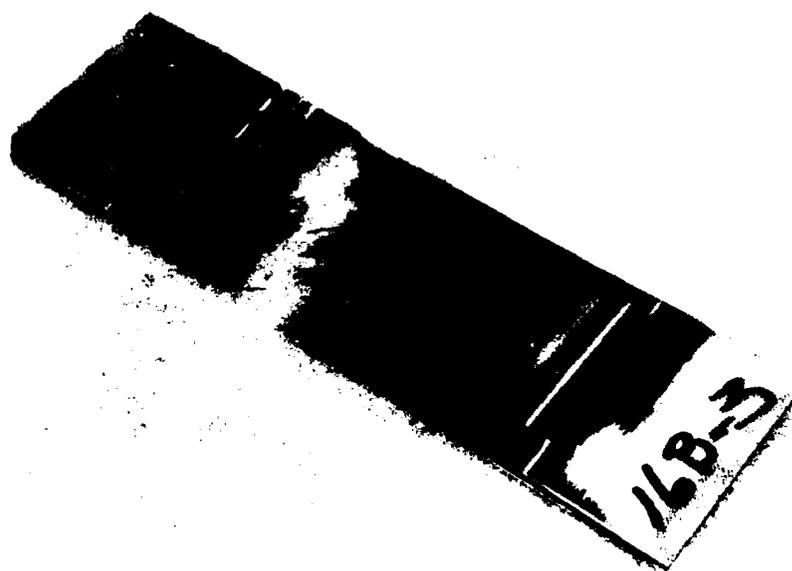
FIGURE 105 SPECIMEN 16B-3 AFTER FATIGUE FAILURE

The specimen failed during fatigue test after an additional 820 cycles. The specimen received a total of 3,820 cycles. Visual inspection after failure showed the failure at the grip doubler on the identification end. The composite was starting to pull loose from under the grip. There was no evidence of failure in the impact damage area.

Figure 105 shows the location of failure for this specimen.

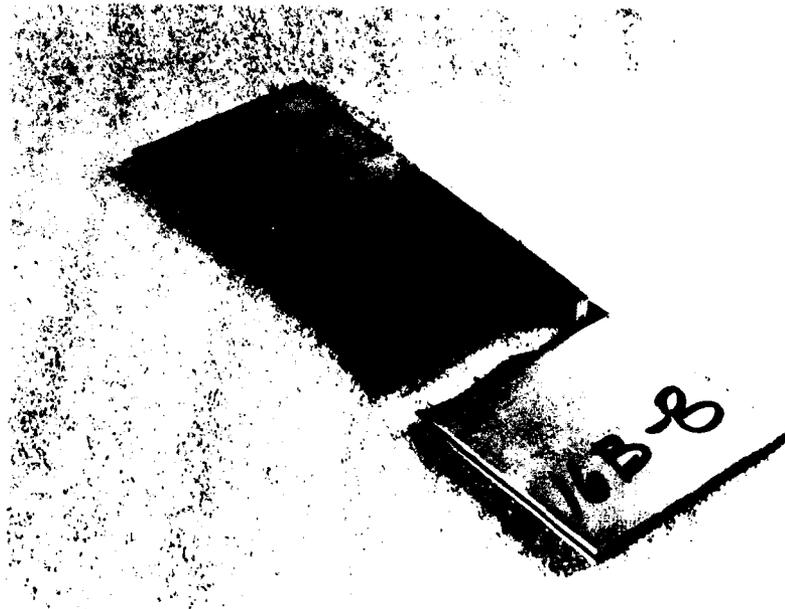
FIGURE 114 SPECIMEN 16B-8 AFTER FATIGUE FAILURE

This specimen failed after receiving 570 cycles. The failure was at the grip and opposite from the specimen identification. There was no evidence of failure through the impact damage area. Radiographic inspection was not performed after failure.

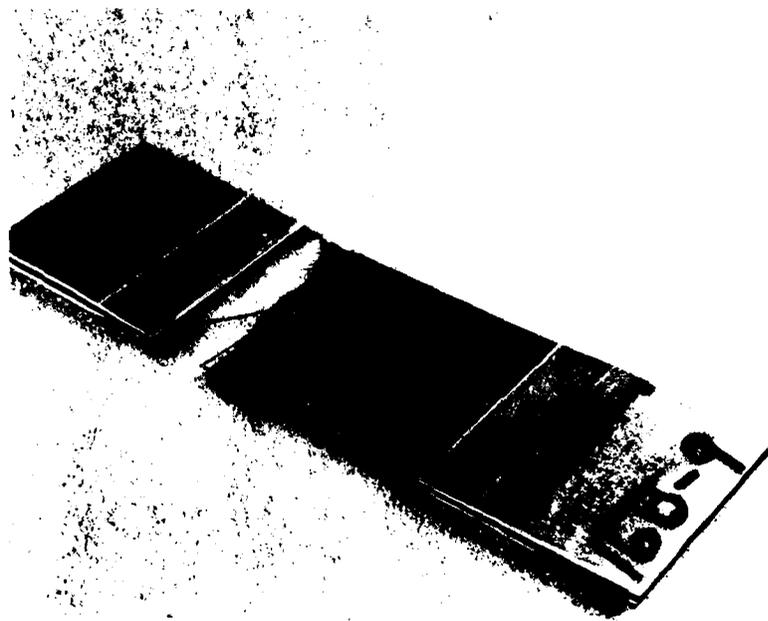
FIGURE 121. SPECIMEN 16B-9 AFTER FATIGUE FAILURE

The specimen failed during fatigue test after receiving an additional 1,227 cycles. The specimen received a total of 2,227 cycles. Visual inspection showed the failure to be at the edge of taper of the grip on opposite end from identification. There was no failure associated with the impact damage area.

Figure 121 shows the location of failure for this specimen.
