DOT/FAA/CT-82/44

Light Aircraft Piston Engine Carburetor Ice Detector/Warning Device Sensitivity/Effectiveness

Final Report

US Department of Transportation
Federal Aviation Administration
Technical Center
Atlantic City Airport, N.J. 08405

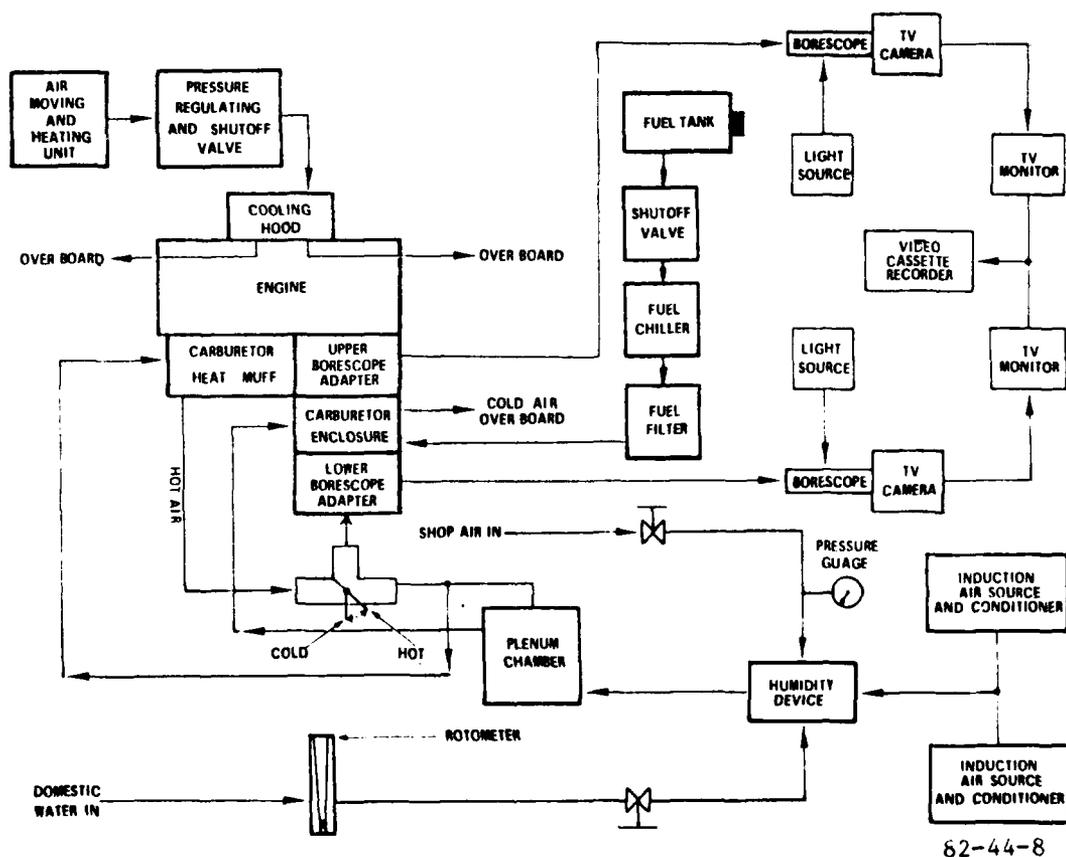
FIGURE 8. TEST SYSTEM SCHEMATIC

Figure 8 depicts overall instrumentation/installation equipment described above.

Two TV monitors were used to view the test continually and check for ice buildup. The monitors allow for varying test conditions and obtain immediate feed-back, relative to data which should be recorded.

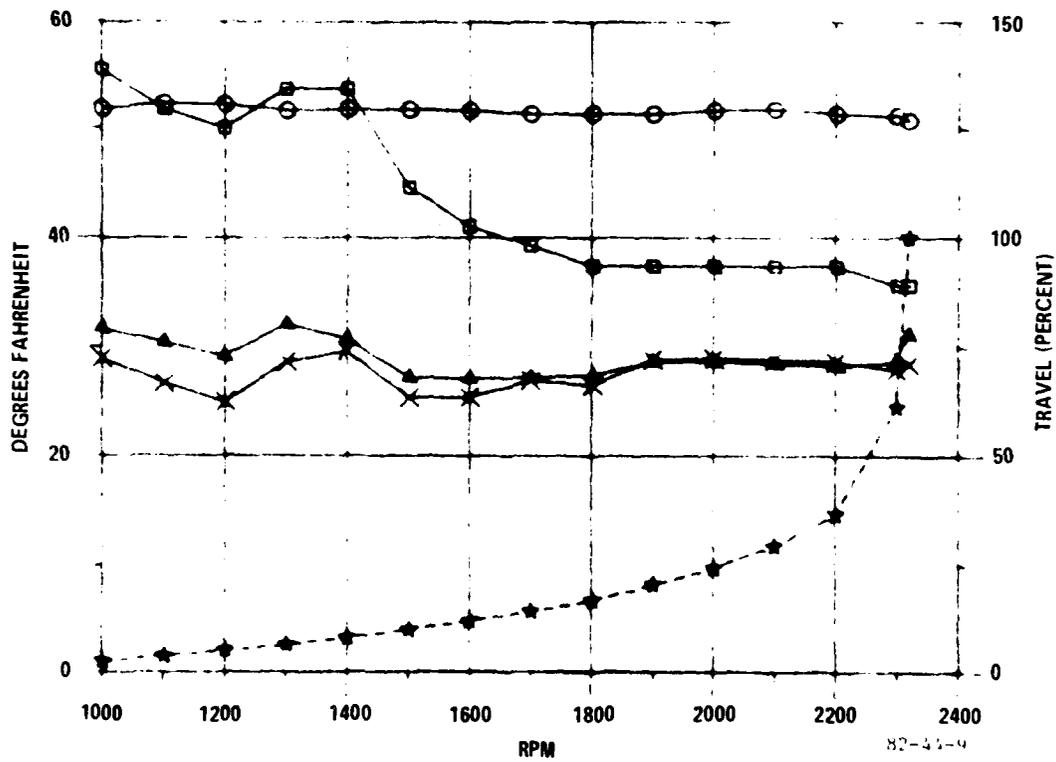
FIGURE 9. CARBURETOR TEMPERATURE DATA VERSUS RPM

NOTE: CARBURETOR INLET TEMP. 59° F

- - TEST PROBE 2 TEMP.
- - CARBURETOR FLOAT BOWL TEMP.
- △ - THROTTLE PLATE LOWER TEMP.
- × - THROTTLE PLATE UPPER TEMP.
- * - THROTTLE PLATE PERCENT TRAVEL.

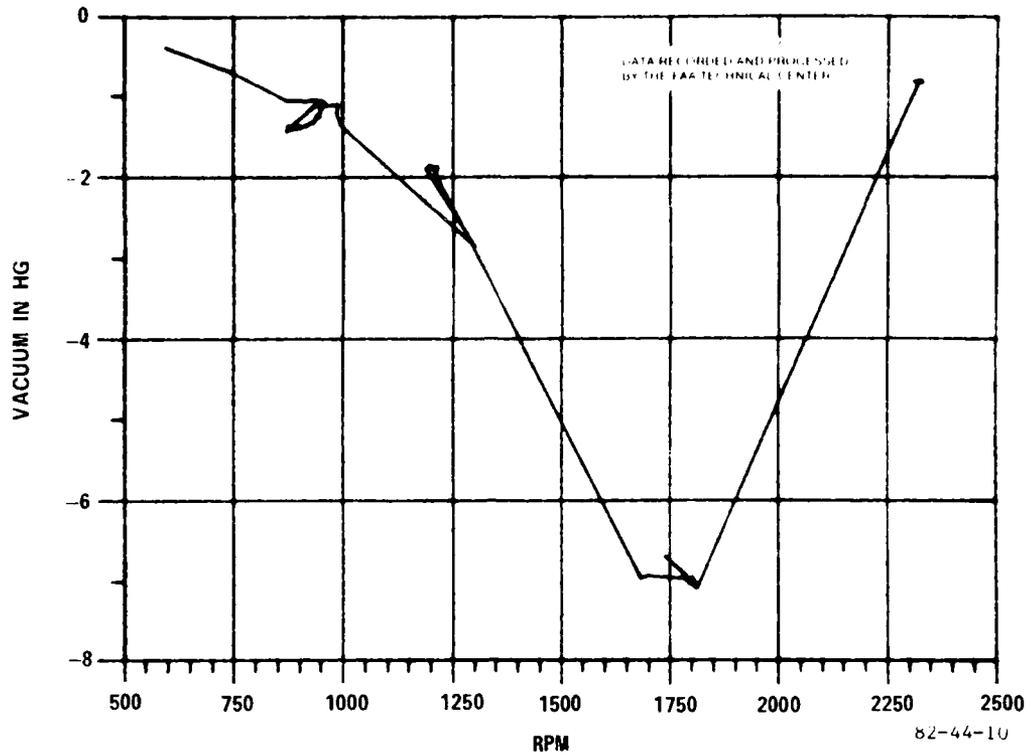
FIGURE 10. IDLE JET PRESSURE VERSUS RPM (NO ICE)

As addressed in GENERAL OBSERVATIONS portion of this report, the carburetor idle jet pressure was useful in monitoring carburetor performance/sensitivity during ice accumulation and propagation. Figure 10 is an idle jet pressure plot versus rpm with pressure being measured in inches of mercury vacuum. Figure 10 was taken from the SUT of a Test Probe 1 test cycle, wherein slight idle jet pressure fluctuations which are evident at 900 and 1300 rpm are attributed to typical engine warm-up characteristics. The pressure fluctuation at 1800 rpm was typical during magneto operational check.

Data collected during each engine test run was plotted as displayed in figures 10 and 11 as well as appendix E. Each parameter was plotted for the complete test run in two formats:

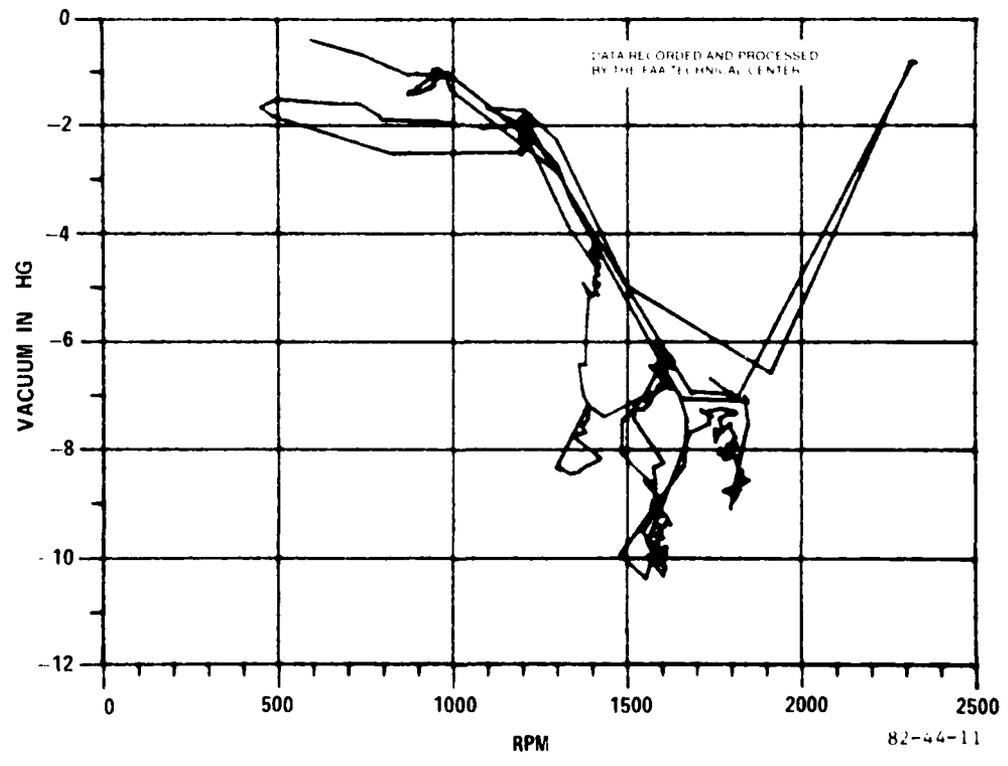
FIGURE 11. IDLE JET PRESSURE VERSUS RPM (WITH ICE)

Figure 11 reflects idle jet pressure fluctuation during the entire Test Probe 1 test cycle initiated in figure 10. Large pressure fluctuations were typical during carburetor icing and were detected prior to engine performance degradation. During some large pressure fluctuations an idle jet vent was opened to check on possible alteration of engine performance characteristics. Whenever venting was initiated, idle jet pressure would return to near ambient. Exhaust emission analyzing equipment would better identify changes in engine performance characteristics due to such a venting operation.

1. Individual parameter versus rpm for complete test run as displayed in figure 11.
2. Individual parameter versus 25-minute increments for complete test run as displayed in appendix E (figure E-5).

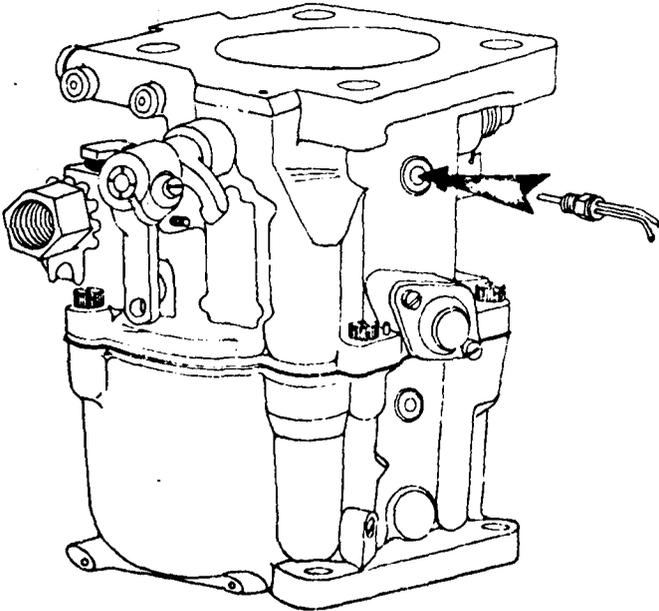
FIG. 3A

PROBE DEPTH INSIDE CARBURETOR

- (4) Thread 7/32" hole with a 1/4"-28 tap to receive the temperature probe.
- (5) Screw temperature probe into tapped hole. Determine the thickness of plain shim washer necessary in addition to the Shakeproof lock washer to prevent the end of the threaded portion of the temperature probe from protruding into the carburetor throat. (Fig. 3A, 3B). Either the .018 or .030 Shakeproof washer may be used alone; but when a shim washer is used there must be a Shakeproof between the shim washer and the Types temperature probe. For additional spacing, the shim washer can have another Shakeproof between it and the carburetor. Only one shim washer can be used. Carburetor wall thickness will vary on individual carburetors because of casting processes. No hard and fast rule in determining the correct amount of spacer washers may be used.
