Field Experiences With Floating Breakwaters in the Eastern United States

MISCELLANEOUS REPORT NO. 82-4

JULY 1982

U.S. ARMY, CORPS OF ENGINEERS
COASTAL ENGINEERING
RESEARCH CENTER

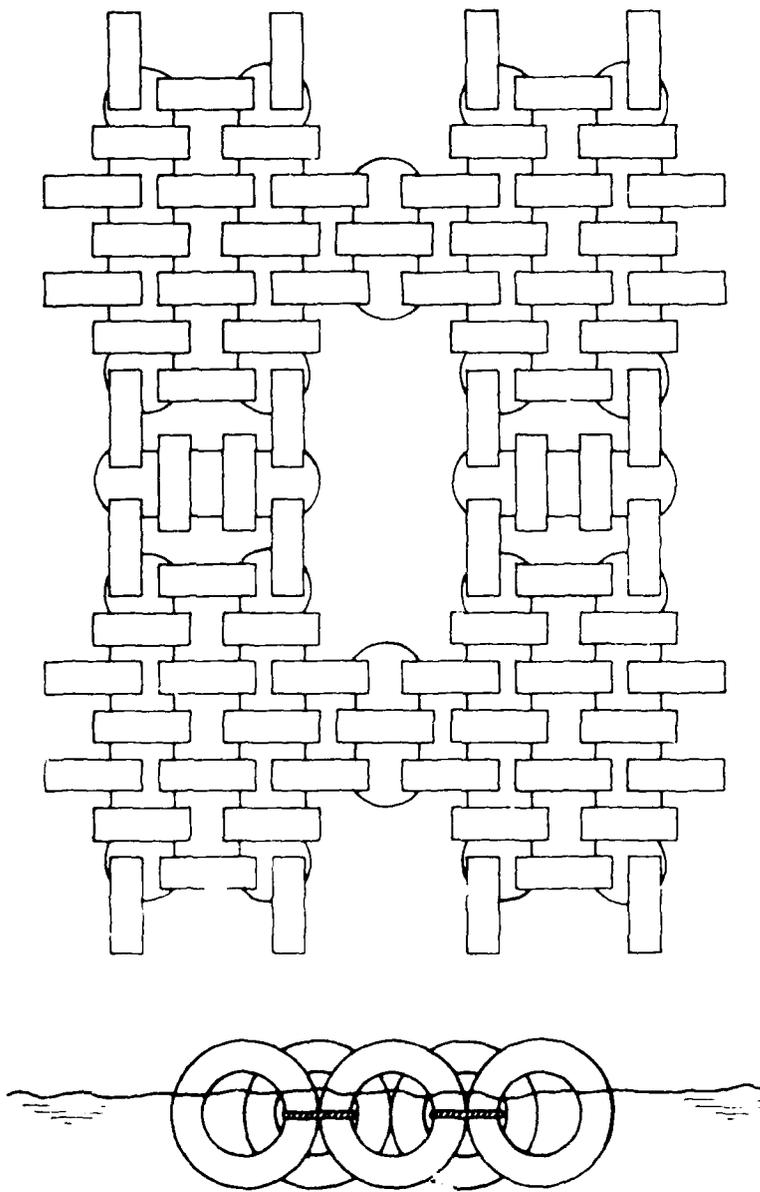
Figure 1. Goodyear FTB--top view of four connected modules (scale - 1:44, spacing between tires exaggerated) and side view of single module (scale - 1:52).

One of the earliest FB designs was the Goodyear Floating Tire Breakwater, conceived by Richard Candle of the Research Division, Goodyear Tire and Rubber Company, as an outgrowth of his automobile crash barrier research. The Goodyear FTB is, in its simplest form, a flexible mat of tires riding the surface of the water. The earmark of this design is the Goodyear module--a set of 18 tires coupled in a 3-2-3-2-3-2-3 vertical fashion (Fig. 1). These modules are bound parallel to one another to form a checkerboardlike mat of whatever dimensions the designer deems necessary for the site.

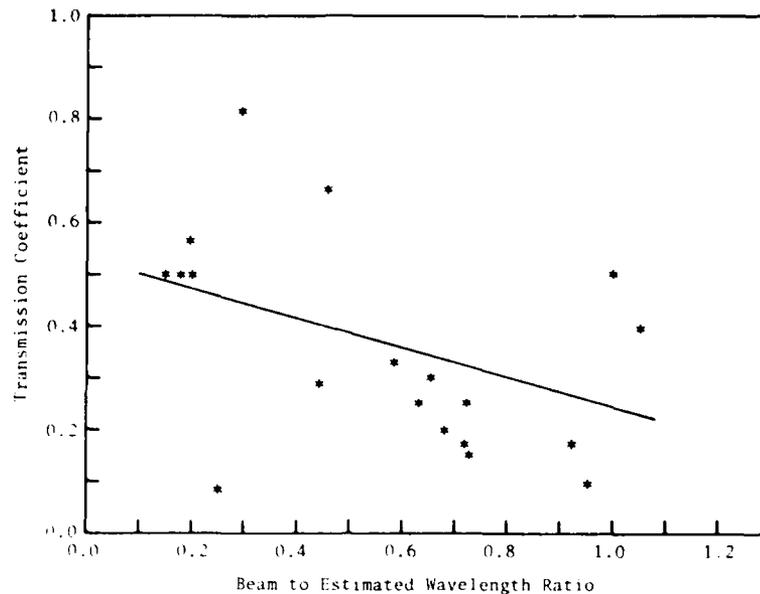
Figure 2. Reported effectiveness of the Goodyear FTB as a function of the ratio of the structure's beam to the estimated length of an incident storm wave.

One of the indicators of an FTB's likely effectiveness in reducing wave height is the ratio of the structure's beam to the length of an incident wave. In theory and as borne out in model tests, as this ratio increases (i.e., as the FTB spans more and more of the wavelength), the effectiveness of the structure likewise improves. To determine if this trend was substantiated by field experiences, MRM plotted the reported transmission coefficients versus the beam to estimated wavelength ratios (see Fig. 2). While there is considerable scatter in the points, the trend is clear as illustrated by a line fitted by the least squares method. This trend agrees with theory. Generally speaking, those FTBs which were most successful were located at sites with reported conditions such that the FTB's beam equaled or exceeded 60 percent of the length of a typical storm wave (see Harms, 1979)².

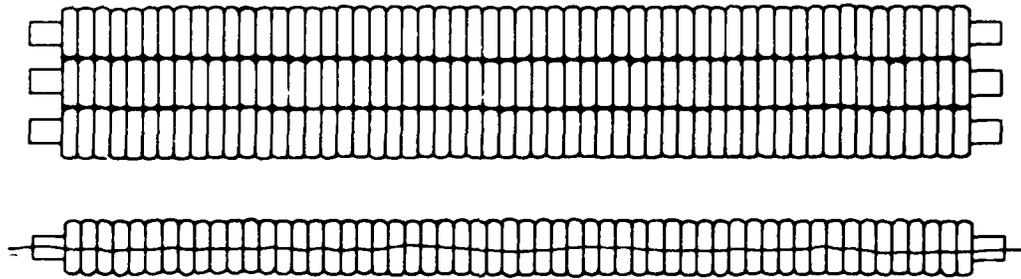
Figure 3. Pole-tire FB--top and side view of single module (scale - 1:84).

Five FB designs radically different from the Goodyear concept were uncovered in the survey of FBs in the Eastern United States. These designs are the pole-tire FB (Fig. 3), the timber caisson FB (Fig. 4), the steel pipe FB (Fig. 5), the steel caisson FB (Fig. 6), and the log boom FB (Fig. 7). In all five cases, only one site was found for each design; consequently, there is no substantial statistical base from which to draw general conclusions.

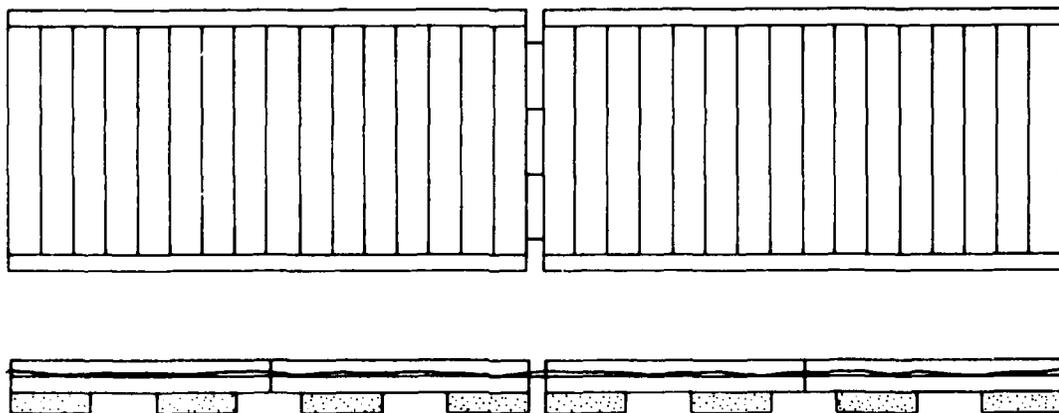
Figure 4. Timber caisson FB--top and side view of two connected modules (scale - 1:78).

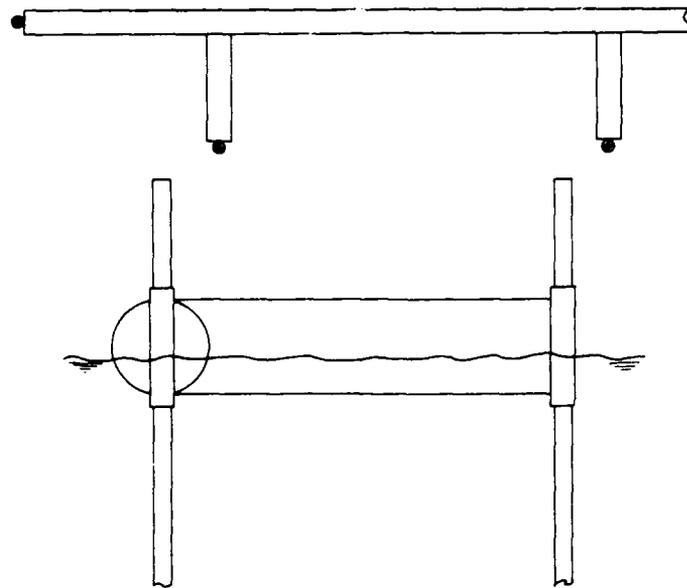
Figure 5. Steel pipe FB--top view of far section (scale - 1:156) and side view (scale - 1:40).

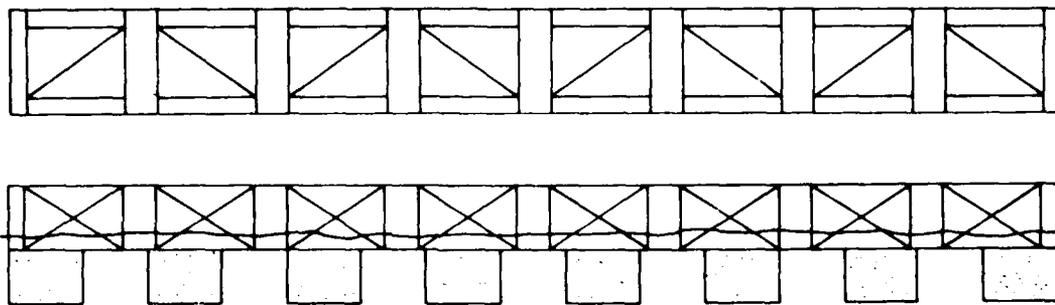
Figure 6. Steel caisson FB--top and side view of single module (scale - 1:78).

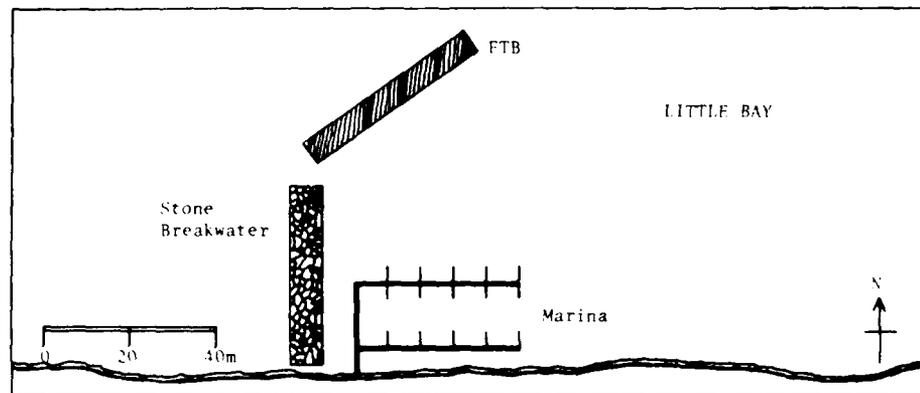
Site:

Construction: This FTB is 45.7 m (150.0 ft) in length and 6.4 m (21.0 ft) in width. Flotation relies on air trapped in the tire crowns and is aided by polyethylene blocks inserted in some of the tires. Rubber conveyor belting fastened with nylon bolts is used to couple the tires.

Installation: The breakwater is fastened at its southern tip to the fixed stone breakwater, elsewhere it is anchored in place. Seven anchoring points are located around the perimeter of the breakwater. The anchors are 1,389-kg (3,500 lb) stone blocks. Mooring lines are of nylon/chain.

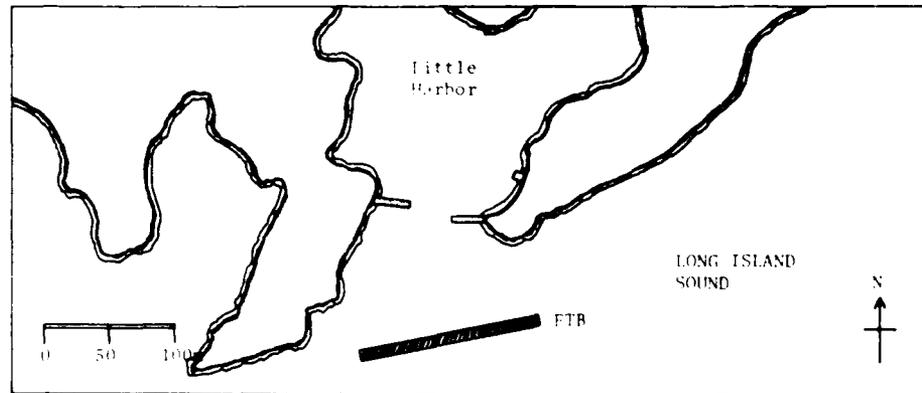
Site:

Construction: This FTB is 137.2 m (450.0 ft) in length and 9.1 m (30.0 ft) in width. The original structure relied on polyethylene blocks inserted in the tire crowns for proper flotation. After reconstruction, the breakwater relied on polyethylene scrap sealed in the tires by wire mesh and polyurethane foam for adequate buoyancy. Rubber conveyor belting fastened by nylon bolts was used to couple the tires. The operator noted that punching holes in the conveyor belting and tightening the belts was difficult.

Installation: The first structure was moored to fourteen 23 kg (50 lb) danforth anchors with ten anchors positioned on the exposed side and four on the leeward side. Mooring lines were of nylon/chain and were 27.4 m (90.0 ft) in length. The reconstructed FTB was moored by a system including eight 91 kg (200 lb) danforth anchors, eight 227-kg (500 lb) cement blocks, one 726-kg (1,600 lb) Navy stockless anchor, and one 908-kg (2,000 lb) Navy stockless anchor. Each anchor was also fitted with 6.1 m (20.0 ft) of one inch steel link chain, weighing 91 kg (200 lb). Mooring lines were of 0.75-inch nylon and were 27.4 m (90.0 ft) long.

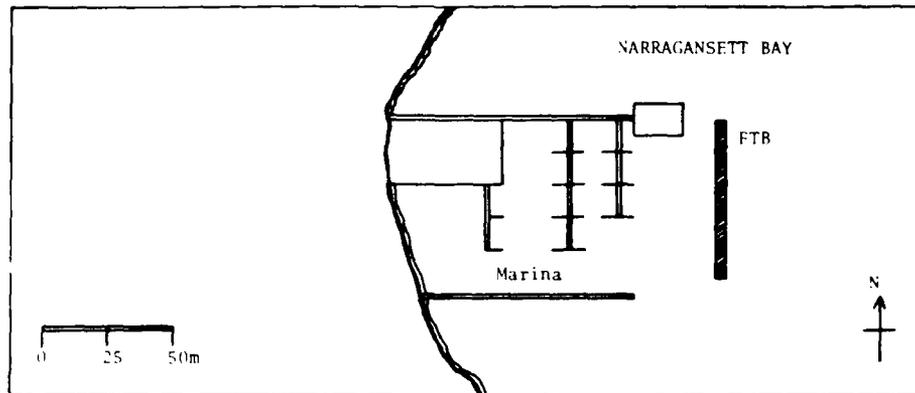
Site:

Construction: This FTB is 61.0 m (200.0 ft) long and 3.7 m (12.0 ft) wide. Primary flotation originally relied on air trapped in the tire crowns. After sinking in 1977, the FTB was retrofitted with polyethylene blocks inserted in the tires. Rubber conveyor belting fastened by nylon bolts is used to couple the tires. Rope is used to couple the modules.

Installation: The breakwater is anchored to four 908-kg (2,000 lb) concrete blocks spaced evenly along the structure's exposed side. Mooring lines are of chain and are 22.9 m (75.0 ft) in length.

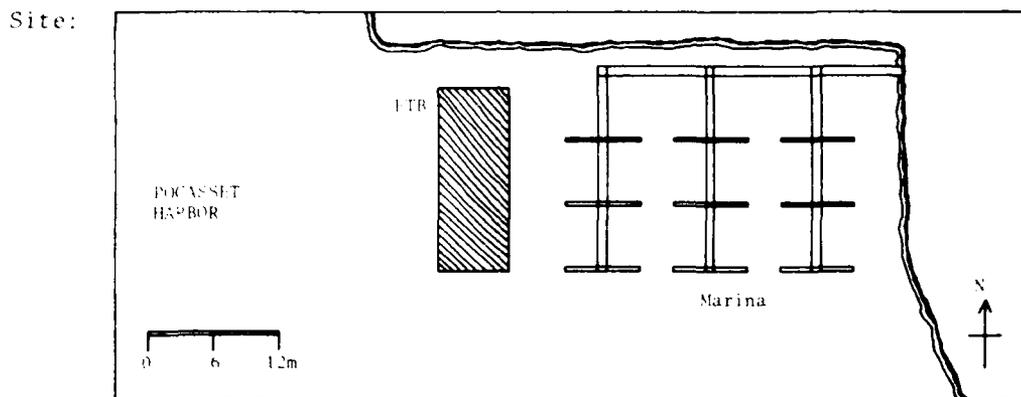
Construction: This FTB is 17.1 m (56.0 ft) in length and 6.4 m (21.0 ft) in width. Originally, the breakwater relied on trapped air for flotation and on a variety of experimental materials, including rope, chain, and stainless-steel cable, for coupling. This structure lasted approximately 2 years before the couplings failed and flotation became a major problem. The reconstructed unit uses rubber conveyor belting fastened with nylon bolts as the coupling material. Polyurethane foam poured into the tire crowns now provides primary flotation. The only problem encountered in constructing the breakwater was difficulty in drilling through the belting.

Installation: The breakwater is anchored by five 909-kg (2,000 lb) concrete blocks. Three of the anchors are positioned on the exposed side of the structure and two on the leeward side. Mooring lines are of nylon/chain and are 4.3 m (14.0 ft) in length.

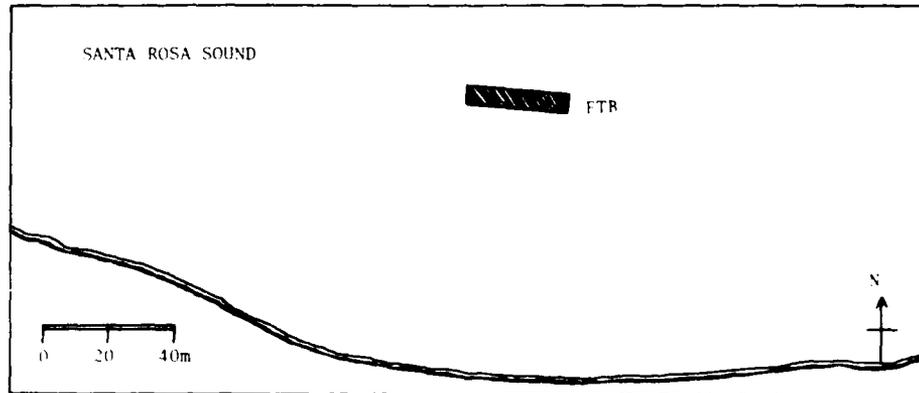
Site:

in the tire bases. Holes, 1.5-inch diameter, were drilled in the truck tire bases to prevent sand from accumulating in them. It was also hoped that the high sidewalls of the larger tires would aid in keeping out sand. Because the tires were substantially exposed at low tide, flotation relied solely on air trapped in the tire crowns. Rubber conveyor belting coupled the tires and was fastened by tying the end of the belting into square knots.

Installation: The breakwater was moored by six 11 kg (25 lb) danforth anchors placed at each corner and in the middle of each end. The mooring lines were of 0.5-inch nylon and were 9.1 m (30.0 ft) in length.

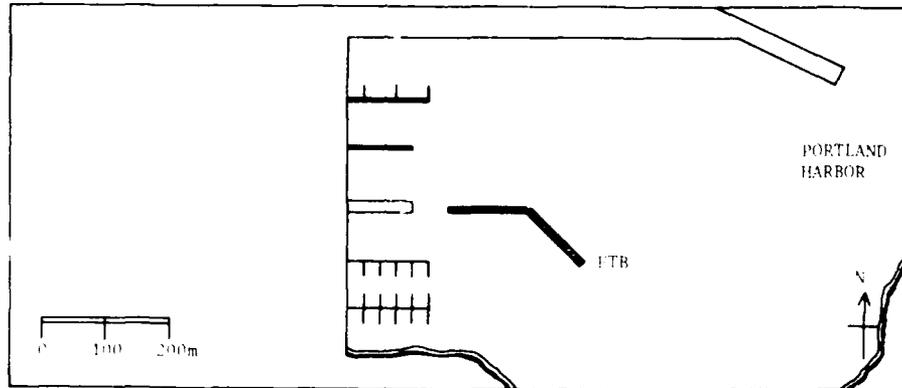
Site:

Construction: This FTB is 243.8 m (800.0 ft) in length with half the structure 10.7 m (35.0 ft) wide and the remainder 6.4 m (21.0 ft) wide. Primary flotation relies on air trapped in the tire crowns. Rubber conveyor belting fastened by bolts is used to couple the tires.

Installation: The breakwater is tied to pilings by rubber conveyor belting. On the structure's exposed side, the pilings are spaced 15.2 m (50.0 ft) apart and on its leeward side, 30.5 m (100.0 ft) apart.

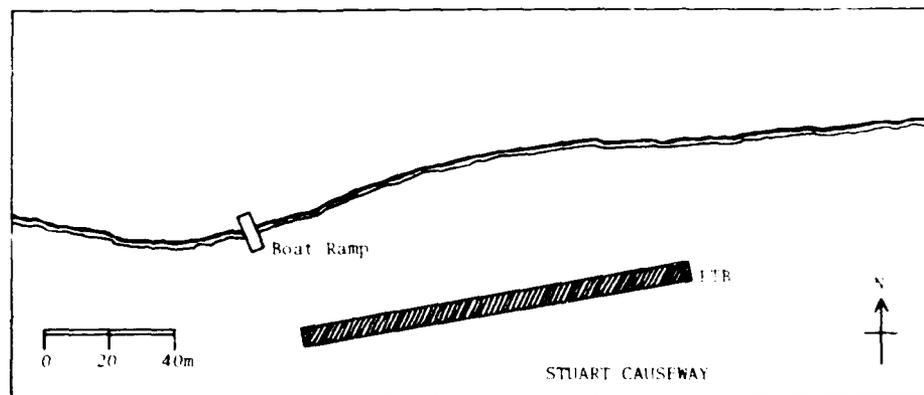
Site:

Construction: The first unit was 118.9 m (390.0 ft) in length and 6.1 m (20.0 ft) in width. Primary flotation relied on polyethylene blocks inserted in the tire crowns. The tires were coupled by polypropylene rope. The reconstructed structure was also 118.9 m (390.0 ft) in length, but only 4.0 m (13.0 ft) in width. Primary flotation was derived from polyurethane foam poured into the tire crowns. Steel cable, 3/8 inch diameter, was used to couple the tires.

Installation: The original structure was moored to 10 danforth anchors. Seven anchors were spaced evenly along the exposed side of the FTB and three were spaced uniformly on the leeward side. Mooring lines were of 3/8-inch steel cable and were 9.1 m (30.0 ft) long. The second breakwater used the same mooring configuration and same type of mooring line, but employed tiedown-type helix anchors in place of the danforths.

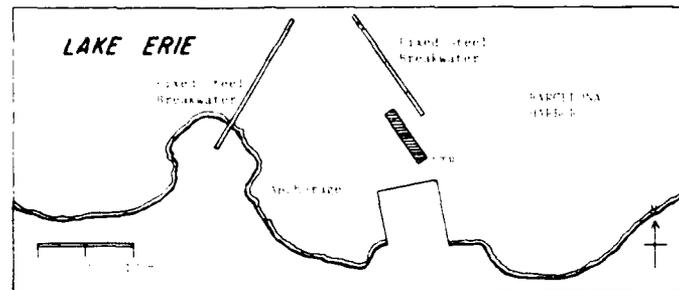
Site:

Construction: This FTB was 61.0 m (200.0 ft) in length and 17.1 m (56.0 ft) in width. Primary flotation relied on air trapped in the tire crowns. Rubber conveyor belting fastened by bolts was used to couple the tires. A volunteer work force was used to build the breakwater and this resulted in inconsistent and poor-quality construction.

Installation: The breakwater was anchored to 1,634-kg (3,600 lb) concrete blocks. On the structure's exposed side, the blocks were spaced 4.3 m (14.0 ft) apart and on its leeward side, 8.5 m (28.0 ft) apart. Mooring lines were of chain and were 12.2 m in length.

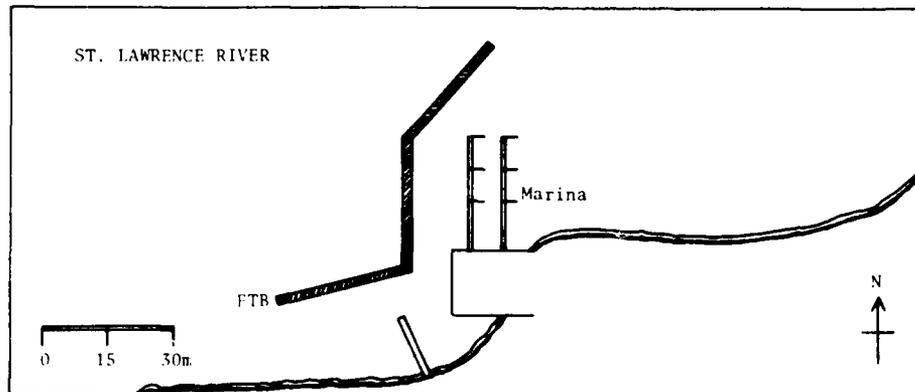
Site:

Construction: This FTB is 91.4 m (300.0 ft) in length and 1.8 m (6.0 ft) in width. Flotation relies solely on air trapped in the tire crowns. Rubber conveyor belting fastened with stainless-steel bolts is used to couple the tires.

Installation: The breakwater is tied to pilings by conveyor belting on its leeward side and anchored on its exposed side. The pilings are spaced 3.0 m (10.0 ft) apart. The anchors are 227-kg (500 lb) concrete blocks and are spaced 7.6 m (25.0 ft) apart. Anchor lines are of chain and are 6.1 m (20.0 ft) long. The builder noted that transporting the breakwater from its inland construction site to the water was a very difficult undertaking.

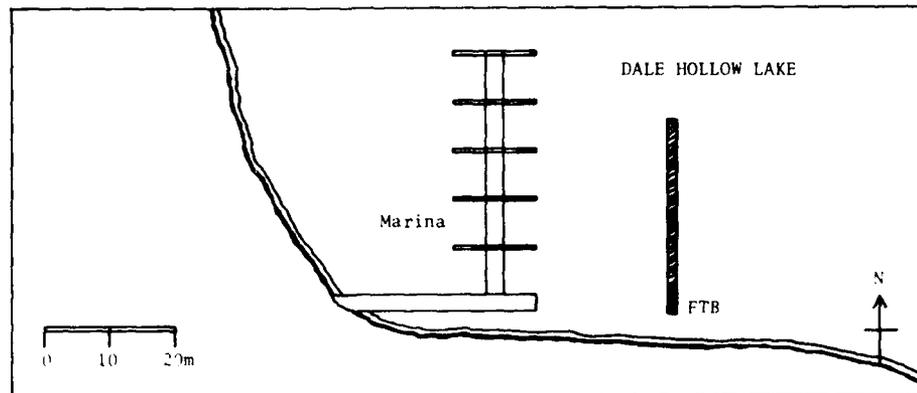
Site:

Construction: This FTB is 30.5 m (100.0 ft) in length and 1.8 m (6.0 ft) in width. Flotation relies on air trapped in the tire crowns. Nylon strapping fastened by banding clamps is used to couple the tires.

Installation: The breakwater is moored by two anchors located at the extreme ends of the structure. Each anchor is a 55-gallon drum filled with concrete. The mooring lines are of wire rope and are 24.4 m (80.0 ft) in length.

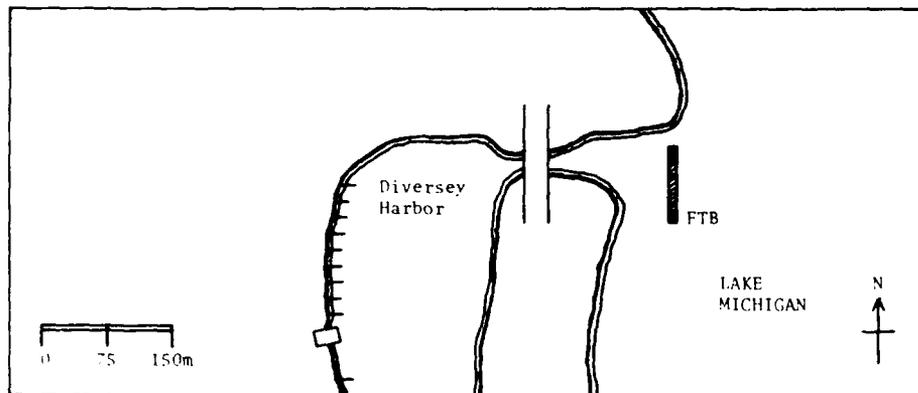
Site:

Construction: This FTB was 91.4 m (300.0 ft) in length and 8.5 m (28.0 ft) in width. Primary flotation was derived from both polystyrene blocks inserted in the tire crowns and polyurethane foam poured into some of the tires. Chain fastened by clamps was used to couple the tires.

Installation: The breakwater was anchored by twenty 1,226-kg (2,700 lb) concrete blocks. On the structure's exposed side, the anchors were spaced 7.6 m (25.0 ft) apart and on its leeward side, 15.2 m (50.0 ft) apart. Mooring lines were of chain and were 10.4 m (34.0 ft) in length.

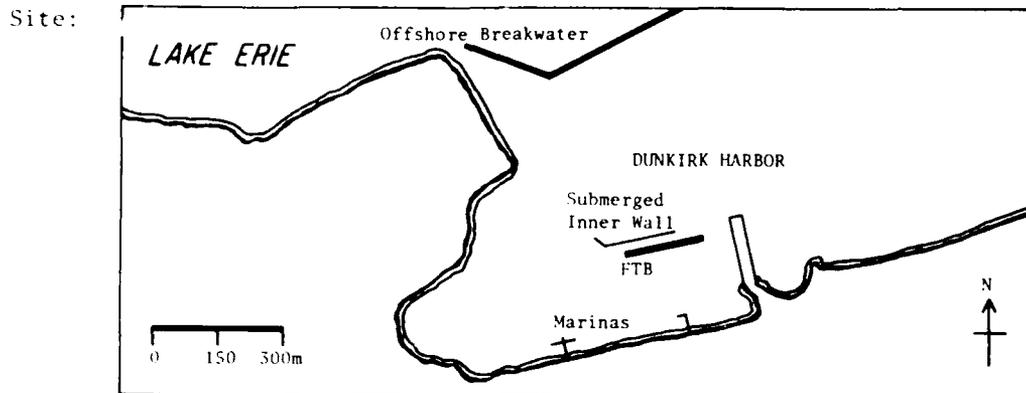
Construction: The original FTB was 182.9 m (600.0 ft) in length and 8.5 m (28.0 ft) in width. This FTB's flotation relied solely on air trapped in the tire crowns. Stainless-steel wire was used as the coupling material. When reconstructed, the FTB was extended to 304.8 m (1,000.0 ft) in length. Polyethylene blocks were inserted in the tires to aid flotation and open link Campbell chain replaced the stainless-steel wire.

Installation: The breakwater was initially anchored by 24 cylindrical-shaped 272-kg (600 lb) cement blocks. These were found to roll on the bottom during strong wave action and so were replaced by a like number of rectangular-shaped cement blocks. Mooring lines were of chain and were 19.5 m (64.0 ft) in length.

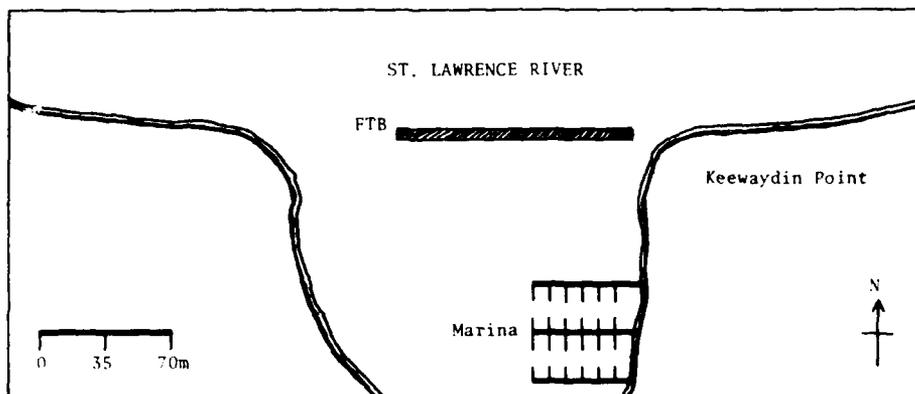
Site:

Construction: This FTB is 121.9 m (400.0 ft) in length and 5.9 m (19.5 ft) in width. Primary flotation is derived from polyurethane foam poured into the crowns of the tires. Rubber conveyor belting fastened with nylon bolts is used to couple the tires. The only problem encountered in the design stage was the public's reluctance to accept the project due to their anticipation that the FTB would have an unsightly effect on the waterfront. The operator noted that this bias vanished once the structure was deployed.

Installation: The breakwater is tied to pilings on both its exposed and sheltered sides and anchored also on its leeward side. The pilings are spaced 18.3 m (60.0 ft) apart. The anchors are 136-kg (300 lb) concrete blocks and are spaced 15.2 m (50.0 ft) apart. Mooring lines are of chain and are 30.5 m (100.0 ft) in length.

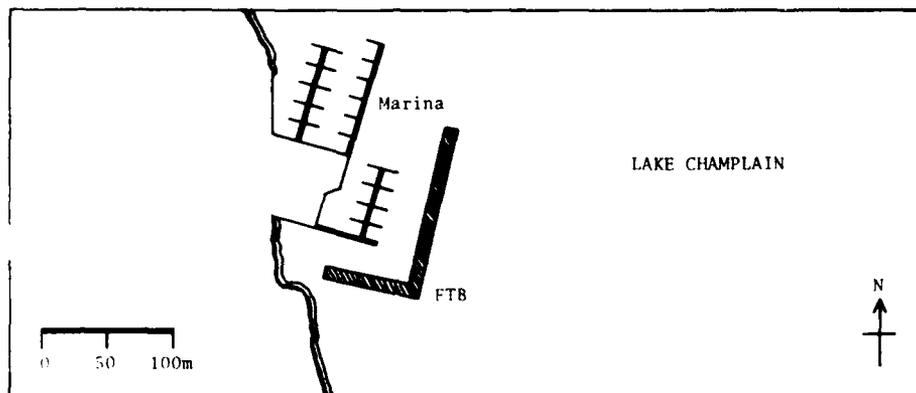
Site:

Construction: This FTB is 198.1 m (650.0 ft) long and 9.1 m (30.0 ft) wide. Flotation relies on air trapped in the tire crowns and is aided by polyethylene blocks inserted in some of the tires. A 3/8-inch-high test chain bolted together is used to couple the tires.

Installation: The breakwater is moored by 45 kg (100 lb) mushroom anchors on its leeward side and 363-kg (800 lb) to 454-kg (1,000 lb) railroad wheels on its exposed side. The anchors are spaced 30.5 m (100.0 ft) apart. Mooring lines are of chain-wire and are 18.3 m (60.0 ft) long.

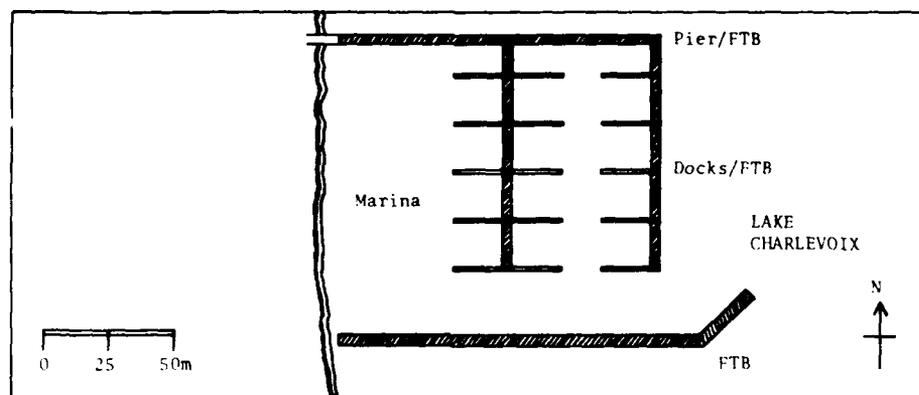
Site:

with two dock-breakwater extensions each 91.4 m (300.0 ft) long. Enclosing the southern side of the marina is a second FTB, 161.6 m (530.0 ft) long. The width of these units is 3.7 m (12.0 ft). Primary flotation is derived from polyurethane foam poured into the tire crowns. Rubber conveyor belting fastened with bolts is used to couple the tires.

Installation: The breakwaters are both tied to pilings and anchored by 9 kg (20 lb) danforth anchors. Anchors and pilings are spaced from 3.0 m (10.0 ft) to 3.7 m (12.0 ft) apart. Mooring lines are of wire rope and vary from 3.0 m (10.0 ft) to 18.3 m (60.0 ft) in length.

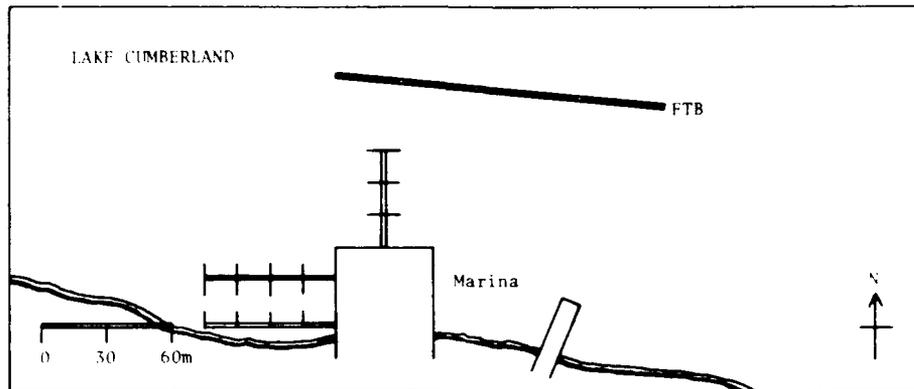
Site:

Construction: This FTB is 152.4 m (500.0 ft) in length and 1.8 m (6.0 ft) in width. Primary flotation is derived from polyethylene blocks inserted in the tire crowns. The tires are coupled together with 0.25-inch cable fastened with clamps. The cable and clamps are of stainless steel due to the acidic nature of the water.

Installation: On its exposed side, the structure is moored by several 454-kg (1,000 lb) anchors. On its leeward side, the breakwater is moored to the shore via three concrete-filled barrels. Mooring lines are of stainless steel wire and are 91.4 m (300.0 ft) in length.

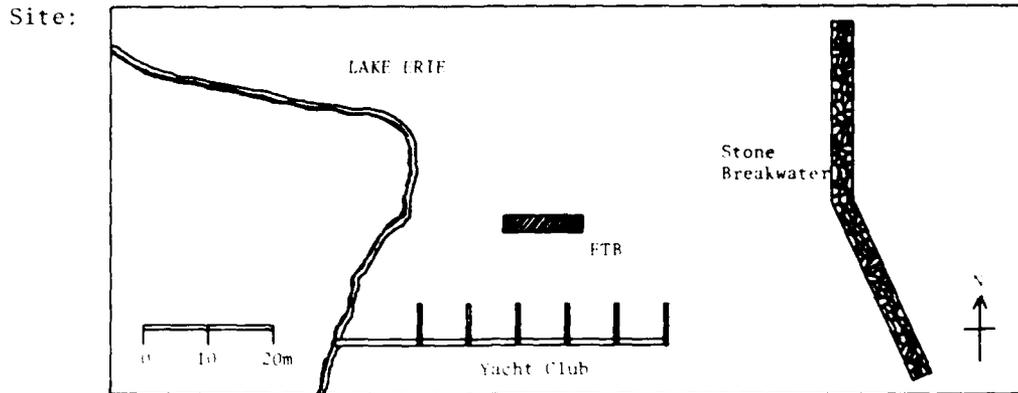
Construction: A pole-tire module consists of three telephone poles coupled parallel to one another by channel and threaded rod. Each pole is skewed with tires held in place by cable. Flotation relies on the

inherent buoyancy of the wooden poles. The prototype consisted of a single module and was 12.2 m (40.0 ft) in length and 2.4 m (8.0 ft) in width.

Installation: The breakwater is anchored by four 227-kg (500 lb) concrete blocks. The mooring points are located at the corners of the structure. The mooring lines are of chain.

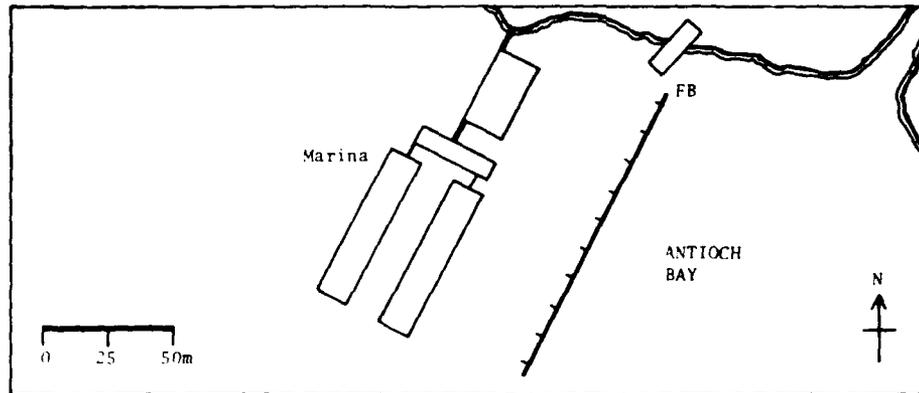
Site:

Ten 3.0-m (10.0 ft) steel fingers extend from the pipe and grasp the 4-inch diameter spudpoles by means of 0.9-m (3.0 ft) -long brackets made from 5-inch pipe.

Installation: The breakwater is free to slide up and down the spudpoles. Ten spudpoles are positioned on the leeward side of the structure at 12.2-m (40.0 ft) intervals. There is also a spudpole at each end of the breakwater.

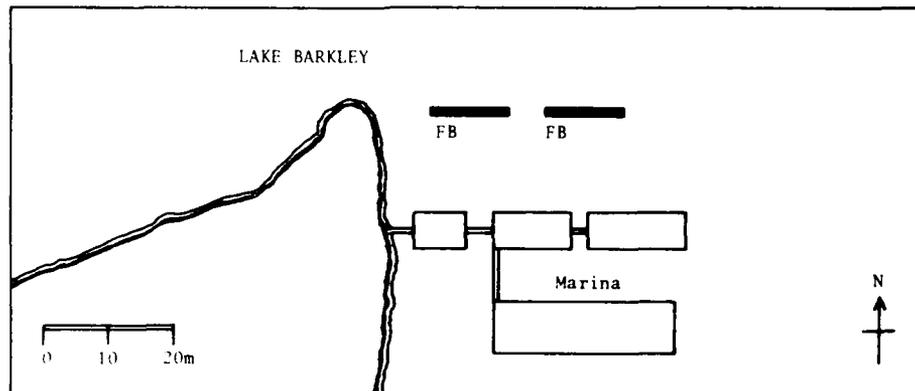
Site:

Installation: Each module is moored to five 50-gallon metal drums filled with concrete. Mooring lines are of wire cable and are 18.3 m (60.0 ft) in length.

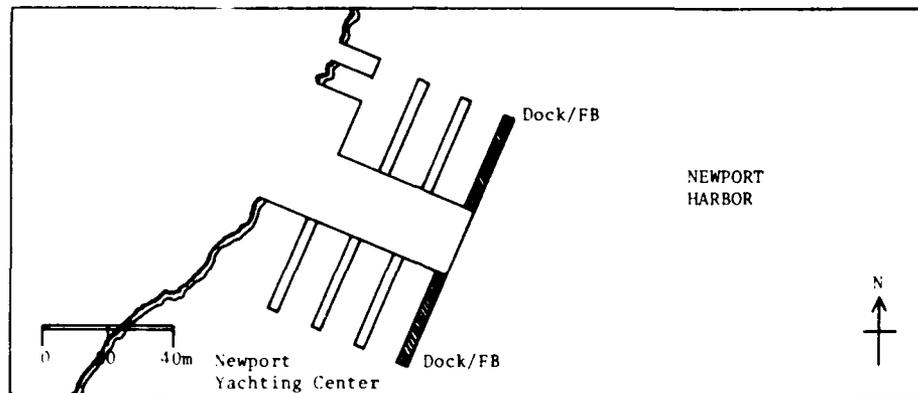
Site:

Construction: Each timber caisson module is 6.1 m (20.0 ft) long and 3.0 m (10.0 ft) wide. In design, this FB is essentially a deep draft floating dock. It is constructed of timber with primary flotation provided by large polyethylene blocks. Modules are coupled together by steel rods held fast by bolts. The finished breakwater will be in two sections, each five modules long.

Installation: The breakwater will be tied to pilings. On the structure's exposed side, the pilings will be spaced 6.1 m (20.0 ft) apart and on its leeward side, 12.2 m (40.0 ft) apart.

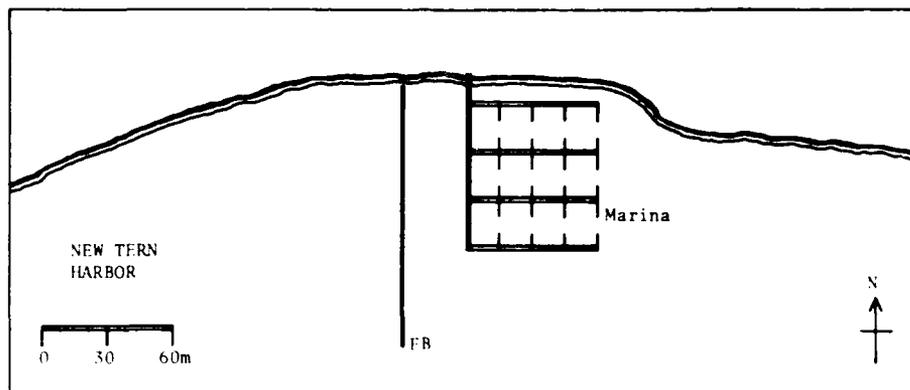
Site:

(170.0 ft) long. It is one log or 0.6 m (2.0 ft) wide. Flotation is aided by a few tires and some polyethylene blocks tied to the structure. Chain is employed to couple the logs.

Installation: The breakwater is anchored to several large concrete blocks. Mooring lines are of chain and are 3.7 m (12.0 ft) to 4.6 m (15.0 ft) long.
