THE NATURE OF QUASICLEAVAGE FRACTURE  
IN TEMPERED 5.5 Ni STEEL  
AFTER HYDROGEN CHARGING

Y. H. Kim and J.W. Morris, Jr.

Department of Materials Science and Engineering  
University of California, Berkeley

Technical Report No. 12  
Office of Naval Research  
Contract No. N00014-75-C-0154

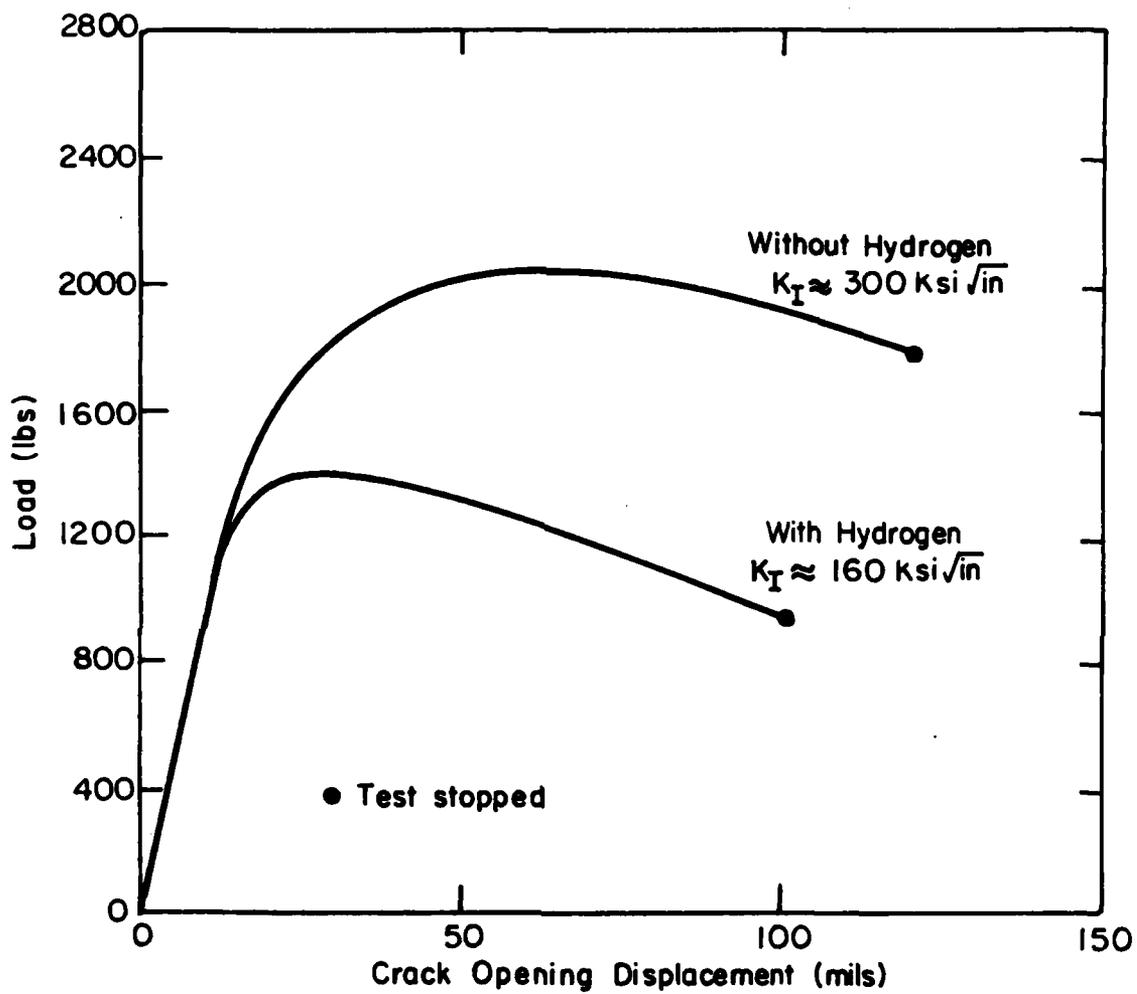
Figure 3. The load-displacement curves of three-point bend specimens of 5.5Ni steel tested before and after hydrogen charging.

Figure 3 shows typical load-deflection curves for 3-point bending specimens fractured with and without hydrogen charging. The hydrogen-free specimen had a high value of the fracture toughness, approximately  $330 \text{ MPa}\cdot\text{m}^{1/2}$  ( $300 \text{ ksi}\cdot\text{in}^{1/2}$ ), and fractured in a totally ductile manner as illustrated by the scanning electron fractographs presented in Figure 4. Hydrogen charging caused a drop in the load-deflection curve and a substantial decrease in the fracture toughness to approximately  $180 \text{ MPa}\cdot\text{m}^{1/2}$  ( $160 \text{ ksi}\cdot\text{in}^{1/2}$ ). In this case, also, the sample was significantly deformed during fracture. The primary fracture mode was quasi-cleavage (Fig. 5), with an occasional admixture of ductile rupture. Secondary quasicleavage cracks were observed branching away from the fracture surface.

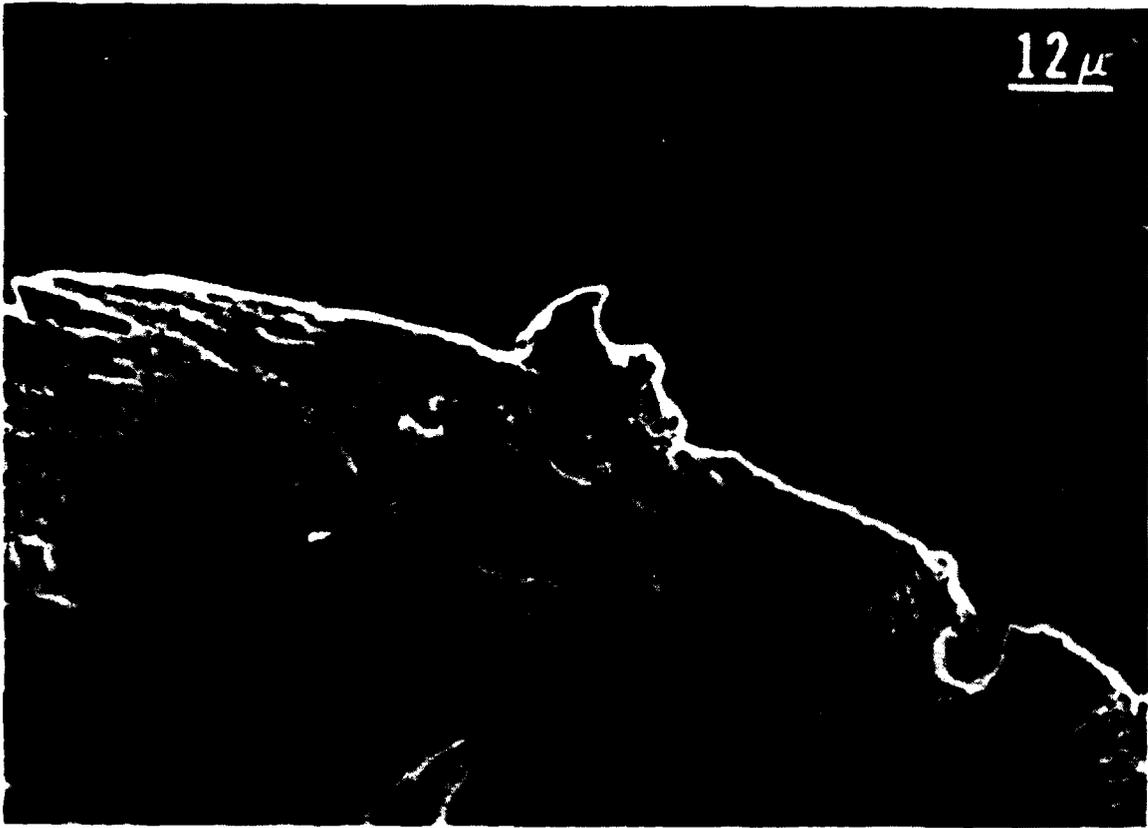
Figure 7. Scanning Electron micrograph of the fracture surface in the specimen embrittled by hydrogen. The specimen has been etched to reveal the lath structure.

A close examination of scanning electron fractographs of the hydrogen-embrittled specimens (for example, Fig. 5) reveals that the quasicleavage portions of the fracture surface are decorated by fine, lath-like features which are comparable in dimension to the martensite laths shown in Figure 2. The etch pits formed on these surfaces (Fig. 6) show the elongated-hexagon shape which is typical of etch pits on  $\{110\}$  surfaces [1,2]. These observations suggest that the fracture propagates preferentially along the martensite laths, and lies either in or parallel to the lath boundaries. Optical and scanning electron micrographs of etched fracture profile specimens (for example, Fig. 7) confirm this conclusion, and suggest that the predominant fracture mode is lath boundary separation.
