DOT/FAA/CT-84/21

# **Suppression and Control of Class C Cargo and Compartment Fires**

David R. Blake

Final Report

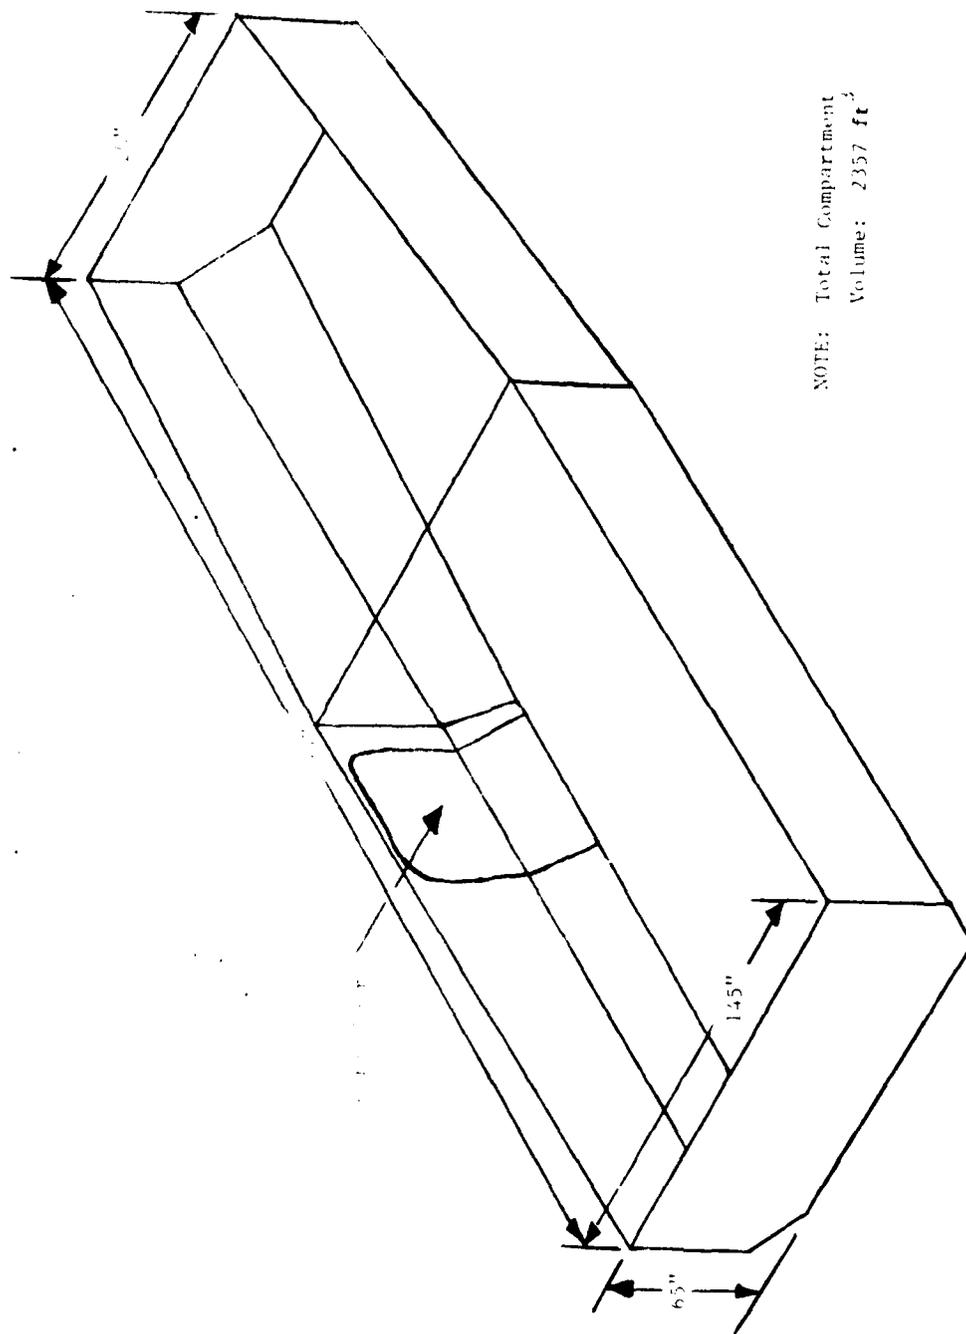
FIGURE 1. DC-10 AFT CARGO COMPARTMENT

NOTE: Total Compartment  
Volume: 2357 ft<sup>3</sup>

The test article was the aft section of a DC-10-30CF fuselage between stations 1460 and 1980. The bulkhead that separated the center cargo compartment and the aft bulk cargo compartment was removed to give the lower cargo compartment with a volume of 2307 cubic feet. Figure 1 shows the shape and dimensions of the cargo compartment. Existing cargo liners were removed and replaced with galvanized steel. Aircraft cabin flooring was installed in the overhead cabin. The ends of the fuselage were capped off with aluminum structure and all unnecessary doors and windows were sealed. Access doors were fabricated for the cabin and cargo compartment. Ventilation was supplied to the cabin through two 10-inch diameter perforated ducts that were installed near the ceiling of the cabin and ran the length of the fuselage. Air was forced through these ducts during testing at the rate of 160 cubic feet per minute (CFM) which provided approximately one air change every four minutes. This air flowed out of the cabin through openings along the sides of the cabin floor, down around the cargo compartment and exited through an outflow valve located in the aft section of the fuselage, under the cargo compartment floor. A system consisting of a fan, valve, and ducting was installed in the cheek area of the test article. This system was used to force air into the cargo compartment at 260 CFM to simulate a heating and ventilation system used on some airplanes. This heating and ventilation system is sometimes referred to as a pet air system and is used to provide an environment suitable for the transportation of live animals. The leakage rate from the cargo compartment was controlled by a perforated duct in the compartment leading to a valve and a calibrated orifice mounted outside the test article. This system was used to raise the leakage rate from the compartment to 200 CFM which was the leakage rate measured from an in-service class C cargo compartment of comparable size. Figures 2, 3, and 4 illustrate the ventilation systems used. The leakage and ventilation rates in the test article cargo compartment were determined by filling the compartment with either carbon dioxide or nitrogen and measuring the rate of decay of the extinguishing agent concentration. This was then equated to a leakage rate (reference 3).

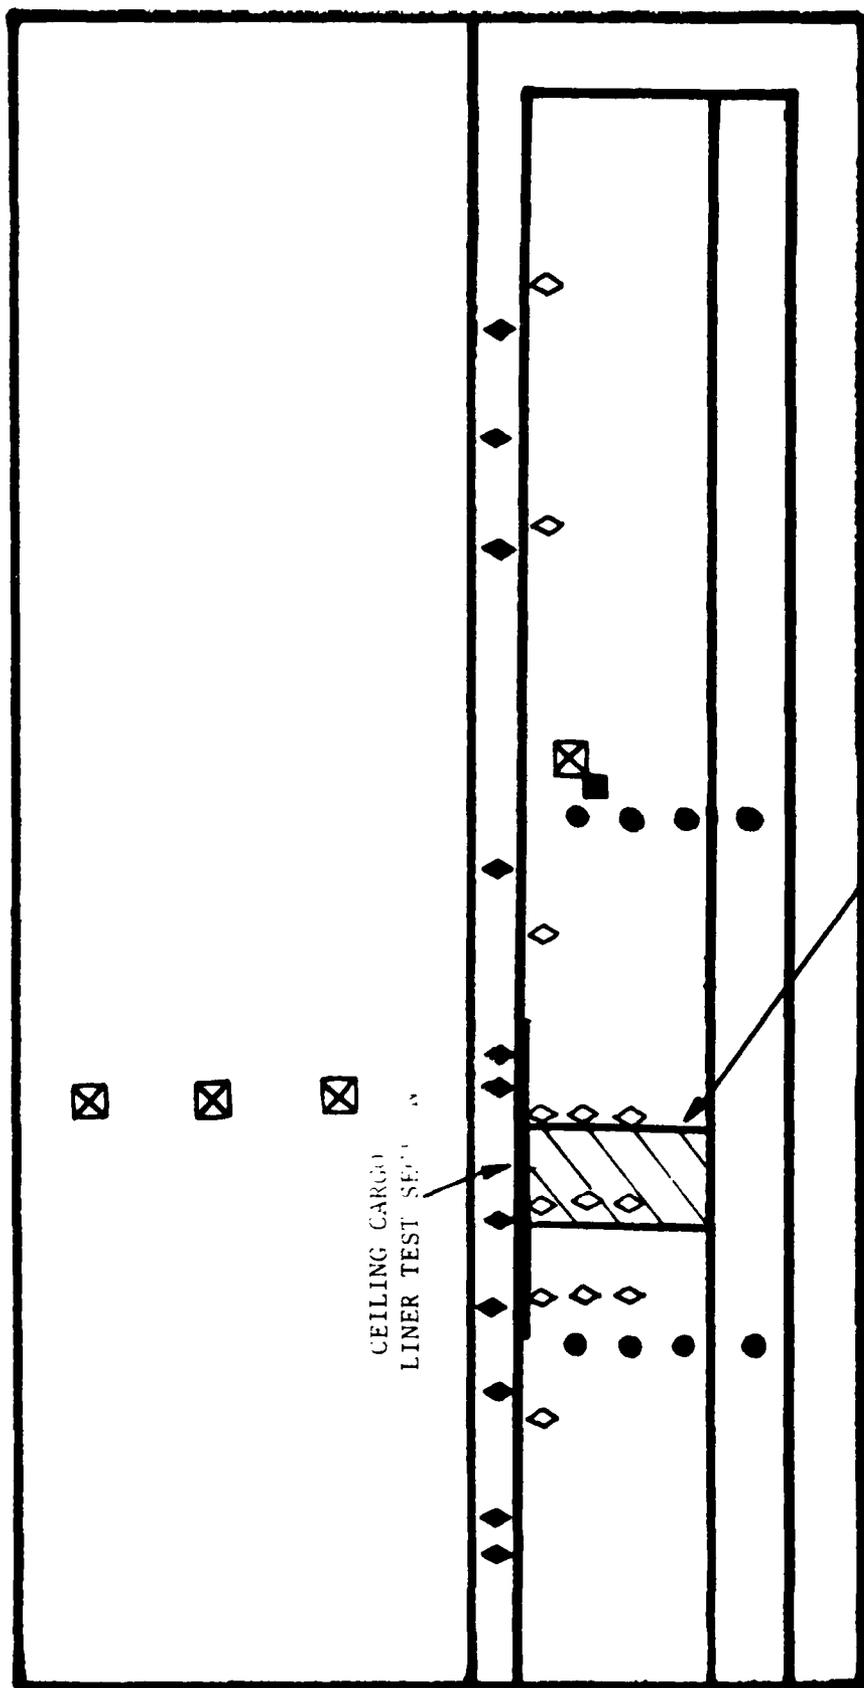
FIGURE 8. INSTRUMENTATION LOCATION SIDE VIEW

SIDEWALL CARGO LINER  
TEST SECTION (TEST 12)

CEILING CARGO  
LINER TEST SECTION

- ☒ - Smoke meter
- ◆ - Thermocouples outside cargo compartment
- ◇ - Thermocouples inside cargo compartment
- - Hydrogen analyzer probes
- - Oxygen analyzer probe

The oxygen concentration in the cargo compartments was measured with a Beckman OM11EA Oxygen analyzer. The sampling point was in the center of the cargo compartment at a height of four feet. Figures 7, 8, and 9 show the location of the instrumentation in the test article.
