EAST COAST AIR COMBAT
MANEUVERING RANGE (EC/ACMR)
OCEAN TOWER CONSTRUCTION
COMPLETION REPORT

EAST COAST AIR COMBAT MANEUVERING RANGE (EC/ACMR)
OCEAN TOWER CONSTRUCTION
COMPLETION REPORT

FPO-1-78(4)
MARCH 1978

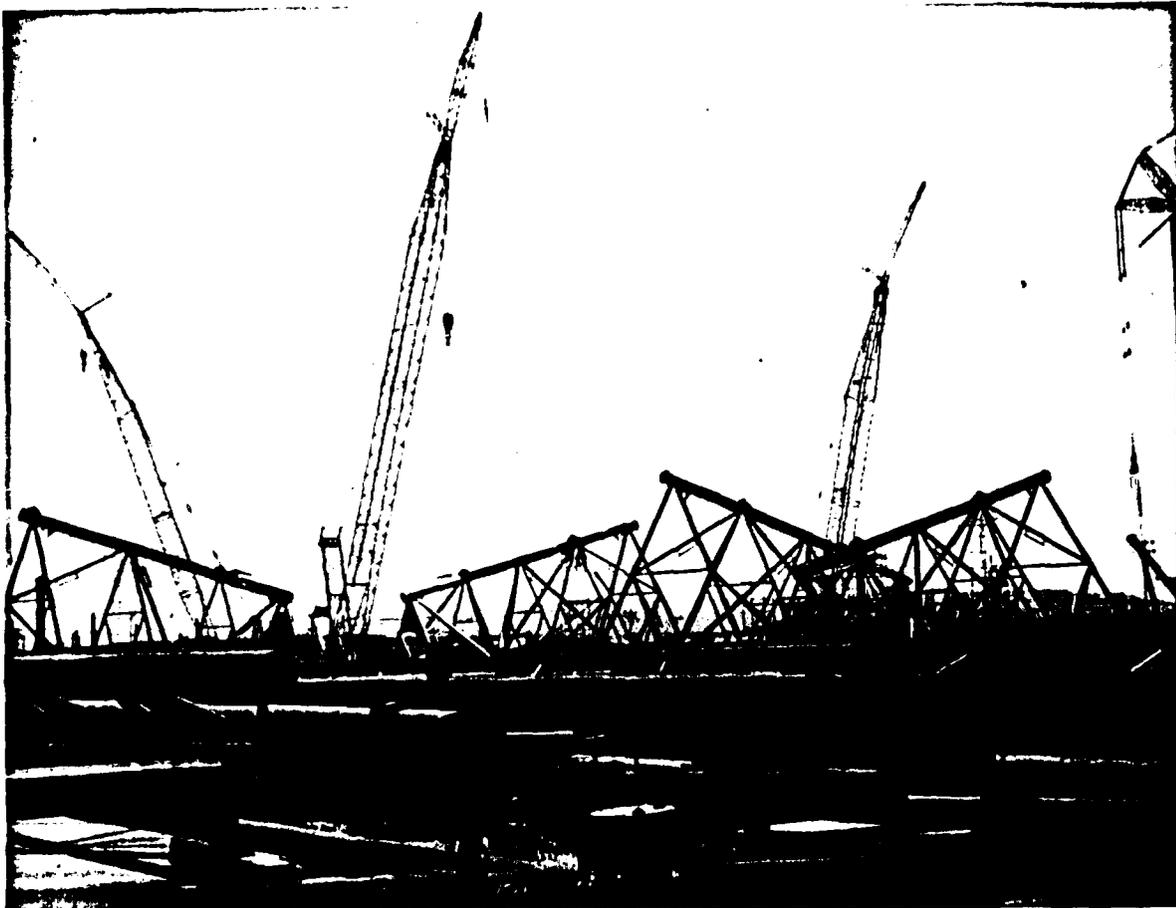
FIGURE 9

JACKETS IN FABRICATION YARD

The first jacket and superstructure (tower #2) were completed by mid-May, nine weeks after initiating fabrication. Because fabrication of each tower including piling was staggered and overlapped, fabrication of all four towers - involving over 3,000 tons of steel and 100,000 man-hours - was completed in twelve weeks, Figure 9. By the first week in June, the contractor was ready to take to sea.

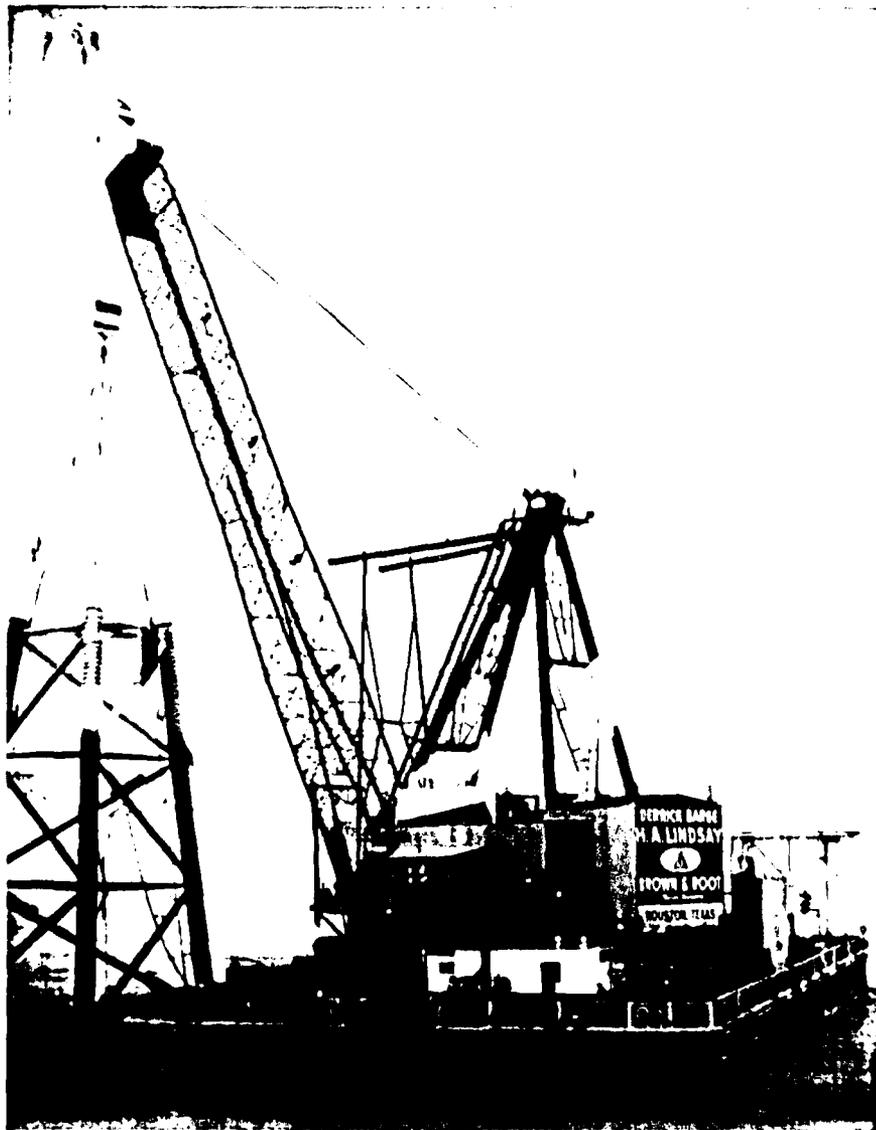
FIGURE 14

CRANE LOWERING A JACKET

- o The crane lifted, positioned, and set the jacket in its proper vertical orientation adjacent the marker buoy. The time required to set the jackets varied from 4 to 6 hours, excluding unnecessary delays, (see construction delays, below). Riggers and welders required two hours to attach lifting hardware and remove sea fastenings; another 2 to 4 hours were required to lift, lower, orient, and position the jacket on the sea bottom, Figure 14.
