DIEGO GARCIA PROJECT DOCUMENTATION REPORT

FEBRUARY 1985

OCEAN ENGINEERING
AND CONSTRUCTION PROJECT OFFICE
CHESAPEAKE DIVISION
NAVAL FACILITIES ENGINEERING COMMAND
WASHINGTON, DC 20374

FLEET MOORING PROJECT

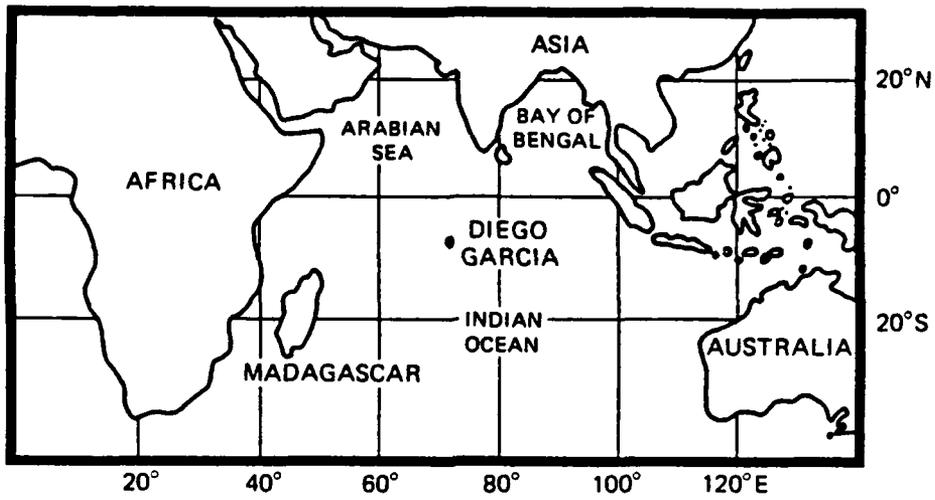
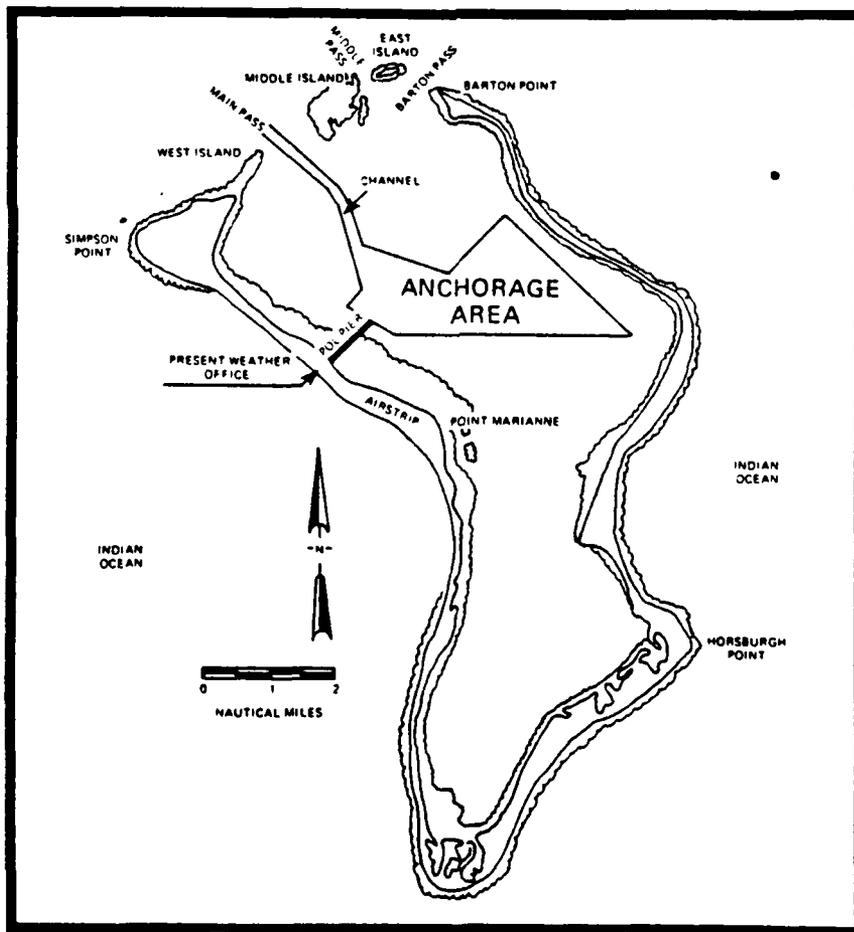
FIGURE 1. Diego Garcia

3. Project Site. Diego Garcia is located in the north central Indian Ocean approximately 7 degrees south of the equator. The island is a coral atoll with an enclosed lagoon about 8 1/2-miles wide by 13-miles long. The closest land mass is southern India, 1200 miles to the north. The island is owned by the United Kingdom, and a bilateral agreement allows the U.S. to occupy the western half (see Figure 1).

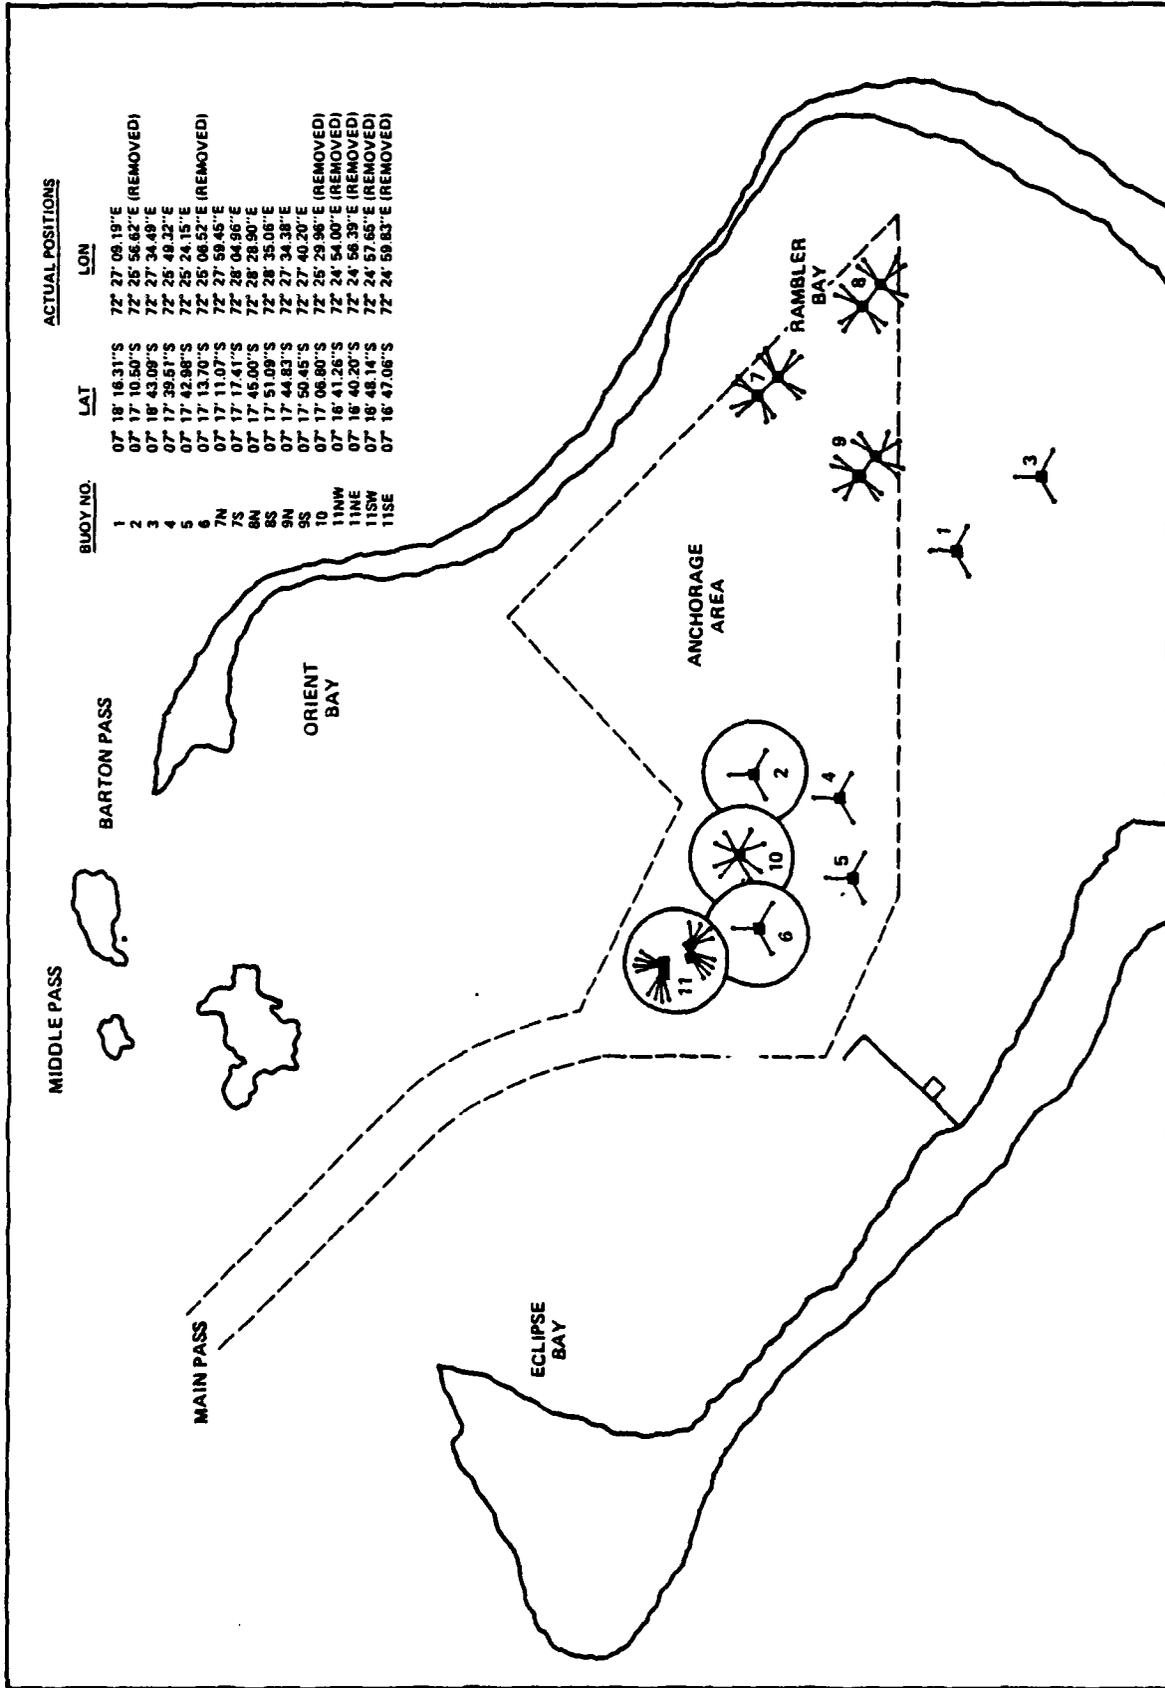
FIGURE 2. Geographic Positions Of Fleet Moorings At Diego Garcia

1. Geographical Data. The locations of the moorings installed in the lagoon at Diego Garcia are shown in Figure 2. The four moorings that were removed have been circled.

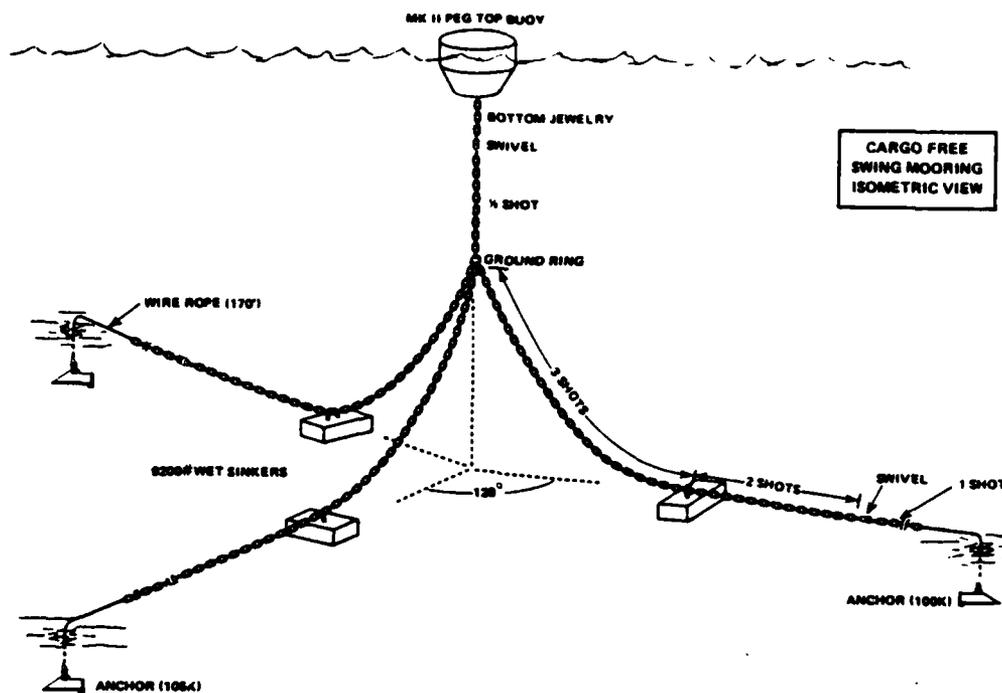
FIGURE 3. CARGO FREE-SWINGING MOORING

- a. Cargo Free-Swinging. Six Cargo Free-Swinging Moorings were installed in the lagoon at Diego Garcia (Moorings 1 through 6). Each of these moorings is a riser type and includes a MK II Peg-Top Buoy, chain swivel, riser chain subassembly, ground ring, three 540-foot anchor chain subassemblies with sinkers, wire rope anchor pendants, and three 100 KIP propellant embedment anchors. The buoy and chain subassemblies of these moorings are cathodically protected with zinc anodes and wire rope continuity cable systems. Figure 3 is an isometric drawing of this type of mooring system.

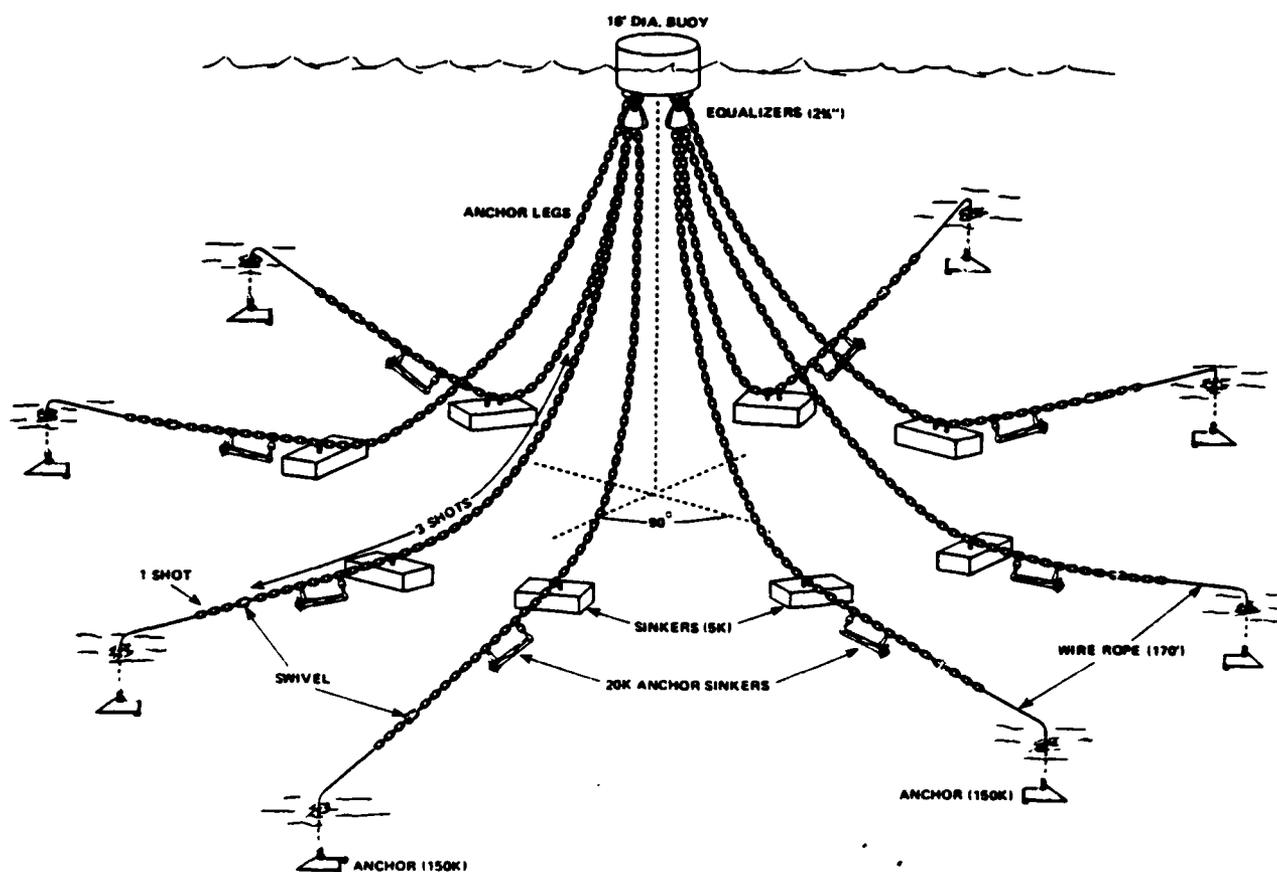
FIGURE 4. TENDER FREE-SWINGING MOORING

- b. Tender Free-Swinging. Mooring 10 was the only Tender Free-Swinging Mooring installed at Diego Garcia. This mooring consisted of a single 16-foot telephone buoy, four 2 3/4-inch equalizers attached to the buoy padeyes, and four ground leg pairs. Each leg of a leg pair consisted of 3 1/2 shots of chain, 25,000 pounds of sinkers, 170 feet of 2 1/4-inch wire rope, and a 150 KIP propellant embedment anchor. Figures 4 and 5 are isometric drawings of this mooring.

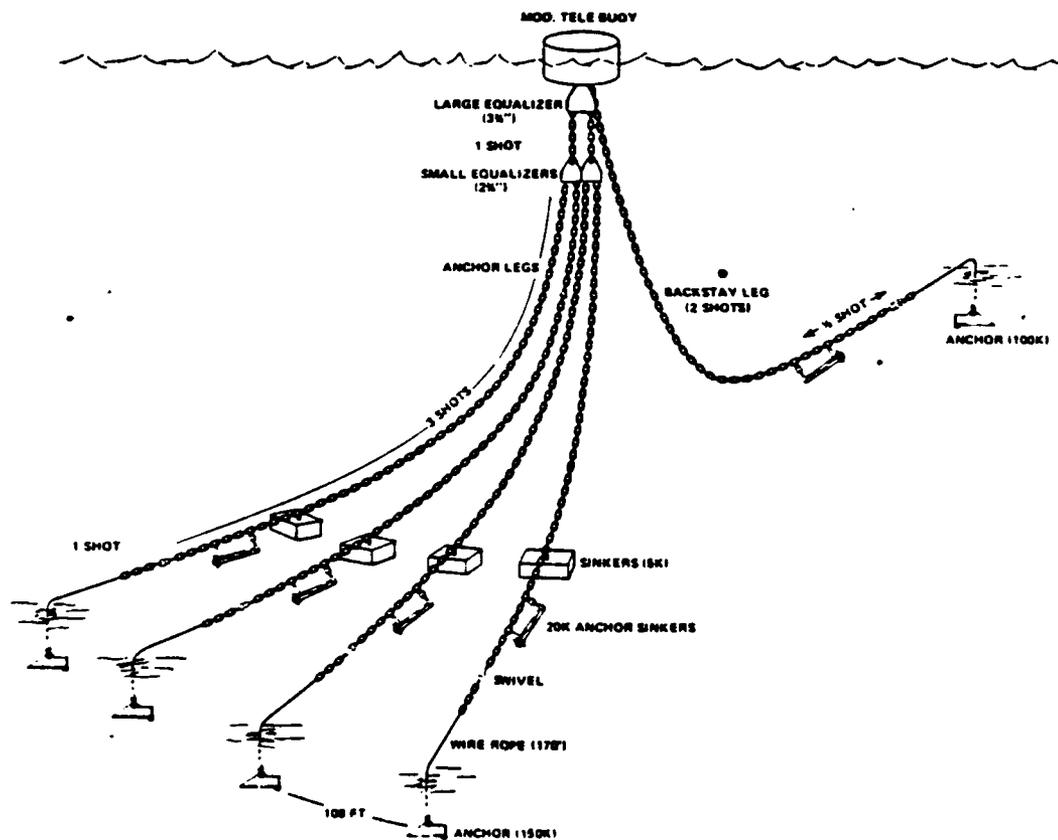
FIGURE 6. TENDER BOW/STERN MOORING

- c. Tender Bow/Stern. The Tender Bow/Stern Mooring consisted of four buoy systems (Buoys 11NE, 11SE, 11SW, and 11NW). Each buoy system consisted of a non-riser buoy and a large (3 3/4-inch) equalizer attached to the buoy's tension bar. A shot of 3 3/4-inch chain passed through this equalizer with a 2 3/4-inch equalizer attached to each end of the chain. A ground leg pair passed through each of

these equalizers. Each leg of a leg pair contained 3 1/2 shots of chain, 25,000 pounds of sinkers, 170 feet of 2 1/4-inch wire rope, and a 150 KIP embedment anchor. In addition, each buoy had a two-shot backstay leg attached to the padeye opposite the direction of the anchor chain subassemblies and anchors. The lower three shots of each half of a leg pair and the backstay leg were cathodically protected. Figures 6 and 7 are isometric views of a typical buoy system of this mooring.

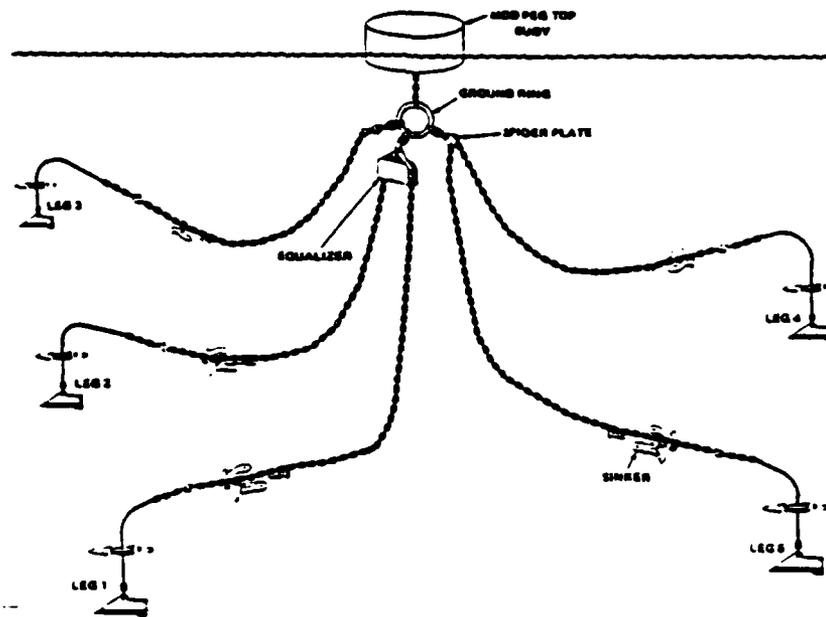
FIGURE 8. BUOY DOLPHIN SYSTEM

- d. Buoy Dolphin System. Each Buoy Dolphin system contained a standard peg-top buoy, modified by the addition of a skirt which gives the buoy a cylindrical shape and provided greater buoyancy. Each buoy was filled with foam. These buoys were changed out with standard peg-top buoys.

Each of the two systems contains a riser assembly, ground ring, and five legs - a single ground leg, a ground leg pair passing through an equalizer, and two backstay legs attached to a spider plate. The lower end of each of the five legs is attached to a 2-inch wire rope anchor pendant leading to a 100 KIP propellant embedment anchor. See Figure 8 for a schematic of a typical Buoy Dolphin system.

Both Buoy Dolphin systems are cathodically protected. There are two anodes attached by brackets to the bottom of each buoy and two attached to the 20K anchor clump shackled to each chain leg. Three quarter-inch wire rope continuity cable is woven through each of the five legs and clamped to the chain and to the anodes on the anchor clumps.

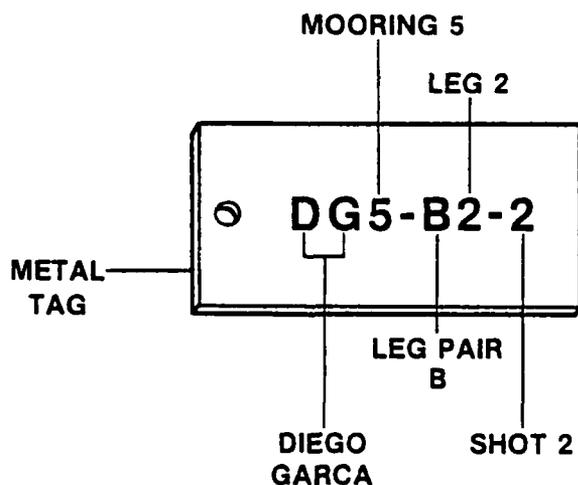
FIGURE 9. INVENTORY MARKING TAG

7. Inventory Marking. Recovered shots of chain destined for fleet mooring inventory storage were each marked with a metal tag which was stamped as shown in Figure 9.

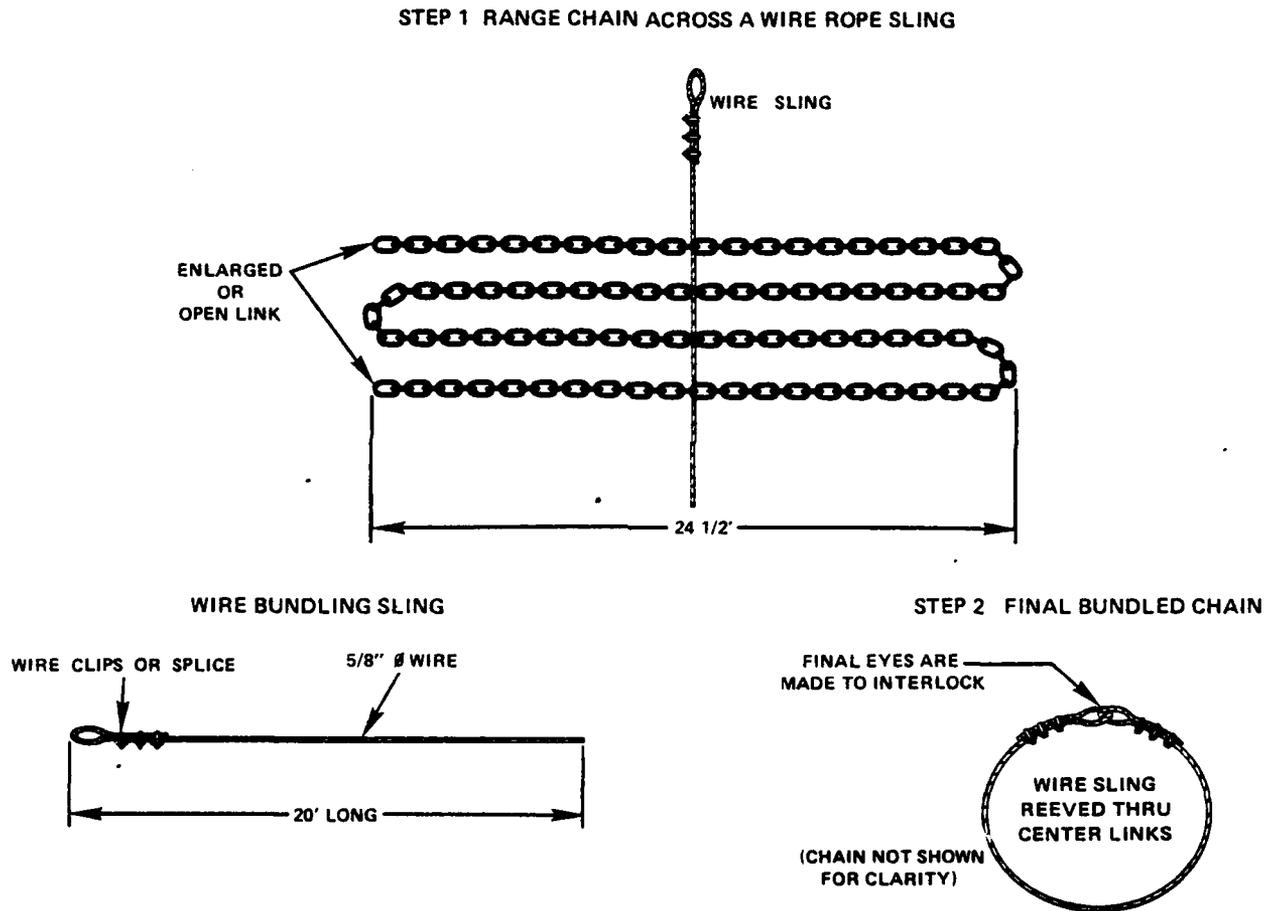
FIGURE 10. BUNDLING CHAIN

8. Inventory Shipment. The recovered chain was separated into shots or partial shots, cleared of wire rope and other extraneous material, and bundled. With the exception that the wire rope was reeved through each of the center links, Figure 10 depicts the bundling procedure followed.
