AFWAL-TR-86-4033

FAILURE ANALYSIS OF COMPOSITE STRUCTURE MATERIALS

Brian Smith
Ray Grove
Thomas Munns
Boeing Military Aircraft Company
P.O. Box 3707 M/S 73-43
Seattle, WA 98124

May 1986
Interim Report for 18 July 1984 to 1 October 1985

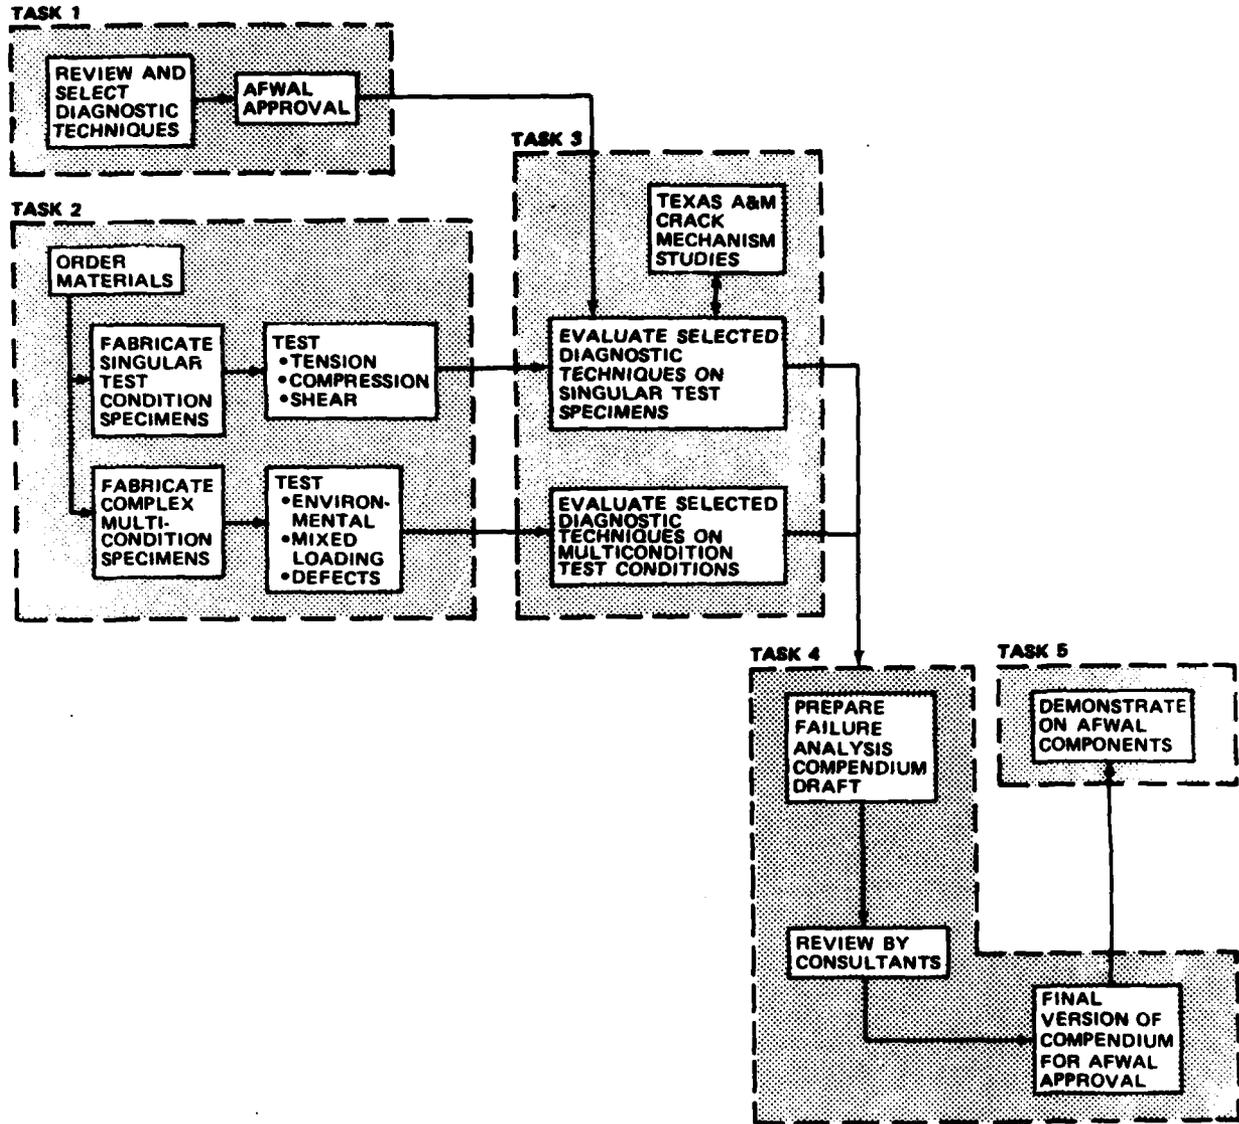
Figure 1-1. Program Task Interrelationships

These tasks and their interrelationships are schematically illustrated in Figure 1-1, and Boeing's FALN is shown in Figure 1-2. Tasks 1 through 3 address the compilation and review of the various diagnostic techniques and protocols available, then select and evaluate their overall utility and effectiveness on test specimens made to fail under controlled conditions. The resulting compendium (Task 4) will provide a listing of the techniques and procedures found to be applicable in Tasks 1 through 3. This compendium will be presented in an instructional format and will include example data/information as well as appropriate FALNs to guide investigators along a logical analysis path. In Task 5 this compendium will be applied by Boeing to three failed components selected and submitted by the Air Force.

Figure 1-1 illustrates the specific interrelationships of these tasks, with Boeing's experience forming the basic foundation at program start. In general, comprehensive failure analysis has been hampered by a lack of clearly defined information requirements. Research, while moving forward, has not always addressed large-scale in-service failures or the needs of the failure analyst. Since Boeing has been involved in composite failure analyses since 1977, that experience and FALN (see Figure 1-2) have produced an initial model defining the necessary requirements, techniques, and procedures.

As illustrated in the Introduction and Objectives (see Figure 1-1), this program involves five tasks that verify and expand Boeing's existing metals and composites failure analysis capabilities. This interim report summarizes Tasks 1 through 3. The bulk of the program's investigative effort, these tasks were to establish:

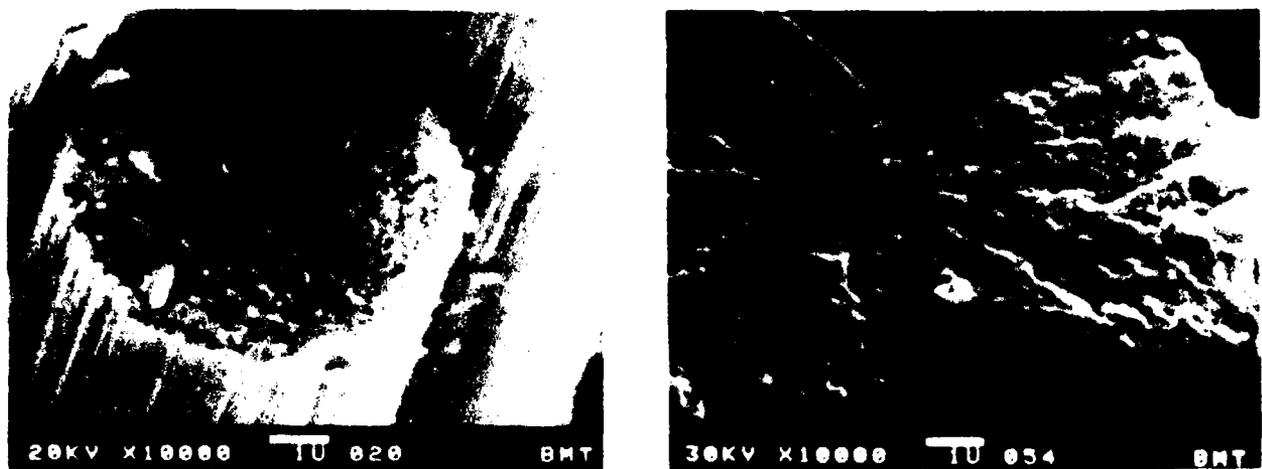
Figure 4-4. Radial Fiber Fracture Topography

On a more detailed level, all of the above researchers observed the features of individual or groups of fiber ends fractured under uniaxial tension. As illustrated in Figure 4-4, Miller and Purslow have demonstrated that fibers fractured under longitudinal tension exhibit a distinct radial topography; these radial patterns were shown to originate from a variety of sources, including internal and surface flaws as well as adjacent fiber fractures. This latter condition is particularly well demonstrated in Figure 4-4, derived from Miller and Wingert's work, both of whom claim that radial patterns illustrate the direction of individual fiber fracture. In Miller's studies, the orientation of individual fiber fractures is said to be extremely localized. As a result, it was reported that the direction of overall crack propagation could not be identified through examination of these features. However, in Purslow's work radial fiber features are shown to have an overall orientation sufficient to establish a global direction of crack propagation. This discrepancy between Miller and Purslow may reflect Miller's use of 0-degree (rather than cross-ply) layups, which are prone to axial-shear splitting. In general, this splitting tends to break the

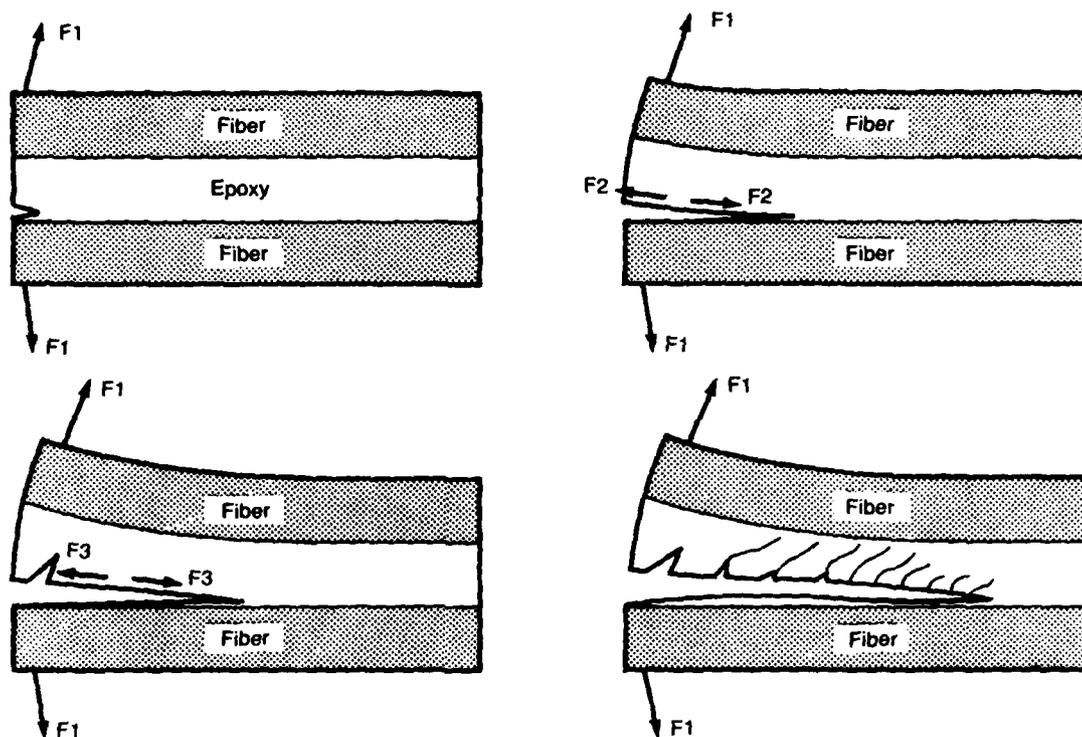
Figure 4-7. Hackle Formation Through Secondary Cracking Due to Bending Behind the Crack Tip

At variance with the above findings, Morris and Robertson have observed hackle structures under conditions of applied interlaminar tension. Morris advances an explanation for his observation by identifying a mechanism that forms hackles as a result of secondary cracks generated by continued flexure behind the crack tip (Figure 4-7). In this model, there is an indication that secondary cracks initiate and grow at an angle in the direction of overall crack growth. This indication gives rise to Morris' proposed method of determining the direction of crack growth by drawing arrowheads on a photograph of the specimen such that the arrowheads appear to be inserted into the open crack tips; the arrowheads then indicate the direction of propagation. This model gives no explanation for the tendency of cracks to grow at an inclined angle. Furthermore, Morris observes the existence of hackles inclined in opposing directions on mating fracture surfaces, which would seem to preclude the use of his proposed model to determine a clear direction of crack growth. As a result, it is difficult to evaluate the effectiveness of Morris' model based on the information available.

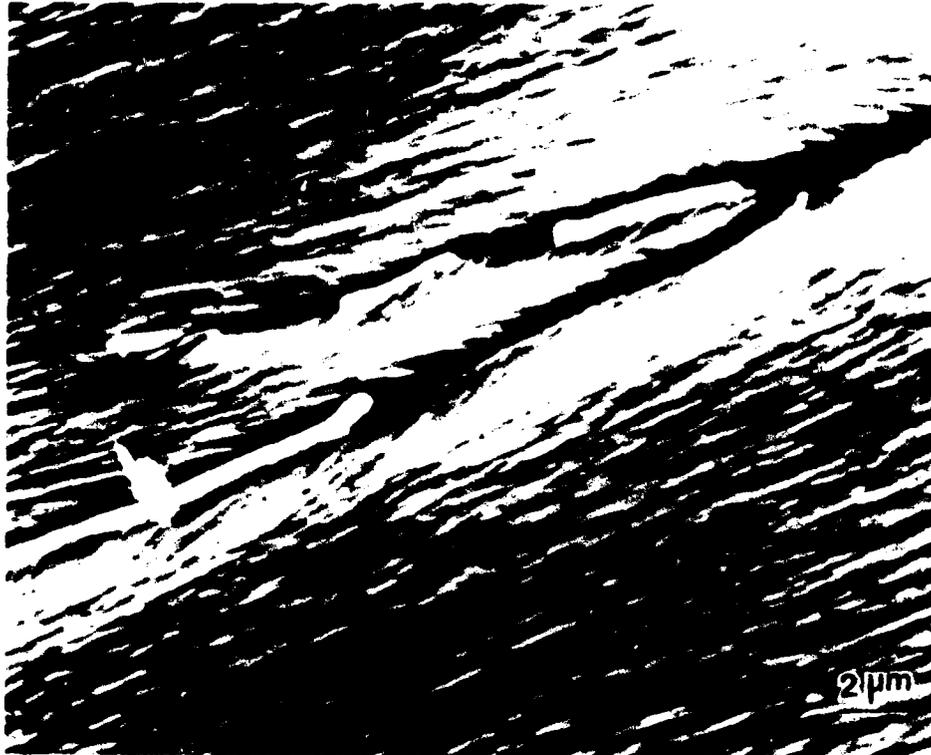
Figure 4-8. Cleavage Steps and Resin Texturing

River markings, often referred to as cleavage lines or cleavage steps, are the second major feature noted by most investigators. As presented by Robertson in Figure 4-8, these features exhibit a distinct branched structure identical to that found in the fracture

In addition to river marks and hackles, investigators Robertson, and Liechti have observed a feathered or textured resin fracture morphology under tensile loading. Robertson notes that this textured morphology tends to be extremely fine—on the order of 350 nm (See Figure 4-8). As a result, it tends to be visible in the scanning electron microscope only when viewed at pronounced tilt. Robertson suggests this fine film texture arises from

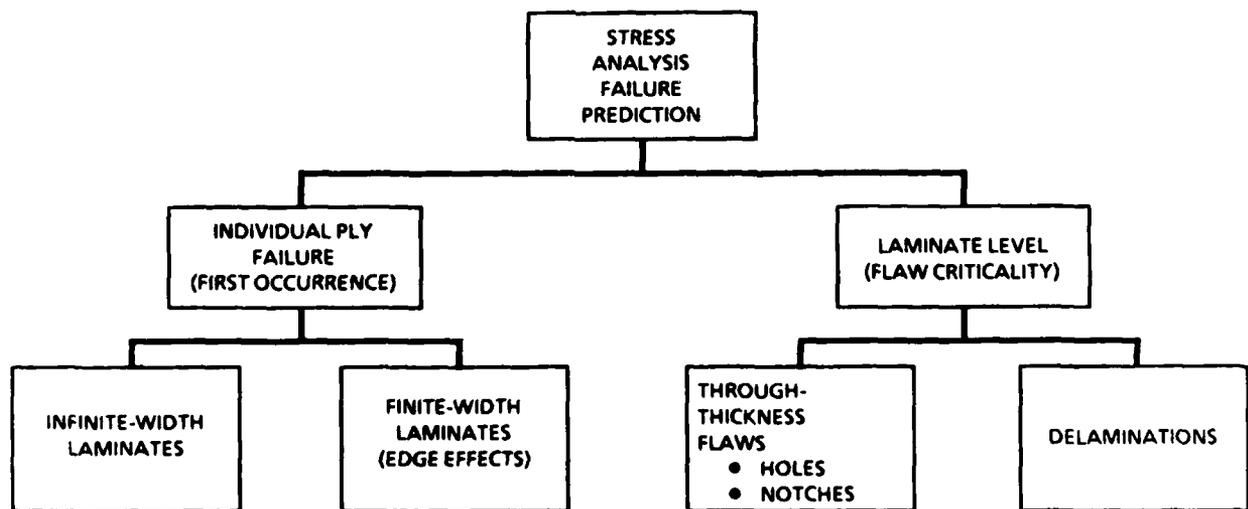
Figure 4-10. Stress Analysis Literature Search Breakdown

To perform a detailed review, the literature was broken down into two broad categories of failure criteria: individual-ply, and laminate-level failure. These two categories and their subdivisions (illustrated in Figure 4-10) reflect a basic division in the level of detail involved in each approach.

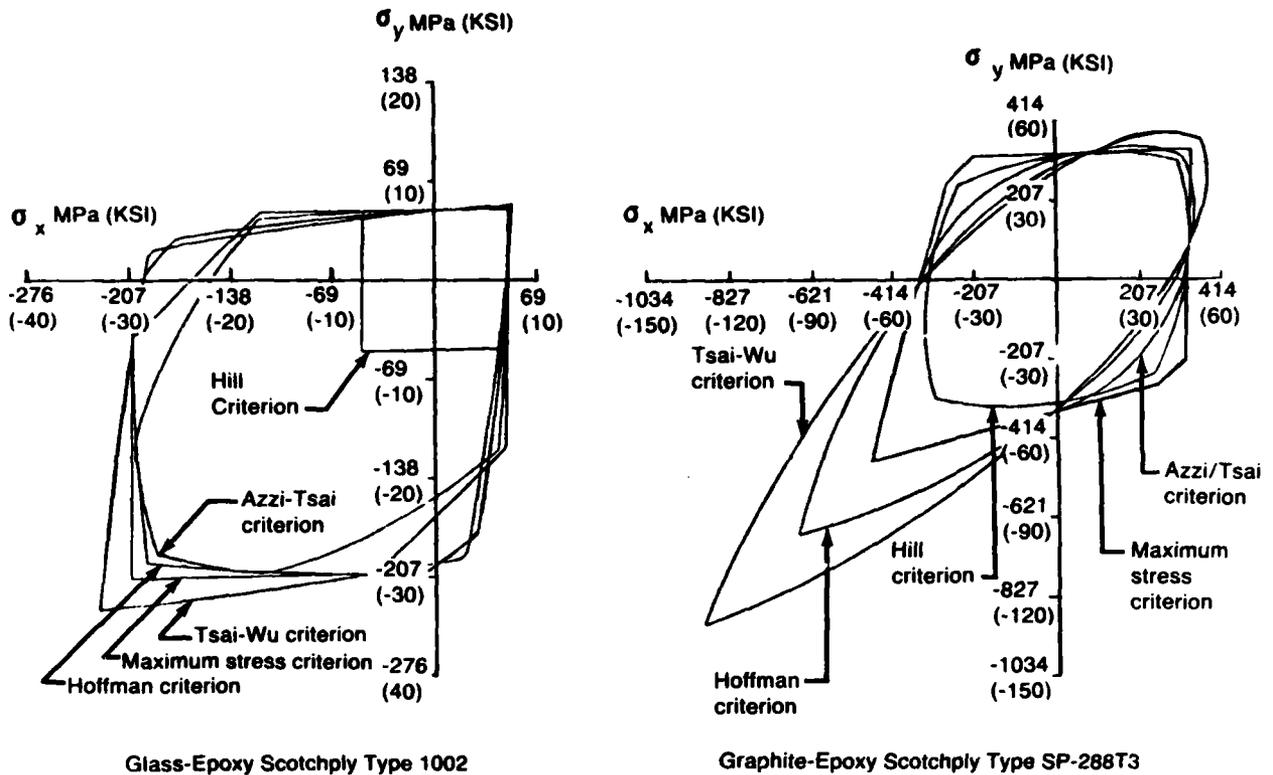
Figure 4-12. Comparison of Yield Criteria for Glass- and Graphite-Epoxy

Many of these failure theories are adaptations of the energy distortion failure theories commonly employed in predicting the onset of failure in metals (Von Mises' Theory). As noted in Craddock's work, the failure envelopes predicted by these criteria vary widely. Figure 4-12 illustrates the laminate failure envelopes predicted by each criteria for fiberglass and graphite-epoxy laminated tubes. To a large extent, the variations reflect

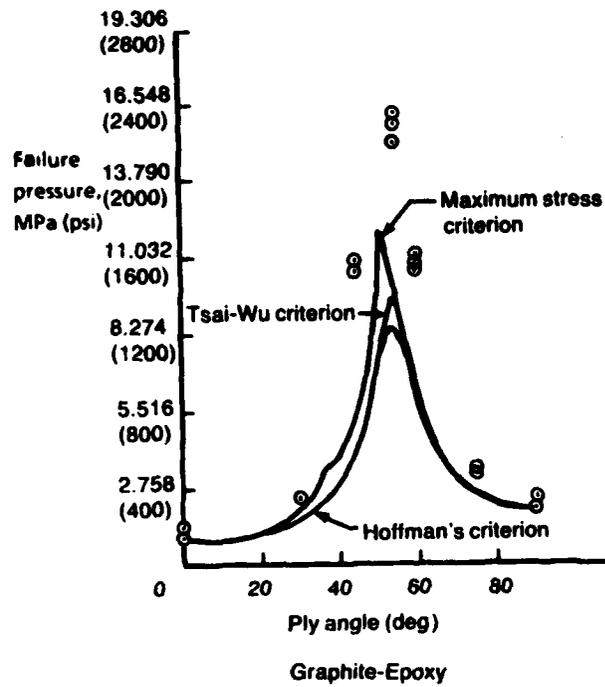
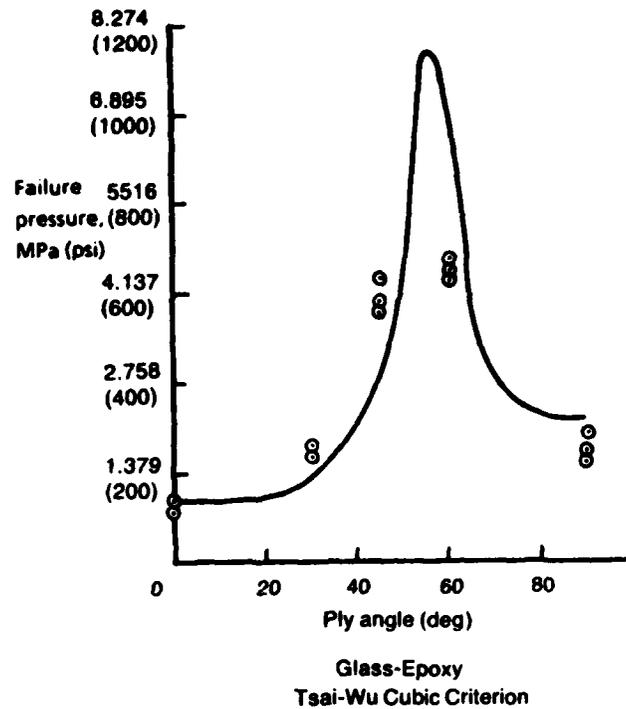
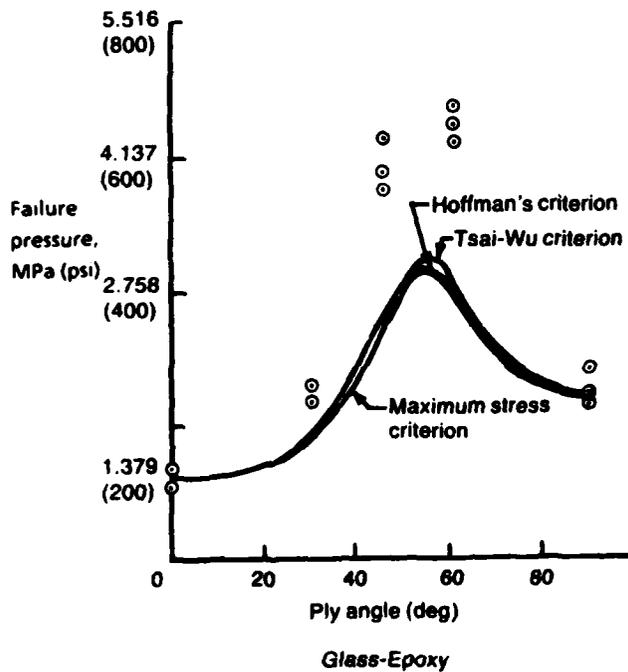
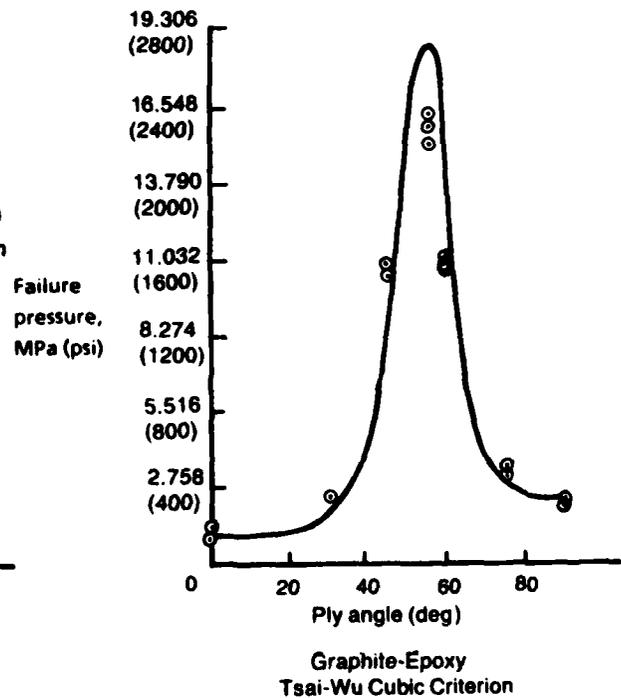
Figure 4-13. Predicted Versus Actual Failure Pressure for Laminated Cylinders.

the extent to which each criteria accounts for anisotropy in material strength. More significant than these differences, however, is the ability of each theory to predict the actual point of failure onset. As presented by Craddock, a comparison of the actual with the predicted onset of failure for relatively simple laminates reveals substantial differences (Figure 4-13). While the criteria indicate general trends in failure stresses, they do not appear capable of predicting failure onset with much accuracy. This situation reflects the difficulty in applying an analytical model to variable material strengths. Another potential contributor to this inaccuracy is the fact that each criterion predicts the occurrence of failure at an individual-ply level rather than at the laminate level, where measurable failure occurs. In either case, the great differences in accuracy and predicted envelopes highlight some of the major problems with attempts to analytically predict the point of failure.

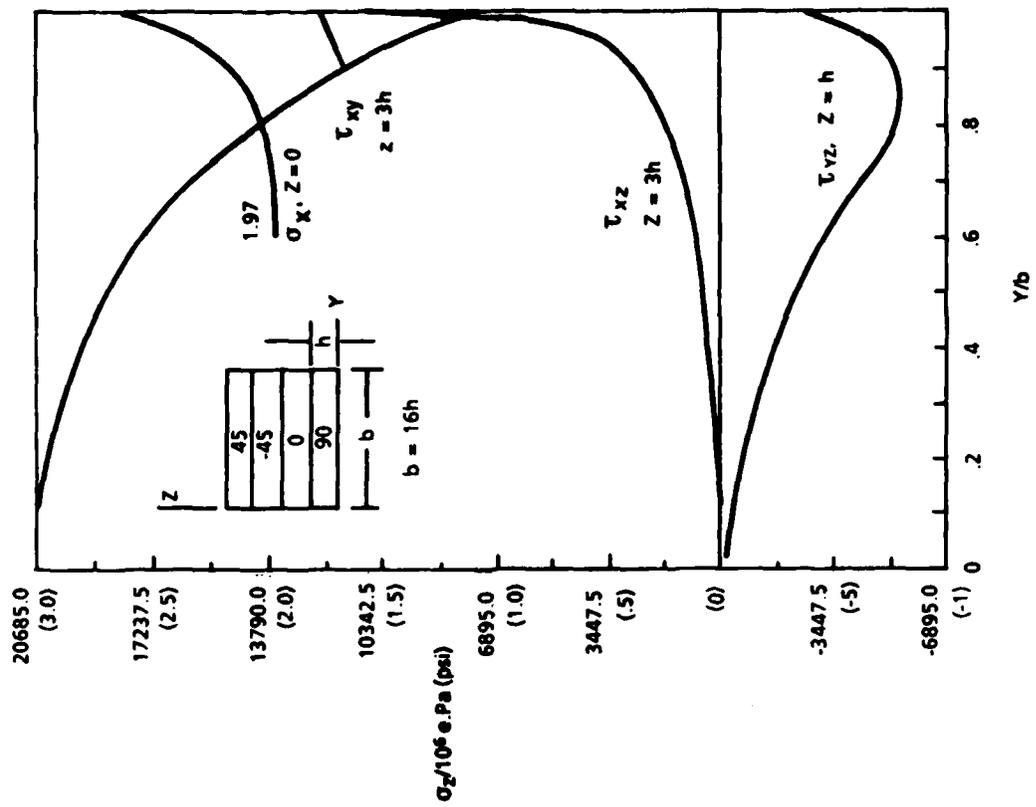
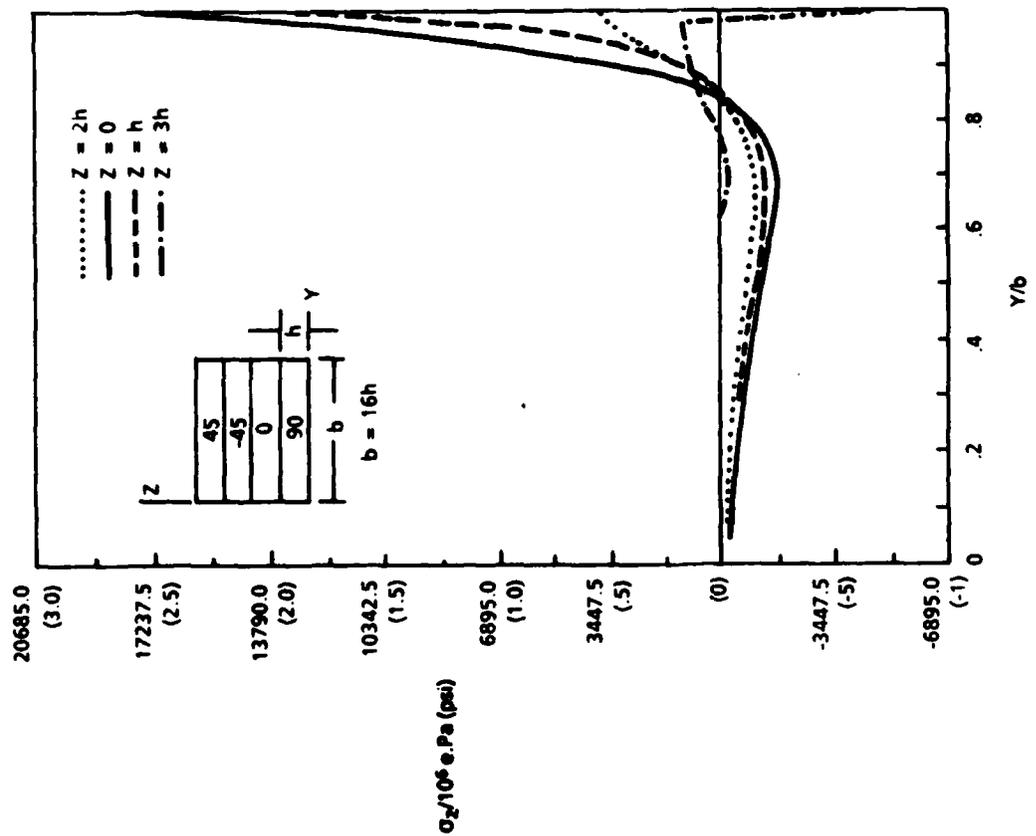
Figure 4-14. Stress Gradients Resulting From Edge Effects

complexity in predicting failure onset using individual-ply failure criteria. For the failure analyst, these works are useful in that they embody considerations likely to be necessary with real-world structures. Both Crossman and Herakovich observed that significant variations in stresses and strains can occur at the free edge of specimens. Both authors show the magnitude of these stresses for relatively simple layups and specimen geometries. Generally, the most significant stresses are those developed near the specimen's free edge. In analyzing these stresses, both authors employed two-dimensional finite-element grids arranged along the specimen cross-section. Using these grids illustrates the degree of complexity involved in determining the stresses (or strains) in microscale with such design details. As noted by Crossman, particularly large gradients can occur in both Z and Y directions (Figure 4-14). Regarding the application of individual-ply failure criteria, the large increase in σ_z , σ_x , and τ_{xz} stresses near the edge of the specimen are particularly significant, since laminate theory methods would have ignored these increases.

Variations stress distributions along several ply interfaces in (+45/-45/0/90 - degrees)_s

Distributions along each ply interface for (+45/-45/0/90 - degree)_s

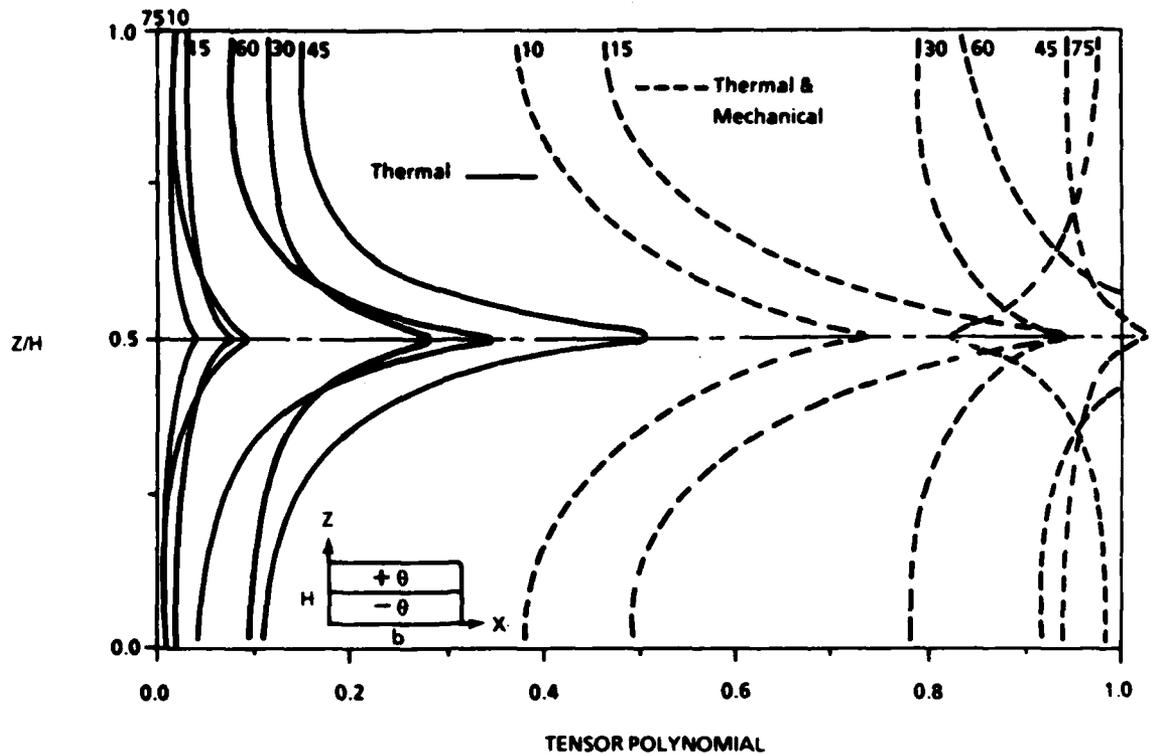
Figure 4-15. Through Thickness Tensor Polynomial Distributions For Curing Stresses and Stresses at First Failure in $[\pm\theta]$, Laminates

Both Crossman and Herakovich predicted that stresses would be further influenced by internal cure stress, test temperature, and conditions of moisture absorption or desorption (Figure 4-15). In Herakovich's work, the relationship of these stresses to failure prediction were considered. Since his finite-element model examined stresses along three dimensions, it was necessary to observe a fully three-dimensional failure criterion. Herakovich used the tensor polynomial criteria advanced by Tsai-Wu, in which strength tensors are given in terms of material principal strengths. As illustrated in Figure 4-16, Herakovich predicted that the onset of failure depends quite strongly on edge stresses, particularly for small ($+0$) laminate angles. While not verified against actual test data, these results, when considered with Crossman's, clearly indicate that both edge and environmental stress effects must be carefully evaluated in predicting the onset of failure for whichever individual-ply criteria are employed.

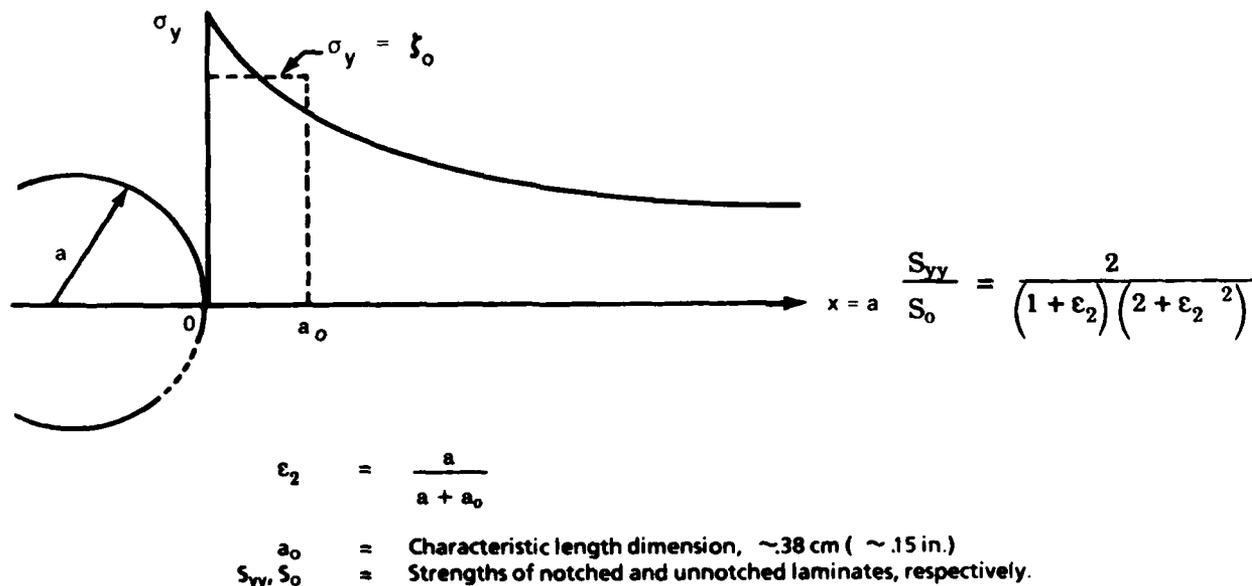
Figure 4-18. Strength Reduction of Uniaxially Loaded Plate With Circular Hole, According to Average Stress Criterion

include two failure criteria which assume failure occurs when the stress at some distance away from the flaw reaches the ultimate material strength. These two are the average stress, and the point stress failure criteria models. As described in Daniel's paper, the average stress failure criterion proposes that failure occurs when the average stress over a characteristic material dimension (a_0) equals the material strength. This criterion is illustrated in Figure 4-18, where a_0 represents the length dimension of a particular layup and material. Similarly, the point-stress failure criterion presented by Mikulas predicts that panel failure occurs when the axial stress at some distance (d_0) from the hole boundary equals the strength of the unnotched laminate as shown in Figure 4-19. Daniel, Mikulas, and other investigators measured both a_0 and d_0 for a variety of layups and found a relatively good correspondence of predicted and measured strengths for open holes (Figure 4-20). Of particular concern to the failure analyst, however, is the ability to predict failure onset for flaw conditions such as through-cracks or impact damage. In this area, Mikulas examined the applicability of the point failure criteria; for the case of a

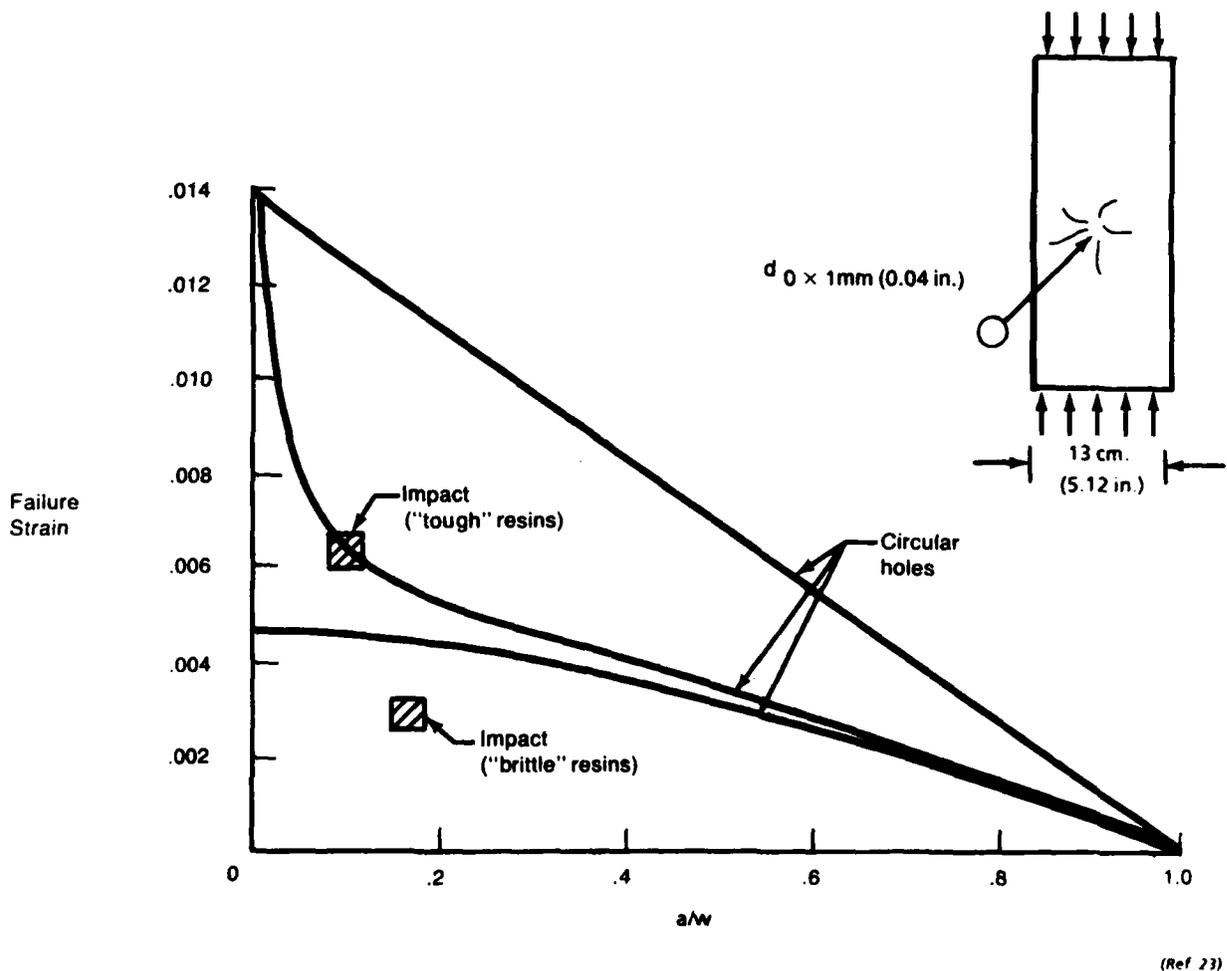
Figure 4-21. Effect of Impact Damage on the Compressive Strength of a Quasi-Isotropic Laminate.

With respect to impact damage, Mikulas reported that the characteristic length d_0 depends on the toughness of the resin system examined. As illustrated in Figure 4-21, a relatively good correlation exists for tough resin chemistries, but not for brittle, delamination-prone resin systems. These observations indicate that the accuracy of failure predictions will depend strongly on the resin system used, and the configuration of damage examined.

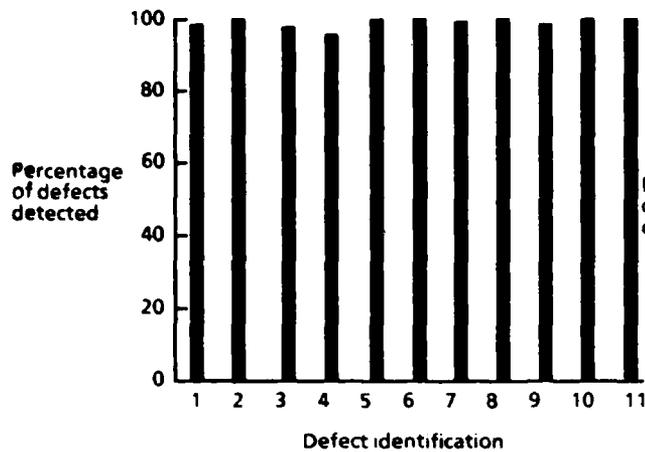
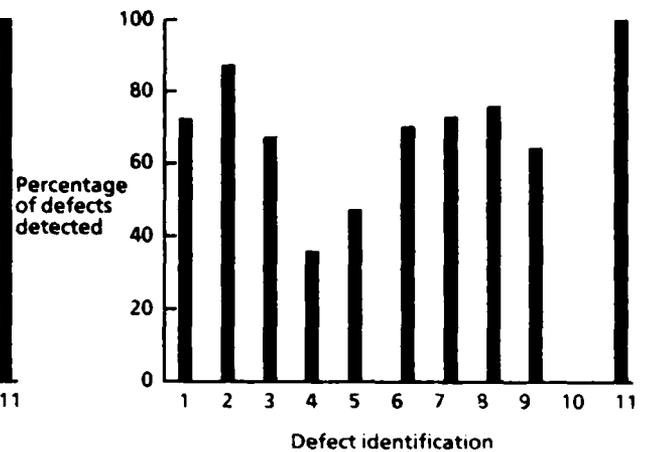
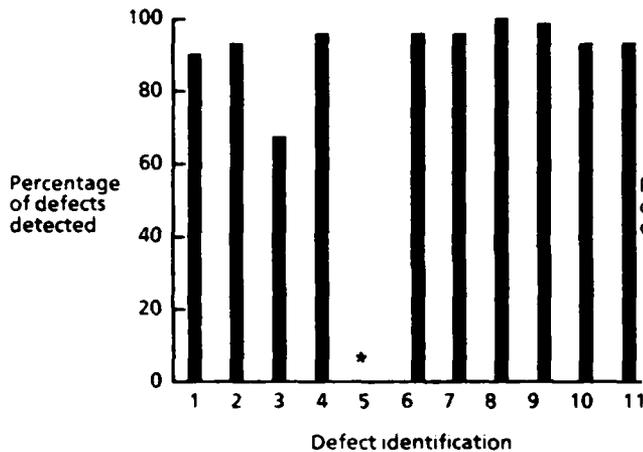
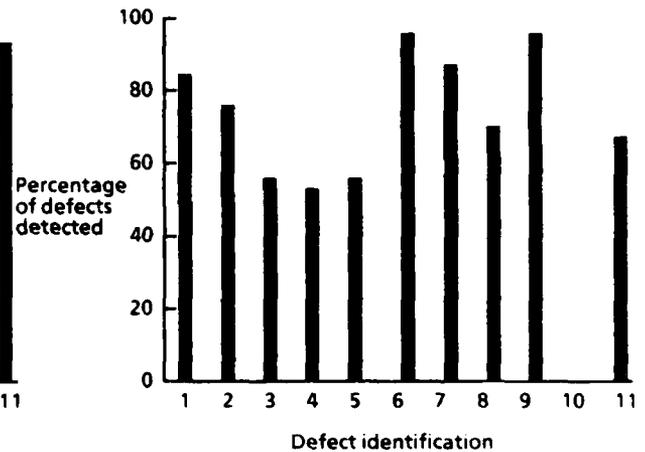
Figure 4-27. Delamination/Disbond Defect Detection Capability (Page 1 of 2)

a) THROUGH-TRANSMISSION ULTRASONIC (TTU)

b) PULSE-ECHO TRANSMISSION

c) TTU SONATEST/SHADOW

d) SINGLE-SIDE SONATEST/SHADOW

While not covered in Figures 4-26 or -27, X-ray radiography was found by both Phelps and Reynolds to be an excellent nondestructive evaluation tool, particularly when used with radio-opaque dye penetrants. As shown by Phelps, radiography without enhancement illustrates fractures running through the specimen thickness with relative clarity (Figure 4-28). As noted by both authors, this result reflects the localized reduction in material thickness associated with such fractures. However, visualization of internal delaminations (as shown in Figure 4-28) was found to require DIB radio-opaque dye penetrant enhancement.

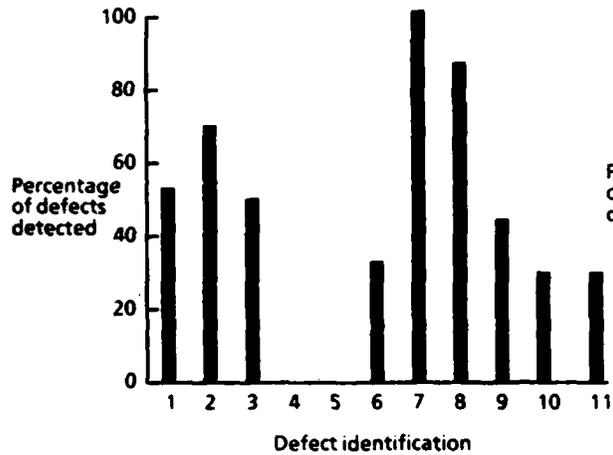
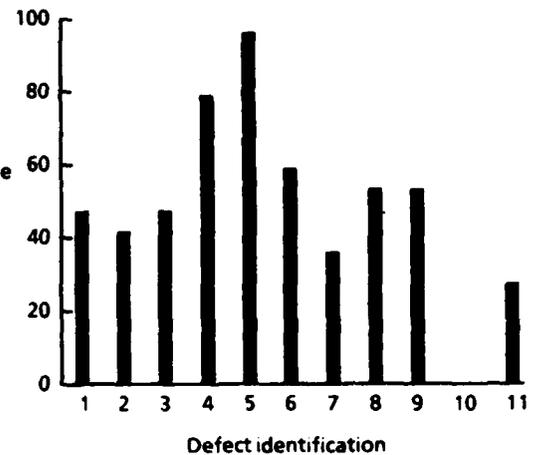
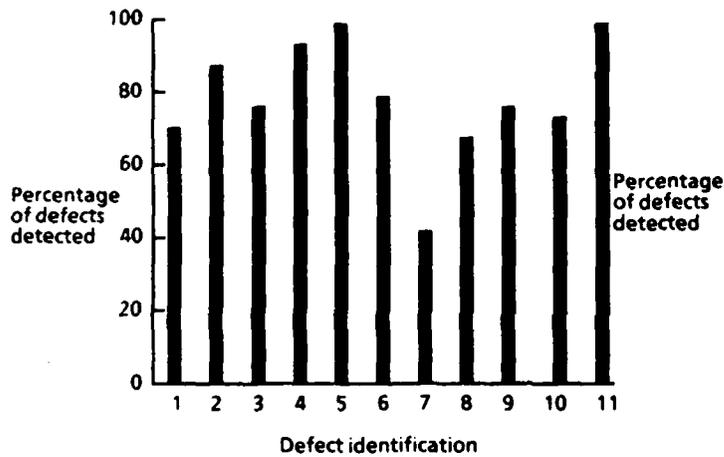
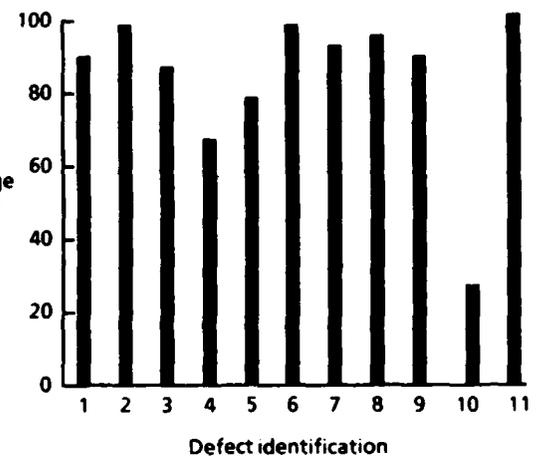
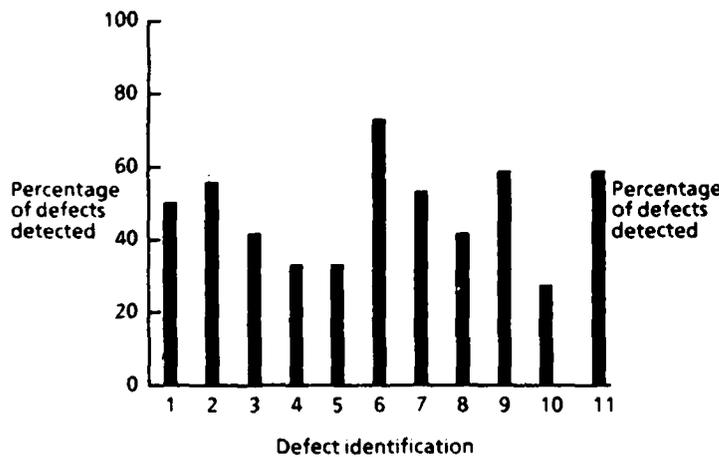
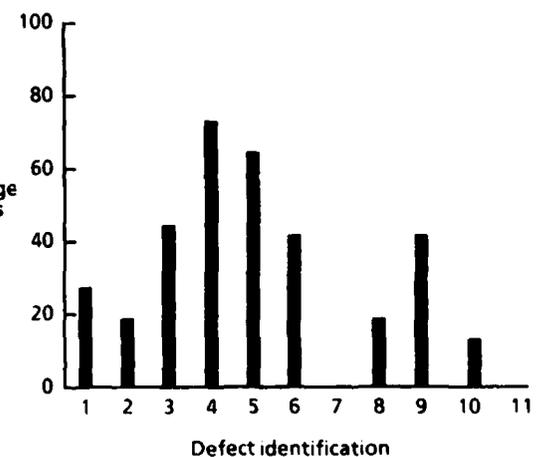
Figure 4-27. Delamination/Disbond Defect Detection Capability (Page 2 of 2)

e) ULTRASONIC THICKNESS GAGE (PULSE ECHO)

f) ANGLE BEAM ULTRASONIC (SINGLE SIDED)

g) SONDICATOR S-1A (HARMONIC BOND TESTER)

h) 210 BOND TESTER (HARMONIC)

i) OTHER BOND TESTERS

j) TAP TEST

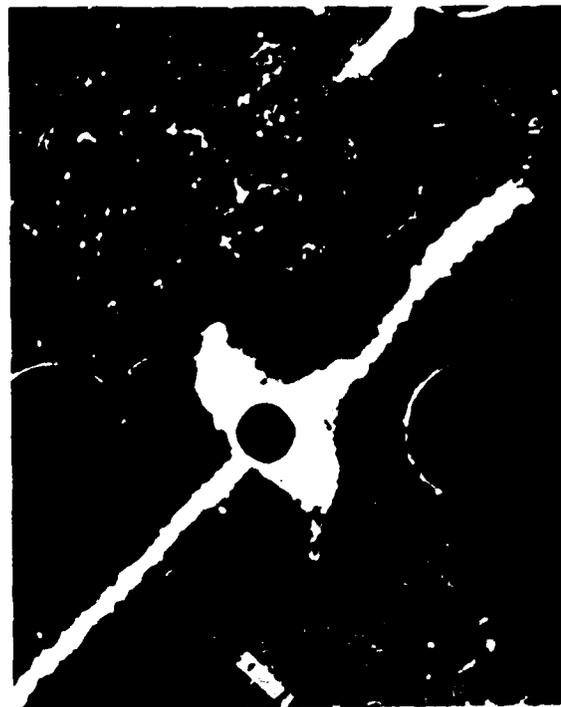
Figure 4-28. Cracks in Gr-Ep Specimen

a) NO ENHANCEMENT

b) DIB-ENHANCED

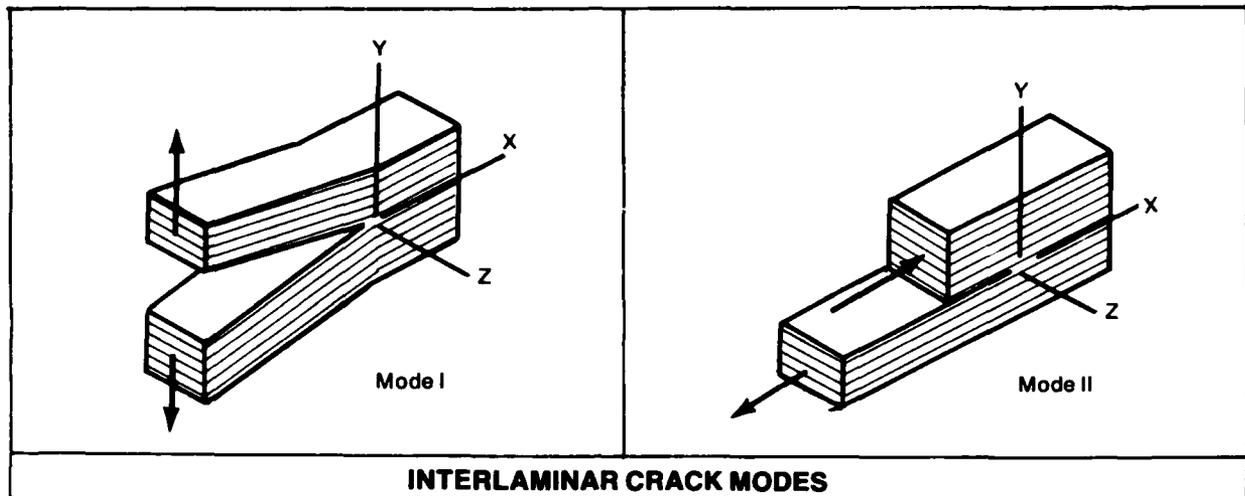
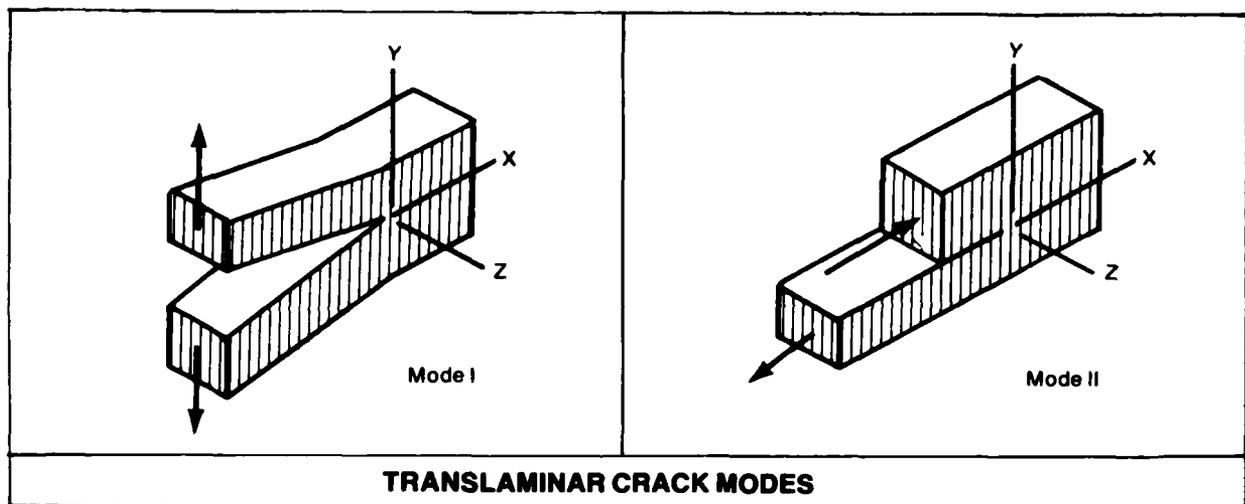
Figure 6-2. Basic Modes of Loading Involving Different Crack Types and Surface Displacements (Interlaminar and Translaminar)

Denotes ply orientation

- Mode I Opening or tensile mode, where the crack surfaces move directly apart.
- Mode II Sliding or in-place shear mode, where the crack surfaces slide over one another in a direction perpendicular to the leading edge of the crack.

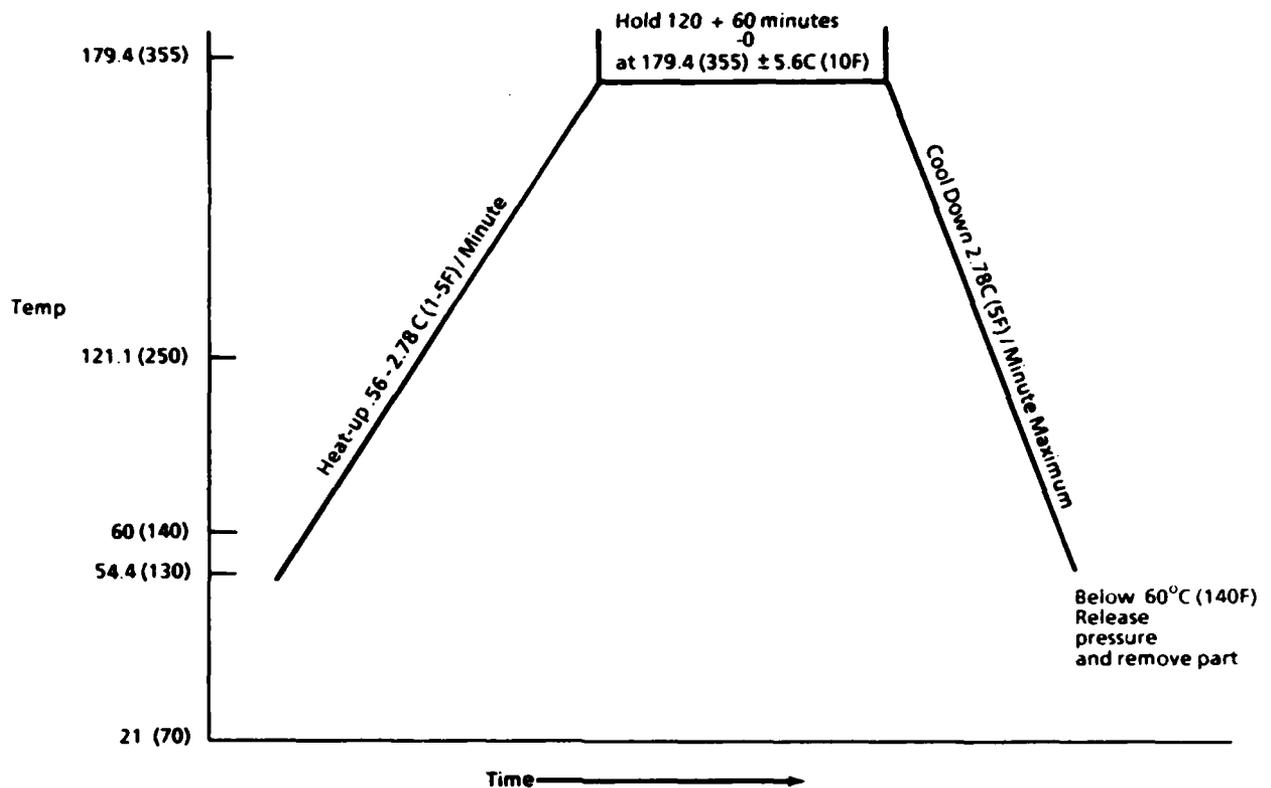
Apply 55.88 cm (22 inches) Hg vacuum minimum to vacuum bag.

Apply $0.586 \begin{smallmatrix} +0.103 \\ -0 \end{smallmatrix}$ MPa ($85 \begin{smallmatrix} +15 \\ -0 \end{smallmatrix}$ psig) pressure.

Specimens for subtask 2A and 2B were fabricated per Boeing process specification BAC 5562 using the layups illustrated in Figure 6-5. In accordance with this specification, panels were cured at 586 Pa (85 psi) and 179°C (355°F) for 120-180 minutes, using a no-bleed vacuum bag system. The cure cycle used is illustrated in Figure 6-4. Following cure, some interlaminar fracture panels were rejected due to warpage and splitting adjacent to the fluorinated ethylene propylene (FEP) crack starter insert. Problems with these panels were corrected and replacement panels fabricated. Analysis of these panels

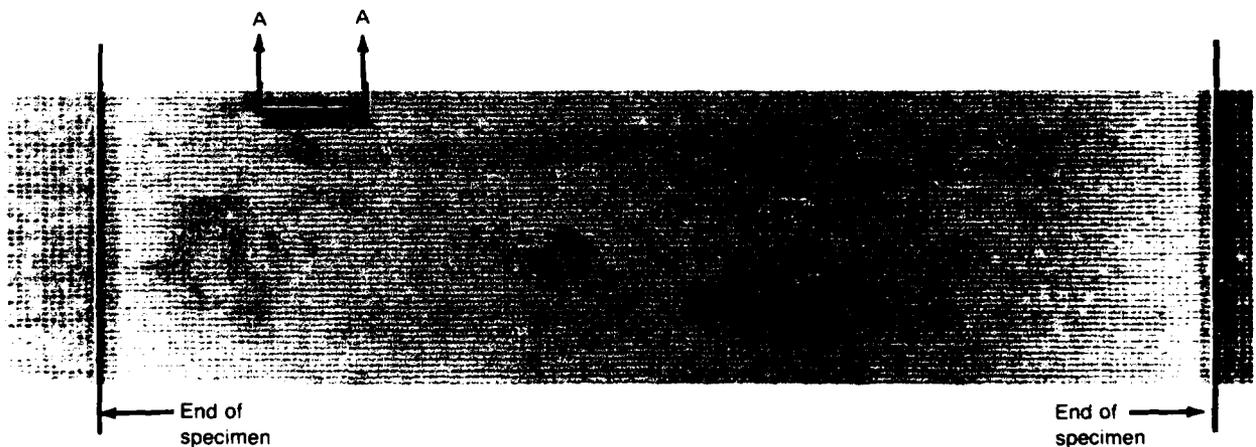
Figure 6-7. Typical TTU Plan View of Specimen No. 7-2

This specimen was rejected and cross-sectioned at location A-A (Figure 3.2.1-4) for evaluation of defect condition. The specimen baseline output symbol is 1. For this program, specimens having areas greater than 322 cm² (0.05 inch²), and exhibiting ultrasonic attenuation indications three levels higher than specimen baseline were rejected. One numerical level change is equal to a six dB change in sound transmittance.

Through-transmission ultrasonic (TTU) techniques were used to inspect each specimen for defects resulting from panel fabrication or subsequent machining. Those specimens with areas greater than approximately 0.322 square cm (0.05 square inch) that exhibited ultrasonic indications 3 levels higher (18 dB) than the baseline were rejected and scrapped. Over 97% of the fabricated specimens were found to be acceptable. Figure 6-7 illustrates a typical TTU scan and reject-specimen condition.

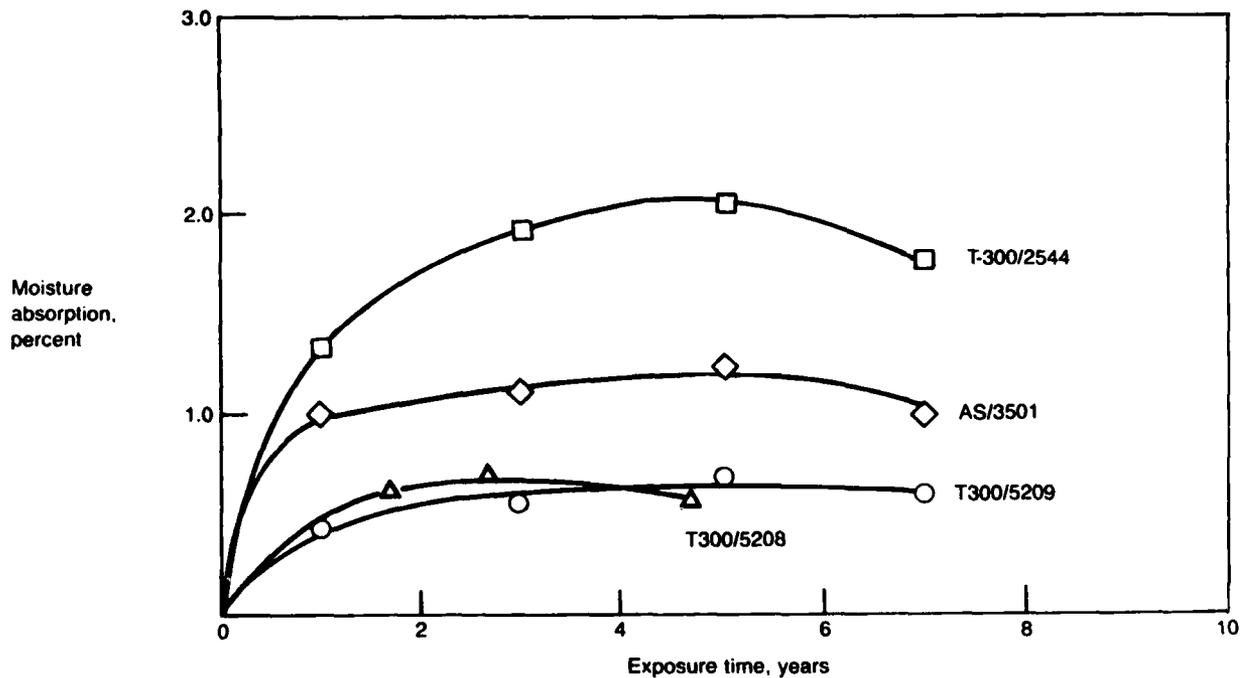
Figure 6-10. NASA Moisture Absorption Data of Composite Materials Following Worldwide Outdoor Exposure

Note: Data from NASA document No. CP 2321.

This maximum moisture content was selected as representative of typical values that can be anticipated for long term in-service exposure. Figure 6-10 illustrates moisture gain data gathered by NASA on ground-rack-exposed samples at various locations around the world, indicating a stable equilibrium value of about 1% for 3501 epoxy systems.
