AFWAL-TR-86-4033

FAILURE ANALYSIS OF COMPOSITE STRUCTURE MATERIALS

Brian Smith
Ray Grove
Thomas Munns
Boeing Military Aircraft Company
P.O. Box 3707 M/S 73-43
Seattle, WA 98124

May 1986
Interim Report for 18 July 1984 to 1 October 1985

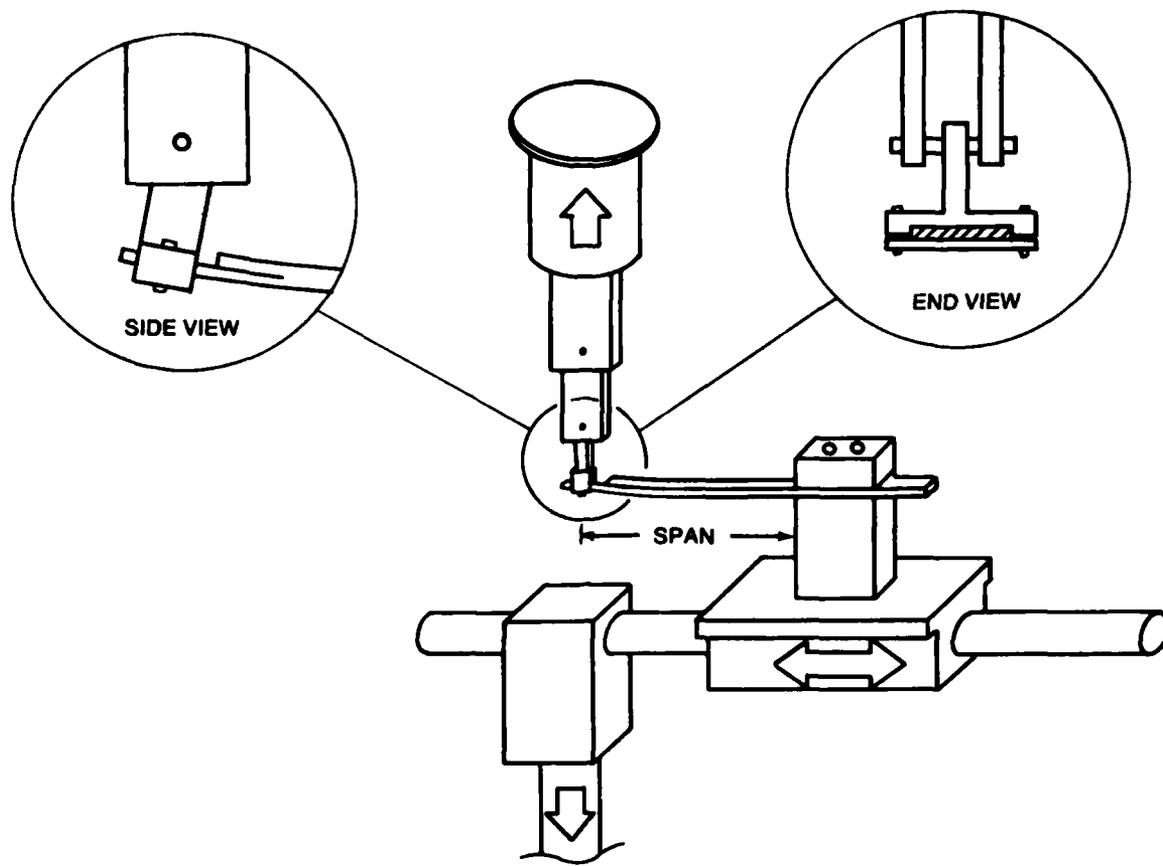
Figure 6-14. Interlaminar Mode 2 (Shear) Test Configuration

ENF TEST SPANS				
LAYUP, deg	SPAN LENGTHS, cm (In)			
0,0	5.08 (2)	10.16 (4)	15.24 (6)	
+45,-45	5.08 (2)	7.62 (3)	10.16 (4)	15.24 (6)
0,45	5.08 (2)	10.16 (4)	15.24 (6)	
0,90	5.08 (2)	10.16 (4)	15.24 (6)	
90,90	5.08 (2)	10.16 (4)	15.24 (6)

In the end-notch flexure geometry used, two beam halves were formed at one end of the specimen by an implanted FEP insert. In this case, conditions of interlaminar shear were imposed at the specimen midplane by cantilever deflection of both beam halves in the same direction. Figure 6-14 schematically illustrates the test configuration as modified for the current program. This test configuration was previously used for assessing interlaminar shear (mode 2) fracture toughness in composite materials. The magnitude of the shear produced at the notch (or crack tip) depended on both the extent of deflection imposed and the percentage of the span length penetrated by the notch (crack length). During trial tests, it was discovered that at least a two-to-one span-length-to-crack-length ratio was required to initiate crack extension without excessive beam bending. As a result, each specimen was tested using step-increased span lengths of 5.1, 10.2, and 15.2 cm (2, 4, and 6 in.). An additional step at 7.6 cm (3 in.) was included for the +45/-45-degree layup configuration to further minimize excessive beam deflection for this more compliant layup. Testing was performed using deflection-controlled loading with the rate of cross-head travel modified between 1.0 and 2.0 cm (0.4 and 0.8 in.)/minute to produce an overall test time of approximately 15 minutes per specimen. Figure 6-15 illustrates the modified fixture during trial testing.

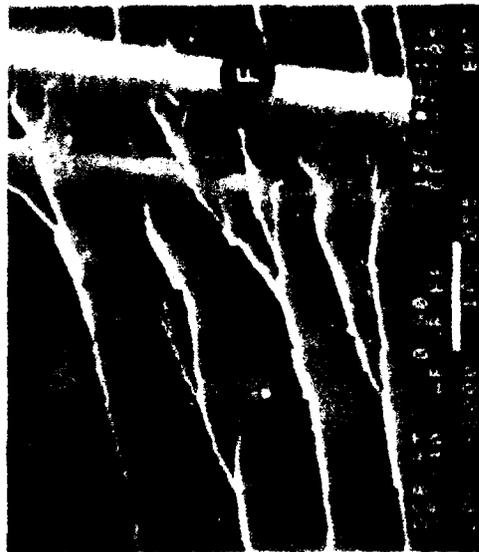
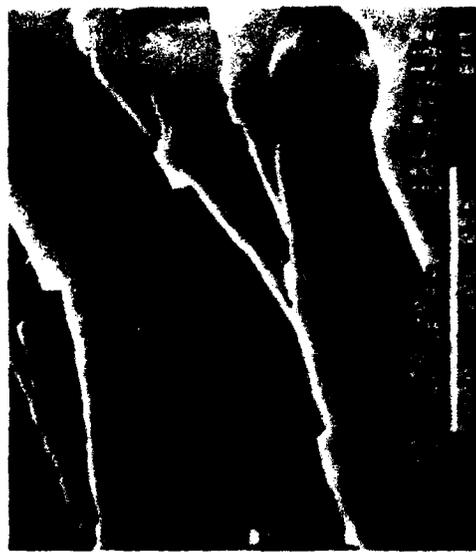
Mechanically induced crack direction

- M Matrix fracture
- F Fiber matrix separation
- R River markings
- T Textured microflow

Figure 7-5. SEM Photomicrographs of Mode I Delamination Between 0/90-Degree Plies

Results of scanning electron microscope examinations are presented in Figure 7-5. Observed at 400X, locations of 0- and 90-degree fiber/matrix separation tended to divide the surface into roughly rectangular areas of matrix fracture. Examining these areas reveals both distinct river markings and subtle conditions of resin microflow. It is particularly interesting to note that in this fracture, river mark branching appears to be associated with areas of partially buried or exposed fibers, suggesting that local disruption of the fracture plane results in crack-plane divergence and initiation of multiple-crack microplanes. Viewed at high magnification, the direction of coalescence of these microplanes and the general texture of microflow coincides with the direction of crack propagation. These findings indicate that such features can be used to identify the direction of crack propagation fractographically.

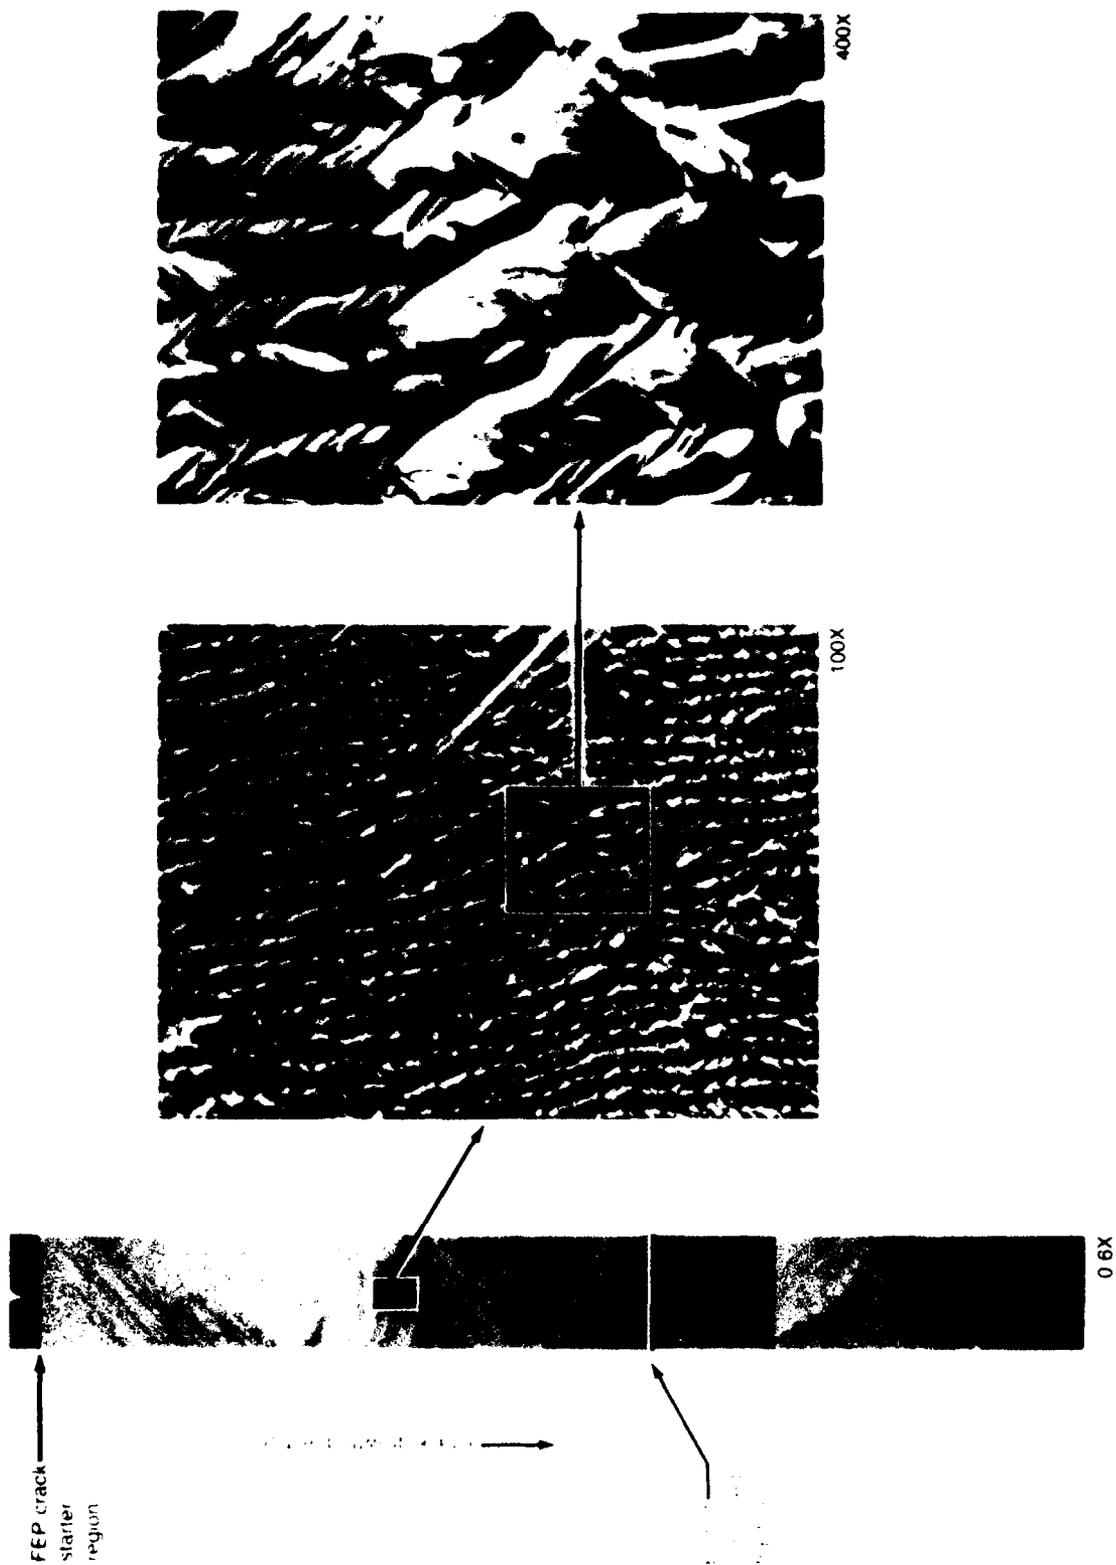
Figure 7-6. Optical Photomicrographs of Intended Fracture Plane Between +45 5-Degree Plies, DCB 21°C (70°F) Specimen

The appearance of fracture surfaces produced by interlaminar tension between +45 and -45-degree ply interfaces are illustrated in Figure 7-6 (optical) and 7-7 (SEM). In Figure 7-6, the fracture occurred between the intended interfaces, with limited amounts of intraply wandering into either of the 45-degree plies. Further visual examination revealed numerous beach mark features similar to those noted previously for other fracture interface conditions. The general shape of these beach marks indicates that fracture began at the FEP insert and progressed towards the opposite end of the specimen as intended. The particularly curved contours of the beach marks indicates that significant crack deflection occurred adjacent to the specimen edge, altering the local direction of propagation by as much as 60-degrees (Figure 7-8). As noted earlier, such divergent

Inspecting the fracture surface at increasing magnifications revealed a relatively rough topography consisting of numerous longitudinal rows of fan-shaped resin fracture zones intersected by the underlying 45-degree oriented fibers. For the optical photomicrograph (Figure 7-6), the strong light/dark contrast of the fracture surface is due to the tilt of fan-shaped zones with respect to the incident coaxial light source. Relatively reflective areas have shallow tilt angles, whereas darker, less reflective regions have relatively large tilt angles. Further SEM examination of the fan-shaped resin fracture areas revealed river markings associated with zones of fiber/matrix separation, and subtle conditions of textured resin microflow (Figure 7-7). The direction of river mark coalescence and microflow progression often deviate from the direction of induced crack propagation; this condition can be attributed to local rotation of the direction of crack propagation toward adjacent microscopic fracture zones. For this layup, deviations in the direction of crack propagation tended to be the most pronounced in small areas of resin fractures. However, these local variations average together, so that the overall direction of river mark branching and resin microflow correspond well with the direction of induced fracture. This finding indicates that the direction of crack propagation may be determined by examining the larger areas of resin fracture or by averaging the detailed crack directions of both large and small areas of resin fracture. The first of these two methods appears attractive in that it requires less effort and produces less data scatter; however, this approach ignores a portion of the actual fracture behavior and may be more susceptible to errors caused by spurious or secondary crack growth. The method choice should be predicated upon both the degree of accuracy desired and the time available for analysis.

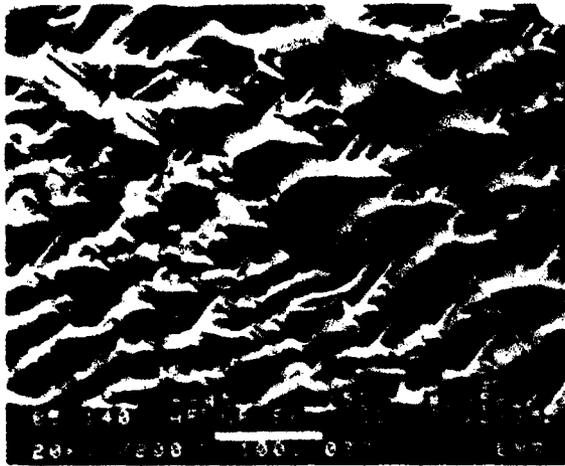
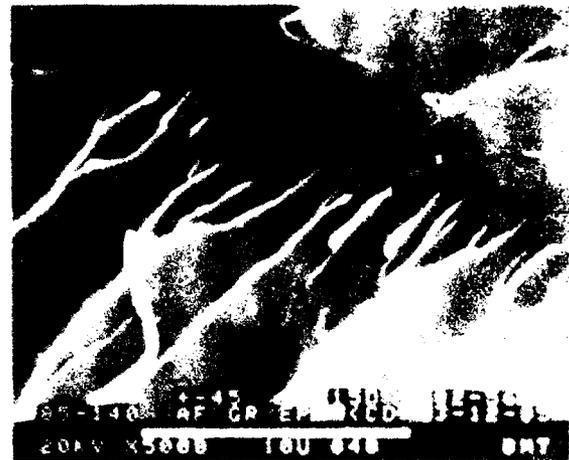
Mechanically induced crack direction

- M Matrix fracture
- F Fiber matrix separation
- R River markings
- T Textured microflow

Figure 7-7. SEM Fractographs of Mode 1 Delamination Between +45/-45-Degree Plies

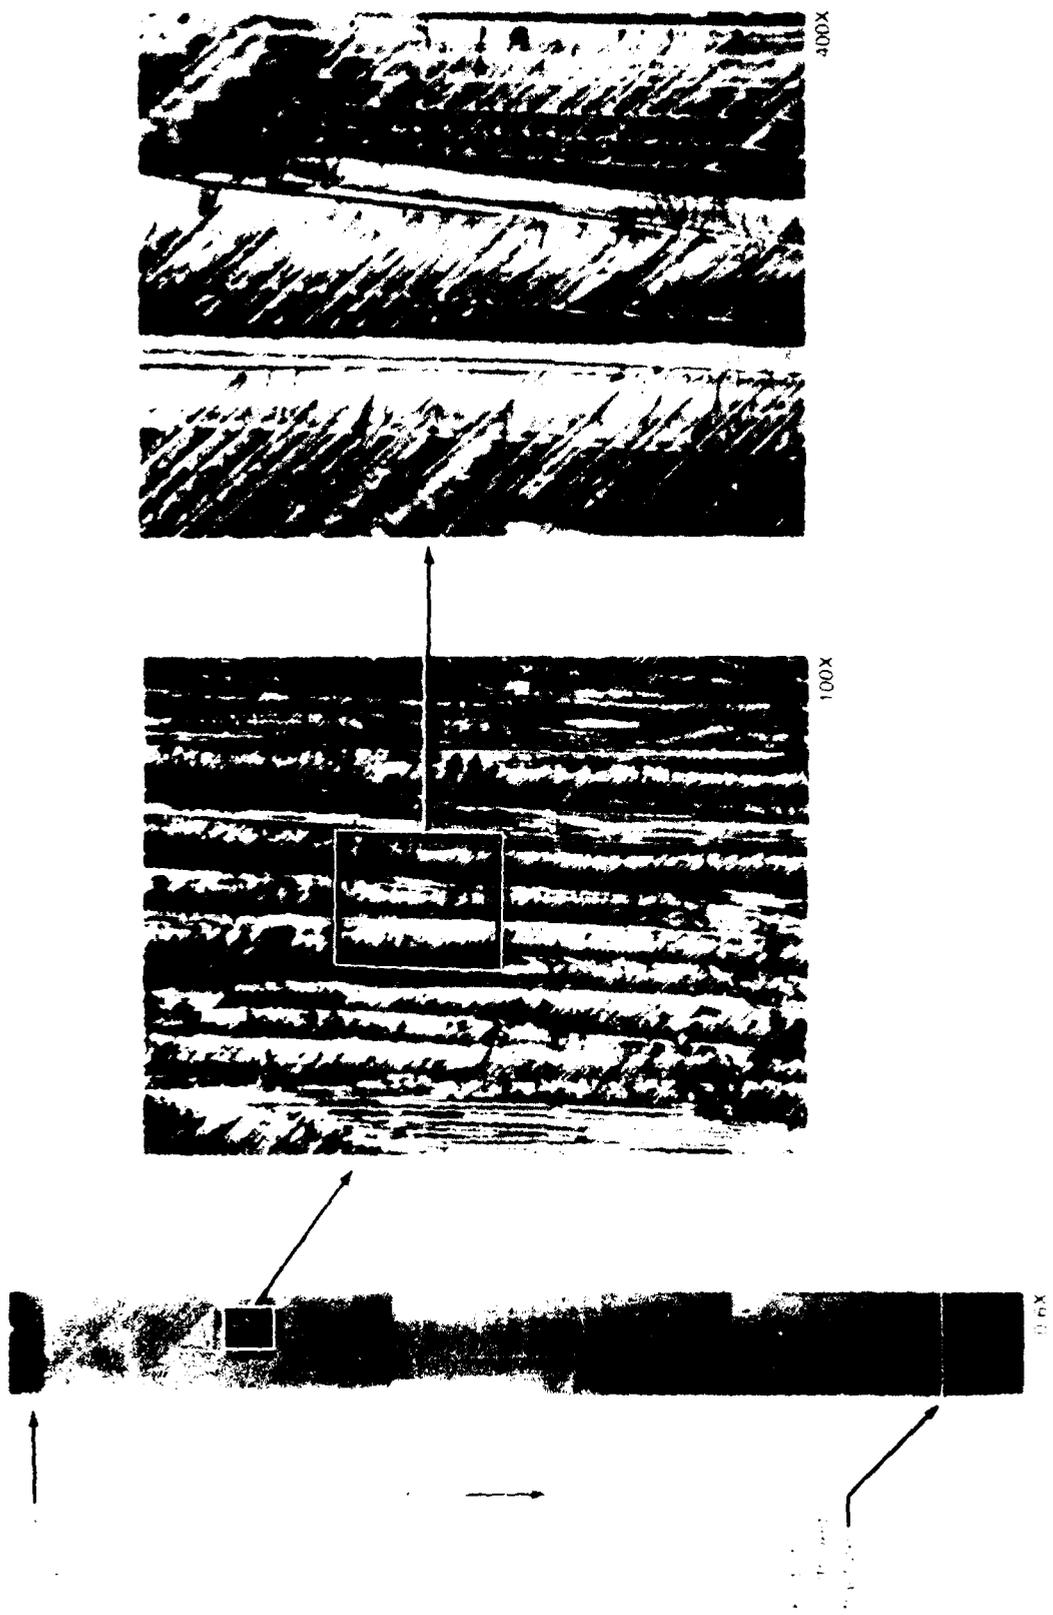
Figure 7-9. Optical Photomicrographs of Intended Fracture Plane Between 0/45-Degree Plies, DCB 21°C (70°F)

The interlaminar tension fractures produced between 0- and 45-degree-oriented plies are illustrated in Figure 7-9 (optical) and 7-10 (SEM). The overall optical macrograph (Figure 7-9), shows that fracture occurred between the desired ply orientations with some limited intraply fracture of the 45-degree ply. As with other orientations described previously, arced bands were apparent running transverse to the specimen length. The contour of

these bands indicate that crack propagation occurred along the specimen length and away from the FEP insert as intended. Additionally, some rotation of the crack direction toward the specimen edge is apparent. Further analyses concentrated on those central fracture regions where the contour of beach markings indicated that the direction of crack propagation coincides with the specimen's longitudinal axis.

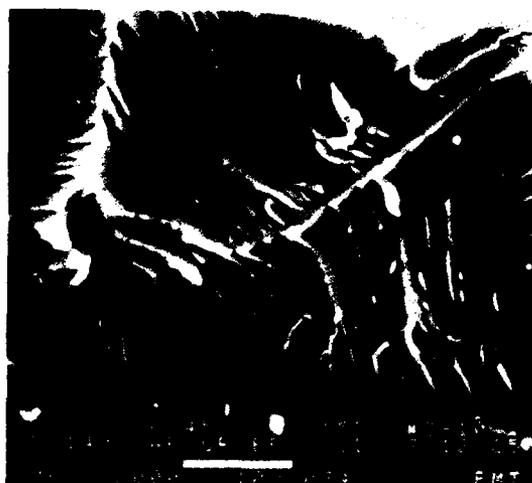
Mechanically induced crack direction

- M Matrix fracture
- F Fiber matrix separation
- R River markings
- T Textured microflow

Figure 7-10. SEM Photomicrographs of Mode I Delamination Between 0/+45-Degree Plies

with the +45/-45-degree interface, most of these resin fracture areas appear inclined at acute angles to the fracture surface. SEM examinations of resin fracture areas exhibited the river marking and resin microflow morphology discussed previously. As evident in the SEM photomicrograph at 2000X, significant variations in the direction of these features can occur. With respect to the direction of induced crack propagation, these variations appear to extend up to 90 degrees from the macroscopic crack direction. However (as with the +45/-45-degree interface) the averaged direction of river marks and resin microflow gives a much better correlation with the macroscopic direction of crack propagation. The averaged direction of these features varied by as much as 30 to 45 degrees from the direction of induced failure. This finding indicates that while the approximate direction of fracture may be determined by examining river markings, precise determination may not be possible for all failure conditions.

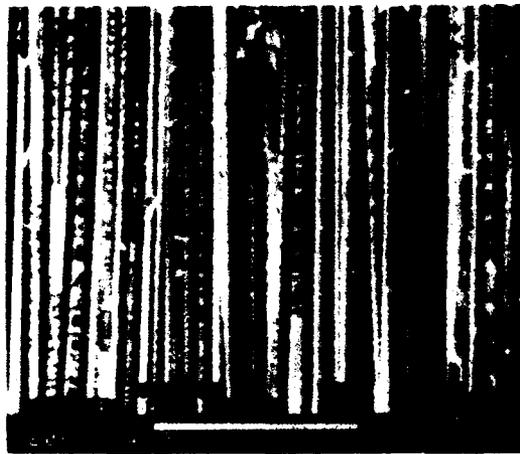
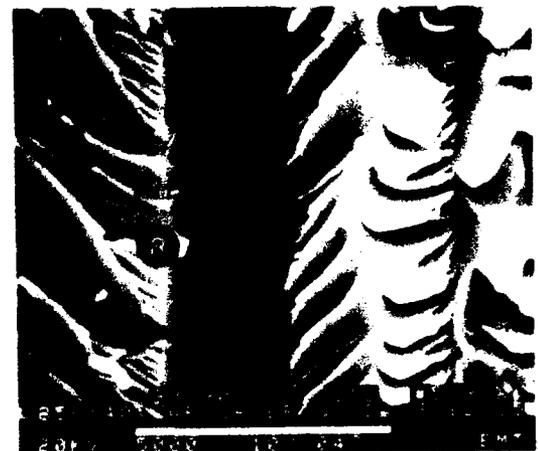
Mechanically induced crack direction

- M Matrix fracture
- F Fiber matrix separation
- R River markings
- T Textured microflow

Figure 7-12. SEM Fractographs Illustrating the Fracture Topography of Mode 1 Delamination Between Adjacent 90-Degree Plies

Fracture surfaces produced under interlaminar tension between adjacent 90-degree plies are illustrated in Figure 7-11 (optical) and 7-12 (SEM). As seen in the optical macrograph, a majority of the fracture diverged from the intended 90/90-degree interface either into the 0/90-degree interface or within a 0-degree ply. Between 15% and 20% of the fracture occurred within a 90-degree ply. While fracture did not occur at the intended interface, separation inside the 90-degree ply does constitute a 90/90-degree fracture condition. Detailed microscopic examinations revealed a distinctly dissimilar morphology than that of the four other ply orientations examined. Fracture along the 90-degree interface produced considerably more exposed fiber/matrix separation combined with relatively small areas of cohesive resin fracture. At low magnifications this topography appears noticeably rough, accounting for the difficulty encountered in optically examining and understanding the morphology of this fracture surface.

SEM analysis at 2000X indicated the presence of two types of cohesive resin fracture morphology. In one type, areas of resin fracture appear relatively flat, similar to those noted in the mode I fracture interface conditions. In the other type, several rougher areas of resin fracture exist that appear to be made up of numerous platelets of fractured epoxy inclined at a shallow angle to the plane of fracture. Both the tilted platelets and flat areas of resin fracture exhibit branched river markings adjacent to areas of fiber/matrix separation. In contrast to the other ply orientation fractures, the direction of river mark coalescence was both coincident with, and opposite to, the direction of

In an attempt to understand this condition, the fracture surface illustrated in Figure 7-12 was examined in detail at several tilt orientations. Figure 7-13 shows that increasing the tilt of this fracture surface to approximately 66 degrees revealed:

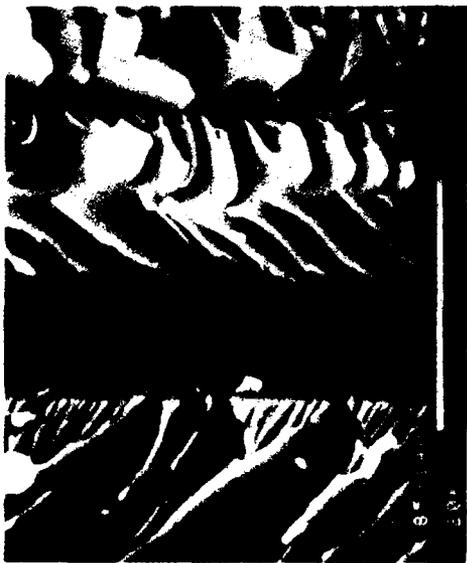
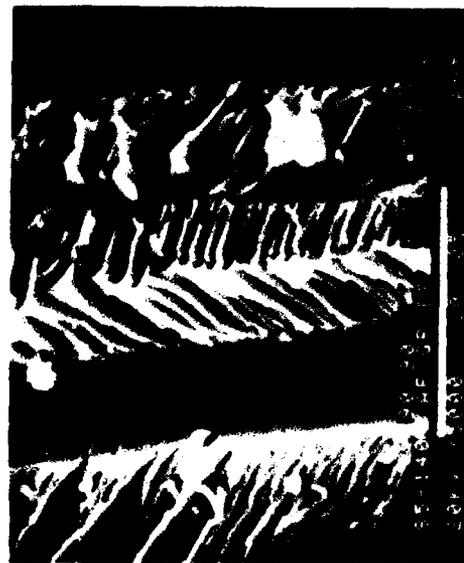
TILT = 15 deg

TILT = 66 deg

Figure 7-13. SEM Fractographs of Mode I Delamination Between Adjacent 90-Degree Plies Illustrating the Effect of Tilt Angle

- o Areas of resin fracture are inclined at a wide variety of angles with respect to the plane of fracture

- o Areas exhibiting river mark coalescence opposite to the direction of induced crack propagation are generally oriented at steep vertical angles to the plane of fracture
- o Resin fracture areas lying roughly in the plane of fracture tend to exhibit river pattern coalescence coincident with the direction of induced crack growth
- o Examinations at higher angles of tilt tend to increase the serrated appearance of all resin fracture areas, both flat and serrated.

Figure 7-13 shows that increasing the tilt of the fracture surface significantly altered the appearance of both specific surface features and the overall morphology. This finding emphasizes the importance of having investigators document the viewing angle, examine features at several angles to understand their actual morphology, and use photographic stereo pairs where possible. The actual fracture morphology in Figure 7-13 is best described by examining both tilt angles. The relatively flat area of fracture on the left actually consists of several localized fracture planes inclined at about 5 to 10 degrees. In many cases, the edges of these planes sweep upward giving them a steeper appearance. The heavily serrated areas on the right consist of fracture planes inclined at between 20 and 30 degrees. In contrast to the area on the left, the overlapping fracture planes on the right tend to be thicker and more undercut. These resin fracture areas exhibit both thicker fracture plates and significant undercutting of adjacent fracture areas. The appearance of this plate structure and its formation is not well understood at present.

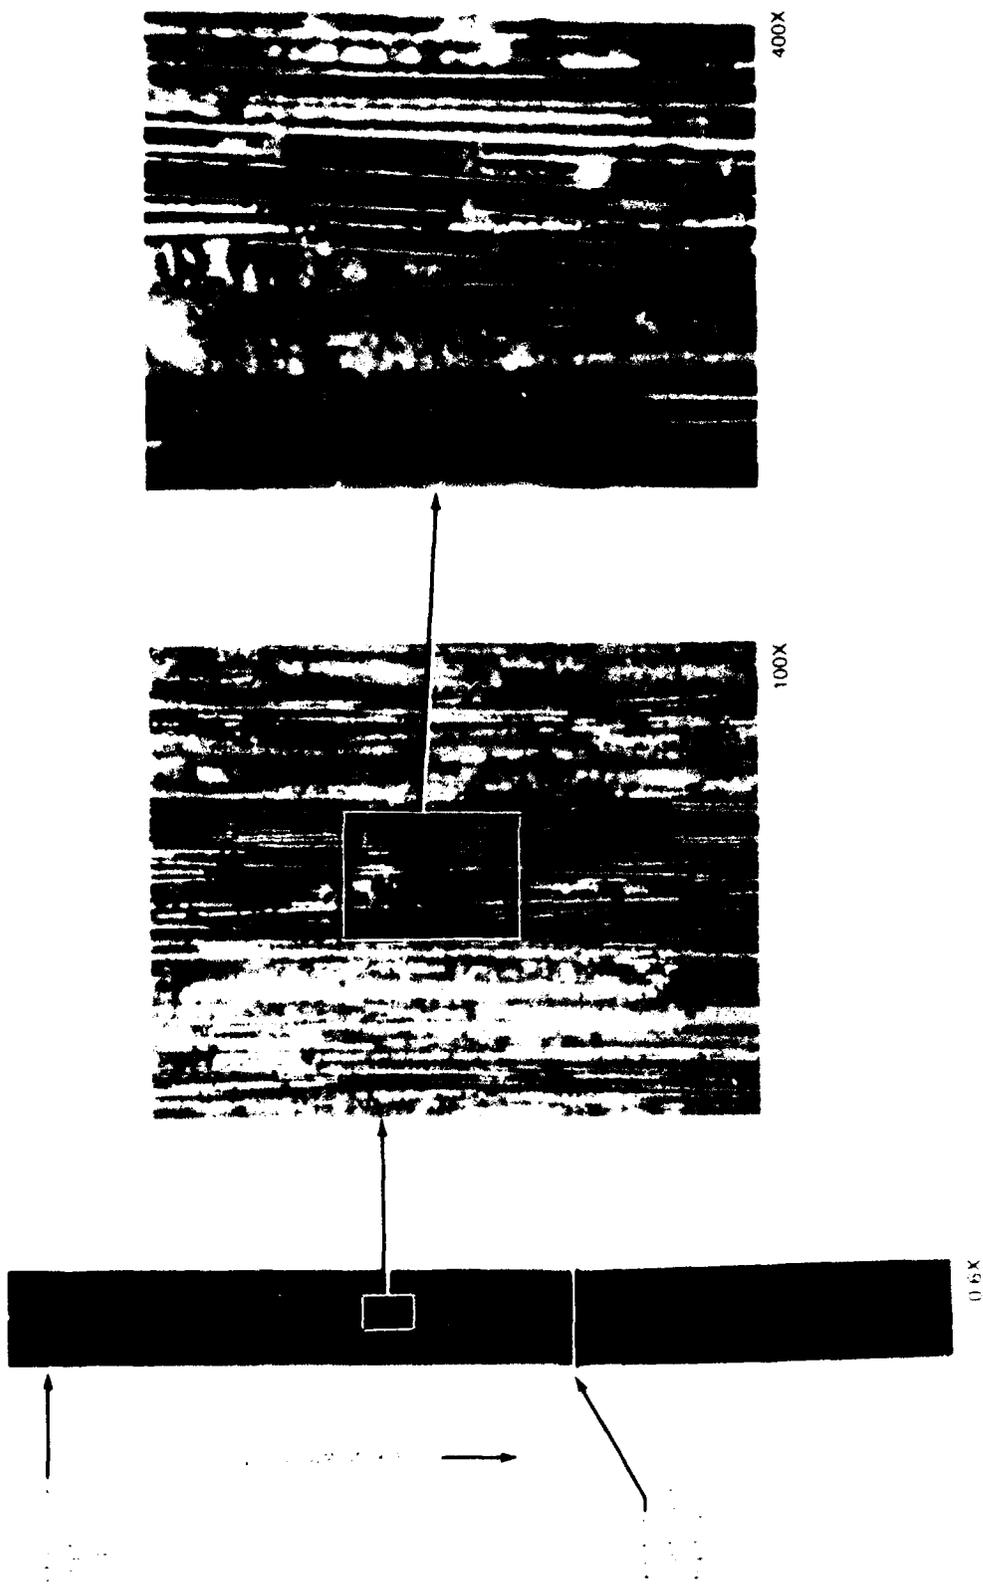
Figure 7-14. Optical Photomicrographs of Intended Fracture Plane Between 0/0-Degree Plies, ENF 21°C (70°F) Specimen

The fracture surface characteristics of mode 2 (shear) delaminations generated between adjacent 0-degree plies is illustrated in Figures 7-14 (optical) and 7-15 (SEM). Macroscopic examination of the fracture surface revealed that fracture occurred between the intended 0-degree plies with no out-of-plane crack divergence. The transversely arced bands (beach marks) typically found in interlaminar tension fractures were absent. Although there were no macroscopic details that suggested any variations or shifts in the direction of crack propagation across the specimen width, further optical and SEM examinations concentrated on the central region of each specimen.

When compared to interlaminar tension fractures, high-magnification inspection of the shear fracture surface revealed a much rougher topography with more fiber/matrix separation. Inspection of narrow resin-fracture zones between fibers at 400X showed a series of small, parallel resin particles. Optical microscopy disclosed that the particles are translucent and stand normal to the fracture surface. The long axes of the particles are aligned normal to the direction of imposed crack propagation. The large, flat zones and river mark branch structure typical of matrix resin areas in mode 1 delaminations are

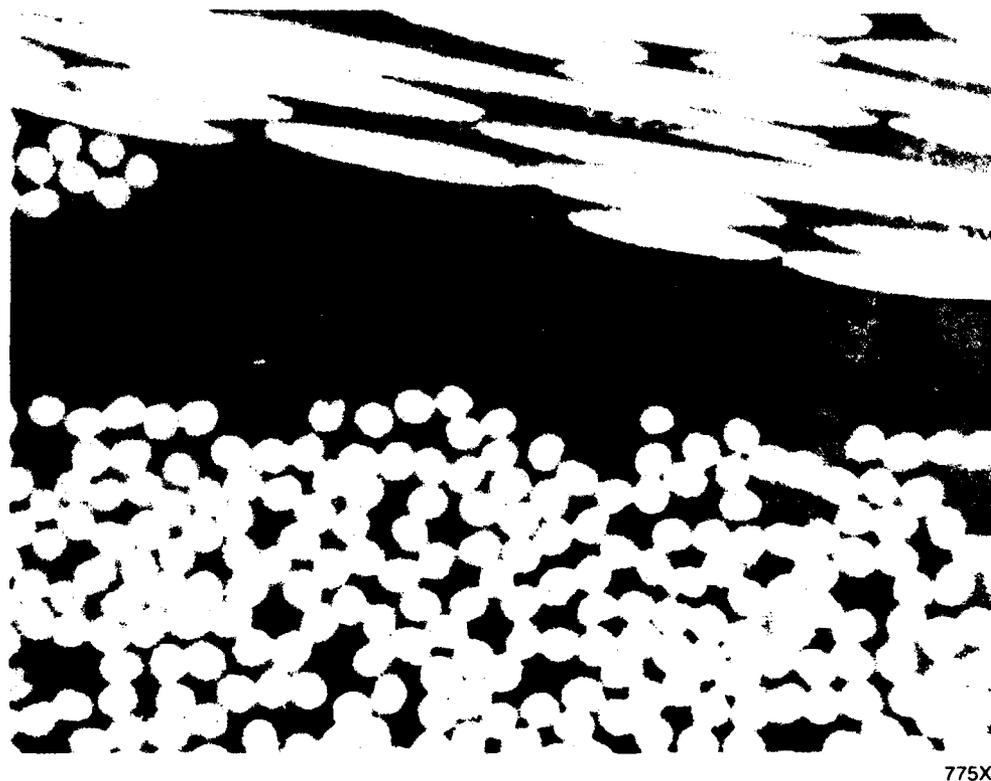
Figure 7-16. Microstructure of Cracks Found in Short Beam Shear Specimen Tested at 132°C (270°F)

Under detailed SEM examination, the narrow rows of cohesive resin fracture between areas of fiber separation exhibited numerous inclined platelets oriented crosswise to the 0-degree fiber orientation. Some investigators (see Section 4.3) refer to these platelets as hackles, and suggest that they result from flexural loading associated with local bending of the fracture surface just behind the crack tip. However, the presence of hackles only under conditions of mode 2 (rather than mode 1), suggests interlaminar shear as the primary load source for their formation. The appearance of hackles suggests that their formation occurs from coalescence of numerous microcracks inclined at an angle to the plane of applied shear. This is supported by the observation of S-shaped cracks at the midplane of short beam shear specimens (highest shear loading) in previous Boeing studies (Figure 7-16). In general, the hackle structures visible in Figure 7-15, and microcracks visible in Figure 7-16, are oriented at angles of 40 to 60 degrees to the plane of applied

While the above discussion has been concerned with the overall structure of hackles, several finer morphological features are apparent on both hackled and scalloped areas. As illustrated in Figures 7-15 and 7-16, these areas exhibit textured resin microflow and branched river markings analogous to those identified under mode I. Additionally, secondary hackles—or rather, smaller platelet structures found on the sides of the large hackles—also align in the direction of overall hackle tilting. The presence of these small

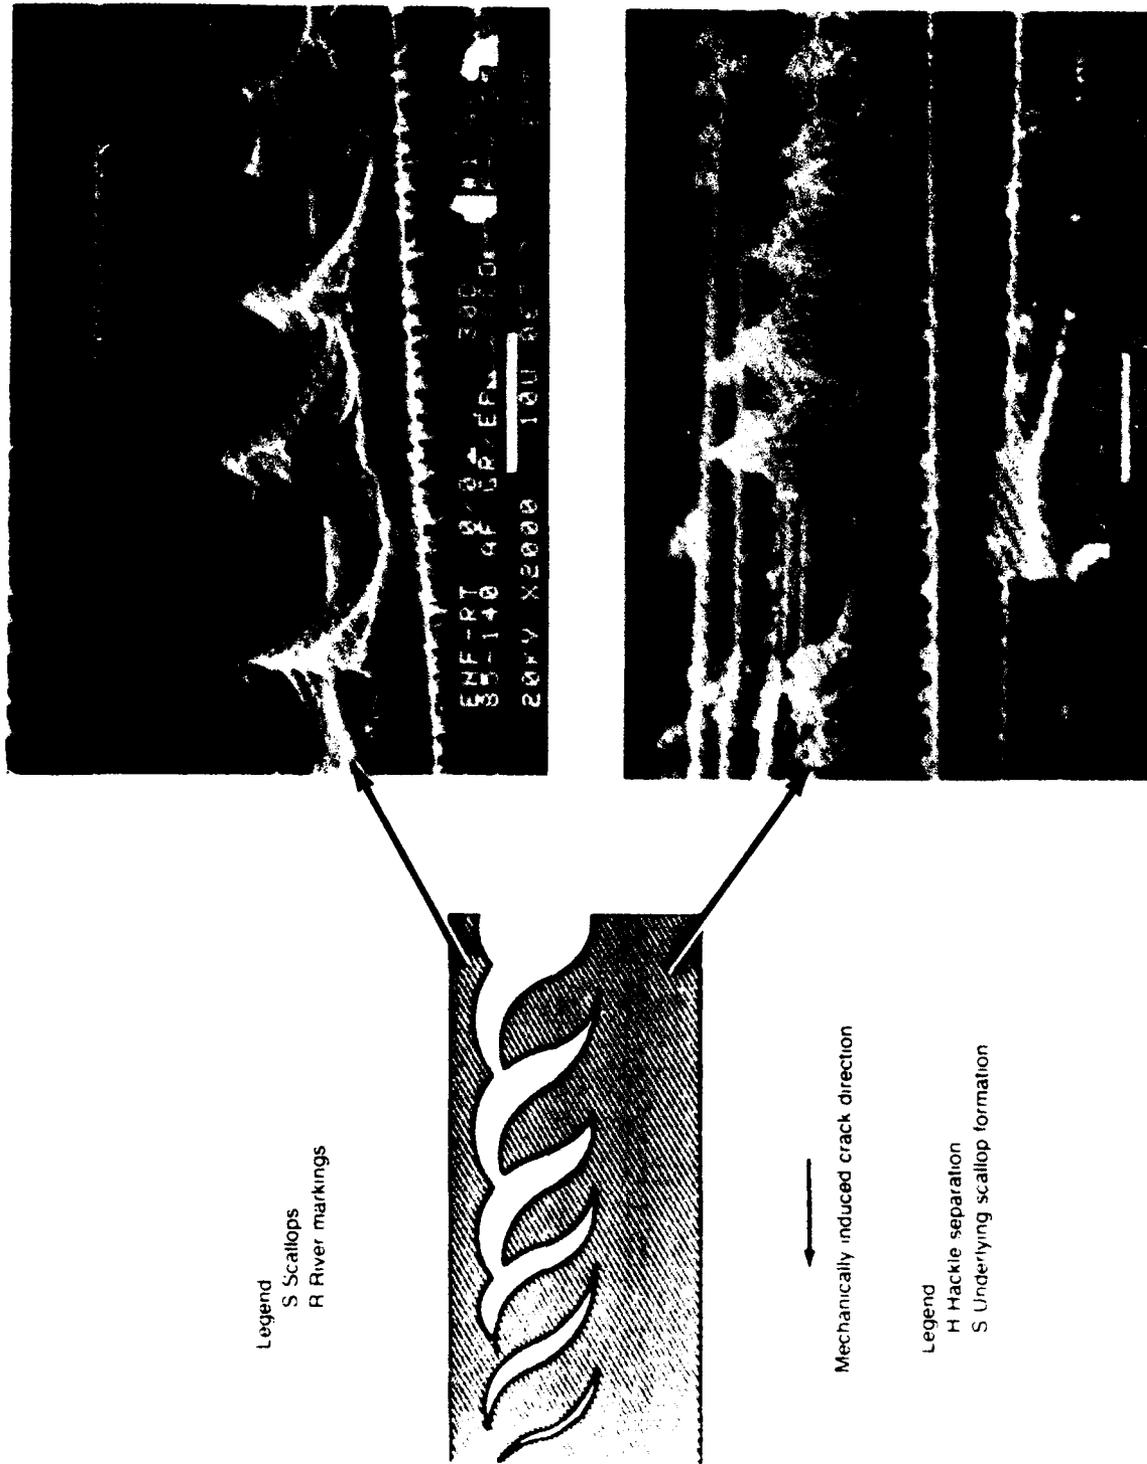
Figure 7-17. Scalloped Resin Fracture Areas and Their Development

Further inspection of the surface revealed areas of scalloped or concave resin fracture (Figure 7-17). Detailed examination of these features suggests that they are formed as hackles separate from the fracture surface. This conclusion is substantiated by the existence of nearly separated hackles and the formation of underlying scalloped areas as shown in Figure 7-17. Separation of hackles can produce two possible relationships (mechanisms A and B) between hackle tilt and the direction of crack propagation, depending on which side of the shear plane retains the hackles (Figure 7-18). In mechanism A, separation occurs such that hackles are retained on the side in which the direction of crack propagation coincides with the direction of the local shear component. This condition produces hackles tilted in the direction of crack propagation, and normal to the direction of resolved tension. Conversely, in mechanism B, separation occurs such that hackles are retained on the side in which the direction of crack propagation opposes the direction of the local shear component. In this condition, the tilt of hackles oppose the direction of crack propagation.

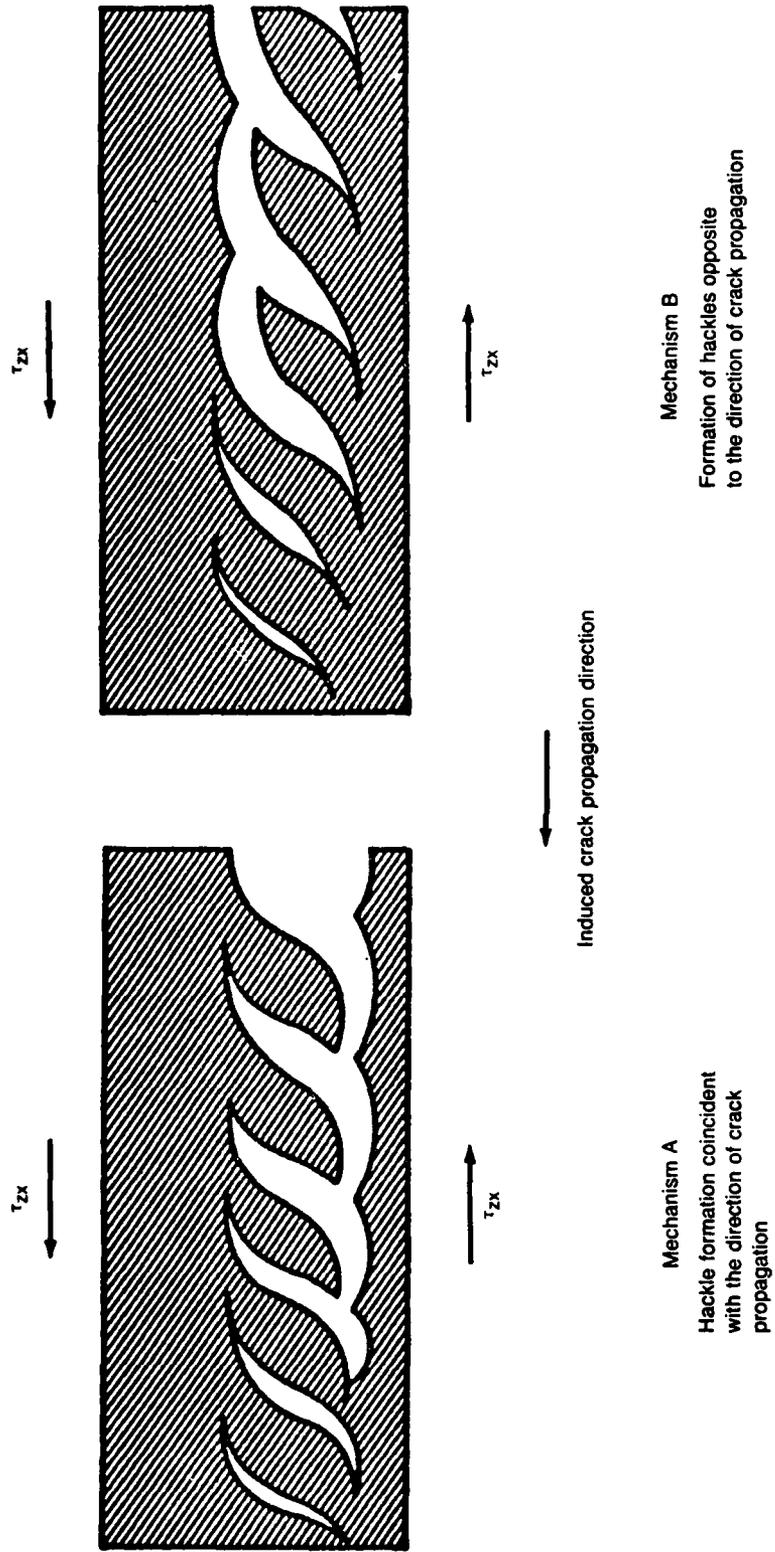
Figure 7-18. Possible Hackle Separation Mechanisms

Hackles are tilted normal to the local direction of resolved tension and occur almost exclusively on one side of the fracture surface, with scallops on the opposite side (Figure 7-22). In Figure 7-18, the hackles are tilted coincident with the direction of crack propagation, indicating separation by mechanism A. In contrast to the 0/0-degree ply condition, this observation indicates a positive correlation between hackle tilt and the direction of crack propagation for the 0/90-degree cross-ply condition. However, further studies should determine if the mechanism of hackle separation depends on conditions such as specimen geometry, layup, or degree of mixed-mode loading.

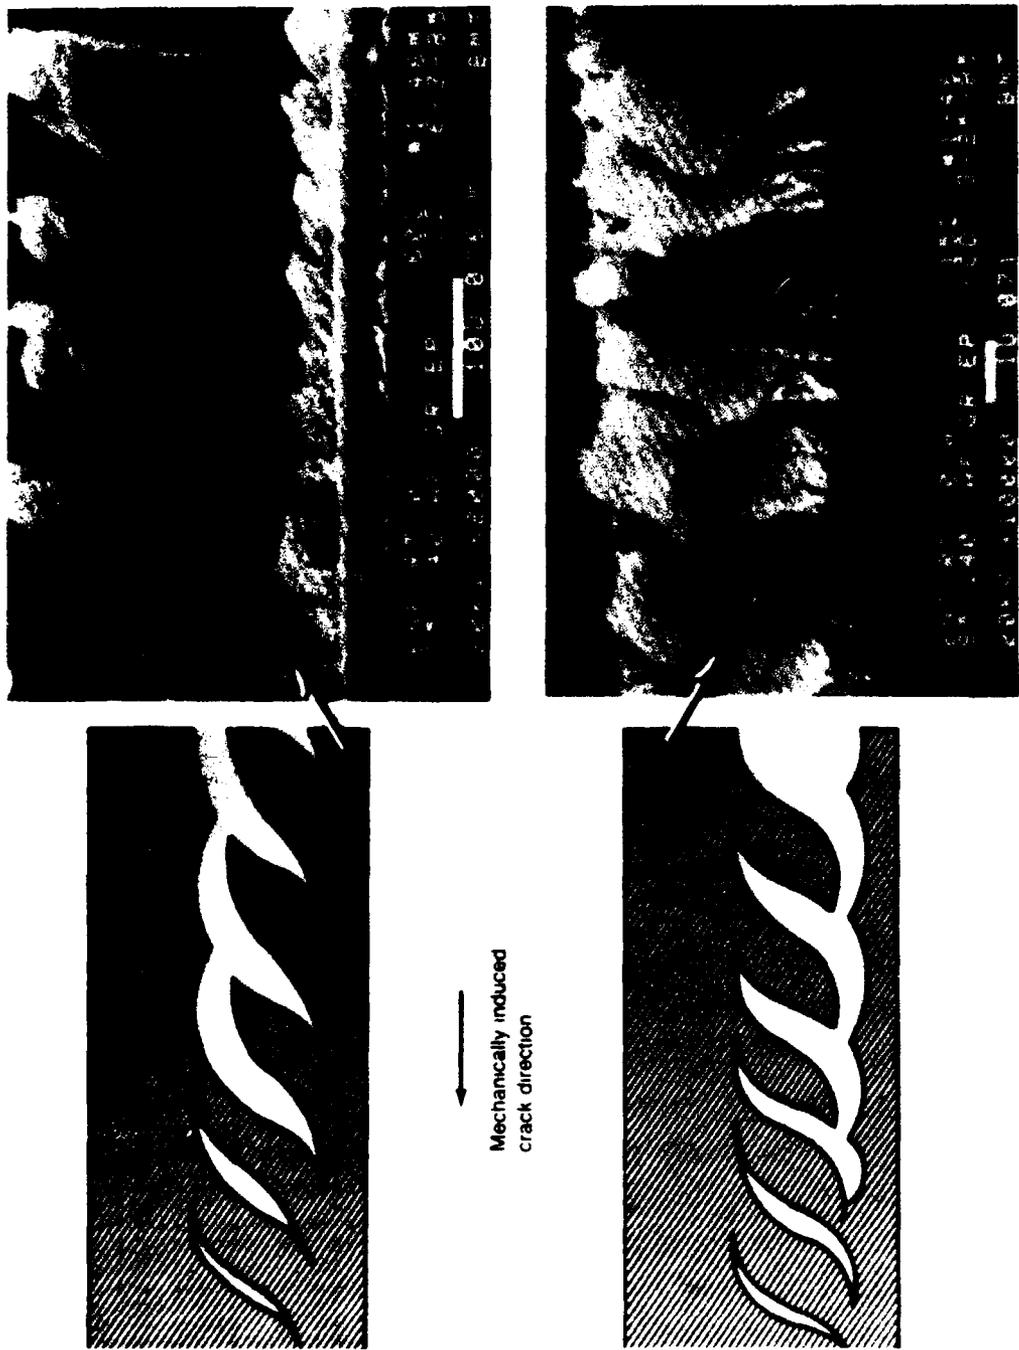
Figure 7-19. Opposing Hackle (H) Tilts on Mating Sides of Mode 2 Delamination Between Adjacent 0-Degree Plies

To identify the dominant mechanism of hackle separation, both sides of each fracture surface were examined. As shown in Figure 7-19, both sides of fracture between adjacent 0-degree plies exhibit pronounced hackle formations. The existence of hackles on both surfaces indicates that hackle separation occurred by both mechanisms A and B. This finding indicates that hackle tilt is not a useful means of fractographically determining the direction of crack propagation for shear fractures between adjacent 0-degree plies. However, it appears that the direction of crack propagation can be generally identified as parallel to the direction of hackle tilt.

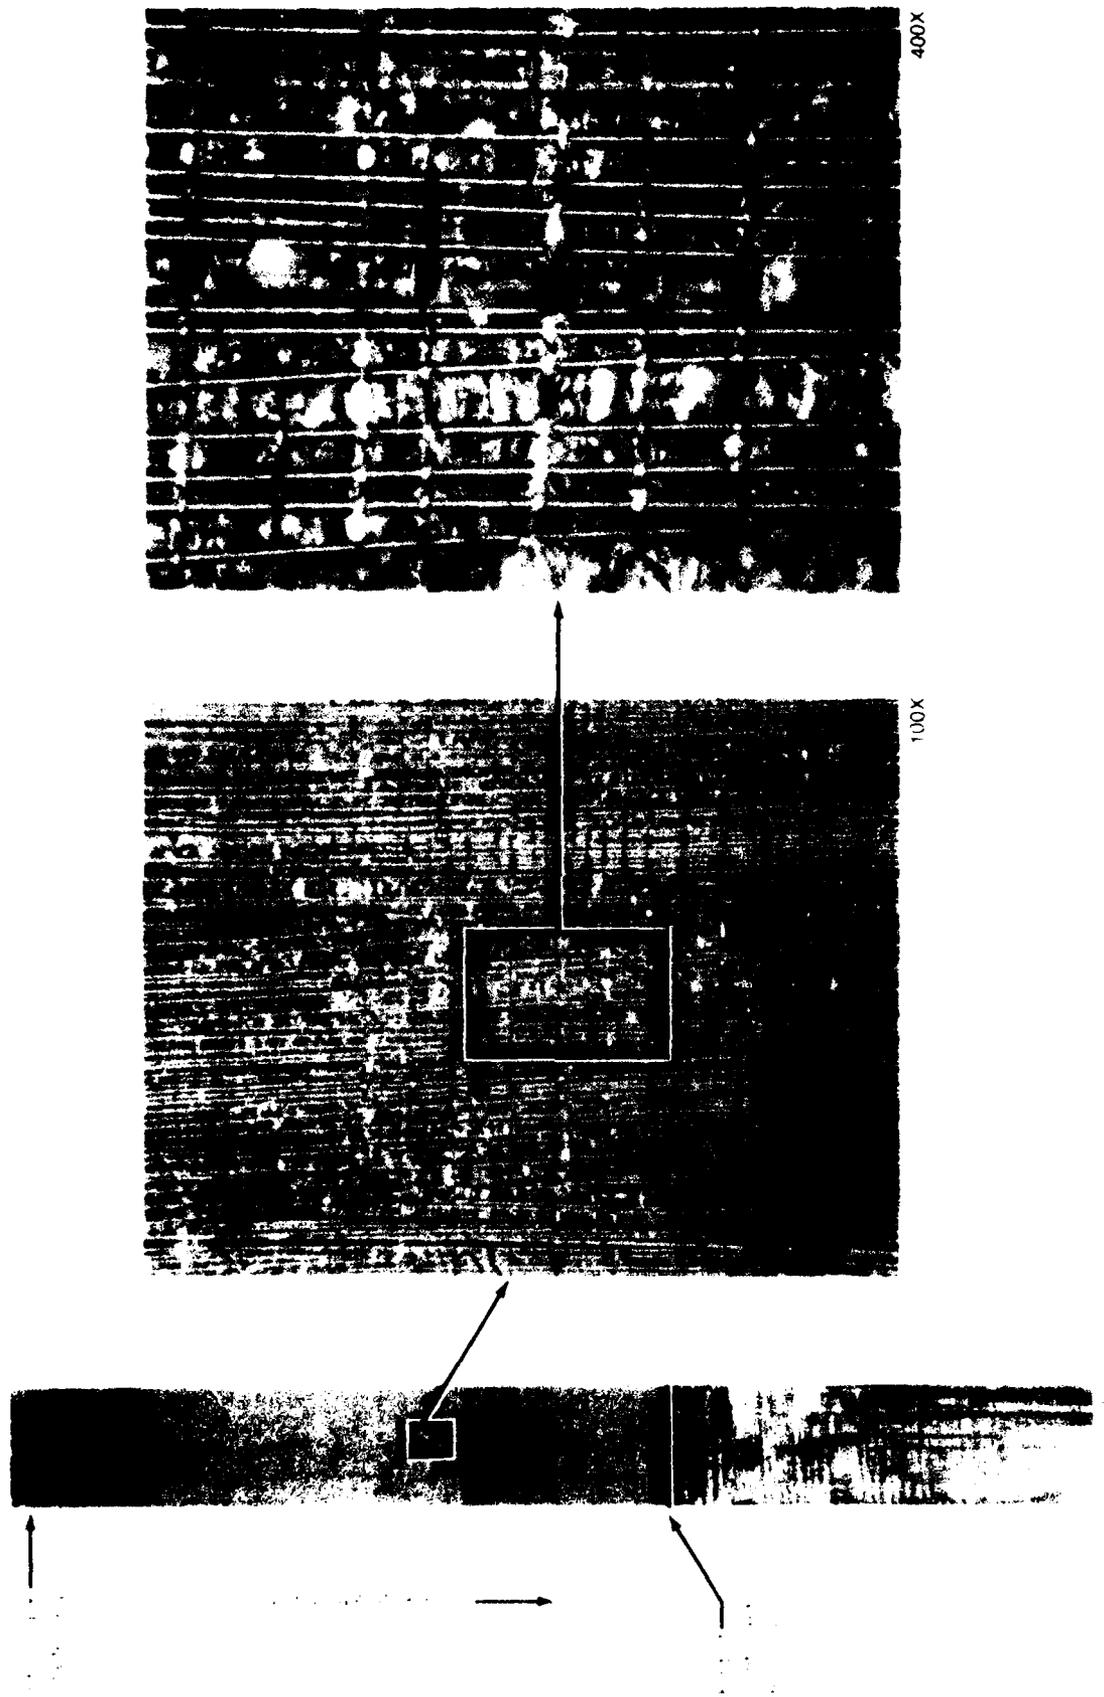
Figure 7-20. Optical Photomicrographs of Intended Fracture Plane Between 0/90-Degree Plies, ENF 21°C (70°F) Specimen

Typical fracture surface features characteristic of mode 2 delaminations for the 0/90-degree cross-ply interface are presented in Figures 7-20 (optical) and 7-21 (SEM). No out-of-plane crack divergence was observed in these specimens. Similar to the interlaminar shear 0/0-degree interfacial fractures, the mode 2 topographies are much rougher and exhibit more fiber/matrix separation than those observed in mode 1 fractures. High-magnification optical inspection of the resin fracture zones between fibers reveals translucent, parallel resin particles whose long axes are aligned normal to the direction of imposed crack propagation. No river mark branching is present. It was concluded that optical microscopy can be used to accurately identify mode 2 fractures and differentiate this load condition from mode 1 delaminations of cross-ply interfacial orientations.

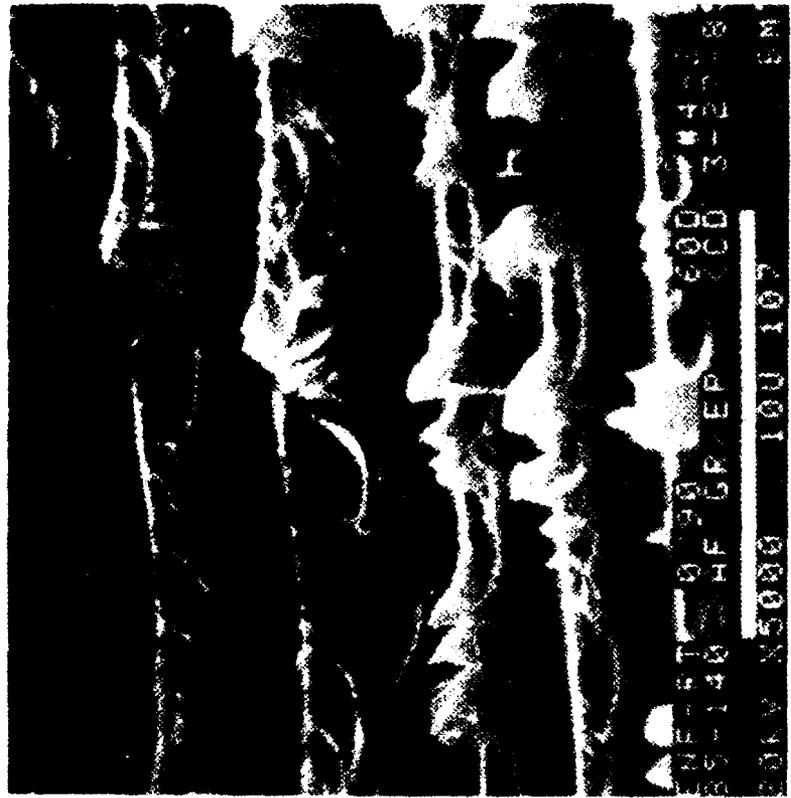
←
Mechanically induced crack direction

Figure 7-21. SEM Photomicrographs of Mode 2 Delamination Between Adjacent 0/90-Degree Plies Illustrating Areas of Fiber/Matrix Separation (F) and Hackles (H)

In addition to the gross topography discussed above, further inspection of hackled and scalloped fracture areas revealed several finer morphological features. As illustrated in Figure 7-21 at 5000X, detailed examination reveals textured resin microflow and branched
