AFWAL-TR-86-4033

FAILURE ANALYSIS OF COMPOSITE STRUCTURE MATERIALS

Brian Smith
Ray Grove
Thomas Munns
Boeing Military Aircraft Company
P.O. Box 3707 M/S 73-43
Seattle, WA 98124

May 1986
Interim Report for 18 July 1984 to 1 October 1985

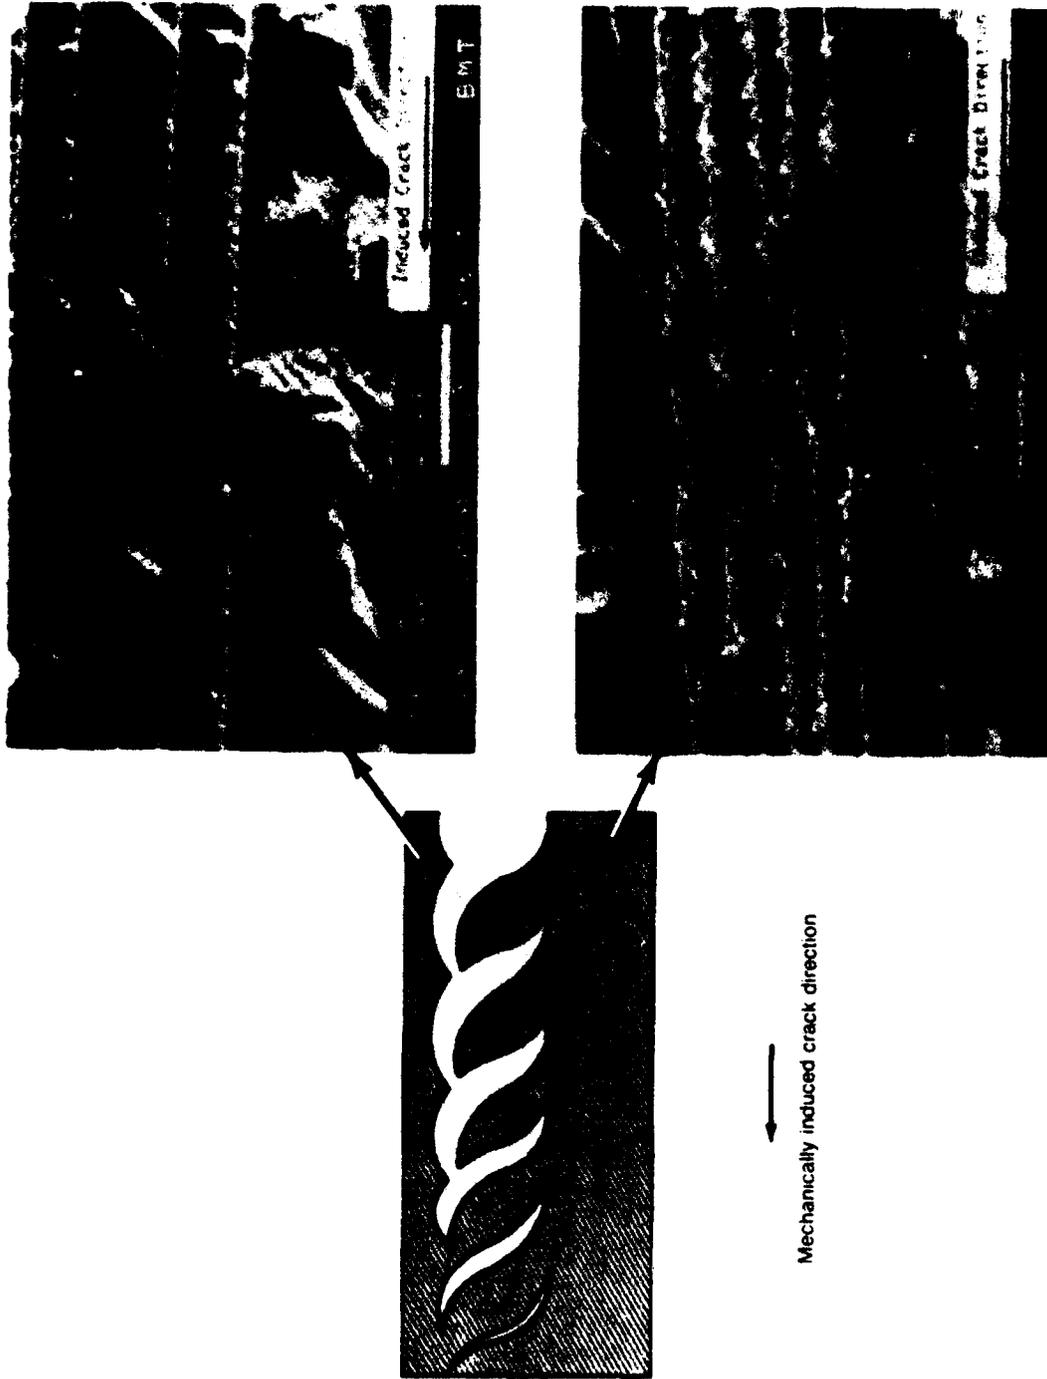
Figure 7-22. Topography of Mating Fracture Surfaces Produced Under Mode 2 Between 0- and 90-Degree Ply Orientations. Hackle (H) Separation Occurs by Mechanism A With Hackles Tilted in the Direction of Crack Propagation

Hackles are tilted normal to the local direction of resolved tension and occur almost exclusively on one side of the fracture surface, with scallops on the opposite side (Figure 7-22). In Figure 7-18, the hackles are tilted coincident with the direction of crack propagation, indicating separation by mechanism A. In contrast to the 0/0-degree ply condition, this observation indicates a positive correlation between hackle tilt and the direction of crack propagation for the 0/90-degree cross-ply condition. However, further studies should determine if the mechanism of hackle separation depends on conditions such as specimen geometry, layup, or degree of mixed-mode loading.

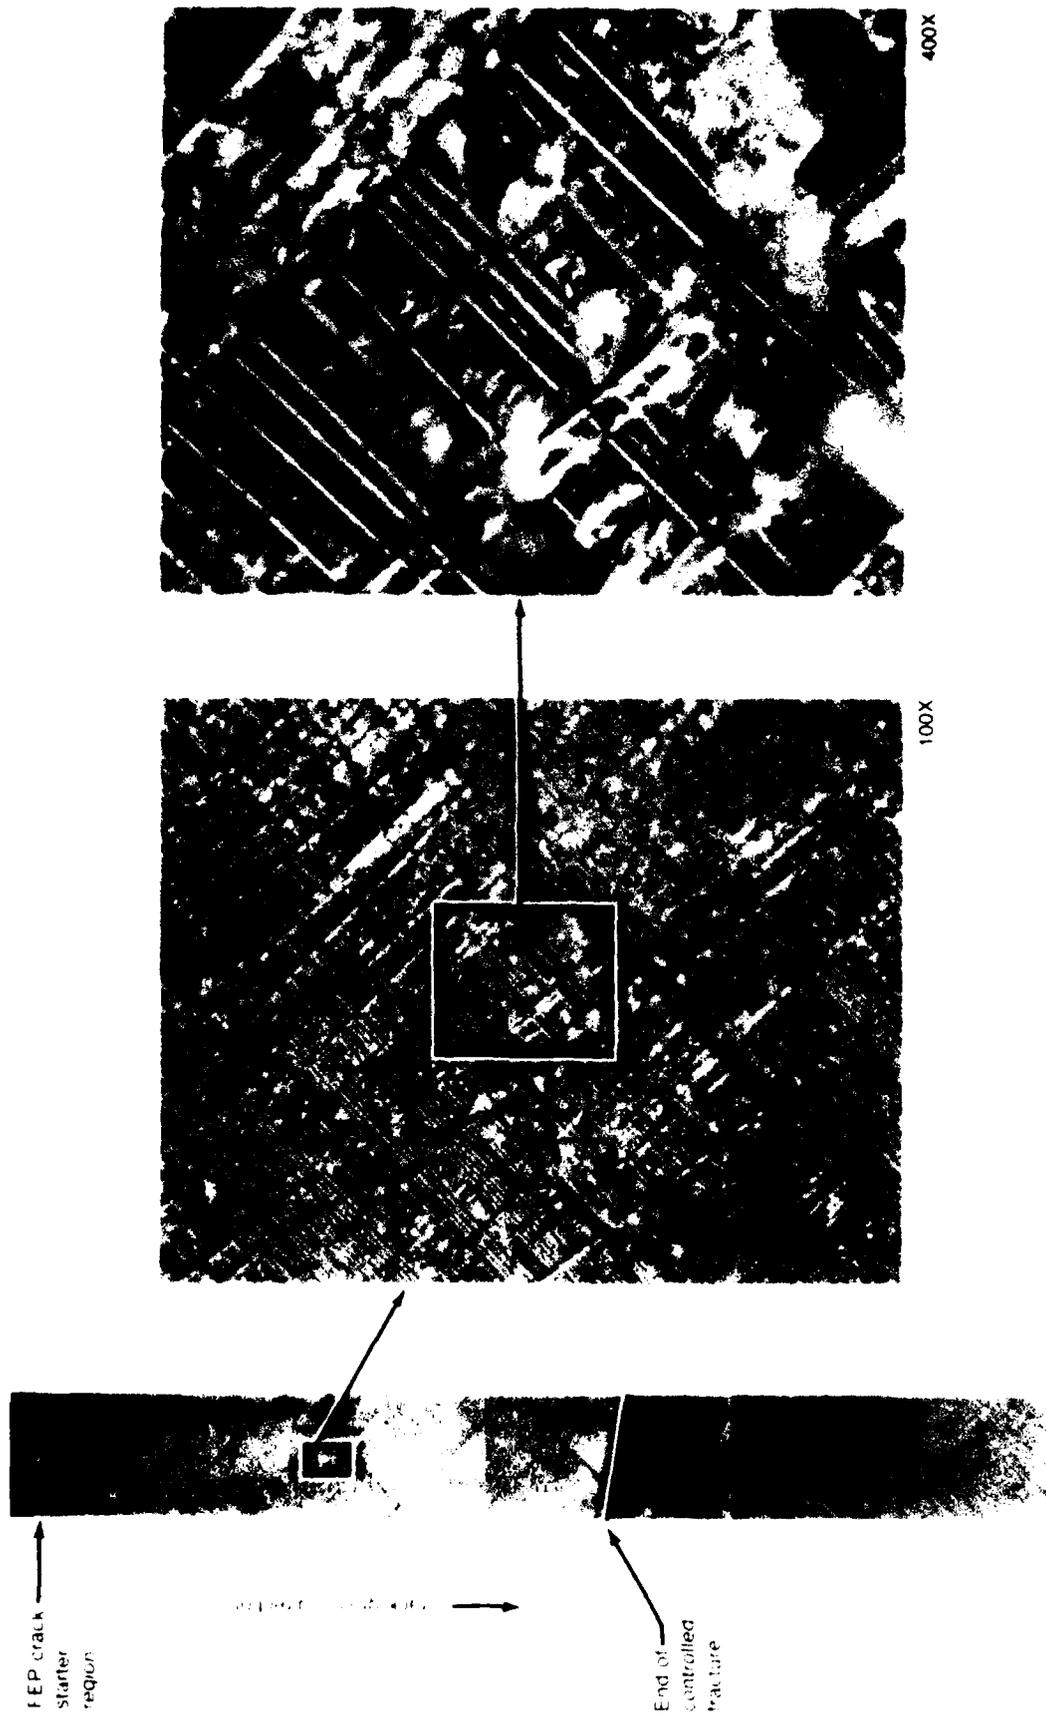
Figure 7-23. Optical Photomicrographs of Intended Fracture Plane Between +45/-45-Degree Plies, ENF 21°C (70°F) Specimen

Typical fracture surface features characteristic of mode 2 delaminations for the +45/-45-degree cross-ply interface are presented in Figures 7-23 (optical) and 7-24 (SEM). No out-of-plane crack divergence was observed in these specimens. Similar to the interlaminar shear 0/0-degree interfacial fractures, the mode 2 topographies are much rougher and exhibit more fiber/matrix separation than those observed in mode 1 fractures. High-magnification optical inspection of the resin fracture zones between fibers reveals translucent, parallel resin particles whose long axes are aligned normal to the direction of imposed crack propagation. No river mark branching is present. It was concluded that optical microscopy can be used to accurately identify mode 2 fractures and differentiate this load condition from mode 1 delaminations of these cross-ply interfacial orientations.

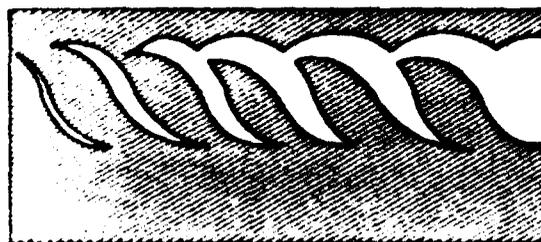
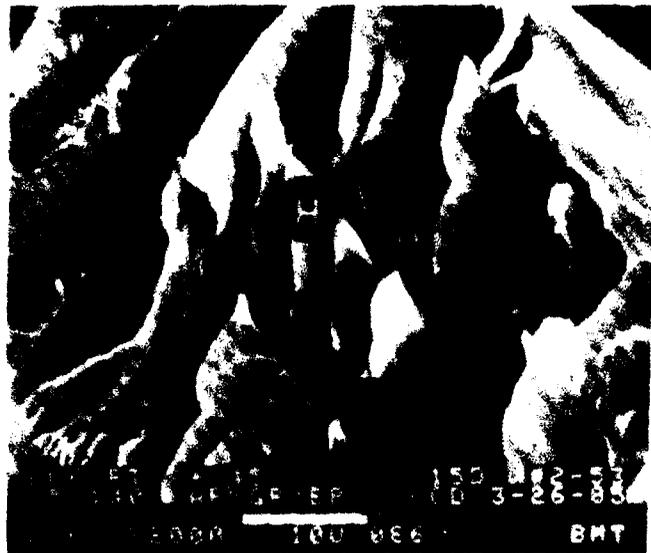
←
Mechanically induced crack direction

Figure 7-25. Fractographs of Mating Fracture Surfaces Produced Under Mode 2 Between +45/-45-Degree Plies. (Hackle Separation Occurs by Mechanism A, in Which Hackles (H) Are Retained on One Side, Tilted Coincident With the Direction of Crack Growth)

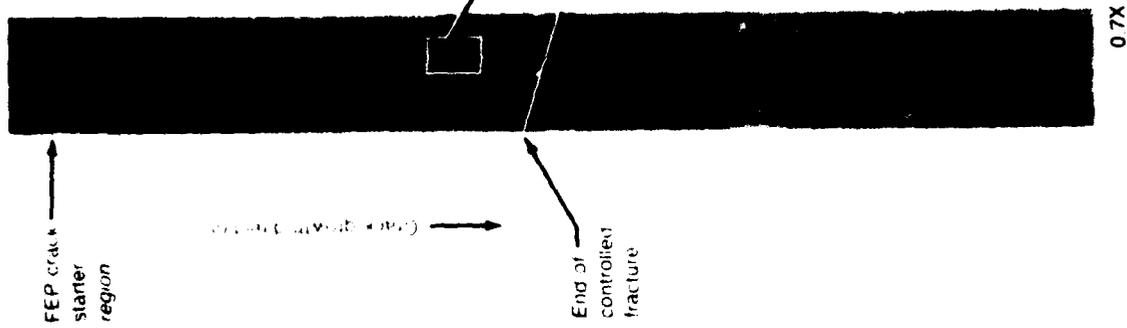
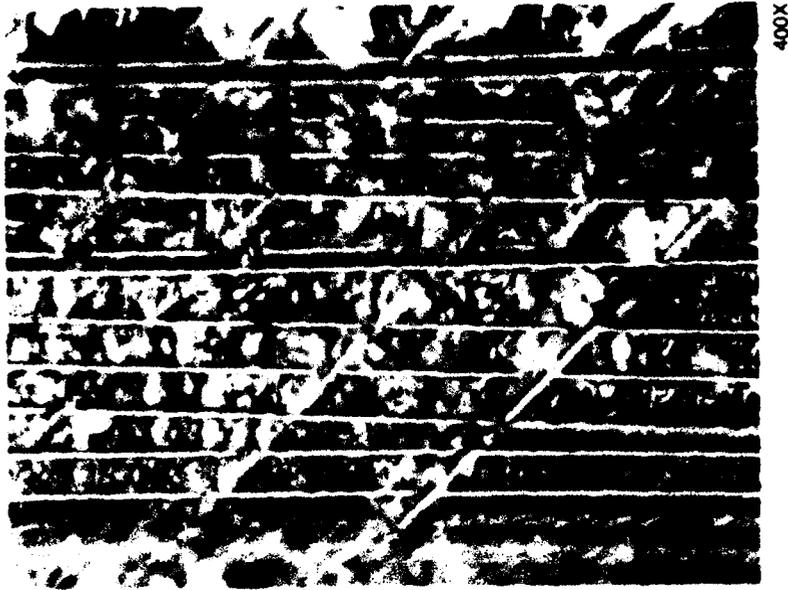
Figure 7-26. Optical Photomicrographs of Intended Fracture Plane Between 0/45-Degree Plies, ENF 210C (700F) Specimen

Typical fracture surface features characteristic of mode 2 delaminations for the 0/+45-degree cross-ply interface are presented in Figures 7-26 (optical) and 7-27 (SEM). No out-of-plane crack divergence was observed in these specimens. Similar to the interlaminar shear 0/0-degree interfacial fractures, the mode 2 topographies are much rougher and exhibit more fiber/matrix separation than those observed for mode 1 fractures. High-

magnification optical inspection of the resin fracture zones between fibers reveals translucent, parallel resin particles, whose axes are aligned normal to the direction of imposed crack propagation. No river mark branching is present. It was concluded that optical microscopy can be used to accurately identify mode 2 fractures and differentiate this load condition from mode 1 delaminations of these cross-ply interfacial orientations.

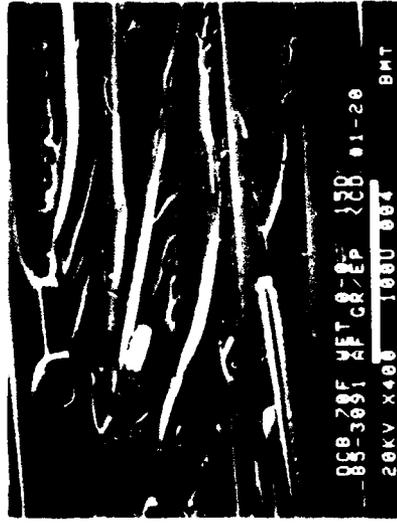
Figure 7-30. Low Magnification Series of Characteristic 0/0-Degree Interface Mode I Fractures at Each Environmental Condition

trend is illustrated in Figures 7-30 and 7-31, in which the effects of environment are listed for fractures produced between adjacent 0-degree plies. The fracture topographies characteristic of -54°C (-65°F) dry and 21°C (70°F) wet appear similar to one another and similar to the 21°C (70°F) dry results presented in Section 7.3.1. All exhibit large amounts of flat resin fracture divided into relatively large longitudinal areas by zones of fiber/matrix separation. The 82°C (180°F) dry/wet specimens are also similar to the lower temperature specimens, with a slightly greater amount of exposed fibers. Microscopic examinations of 132°C (270°F) dry and wet specimens indicated that these elevated temperature fractures are similar to one another, although quite different from the -54°C (-65°F) dry and 21°C (70°F) fractures. All 132°C (270°F) fracture topographies are characterized by significantly larger amounts of exposed fiber/matrix separation. Consequently, a corresponding decrease in the size and amount of flat-resin matrix-fracture zones is evident. Fractures at 132°C (270°F), dry and wet, result in large amounts of randomly oriented fibers, apparently pulled out from the surrounding matrix, scattered over the fracture surface. Macroscopically, the 132°C (270°F) fracture surfaces appear distinctly different than those generated at -54°C (-65°F) and 21°C (70°F) because of these easily visible pulled-out fibers.

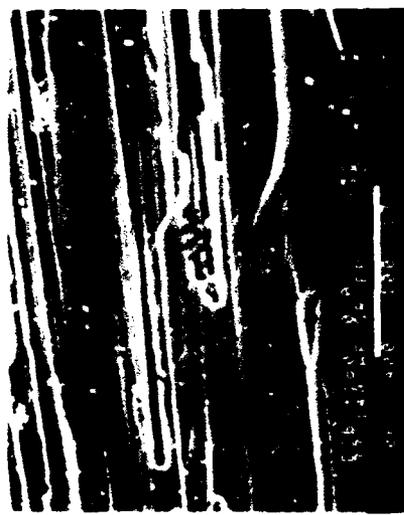
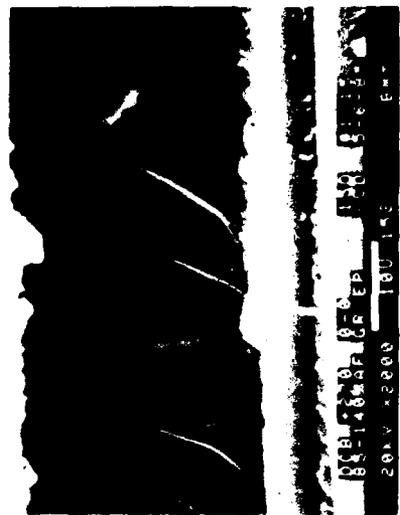
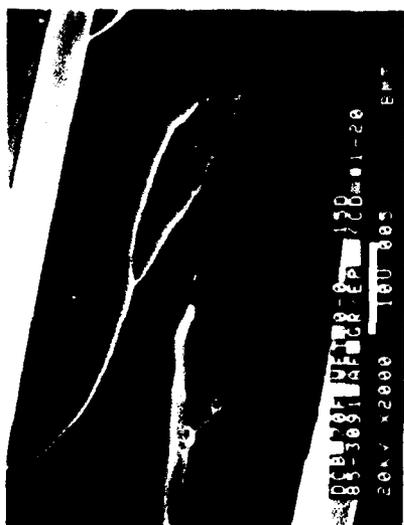
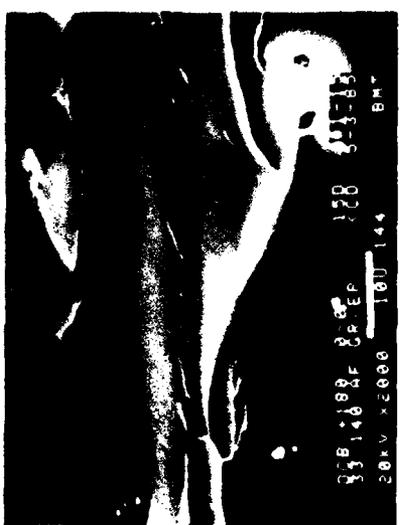
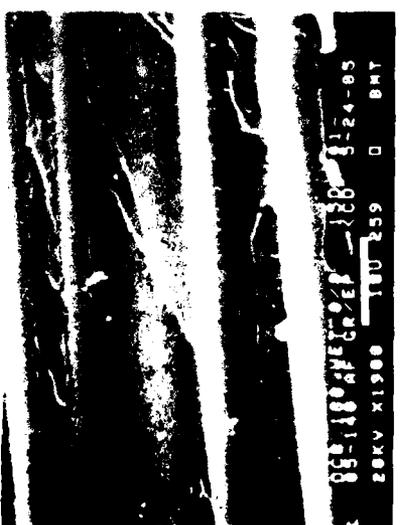
Figure 7-31. Higher Magnification Series of 0/0-Degree Interface Mode 1 Fractures Presented in Figure 7-30 Showing Features of Fiber/Matrix (F) Separation and River Markings (R)

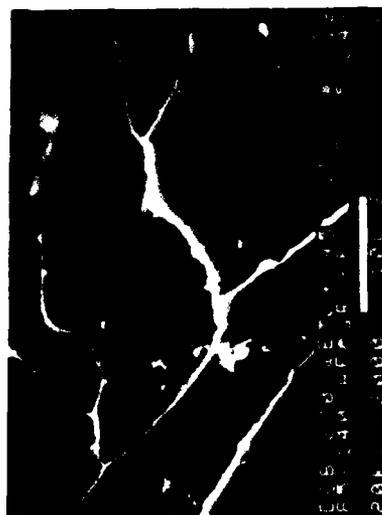
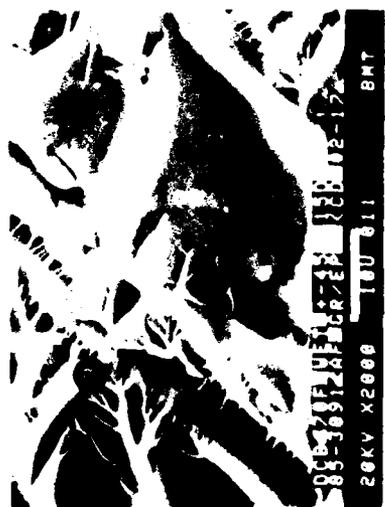
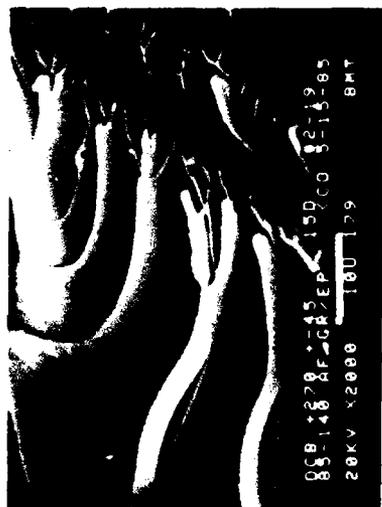
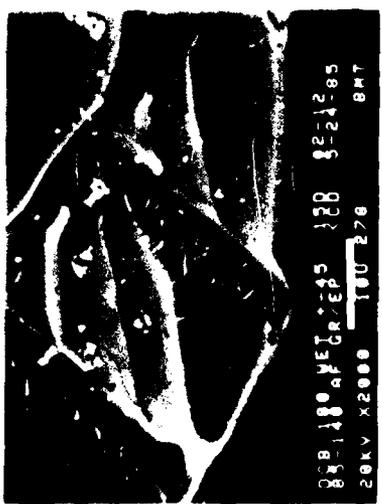
Figure 7-33. Higher Magnification Series of +45/-45-Degree Interface Mode I Fractures Presented in Figure 7-32 Showing Features of Fiber/Matrix (F) Separation and River Markings (R)

Similar to the 0/0-degree interfaces, interlaminar fractures exhibit increasing amounts of fiber/matrix separation with increasing temperature and absorbed water content. As illustrated in Figures 7-32 through 7-37, the -54°C (-65°F) dry, 21°C (70°F) wet, and 82°C (180°F) dry/wet fracture conditions appear similar. In general, for these lower temperature conditions, regions of cohesive resin fracture appear somewhat smaller than those noted for adjacent 0-degree fractures, and are divided into discrete regions by areas of exposed cross-ply fiber/matrix separation. The fracture surfaces generated at 132°C (270°F) dry and wet conditions for each cross-ply configuration appear distinctly different than those generated at lower temperatures. These figures show that the overall fracture surface topography is dominated by large amounts of fiber/matrix interfacial fracture, with occasional regions of cohesive matrix fracture; randomly pulled-out fibers (similar to the 0/0-degree interface fractures noted above) are visible without magnification.

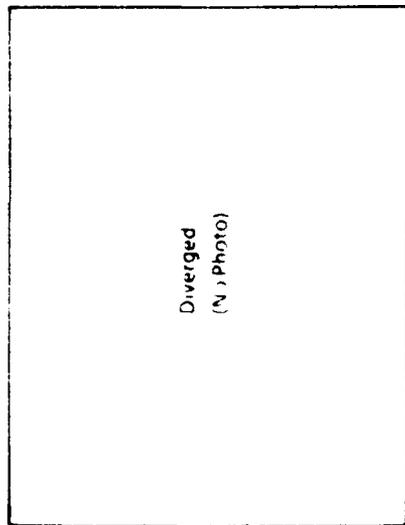
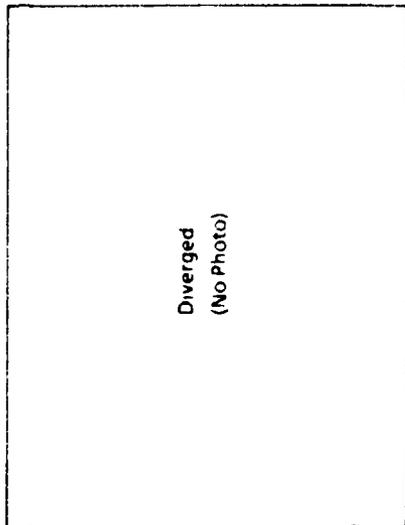
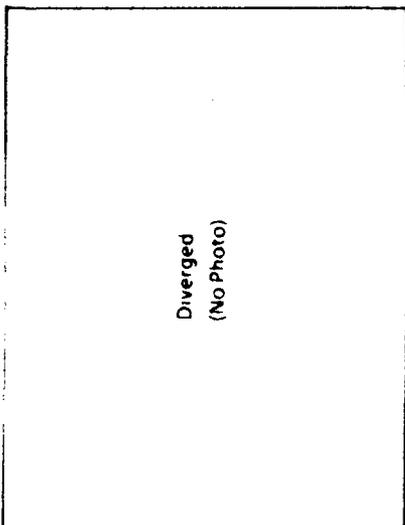
Figure 7-34. Low Magnification SEM Series of Characteristic 0/90-Degree Mode 1 (Tension) Fractures at E_2 -h Environmental Condition

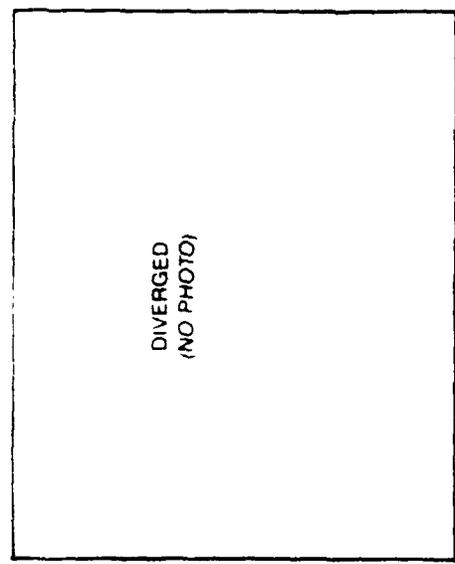
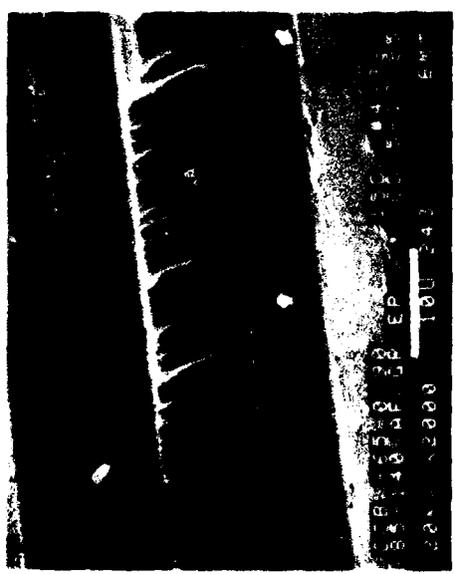
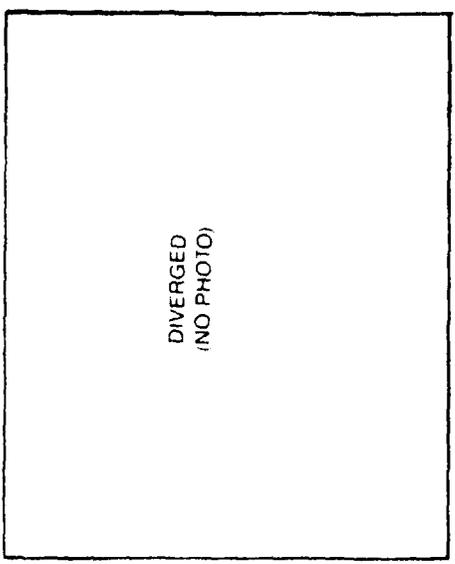
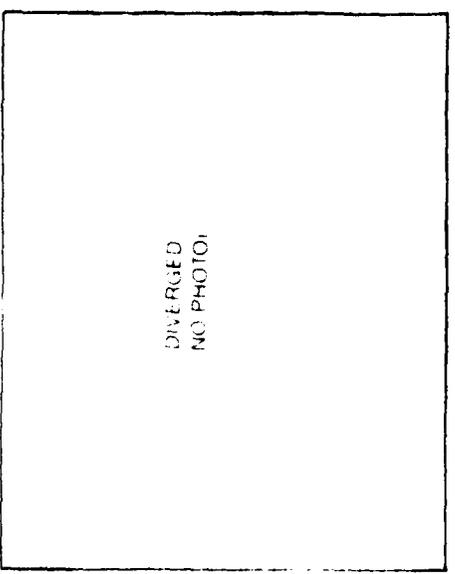
Figure 7-35. Higher Magnification Series of 0/90-Degree Interface Mode 1 (Tension) Fractures Presented in Figure 7-34 Showing Features of Fiber/Matrix (F) Separation and River Markings (R)

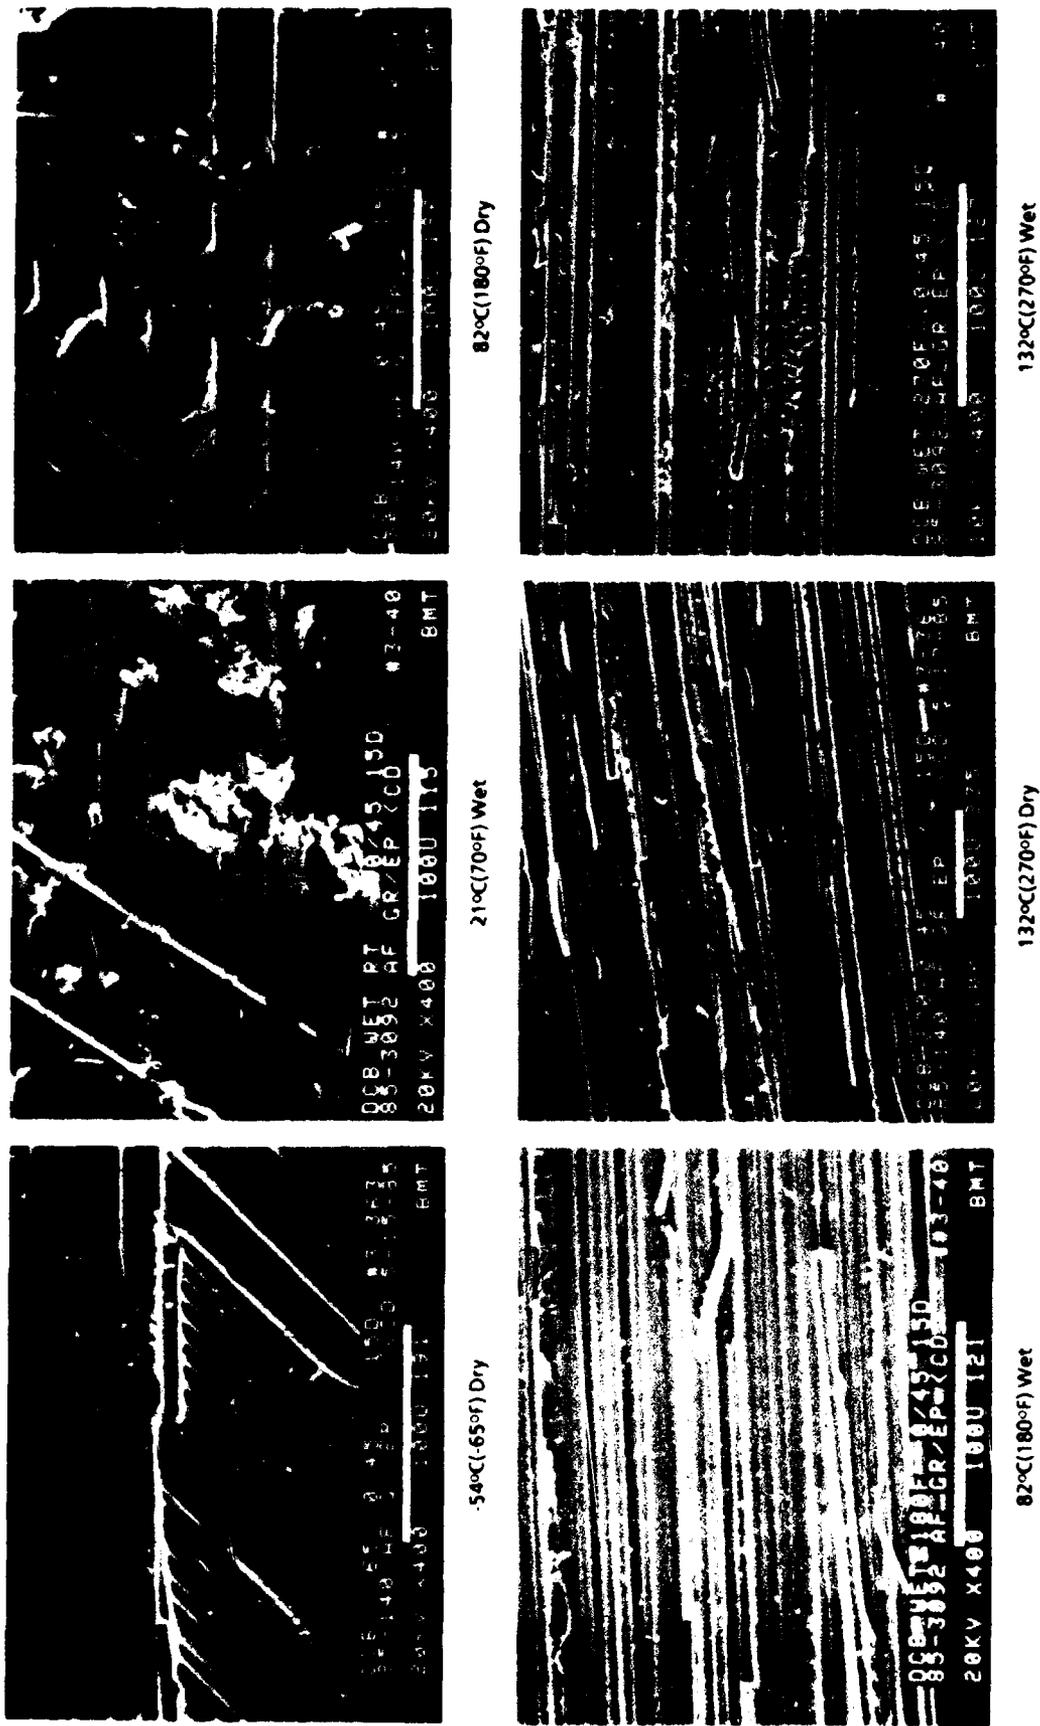
Figure 7-36. Low Magnification SEM Series of Characteristic 0/45-Degree Interface Mode I Fractures at Each Environmental Condition

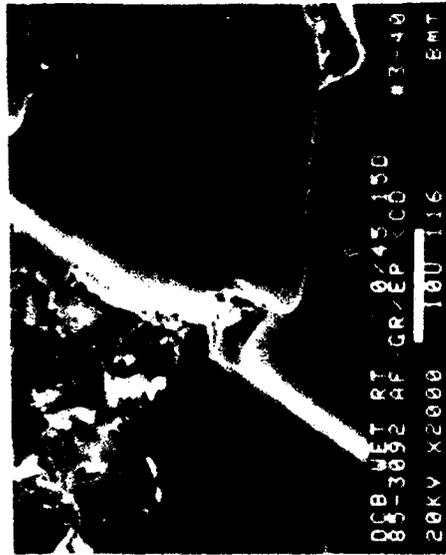
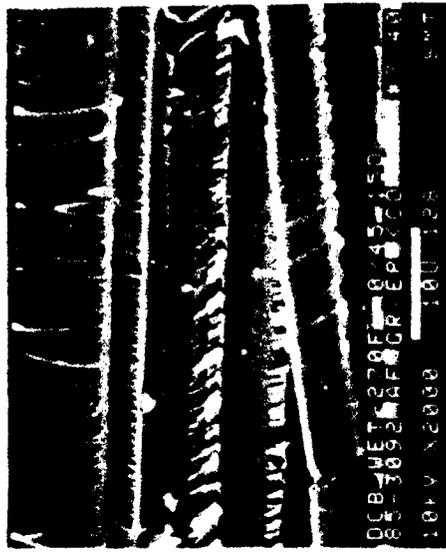
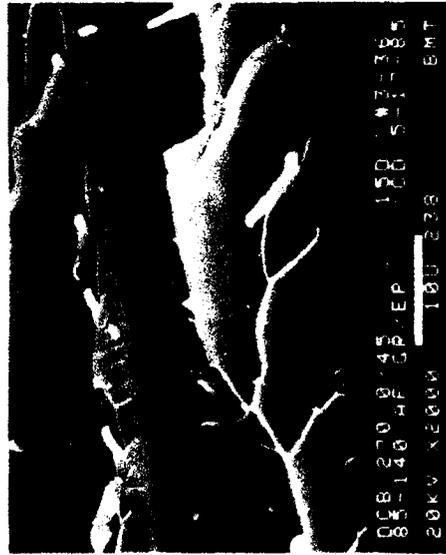
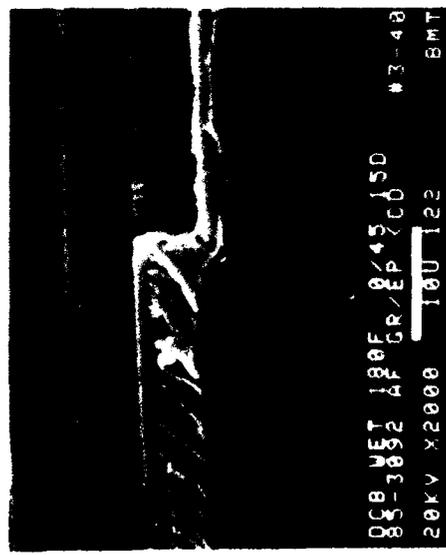
←
Mechanically induced crack direction

Figure 7-37. Higher Magnification SEM Series of 0/45-Degree Interface Mode 1 Fractures Presented in Figure 7-36 Showing Features of Fiber/Matrix (F) Separation and River Markings (R)

7-37	Higher Magnification SEM Series of 0/45-Degree Interface Mode 1 Fractures Presented in Figure 7-36 showing Features of Fiber/Matrix (F) Separation and River Markings (R)	170

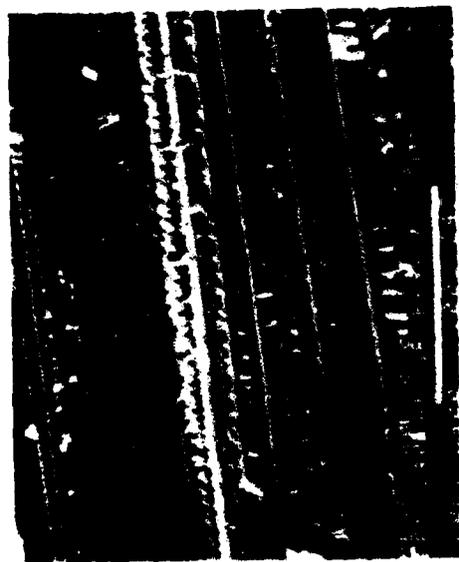
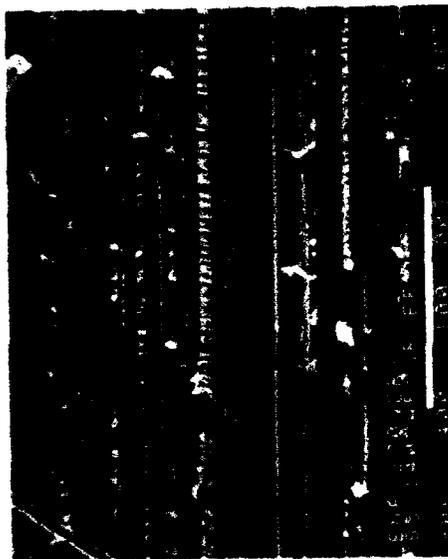
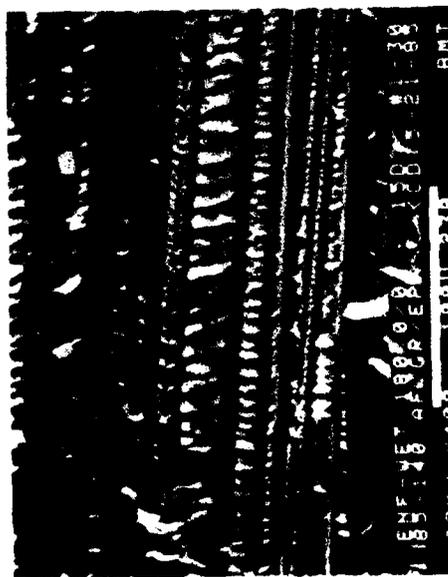
← Mechanically induced crack direction

Figure 7-38. Low Magnification SEM Series of Characteristic 0/0-Degree Interface Mode 2 (Shear) Fractures at Each Environmental Condition

Similar to mode 1 (tension), fractures produced under mode 2 (shear) conditions typically exhibit a mixture of fiber/matrix separation and cohesive resin fracture. However, in contrast to the nearly flat matrix topography representative of mode 1, mode 2 cohesive matrix fractures exhibit characteristic hackles. These hackles provide a means to positively differentiate mode 2 from mode 1 fractures for all environmental conditions tested. In general, the effect of high temperature on mode 2 fractures is a pronounced increase in the amount of fiber/matrix separation, similar to that found for mode 1 (tension) fractures. However, such areas were not documented in the interest of recording the appearance of resin-dominated fracture features. The appearance of resin fracture features is illustrated in Figures 7-38 through 7-45, in which controlled fractures were produced between 0/0-, 0/90-, +45/-45-, and 0/45-degree interfaces at -54°C (-65°F) dry, 21°C (70°F) wet, 82°C (180°F) dry/wet and 132°C (270°F) dry/wet. The topographies characteristic of -54°C (-65°F), 21°C (70°F), and 82°C (180°F) fractures appear very similar. These lower temperature delaminations exhibit large amounts of fractured resin, in which long rows of inclined hackles are bounded by zones of fiber/matrix separation. In contrast, fractures produced under 132°C (270°F) dry and wet conditions are characterized by a significantly larger amount of fiber/matrix separation, and a corresponding decrease in the size and amount of resin-hackle features. The hackles are sometimes twisted and deformed, indicative of an increase in matrix ductility at elevated temperatures. As found for interlaminar tension, the 132°C (270°F) conditions result in pulled-out fibers scattered over the fracture surface; while not shown in the figures illustrated, these fibers could be seen at both a macroscopic and microscopic level. For each cross-ply orientation, delamination surfaces exhibit increasing amounts of fiber/matrix separation with increasing temperature and absorbed water content. This phenomenon is particularly evident in the lower magnification photomicrographs in which an overview of the fracture surface morphology can be seen.

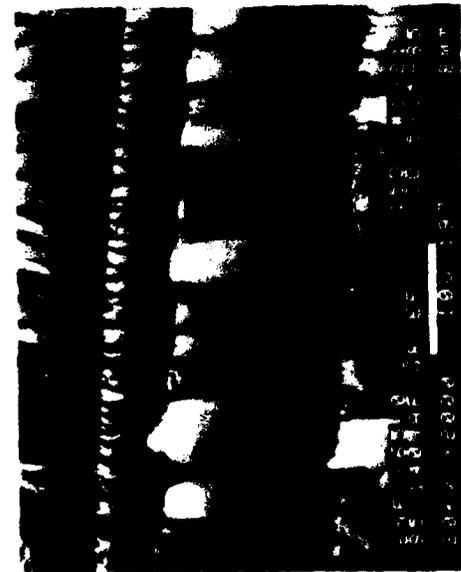
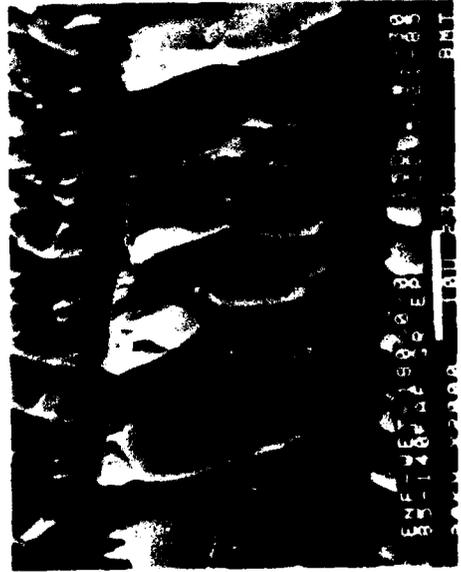
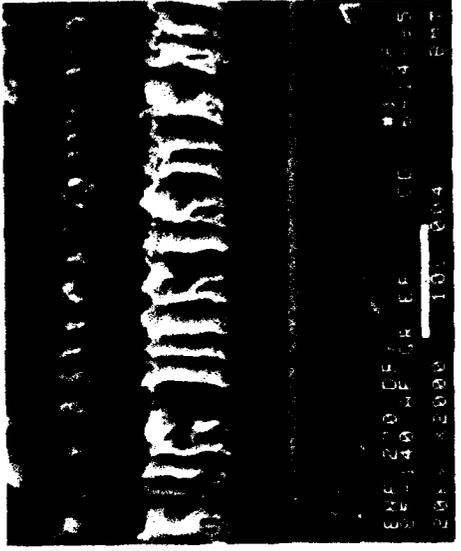
← Mechanically induced crack direction

Figure 7-39. High Magnification SEM Series of 0/0-Degree Interface Mode 2 (Shear) Fractures Presented in Figure 7-38 Showing Features of Fiber/Matrix (F) Separation and Hackles (H)

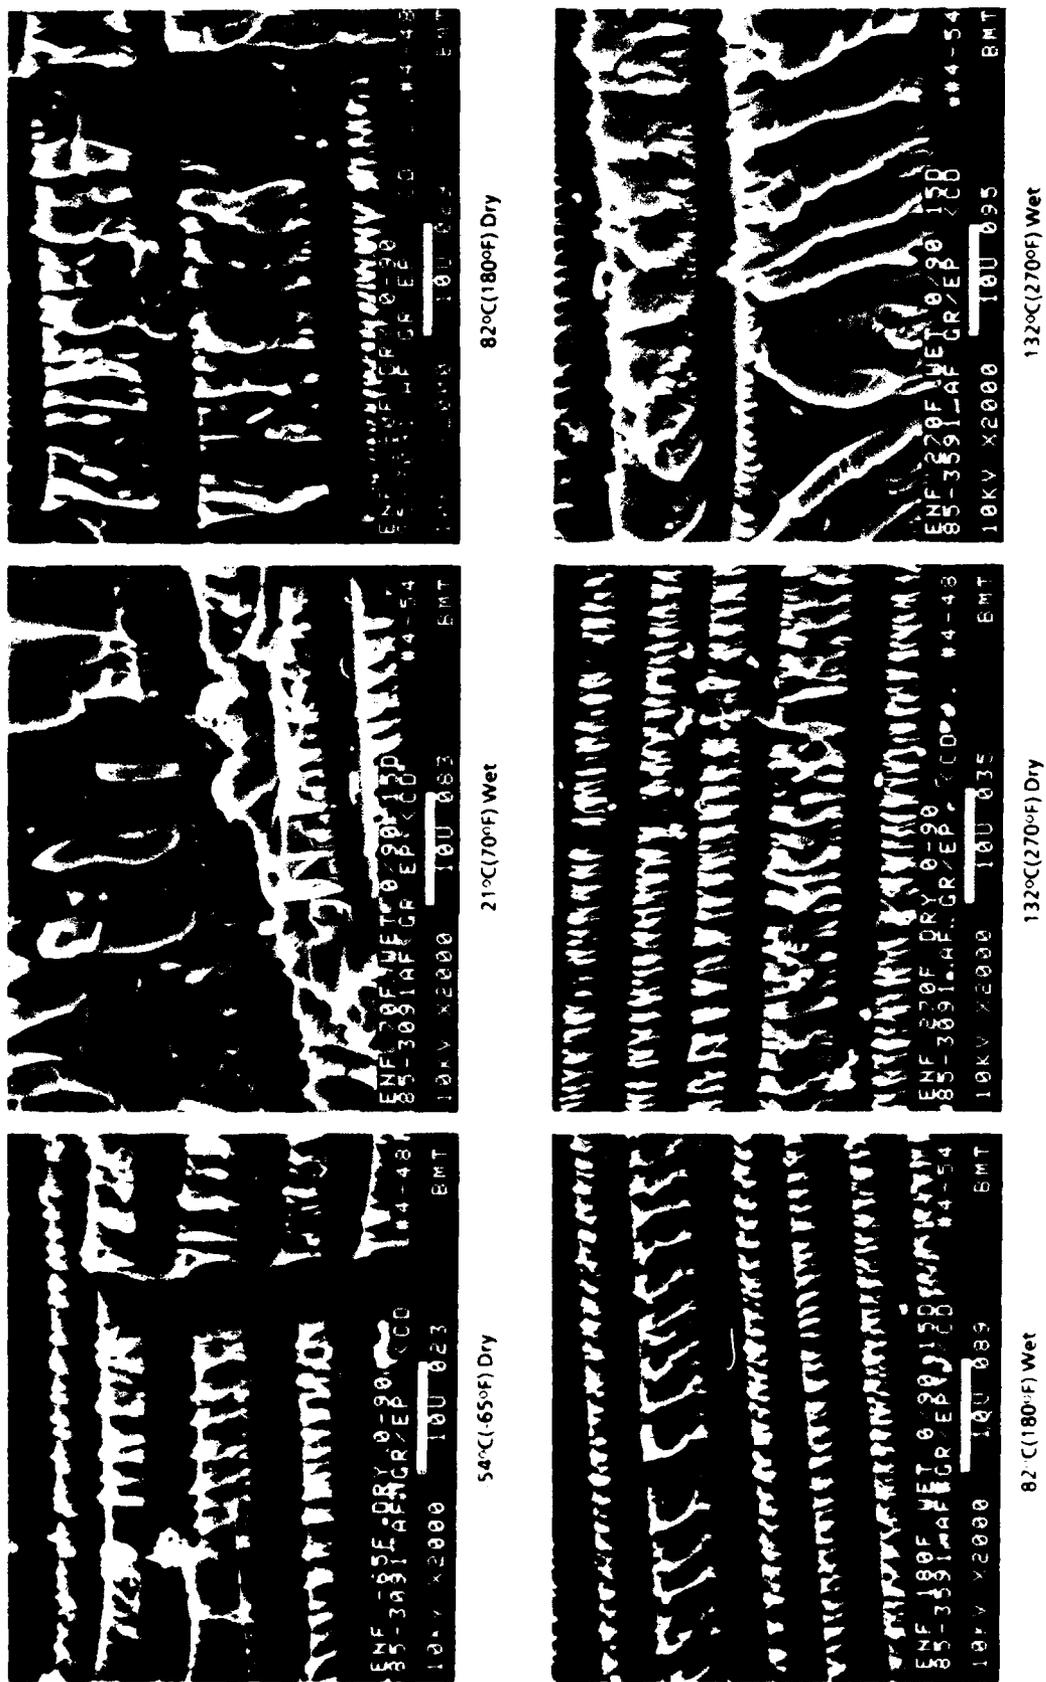
Figure 7-41. Higher Magnification SEM Series of 0/90-Degree Interface Mode 2 (Shear) Fractures Presented in Figure 7-40 Showing Features of Fiber/Matrix (F) Separation and Hackles (H)

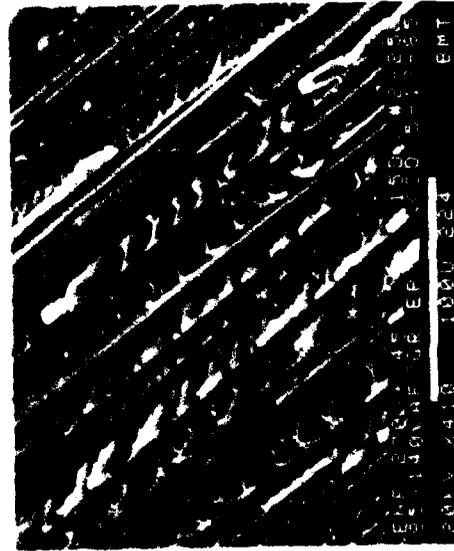
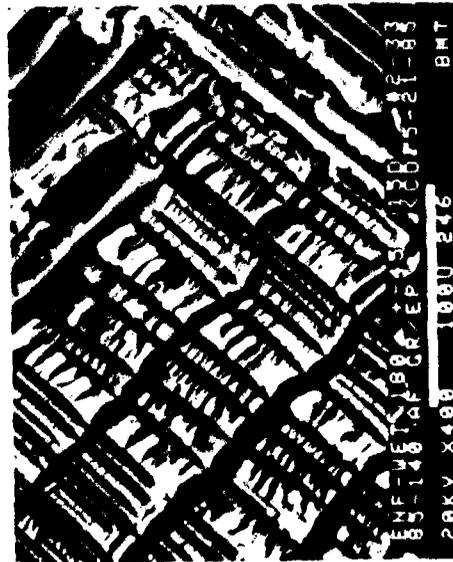
←
Mechanically induced crack direction

Figure 7-42. Low Magnification SEM Series of Characteristic +45/-45-Degree Interface Mode 2 Fractures at Each Environmental Condition

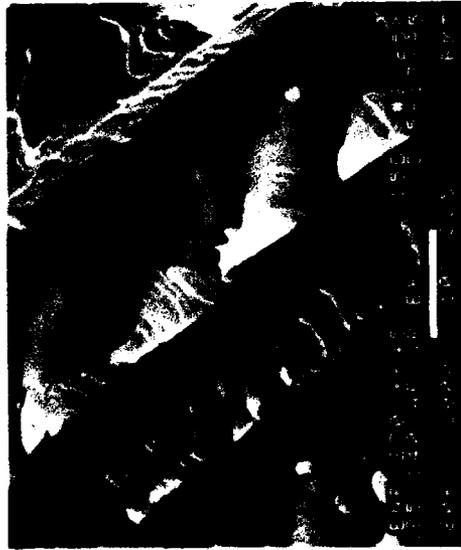
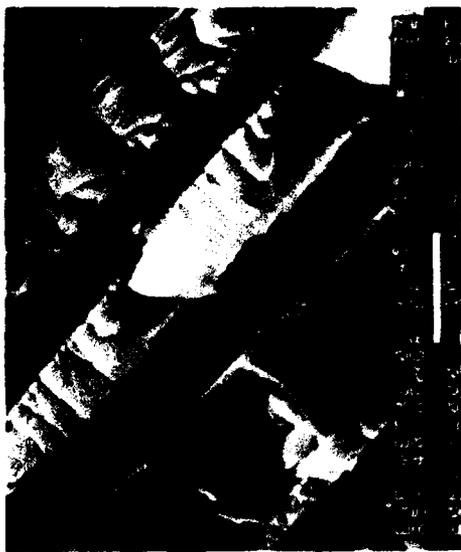
←
Mechanically induced crack direction

Figure 7-43. Higher Magnification SEM Series of +45/-45-Degree Interface Mode 2 (Shear) Fractures Presented in Figure 7-42 Showing Features of Fiber/Matrix (F) Separation and Hackles (H)

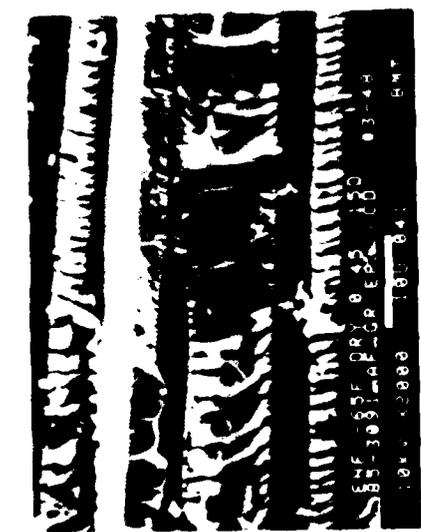
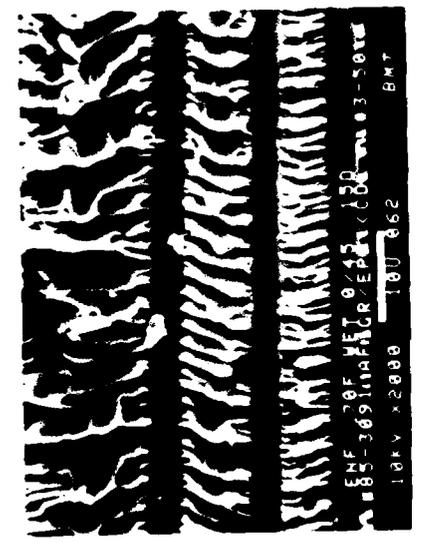
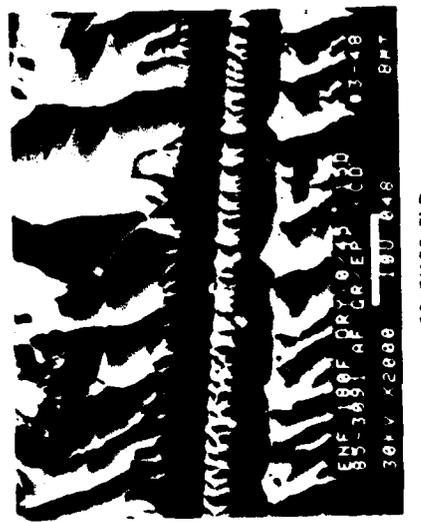
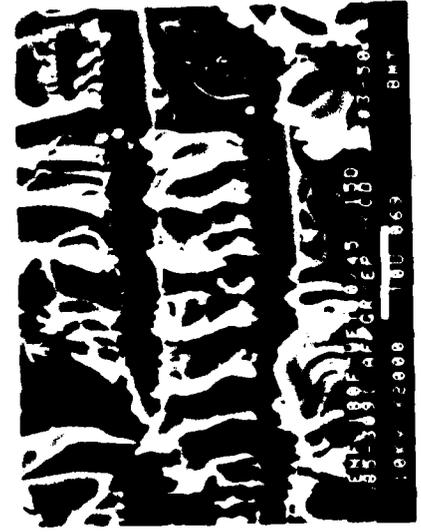
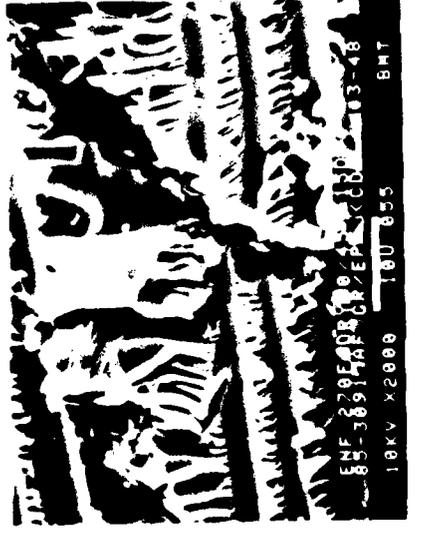
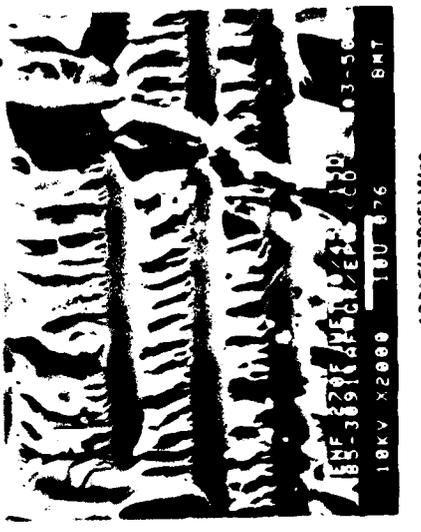
Figure 7-45. Higher Magnification SEM Series of 0/-45-Degree Mode 2 (Shear) Fractures Presented in Figure 7-44 Showing Features of Fiber/Matrix (F) Separation and River Markings (R)

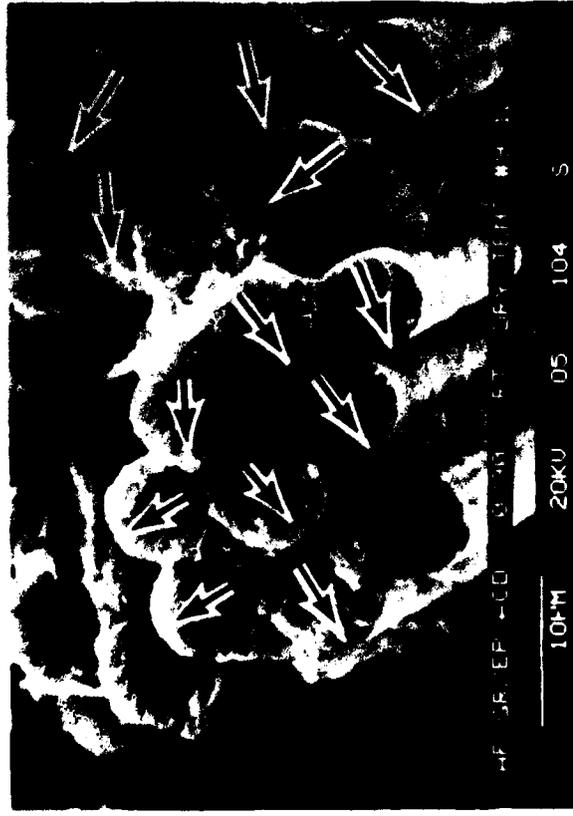
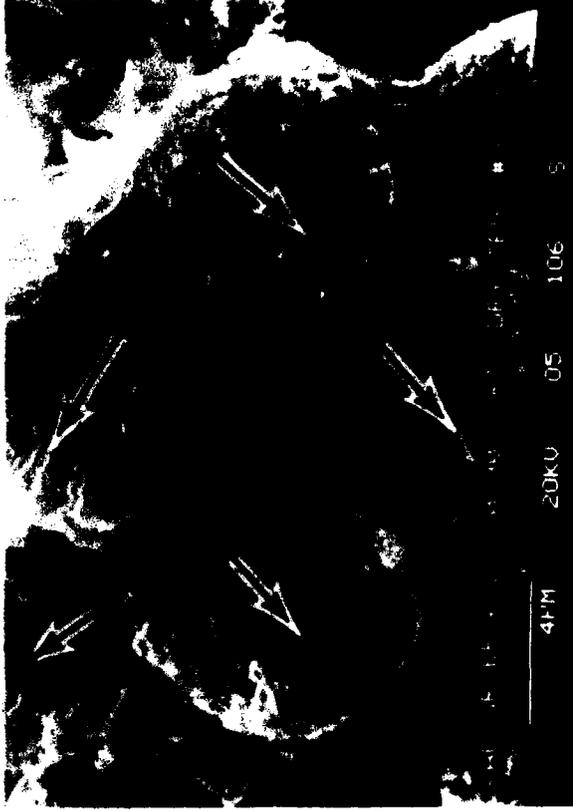
Figure 7-46. Translamellar Tension Fractures; 0/90-Degree Laminate

The typical surface characteristics of translaminar tension fractures generated across the 0/90-degree specimen is illustrated in Figure 7-46. Macroscopic examination of the overall surface revealed that fracture occurred at the intended plane: parallel to the 90-degree fiber orientation. Visual observation during testing revealed that cracking initiated at the specimen notch tip and progressed toward the specimen's opposite side.

SEM examinations were principally focused on the fracture regions in which fiber bundles, pullout, and end-fracture features were evident (see Figure 7-46). 0-degree fibers tend to fracture in bundles or tiers, with each bundle having a relatively flat, common fracture zone. Fibers within the bundles, as well as individual pulled-out fibers, were found to have significant amounts of adhering matrix resin, indicative of good fiber/matrix adhesion and adhesive fracture. Detailed inspection of this adhering matrix resin revealed the presence of hackles, associated with mode 2 shear fracture. Examinations of the fractured end of each fiber revealed a radial morphology—axially diverging lines emanating from a single point. The radial morphology is analogous to the chevron patterns commonly recognized in brittle metals—particularly for fractured bar or rod forms. The appearance of chevrons in metals is associated with microscopic variations in the plane of fracture, aligned in the direction of local crack propagation, and diverging from the point of initiation. Based on this interpretation, the localized direction of crack propagation for each individual fiber fracture can be determined by examining the radial morphology. The initiation points—origins—were primarily located at flaws or notches in the crenulated fiber surfaces, although isolated origins were found at internal flaws such as voids. Crack propagation along the fiber ends did not progress by the development and motion of a well-defined crack front. This was evidenced by the variety of directions of radials within a given bundle, even to the point of opposite directions for adjacent fibers. However, through overall mapping of the fracture growth direction for the individual 0-degree fiber ends, it was determined that the direction of radial features coincided with the direction of induced fracture. As illustrated in the lower photomicrographs of Figure 7-46, the induced crack direction coincides with the general direction of fiber-end fracture (note arrows on fiber ends indicating individual fracture direction).
