AFWAL-TR-86-4033

FAILURE ANALYSIS OF COMPOSITE STRUCTURE MATERIALS

Brian Smith
Ray Grove
Thomas Munns
Boeing Military Aircraft Company
P.O. Box 3707 M/S 73-43
Seattle, WA 98124

May 1986
Interim Report for 18 July 1984 to 1 October 1985

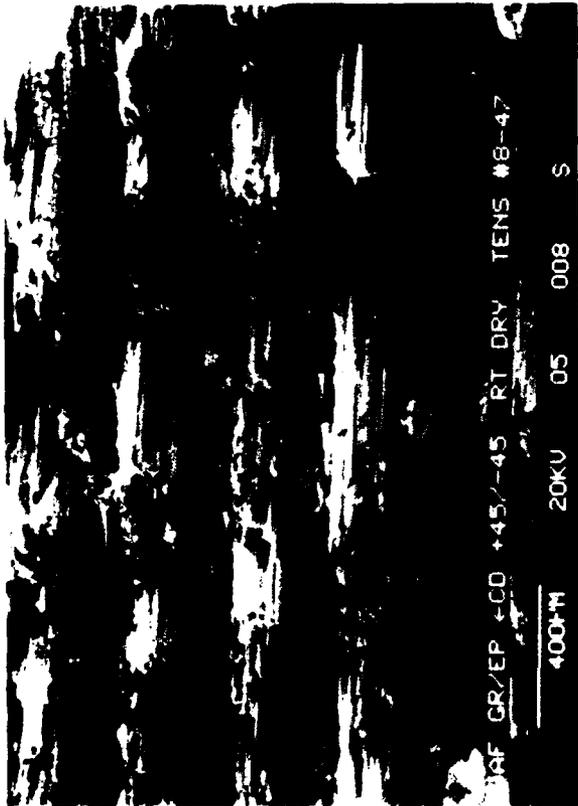
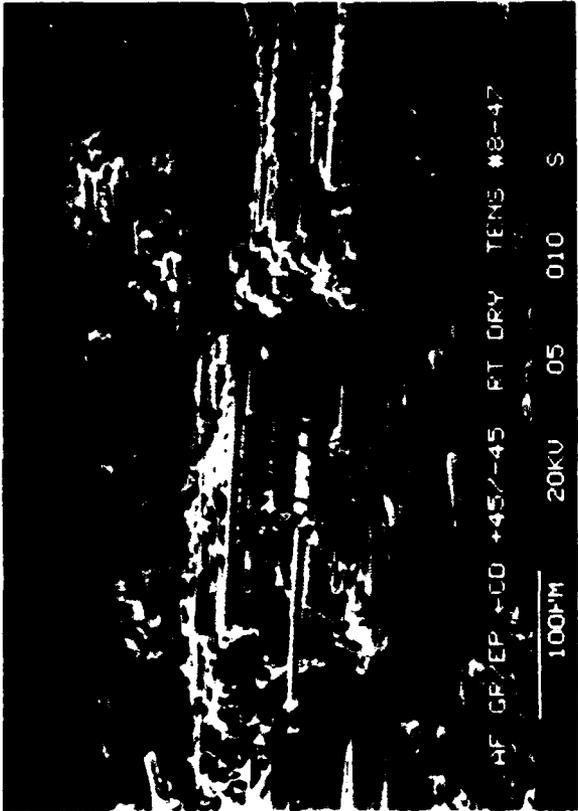
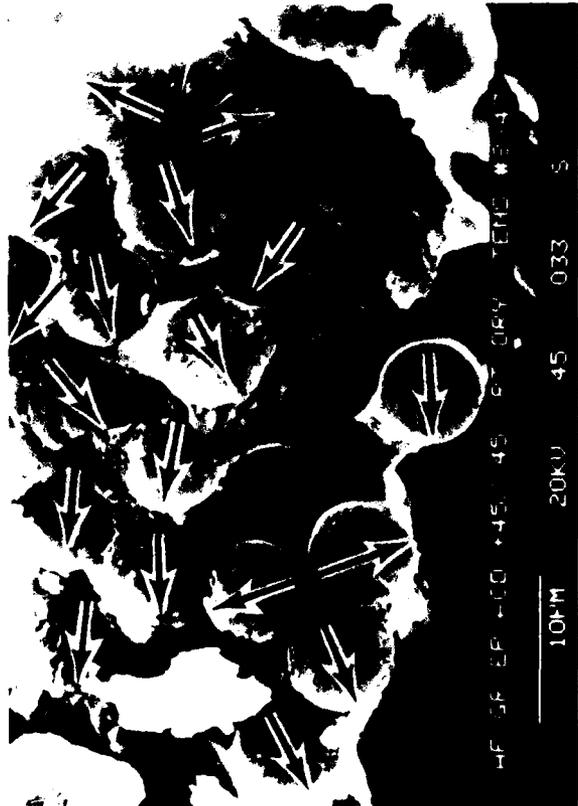
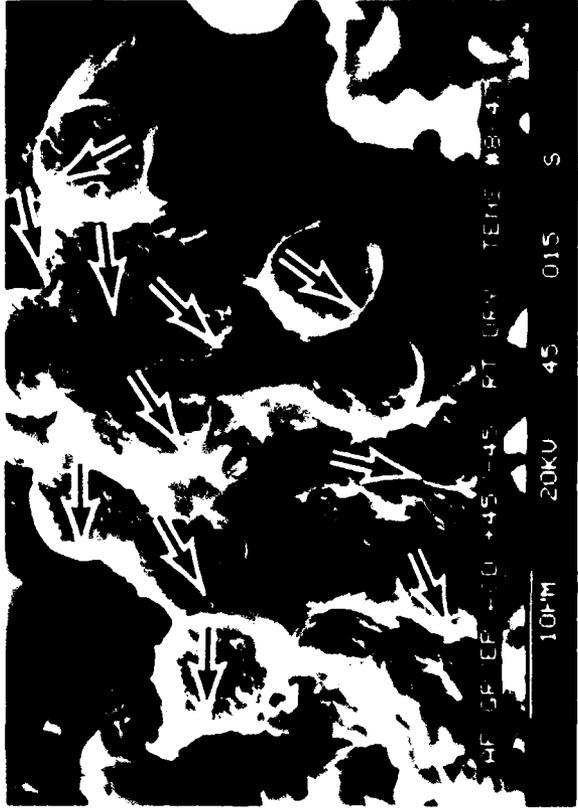
Figure 7-47. Translaminar Tension Fractures; +45/-45-Degree Laminate

The typical surface characteristics of translaminar tension fractures generated in +45/-45-degree specimens are illustrated in Figure 7-47. Macroscopic examination of the overall surface indicated that fracture occurs at the intended plane, parallel to the 90-degree orientation. High-magnification optical and SEM analysis concentrated on the tensile-dominated initiation zone.

The SEM photographs in Figure 7-47 show that the fracture surface consists primarily of large bundles of fibers which have a common, rather flat fracture plane. Each bundle of the +45/-45-degree laminates contained between 10 and 100 fibers, more fibers than were found in the 0/90-degree laminate. However, the fracture surface exhibited fewer single, standalone, pulled-out fibers than the 0/90-degree laminate. Most fibers had a significant amount of matrix resin adhering to them, indicating a good fiber/matrix adhesion and cohesive resin fracture. Examination of the fractured end of each fiber (for both the +45- and -45-degree bundles) revealed a radial morphology, and the average individual crack direction coincided with the direction of induced fracture (see bottom photomicrographs in Figure 7-47).

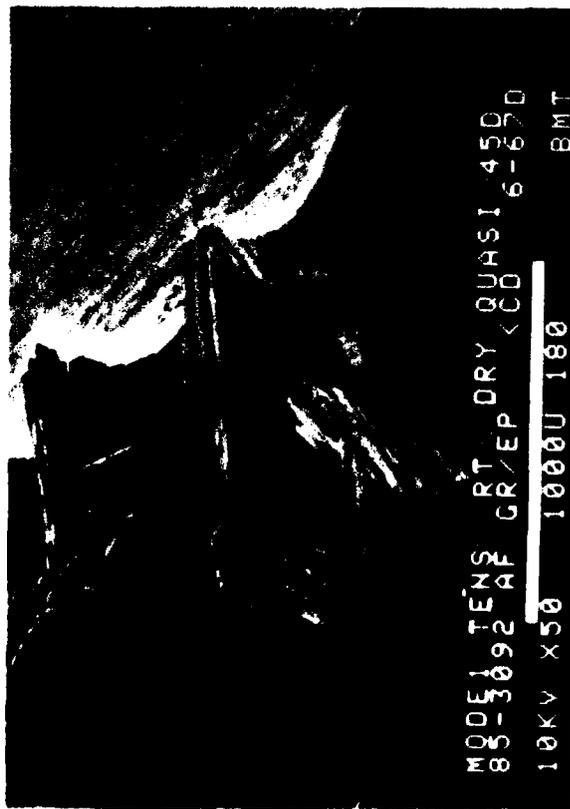
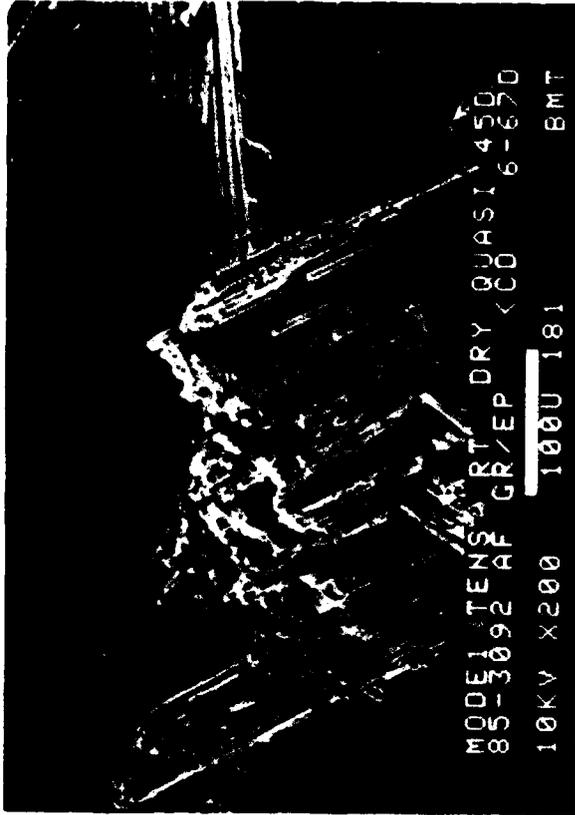
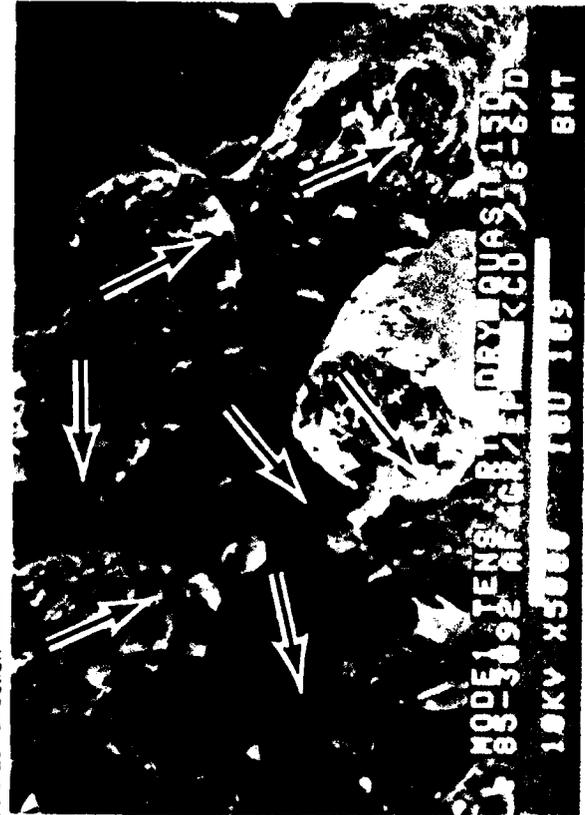
Figure 7-48. Translamellar Tension Fractures: Quasi-Isotropic Laminate

The typical fracture surface characteristics of translaminar tension fractures generated in the quasi-isotropic specimens are illustrated in Figure 7-48. Similar to the other two laminates discussed previously, macroscopic examination verified that cracking occurs parallel to the 90-degree plies.

Examination of the fiber ends for both 0- and 45-degree oriented fibers revealed a radial fracture morphology, as shown in the lower photomicrographs in Figure 7-48. In these photos, the fiber ends of a 45-degree bundle are illustrated. After thorough analysis of the fiber-end fractures, it was concluded that the average of the individual crack directions coincided with the direction of induced fracture. The findings presented above indicate that optical and/or SEM analysis can be used to identify river marks and radial features which define the overall direction of crack growth for quasi-isotropic translaminar fractures.

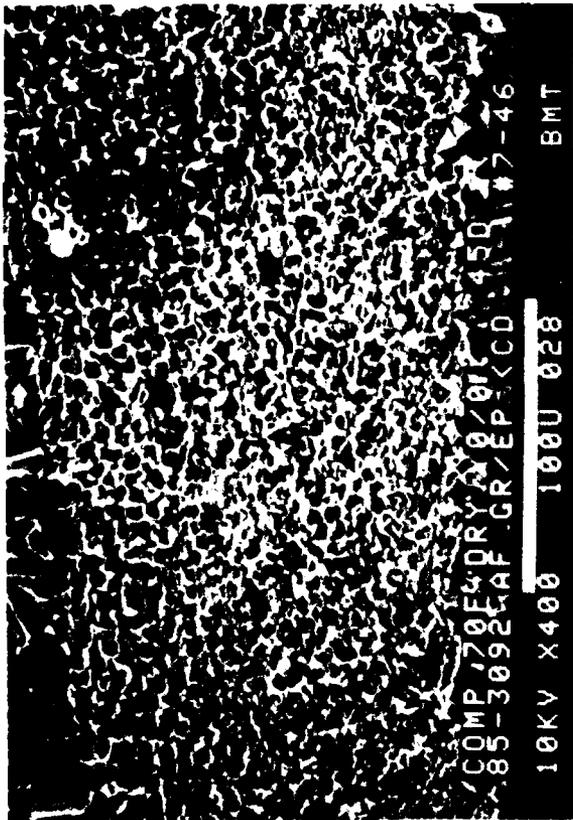
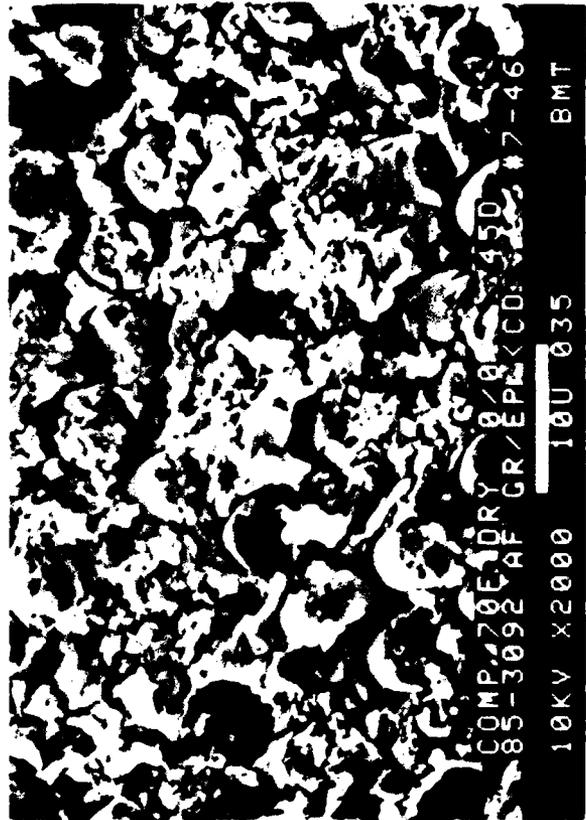
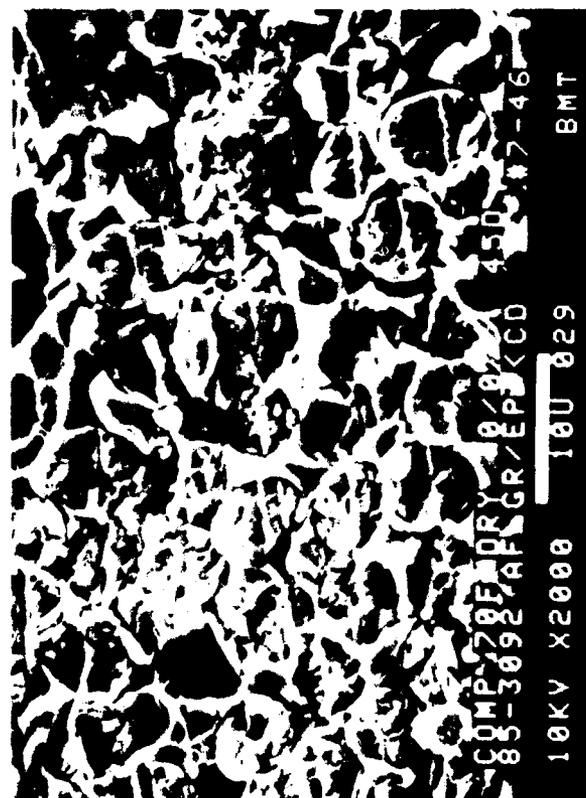
Figure 7-49. Translaminar Compression Fractures; Unidirectional 0-Degree Laminate

Macroscopic and optical microscopic examinations revealed a distinct, flat fracture that occurred on the intended plane. The surface was much flatter than those of translaminar tension fractures, and was virtually devoid of pulled-out fibers. This flat fracture morphology can be seen in the upper left photomicrographs of Figures 7-49 through 7-52, and is most visible in Figure 7-49 of the unidirectional laminate. SEM examination

revealed a combination of fiber buckling, fiber-end fracture, resin-matrix fracture, and postfailure damaged regions. In the upper and lower right photomicrographs in each series, extensive fiber-end damage and many fractured resin particles can be seen. This obliteration of fracture surface features was attributed to postfailure abrasion between mating fracture surfaces.

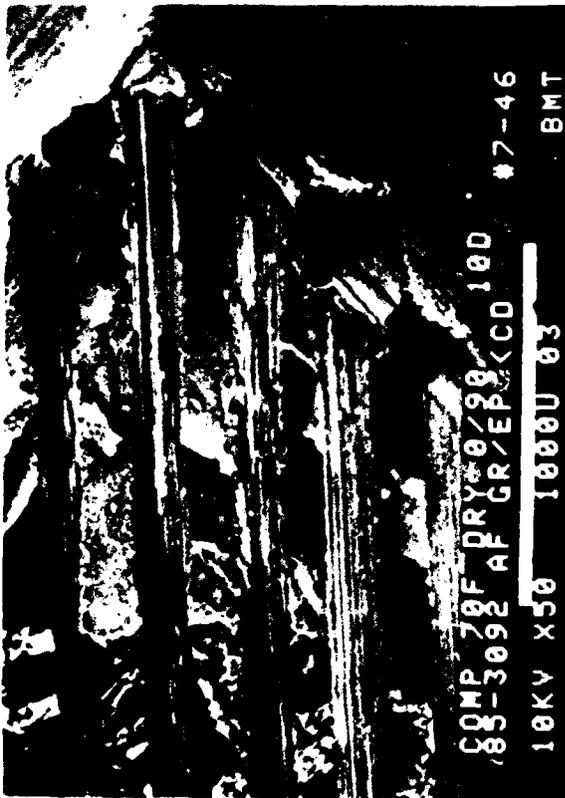
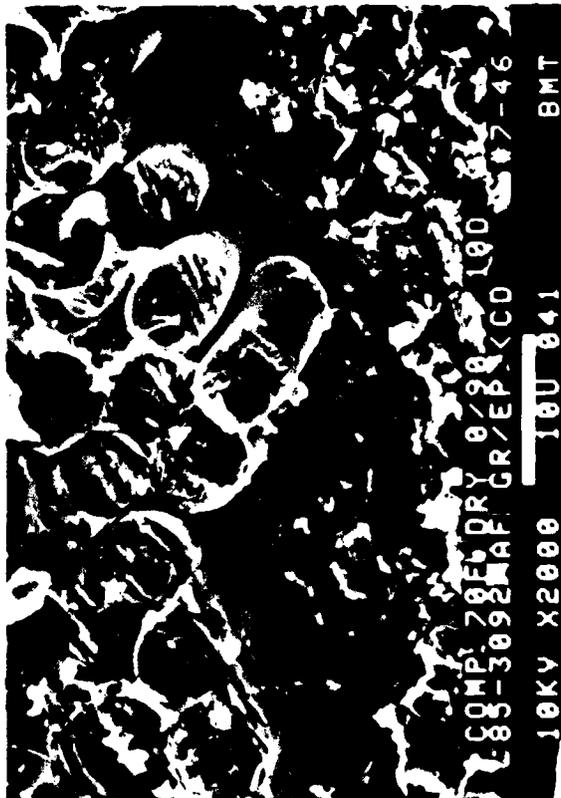
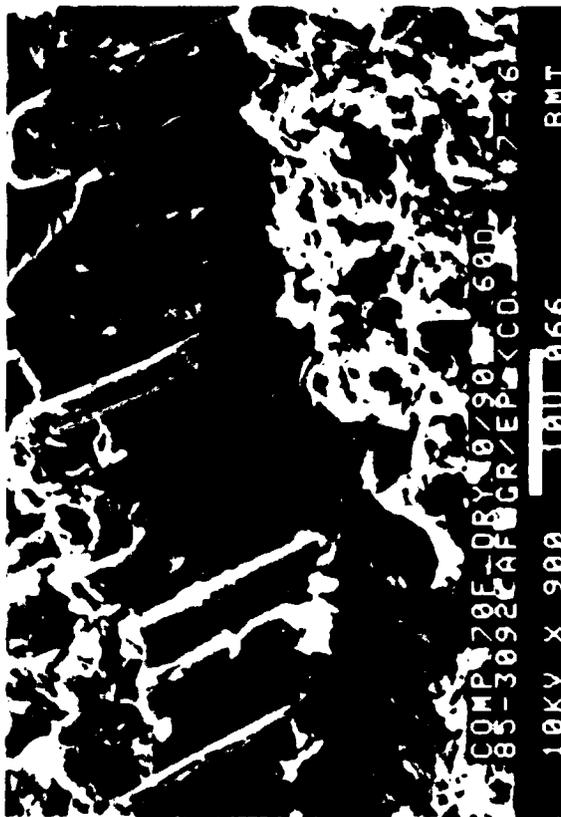
Figure 7-50. Translamellar Compression Fractures; 0/90-Degree Laminate

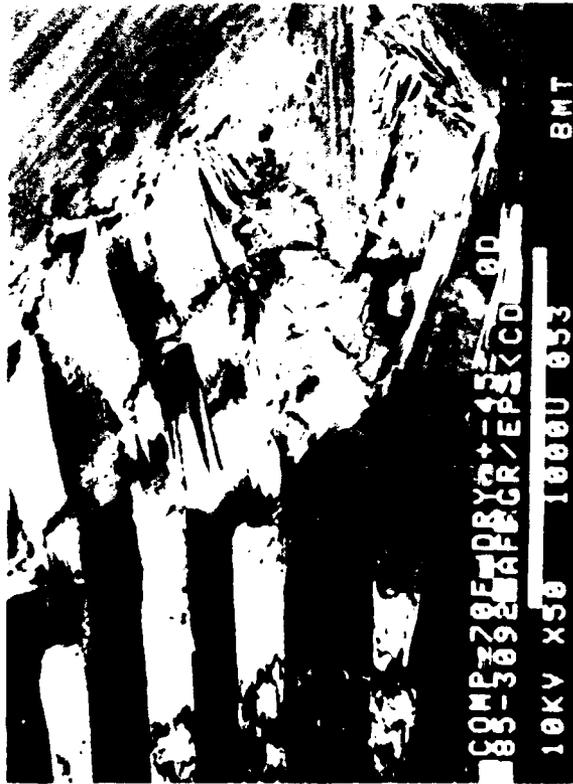
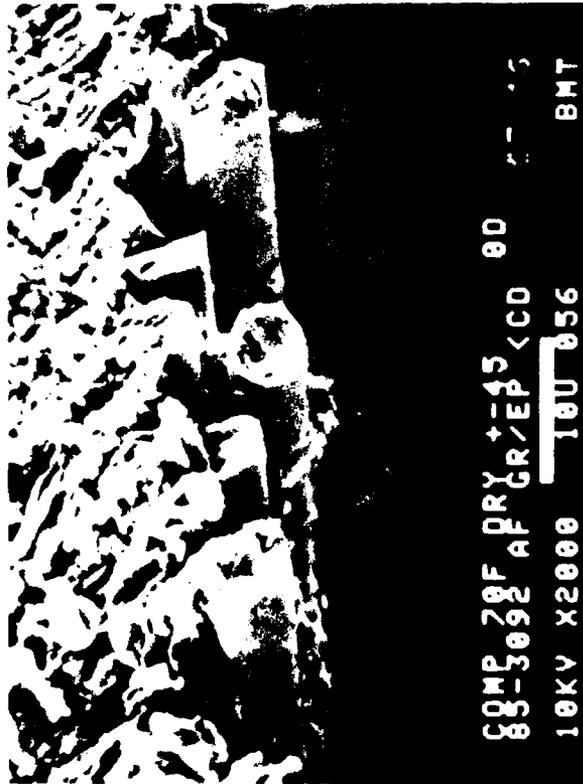
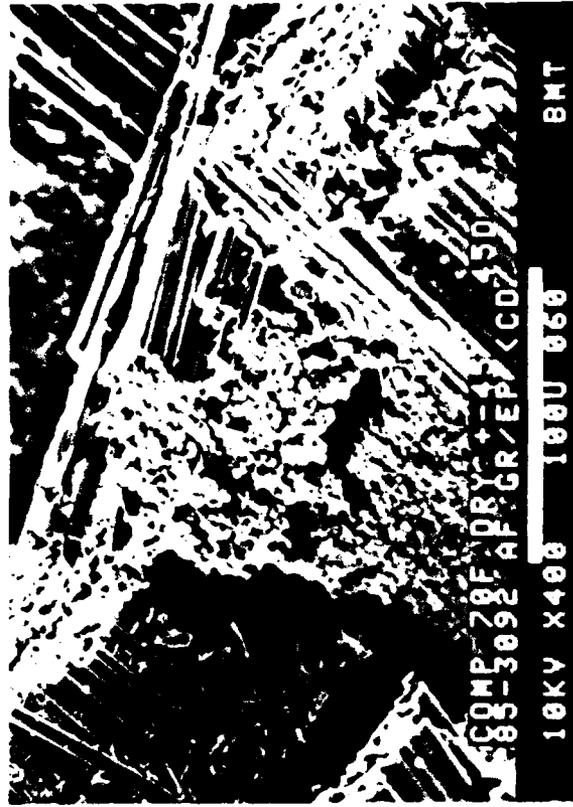
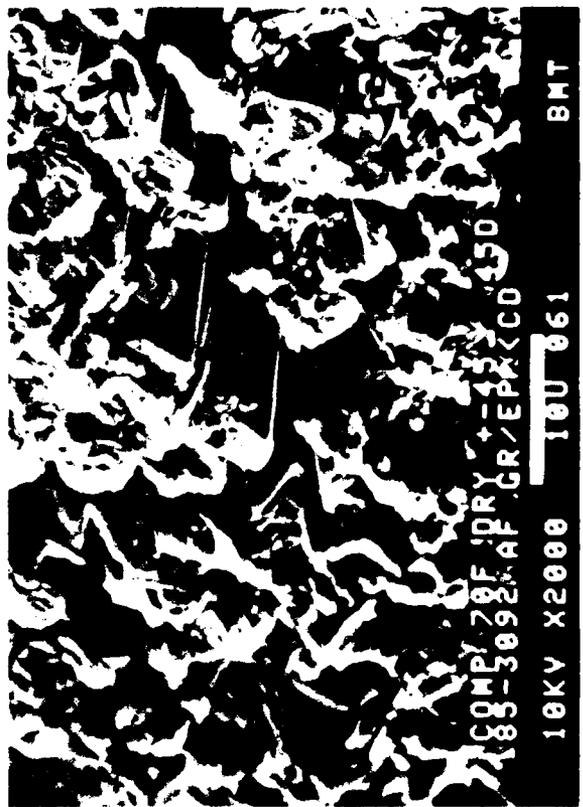
Figure 7-51. Translamellar Compression Fractures; +45/-45-Degree Laminate

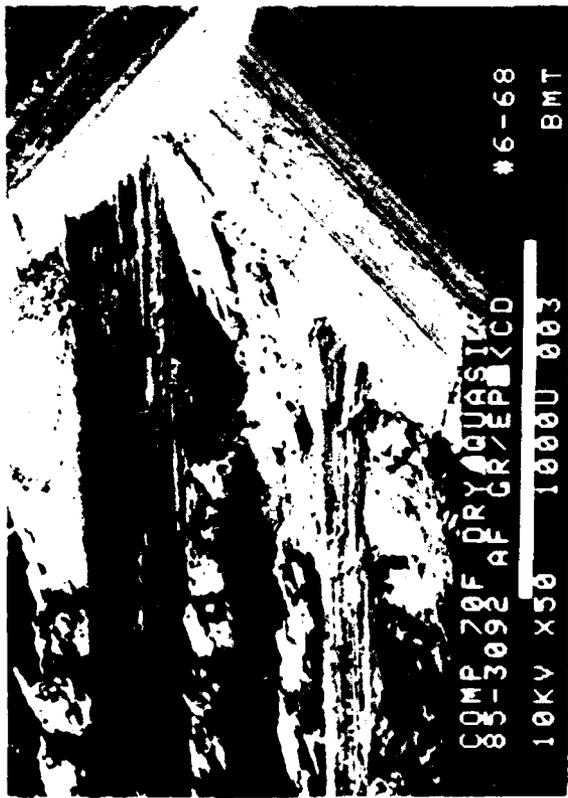
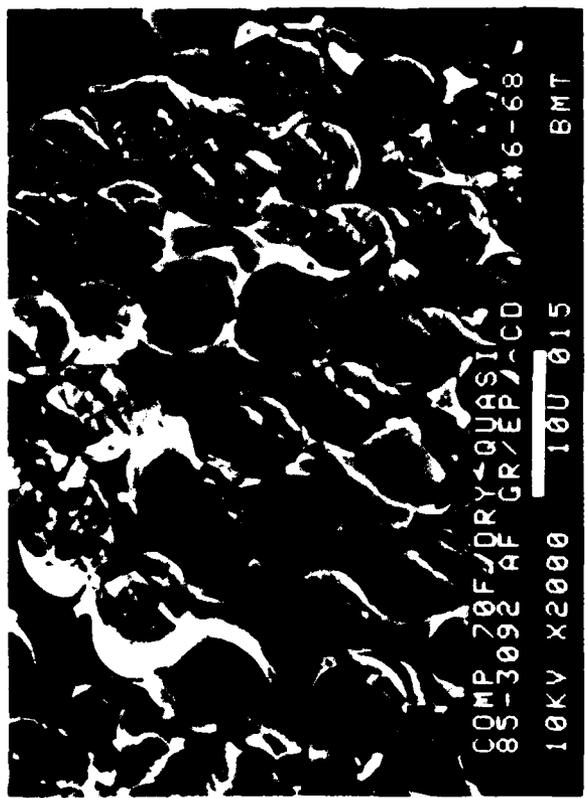
Figure 7-52. Translamellar Compression Fractures; Quasi-Isotropic Laminate
