**DEPARTMENT OF DEFENCE
DEFENCE SCIENCE AND TECHNOLOGY ORGANISATION
AERONAUTICAL RESEARCH LABORATORIES**

Structures Technical Memorandum 438

**DYNAMIC RESPONSE OF A GRAPHITE/EPOXY
COMPOSITE PLATE**

M. HELLER AND S. J. RUMBLE

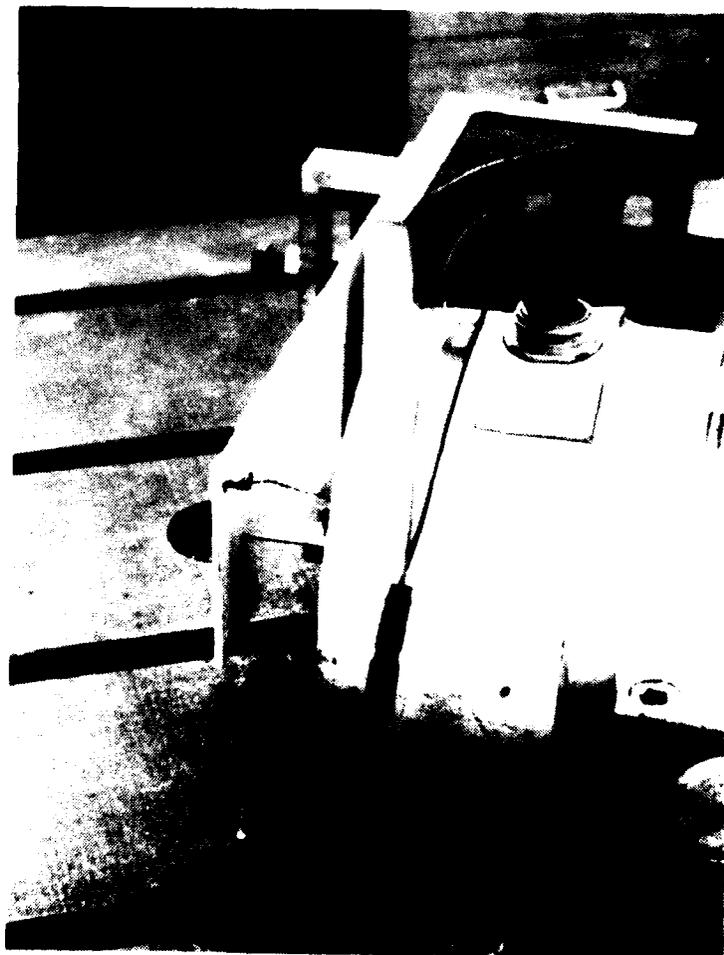
FIG. 3. SPECIMEN EXCITATION ARRANGEMENT

The excitation source used in these tests was the periodic random output of a HP3582A Fourier analyser. The excitation was fed to an ARL high output impedance power amplifier which in turn drove a Ling 409 electromagnetic shaker. The response was measured using a PCB309-A accelerometer and analysed using a Nicolet 411B analyser. The analysed data were subsequently stored on a NOVA3 minicomputer and plotted on a Tektronix 4662 plotter. The specimen was mounted in a clamping arrangement at one end as shown in Figs. 2 and 3, the excitation force being applied laterally at the other end on the back face of the specimen. The mounting position of the accelerometer is also clearly shown. Accelerometer response data were first recorded and analysed with the shaker and specimen in an initial condition.

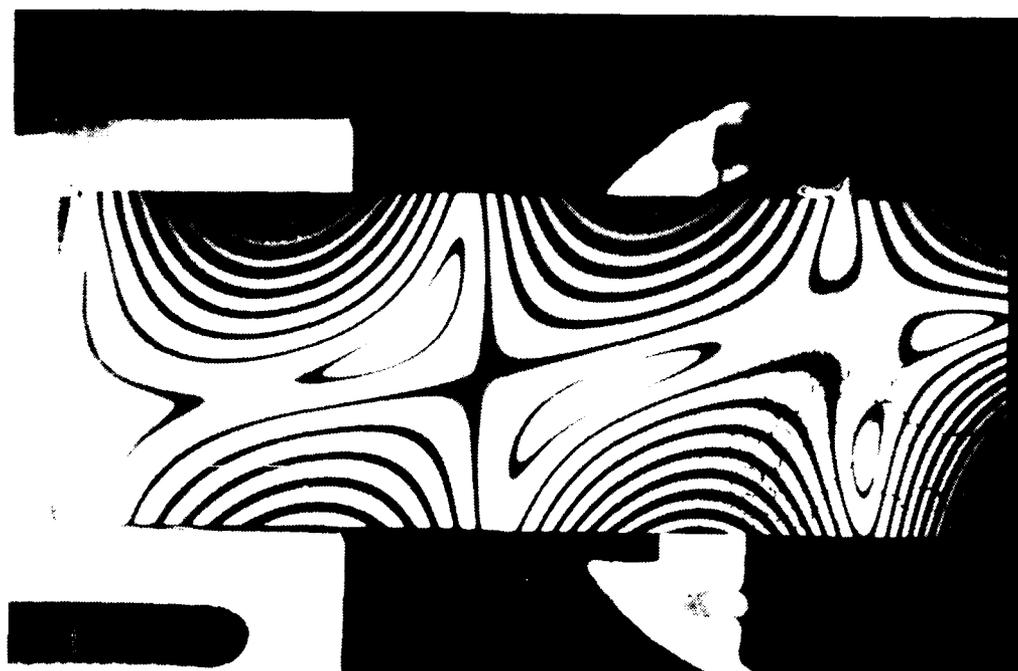
FIG.15 HOLOGRAM AT 2100 Hz FOR UNDAMAGED SPECIMEN

Photographs of the holograms taken of various modes before and after damage are given in Figs. 12 to 18.

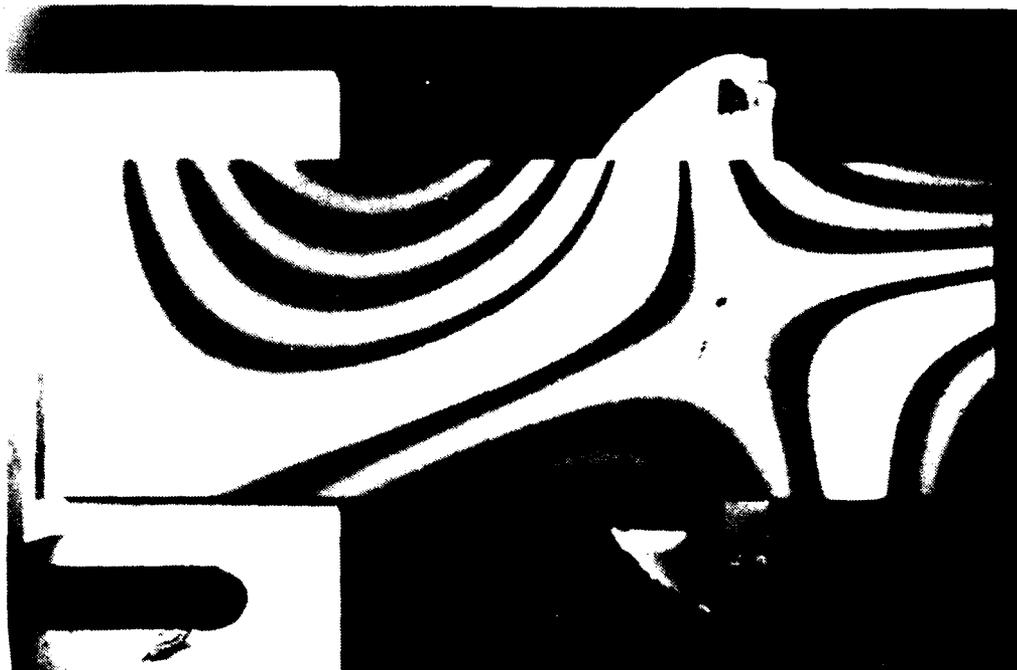
FIG.16 HOLOGRAM AT 1157 Hz FOR DAMAGED SPECIMEN
