DOT/FAA/CT-86/42

# Statistics on Aircraft Gas Turbine Engine Rotor Failures that Occurred in U.S. Commercial Aviation During 1981

Naval Air Propulsion Center  
Trenton, New Jersey

March 1987

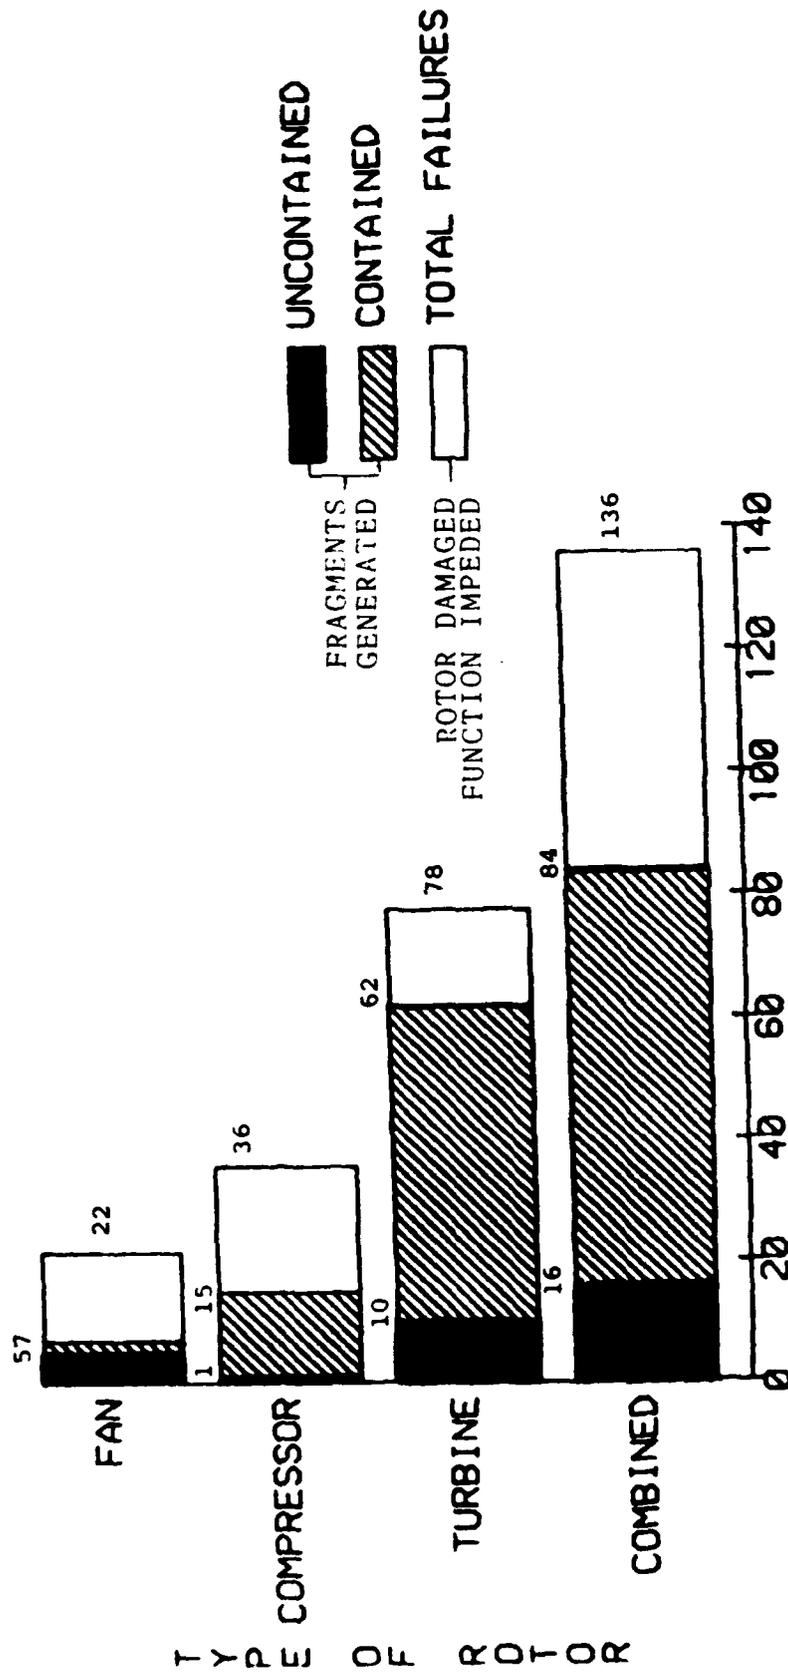
FIGURE 1: INCIDENCE OF ENGINE ROTOR FAILURE  
IN U. S. COMMERCIAL AVIATION 1981

a. Figure 1 shows that 136 rotor failures occurred in 1981. These rotor failures accounted for approximately 2.7 percent of the 5095 shutdowns experienced by the gas turbine powered U. S. commercial aircraft fleet during 1981. Rotor fragments were generated in 84 of the failures experienced and, of these, 16 (19.0 percent of the fragment producing failures) were uncontained. This represents an uncontained failure rate of 2.1 per million gas turbine engine powered aircraft flight hours, or 0.8 per million engine operating hours. Approximately 7.5 million and 20.7 million aircraft flight and engine operating hours, respectively, were logged by the U. S. commercial aviation fleet in 1981. Gas turbine engine fleet

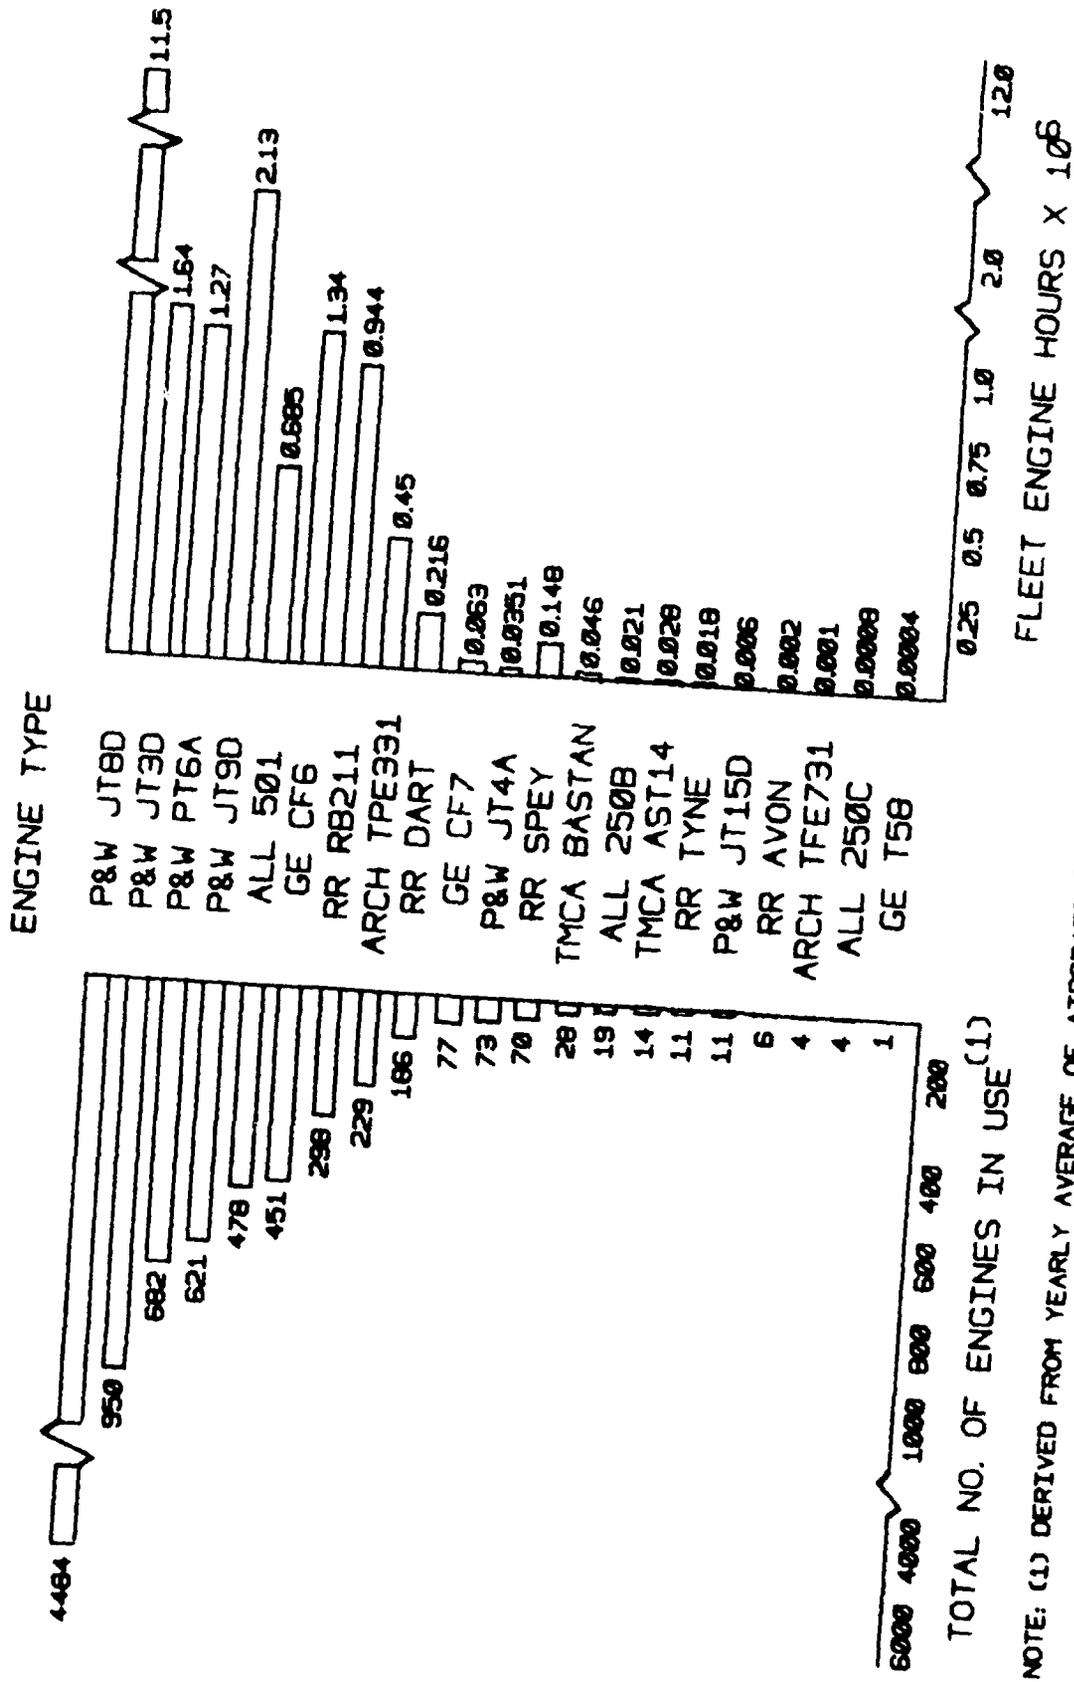
FIGURE 2: GAS TURBINE ENGINE FLEET OPERATING HOURS IN U.S. COMMERCIAL AVIATION ACCORDING TO NUMBER OF ENGINES IN SERVICE - 1981

operating hours according to the number and type of engines in use is shown in Figure 2.

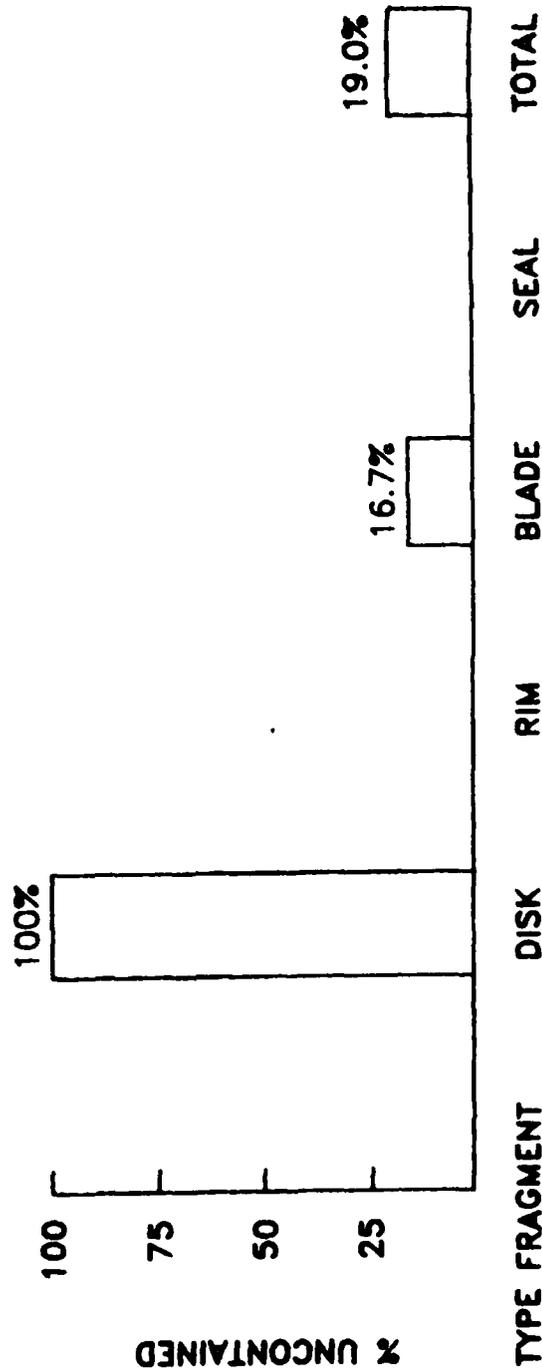
ENGINE ROTOR COMPONENT	TYPE OF FRAGMENT GENERATED											
	DISK		RIM		BLADE		SEAL		TOTAL			
	TF	UCF	TF	UCF	TF	UCF	TF	UCF	TF	UCF		
FAN	0	0	0	0	7	5	0	0	7	5		
COMPRESSOR	1	1	1	0	12	0	1	0	15	1		
TURBINE	2	2	1	0	59	8	0	0	62	10		
TOTAL	3	3	2	0	78	13	1	0	84	16

FIGURE 3: COMPONENT AND FRAGMENT TYPE DISTRIBUTIONS FOR CONTAINED AND UNCONTAINED ROTOR ENGINE FAILURES (FAILURES THAT PRODUCED FRAGMENTS) - 1981

b. Figure 3 shows the distribution of rotor failures that produced fragments according to the engine component involved (fan, compressor, turbine), the types of fragments that were generated, and the percentage of uncontained failures according to the type of fragment generated. These data indicate that:

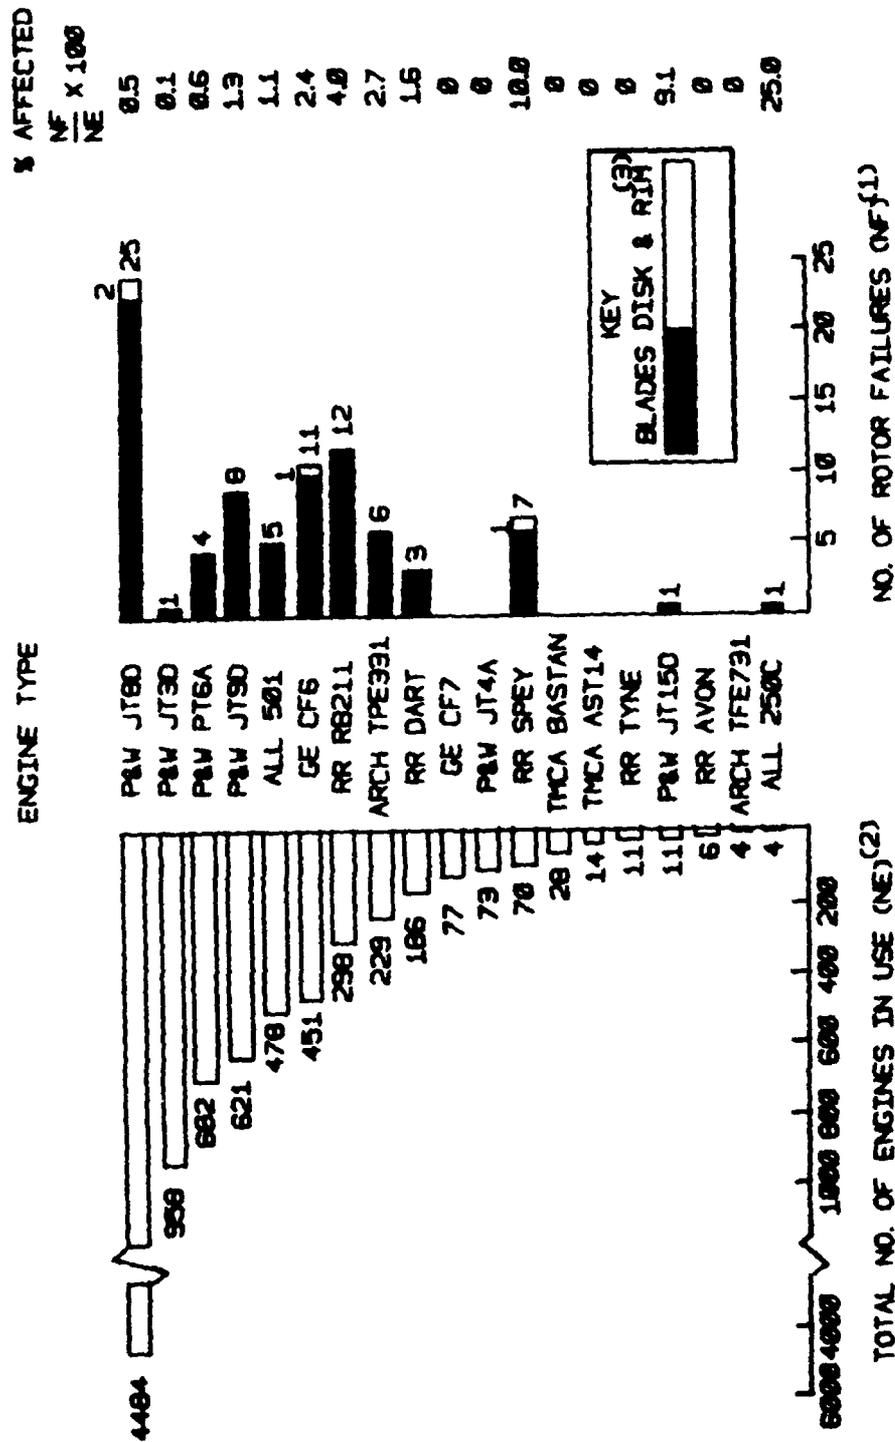
NOTES: (1) FAILURES THAT PRODUCED FRAGMENTS  
 (2) YEARLY AVG. OF ENGINES IN USE AT END OF EACH MONTH  
 (3) SEAL/SPACER FAILURES INCLUDED IN DISK/RIM COMPILATION

FIGURE 4: THE INCIDENCE OF ENGINE ROTOR FAILURE IN U.S. COMMERCIAL AVIATION ACCORDING TO ENGINE TYPE AFFECTED - 1981

c. Figure 4 shows the rotor failure distribution among the engine models that were affected, and the total number of the models in use.

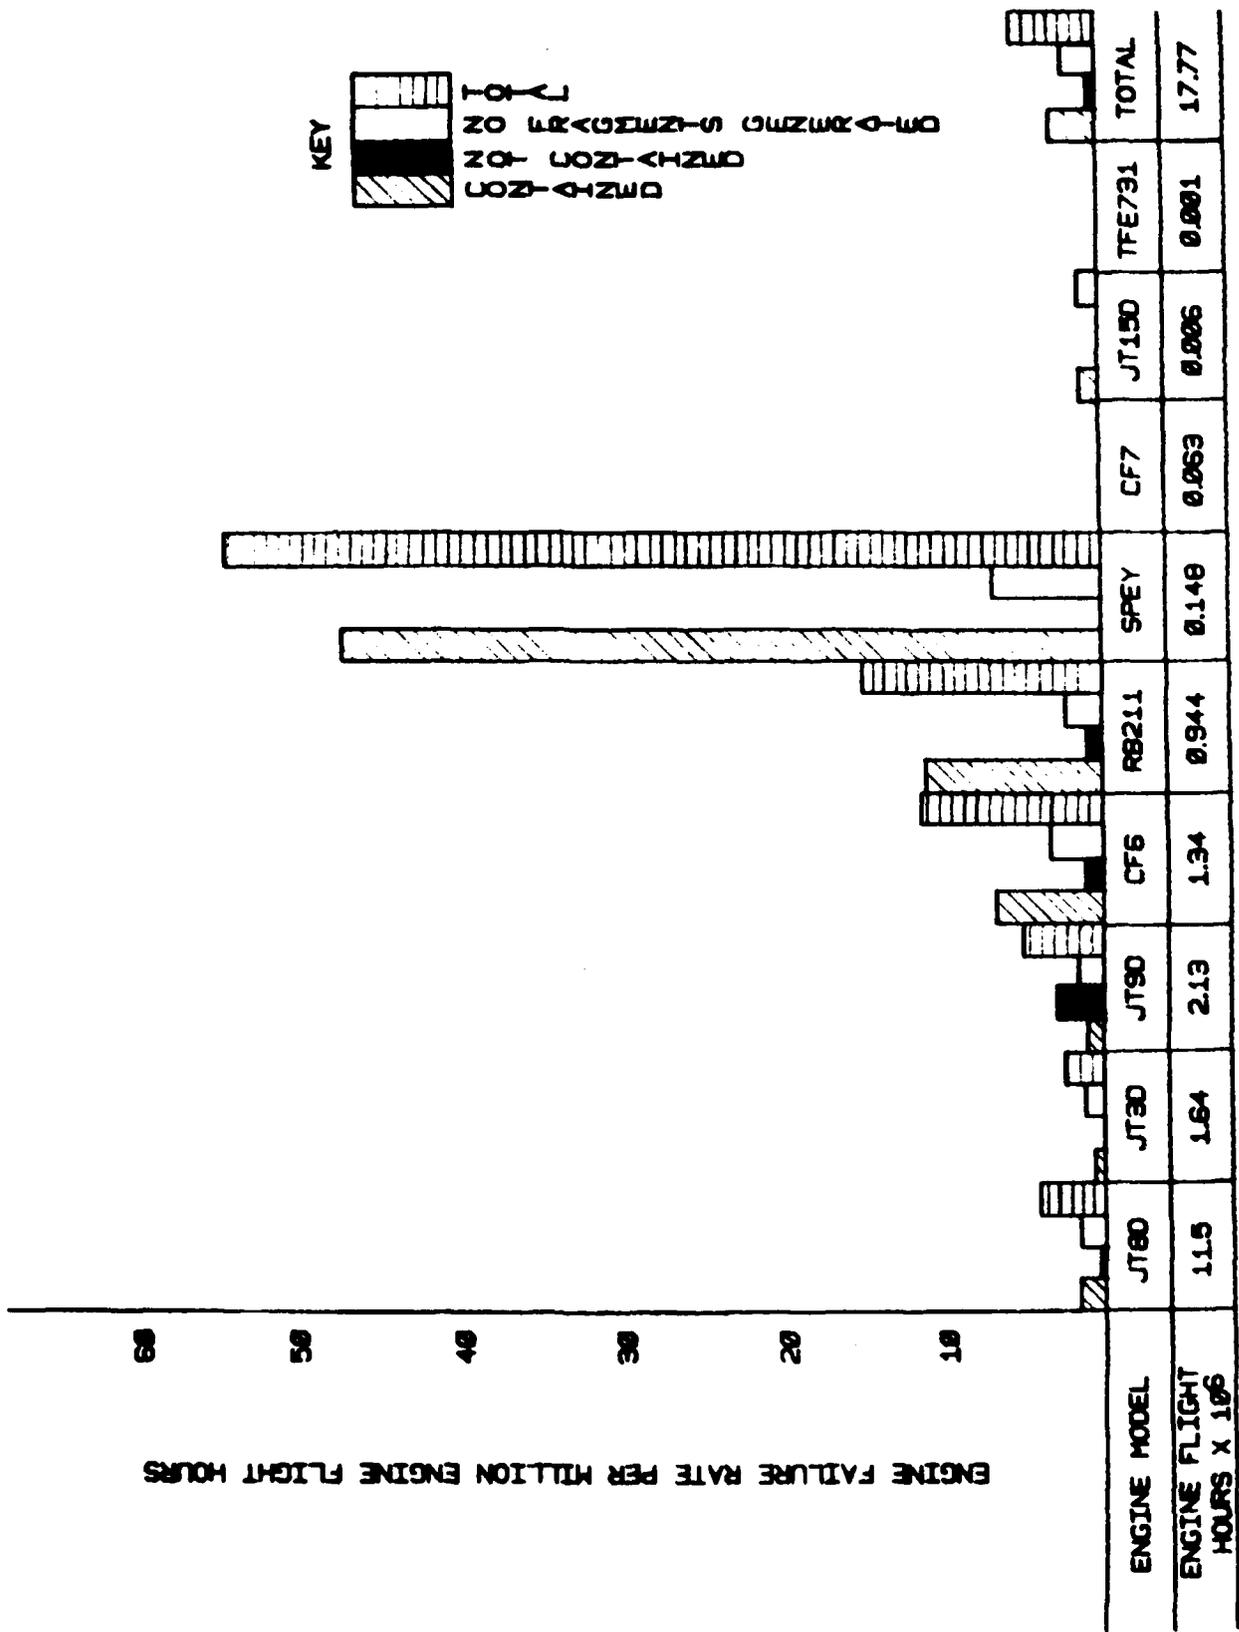
FIGURE 5: TURBOFAN ENGINE FAILURE RATE ACCORDING TO ENGINE MODEL - 1981

d. Figures 5, 6, and 7 illustrate engine failure rates per million engine flight hours according to engine model, engine type, and containment condition. The total engine failure rate per million engine type flight hours are: turbofan 5.7, turboprop 11.8, turboshaft 34.2, and turbojet 27.0. Total uncontained engine failure rates per million engine type flight hours were: turbofan 0.7 and turboprop 1.5. No uncontained rotor failures were reported for turboshaft and turbojet engines in 1981.

The data used to generate figures 5, 6, and 7 is contained in appendix B, page B-1.

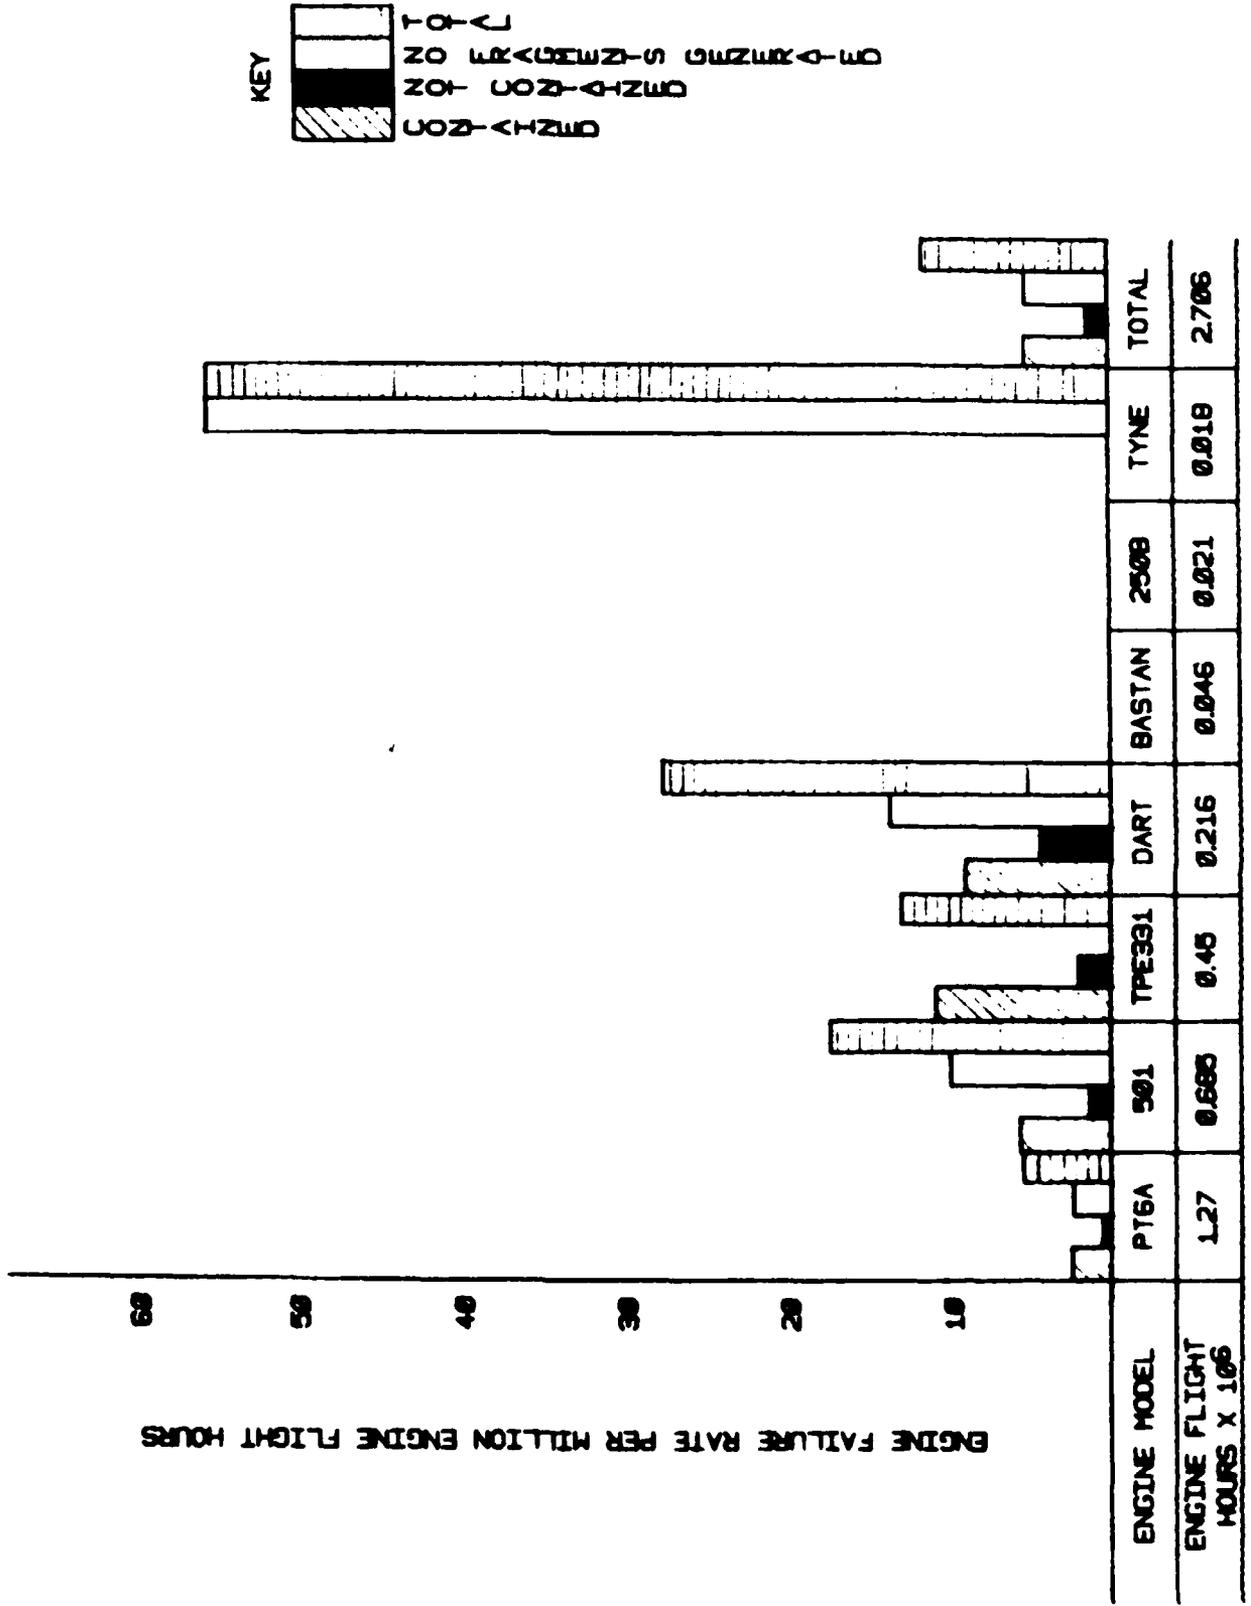
FIGURE 6: TURBOPROP ENGINE FAILURE RATE ACCORDING TO ENGINE MODEL - 1981

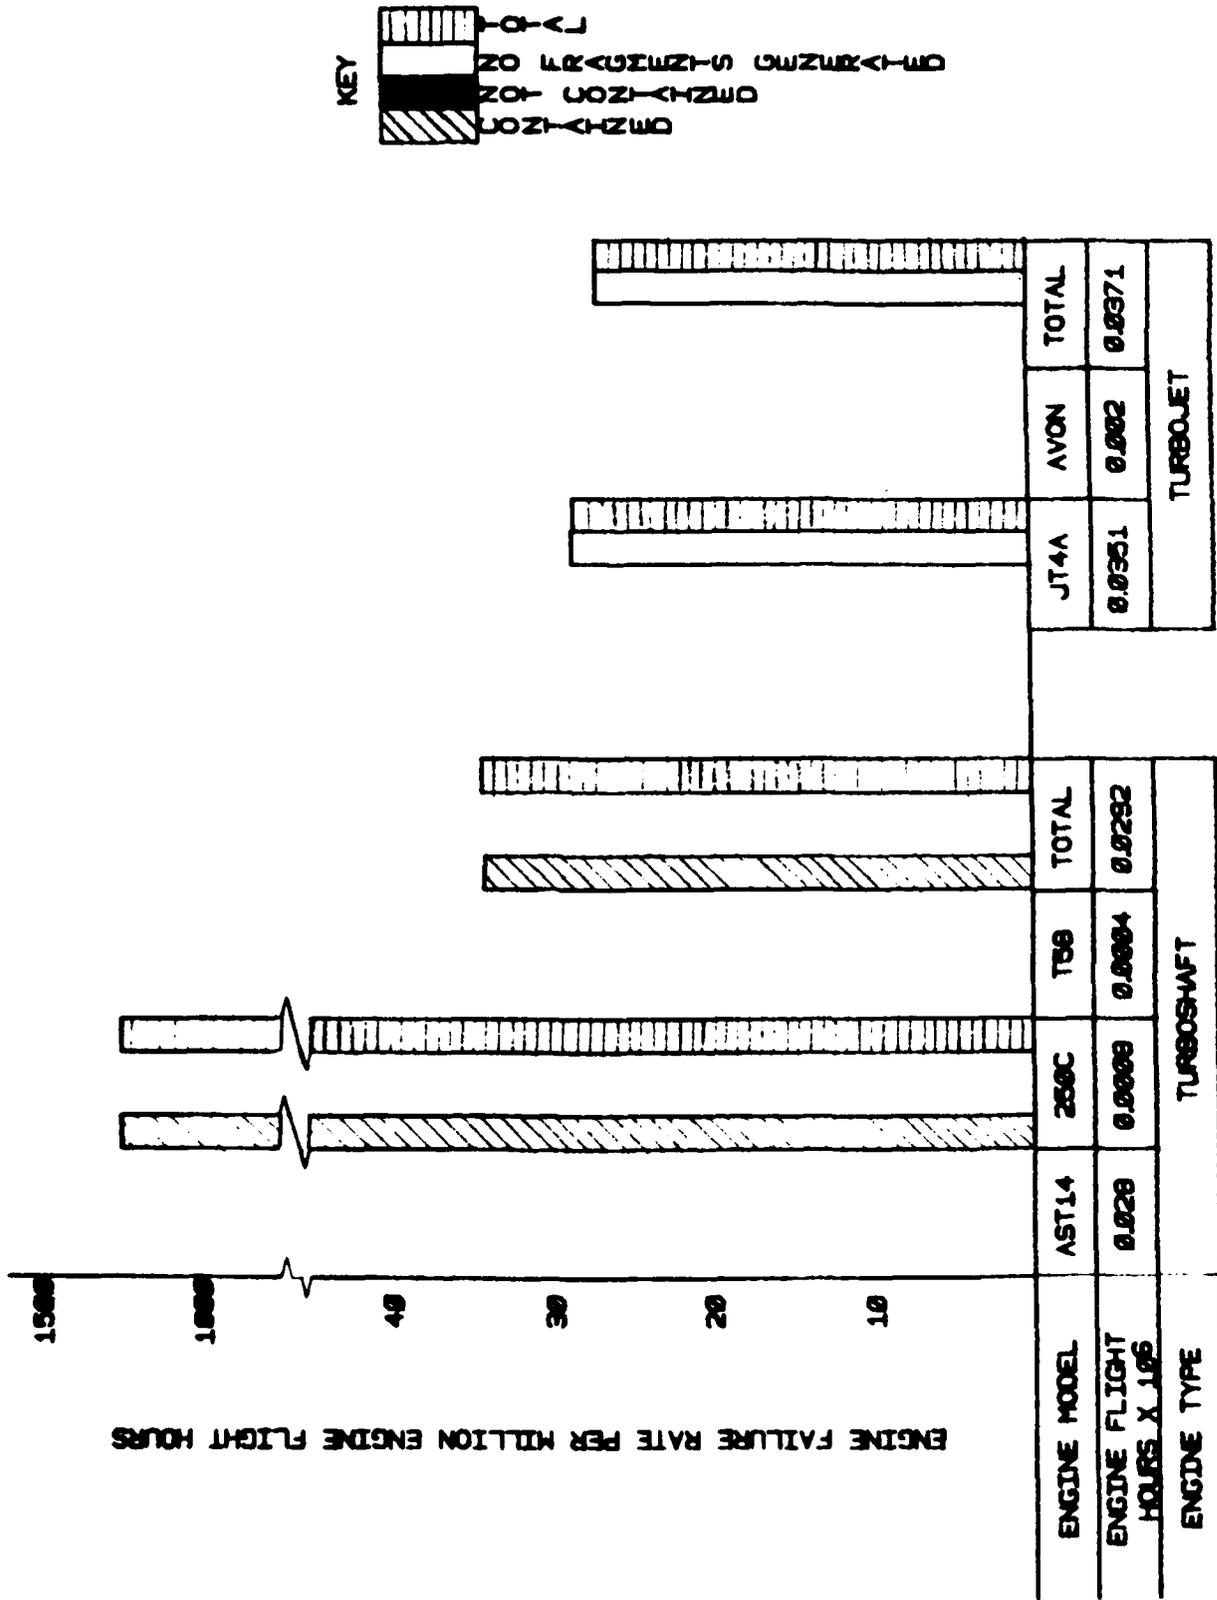
FIGURE 7: TURBOSHAFT AND TURBOJET ENGINE FAILURE RATE ACCORDING TO ENGINE MODEL - 1981

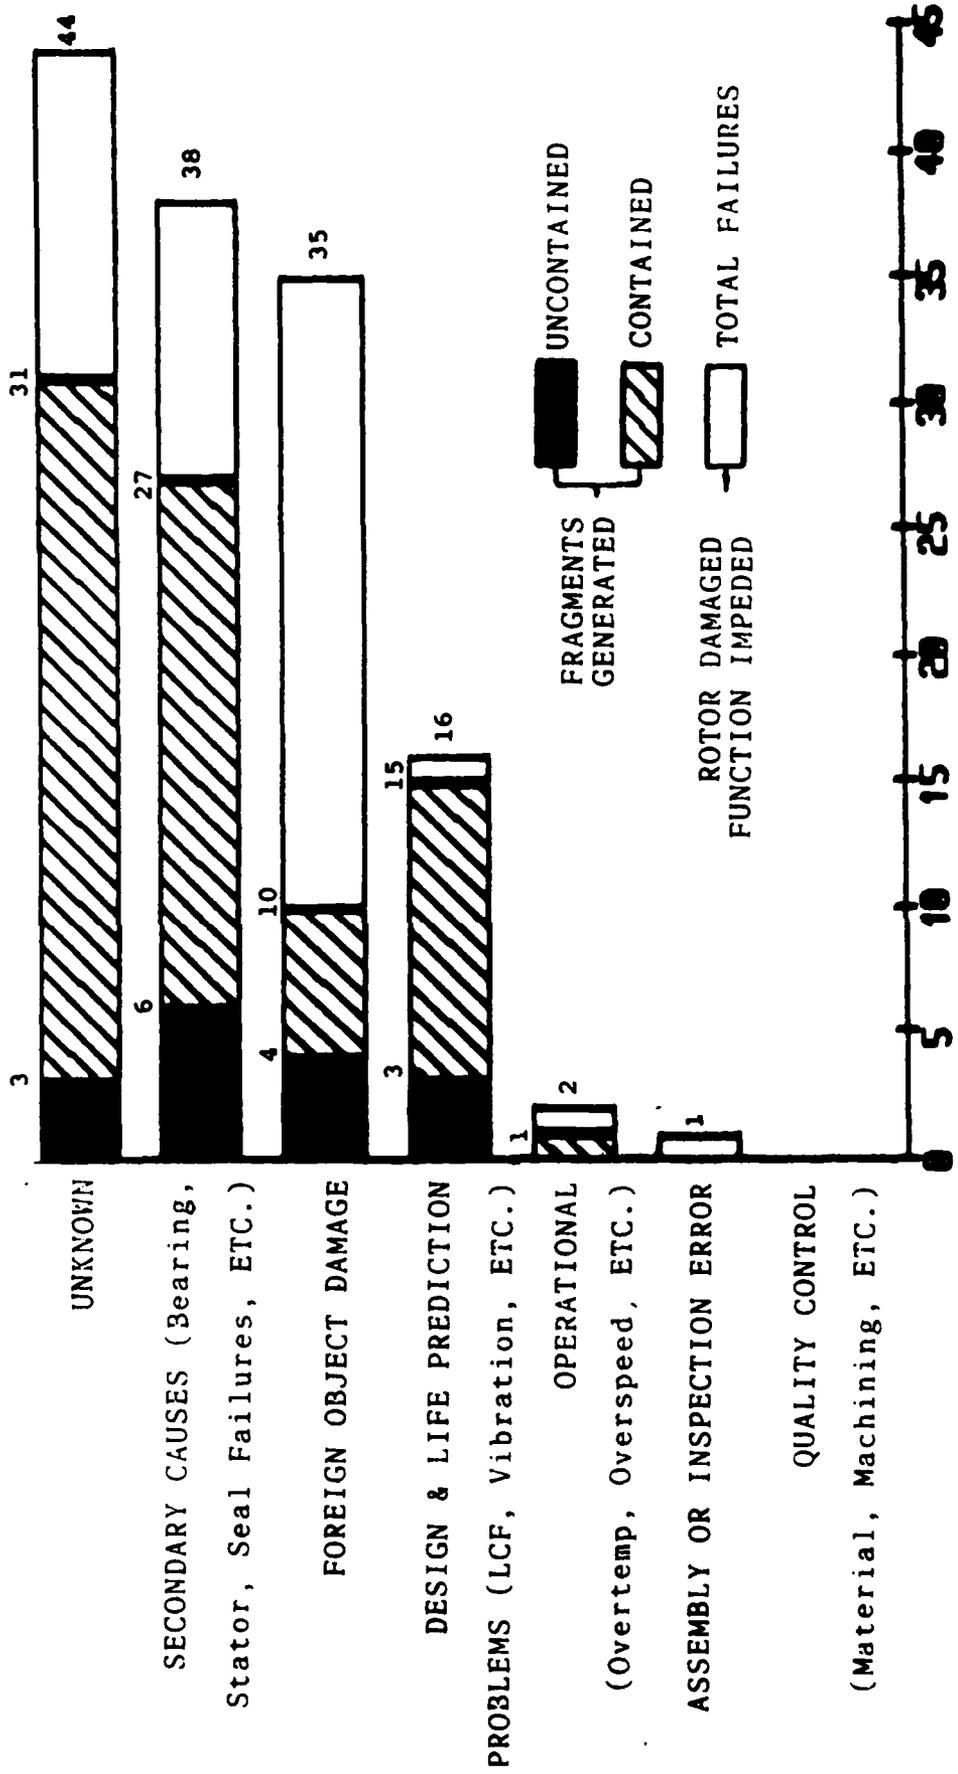
FIGURE 8: ENGINE ROTOR FAILURE CAUSE CATEGORIES - 1981

e. Figure 8 shows what caused the rotor failures to occur. Of the 92 known causes of failure (because of the high percentage of unknown causes of rotor failure, the percentages were based on the total number of known causes), the causal factors were: (1) Secondary Causes 38 (41.3 percent); (2) Foreign Object Damage 35 (38.0 percent); (3) Design and Life Prediction Problems 16 (17.4 percent); and Other 3 (3.3 percent).

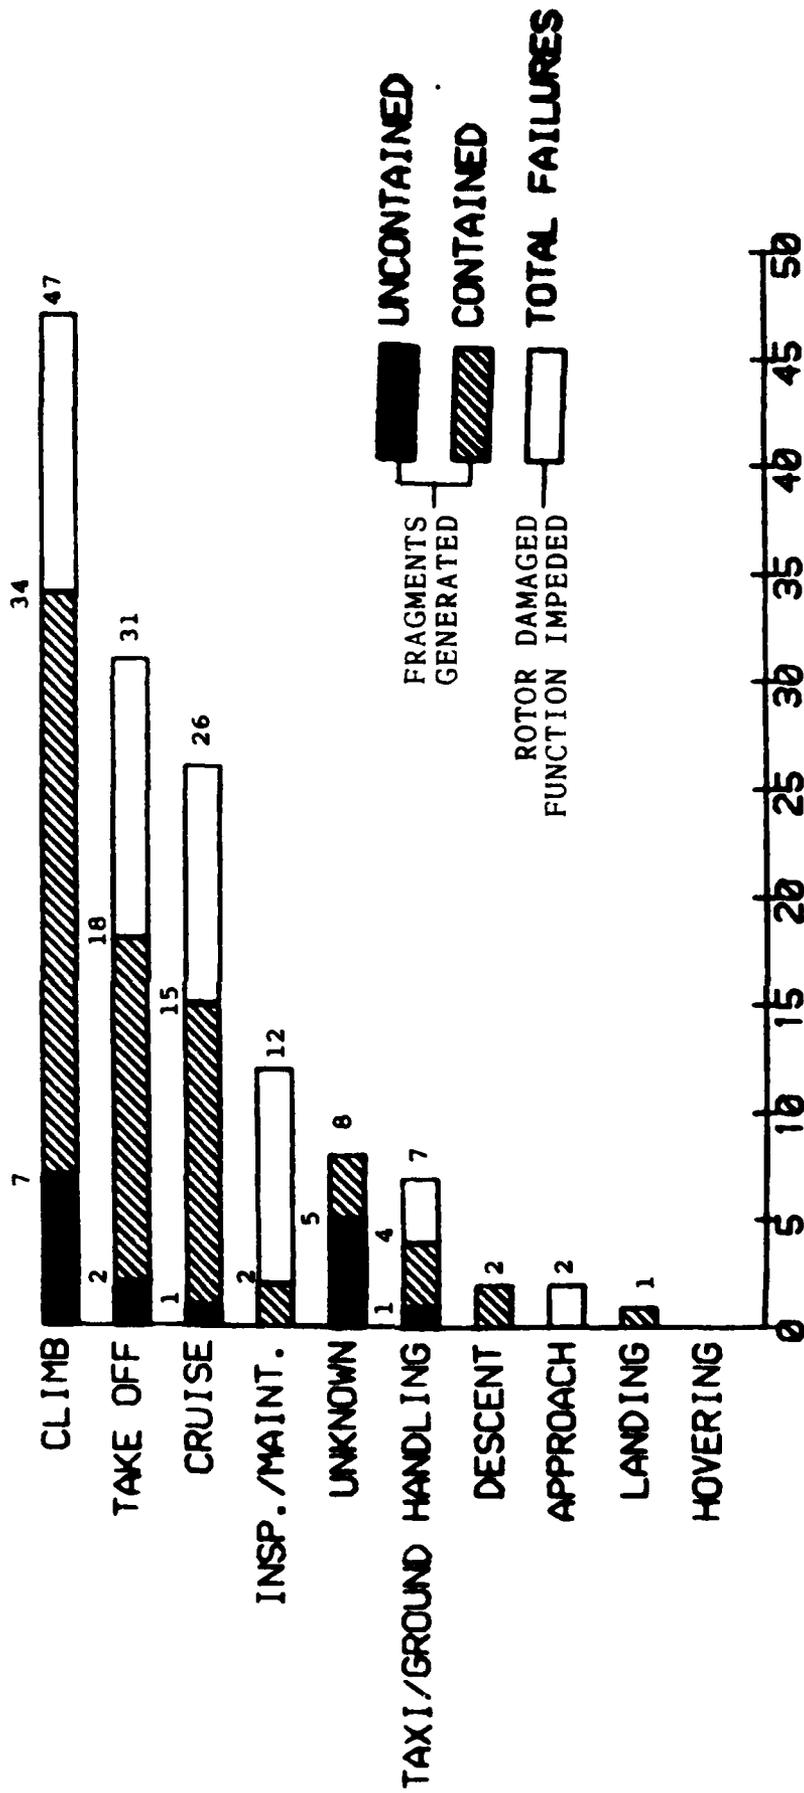
FIGURE 9: FLIGHT CONDITION AT ENGINE ROTOR FAILURE - 1981

f. Figure 9 indicates the flight conditions that existed when the various rotor failures occurred. Seventy-eight (57.4 percent) of the 136 rotor failures occurred during the takeoff and climb stages of flight. Fifty-two (61.9 percent) of the rotor fragment producing failures and 9 (56.3 percent) of the uncontained rotor failures occurred during these same stages of flight. The highest number of uncontained rotor failures, 7 (43.8 percent) was experienced during climb.

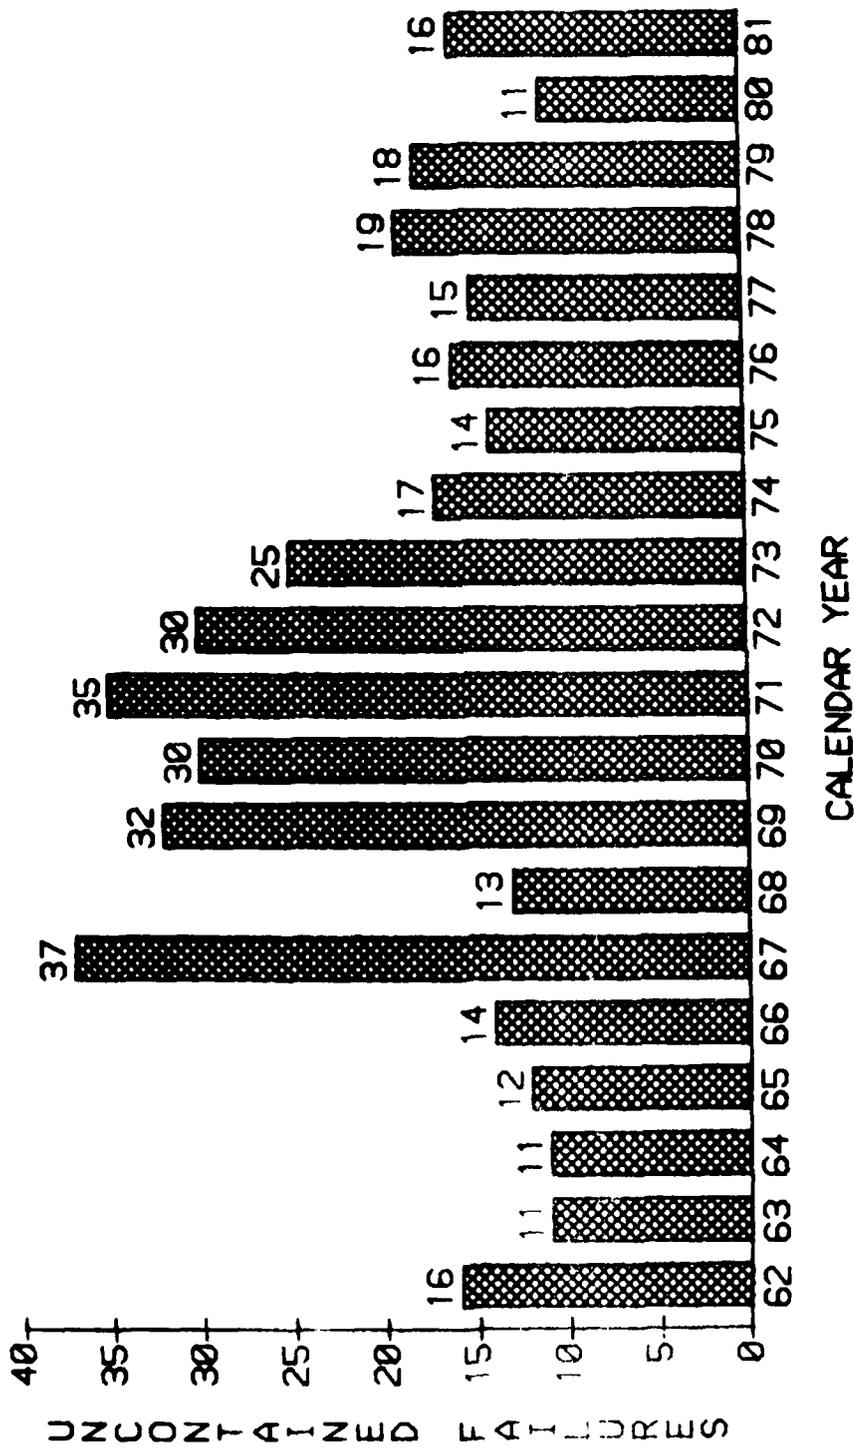
FIGURE 11: THE INCIDENCE OF UNCONTAINED ENGINE ROTOR FAILURE IN U.S. COMMERCIAL AVIATION 1962 - 1981

h. Figure 11 shows the annual incidence of uncontained rotor failures in commercial aviation for the years 1962 through 1981. During 1981, the incidence of uncontained rotor failure increased by five over the previous year, 1980. Over the past six years, 1976 through 1981, an average of 16 uncontained rotor failures per year have occurred. During the same time period, the rate of uncontained rotor failures has remained relatively constant at an average of approximately one per million engine operating hours.

Although the incidence of engine rotor failures producing fragments has declined 20 percent (84 in 1981 compared to a 1975 through 1980 average of 105), the uncontained engine rotor failures has remained constant (16 in 1981 compared to a 1975 through 1980 average of 16).
