REPAIR, EVALUATION, MAINTENANCE, AND  
REHABILITATION RESEARCH PROGRAM

TECHNICAL REPORT REMR-CO-10

STUDY OF BREAKWATERS CONSTRUCTED  
WITH ONE LAYER OF ARMOR STONE  
DETROIT DISTRICT

John R. Wolf

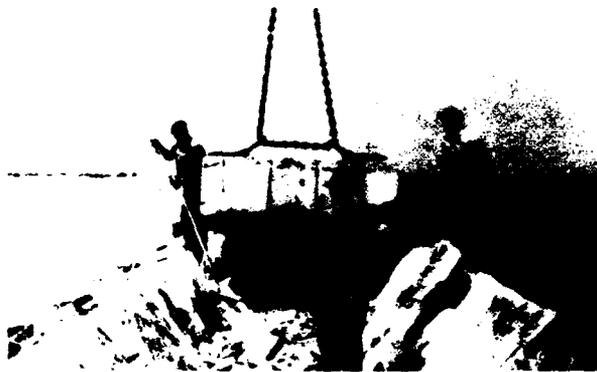
Figure 2. Block of cut armor stone being placed on the crest of rubble-mound breakwater using a chain sling and hooks

25. Figures 1 through 9 show breakwater construction, armor-stone quarrying, and breakwater structures. Figures 1 through 3 show armor stone being placed on a breakwater and being cut in the quarry. Figures 4 through 9 show six breakwaters in the Great Lakes which have one layer of armor stone.

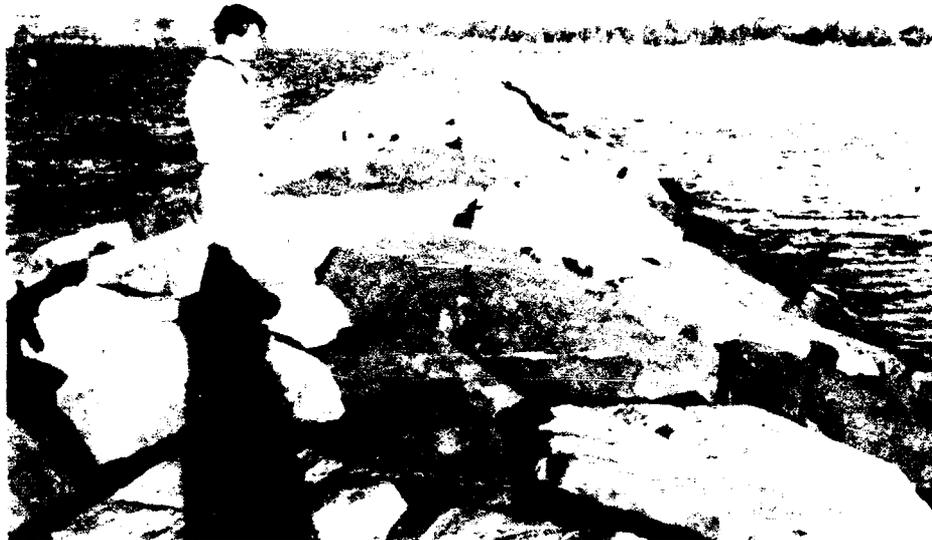
Figure 4. Marquette Harbor breakwater constructed with one layer of armor stone of hard rock

10. The rubble-mound breakwater has required some maintenance which was completed by hired labor. The rubble-mound breakwater did not require rehabilitation in 1965 when the concrete portion of the breakwater was rehabilitated under contract. The armor stones are boulders which were dredged from the lake. The estimated weight of the armor stones is 15 to 25 tons.

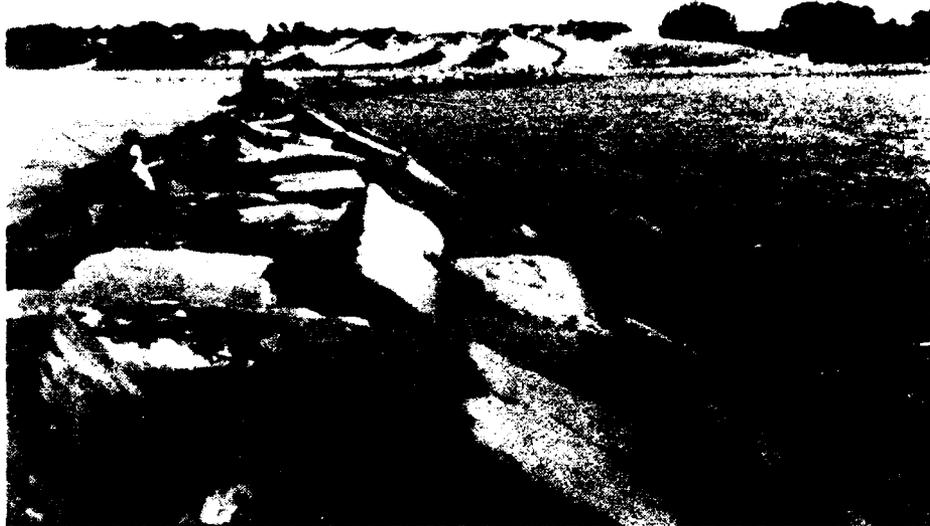
Figure 6. New Buffalo Harbor breakwater constructed with one layer of Bedford Limestone armor stone
