REPAIR, EVALUATION, MAINTENANCE, AND REHABILITATION RESEARCH PROGRAM

TECHNICAL REPORT REMR-OM-7

INSPECTION AND RATING OF MITER LOCK GATES

ENGINEERING RESEARCH INSTITUTE
Iowa State University
Ames, Iowa 50011

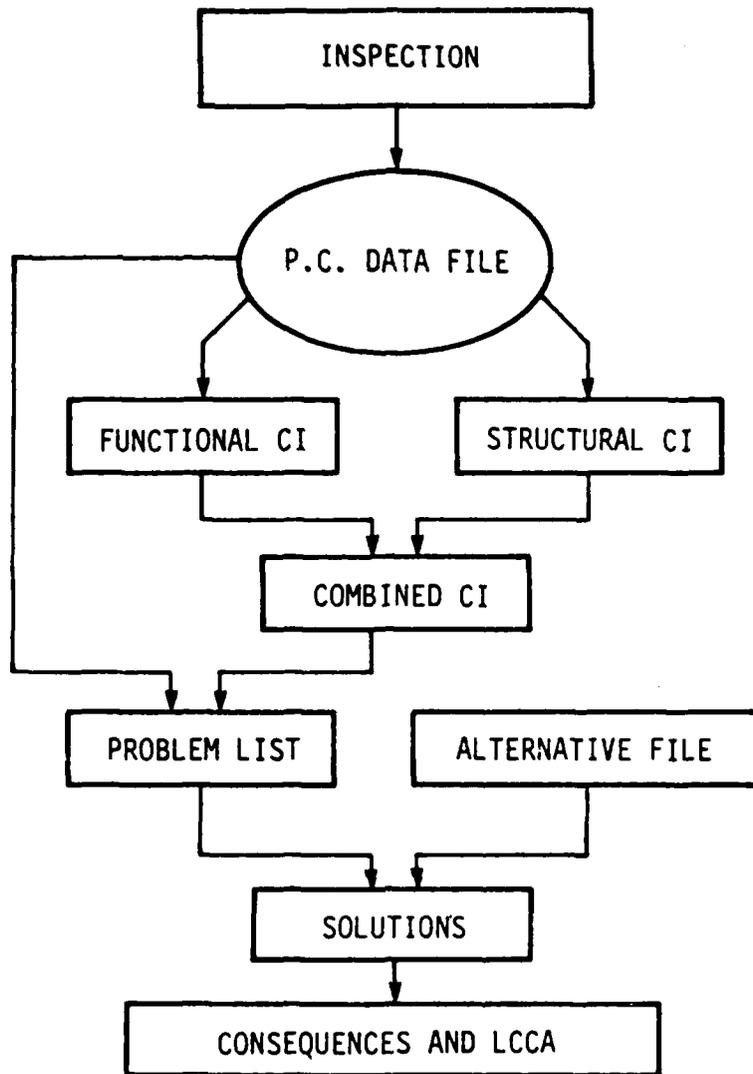
Figure 1. Maintenance and repair analysis of miter lock gate

7. The maintenance and repair procedure is illustrated schematically in Figure 1. The process is based on a good field inspection of the miter lock gate structure. During this inspection, current physical attributes of the systems are obtained. Data, such as the location of the gate, inspection history, historical water level, and maintenance history, are recorded on the first two pages of the inspection form. Other inspection form pages are used to describe some structural details such as girder cross sections, skin plate, and intercostal size. The information on these pages is used as the basis for a structural evaluation of the gate. Additional pages provide space for several field measurements such as anchorage movements, elevation changes, downstream movement, cracks, dents, and corrosion. These measurements are used directly to rate the condition of the gate.

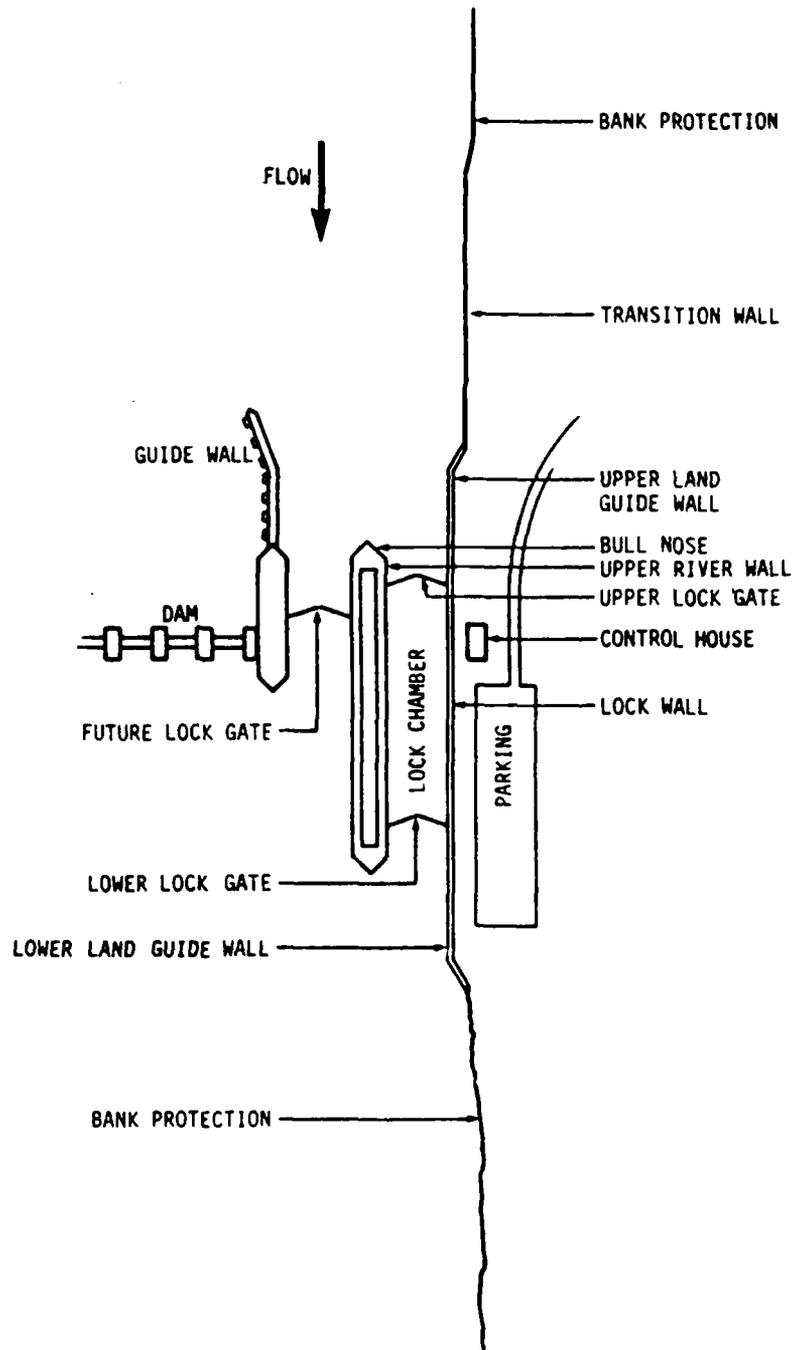
Figure 2. Lock and dam facility

14. To inspect and rate miter lock gate structures, the user must clearly identify their components; definitions for these components are presented in the following paragraphs. Figure 2 illustrates a typical lock and dam facility.

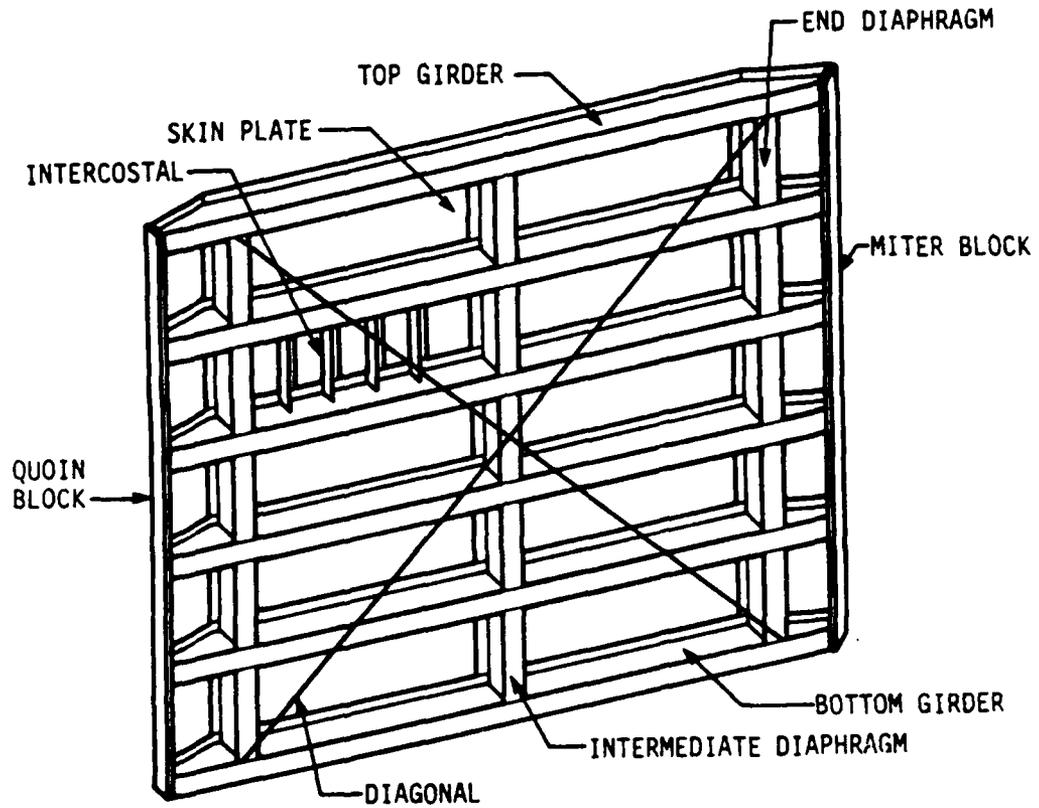
Figure 3. Horizontally framed miter lock gate

15. Horizontal girders are plate steel sections that span horizontally. Their main function is to transfer load to the quoin. In the horizontally framed miter lock gate (Figure 3), the load is transferred from the skin plate through the horizontal girders and back into the lock wall. The bottom horizontal girders on a horizontally framed gate does not transfer load into framed gate (Figure 4), two horizontal girders carry the load from the vertical girders. The top girder then transmits the load to the lock wall. Figure 3. Horizontally framed miter lock gate vertical girders. The top girder then transmits the load to the lock wall. The bottom horizontal member transfers the load directly into the sill.

18. The horizontal girders are connected vertically by several intermediate diaphragms and two end diaphragms, one at the quoin end and one at the miter end of the horizontally framed miter lock gate in Figure 3. The end diaphragms also serve to dam the water in the tapered end section (Figure 5). The vertically framed gate contains no diaphragms.

19. Intercostals are provided between diaphragms on the horizontally framed gate (Figure 3) and between girders on the vertically framed gate (Figure 4). Intercostals serve to stiffen and support the skin plate.

convex surface of about the same radius. These two surfaces bear on each other when the gate is in the mitered position. On horizontally framed gates, the quoin block and wall quoin are continuous from the top of the gate to the bottom (Figure 3). On vertically framed gates (Figure 4), load is transferred into the lock wall at the top and bottom horizontal girder, and the quoin block and wall quoin are present only at these locations.

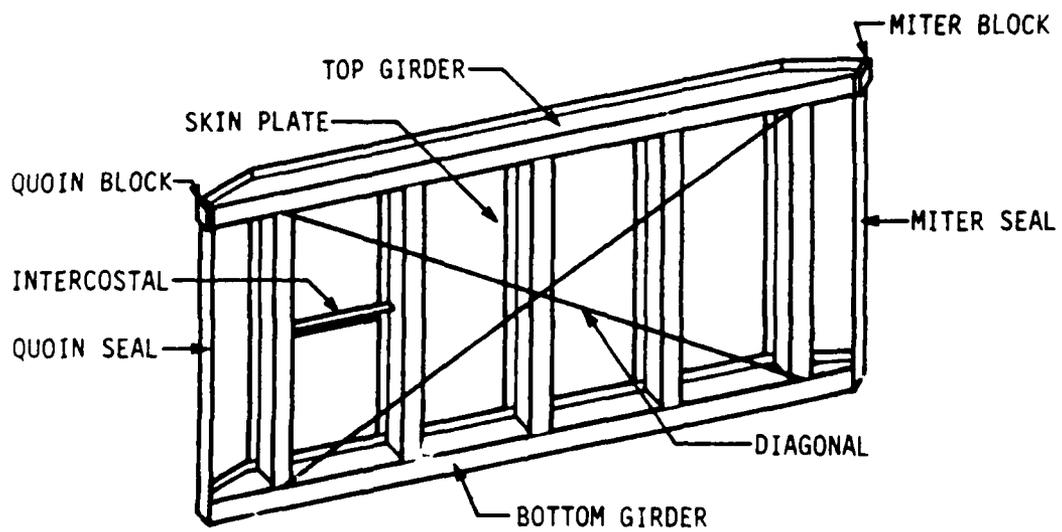
Figure 4. Vertically framed miter gate

16. Vertical girders are plate steel sections that span vertically to transfer load to the horizontal girders. In the vertically framed gate (Figure 4), the load is transferred from the skin plate through the vertical girders to the top and bottom horizontal girder.

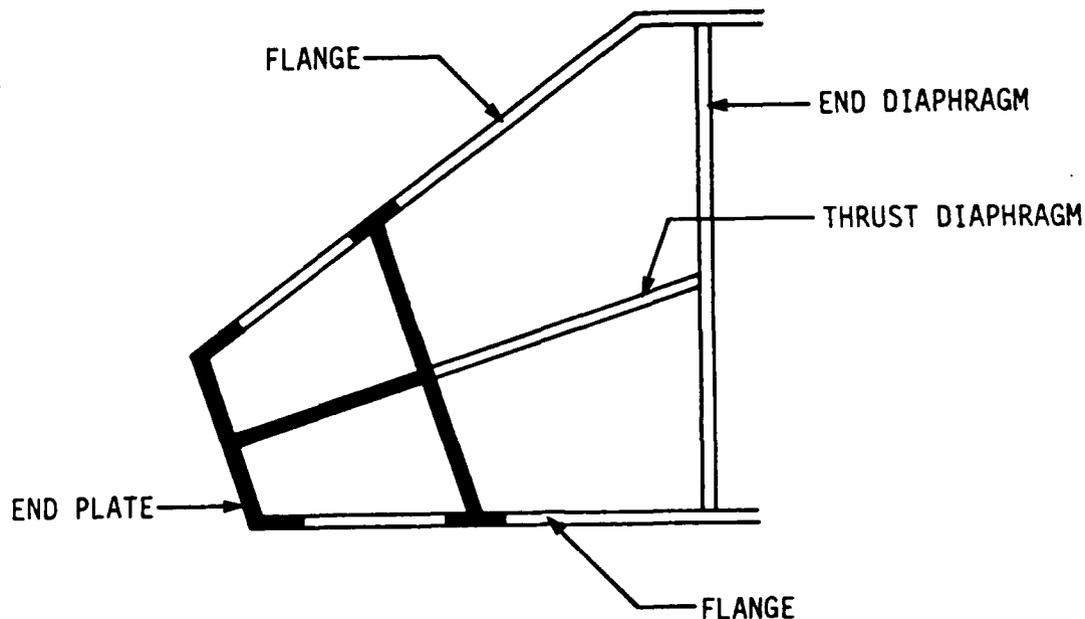
Figure 5. Tapered end and quoin post

20. The thrust diaphragm shown in the tapered end section of Figure 5 distributes the horizontal girder reactions from the quoin block into the girder webs.

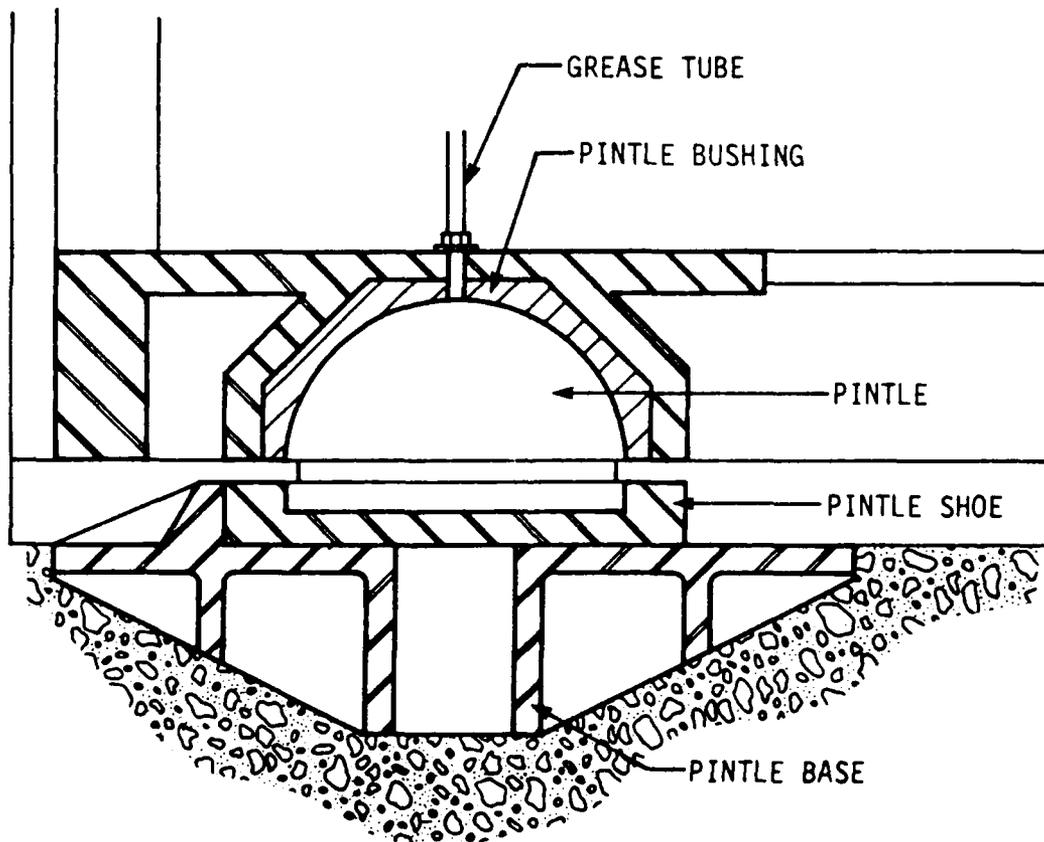
Figure 6. Floating pintle assembly

23. Pintle assemblies used for both horizontally and vertically framed miter lock gates consist of two types: floating and fixed. The floating pintle (Figure 6) fits into a cast steel shoe that is not fastened to the pintle base, allowing the lower corner of the gate leaf to move outward if debris is lodged in the quoin. The fixed pintle fits into a cast steel shoe that is bolted to the pintle base. Keyed pintles, which permit sliding in only one direction, are also used.

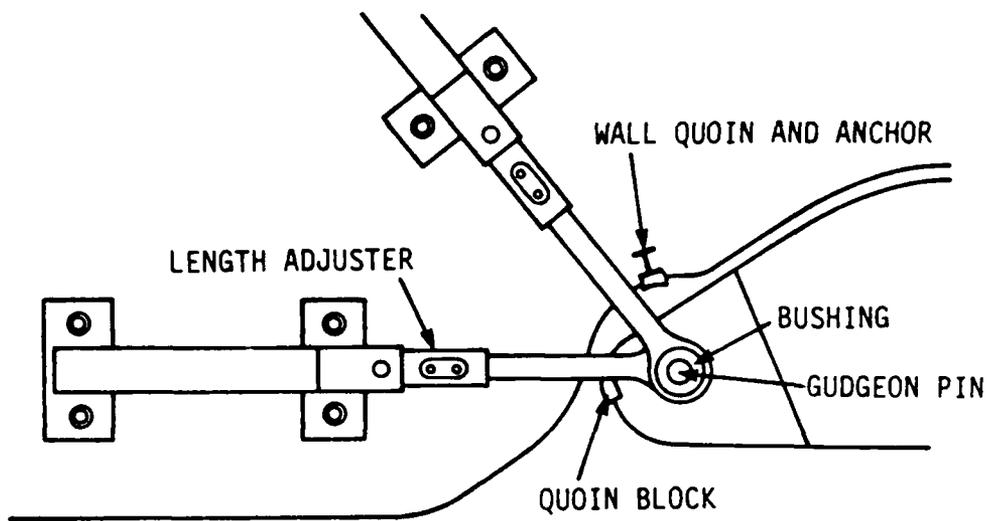
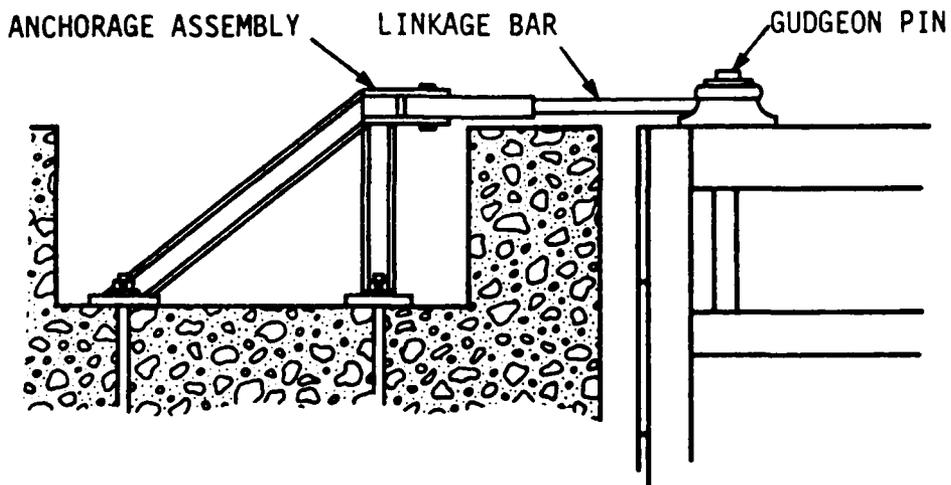
a. PLAN VIEW

b. SECTION VIEW

Figure 7. Upper anchorage assembly

25. Embedded anchorages distribute the top reaction of the leaf into the concrete wall (Figure 7).

26. The parallel and perpendicular anchorage links are made up of pinned ends connecting the gudgeon pin to the embedded anchorage. Most anchorage links have an adjustable length, typically either a threaded section or wedges (Figure 7). An alternative parallel anchorage is shown in Figure 8. This assembly is made of two anchor links connected by a linkage pin.

27. Gudgeon pins are large-diameter pins of forged alloy steel (Figure 7). The gudgeon pin fits into a bronze bushing (Figure 7). This assembly serves as the only connection between the top of the gate and anchorage links.

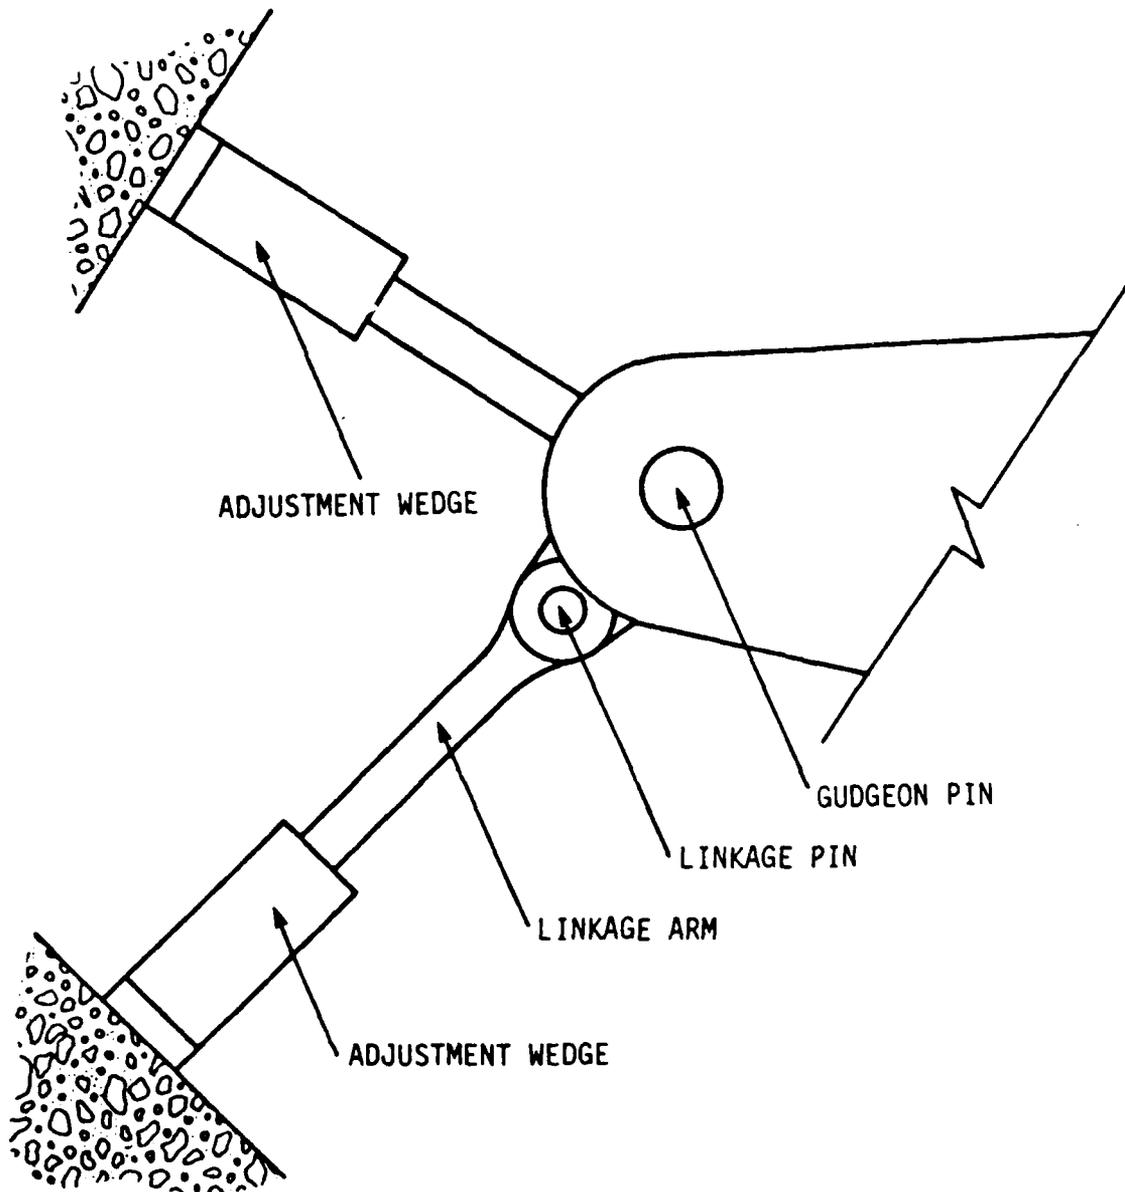
Figure 8. Double linkage pin assembly (components)

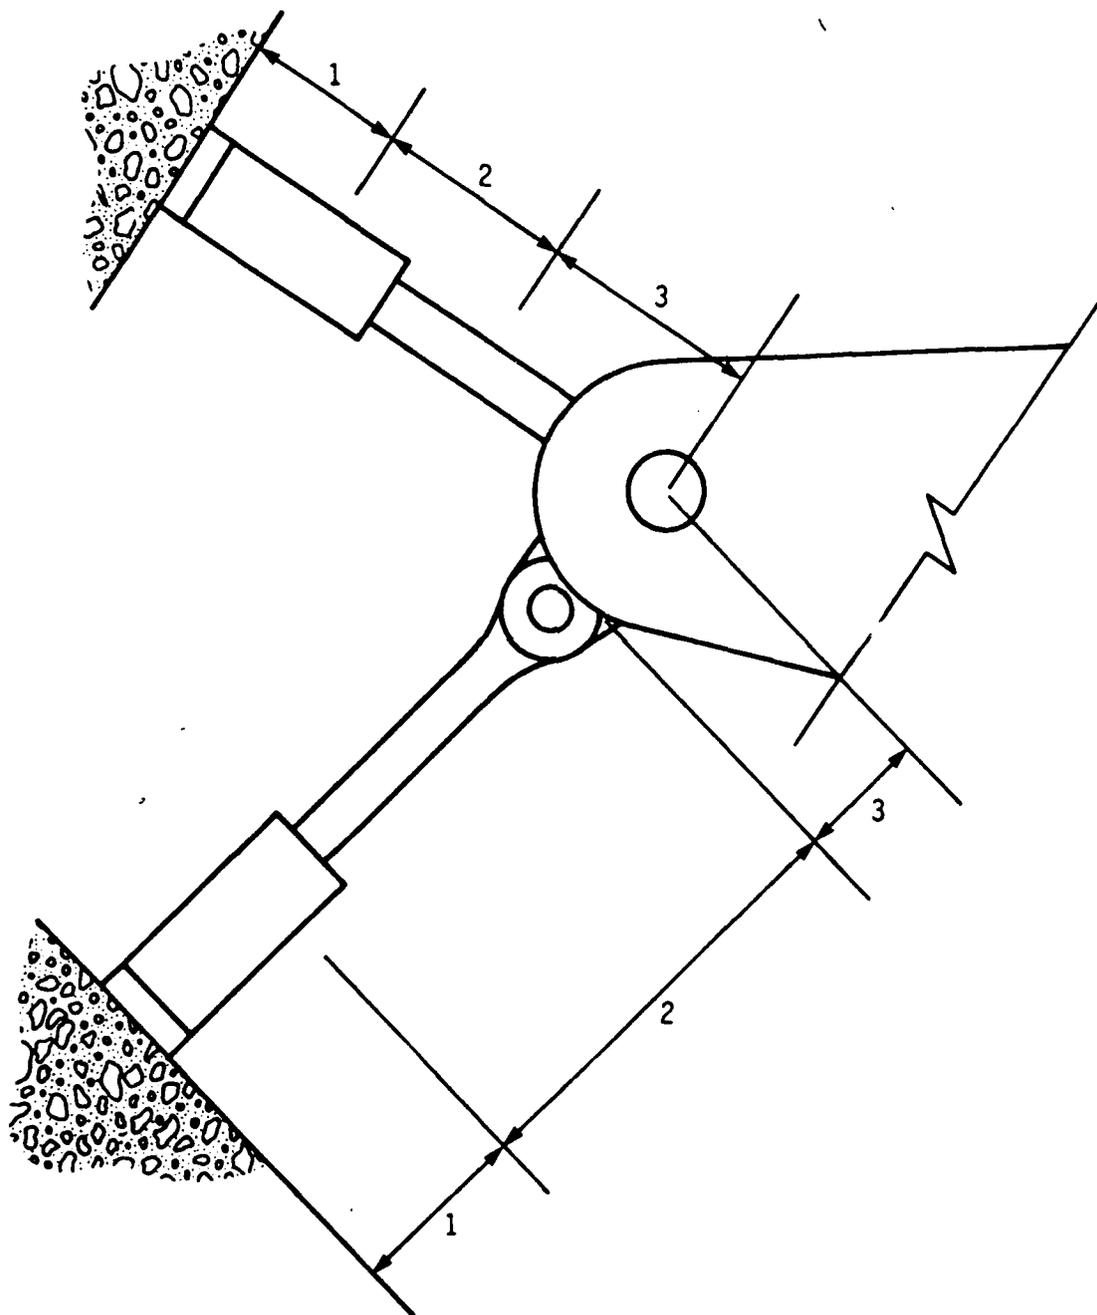
Figure 10. Double linkage pin assembly (dimensions)

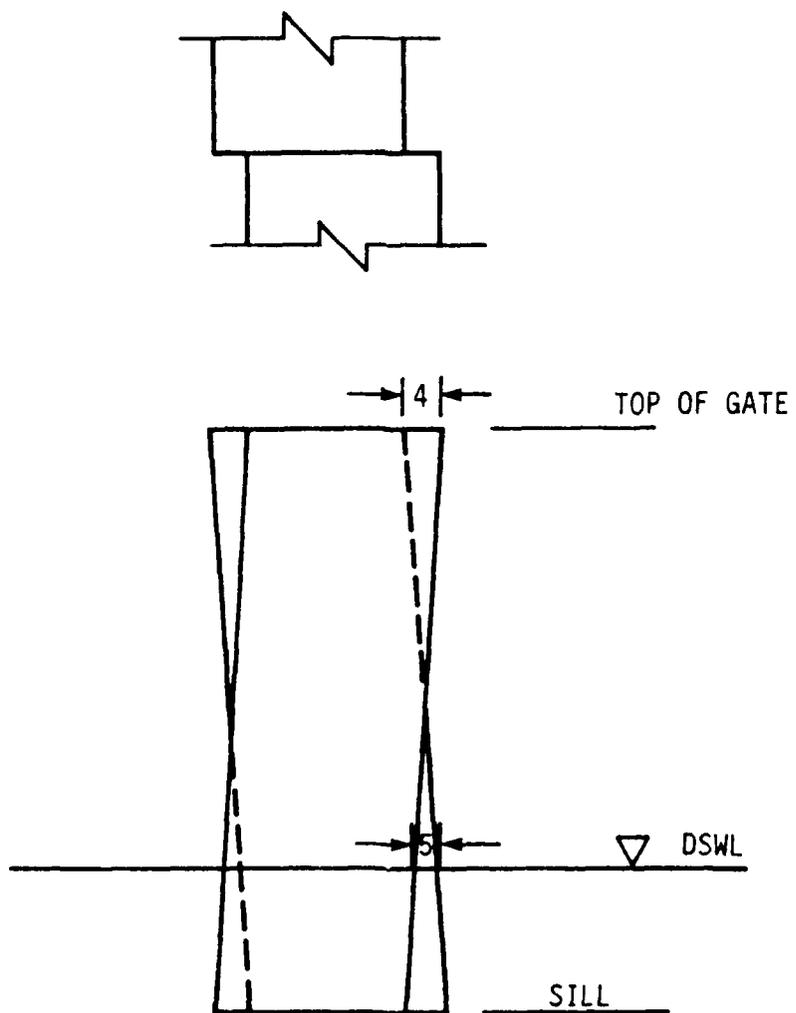
Figure 11. Miter block offset

97. For a horizontally framed leaf, the miter offset will be measured at the top of the gate, O_1 (Dimension 4, Figure 11) and at the water level, O_2 (Dimension 5, Figure 11) with 1 ft of head (Figure 23). The distance from the

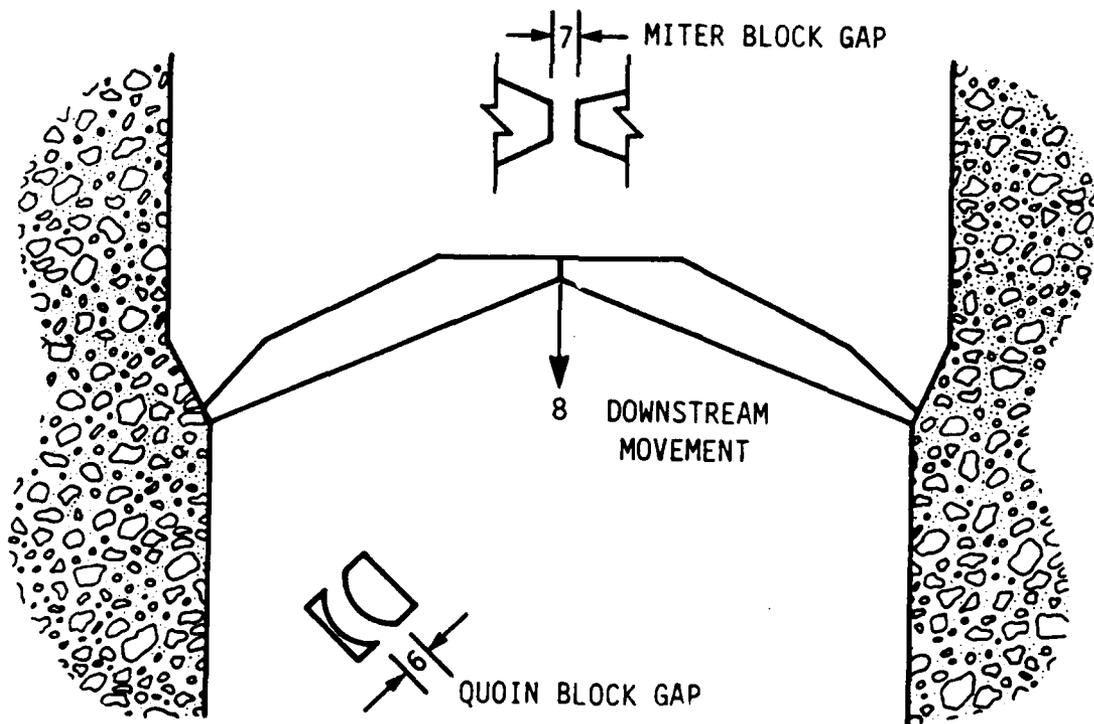
Figure 12. Gaps, downstream movement

103. The bearing gap distress represents an opening or separation of the bearing blocks at the miter, quoin, or both (Figure 12). Vertically framed gates can have a gap at the top girder only, whereas on horizontally framed gates the bearing gaps can run anywhere along the continuous length of the bearing blocks. Bearing gaps introduce additional stresses into the gate

104. For a horizontally framed gate, measurements of the miter block gap will be made at the top of the gate, MG_1 , and at the water level, MG_2 , under a 1-ft-head situation (Dimension 7, Figure 12). Since gaps will not be measured along the entire length, the miter blocks will be assumed to remain straight, as for the offset distress. The recorded gaps and the respective vertical locations, Y_1 and Y_2 , can be used to extrapolate the bearing gap between miter blocks at the sill, MG_S , by a straight-line equation,

105. For a horizontally framed gate, measurements of the quoin block gap will also be made at the top of the gate, QG_1 , and at the water level, QG_2 , under a 1-ft-head situation (Dimension 6, Figure 12). If the quoin blocks are assumed to remain straight, the recorded gaps and respective vertical locations, Y_1 and Y_2 , can be used to extrapolate the gap between quoin blocks at the sill, QG_S , by a straight-line equation,

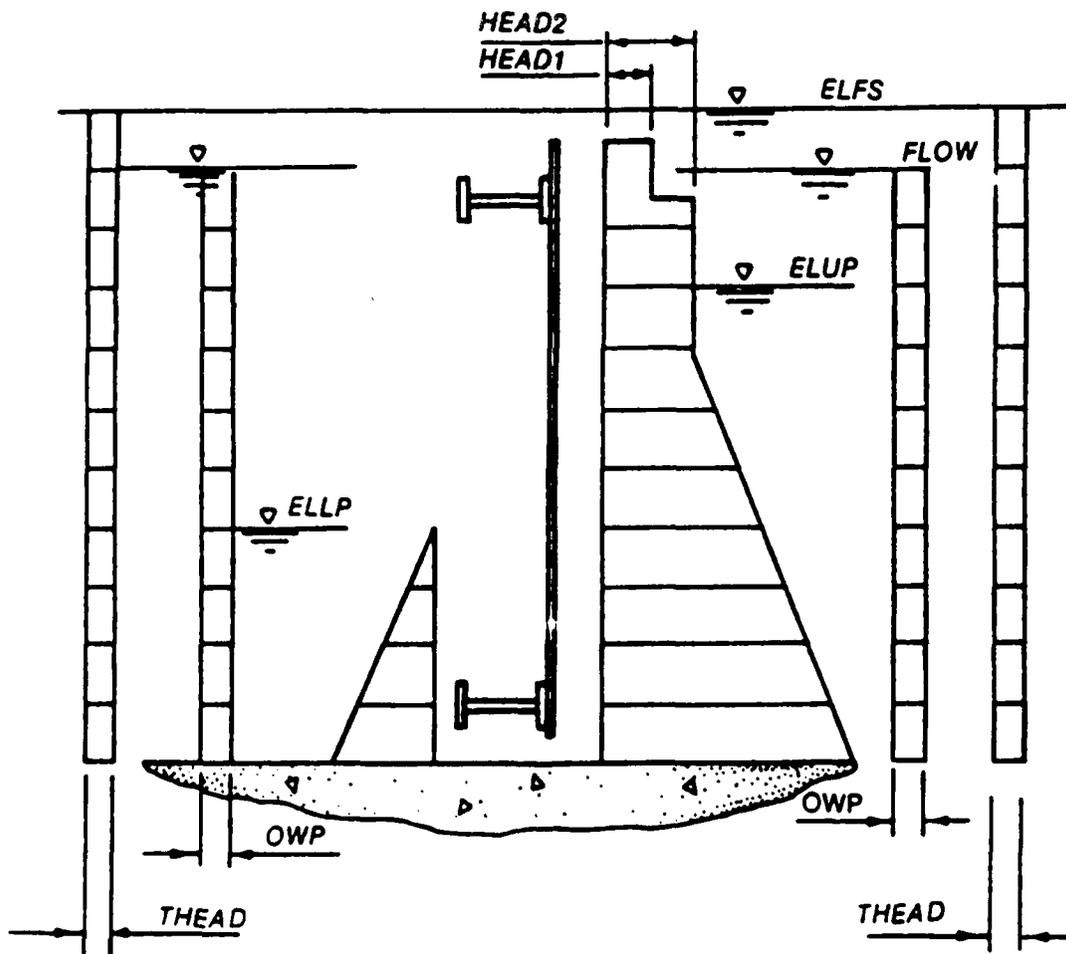
Figure 14. Water elevations (computer input)

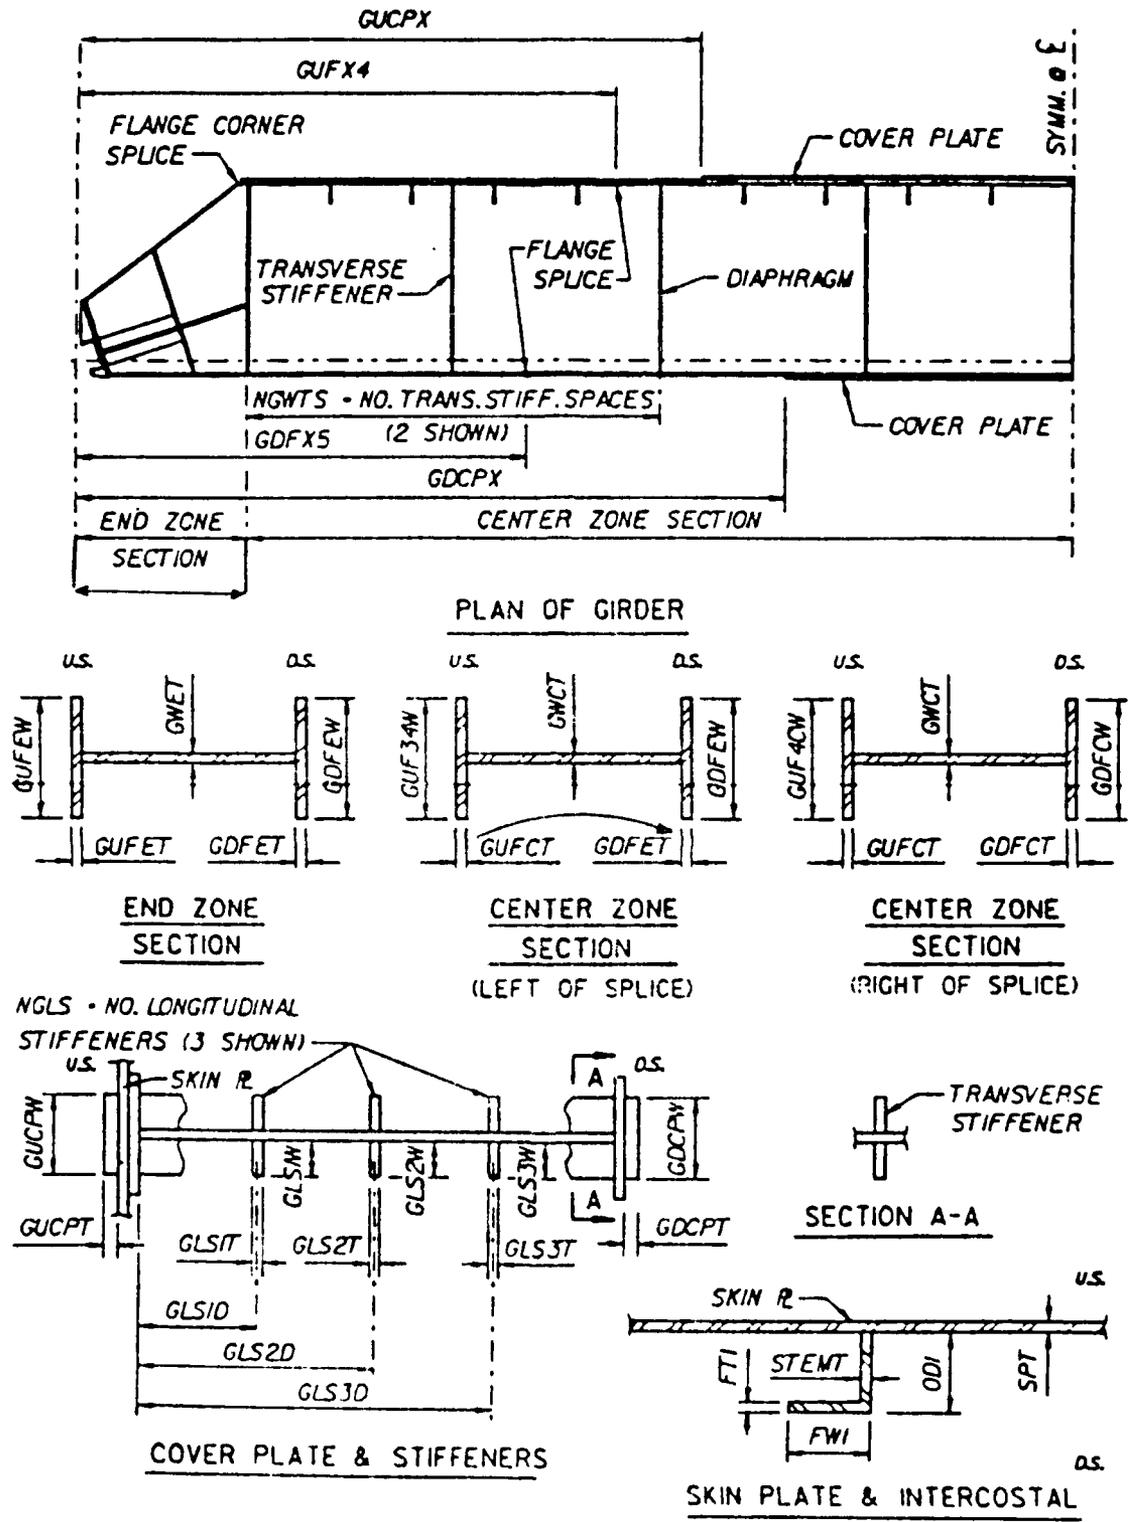
Figure 15. Component geometry

GIRDER WEB STIFFENERS: Provide the girder web stiffener information on the basis of the available design drawings. For each similar group of girder web stiffeners, record the top girder number, NGIRDI, and the bottom girder number, NGIRDN. Also, record the number of girder web transverse (vertical) stiffener spaces, NGWTS, between adjacent intermediate diaphragms, and the number of longitudinal stiffeners, NGLS, between girder flanges. In addition, indicate for each of the longitudinal web stiffeners (1) the distance from the downstream web edge, GLSD, (2) the width, GLSW, and (3) the thickness, GLST. A zero entry indicates no stiffener present, and a negative entry for a longitudinal web stiffener width indicates stiffeners on only one side of the web. See Figure 15 for illustration.

INTERCOSTAL AND SKIN PLATE GEOMETRY: Provide the intercostal and skin plate geometry on the basis of the available design drawings. For each similar group of panels, record the top girder, NPANLI, and the bottom girder, NPANLN, and the corresponding skin plate thickness, SPT, within this region. In addition, record (1) the overall depth of the intercostal, ODI (including the flange thickness), (2) the thickness of the perpendicular leg touching the skin plate, STEMT, (3), the width of the angle parallel to the skin plate (flange), FWI, and (4) the flange thickness of the intercostal, FTI. See Figure 15 for illustration.

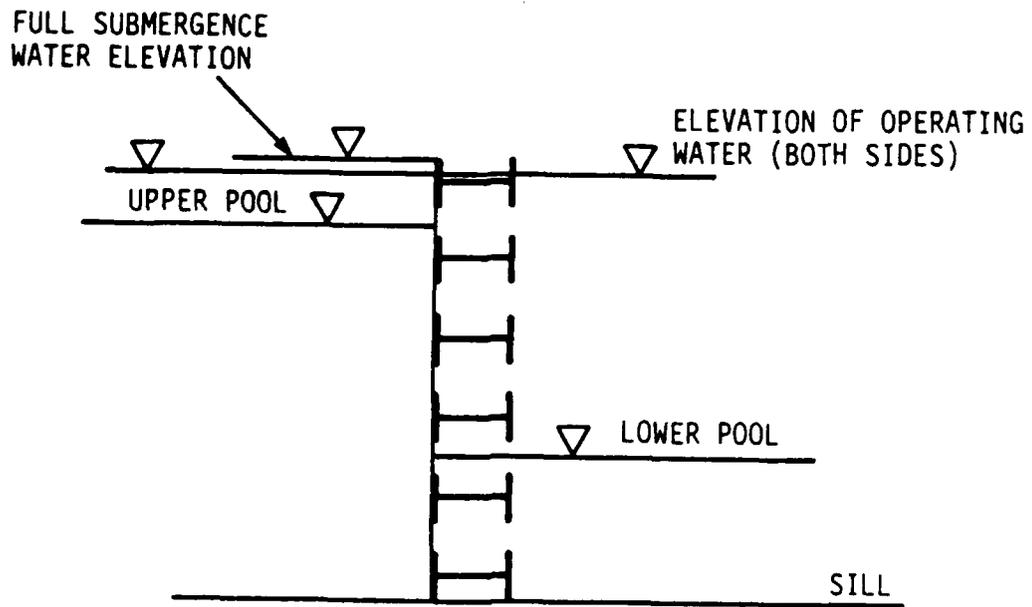
Figure 16. Water elevations

48. Load Case 1 is a normal operating condition in which the gate leaves are in the mitered position and subjected to both upper and lower pools (Figure 16). The Corps permits the use of 10 ft of head for girders and 6 ft of head for skin plate to act as equivalent impact loads. The equivalent boat impact load represents a minimum load to which the girders and skin plate are subjected (Figure 17). Hence, it only loads the girders and skin plate in the upper part of the gate.

50. Load Case 2 consists of the gate leaves in the mitered position with water pressure due to the full upper pool only. This is the dewatered condition (Figure 16).

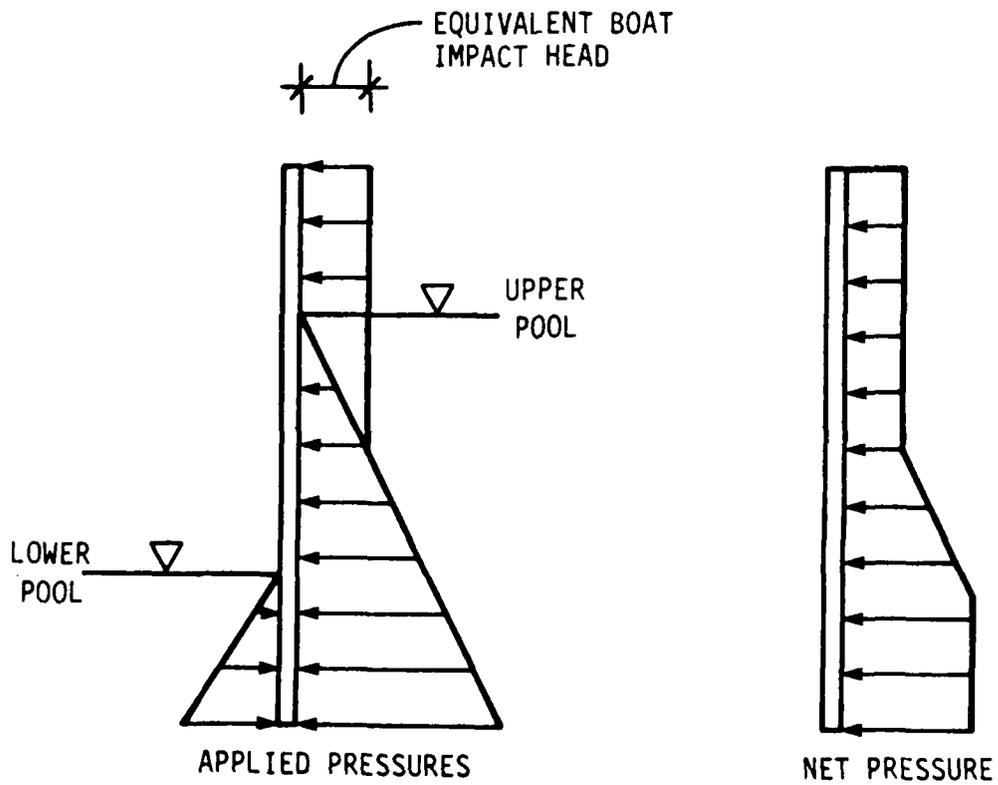
Figure 17. Load case 1

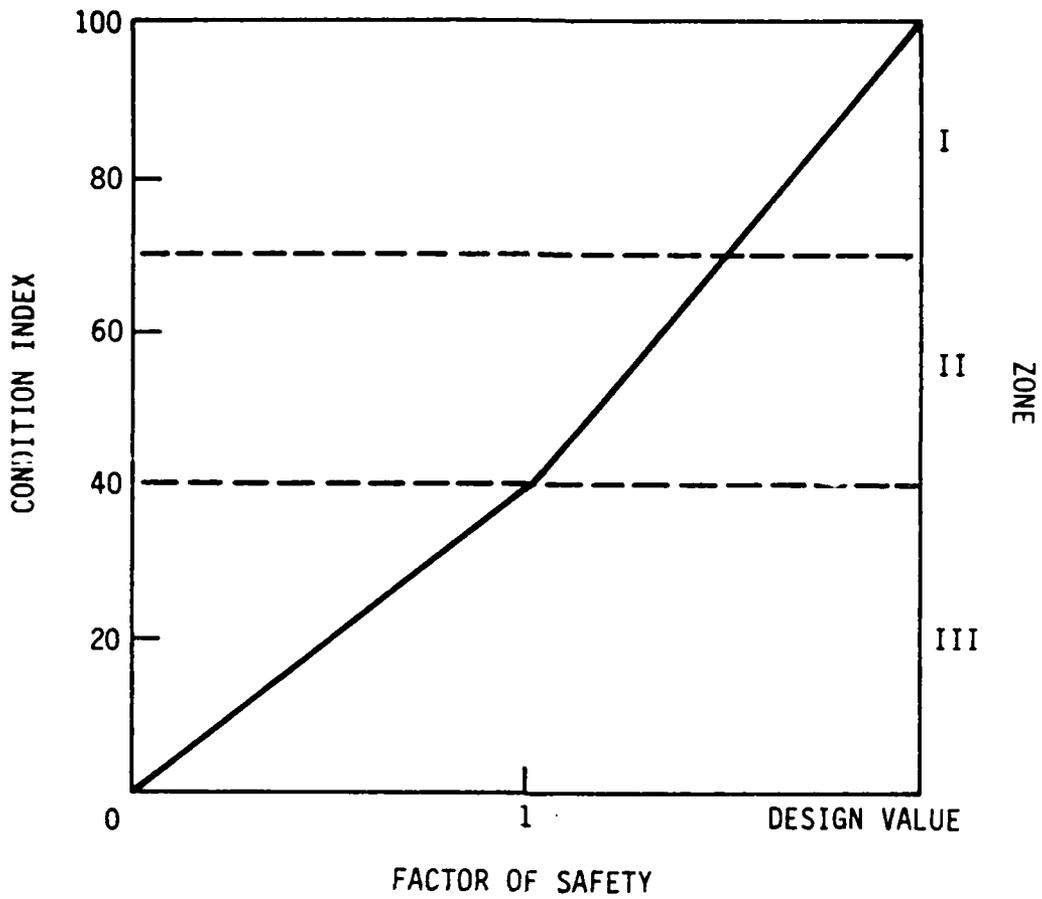
Figure 18. Relationship between factor of safety and structural condition index (Eq 1).

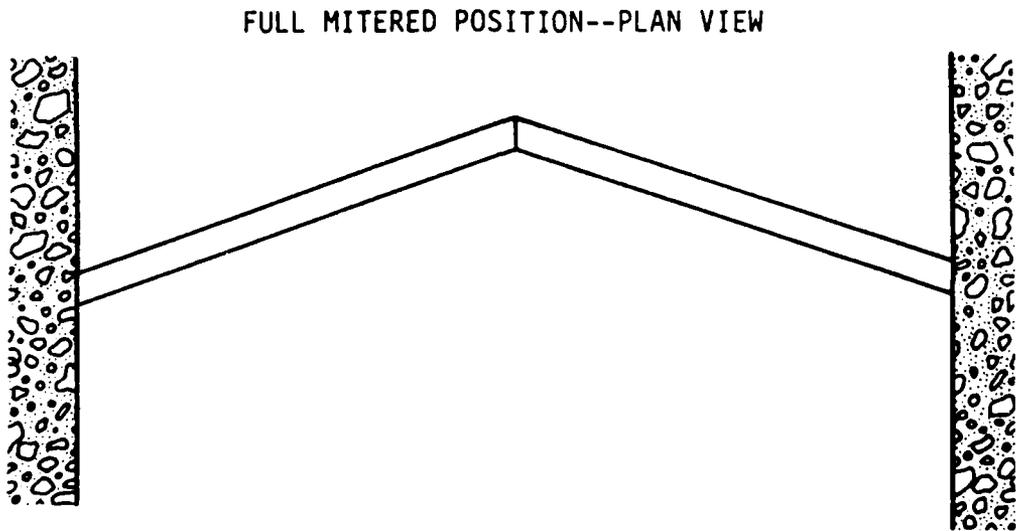
Figure 19. Three-hinged arch

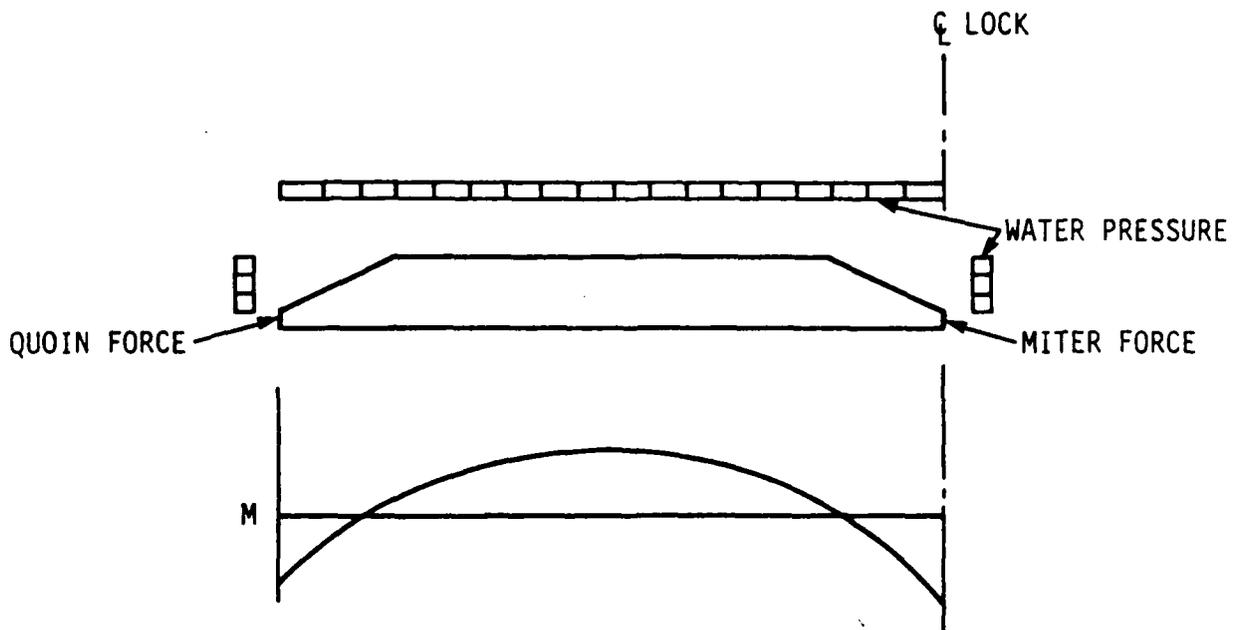
Figure 20. Forces and reactions on miter lock gate

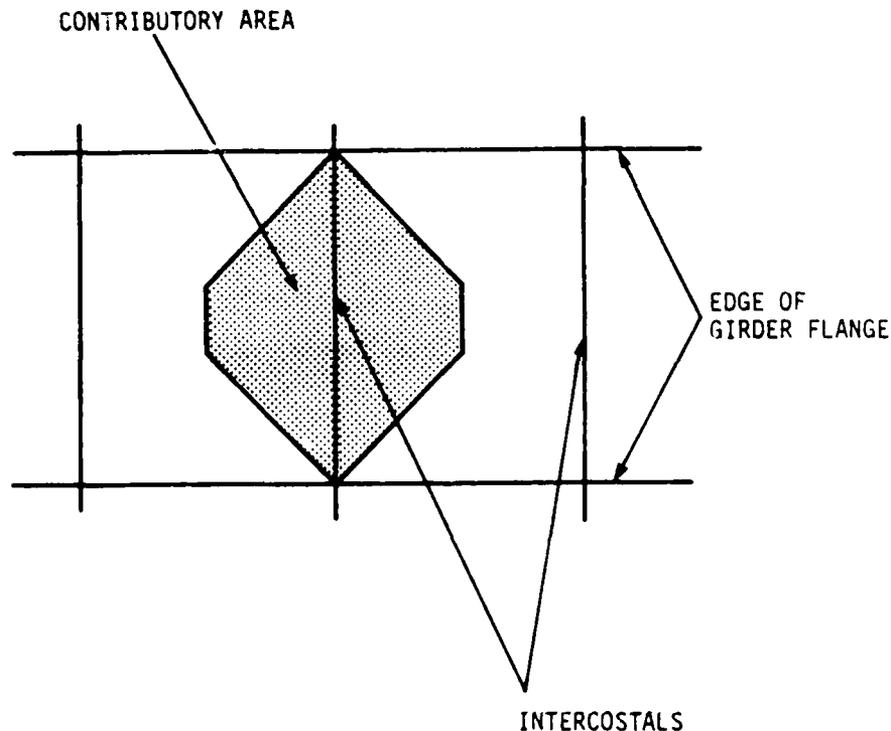
Figure 21. Contributory area for intercostal

70. Intercostals provide stiffness to the skin plate between vertical diaphragms. An effective width of the skin plate is assumed to act with an intercostal (Eq 2). Intercostals are assumed fixed at the girder centerline with the average water pressure at the center of the panel acting on a contributing area as shown in Figure 21. The intercostal stress is determined at the midspan and ends of the intercostal.

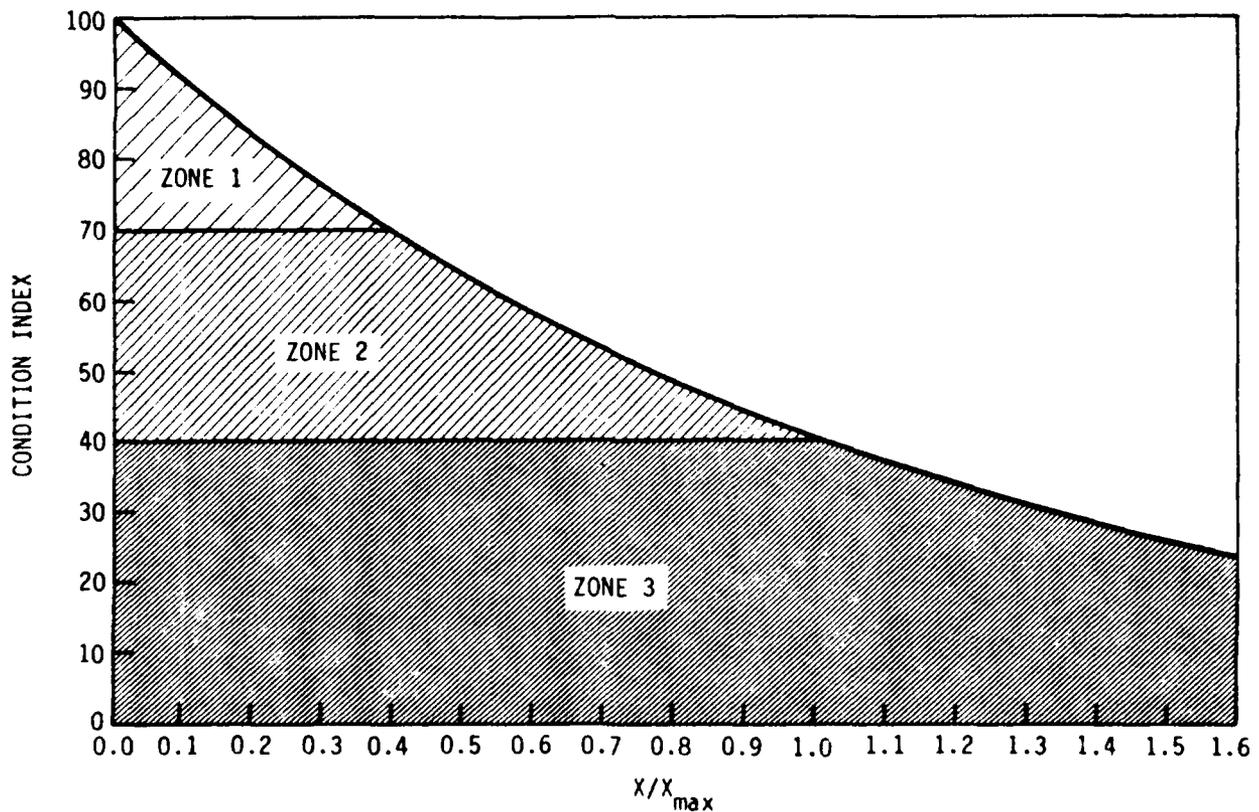
Figure 22. Functional condition index related to X/X_{max} (Eq 14)

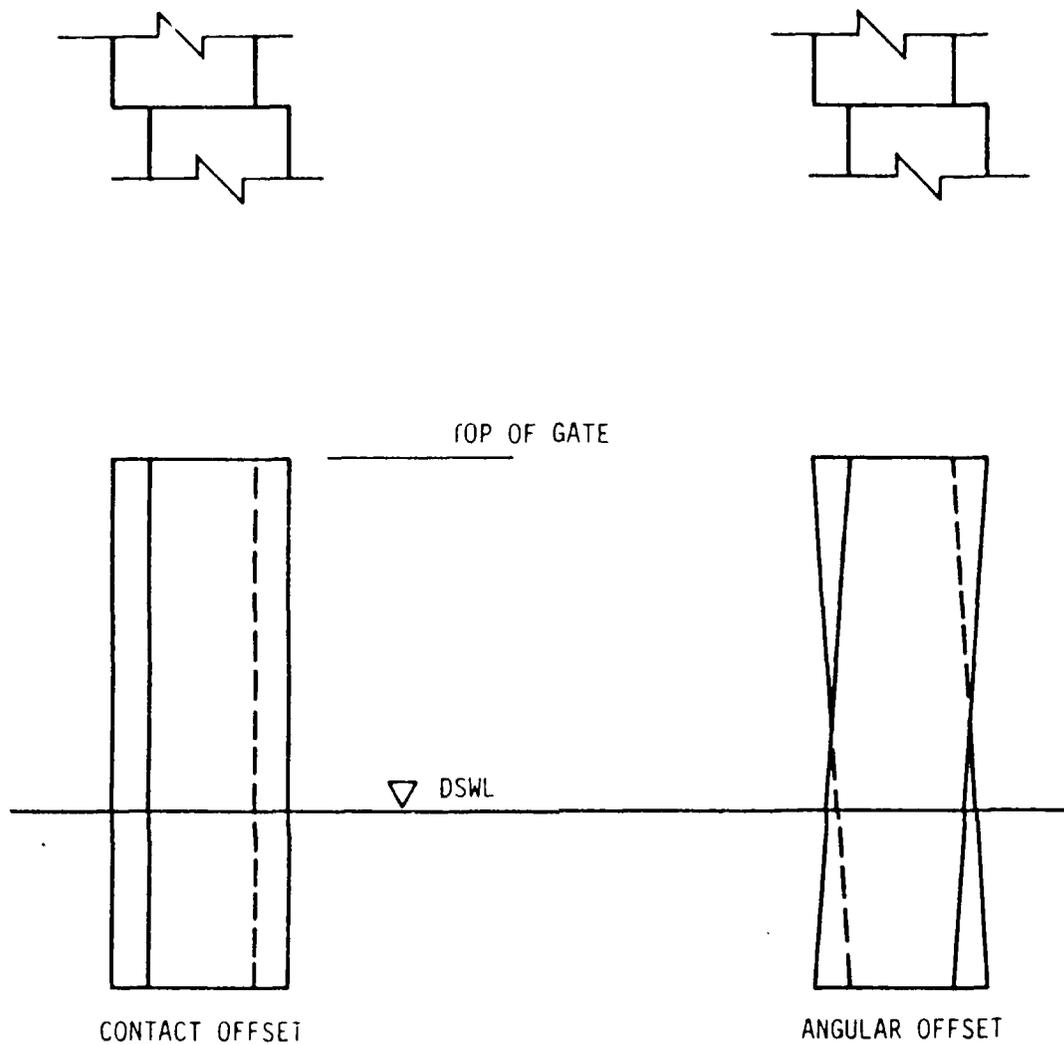
Figure 23. Miter block offsets (contact and angular)

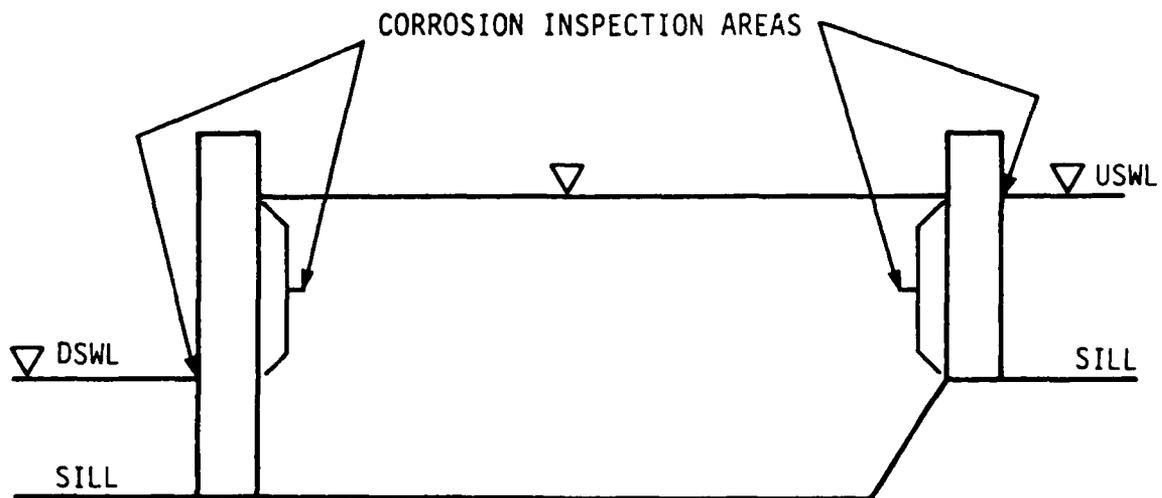
Figure 24. Corrosion inspection areas

129. Corrosion is the loss of the steel material in a miter lock gate leaf due to interaction with its environment. The rate of corrosion is dependent on the concentration of moisture in contact with the steel. A miter lock gate structure is exposed to different areas of corrosion (Figure 24). While corrosion is usually very evident and easily noticed in the exposed
