REPAIR, EVALUATION, MAINTENANCE, AND REHABILITATION RESEARCH PROGRAM

TECHNICAL REPORT REMR-OM-7

INSPECTION AND RATING OF MITER LOCK GATES

ENGINEERING RESEARCH INSTITUTE
Iowa State University
Ames, Iowa 50011

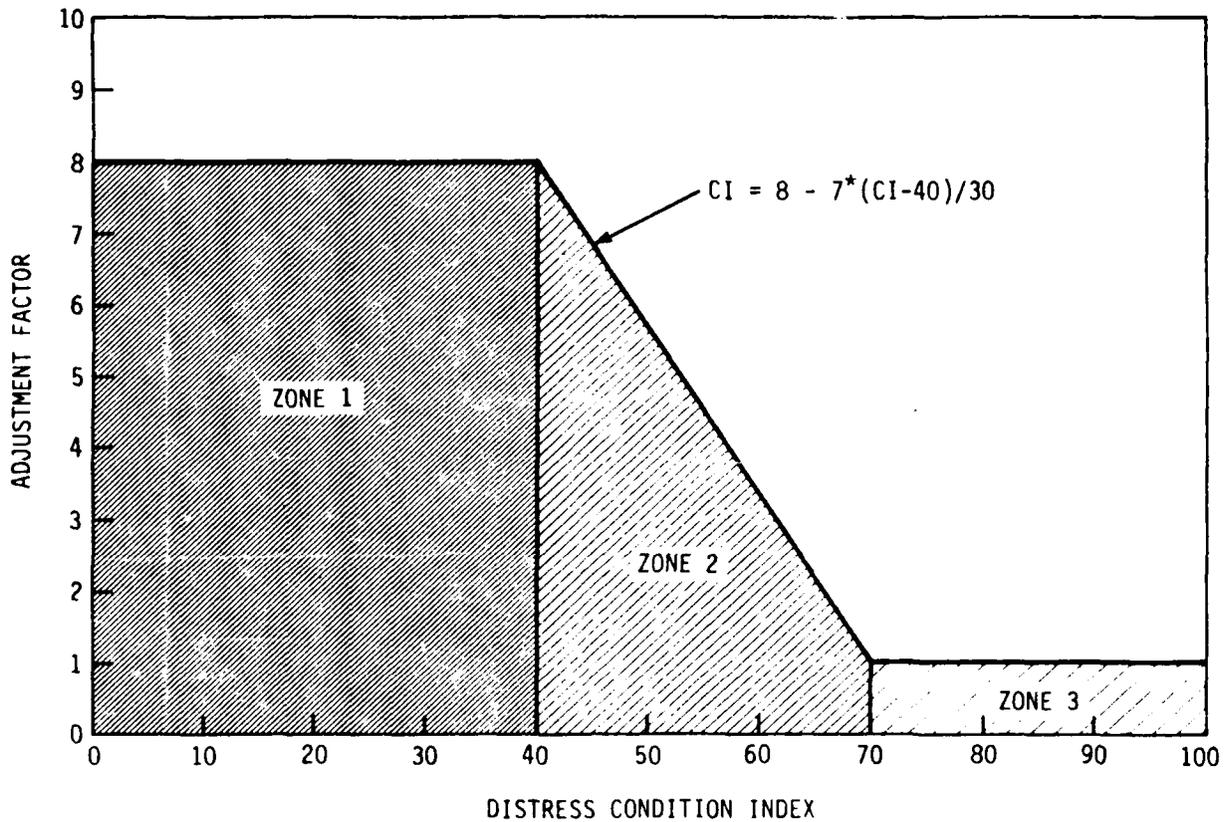
Figure 30. Weight adjustment factor for subjective condition index

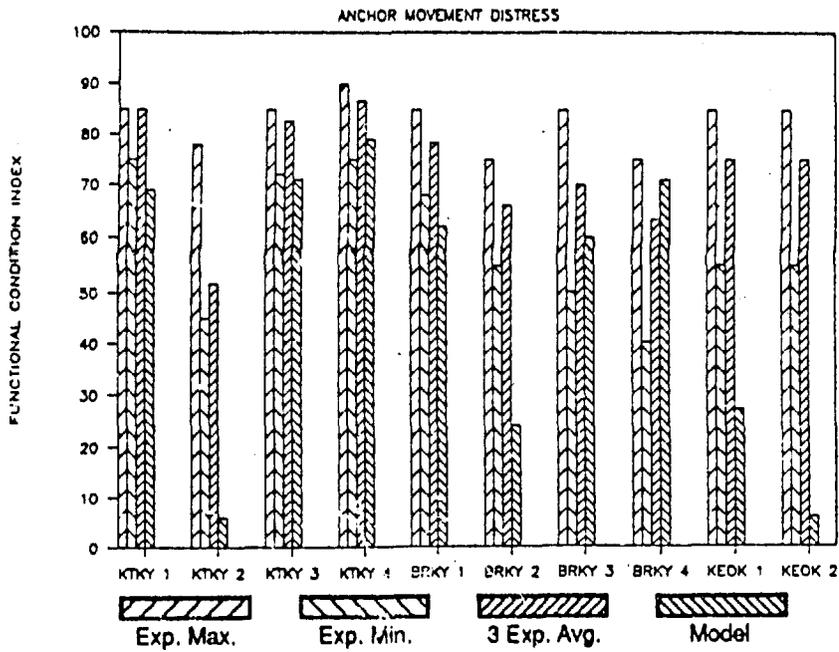
Figure 31. Anchor movement distress

Anchor movement: Figure 31

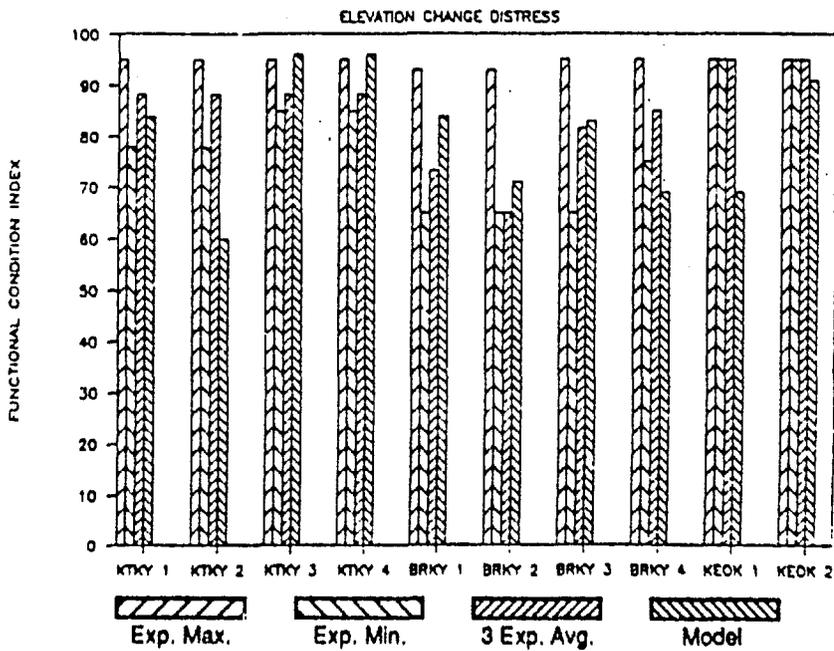
Figure 32. Elevation change distress

Elevation changes: Figure 32

143. The calculated functional condition indexes of 8 of the 10 gate leaves closely approximated the three-expert average. In the other two cases, KTKY 2 and KEOK 1, measured elevation changes were observed, calculated, and

rated in the upper part of Zone 2 by the computer model, whereas the experts rated the changes in the middle of Zone 1.

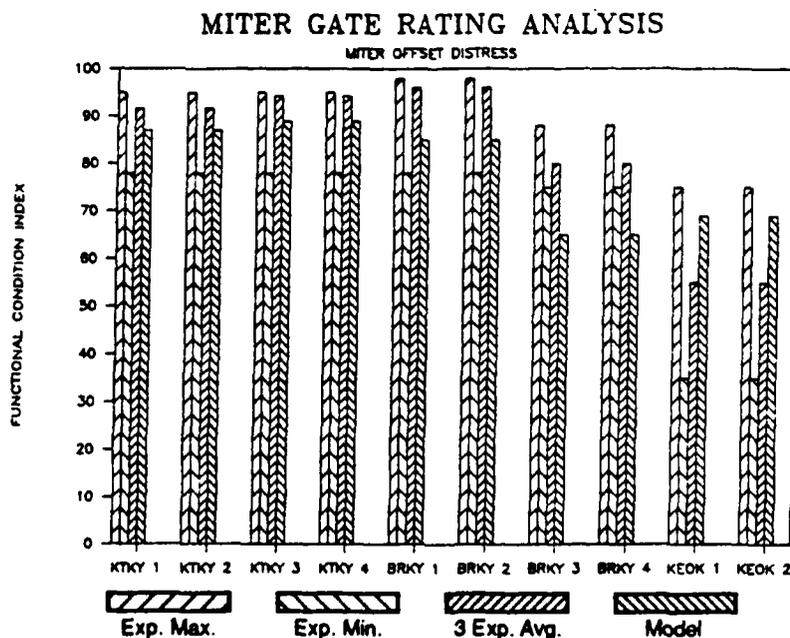
Figure 33. Miter offset distress

Miter offset: Figure 33

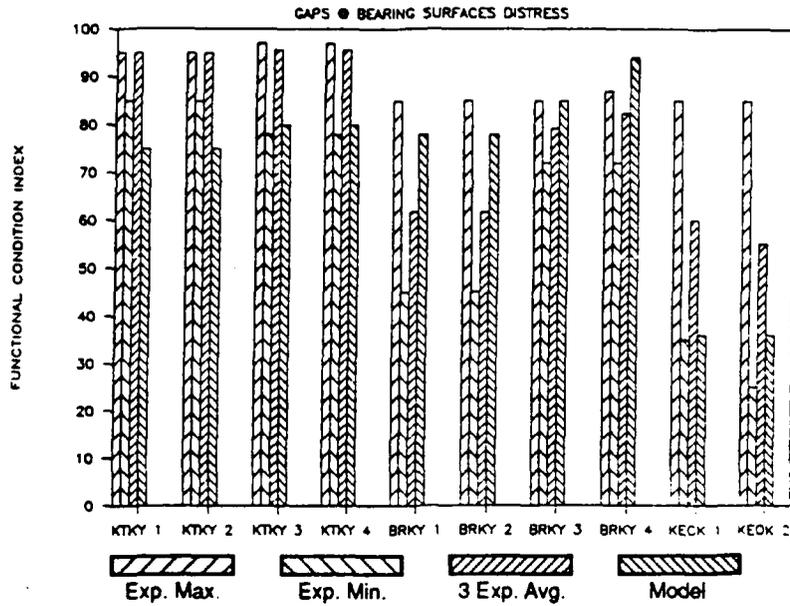
Figure 34. Gaps at bearing surface distress

Gaps: Figure 34

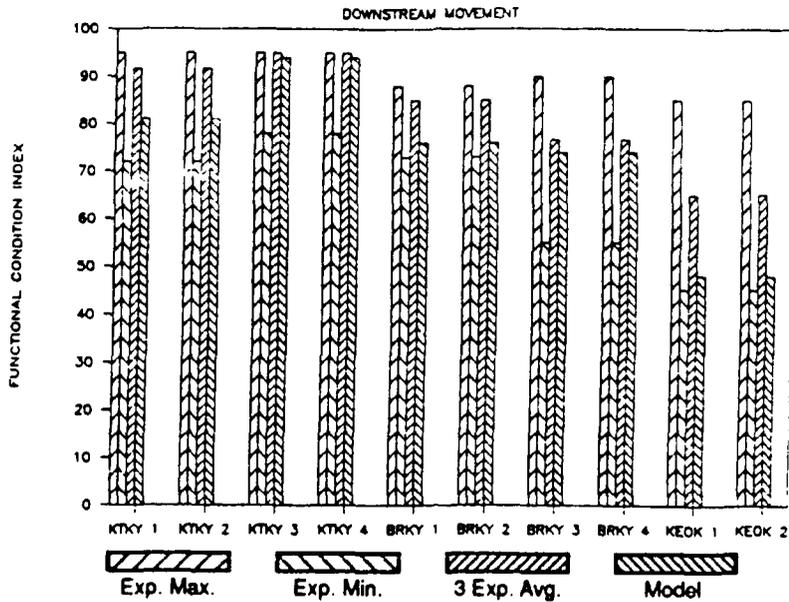
Figure 35. Downstream movement

Longitudinal or Downstream Movement: Figure 35

146. The calculated functional condition indexes of all 10 gate leaves closely approximated the three-expert average.

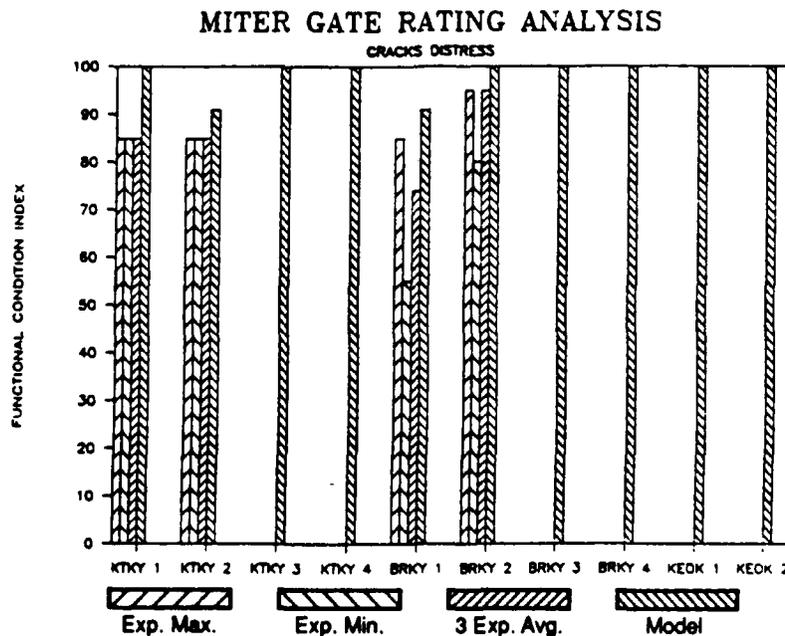
Figure 36. Crack distress

Cracks: Figure 36

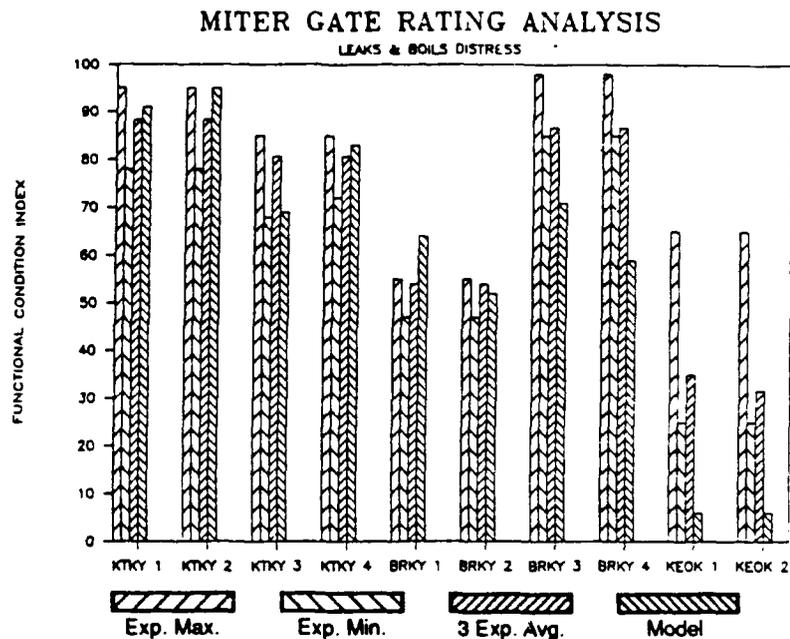
Figure 37. Leak and boils distress

Leaks and Boils: Figure 37

148. The calculated functional condition index of 6 of the 10 gate leaves closely approximated the 3-expert average for 2 other cases, BRKY 3 and 4, minor leaks at the lower sill seal on the upper gate set were recorded as boils. These leaks became apparent as the chamber water level dropped below the upper miter sill. If the minor leaks had not been recorded as boils, the calculated index value would have been very close to the experts' rating. However, the authors think it appropriate and necessary to record the leak in this manner. The remaining two cases, KEOK 1 and 2, were very severe leakage conditions and the experts and the computer model both rated the condition severely, that is, in Zone 3, but to a different degree.

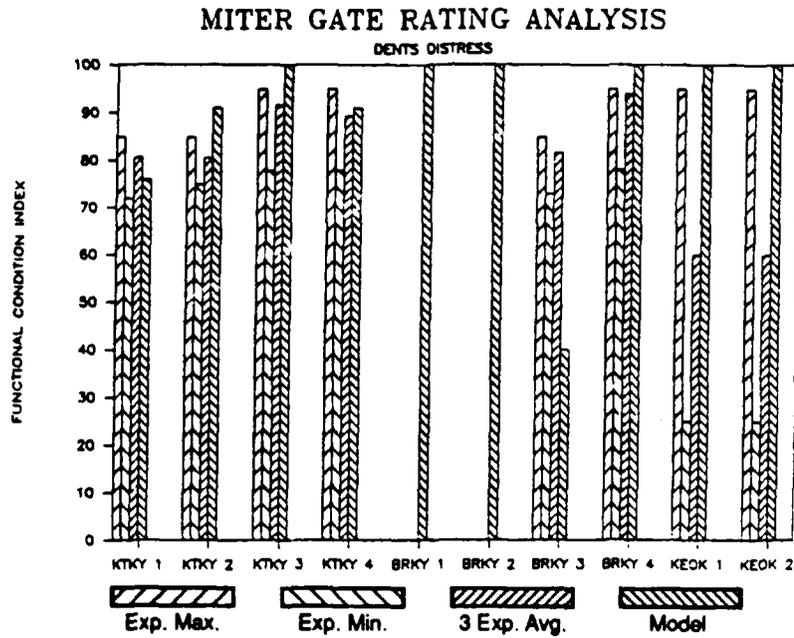
Figure 38. Dent distress

Dents: Figure 38

149. The calculated functional condition indexes of 5 of the 10 gate leaves closely approximated the three-expert average. In two of the remaining cases, BRKY 1 and BRKY 2, the experts did not put a rating on dents, but the computer model calculated a 100 because no dents were observed. In one case, BRKY 3, one girder dent was observed, which, by the distress rules, resulted in a calculated condition index of 40. However, the three experts did not rate the gate accordingly. In the last two cases, KEOK 1 and 2, no correlation can be made between the three-expert ratings that ranged from 95 to 25 and the computer model that calculated a 100 because no dents were observed.

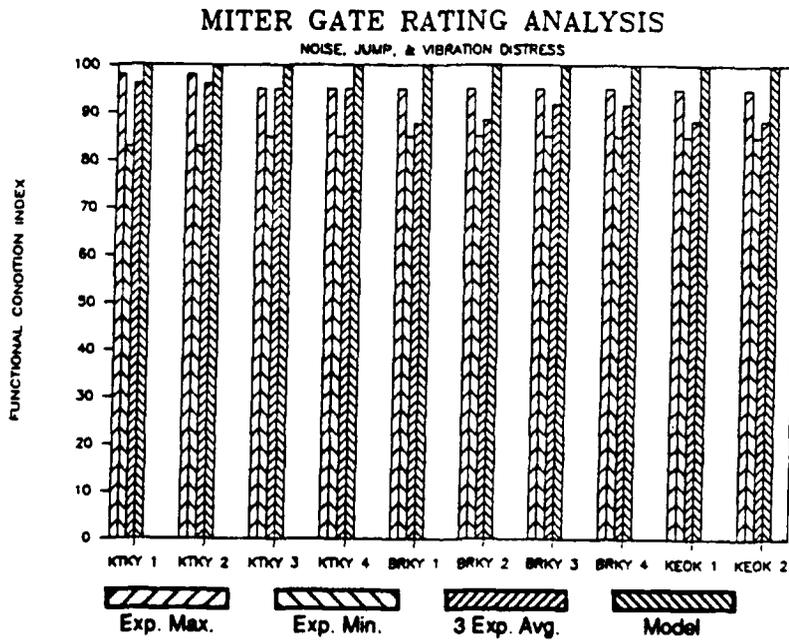
Figure 39. Noise, jump, and vibration distress

Noise, jump, and vibration: Figure 39

150. The calculated functional condition indexes of all 10 of the gate leaves closely approximated the three-expert average. It is noted the experts rated all the gate leaves in the 85 to 95 range, even though there were no identifiable occurrences of noise, jumps, or vibrations. The computer model will calculate a 100 index value under those circumstances.

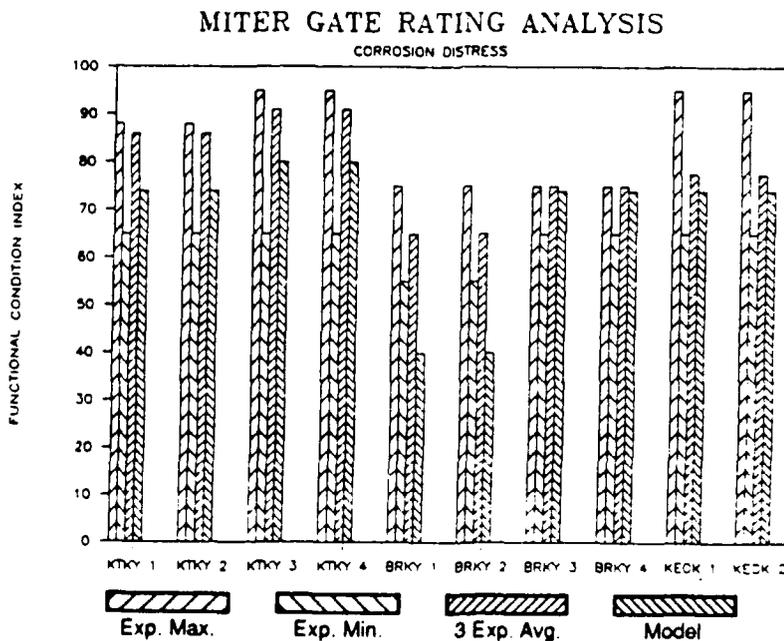
Figure 40. Corrosion distress

Corrosion: Figure 40

151. The calculated functional condition indexes of 8 of the 10 gate leaves closely approximated the three-expert average. The remaining two calculated indexes at BRKY 1 and BRKY 2 are evaluated at the lowest value of Zone 2 (40) because the downstream girders were judged to have a corrosion level of 3 (X_{max} for girders). This conservative evaluation will highlight the corrosion problem, and a subsequent investigation may be in order. A Level 2 rating on the girder corrosion level would yield a condition index of 54, closely approximating the three-expert average. This case illustrates the subjective nature still inherent in the evaluation of corrosion.

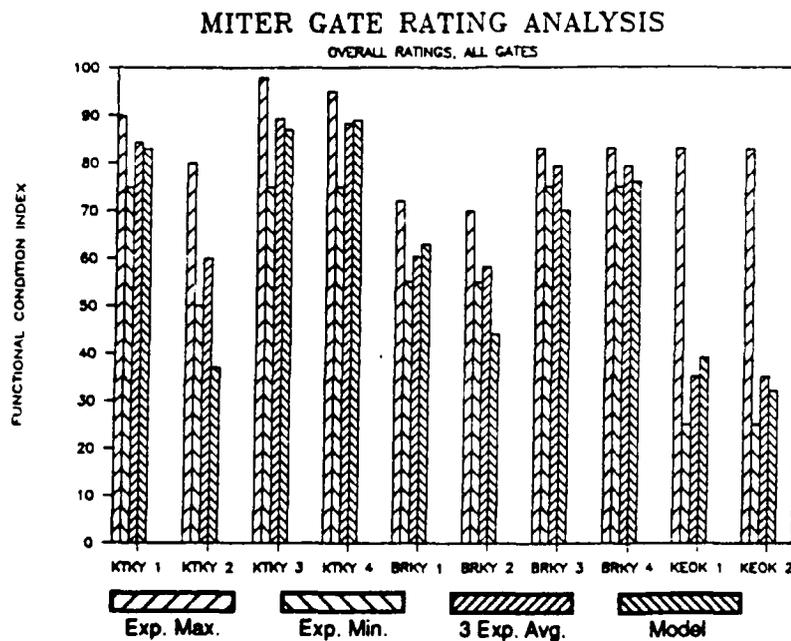
Figure 41. Overall ratings

Overall gate leaf ratings: Figure 41

152. The overall gate rating by the computer model tended to track very consistently with the three-expert average, and 9 of the 10 calculated combined functional condition indexes closely approximated the three-expert average. In one case, however, KTKY2, the difference was approximately 20 points. The lower rating by the computer model is directly attributable to the low rating on several individual distresses: anchor movement, gaps, and elevation change. These individual ratings lowered the combined index rating as well. While the 20-point differential is significant, the authors believe the computer model corresponds to a very reasonable degree with the experts' judgment on all 10 gate leaves.
