Construction Engineering  
Research Laboratory

USACERL Technical Report M-91/16  
February 1991

# **Evaluation of X-ray Fluorescence Unit for Detecting Lead in Paint on Military Structures**

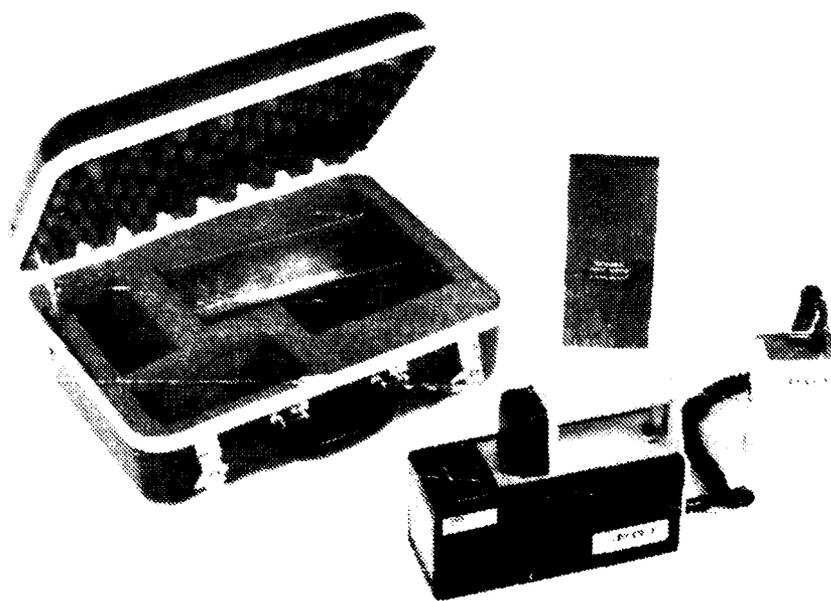
The PGT XK-3 (Figure 1), costing less than \$10,000, comes in a briefcase-size carrying case. It is a hand-held unit containing a radioactive source, a detector, and a liquid crystal display (LCD). A battery pack belt and a 120-volt alternating current (AC) battery charger are included. To determine the lead content of a flat surface, the unit is turned on and pressed against the surface. Pressure on a handle automatically opens an internal radiation shield and activates the testing mechanism. When the test is complete, the LCD will display the value of the lead directly in milligrams of lead per square centimeter ( $\text{mg}/\text{cm}^2$ ) of surface. The amount of time to perform a test varies with the age of the radioactive source and ranges from 10 to 15 seconds when the source is new, to 25 to 30 seconds when the source is a year old. The limited life of the source means that the source must be replaced annually. The unit must be returned to the manufacturer. Although the actual time necessary to replace the source is quite short, it is necessary to coordinate the replacement 1 or 2 months in advance so the manufacturer will have the source material available. The cost to replace the source and recalibrate the unit ranges from \$1500 to \$2000.

**Figure 1. The x-ray fluorescent lead analyzer.**

The radiation source is 10 microcuries (mCi) of  $^{57}\text{Co}$  (cobalt-57). If used improperly, exposure to gamma radiation and X-rays could occur. Because the source is radioactive, the owner of the unit must have an Atomic Energy Commission license. A "wipe test" must be performed every 6 months (at a cost of about \$20) to ensure the source is properly shielded.

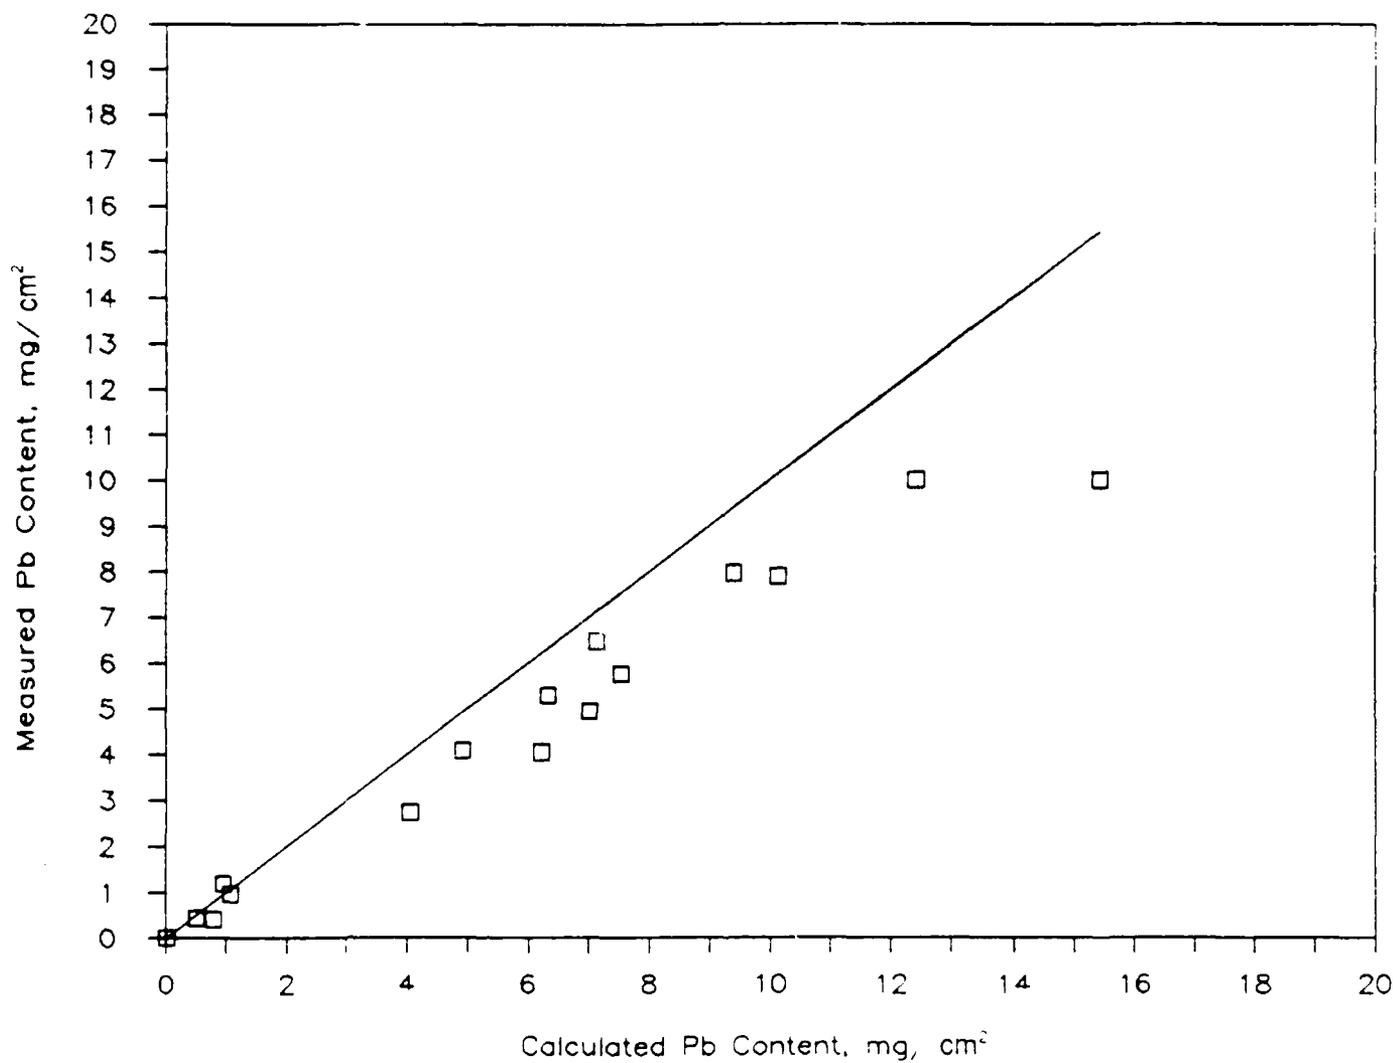
A series of tests on samples of known lead content were conducted to gauge the accuracy of the analyzer. To prepare standards with low lead levels, yellow lead oxide ( $\text{PbO}$ ), was added incrementally by weight to a lead-free oil-base paint. For lead levels over about  $4 \text{ mg}/\text{cm}^2$ , TT-P-86 Type I red lead linseed oil paint was selected as a standard. This paint is pigmented solely with red lead oxide ( $\text{Pb}_3\text{O}_4$ ). For each paint, the percent lead by weight of dry paint was calculated. To prepare a set of standards for evaluation, the paints were applied to chart papers to yield a range of thicknesses from 0 to greater than  $10 \text{ mg}/\text{cm}^2$ . The chart papers are lead free and uniform in weight per unit area. The true lead content of each sample was derived from the weight of paint per unit area of the chart paper. The results are shown in Table 1. Figure 2 is a graphical comparison of the results. Each data point represents the average of three readings. Figure 2 shows a correlation between measurements made with the XK-3 and the true lead content. The maximum reading on the unit is  $10.0 \text{ mg}/\text{cm}^2$ ; measurements of lead contents over that amount will be given as 10.0. Measurements made by the XK-3 test unit consistently fall below the true lead content (Table 1 and Figure 2). Although a calibration curve or table can be constructed for the test instrument, the results would not necessarily be applicable to other lead analyzers, for which similar tests can be run.

Figure 2. Measured vs. calculated lead content of samples.

As shown earlier (Table 1 and Figure 2) the measurements made by the XRF are consistently below the true lead content. The unit is quite accurate at the lower end of the scale but the accuracy decreases with increasing lead content in the paint.
