REPAIR, EVALUATION, MAINTENANCE, AND
REHABILITATION RESEARCH PROGRAM

TECHNICAL REPORT REMR-EI-5

THE EFFECTS OF VEGETATION ON THE
STRUCTURAL INTEGRITY OF SANDY LEVEES

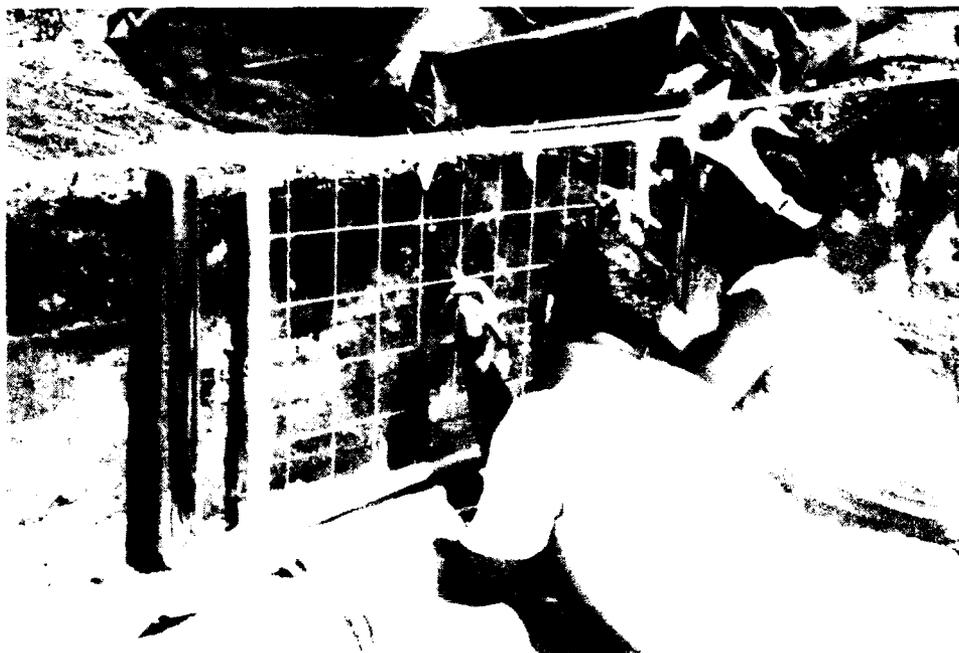
Figure 16. Closeup view of mapping frame showing acetate sheet, take-up and supply holders, and string grid

features mapped directly on the acetate. Mapping was done along the upper half of the trench by successively moving the frame along the ledge and advancing the acetate roll to a new position. After the upper half was mapped, the ledge at midheight was trimmed away, and the bottom half mapped in a similar fashion. Views of a mapping operation in progress are shown in Figures 15 and 16.

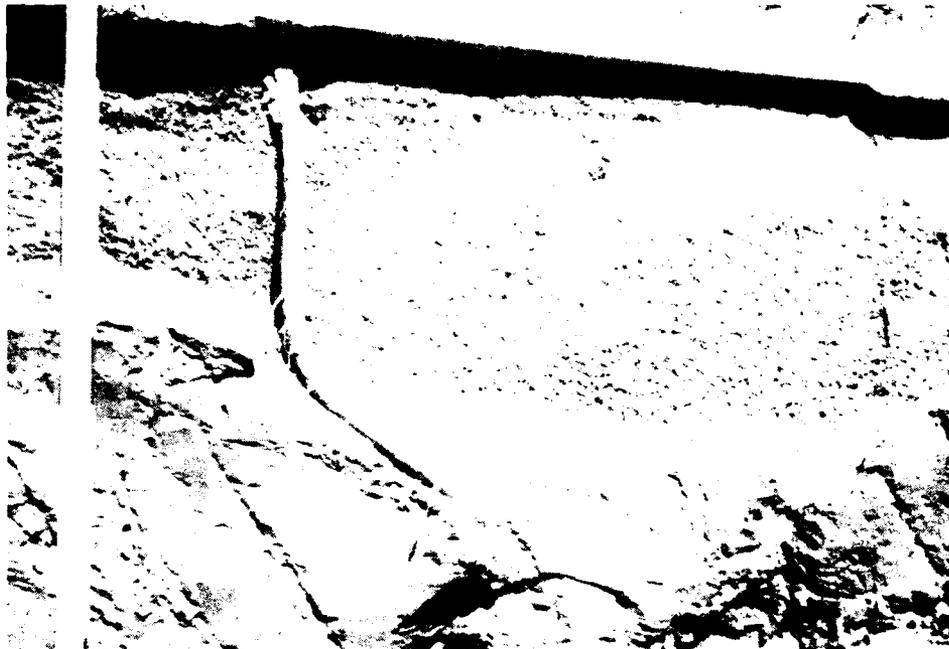
Figure 21. Fissure in large clay clod or inclusion that has been permeated by a tree root

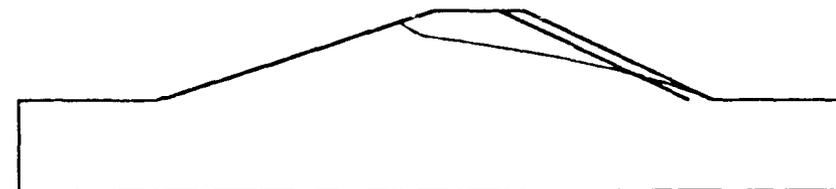
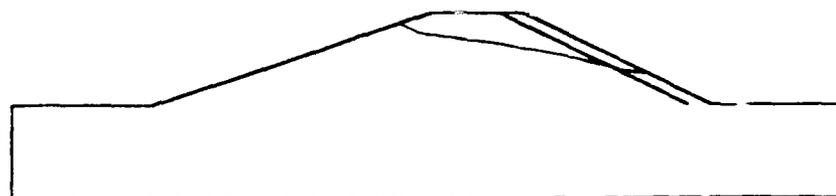
a) levee with constant permeability , k_2

b) levee with a 1-ft layer of permeability , k_1 and $k_1 / k_2 = 10$

c) levee with a 1-ft layer of permeability , k_1 and $k_1 / k_2 = 0.1$

d) levee with 1-ft layer of permeability , k_1 and $k_1 / k_2 = 10$

e) levee with 1-ft layer of permeability , k_1 and $k_1 / k_2 = 0.1$

Figure 54. Schematic illustration showing influence of a modified surface permeability on the line of seepage

124. The first task was to determine the influence of a surface layer or skin on the location of the phreatic surface as shown schematically in Figure 54. This was accomplished by following the transfer condition rules summarized earlier in Figure 51. The "skin" was assumed to be either more or less permeable than the core by a factor of 10. The subsequent influence on the location and orientation of the phreatic surface as a result of this permeability contrast is depicted schematically in Figure 55.

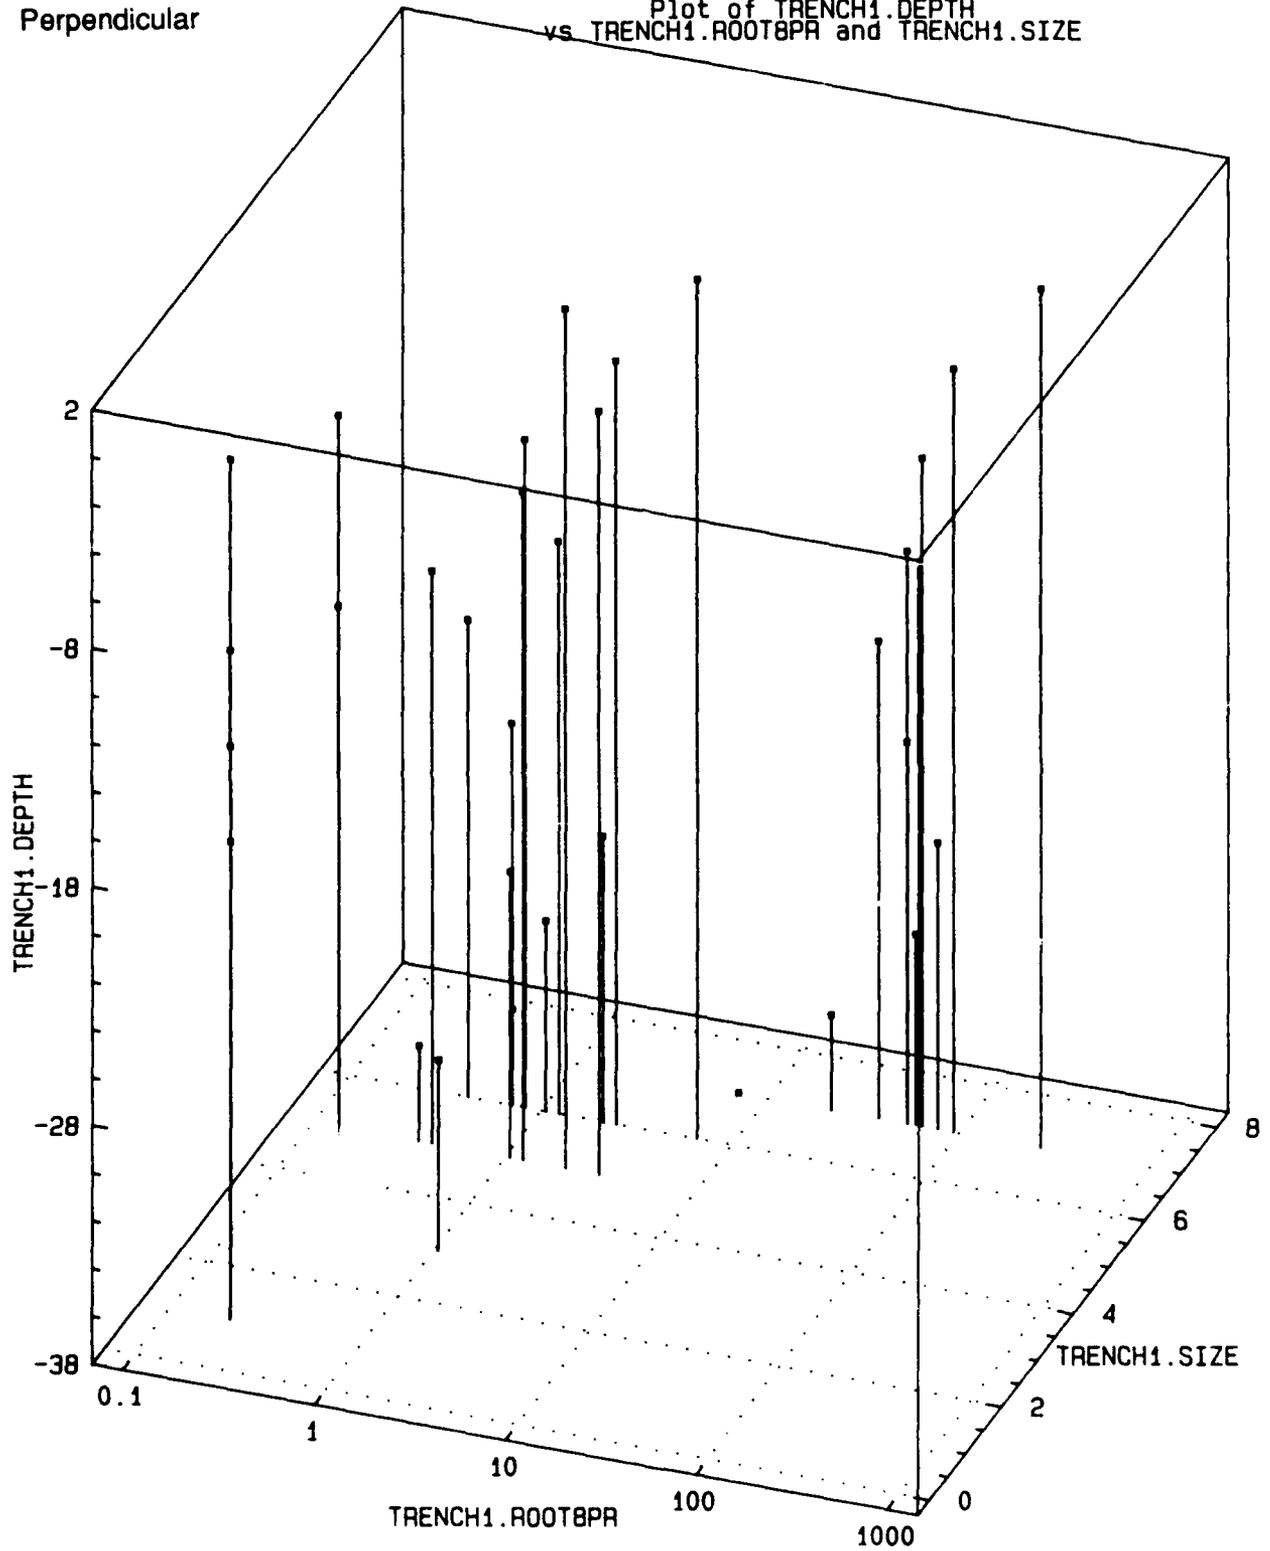
Site 8
Perpendicular

Plot of TRENCH1.DEPTH
vs TRENCH1.ROOTBPR and TRENCH1.SIZE
