WL-TR-91-4026

LASER PAINT STRIPPING

J.D. Head, J. Peter Niedzielski
Laser Technologies, Inc.
10131 Colonial Industrial Drive
South Lyon, Michigan 48178

Final Report for Period April 1988 - January 1991

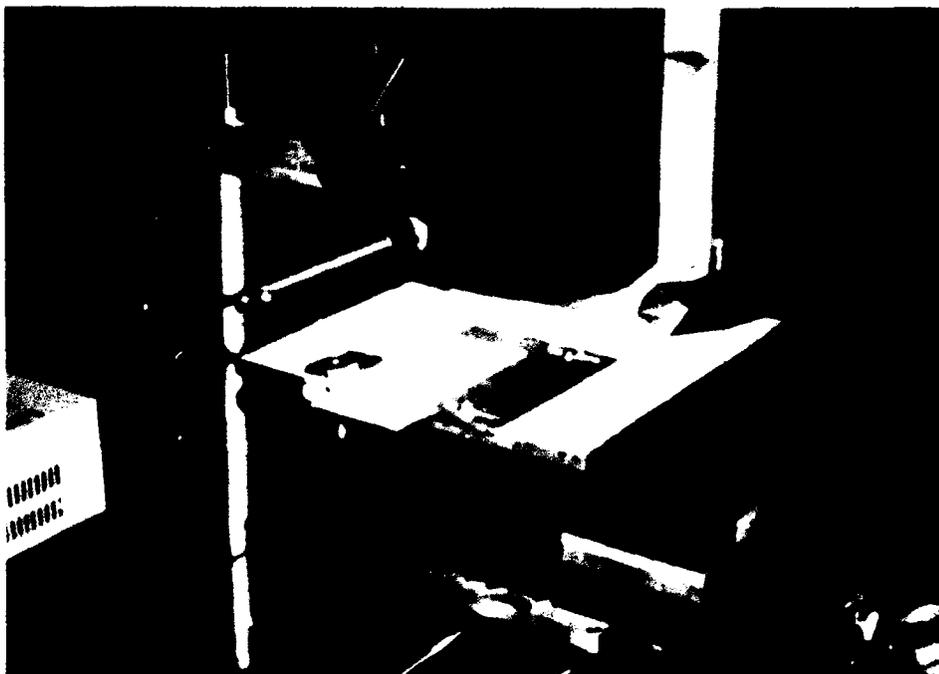
Figure 3. High Power Rapid Pulse Equipment

1.4.3 High Power Rapid Pulse Equipment

Larger paint removal areas were achieved with the full scale LTI equipment which produces an output of 1.2 joules per pulse at a variable rate from 40-250 pulses per second. This equipment can produce pulses of controlled duration varying from 10 to 30 microseconds. The pulse characteristics are very nearly identical to those produced by the lower powered equipment described under 1.4.2. The same x-y table and lens system allowed similar control of uniformity of treatment and variations of fluence.

The simple vacuum system was satisfactory for removal of waste products. The equipment was also used for the development of the wobbler system for automatic distribution of the pulses along a line which was manually advanced across a sample by the use of the x-y table. The wobbler was equipped with a 10 inch focal length reflector and samples exposed beyond focus were given exposures of 8-20 J/sqcm according to the distance from focus.

The higher powered laser equipment (1.4.3) in the unprotected laboratory demonstration version does introduce moderate static into the local phone system and the static could be detected on a portable battery operated radio at 100 yards distance. No change in this static was detected during depainting operations and it is probable that the static was entirely produced by the unshielded power supply and pulse forming electronics of the laboratory version of the laser.
