# Helicopter Nighttime Parking Test Results - UH-1

DOT/FAA/CT-TN92/1

1. Report No. DOT/FAA/CT-TN92/1		2. Government Accession No.		3. Recipient's Catalog No.	
4. Title and Subtitle HELICOPTER NIGHTTIME PARKING TEST RESULTS - UH-1H				5. Report Date March 1992

Flight tests were conducted at the FAA Technical Center to measure pilot performance and perception during helicopter parking maneuvers. These tests were initiated as a follow-on to previous parking tests as documented in DOT/FAA/CT-TN88/30, "Heliport Surface Maneuvering Test Results." This work was conducted under nighttime, low ambient lighting conditions, between January 1989 and August 1989.

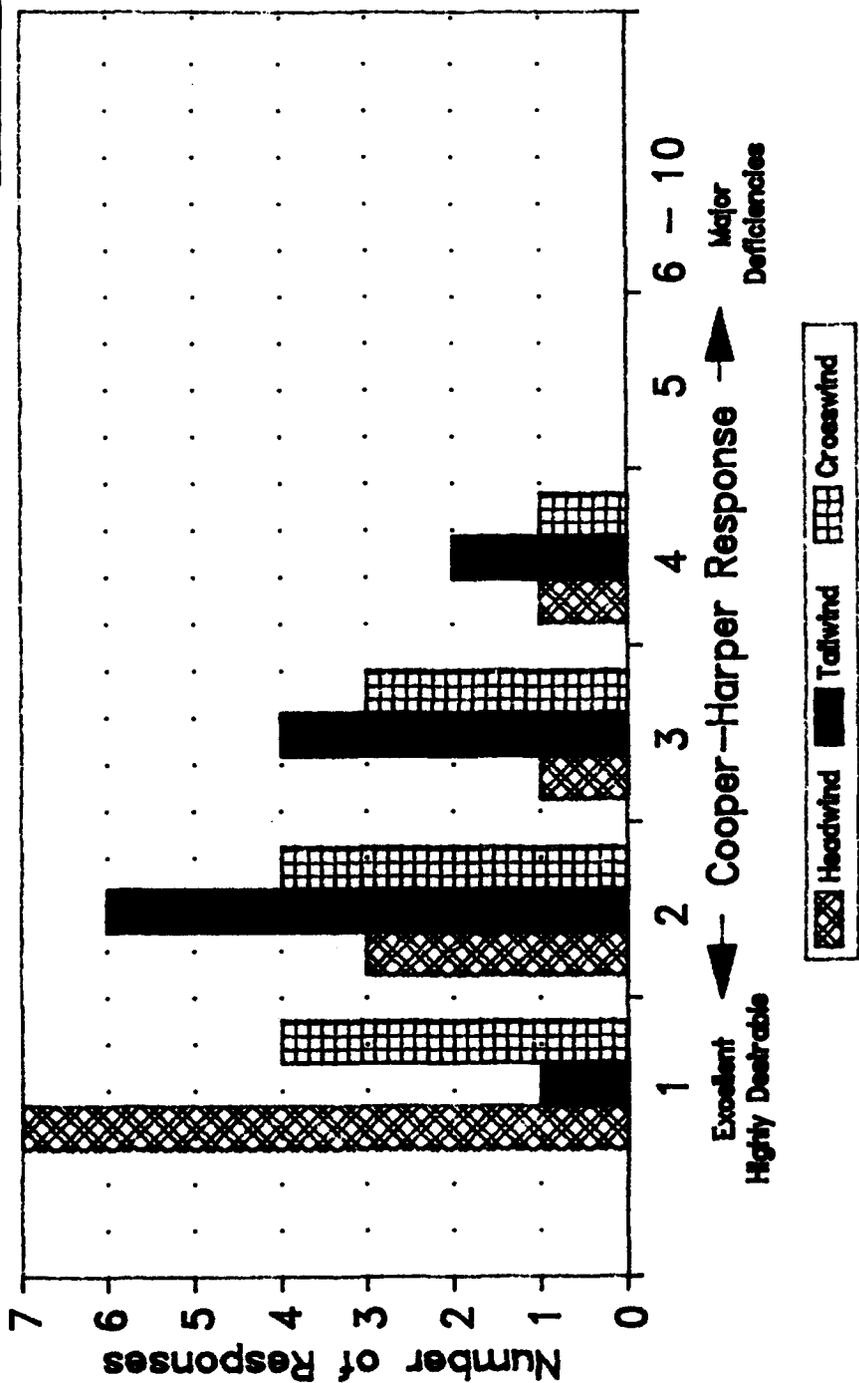
FIGURE 9. COOPER-HARPER RATINGS FOR CONTROL MARGIN: UNLIT OBJECT

Figures 8, 9, and 10 present the results of the Cooper-Harper ratings in graphic form for the control factor. As can be seen, the control margin was rated as unacceptable for routine operations in 13 of 110 responses (4 out of 37 with no
