**DEPARTMENT OF DEFENCE
DEFENCE SCIENCE AND TECHNOLOGY ORGANISATION
AERONAUTICAL RESEARCH LABORATORY**

Research Report 4

**DAMAGE MONITORING IN METALLIC AND COMPOSITE
STRUCTURES USING PIEZOELECTRIC THIN FILM SENSORS**

MAY 1993

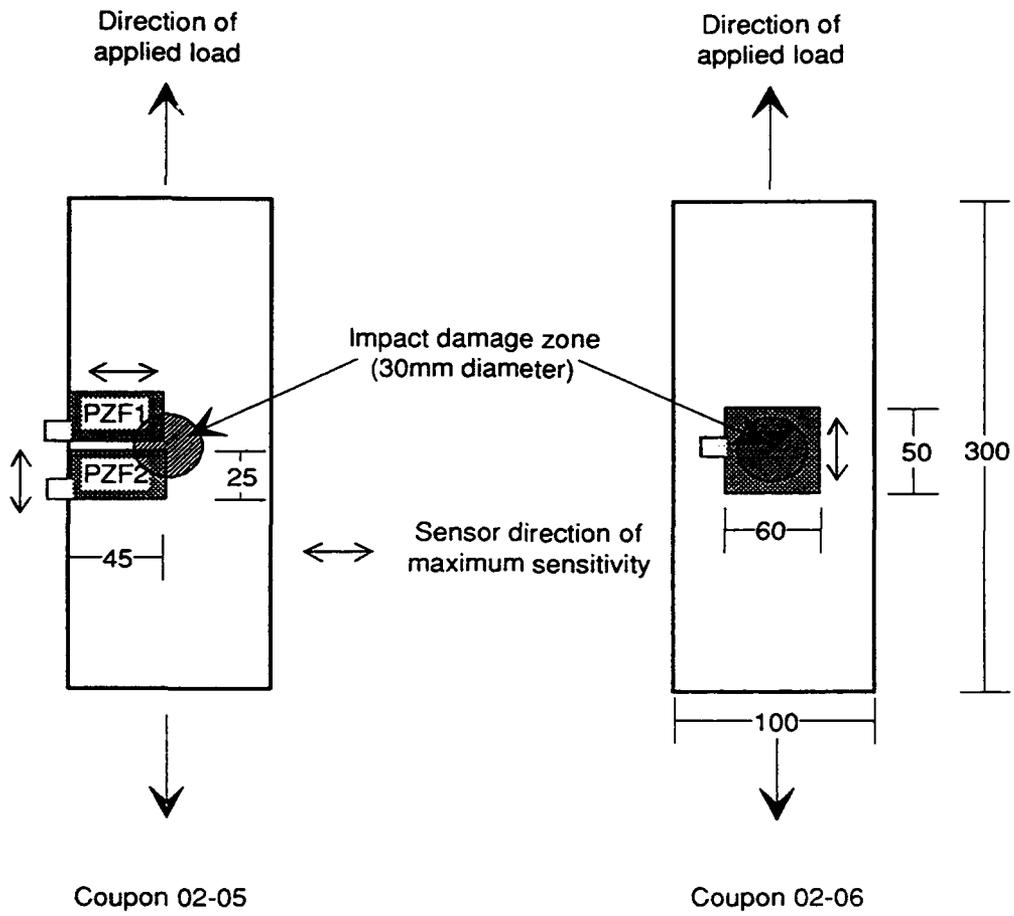
Figure 1: Location and size of the piezoelectric sensors on the non-impact side of an impact damaged composite coupon (all dimensions in mm).

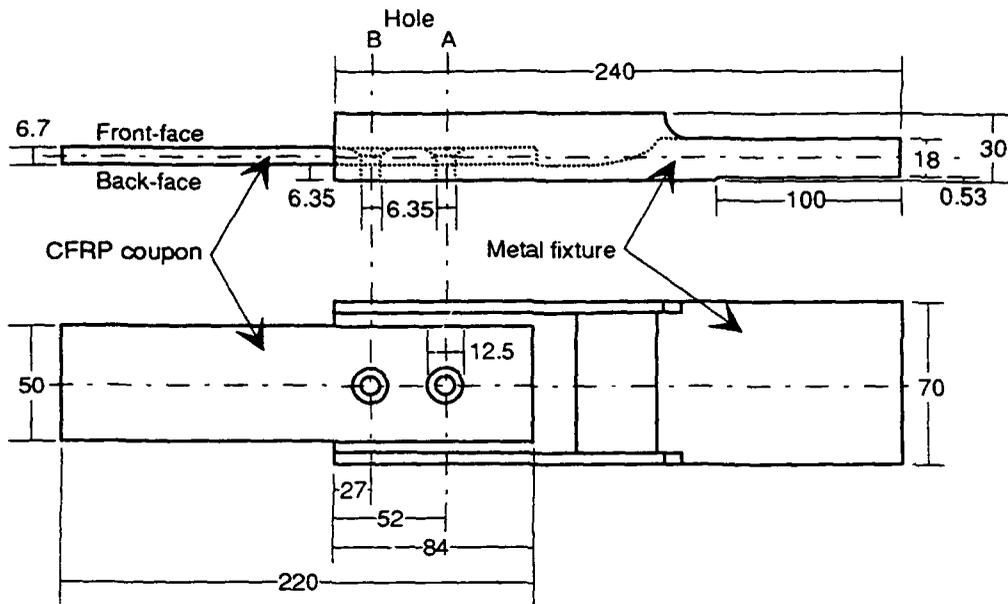
Figure 2: The composite-to-metal specimen configuration for the fatigue testing of mechanical fastened joints (all dimensions in mm).

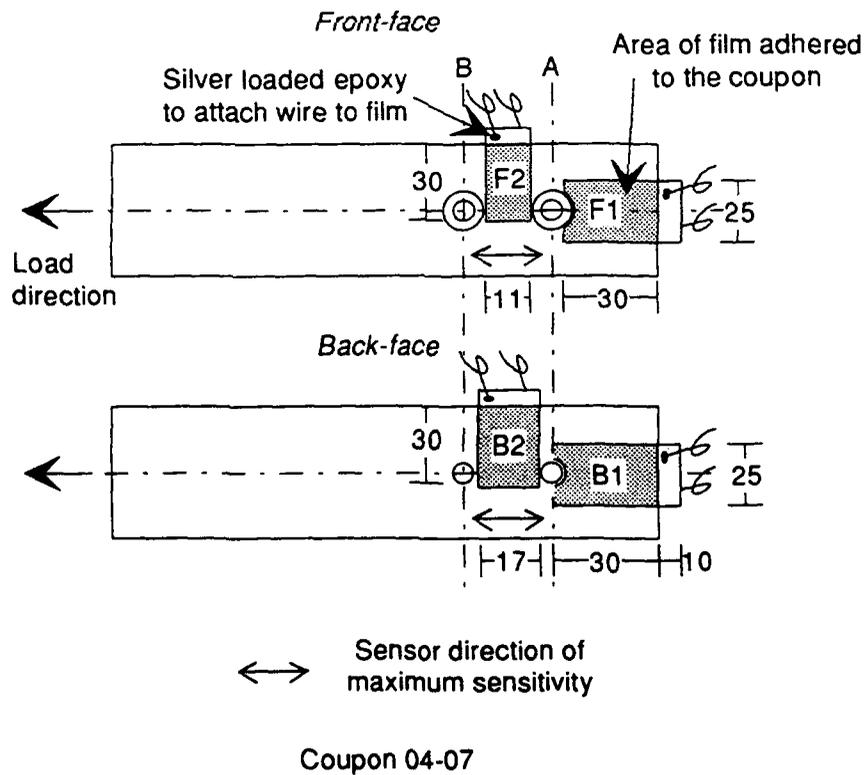
Figure 3: Location and size of piezoelectric sensors on the composite bolted joint coupons (all dimensions in mm).

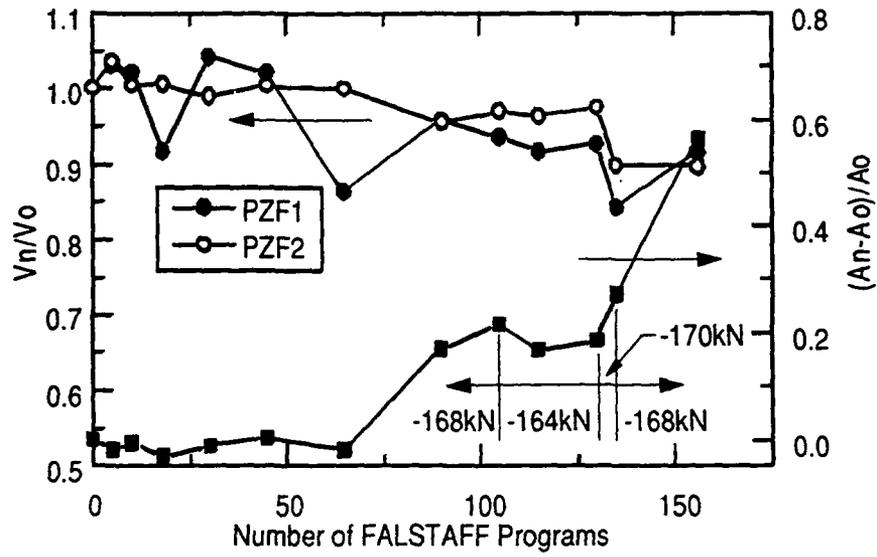
Figure 4: Variation of damage area and piezoelectric sensor outputs (for the load case 0 ± 10 kN) against number of FALSTAFF programs for coupon 02-05.

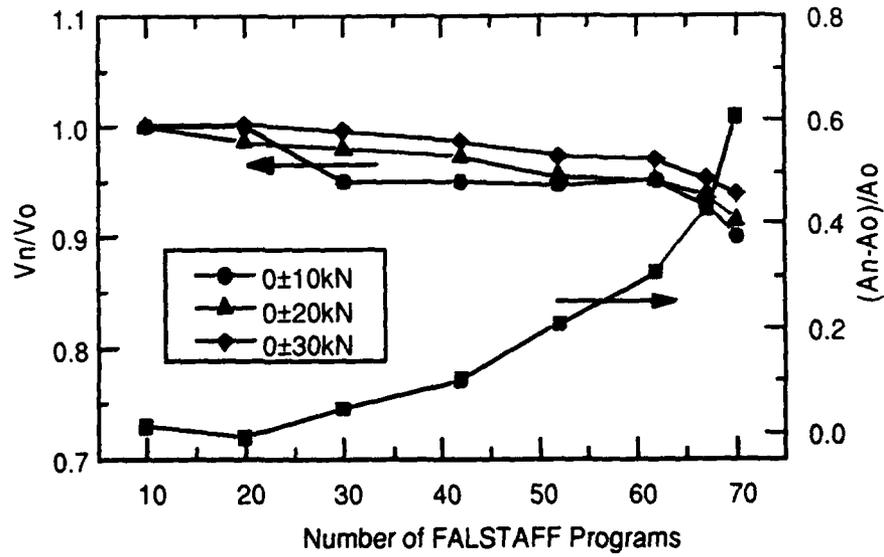
Figure 5: Variation of damage area and piezoelectric sensor outputs against number of FALSTAFF programs for coupon 02-06.

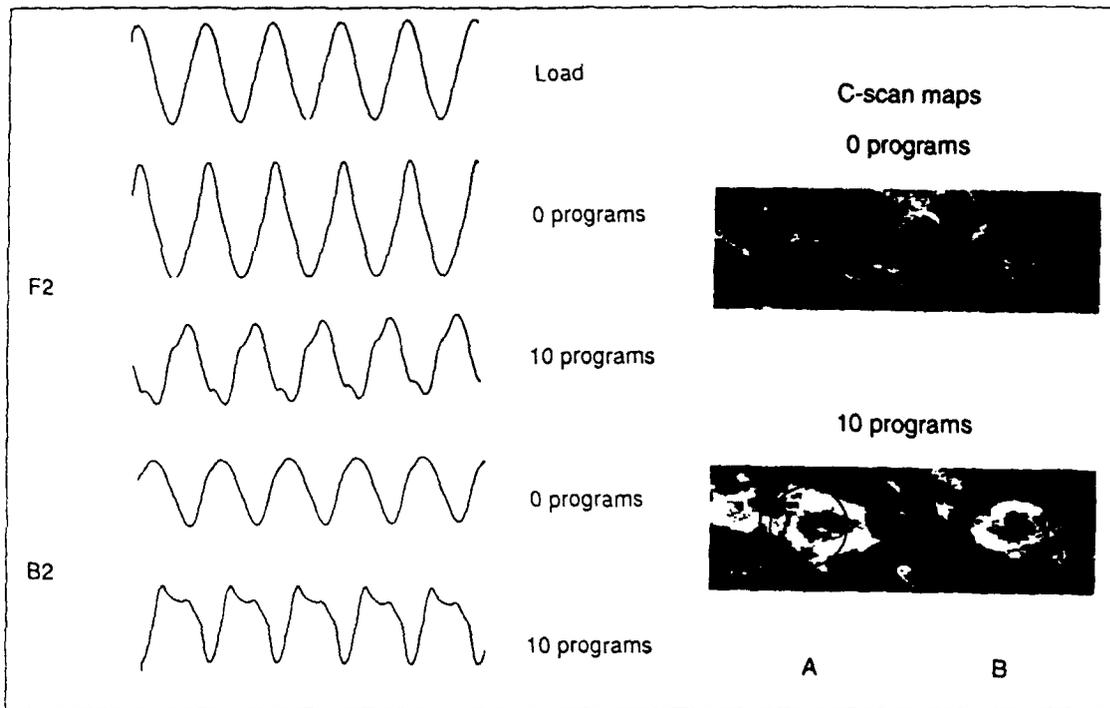
Figure 6: Typical signals from sensors F2 and B2 (0 ± 10 kN) on coupon 04-07 with the corresponding C-scans.

The interpretation of the signals in Figure 6 is complicated. For example, for sensor B2, when a tensile load was applied the main areas of deformation measured were a combination of compressive (bearing) near hole B and tensile in the region between the holes and toward the coupon edge due to loads by-passing hole B. When a compressive load was applied, sensor B2 was subjected to compressive loads by-passing hole B as well as compressive (bearing) loads around hole A. The changes in signals, observed in these figures, with increasing number of applied MACSEQ programs are the result of a number of factors, viz., changes in compliance due to damage, hole elongation causing fastener tilt, variations in fastener clamping forces and changes in load path.

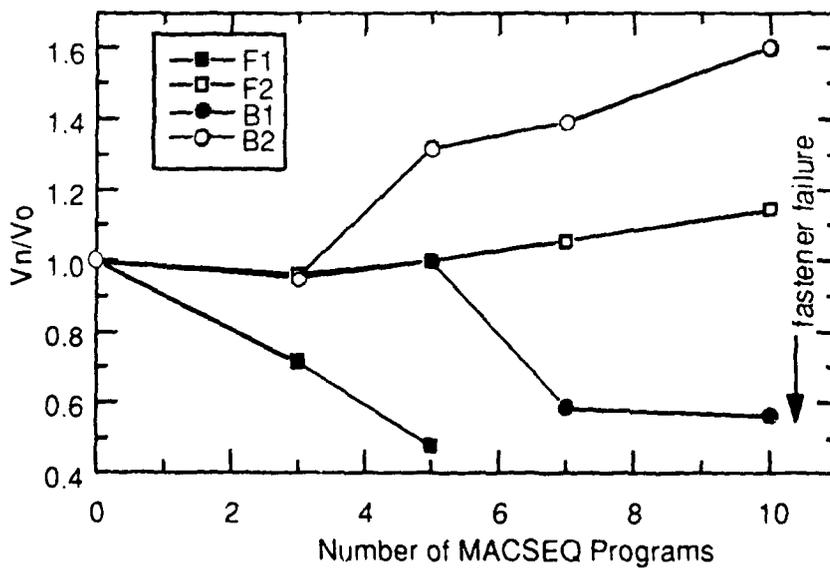
Figure 7: Variation of piezoelectric sensor outputs (for the load case 0 ± 10 kN) against number of MACSEQ programs for coupon 04-07.

Figure 7 shows variations in the normalised piezoelectric sensor voltages, V_n/V_0 taken at the load case 0 ± 10 kN, with increasing number of applied MACSEQ programs for coupon 04-07. Here V_n and V_0 are the peak-to-peak piezoelectric sensor voltages at program n and 0 respectively. The increase in sensor output for B2 and F2, i.e. sensors between holes A and B, is due to changes in by-pass loads and increases in compliance of the composite material between the holes (see Figure 7). Changes of up to 60 and 14% were measured for the two sensors, respectively, before fastener failure occurred. Optical microscopic studies of cross-sectioned composite coupons [9] have shown that the back side of the composite coupon is more likely to suffer damage, due to fastener rocking, hence this side should experience the greater change in signal, as was found in Figure 7 for sensor B2.

In summary, the results for coupon 04-07, shown in Figure 7, indicated that this technology has the potential to measure variations in the by-pass loads.

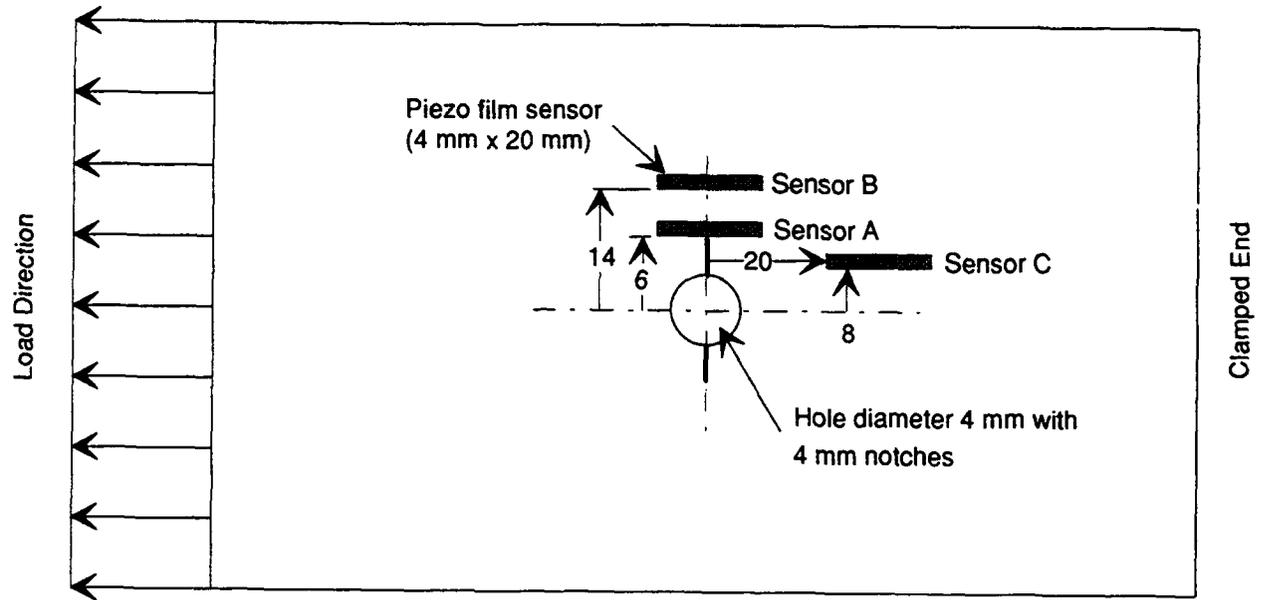
Figure 8: Schematic of the aluminium specimen (dimensions in mm)

The specimen used, shown in Figure 8, was an aluminium alloy (US alloy 2214) centre-cracked-tension specimen subjected to constant amplitude, cyclic loading. The specimen was 12.5 mm thick. A mean load of 40 kN with a constant cyclic amplitude of 20 kN, at frequency of 5 Hz, was applied. The crack growth resulting from this cyclic loading was measured periodically with a travelling vernier microscope.

A number of NiCr sputtered 28 μm thick piezoelectric sensors, of dimension is 4 x 20 mm, were located on the specimen as shown in Figure 8. An epoxy adhesive was used to adhere the sensors to the aluminium specimen. The signal from sensor C (see Figure 8), which is located away from the "damage" area, is used as a reference signal and is known as the "far-field" signal. The "near-field" signals are obtained from sensors A and B. Since piezoelectric sensors are dynamic devices, the sensor readings were obtained under cyclic loading at a frequency of 5 Hz. The sensor output was conditioned using a charge amplifier and the peak-to-peak voltage readings were measured using a digital storage oscilloscope. After a predetermined number of loading cycles the crack length and peak-to-peak sensor voltages were measured. In this report, the crack length is the distance from the edge of the hole to the crack tip.

where V_A , V_B and V_C are the signals obtained from piezoelectric sensors A, B and C, respectively, as shown in Figure 8.

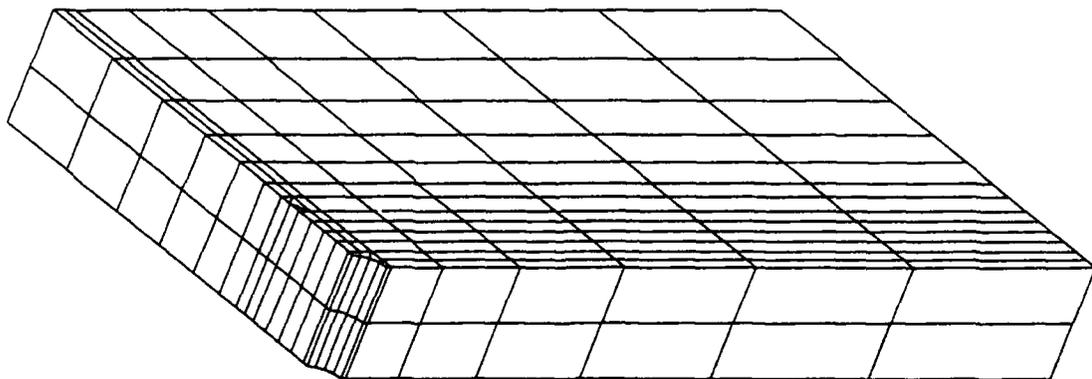
Figure 9: Finite element mesh for the aluminium specimen

To support the experimental results, the change in the piezoelectric sensor reading with crack growth was predicted numerically using Finite Element Analysis. Due to symmetry, only a quarter of the specimen was modelled using 15 and 20 noded isoparametric brick elements, as illustrated in Figure 9. The end loads and constraints used were similar to those applied in the experiment. The output from the piezoelectric sensor is related to the surface strains as shown below.

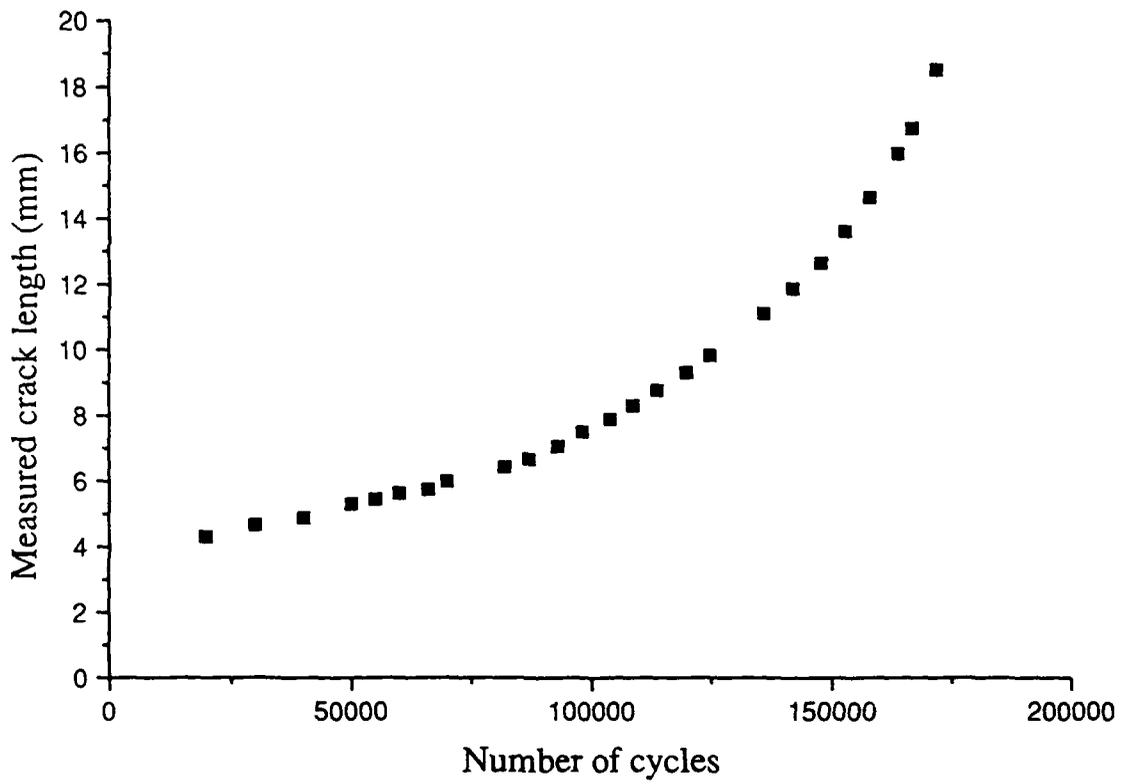
Figure 10: Measured crack growth versus number of applied cycles

Figure 10 shows the crack growth measured in the specimen with increasing number of applied cycles. The variation of the piezoelectric sensor outputs with increasing crack length are shown in Figure 11. Note that the sensor signal undergoes a change in its gradient when the crack propagates under the sensor, as shown in curve (B) of Figure 11. This is due to the changes in stress states in the piezoelectric sensor as will be discussed below.

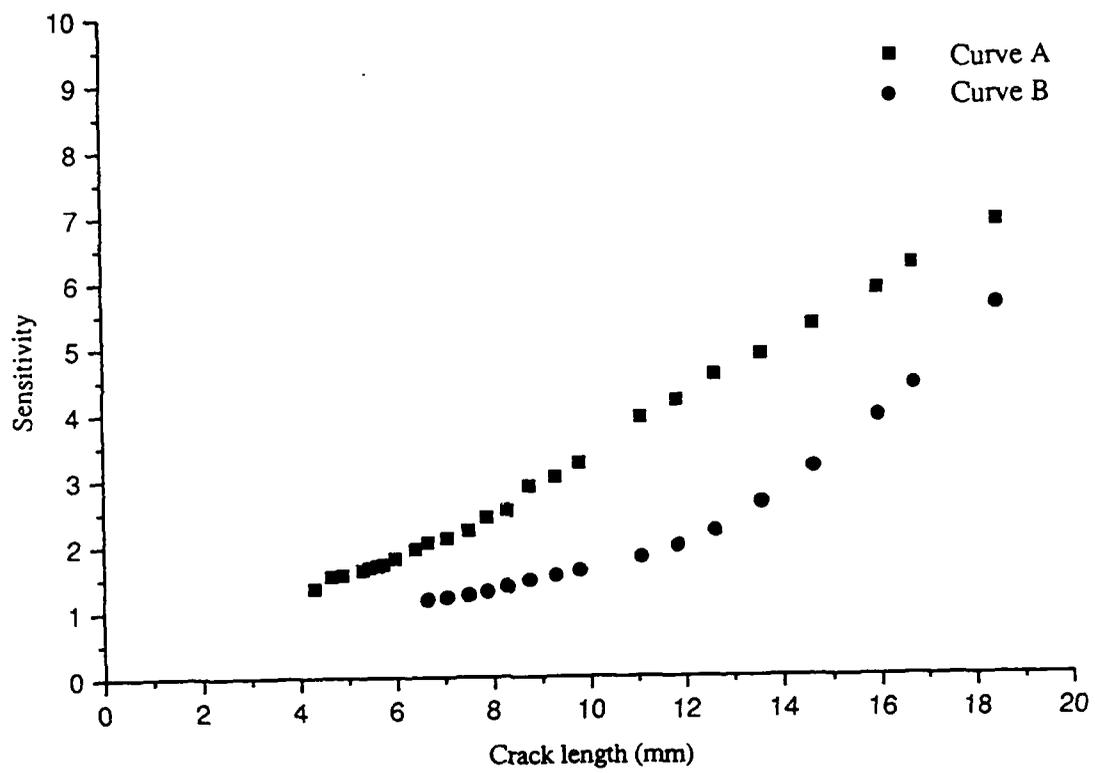
Figure 11: Piezo electric sensor output versus measured crack length.
 Curve A - V_A/V_C ; Curve B - V_B/V_C

Figures 12(a) and (b) show the comparison between the predicted signal and the measured signal with increasing crack length. The agreement between the two results confirms the ability of a piezoelectric sensor to monitor the crack growth. The change in gradient observed in curve (B) of Figure 11 is attributed to the change in the stress state in the piezoelectric sensor when the crack propagates under the sensor.

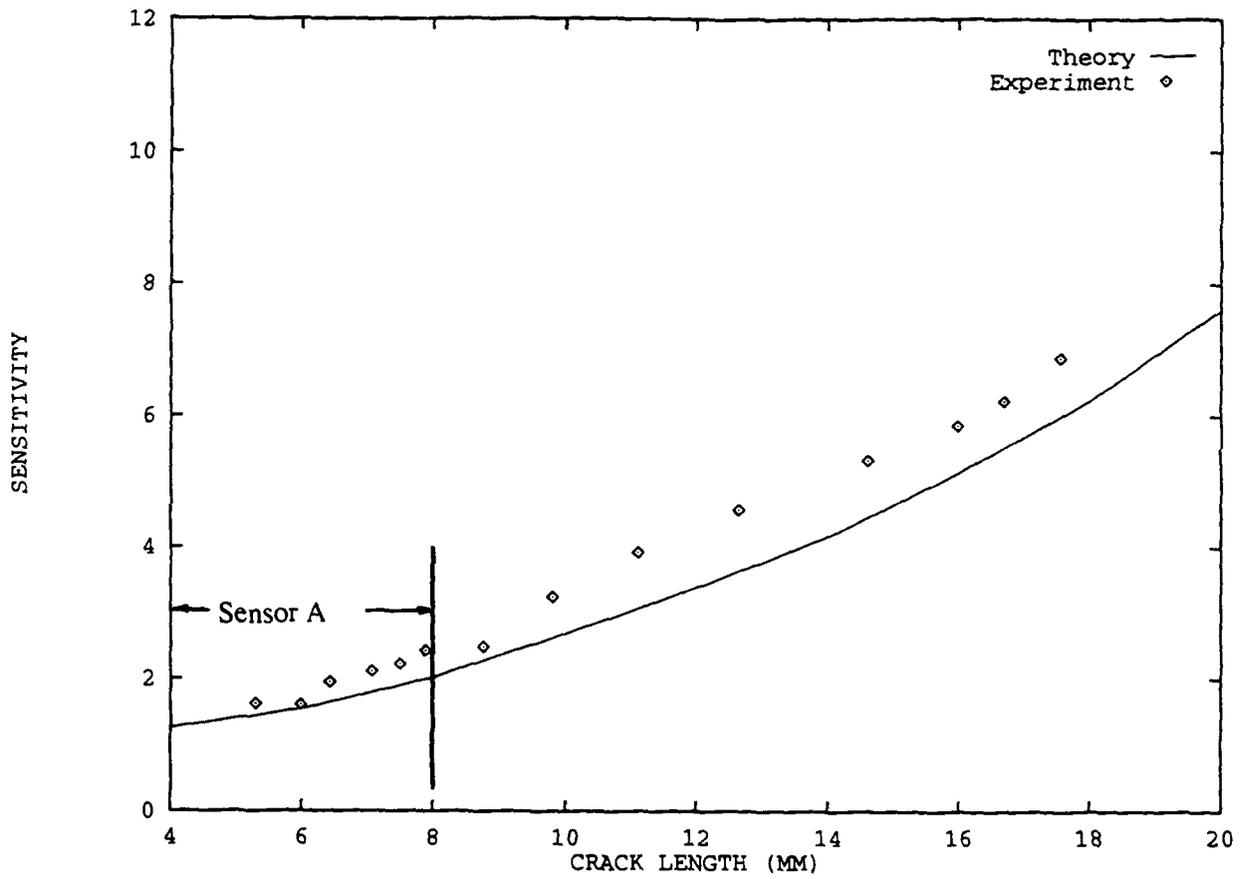
Figure 12: Comparison between the predicted sensor output and the measured signals with increasing crack length. (a) V_A/V_C ; (b) V_B/V_C

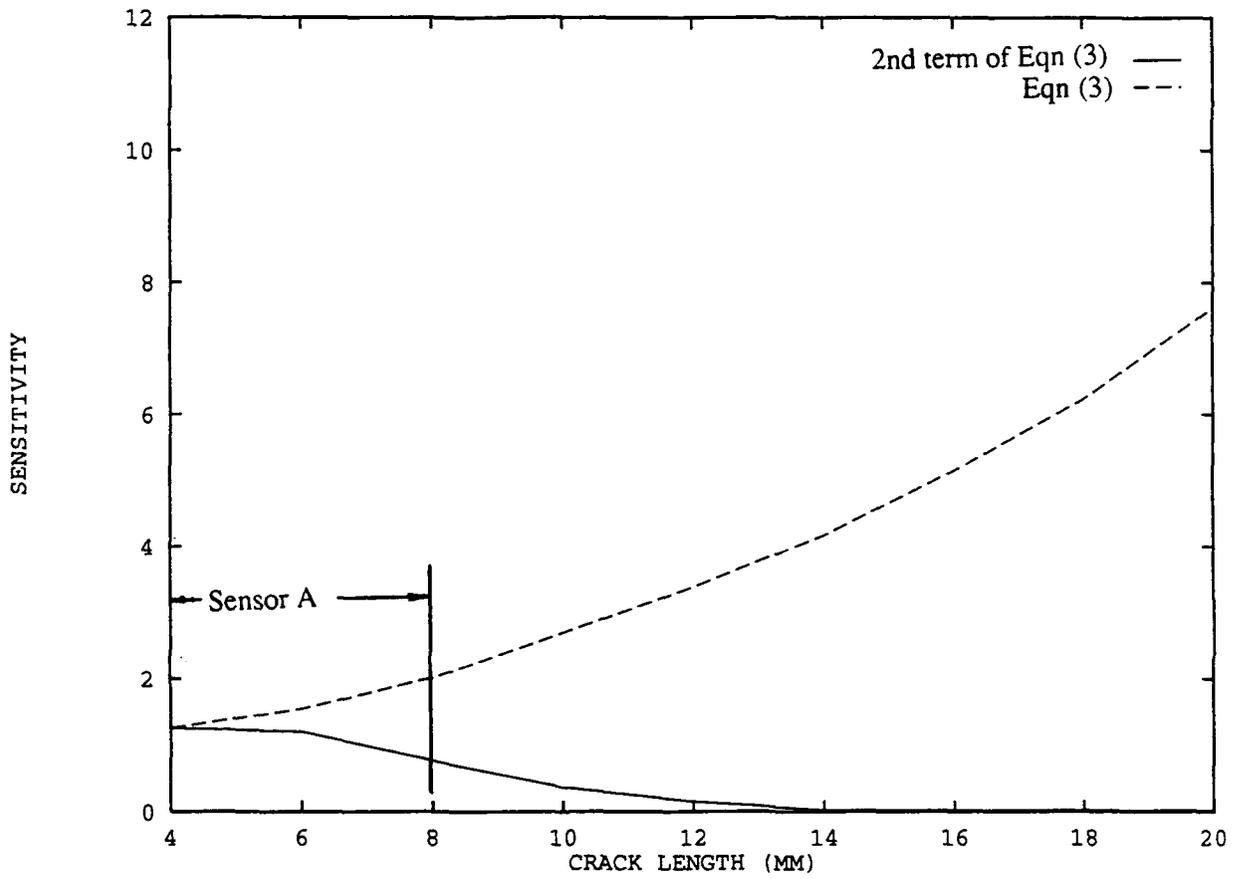
Figure 13: Contribution from the various components in Equation (3).
 (a) V_A/V_C (b) V_B/V_C

Figure 13 shows the contribution of the two components described in equation (3) to the total piezoelectric sensor signal. This figure also reveals that when the crack propagates past the sensor the first term of equation (3) dominates. In this case, the rest of the sensor is located in a region of decreasing load. The piezoelectric sensor is therefore seen to be capable of detecting the change in the stress field due to the presence of a crack, even though the crack tip may be distant from the sensor. The slope of the sensitivity curve changes when the crack propagates past the sensor. The total sensor output in the latter case is an indication of the crack opening displacement.
